## **State of Conservation Report**

**Birthplace of Jesus**

**Church of the Nativity and the Pilgrimage Route, Bethlehem**

February 2015

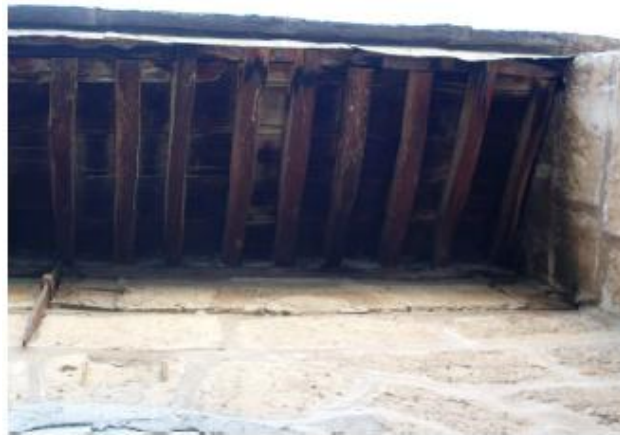
The inspection started from the windows of the high level. In each longitudinal wall there are ten windows, numbered in this report from west to east. The overhang of the wooden roof protects the semi-circular windows in the walls of the central nave and the transepts. The wooden elements of the overhang showed attacks by insects and fungi (Figure 8).

Figure 8: overhang of north transept

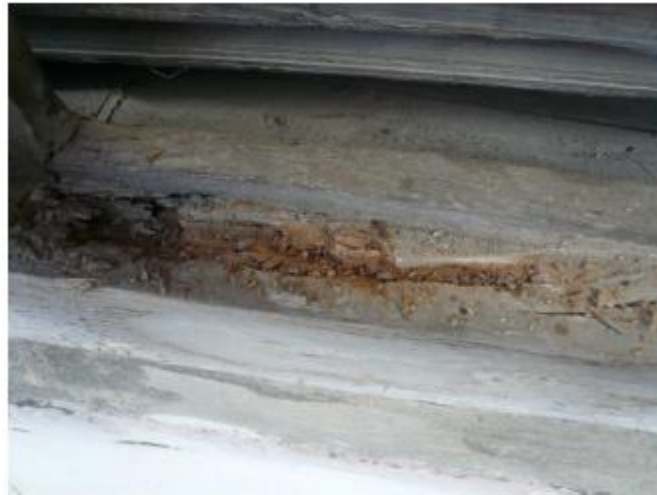
Many windows have decay mainly due to the weathering and fungi (Figure 10). One of them has a bullet hole whereas some others have some glass pieces missing.

Figure 10: window 9 south wall, fungal decay in the bottom

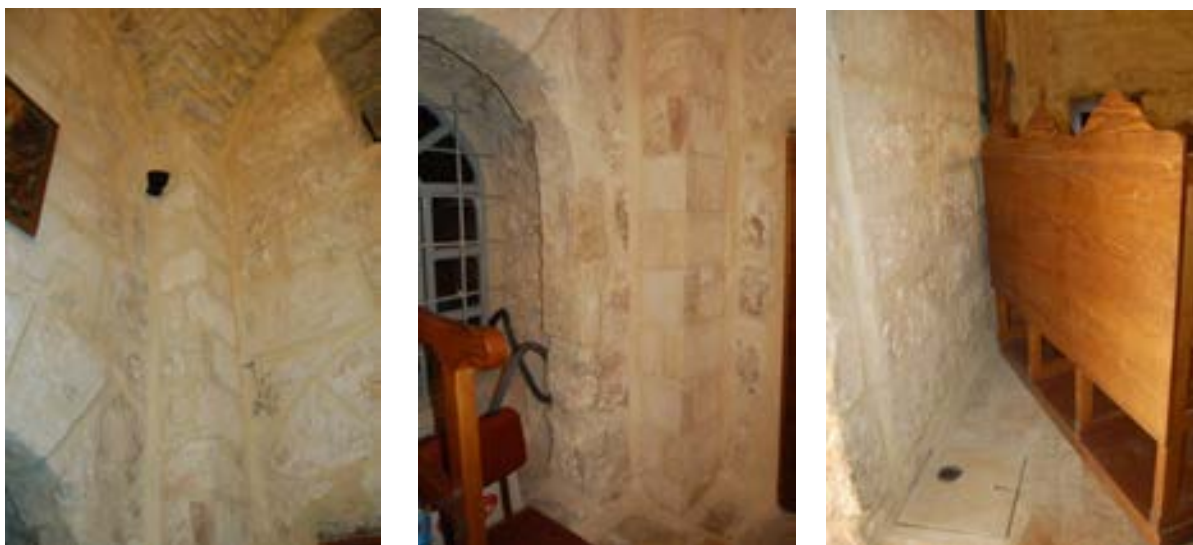
Figure 19: Drainpipe hidden in the masonry in the Orthodox corner (2B)

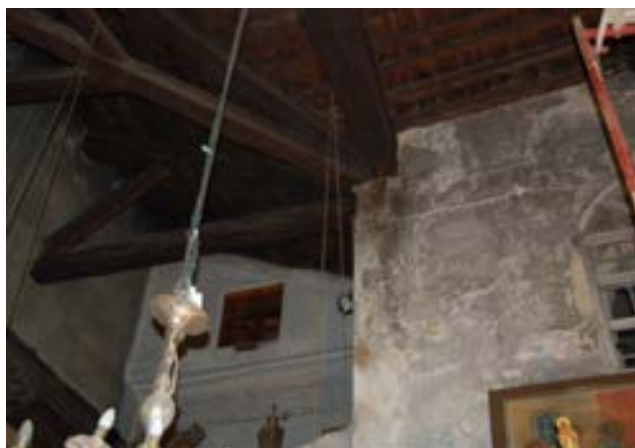
Figure 20: Damage due to the rain leakage in the Orthodox corner (2B)

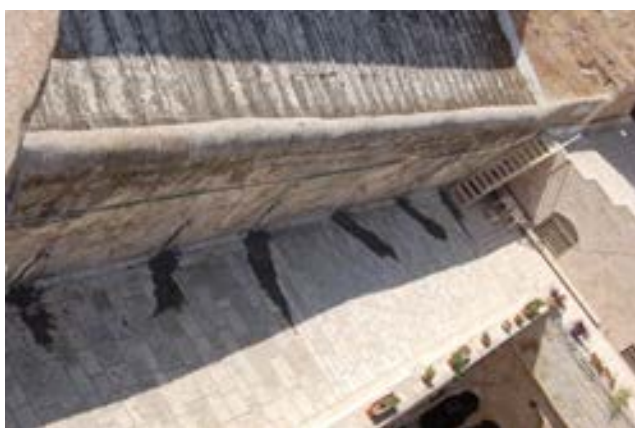
Figure 21: Franciscan side 3A

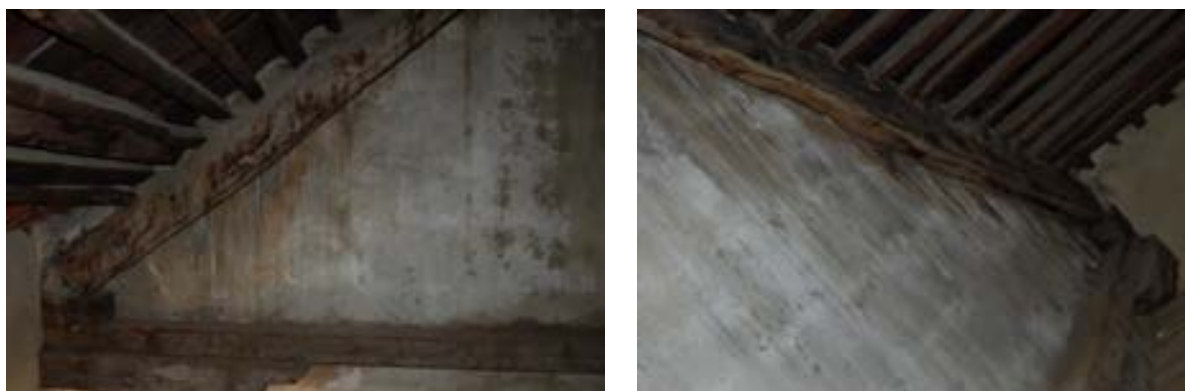
Finally special attention must be paid to the roof area nearby the tympanum close the main entrance. The problem is similar to what occurs to the areas 3A and 3B and the leakage is evident from inside as depicted in Figure 24.

Figure 24: Rainwater leakage signs inside the central nave on the tympanum nearby the main entrance

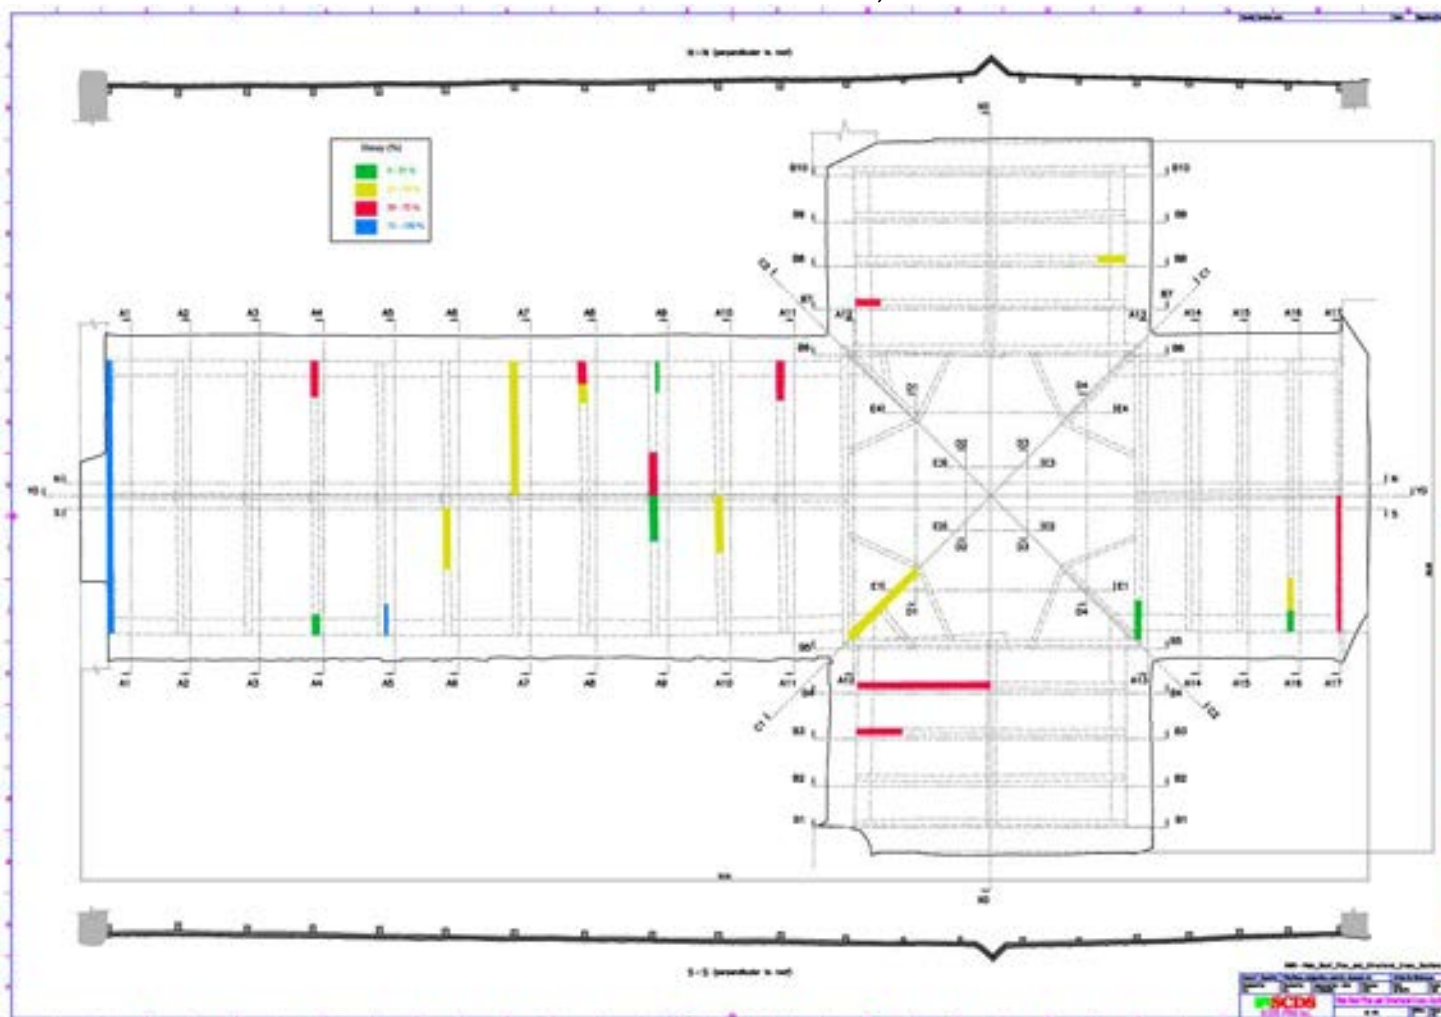
# BIOLOGICAL DAMAGE ON NAVE, TRANSEPT AND APSE

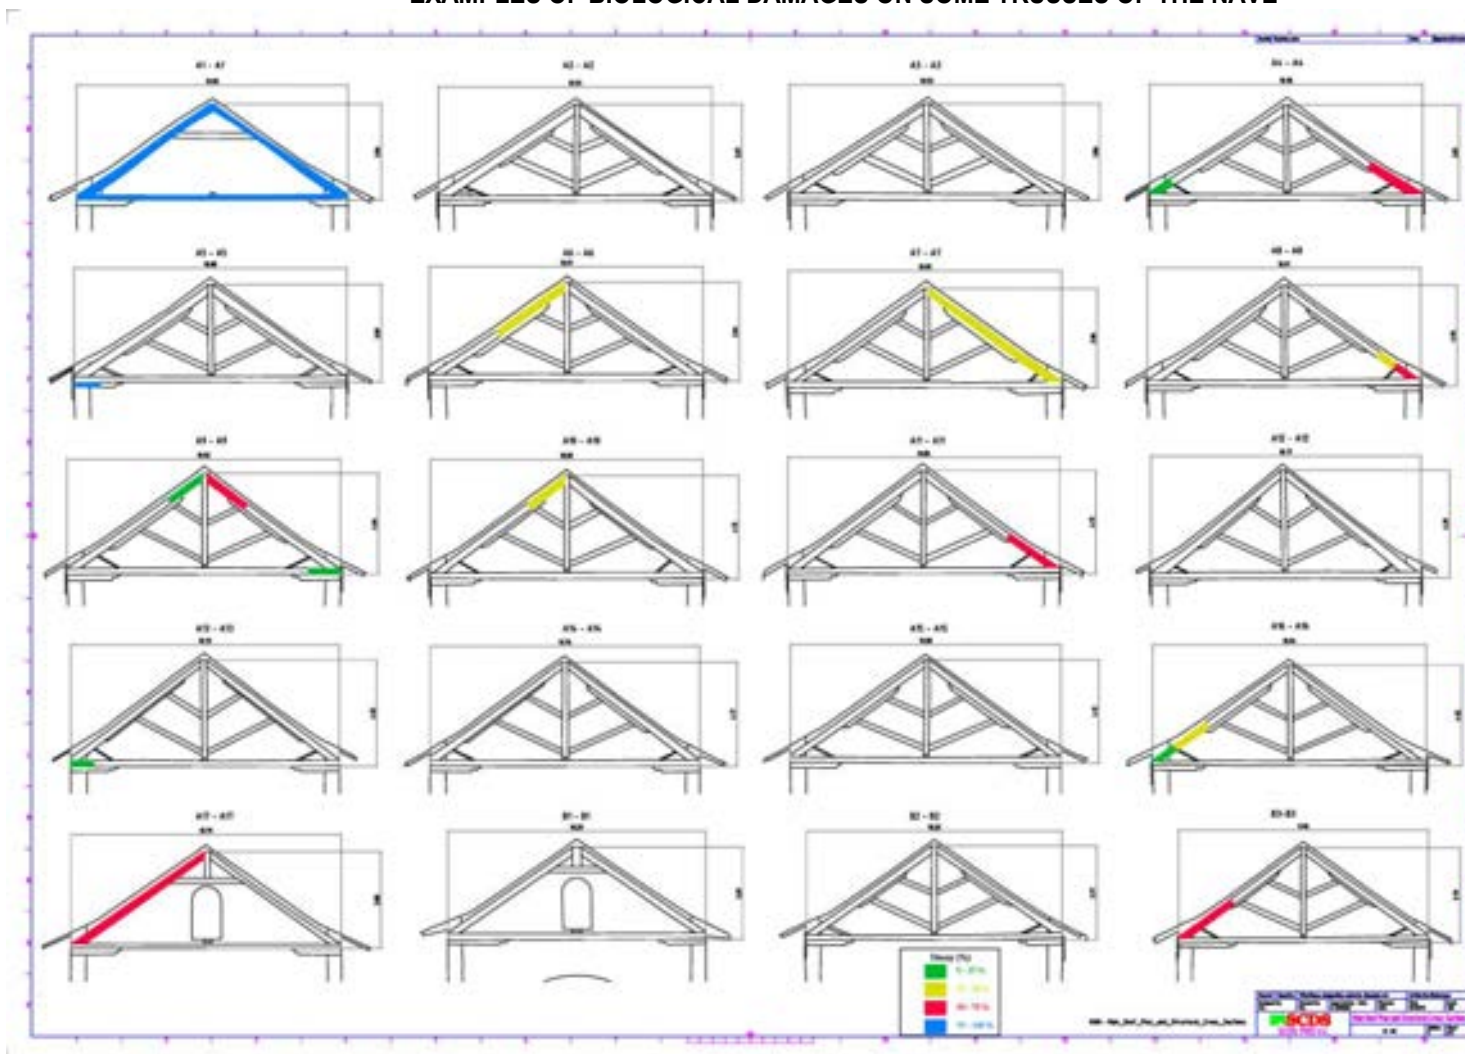
### EXAMPLES OF BIOLOGICAL DAMAGES ON SOME TRUSSES OF THE NAVE

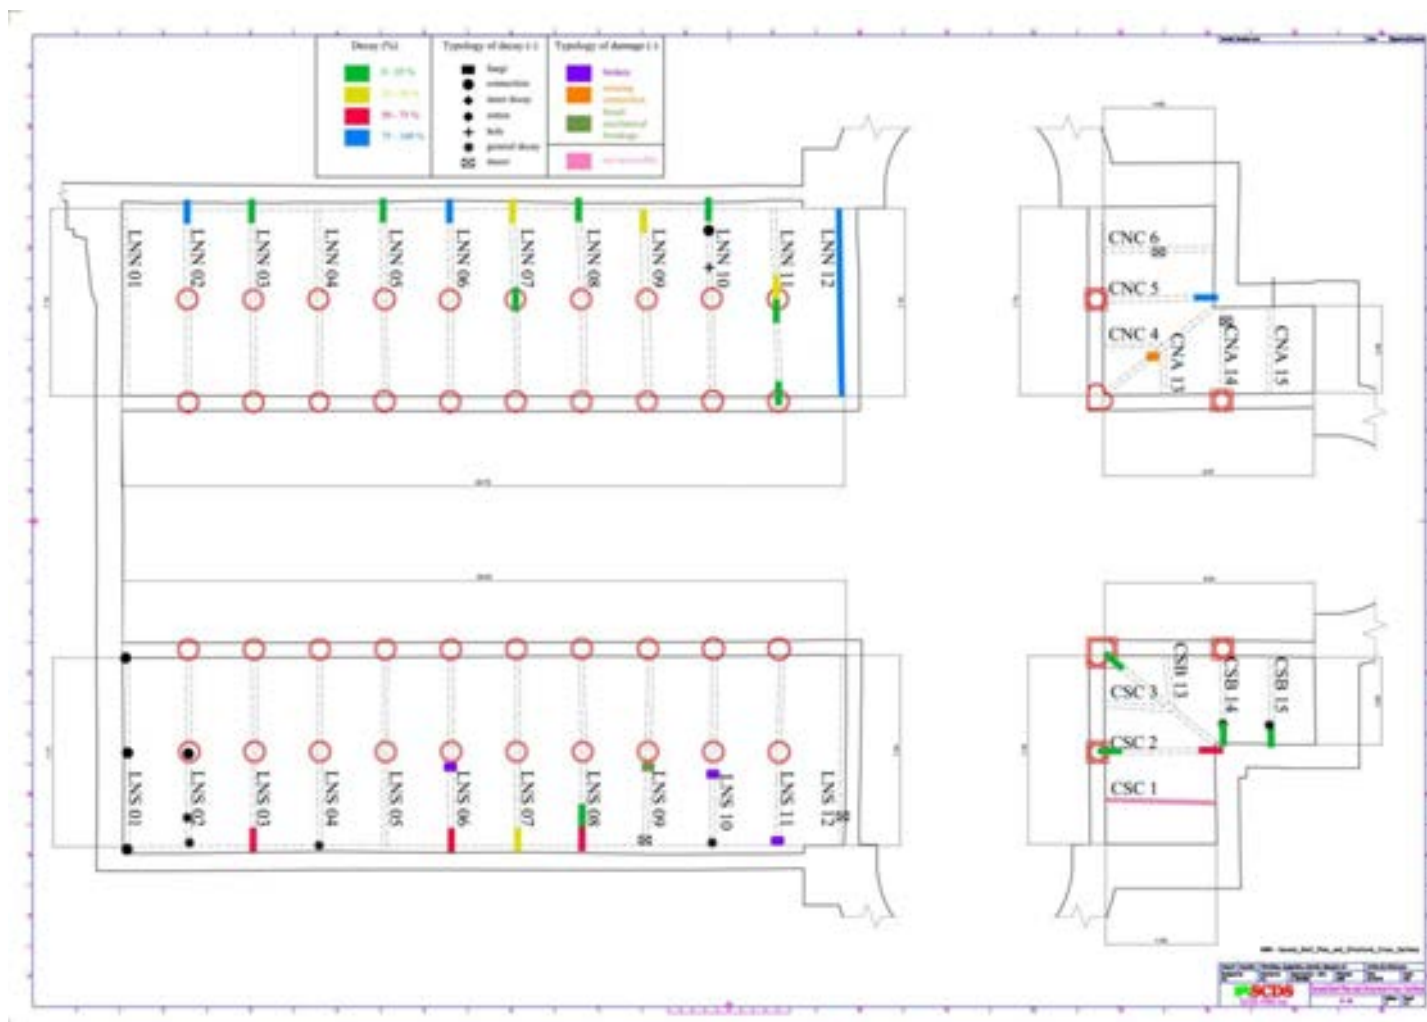
### BIOLOGICAL DAMAGE ON AISLES AND CORNERS

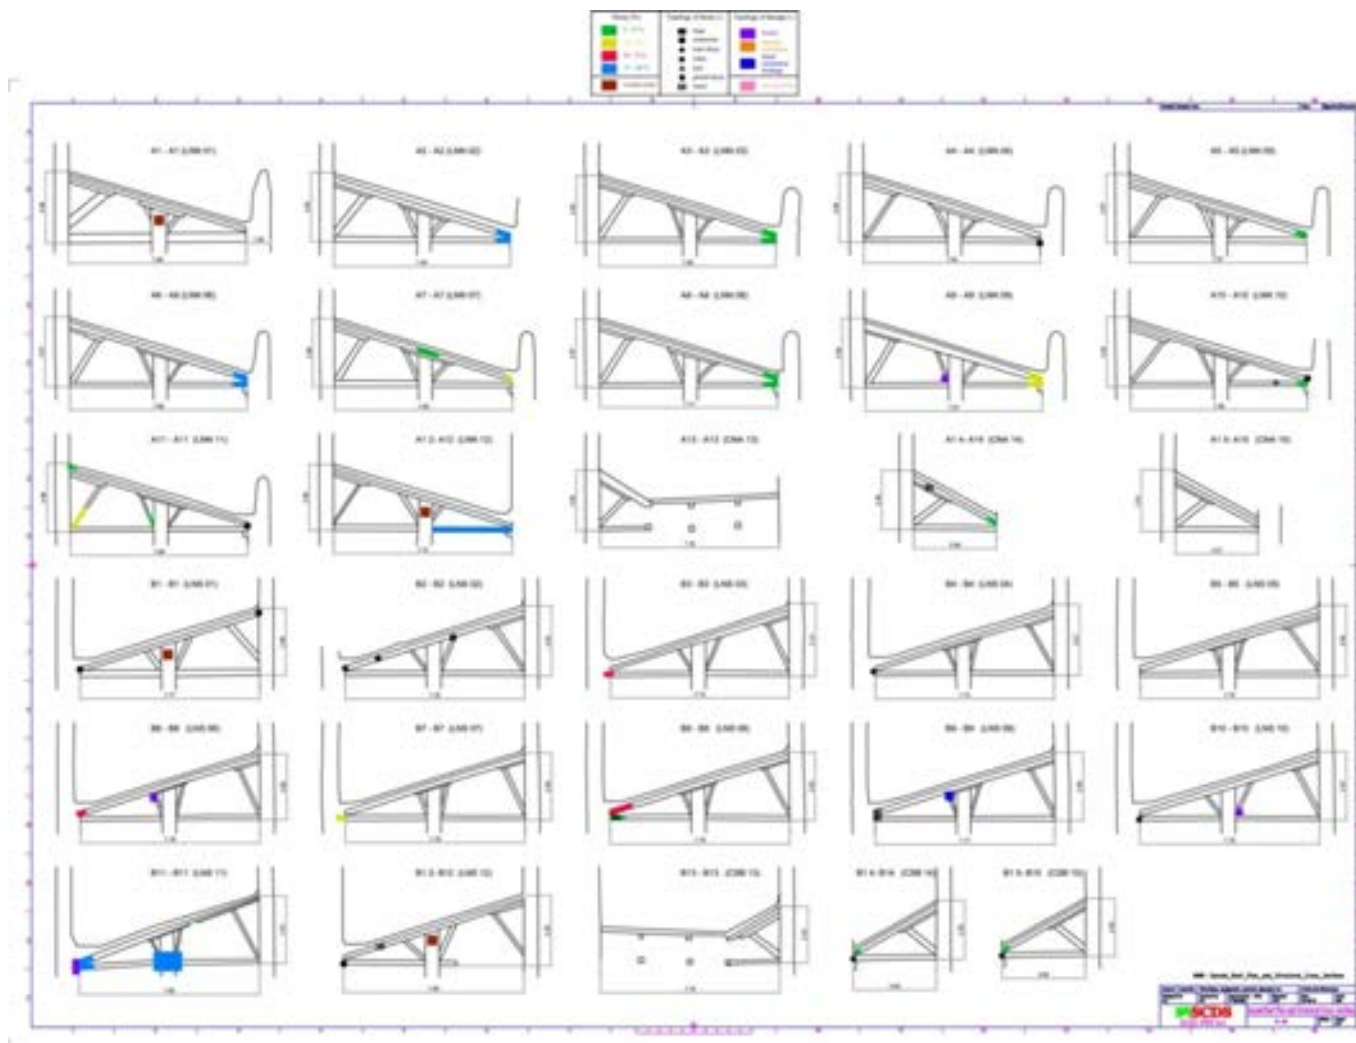
### EXAMPLES OF BIOLOGICAL DAMAGE ON SOME TRUSSES OF THE AISLES

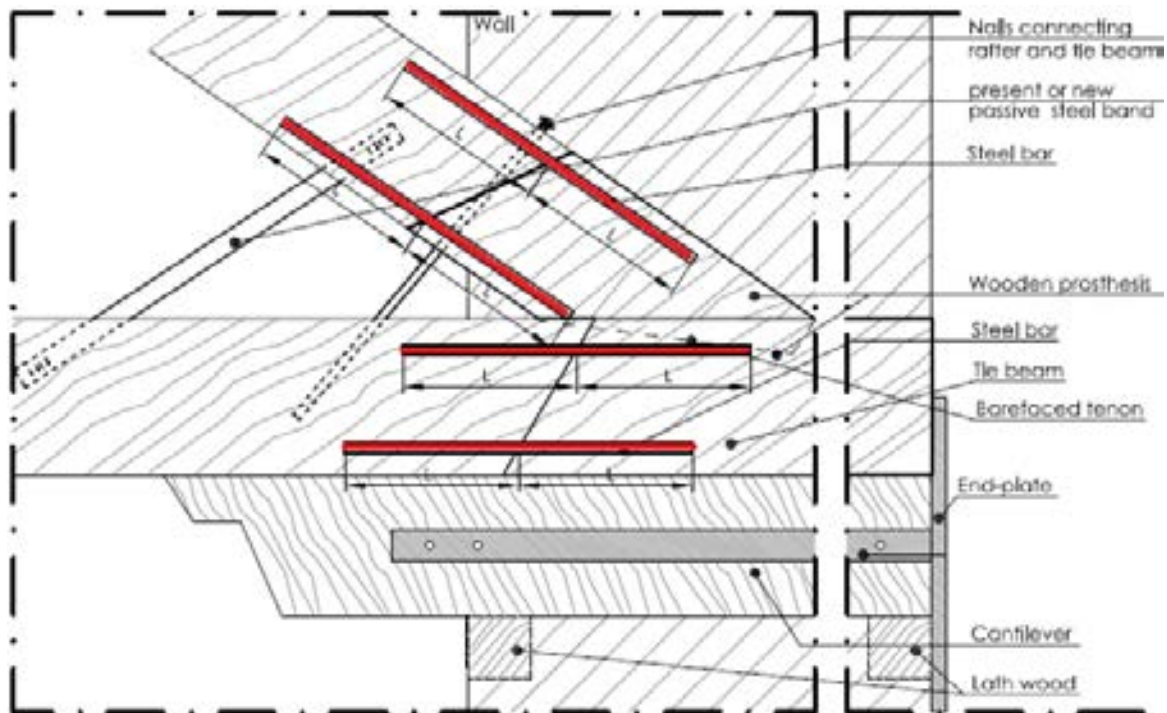
Figure 72: example of prosthesis in a node rafter-tie beam

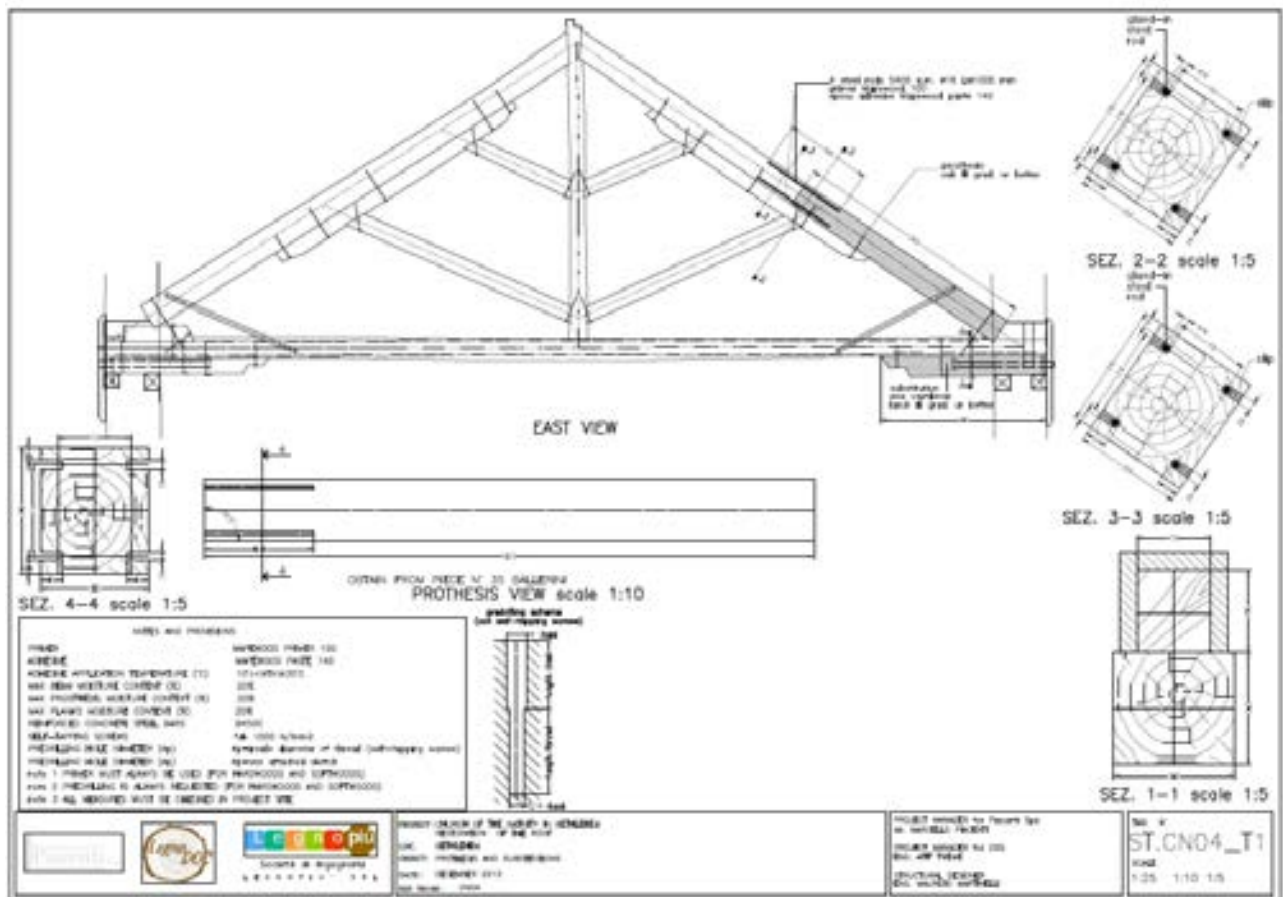
Figure 75: design of intervention of consolidation by prosthesis (in the rafter) and replacement (in the cantilever)

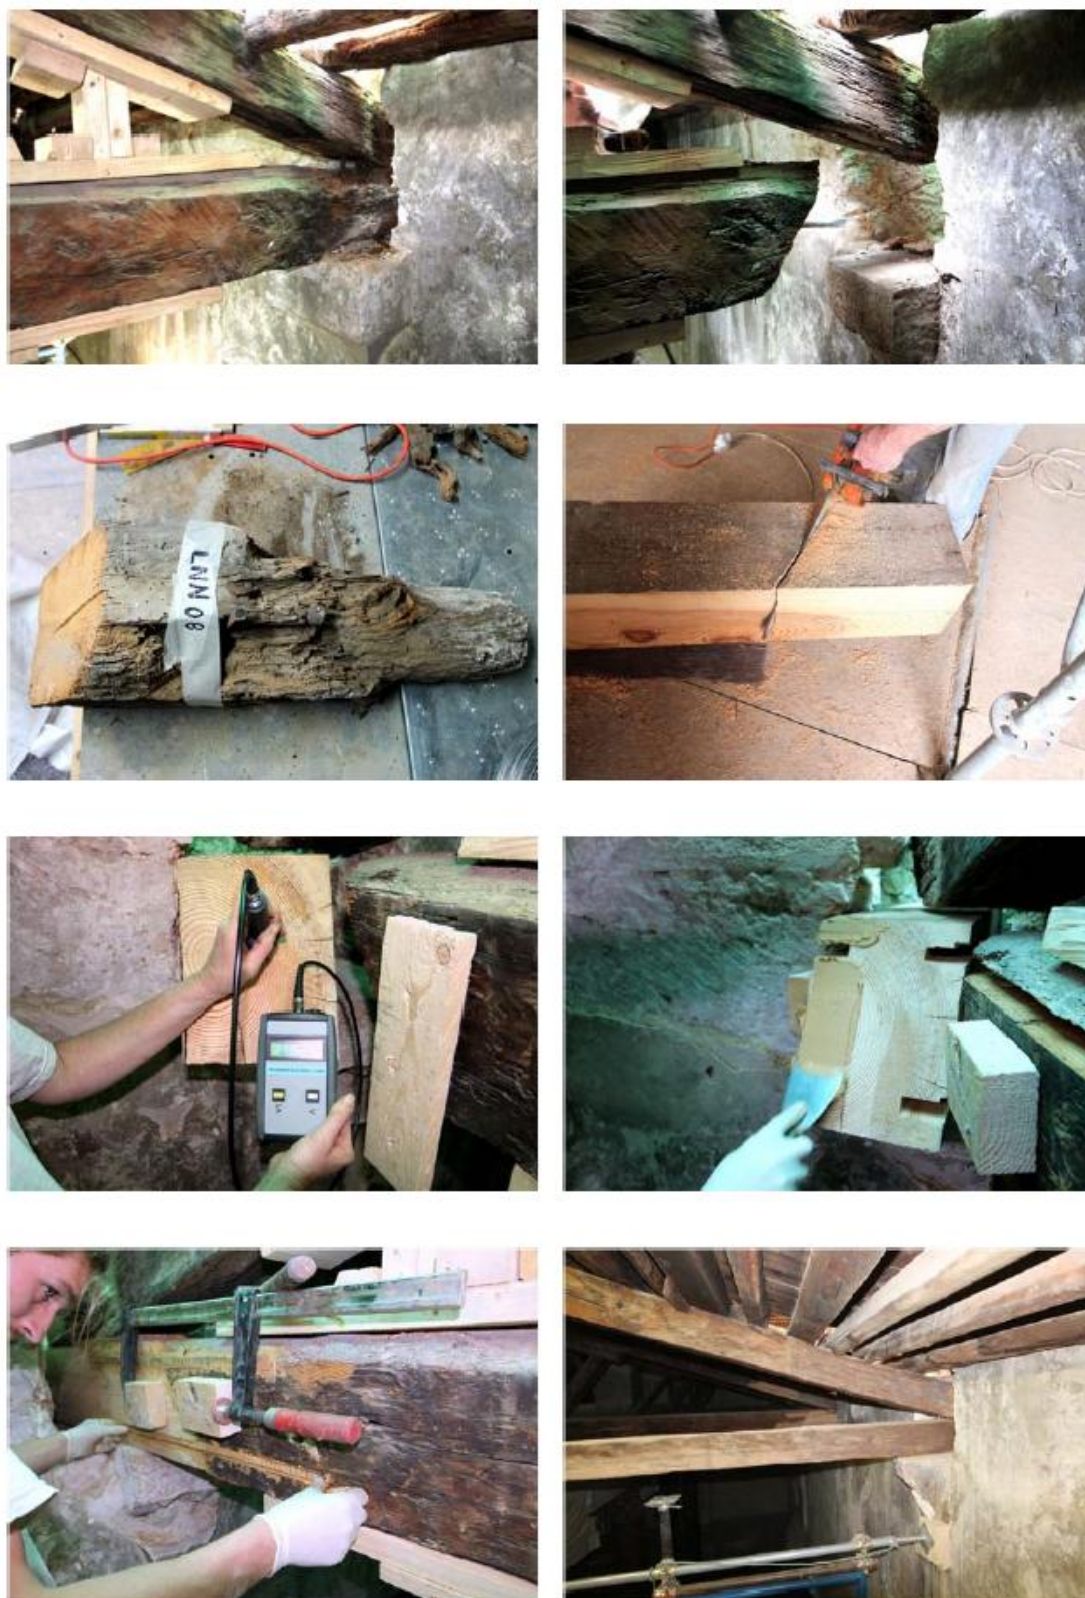
Figure 77 shows all steps for an intervention of restoration by prosthesis ( in this case on LNN08, a truss of the North aisle). Figure 78, Figure 79 show in detail the grooves to host the steel bars and the intervention by prosthesis already completed.

Figure 77 : (from the top – from left to right): damaged tie-beam end, removal of the damage part, damaged part catalogued, cutting of the new part, check of the moisture content, application of epoxy resin on the section of the beam, insertion of bars and resins in the grooves, tie-beam end after the intervention

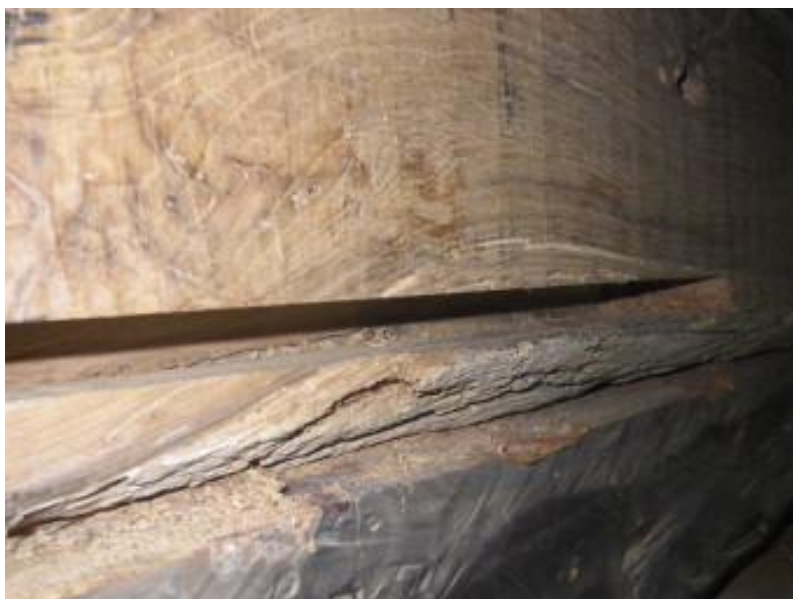
Figure 78: groove to host the steel bars and resin

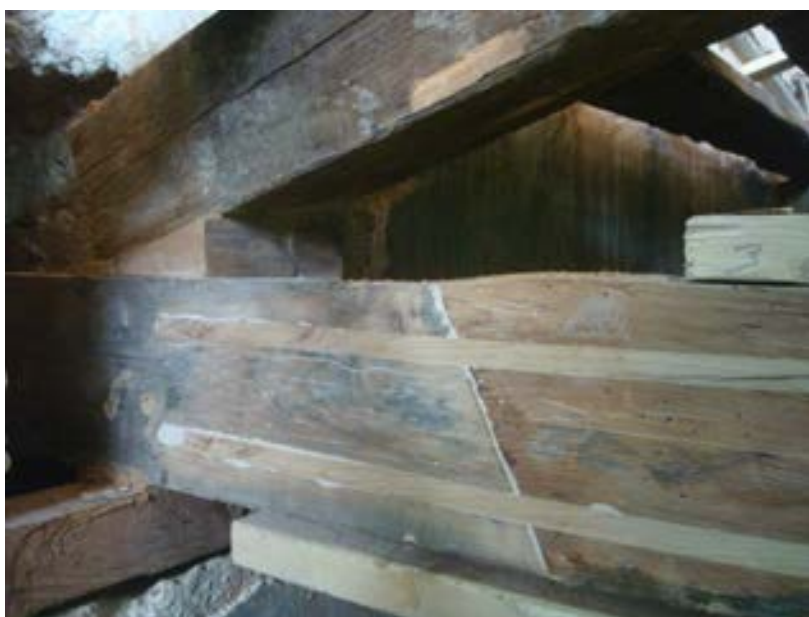
Figure 79: prosthesis already finished

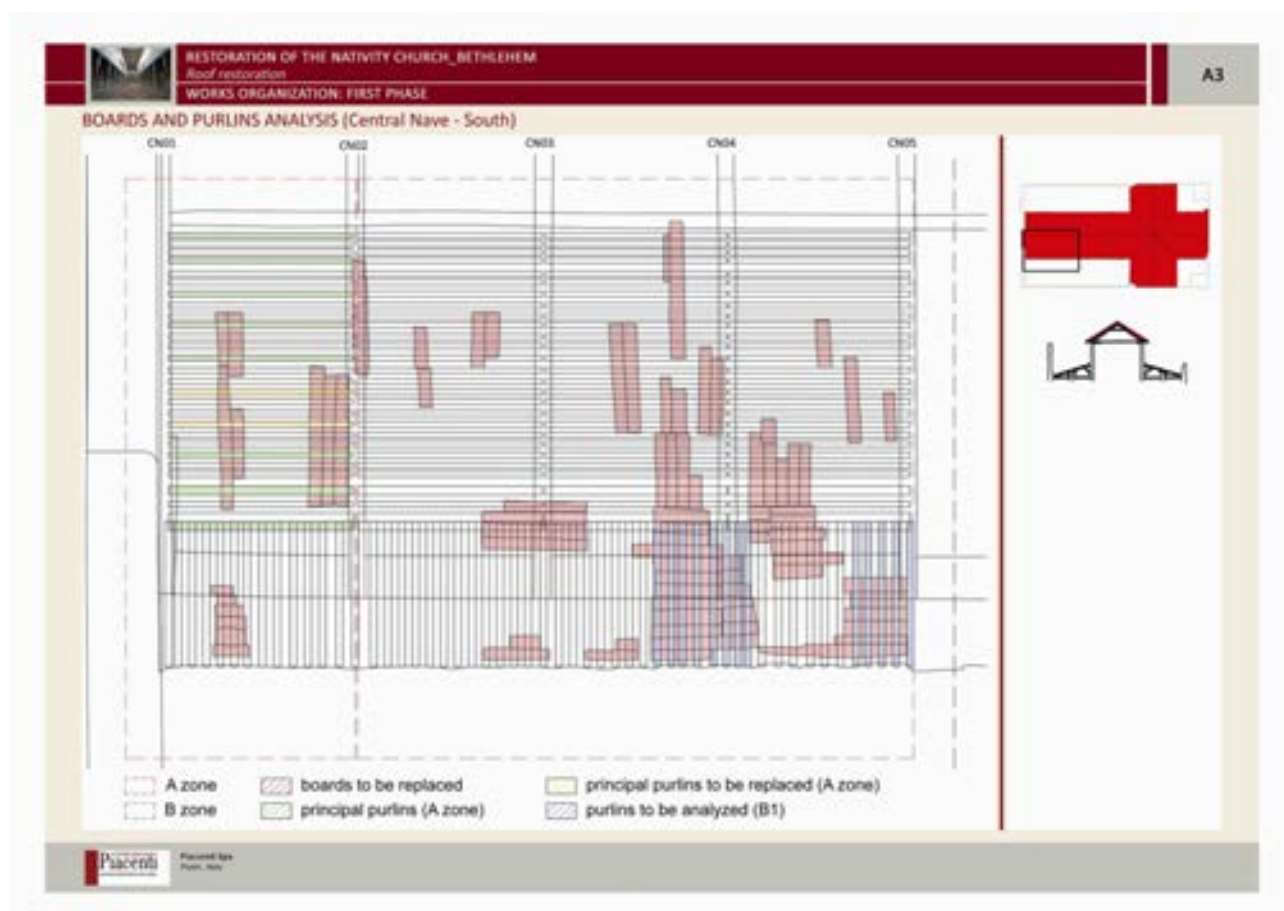
Figure 81: detailed map of purlins and boards to be replaced

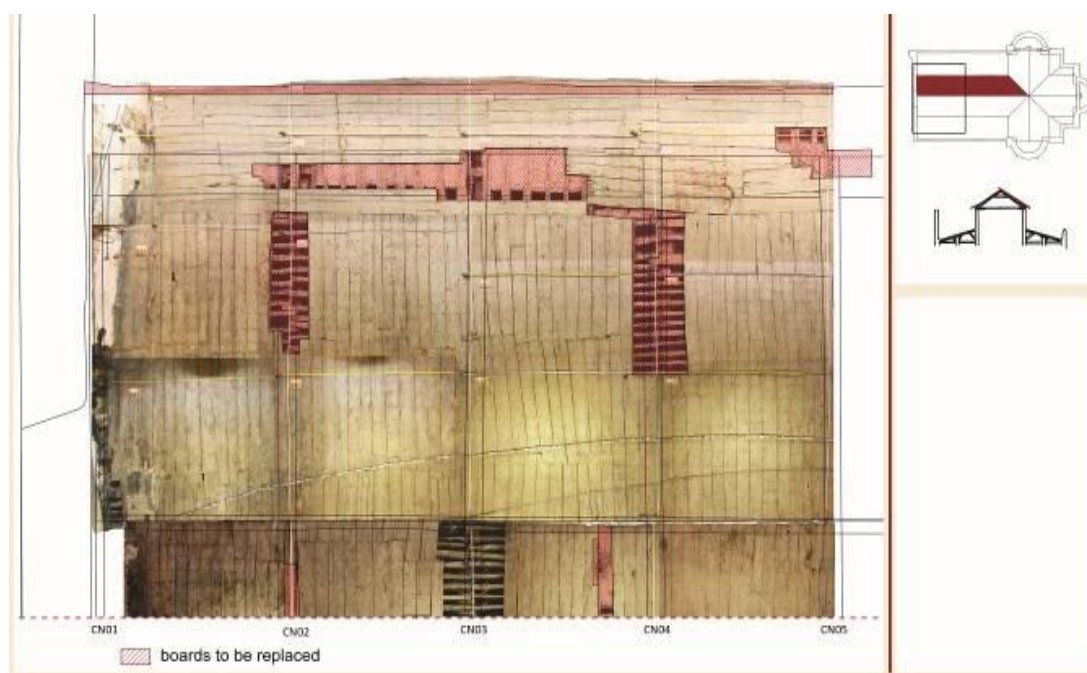
Figure 82: detailed map of boards to be replaced

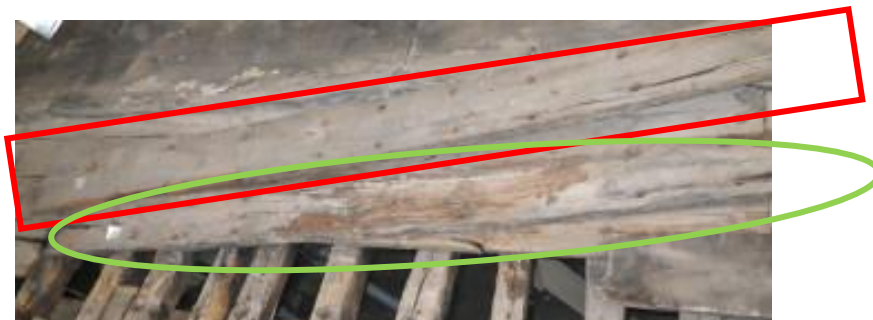
Figure 83: two adjacent boards evidencing a completely different extent of decay (both have been removed from the purlins): the board within the rectangle in red is in an excellent state of preservation and it can be kept without any additional treatment; the board within the oval in green has been attacked by fungi, and it needs to be partially or totally replaced (the decayed surface is >50% of the board surface).

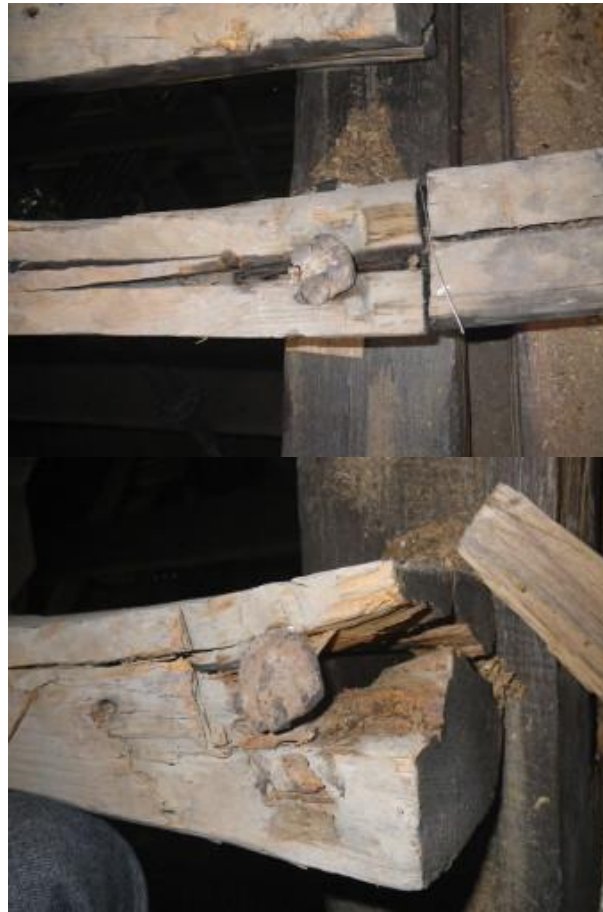
thus preventing the purlins to withstand loads along their longitudinal axis (loads perpendicular to nails and parallel to purlins).

Figure 84: two examples of purlins to be replaced.

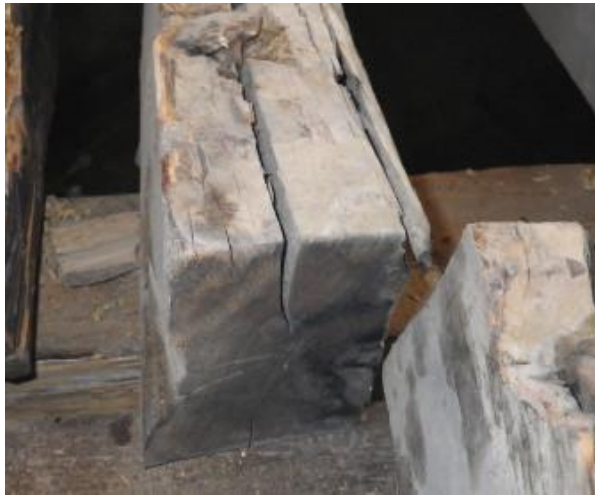
a)

In Figure 85 some examples in which the purlins do not need to be replaced is shown. Figure 85a shows a purlin in which the shrinkage crack stops to the pith. Figure 85b and Figure 85c show two examples in which, although a crack is present, the lateral contact between nails and wood (which allow the longitudinal stresses to be transferred from rafter to walls through purlins) is still present and active.

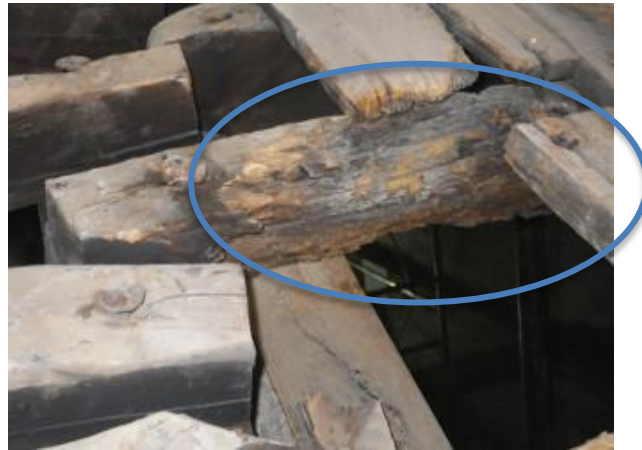
Figure 86 shows an example in which the presence of an extensive biological decay (mostly due to fungal attack) may prevent the efficient transmission of loads along the axis of the element, which is mostly important for purlins to be connected to tympanum walls. In that case, the element needs to be replaced.

Figure 86: example of a purlin that need to be replaced because of the presence of an extensive biological decay.

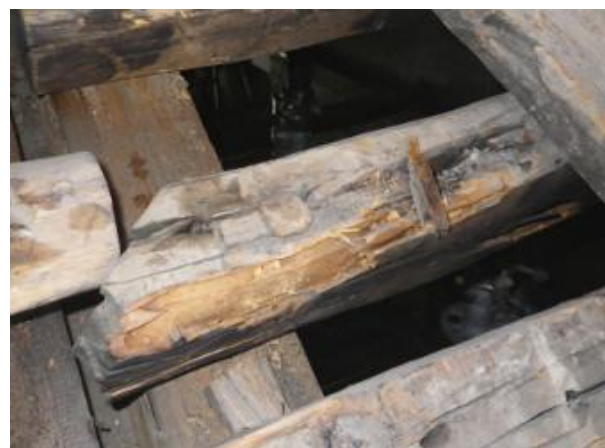
Finally, Figure 87 shows the example of a purlin in which an apparently limited biological attack is present. However, in similar cases only a more accurate diagnostic analysis can ensure that the purlin may be considered as capable in fact of withstanding longitudinal loads.

Figure 87: a purlin where a more accurate diagnostic analysis is needed to ascertain its effective static efficiency.

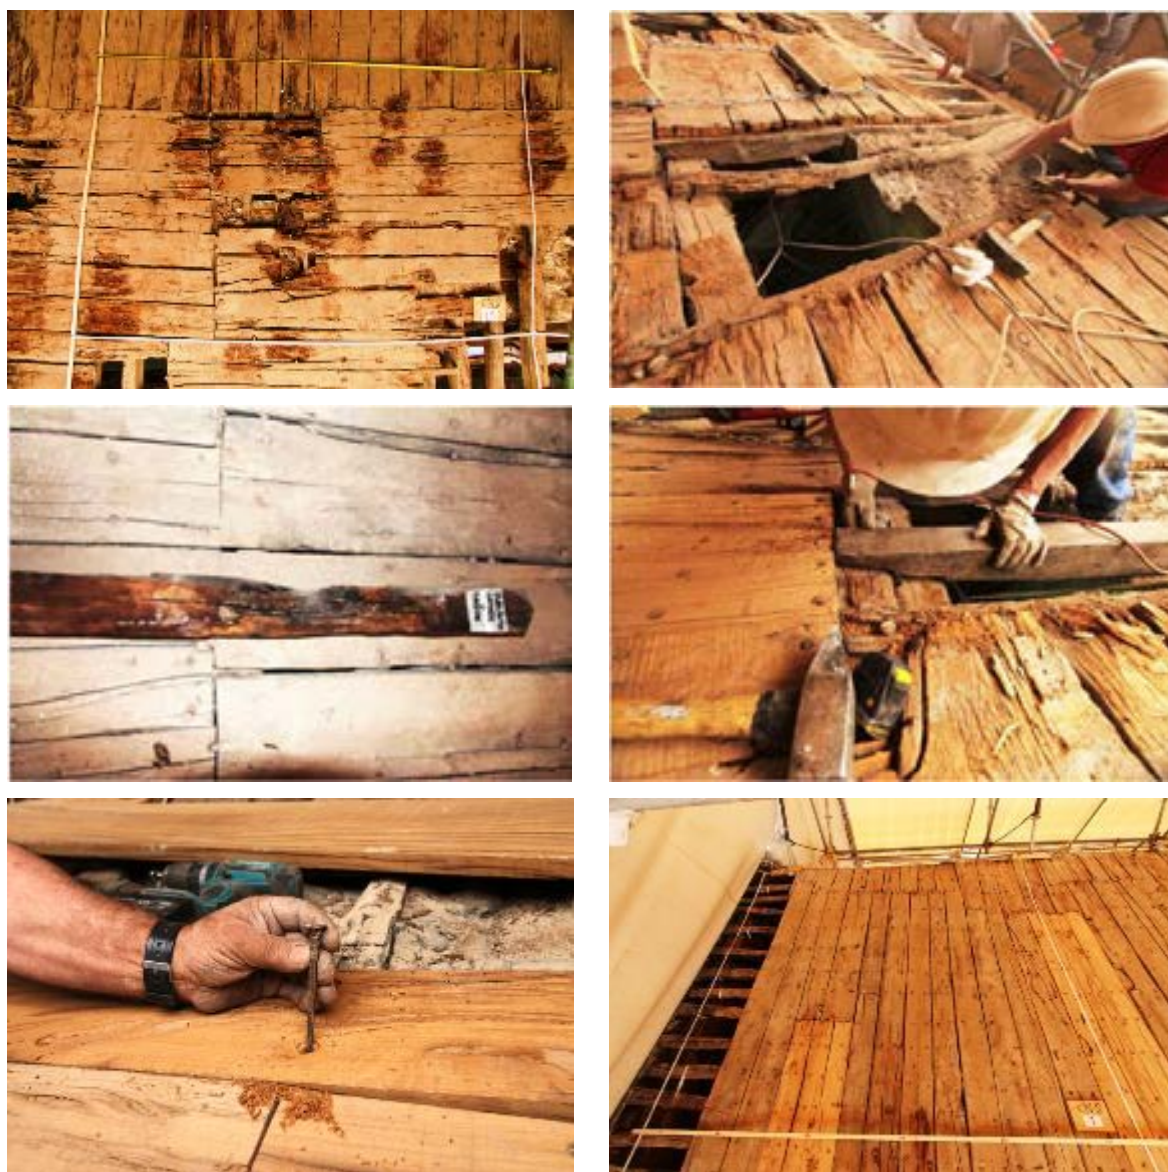
Figure 89 (from the top – from left to right): delimitation of the area with timber elements to be replaced, removal of purlins and boards, damaged purlins catalogued, replacement of a new purlin, replacement of the new board, the area at the end of the intervention
