2015 Earthquake Damage Mapping
Changunarayan Monument Zone
Kathmandu Valley World Heritage Property

November 2015

This assessment was supported by
UNESCO Office in Kathmandu

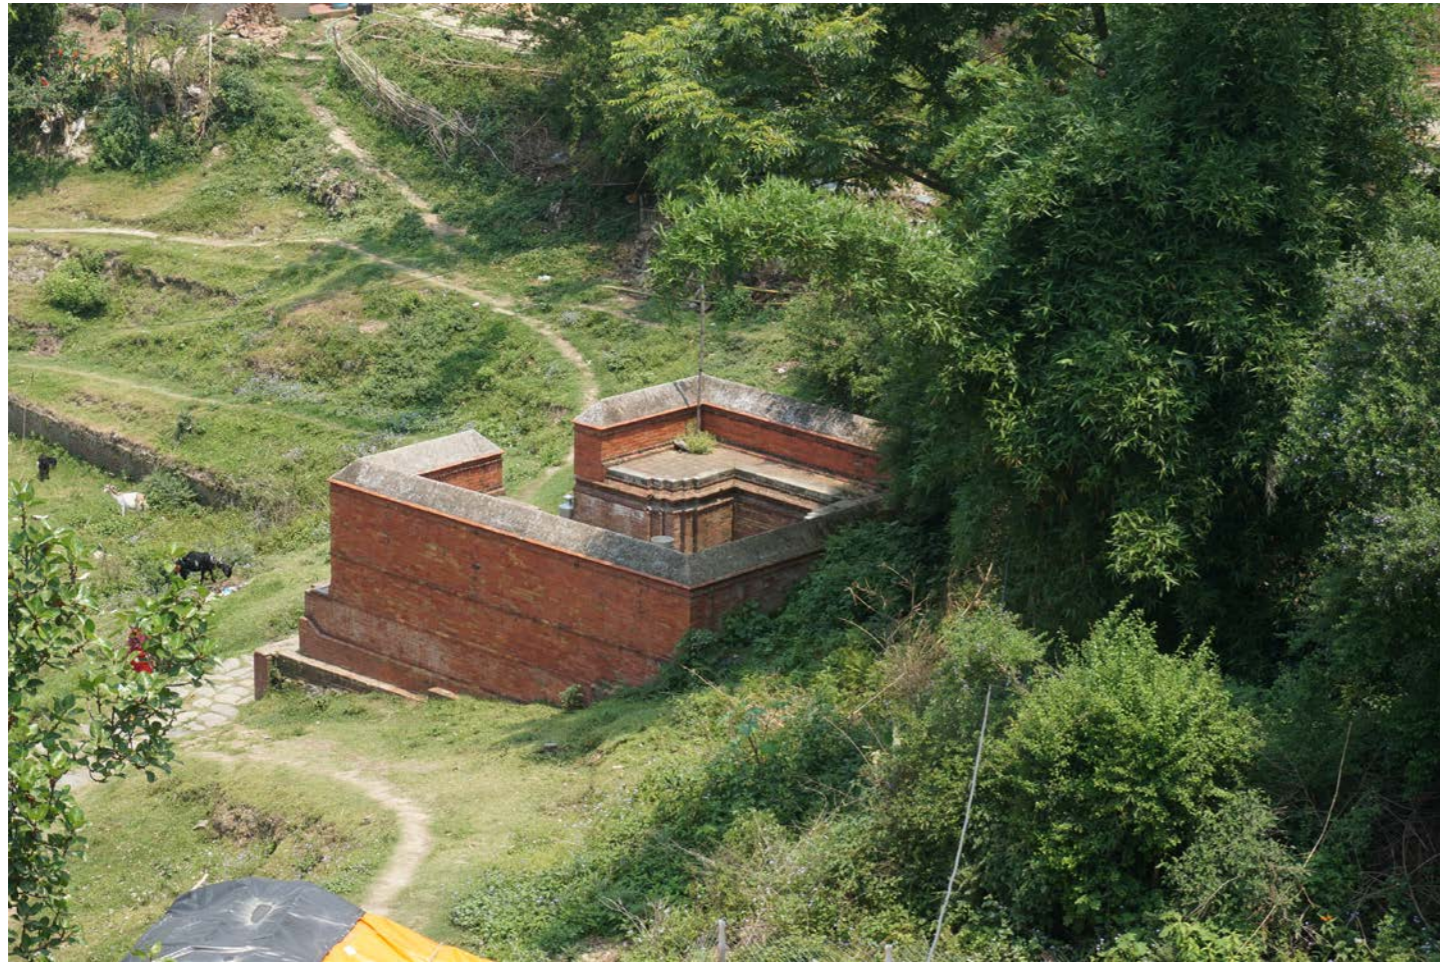
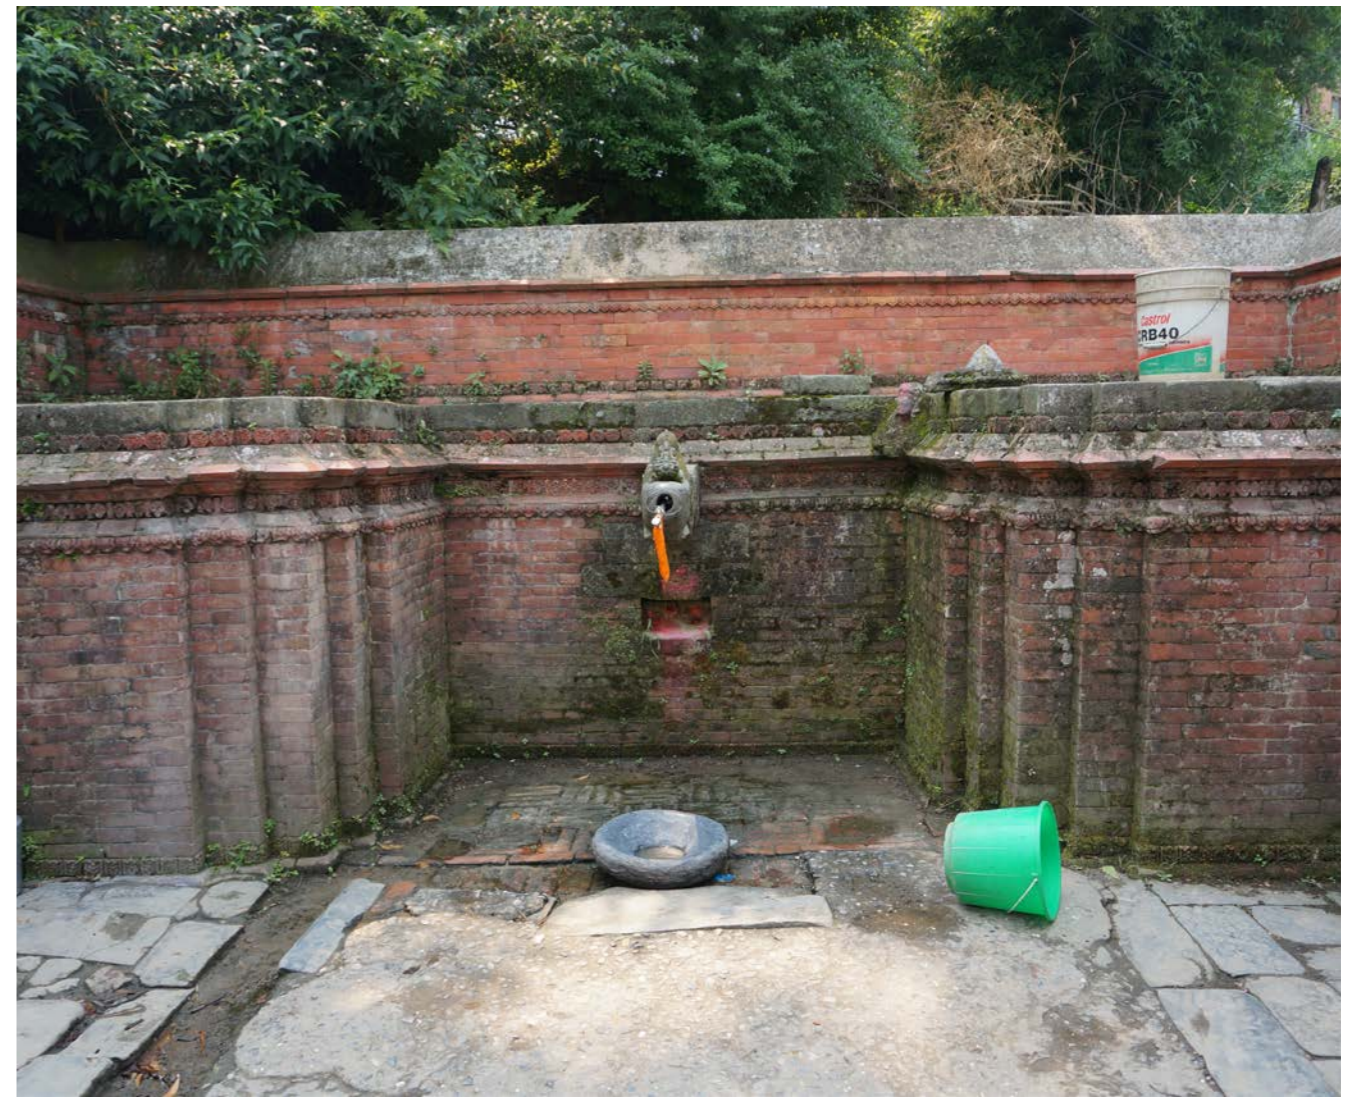
1 WATER SPOUT

NUMBER	NAME	DATE A.D.	TYOLOGY	GENERAL DESCRIPTION	DESCRIPTION OF DAMAGE	DANGER
1			Water Spout	Brick and carved stone in cement mortar Walls recently renovated	No visible structural damage Rising damp Needs maintainance

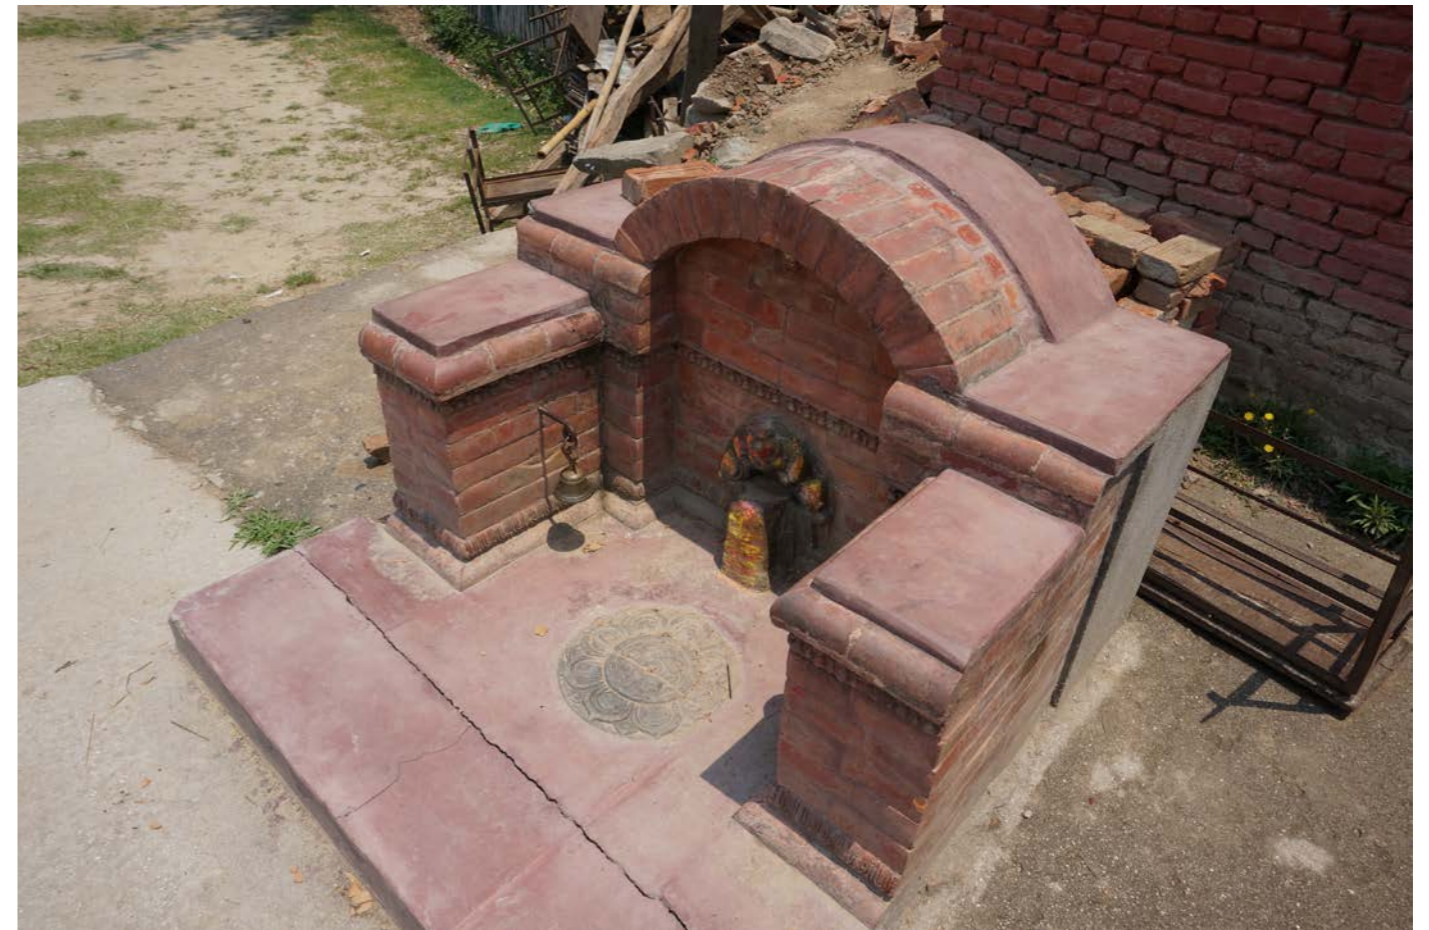
6 SHRINE

NUMBER	NAME	DATE A.D.	TYPOLOGY	GENERAL DESCRIPTION	DESCRIPTION OF DAMAGE	DANGER	
2			Pond	Brick made walls	Dried up and filled with grass Eroded brick walls		
6			Open shrine	Cult deity of Shresthas' Recent brick work

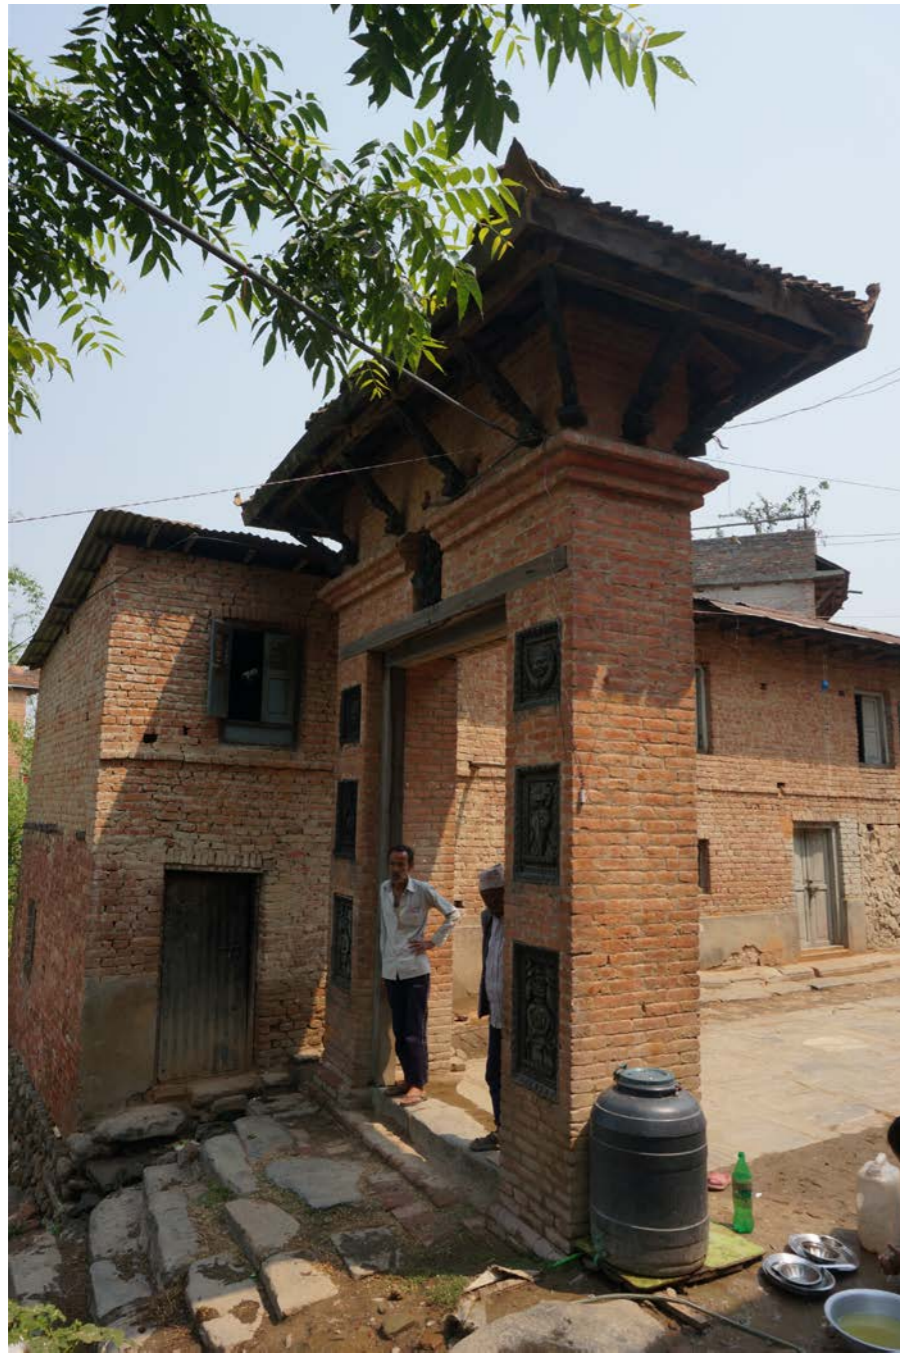
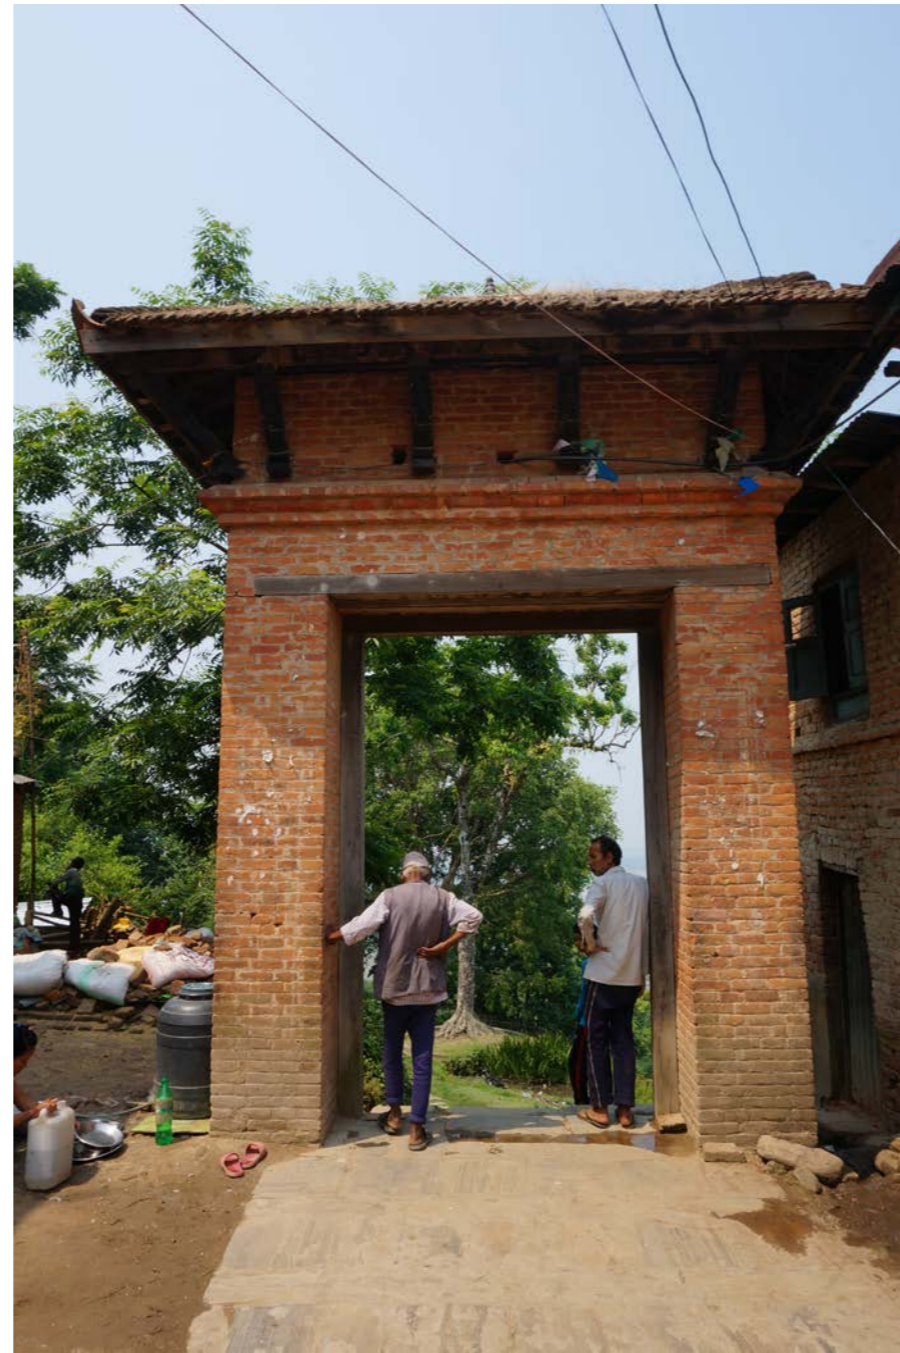
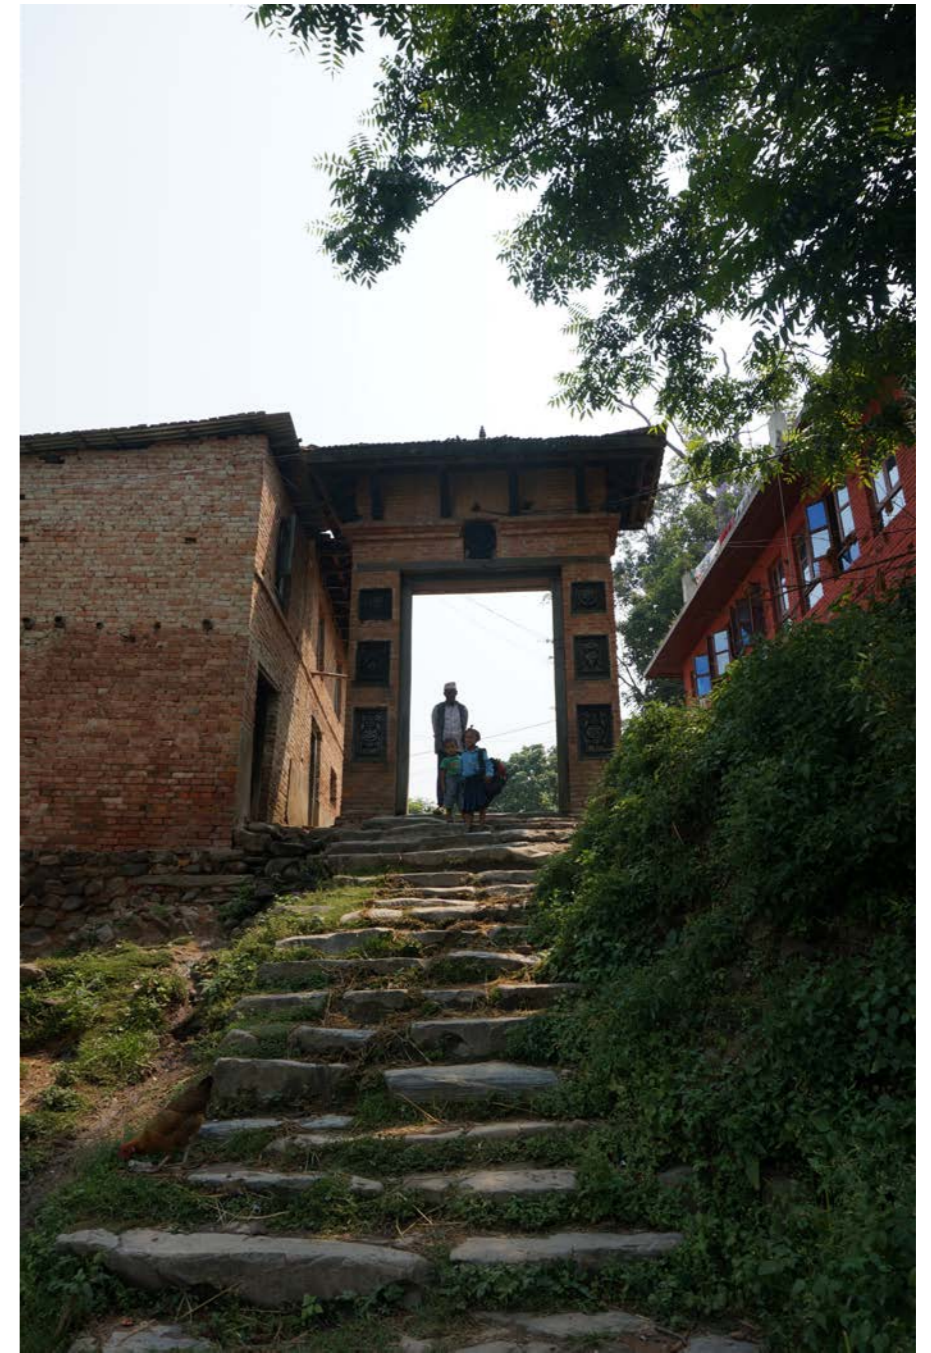
3 GATE

NUMBER	NAME	DATE A.D.	TPOLOGY	GENERAL DESCRIPTION	DESCRIPTION OF DAMAGE	DANGER	
3			Entrance gate	Brick and wooden structure with stone treshhold made in cement mortar Relatively recent construction	No visible damages

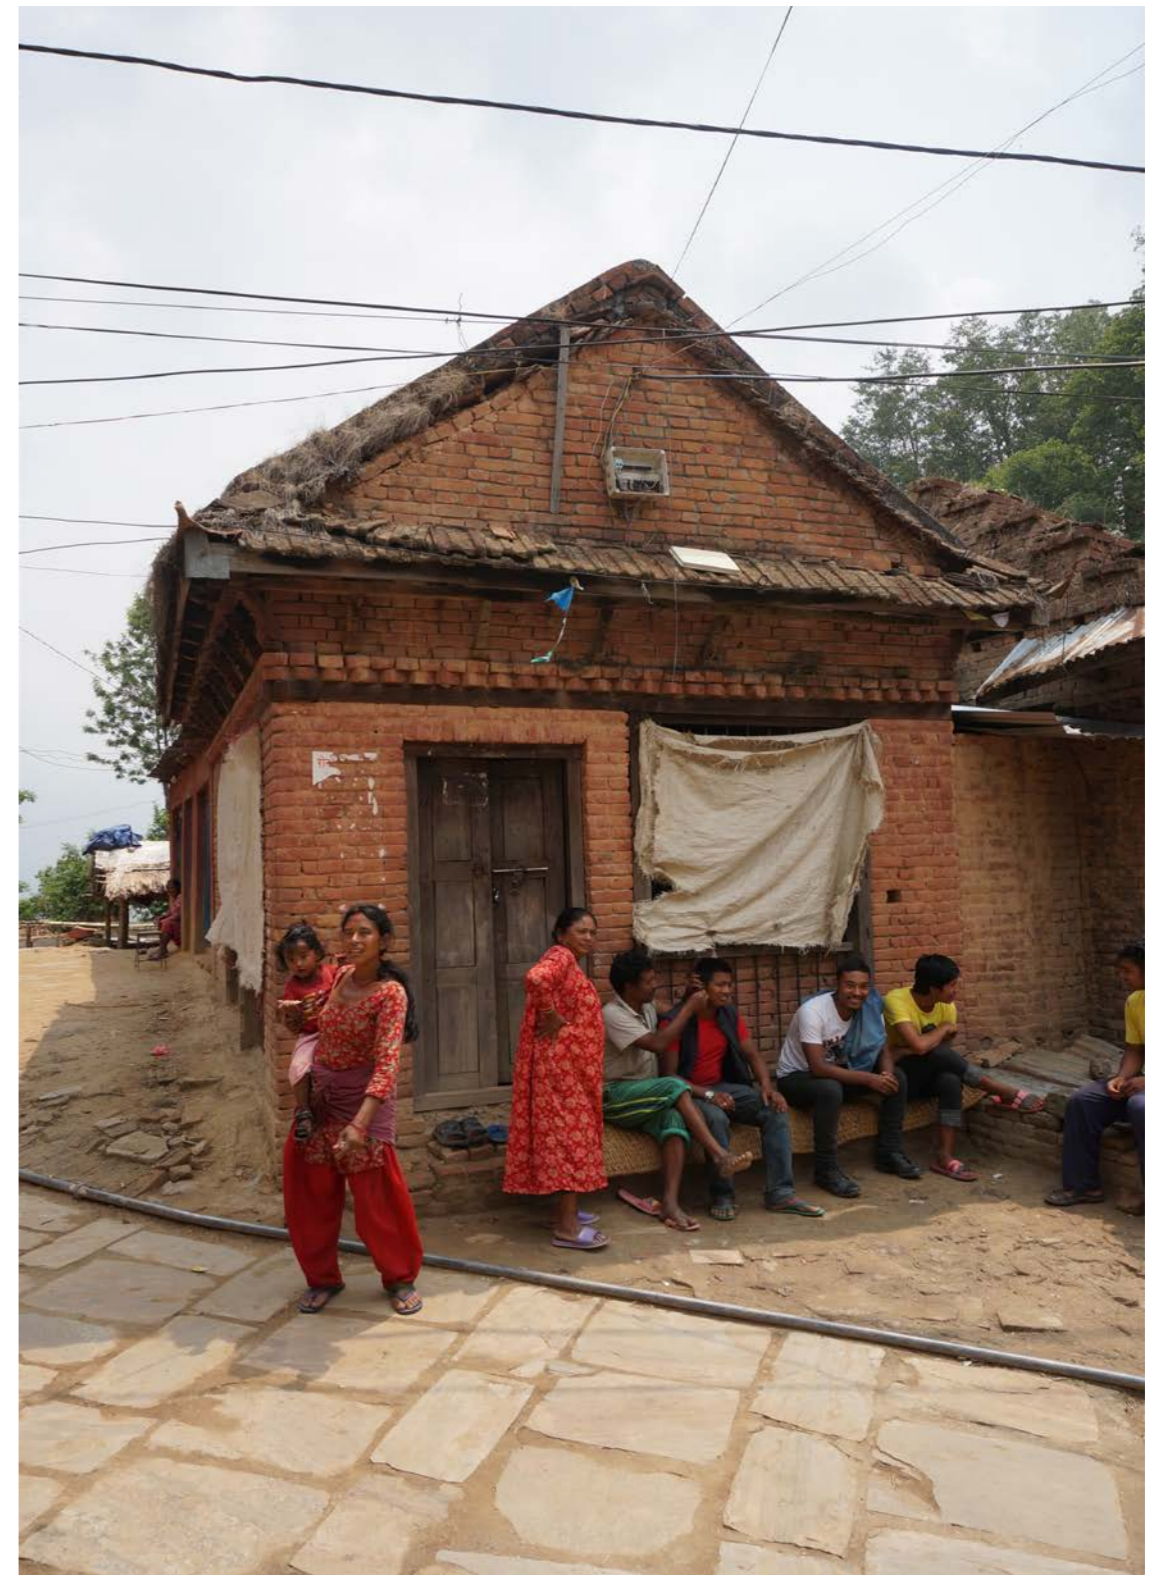
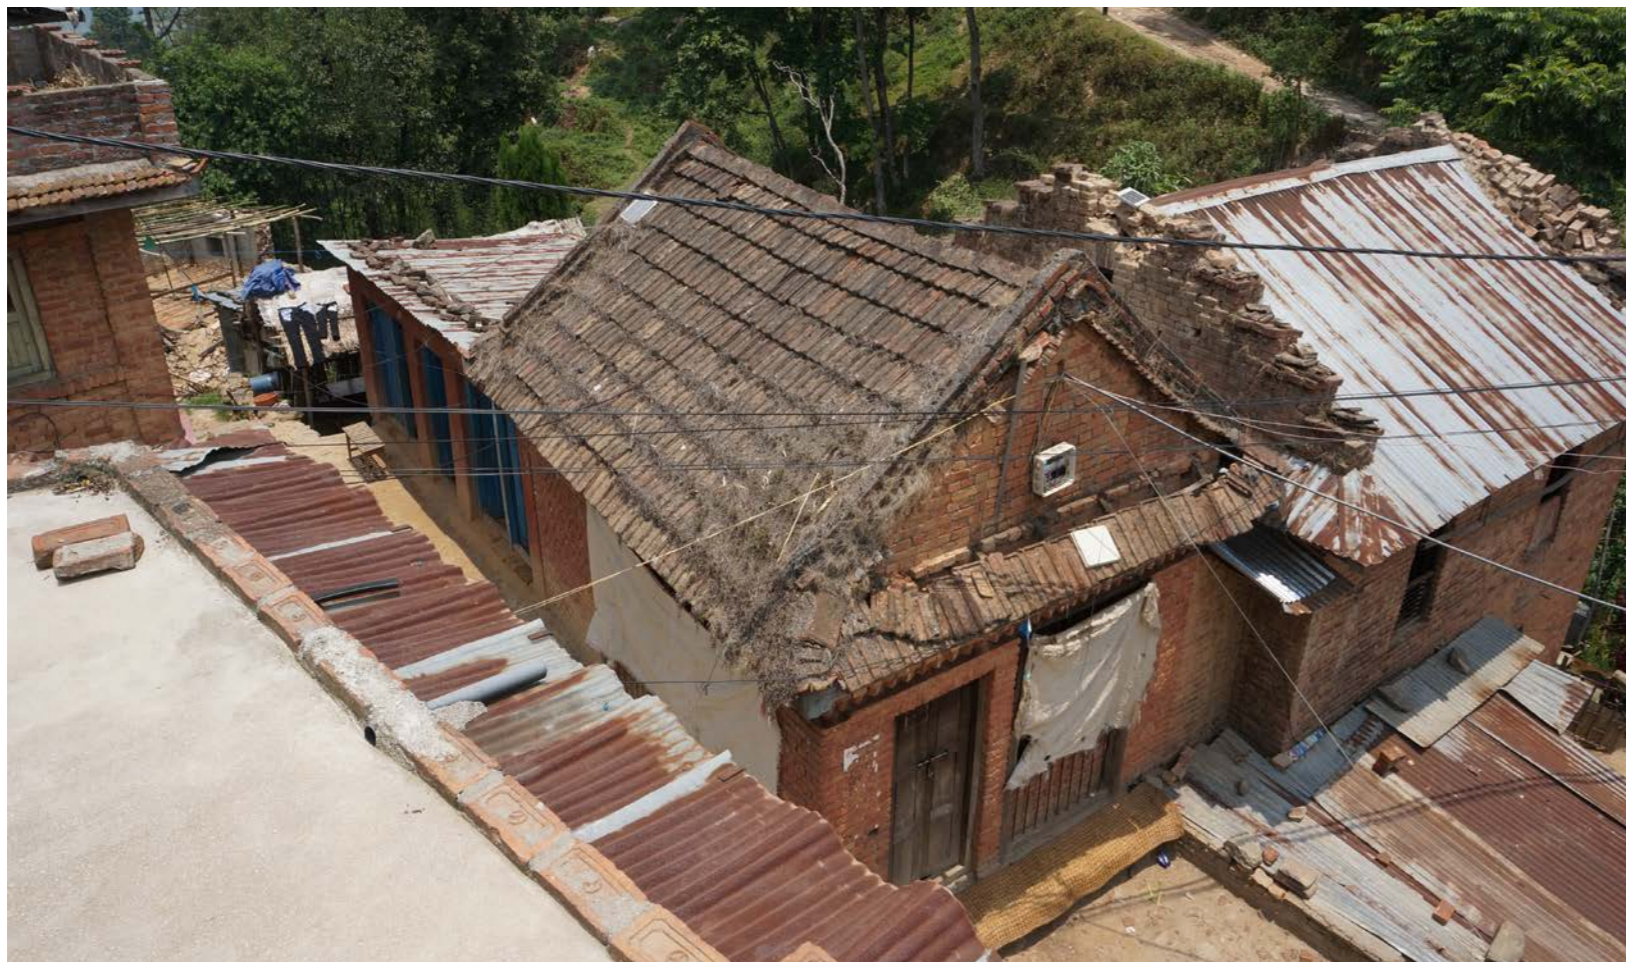
11 REST HOUSE

NUMBER	NAME	DATE A.D.	TYPOLOGY	GENERAL DESCRIPTION	DESCRIPTION OF DAMAGE	DANGER
11			<i>Pati</i> (Rest house)	Brick and timber structure with pan tile roof cover	No visible structural damage but poorly maintained. Parts of the roof are unstable

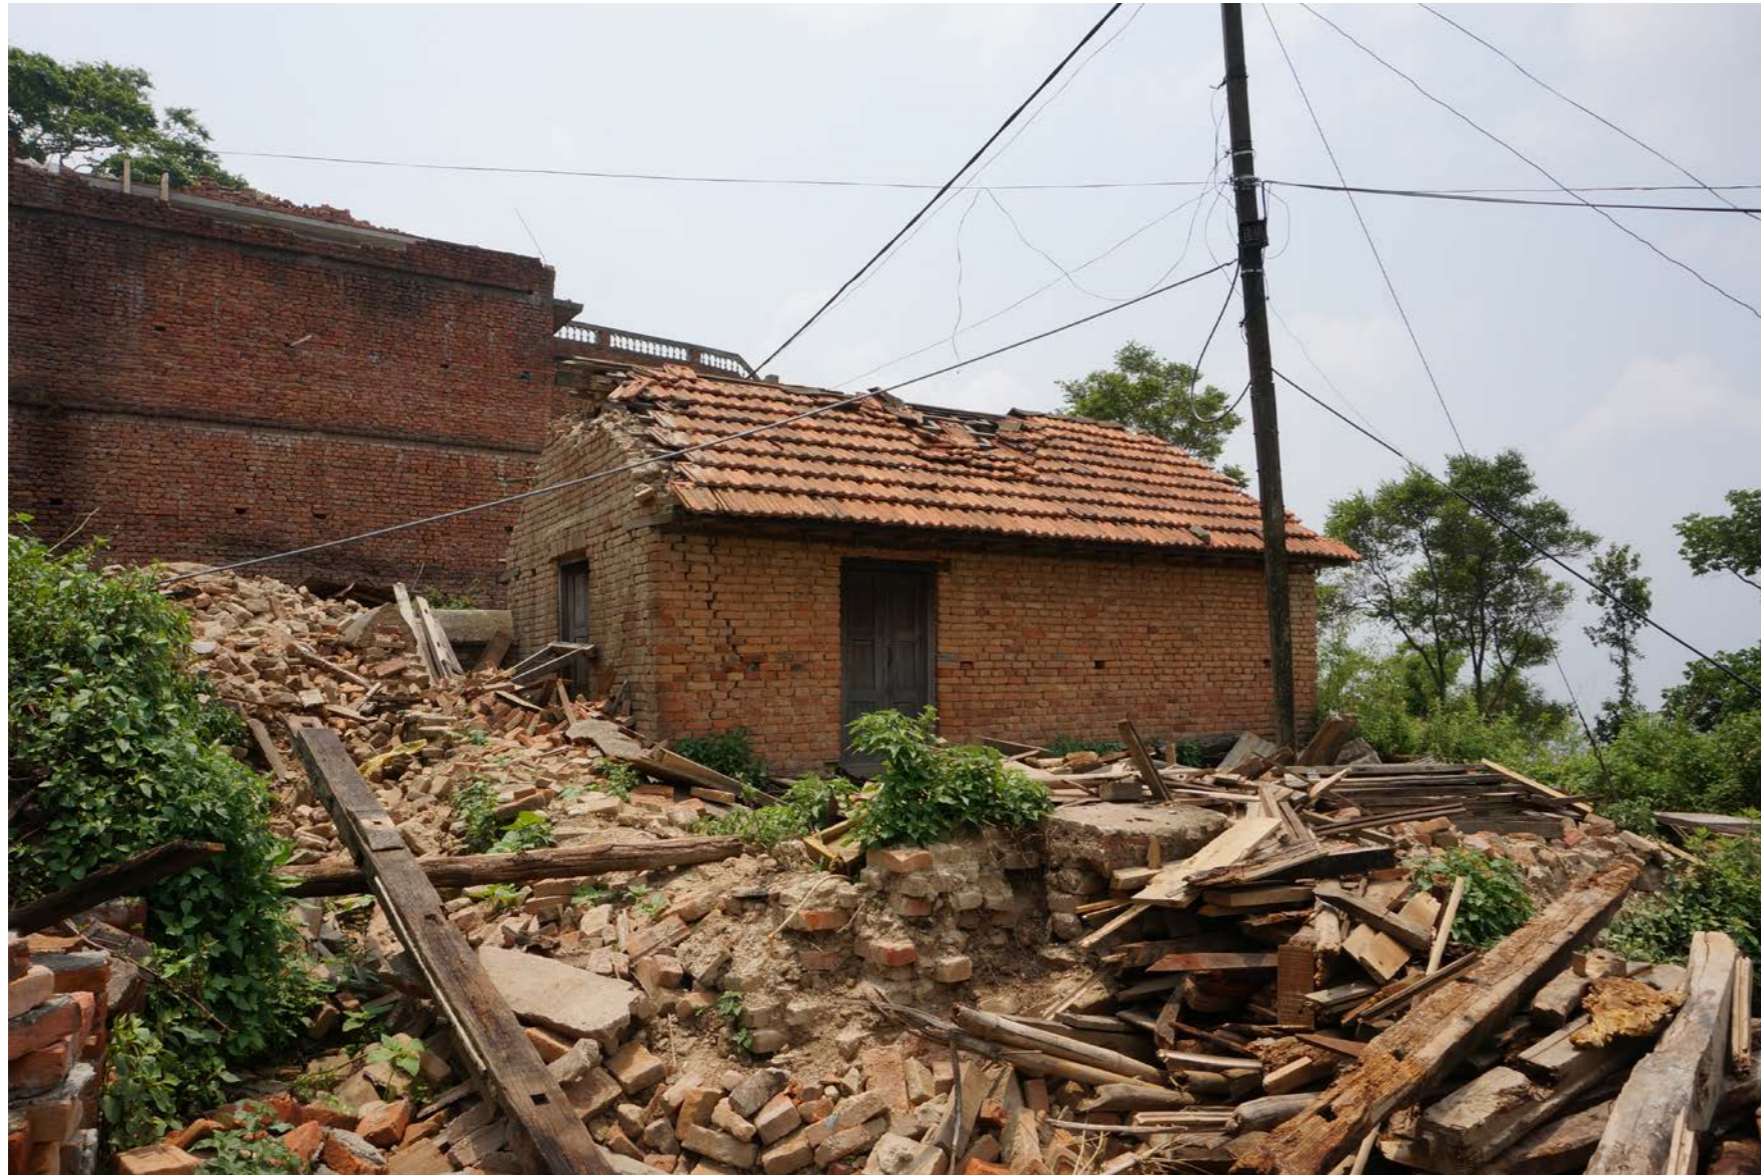
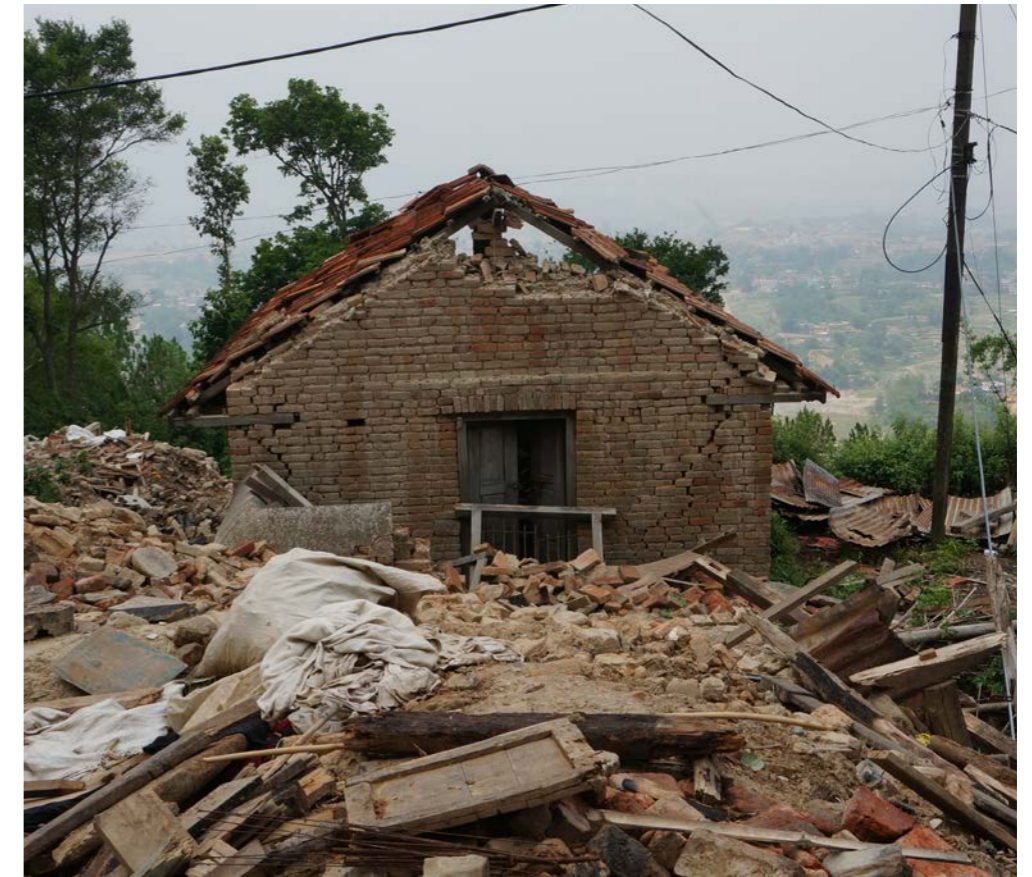
12 REST HOUSE (BHAIRAV PATI)

NUMBER	NAME	DATE A.D.	TPOLOGY	GENERAL DESCRIPTION	DESCRIPTION OF DAMAGE	DANGER	
12	Bhairav Pati		<i>Pati</i>	Brick and timber structure	Roof partially collapsed Gable end walls partially collapsed Large cracks on N-wall Boundary wall collapsed

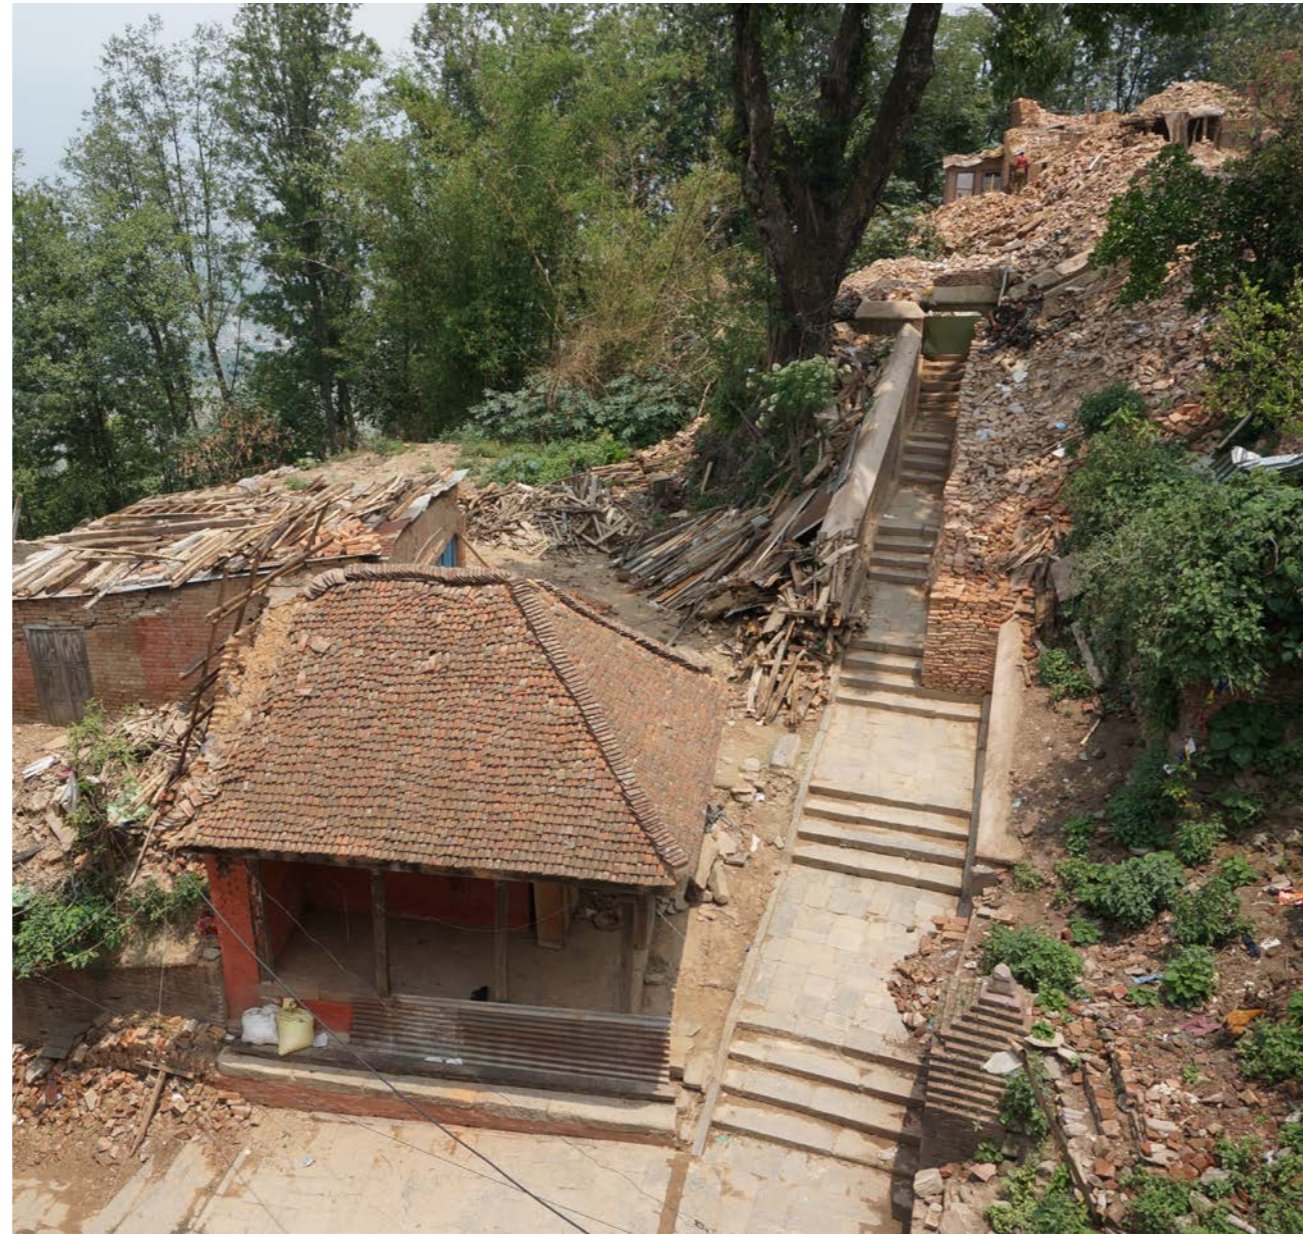
15 REST HOUSE (BHAIRAV PATI)

NUMBER	NAME	DATE A.D.	TPOLOGY	GENERAL DESCRIPTION	DESCRIPTION OF DAMAGE	DANGER
14			Open Shrine		Brick deteriorated and vegetation growth	
15	Bhairav Pati		<i>Pati</i>	Single storey brick and timber structure with jingati tile roof	North roof tile cover collapsed. Dislocated bricks and vertical cracks on the 2 inner walls Major vertical crack in the South-West corner	⚠

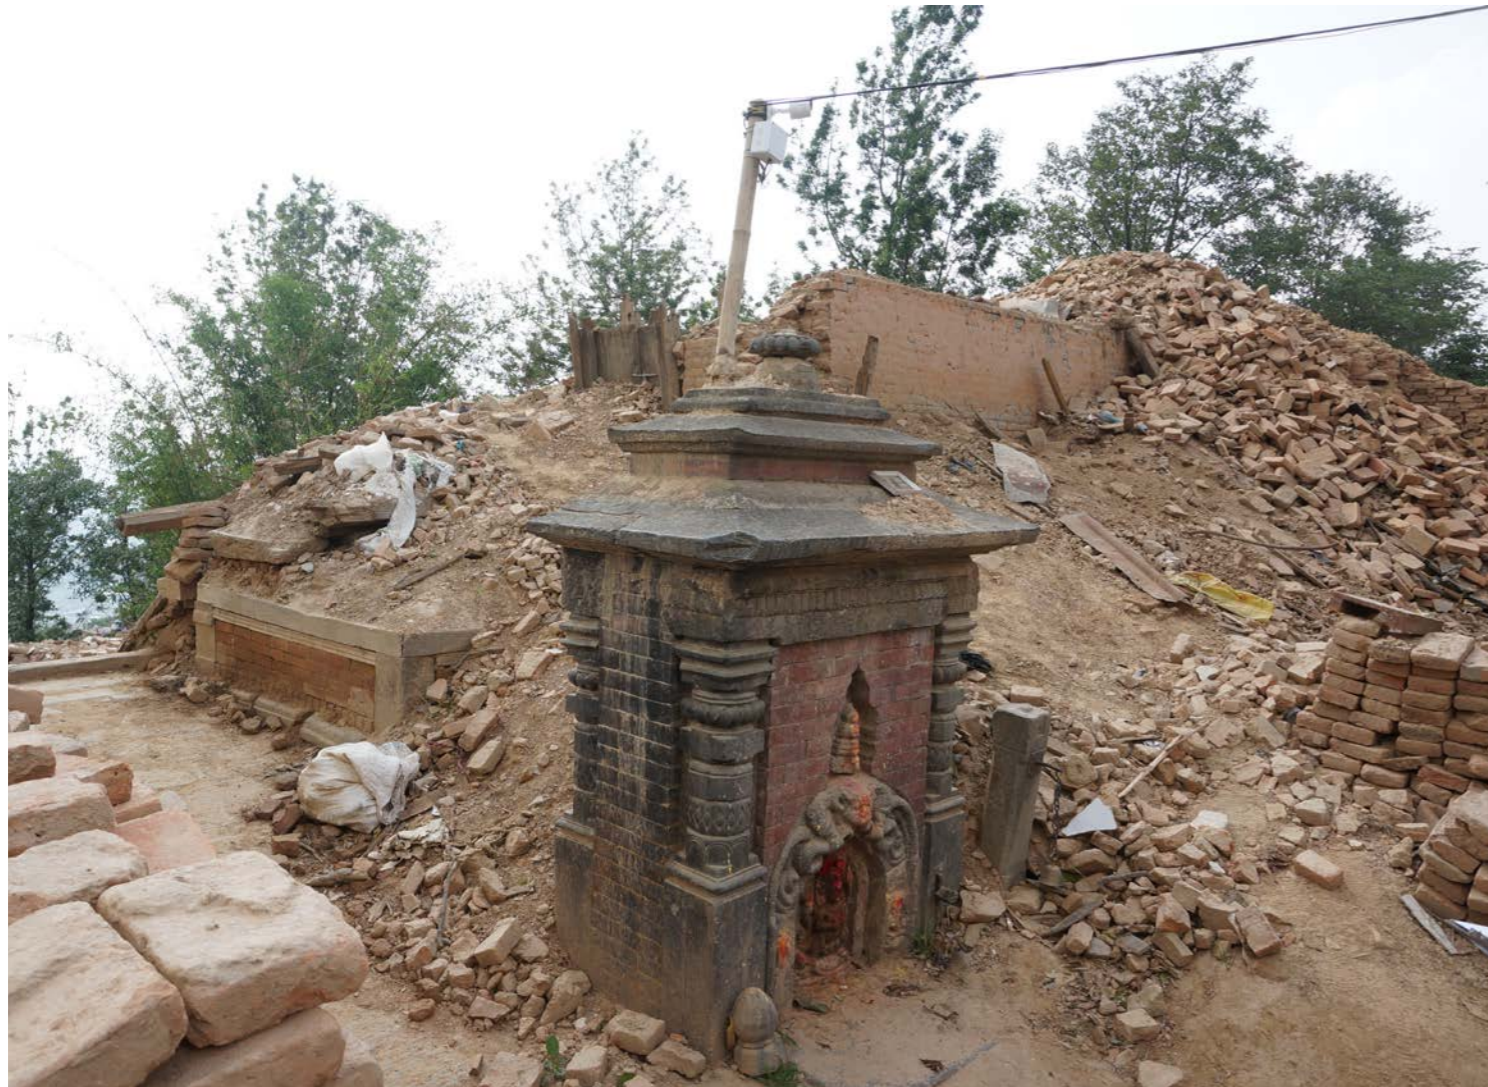
16 MAHANKAL SHRINE

NUMBER	NAME	DATE A.D.	TPOLOGY	GENERAL DESCRIPTION	DESCRIPTION OF DAMAGE	DANGER
16	Mahankal shrine		Shrine	Shrine made of stone and brick. Stone post supports a small bell	The dislocated <i>Gajur</i> (finial) is kept next to the shrine

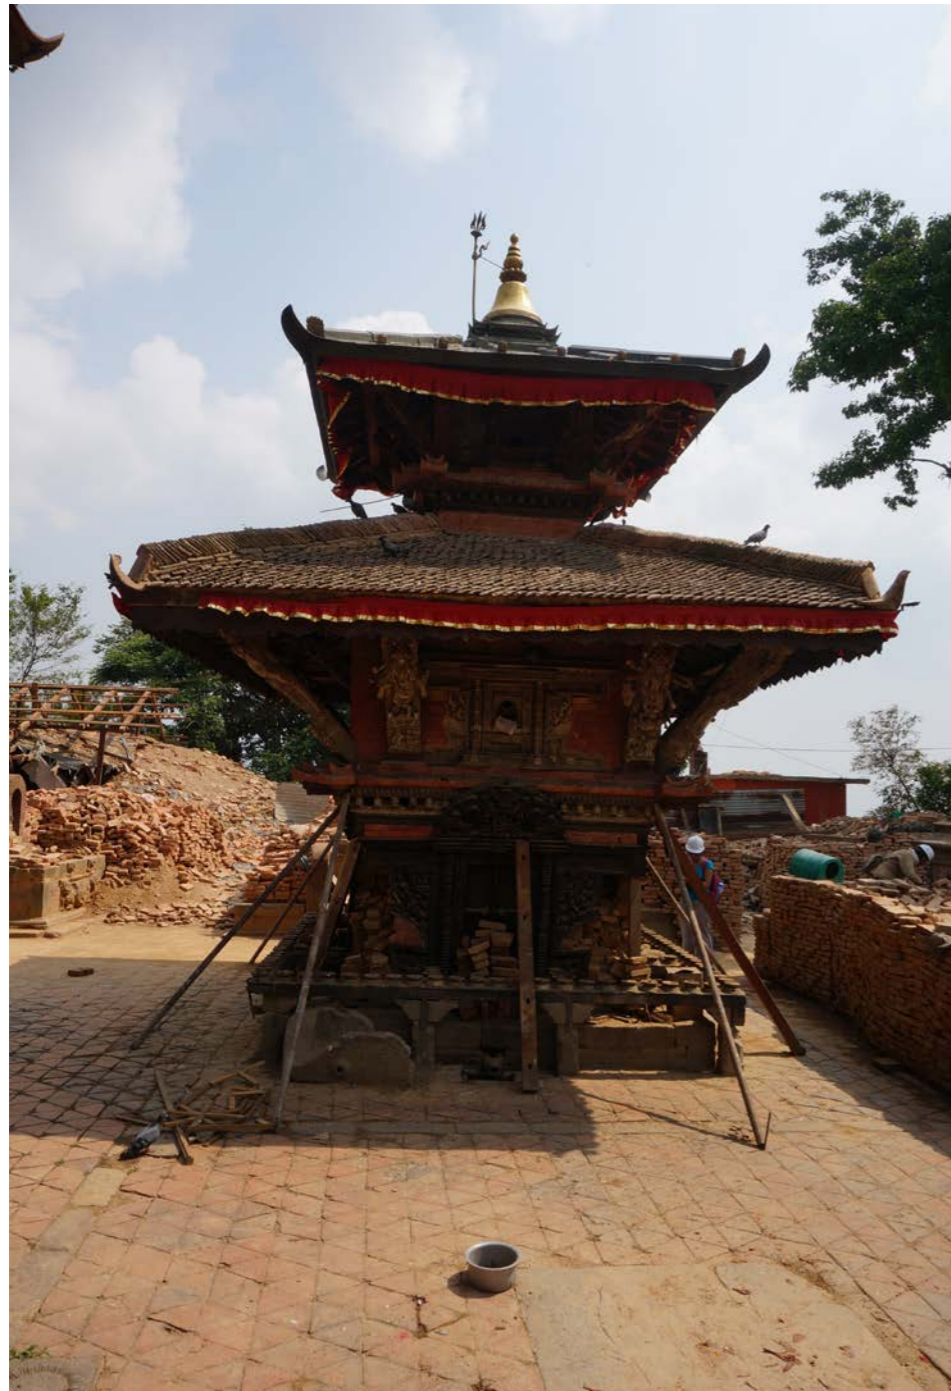
17 KILESHWOR MAHADEV TEMPLE

NUMBER	NAME	DATE A.D.	TYPOLOGY	GENERAL DESCRIPTION	DESCRIPTION OF DAMAGE	DANGER
17	Kileshwor Mahadev		Two-tiered Pagoda Temple	Pagoda temple with 3 nandis in front of West Door	All corners and N-W wall of ground floor have fallen. Cracks on 1st and ground floor. East door frame partially collapsed. Vertical cracks on the frame of East and West windows. Horizontal cracks on central frame of North window. Cracks in struts on the West and on the N-E corner.

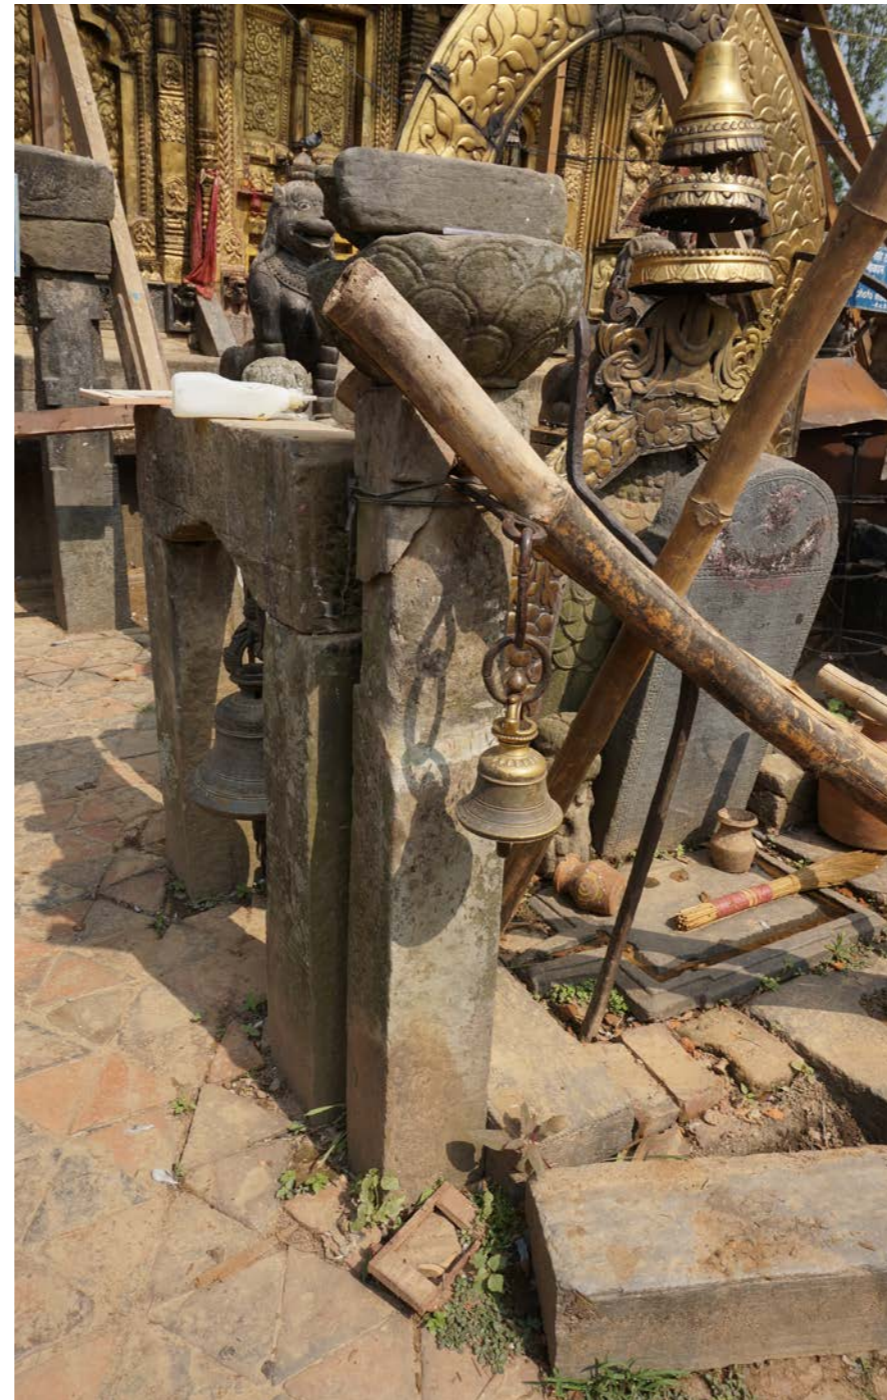
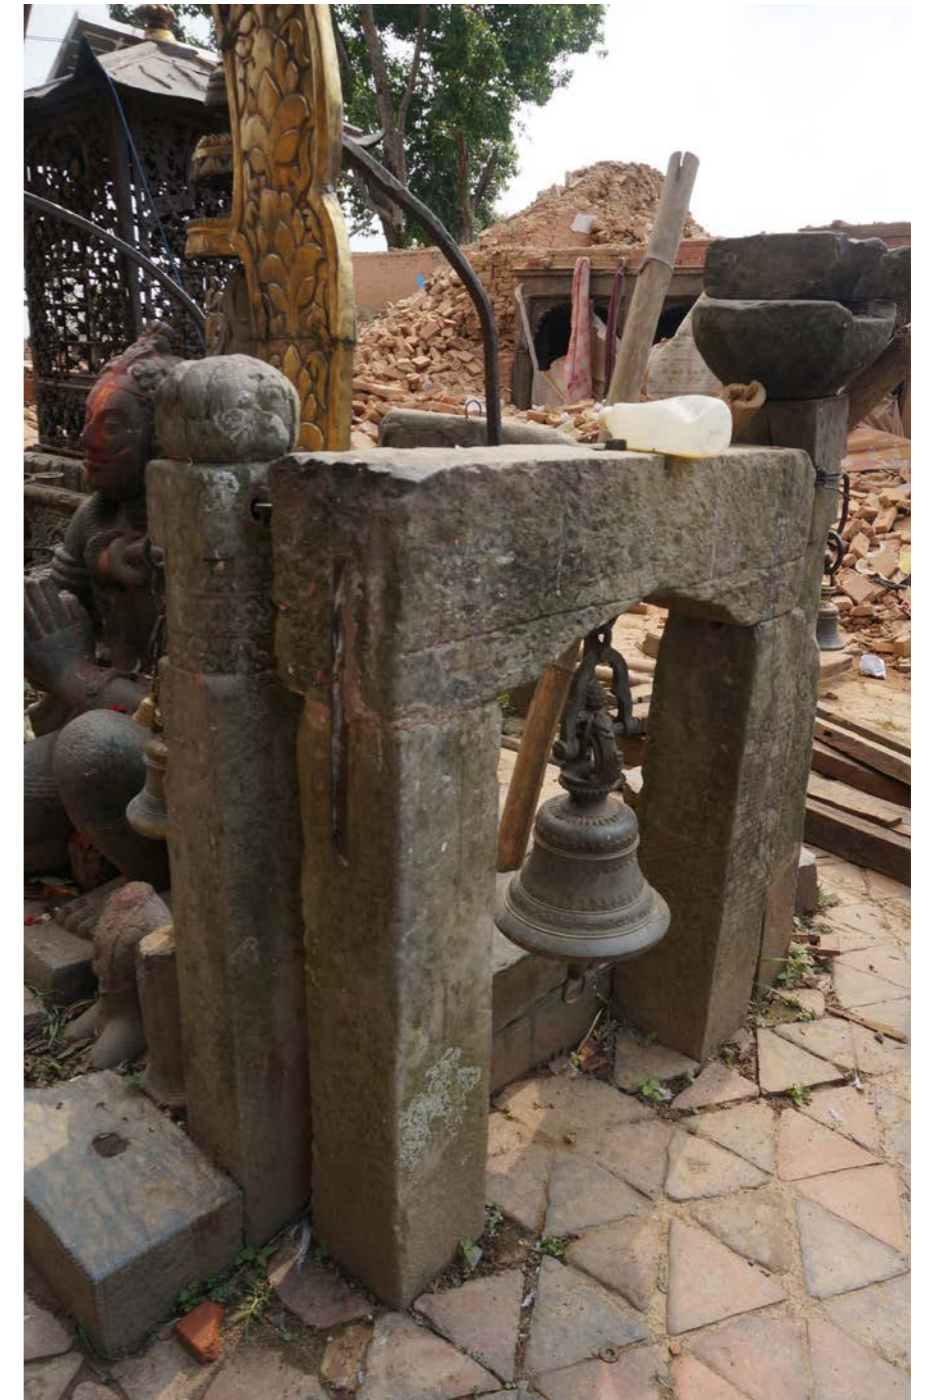
21 STONE FRAME WITH BELL

NUMBER	NAME	DATE A.D.	TPOLOGY	GENERAL DESCRIPTION	DESCRIPTION OF DAMAGE	DANGER	
20			Stone stele	Stone inscription with a jalahari (base of shiva lingam) in front and a re-pouseé arch and gajur (finial) behind.	Stele slightly tilted to the South-West		
21			Stone frame and post with two bells	Stone frame supporting a bell. Another stone post rests next to it and also supports a bell.	The top of the stone post is broken and mended with wire.	⚠
