2015 Earthquake Damage Mapping
Changunarayan Monument Zone
Kathmandu Valley World Heritage Property

November 2015

This assessment was supported by
UNESCO Office in Kathmandu

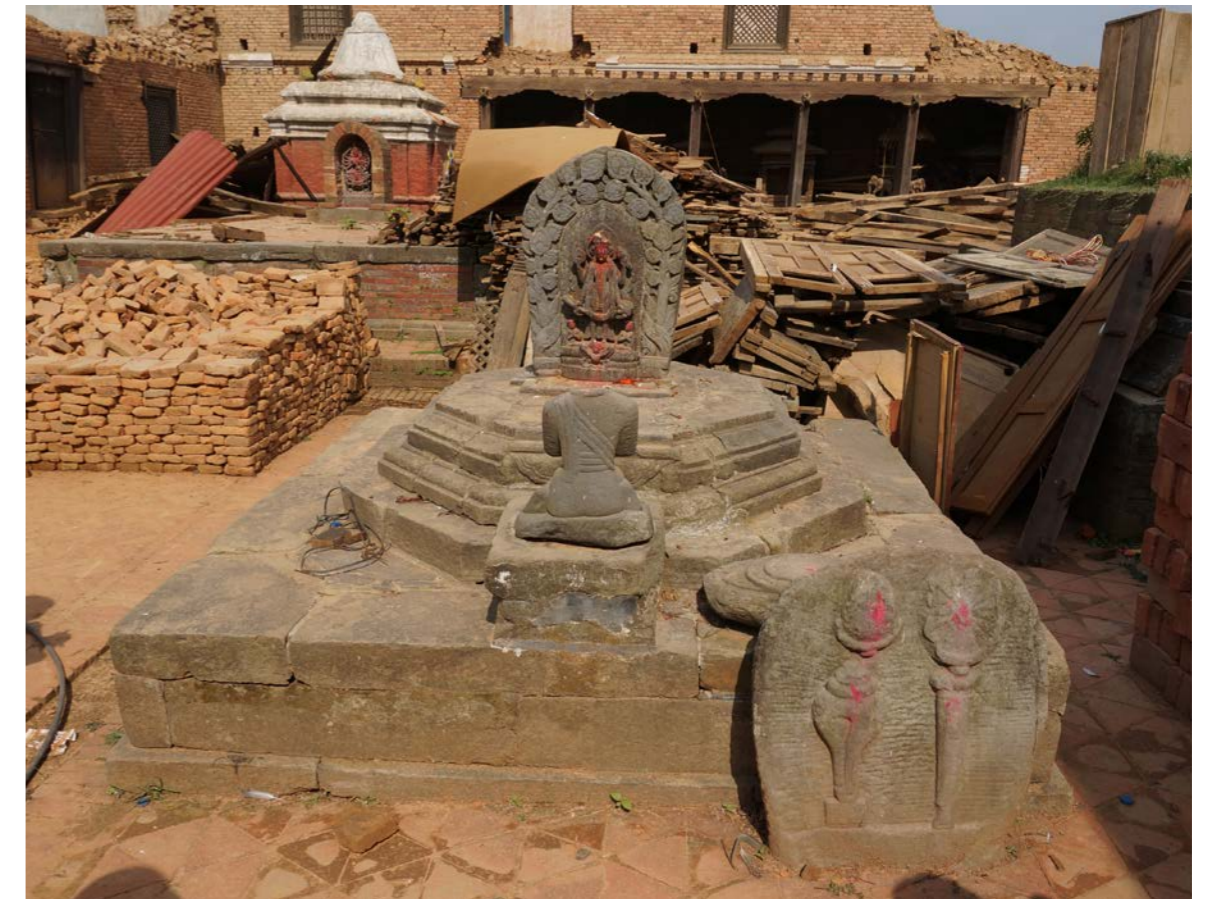
27 VISHNU STATUE

NUMBER	NAME	DATE A.D.	TPOLOGY	GENERAL DESCRIPTION	DESCRIPTION OF DAMAGE	DANGER
25	ShreeDhar Bishnu		Open Shrine	Brick structure with stone sculpture	No Visible Damage	
27	Vishnu Statue		Open Shrine	Vishnu statue on stone pedestal with a headless devotee in front .Stone inscription of Sankha-Chakra-Padma-Gadha on W-S corner.	Stone cracks on the base of statue at S-W side Some stone of the base has slight separation

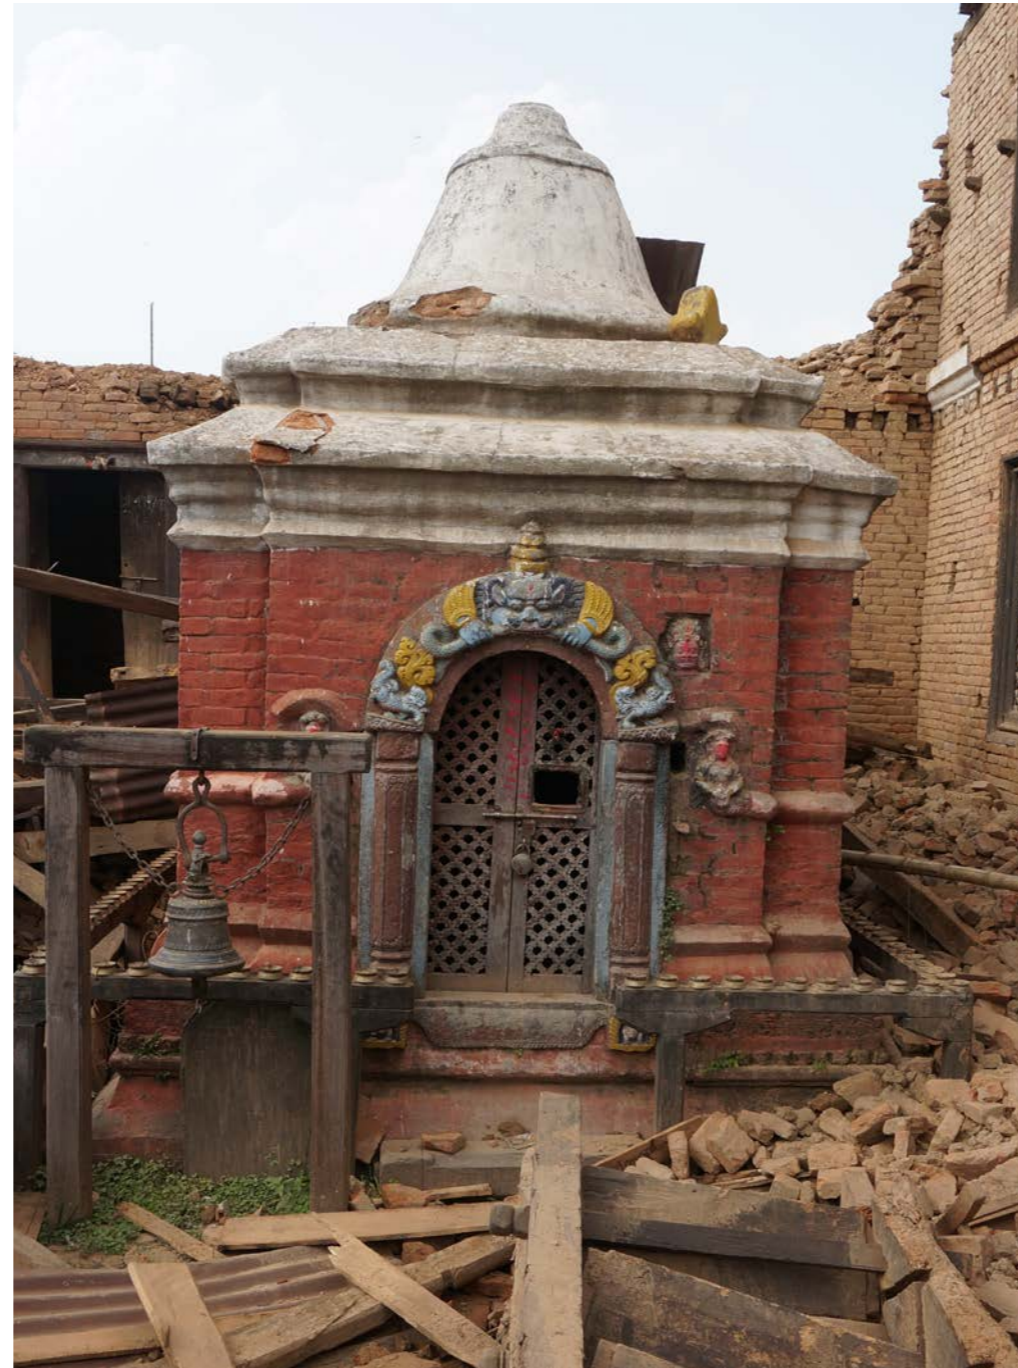
29 SHIVA TEMPLE

NUMBER	NAME	DATE A.D.	TYPOLOGY	GENERAL DESCRIPTION	DESCRIPTION OF DAMAGE	DANGER
28	Laxmi Narayan		Open Shrine	Temple platform with a Laxmi-Narayan statue with a brick and stone enclosure	North side of sculpture base is broken	
29	Shiva Temple		Temple	Brick structure with a lime plastered roof	Dome has small hole on South side Plaster coming off on E and N side Gajur is missing

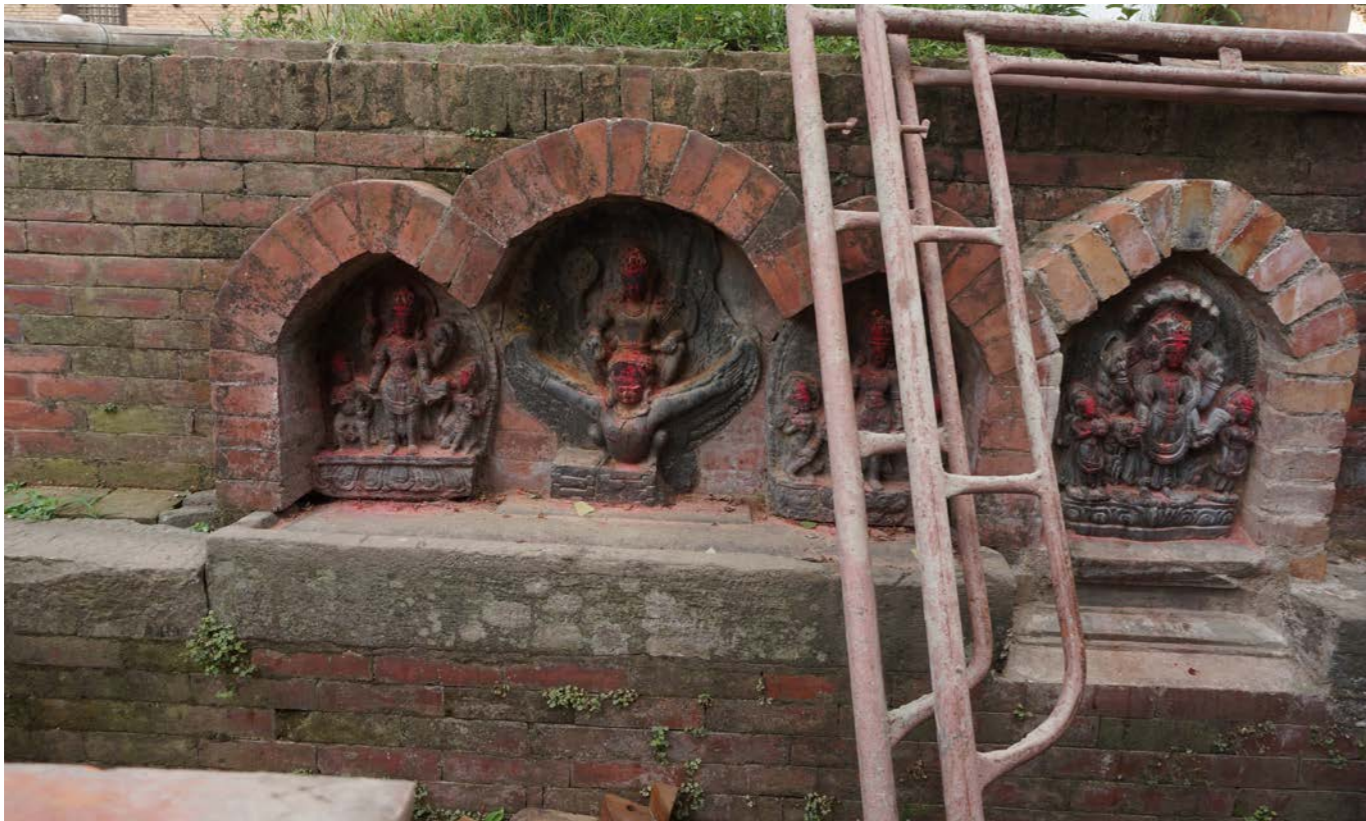
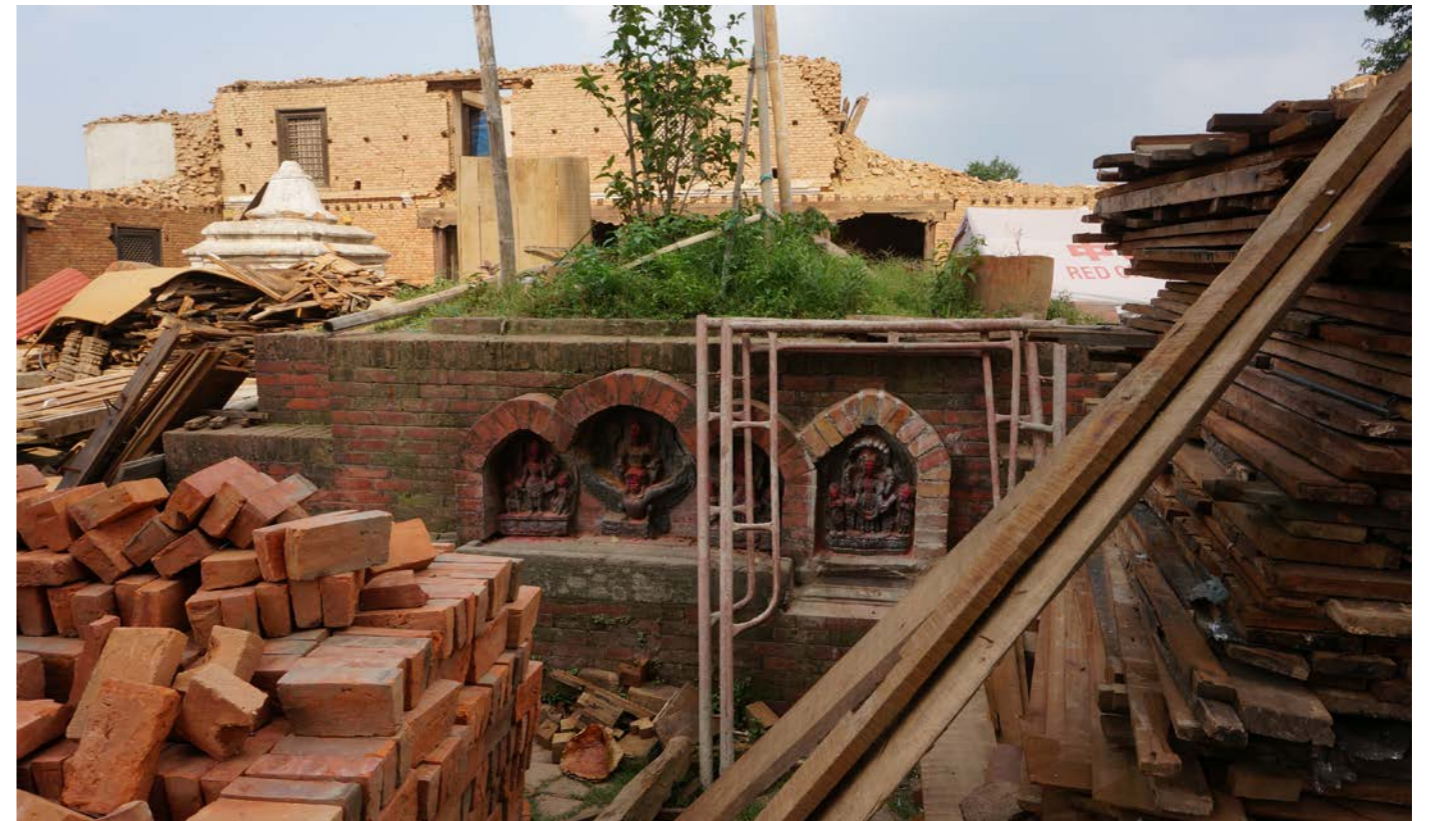
30 PLATFORM WITH IDOLS

NUMBER	NAME	DATE A.D.	TPOLOGY	GENERAL DESCRIPTION	DESCRIPTION OF DAMAGE	DANGER
30			Open Shrine	Shrine of Garud Narayan with stone and brick base Shiva Linga present at the West	Vegetation on top of platform Garud Narayan sculpture base is slightly broken Some portion of wing of Garud is damaged The top of Garuda's head is damaged

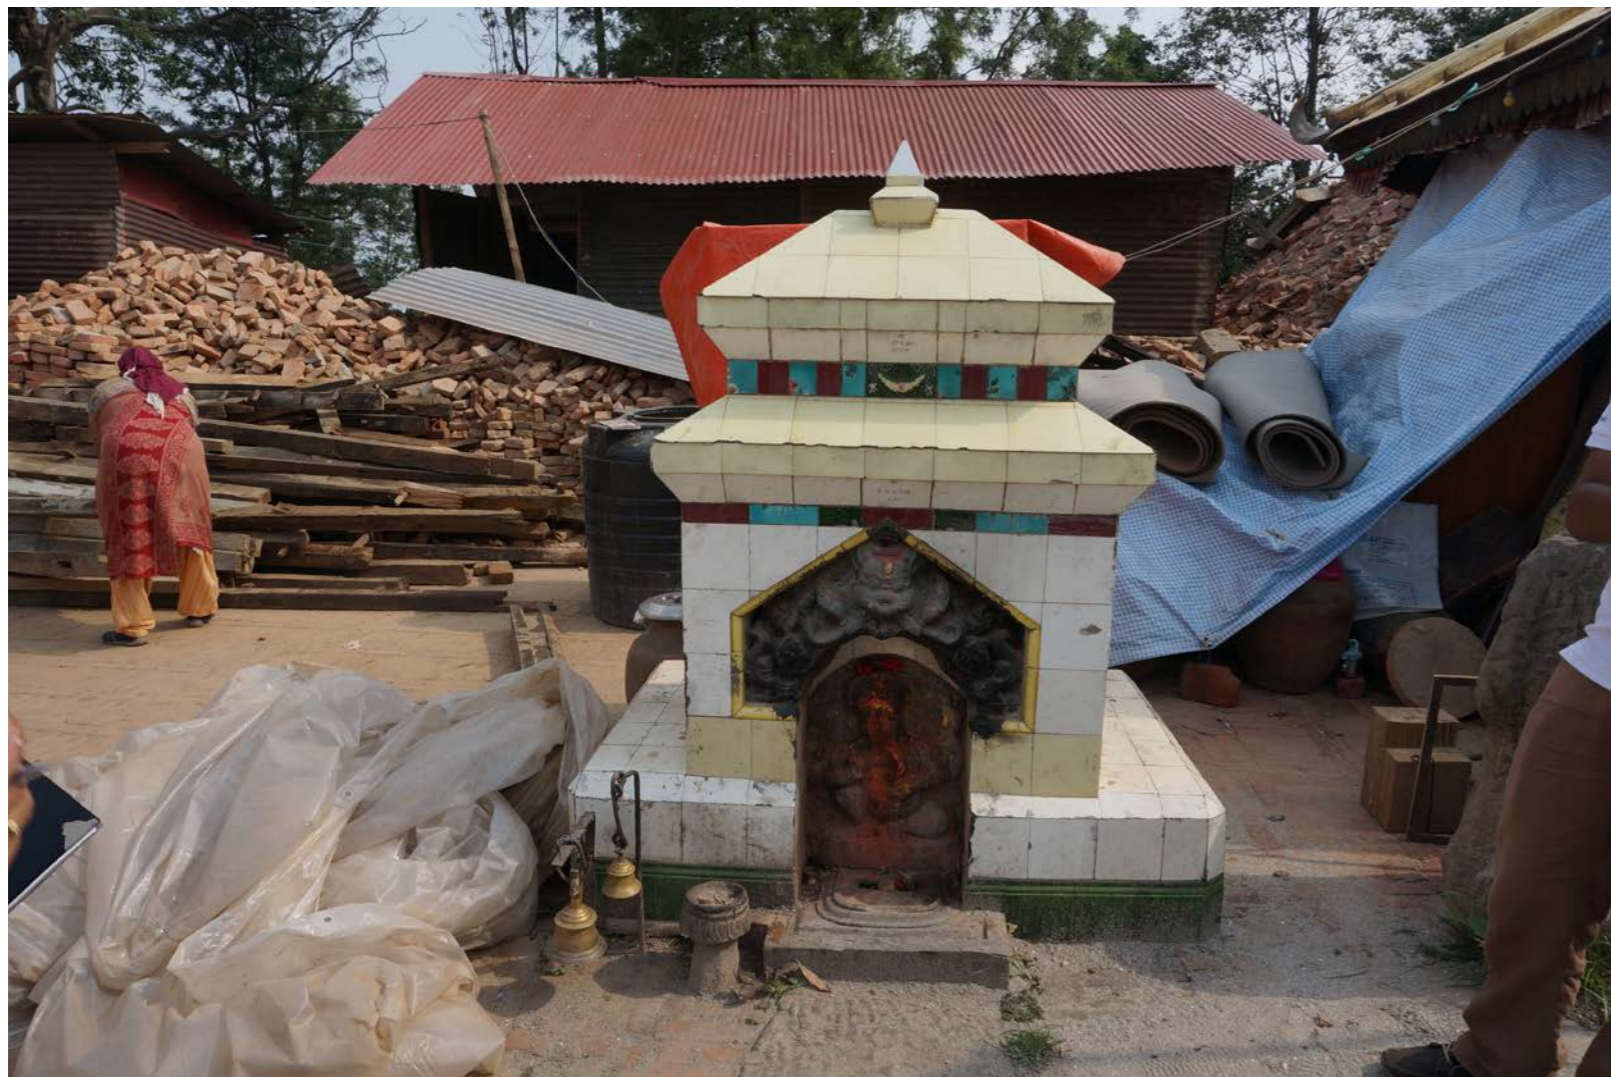
31 GANESH SHRINE

NUMBER	NAME	DATE A.D.	TYPOLOGY	GENERAL DESCRIPTION	DESCRIPTION OF DAMAGE	DANGER
31	<i>Ganesh</i>		Open Shrine	Ganesh shrine with ceramic tiled façade. Two small bells, a stone oil lamp and a jalahari are installed in front of it.	No major damage Some cracks on tile joint

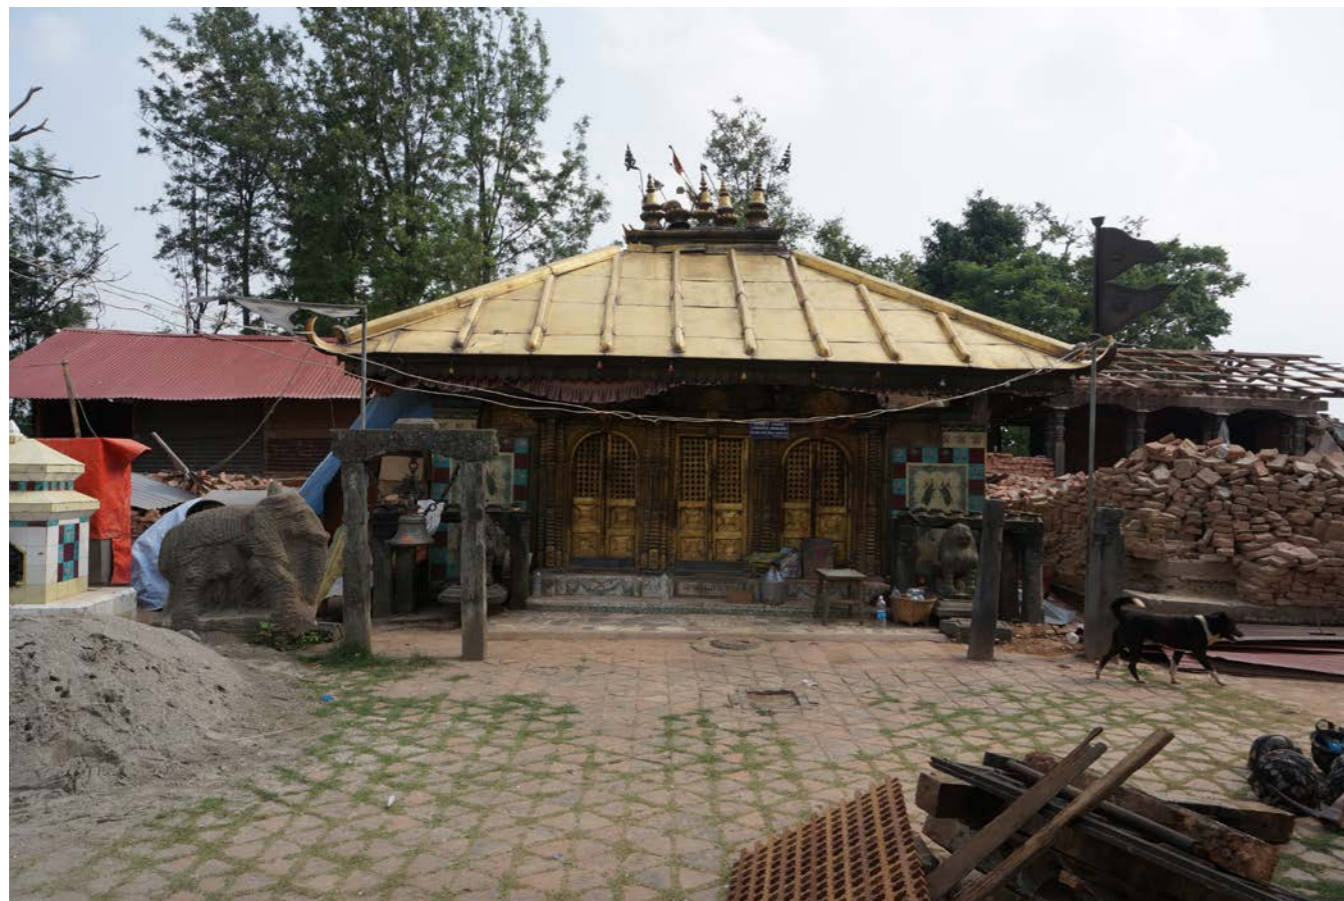
34 CHINNAMASTA TEMPLE

NUMBER	NAME	DATE A.D.	TYPOLOGY	GENERAL DESCRIPTION	DESCRIPTION OF DAMAGE	DANGER
34	Chinnamasta Temple		One-tiered pagoda temple	Rectangular shaped temple with tile and mosaic finish and gilded doors, roof and 5 gajurs.	2nd gajur from left is tilted back The flag pole on the left is bent 90 degrees. The flag (<i>dhwoja</i>) on the right is missing its finial. The N-W corner has some cracks. The lower part of the North door is damaged and parts of its lintels shifted. The toran has missing parts in the lower center.

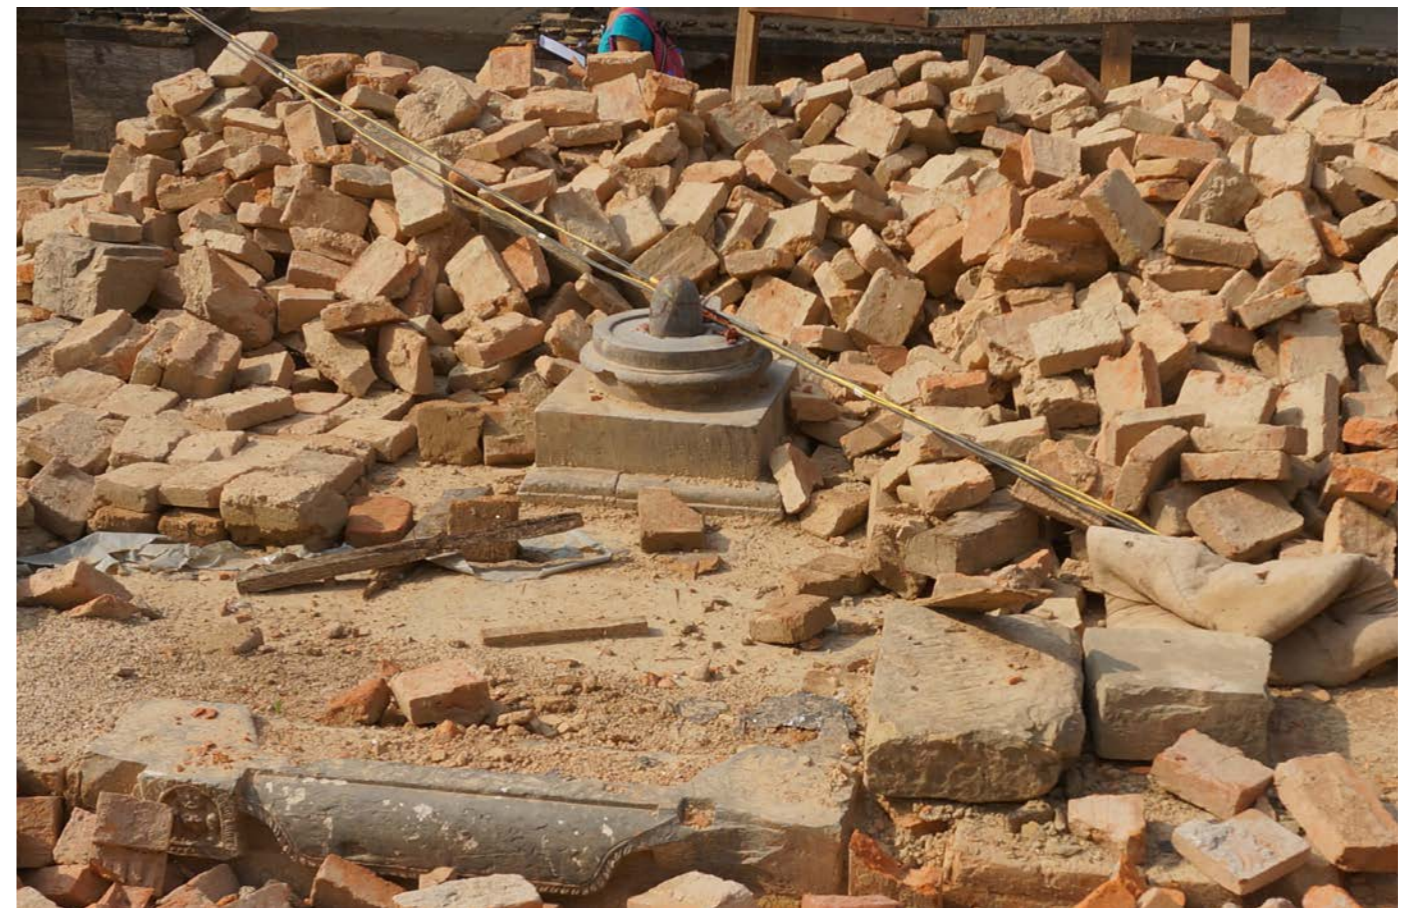
36 SHIVA TEMPLE

NUMBER	NAME	DATE A.D.	TPOLOGY	GENERAL DESCRIPTION	DESCRIPTION OF DAMAGE	DANGER
35			Stone framed bell	Stone structure	Only two posts remain, top part of the frame and the bell are missing The post at right is slightly tilted.	
36			Shiva Temple		Totally collapsed

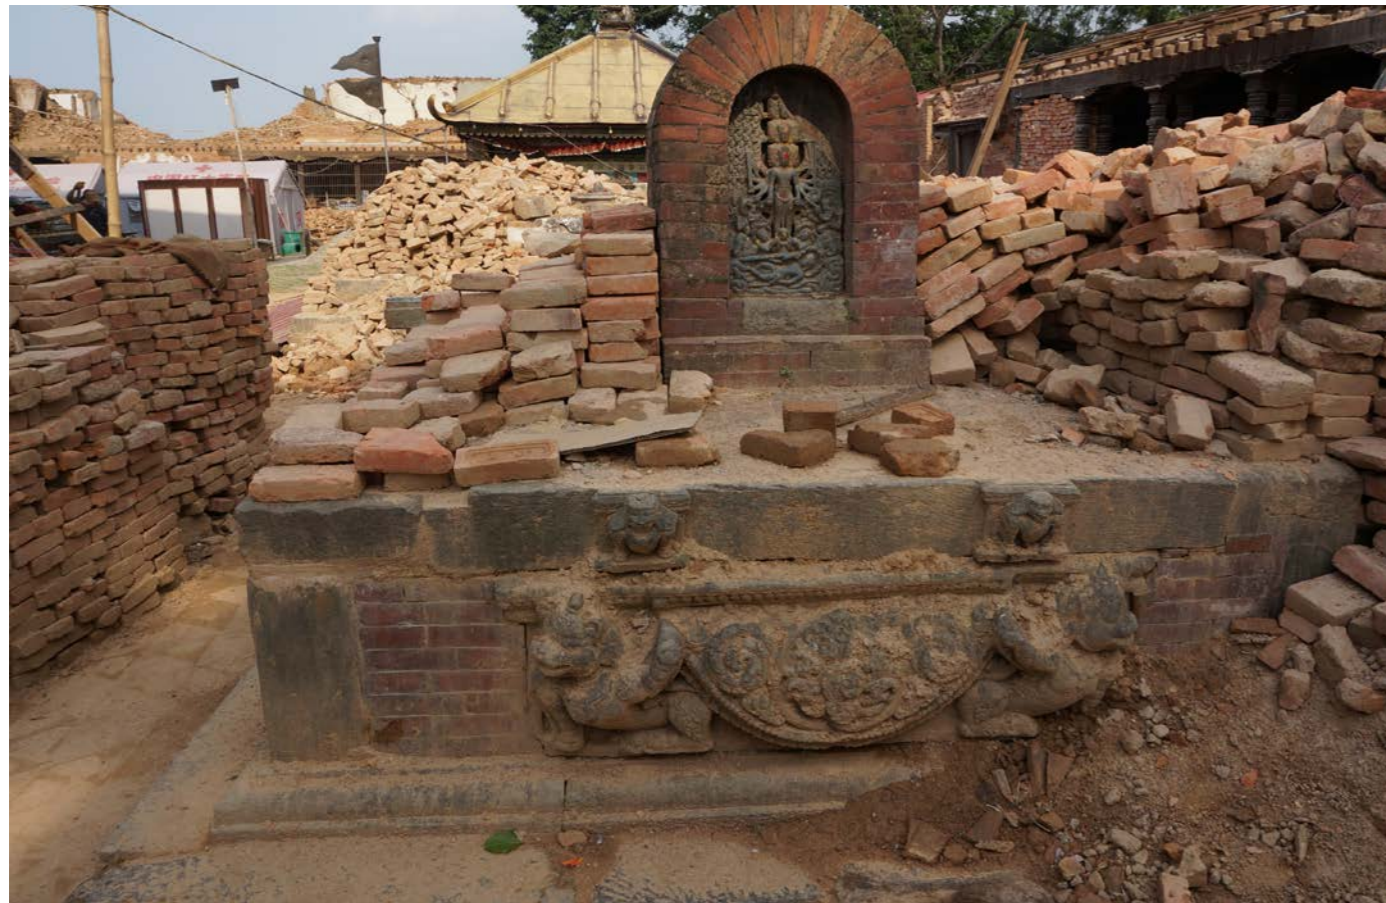
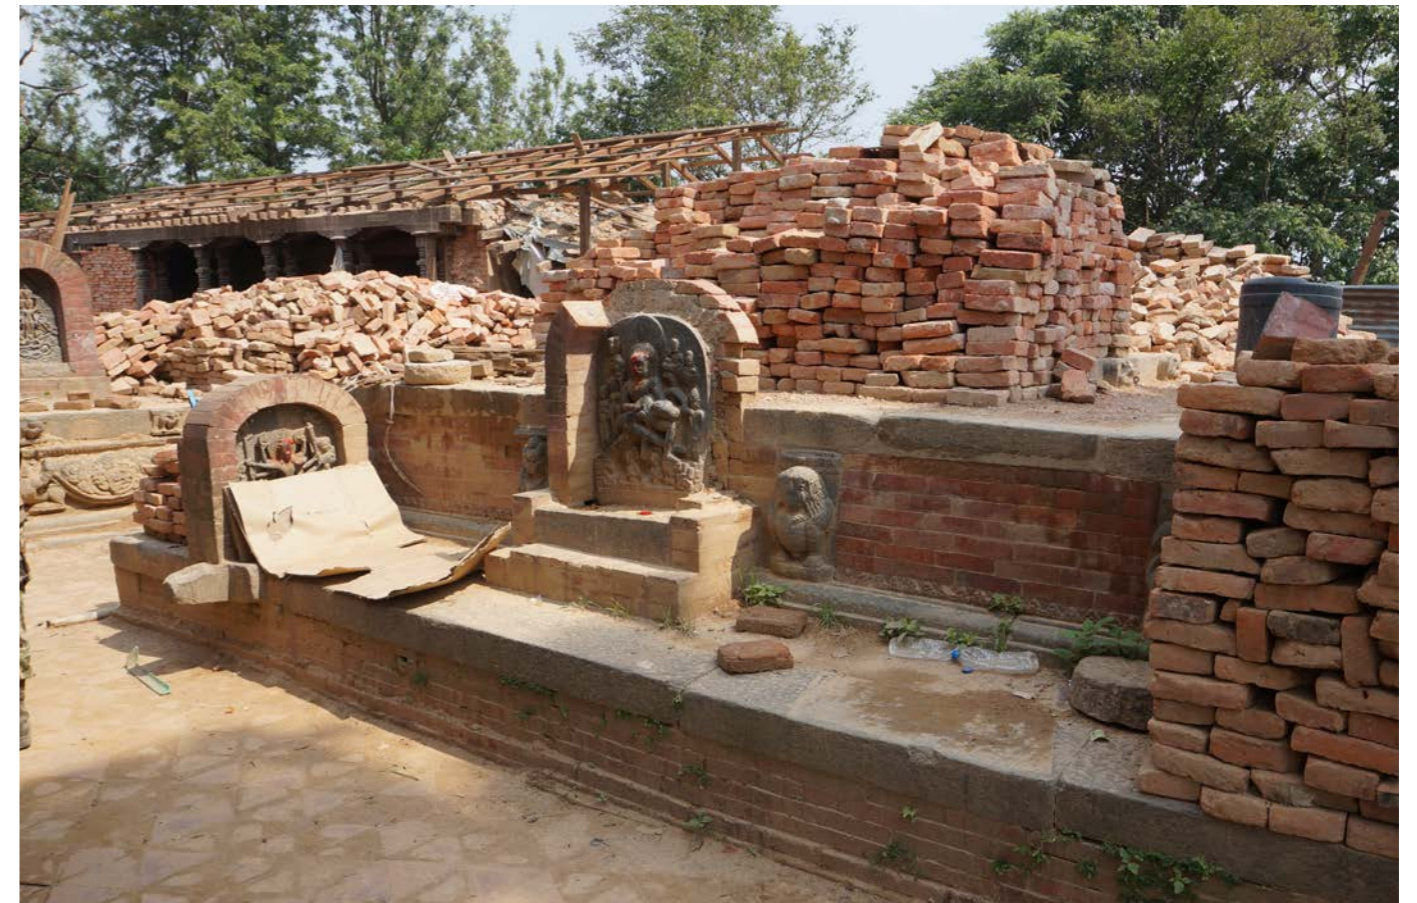
38 VISHNU TEMPLE

NUMBER	NAME	DATE A.D.	TPOLOGY	GENERAL DESCRIPTION	DESCRIPTION OF DAMAGE	DANGER
37	Vishworoop		Open Shrine	Brick enclosed Vishnu statue resting on the platform of a former temple.	Sculpture of Vishnu was damaged before the earthquake. Many bricks and images/elements are kept on top of it, threatening the main sculpture.	
38	Vishnu Temple		Temple	Statues of Baman Awatar and Narsingh resting on the lower platform of a former temple.	The statues are undamaged but the brick arch above Narsingh collapsed.

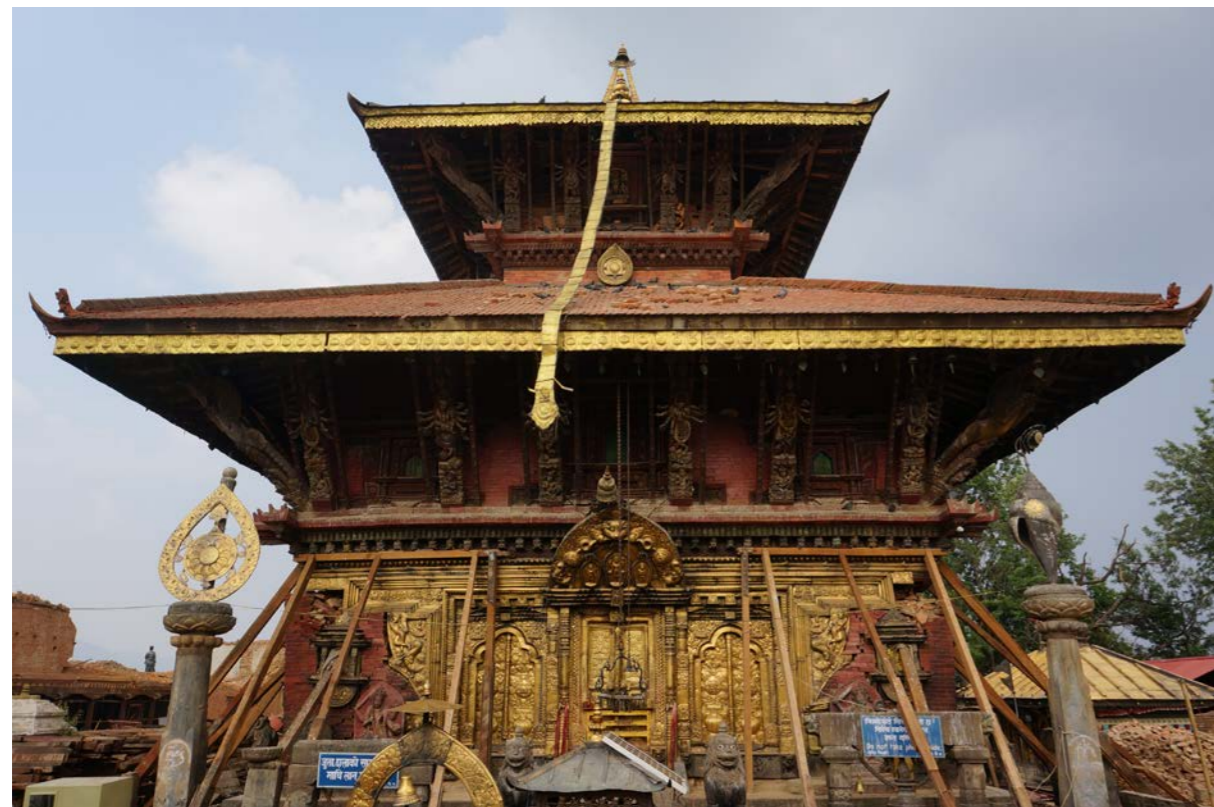
40 CHANGU NARAYAN TEMPLE

NUMBER	NAME	DATE A.D.	TYPOLOGY	GENERAL DESCRIPTION	DESCRIPTION OF DAMAGE	DANGER
40	Changu Narayan Temple		2 tiered Pagoda Temple	Pagoda temple constructed with dachi apa on outer façade and multiple inner walls in uncooked bricks Gilt metal roof	Corner cracks on all façades - most critical on W side (nearly in a state of collapsing). Stepped cracks above entrance gate and between tundals. Corner walls heavily damaged, Plinth are in good condition. Wooden ladder has damaged the roof. Gajur is tilted

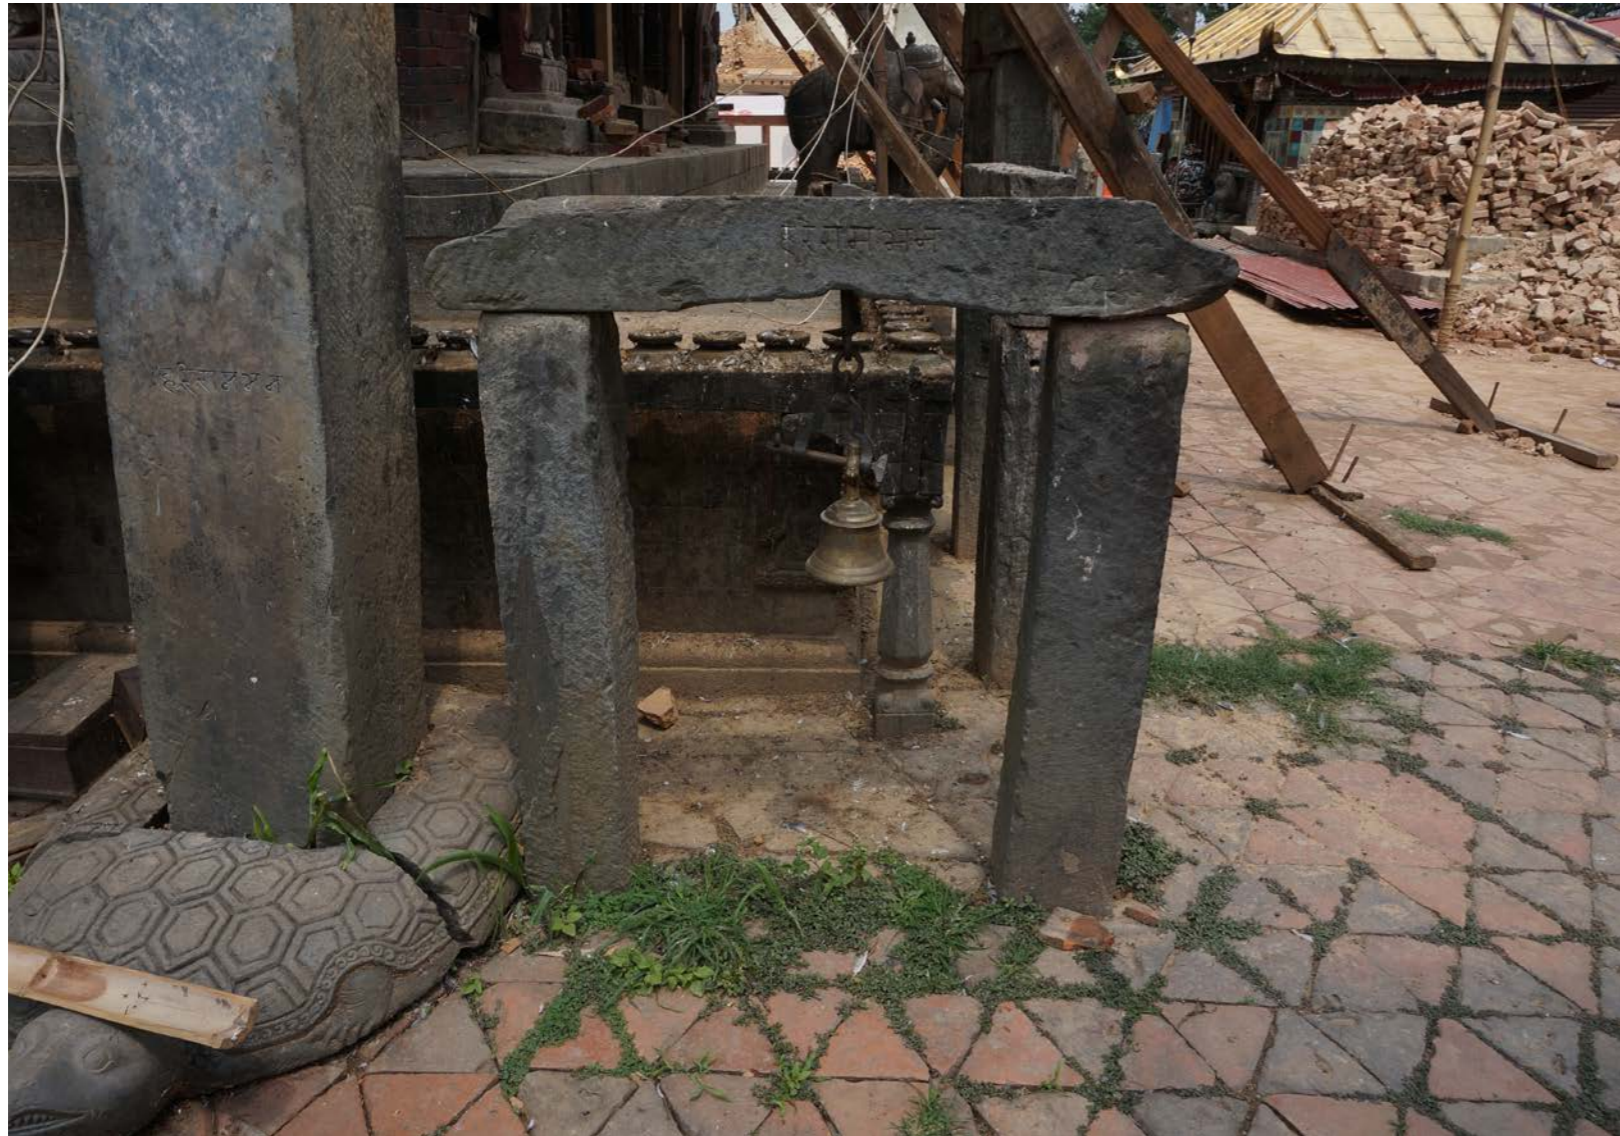
40 b STONE PILLAR 40 e LION STATUE

NUMBER	NAME	DATE A.D.	TPOLOGY	GENERAL DESCRIPTION	DESCRIPTION OF DAMAGE	ANGER
40 a			Stone framed bell	Stone frame with small bell	No major damages, Consolidated	
40 b			Stone pillar	Stone pillar on a turtle base supporting a stone lotus base and a metal conch	Tilting towards south. Cracked Stone turtle	
40 e			Statue of lion	Guardian Lions	Minor gap in the stone base No other damage

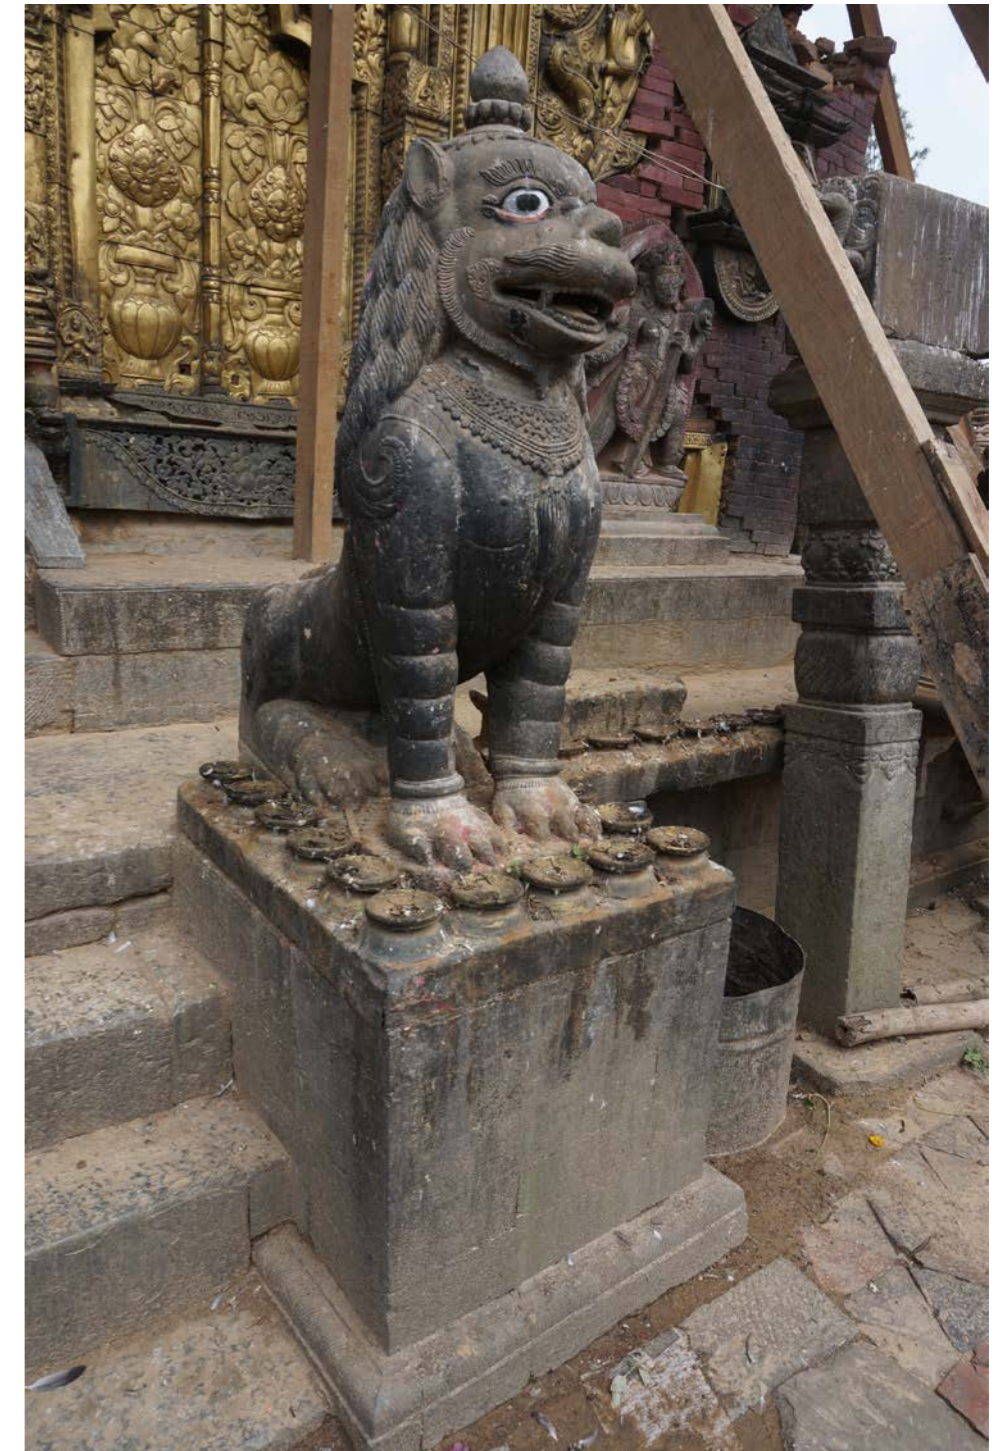
40 d LION STATUE

NUMBER	NAME	DATE A.D.	TYPOLOGY	GENERAL DESCRIPTION	DESCRIPTION OF DAMAGE	DANGER
40 c	Stone framed bell		Stone Structure	Stone Structure	Cracked base of south post Upper part of the frame is not stable Entire Structure is tilted	
40 d	Statue of lion		Guardian Lions	Guardian Lions	Oil lamp base is slightly dislocated

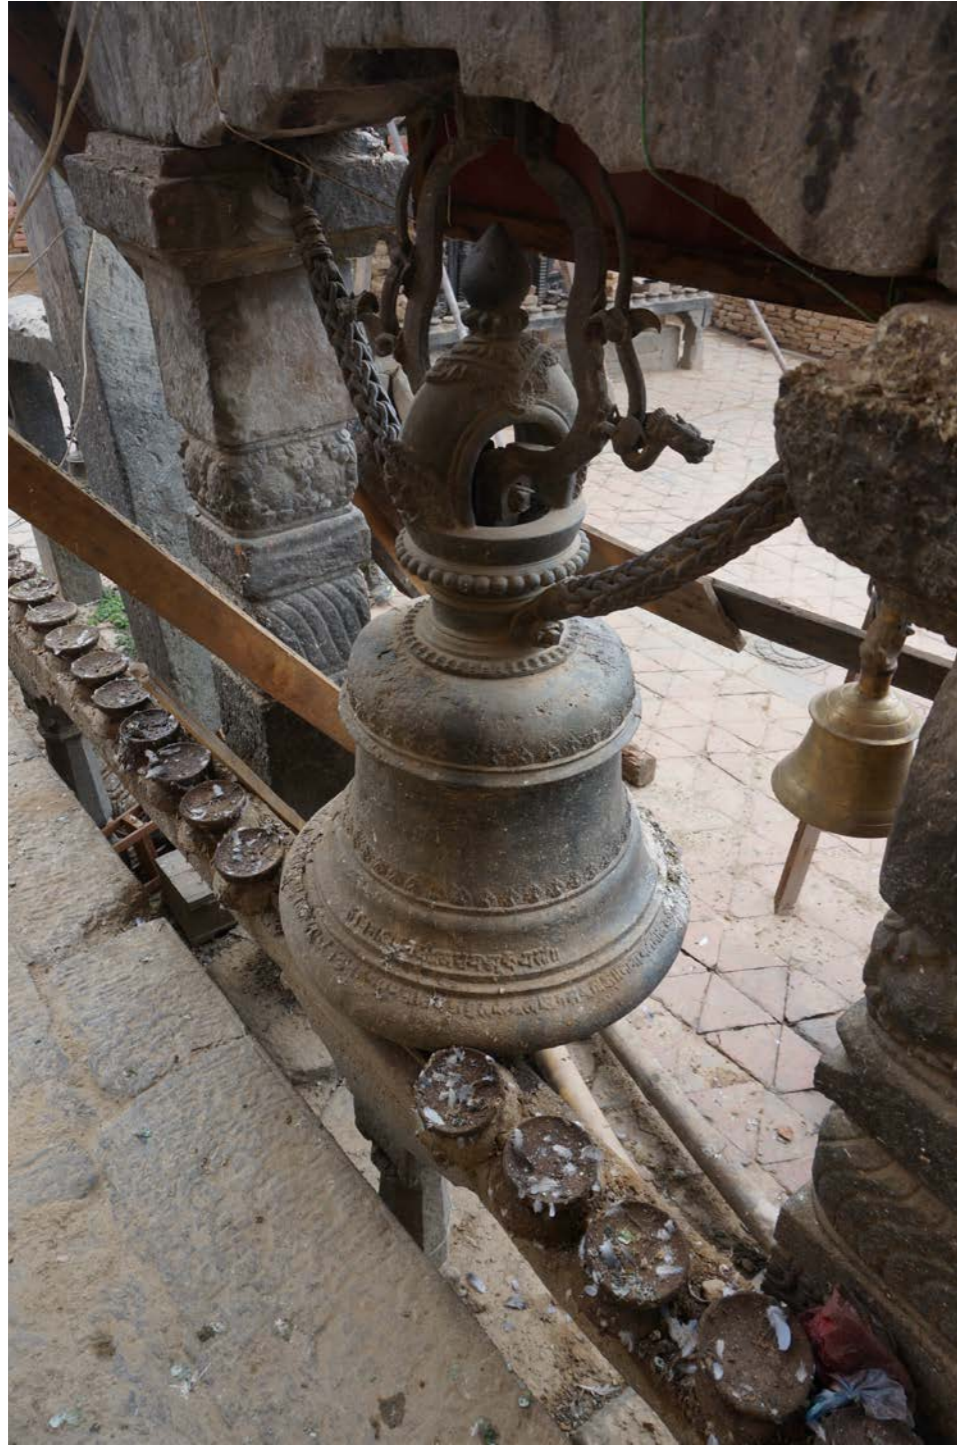
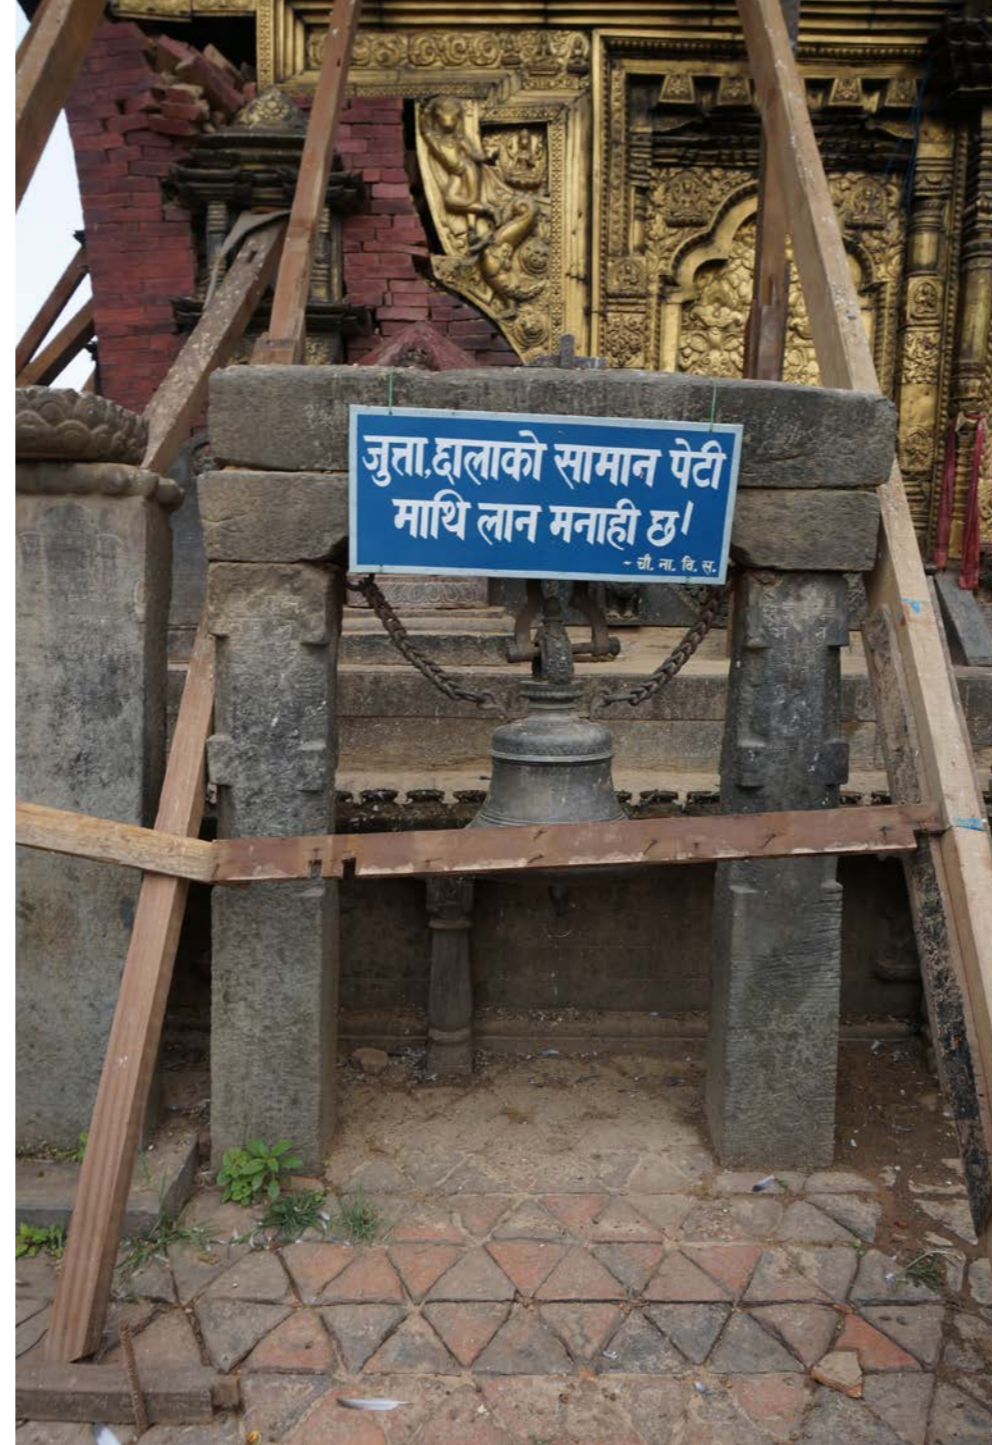
40 f STONE FRAMED BELL

NUMBER	NAME	DATE A.D.	TPOLOGY	GENERAL DESCRIPTION	DESCRIPTION OF DAMAGE	ANGER
40 f			Stone framed bell	Stone structure	Upper part of the frame is tilted

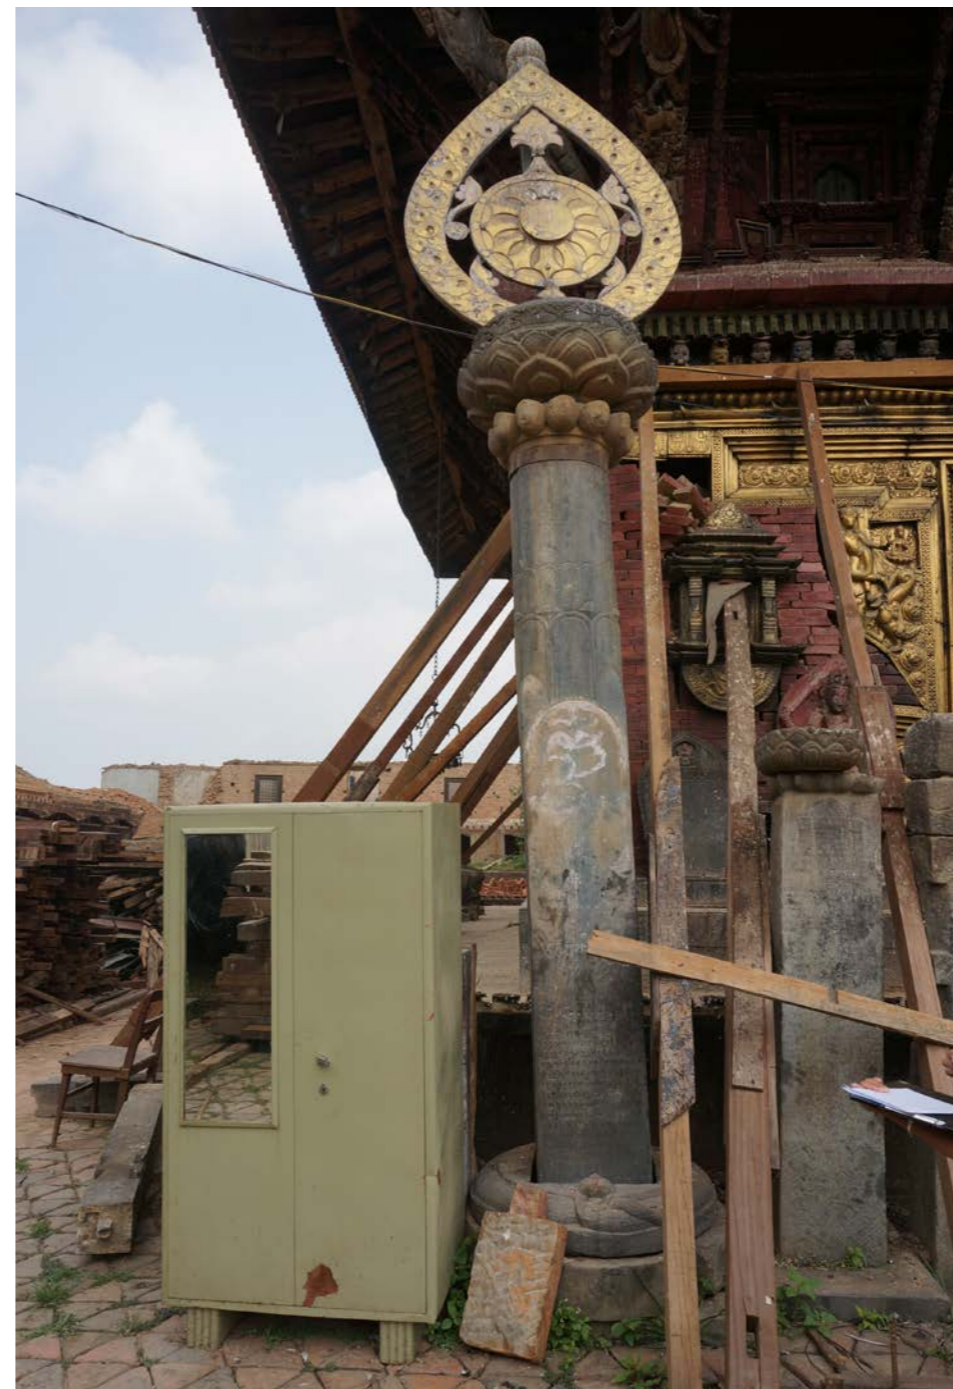
40 h STONE POST

NUMBER	NAME	DATE A.D.	TYPOLOGY	GENERAL DESCRIPTION	DESCRIPTION OF DAMAGE	DANGER
40 g			Stone Pillar	Stone post on a stone base Post has an ancient inscription	Post tilting towards south Lotus on top of post rotated 90 degree	
40 h			Stone Pillar	Stone Post on a stone serpent base there is a lotus structure on the top of the post with metal Chakra.	Tilted towards north east.

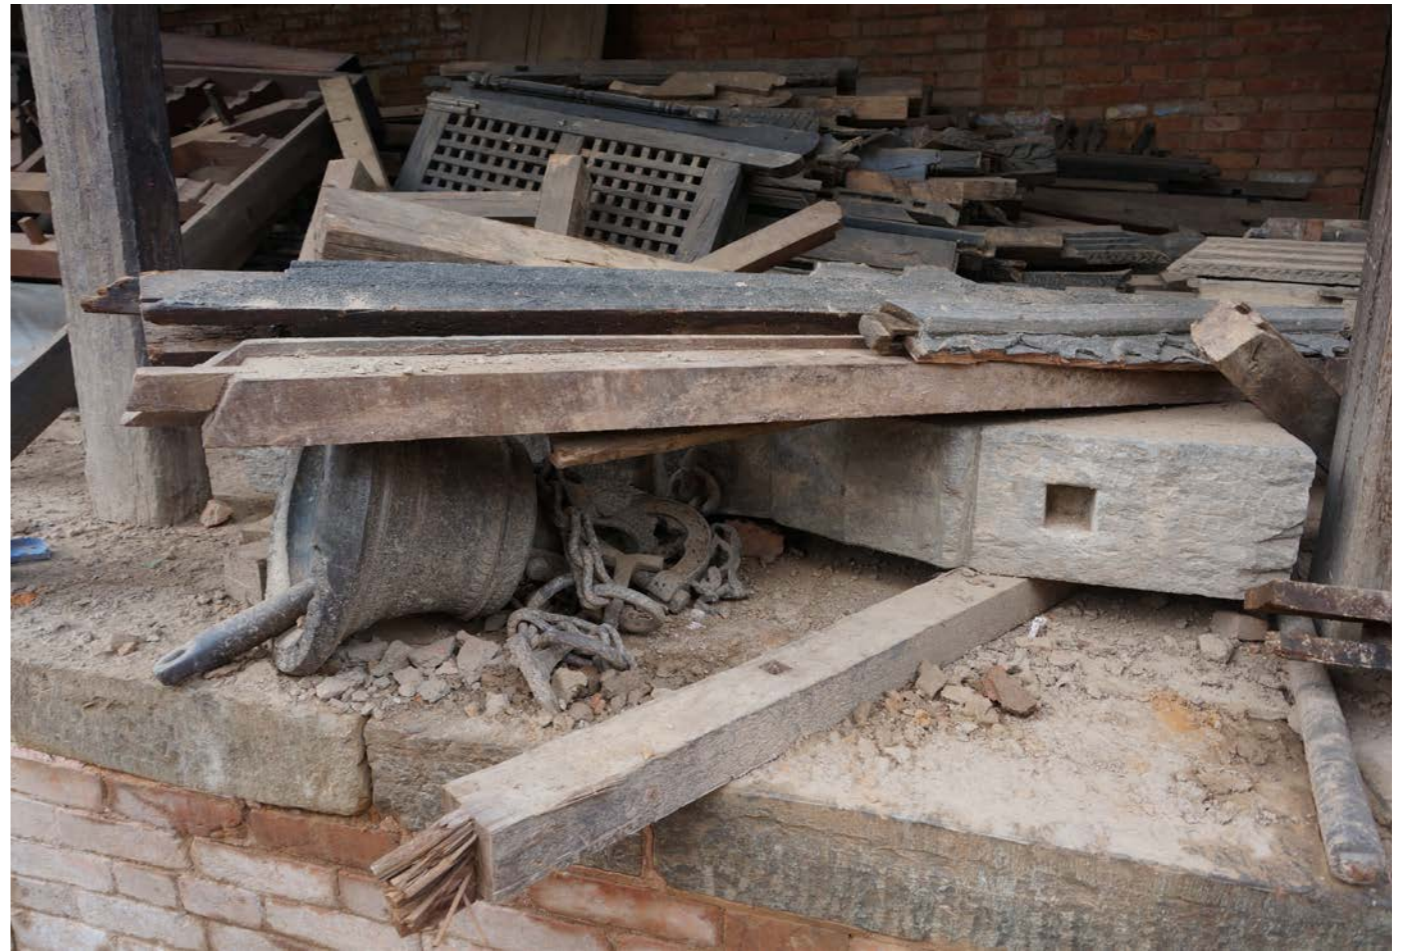
40 j STONE FRAMED BELL

NUMBER	NAME	DATE A.D.	TPOLOGY	GENERAL DESCRIPTION	DESCRIPTION OF DAMAGE	ANGER
40 i			Stone Inscription	Stone inscription about 3'6" tall	Stone frame top of S-frame fallen nearby	
40 j		2067 BS	Stone framed bell	Stone structure (Bells Stored by DoA)	Completely Collapsed
