2015 Earthquake Damage Mapping
Changunarayan Monument Zone
Kathmandu Valley World Heritage Property

November 2015

This assessment was supported by
UNESCO Office in Kathmandu

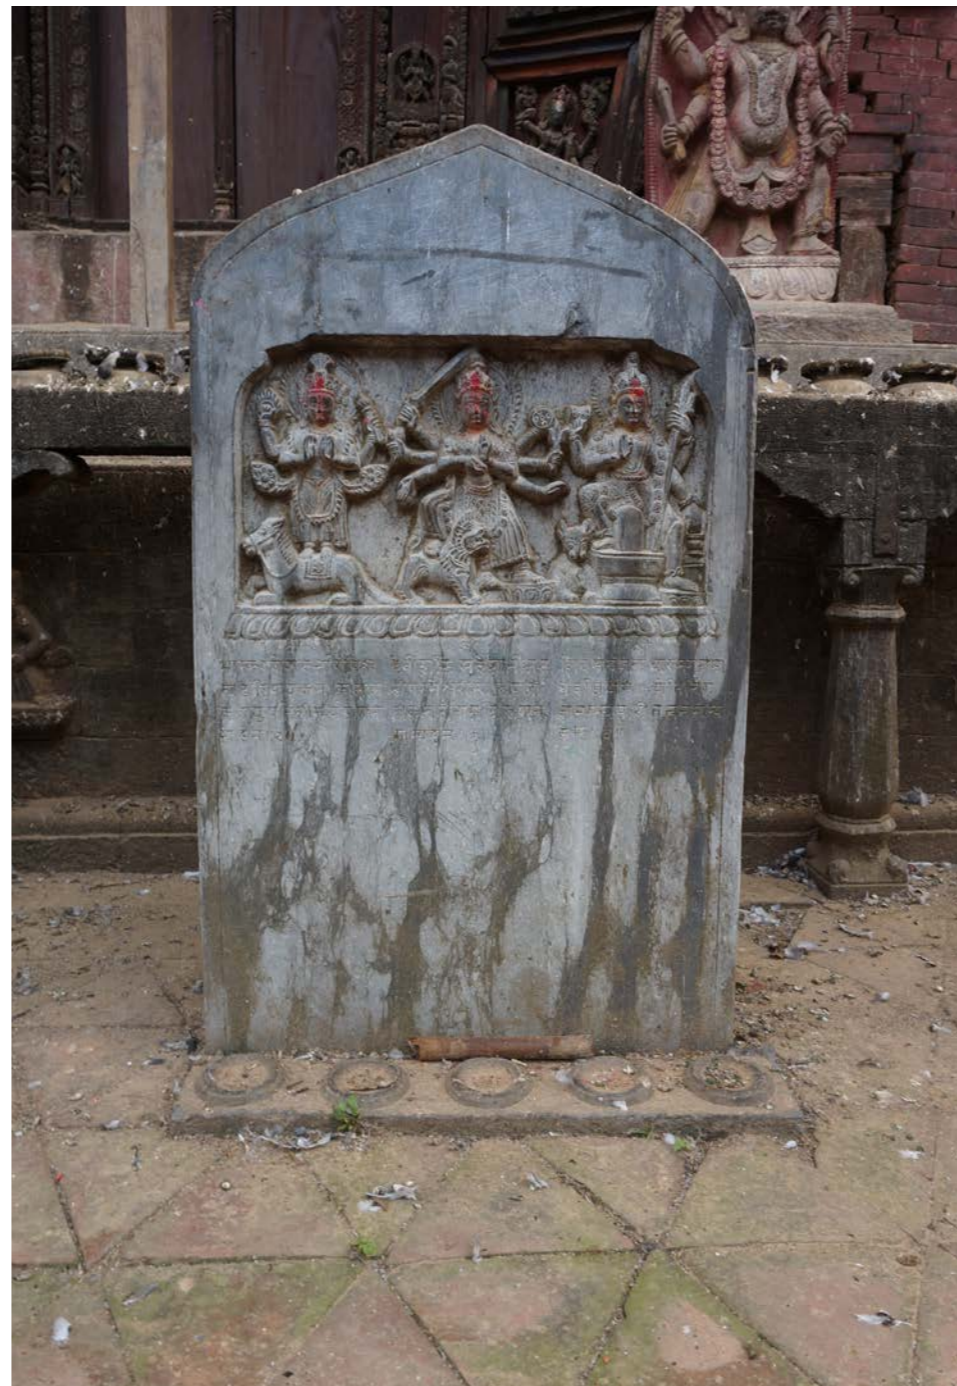
40 l STELE

NUMBER	NAME	DATE A.D.	TYPOLOGY	GENERAL DESCRIPTION	DESCRIPTION OF DAMAGE	DANGER
40k			Stone framed bell	Stone structure (Bells Stored by DoA)	Collapsed, stone post standing but tilted	
40 l			Stone In-scription	Stone stele with 3 carved images on the front, Ganesh to the east and Narayan to the west	Slightly tilted towards back

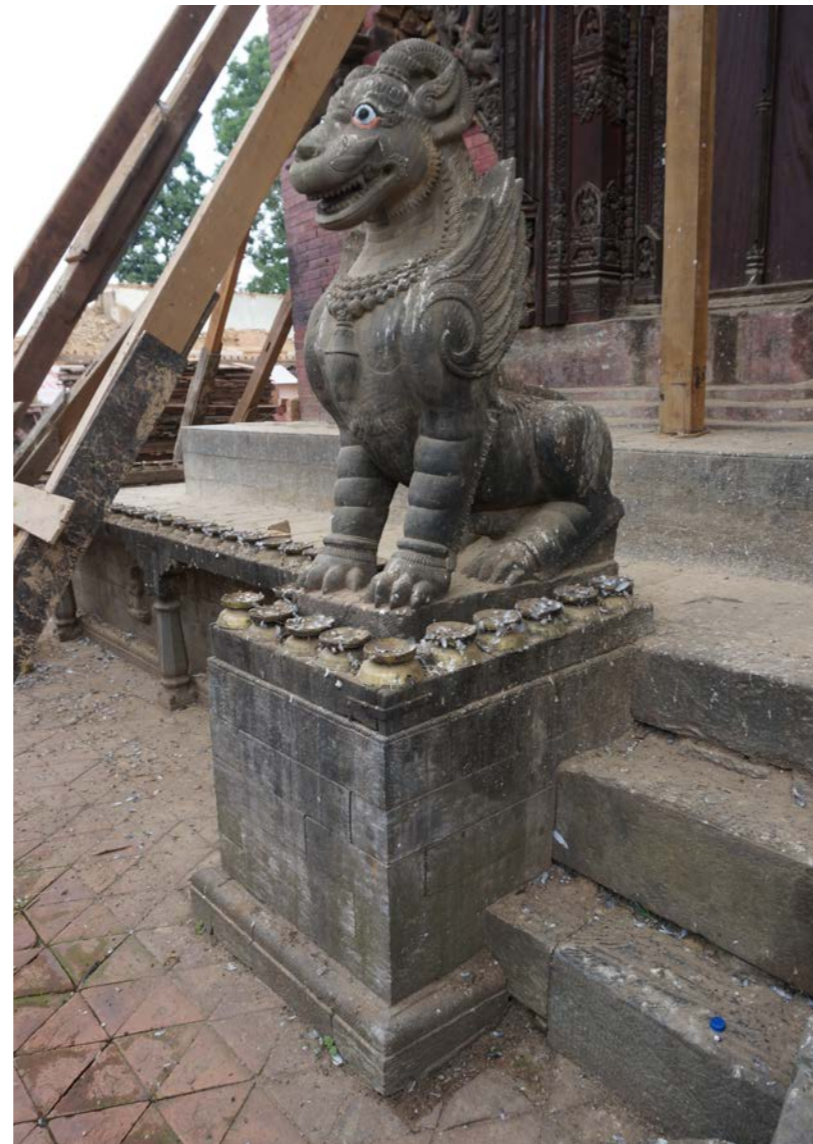
40 o STONE STATUE

NUMBER	NAME	DATE A.D.	TPOLOGY	GENERAL DESCRIPTION	DESCRIPTION OF DAMAGE	ANGER
40m			Stone statue		No visible Damage	
40n			Stone water spout	Stone statue with stone collecting bowl		
40o			Stone Statue		Small gaps between stones of the base, No other damages

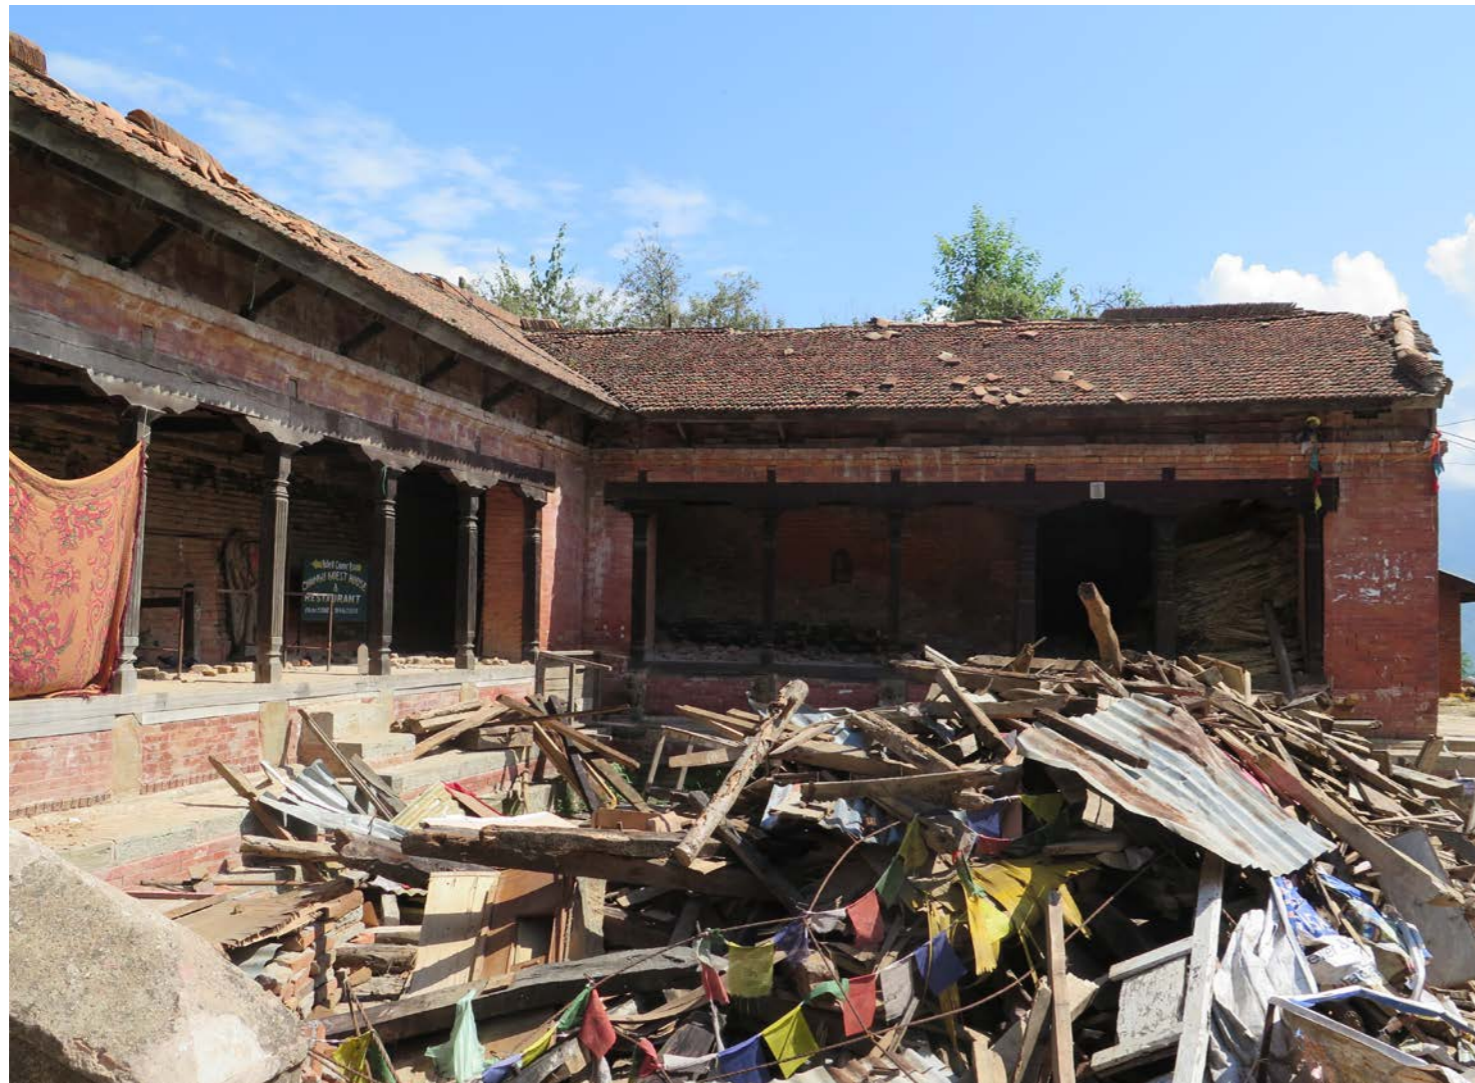
41 PATI

NUMBER	NAME	DATE A.D.	TYPOLOGY	GENERAL DESCRIPTION	DESCRIPTION OF DAMAGE	DANGER
41	17th Century (renovated on 2046 BS)		Pati	Brick and wooden structure with <i>jhingati</i> on the roof.	There are gaps between bricks and wooden post in S-façade There are cacks in the N-façade Roof tiles damages and fallen Inner walls have severe multiple cracks Wooden struts are displaced.

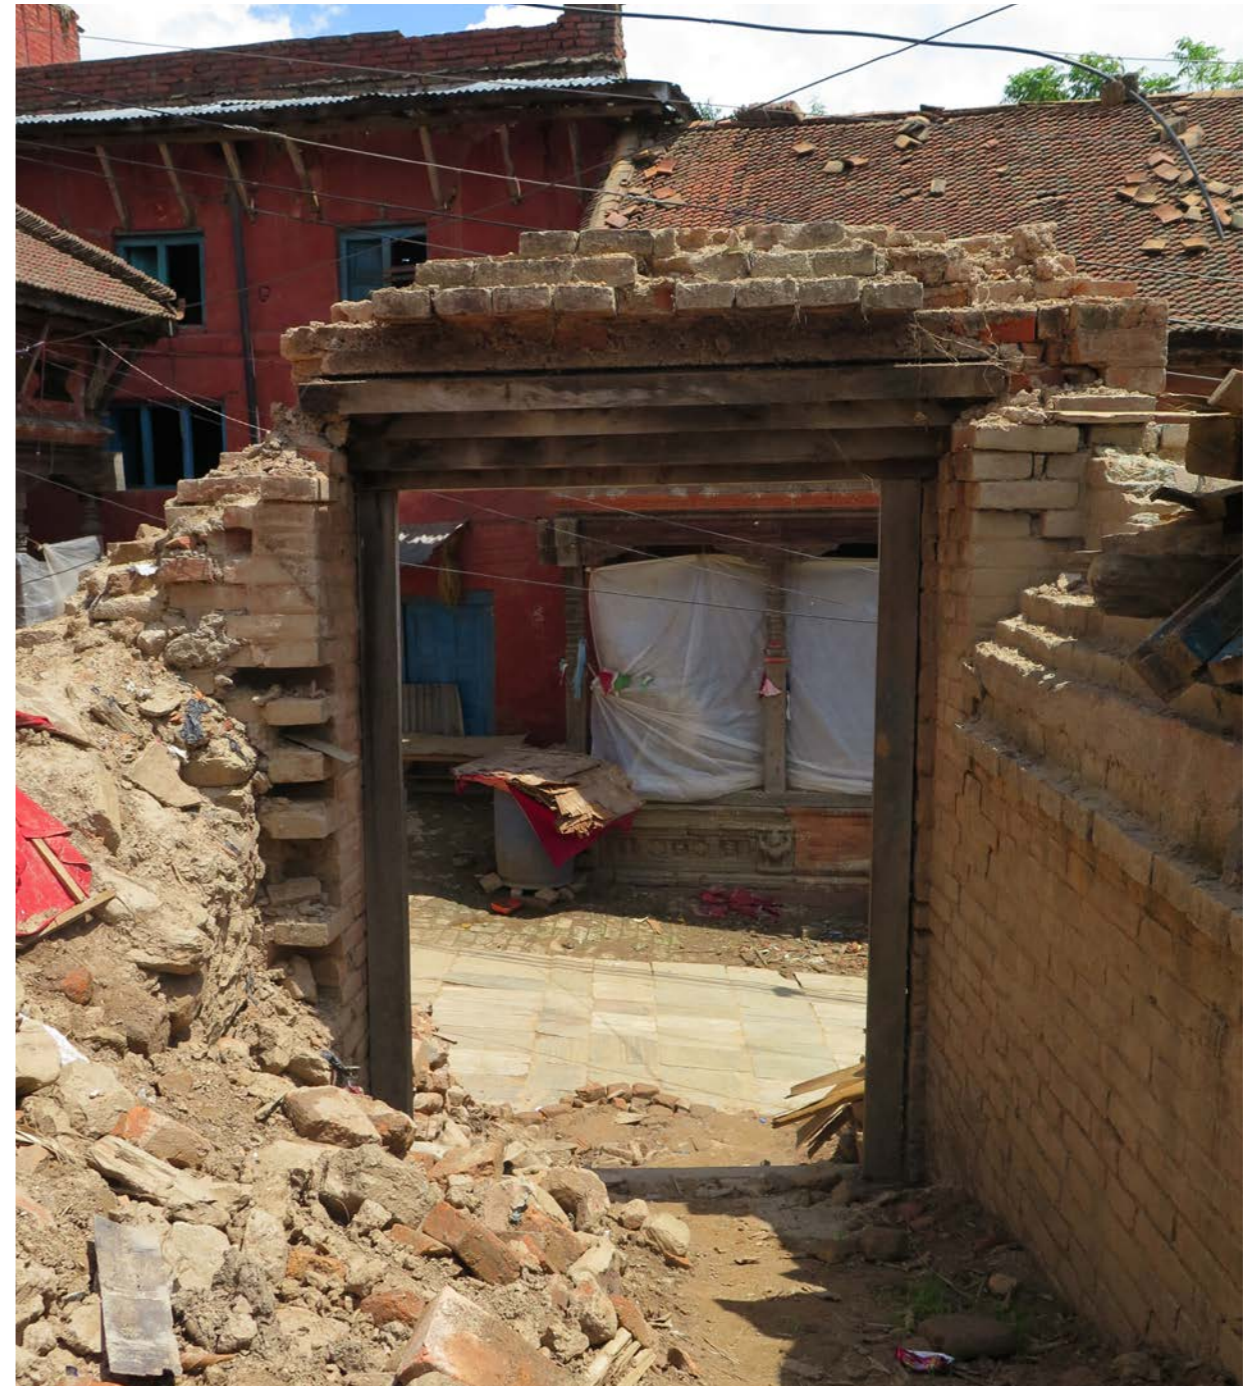
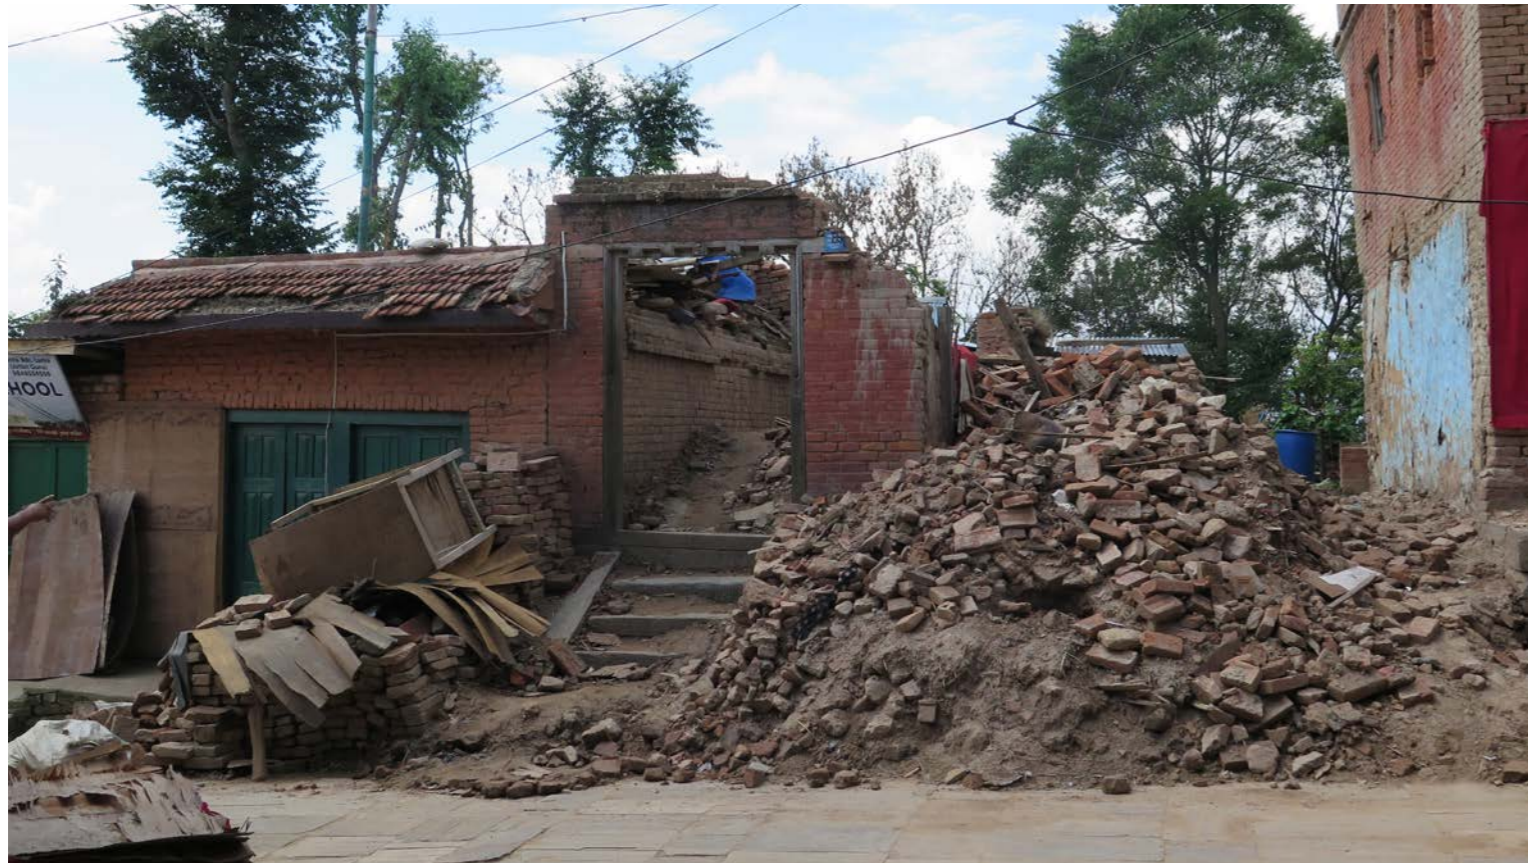
42 DOOR

NUMBER	NAME	DATE A.D.	TPOLOGY	GENERAL DESCRIPTION	DESCRIPTION OF DAMAGE	DANGER
42			Wooden Door	Wooden door of Open Sky Museum	Prone to collapse

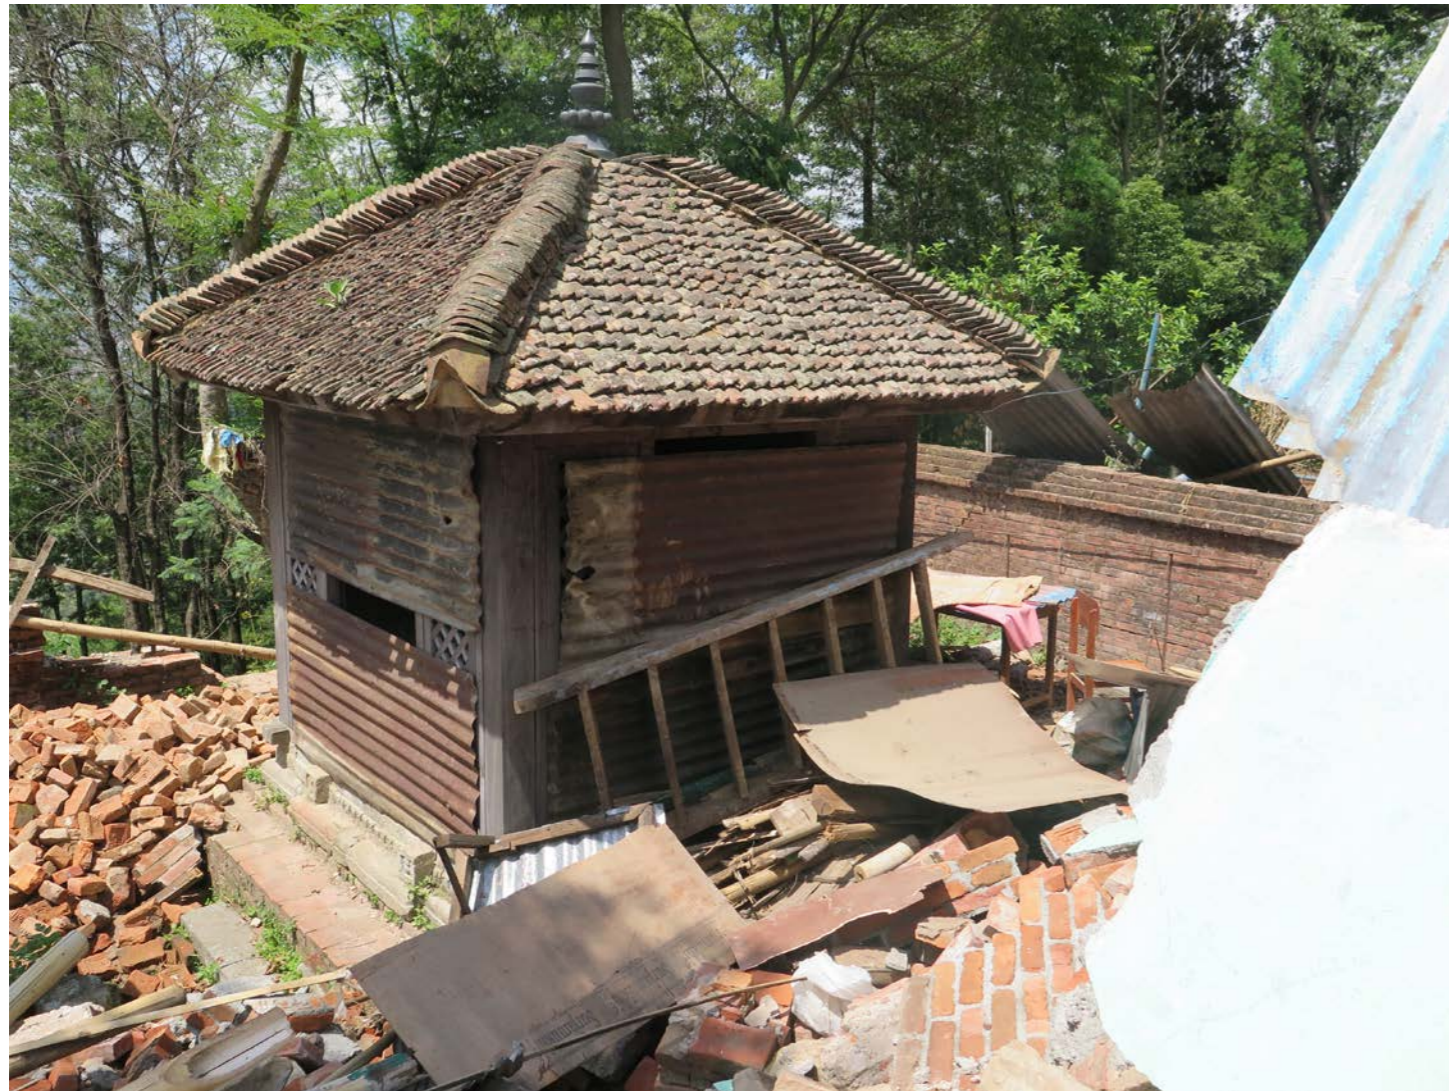
43 MUSEUM

NUMBER	NAME	DATE A.D.	TYPOLOGY	GENERAL DESCRIPTION	DESCRIPTION OF DAMAGE	DANGER
43		1998 BS	Museum	Single storey structure at middle of the museum.	Walls have collapsed

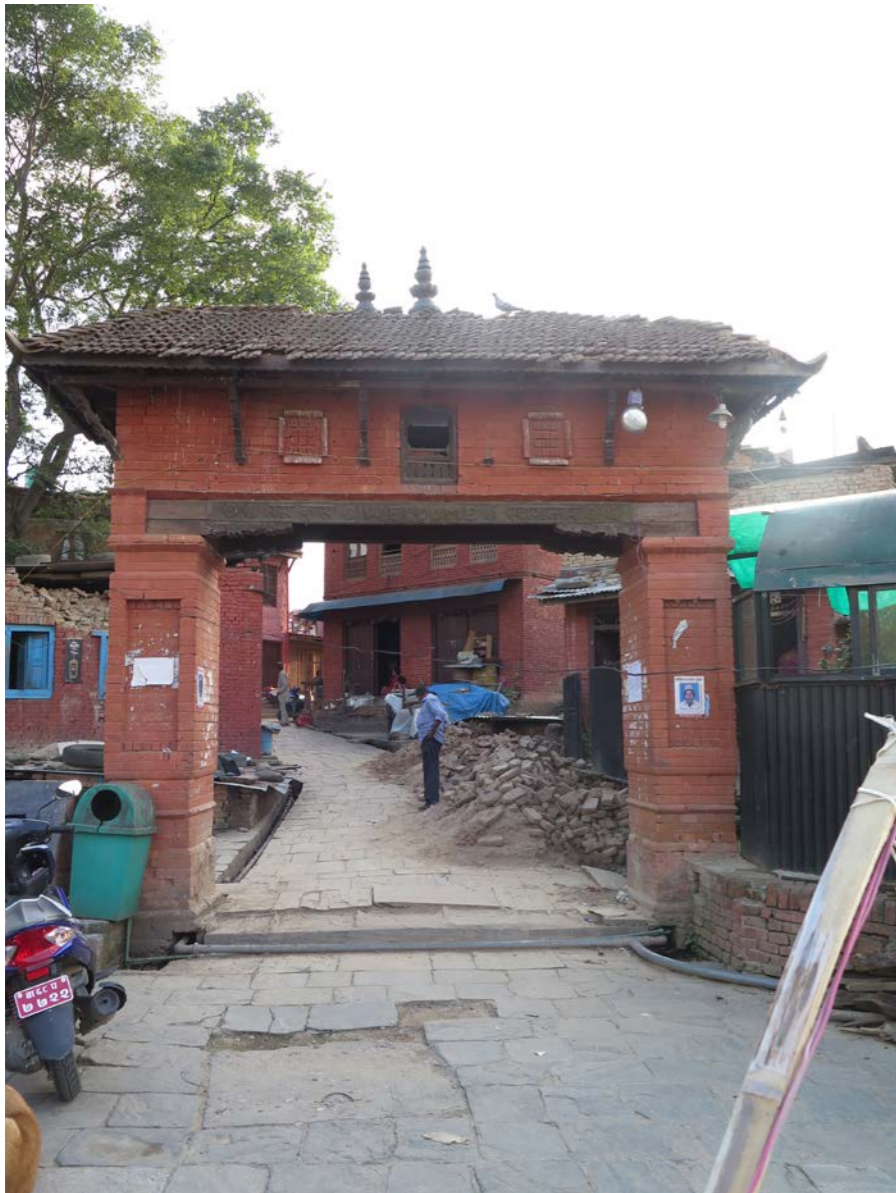
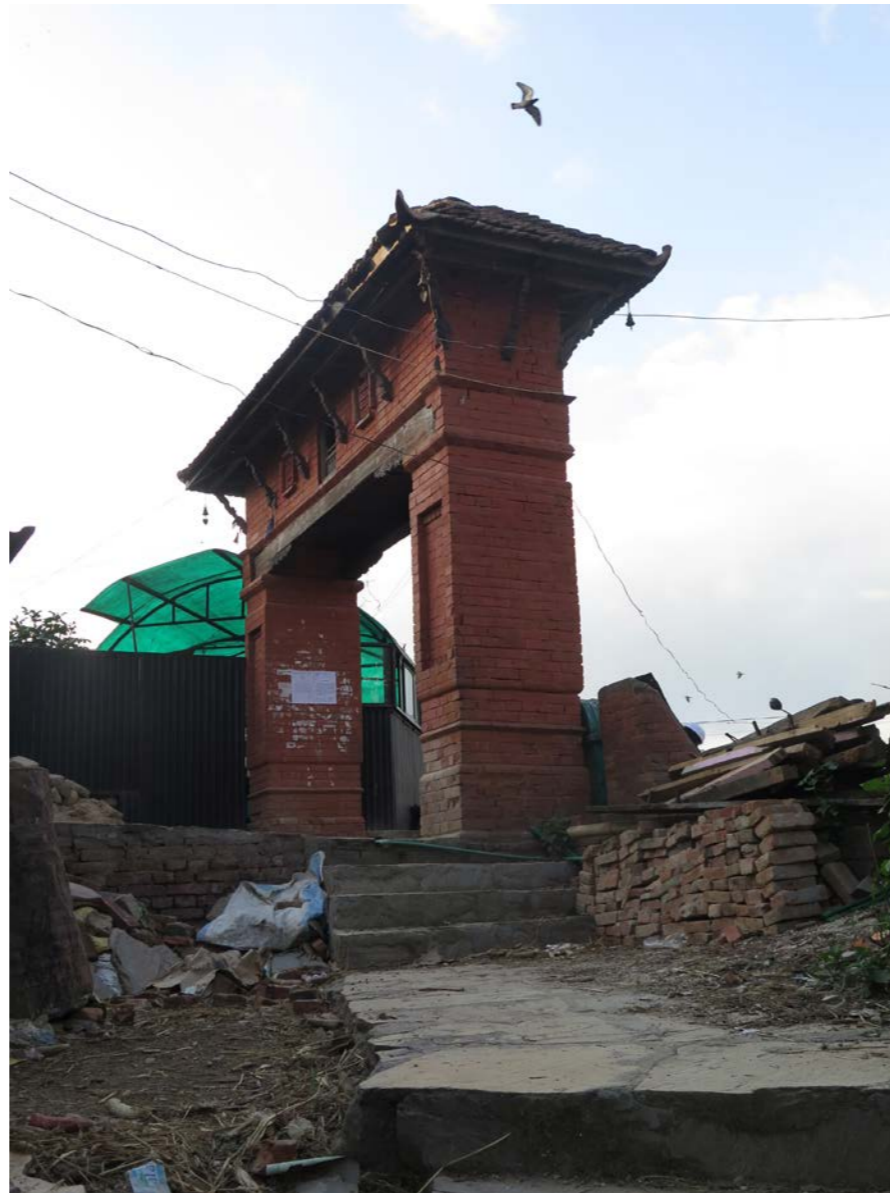
46 GATE

NUMBER	NAME	DATE A.D.	TPOLOGY	GENERAL DESCRIPTION	DESCRIPTION OF DAMAGE	DANGER
46			Gate	Brick structure in cement mortar	Cracks in West pillar.

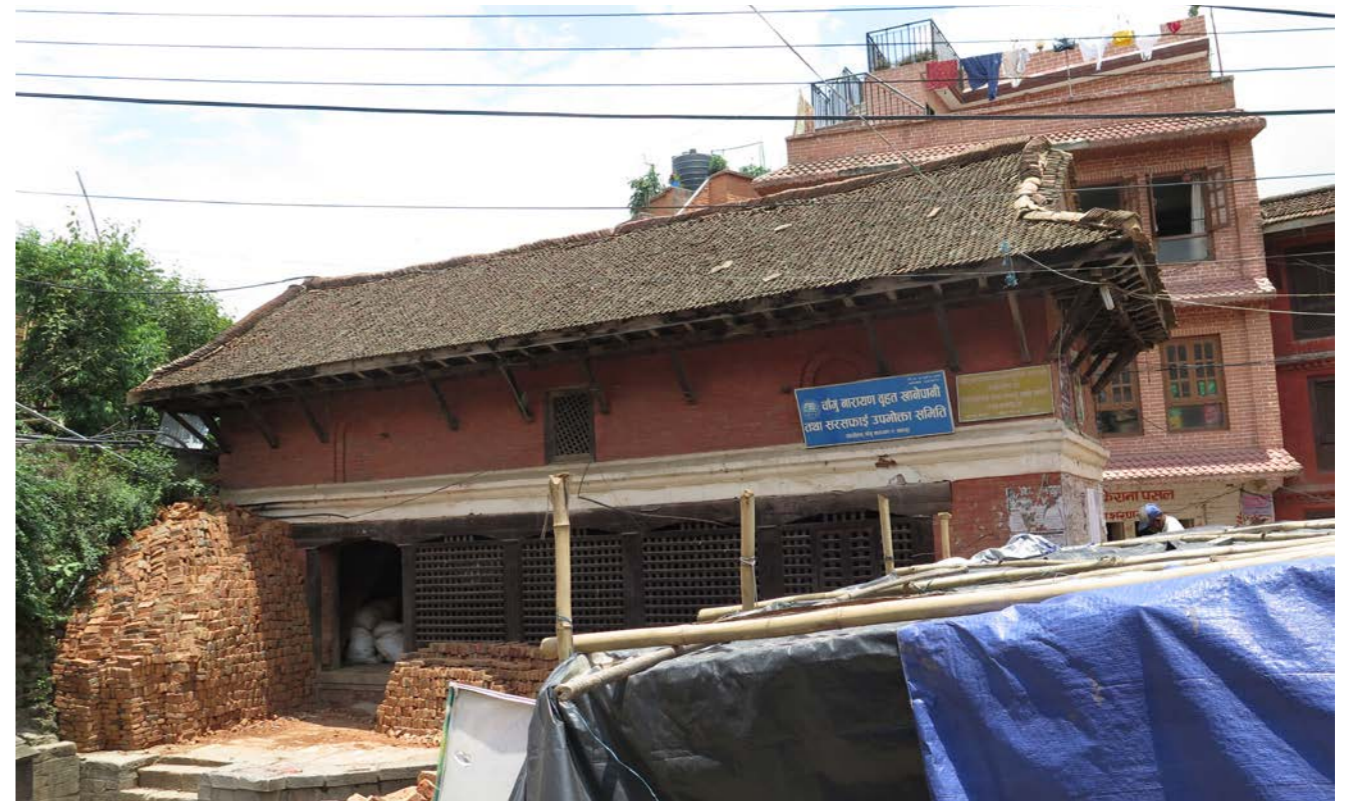
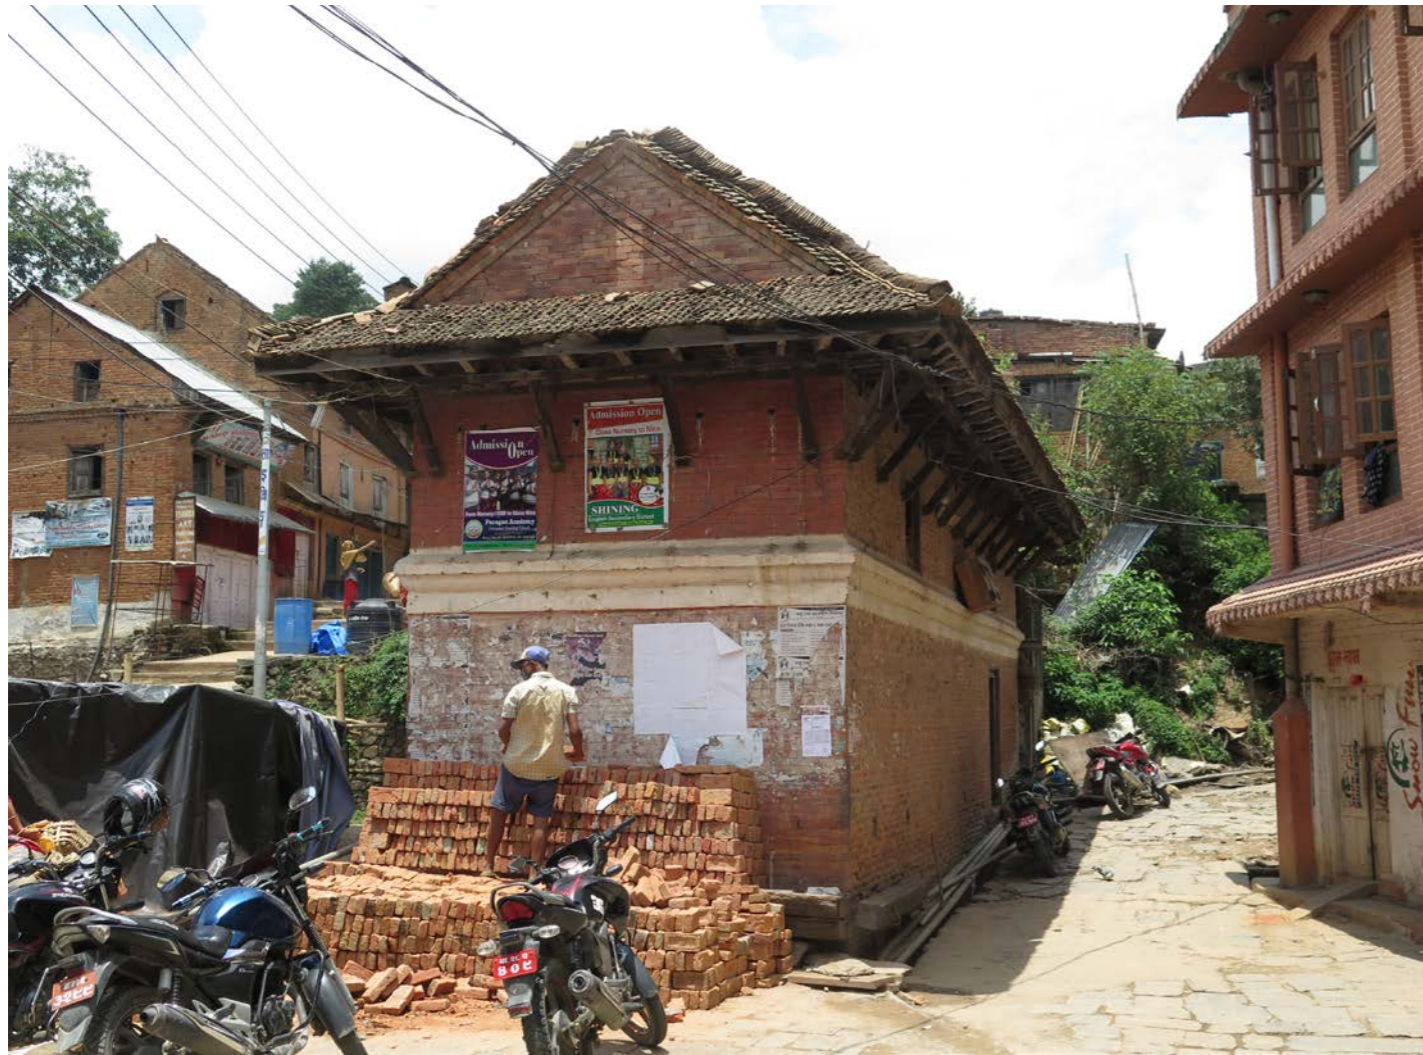
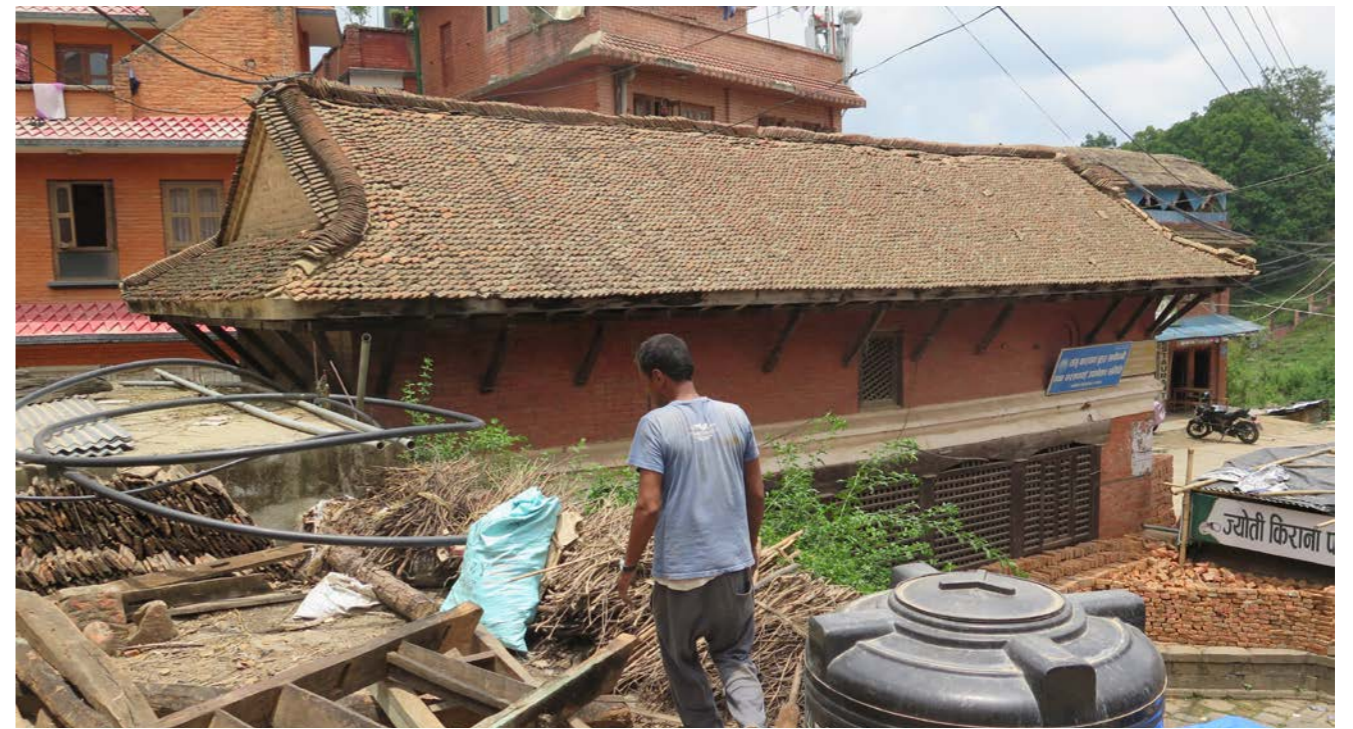
53 PATI

NUMBER	NAME	DATE A.D.	TYOLOGY	GENERAL DESCRIPTION	DESCRIPTION OF DAMAGE	ANGER
53			<i>Pati</i>	<i>Pati</i> is adopted as Water supply and sanitation office.	Missing few tiles of the roof Minor cracks in the walls

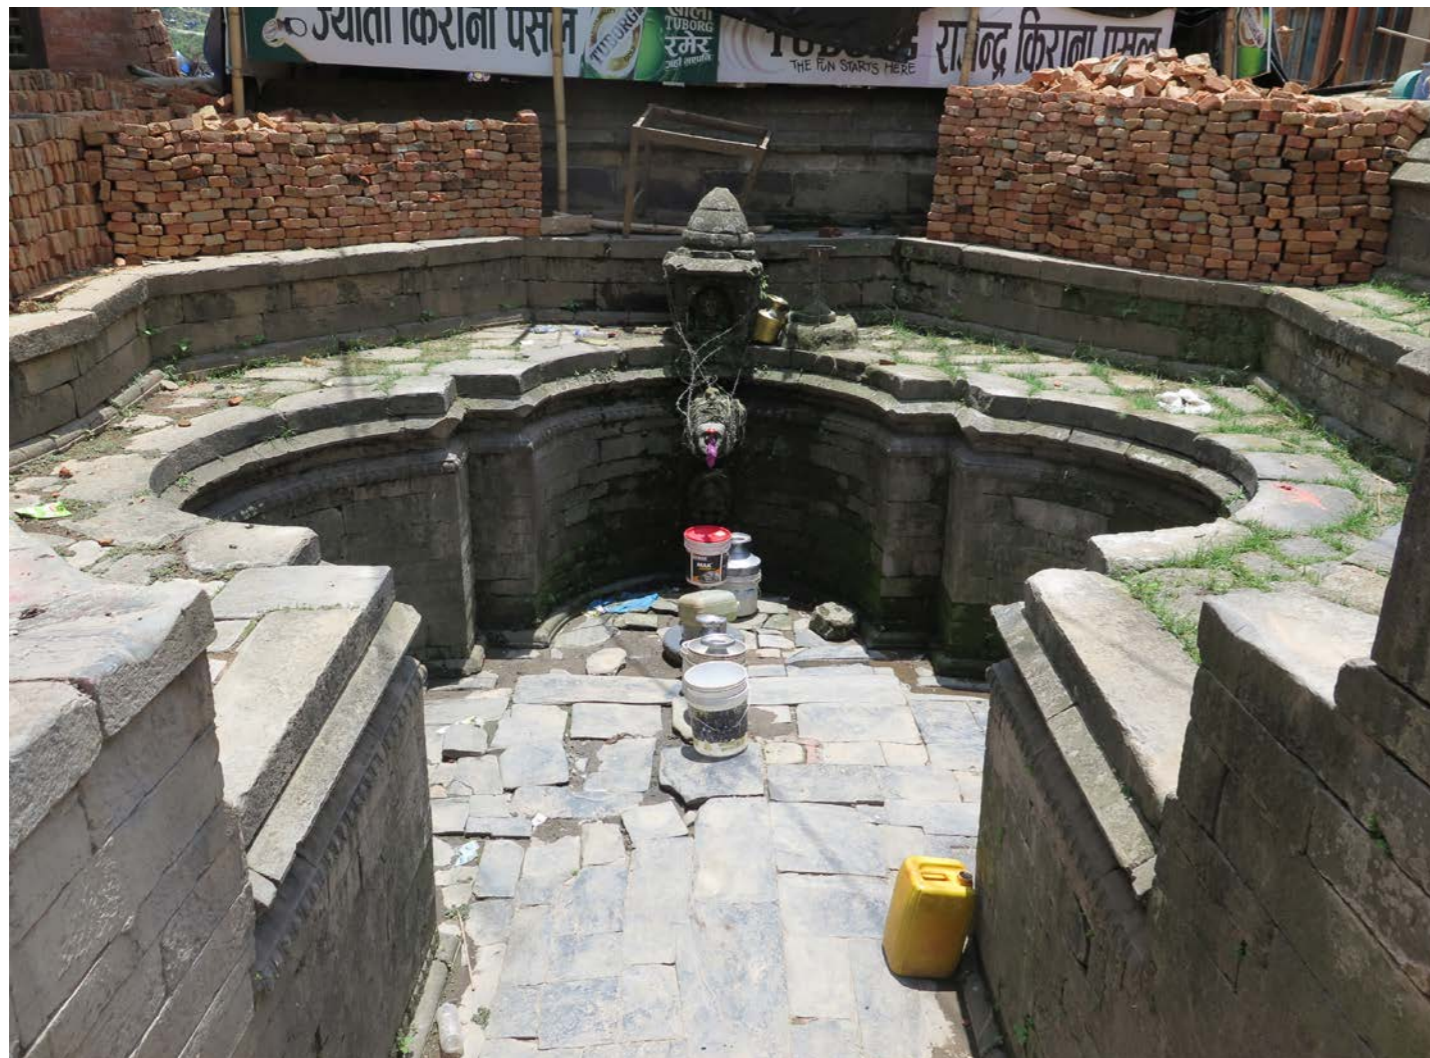
54 WATER SPOUT

NUMBER	NAME	DATE A.D.	TYPOLOGY	GENERAL DESCRIPTION	DESCRIPTION OF DAMAGE	DANGER
54			Hiti	Approximately 3 m deep stone water spout with various sculptures.	No visible structural damage Stone tap covered with barbed wire to prevent form theft of sculptures

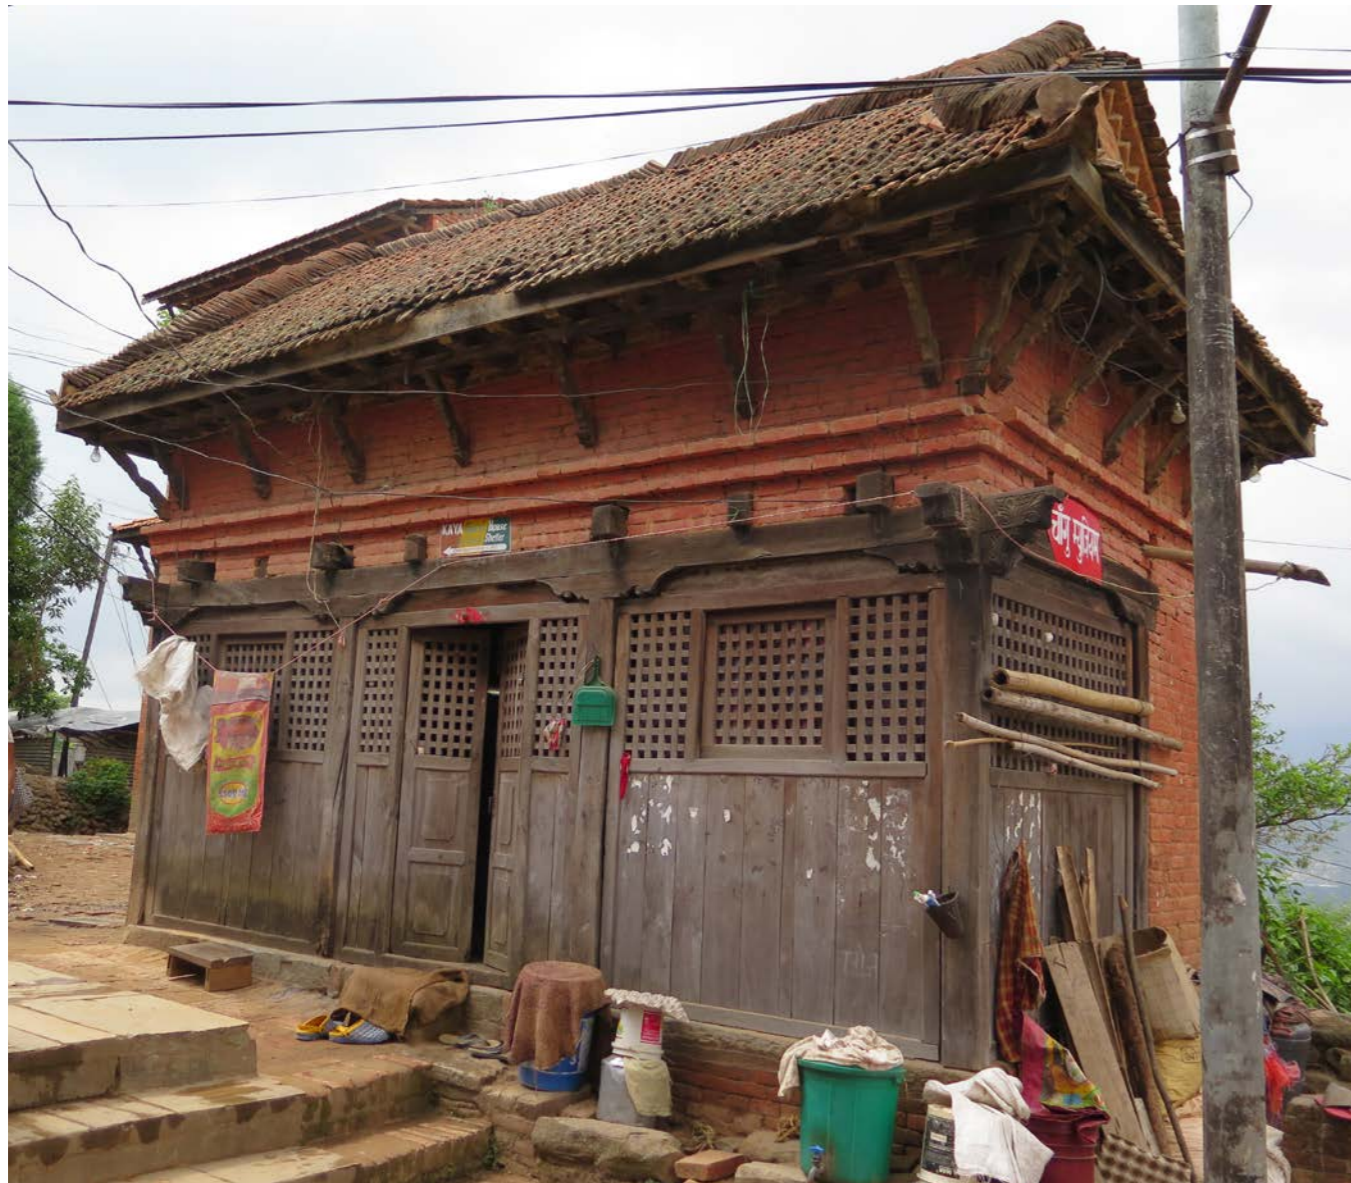
56 PATI

NUMBER	NAME	DATE A.D.	TYPOLOGY	GENERAL DESCRIPTION	DESCRIPTION OF DAMAGE	DANGER
56			<i>Pati</i> (<i>Bhajan ghar</i>)	Single storey <i>pati</i>	Minor cracks Few roof tiles are missing.	
57			Shrine (<i>Chetrapal</i>)	Stone Mandap like structure	No visible damage

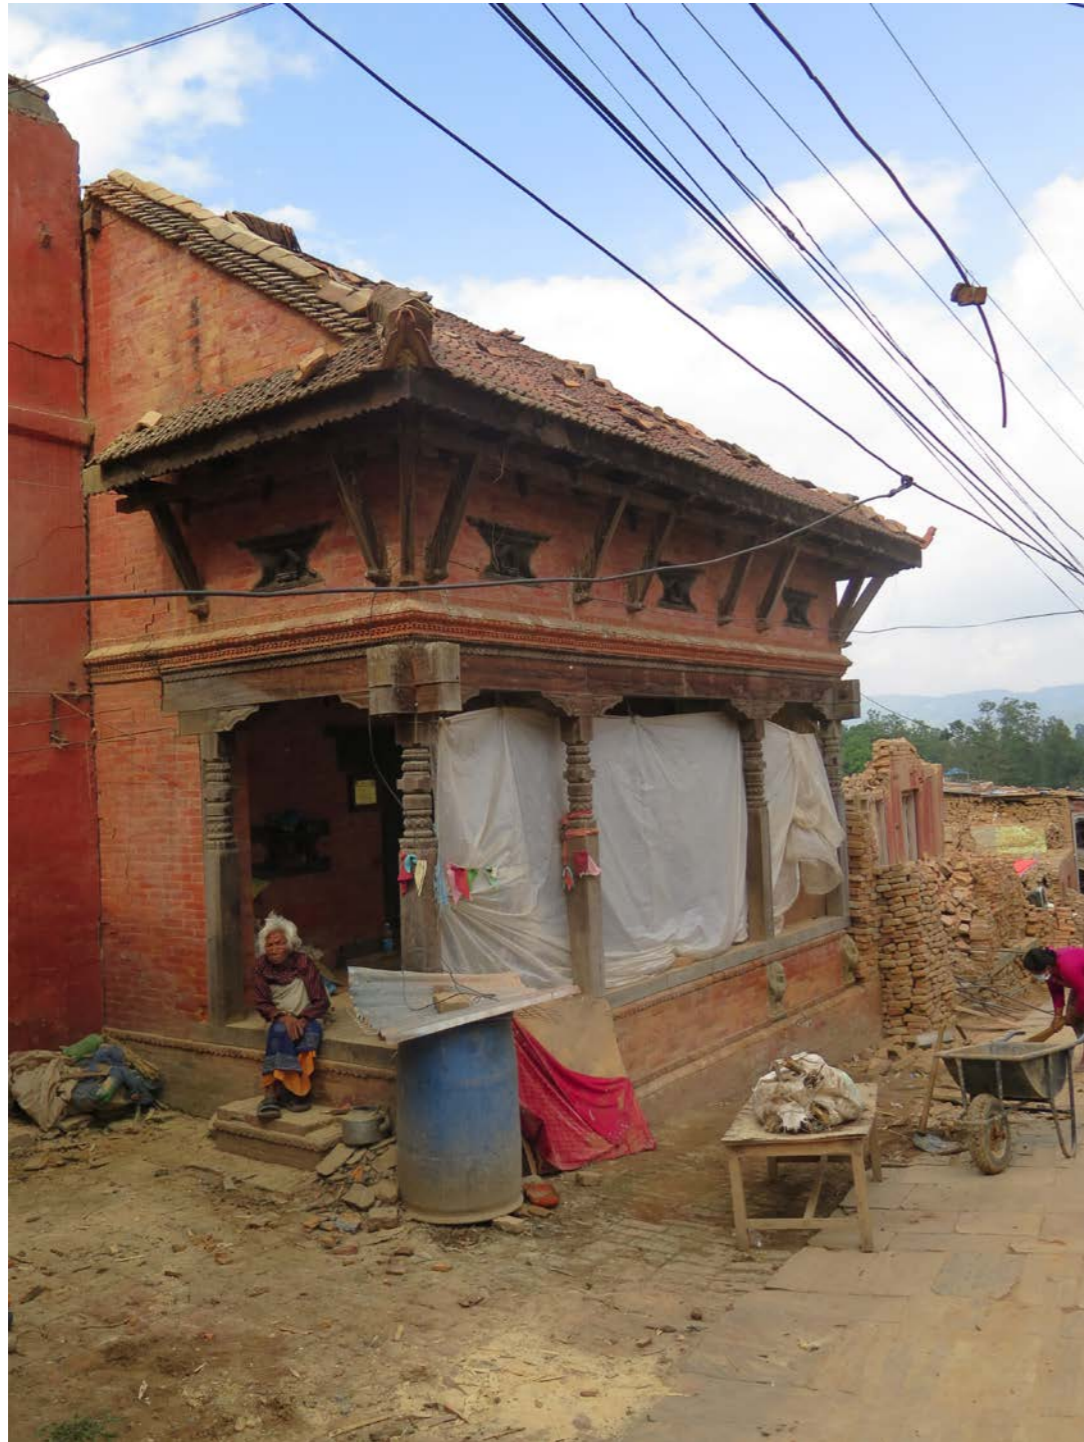
58 SATTAL

NUMBER	NAME	DATE A.D.	TPOLOGY	GENERAL DESCRIPTION	DESCRIPTION OF DAMAGE	DANGER
58			Sattal		Diagonal and vertical cracks on wall

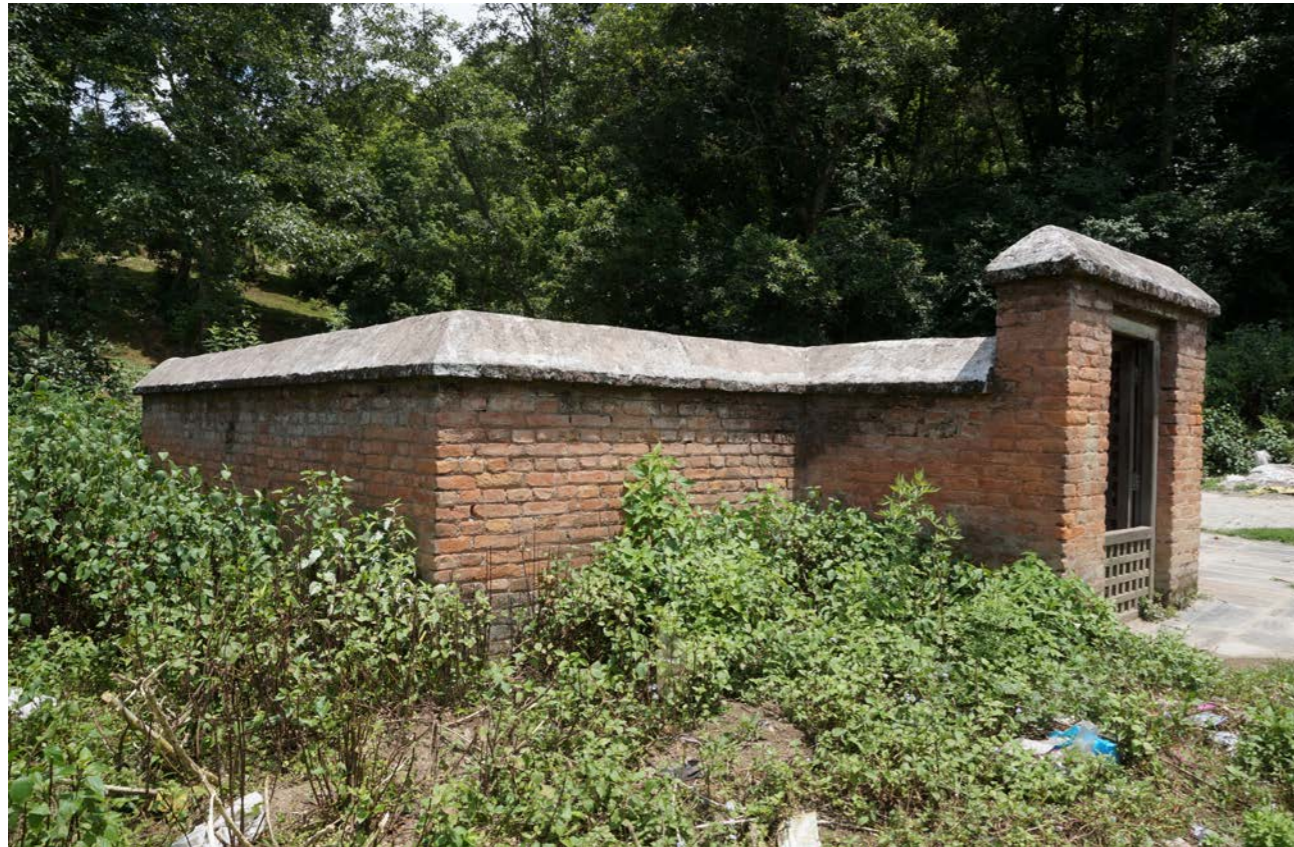
66 WATER SPOUT

NUMBER	NAME	DATE A.D.	TPOLOGY	GENERAL DESCRIPTION	DESCRIPTION OF DAMAGE	DANGER
66			Water Spout	Stone water spout with stone base and steps. There is a Shiva Linga at east side of north wall. Stone artefacts in northeast corner. Two stone spouts with sculptures on the wall at the back.	No water flow after earthquake No visible damage.

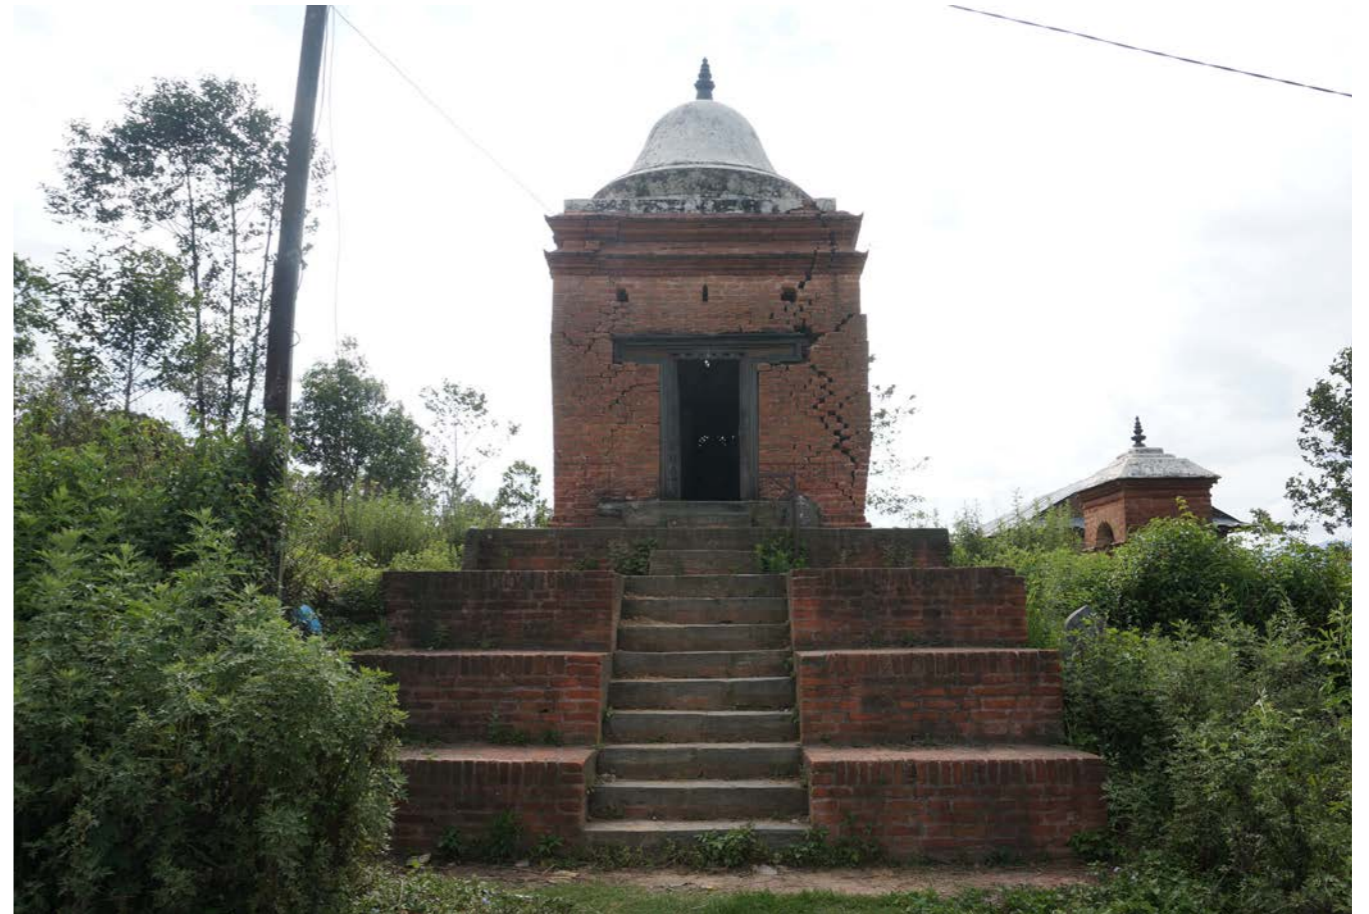
68 SARASWOTI TEMPLE

NUMBER	NAME	DATE A.D.	TYPOLOGY	GENERAL DESCRIPTION	DESCRIPTION OF DAMAGE	DANGER	
67			Water Spout	A shiva linga at east side of north wall, artefacts in north east corner and 2 spouts in front of two sculptures.	No water supply since the Earthquake No other damage		
68	Saraswoti		Temple	Stone sculpture on a base of Jalahari. A wooden post with bells at the left	Stone element to the left of entrance is missing Corners of the temples collapsed Major Diagonal cracks on all 3 sides (except on E-side)	⚠
