2015 Earthquake Damage Mapping
Changunarayan Monument Zone
Kathmandu Valley World Heritage Property

November 2015

This assessment was supported by
UNESCO Office in Kathmandu

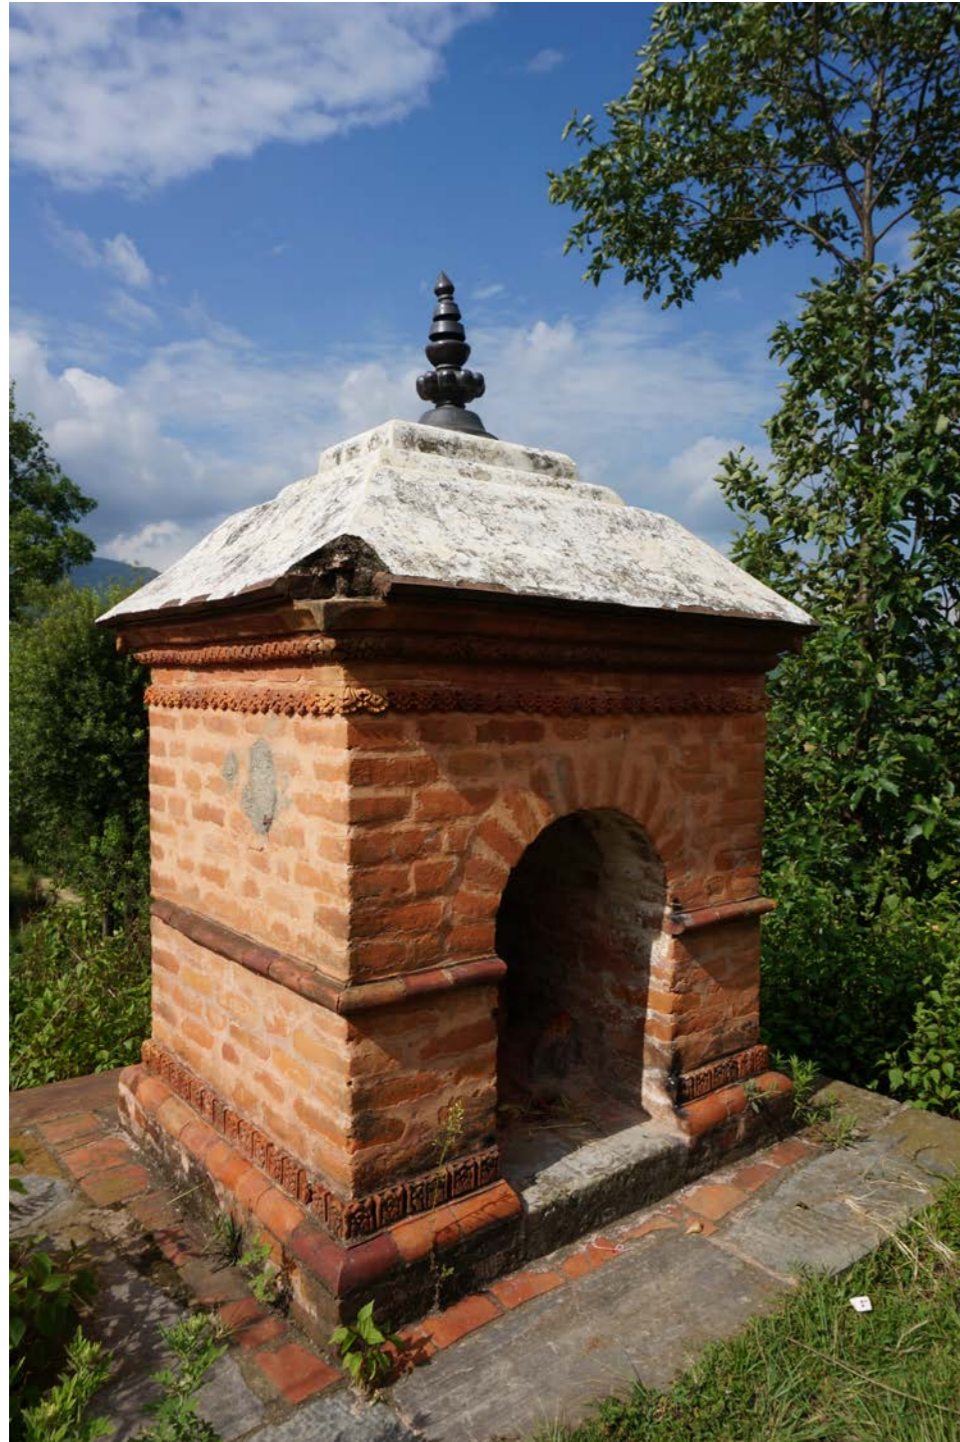
69 GANESH SHRINE

NUMBER	NAME	DATE A.D.	TPOLOGY	GENERAL DESCRIPTION	DESCRIPTION OF DAMAGE	DANGER
69	Ganesh shrine		Open Shrine	Statue of <i>ganesh</i> facing South is enclosed in a brick structure with white plastered roof.	There is a minor crack at South west corner Gajur is new and not properly fixed	
70	Shiva Shrine		Open Shrine	Small Shrine with <i>Jalahari</i> Brick structure with white plastered top and a metal <i>gajur</i>	<i>Gajur</i> is new and not properly fixed No other visible damage.

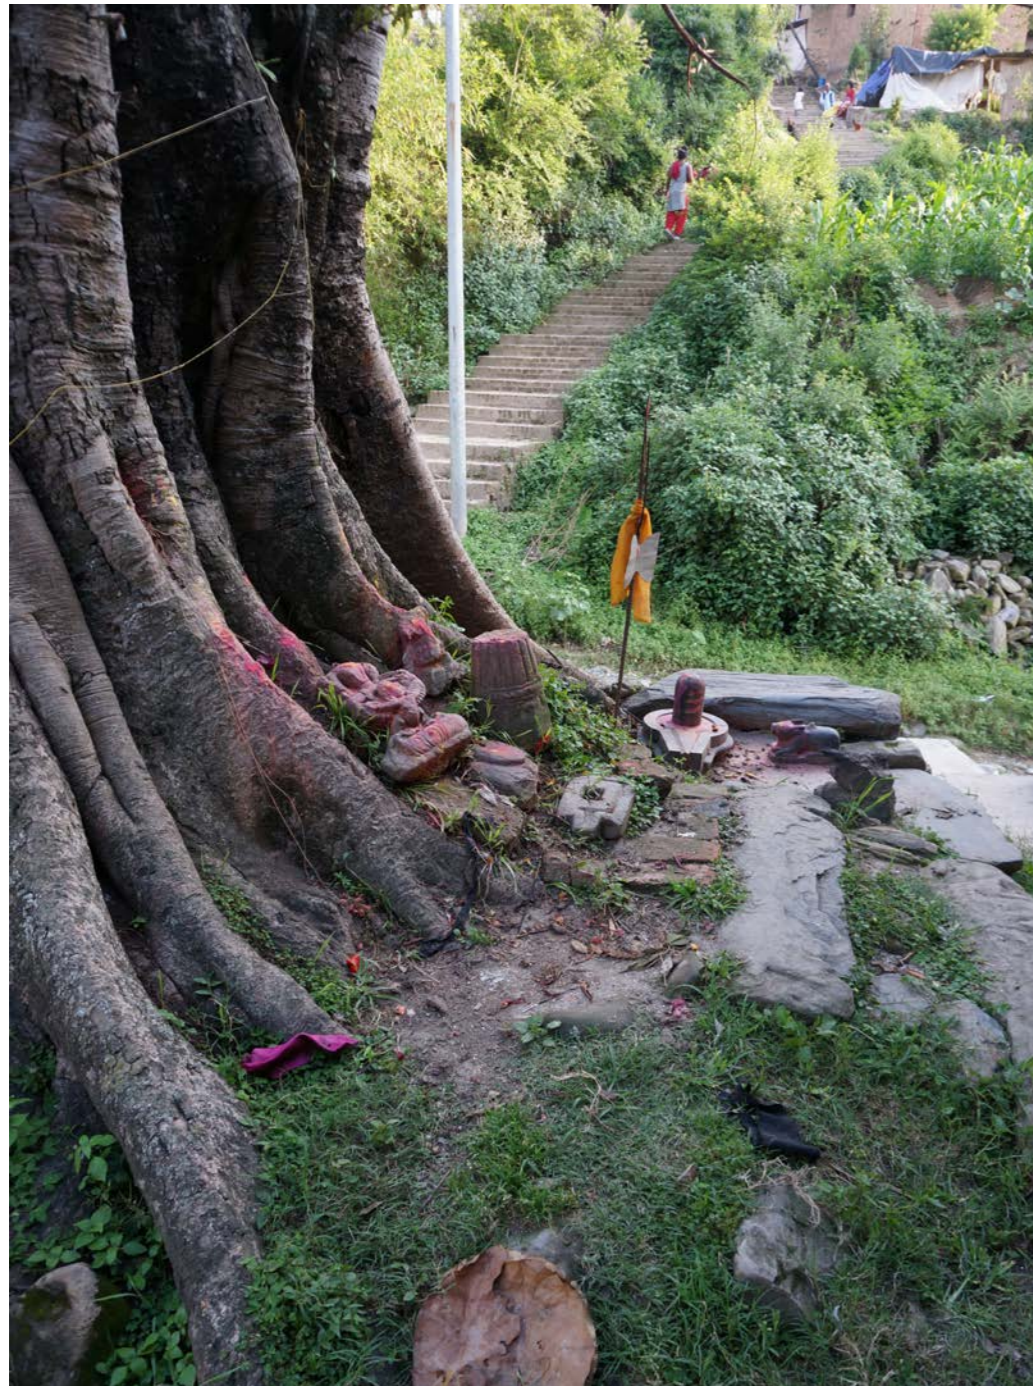
73 SHRINE

NUMBER	NAME	DATE A.D.	TPOLOGY	GENERAL DESCRIPTION	DESCRIPTION OF DAMAGE	DANGER
73			Open shrine	Open shrine below <i>peepal</i> tree There are statues of <i>shiva linga</i> , <i>nandi</i> etc.	Broken image of Garuda Narayan

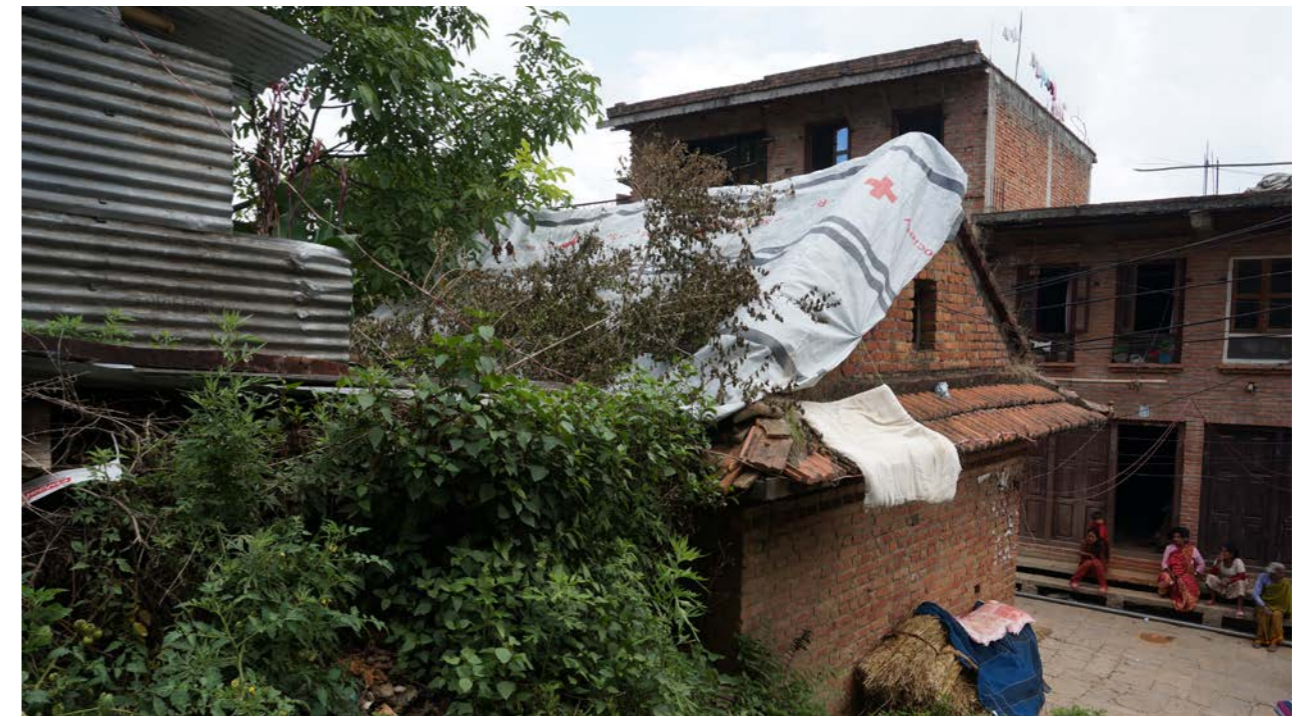
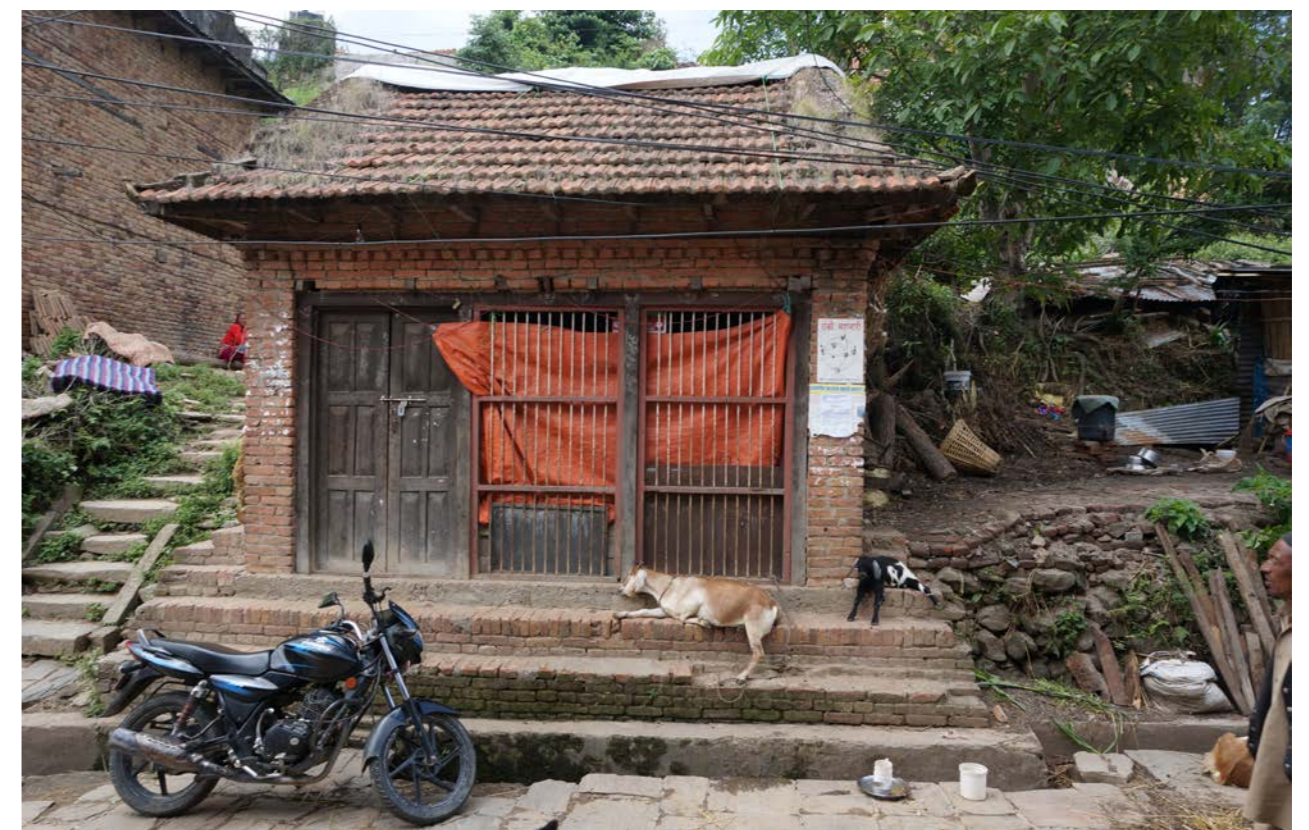
77 PATI

NUMBER	NAME	DATE A.D.	TYPOLOGY	GENERAL DESCRIPTION	DESCRIPTION OF DAMAGE	DANGER
76	Ganesh Mandir		Open Shrine	Open shrine with stone statue of <i>Ganesh</i> which is more than 100 years old.	No visible damage	
77	Magam Tole Falcha		<i>Pati</i>	Brick walled pati with tiled roof.	Roof is delapidated. Half of roof has collapsed.	⚠

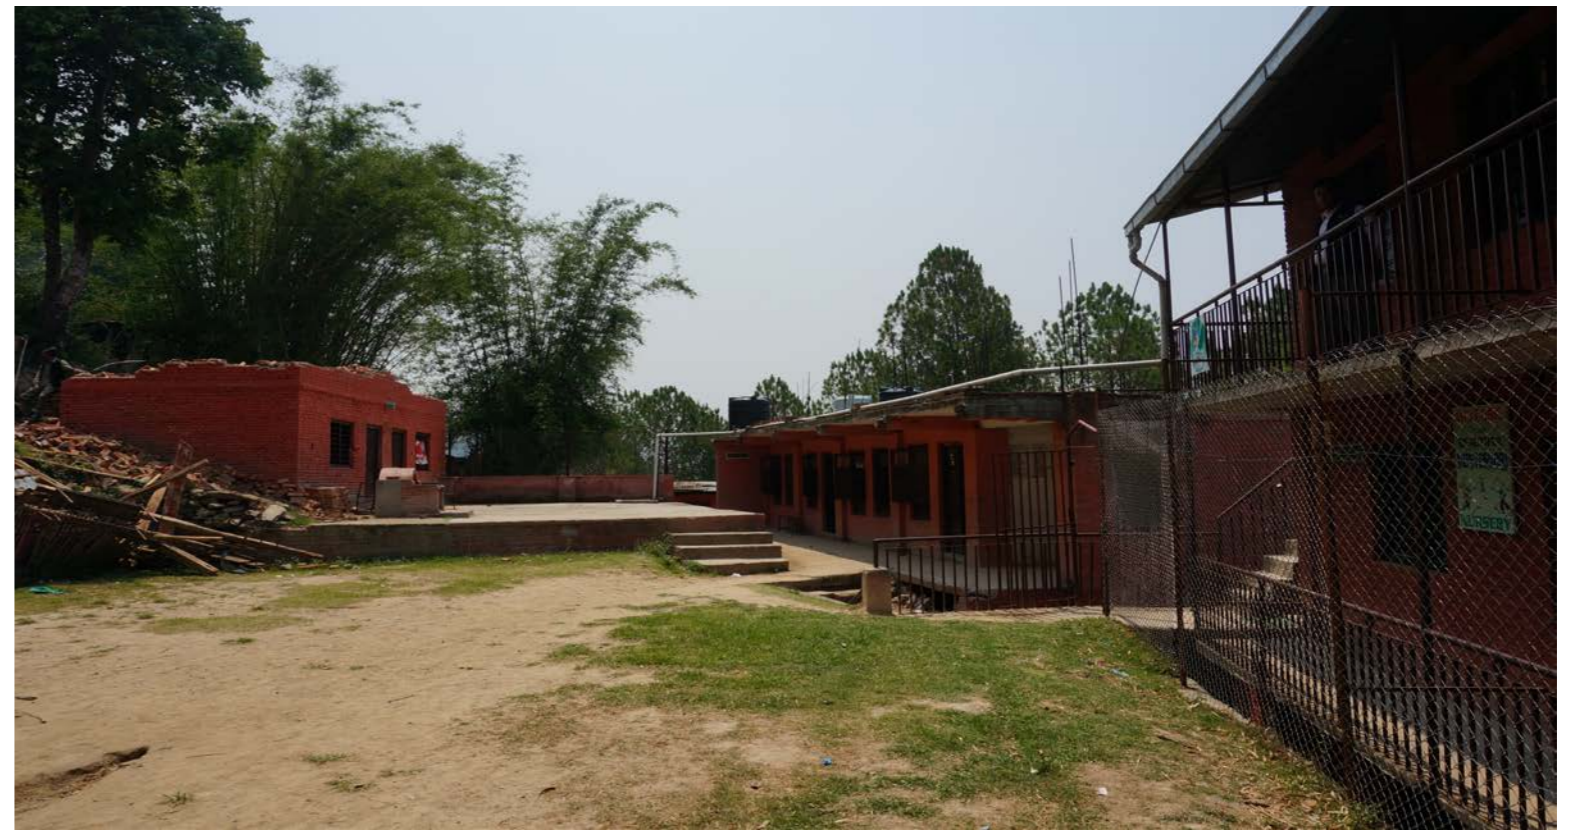
5 DOLAGIRI HIGH SECONDARY SCHOOL

NUMBER	NAME	DATE A.D.	TYPOLOGY	GENERAL DESCRIPTION	DESCRIPTION OF DAMAGE	DANGER	
5	Dolagiri H.S. School Pancha Narayan Hadel (Principal) 9841430973		School	G+1 Load bearing, Brick and concrete structure.	First floor collapsed. Ground floor is unstable

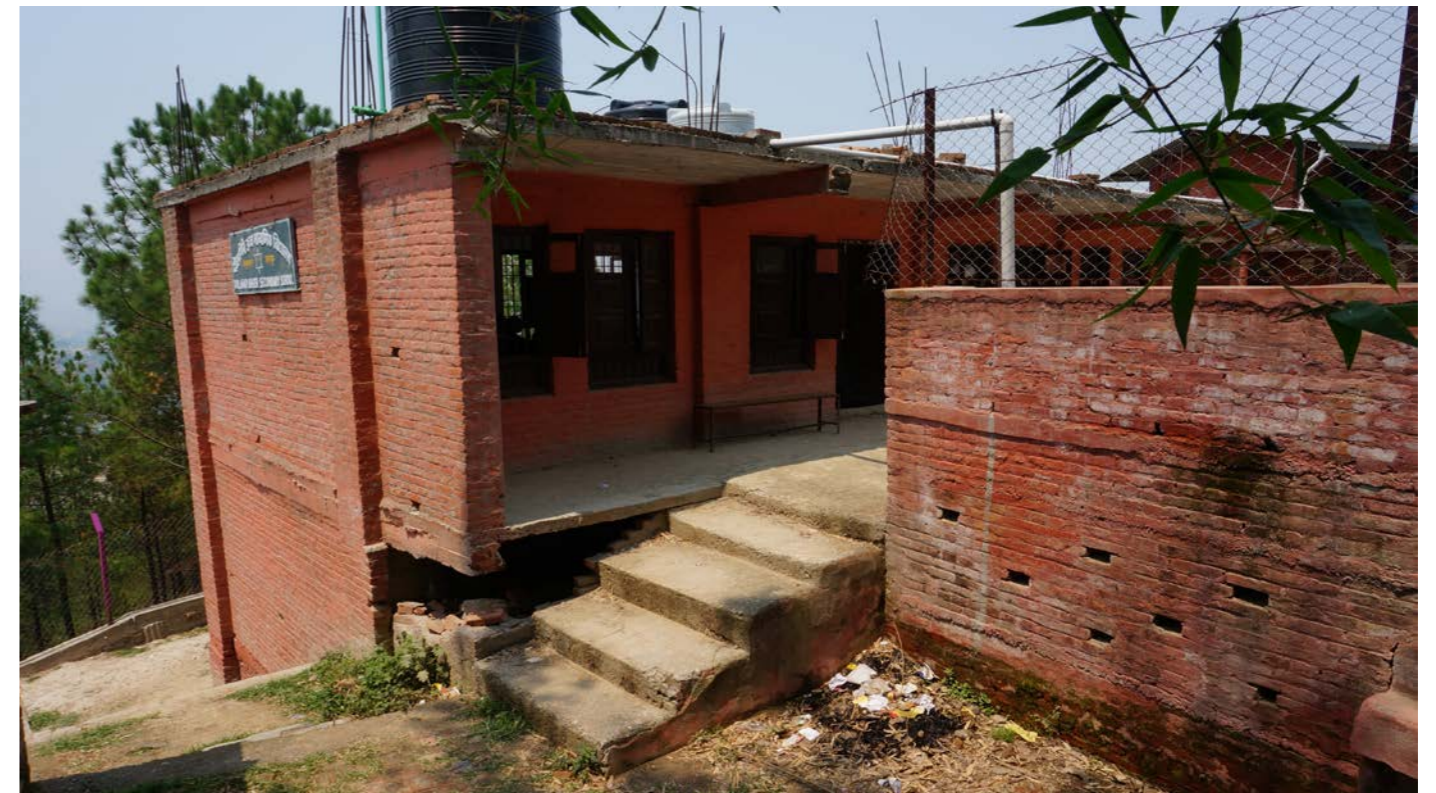
7 DOLAGIRI HIGH SECONDARY SCHOOL

NUMBER	NAME	DATE A.D.	TPOLOGY	GENERAL DESCRIPTION	DESCRIPTION OF DAMAGE	DANGER	
7	Dolagiri H.S. School Pancha Narayan Bhadel (Principal) 9841430973		School	G+1 Concrete structure.	Minor cracks in infill walls

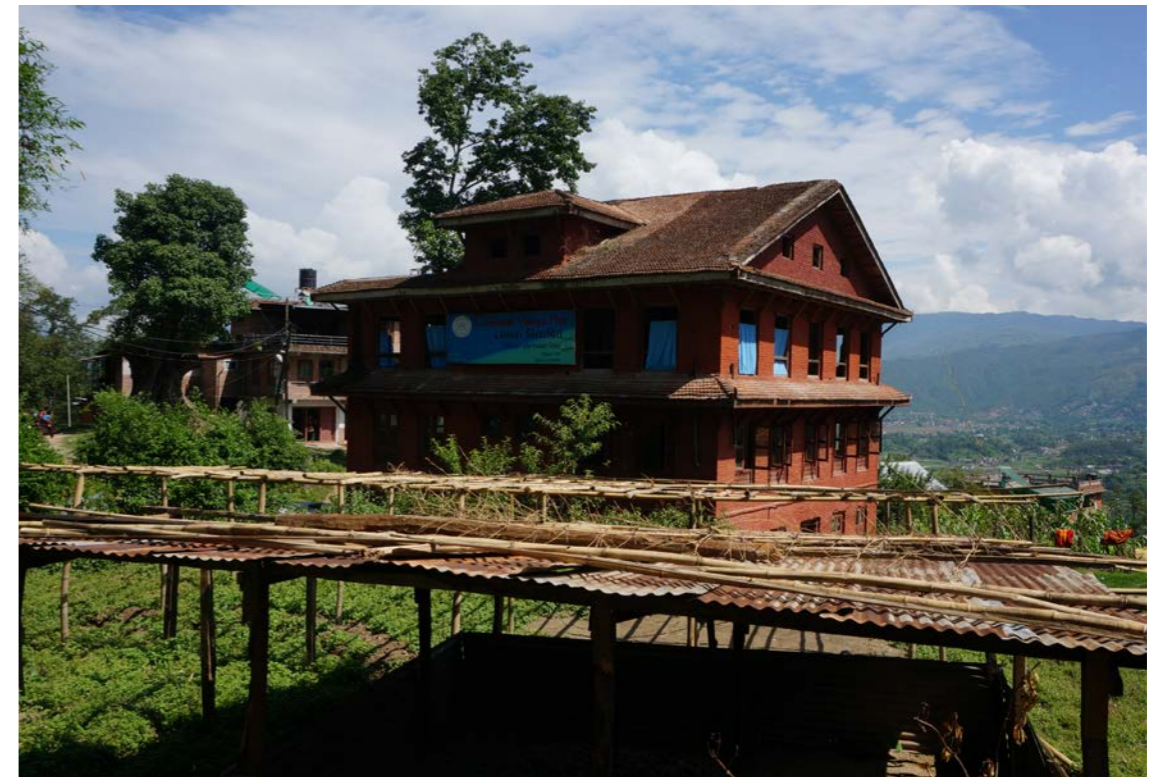
63,65 & 74 CHAMPAK VIDHYA PITH

NUMBER	NAME	DATE A.D.	TYOLOGY	GENERAL DESCRIPTION	DESCRIPTION OF DAMAGE	ANGER
63	Champak Vidhya Pith (Ramesh Suwal - 5141183)		School	G+3 Concrete frame structure	No visible structural damage. Vegetation growth in wall and roof.	
65				G+2 Concrete frame structure	Minor cracks in plaster	
74				Brick structure with wooden rafters and CGI sheet on the Roof.	Vertical cracks in joints of inner walls. Tilted inner walls. No other major damage.

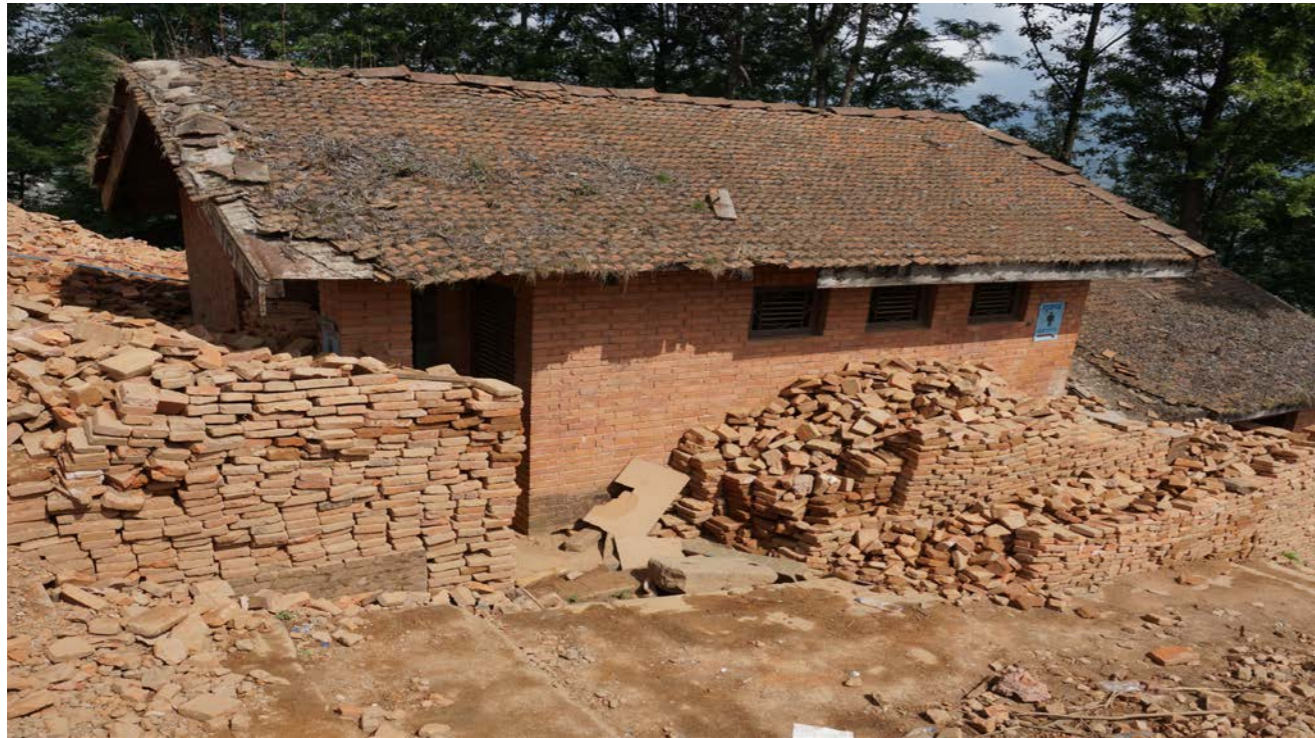
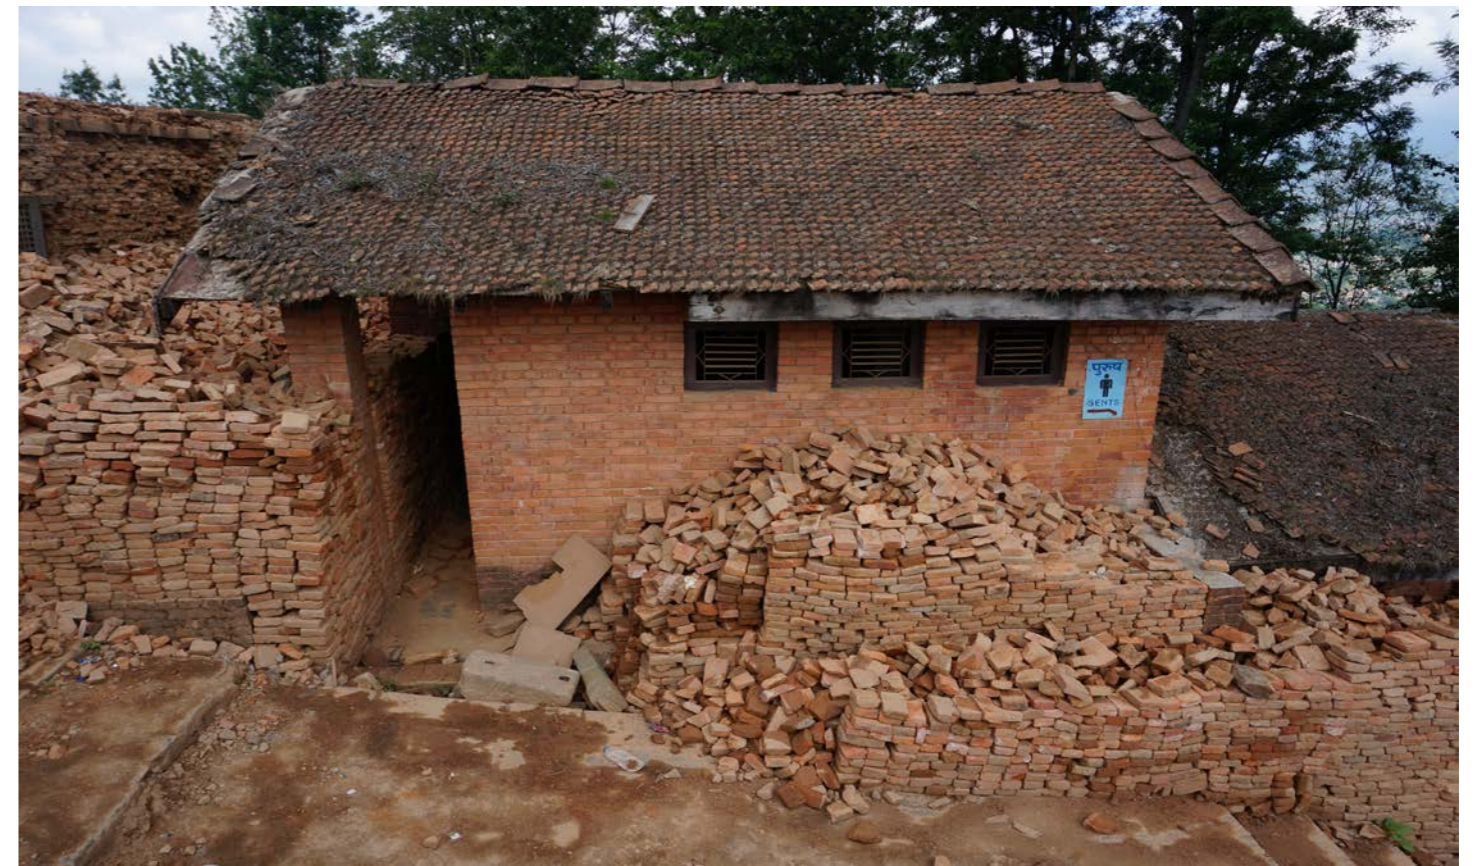
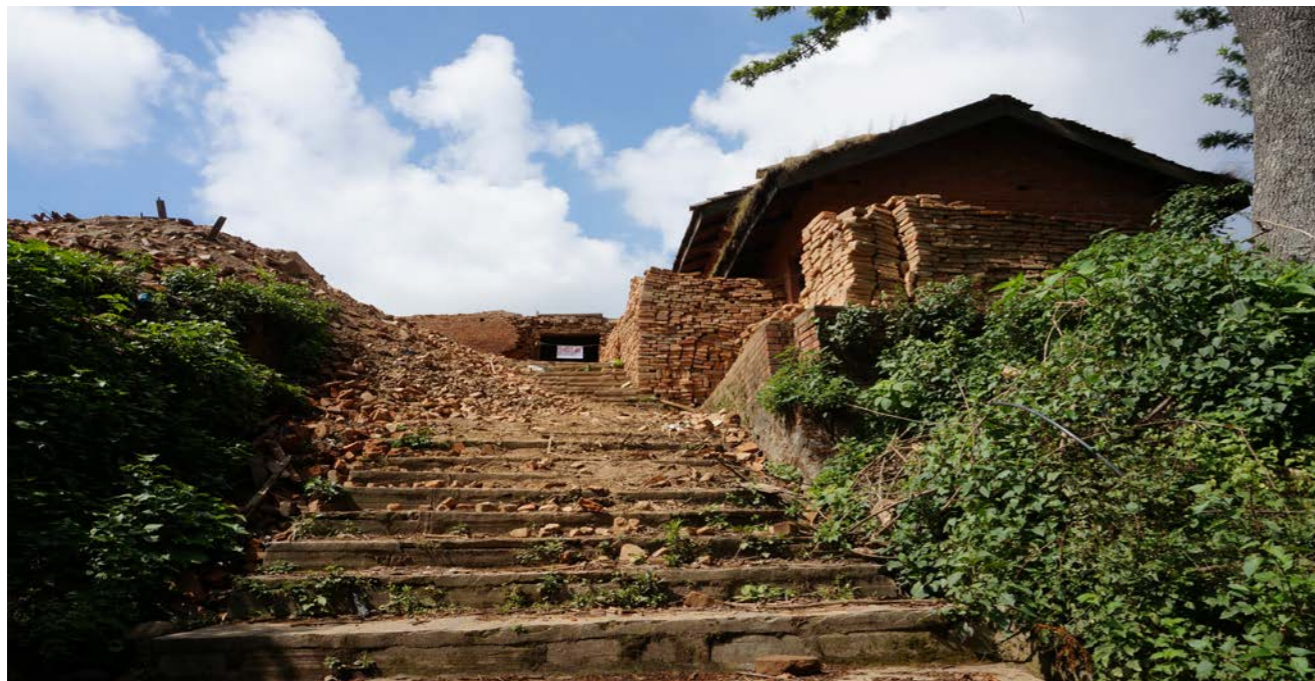
75 PUBLIC TOILET

NUMBER	NAME	DATE A.D.	TYPOLOGY	GENERAL DESCRIPTION	DESCRIPTION OF DAMAGE	DANGER	
75			Public Toilet	Single storey structure. Brick and cement mortar. Jhingati used in roofing.	Roof tiles have fallen. Cracks and slight bulging at left brick pillar near entrance opening. Upper ridge tile damaged. Eave boards and purlins are uncovered.

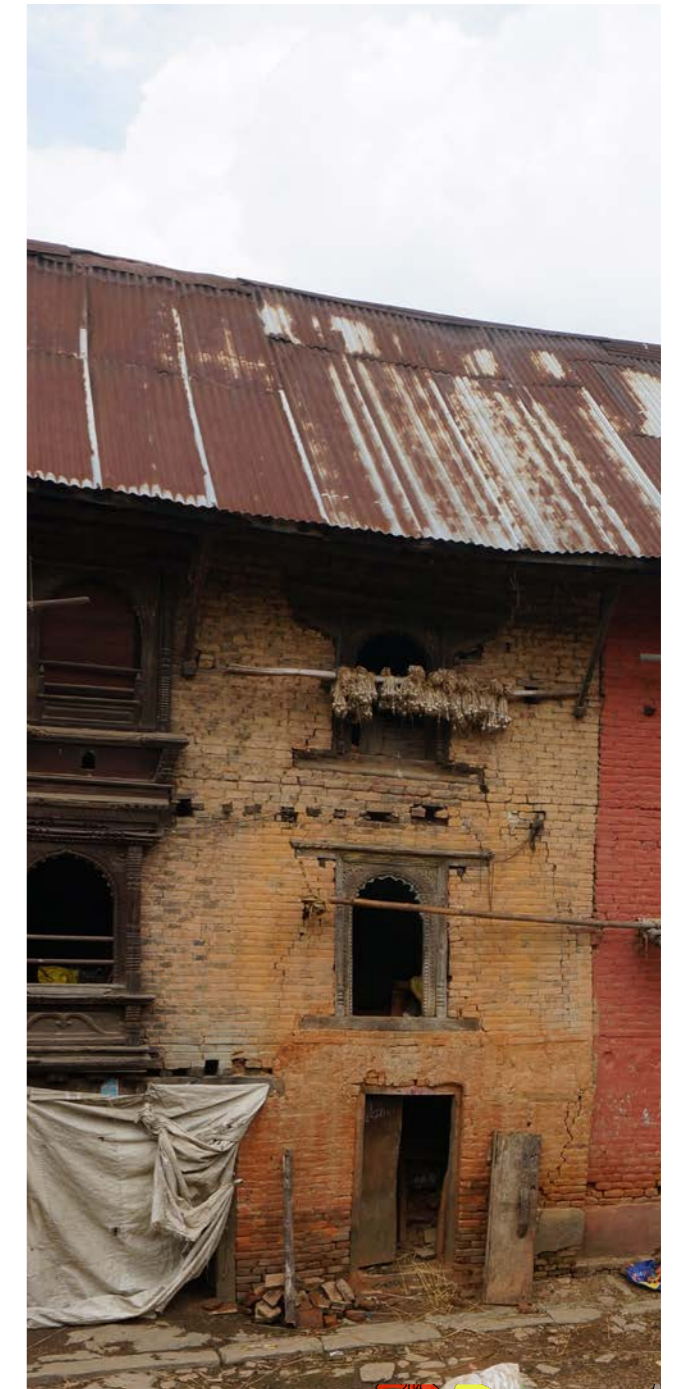
217 KRISHNA B. S.

NUMBER	CONTACT	STOREY NO. RELATIVE POSITION	STRUCTURAL SYSTEM	DESCRIPTION OF DAMAGE	DANGER	CONDITION
215	Chandra L.Shrestha/ Navraj Shrestha 9843453720	G+3	UnB + B	Vertical cracks in corners, diagonal and stepped shear cracks in the walls. Staircase dislocated.		
216	Dherja Bir Shrestha	G+3	UnB + B			
217	Krishna B.Shrestha/ Chakra B Shrestha	G+3	UnB + B
