2015 Earthquake Damage Mapping

Hanuman Dhoka Darbar Square Monument Zone
Kathmandu Valley World Heritage Property

December 2015

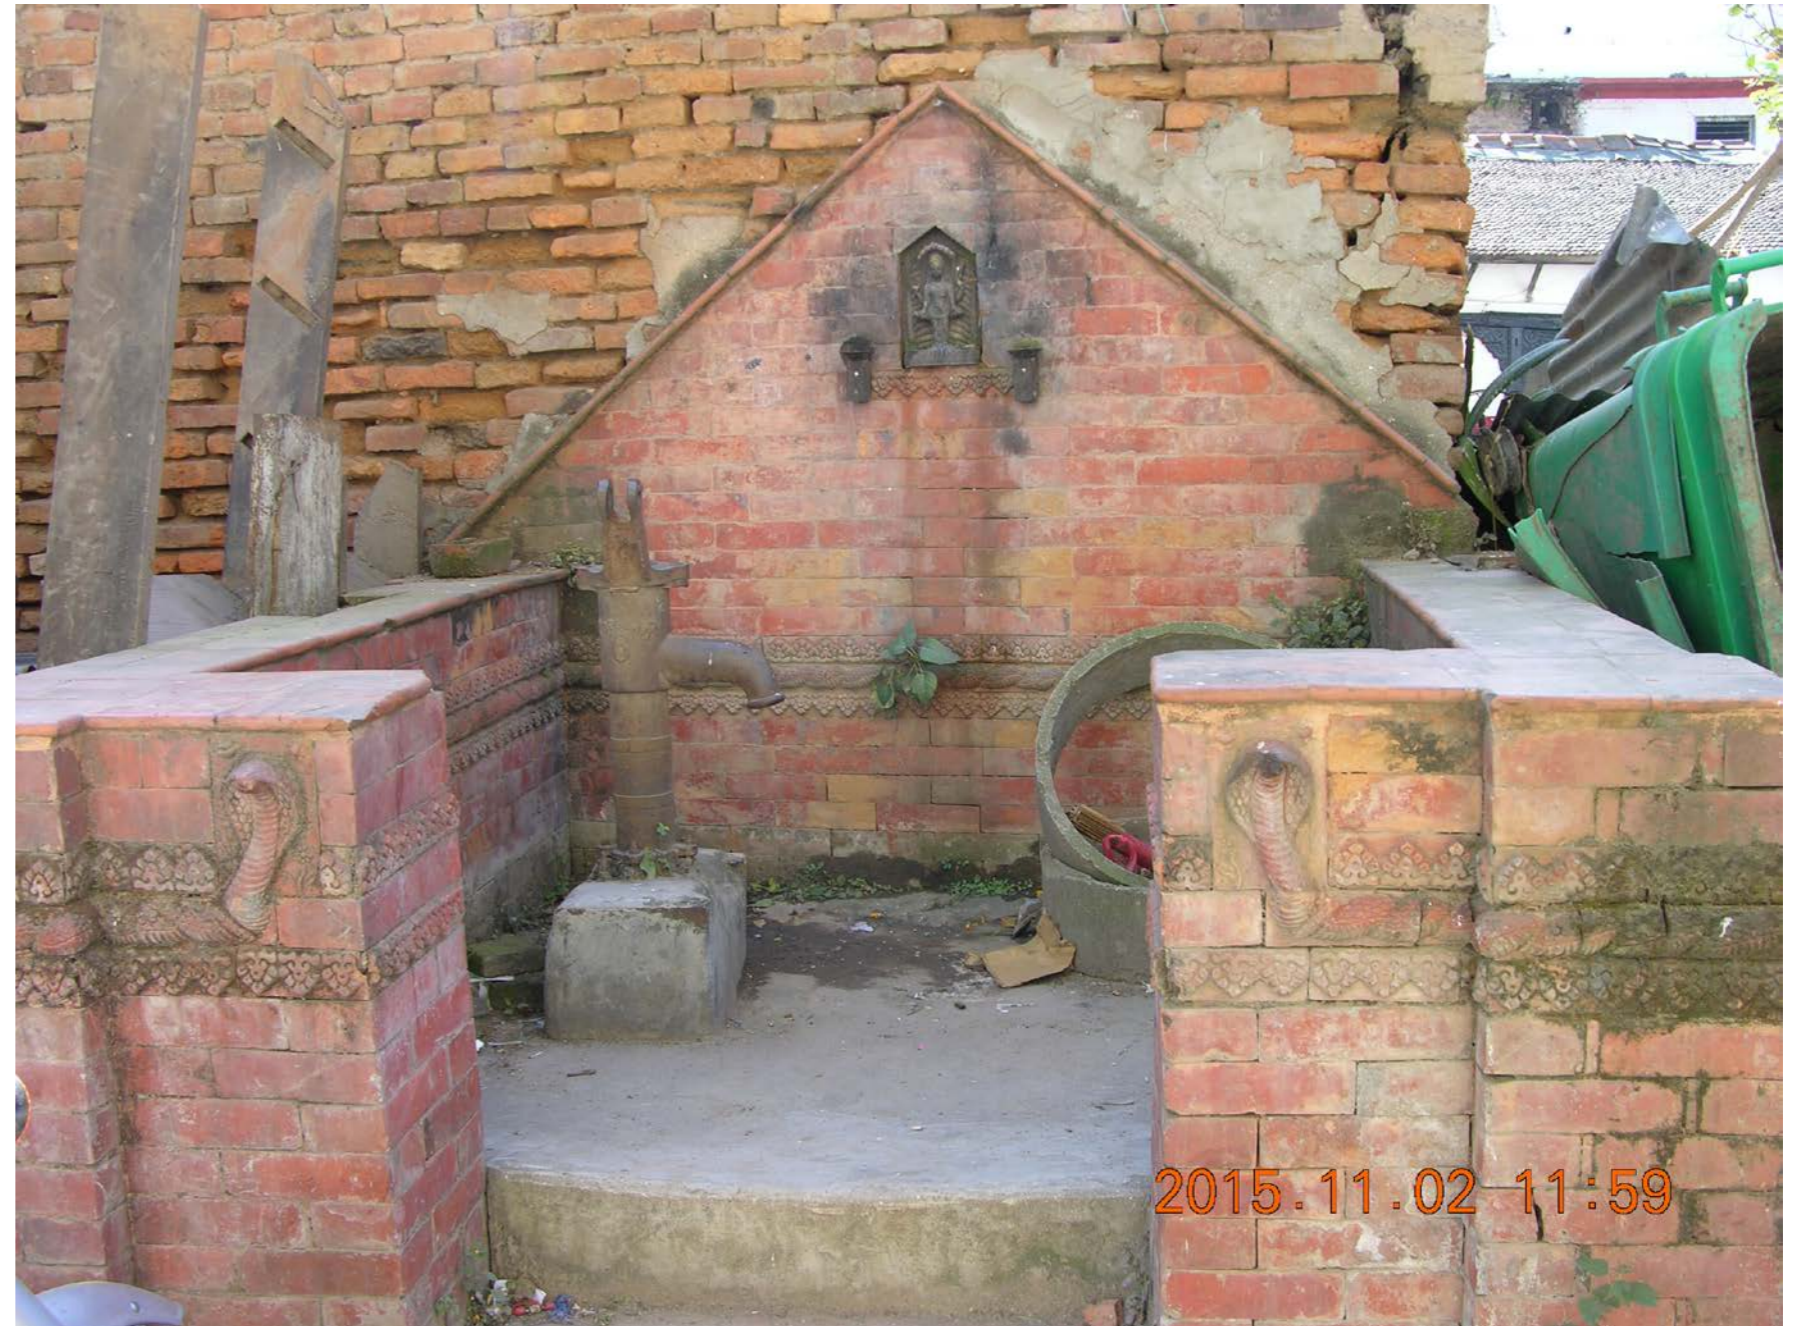
4r HAND PUMP

CODE NO	TYOLOGY	MONUMENT NAME	ESTABLISHED/ RENOVATED	STRUCTURAL SYSTEM	MATERIAL	GENERAL DESCRIPTION	PROBLEM DESCRIPTION	DANGER	REMARKS	
4q	Open shrine					plastered by cement	No visible damage			
4r	Hand pump					handpump enclosed by low wall	vegetation growth			
4s	Pati					image on west	brick degraded due to dampness, SW corner separating

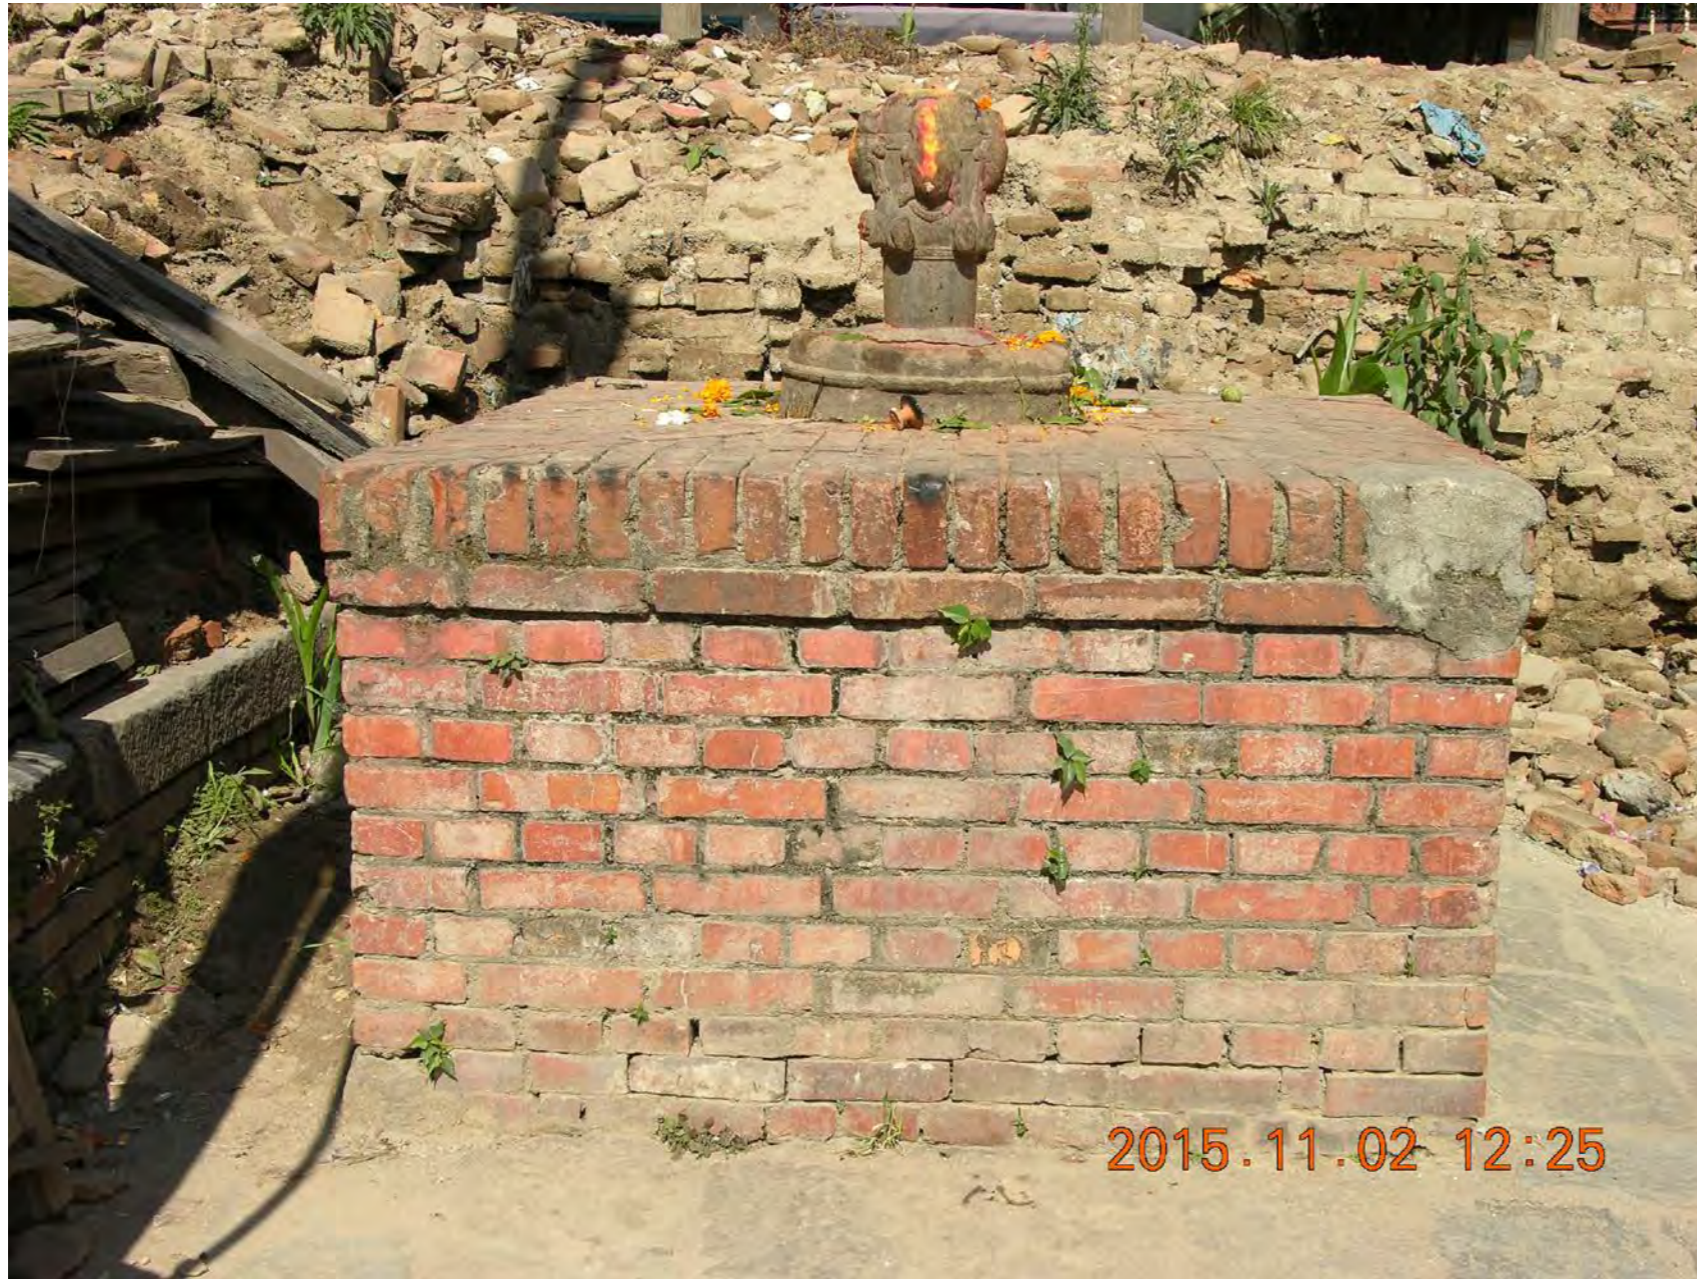
5b SHIVA LINGA

CODE NO	TYOLOGY	MONUMENT NAME	ESTABLISHED/ RENOVATED	STRUCTURAL SYSTEM	MATERIAL	GENERAL DESCRIPTION	PROBLEM DESCRIPTION	DANGER	REMARKS	
5b	Shiva linga					Stone 4 faced shiva linga on brick base	No visible damage

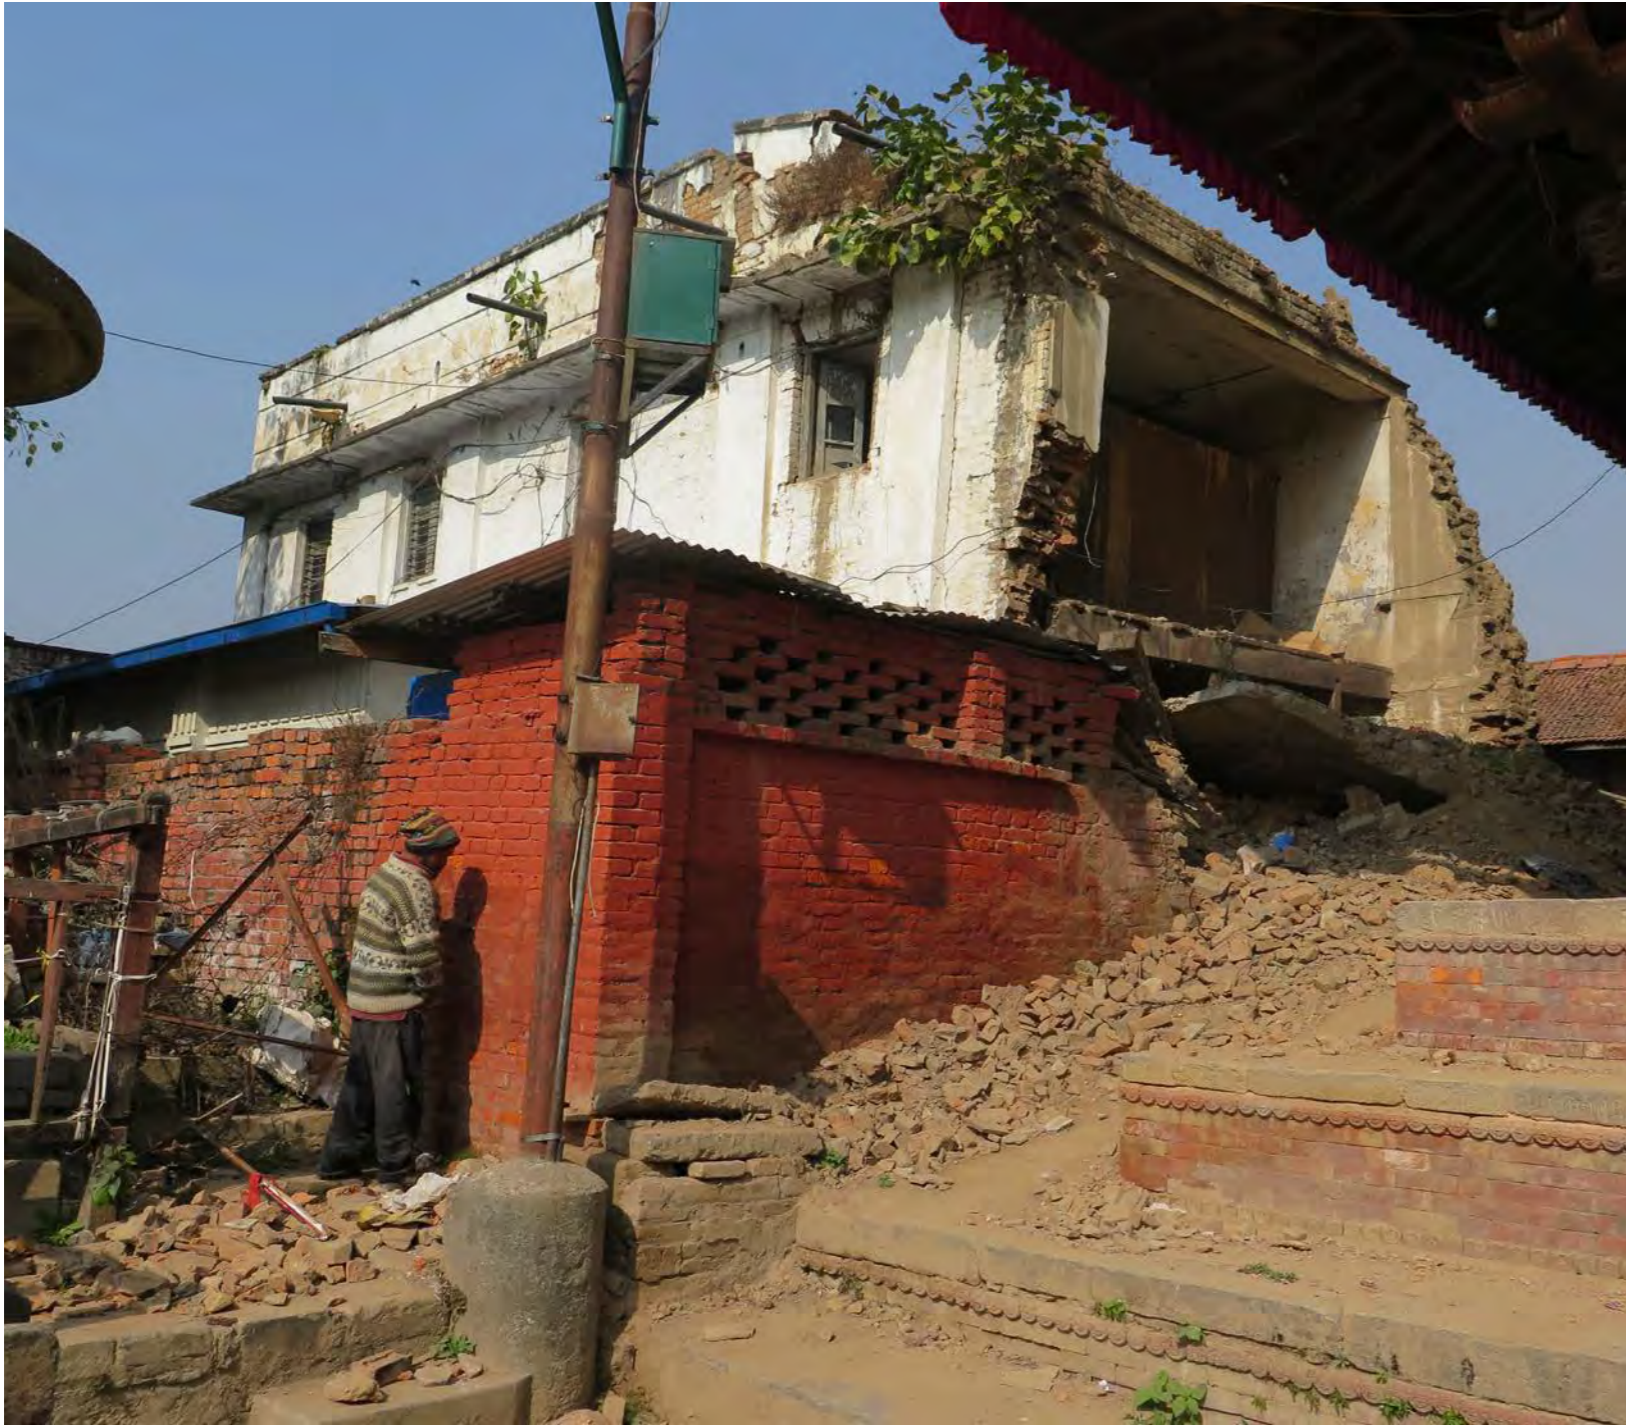
CODE NO	TYOLOGY	MONUMENT NAME	ESTABLISHED/ RENOVATED	STRUCTURAL SYSTEM	MATERIAL	GENERAL DESCRIPTION	PROBLEM DESCRIPTION	DANGER	REMARKS	
5d						Two storeyed building used by Police Station	Half part collapsed. Remaining structure has extensive crack.

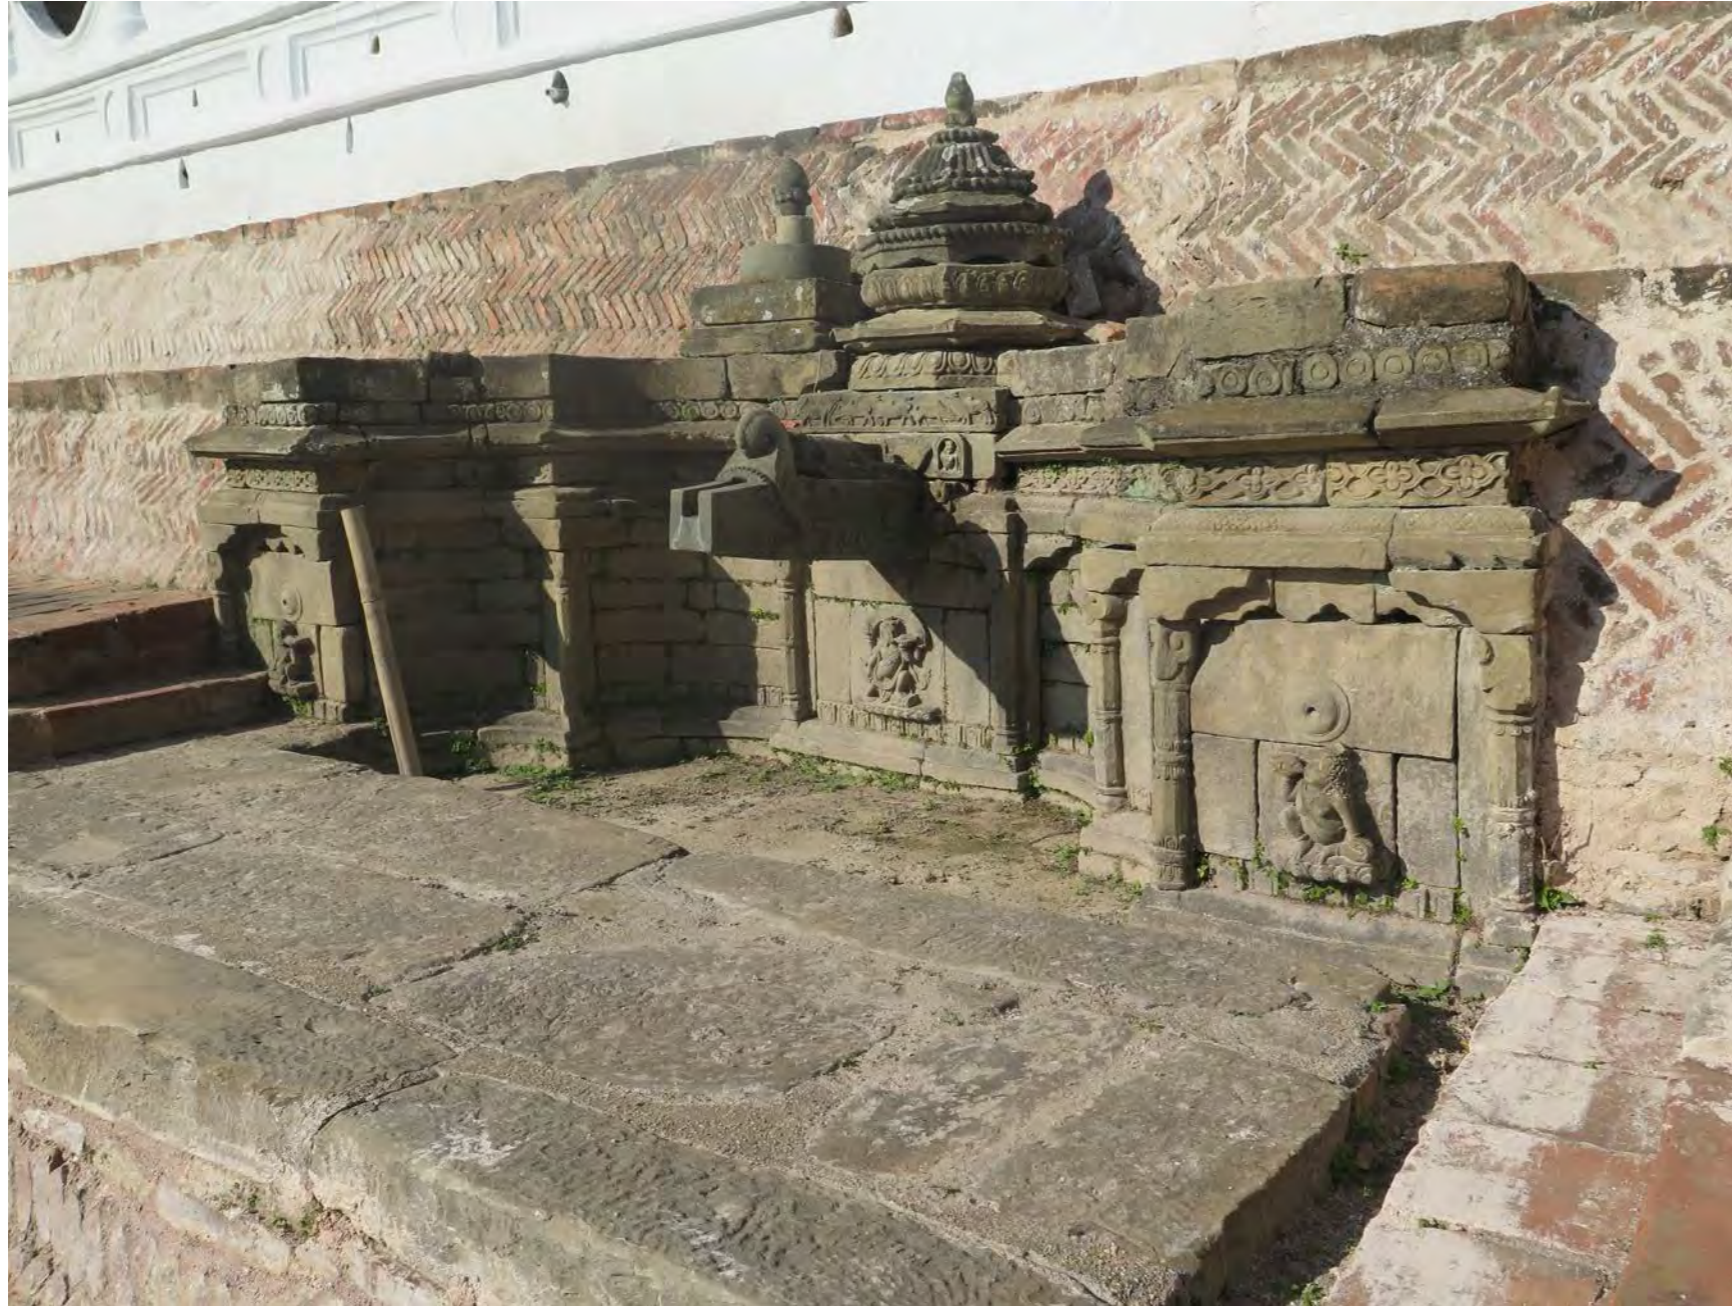
CODE NO	TYOLOGY	MONUMENT NAME	ESTABLISHED/ RENOVATED	STRUCTURAL SYSTEM	MATERIAL	GENERAL DESCRIPTION	PROBLEM DESCRIPTION	DANGER	REMARKS	
11b	Stone water spout				Stone		Vegetation Growth;Cracks at base

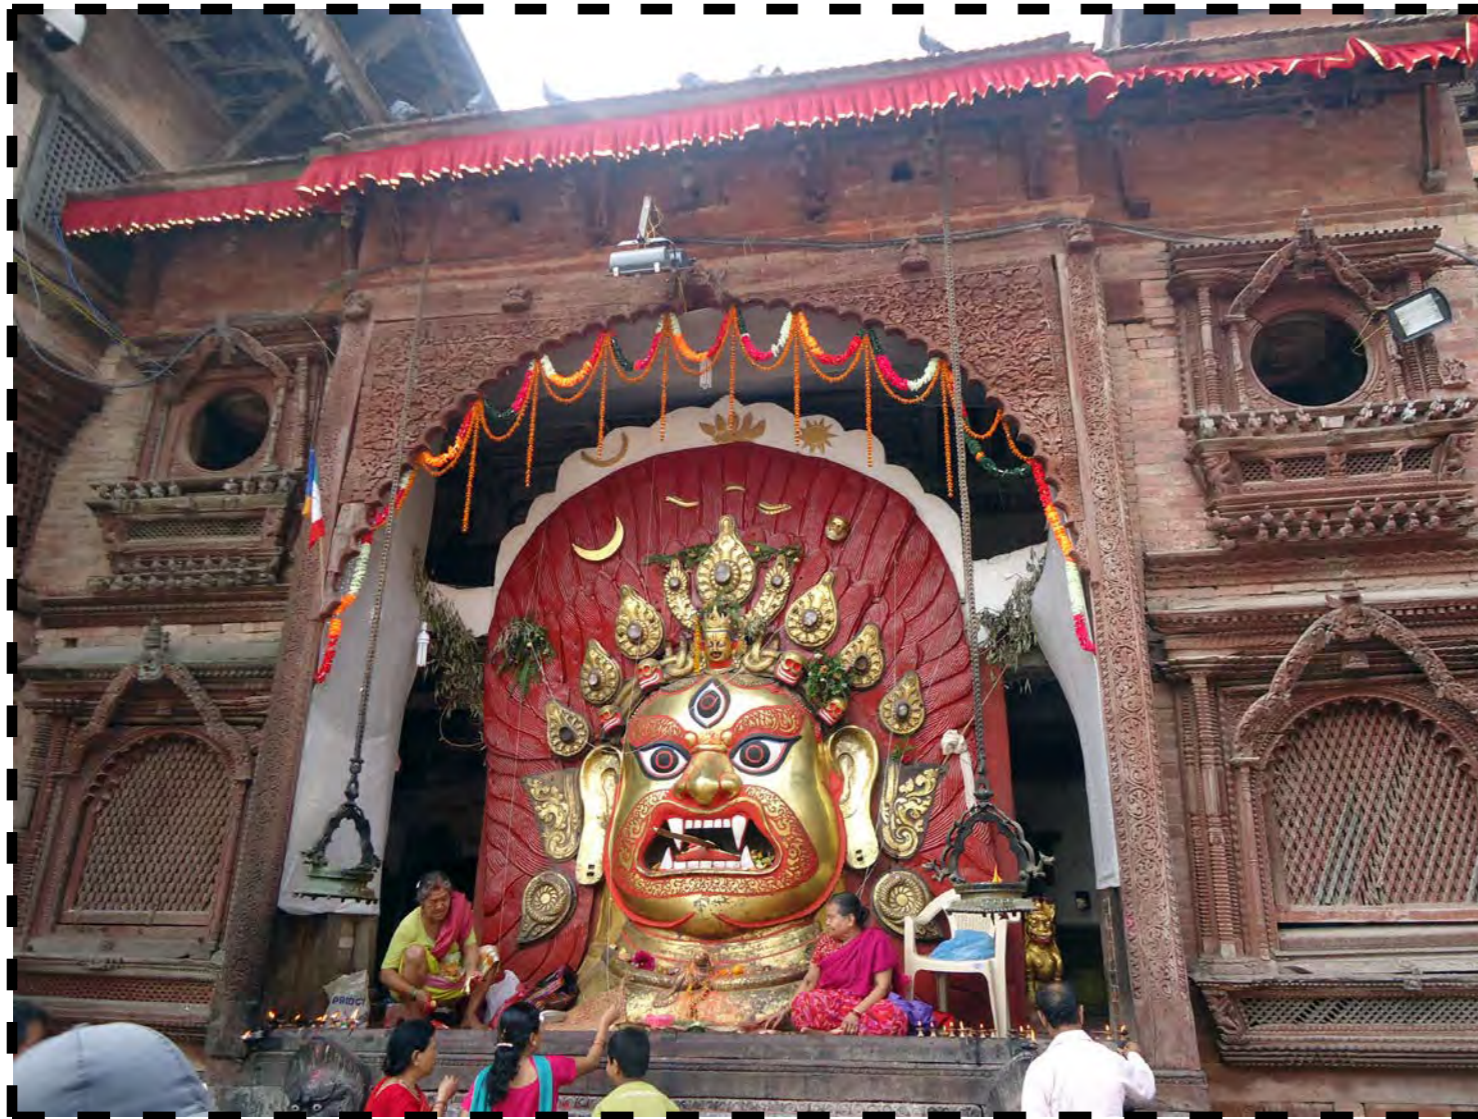
CODE NO	TYOLOGY	MONUMENT NAME	ESTABLISHED/ RENOVATED	STRUCTURAL SYSTEM	MATERIAL	GENERAL DESCRIPTION	PROBLEM DESCRIPTION	DANGER	REMARKS
33		Swet Bhairab	1795 by king Raha Bahadur Shah	Load Bearing	Brick;Stucco	The façade almost covered with carved windows. The central large window covers the large face of Bhairav.	Major cracks, tilted and bulging on the north. Bricks in the base falling down. Structure unstable.

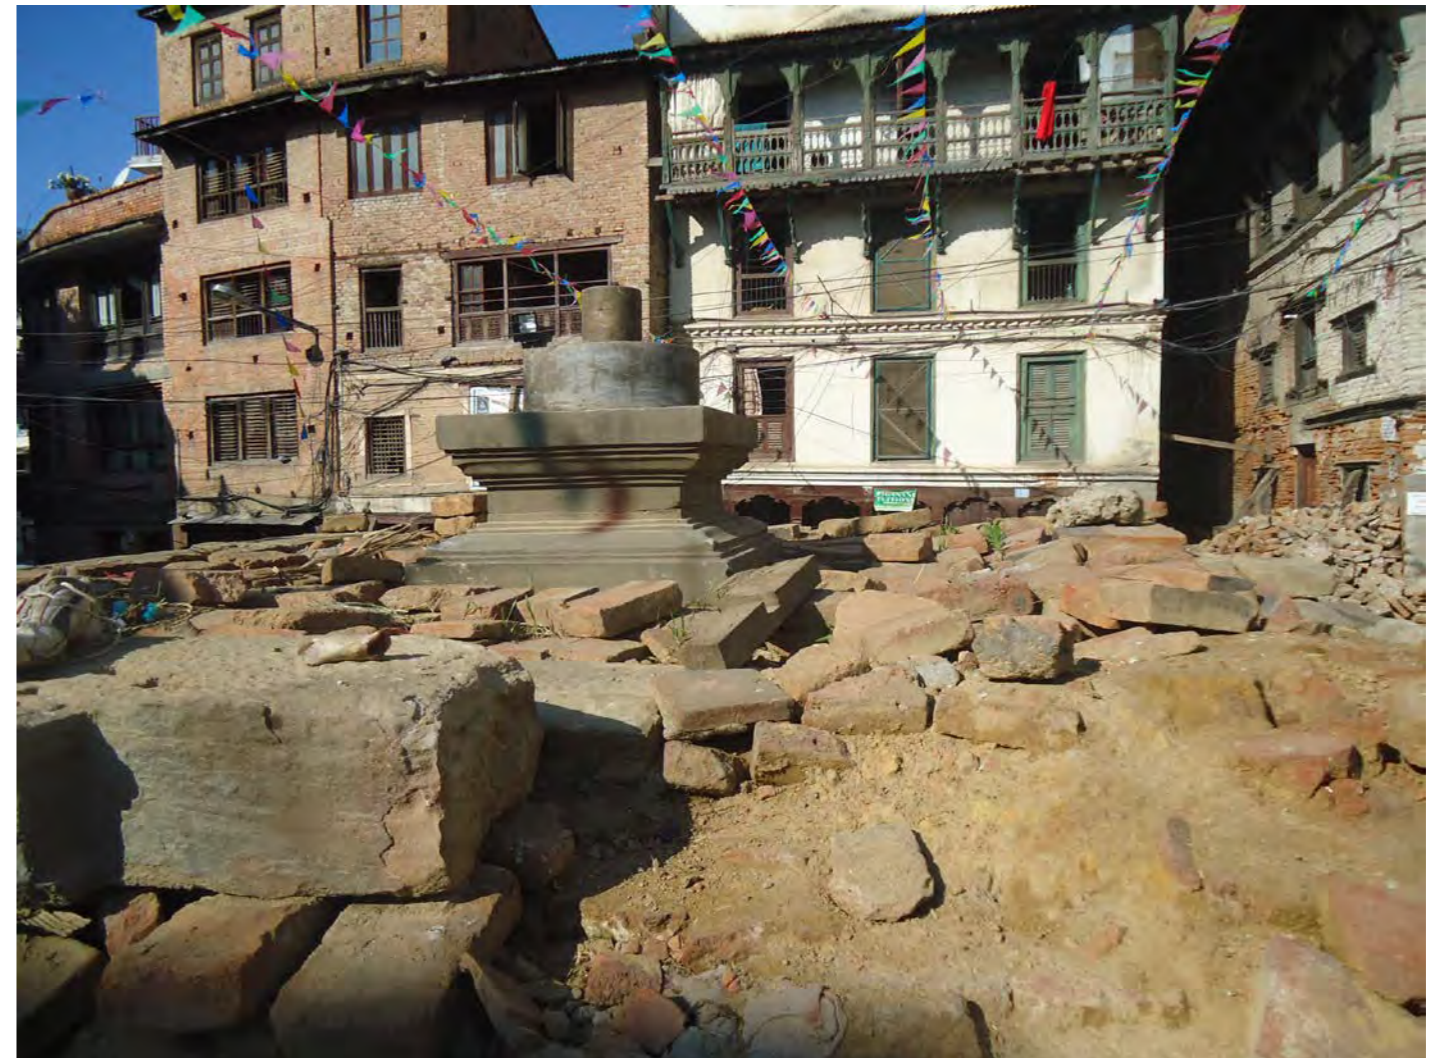
CODE NO	TYOLOGY	MONUMENT NAME	ESTABLISHED/ RENOVATED	STRUCTURAL SYSTEM	MATERIAL	GENERAL DESCRIPTION	PROBLEM DESCRIPTION	DANGER	REMARKS	
49	Two Storey Temple	Shiva linga Temple		Load Bearing	Brick;Timber	Shiva linga on raised plinth	Totally collapsed;Extensive cracking on plinth

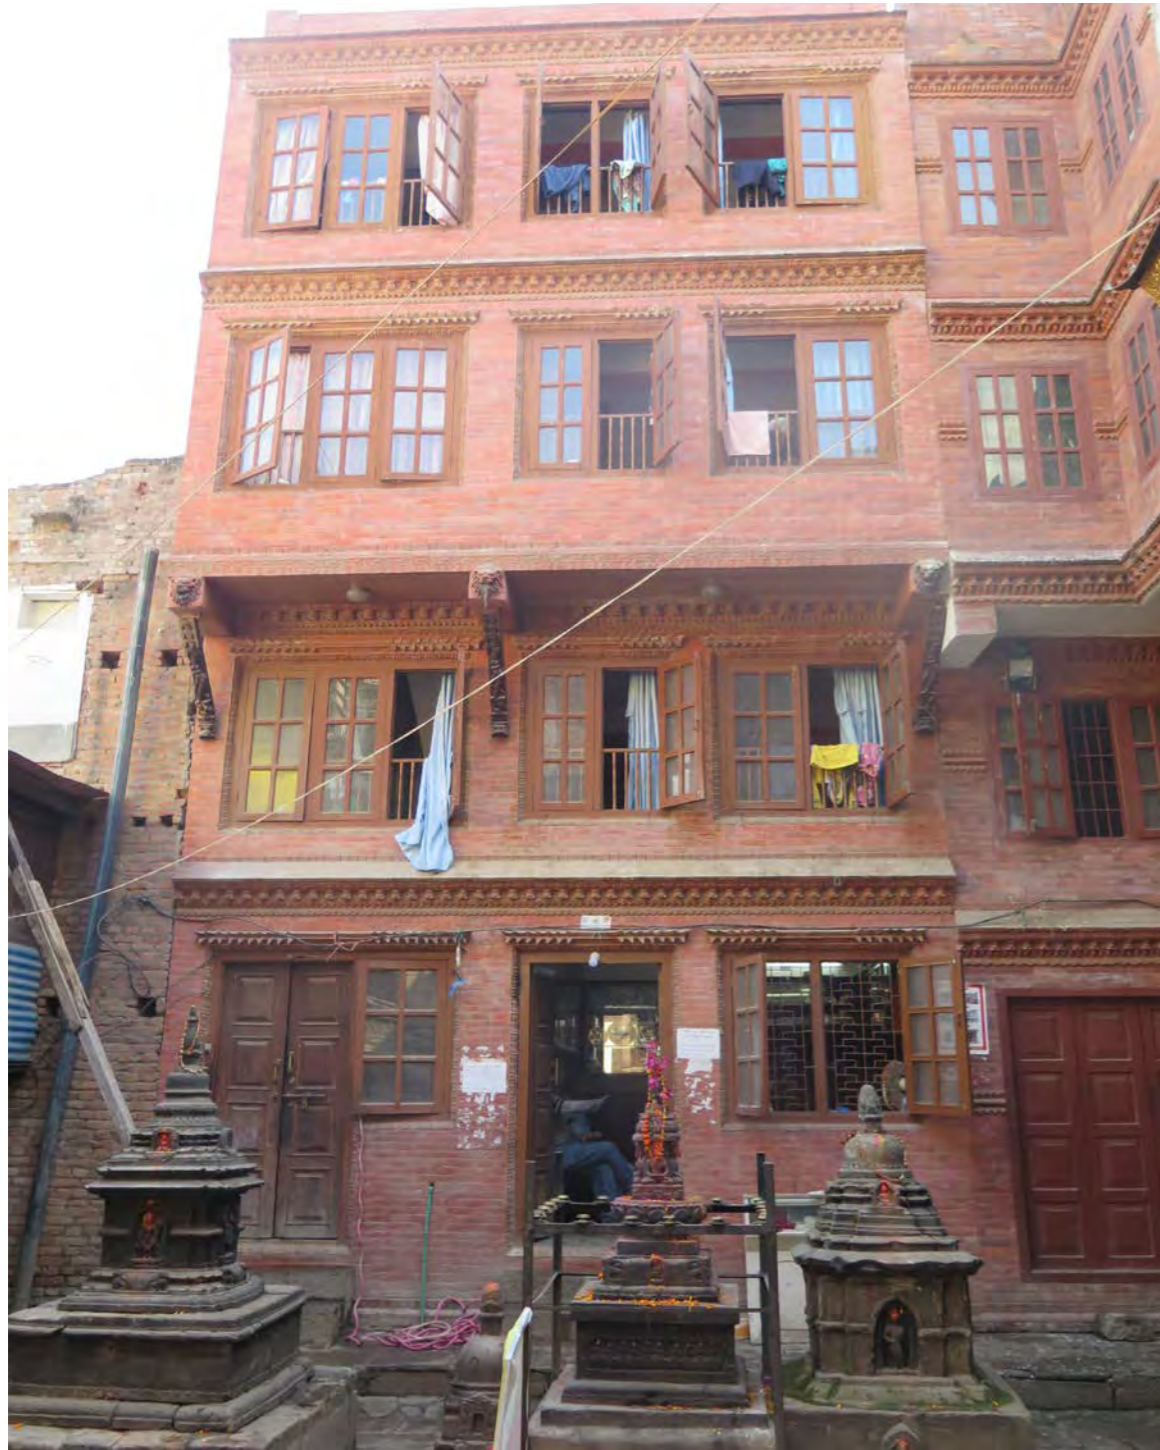
CODE NO	OWNERS NAME/CONTACT	STOREY NUMBER	PRESENT STOREY NUMBER	STRUCTURAL SYSTEM	MATERIAL	GENERAL DESCRIPTION	PROBLEM DESCRIPTION	DANGER	Heritage Significance	REMARKS
a02	Nani Maya Joshi	G+3	G+1	Load Bearing	Uncooked Brick		Two storey collapsed;Cracks in found floor;Rising damp;Vegetation growth

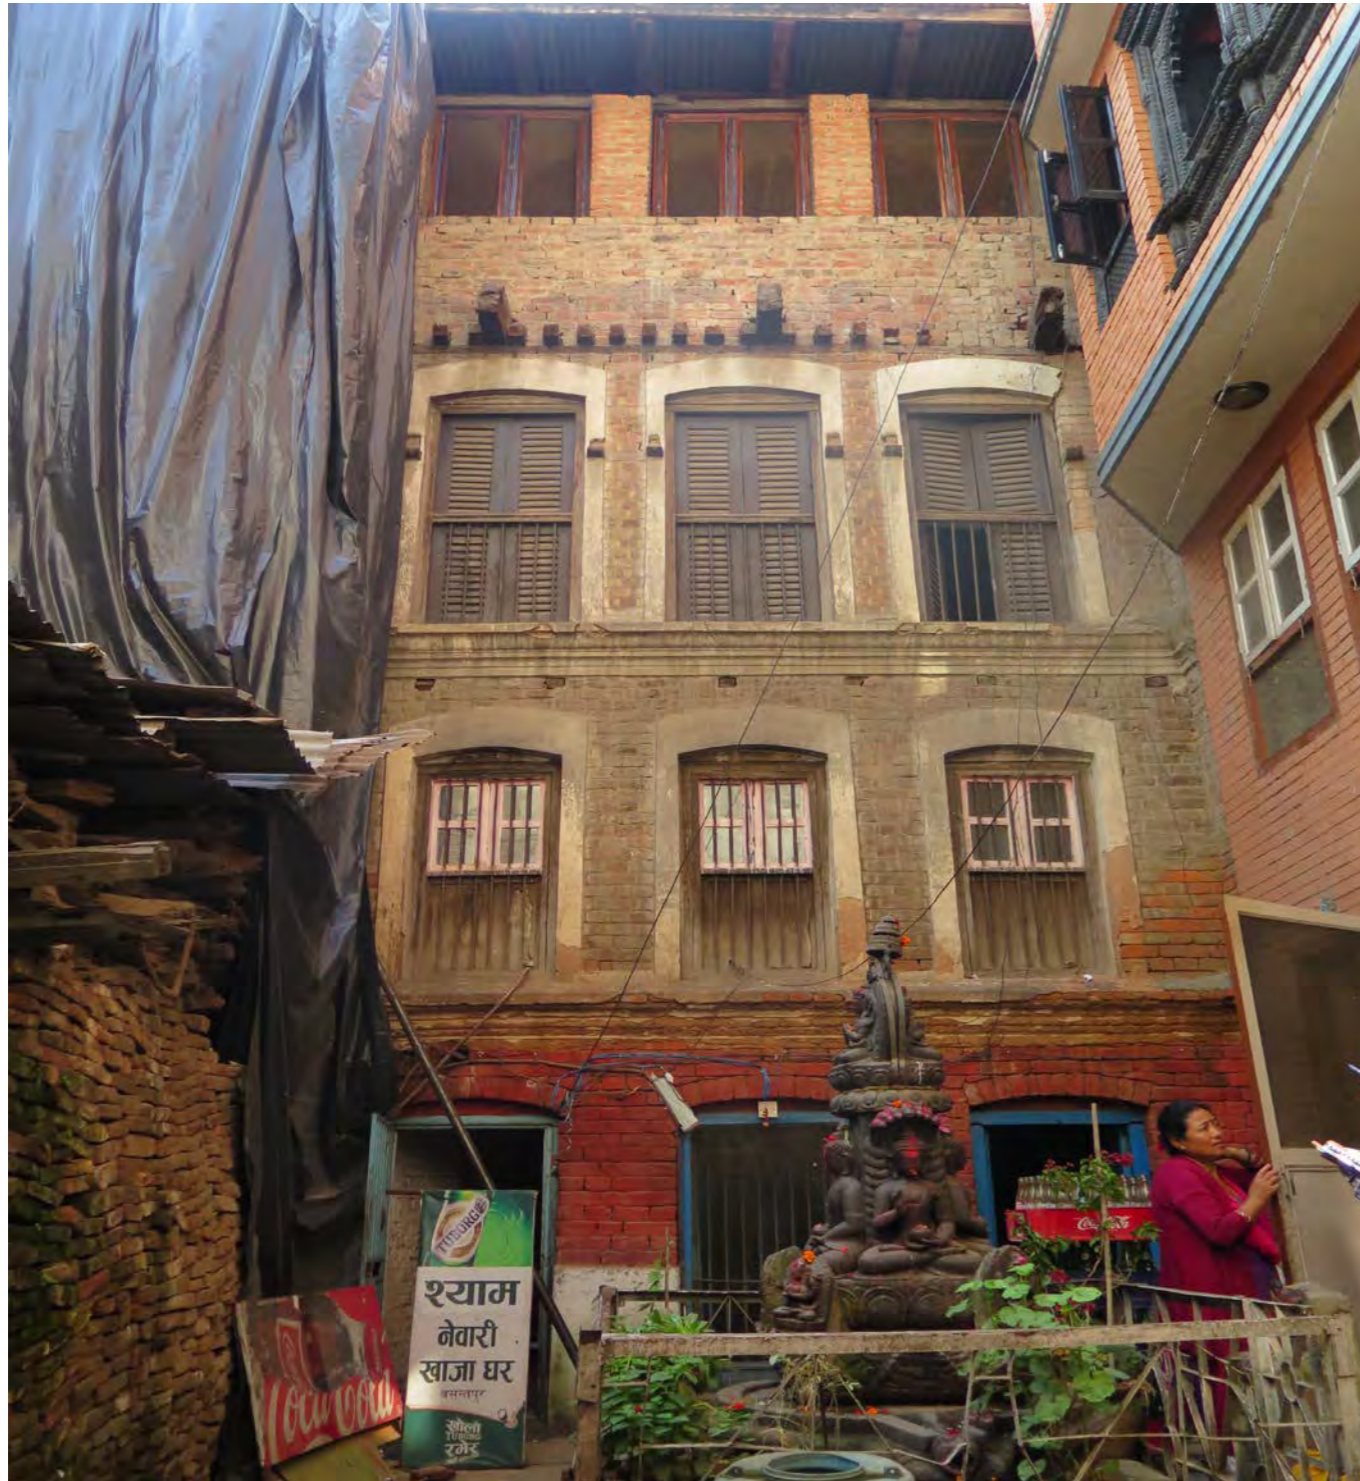
CODE NO	OWNERS NAME/CONTACT	STOREY NUMBER	PRESENT STOREY NUMBER	STRUCTURAL SYSTEM	MATERIAL	GENERAL DESCRIPTION	PROBLEM DESCRIPTION	DANGER	Heritage Significance	REMARKS
a18	Basundhara Bhakta Manandhar	G+3	G+3	Load Bearing	Brick		Partly collapsed; Extensive cracking and bulging of walls		+

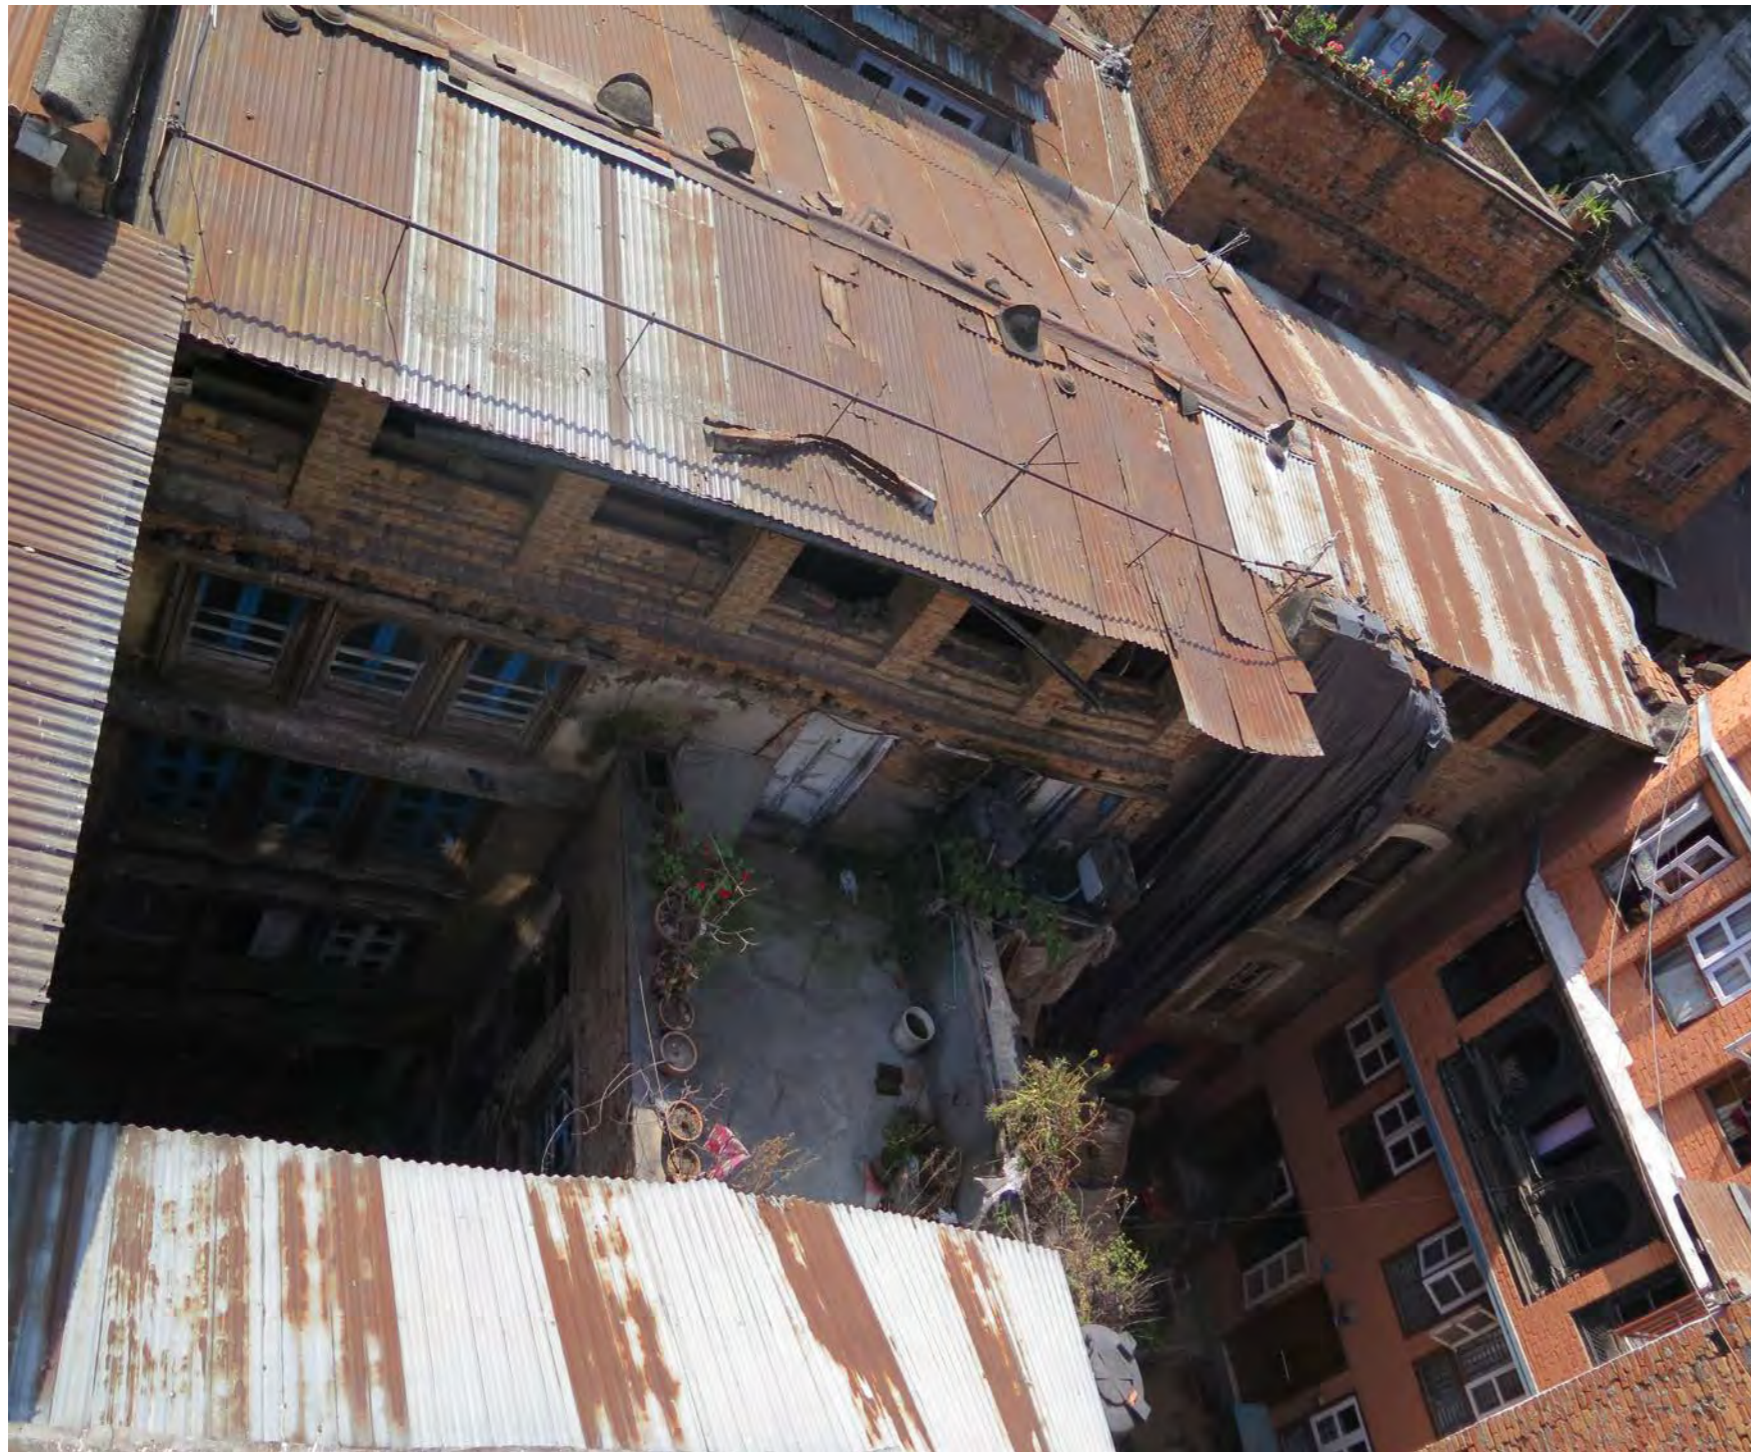
CODE NO	OWNERS NAME/CONTACT	STOREY NUMBER	PRESENT STOREY NUMBER	STRUCTURAL SYSTEM	MATERIAL	GENERAL DESCRIPTION	PROBLEM DESCRIPTION	DANGER	Heritage Significance	REMARKS
a20		G+4	G+4	Load Bearing	Brick		Bulging of walls; Extensive cracking

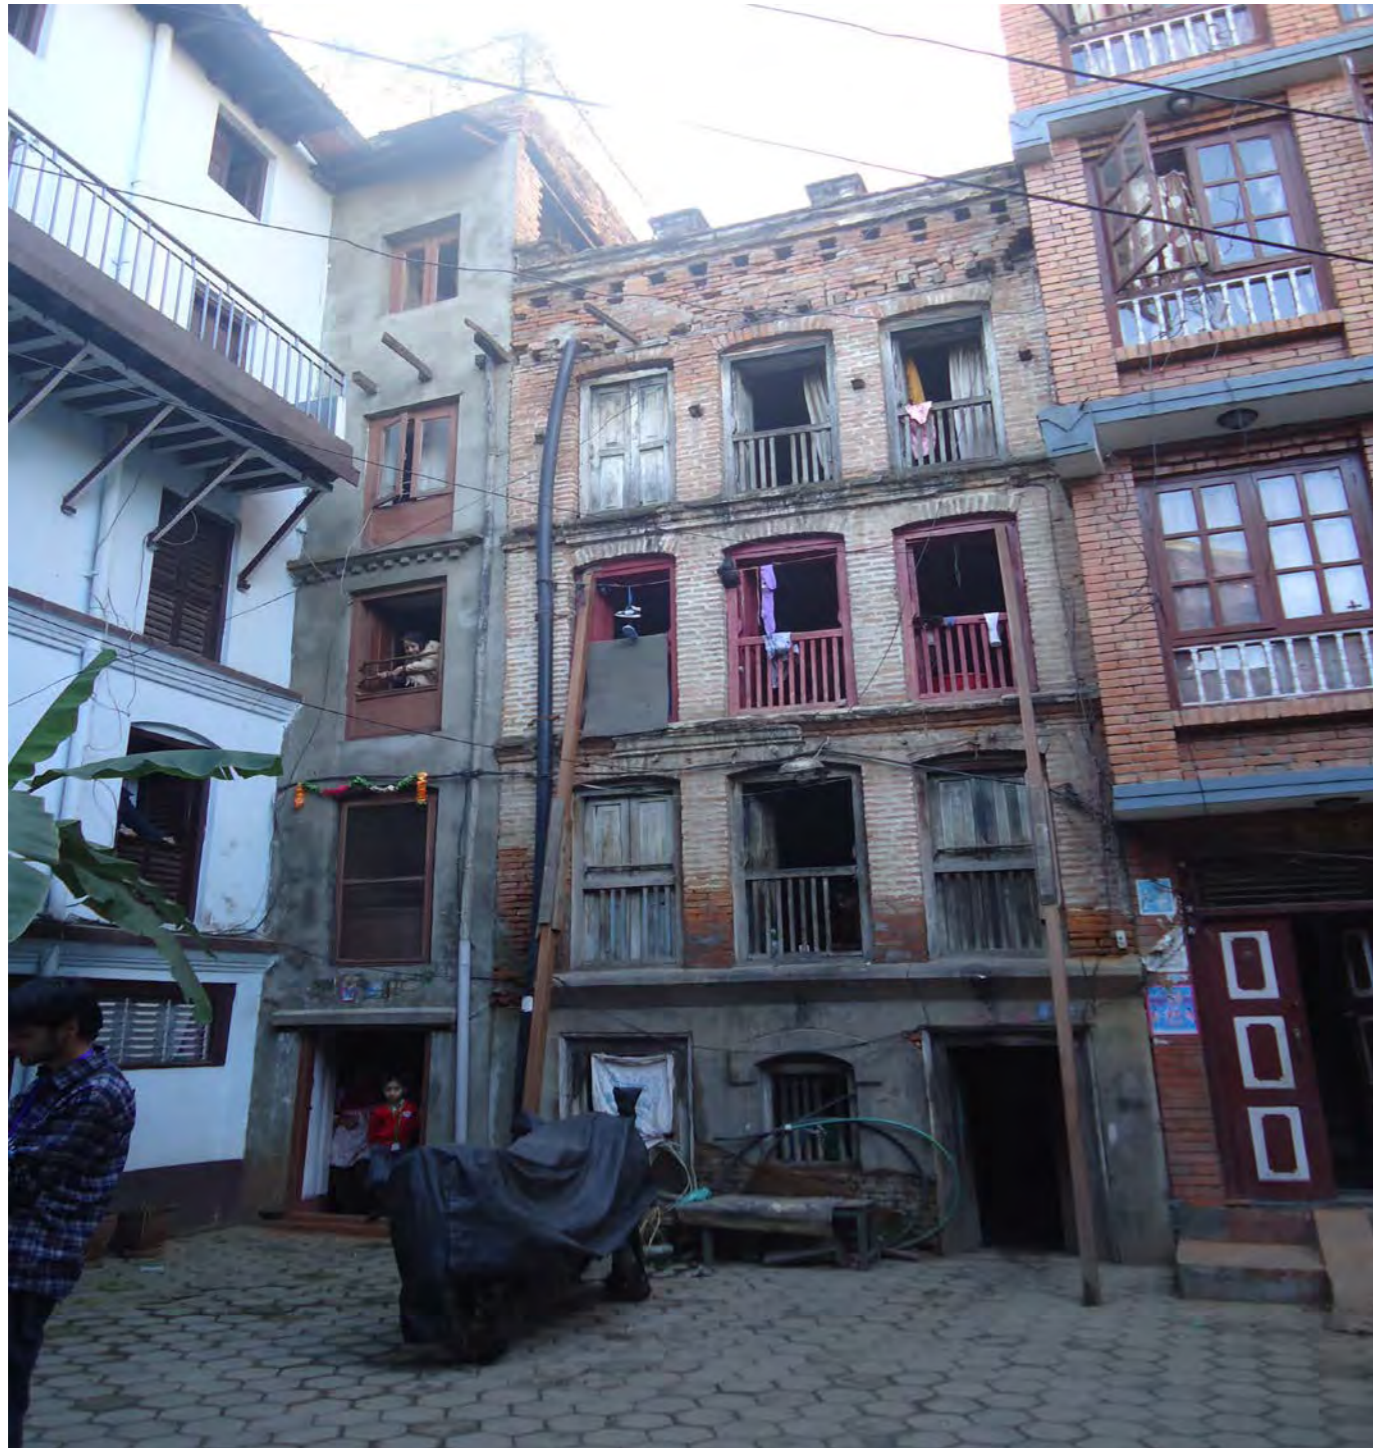
CODE NO	OWNERS NAME/ CONTACT	STOREY NUM- BER	PRESENT STO- REY NUMBER	STRUCTURAL SYSTEM	MATERIAL	GENERAL DESCEIPTION	PROBLEM DESCRIPTION	DANGER	Heritage Sig- nificance	REMARKS
b03	Prabin Pradhan	G+4	G+4	Load Bearing	Brick	Tin roof and outer façade not plastered	Minor internal cracks present			
b04	Diwas Shres- tha	G+3	G+3	Load Bearing	Brick		Bulging of walls and unstable	D!
