2015 Earthquake Damage Mapping

Hanuman Dhoka Darbar Square Monument Zone
Kathmandu Valley World Heritage Property

December 2015

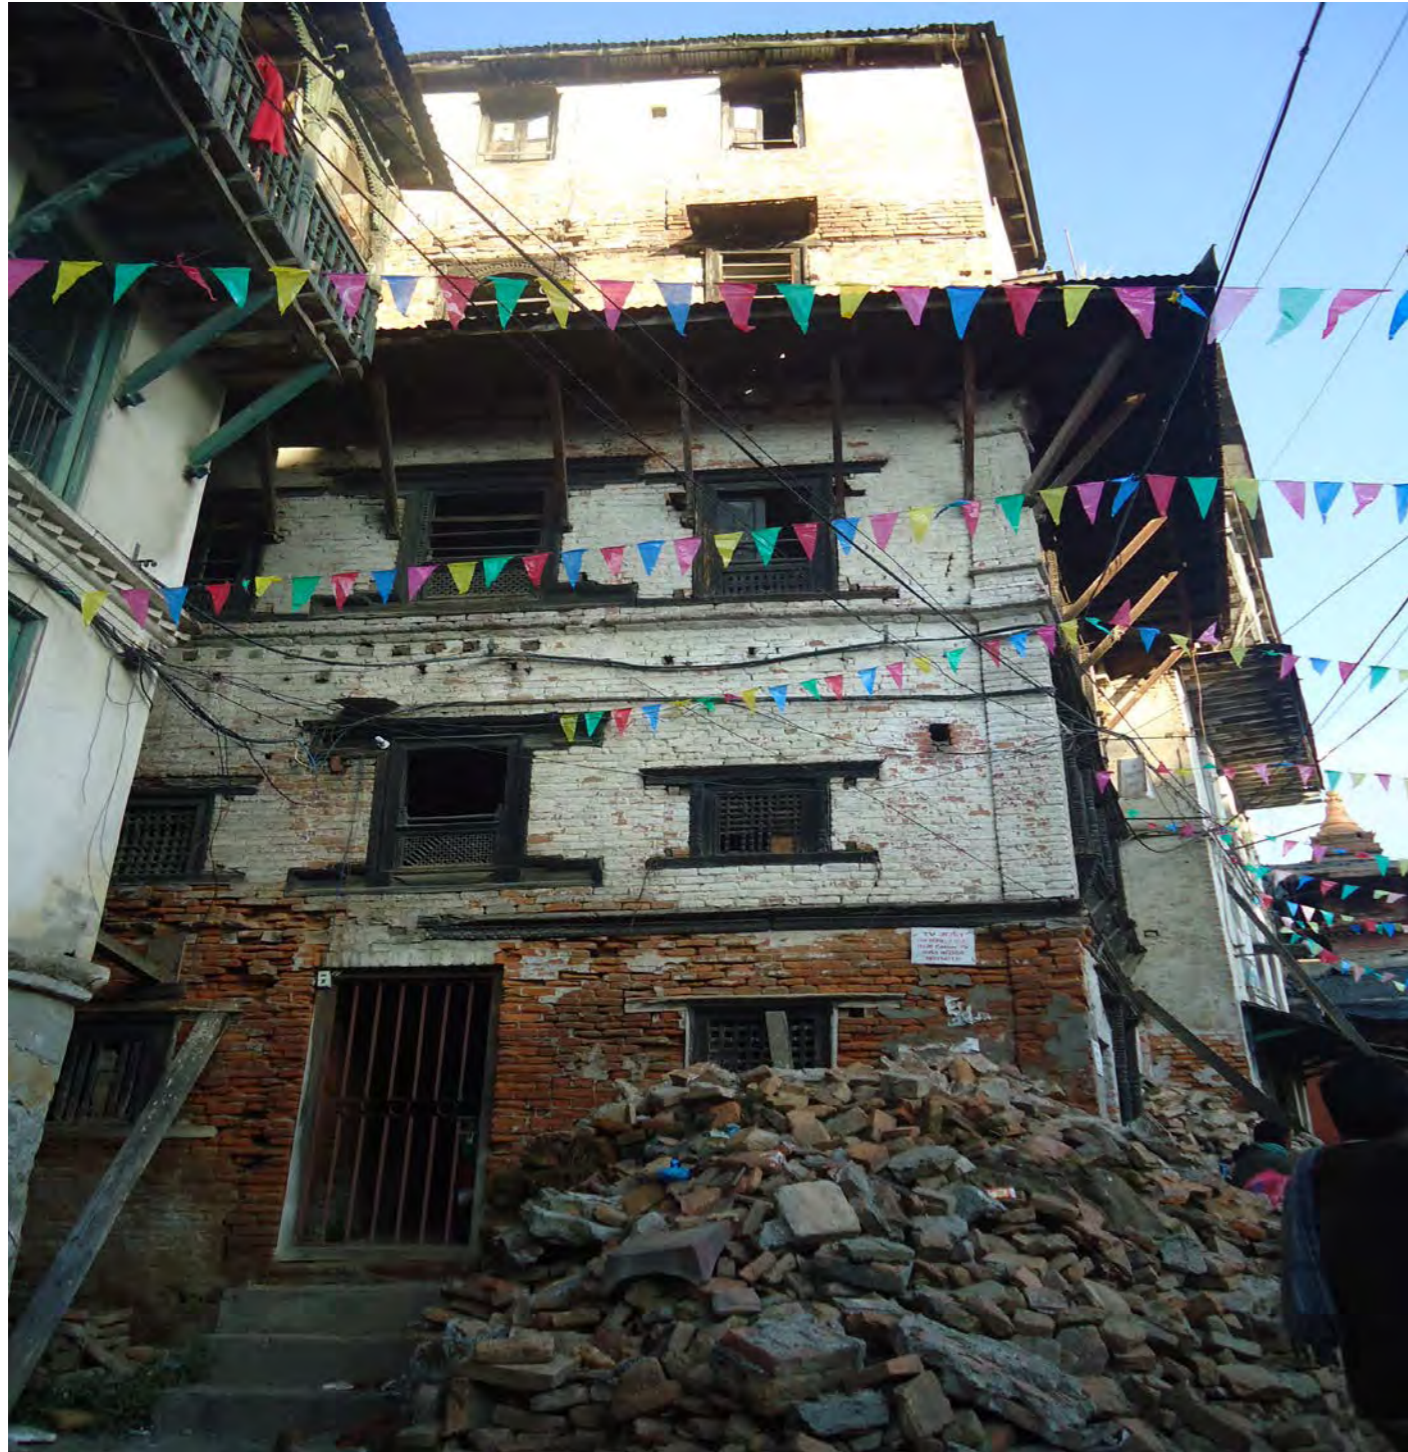
CODE NO	OWNERS NAME/ CONTACT	STOREY NUM- BER	PRESENT STO- REY NUMBER	STRUCTURAL SYSTEM	MATERIAL	GENERAL DESCEIPTION	PROBLEM DESCRIPTION	DANGER	Heritage Sig- nificance	REMARKS
b13	Bidhya Vaidya	G+4	G+4	Load Bearing	Brick; Timber		Extensive cracking of walls; Settlement and bulging of walls

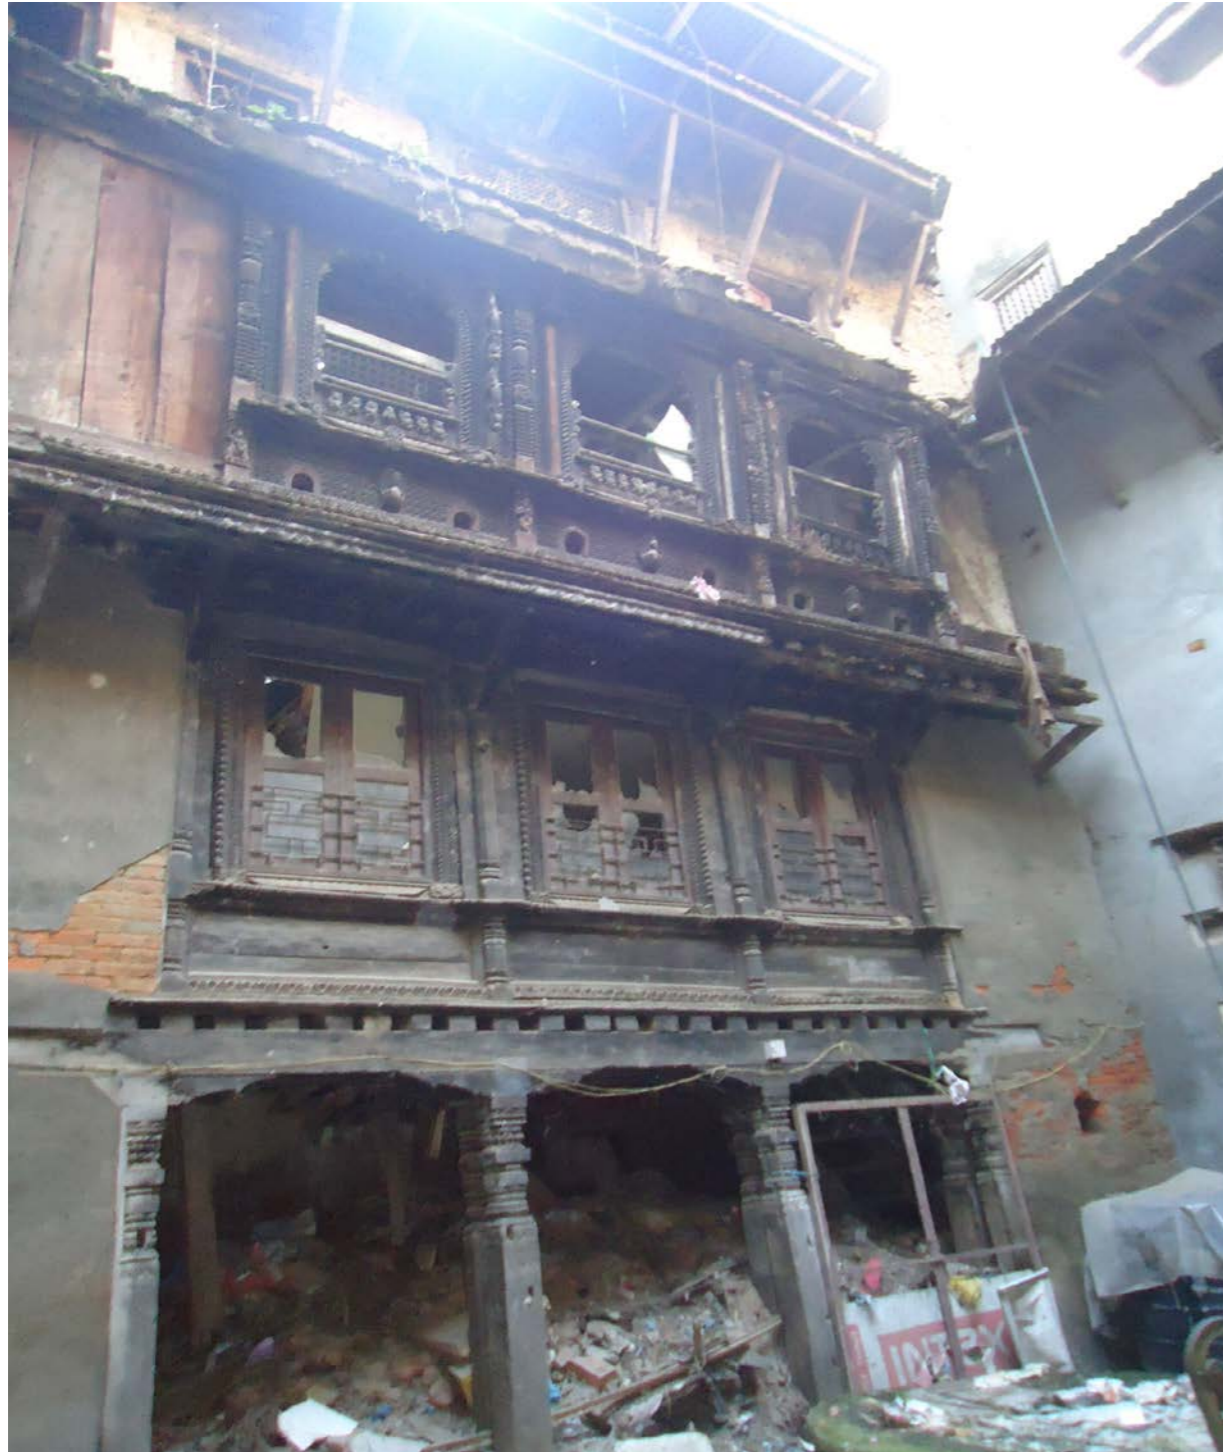
CODE NO	OWNERS NAME/ CONTACT	STOREY NUM- BER	PRESENT STO- REY NUMBER	STRUCTURAL SYSTEM	MATERIAL	GENERAL DESCEIPTION	PROBLEM DESCRIPTION	DANGER	Heritage Sig- nificance	REMARKS
b16		G+4	G+4	Load Bearing	Brick;Timber		Extensive internal cracks and bulging of walls. Cracks in timber elements.
