กรณีศึกษาโครงการอนุรักษ์ ของสำนักงานทรัพย์สินส่วนพระมหากษัตริย์

Rehabilitation of Na Phra Lan Shop-houses

กรณีศึกษา โครงการตึกแถวถนนหน้าพระลาน

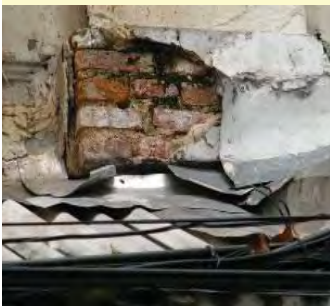
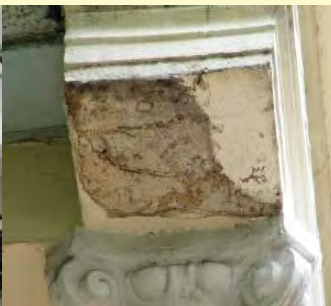
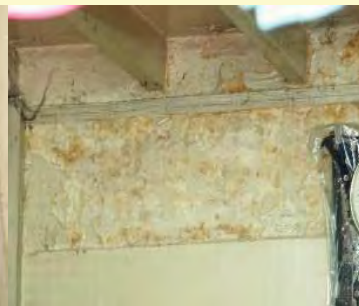
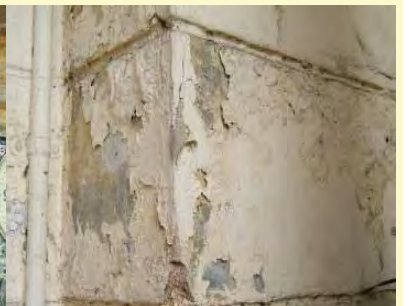
Exterior damages due to lack of maintenance

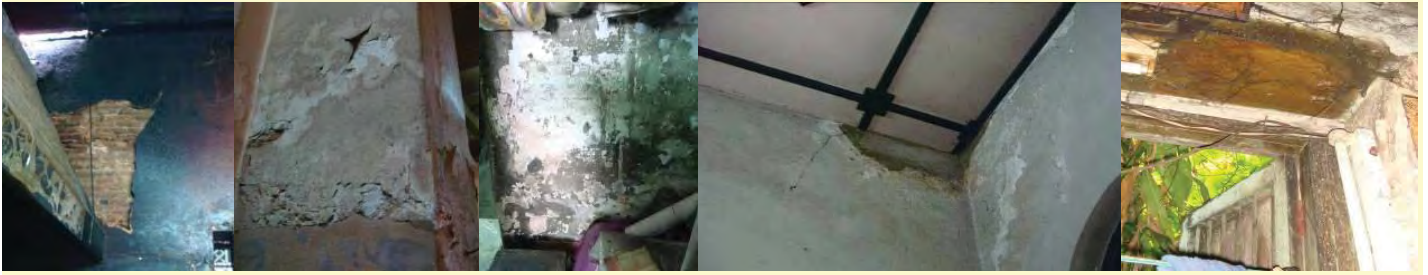
Interior deterioration due to humidity and negligence

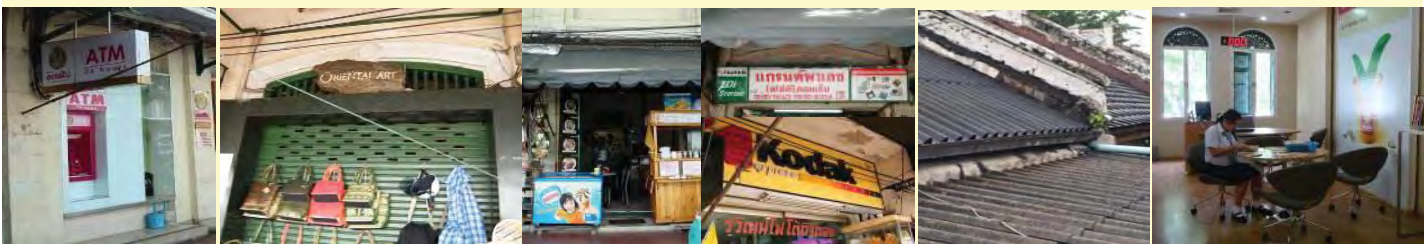
Illegal building alterations

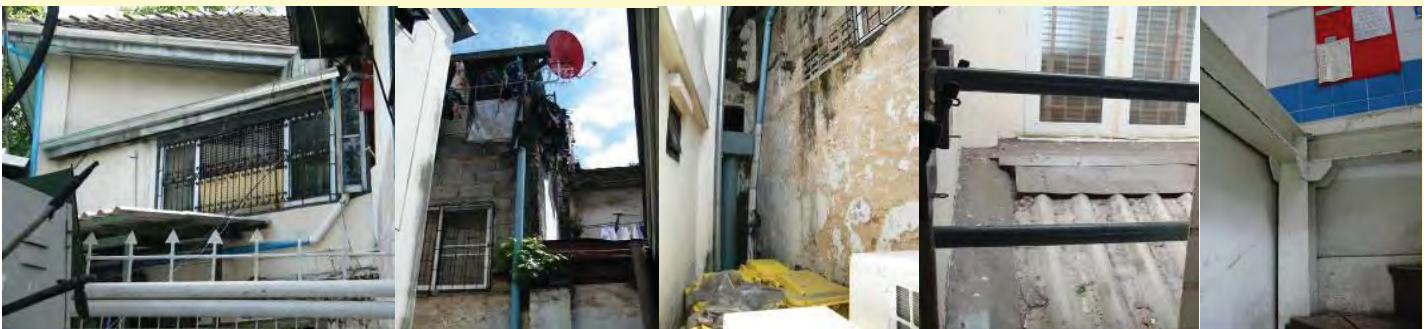
Exterior modification

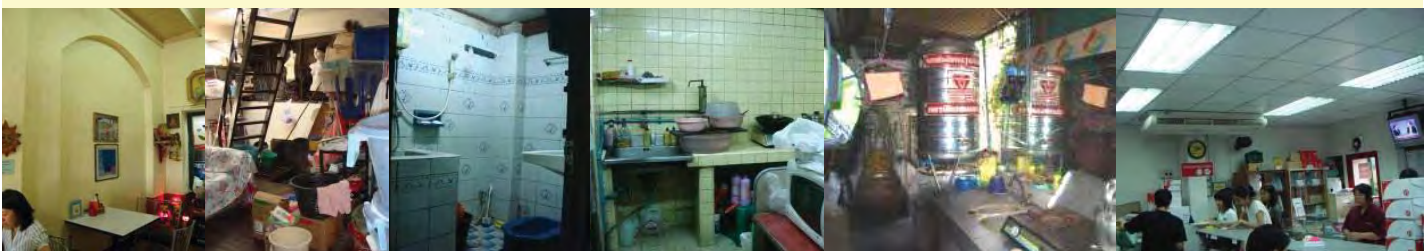
Interior modification

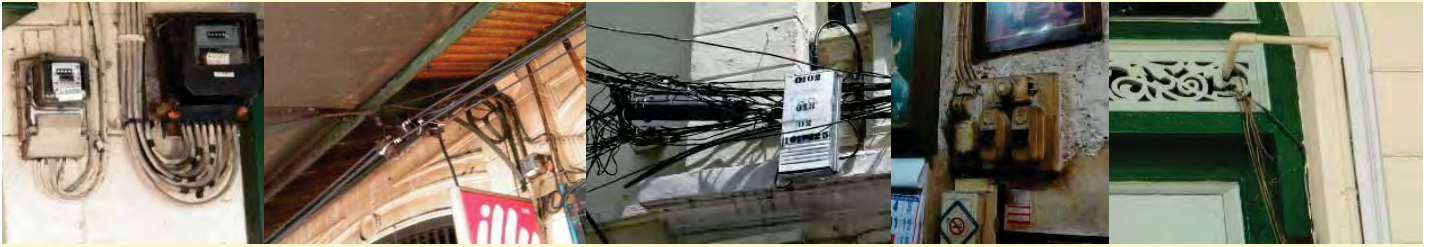
Inappropriate installment of facilities and wires

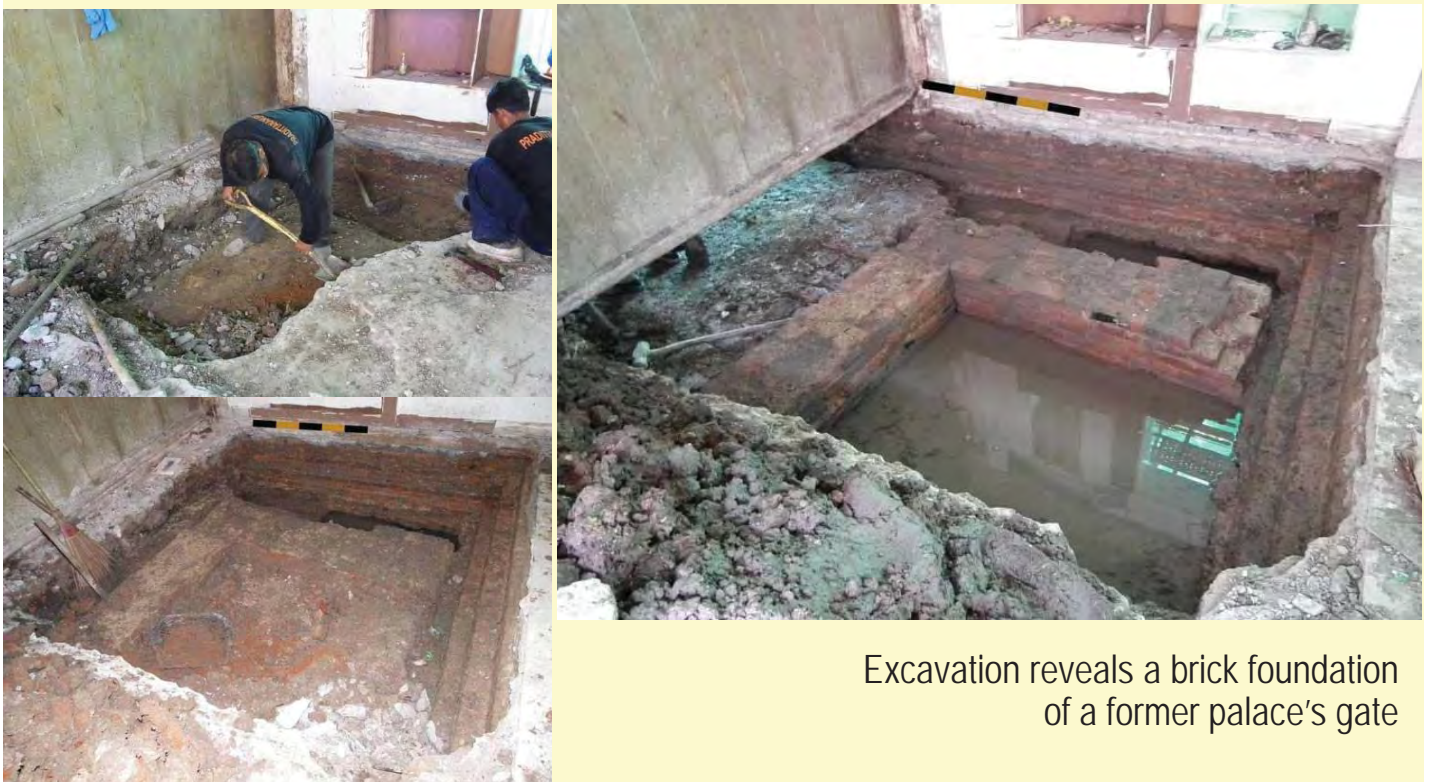
Excavation reveals a brick foundation of a former palace's gate
