2015 Earthquake Damage Mapping

Swayambhu Monument Zone
Kathmandu Valley World Heritage Property

Submitted to UNESCO by

June 2015

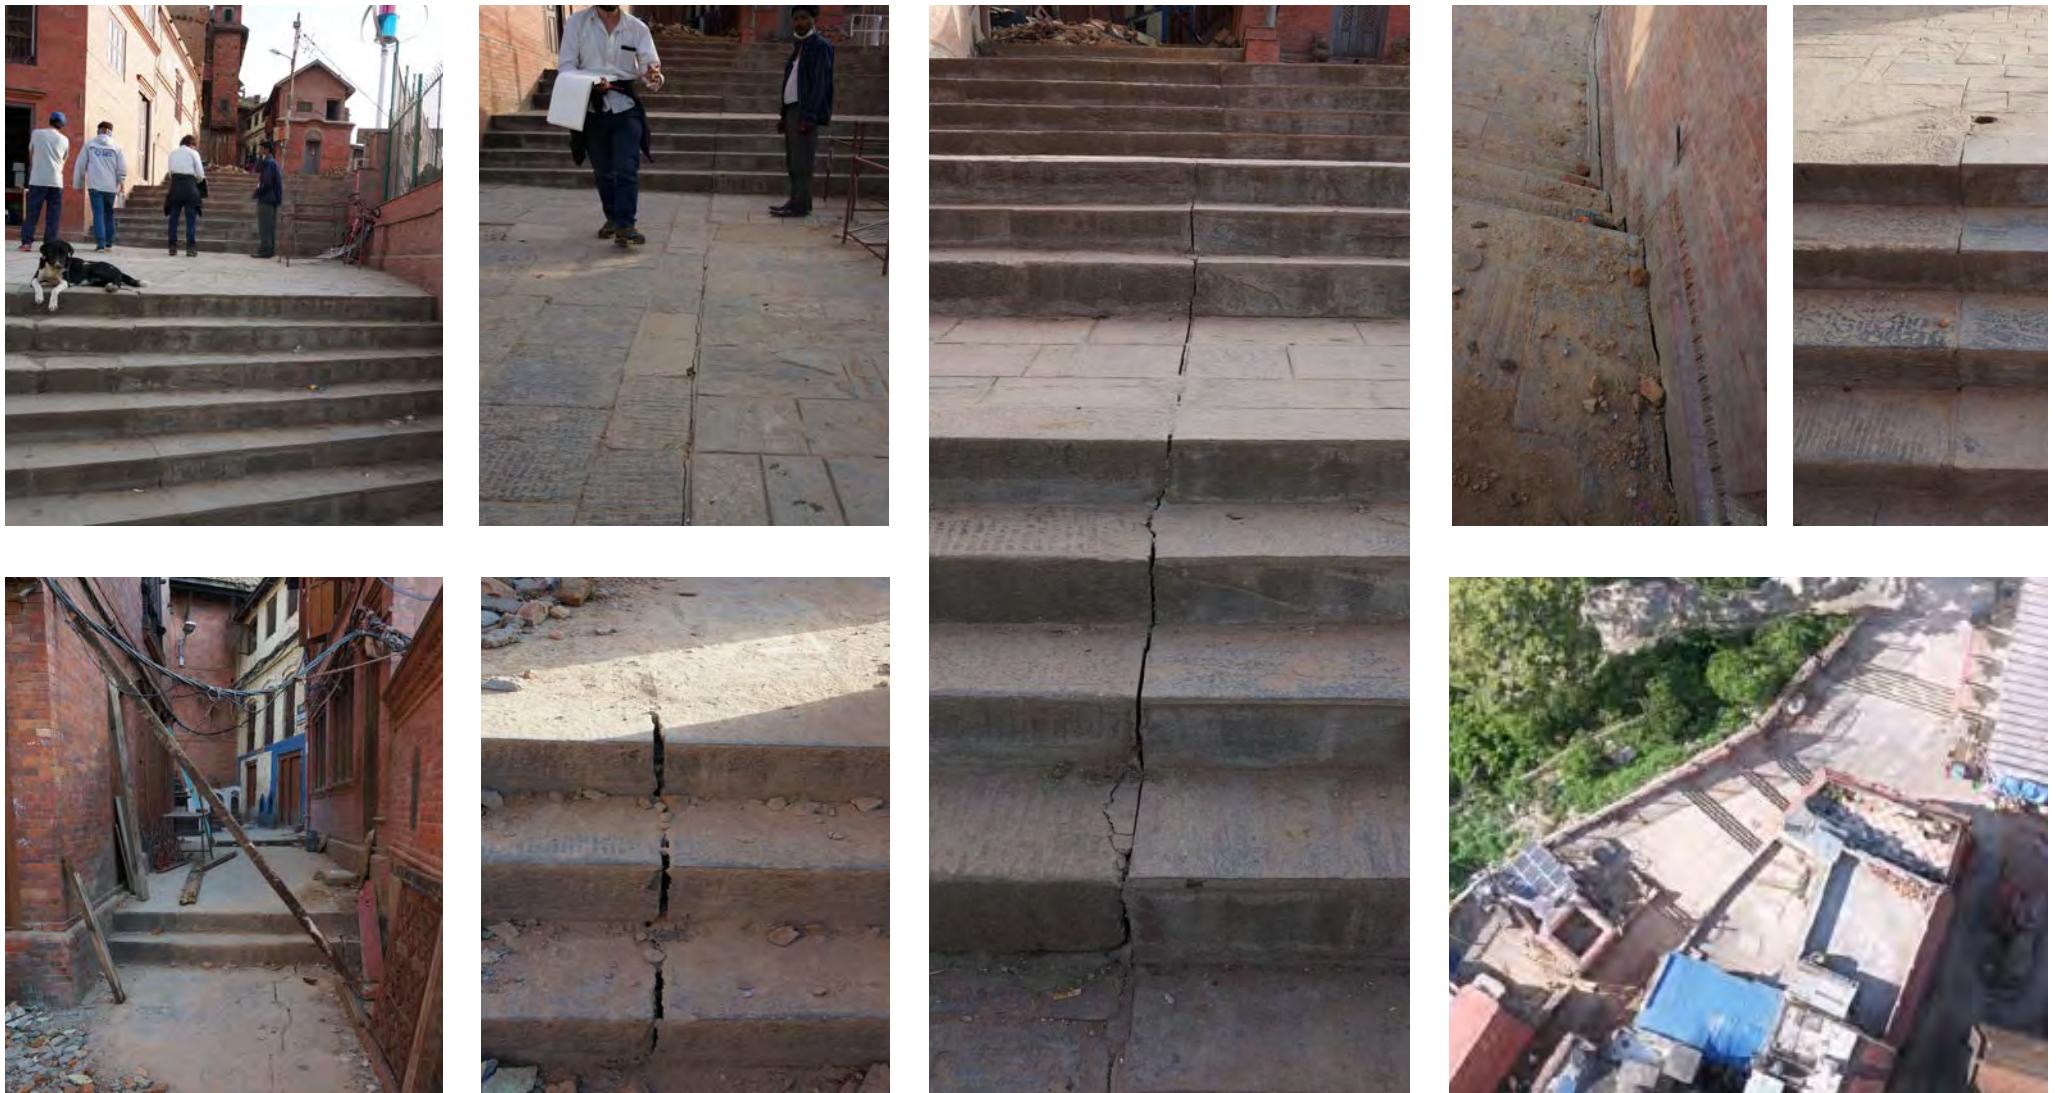
NUMBER NAME	CONSTRUCTION MATERIAL	GENERAL DESCRIPTION	
A B	Stone paved staircase and walkway	Longitudinal cracks seen on the joints of stone pavement and staircase. Crack A is extends about 12 meters and crack B is about 6 meters long, average width is approximately 7-8 mm.

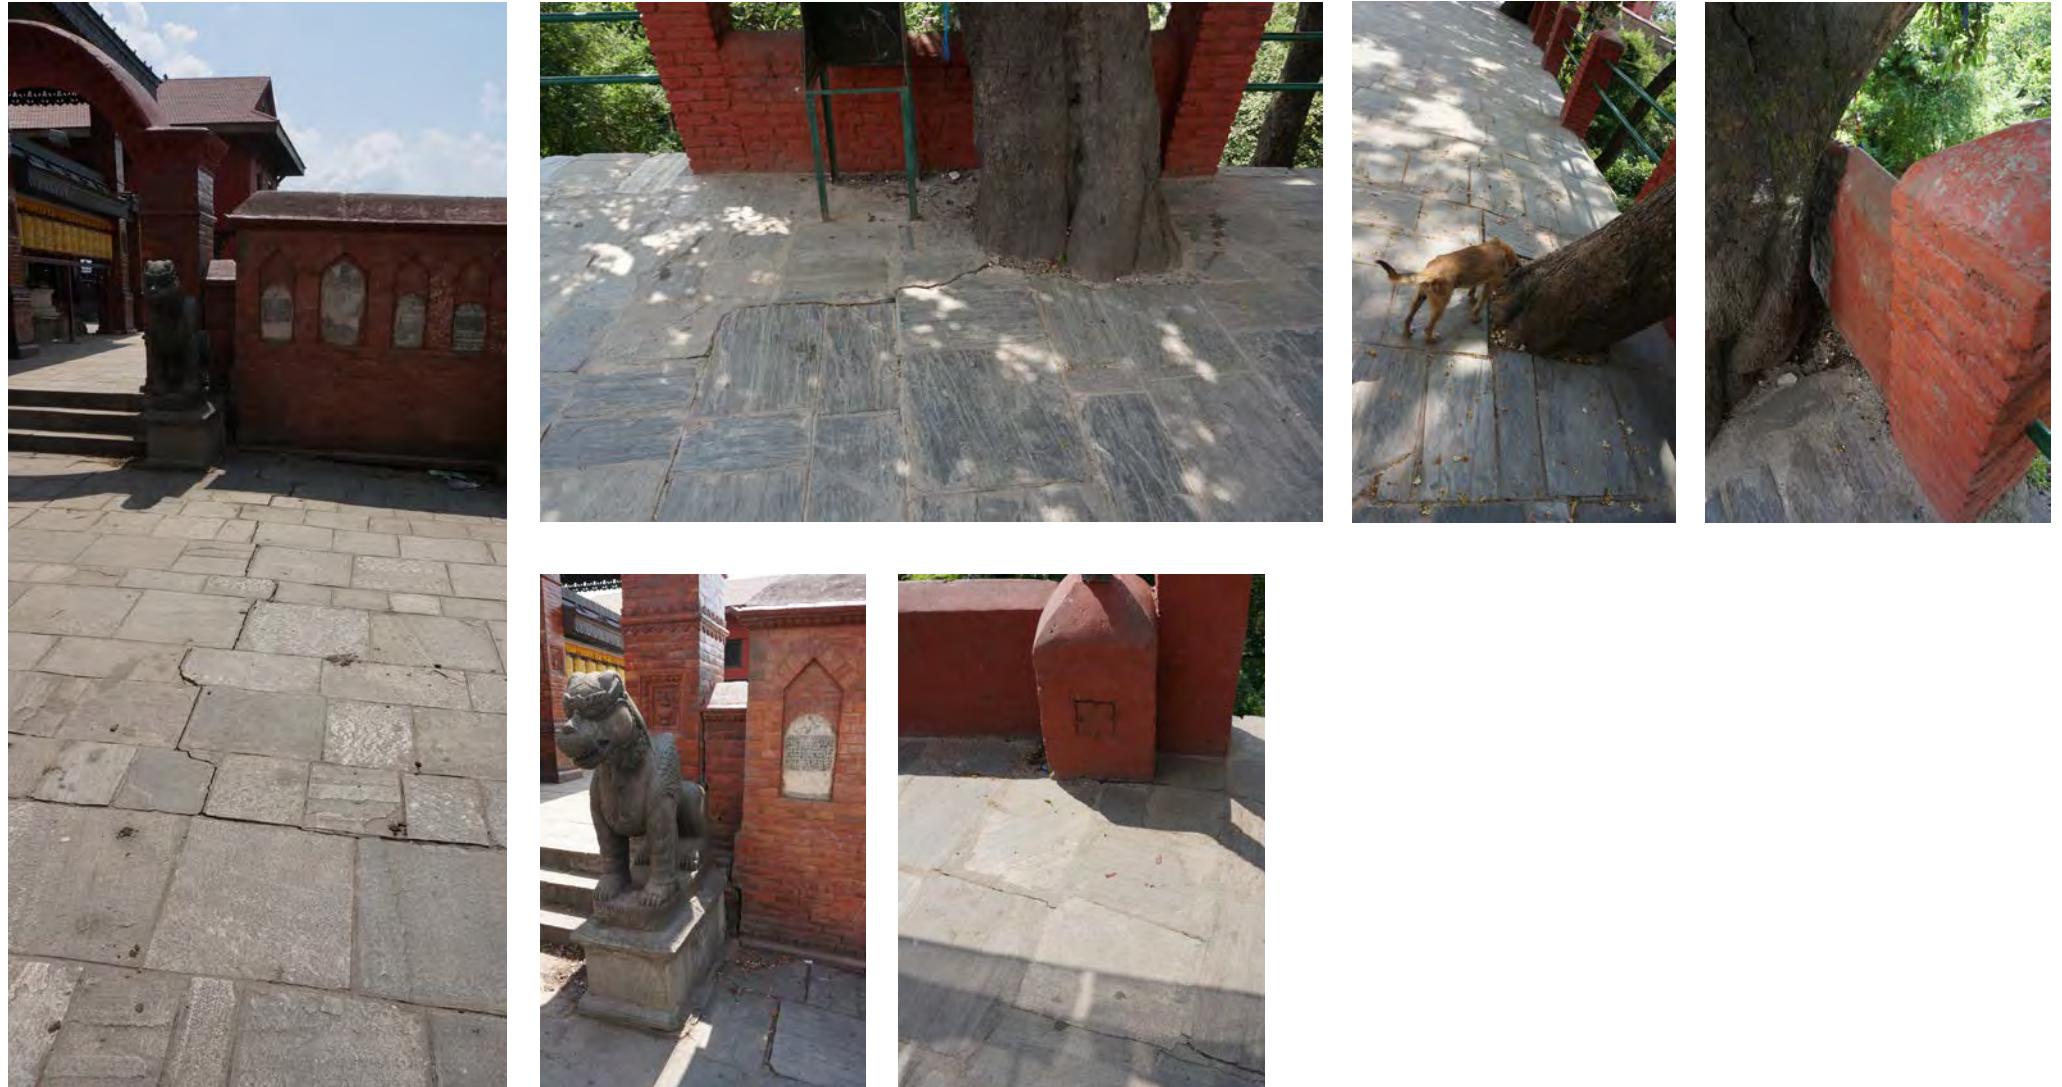
NUMBER NAME	CONSTRUCTION MATERIAL	GENERAL DESCRIPTION
K	Stone paved walkway platform	Two parallel longitudinal cracks along the paths of nearly 1cm wide extending from trees to temple gateways

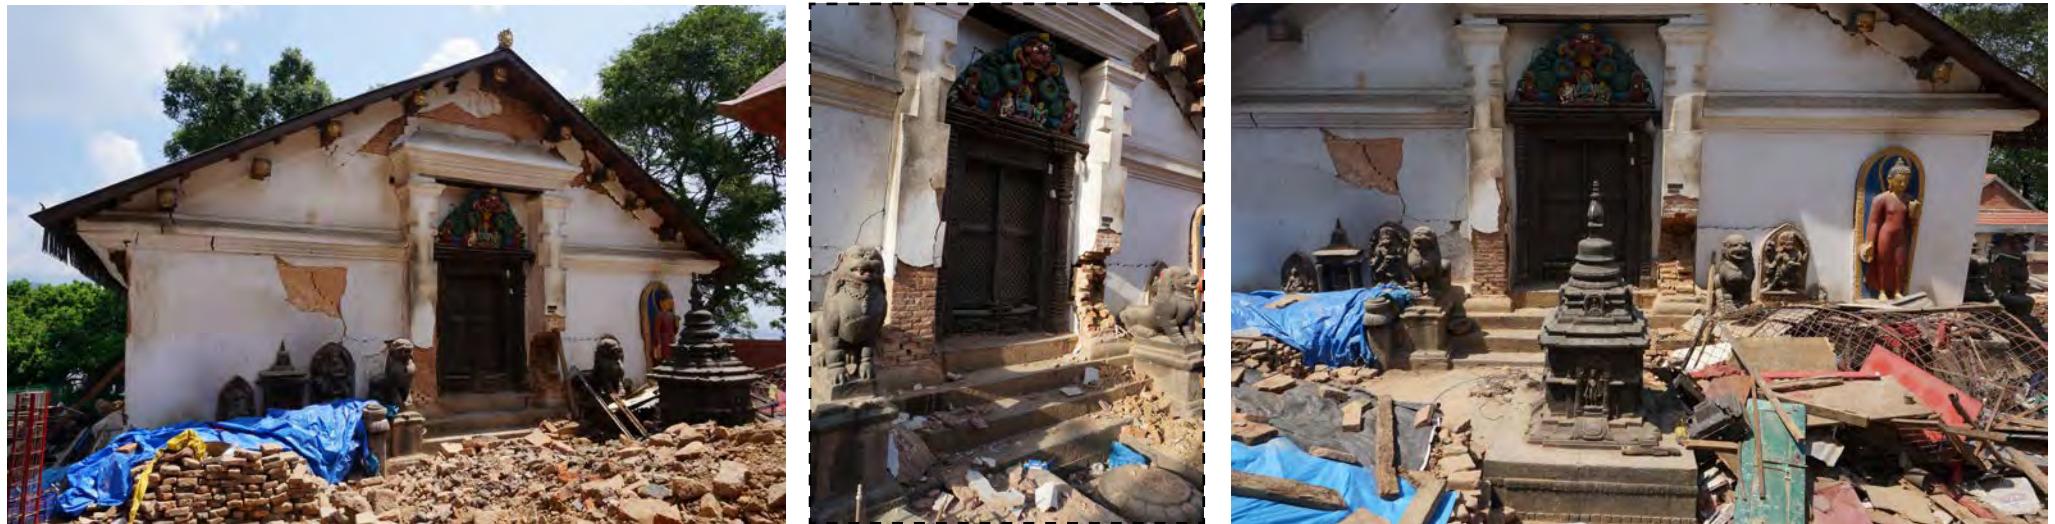
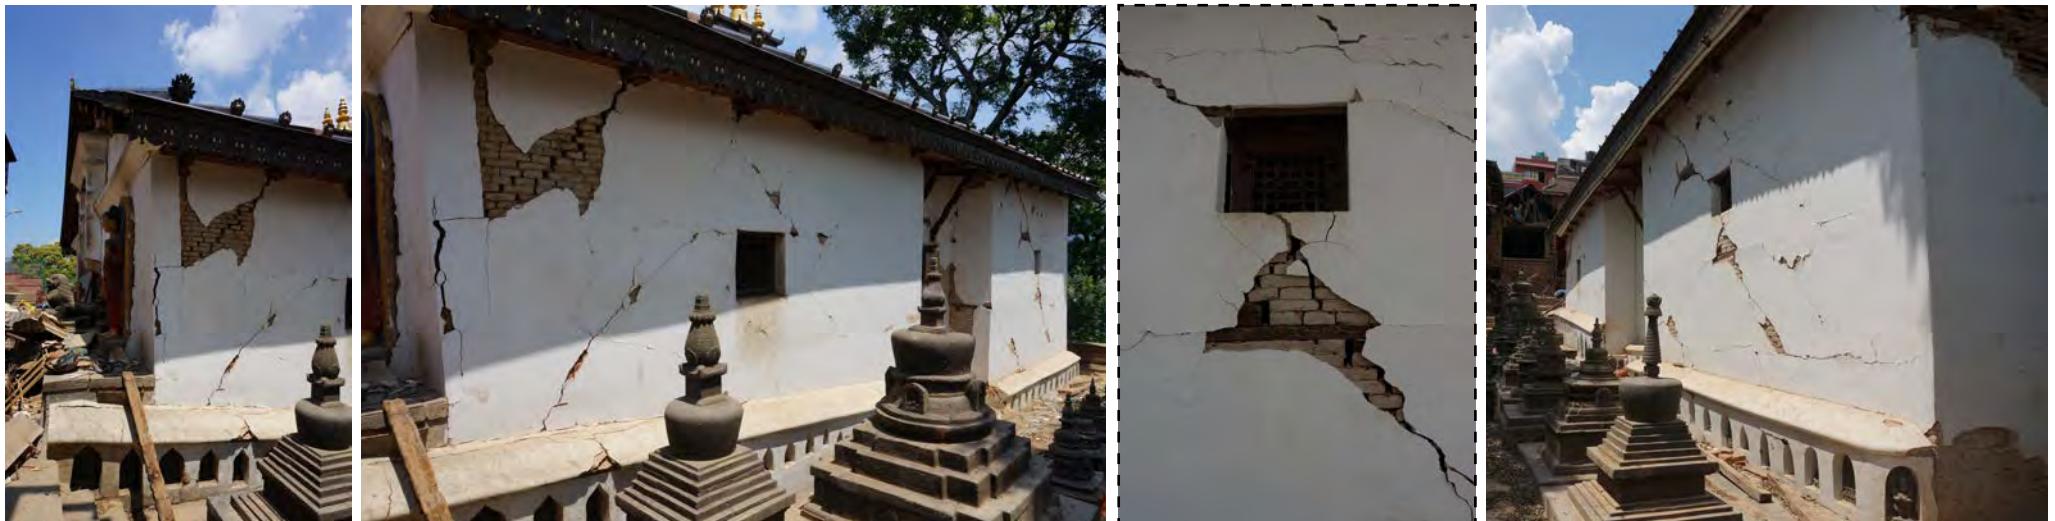
The monastery "Swayambhu Gumba" (no 30) is severely damaged and the "Singu Bahaal" (no 41 and 42) is mostly collapsed (rear part towards hillside). At the North of the hillock, the monastery "Shantipur" (no 1) has severe cracks on all facades, the North-East part partly collapsed. This building is restricted for every personnel except for the priests, so a special arrangements may need to be taken for its restoration or removal for treatment of its interior frescoes. On the hill of Manjushree "Swayambhu Zone-II", the monastery of Dharma Chakra Bihar, more recent construction, has suffered in its oldest parts.

NUMBER NAME	DATE A.D.	TYPE OF MONUMENT HERITAGE SIGNIFICANCE	GENERAL DESCRIPTION	DESCRIPTION OF DAMAGE	DANGER DESTROY	N ↑
1(K-326) Shantipur Temple		Temple	G+1 Building Structure Brick laid in mud mortar, timber roof framing, metal roof	S wall with diagonal and horizontal cracks with cracks and spalling in right pillar	1/2 X N Wall

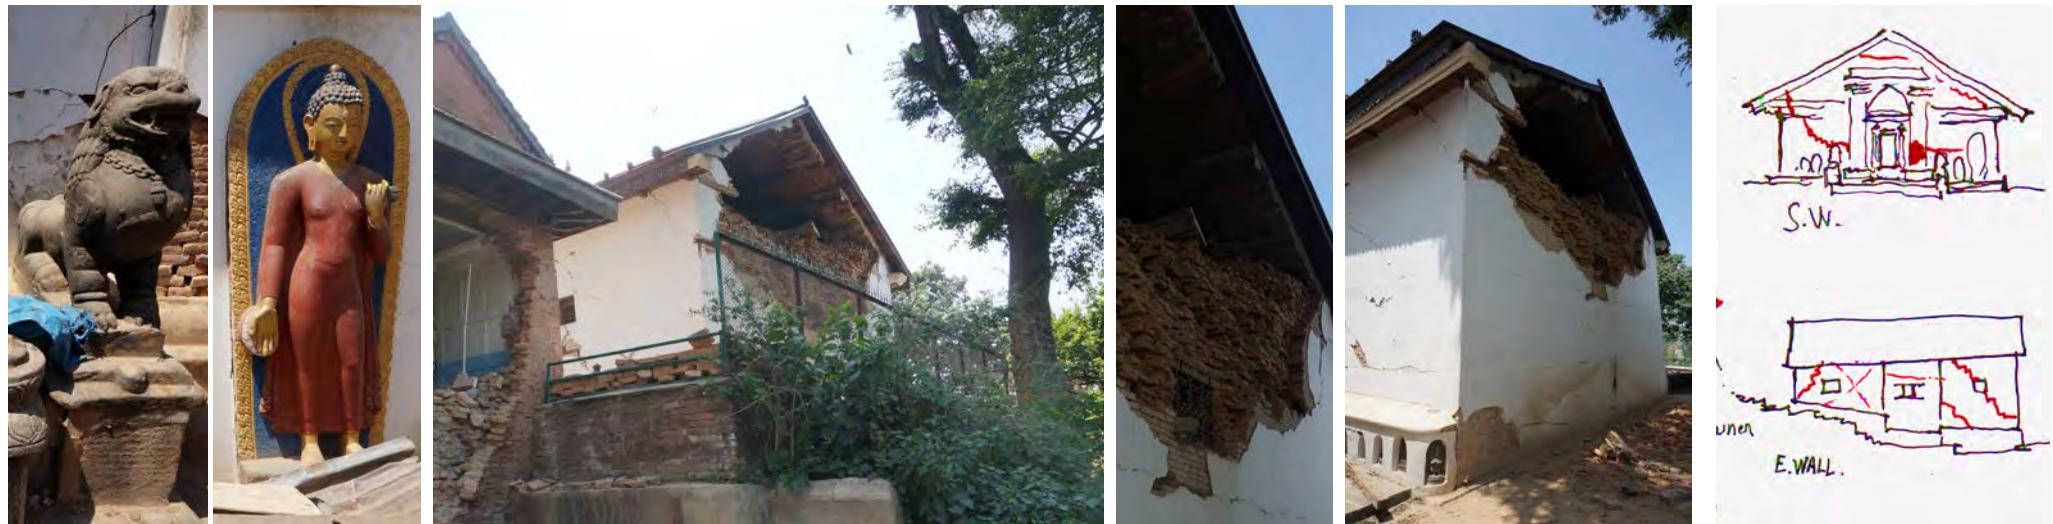
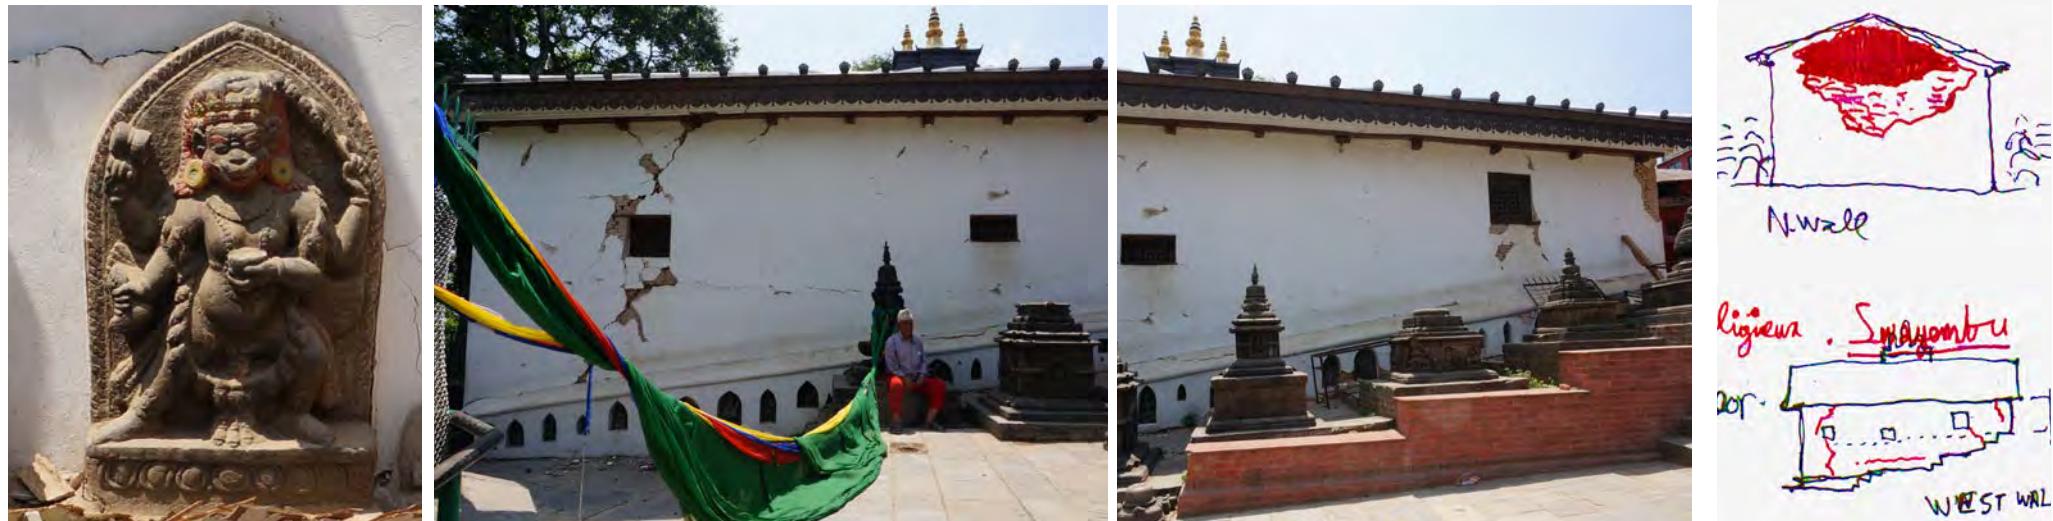
NUMBER NAME	DATE A.D.	TYPE OF MONUMENT HERITAGE SIGNIFICANCE	GENERAL DESCRIPTION	DESCRIPTION OF DAMAGE	DANGER DESTROY	N ↑
1 (K-326) Shantipur Temple		Temple	G+1 Building Structure Brick laid in mud mortar, timber roof framing, metal roof	W and E wall with diagonal and horizontal cracks N wall with major diagonal cracks and gable wall collapsed	1/2 X N Wall

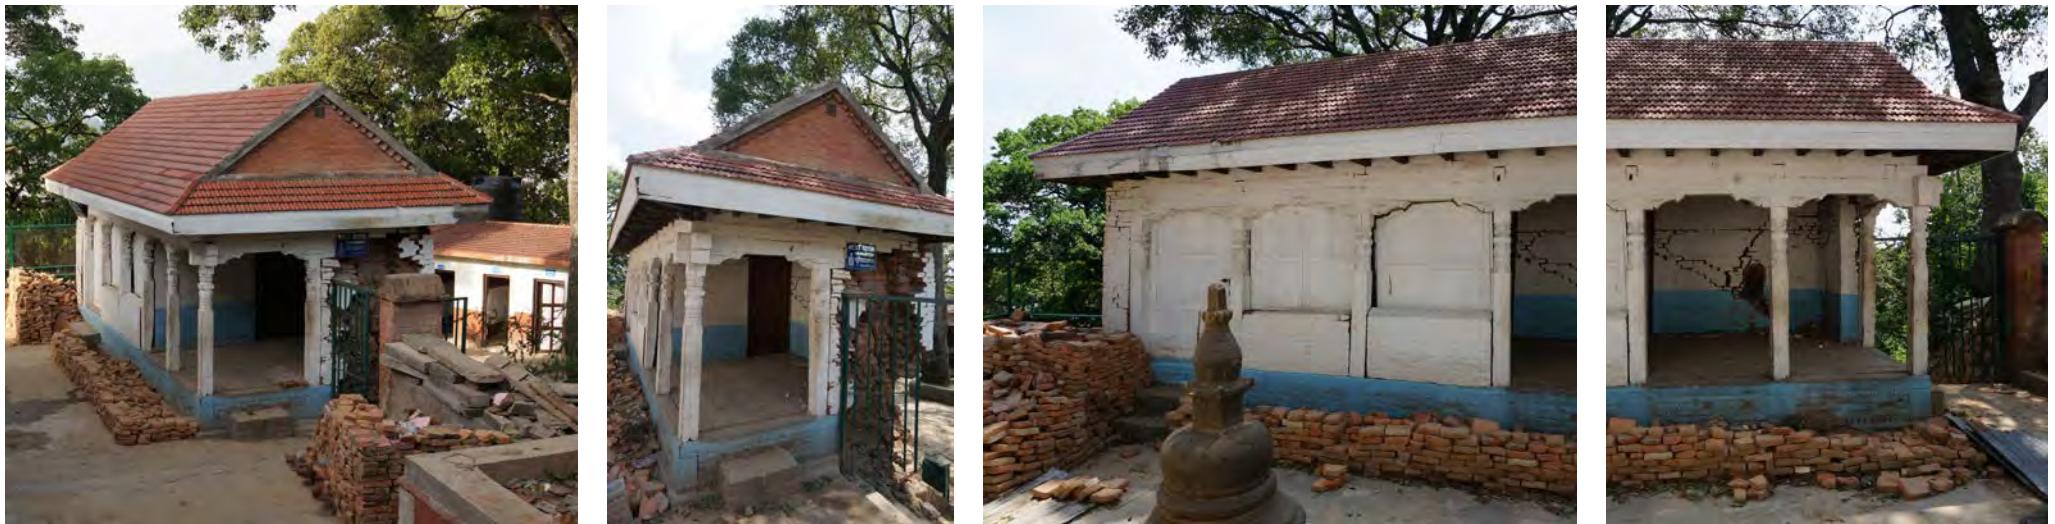
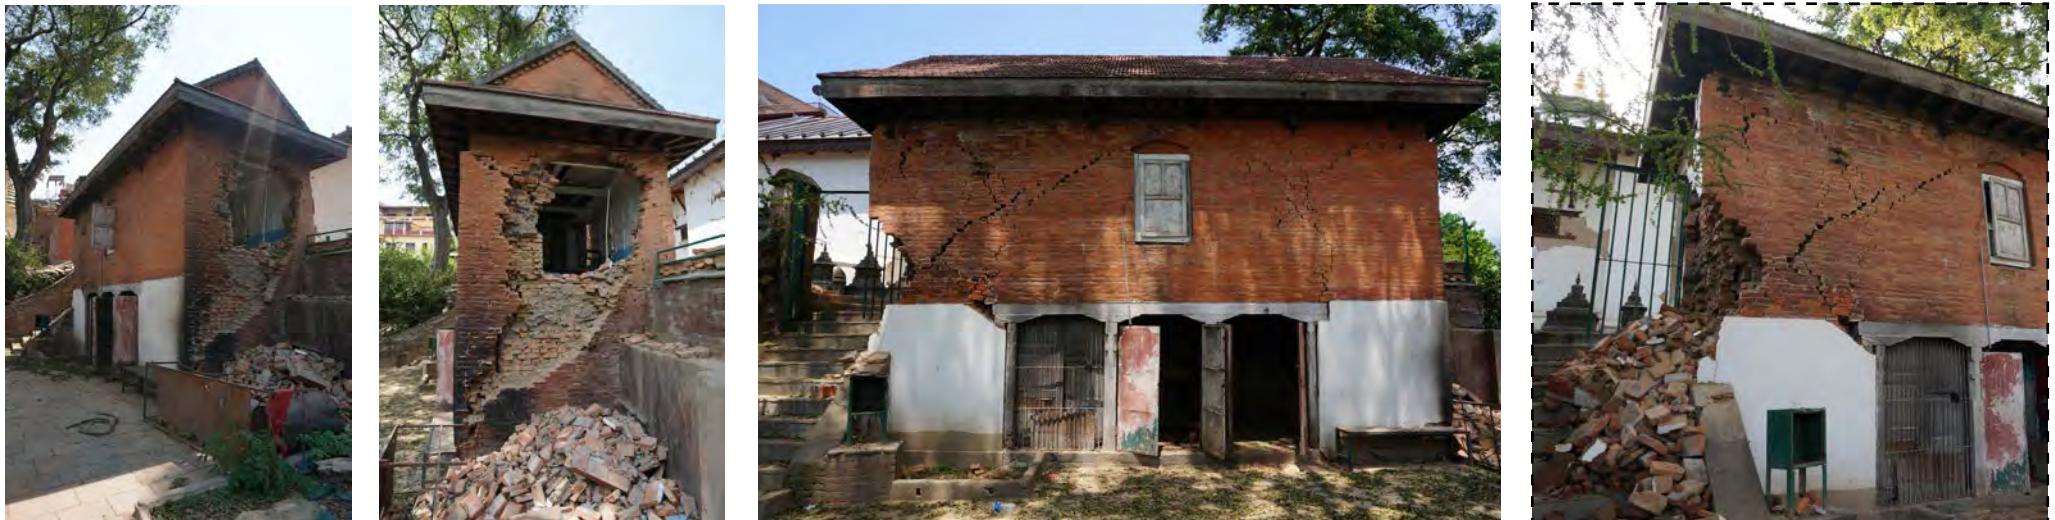
NUMBER NAME	DATE A.D.	TYPE OF MONUMENT HERITAGE SIGNIFICANCE	GENERAL DESCRIPTION	DESCRIPTION OF DAMAGE	DANGER DESTROY	N
4		Sattal (public rest house)	G+1 Building Structure Brick and wooden joist system construction	N-E corners with major cracks and falling off N wall with half of wall collapsed E wall with major diagonal cracks	1/2 X N WALL

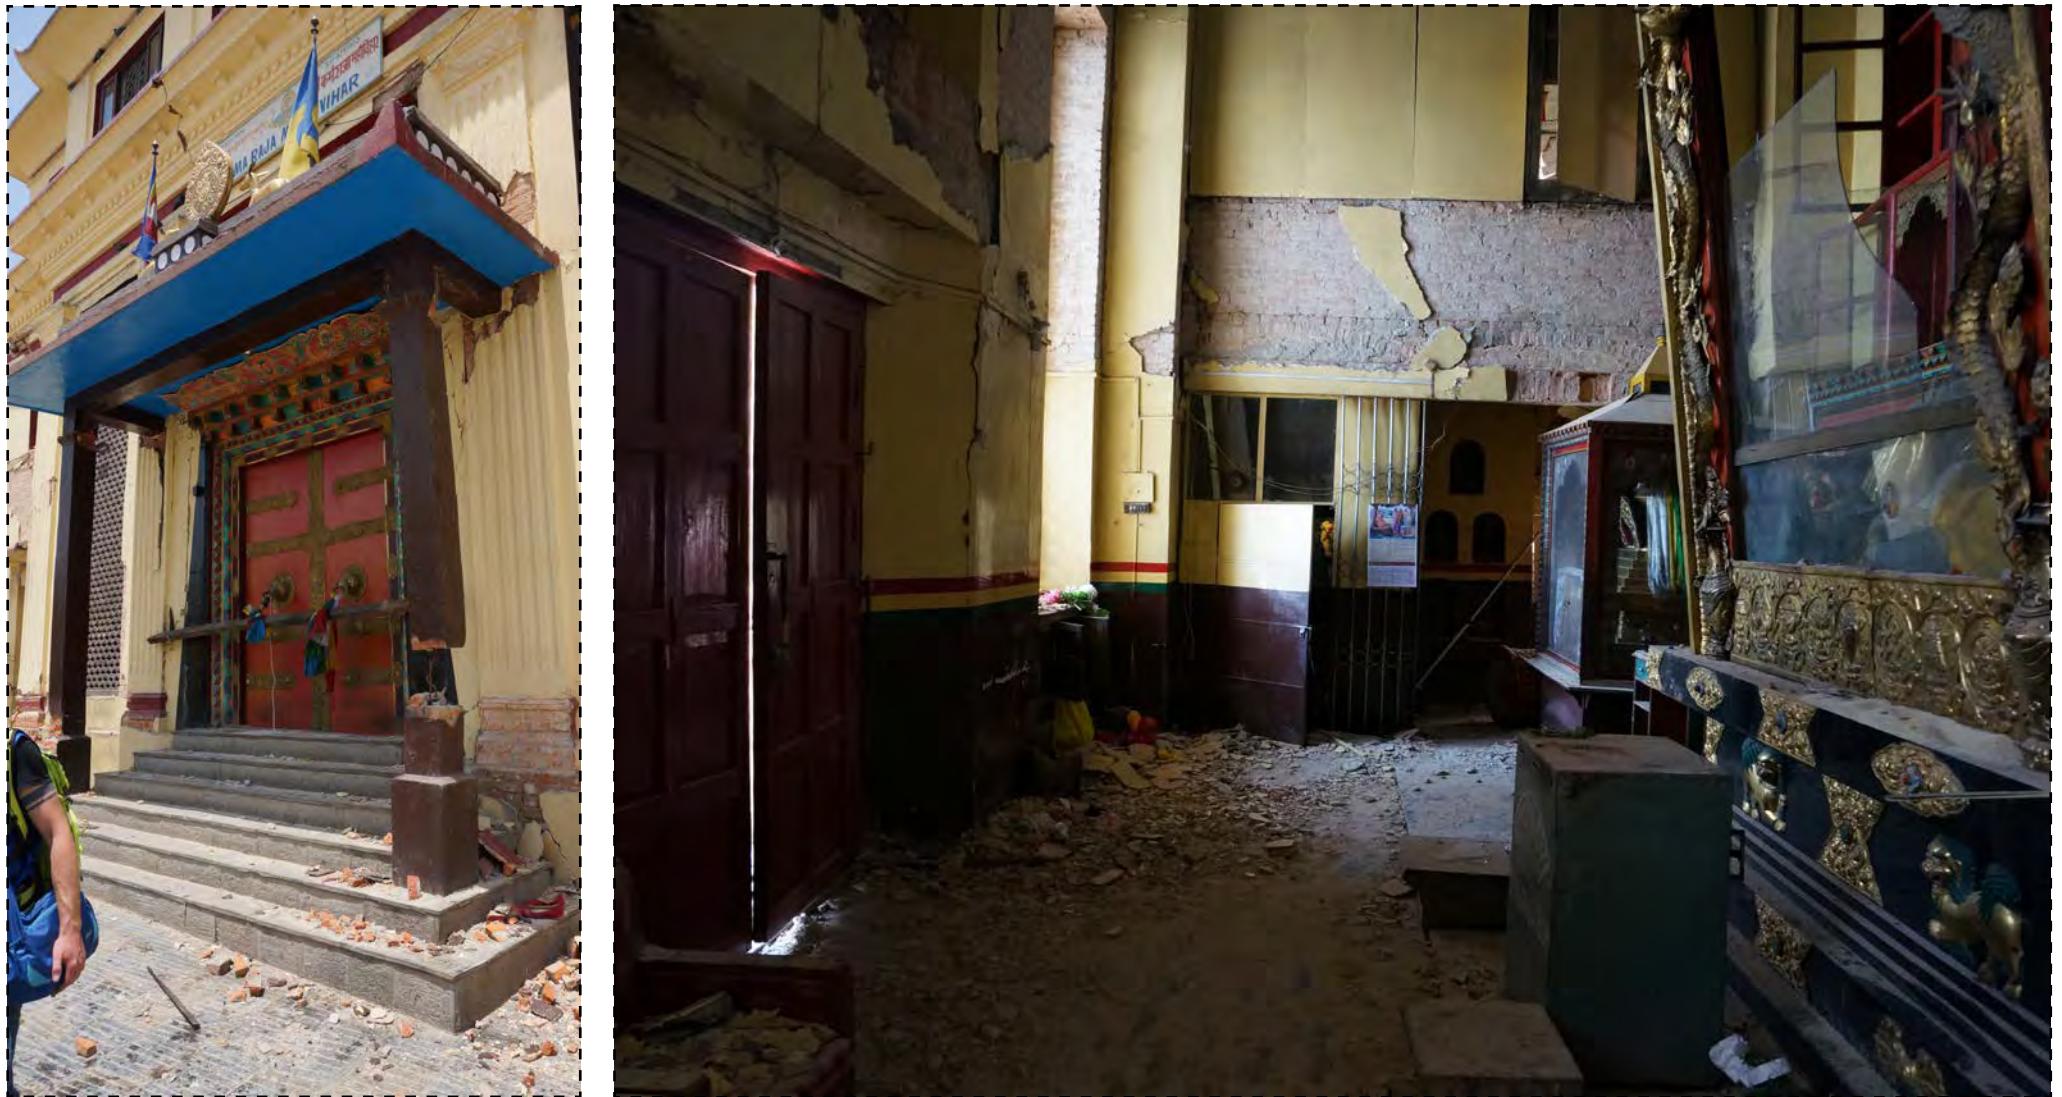
Right at the edge of the Swayambhu Stupa, the "Karmaraj Gumba" (no. 14) is severely damaged. This massive brick building on the hillside was subjected to a newer concrete over-elevation, which probably contributed to weaken the primary structure. Within this Gumba, there were numerous religious elements established (large statue of Buddha, imposing prayer wheel, metalwork...). Safeguarding these works require a particular

NUMBER NAME	DATE A.D.	TYPE OF MONUMENT HERITAGE SIGNIFICANCE	GENERAL DESCRIPTION	DESCRIPTION OF DAMAGE	DANGER DESTROY	N
14 (K-327) Karmaraj Gumba		Gumba	“G+2(EL) Ground and 1st storey brick made 2nd storey concrete made Big Buddha statue is established and big Buddhist wheel”	N-W and N-E corner is half collapsed Over weight due to over elevation S-E corner with diagonal cracks	1/2

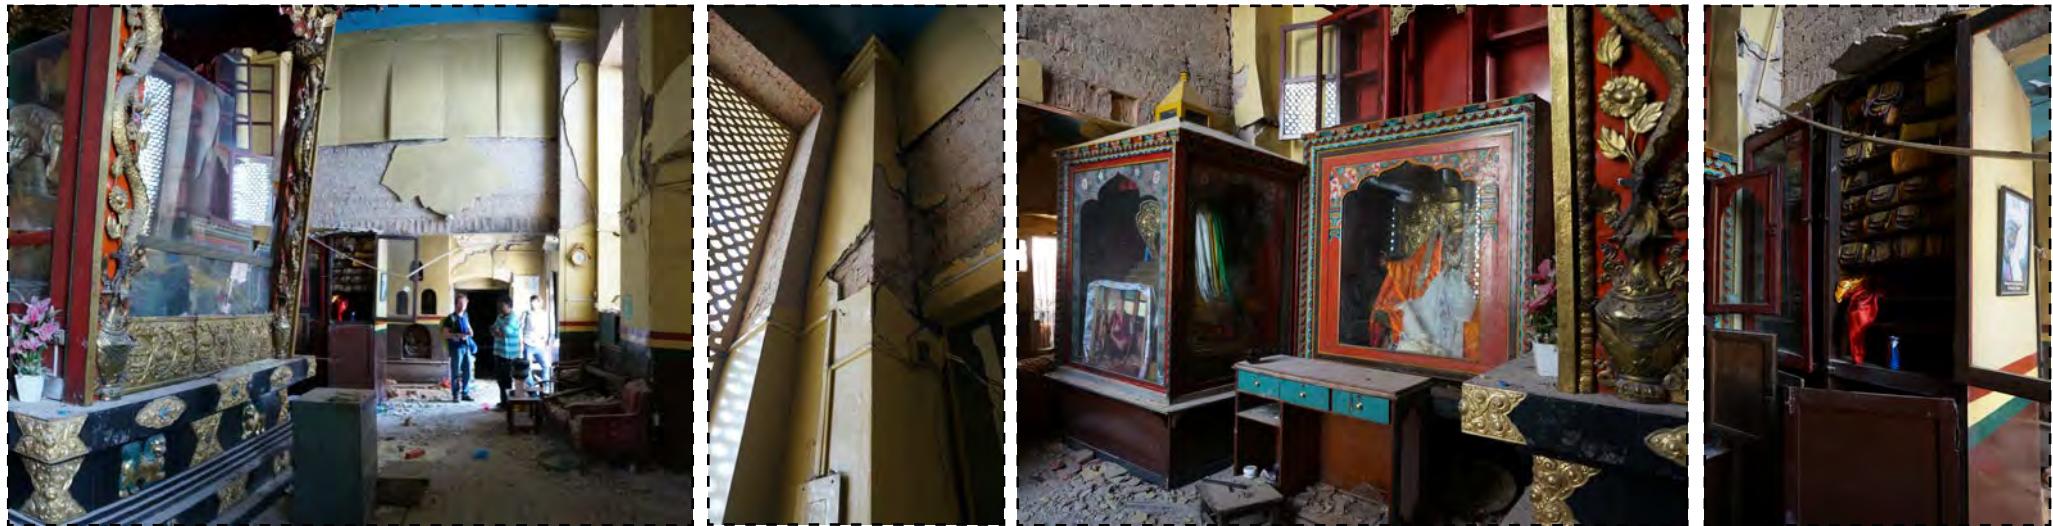
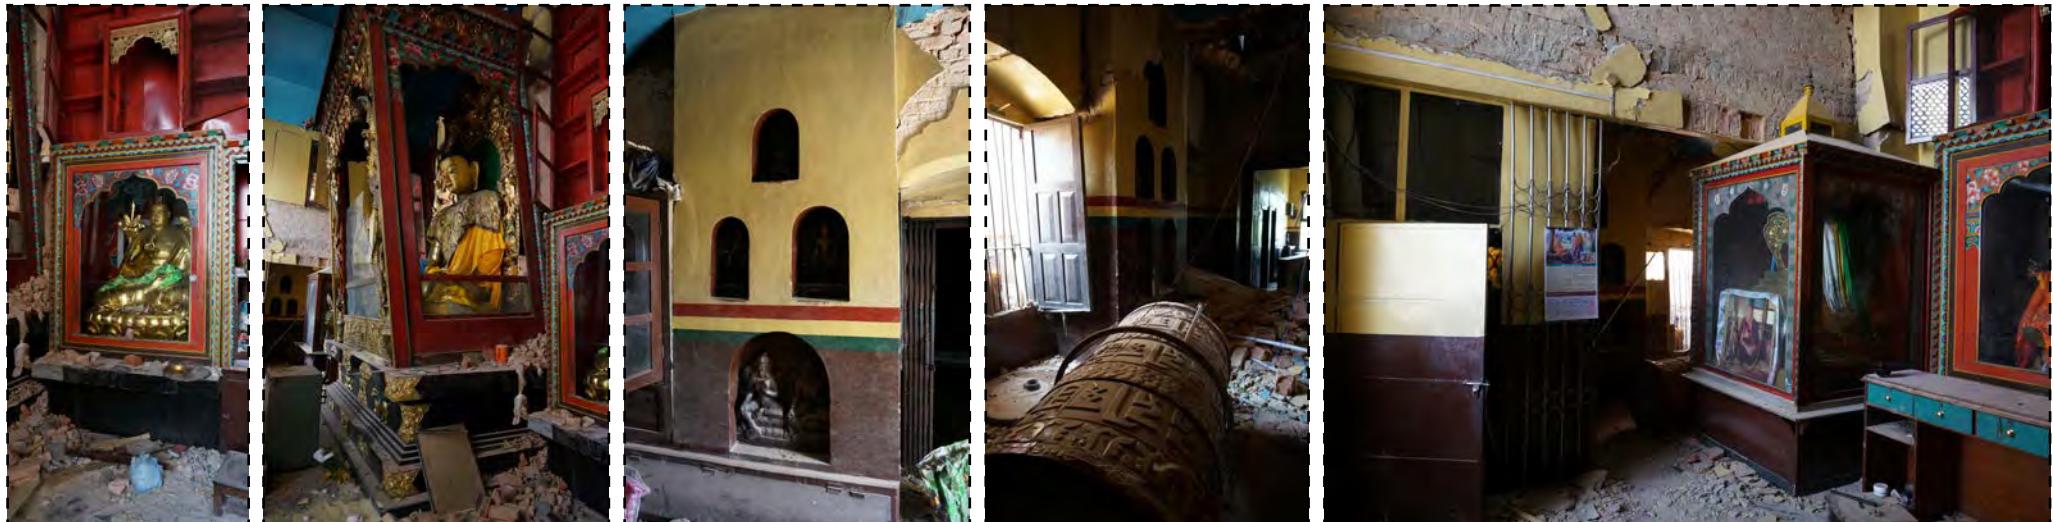
NUMBER NAME	DATE A.D.	TYPE OF MONUMENT HERITAGE SIGNIFICANCE	GENERAL DESCRIPTION	DESCRIPTION OF DAMAGE	DANGER DESTROY	N
14 (K-327) Karmaraj Gumba		Gumba	G+2(EL) Ground and 1st storey Brick made 2nd storey concrete made Big Buddha statue is established and big Buddhist wheel	N-W and N-E corner is half collapsed Over weight due to over elevation S-E corner with diagonal cracks	1/2

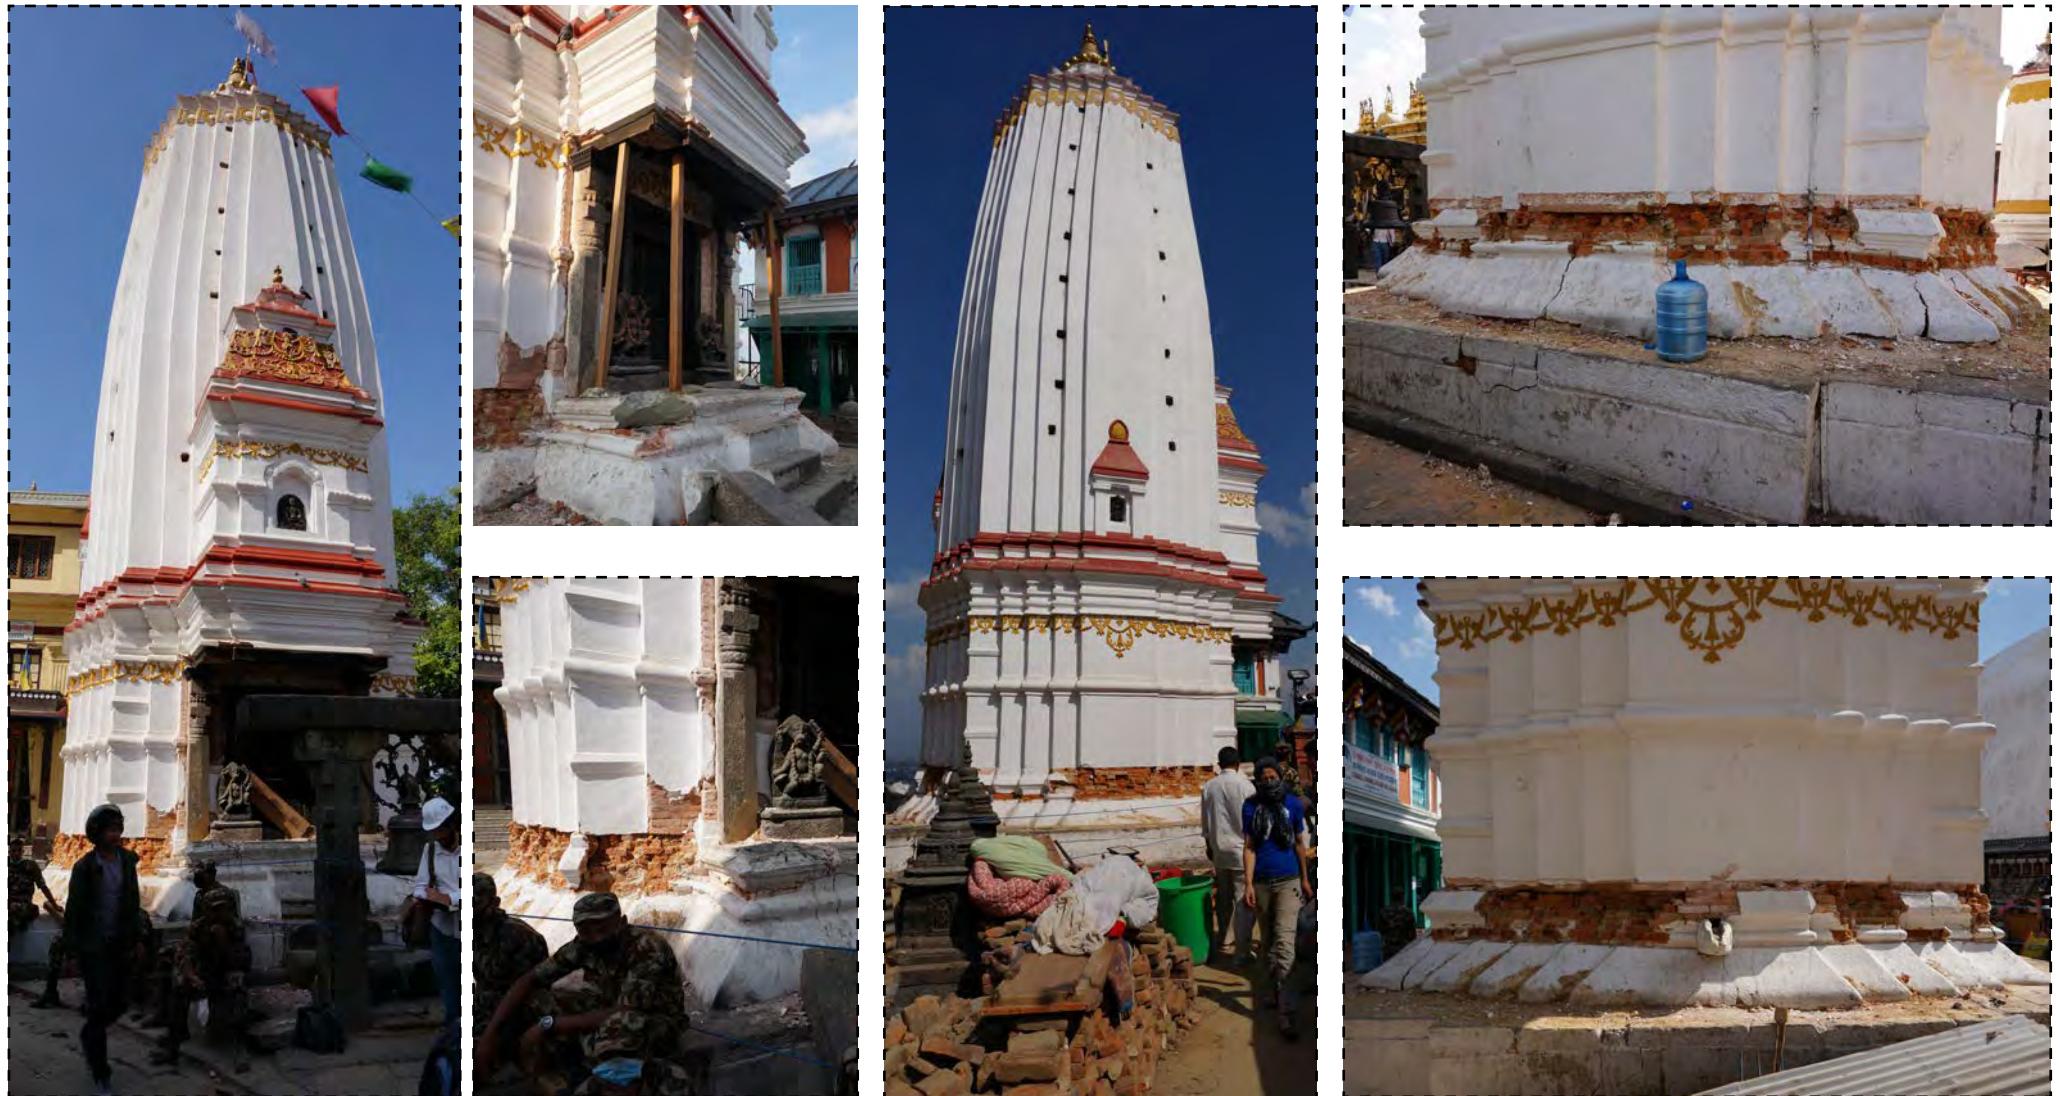
Another Sikhara temple (no 15), although still standing, has horizontal cracks on the base perimeter (suggesting a significant sway due to its height). Given the behavior of these temples typology during the earthquakes in Swayambhu and other heritage sites (it is rather prone to destruction), an investigation of the structural principles underlying its design should be conducted for the proper reinforcement of such structures.

NUMBER NAME	DATE A.D.	TYPE OF MONUMENT HERITAGE SIGNIFICANCE	GENERAL DESCRIPTION	DESCRIPTION OF DAMAGE	DANGER DESTROY	N ↑
15 (K-328) Pratapur Temple		Shikhara style temple	Brick, Lime and stone made structure of about 15 m height	Basement heavily damaged Stone pillars at entrance collapsed and some temporary wooden poles are installed to support the upper part

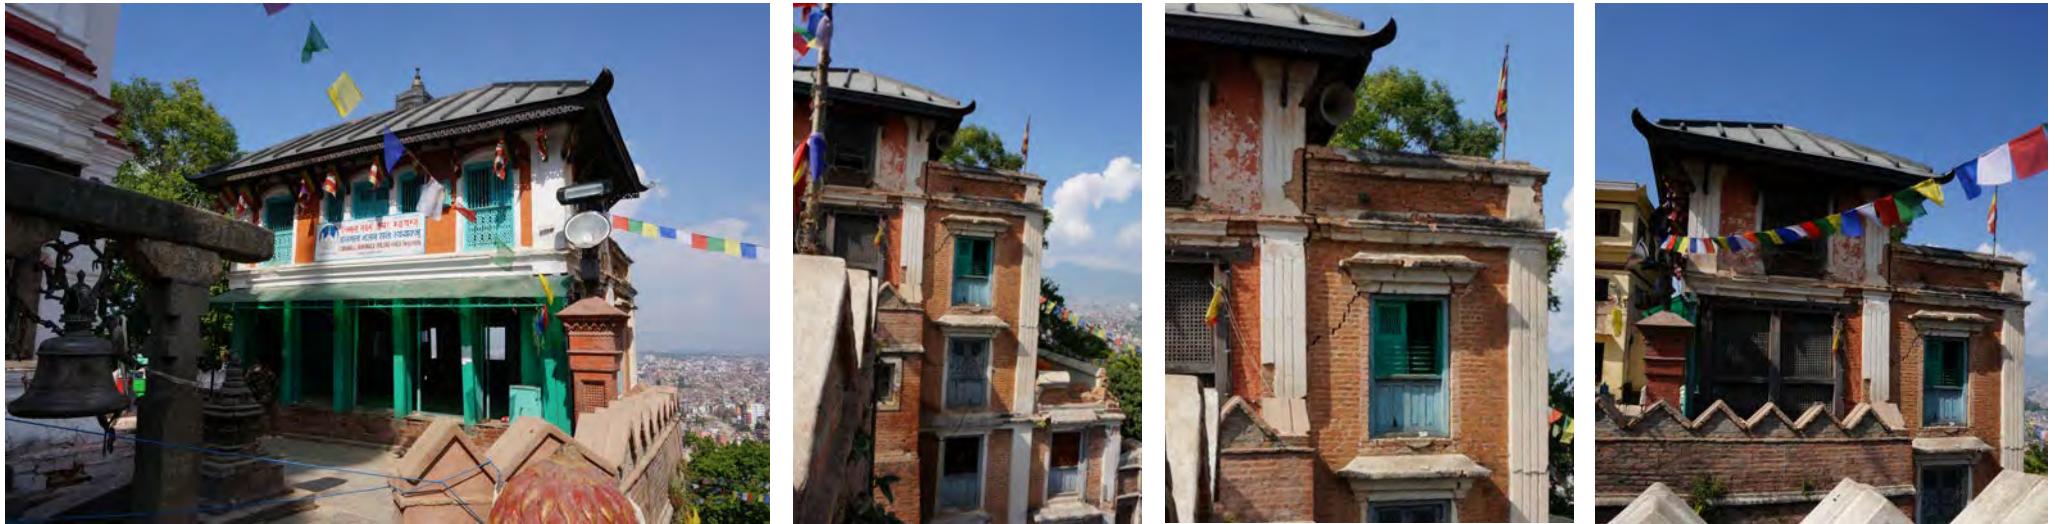
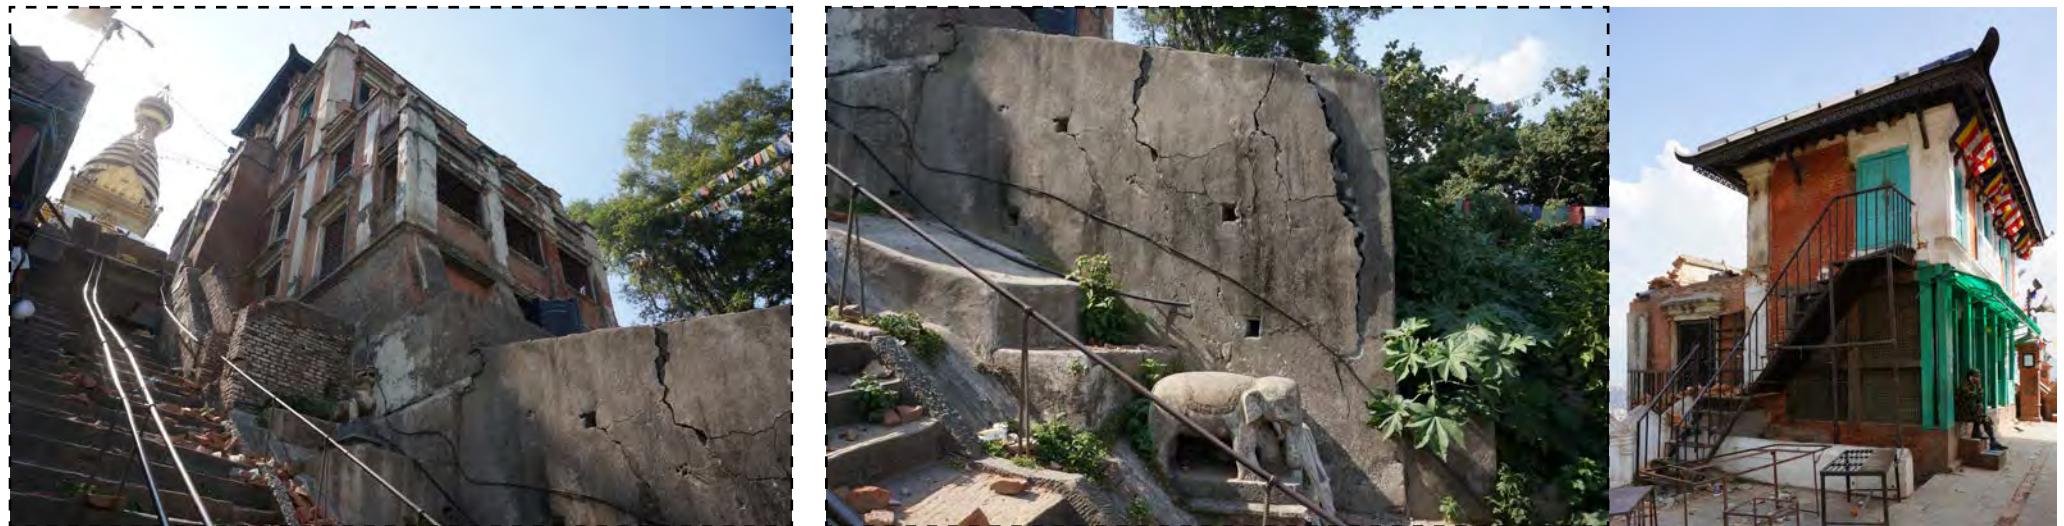
NUMBER NAME	DATE A.D.	TYPE OF MONUMENT HERITAGE SIGNIFICANCE	GENERAL DESCRIPTION	DESCRIPTION OF DAMAGE	DANGER DESTROY	N ↗
17		Sattal + building	G+4 Brick and wooden structure 2 storey sattal built at platform and other house attached at its back part	4th floor slightly drifting towards N and E Basement cracks Slight joint separation between front and back part of building Weak wood structure parts in 3rd floor Bricks falling	⚠

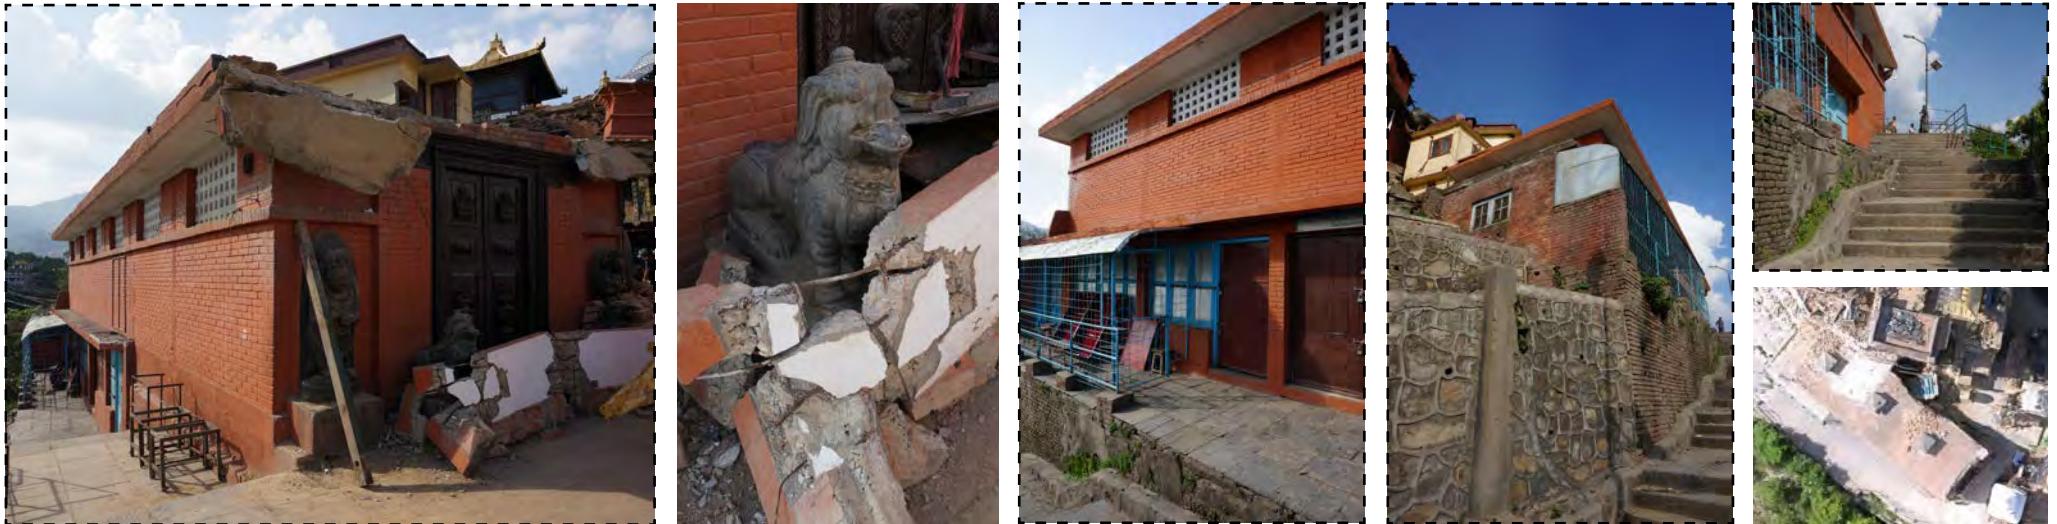
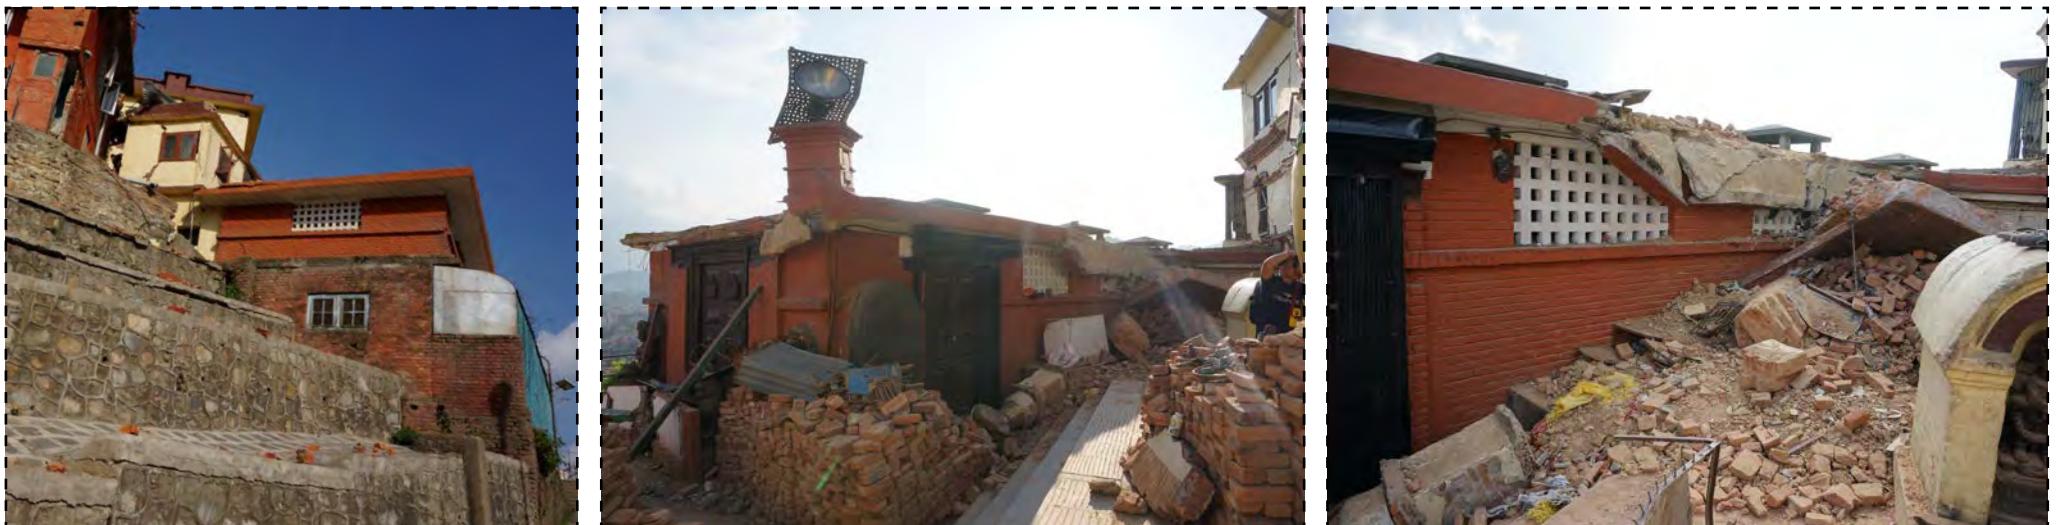
NUMBER NAME	DATE A.D.	TYPE OF MONUMENT HERITAGE SIGNIFICANCE	GENERAL DESCRIPTION	DESCRIPTION OF DAMAGE	DANGER DESTROY	N ↑
29		Museum	G+1, RCC structure and cantilevered slabs	Partially collapsed wall Cantilever part of slab is partly collapsed which caused some damage to the monuments
