2015 Earthquake Damage Mapping

Swayambhu Monument Zone
Kathmandu Valley World Heritage Property

Submitted to UNESCO by

June 2015

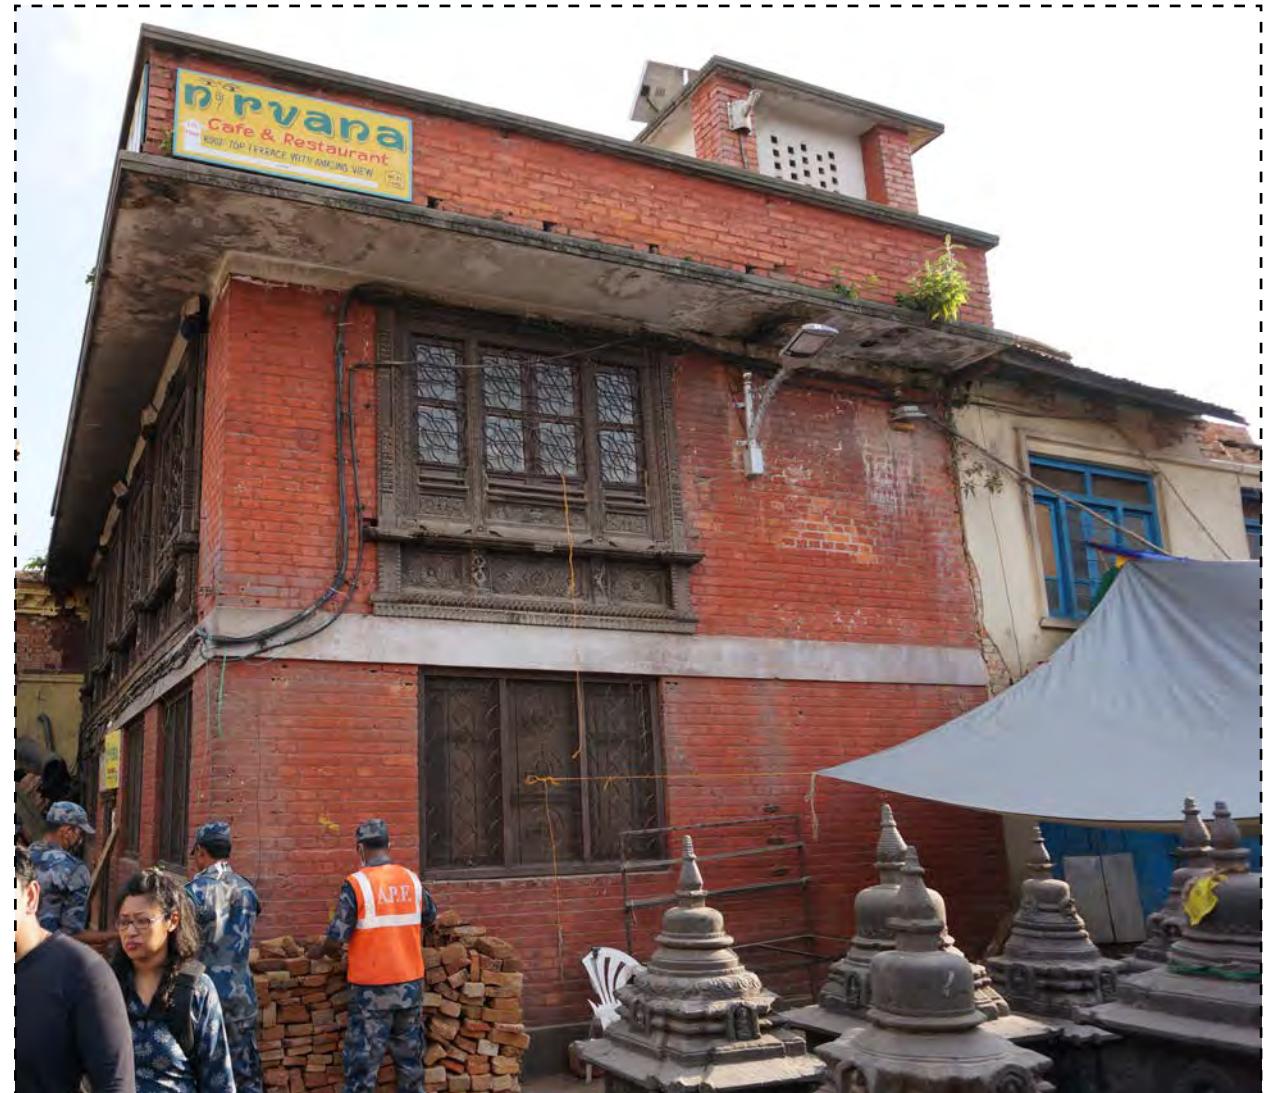
NUMBER NAME	DATE A.D.	TYPE OF MONUMENT HERITAGE SIGNIFICANCE	GENERAL DESCRIPTION	DESCRIPTION OF DAMAGE	DANGER DESTROY	N ↑
41 Singu Bahal		Bahal	G+1 Right corner and entry portion of the bahal Concrete and brick structure	No visible damage

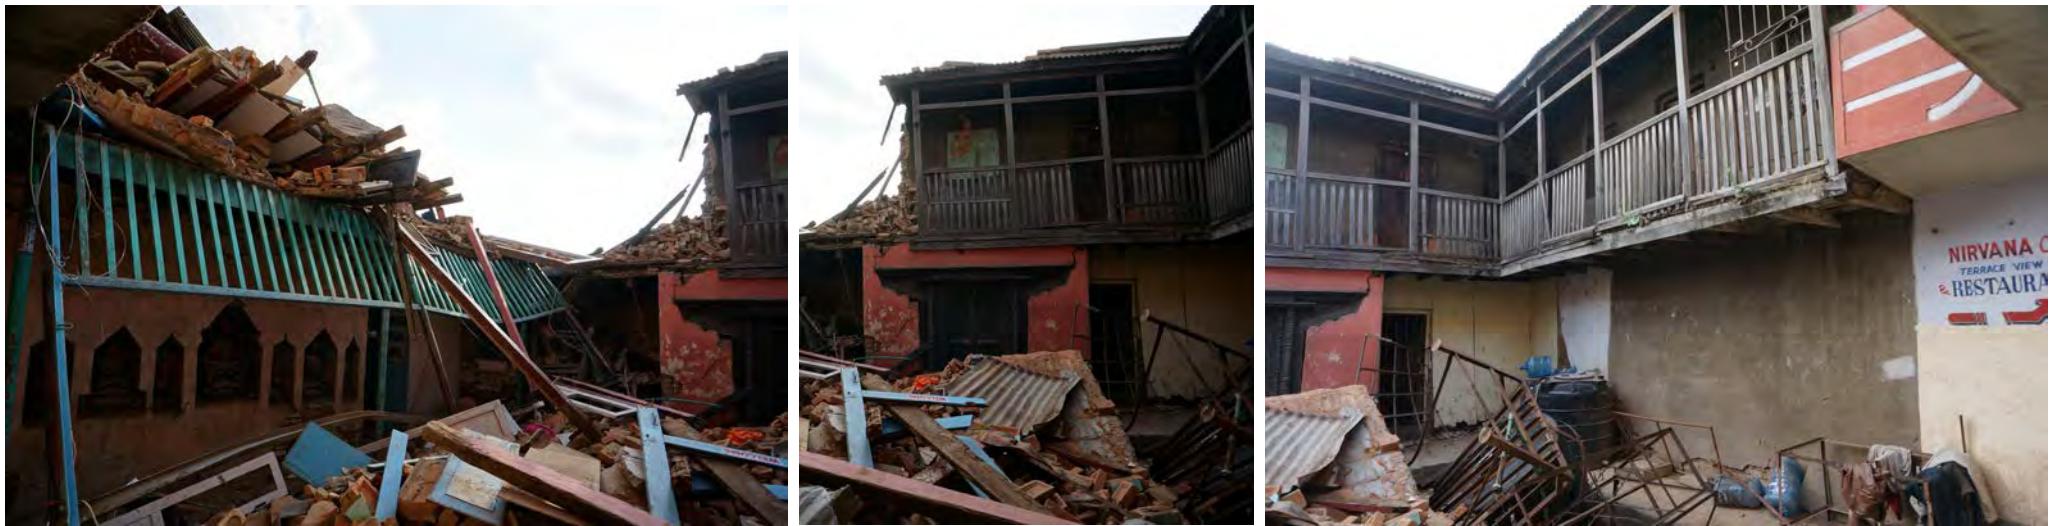
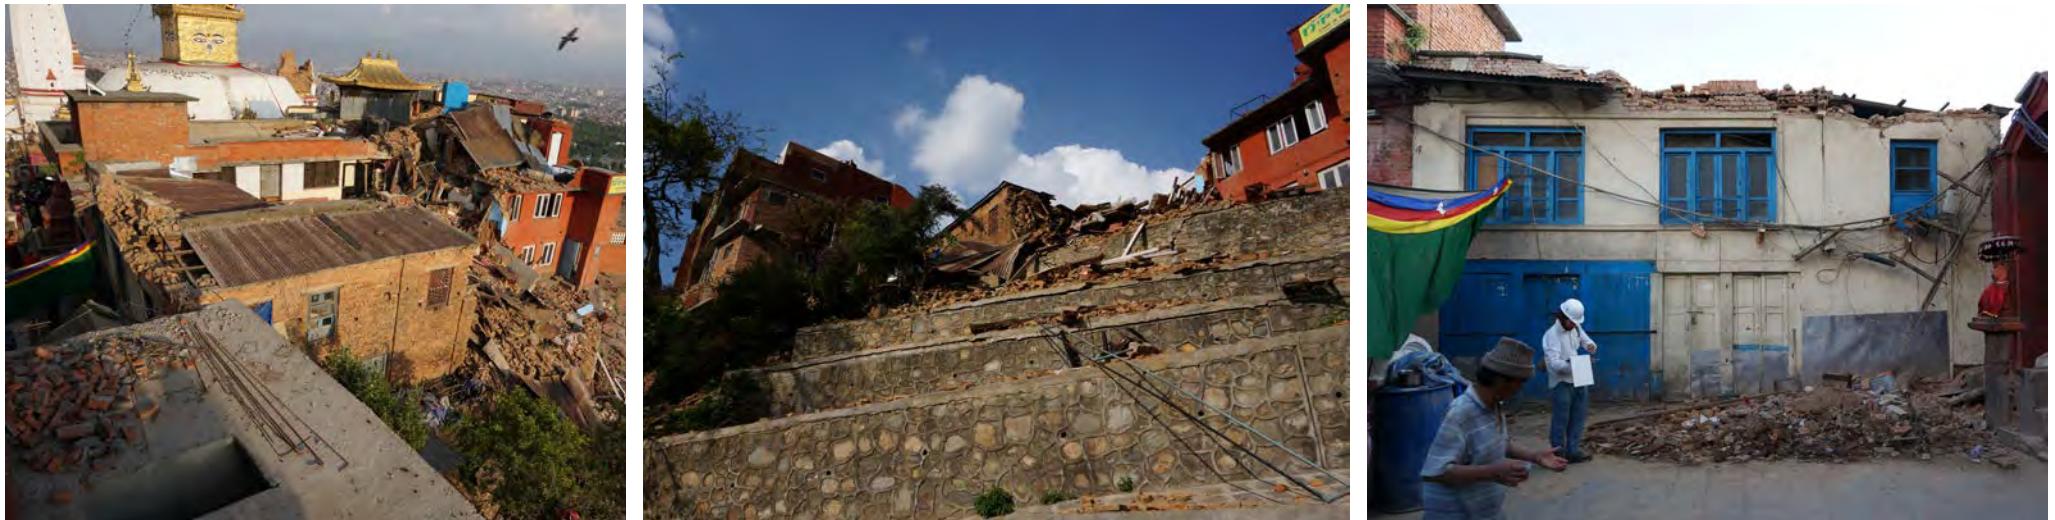
NUMBER NAME	DATE A.D.	TYPE OF MONUMENT HERITAGE SIGNIFICANCE	GENERAL DESCRIPTION	DESCRIPTION OF DAMAGE	DANGER DESTROY	N ↑
42 (K-324) Singu Bahal		Bahal	G+1 All the remaining portion the bahal Brick structure	Courtyard filled with debris Collapsed Risk of falling parts

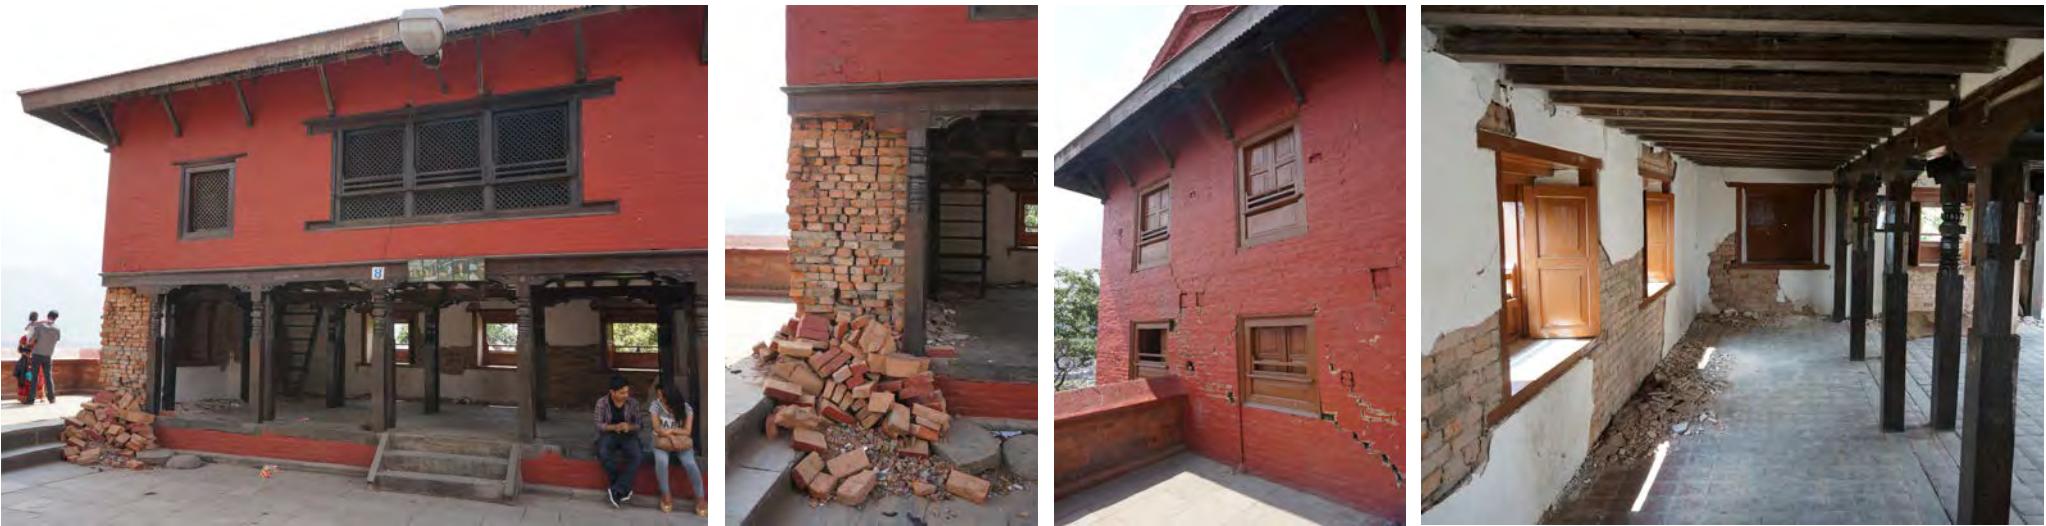
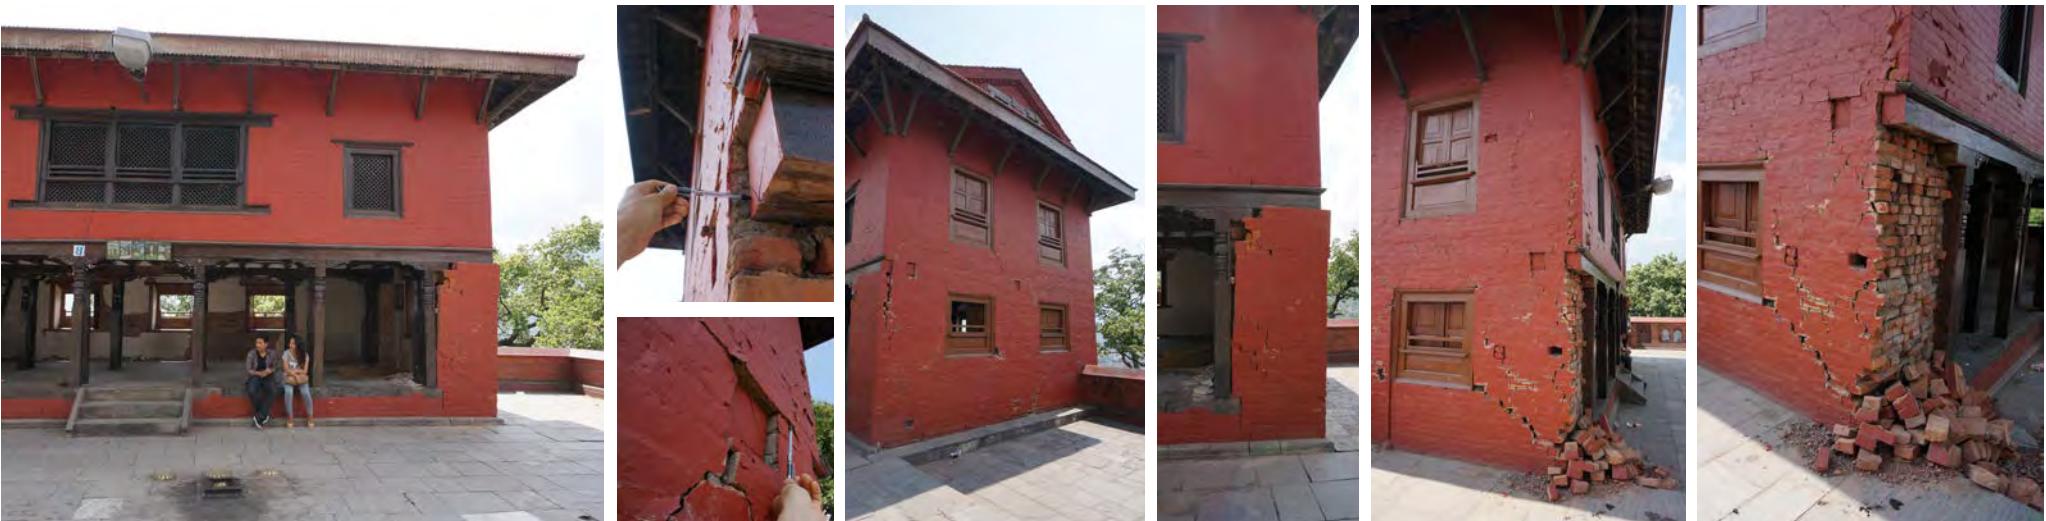
NUMBER NAME	DATE A.D.	TYPE OF MONUMENT HERITAGE SIGNIFICANCE	GENERAL DESCRIPTION	DESCRIPTION OF DAMAGE	DANGER DESTROY	N ↑
66		Sattal	G+1 Brick and wooden structure	Major vertical cracks at front face corners Outer part of front left corner wall is partly collapsed Plaster are mostly off from wall inside the sattal Left and right face walls are bulging and tilted by small amount

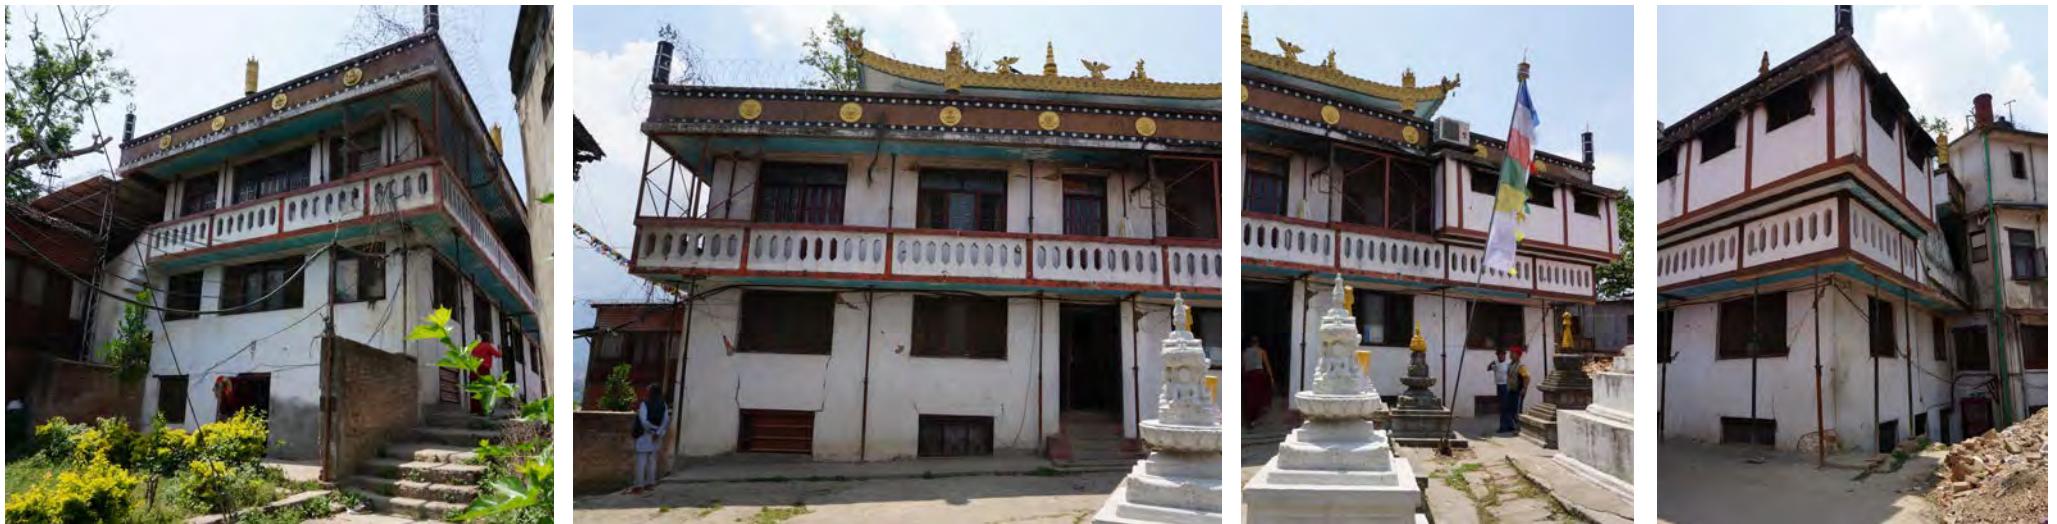
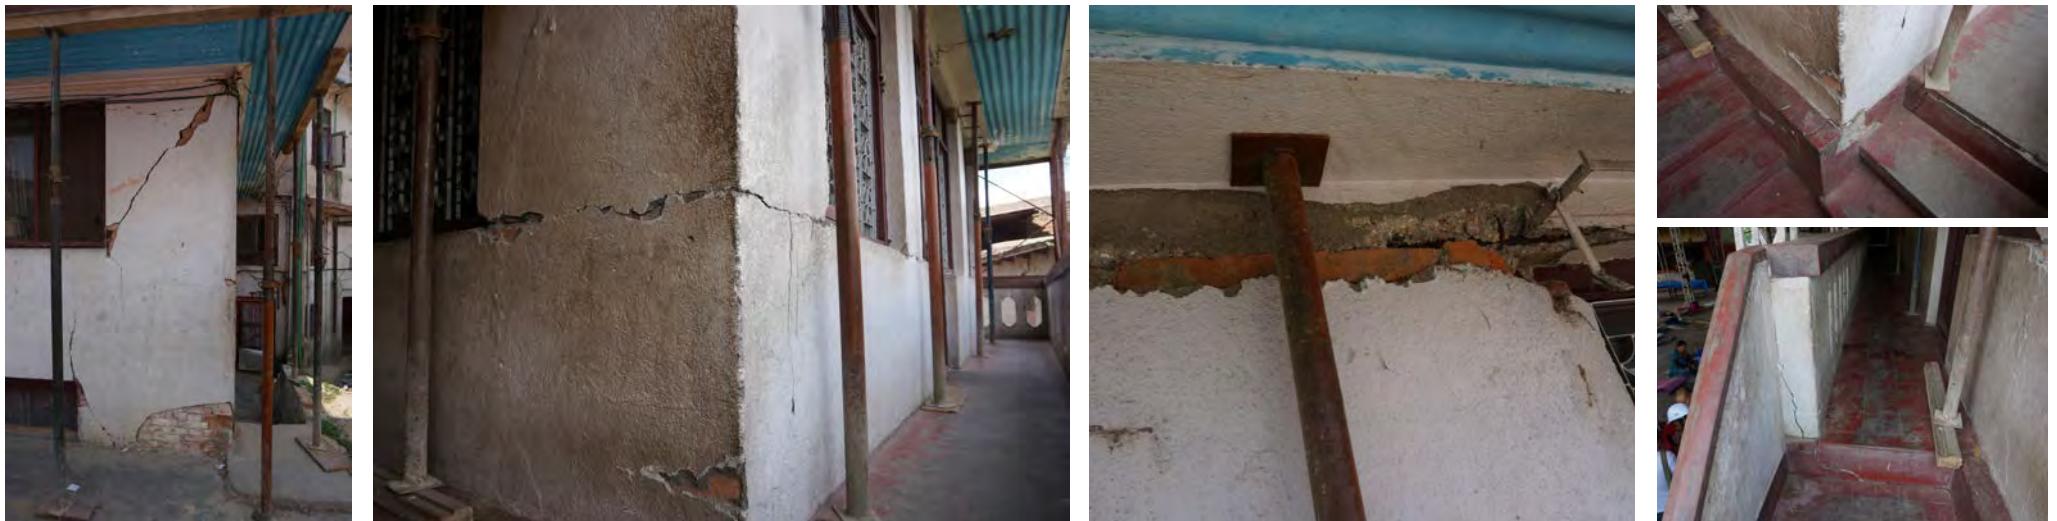
NUMBER NAME	DATE A.D.	TYPE OF MONUMENT HERITAGE SIGNIFICANCE	GENERAL DESCRIPTION	DESCRIPTION OF DAMAGE	DANGER DESTROY	N ↑
75 Dharma Chakra Bihar		Public house	G+2 Concrete structure	Cracks (mostly horizontal) above doors and windows and in stairs Balcony tends to fall down Suspect of over-weight Metal Poles are provided to support at 2nd floor but seems to not very useful

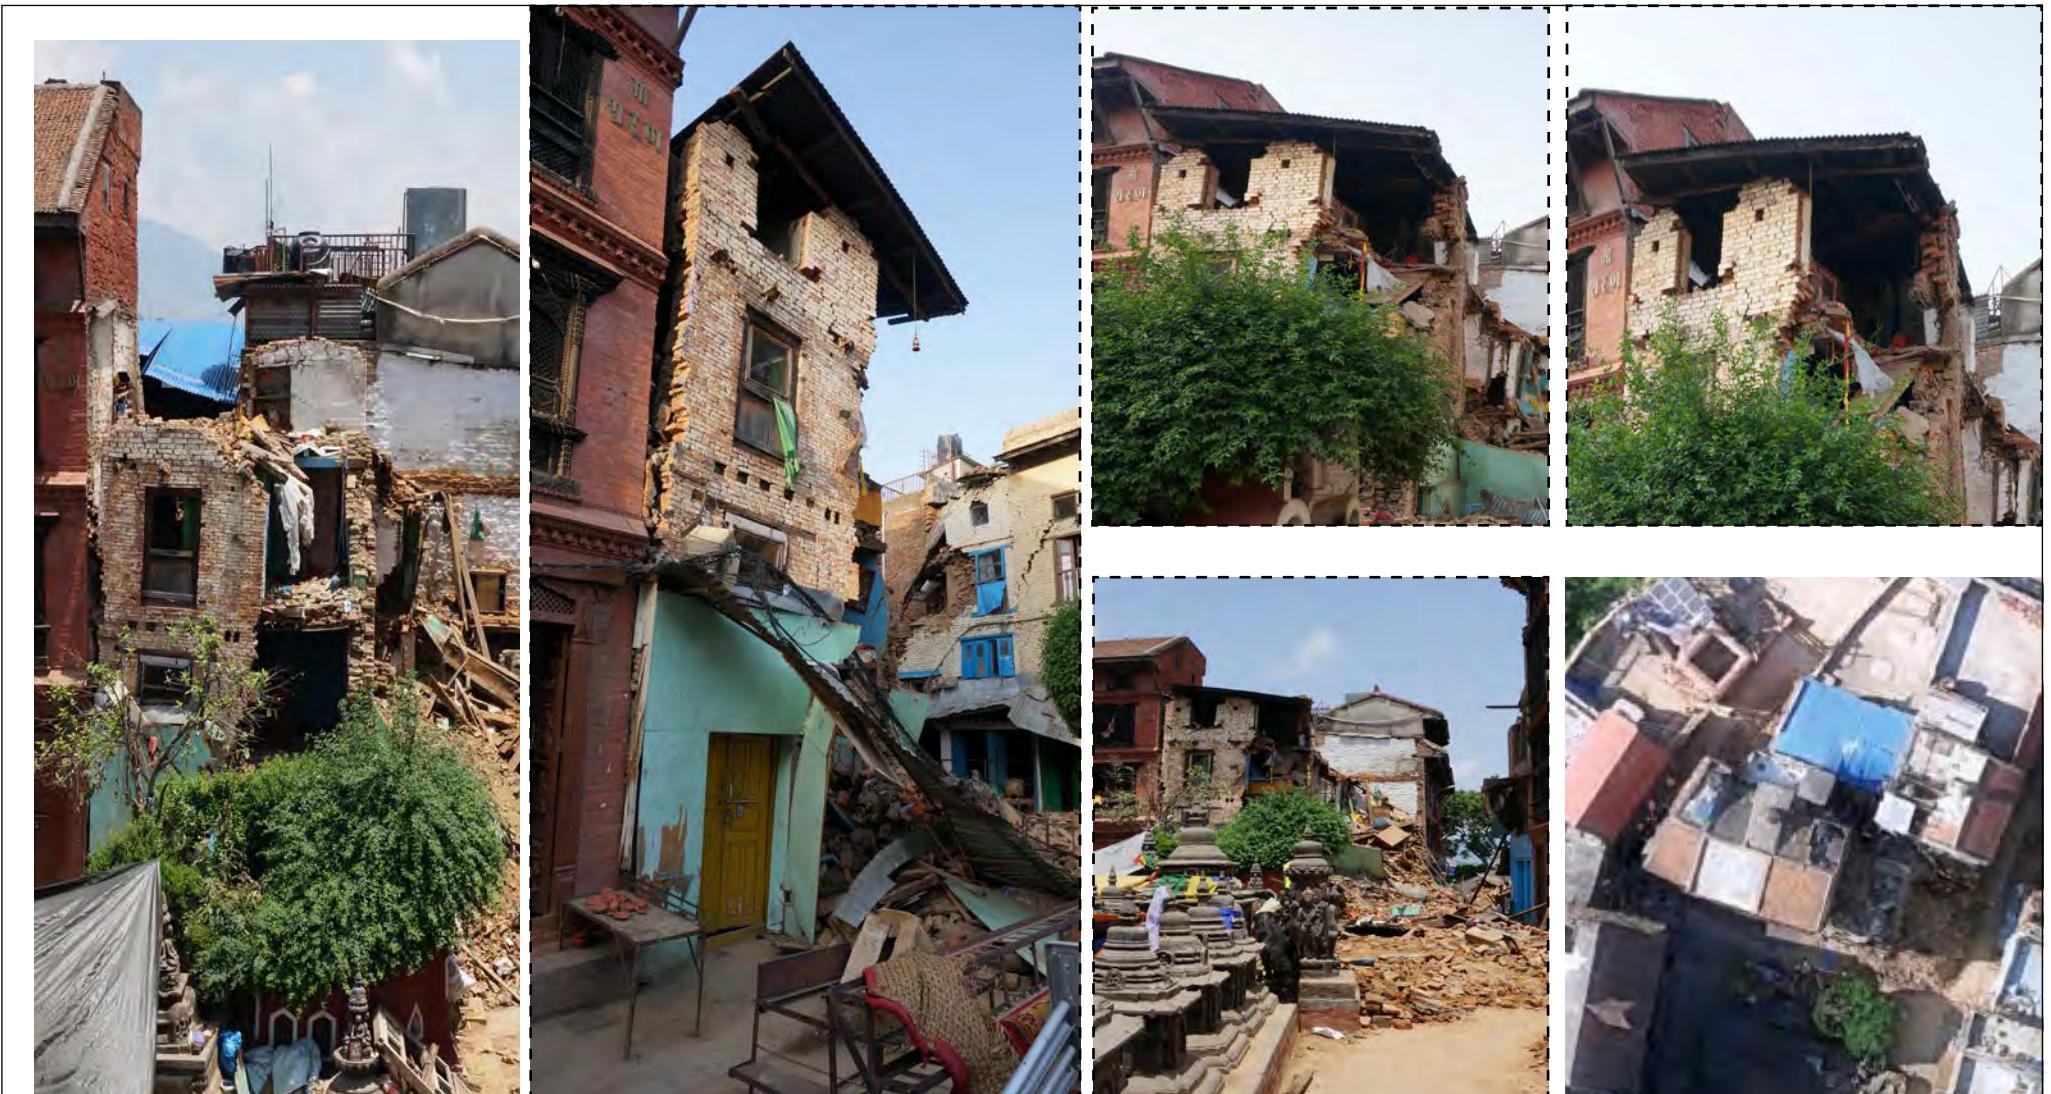
NUMBER NAME	NUMBER OF STORIES RELATIVE POSITION	STRUCTURAL SYSTEM	DESCRIPTION OF DAMAGE	DANGER DESTROY	HERITAGE SIGNIFICANCE	N ↑
6	G+2	B	S-E corner collapsed E wall heavily damaged	1/2 ✗ ⚠

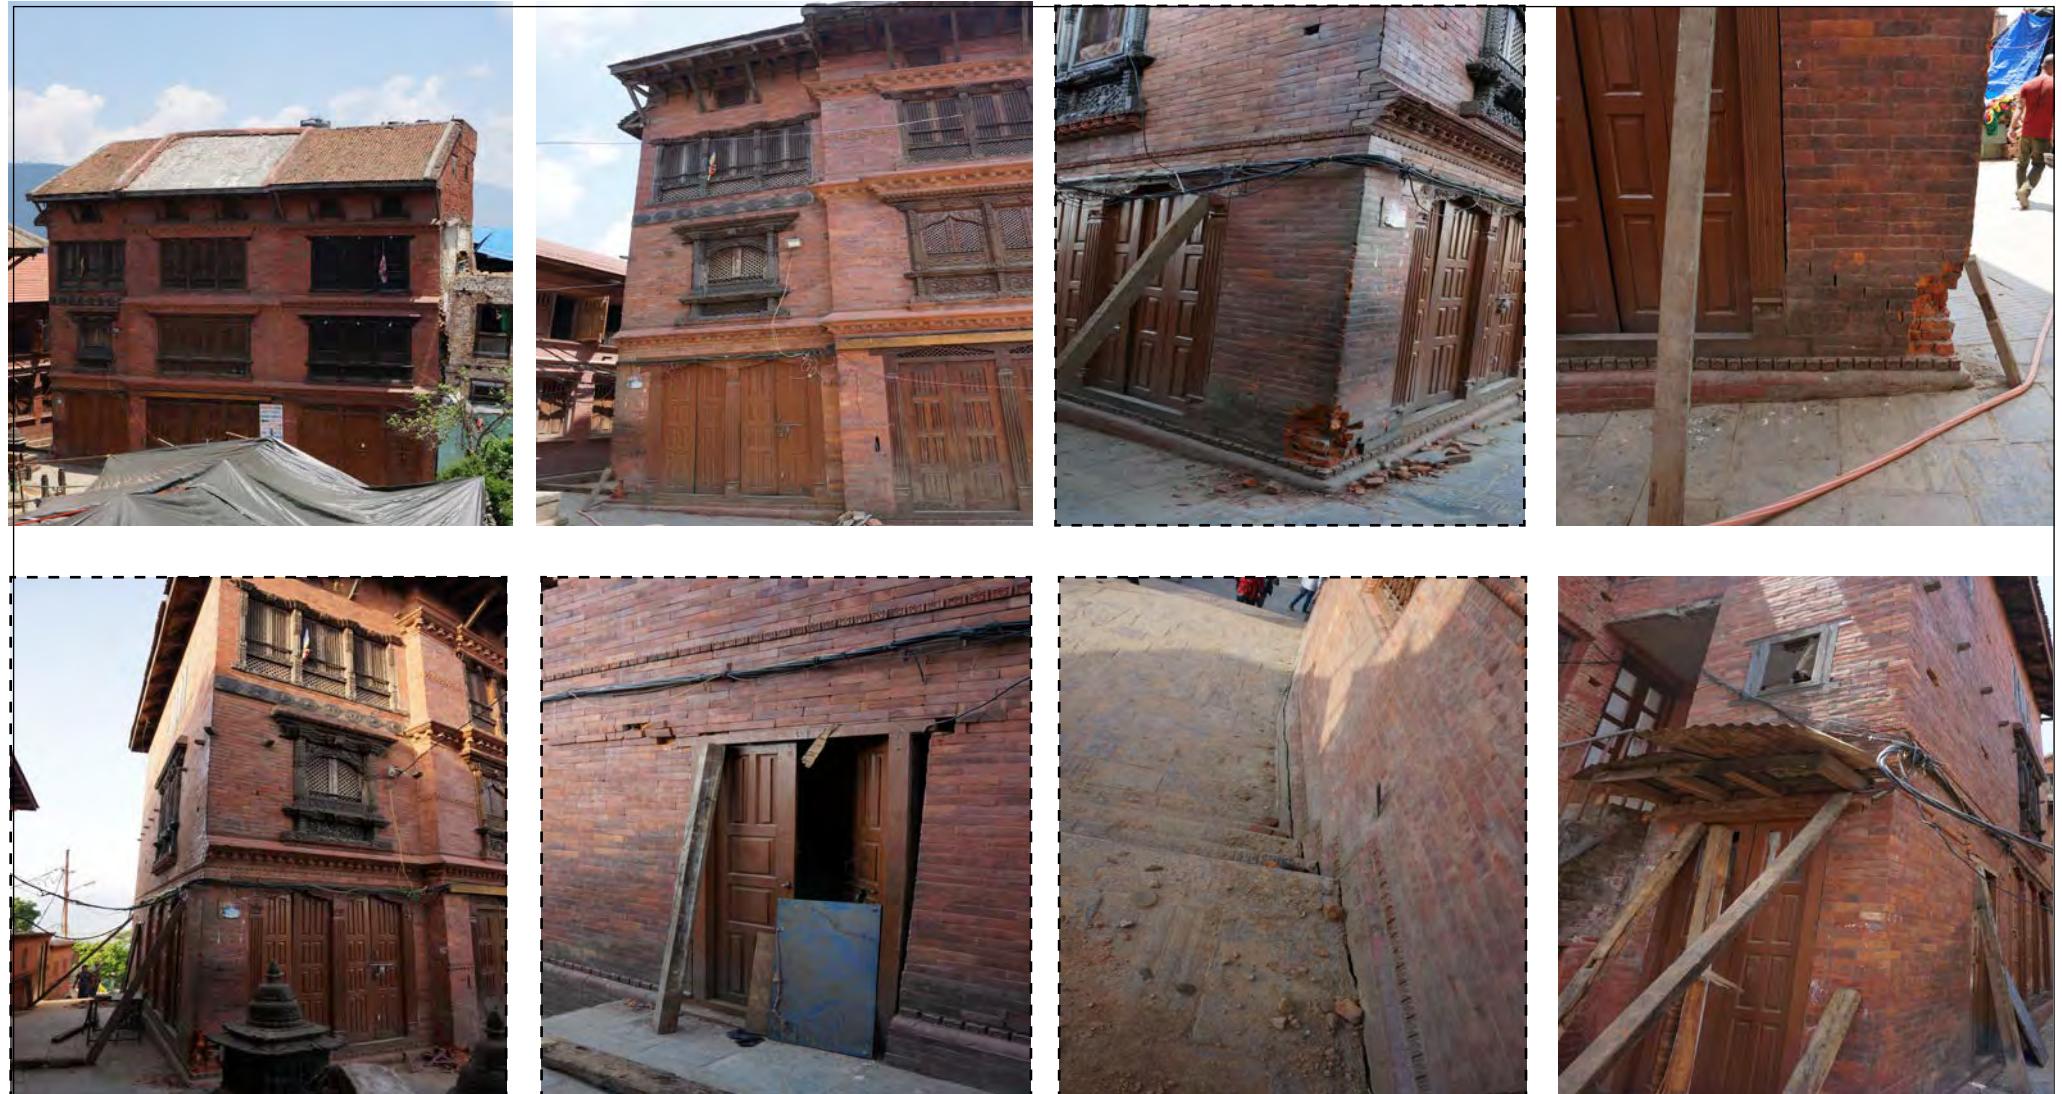
NUMBER NAME	NUMBER OF STOREYS RELATIVE POSITION	STRUCTURAL SYSTEM	DESCRIPTION OF DAMAGE	DANGER DESTROY	HERITAGE SIGNIFICANCE	N ↑	PLAN 1/1000
9	G+3	B	N wall corner at ground floor is offset of about 7-8 cm		+

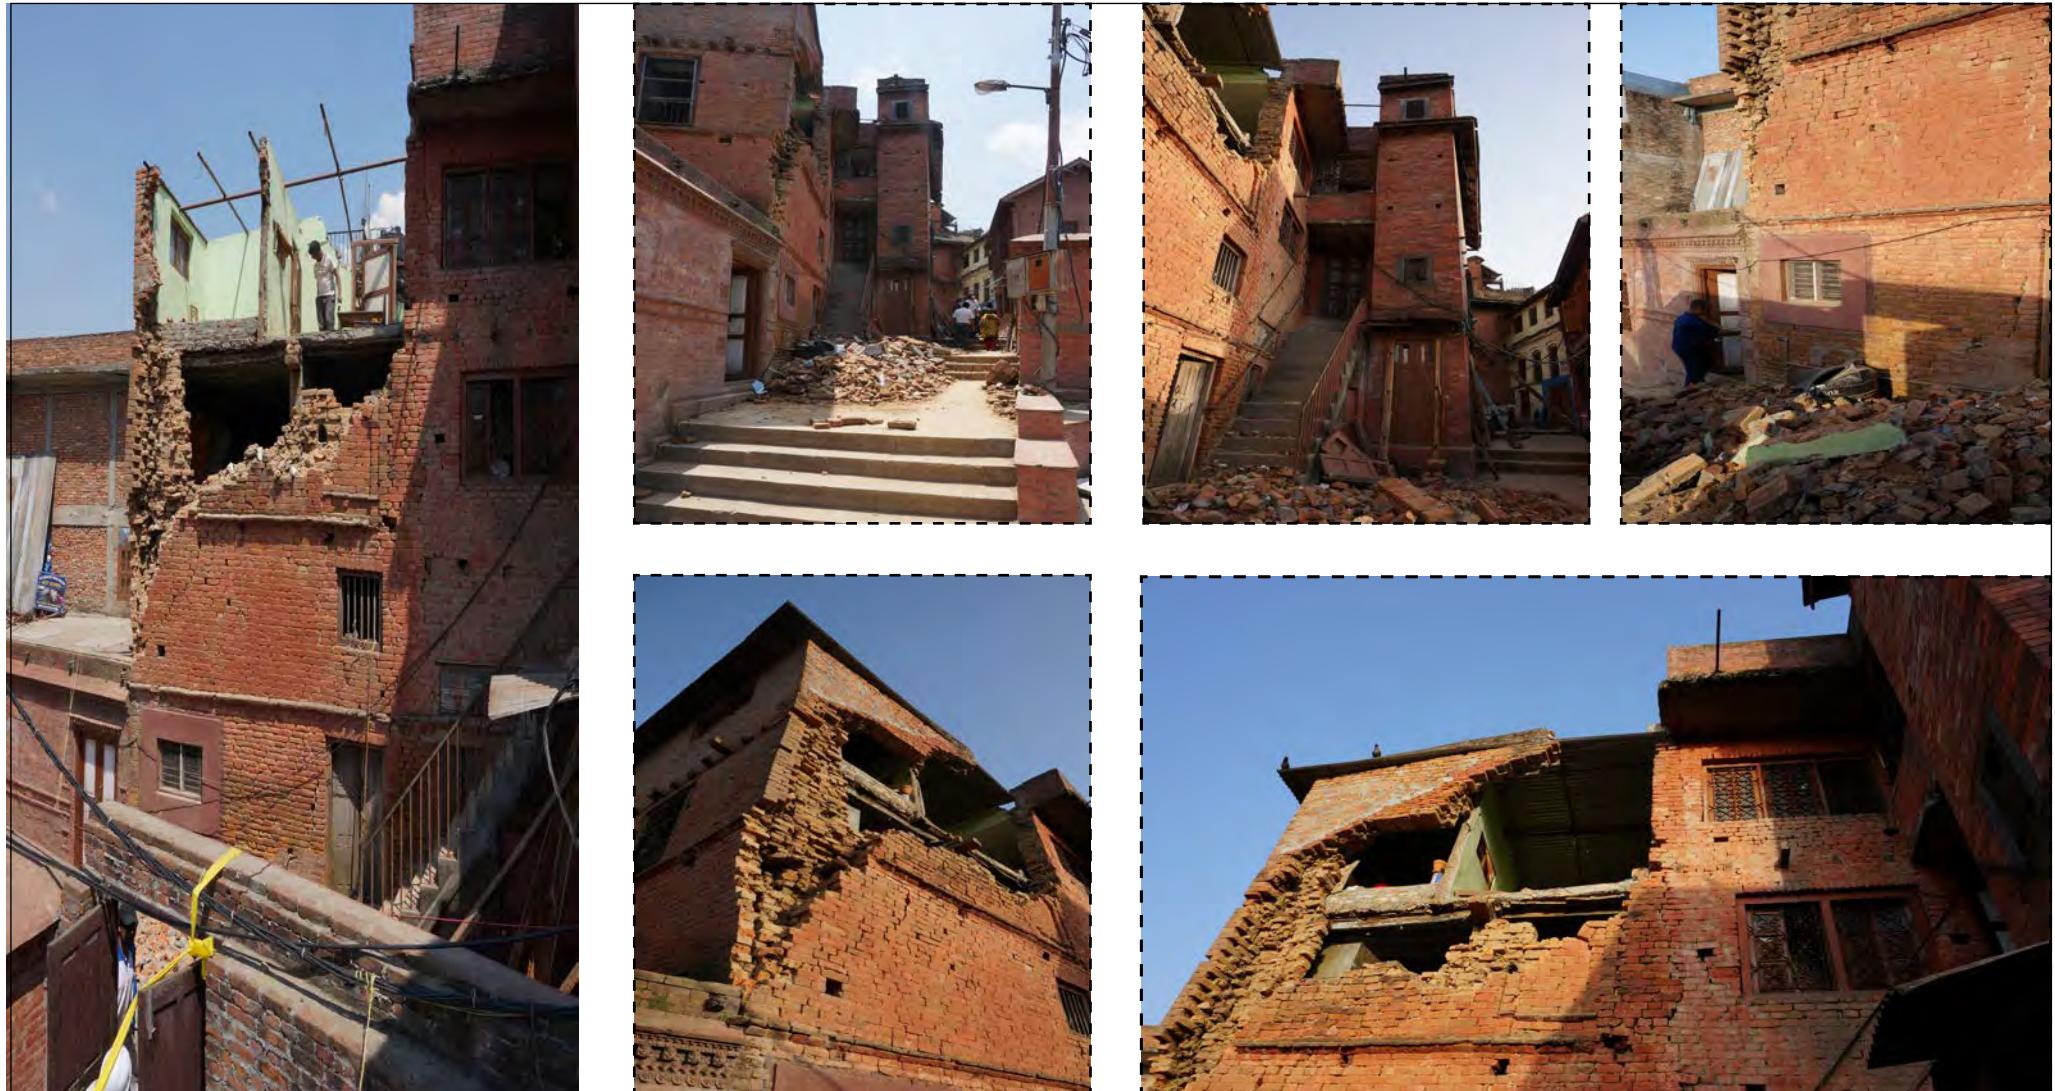
NUMBER NAME	NUMBER OF STORIES RELATIVE POSITION	STRUCTURAL SYSTEM	DESCRIPTION OF DAMAGE	DANGER DESTROY	HERITAGE SIGNIFICANCE	N ↑
10	G+3(EL)	B	W wall partially collapsed N wall heavily bulging out	⚠

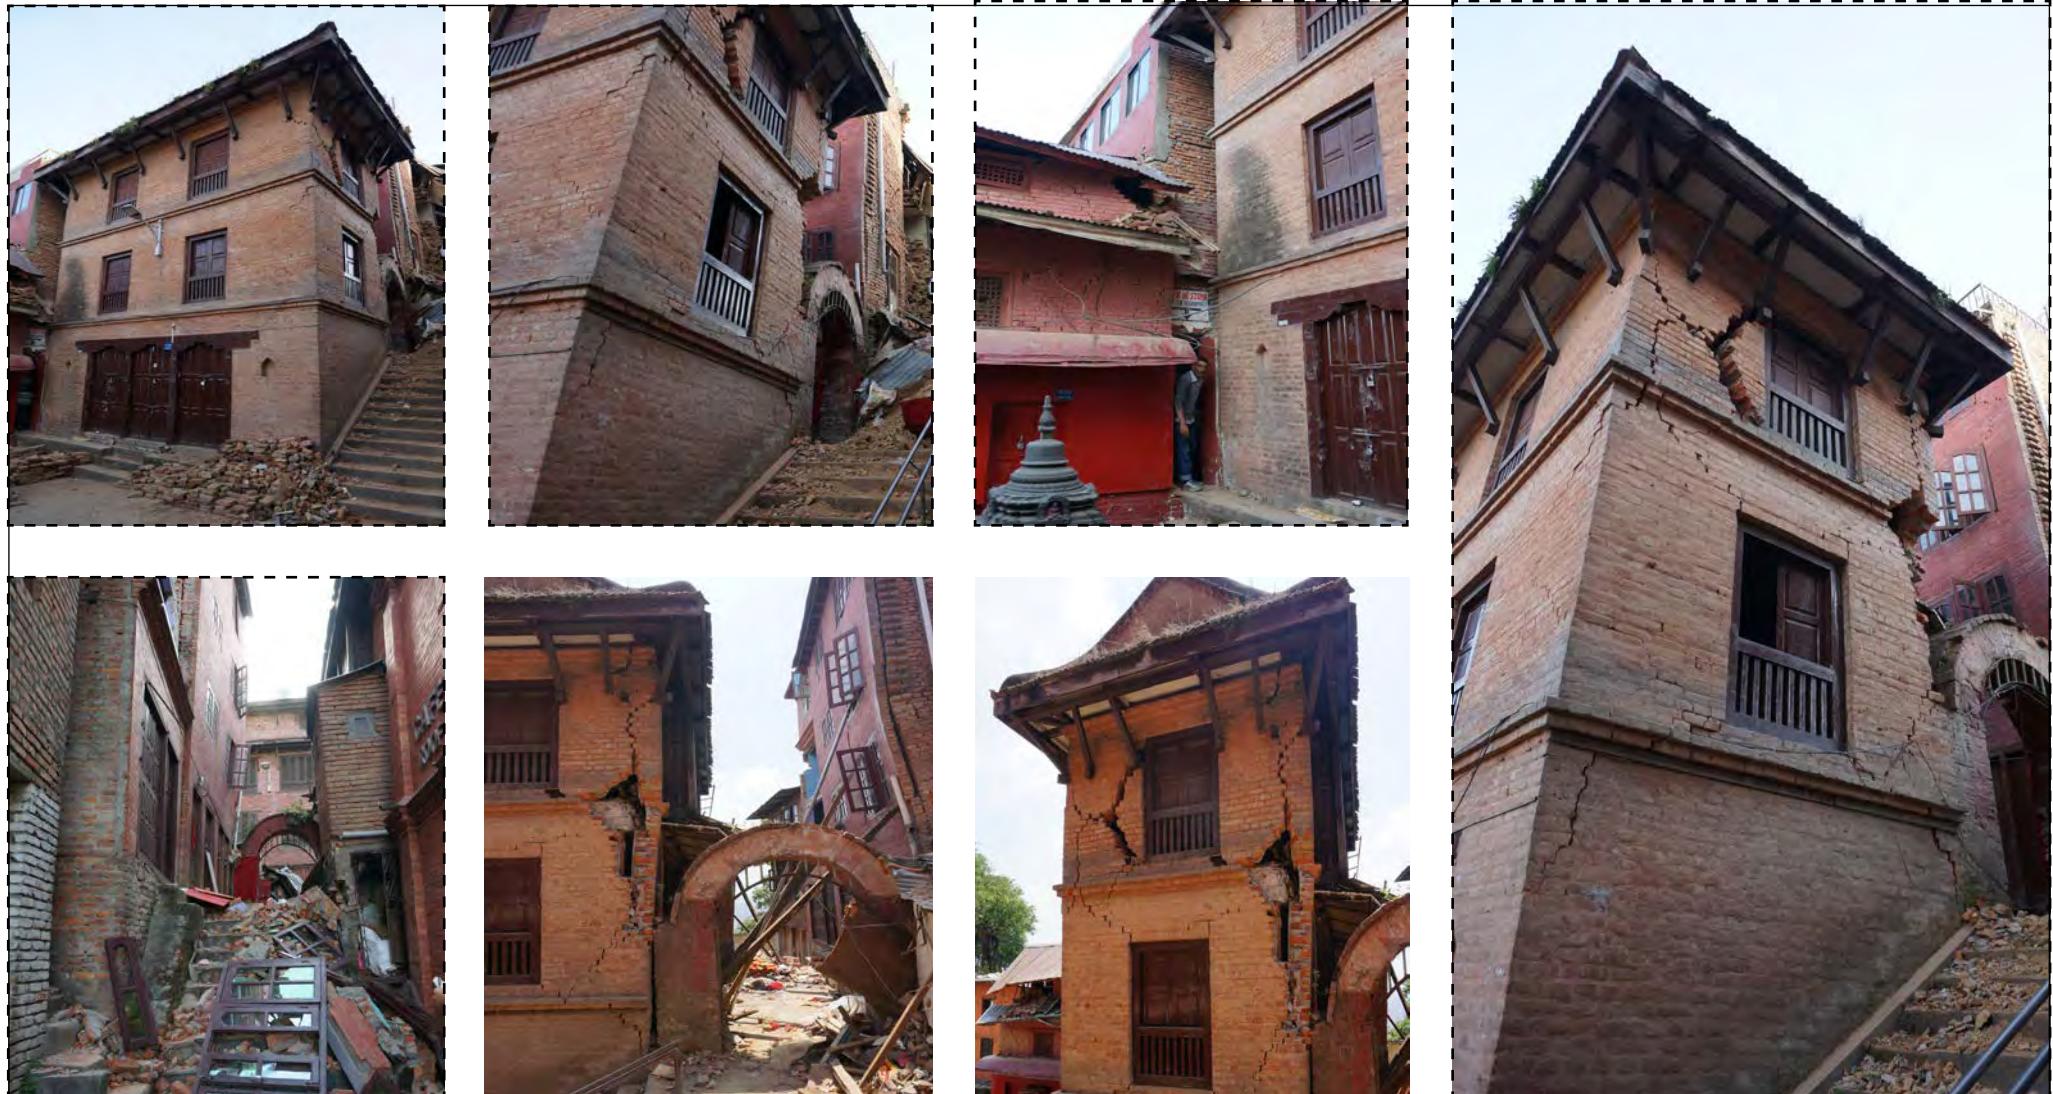
NUMBER NAME	NUMBER OF STORIES RELATIVE POSITION	STRUCTURAL SYSTEM	DESCRIPTION OF DAMAGE	DANGER DESTROY	HERITAGE SIGNIFICANCE	PLAN 1/1000
14	G+2	B	S-W corner collapsed S wall bulging and tilting	⚠

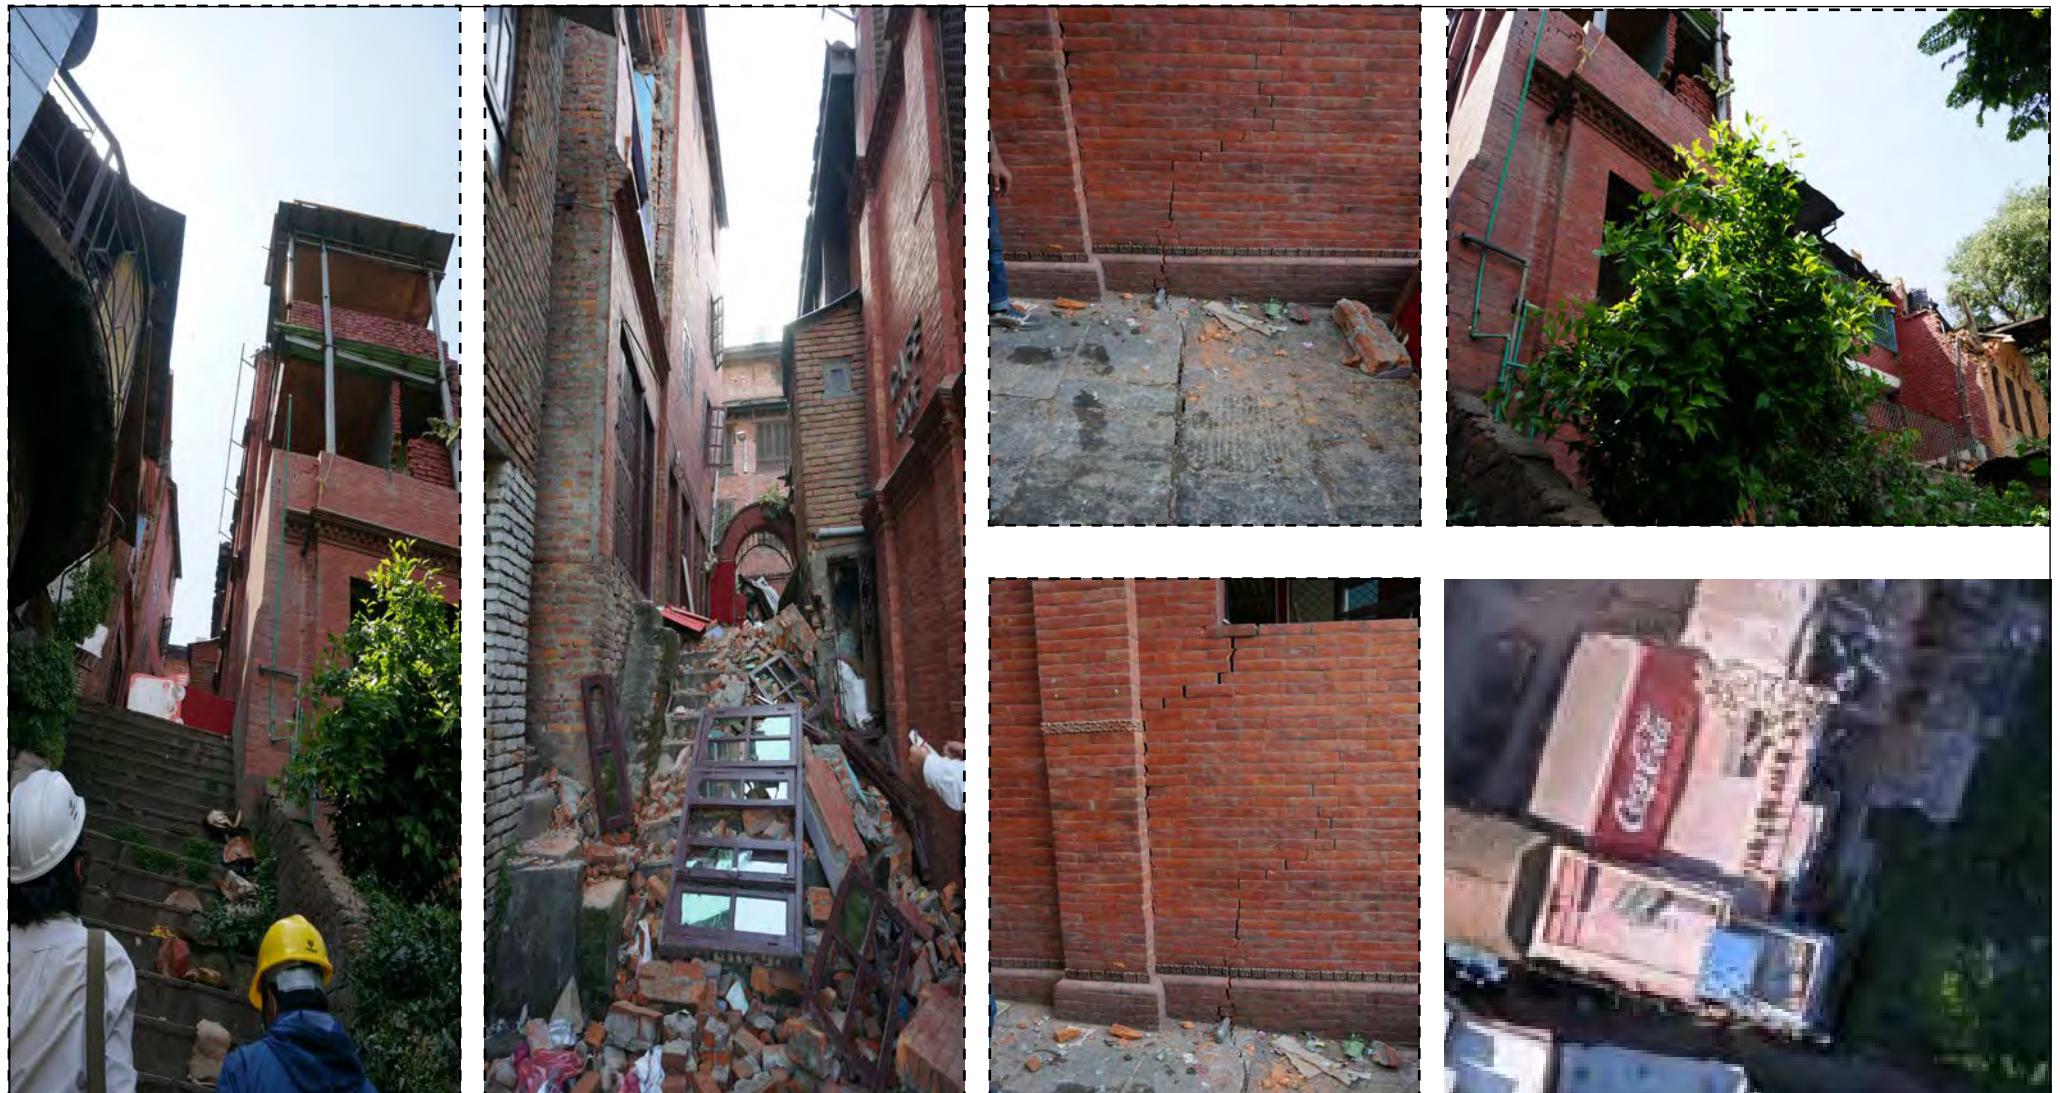
NUMBER NAME	NUMBER OF STOREYS RELATIVE POSITION	STRUCTURAL SYSTEM	DESCRIPTION OF DAMAGE	DANGER DESTROY	HERITAGE SIGNIFICANCE	N ↑
15	G+2	B	Foundation in unstable condition Half portion of building about to fall on E side	⚠

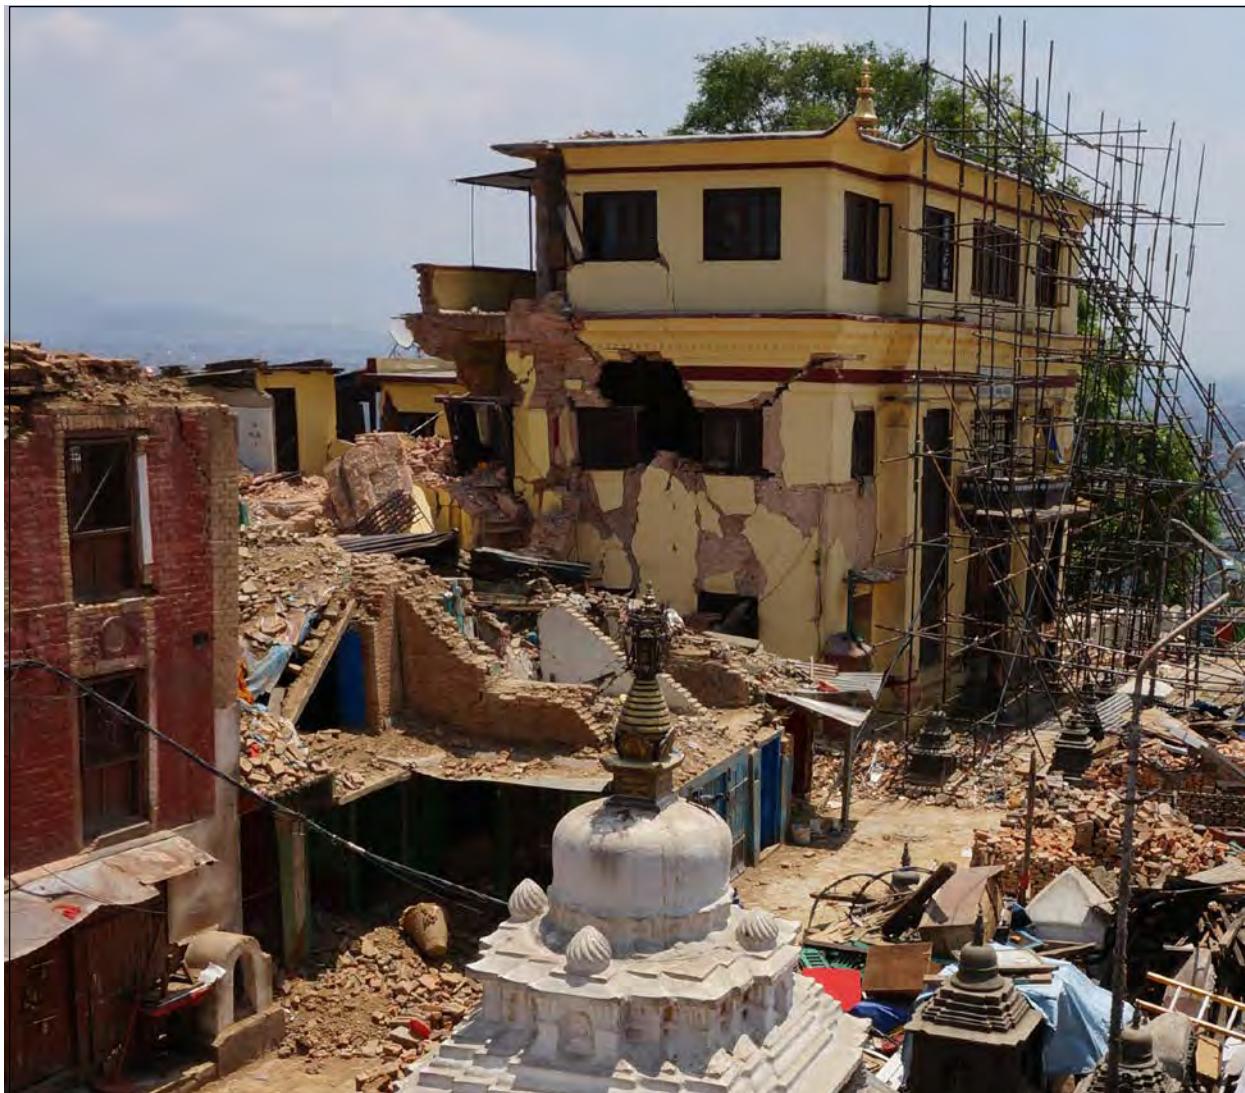
NUMBER NAME	NUMBER OF STOREYS RELATIVE POSITION	STRUCTURAL SYSTEM	DESCRIPTION OF DAMAGE	DANGER DESTROY	HERITAGE SIGNIFICANCE	N ↑
17 18 19 29 30 31 32 33	G+2	B	Totally collapsed	☒
