2015 Earthquake Damage Mapping

Swayambhu Monument Zone
Kathmandu Valley World Heritage Property

Submitted to UNESCO by

June 2015

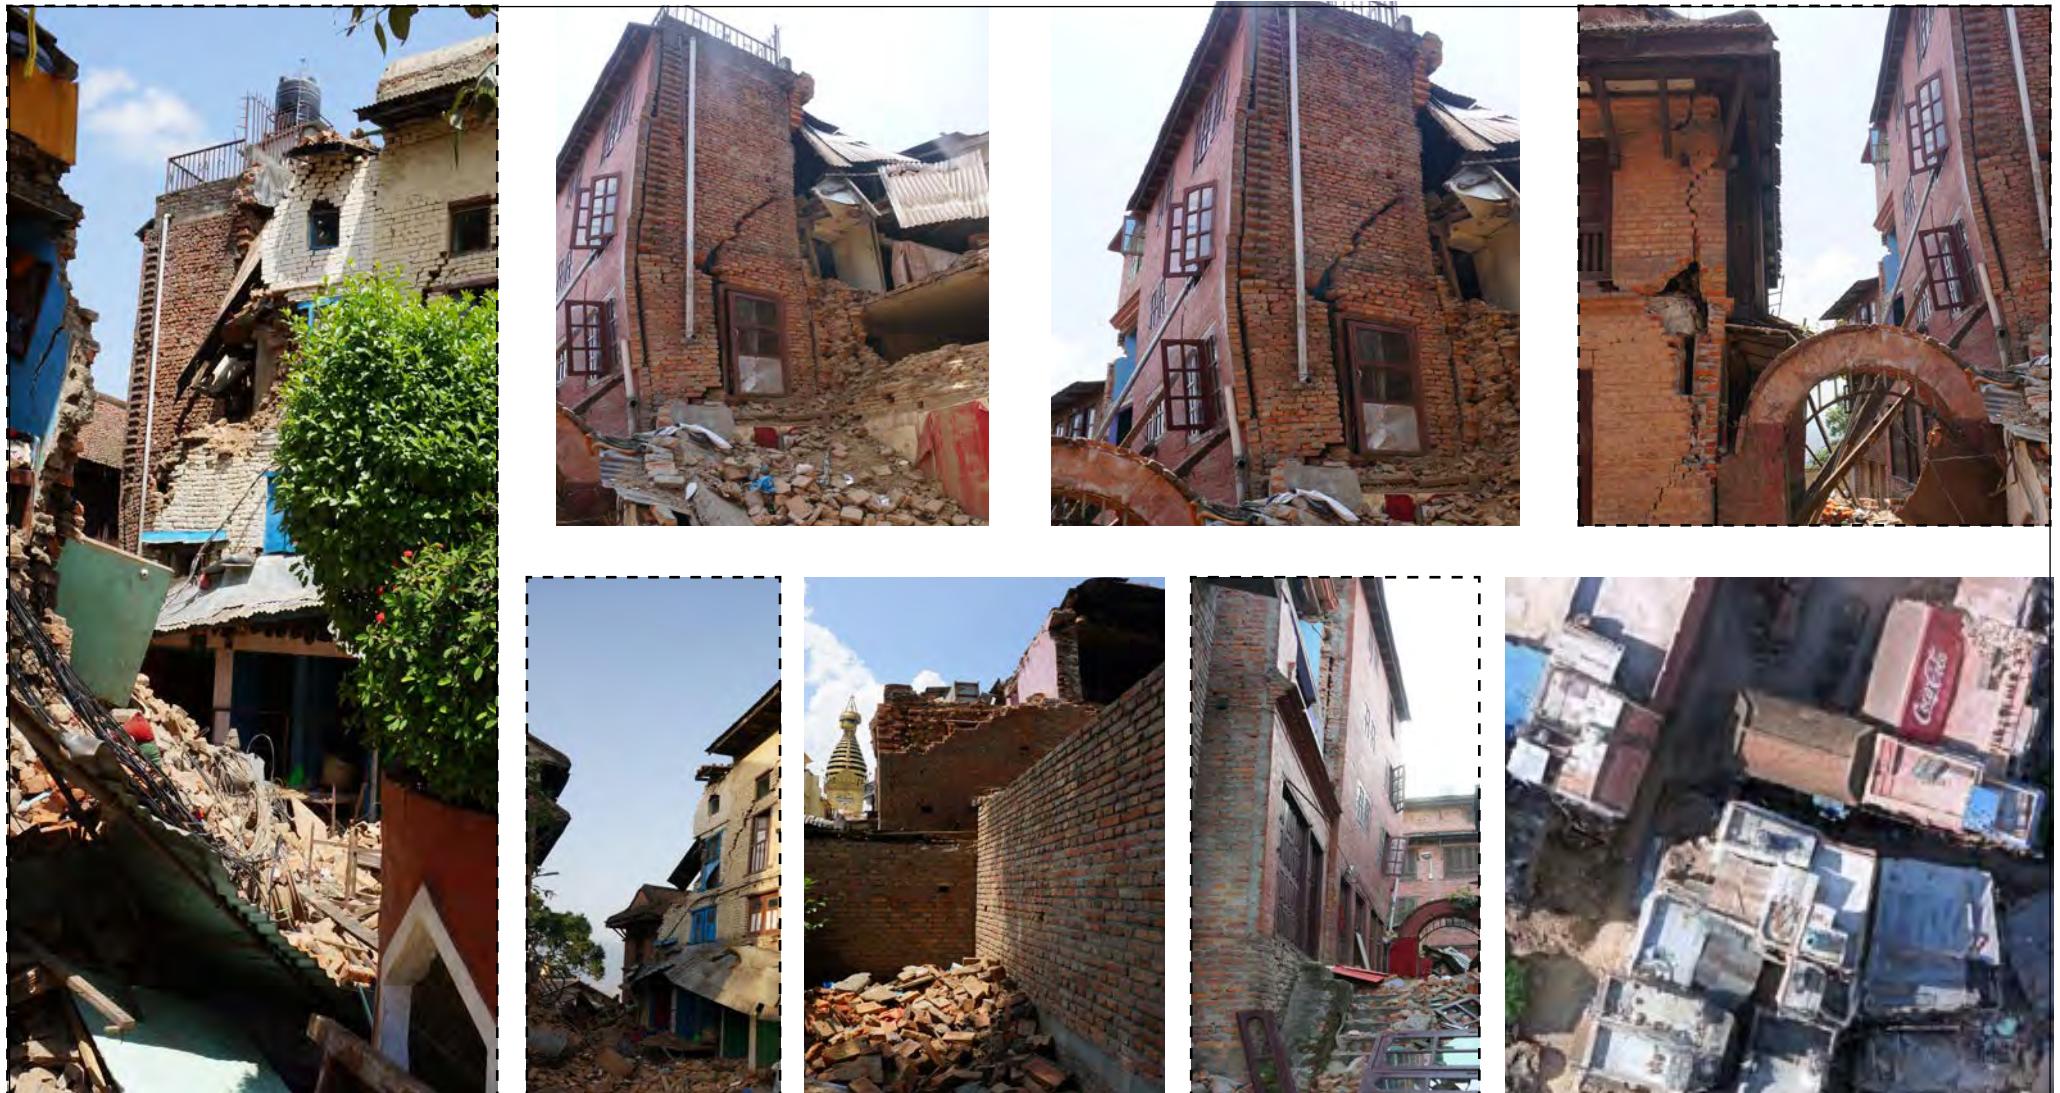
NUMBER NAME	NUMBER OF STOREYS RELATIVE POSITION	STRUCTURAL SYSTEM	DESCRIPTION OF DAMAGE	DANGER DESTROY	HERITAGE SIGNIFICANCE	N ↑
23	G+3	B	N wall with major bulging Risk of collapsing	⚠

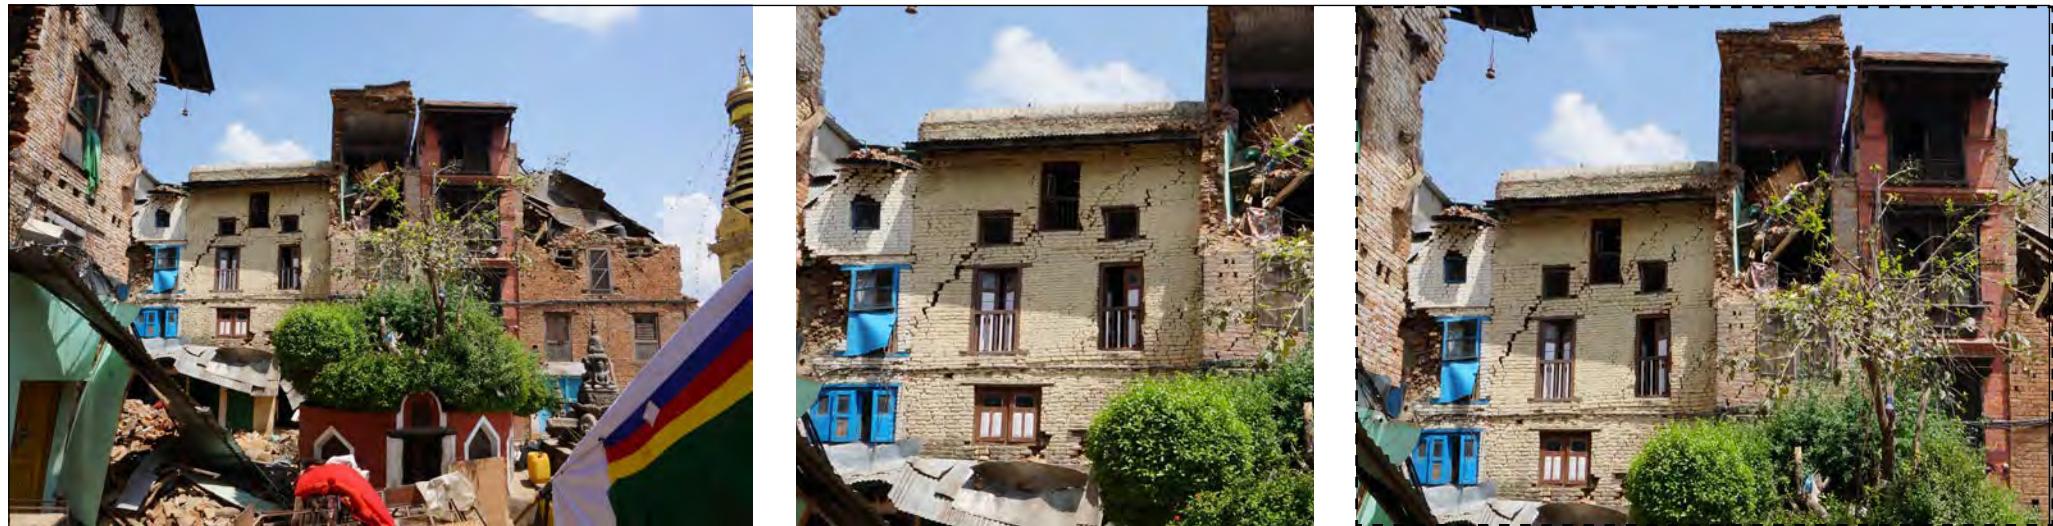
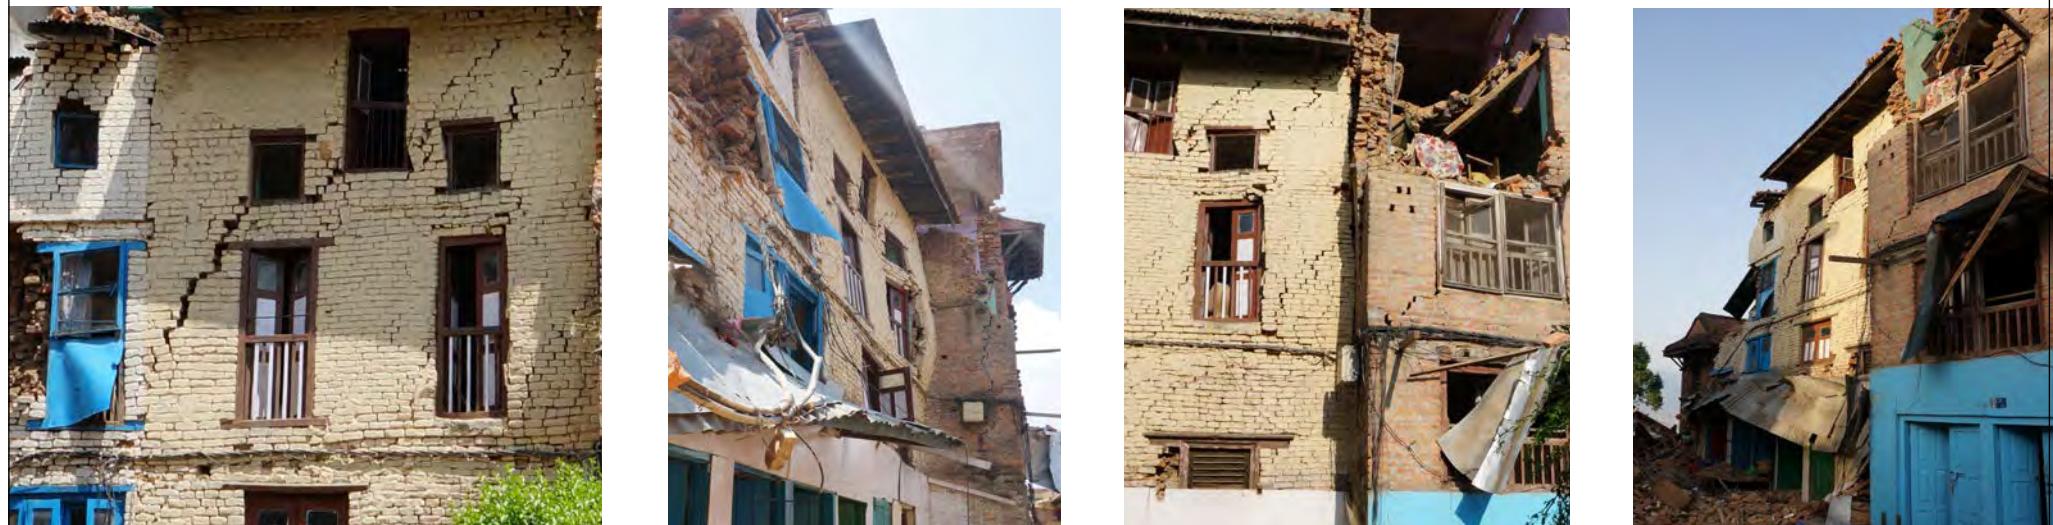
NUMBER NAME	NUMBER OF STORIES RELATIVE POSITION	STRUCTURAL SYSTEM	DESCRIPTION OF DAMAGE	DANGER DESTROY	HERITAGE SIGNIFICANCE	N ↑
24	G+2	B	W wall bulging and cracks	⚠

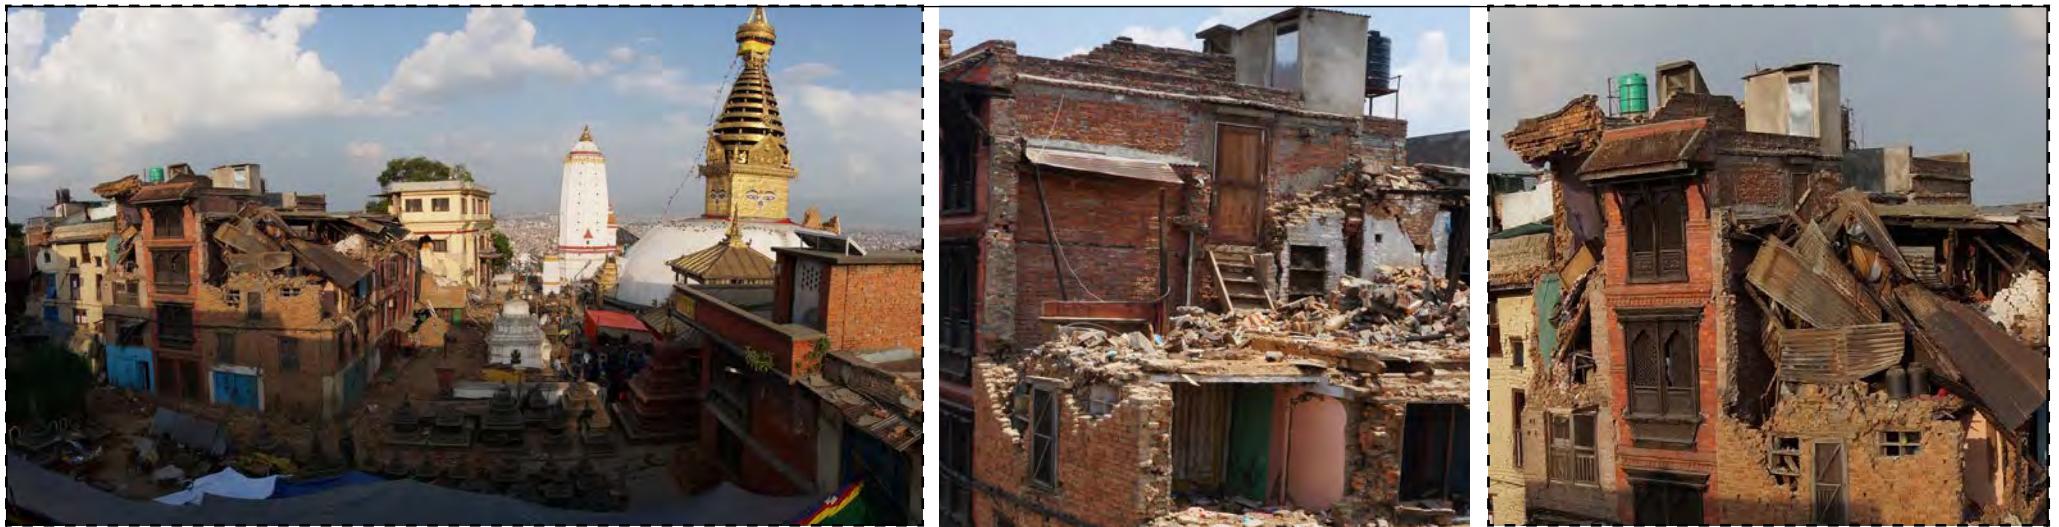
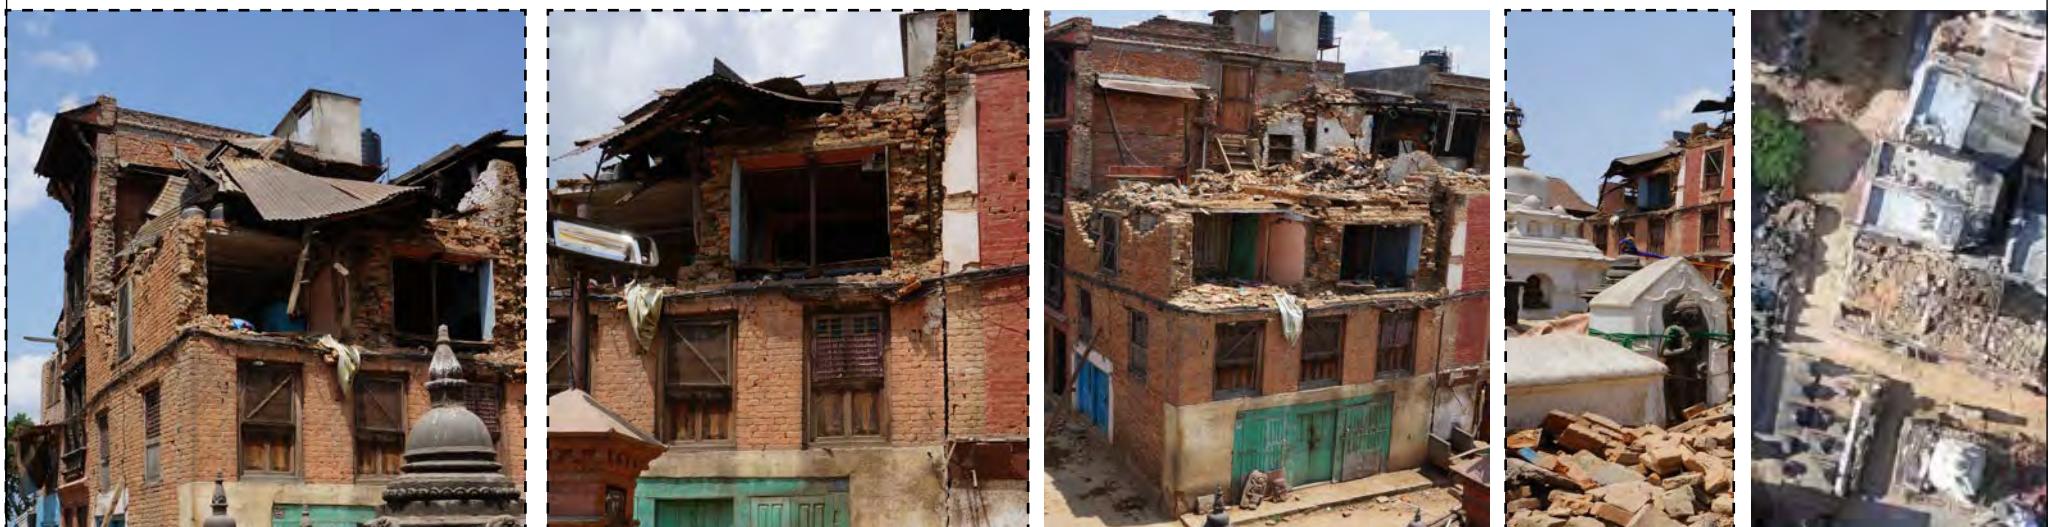
NUMBER NAME	NUMBER OF STOREYS RELATIVE POSITION	STRUCTURAL SYSTEM	DESCRIPTION OF DAMAGE	DANGER DESTROY	HERITAGE SIGNIFICANCE	N ↑
27	G+3	B	2nd, 3rd and 4th floor collapsed Bulging problem	⚠

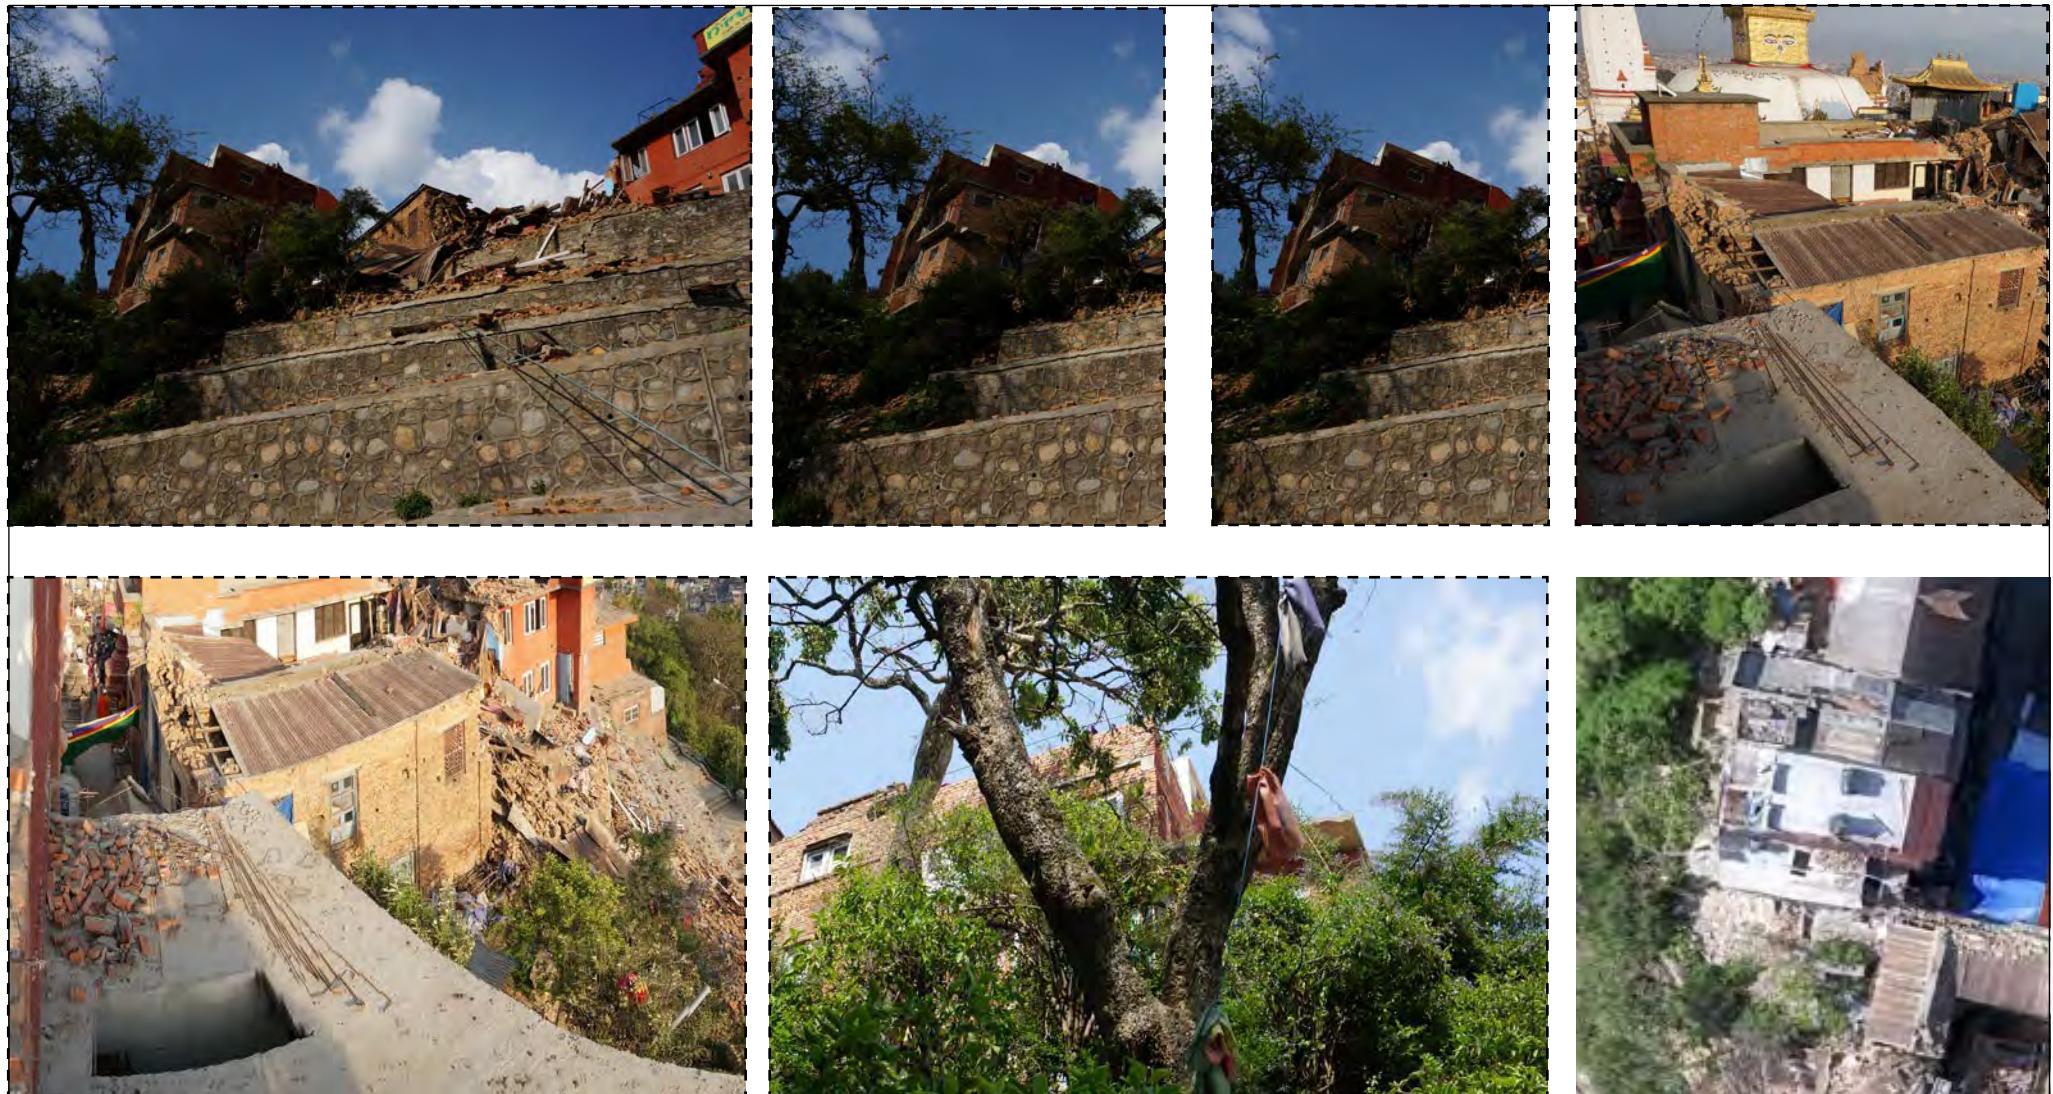
NUMBER NAME	NUMBER OF STORIES RELATIVE POSITION	STRUCTURAL SYSTEM	DESCRIPTION OF DAMAGE	DANGER DESTROY	HERITAGE SIGNIFICANCE	N ↑
35	G+3	C	Major X-shaped cracks in inner walls

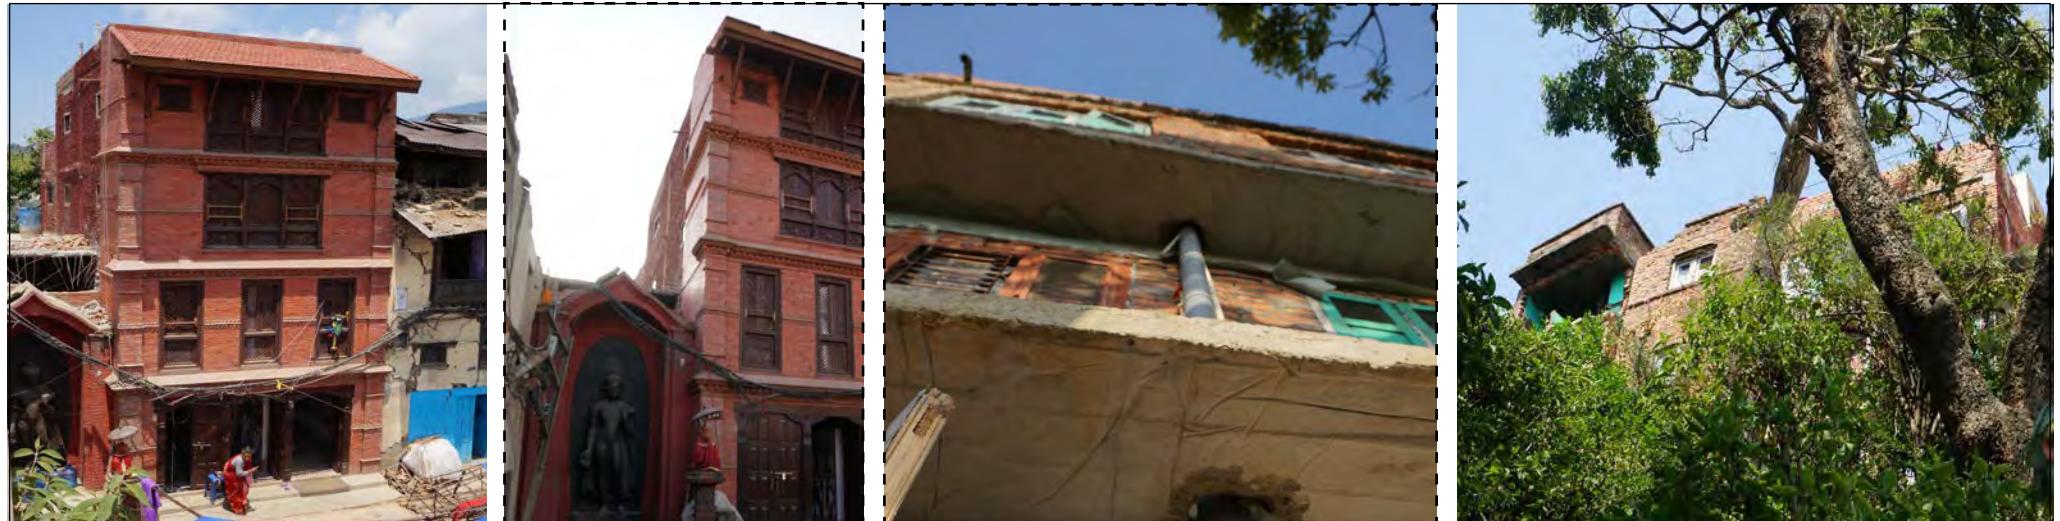
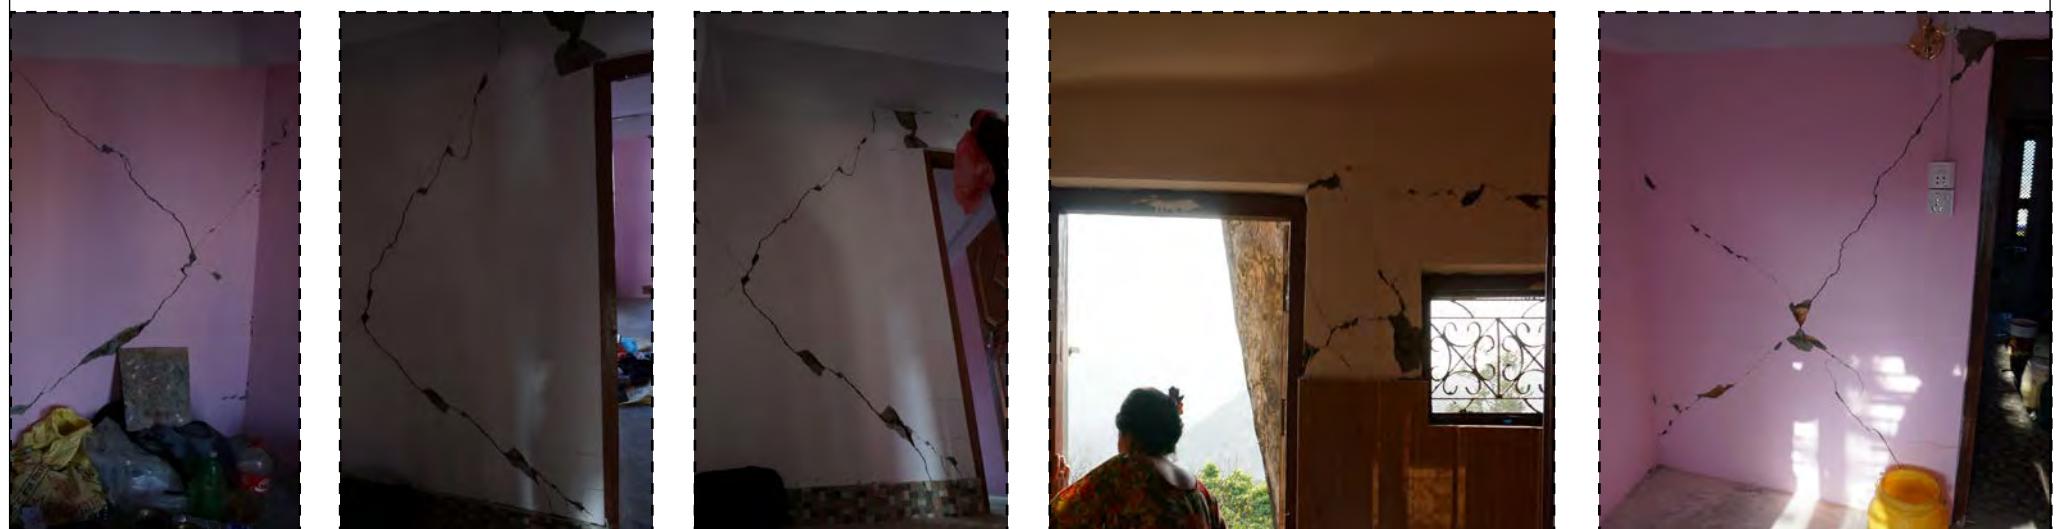
NUMBER NAME	NUMBER OF STOREYS RELATIVE POSITION	STRUCTURAL SYSTEM	DESCRIPTION OF DAMAGE	DANGER DESTROY	HERITAGE SIGNIFICANCE	N ↑
36	G+3	C	Major X-shaped cracks in inner walls		+	
37

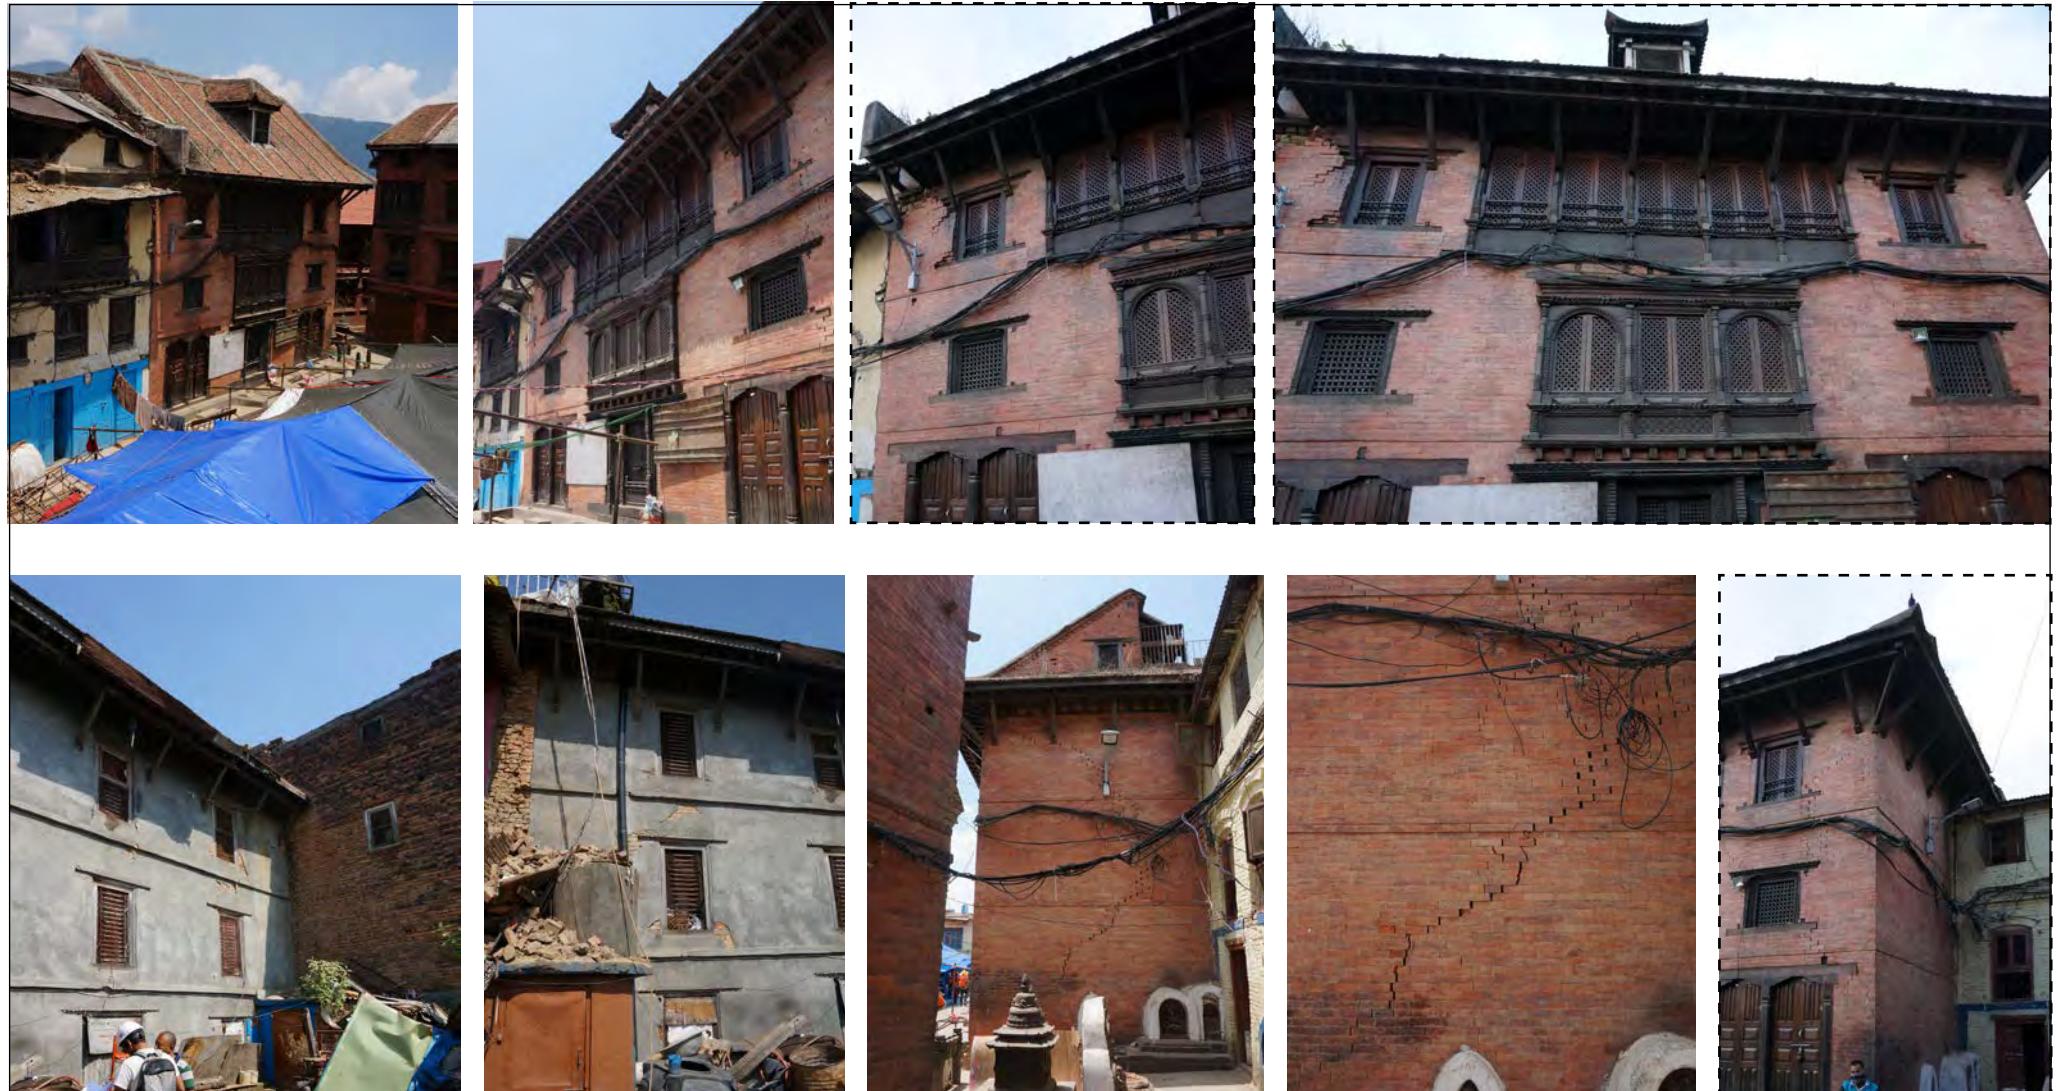
NUMBER NAME	NUMBER OF STOREYS RELATIVE POSITION	STRUCTURAL SYSTEM	DESCRIPTION OF DAMAGE	DANGER DESTROY	HERITAGE SIGNIFICANCE	N ↑
40	G+2	C	N wall with major stepped cracks E wall with stepped cracks from window corners Upper left part of E wall with risk of falling wall bricks		+

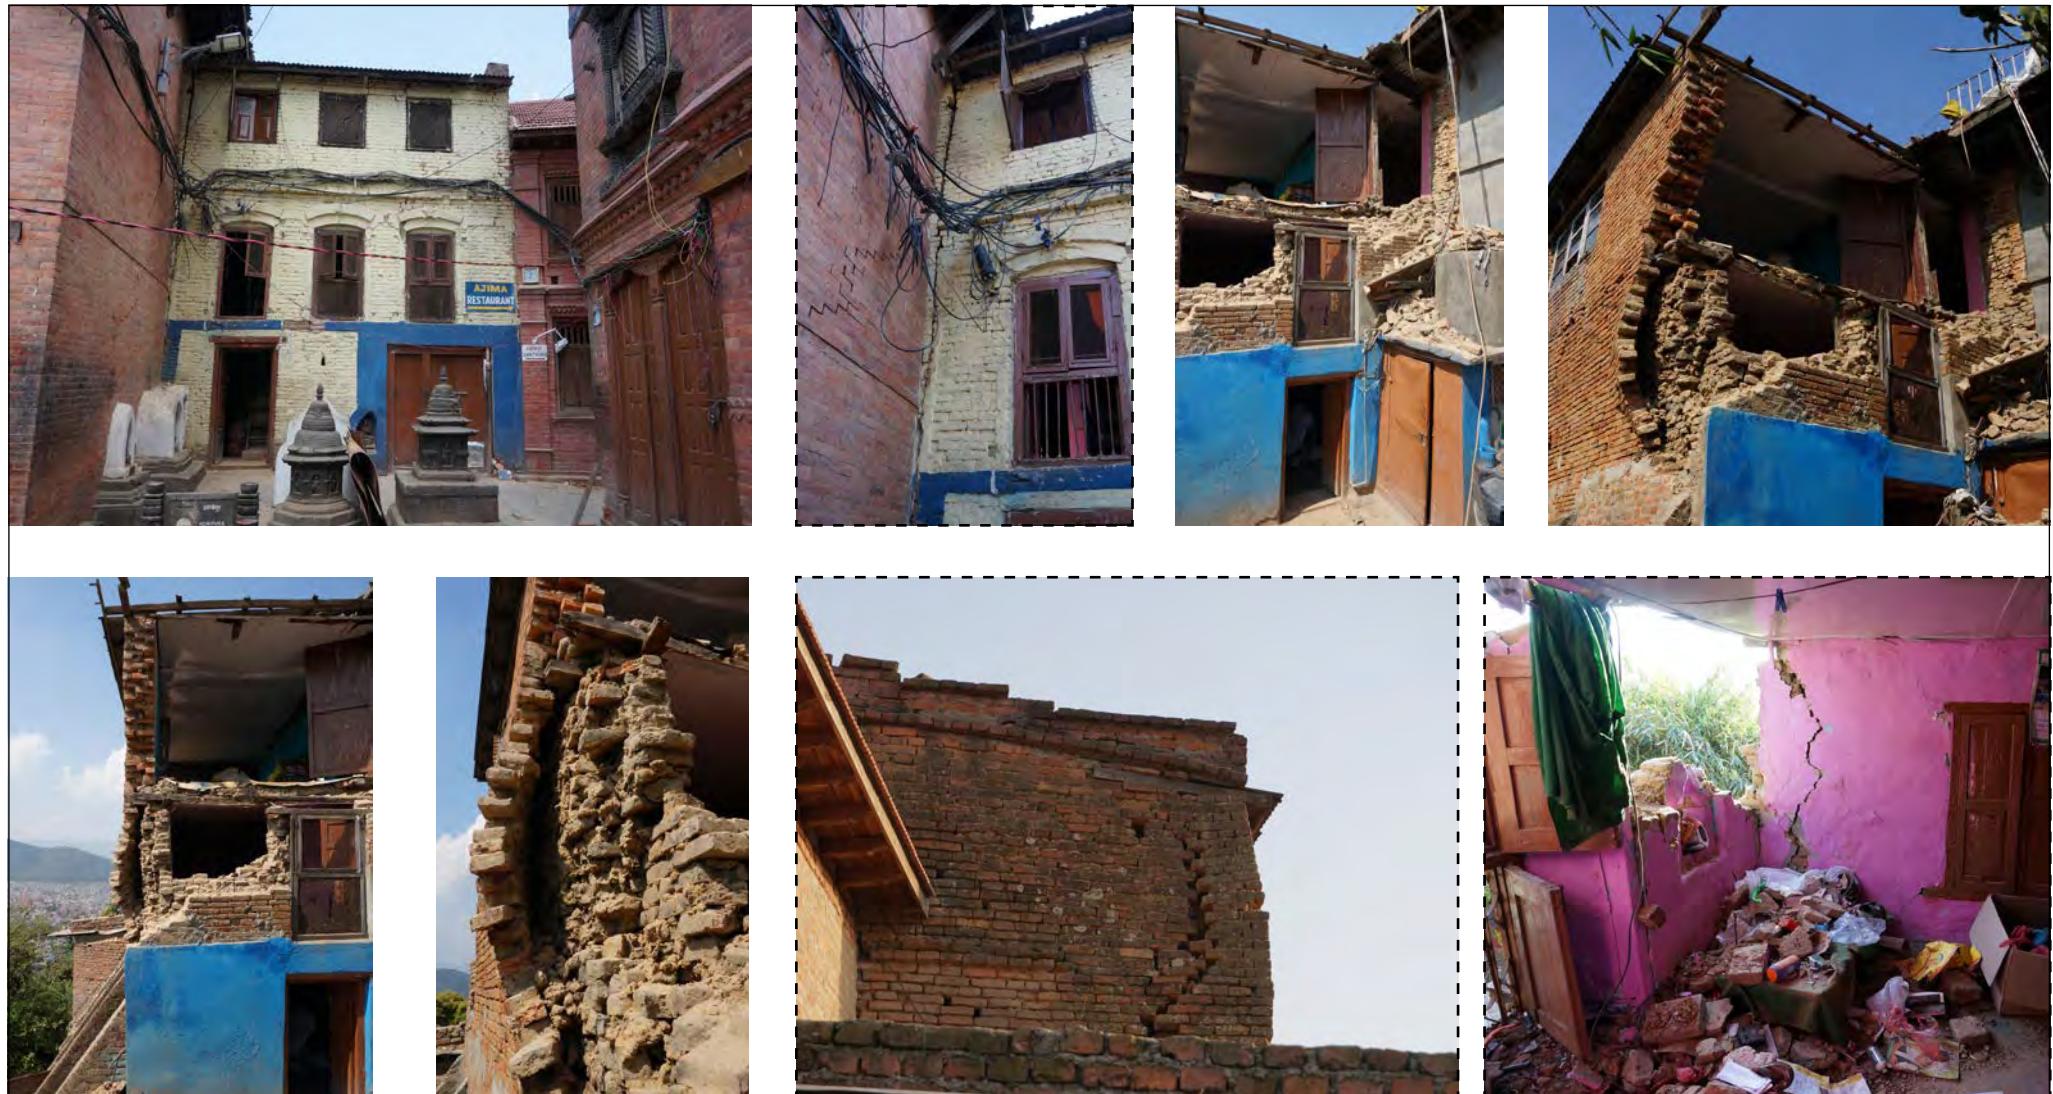
NUMBER NAME	NUMBER OF STORIES RELATIVE POSITION	STRUCTURAL SYSTEM	DESCRIPTION OF DAMAGE	DANGER DESTROY	HERITAGE SIGNIFICANCE	N ↑	PLAN 1/1000
41	G+2	B	W wall partially collapsed and tilted Front wall with upper part tilted

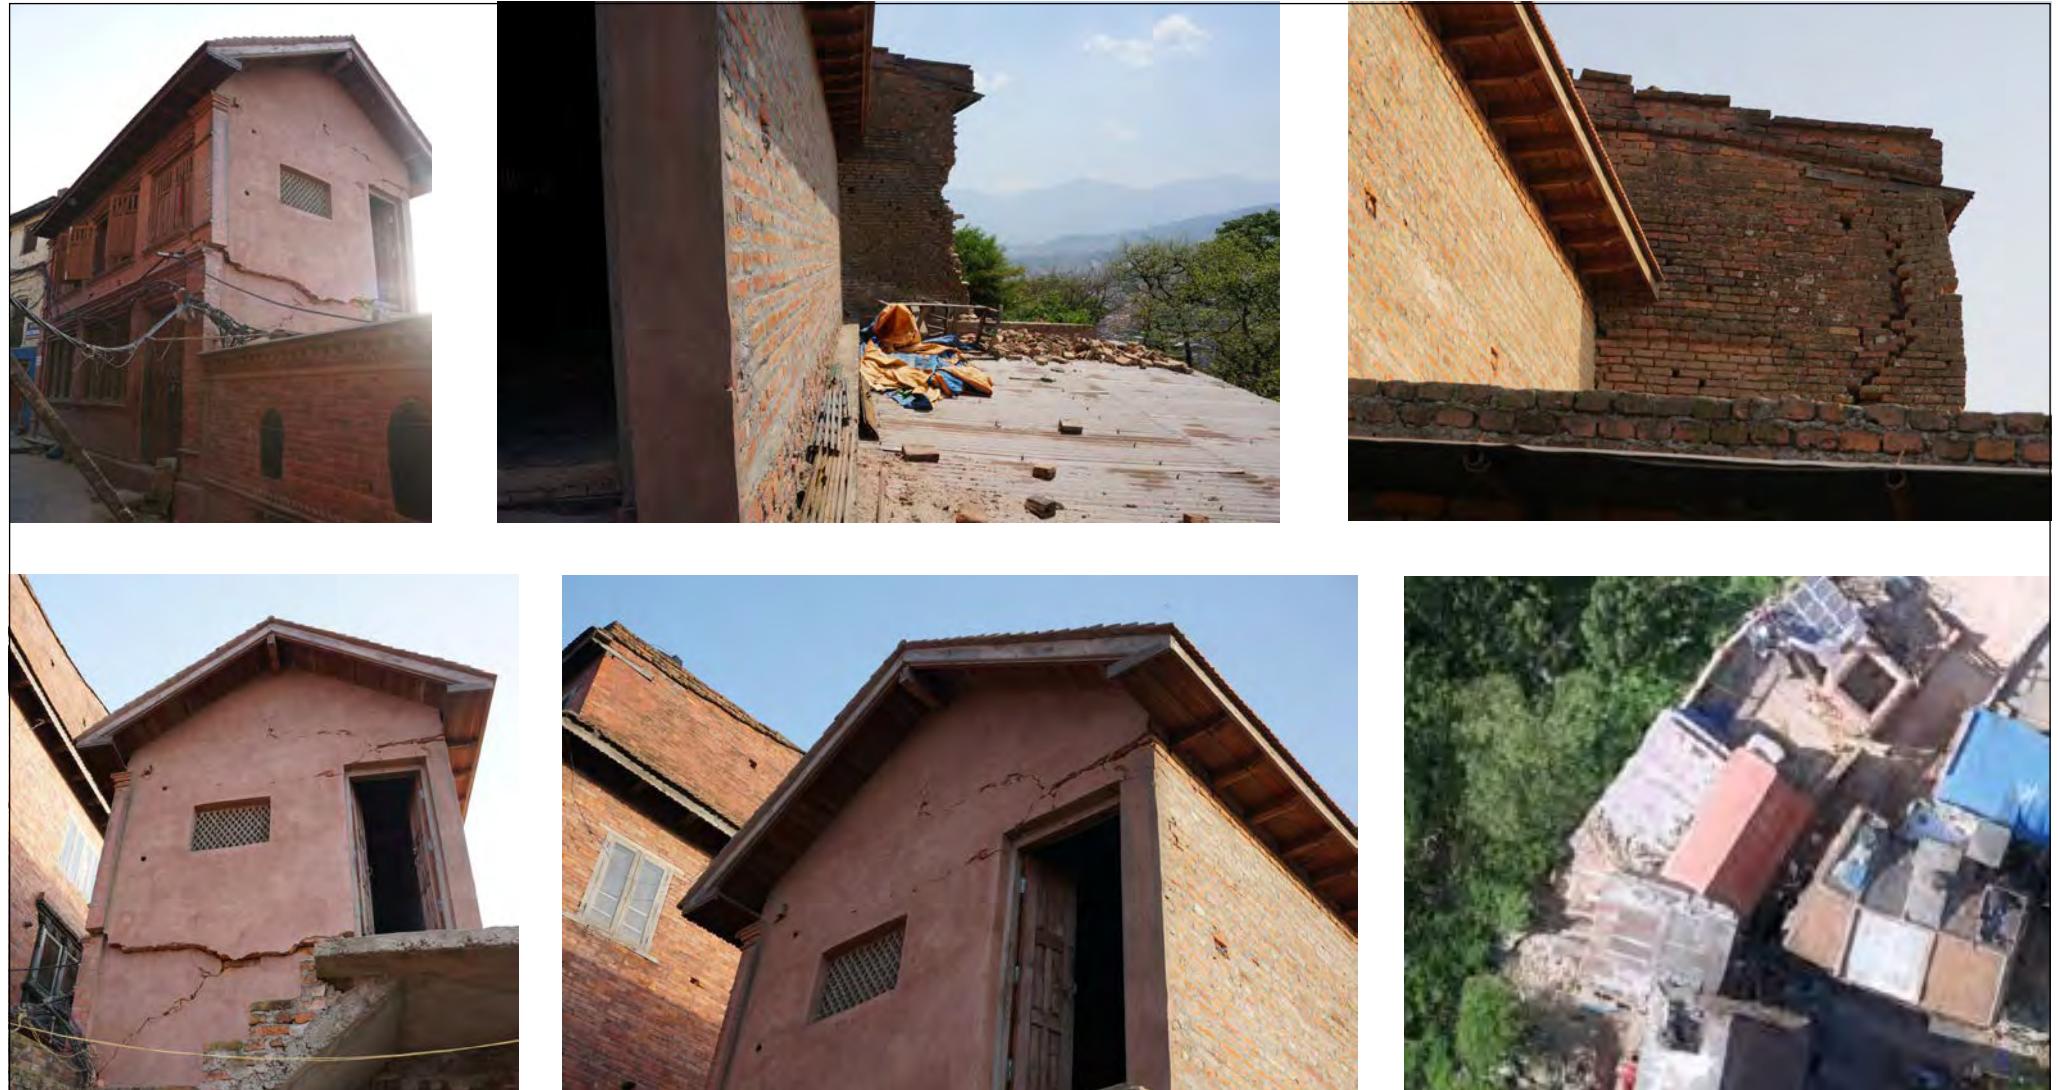
NUMBER NAME	NUMBER OF STOREYS RELATIVE POSITION	STRUCTURAL SYSTEM	DESCRIPTION OF DAMAGE	DANGER DESTROY	HERITAGE SIGNIFICANCE	N ↑
42	G+1	B	N wall with major horizontal floor cracks Offset of walls About to collapsed	⚠

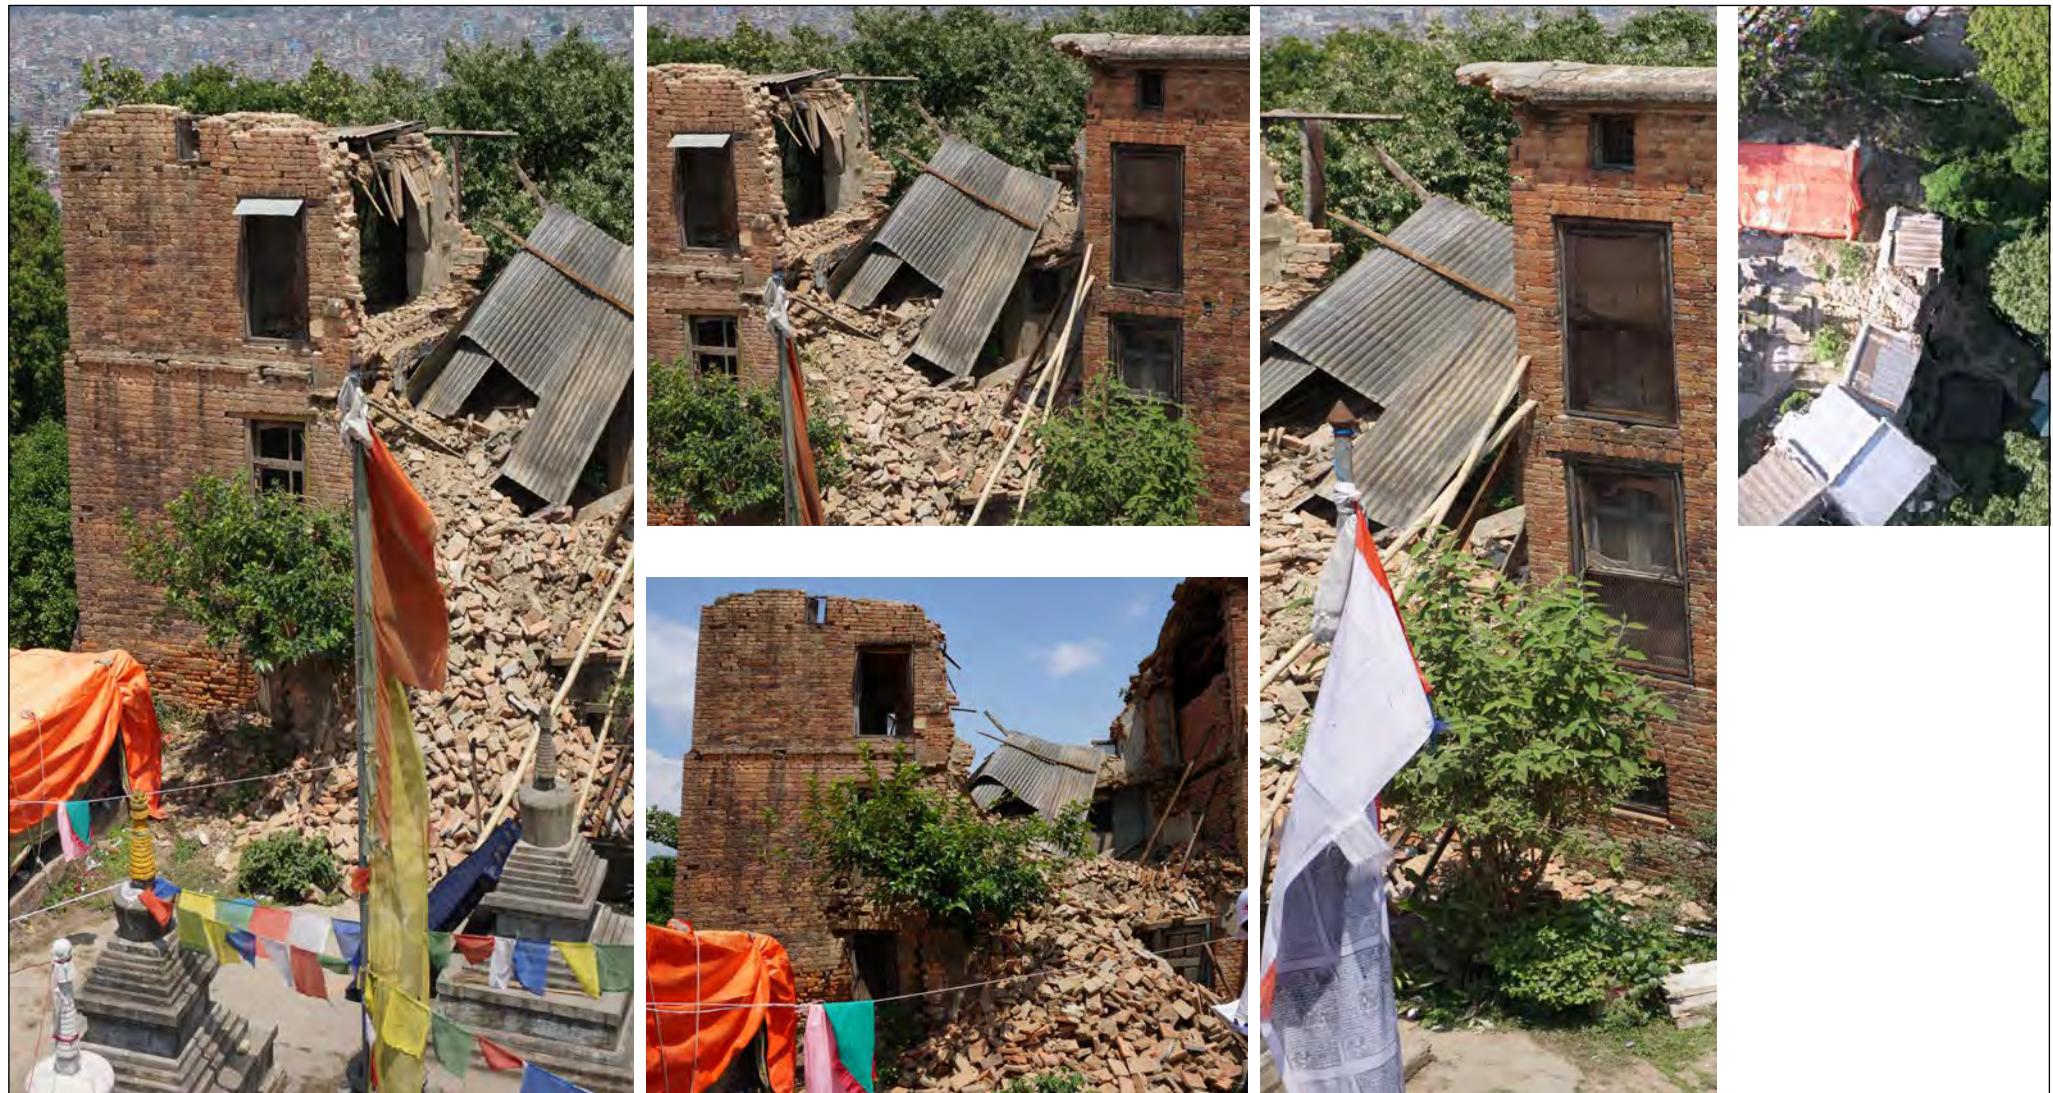
NUMBER NAME	NUMBER OF STORIES RELATIVE POSITION	STRUCTURAL SYSTEM	DESCRIPTION OF DAMAGE	DANGER DESTROY	HERITAGE SIGNIFICANCE	N ↑
43	G+2	B	Half collapsed Imposing danger to neighboring house	⚠ 1/2 ✗

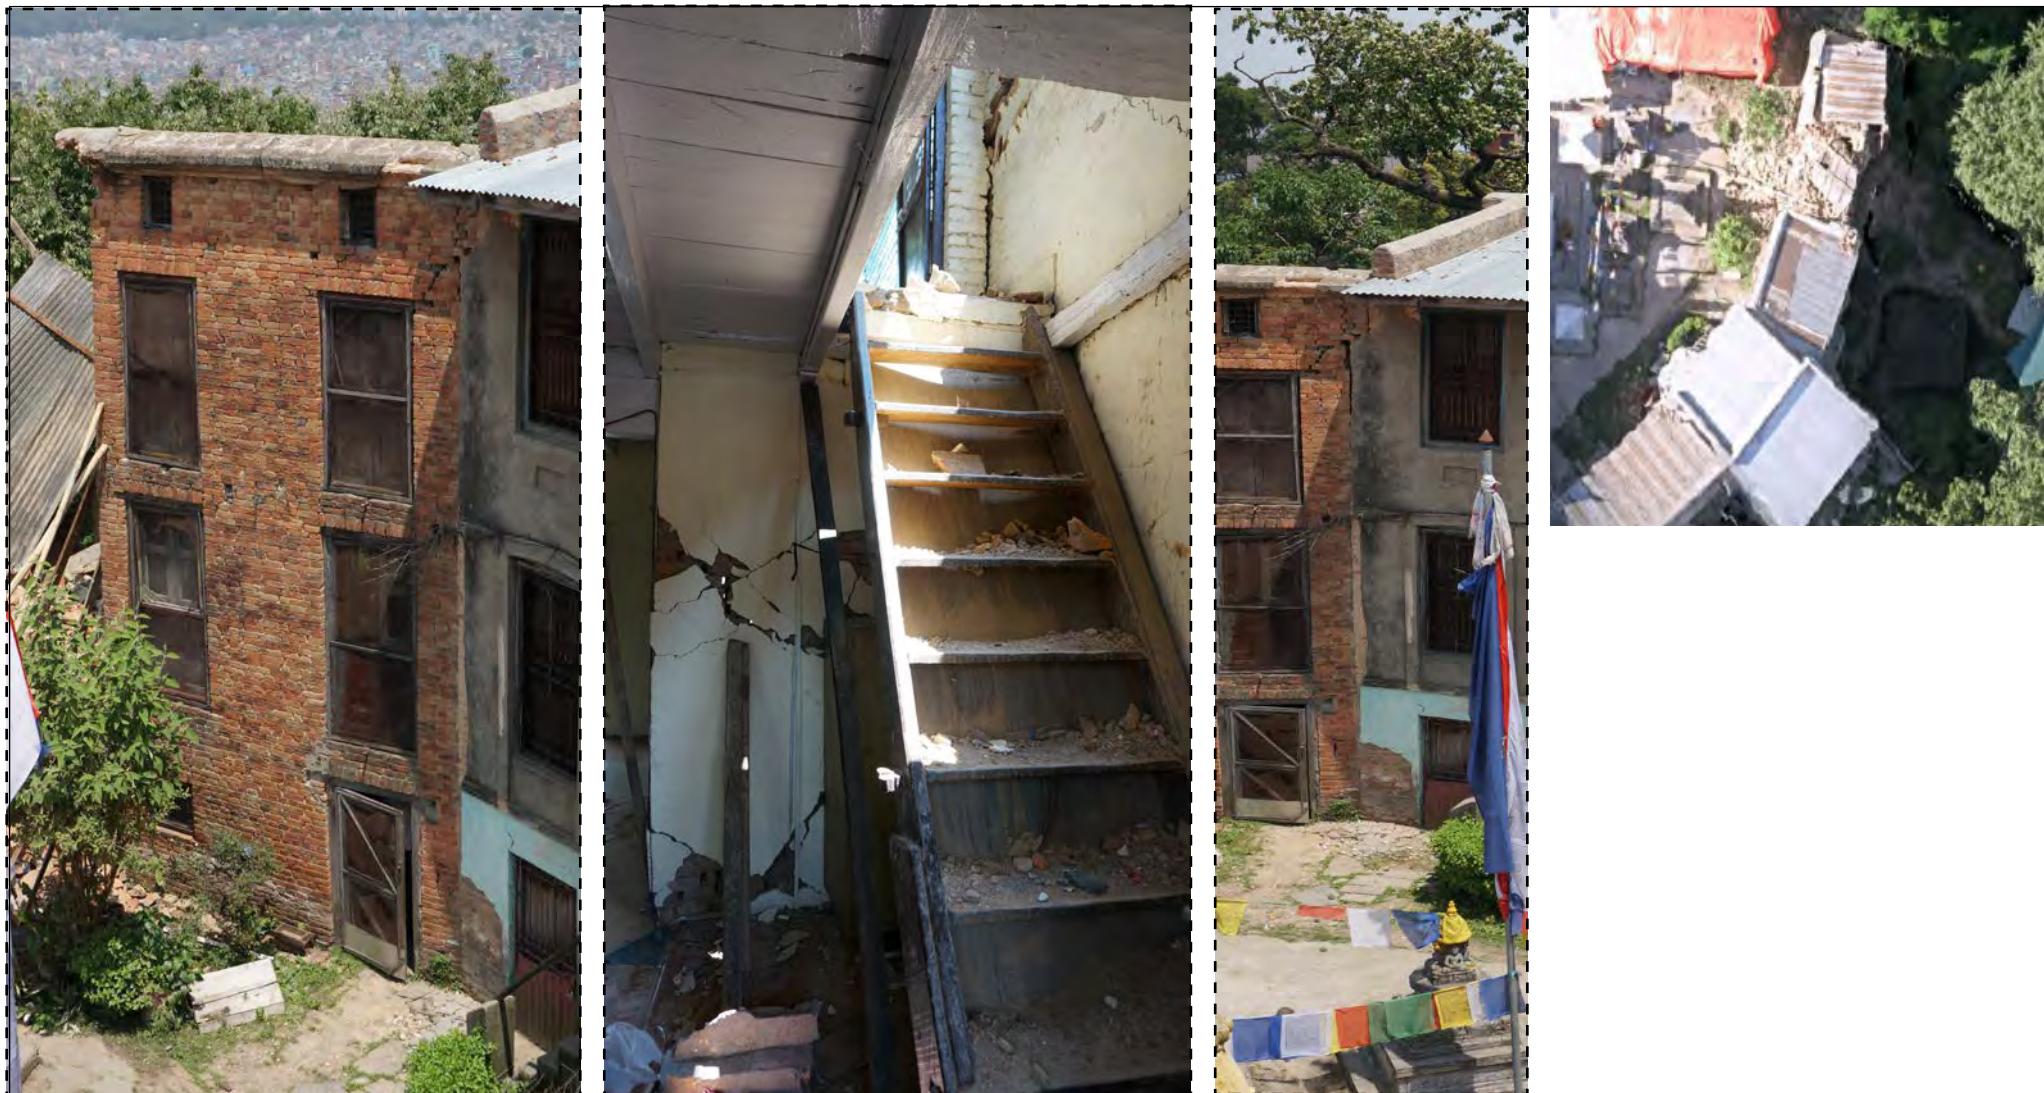
NUMBER NAME	NUMBER OF STOREYS RELATIVE POSITION	STRUCTURAL SYSTEM	DESCRIPTION OF DAMAGE	DANGER DESTROY	HERITAGE SIGNIFICANCE	PLAN 1/1000
44	G+2	B	Standing but in critical state G floor is only accessible House of American nun living there for 39 years
