2015 Earthquake Damage Mapping

Swayambhu Monument Zone
Kathmandu Valley World Heritage Property

Submitted to UNESCO by

June 2015

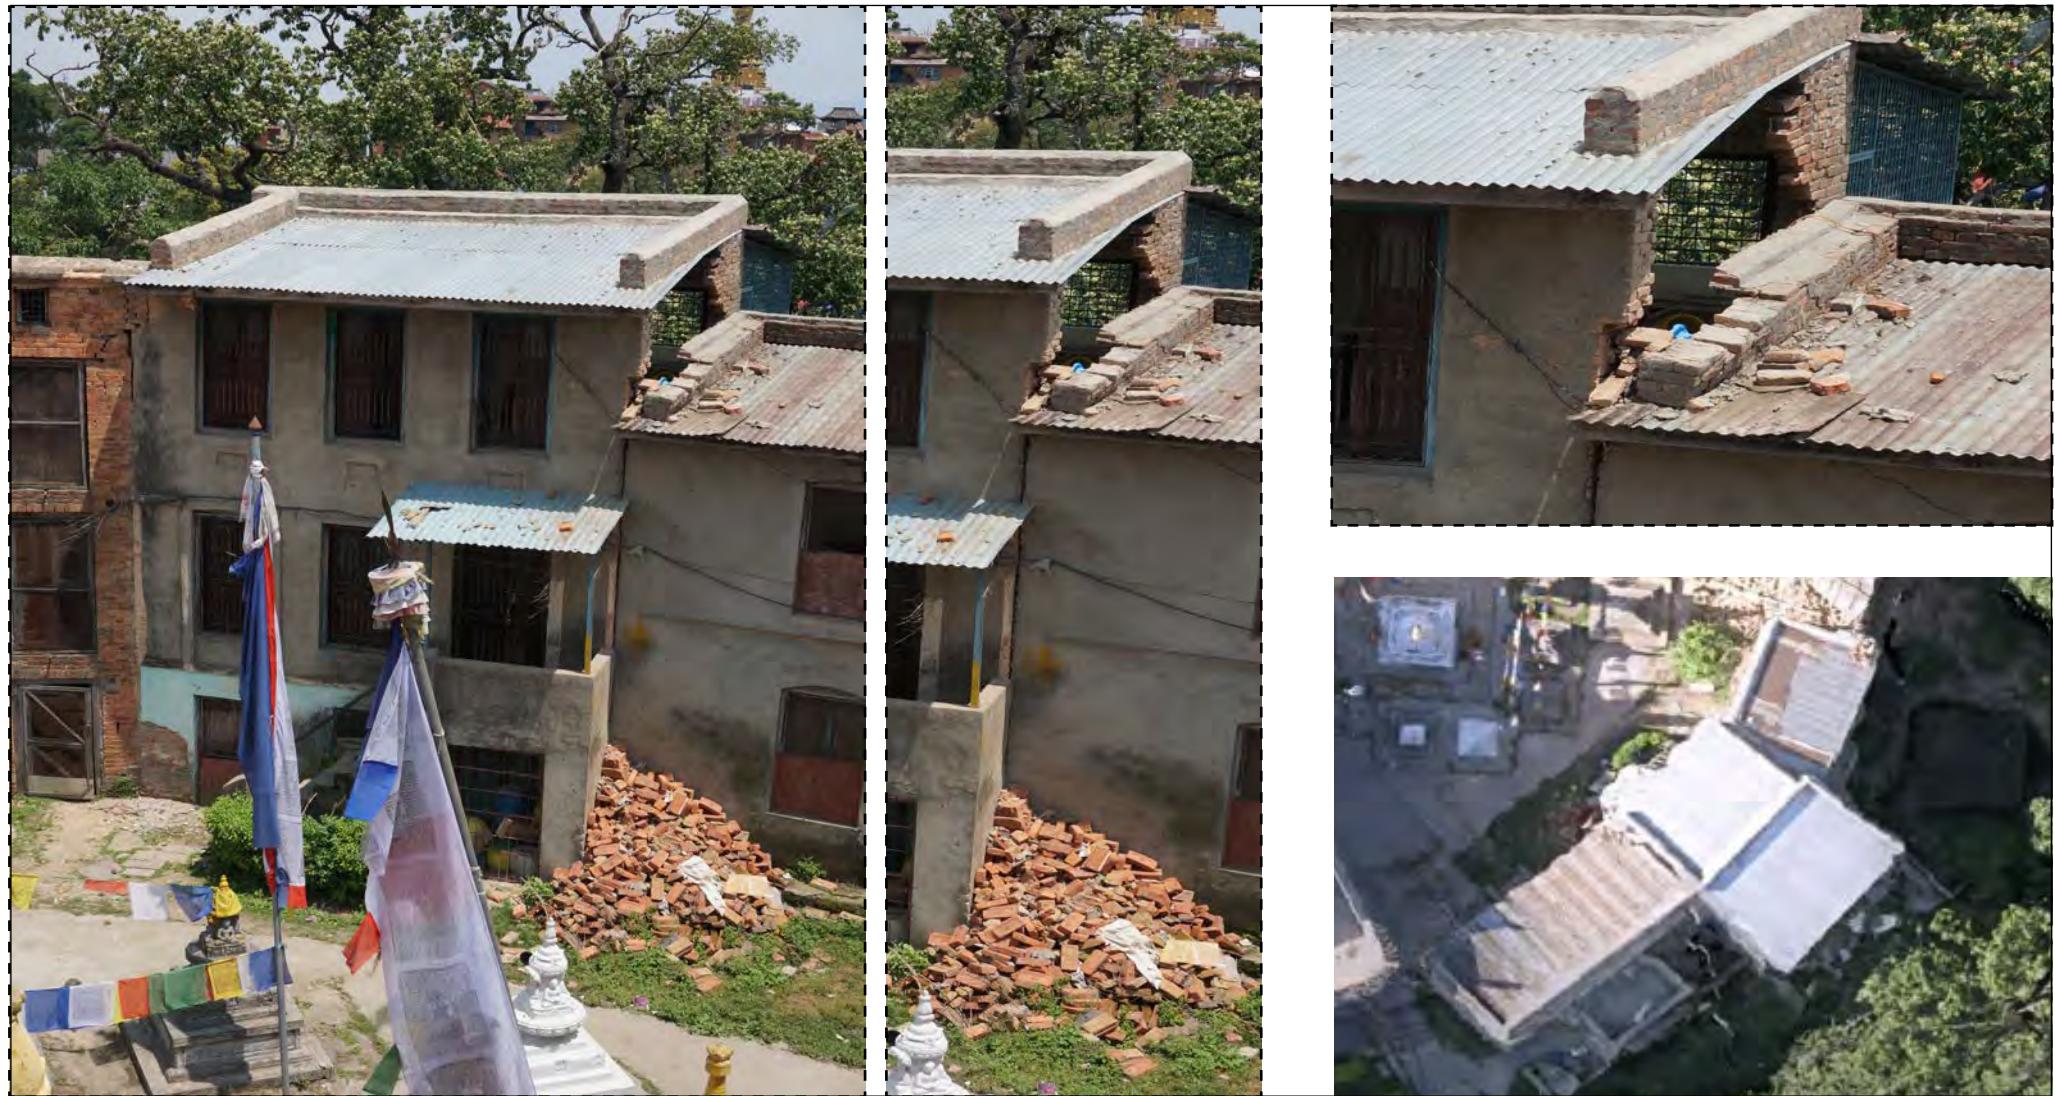
NUMBER NAME	NUMBER OF STORIES RELATIVE POSITION	STRUCTURAL SYSTEM	DESCRIPTION OF DAMAGE	DANGER DESTROY	HERITAGE SIGNIFICANCE	N ↑
45	G+2	B	Standing but in critical state and inner part heavily damaged according to American nun living there for 39 years.

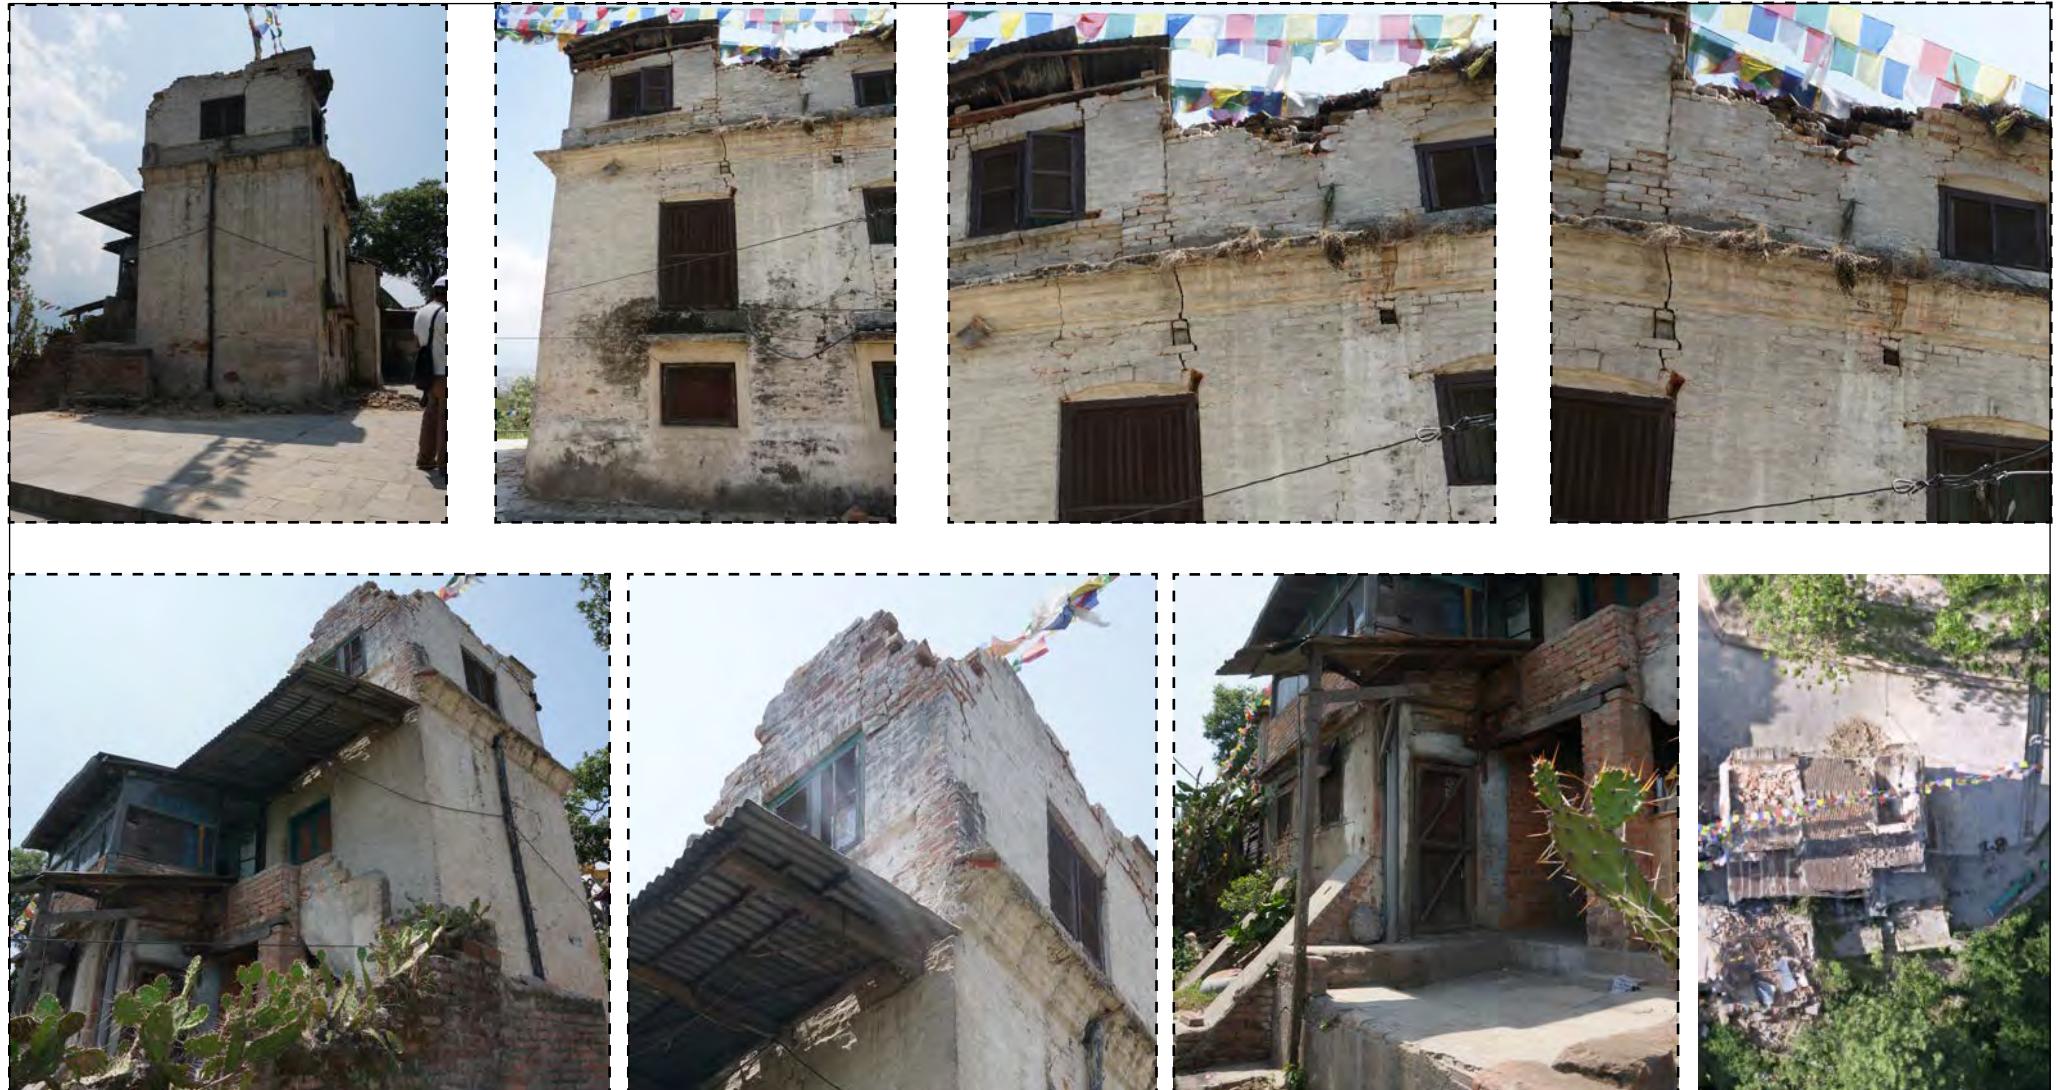
NUMBER NAME	NUMBER OF STOREYS RELATIVE POSITION	STRUCTURAL SYSTEM	DESCRIPTION OF DAMAGE	DANGER DESTROY	HERITAGE SIGNIFICANCE	N ↑
48	G+2	B	Many cracks extending from windows and doors Half of the roof collapsed	1/2
