2015 Earthquake Damage Mapping

Sankhu

October 2015

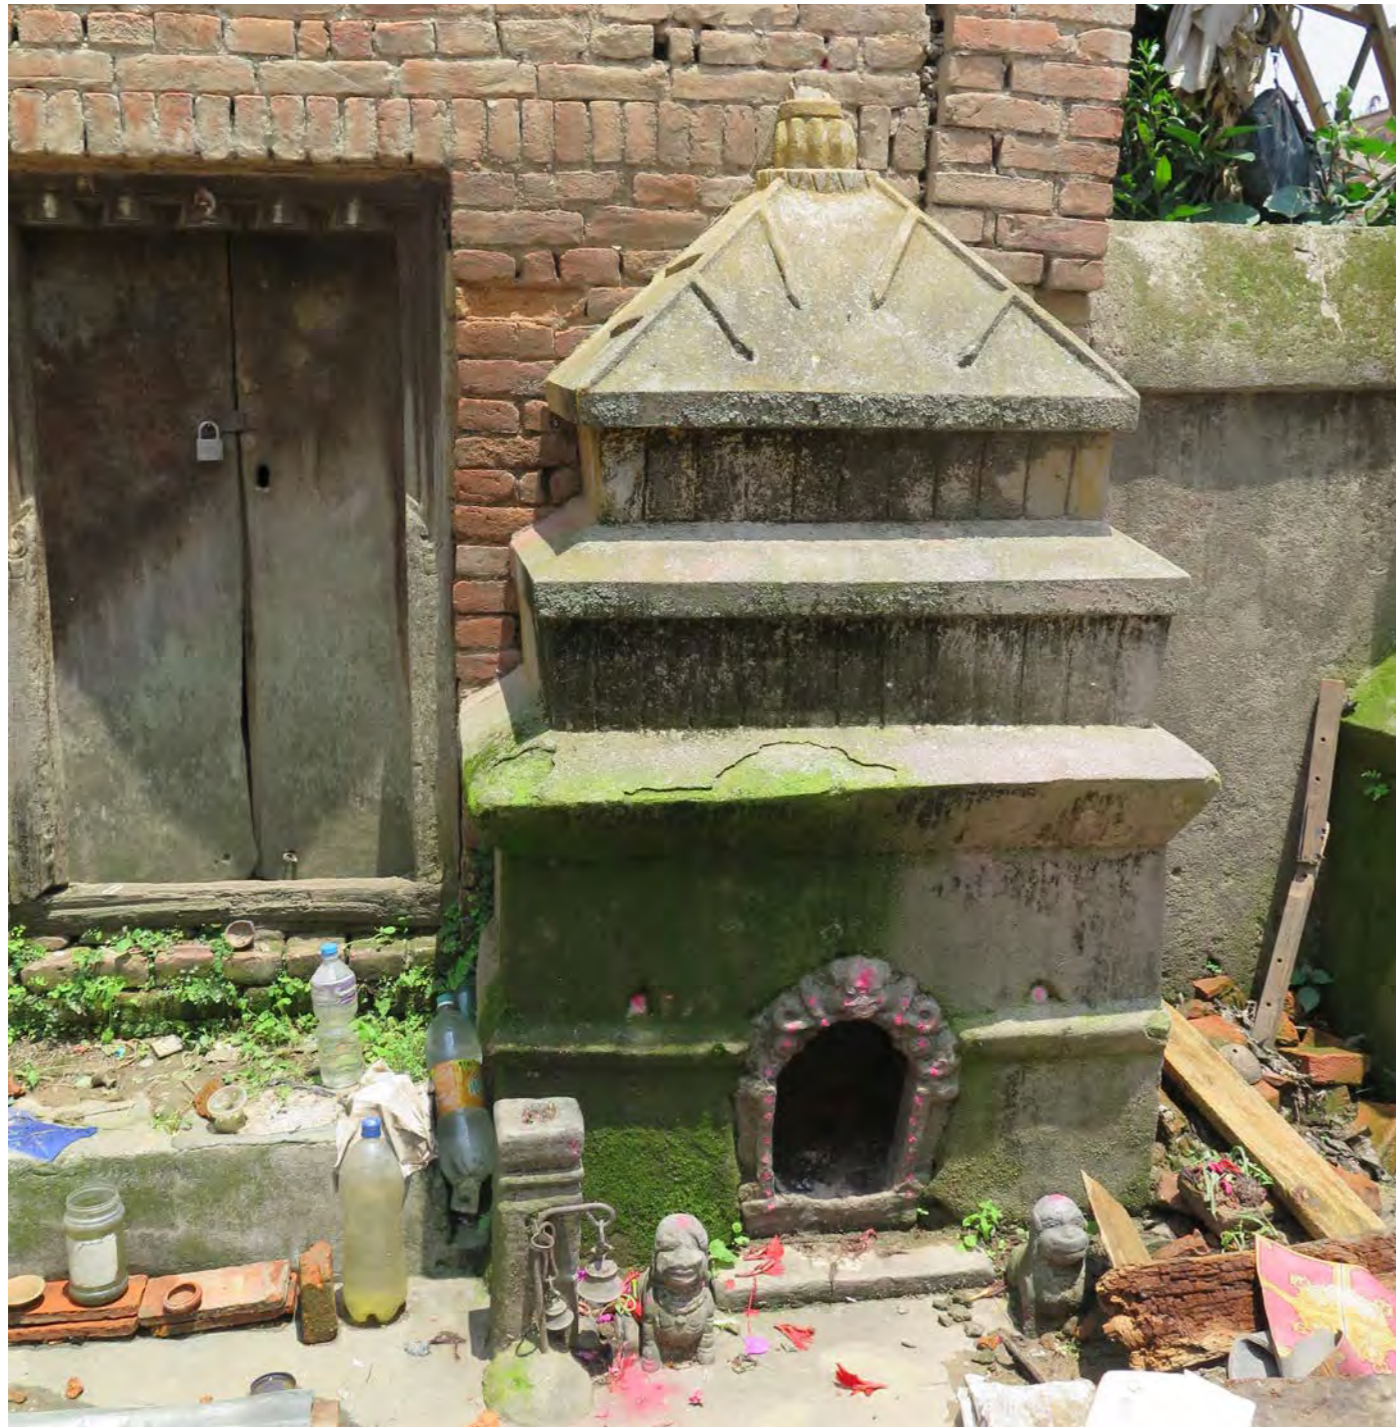
NUMBER	NAME	ESTABLISHED DATE (A.D.)	TPOLOGY	GENERAL DESCRIPTION	PROBLEMS DESCRIPTION	DANGER/ DESTROY
E-12	Nasa Dya		Enclosed Shrine	Cement plastered	No visible damage

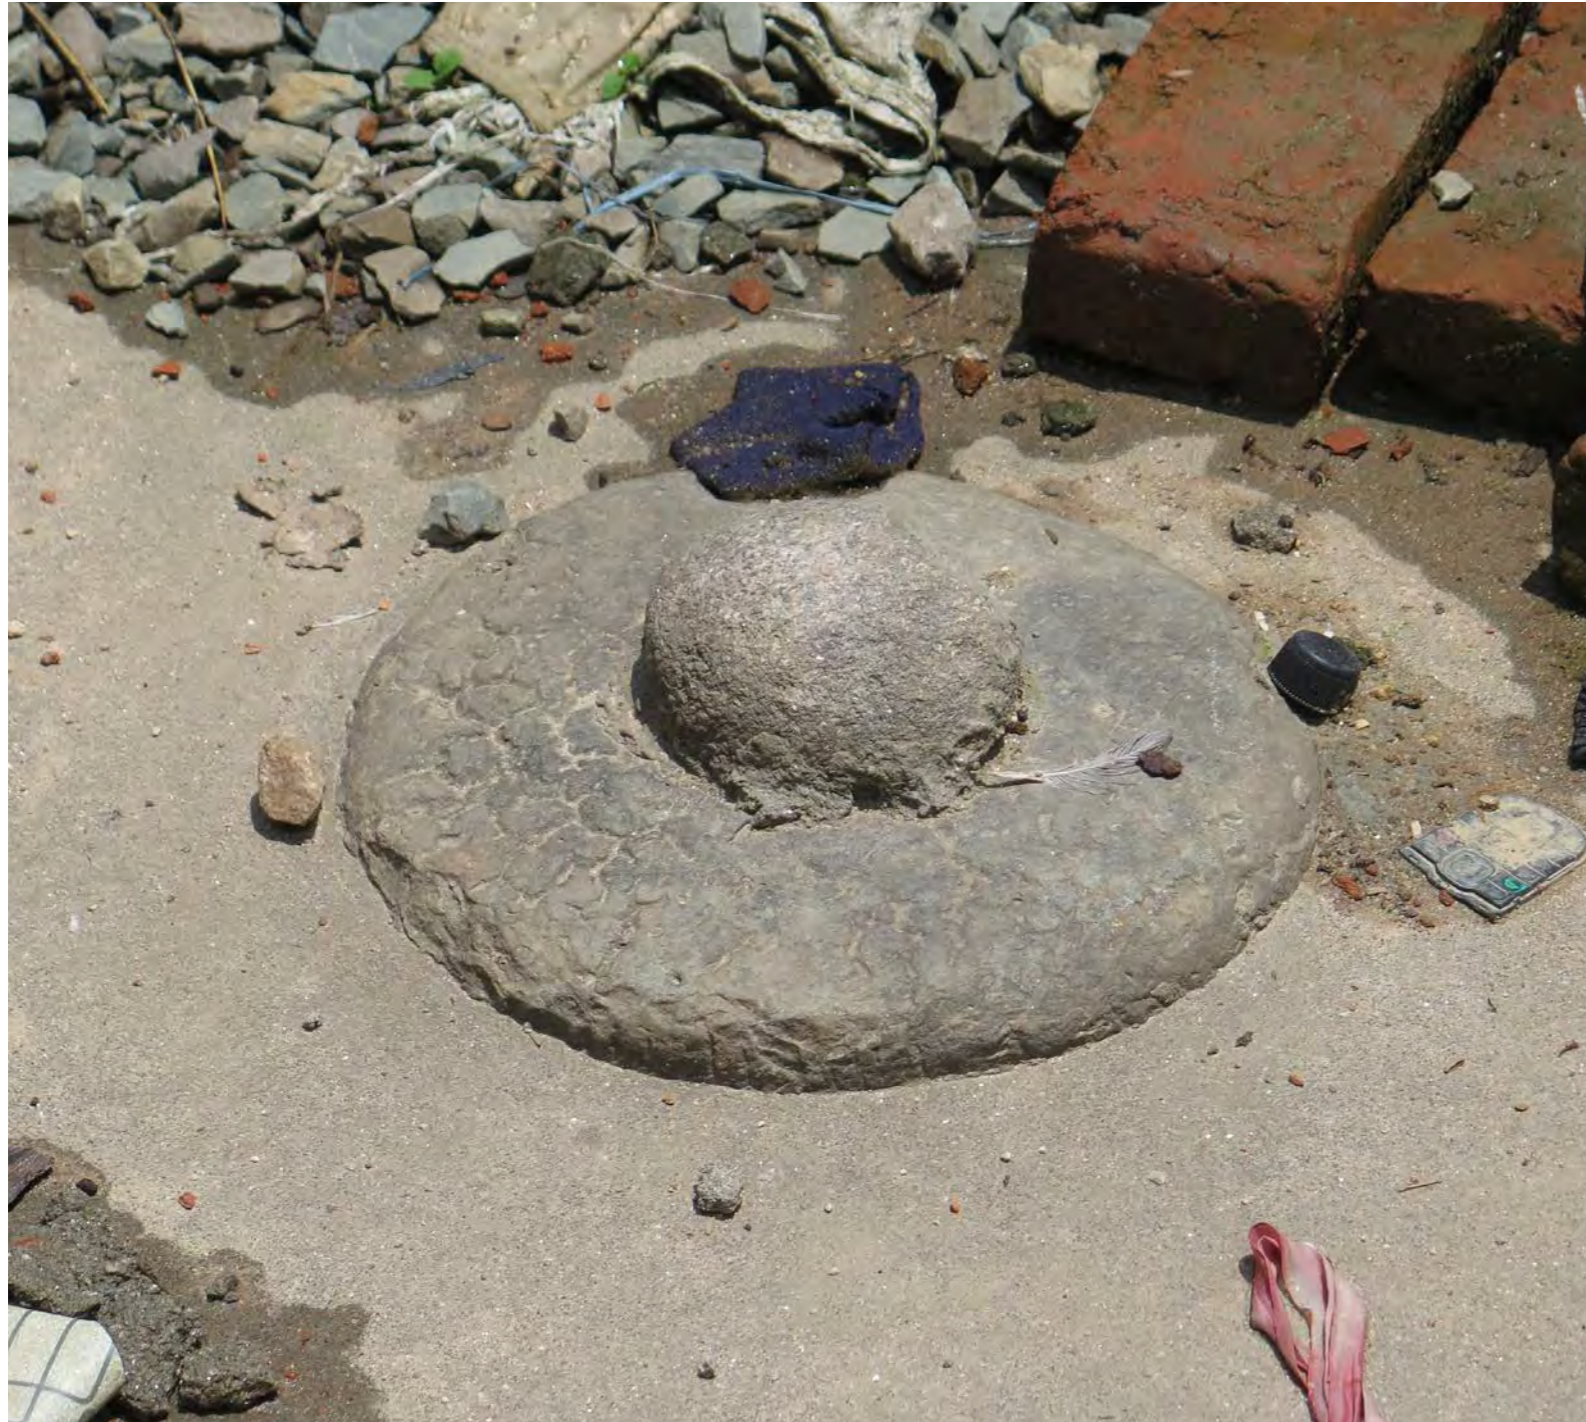
NUMBER	NAME	DATE A.D.	TPOLOGY	GENERAL DESCRIPTION	PROBLEMS DESCRIPTION	DANGER/ DESTROY
E-13			Open Shrine	2 Stone sculpture on wall and shiva linga type image in the ground	No visible damage

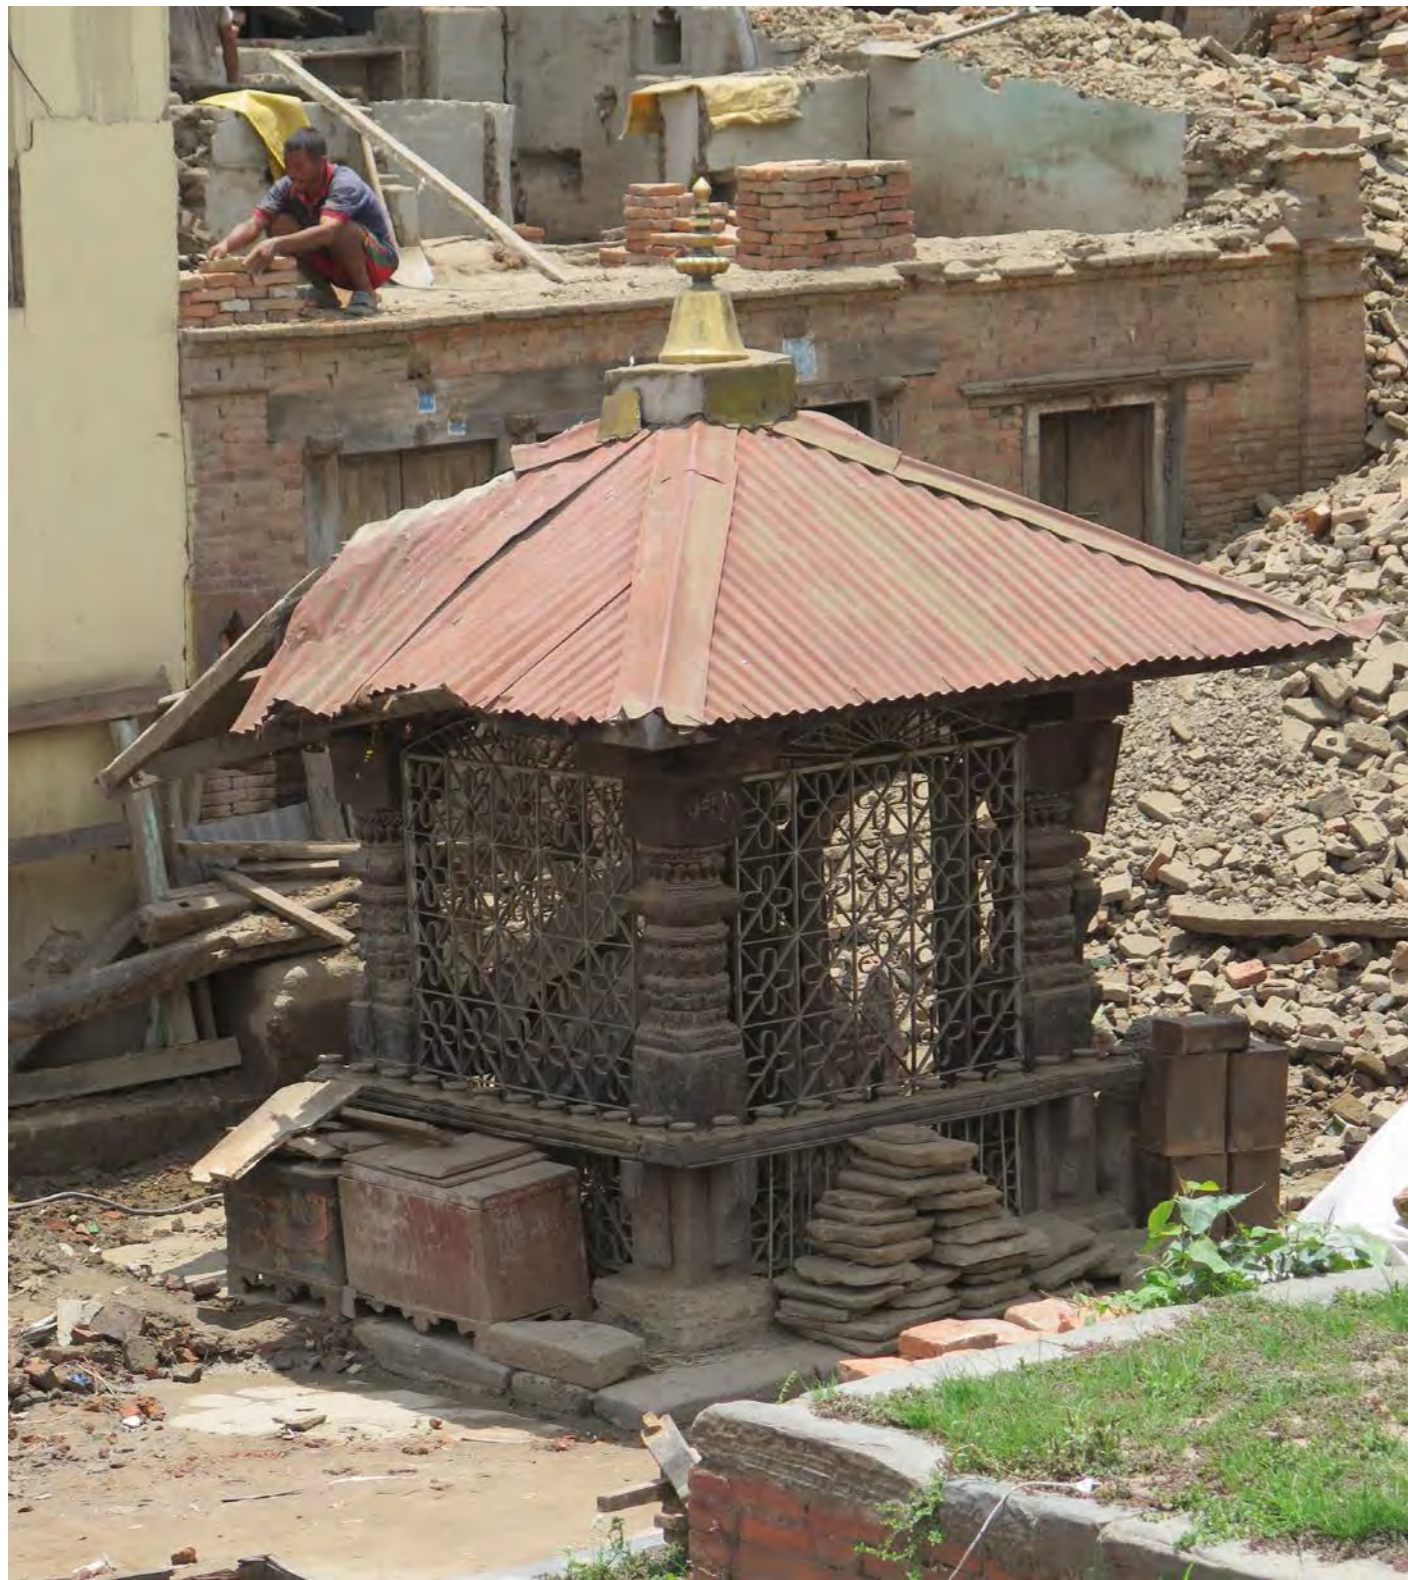
NUMBER	NAME	DATE A.D.	TYPOLOGY	GENERAL DESCRIPTION	PROBLEMS DESCRIPTION	DANGER/ DESTROY
E-19	Aajima Temple		Temple	Single tiered temple with CGI roofing	Roof damaged at south west corner. Temple bounded by iron channels. Base of Pinnacle damaged.

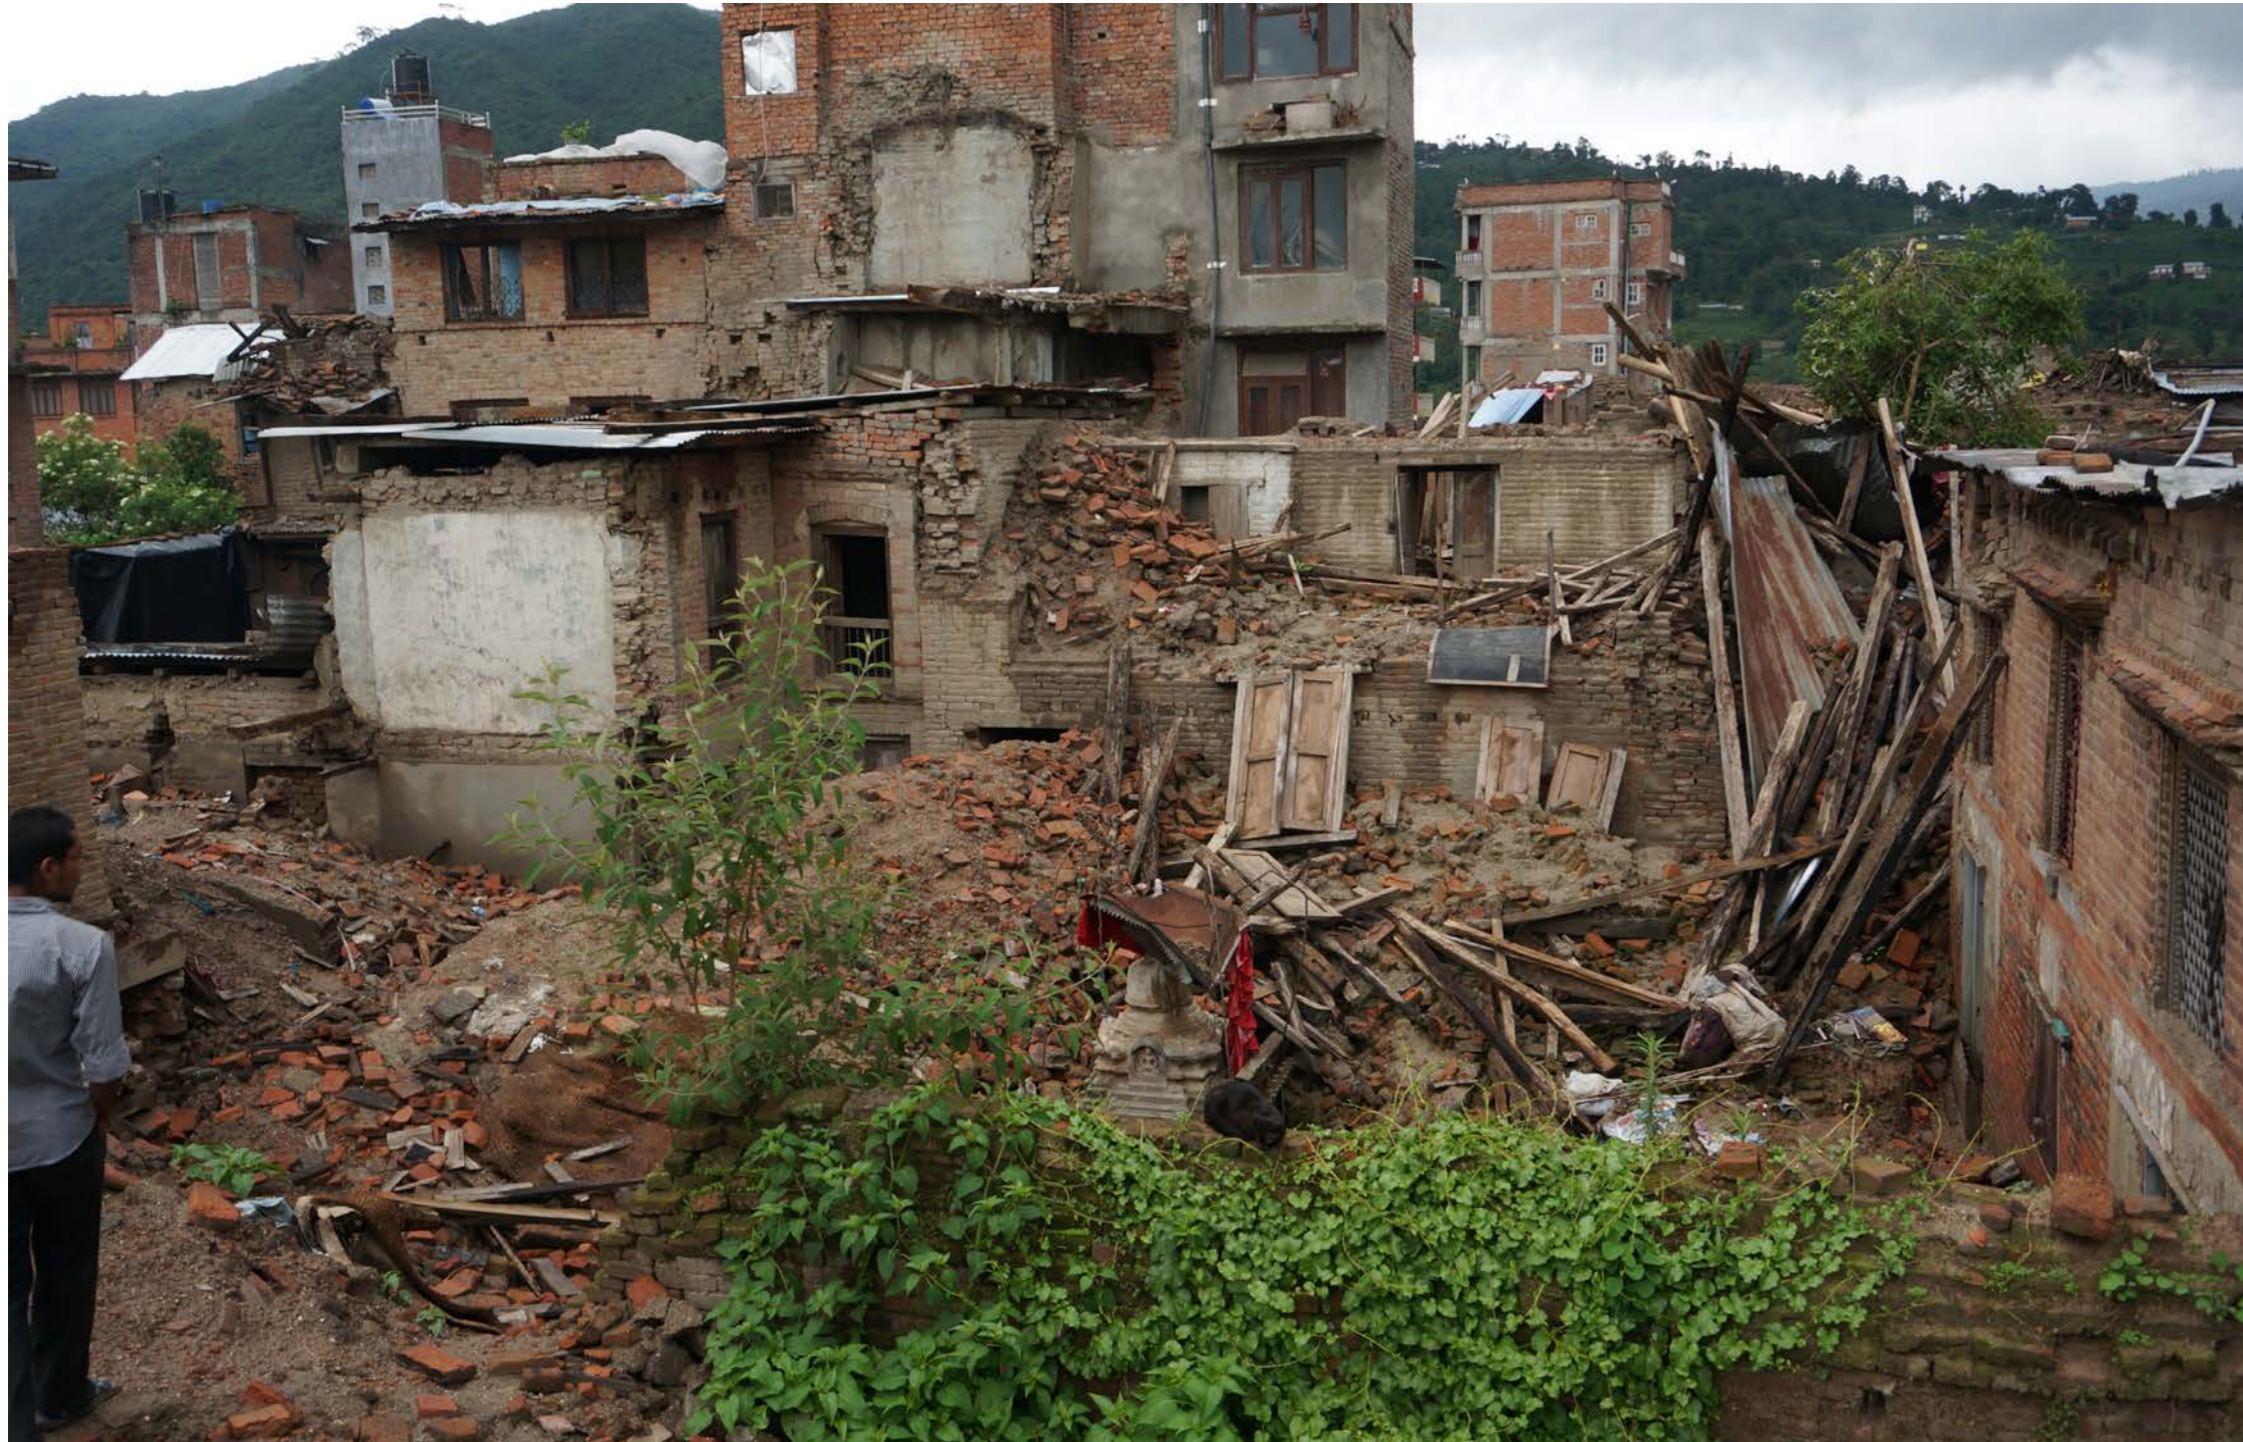
NUMBER	NAME	ESTABLISHED DATE (A.D.)	TYPOLOGY	GENERAL DESCRIPTION	PROBLEMS DESCRIPTION	DANGER/ DESTROY
F-02			Dyo Chen	G+4 Uncooked and cooked brick structure Pagoda style on upper roof	3 floors collapsed.

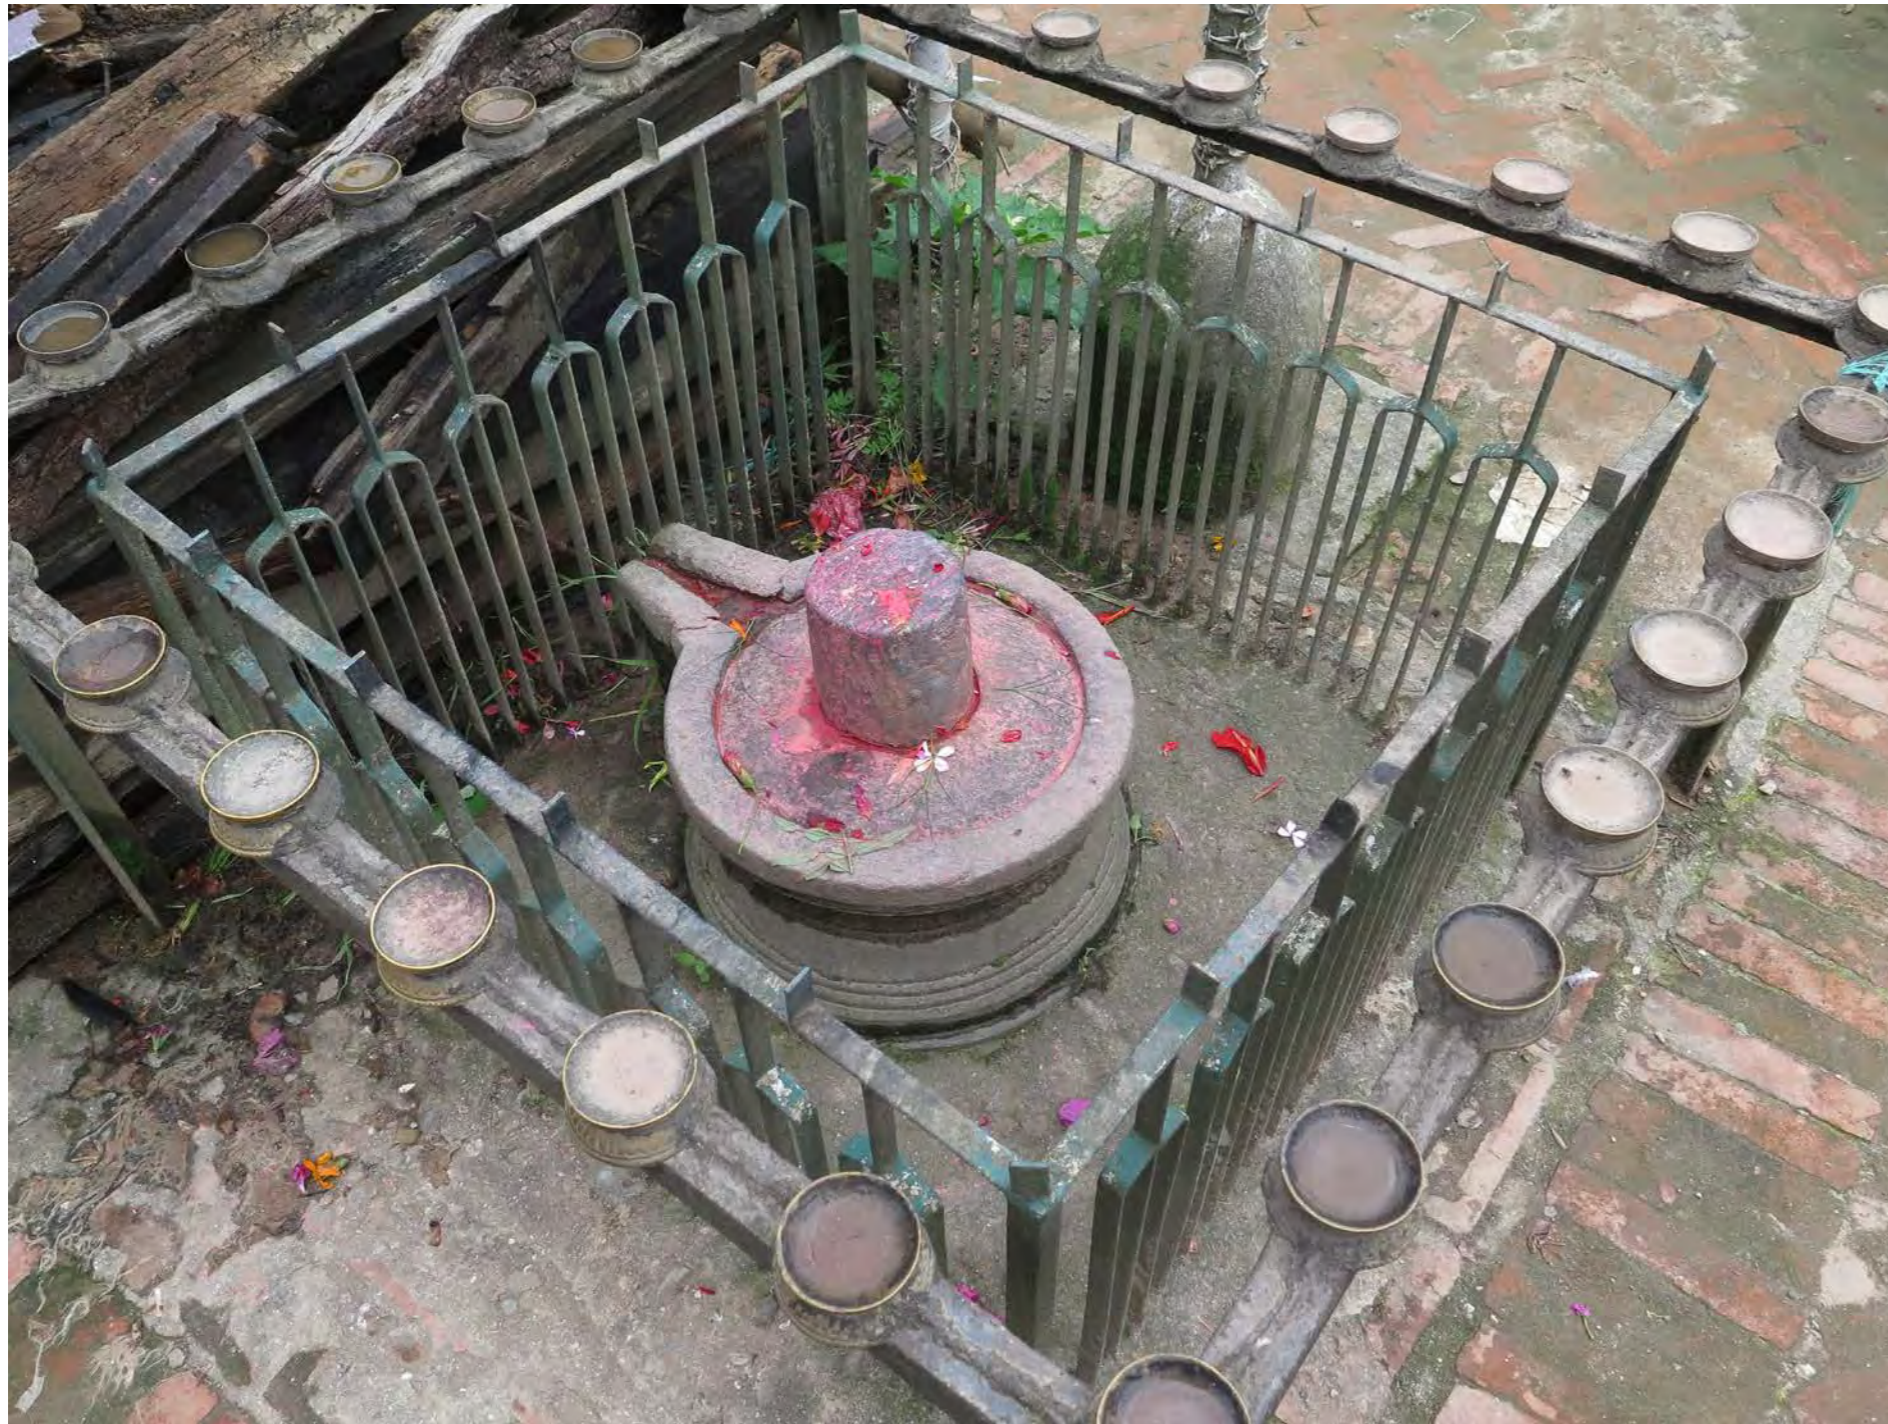
NUMBER	NAME	DATE A.D.	TPOLOGY	GENERAL DESCRIPTION	PROBLEMS DESCRIPTION	DANGER/ DESTROY
I-11	Dhola Shiva Linga		Shiva Linga		In good condition. Surrounded by railing

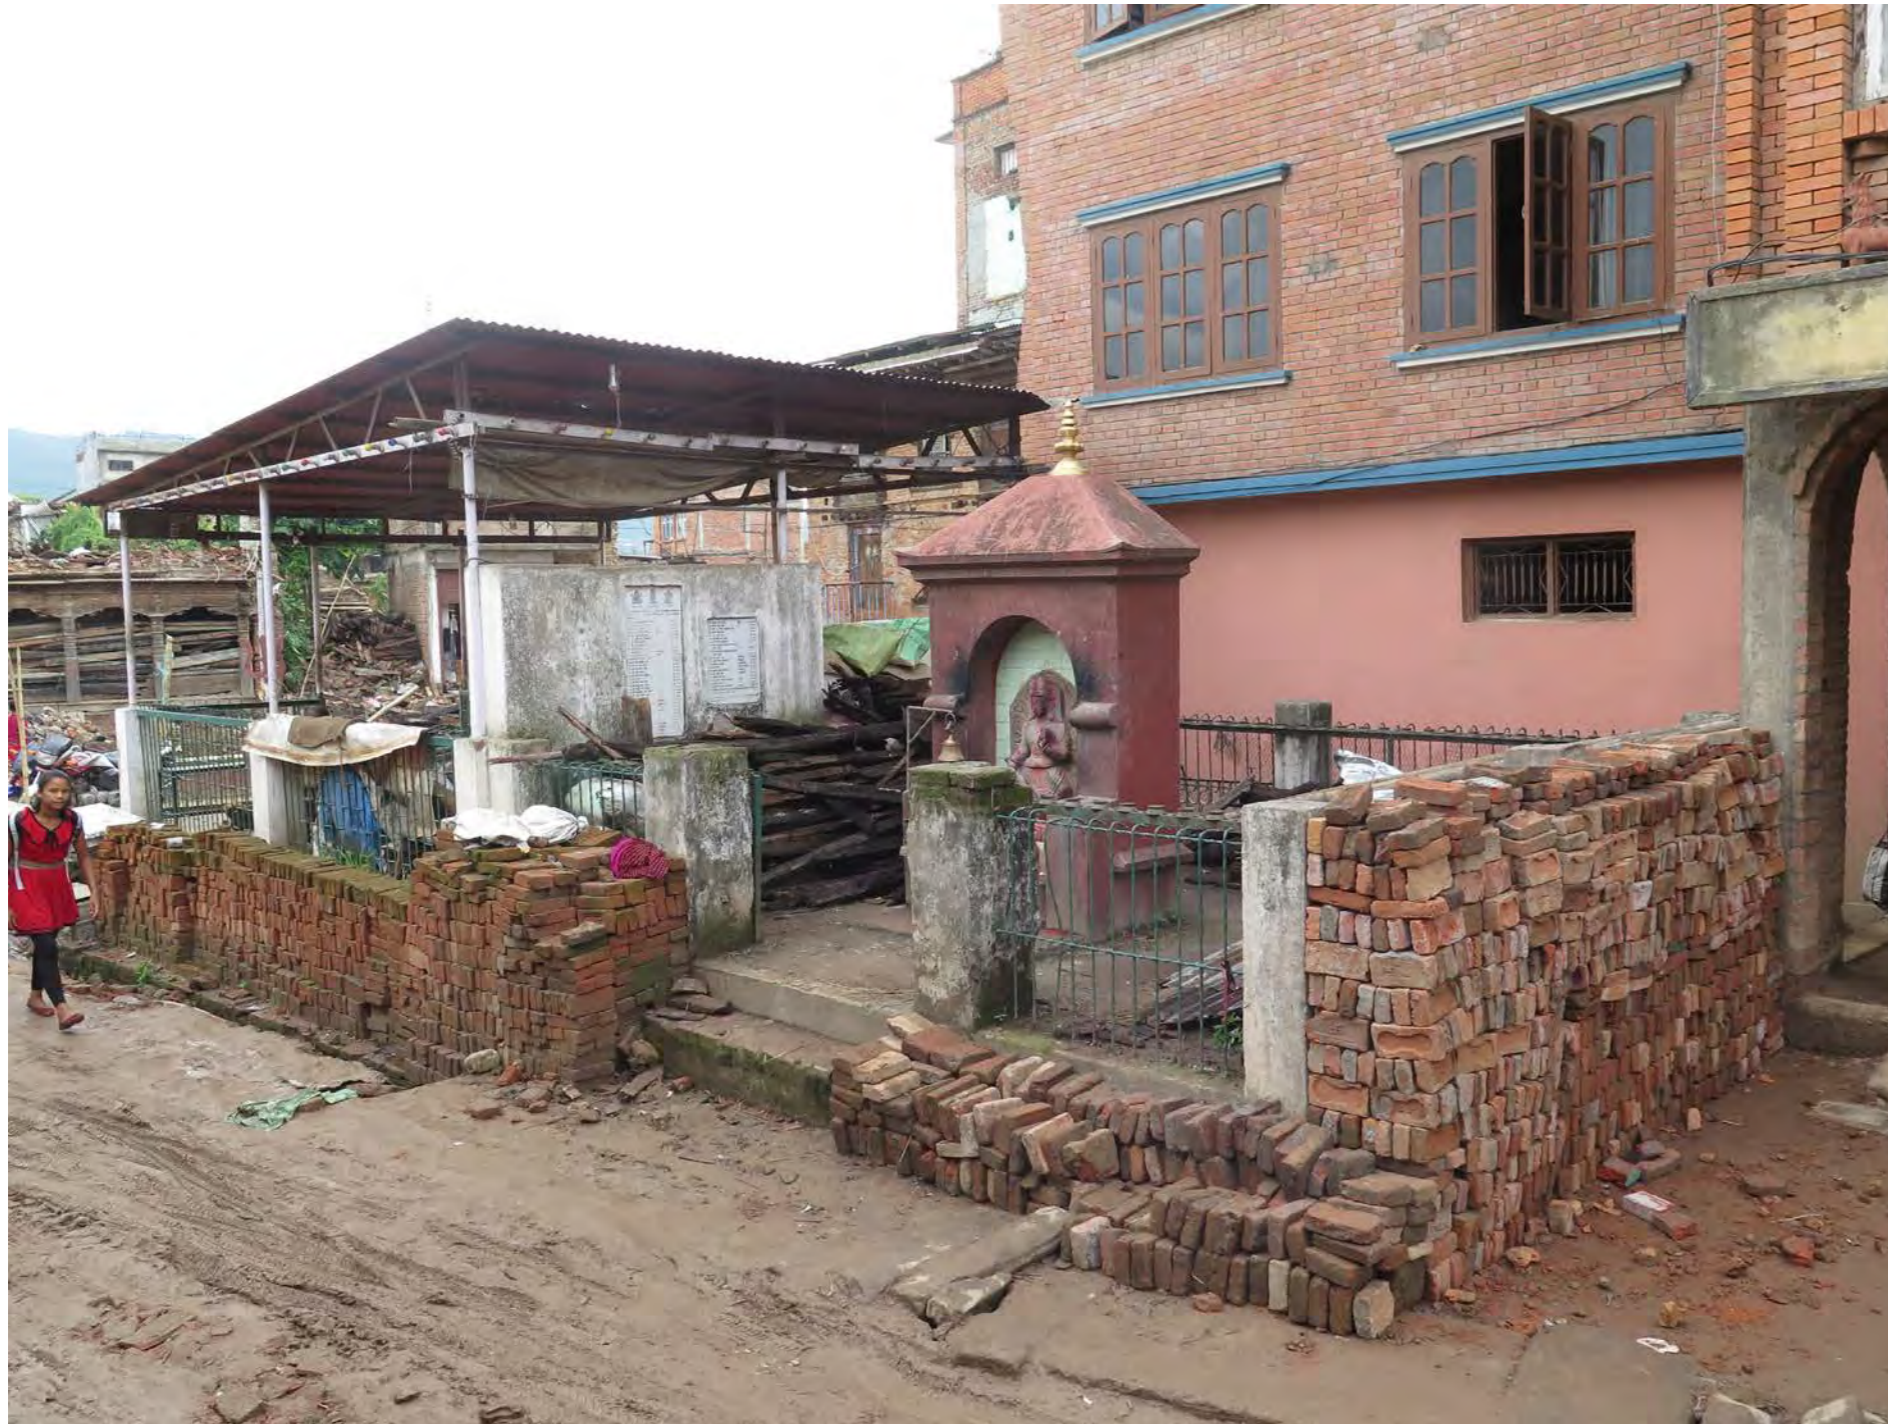
NUMBER	NAME	DATE A.D.	TPOLOGY	GENERAL DESCRIPTION	PROBLEMS DESCRIPTION	DANGER/ DESTROY
I-13	Dhola Bhimsen		Open Shrine		No visible damage.

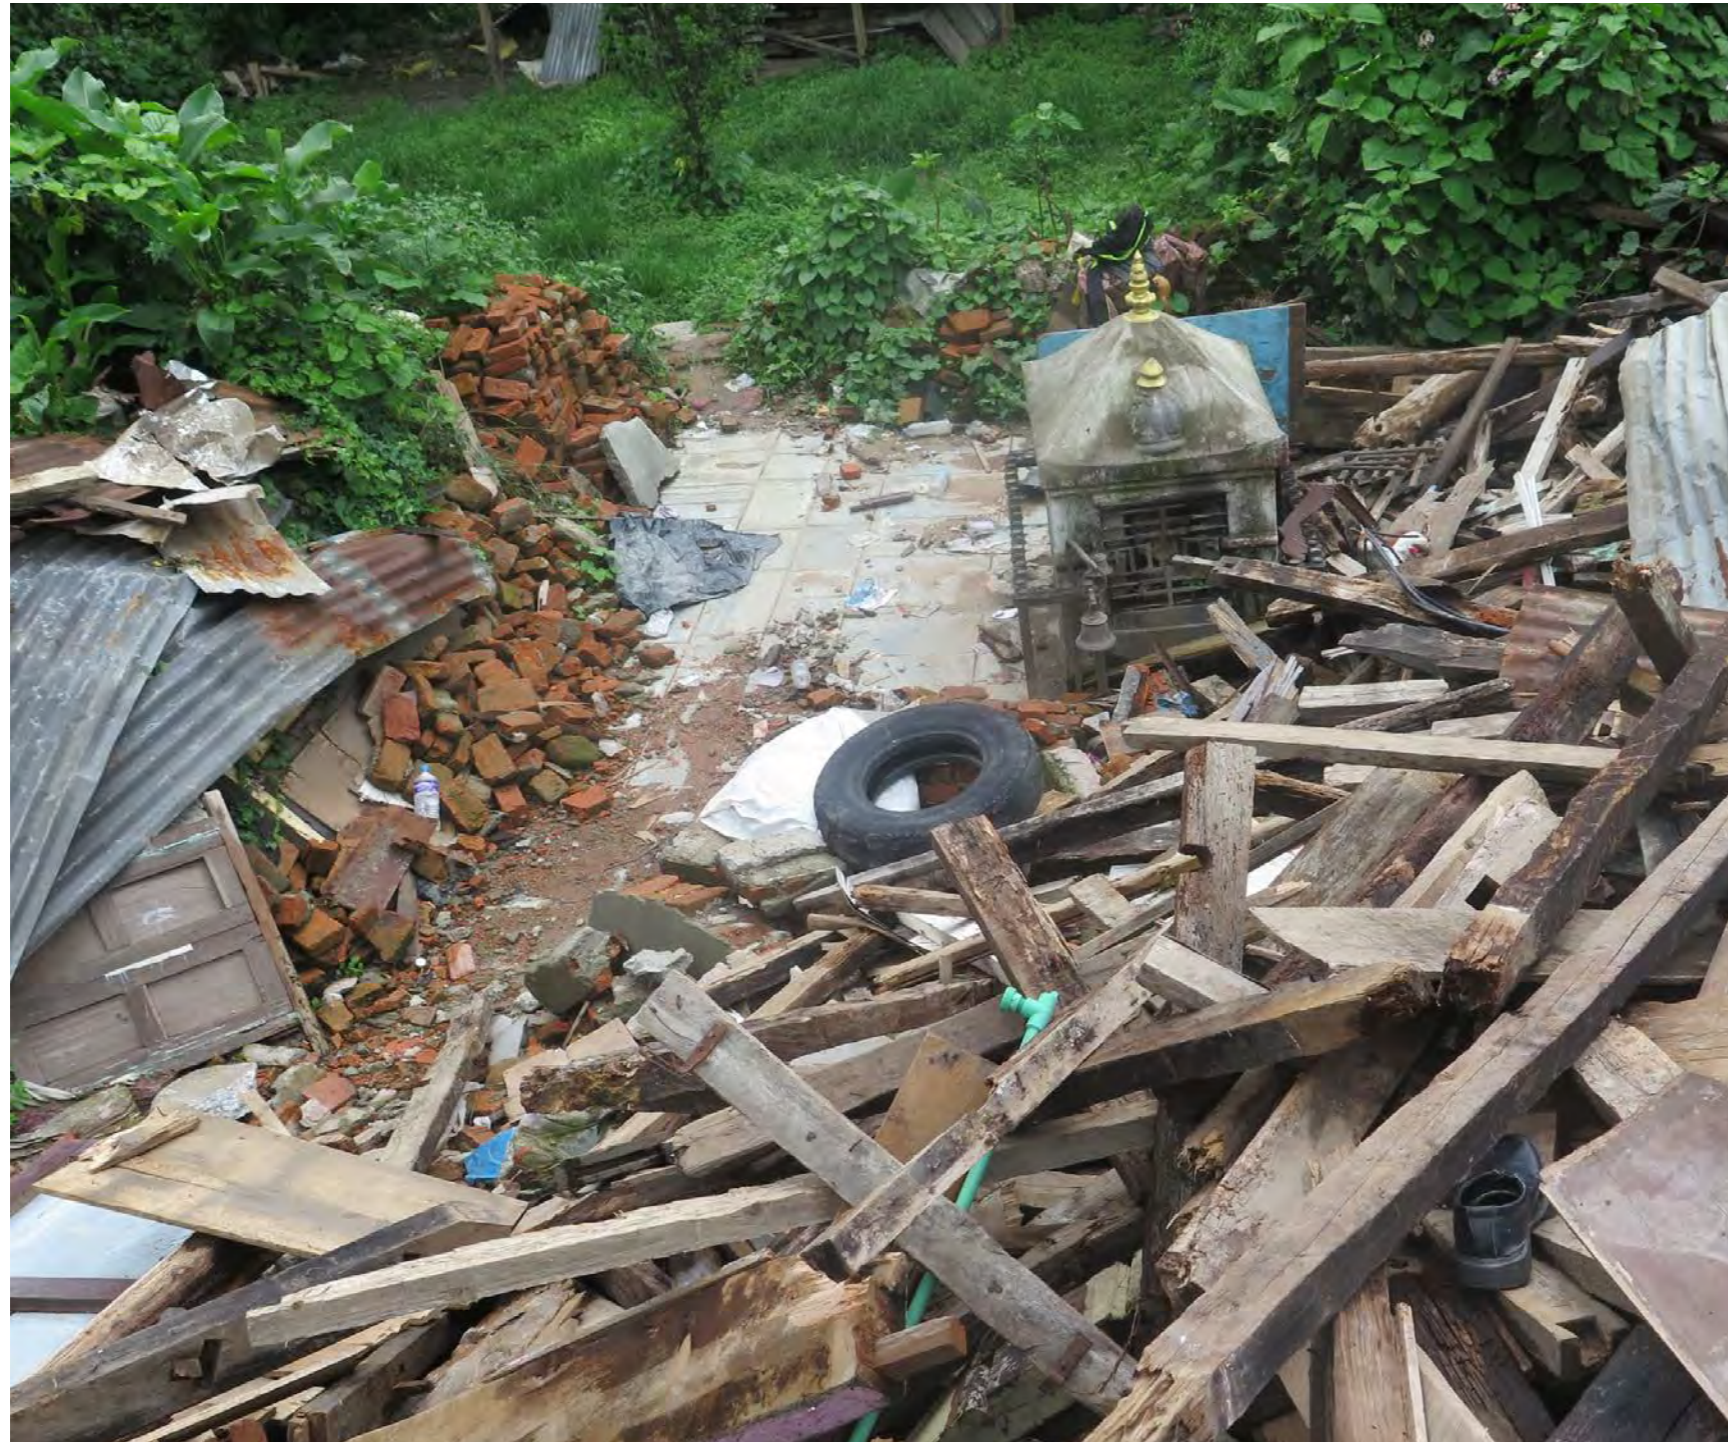
NUMBER	NAME	DATE A.D.	TPOLOGY	GENERAL DESCRIPTION	PROBLEMS DESCRIPTION	DANGER/ DESTROY
J-16	Narayan Shrine		Enclosed Shrine	Cement plastered	No visible damage

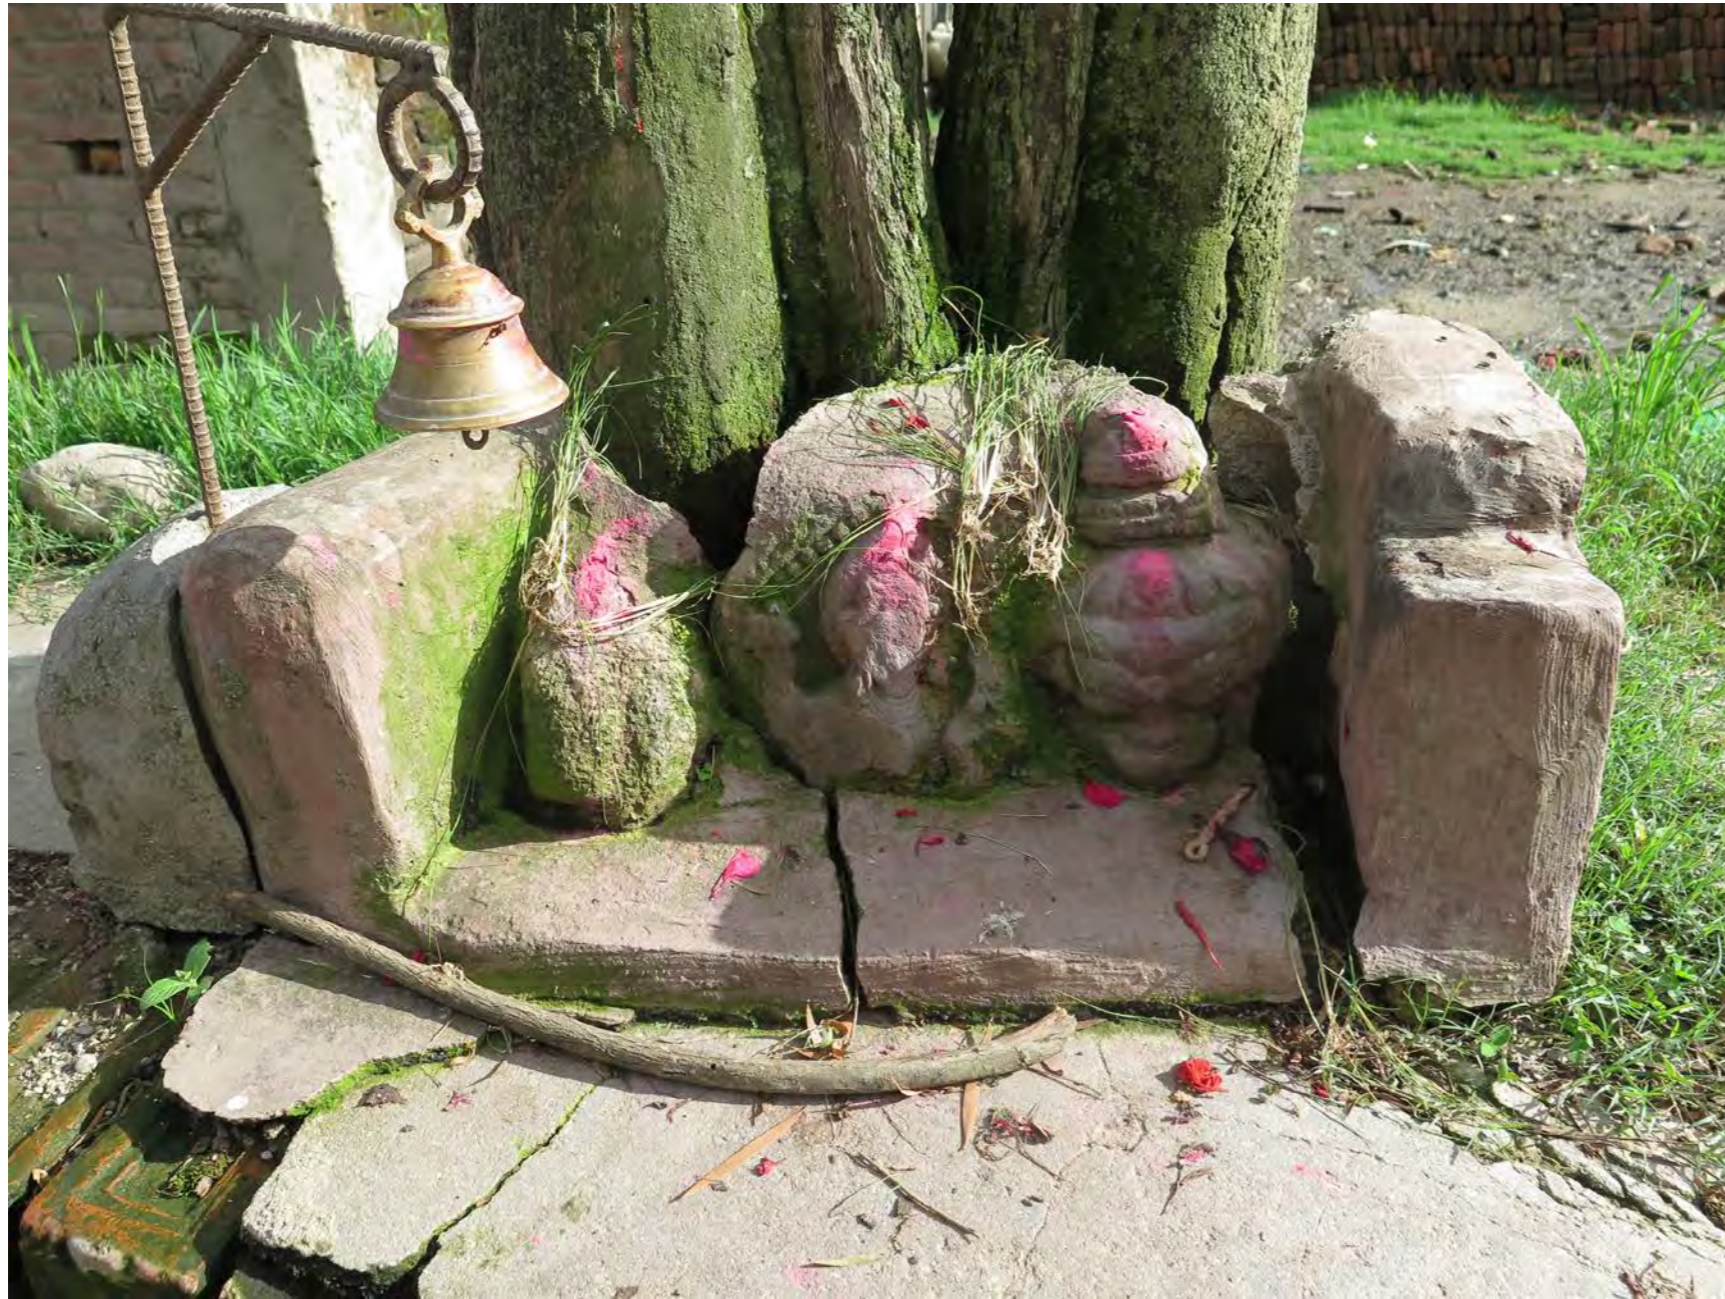
NUMBER	NAME	ESTABLISHED DATE (A.D.)	TYPOLOGY	GENERAL DESCRIPTION	PROBLEMS DESCRIPTION	DANGER/ DESTROY
J-20			Open Shrine	Shrine under roof	Base and side wall seperating

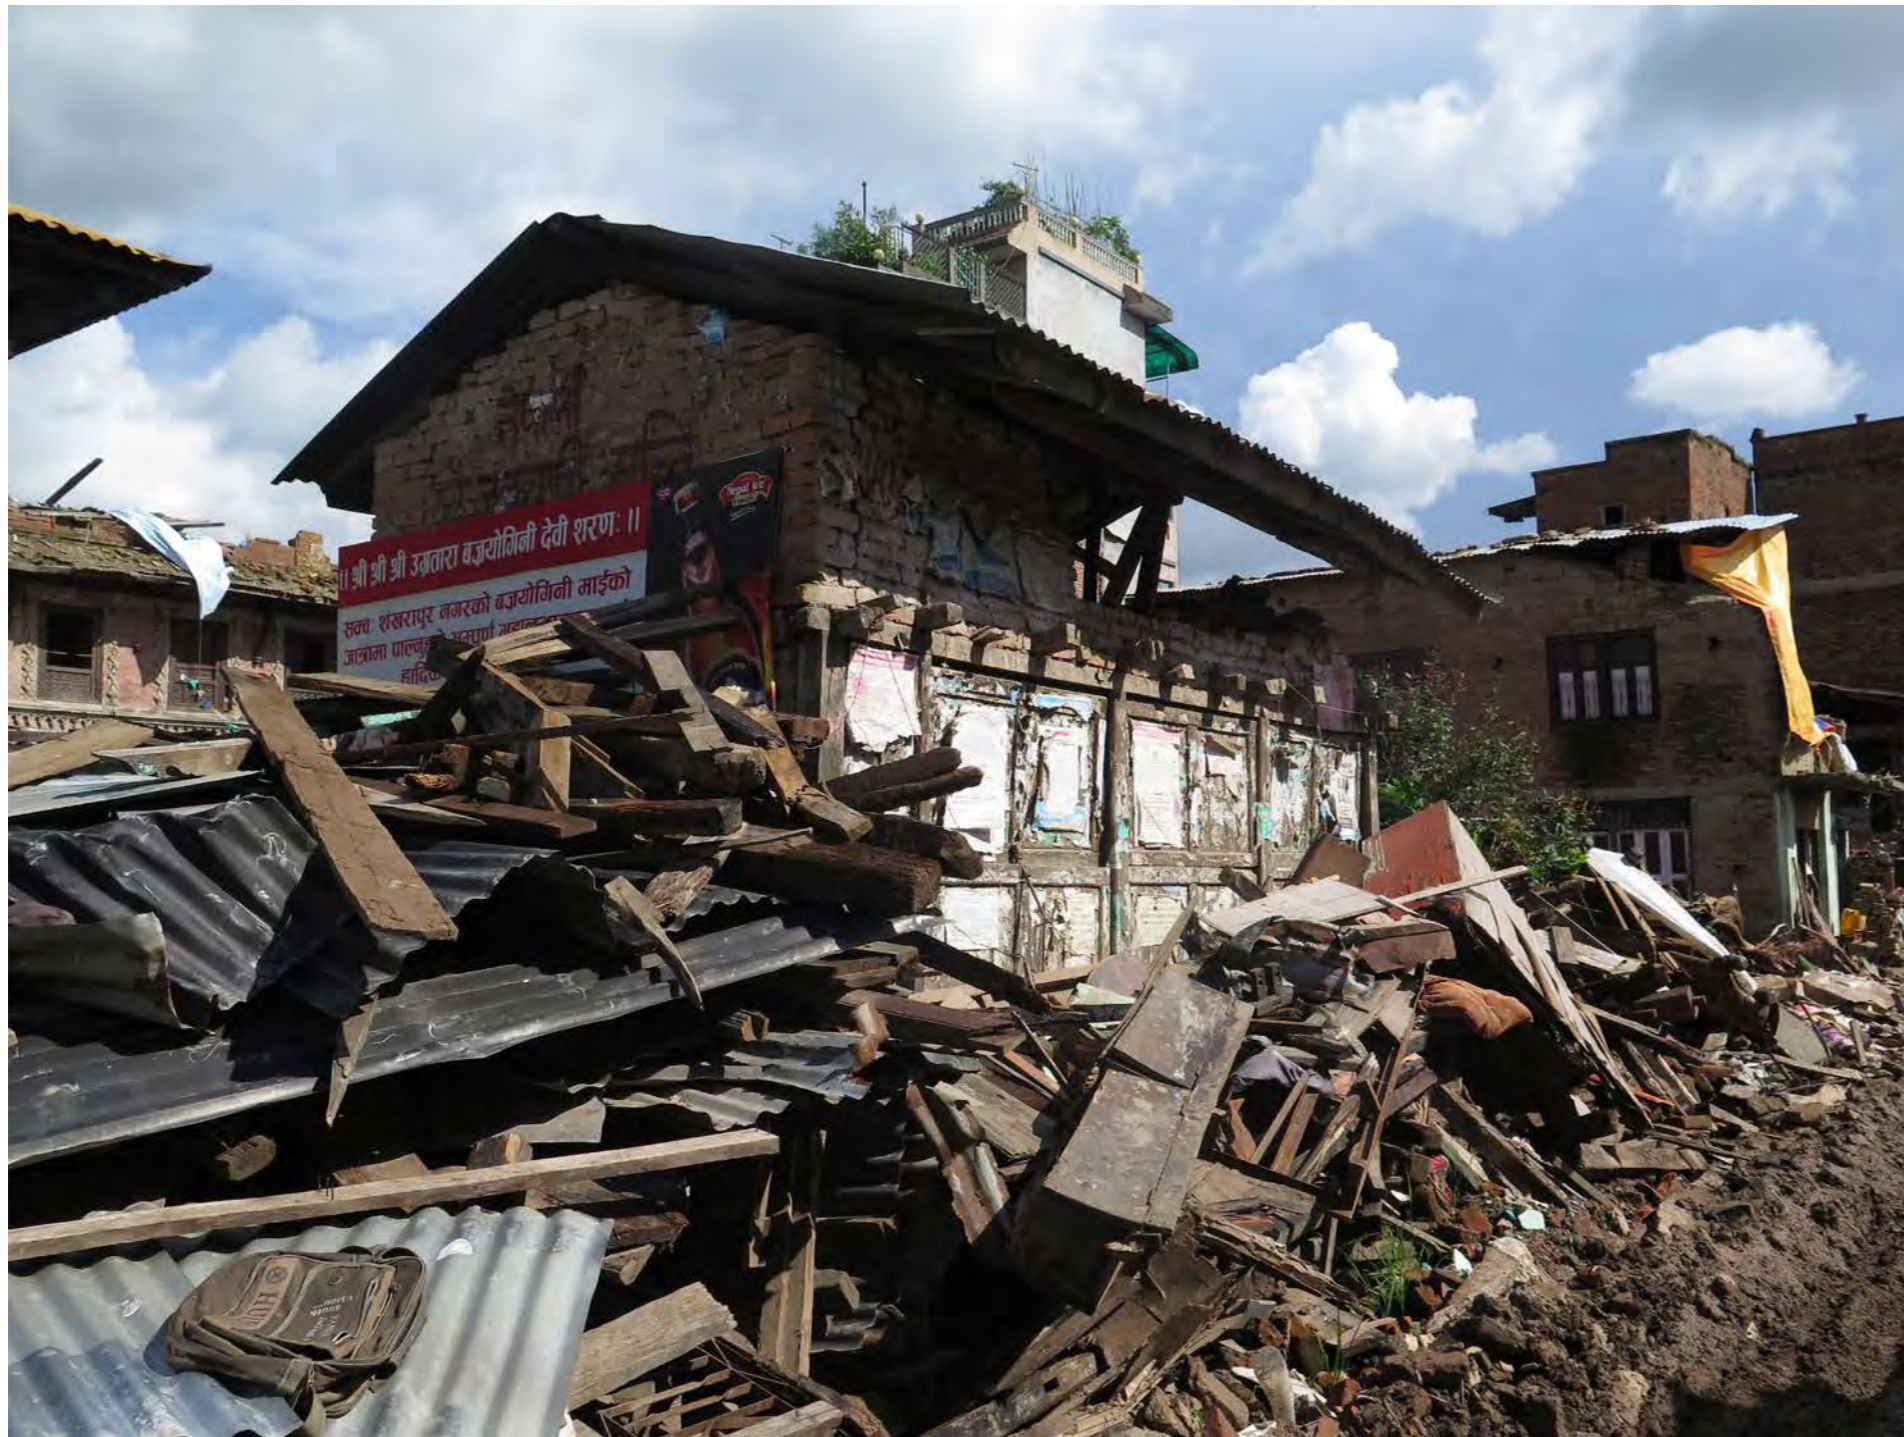
NUMBER	NAME	DATE A.D.	TPOLOGY	GENERAL DESCRIPTION	PROBLEMS DESCRIPTION	DANGER/ DESTROY	
J-06	Shop		Pati		Southern part fell down. Major cracks all over.
