2015 Earthquake Damage Mapping

Sankhu

October 2015

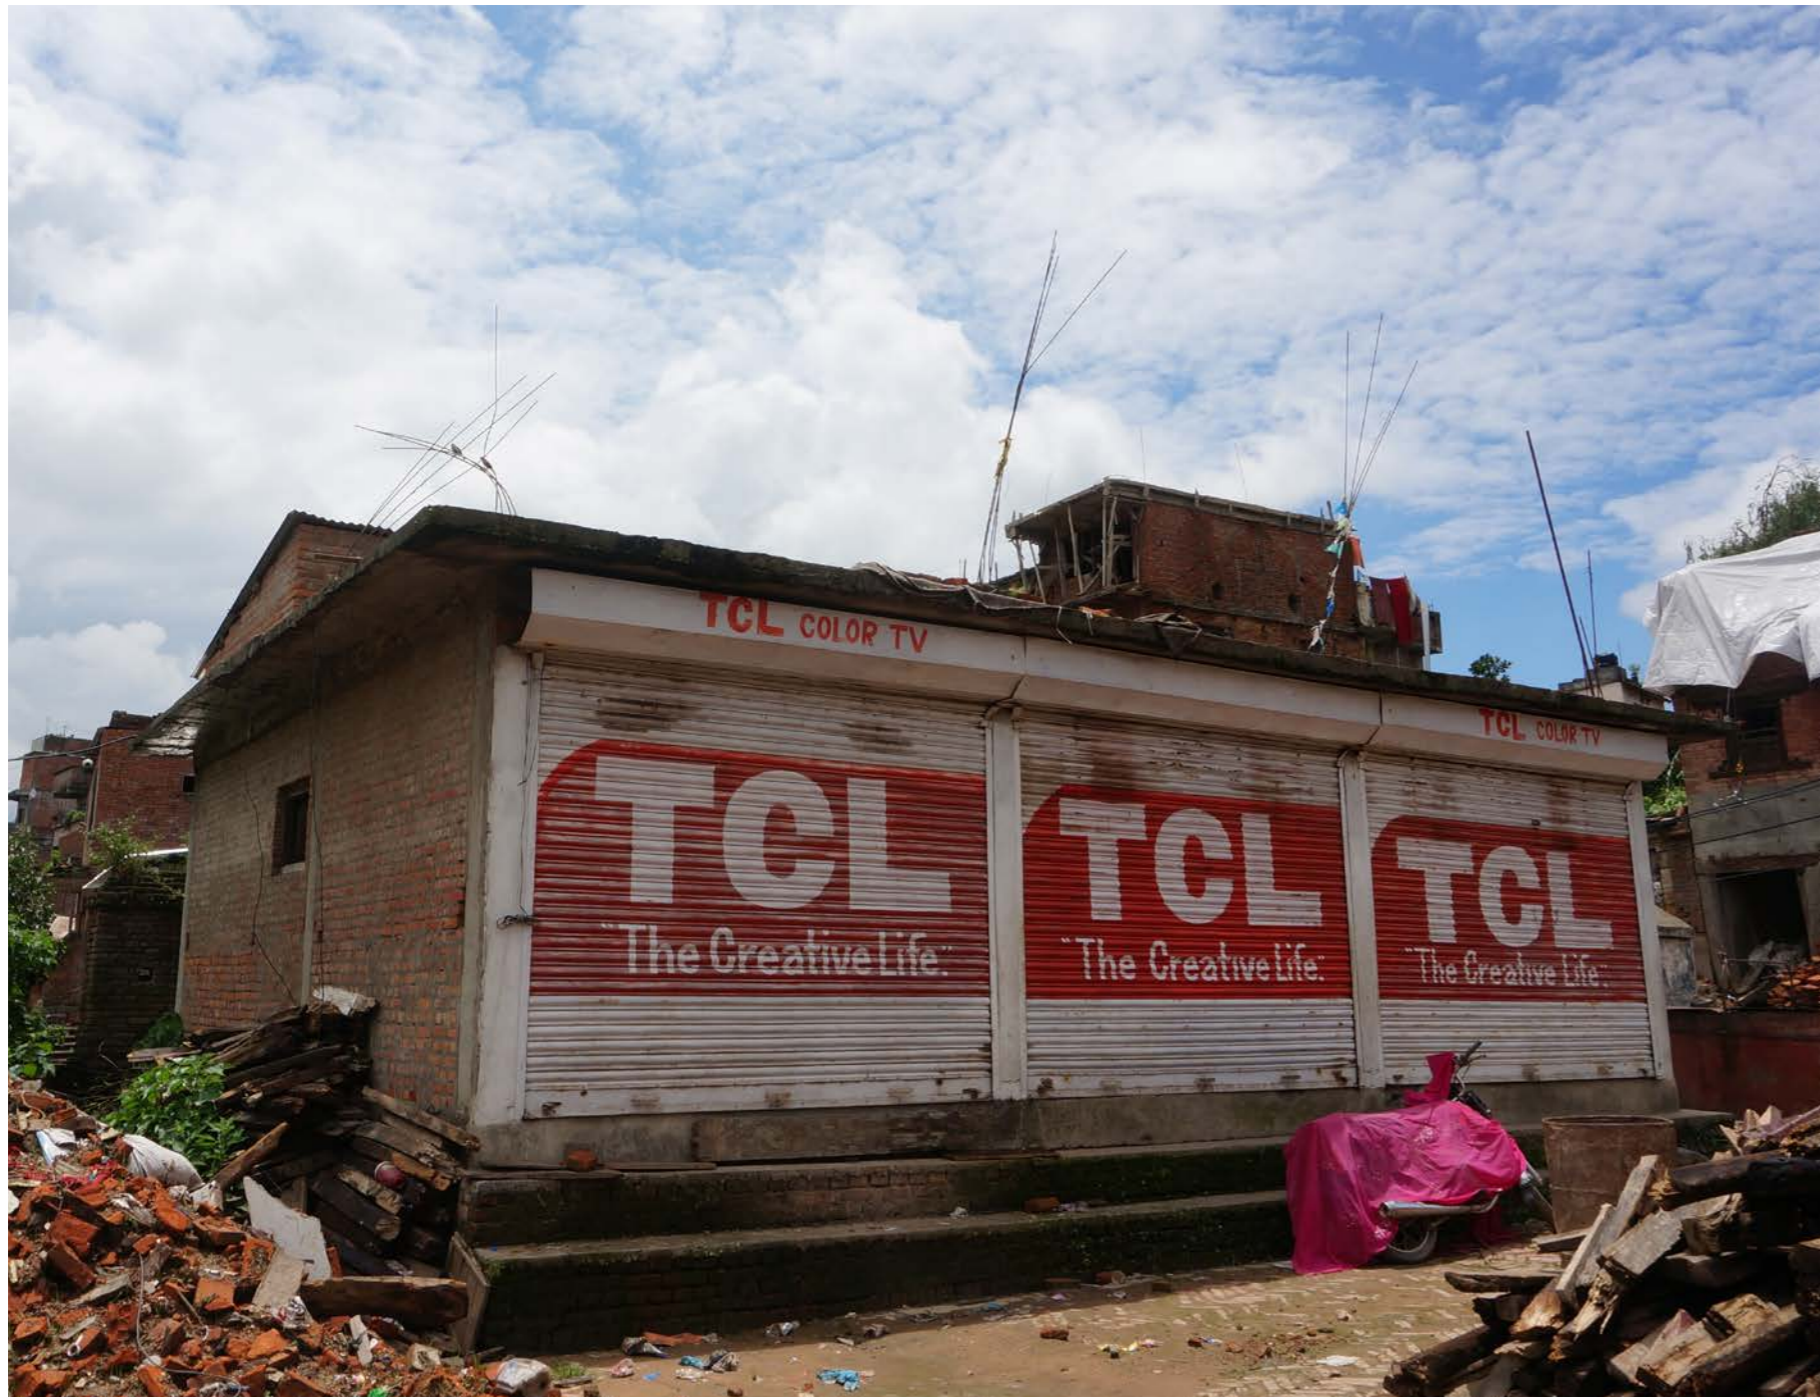
NUMBER	NAME	DATE A.D.	TPOLOGY	GENERAL DESCRIPTION	PROBLEMS DESCRIPTION	DANGER/ DESTROY	
K-03	Bhairav Chandi Devi Sattal		Sattal	Single Storey concrete structure	No visible damages Slight problem of rising damp

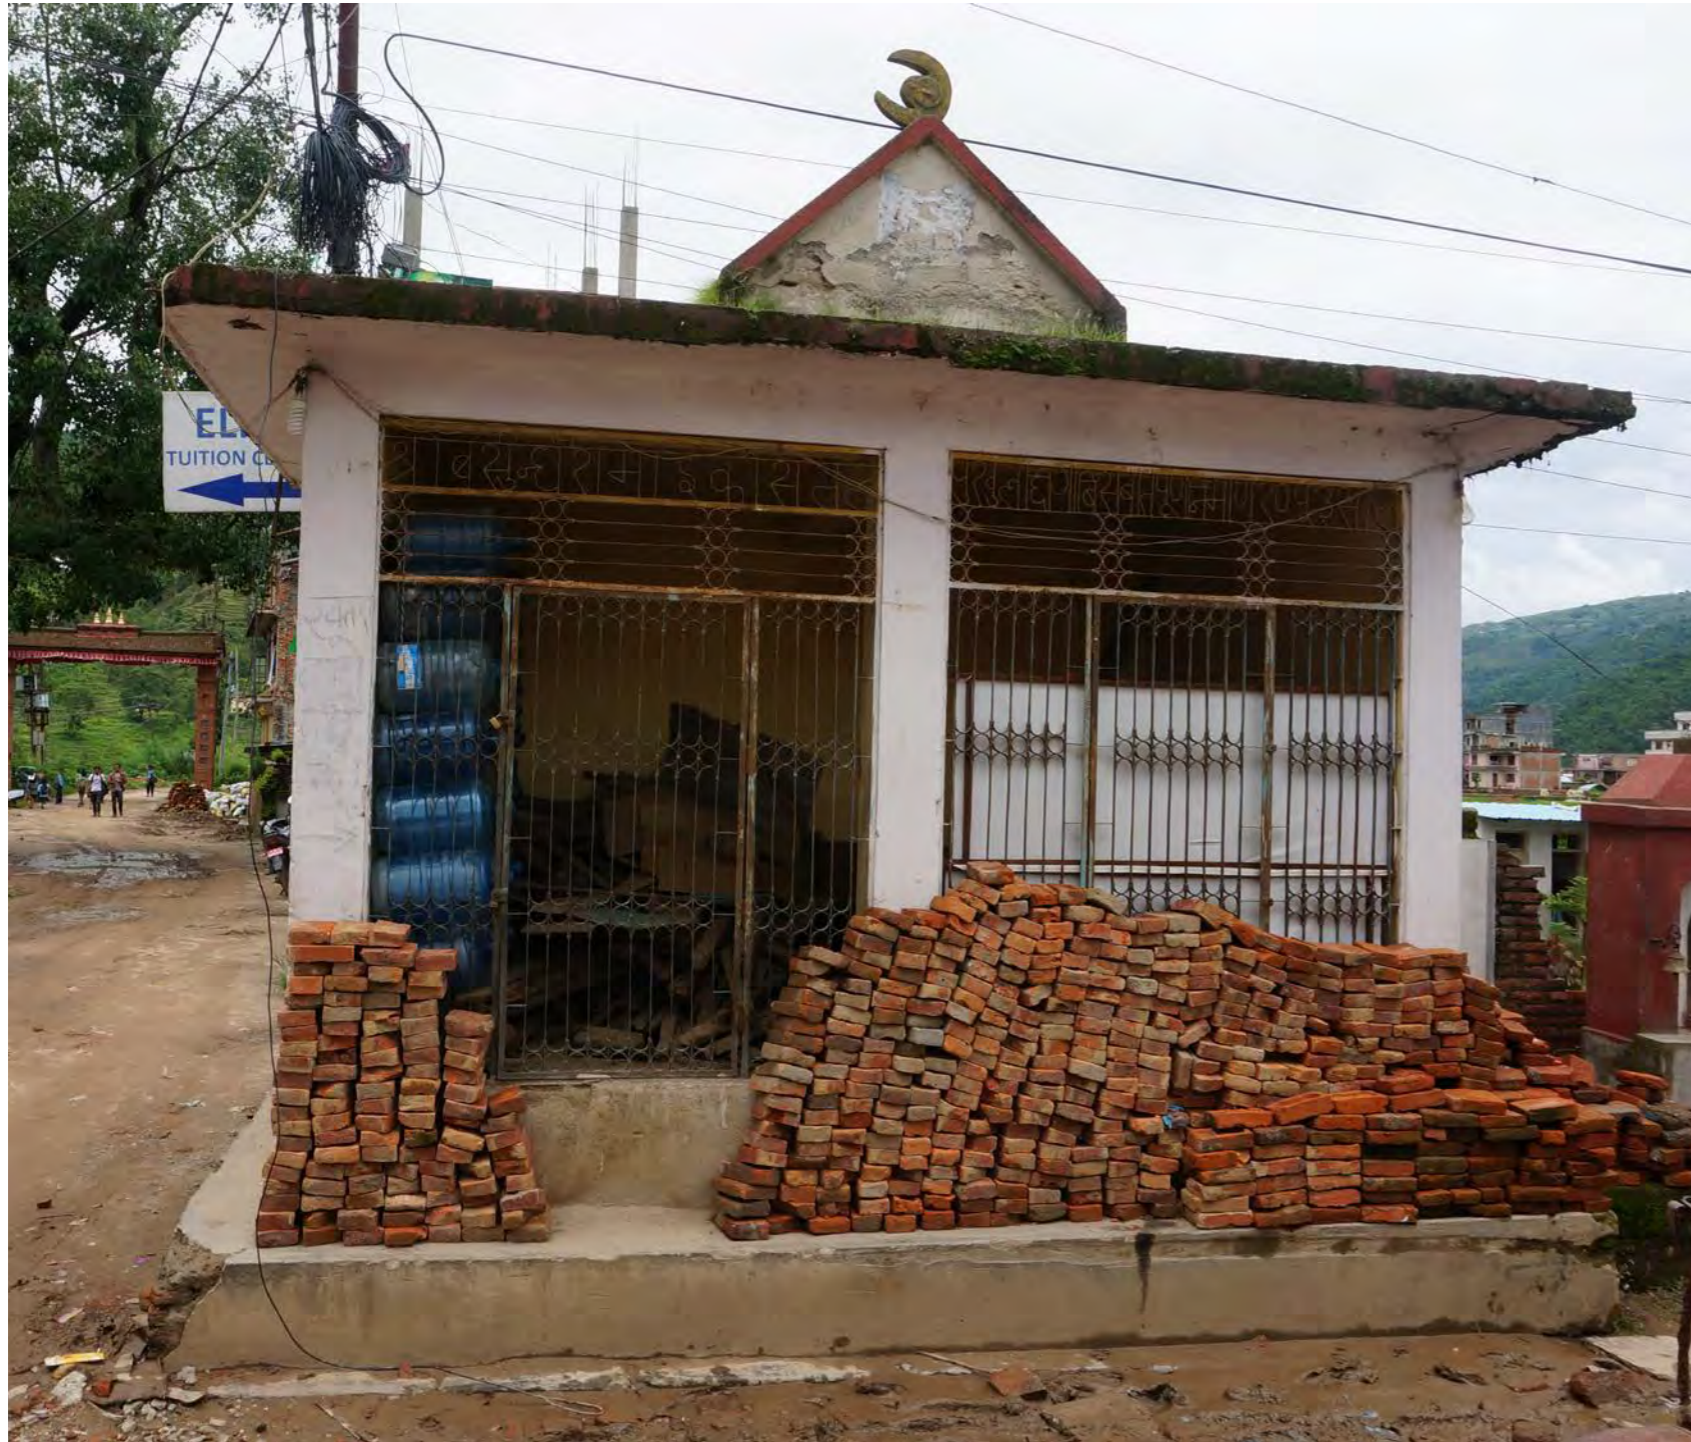
NUMBER	NAME	DATE A.D.	TYOLOGY	GENERAL DESCRIPTION	PROBLEMS DESCRIPTION	DANGER/ DESTROY
H-02	Basundhara Falcha		Pati	Brick masonry with concrete slab	Horizontal cracks on upper wall at E-facade Needs repair

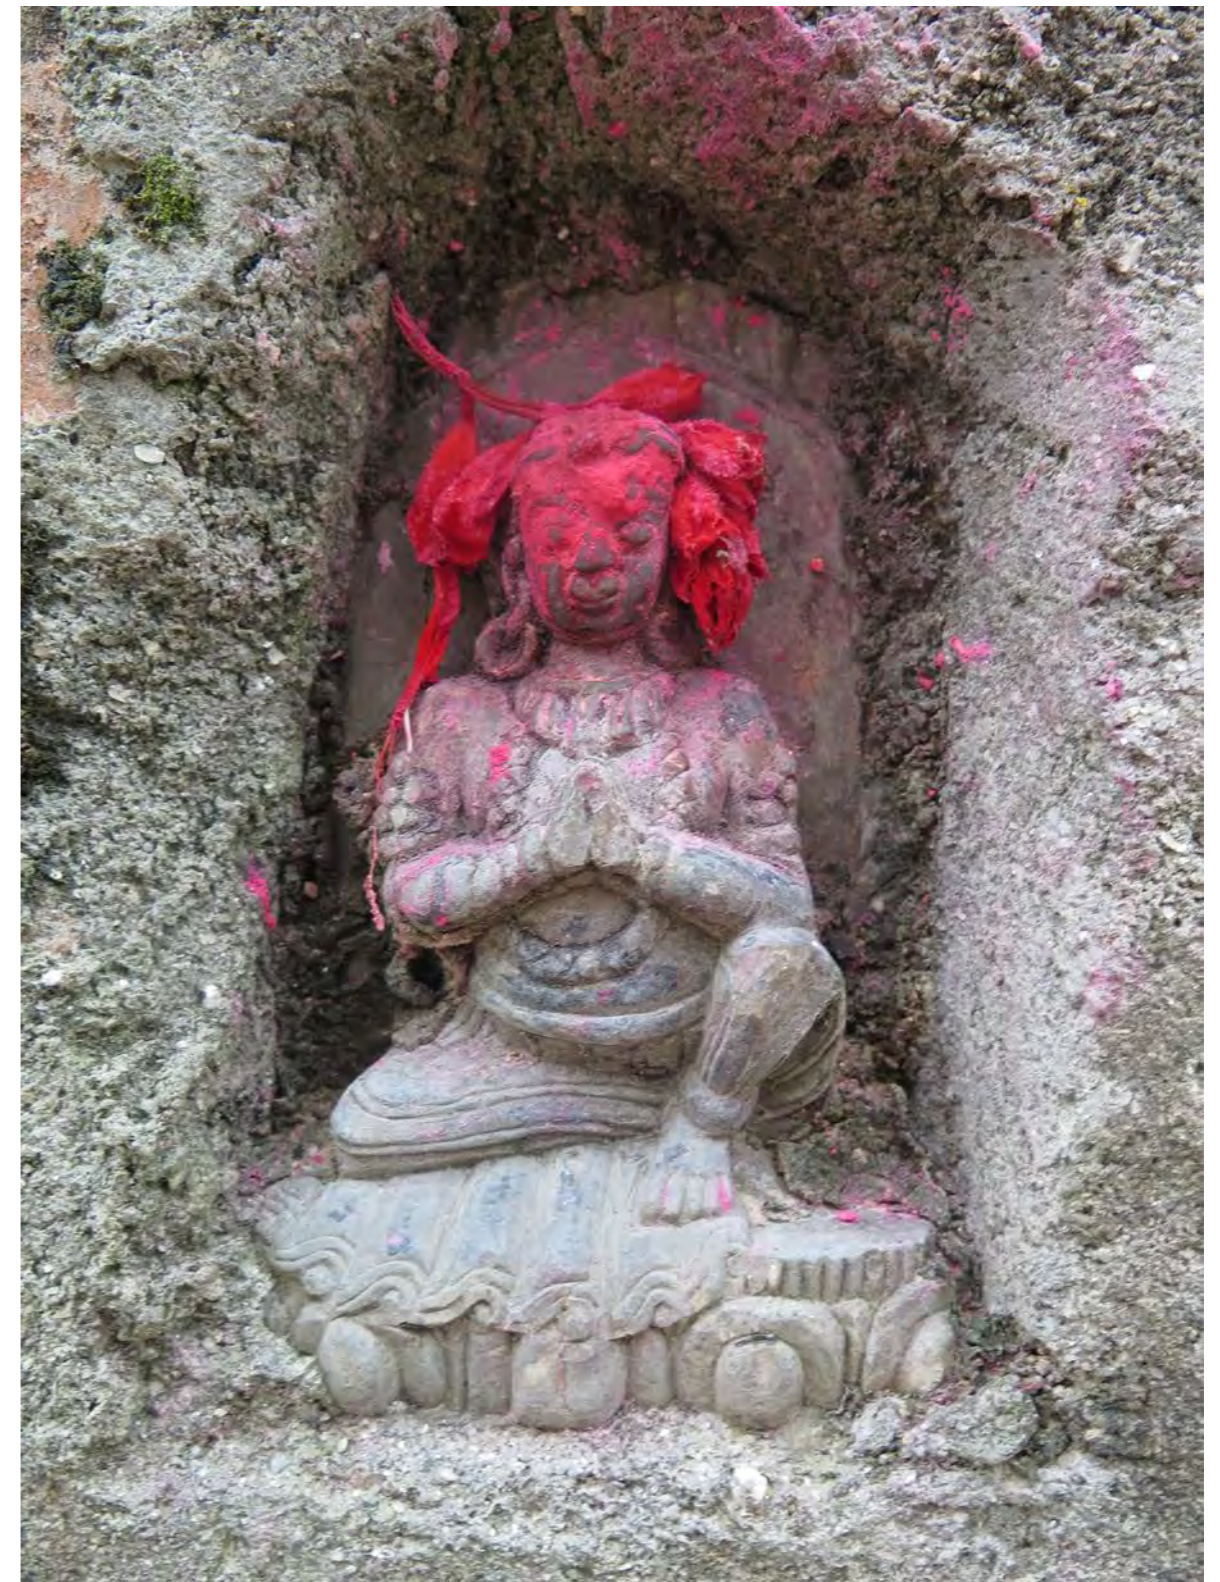
NUMBER	NAME	DATE A.D.	TPOLOGY	GENERAL DESCRIPTION	PROBLEMS DESCRIPTION	DANGER/ DESTROY
I-01			Tap		In degradated condition

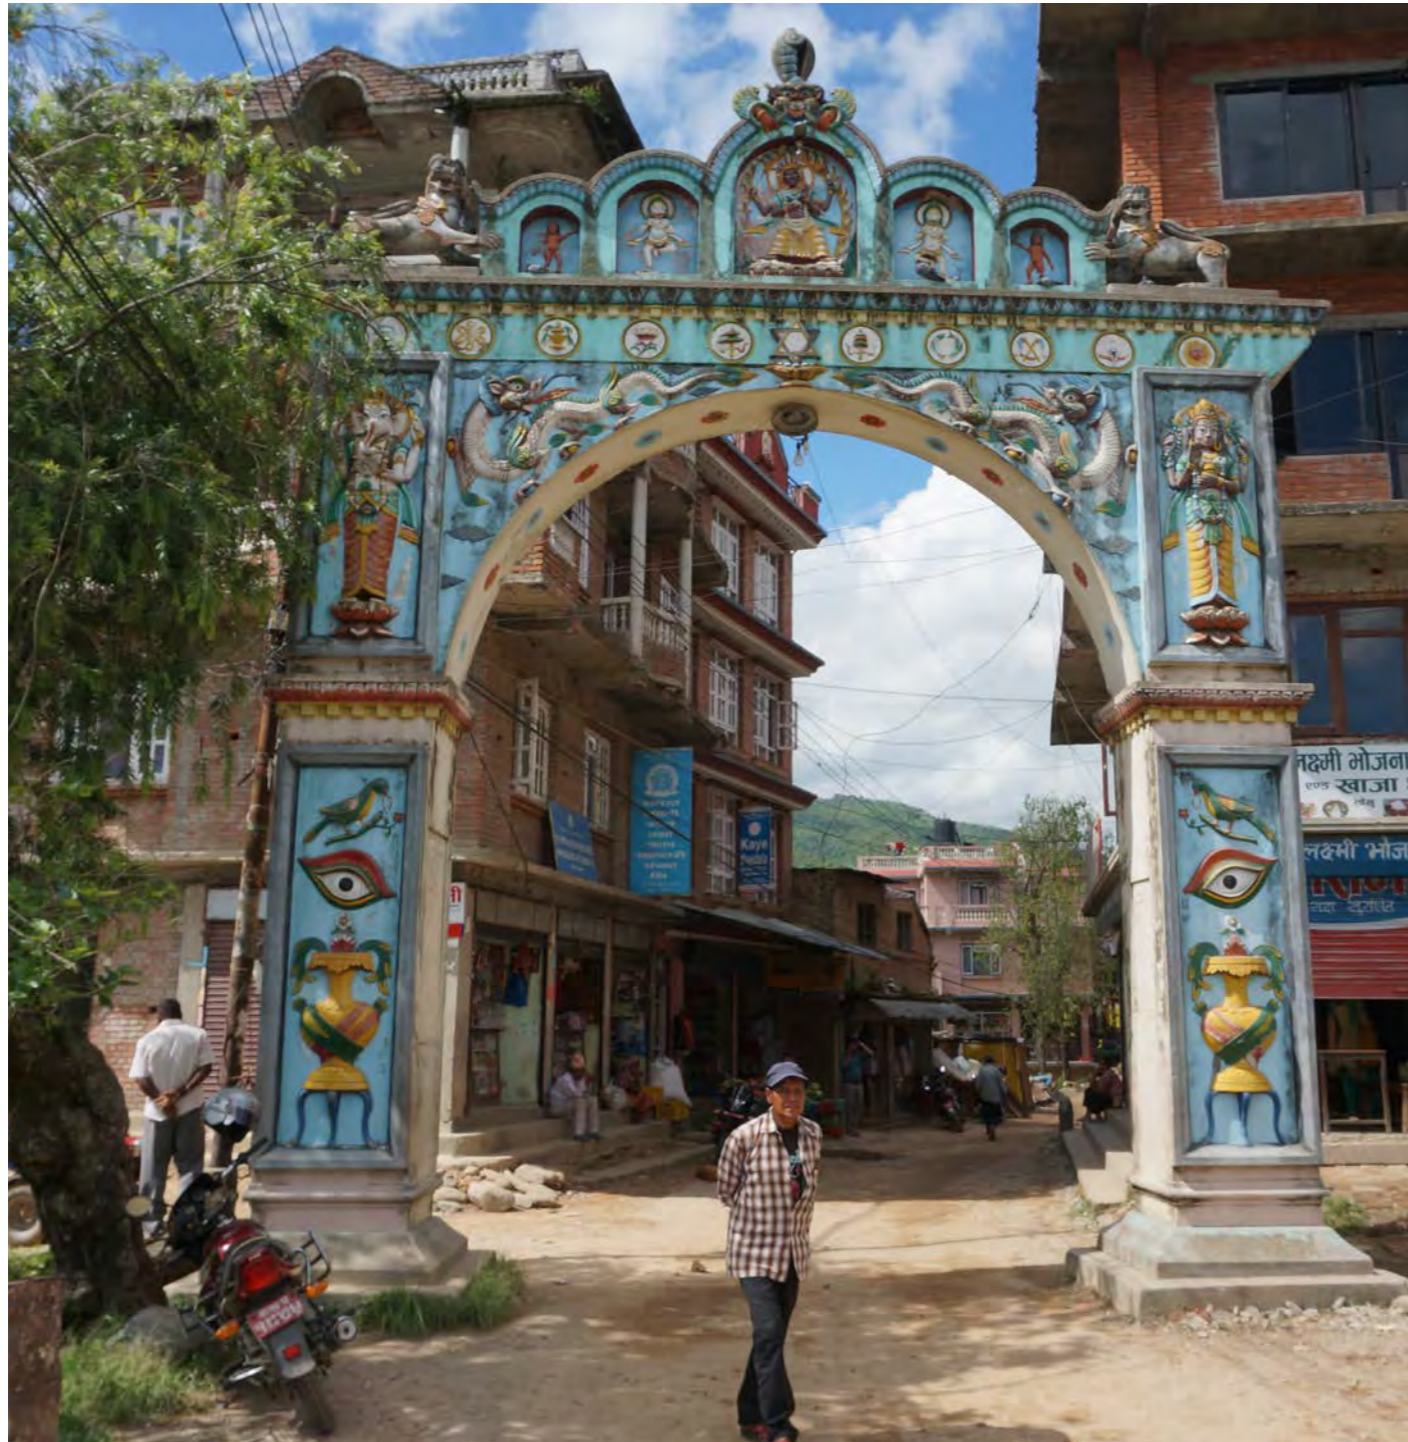
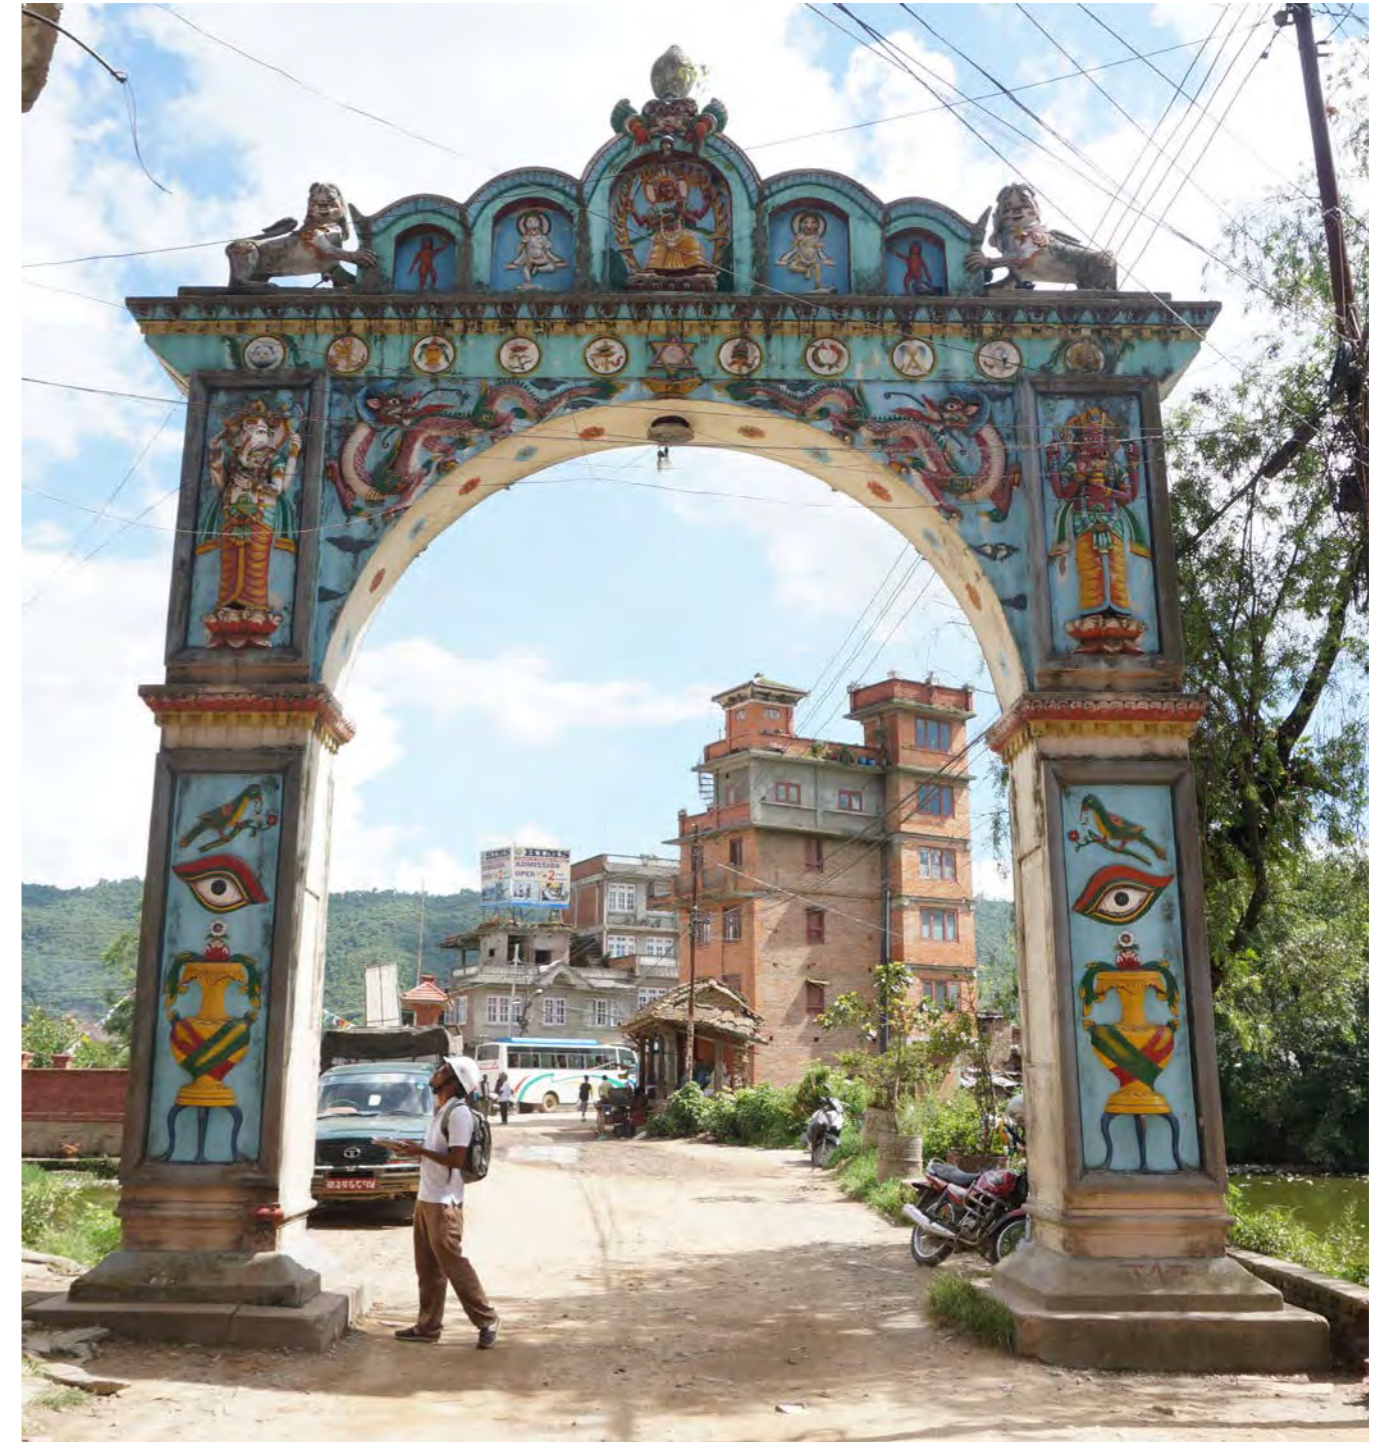
NUMBER	NAME	ESTABLISHED DATE (A.D.)	TYPOLOGY	GENERAL DESCRIPTION	PROBLEMS DESCRIPTION	DANGER/ DESTROY
A-03	Bhau Dhoka (Bhagawati Gate)	11/4/2047 (16 Feb 1991)	Gate	Newly constructed brick and concrete made entrance gate	No visible damages except for some minor cracks at bottom part of right pillar

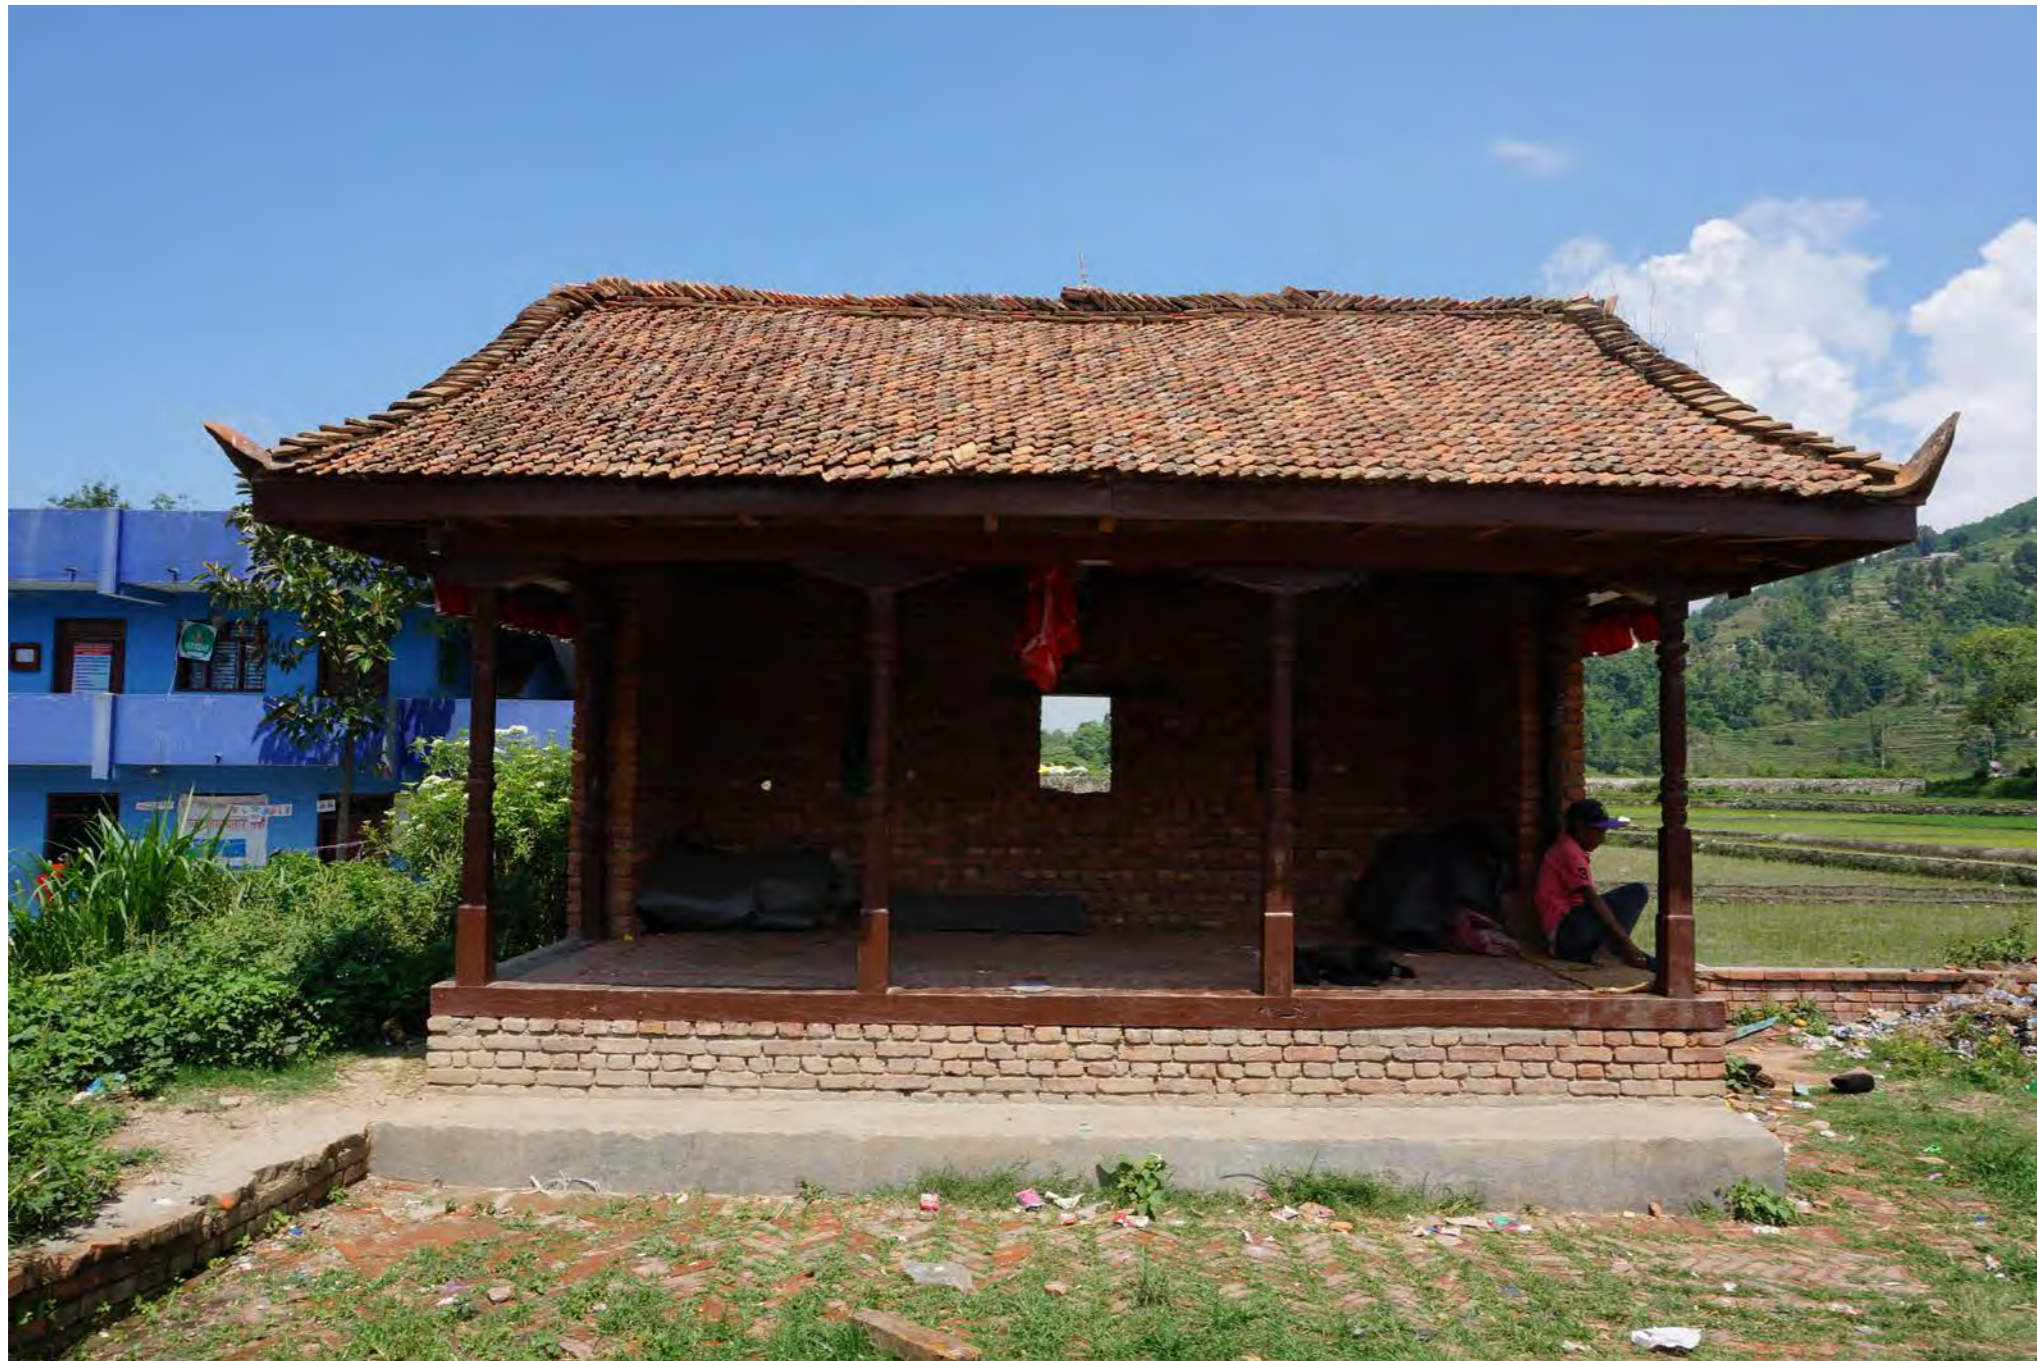
NUMBER	NAME	DATE A.D.	TYPOLOGY	GENERAL DESCRIPTION	PROBLEMS DESCRIPTION	DANGER/ DESTROY	
M02			Pati	Brick wall and new pillars.	No visible damage.

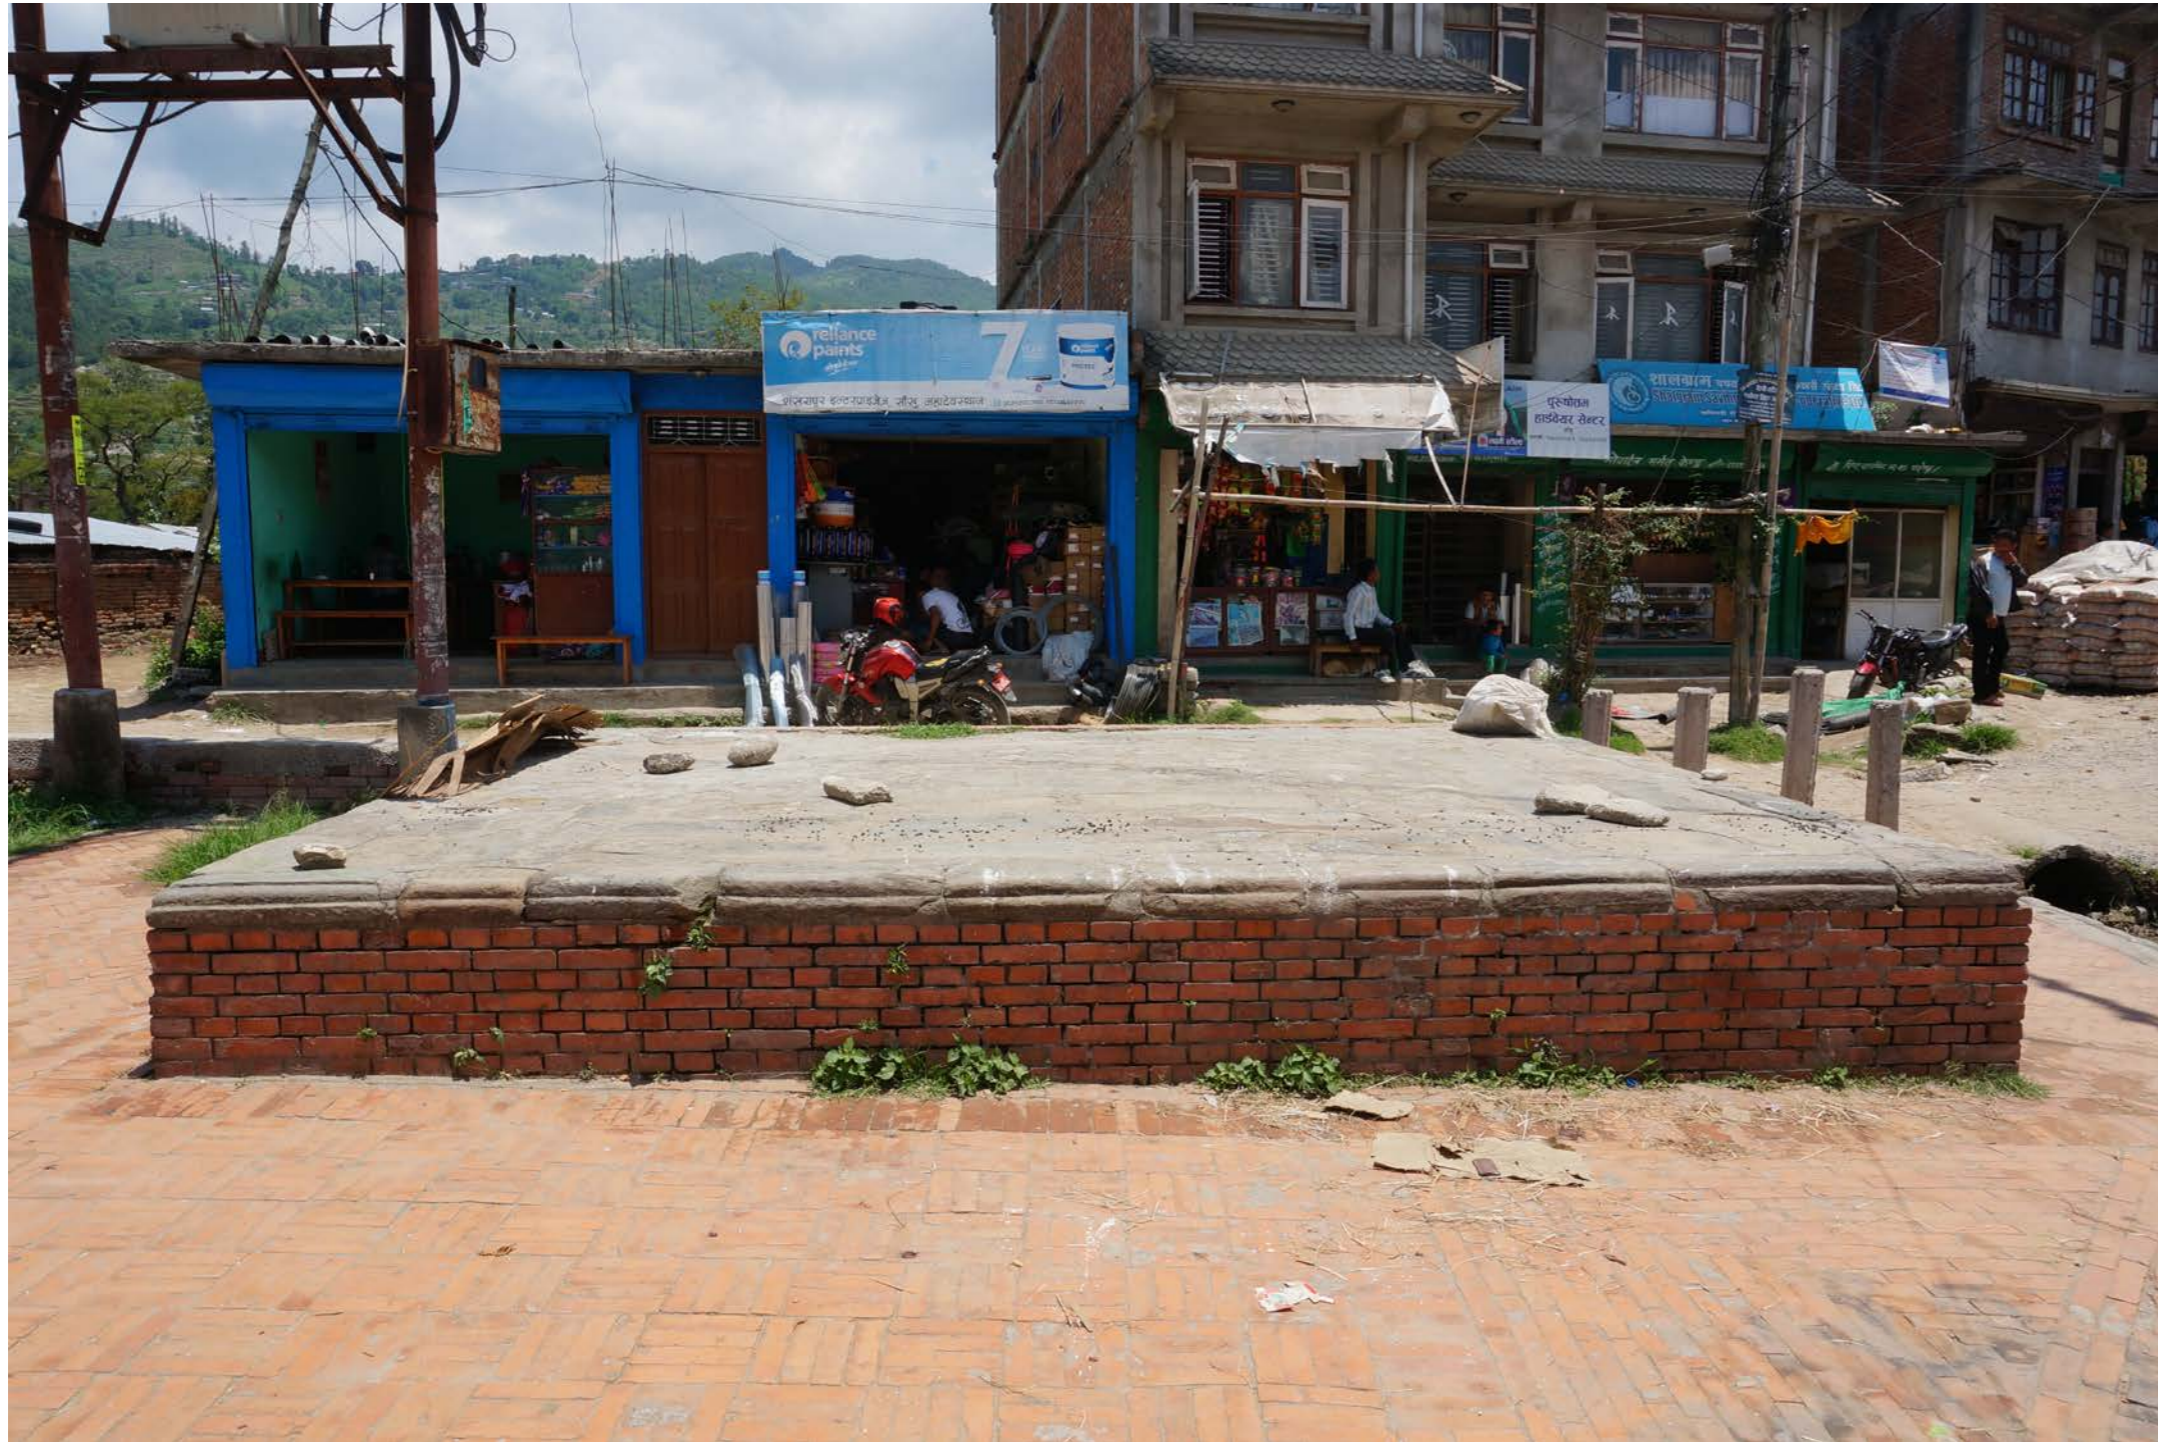
NUMBER	NAME	DATE A.D.	TYPOLOGY	GENERAL DESCRIPTION	PROBLEMS DESCRIPTION	DANGER/ DESTROY	
M11			Dabali	Brick wall with stone pavement with cement mortar on the top.	A stone on the side side is boken. Vegetations on the walls.

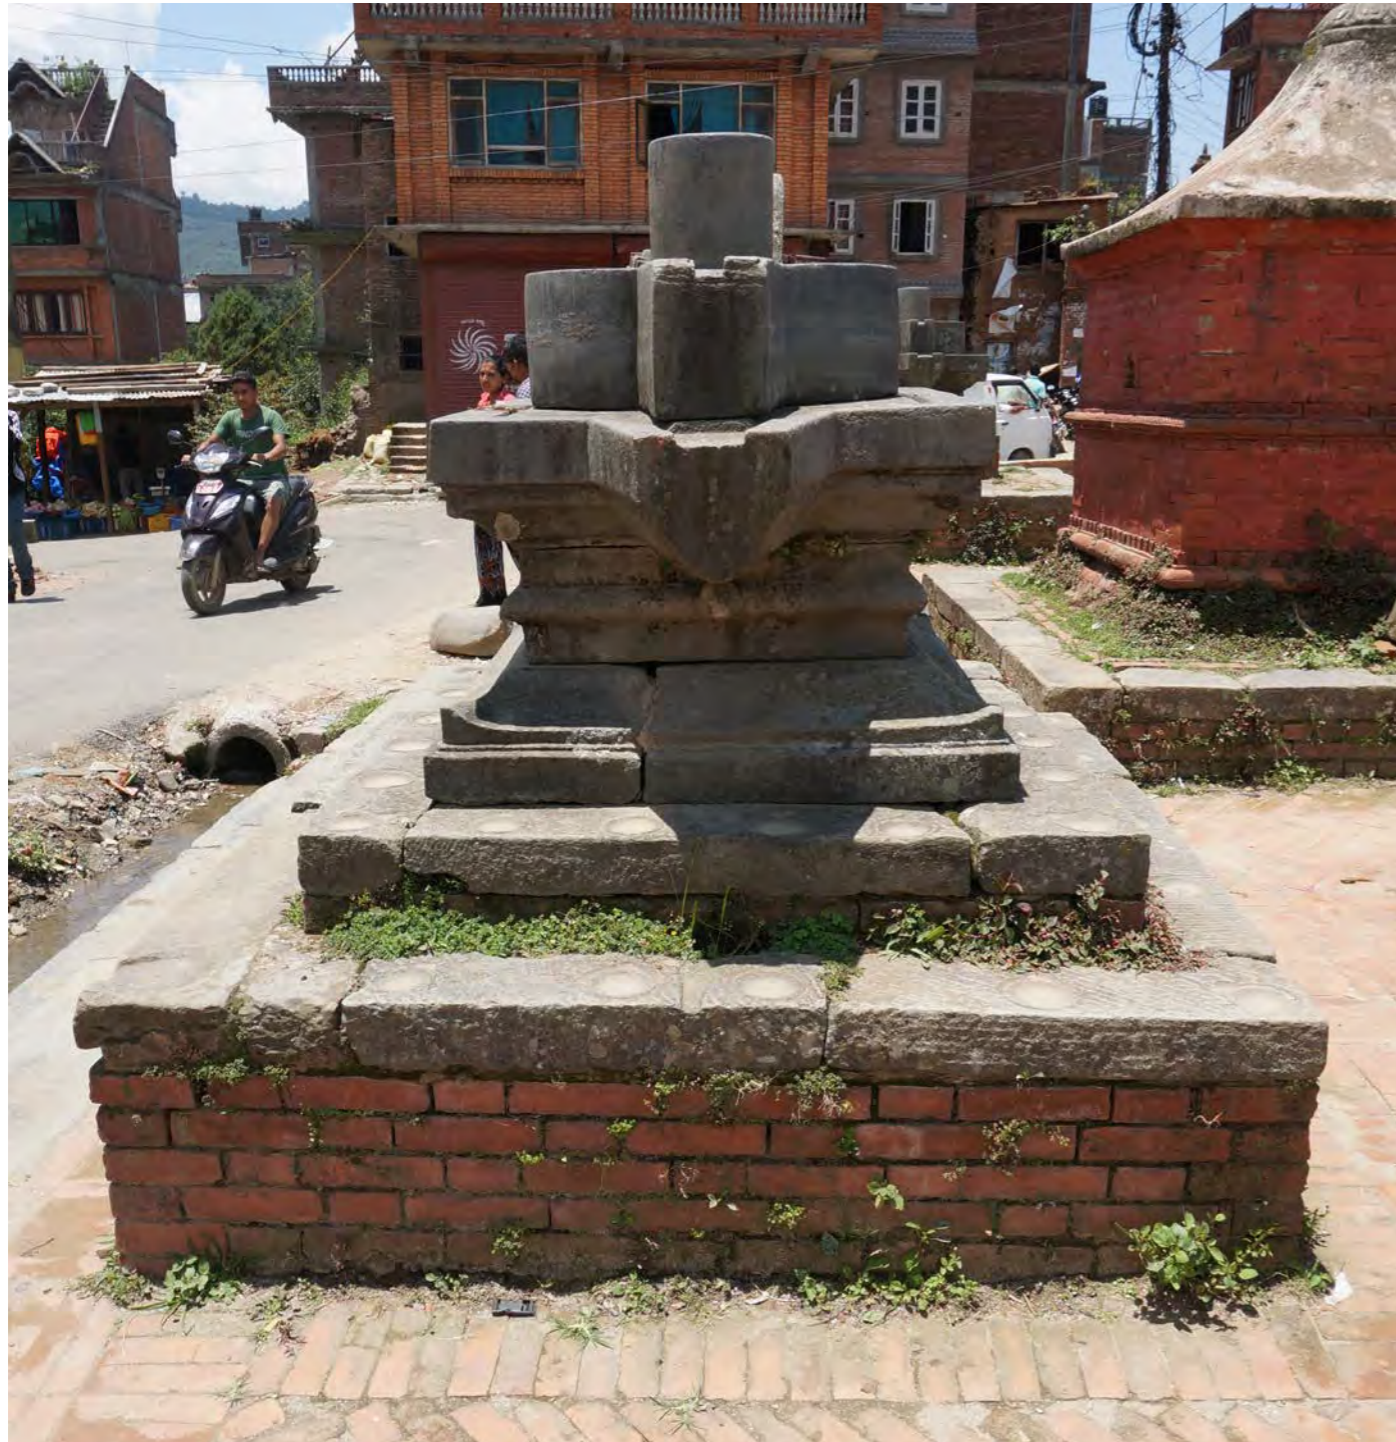
NUMBER	NAME	DATE A.D.	TPOLOGY	GENERAL DESCRIPTION	PROBLEMS DESCRIPTION	DANGER/ DESTROY	
M15			Shiva linga	Shiva linga on two jalaharis one on top of another. The second jalahari is relatively new. Stone faced platform on brick wall.	Seperation on joints of stone wall. Part of stone base to the south is broken. Vegetation growth at joints.

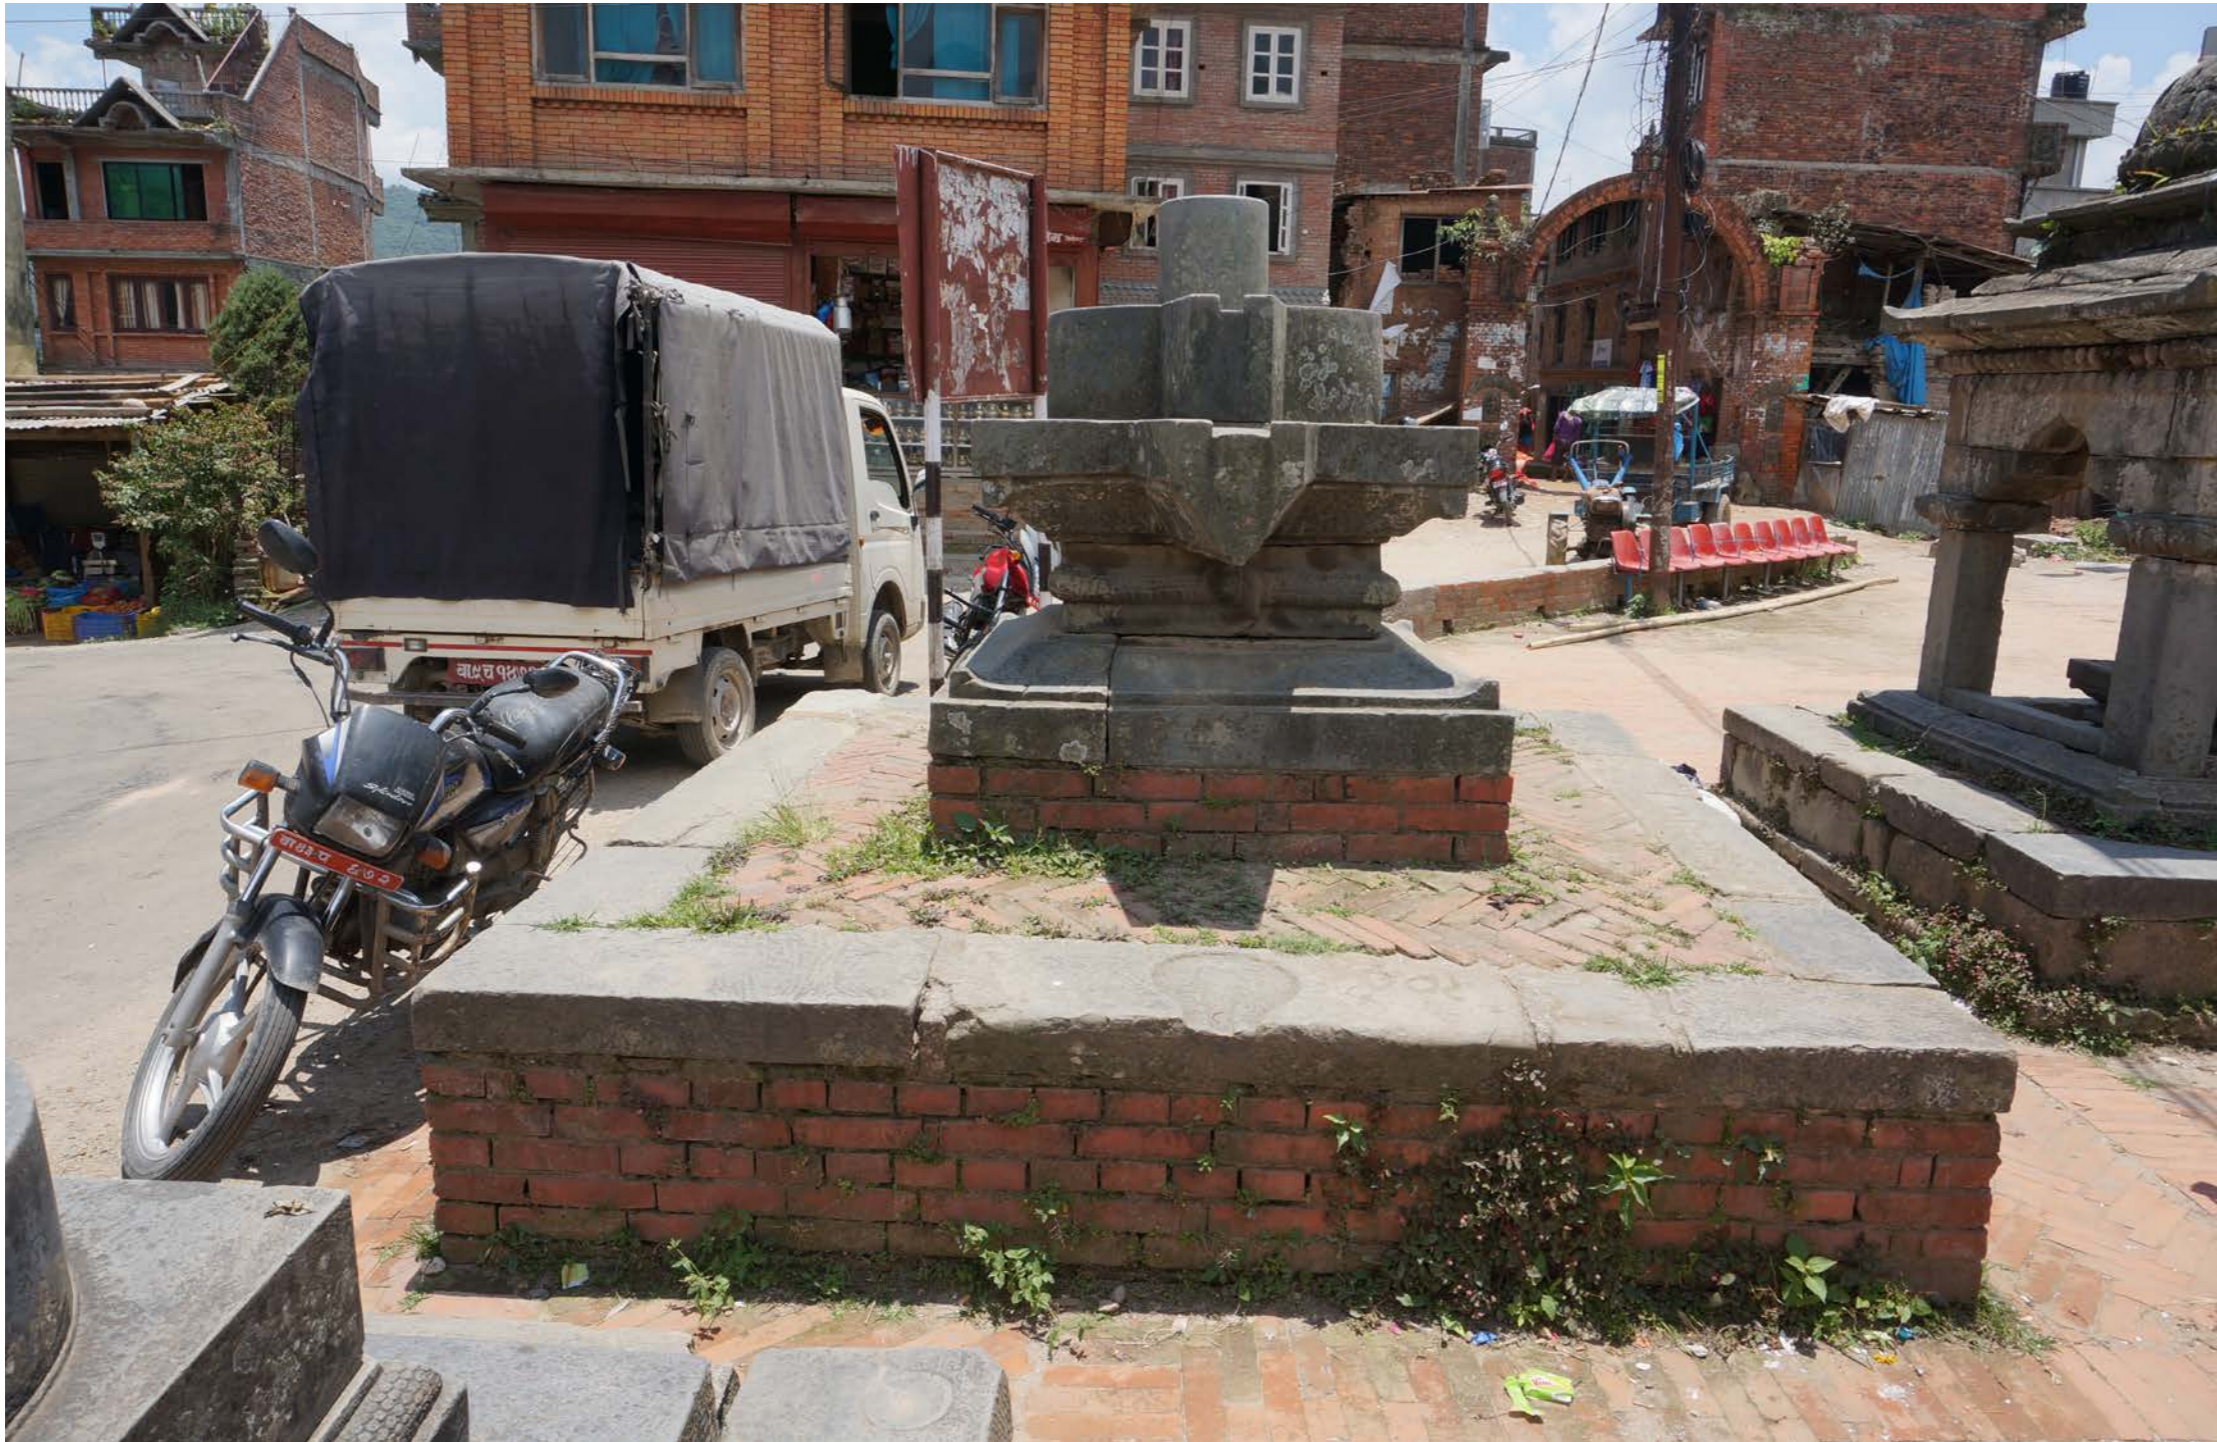
NUMBER	NAME	ESTABLISHED DATE (A.D.)	TPOLOGY	GENERAL DESCRIPTION	PROBLEMS DESCRIPTION	DANGER/ DESTROY
M18			Shiva linga	Two jalaharis on brick wall base.	Bricks on south east corner missing. Vegetation growth on platform.
