2015 Earthquake Damage Mapping

Sankhu

October 2015

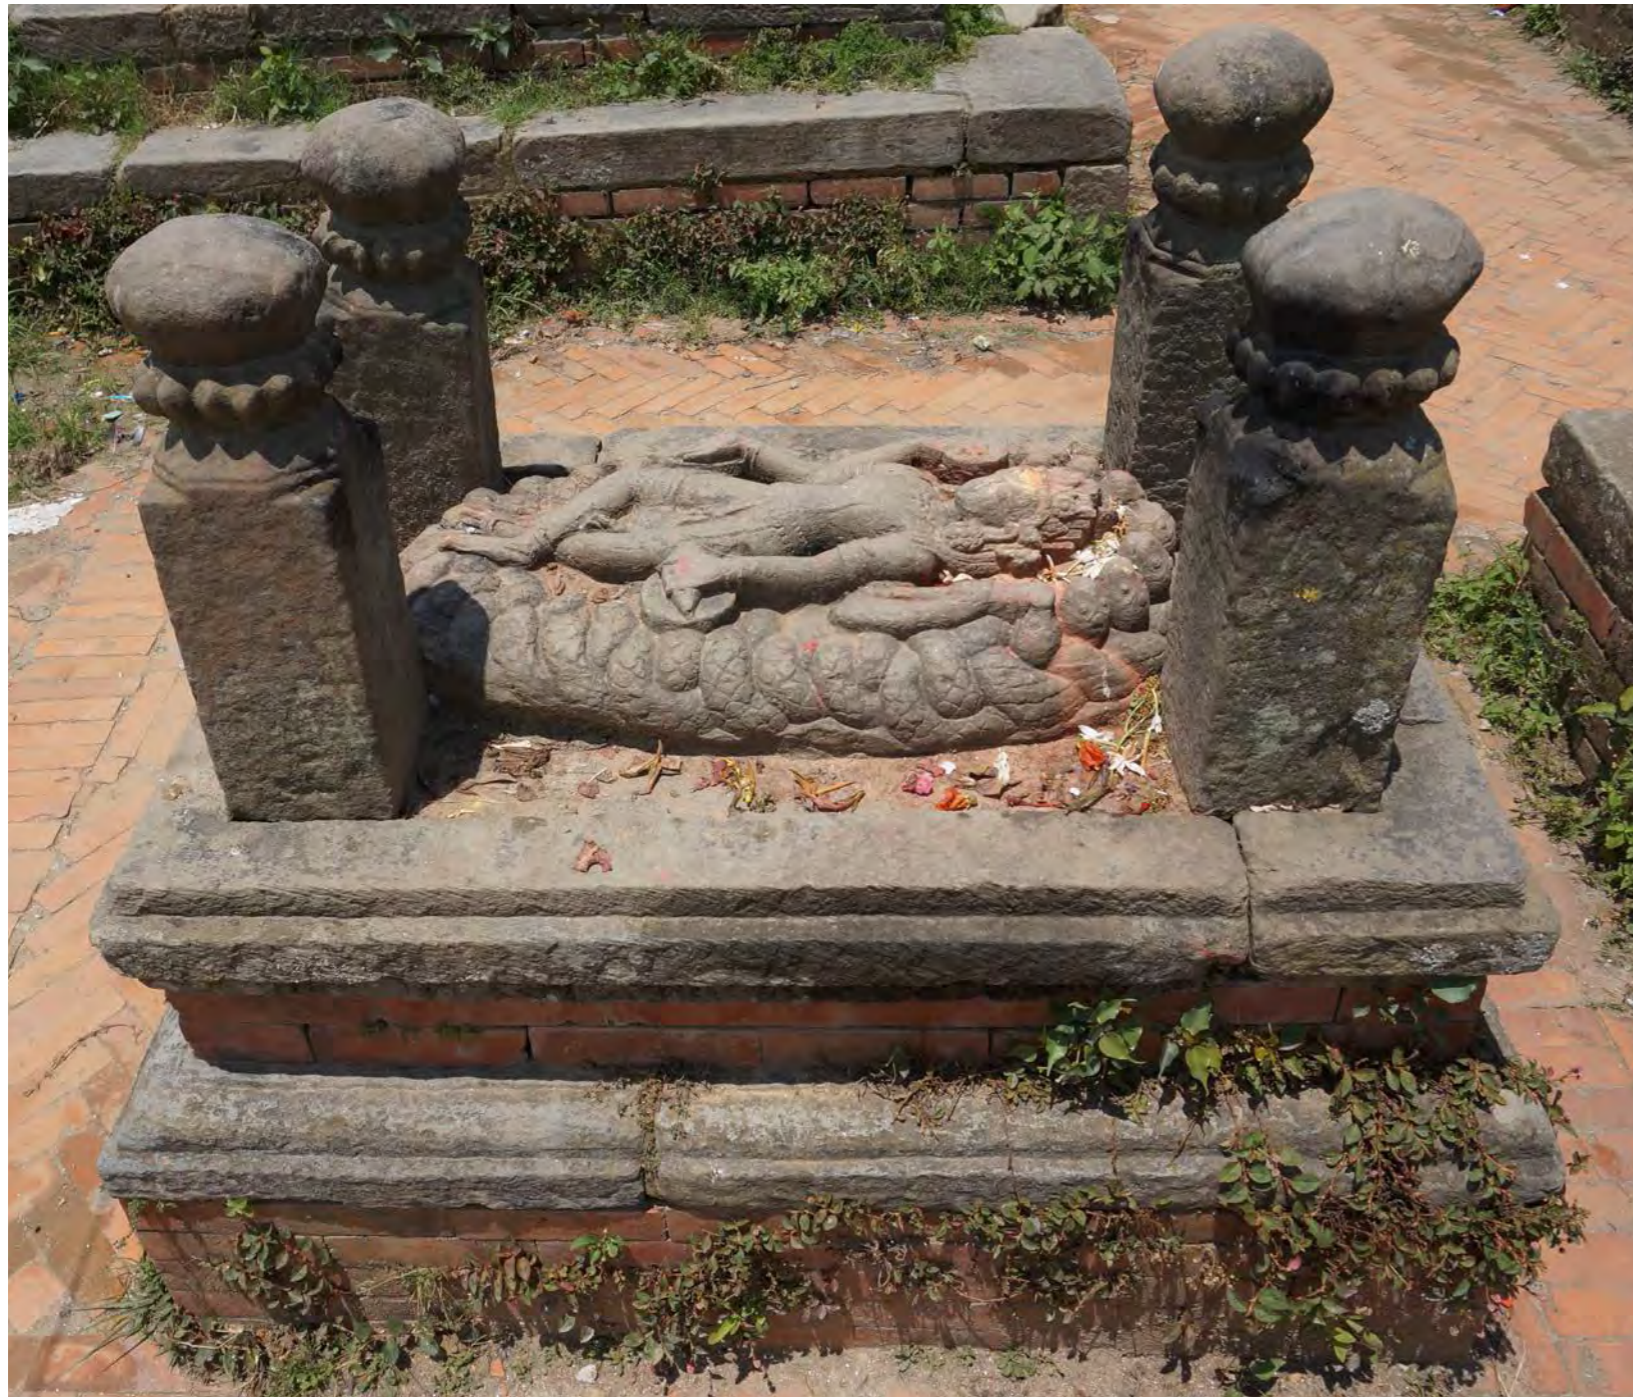
NUMBER	NAME	DATE A.D.	TPOLOGY	GENERAL DESCRIPTION	PROBLEMS DESCRIPTION	DANGER/ DESTROY	
M31	Vishnu Idol		Open Shrine	Jalashai Vishnu with four stone post on top of brick and stone platform.	Crack on bricks and stone wall at north west. Bricks are displaced on 3 sides (except south).

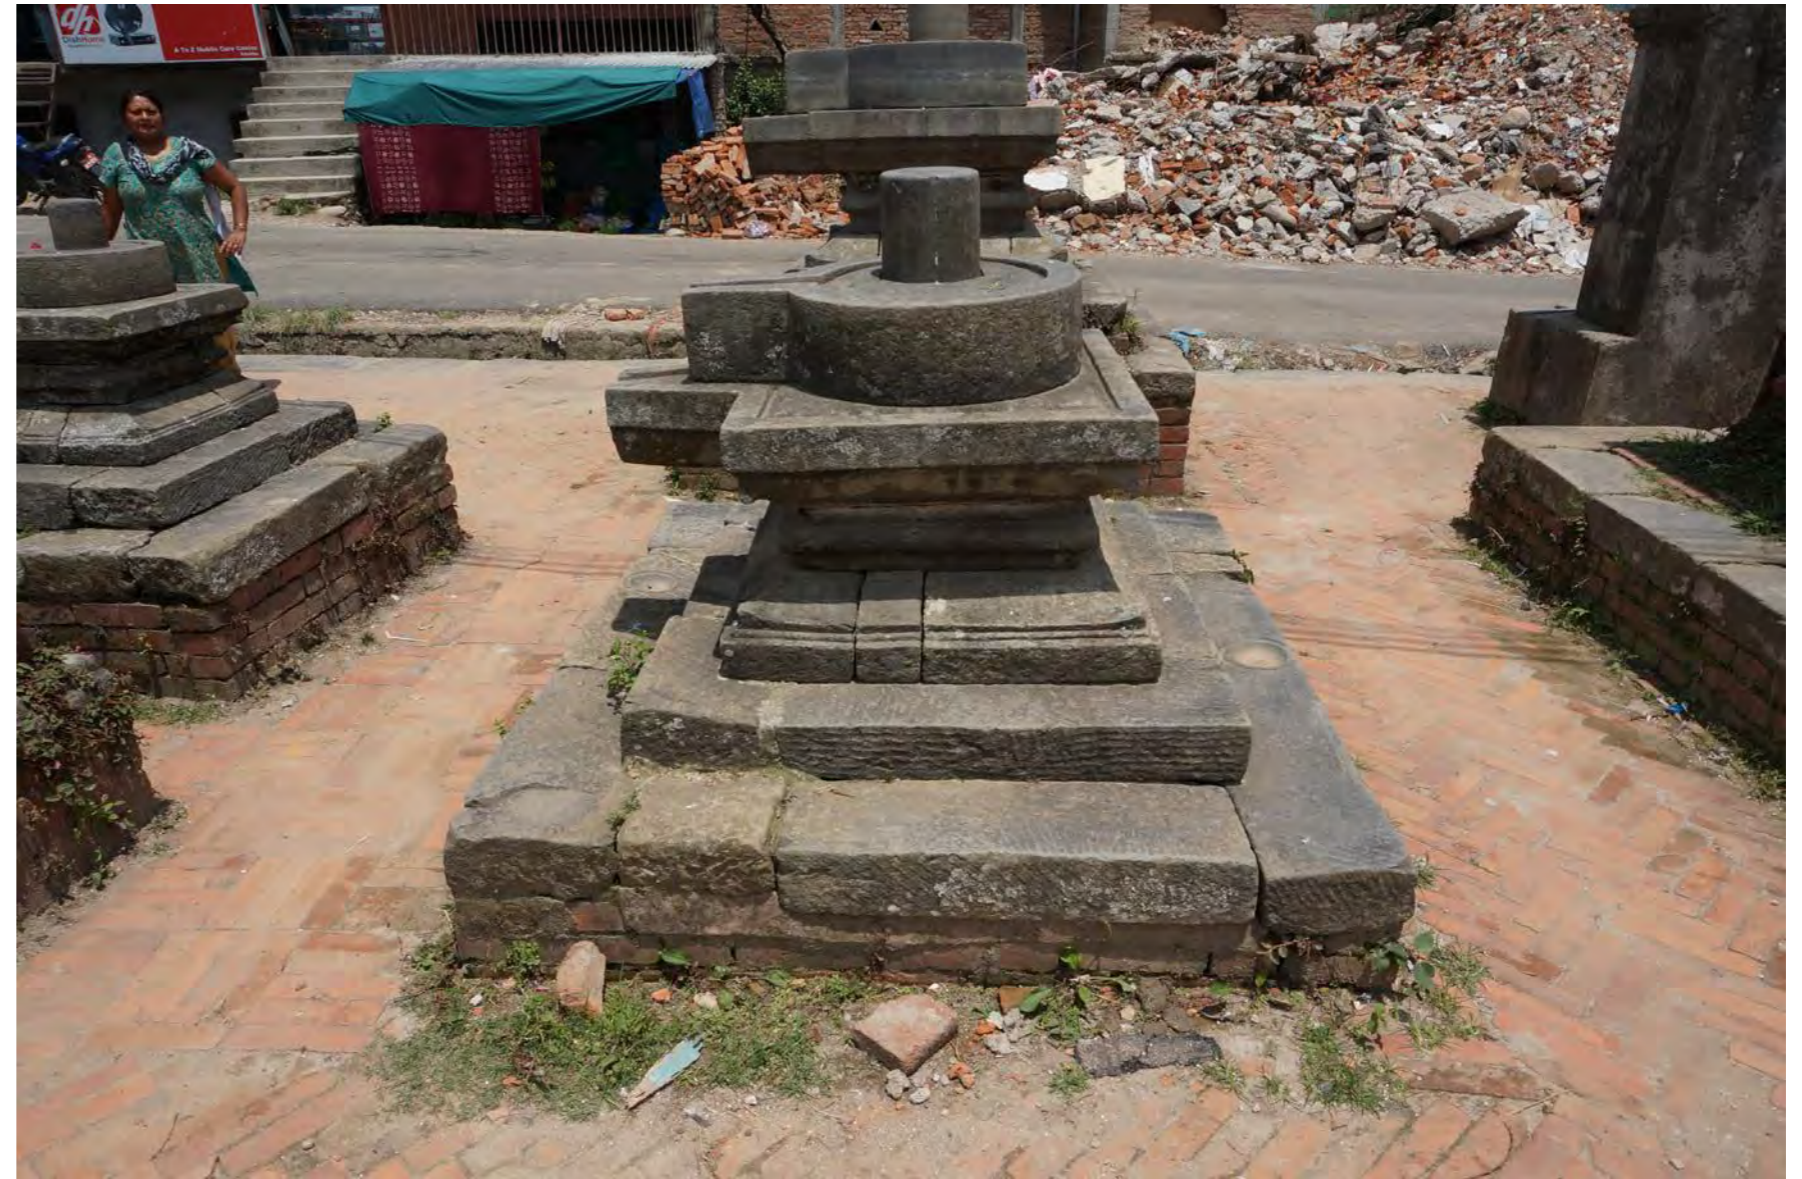
NUMBER	NAME	DATE A.D.	TYPOLOGY	GENERAL DESCRIPTION	PROBLEMS DESCRIPTION	DANGER/ DESTROY
M33			Shiva linga	Brick wall stone paved platform. 2 jalaharis.	Settlement at the center. Cracks at joints.

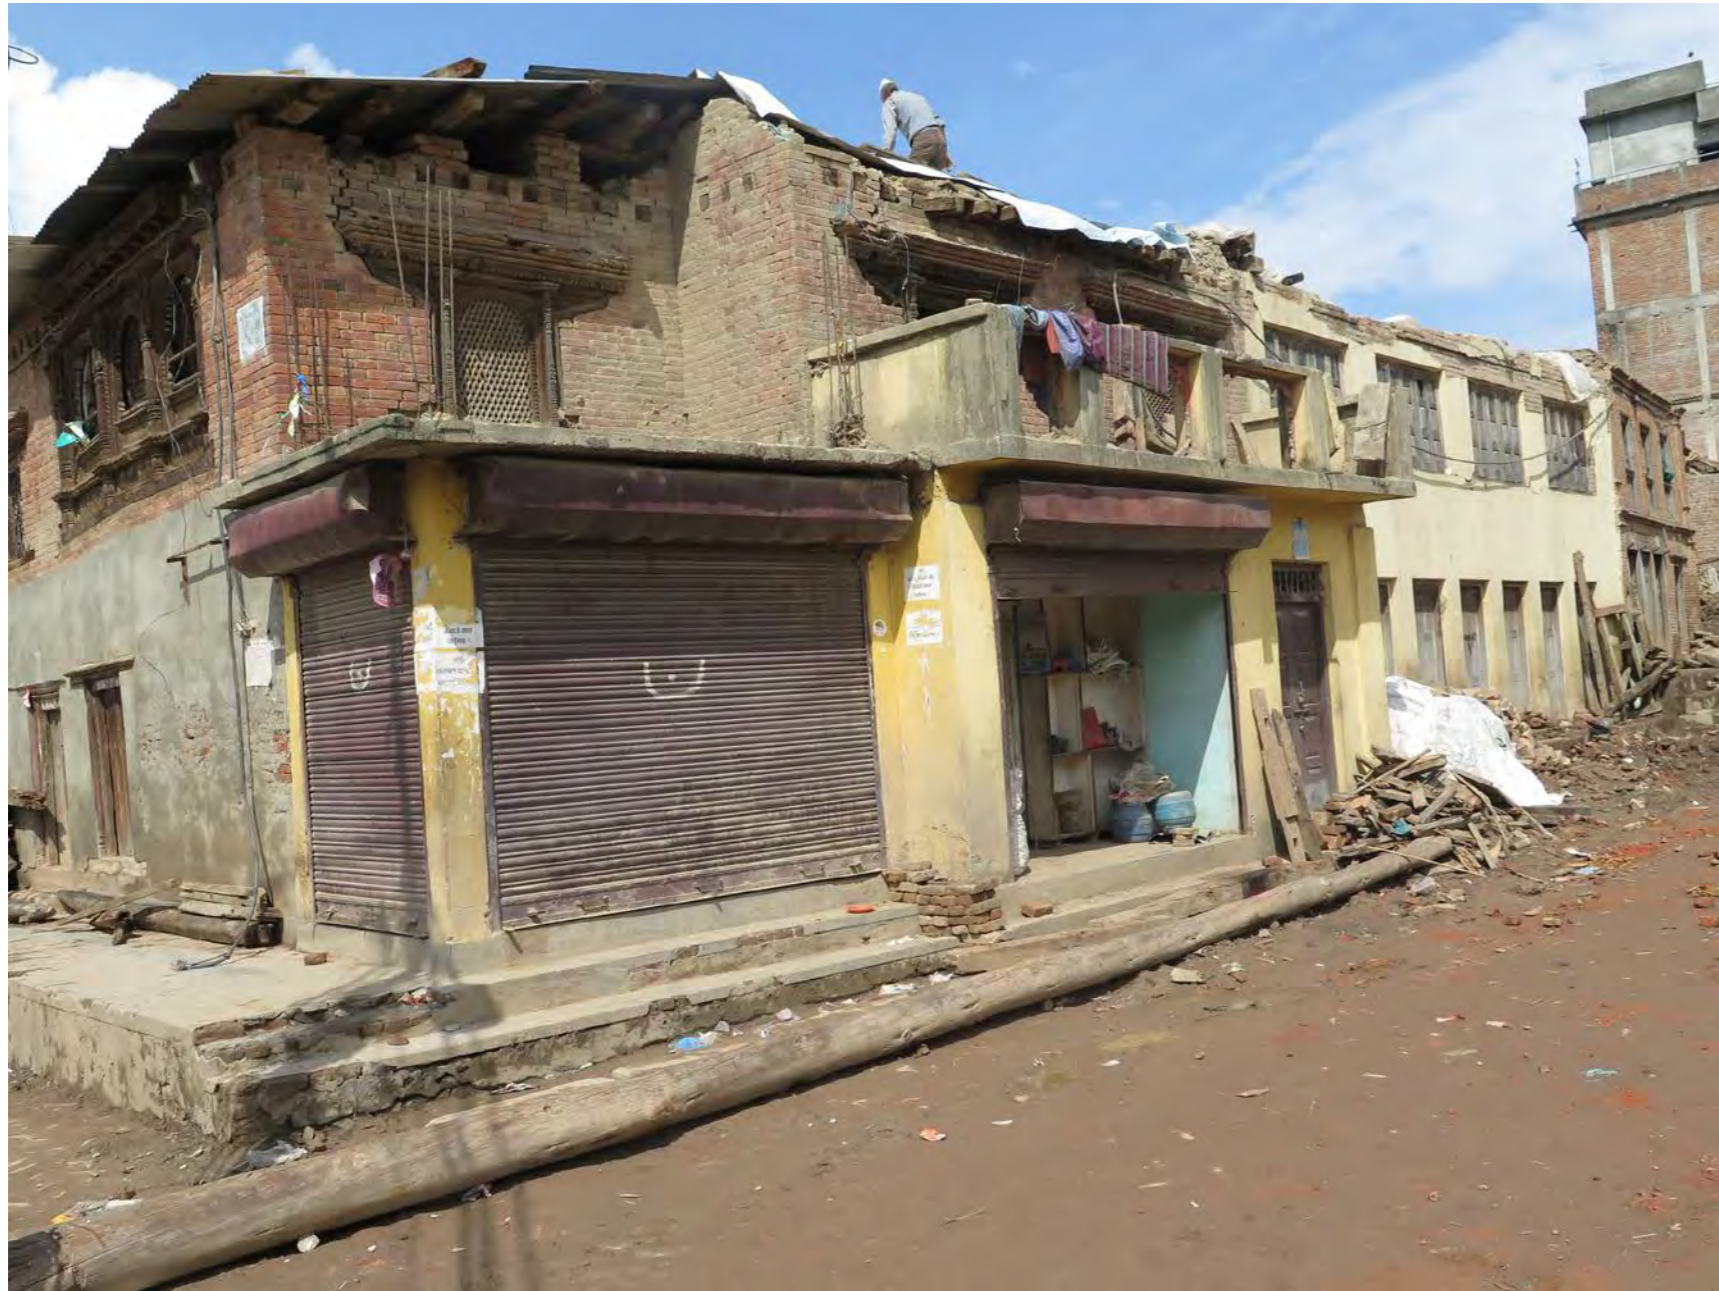
NUMBER	CONTACT	STOREY NO. RELATIVE POSITION	STRUCTURAL SYSTEM	PROBLEMS DESCRIPTION	DANGER	CONDITION
d57	Maheshwor Shrestha (9841436824)	G+3	B	2 floors collapsed	1/2 ☒

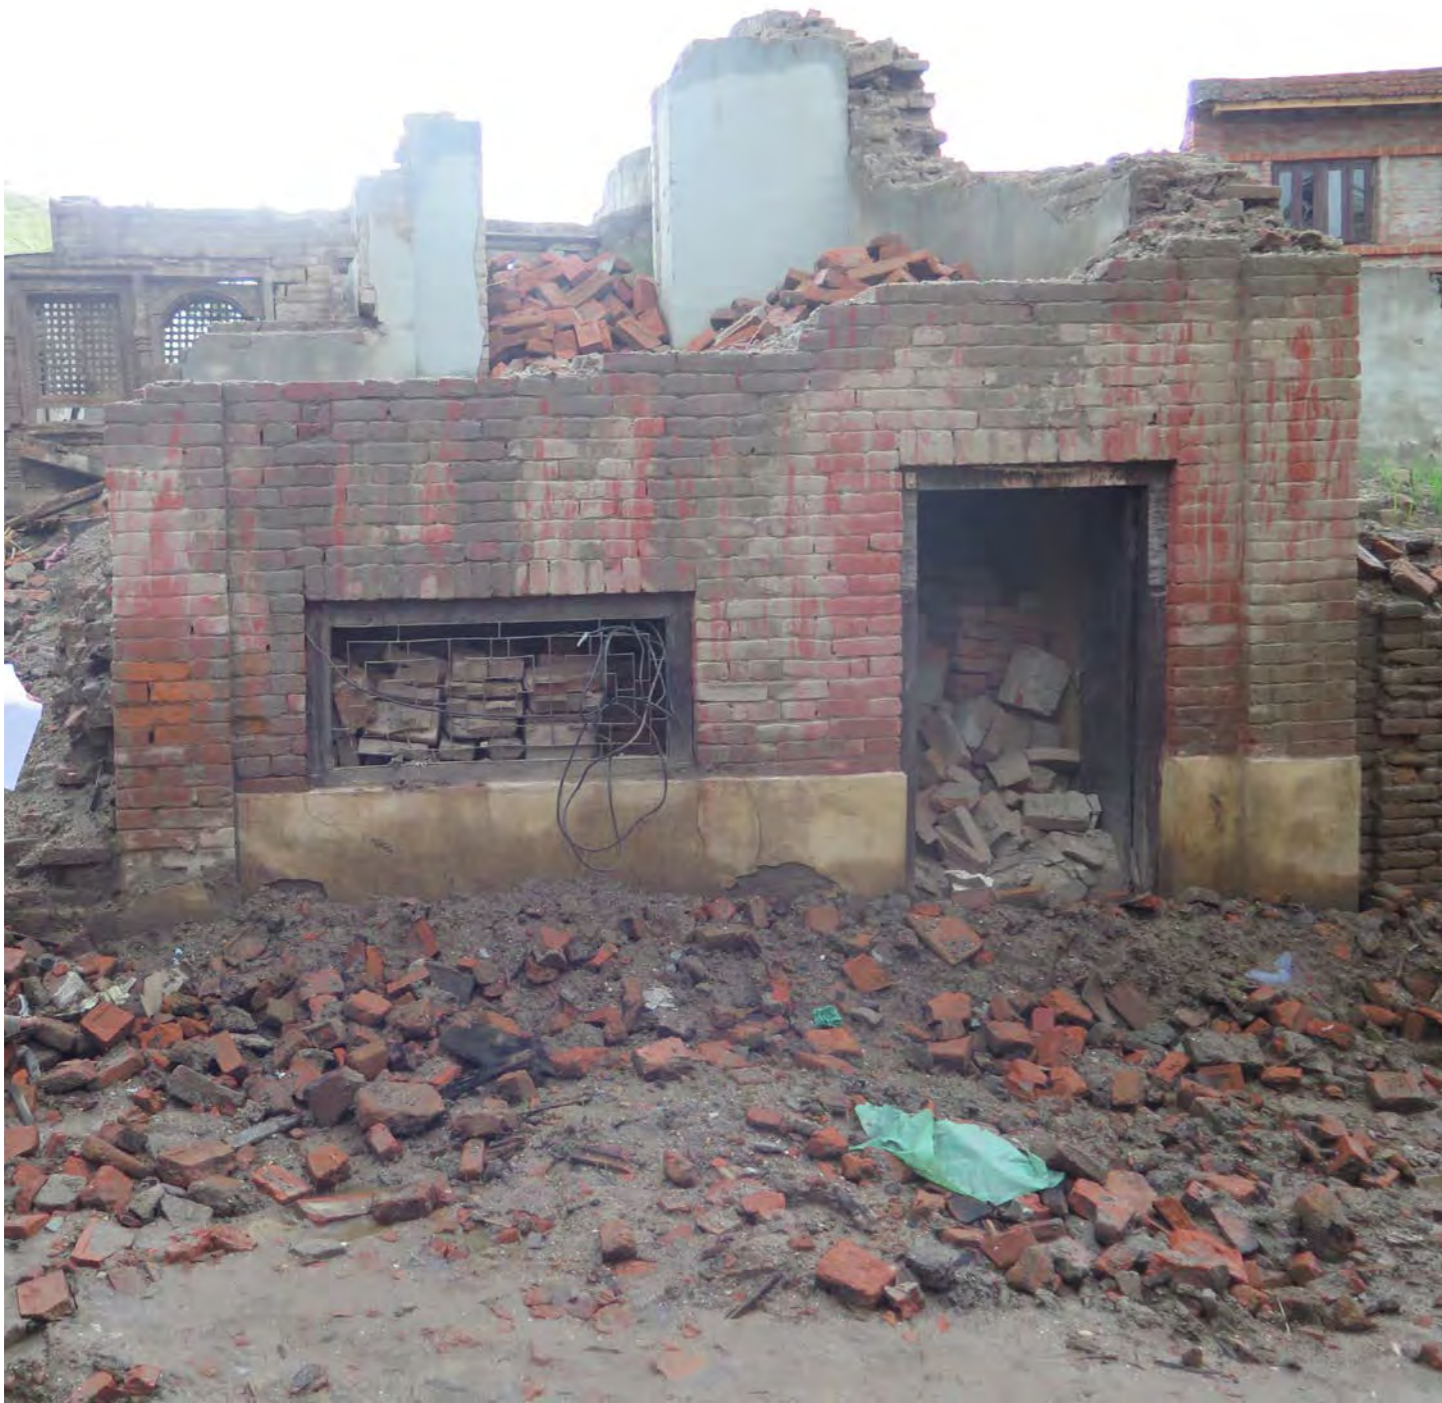
NUMBER	CONTACT	STOREY NO. RELATIVE POSITION	STRUCTURAL SYSTEM	PROBLEMS DESCRIPTION	DANGER	CONDITION	
i32	Hari Bhakta Shrestha	G+3	B+UnB	2 Floors collapsed. Covered by rubbles	⚠️ ☒	R ++

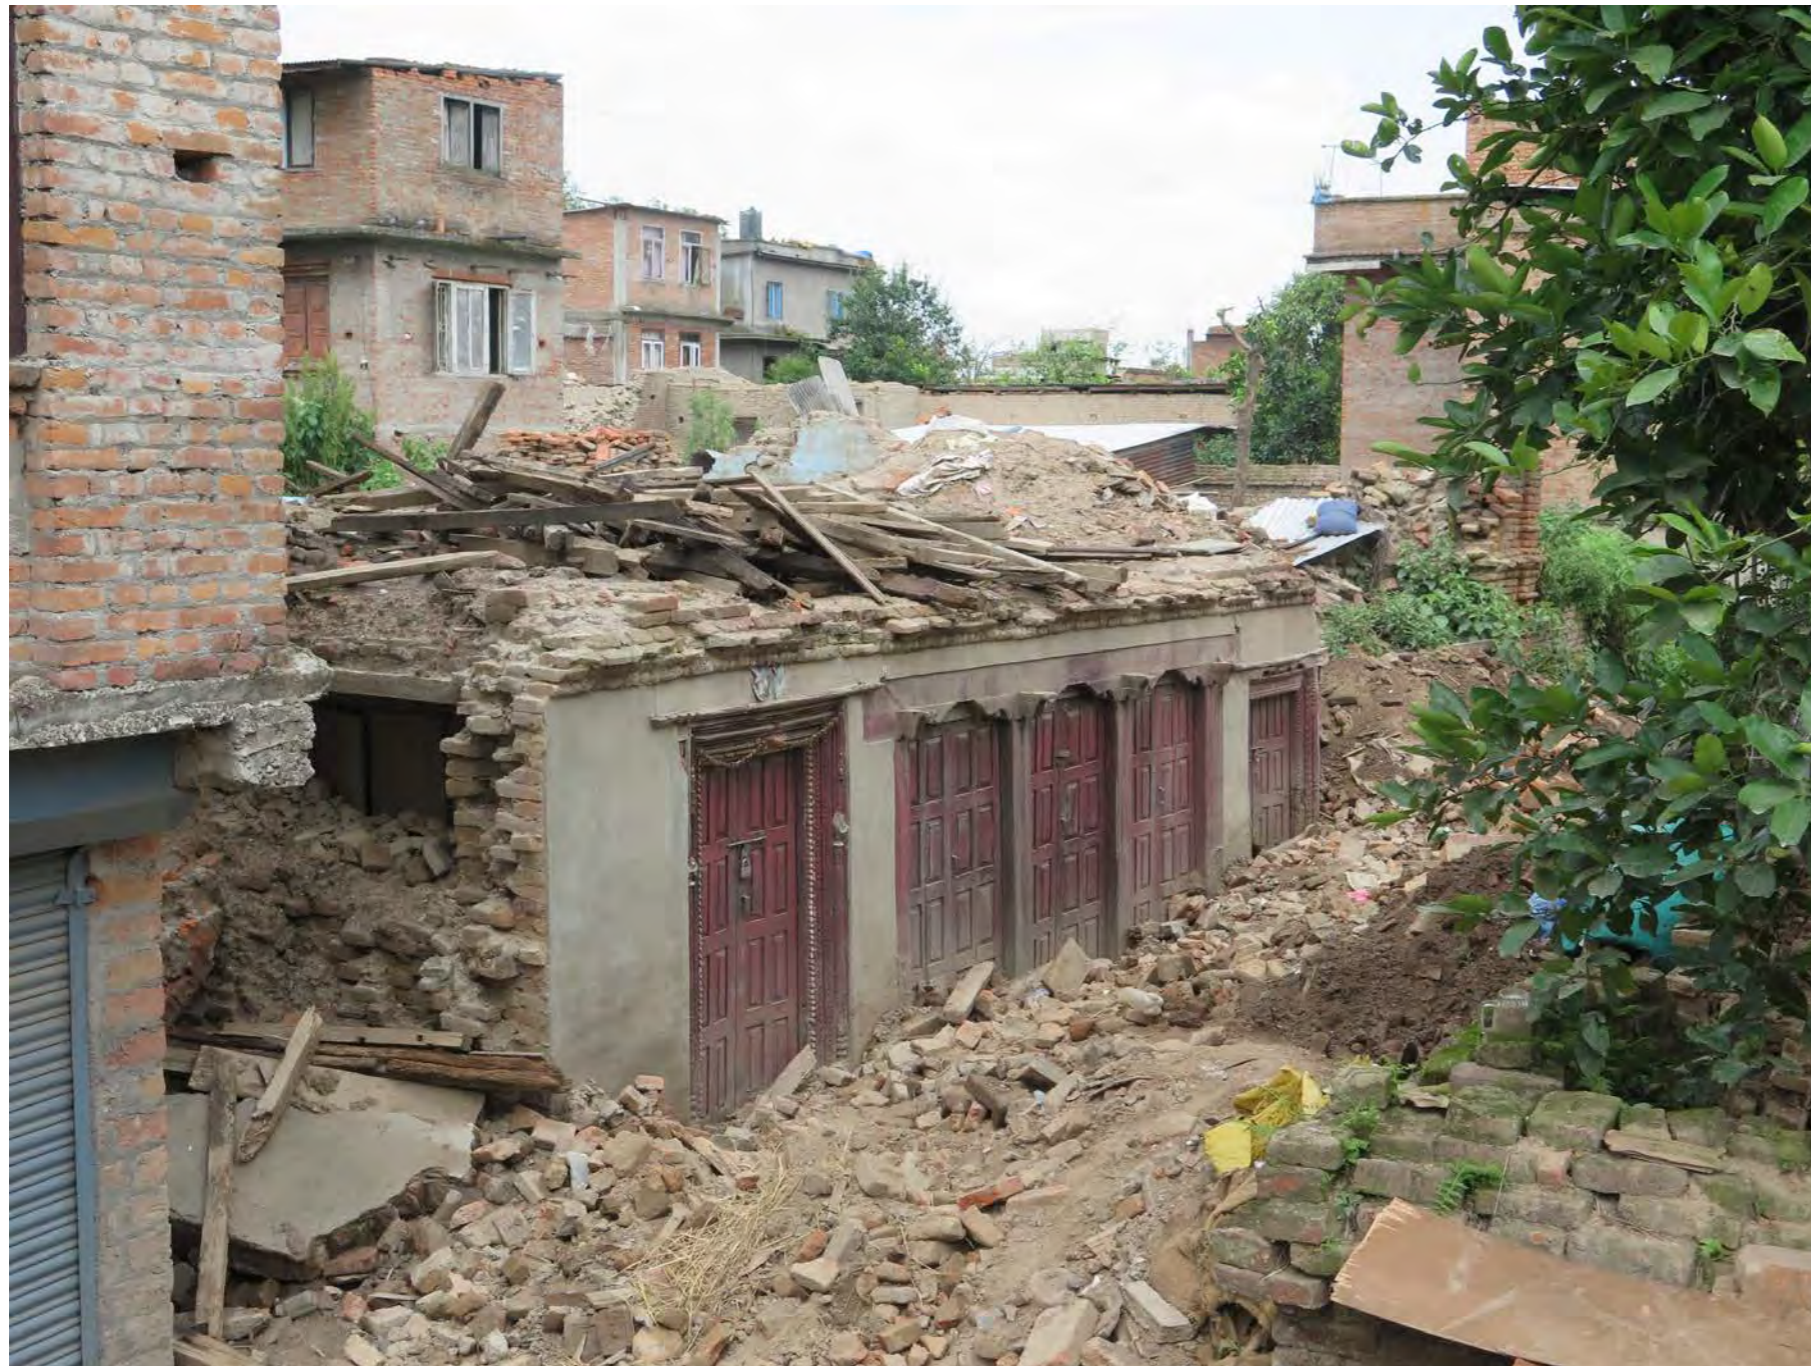
NUMBER	CONTACT	STOREY NO. RELATIVE POSITION	STRUCTURAL SYSTEM	PROBLEMS DESCRIPTION	DANGER	CONDITION	
d68	Ishwor Shrestha (9841954869)	G+3	B	Collapsed upto ground floor. Ground floor under rubbles.		+

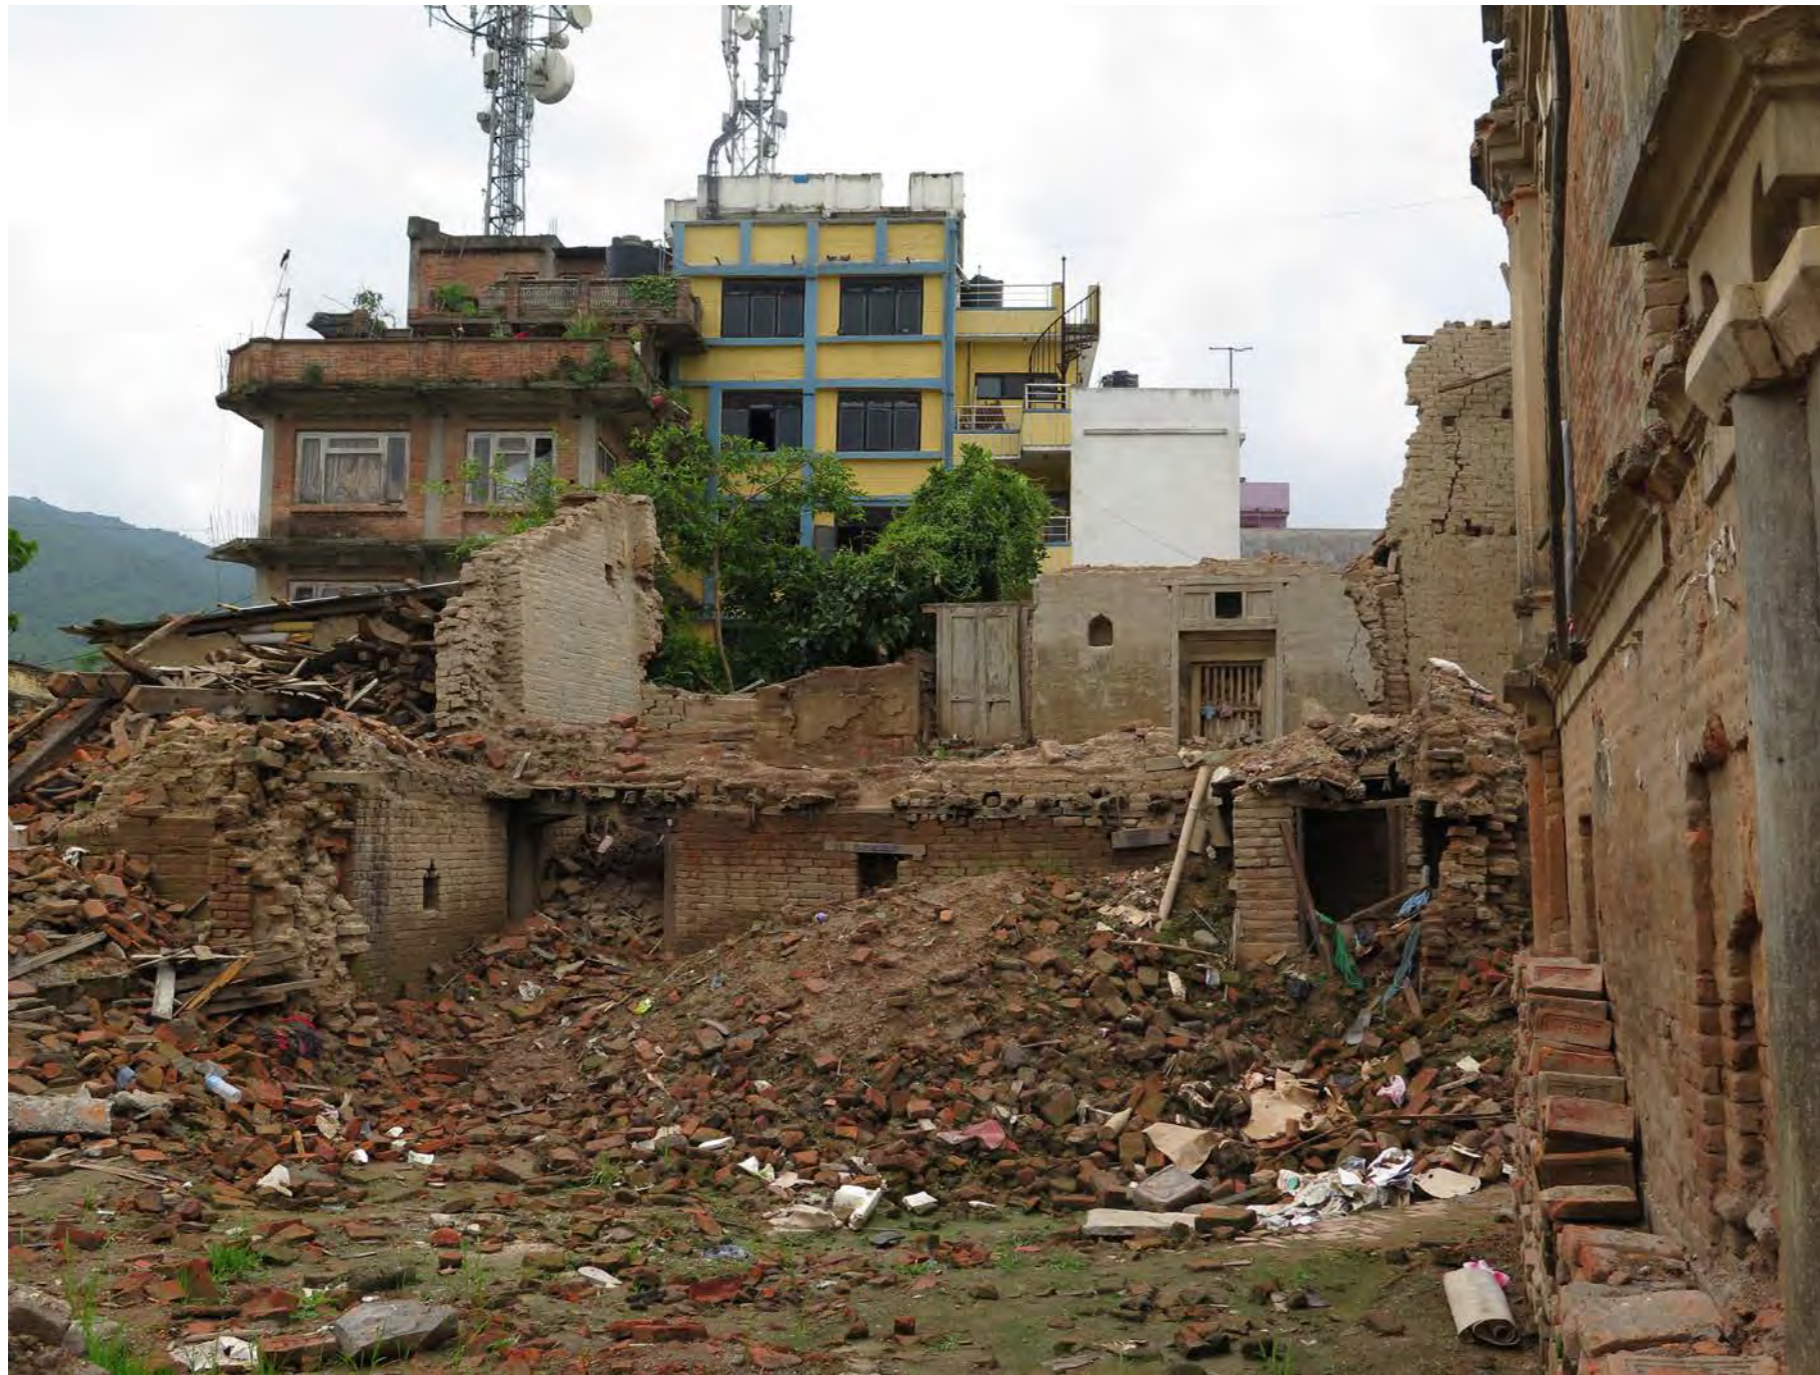
NUMBER	CONTACT	STOREY NO. RELATIVE POSITION	STRUCTURAL SYSTEM	PROBLEMS DESCRIPTION	DANGER	CONDITION
e04	Hridya Chandra Shrestha	G+3 (EH)	B+UnB	2 floors collapsed	⊗	+

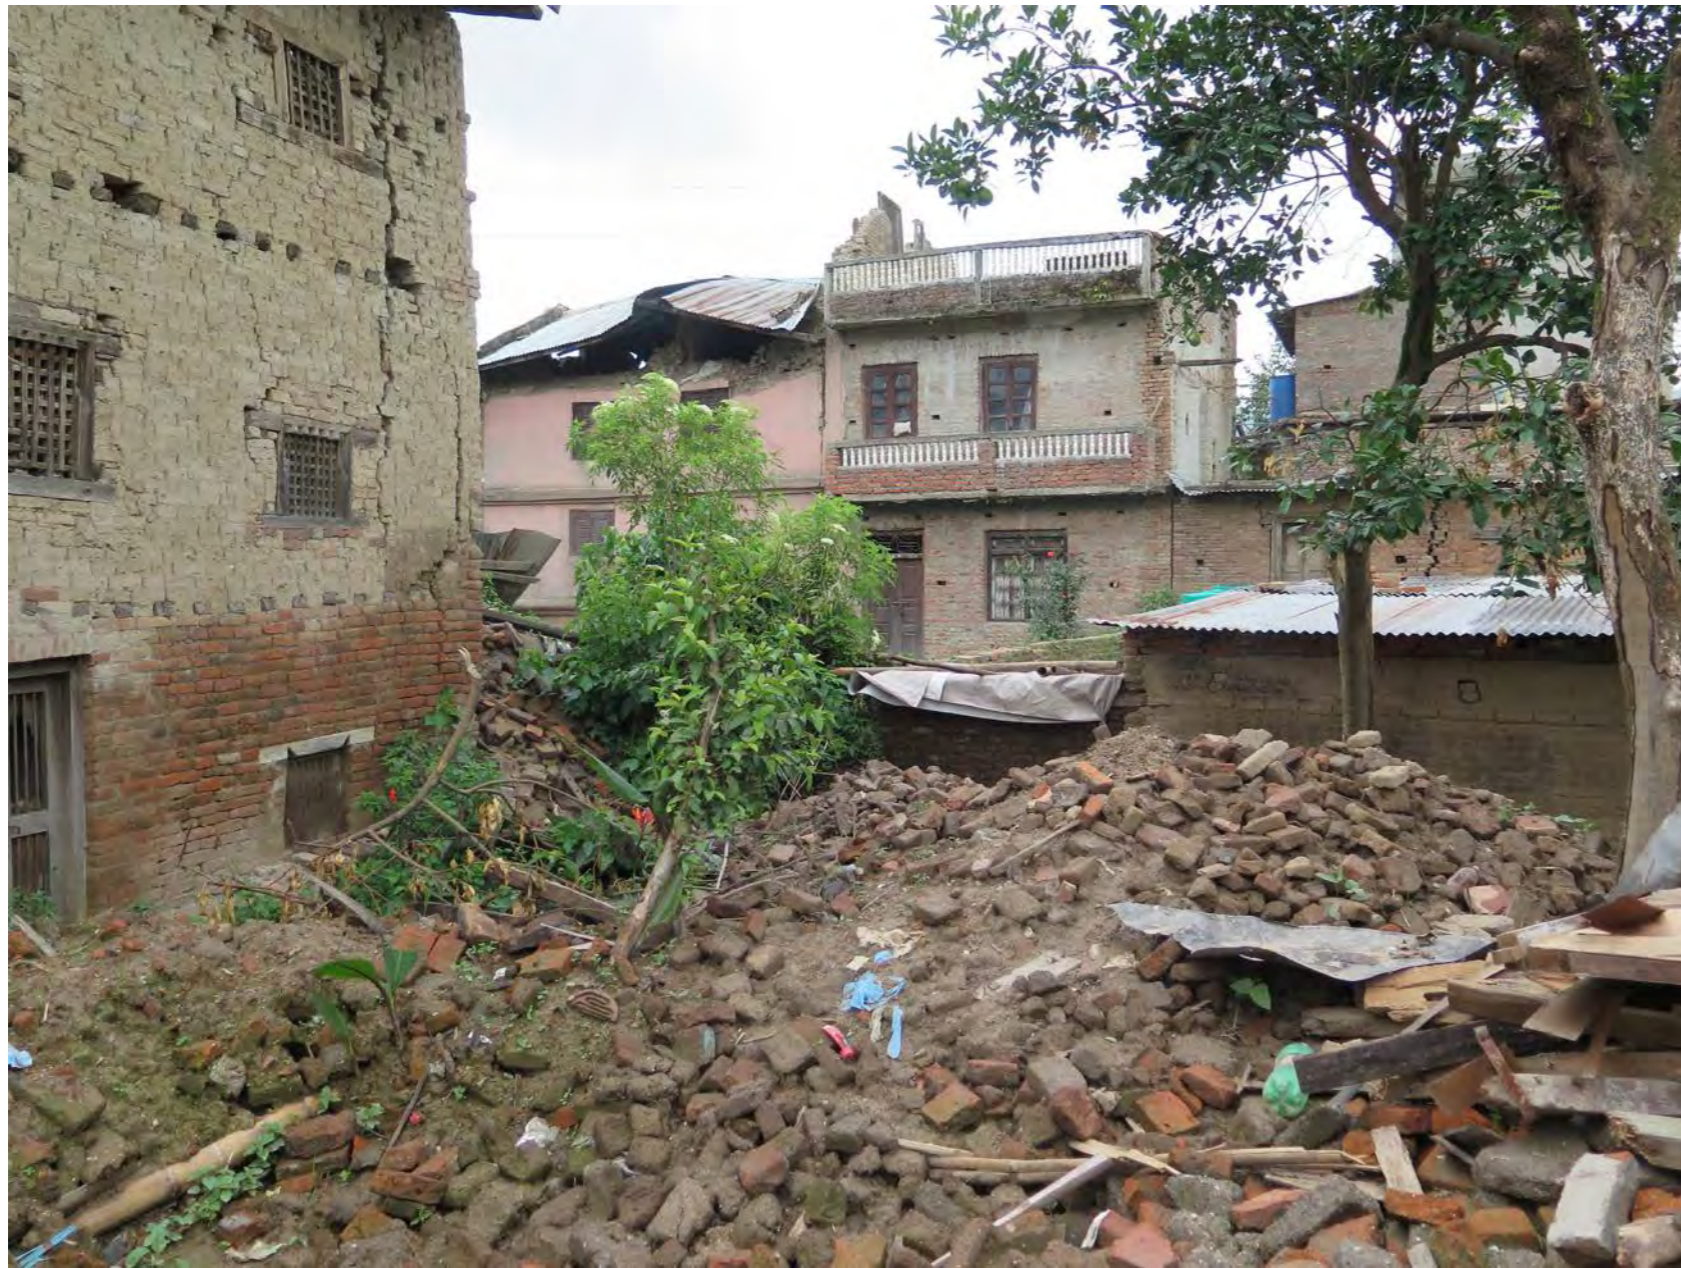
NUMBER	CONTACT	STOREY NO. RELATIVE POSITION	STRUCTURAL SYSTEM	PROBLEMS DESCRIPTION	DANGER	CONDITION	
e13	Gagan Bahadur Ranjit	G+4	B	Demolished to G+1 for reconstruction before earthquake. West wall collapsed. Vertical cracks on north wall.		+

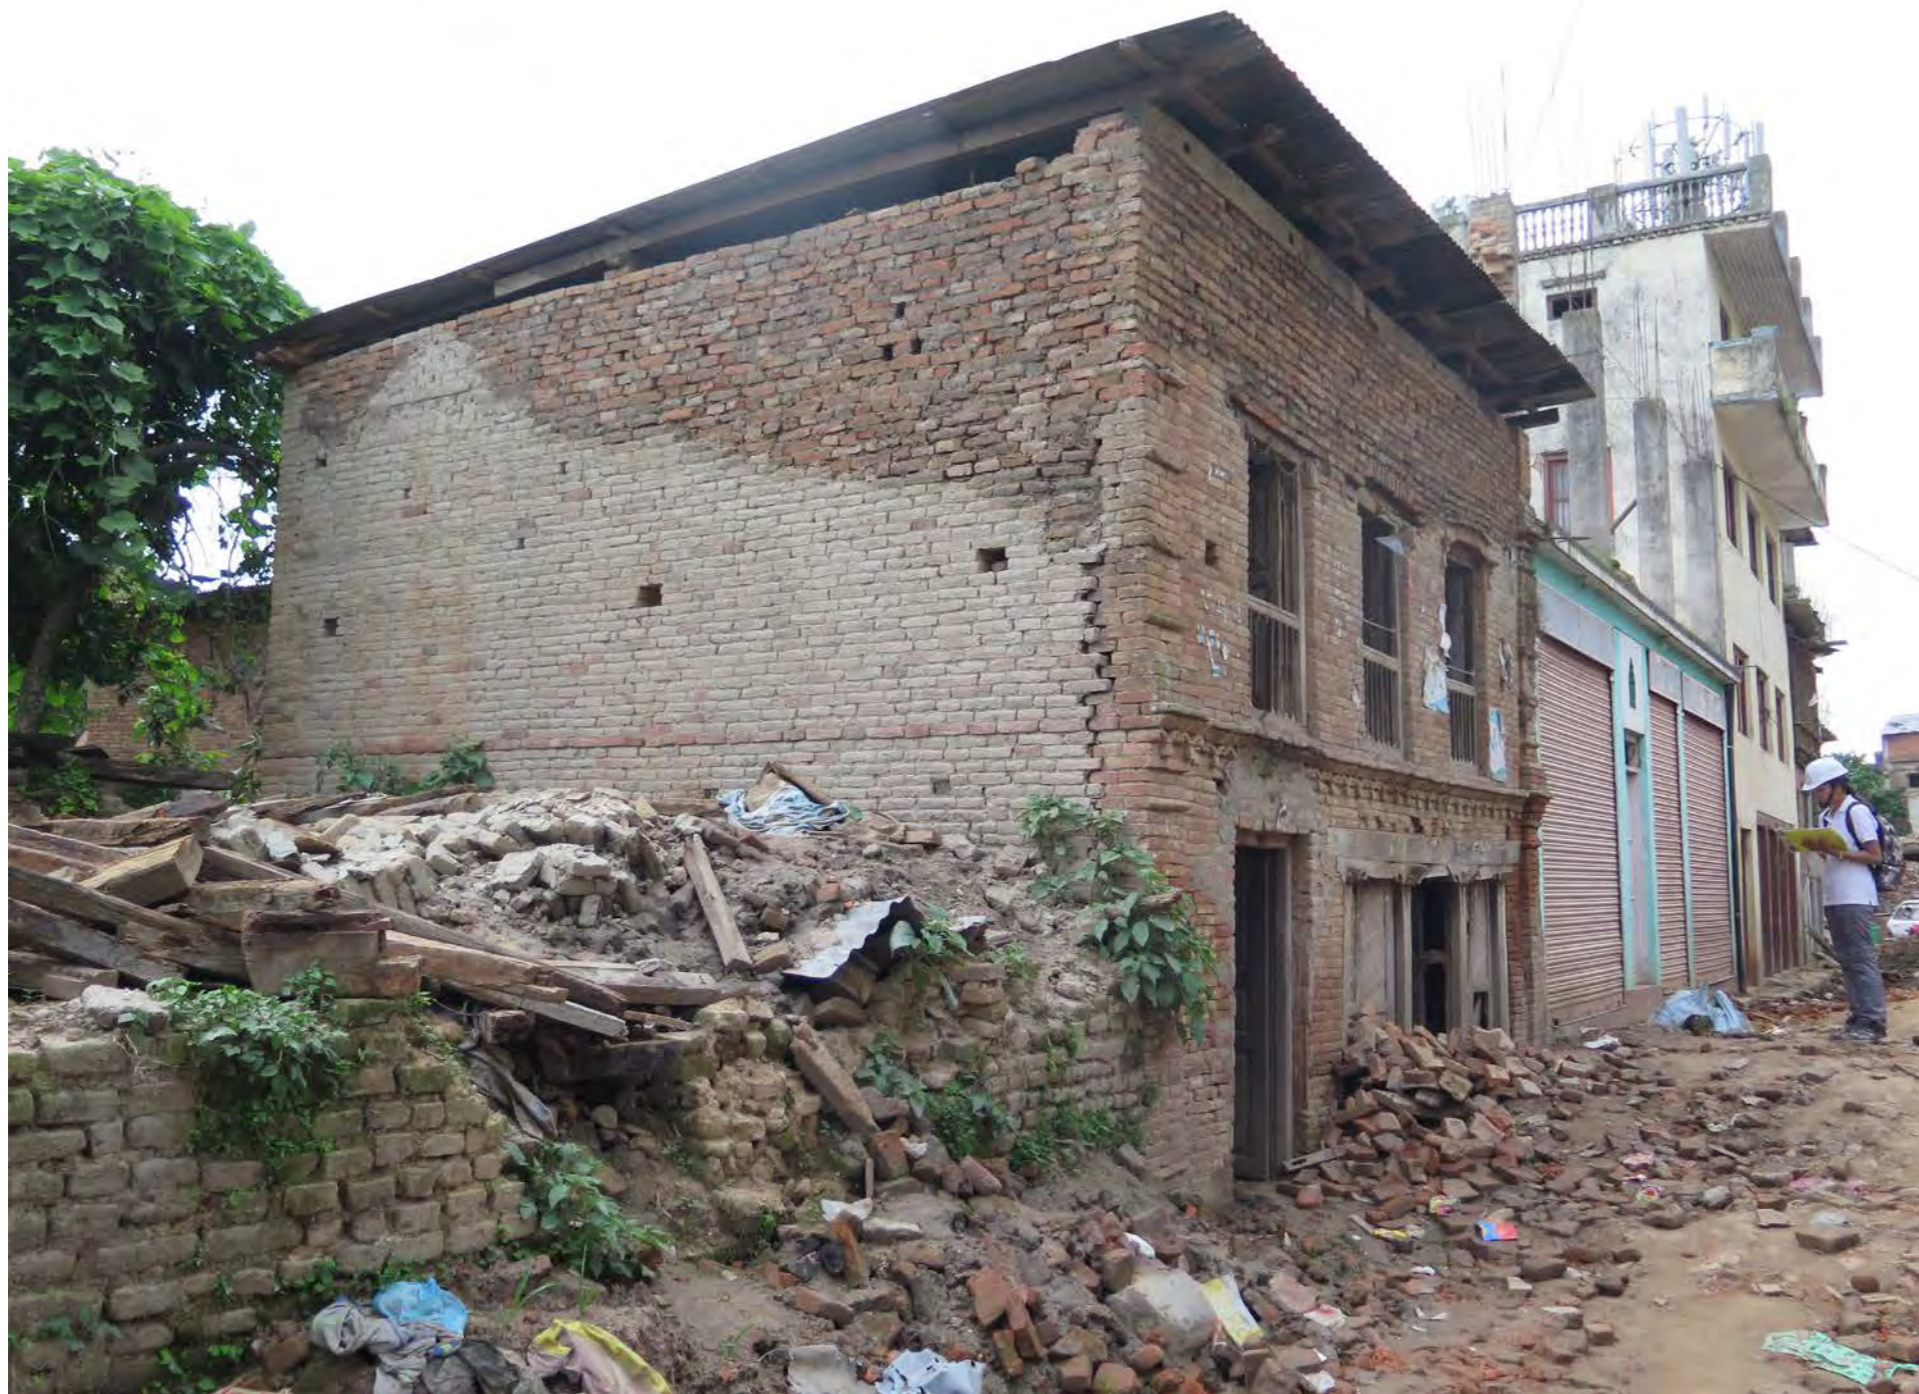
NUMBER	CONTACT	STOREY NO. RELATIVE POSITION	STRUCTURAL SYSTEM	PROBLEMS DESCRIPTION	DANGER	CONDITION
e36	Jhamak Shrestha	G+3 (EH)	B	2 floors collapsed. Vertical crack on North west and south east corner. North wall buldging. Ground floor doors damaged. Rising damp.

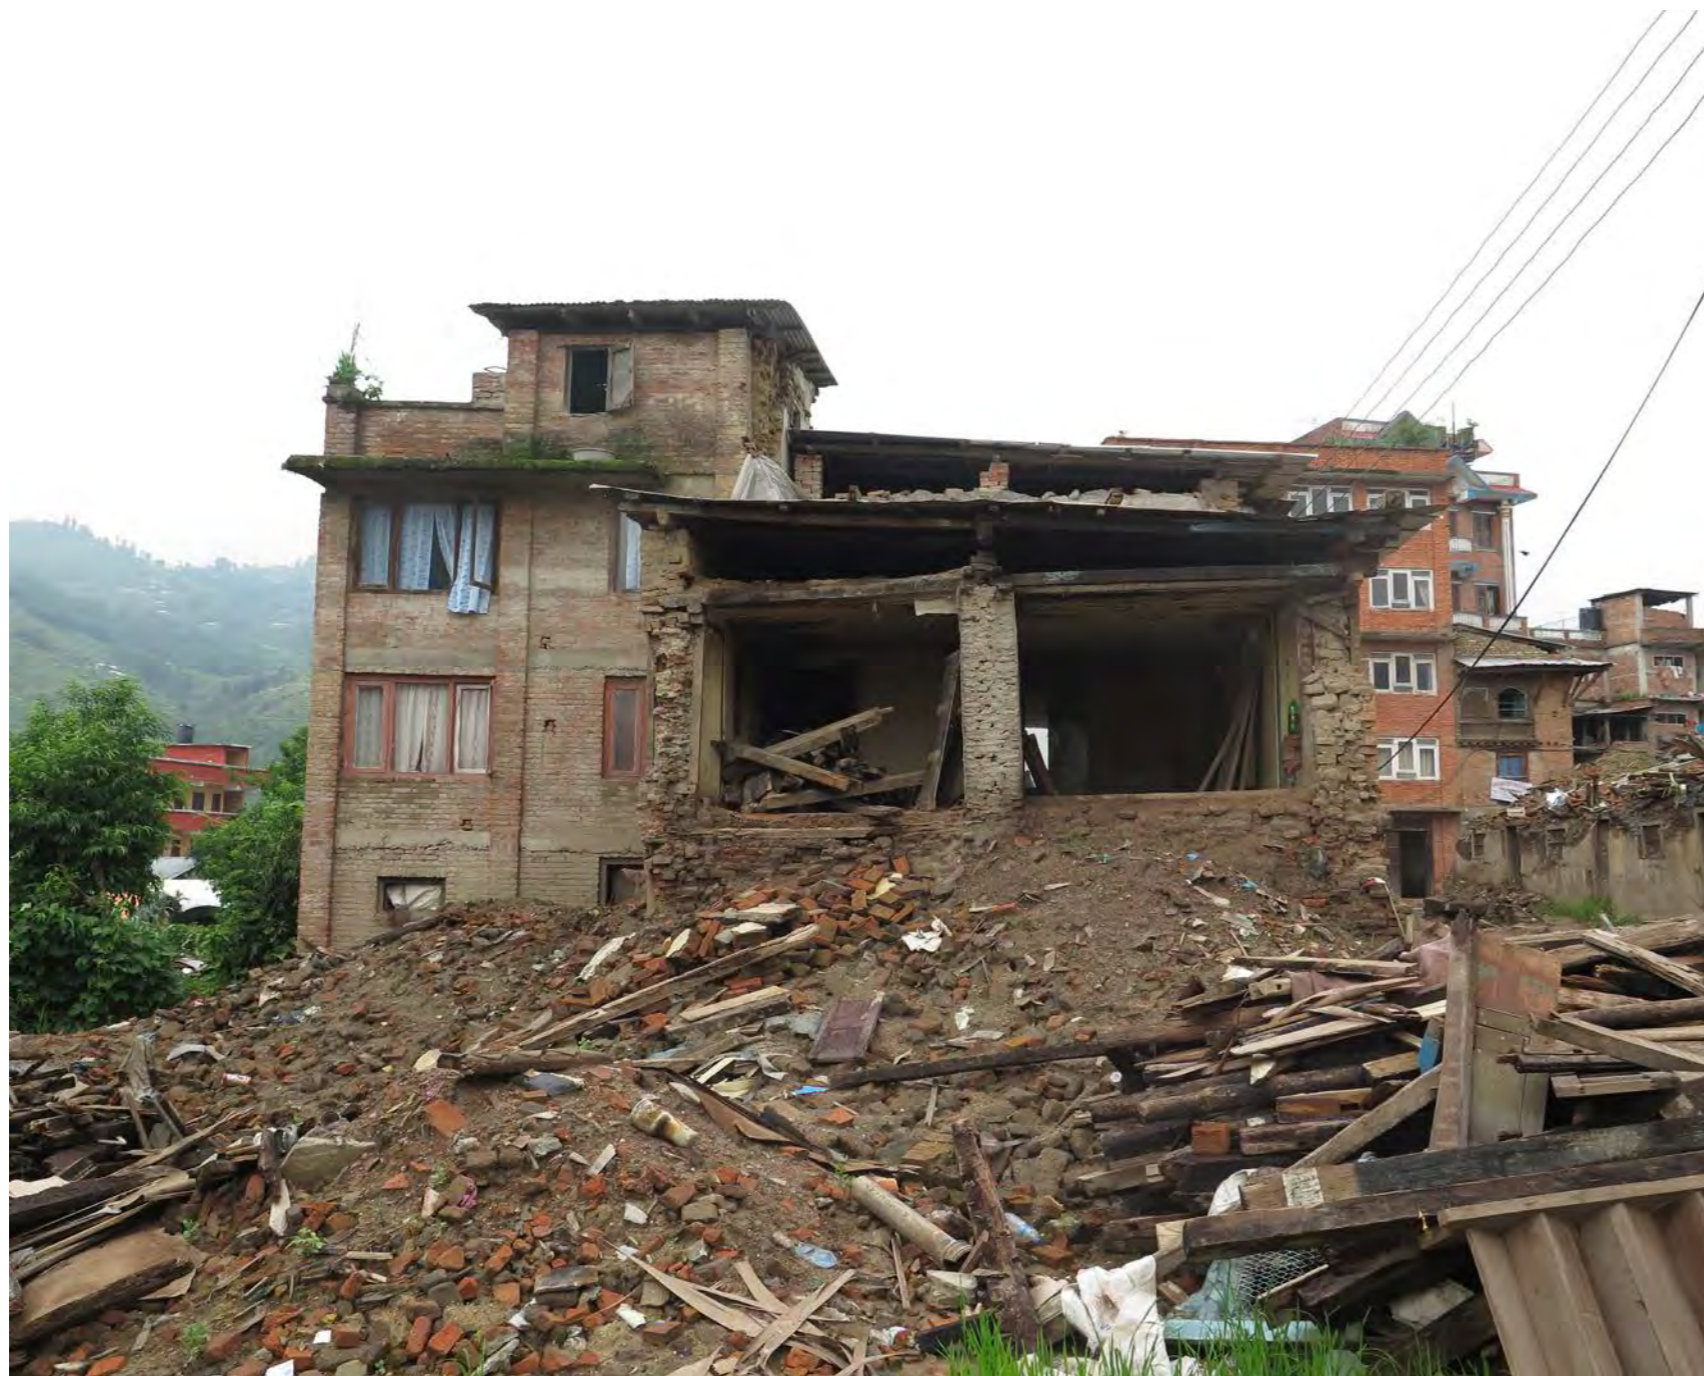
NUMBER	CONTACT	STOREY NO. (SI) RELATIVE POSITION	STRUCTURAL SYSTEM	PROBLEMS DESCRIPTION	DANGER	CONDITION
i63	Gobinda Bahadur Shrestha (9851008099)	G+1	B	Totally collapsed	⊗	R +
i64	Krishna Bahadur Shrestha (9843791039)	G+4	B	Totally collapsed	⊗	R + Jhya lost
