2015 Earthquake Damage Mapping

Sankhu

October 2015

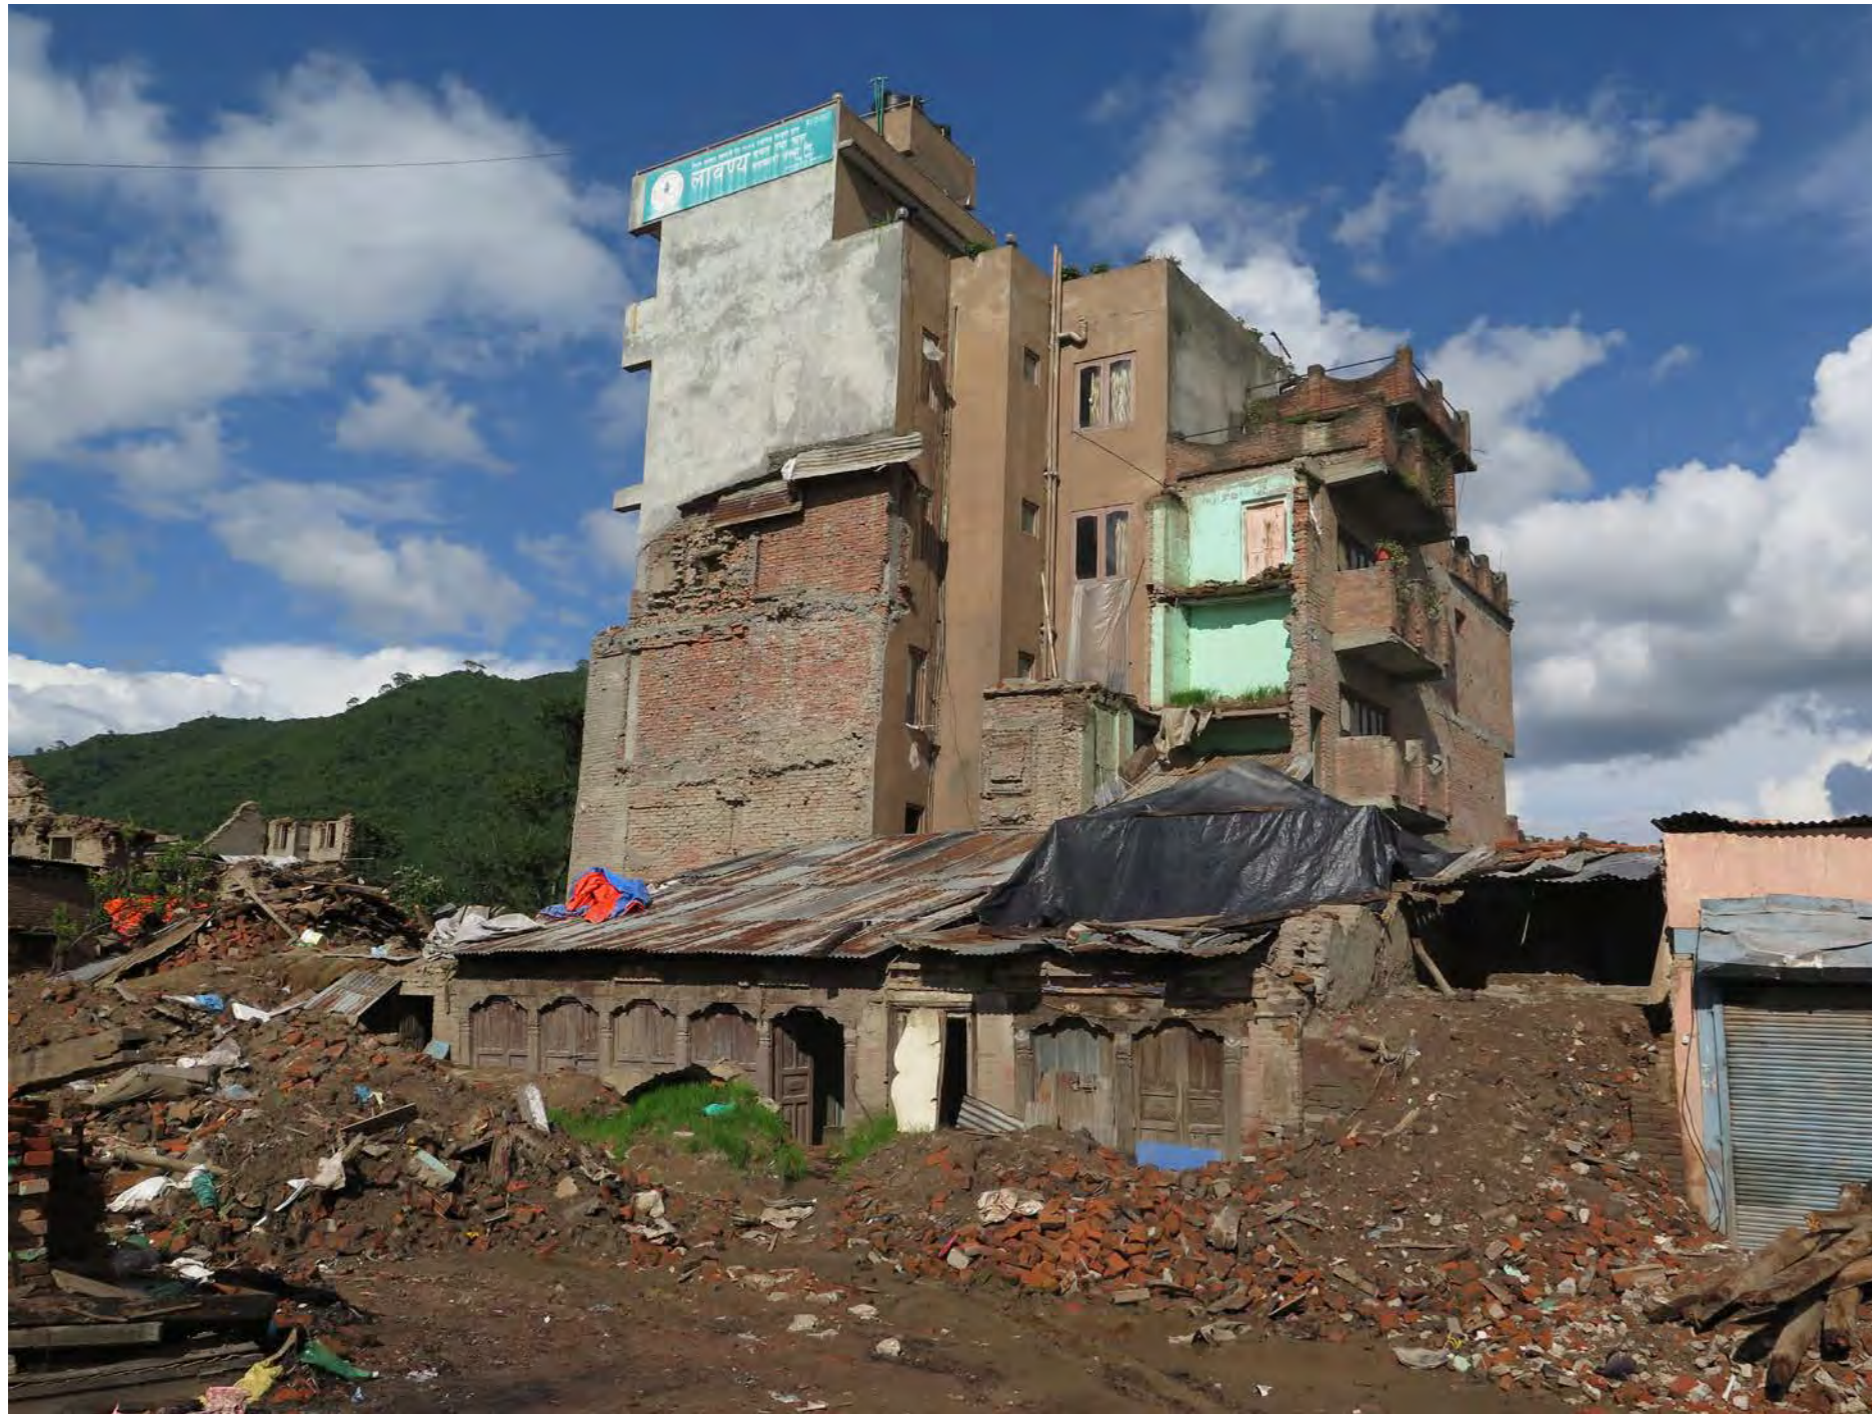
NUMBER	CONTACT	STOREY NO. RELATIVE POSITION	STRUCTURAL SYSTEM	PROBLEMS DESCRIPTION	DANGER	CONDITION
j05	Ashok Lal Shrestha (9841492326)	G+4	B	4 floors collapsed. Ground floor very degraded.	⊗	P +

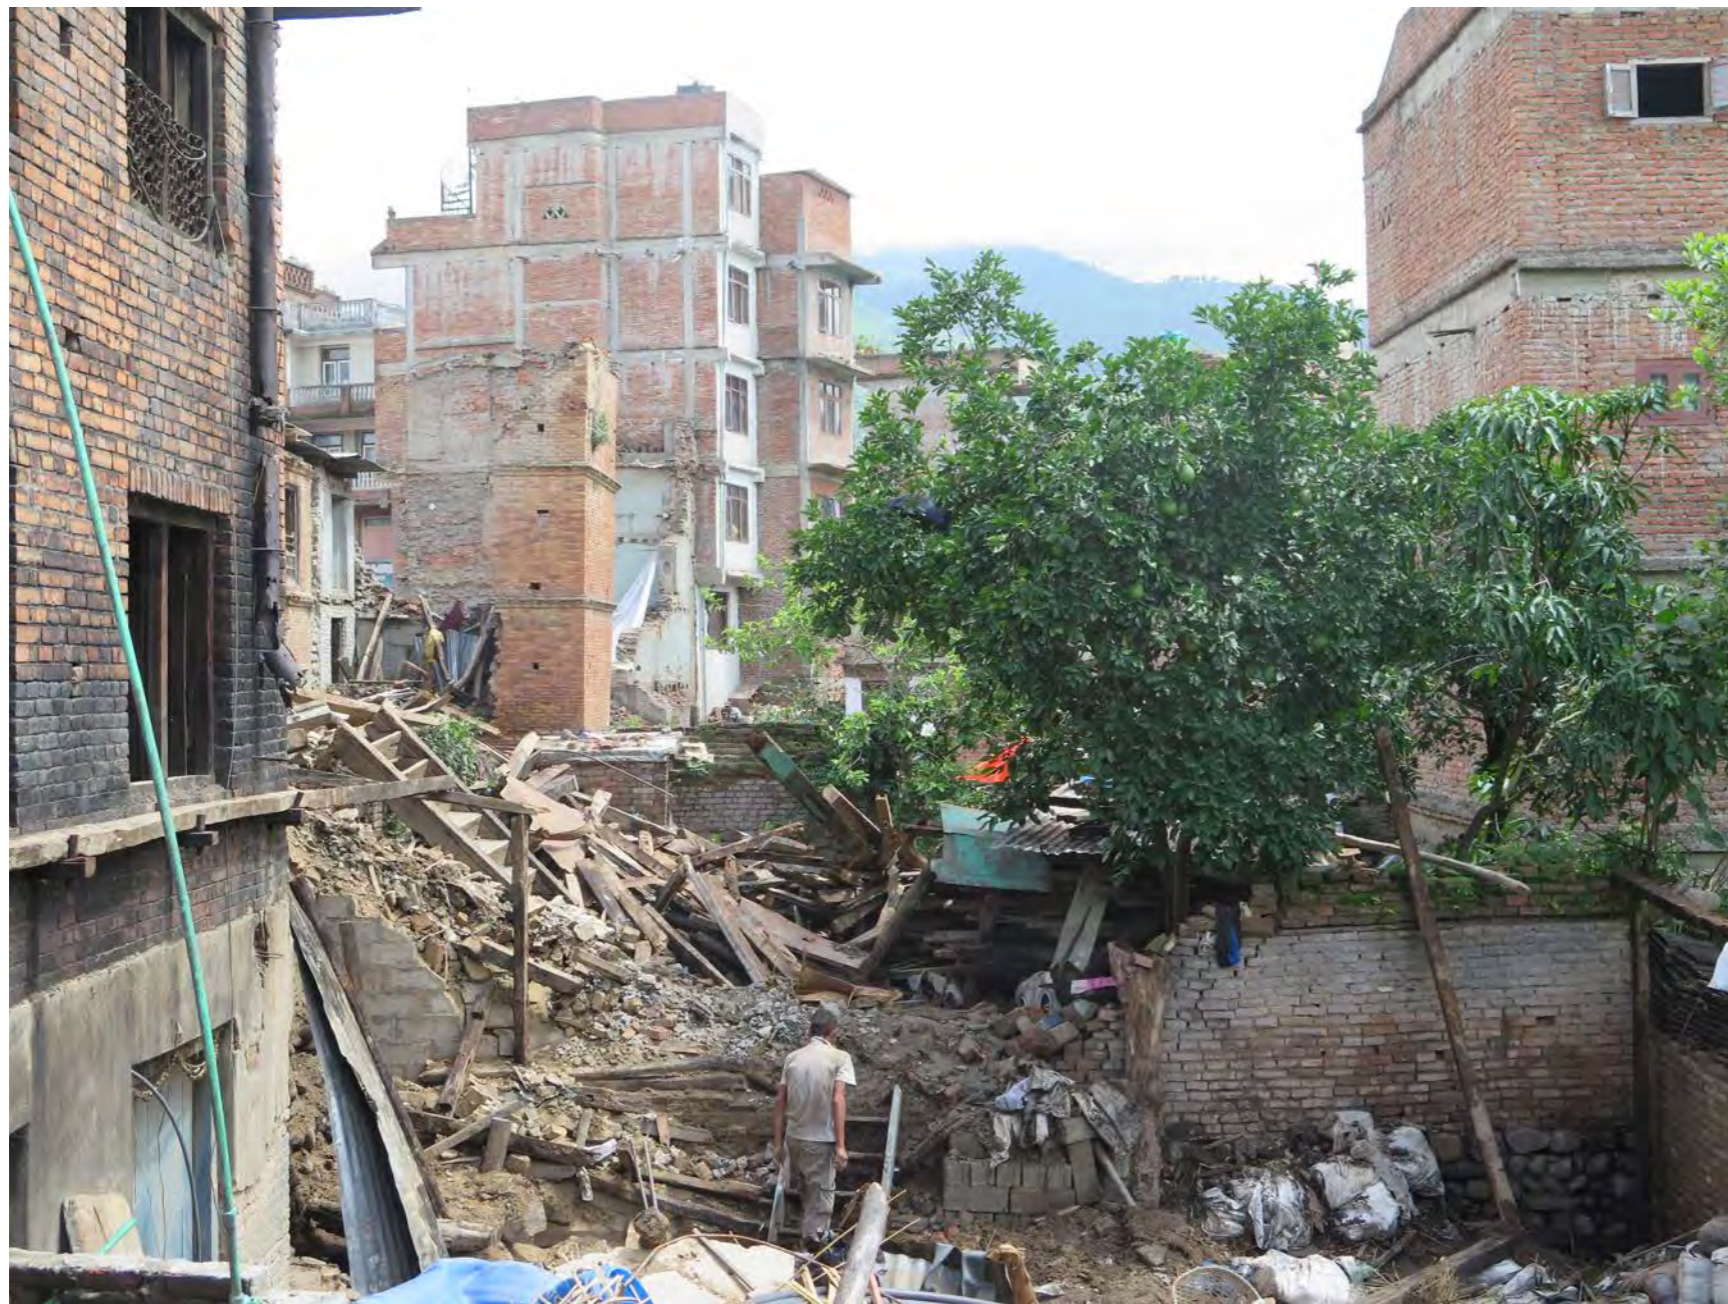
NUMBER	CONTACT	STOREY NO. RELATIVE POSITION	STRUCTURAL SYSTEM	PROBLEMS DESCRIPTION	DANGER	CONDITION
I24	Bhakti Das Shrestha (9841239782)	G+4 (1EL)	B	Totally collapsed	⊗	
I25	Madan Shrestha (9841176507)	G+4	B	Totally collapsed	1/2 ⊗

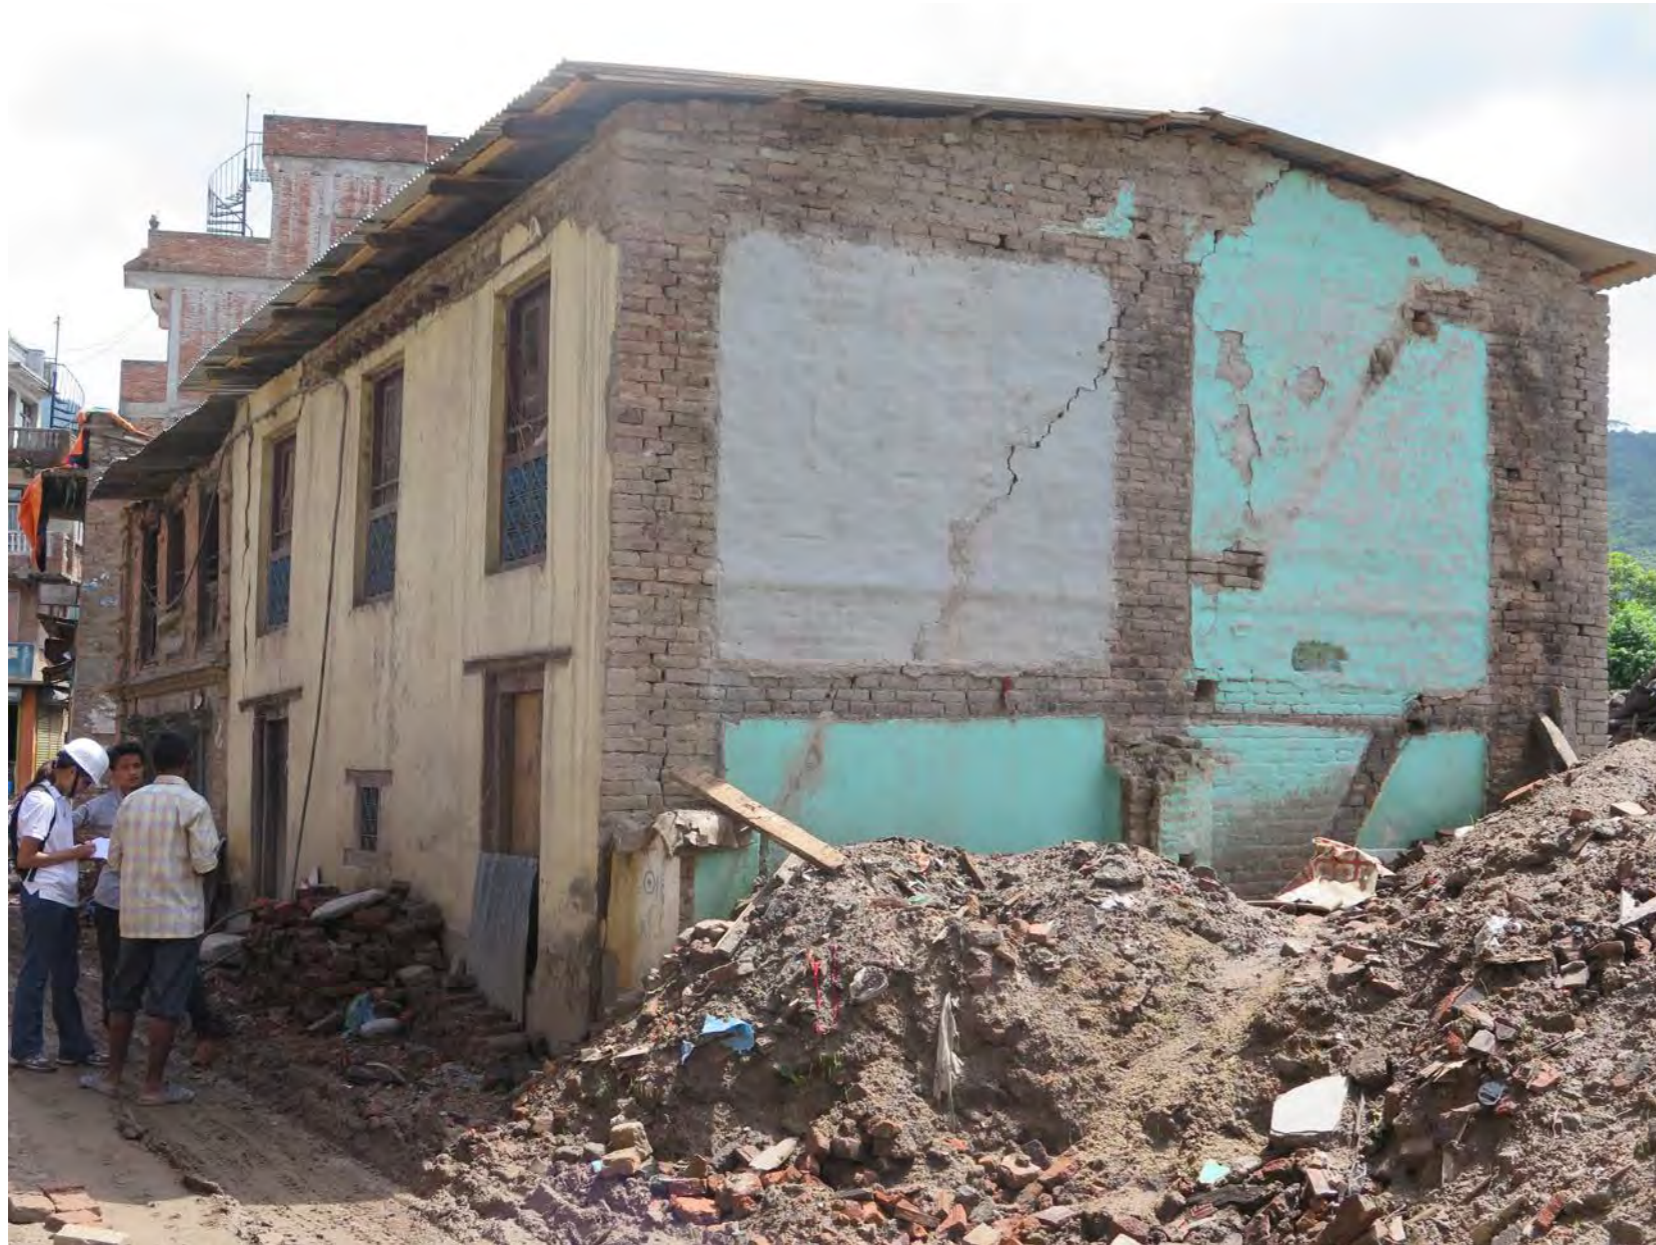
NUMBER	CONTACT	STOREY NO. RELATIVE POSITION	STRUCTURAL SYSTEM	PROBLEMS DESCRIPTION	DANGER	CONDITION
I26	Sumsher Raj Rajbhandari	G+3.5	B	top floor demolished. South eastern end bulding	1/2 ⊗	+

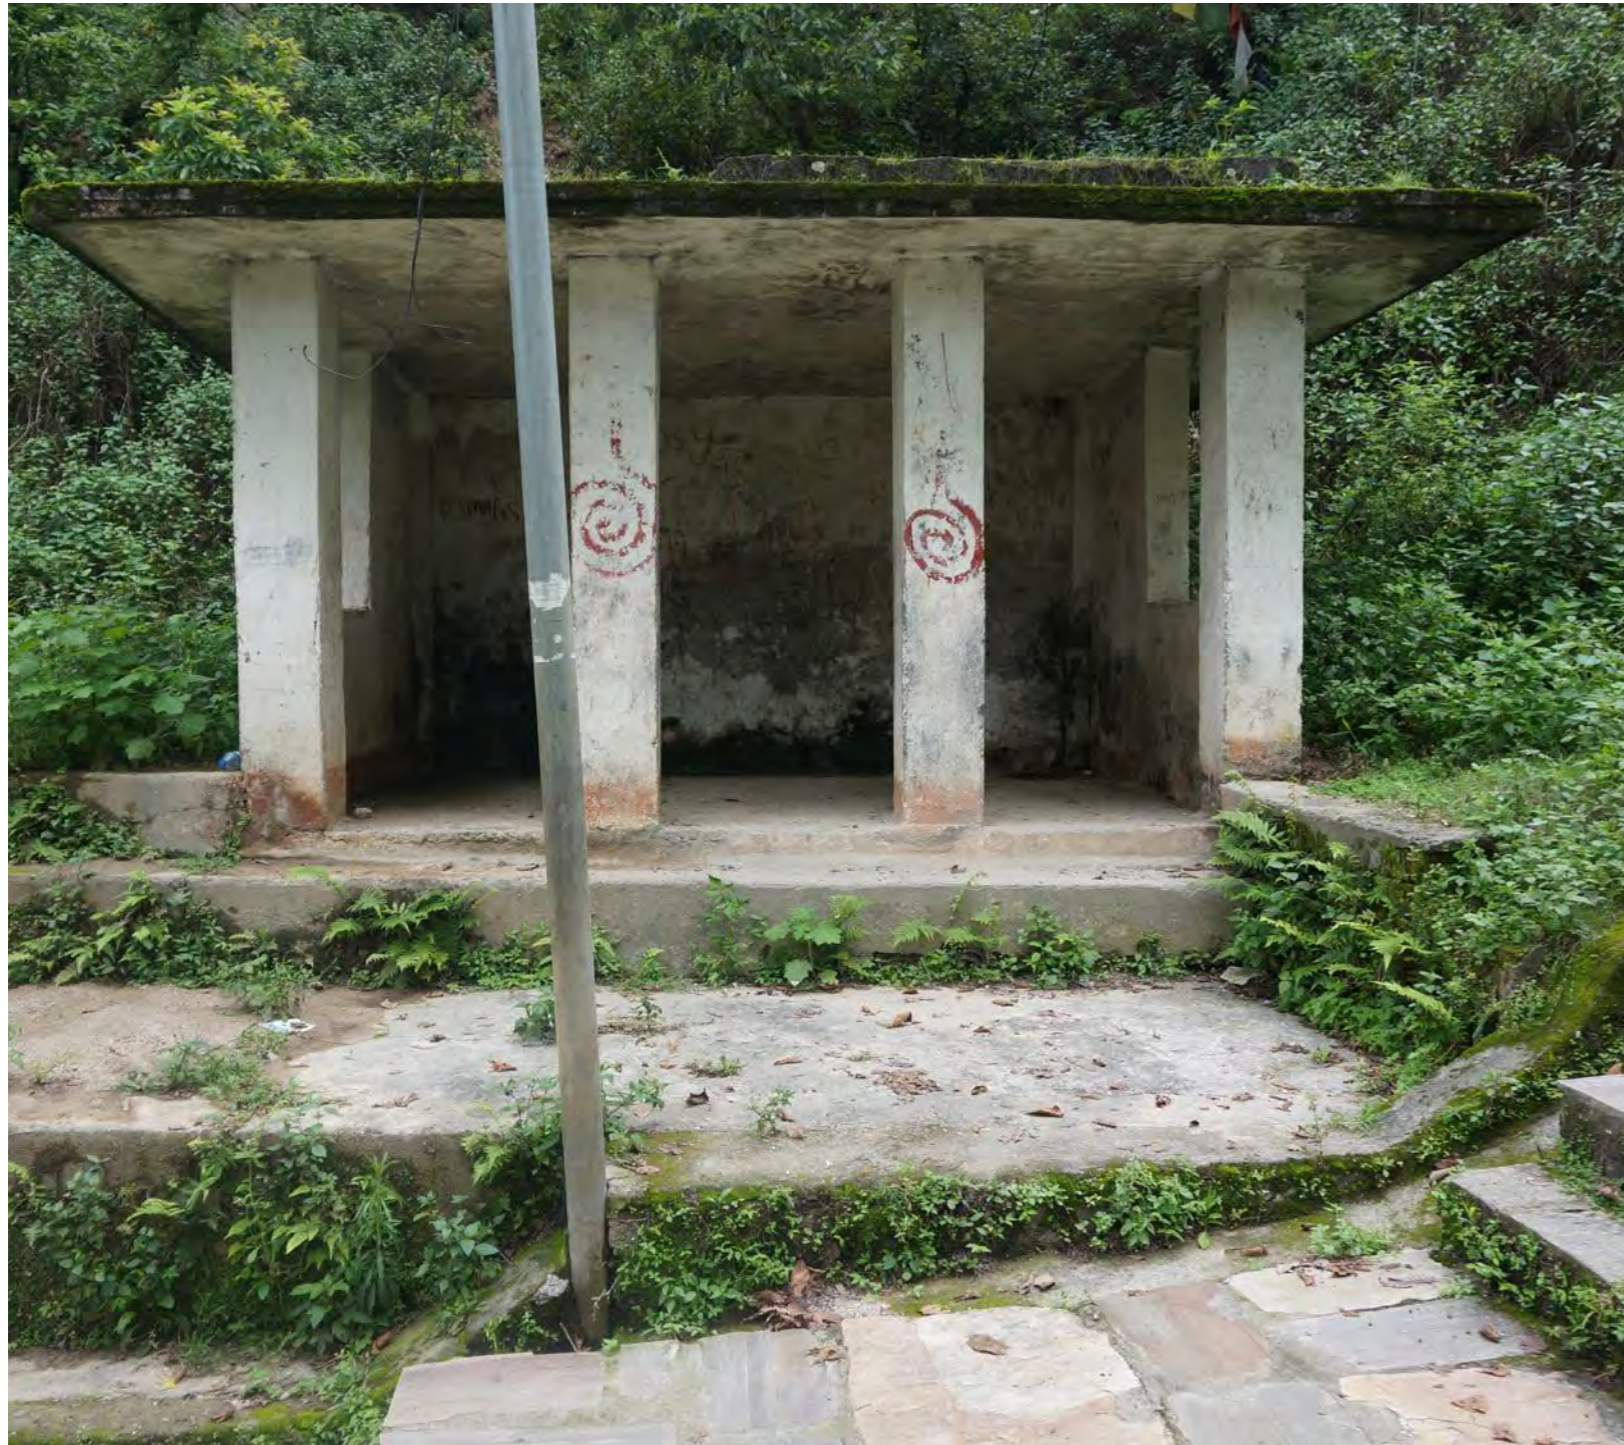
NUMBER	NAME	DATE A.D.	TPOLOGY	GENERAL DESCRIPTION	PROBLEMS DESCRIPTION	DANGER/ DESTROY	
06	Pati			Concrete structure. G.	Dampness at the west wall

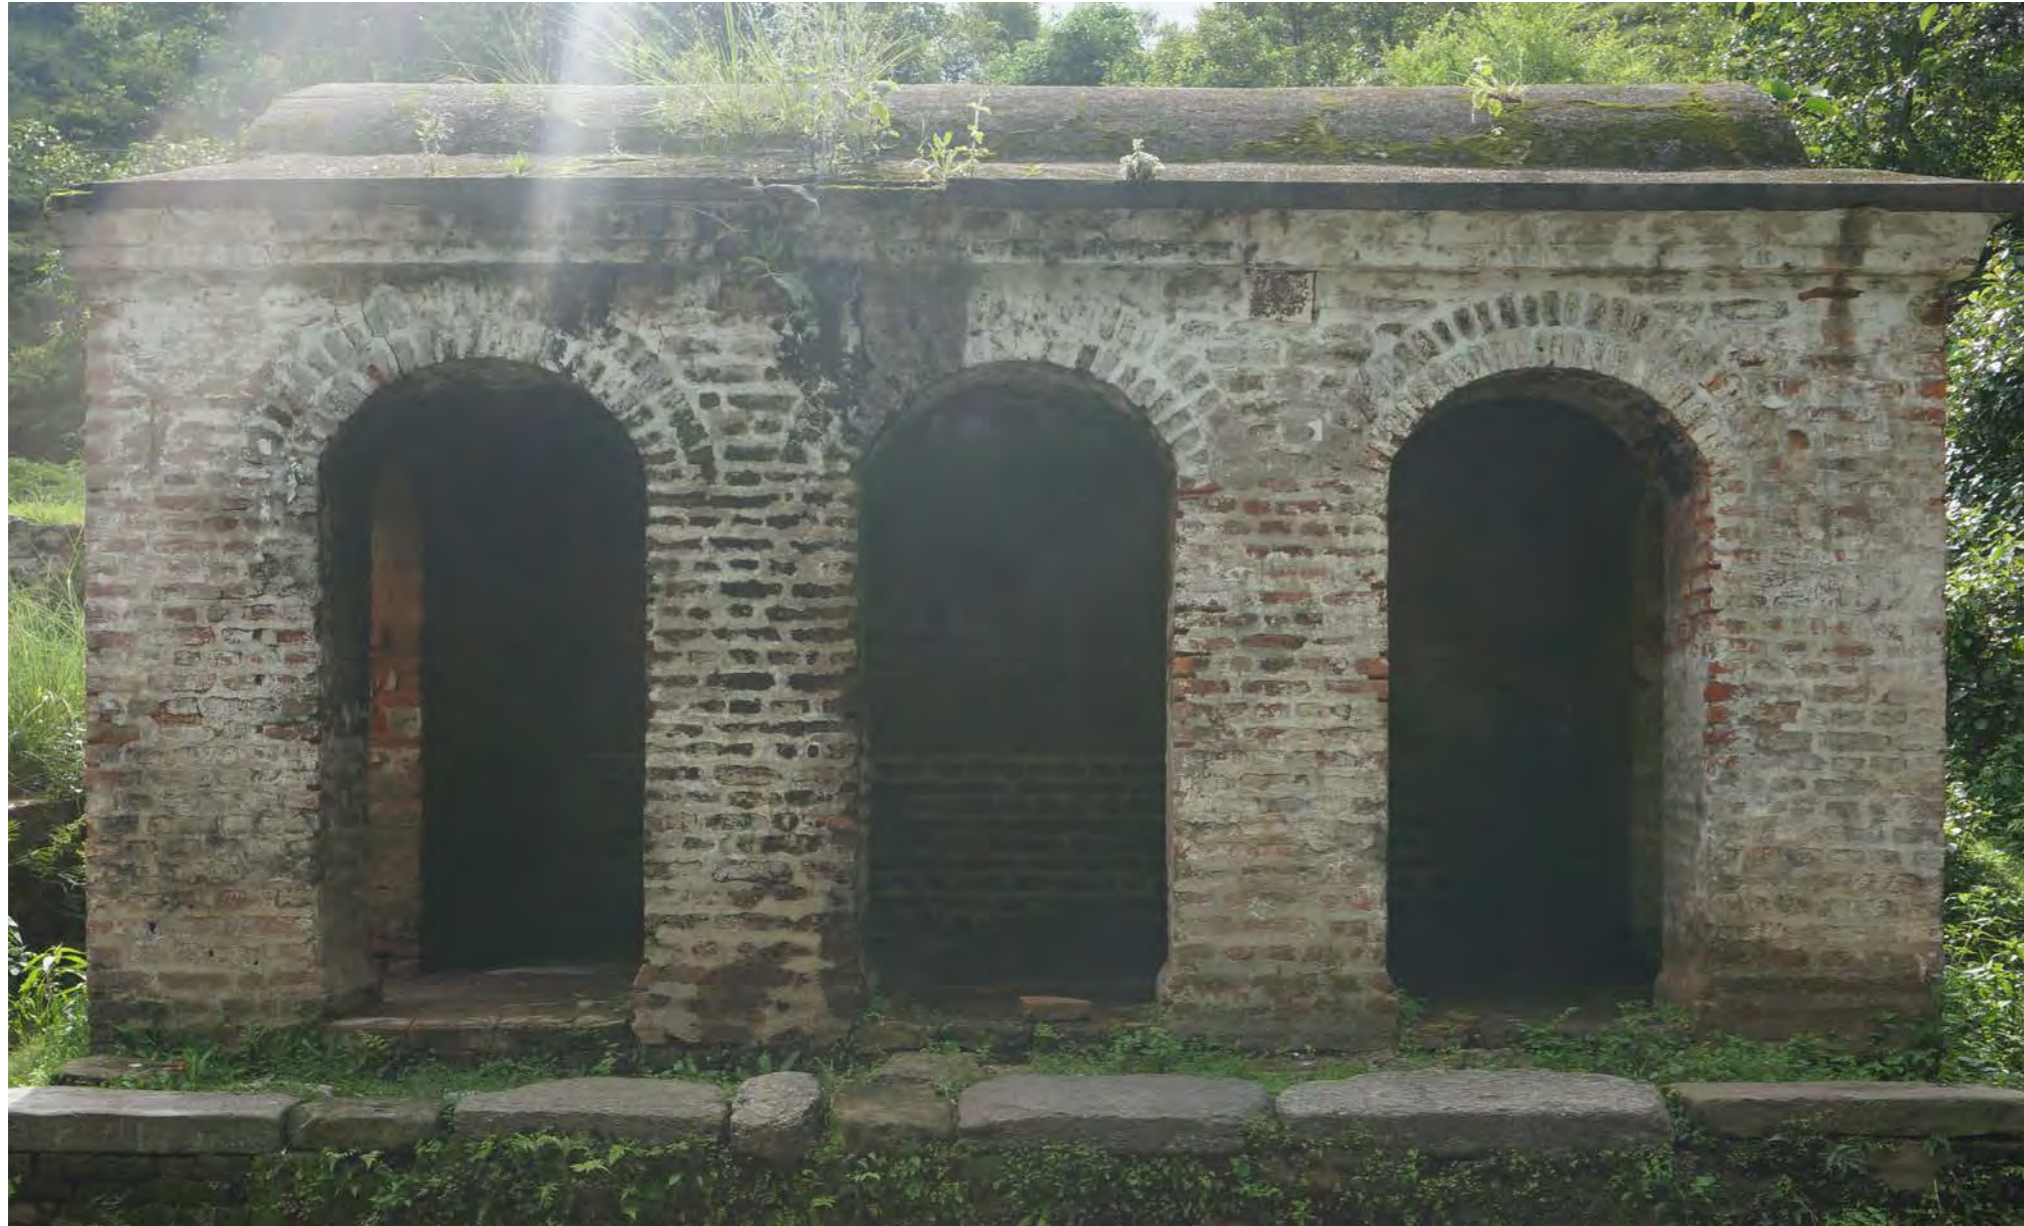
NUMBER	NAME	ESTABLISHED DATE (A.D.)	TYPOLOGY	GENERAL DESCRIPTION	PROBLEMS DESCRIPTION	DANGER/ DESTROY	
12			Pati	Cemenetd roof of arcade space	Cracked south wall and dampness. West wall has diagonal crack. The living space has problem of dampness.		A site plan diagram showing the location of structure 12. The structure is highlighted in yellow and labeled with the number 12. It is situated near a road and other structures.

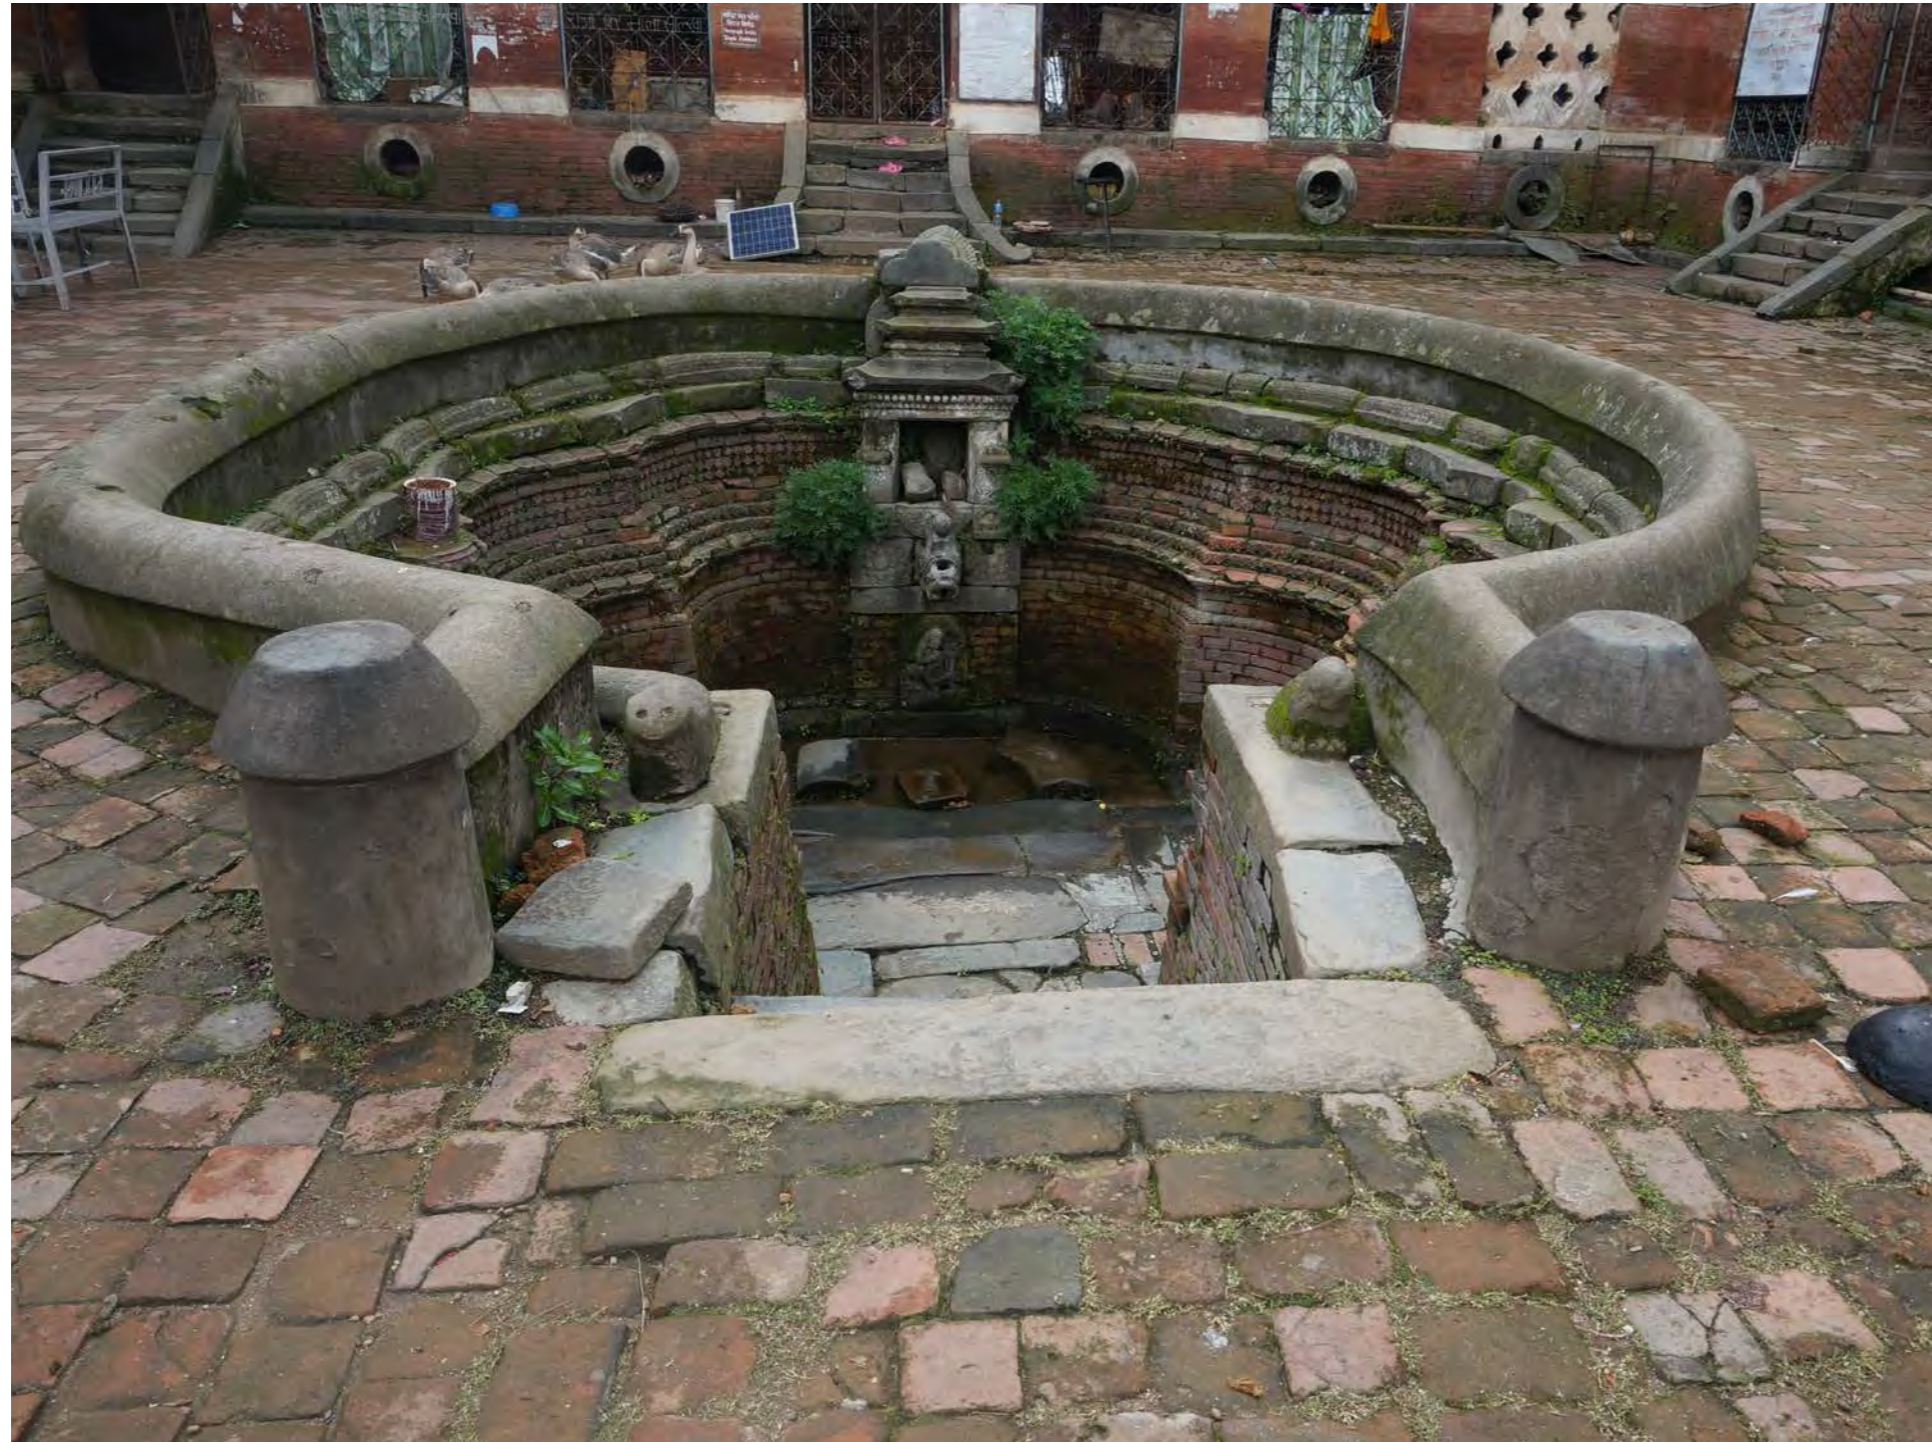
NUMBER	NAME	DATE A.D.	TYOLOGY	GENERAL DESCRIPTION	PROBLEMS DESCRIPTION	DANGER/ DESTROY	
11			Hiti	Stone Water spout	Growing vegetation on wall Some bricks out of plane

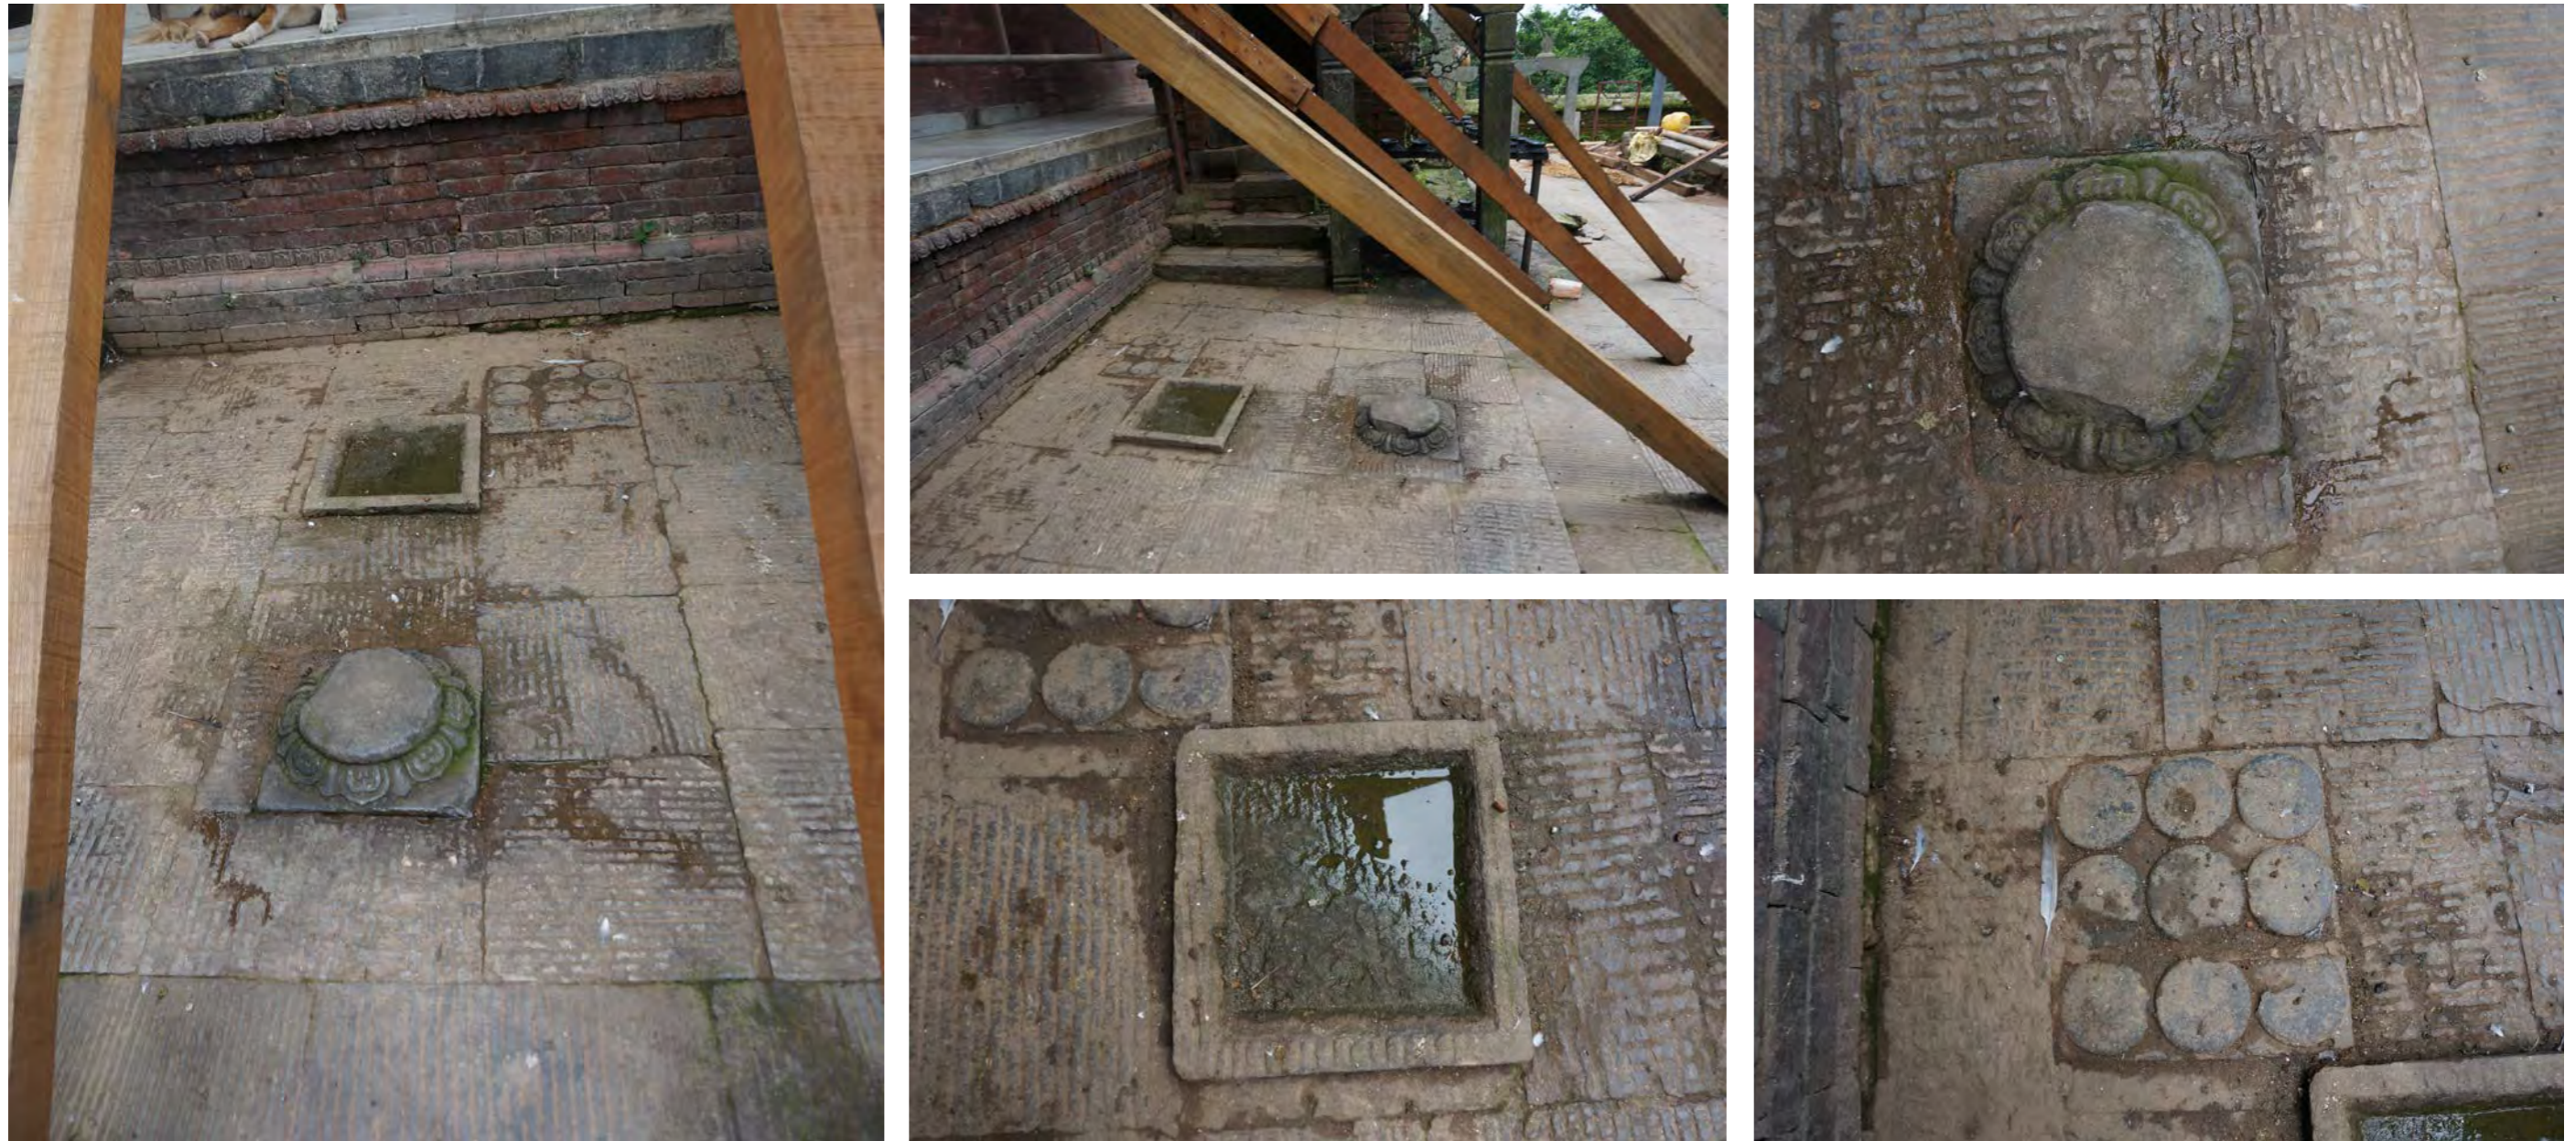
NUMBER	NAME	DATE A.D.	TYOLOGY	GENERAL DESCRIPTION	PROBLEMS DESCRIPTION	DANGER/ DESTROY
16-g			Jagyasala, Mandap and Astamandal	Stone Mandap, Jagyasala and Astamandal in front of Manjushree	Northern part damaged

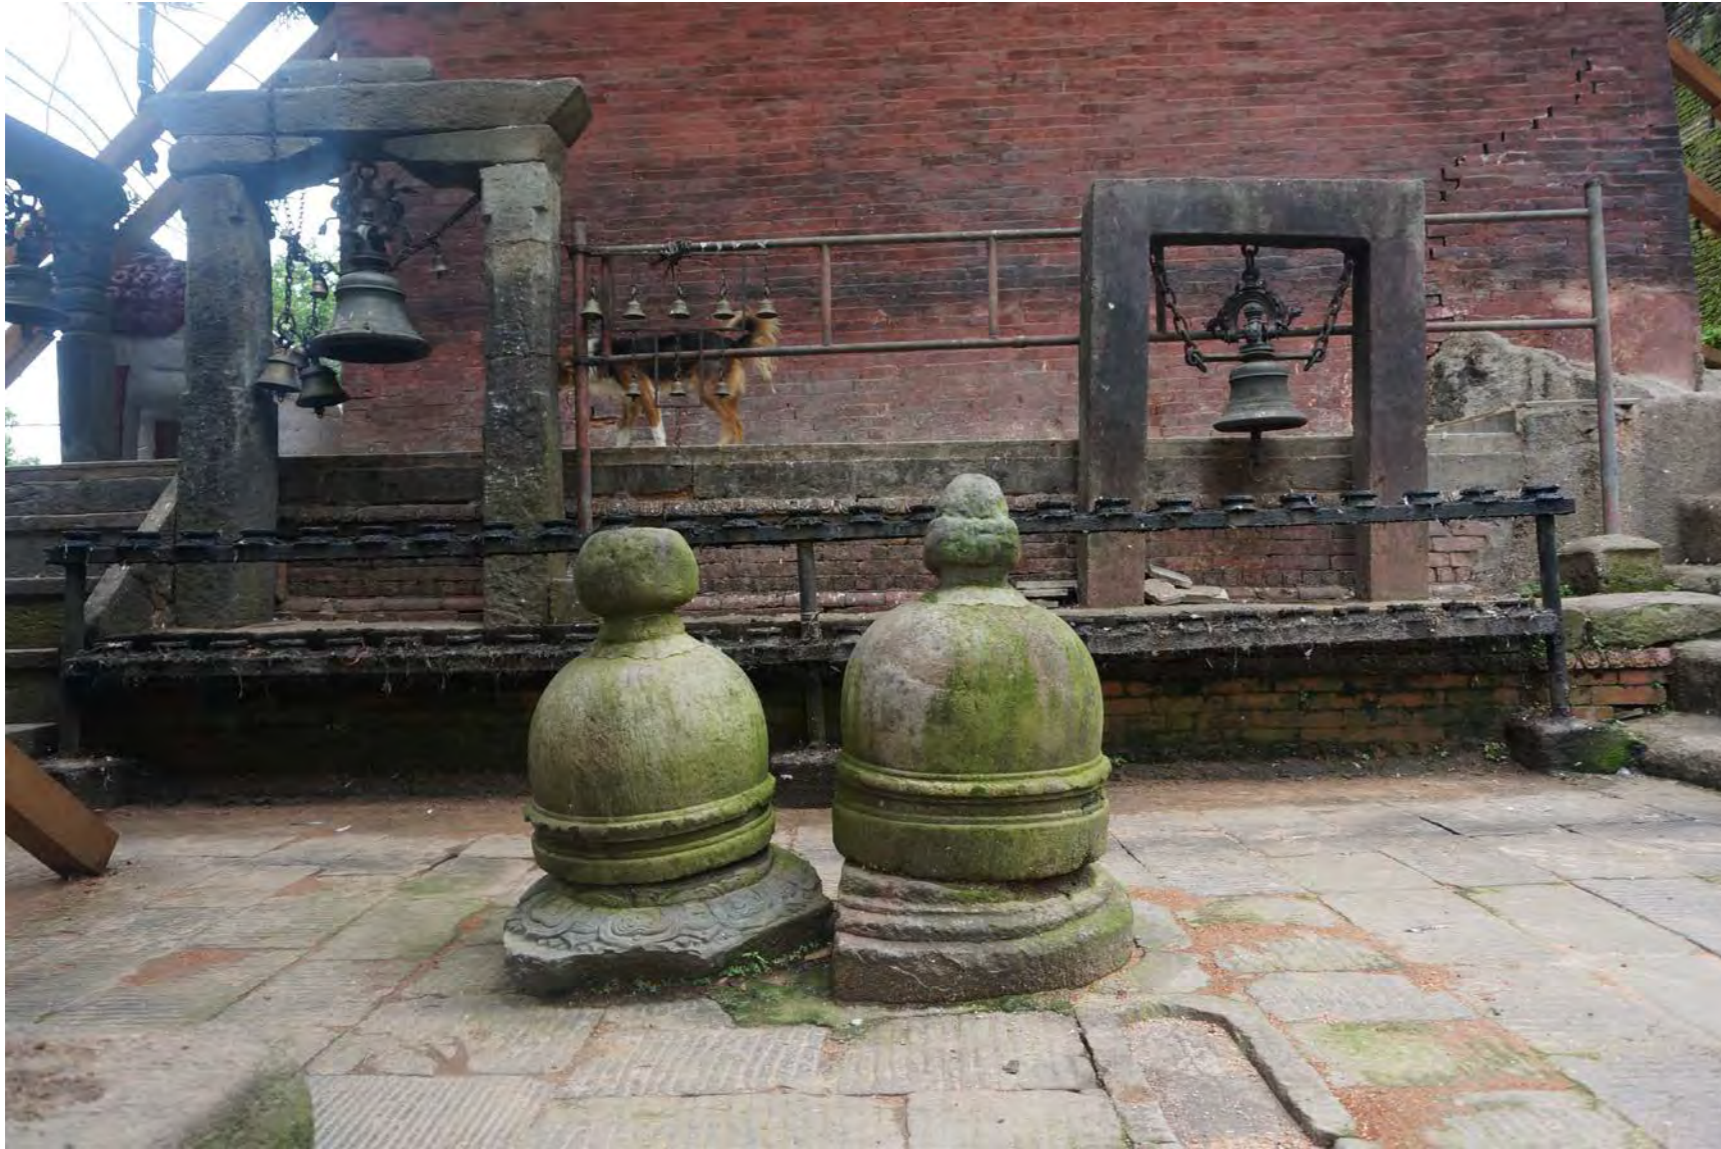
NUMBER	NAME	ESTABLISHED DATE (A.D.)	TYPOLOGY	GENERAL DESCRIPTION	PROBLEMS DESCRIPTION	DANGER/ DESTROY
16-i, j	Ashoka Chaitya		Chaitya	Stone Structure	Stone deteriorated

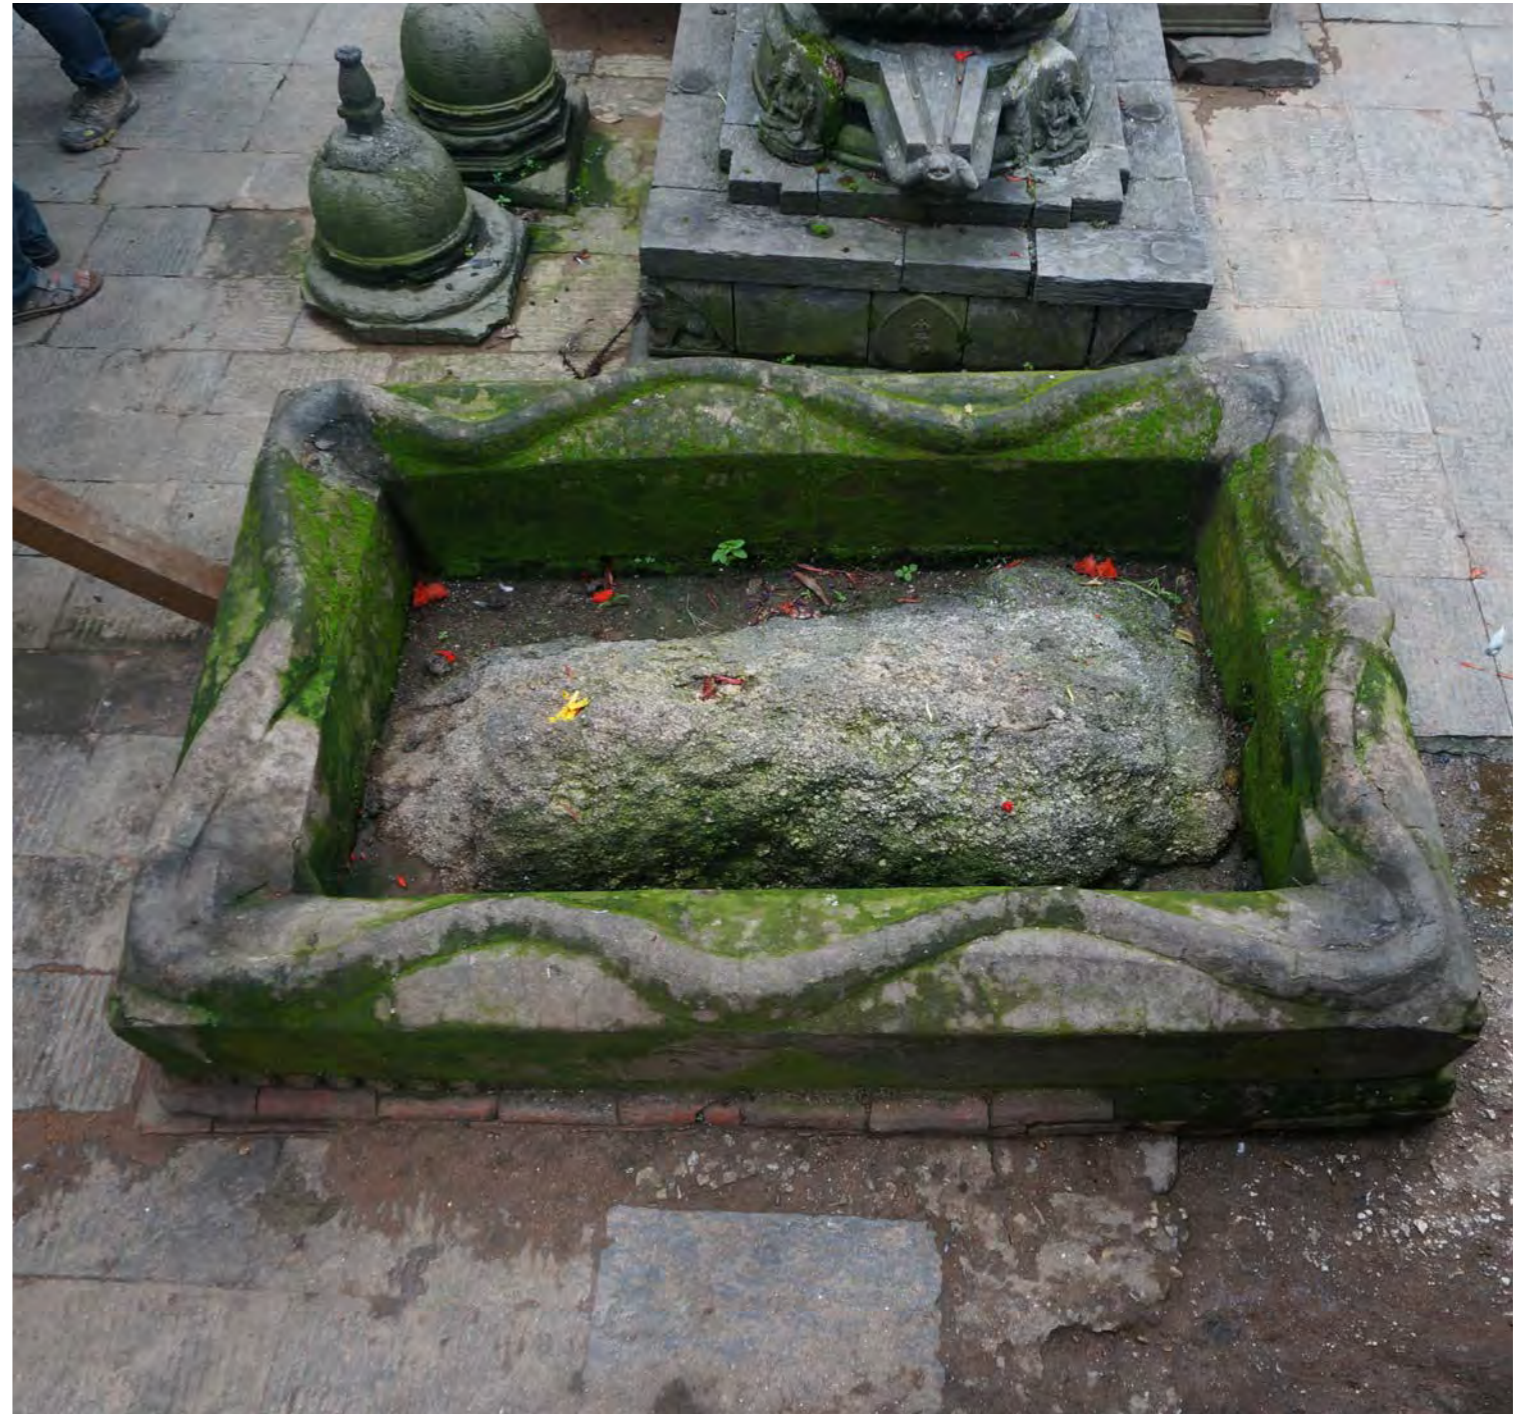
NUMBER	NAME	ESTABLISHED DATE (A.D.)	TYPOLOGY	GENERAL DESCRIPTION	PROBLEMS DESCRIPTION	DANGER/ DESTROY
16-I			Inscription	Stone tablet	No Visible Damages	
17	Vasuki Naga		Temple		Some Vegetation growth on wall Dampness problem
