2015 Earthquake Damage Mapping

Sankhu

October 2015

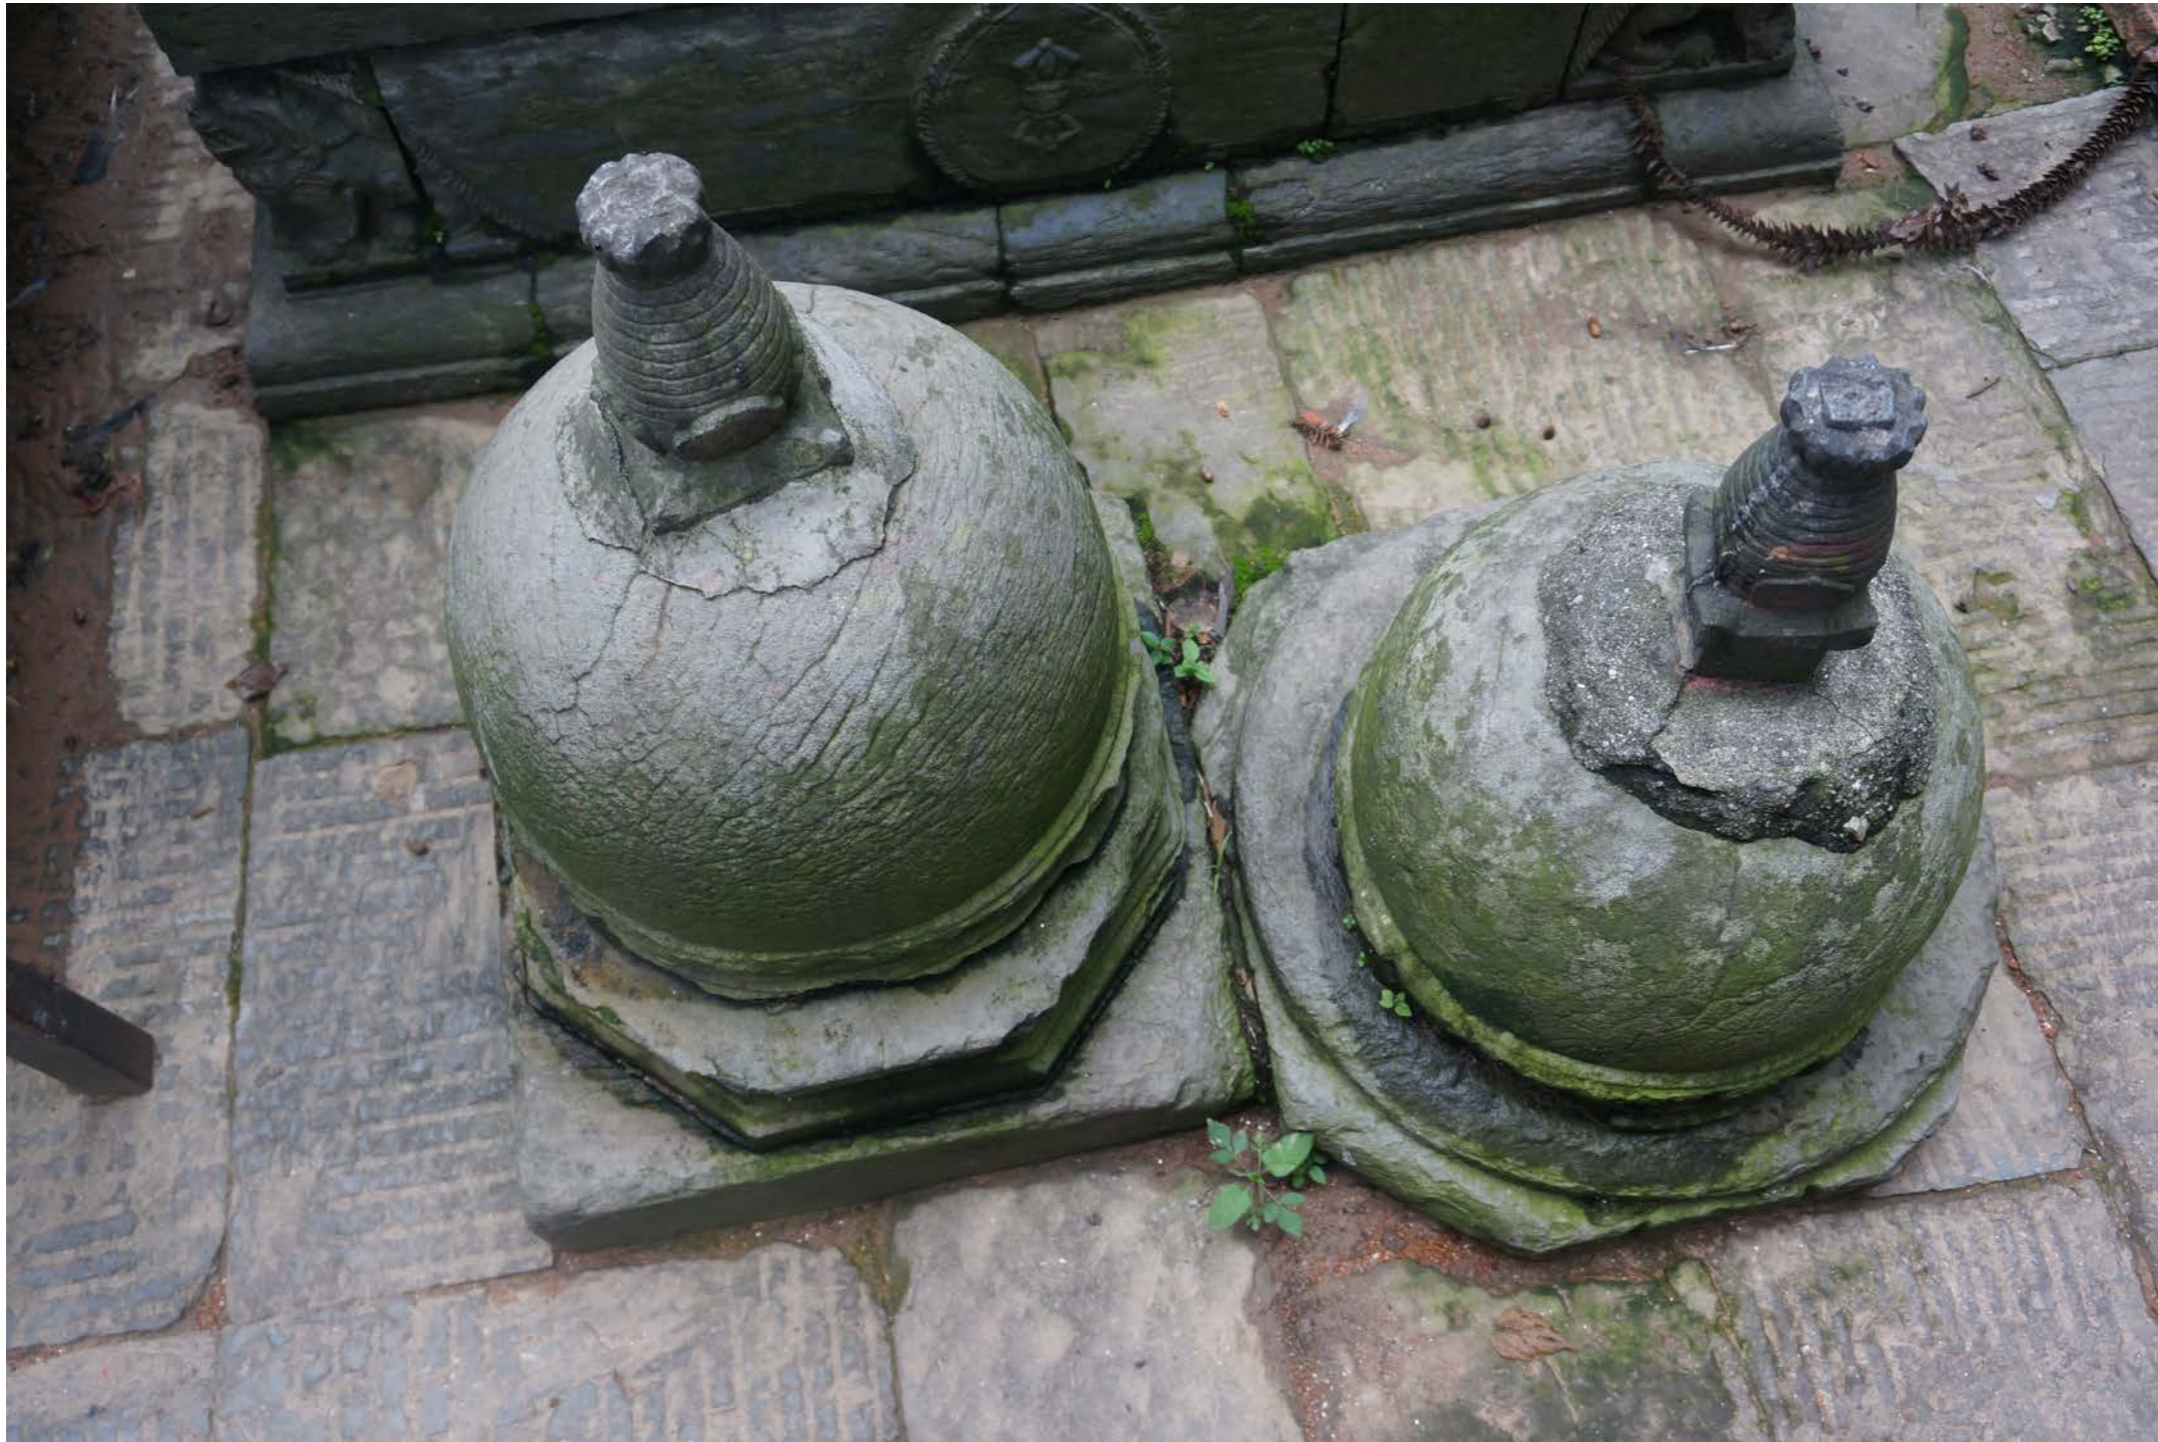
NUMBER	NAME	ESTABLISHED DATE (A.D.)	TYPOLOGY	GENERAL DESCRIPTION	PROBLEMS DESCRIPTION	DANGER/ DESTROY
19 & 20	Lichchhavi Chaitya		Chaitya	.	Damage is in N-W corner

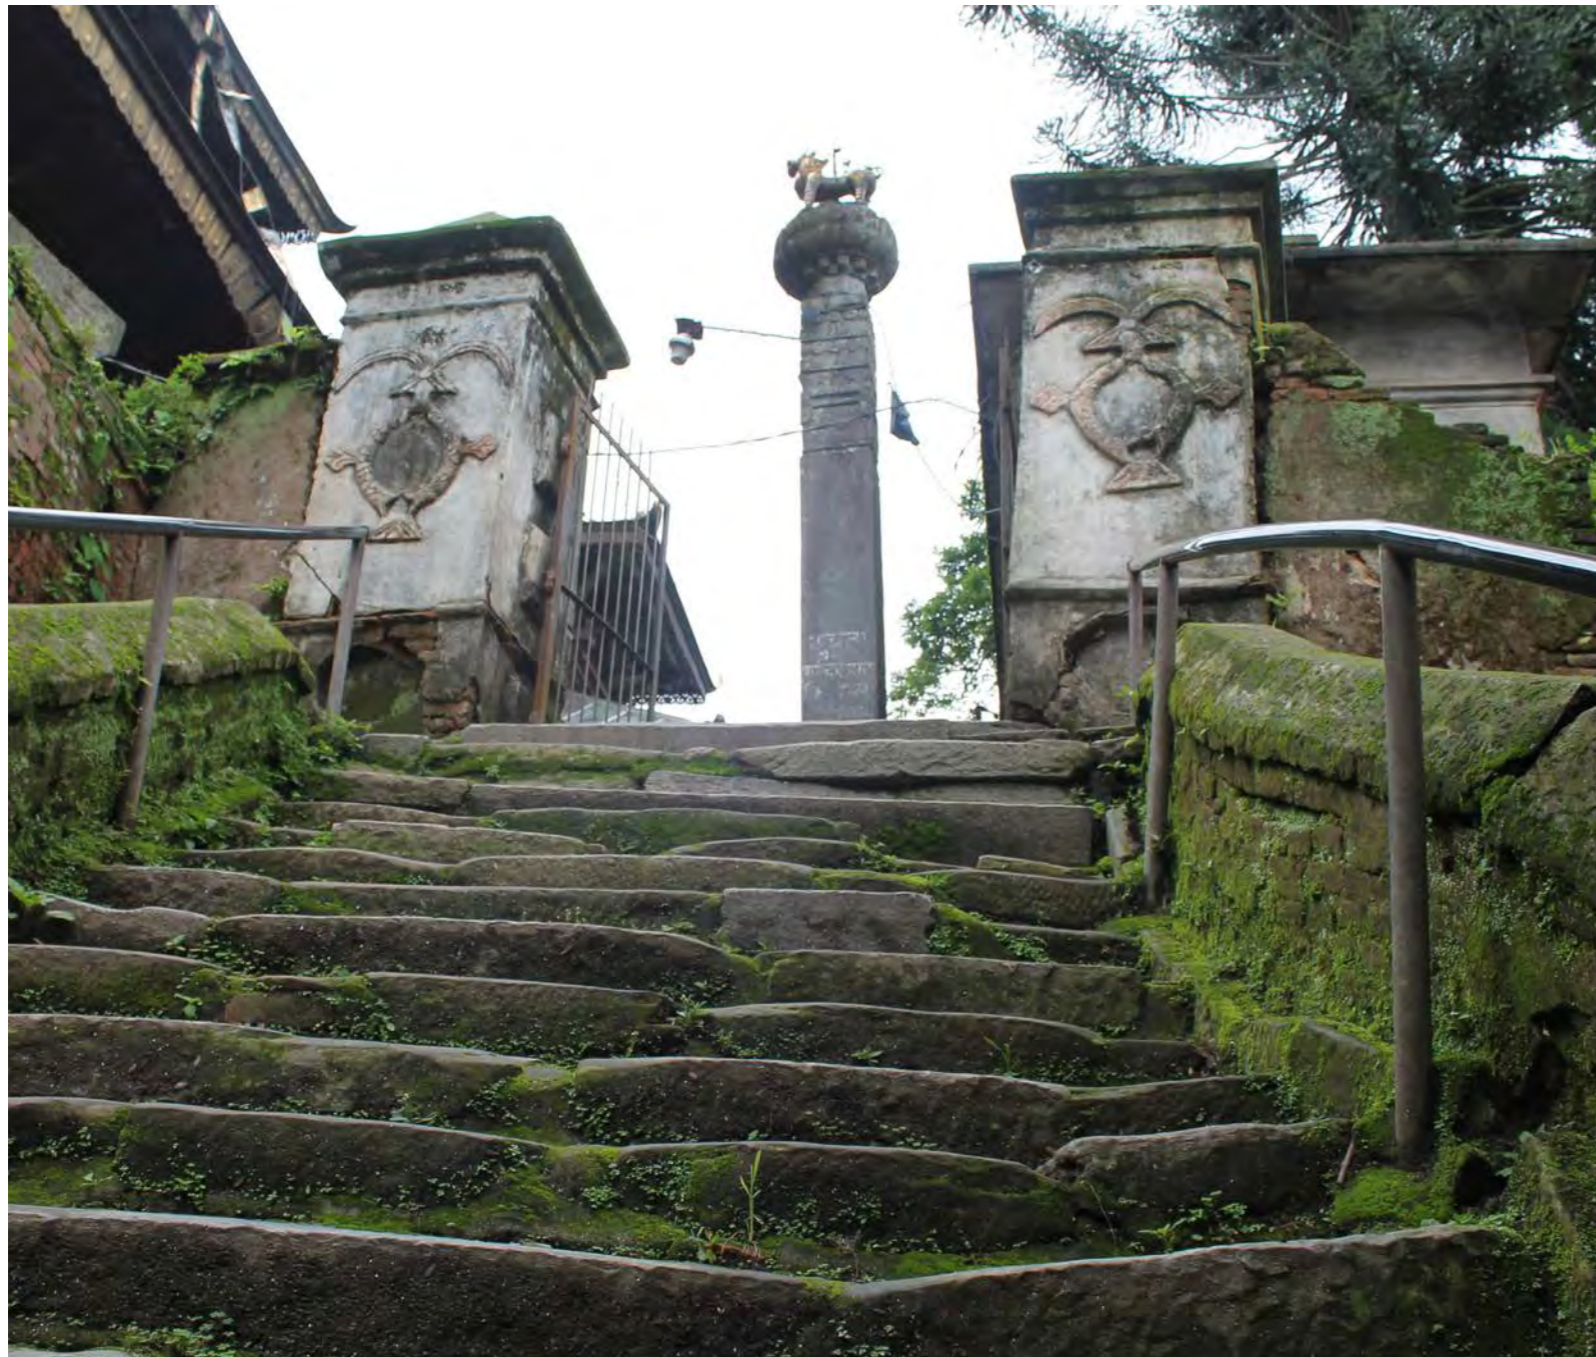
NUMBER	NAME	DATE A.D.	TYPOLOGY	GENERAL DESCRIPTION	PROBLEMS DESCRIPTION	DANGER/ DESTROY
21			Entrance gate	Metal bar Doors with two big sized supporting brick pillars	Both pillars with major cracks and offsets Two stone lion statues are missing, probably damaged

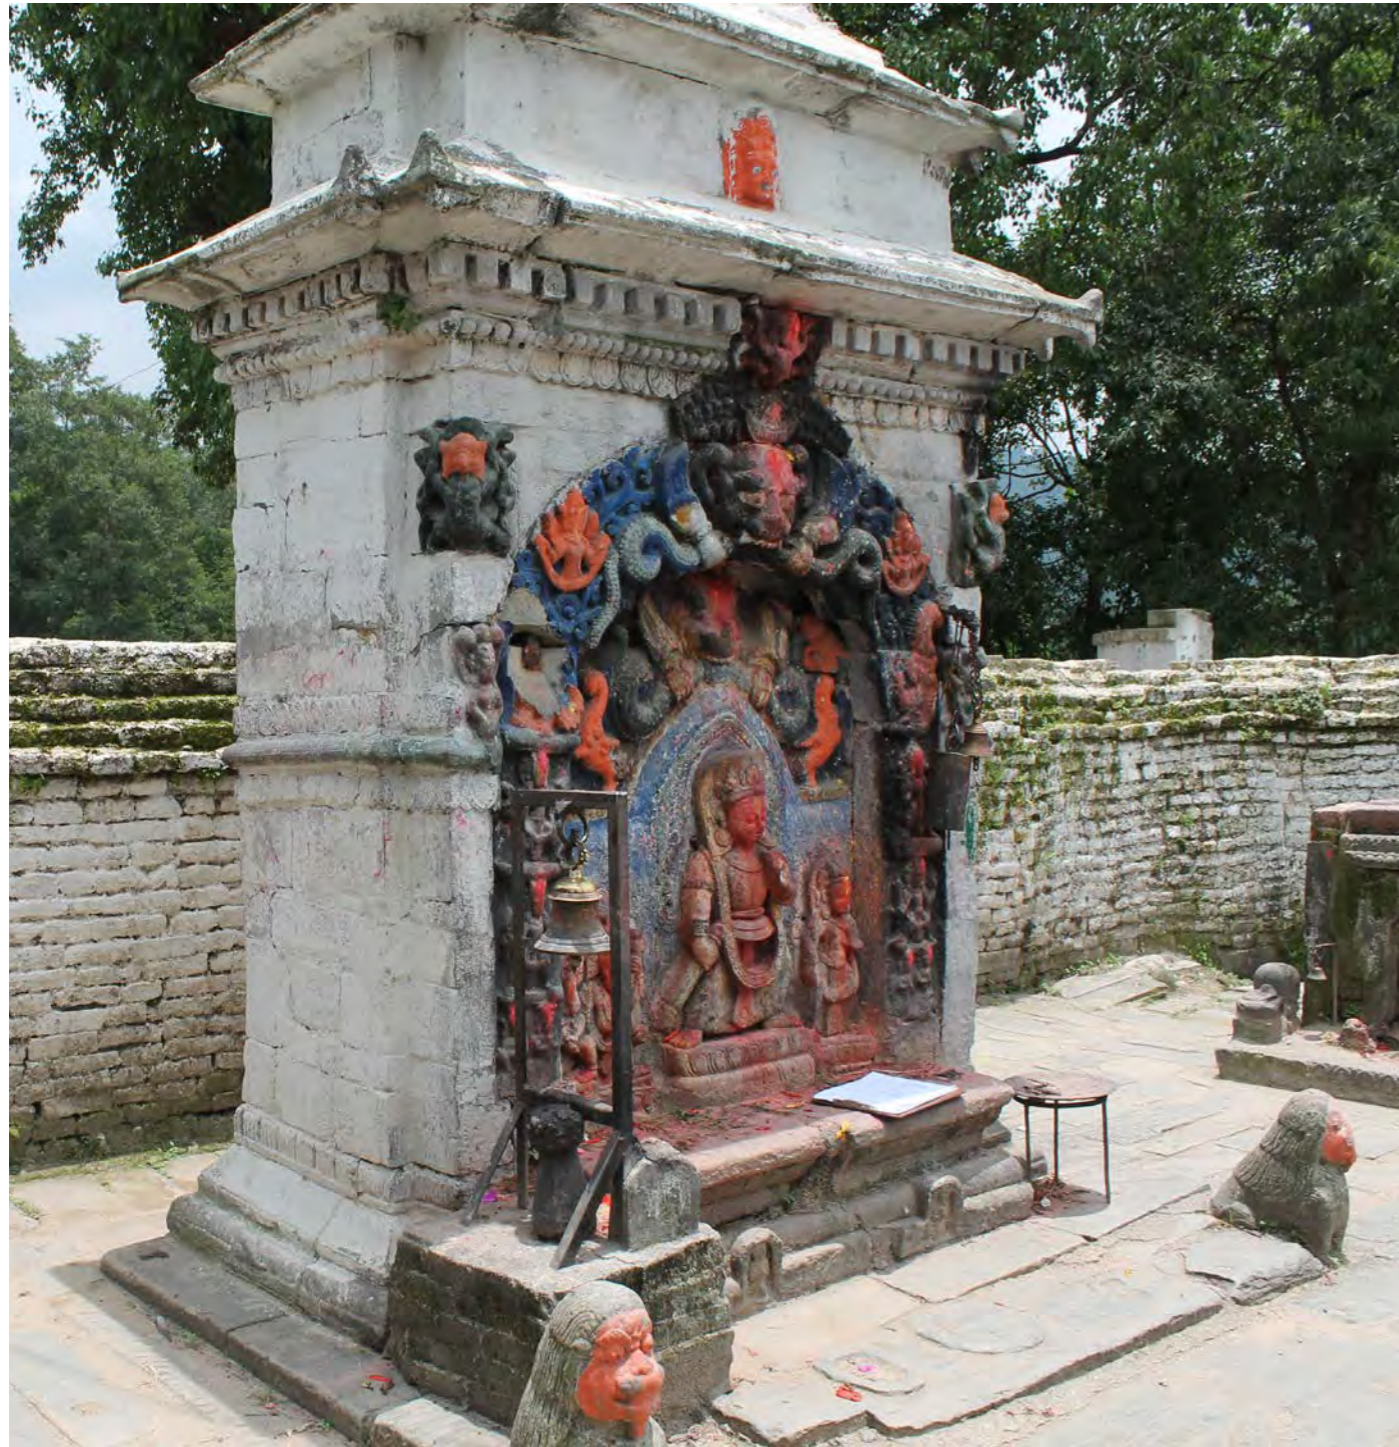
NUMBER	NAME	ESTABLISHED DATE (A.D.)	TYPOLOGY	GENERAL DESCRIPTION	PROBLEMS DESCRIPTION	DANGER/ DESTROY	
01	Bhindya (Bhimsen temple)		Open Shrine	Brick and Stone Structure	S-part with stepped cracks Needs proper repair and maintainance

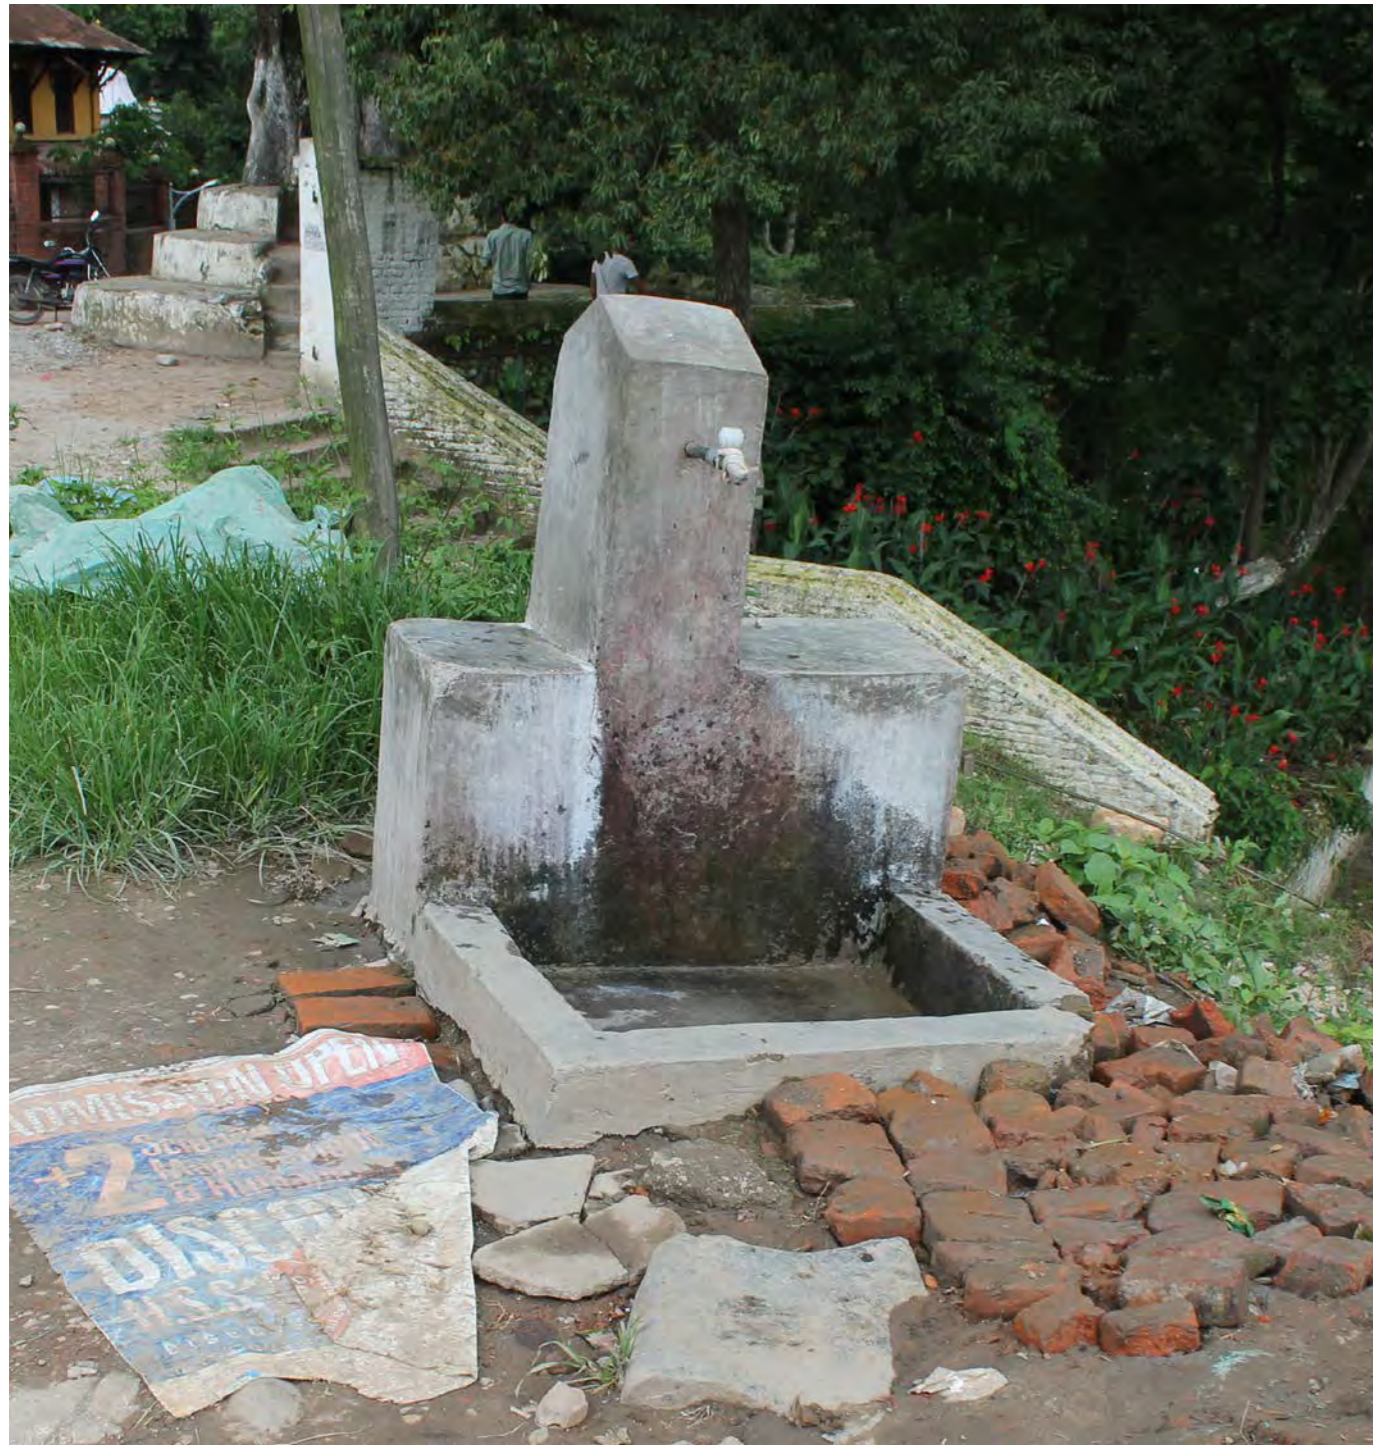
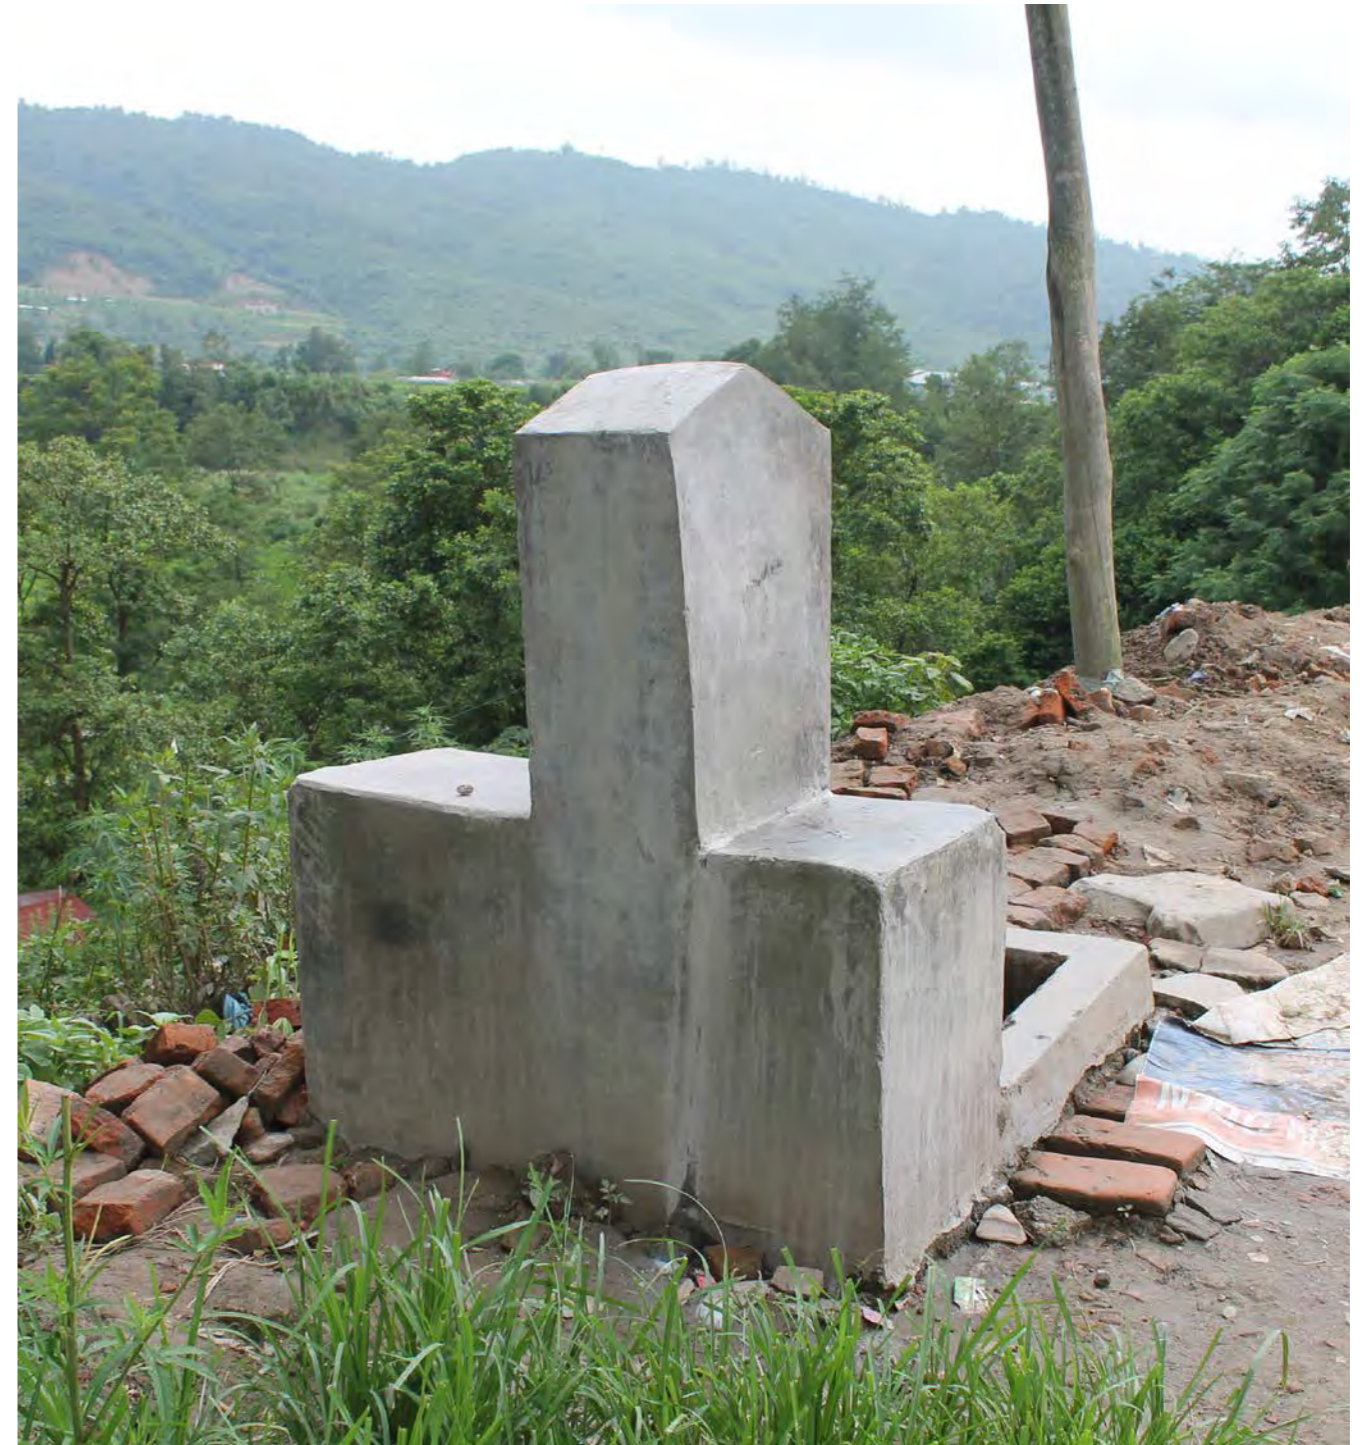
NUMBER	NAME	DATE A.D.	TYPOLOGY	GENERAL DESCRIPTION	PROBLEMS DESCRIPTION	DANGER/ DESTROY	
10			Public water tap	Brick made structure with plastered	Slightly tilted towards North Good Condition

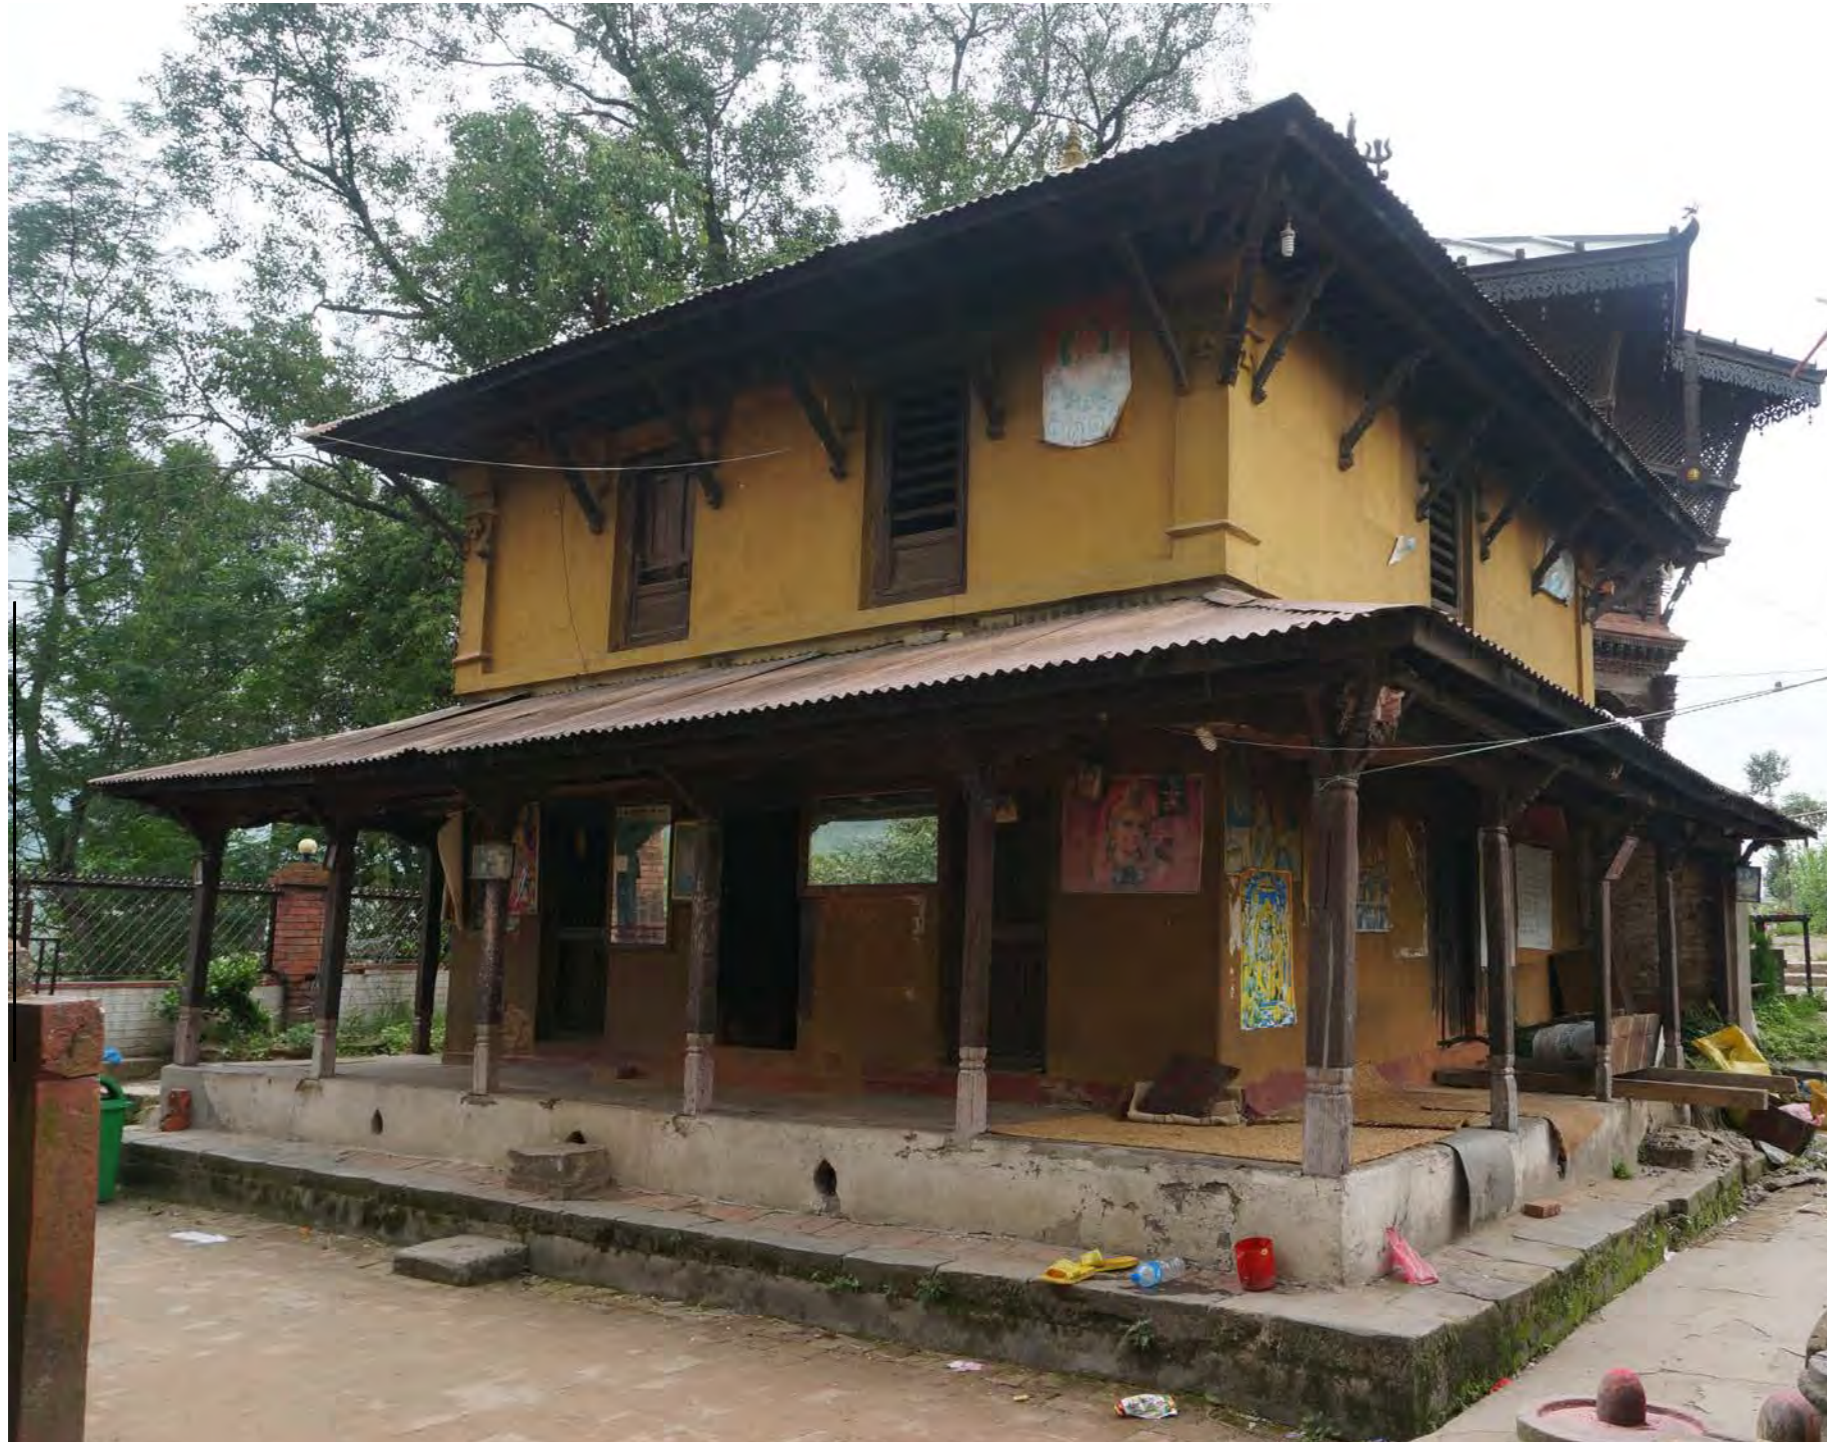
NUMBER	NAME	DATE A.D.	TYPOLOGY	GENERAL DESCRIPTION	PROBLEMS DESCRIPTION	DANGER/ DESTROY	
06	Narbadeshwor Kuti		Kuti	Two storey building	Plaster falling off at base of North Partition wall cracked Shiva Linga at W-wall and other idols at centre.

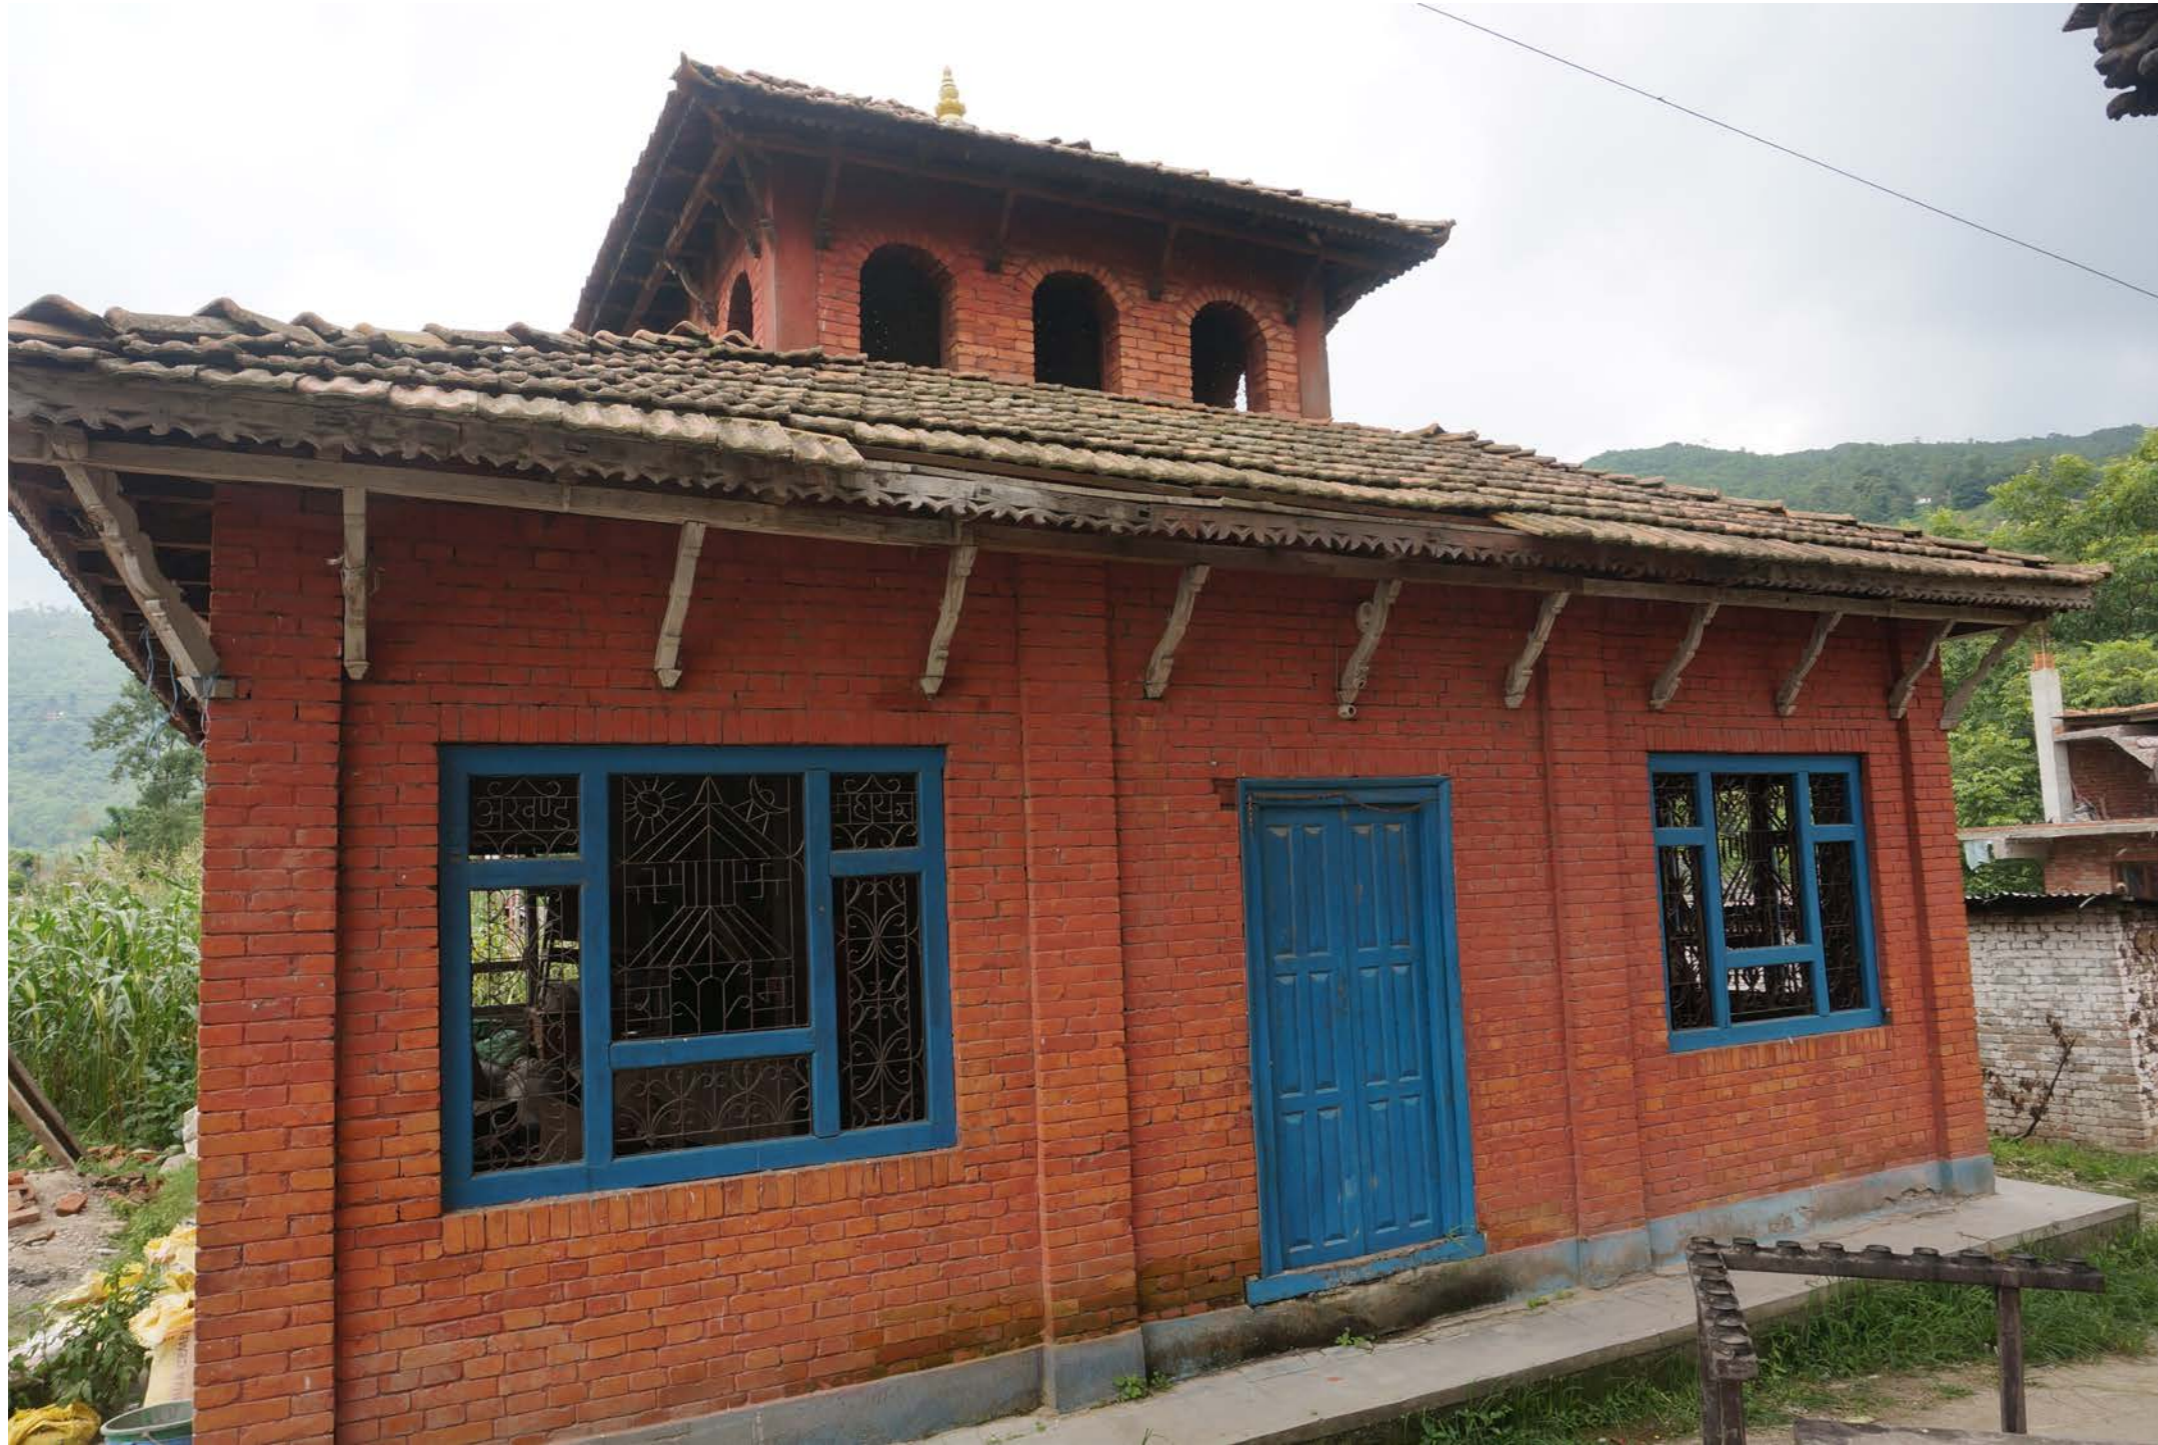
NUMBER	NAME	DATE A.D.	TPOLOGY	GENERAL DESCRIPTION	PROBLEMS DESCRIPTION	DANGER/ DESTROY	
08				Concrete with tile and ooden roof 1 storey two tiered building used for storage.	Roof tiles falling Cracks on joint of building and plinth on NE corner. Vegetation growth on base of all walls.

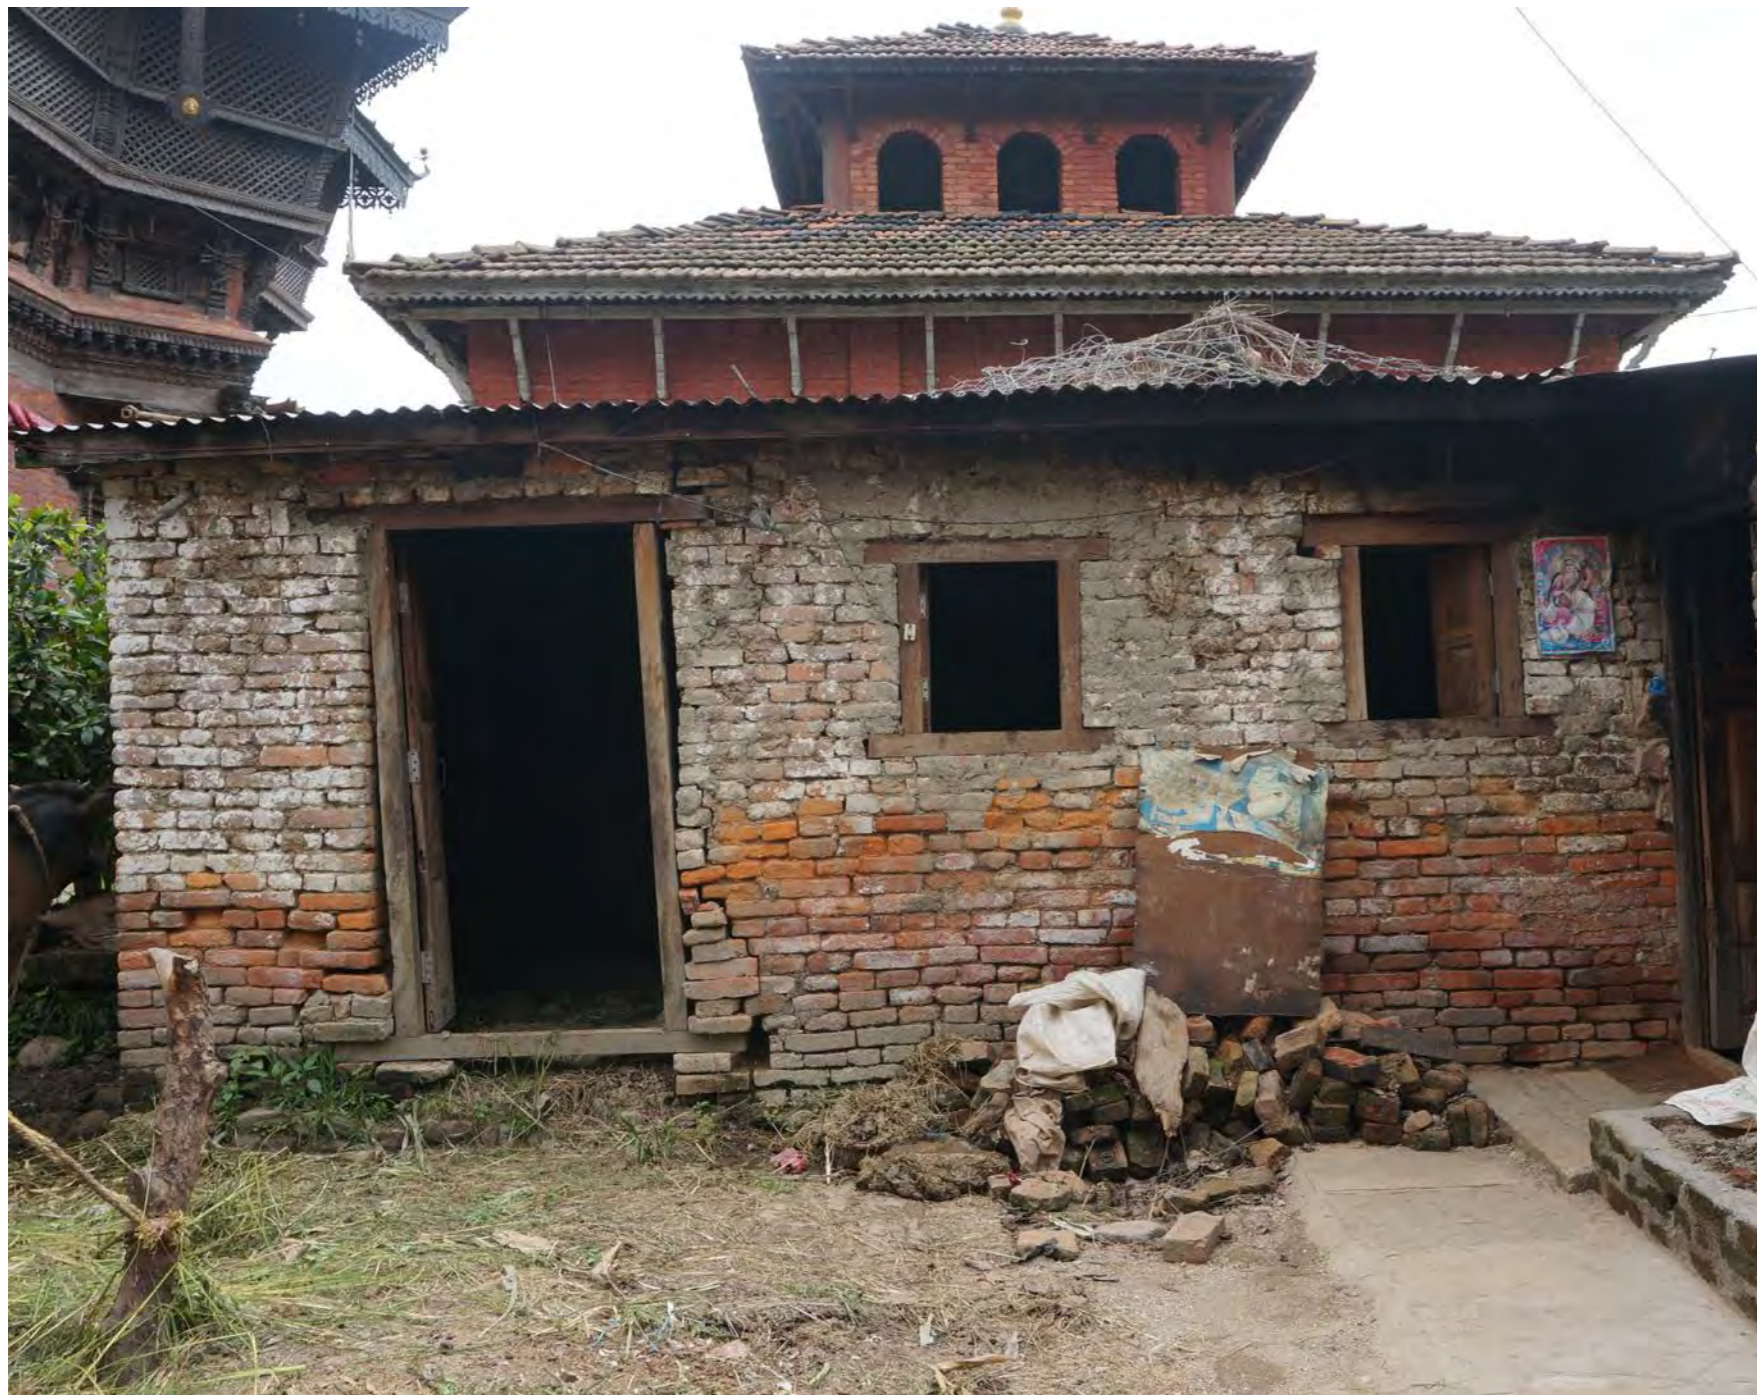
NUMBER	NAME	ESTABLISHED DATE (A.D.)	TYPOLOGY	GENERAL DESCRIPTION	PROBLEMS DESCRIPTION	DANGER/ DESTROY
09			Cow Shed		Brick deterioration due to rising damp. Vertical cracks on S-wall S-wall top bricks falling. E-wall bricks above lintel falling.

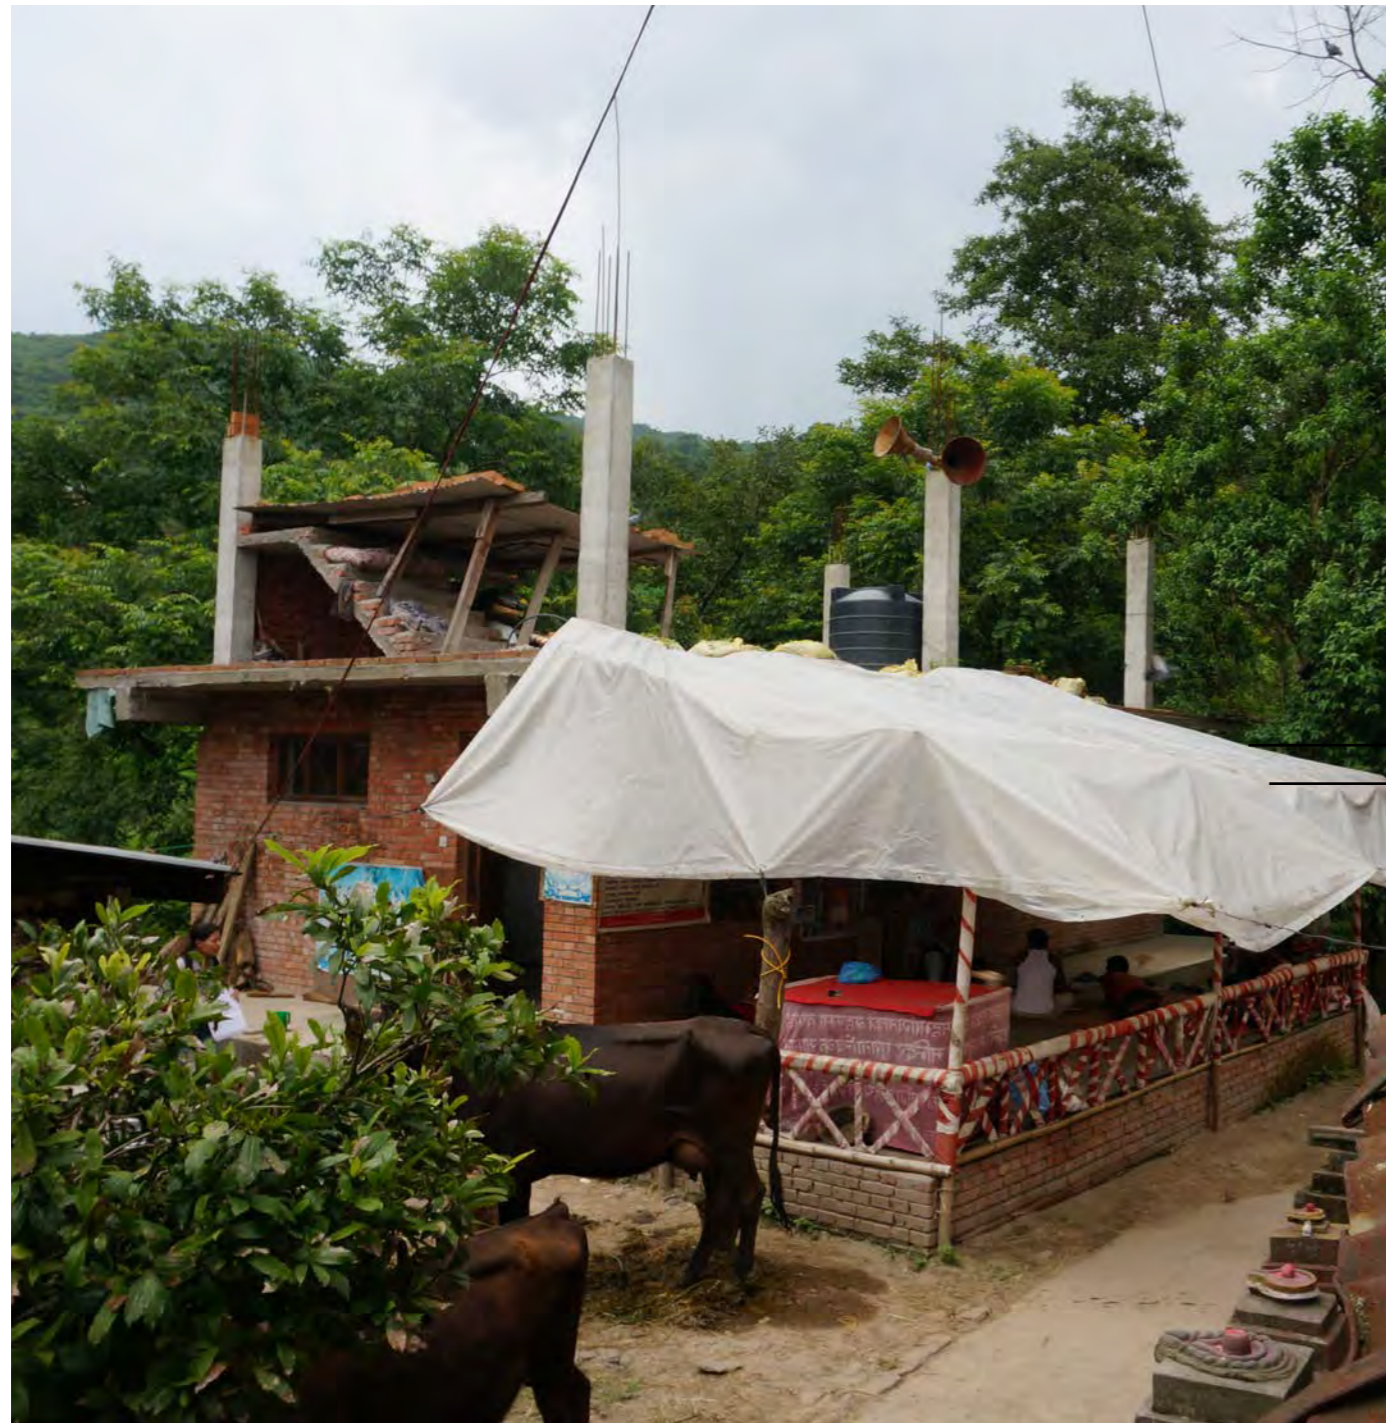
NUMBER	NAME	DATE A.D.	TPOLOGY	GENERAL DESCRIPTION	PROBLEMS DESCRIPTION	DANGER/ DESTROY	
11			Ashram	G + Basement Concrete structure.	Rising Damp on S-wall. No Visible Damages Minor Plinth Cracks
