2015 Earthquake Damage Mapping

Sankhu

October 2015

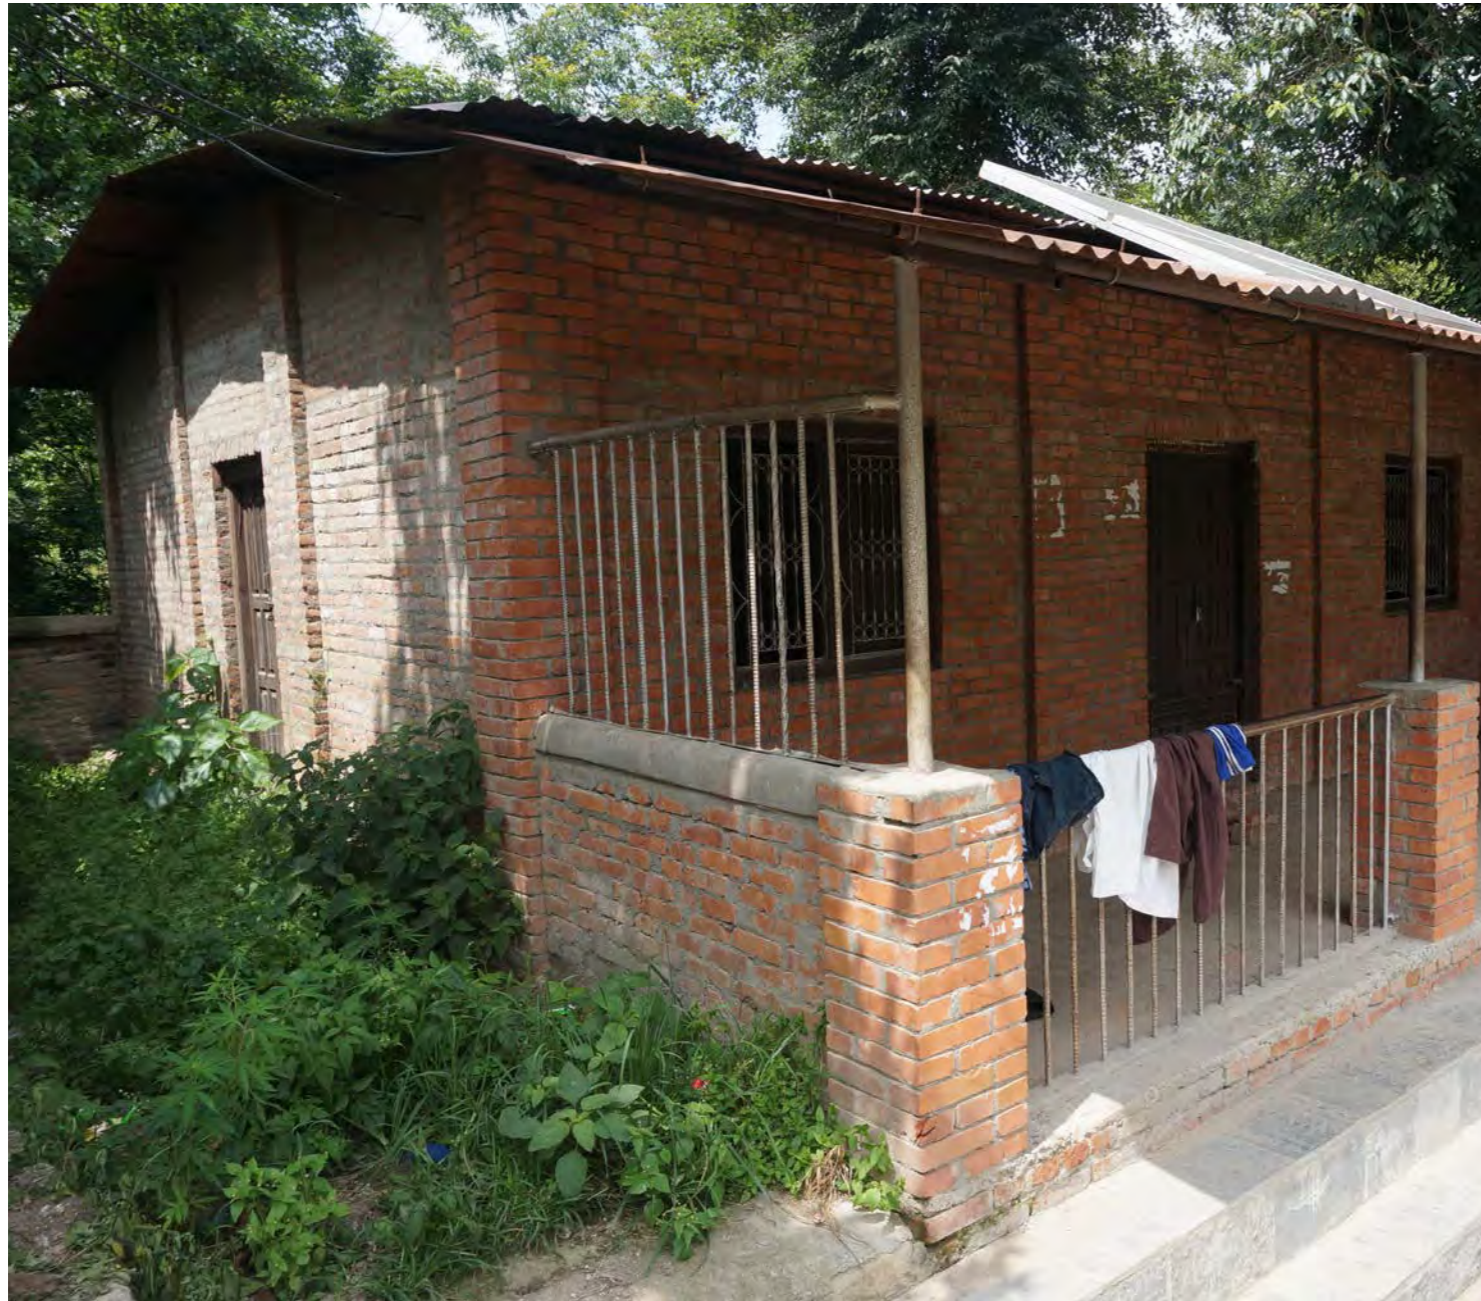
NUMBER	NAME	DATE A.D.	TYPOLOGY	GENERAL DESCRIPTION	PROBLEMS DESCRIPTION	DANGER/ DESTROY
20	Mijan Chen (Dyo Chhen)		God House	One storey shelter with CGI Roof.	No Visible Damages	
21	Nag Mandir		Shrine		No Visible Damages.Minor rising damp and vegetation growth.
