Salvaging, recovering and inventorying wooden elements and artifacts from the earthquake damaged monuments of Hanuman Dhoka Durbar Square

FINAL REPORT

ICOMOS Nepal October 2016

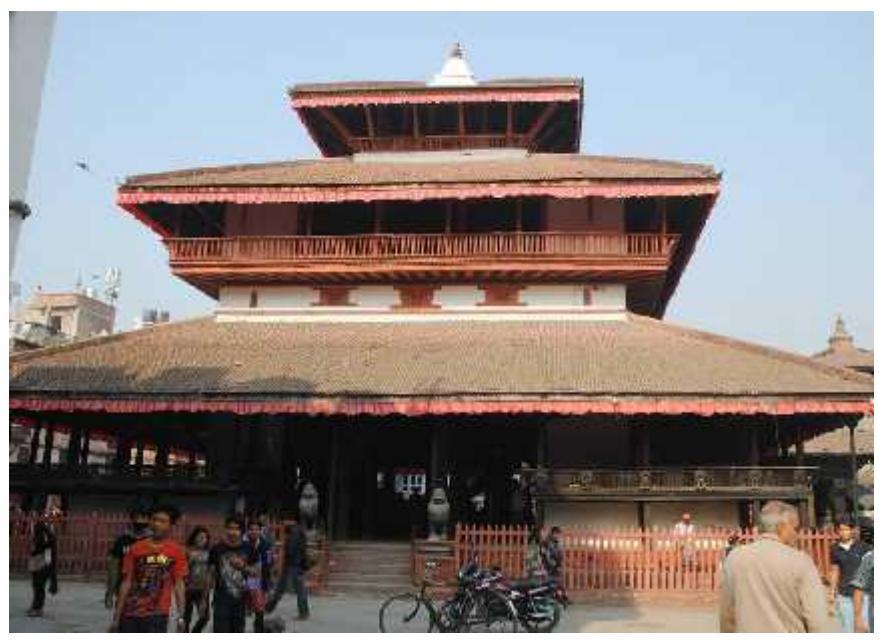
Kasthamandapa (Before earthquake)

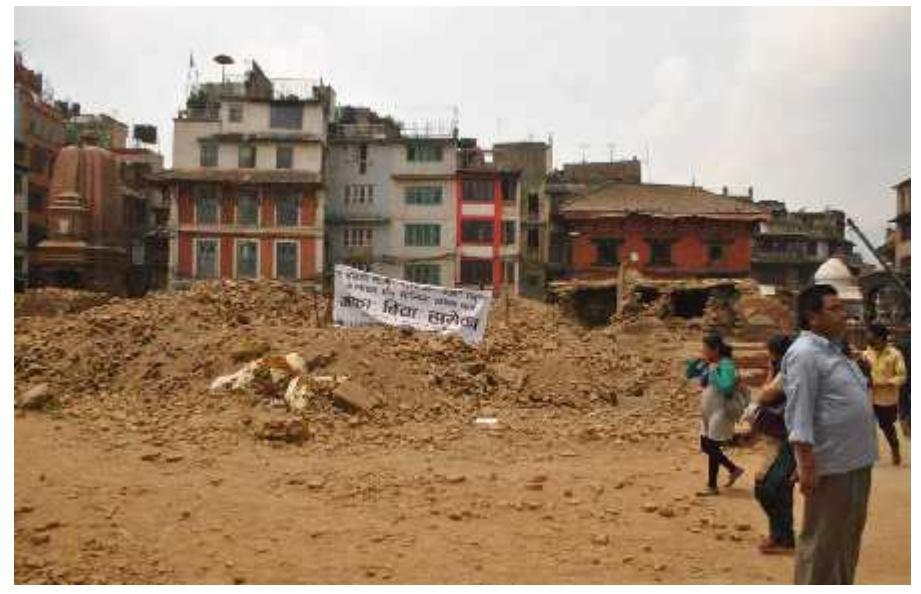
Kasthamandapa (After earthquake) Page 3

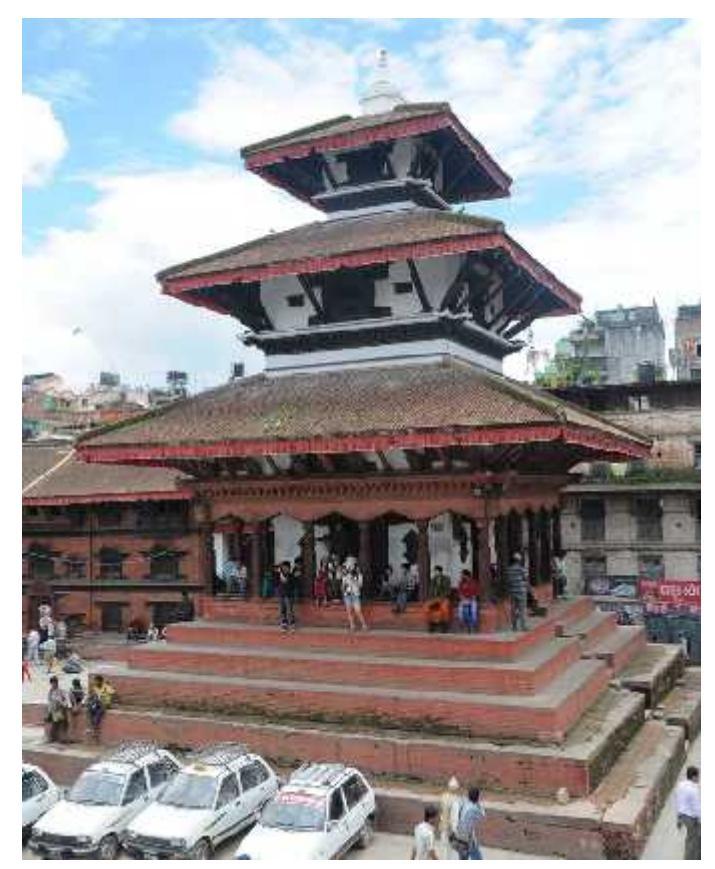
Pun Dega (Before earthquake)

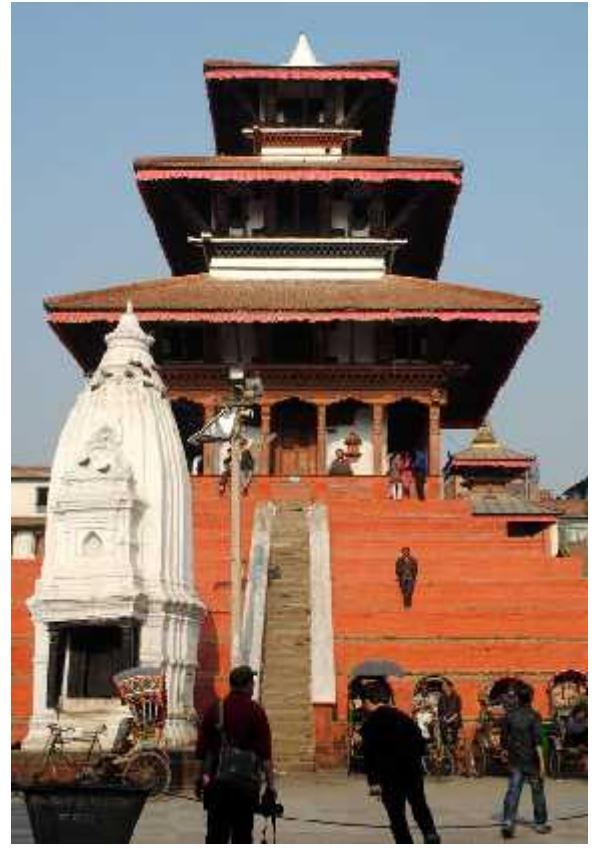
Maju Dega & Santanesvara (Before earthquake)

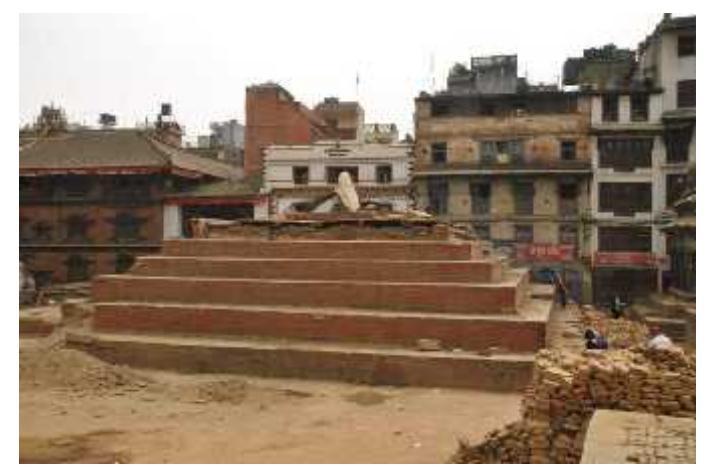
Pun Dega (After earthquake)

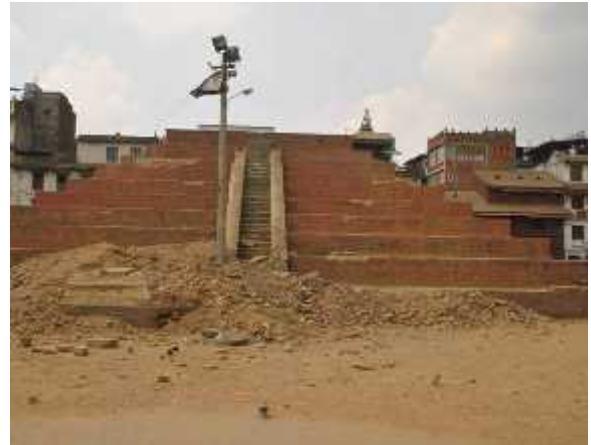
Maju Dega & Santanesvara (After earthquake)

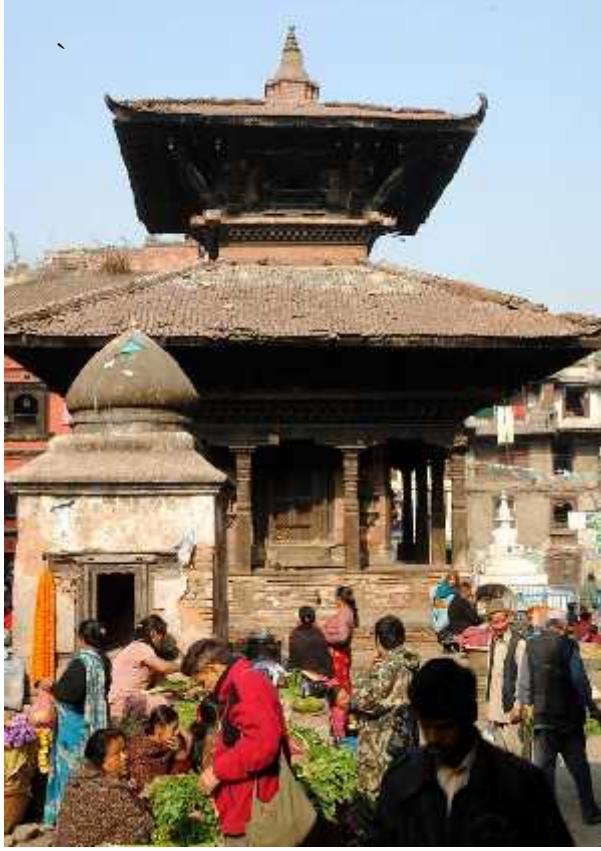
Nau Dega (Before earthquake)

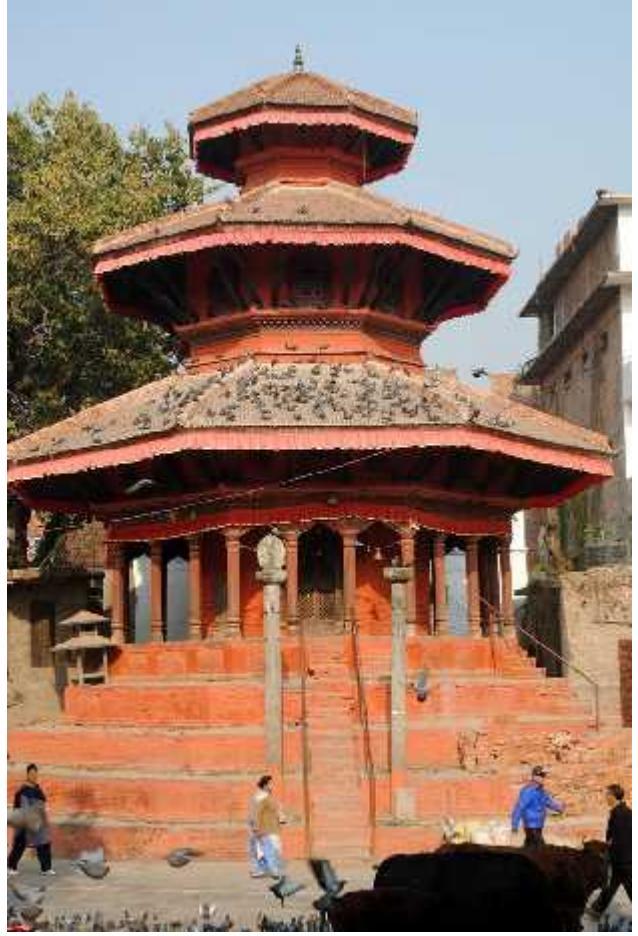
Chyasilin Dega (Before earthquake)

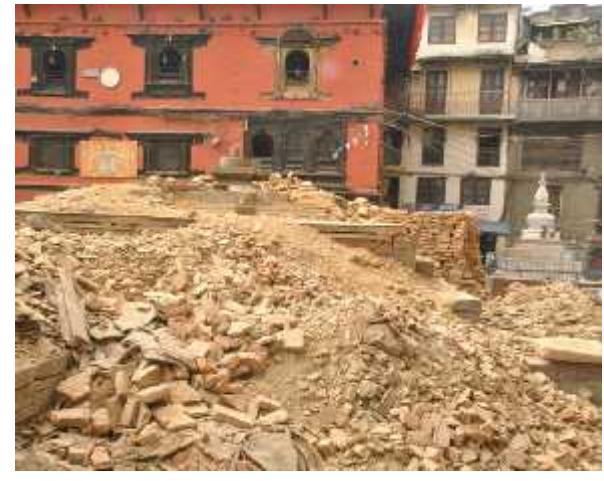
Nau Dega (After earthquake)

The items from this temple is mostly saved.

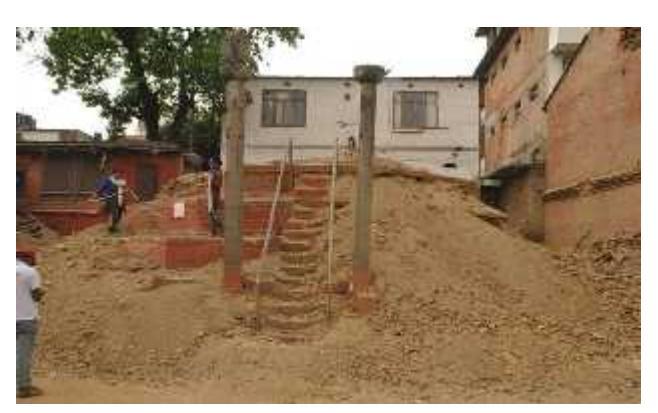
Chyasilin Dega (After earthquake)

As the restoration/reconstruction of this temple was undertaken before the inventorying of the recovered artifacts could be done and its artifacts were taken away to be reused.

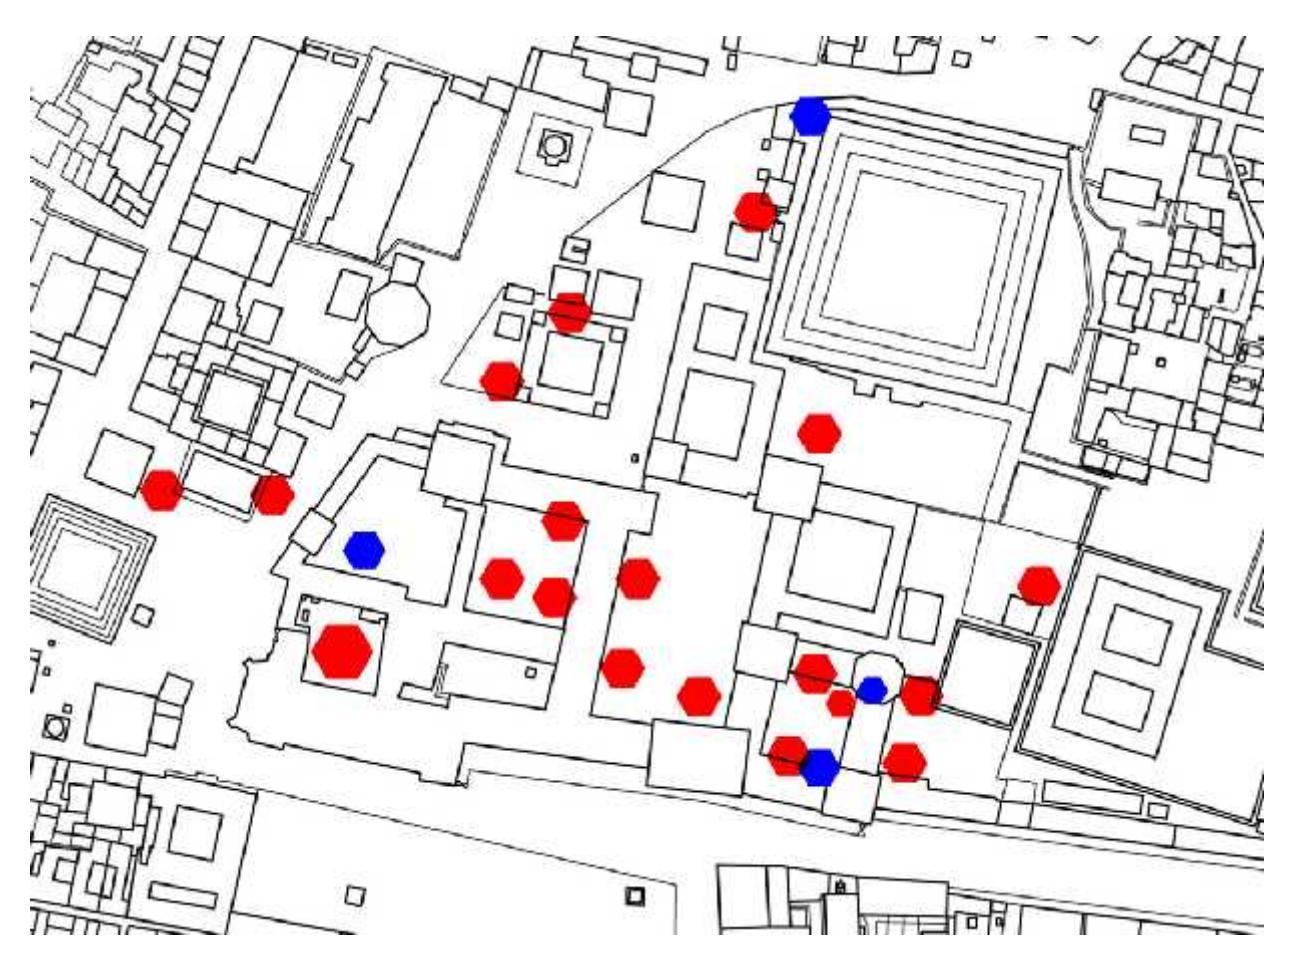
In the initial reconnaissance, it was found that timber piles were dumped in at least 19 different places (*shown in red*). During the subsequent salvaging and screeing work, four additional heaps (*shown in blue*) were discovered making a total of 23 heaps of timber artifacts that had to be salvaged and screened.
