STATE OF CONSERVATION OF THE
TOMBS OF BUGANDA KINGS AT KASUBI (UGANDA)

PROPERTY ID NO C1022

IN RESPONSE TO WHC 38 COM 7A.26

FEBRUARY 2015

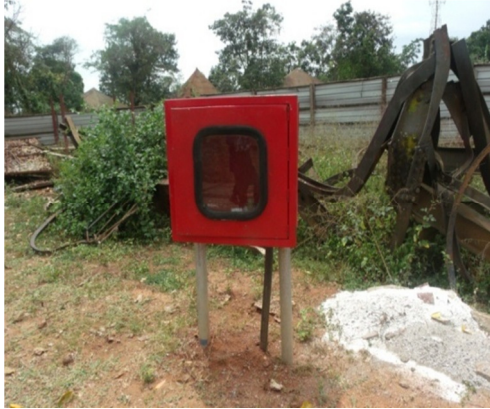
Temporary Fire Fighting Equipment

The Current design in the picture below

This visible fire fighting system on the site is only temporary. It was installed as part of the emergency plan after the fire. Designs for permanent fire fighting equipment, that are obscured underground and only pop up when this need arises have been elaborated in the electrical and fire fighting design, which is part of the program supported by the Japanese's Funds in trust yet to commence with the thatching phase.

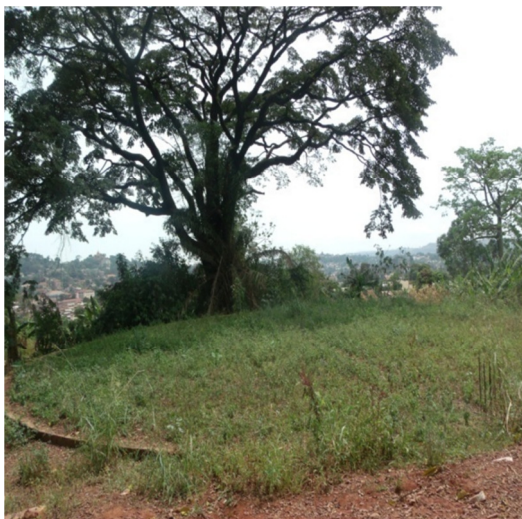
The *draft master* plans that were presented to the UNESCO mission that visited in May 2014 are yet to be discussed by the tripartite. As of now the Museum plan has been abandoned,

The Museum proposal has been abandoned and grass has been left to grow on the concrete plinth that had been laid down.

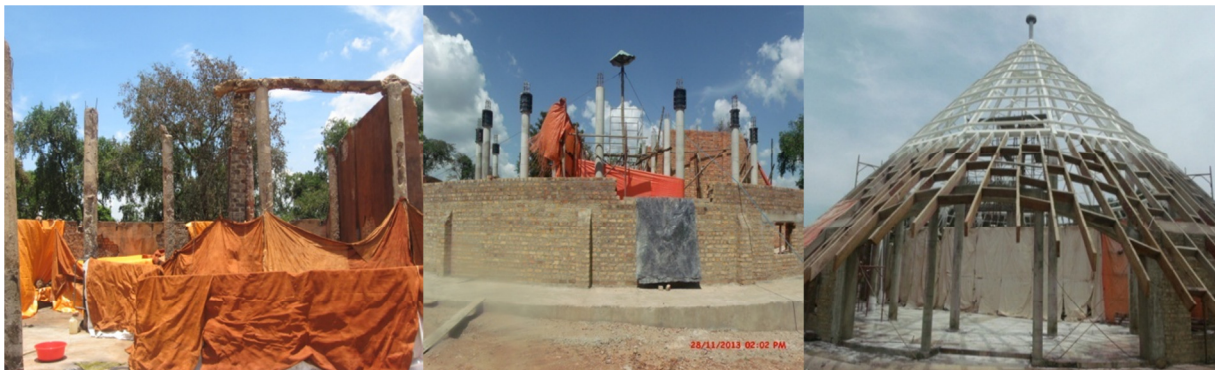
Muzibu Azaala Mpanga progress on reconstruction

The reconstruction of Muzibu Azaala Mpanga commenced December 2013, following the approved reconstruction strategy by UNESCO-WHC. All issues of concern raised on intangible, tangible and technical aspects have been addressed by the restoration committee. The walling of the tomb house, the columns have all been completed. A specialist with steel works has erected the steel strum roof structure. Fire proof paint has been applied and the house is now ready for the thatching phase.

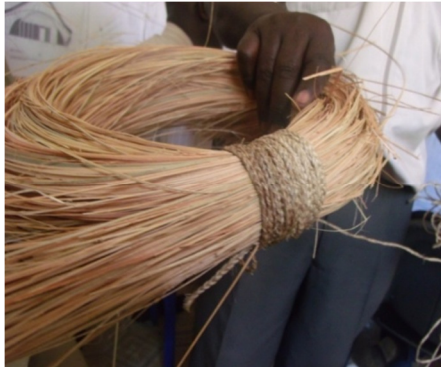
Photo showing ring demonstration of central rings

The traditional artisan's works on the roof ceiling have commenced with the first three central rings in the house, they are now busy weaving the strings that are meticulously tied to make the ring as being demonstrated below.

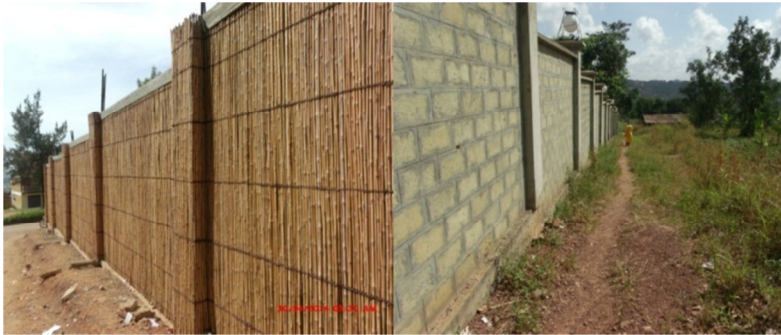
This is the perimeter wall both outside and inside.

Furthermore the site manager is to coordinate a program for replacement of the missing boundary trees on the perimeter wall.

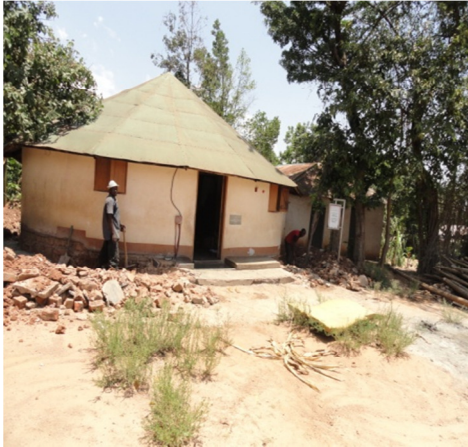
Gazimbye before

As a result of deterioration of the conservation of the site, several of the courtyard houses were roofed by green iron sheets around the 1970s. Which is not in symbolic of the Ganda traditional architecture? Part of the program of the Buganda Reconstruction Committee is to remodel all the houses to their original status so as to restore the OUVs of the site; the program has started with *Gazimbye* as seen below.

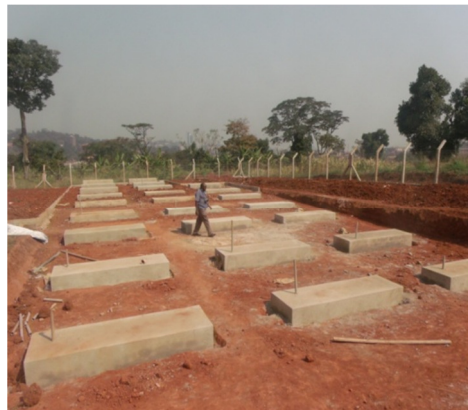
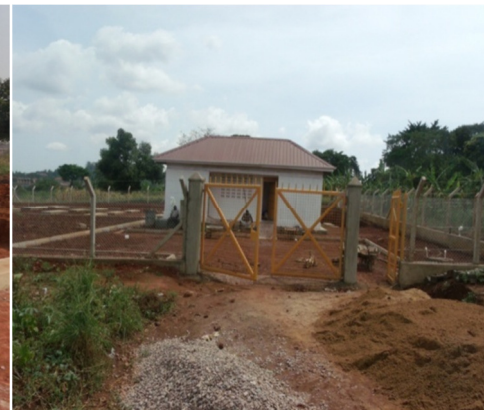
The Solar Plant and Power house

A solar plant introduced to reduce on the huge cost of hydro power for the site.

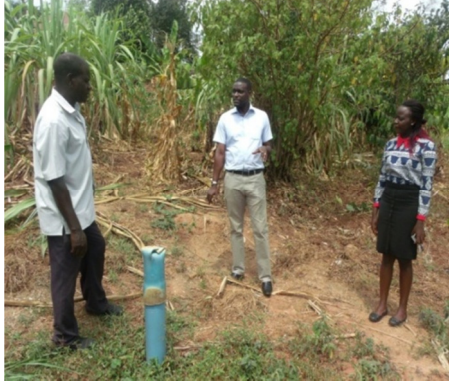
The Borehole

Water is an essential and integral part for the conservation of the site and hope with this borehole already in place and a water reservoir yet to be constructed will be a big boost to the sustainable development of the site.

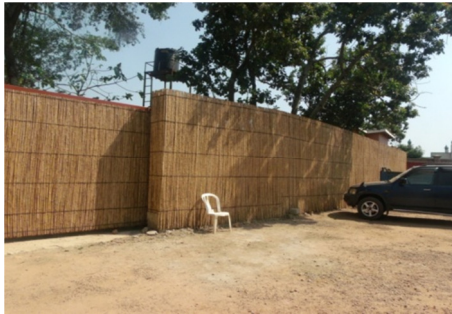
The private Entrance has been remonstrated now look like this.

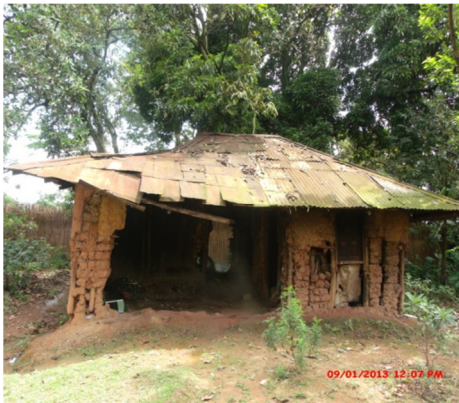
Before Restoration

Kaddulubale's house Restored.
