# Brihadishvara Temple, Thanjavur

### II.1 Introduction

## State of Conservation of the World Heritage Properties in the Asia-Pacific Region

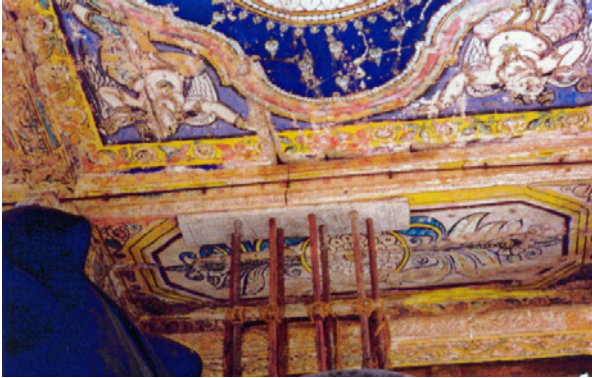
*View of Cracks in the Nandi Mandapa ceiling before restoration*

- Monitoring system: dehumidifier installed in the painting chamber and tale glasses fixed on the ceilings of the mandapa cloister.
- Partners: the ASI, Hereditary Trustee and District authorities.
- Foreseen improvements: installation of CCTV for visitors movement surveyance. Burglar alarm to prevent theft of sculptures.
