# **PROTECTING STRUCTURES, SAVING LIVES**

**UNESCO-IPRED-PUC INTERNATIONAL WORKSHOP  
SANTIAGO DE CHILE, CHILE, 26-28 JULY 2011**

Unit for Natural Disasters  
© UNESCO 2012  
Electronic version only  
SC/DIS/2012/IPRED/1

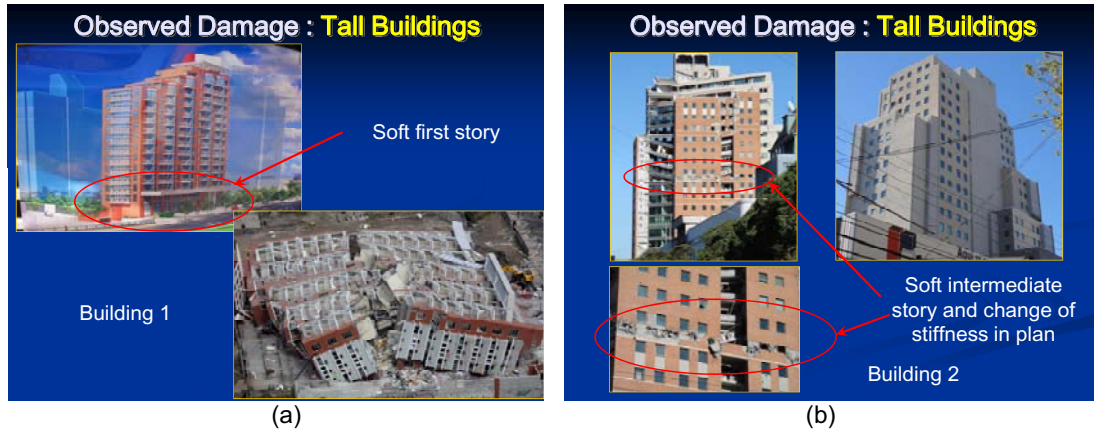
Figure 4 (a) shows the only tall structure with total collapse due to earthquake. This building had a double height soft first story, very common in Chilean construction. Figure 4 (b) shows an intermediate soft story collapsed, without a total collapse of building. Both buildings are in Concepción city.

**Figure 4.** (a) Collapsed building with soft first story, (b) Building with partially collapsed soft intermediate story.

A typical damage observed in tall buildings, where one can observe the presence of soft stories, with high stiffness change in both the first level as in intermediate levels.

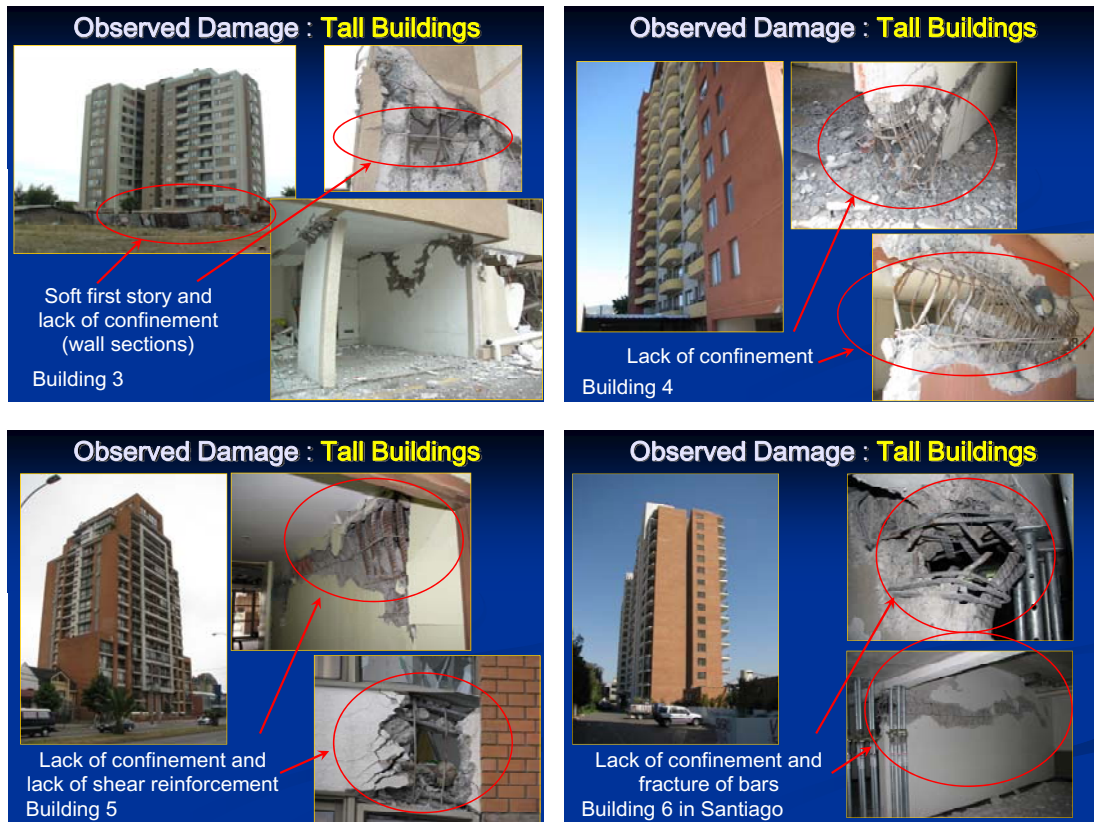
Another typical damage was concrete crushing and vertical steel reinforcement buckling in the edges of shear walls, as shown in Figure 5. This damage is due to the poor confinement of the shear wall boundary element, which was not required by the Chilean code before 2008.

**Figure 5.** Typical observed failures due to the poor confinement in shear wall boundary elements.

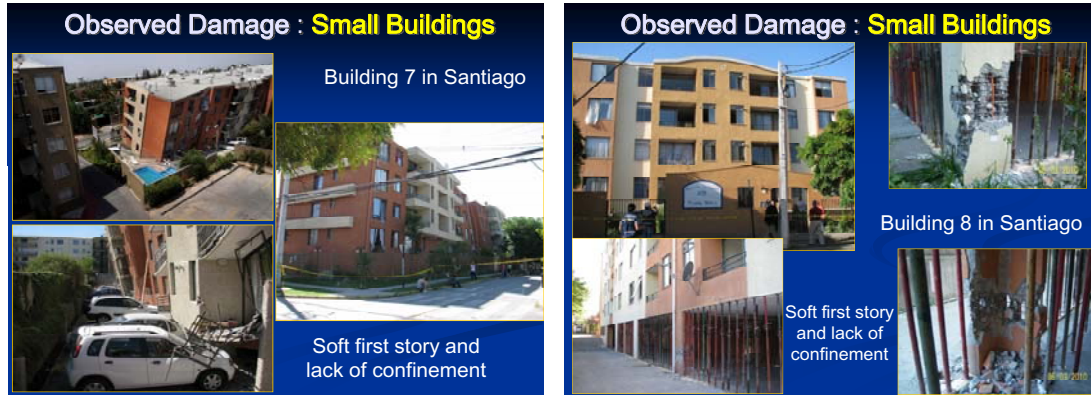
The damages in low rise buildings were not very different from those already mentioned in high rise buildings. In addition, development or splice length failures were observed, especially for large diameter reinforcing bars in very thin shear walls (Figure 6).

**Figure 6.** Typical observed failures: poor confinement in shear wall boundary element, vertical reinforcing steel buckling, and development or splice length failures in thin shear walls.

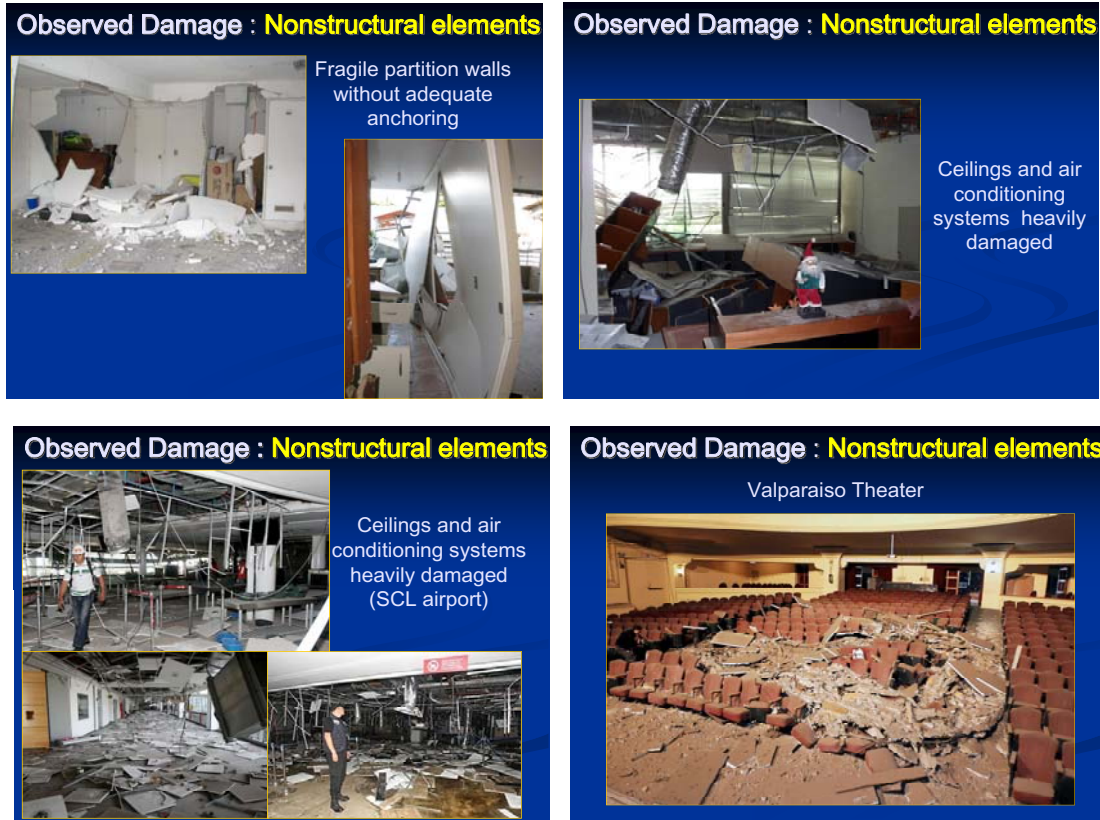
Ceilings and air conditioning units with poor seismic anchorage presented severe damages and in many cases theirs fall, injuring people crossing under the affected areas, as shown in Figure 7.

Figure 7. Typical damages in non-structural elements.

The most common damage observed in buildings was in non-structural elements. Many buildings had brittle partition walls, composed mainly of gypsum board. These partition walls did not have proper seismic anchoring and seismic separation from the structural walls and slabs.

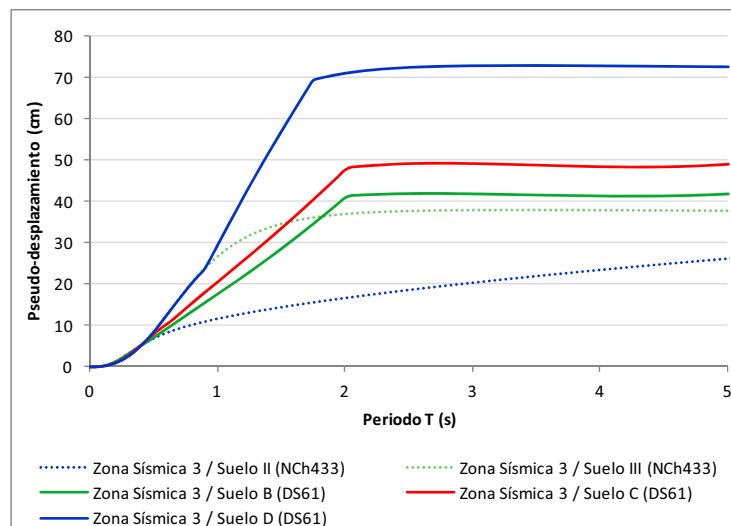
**Figure 13.** Elastic pseudo-displacement spectrum (Comparison between NCh433. of 1996 and DS61 MINVU 2011)

In the particular case of the structures of reinforcement concrete, the maximum lateral roof displacement at top of the building can be considered equal to the ordinate of the elastic displacement spectrum to 5% of the critical damping, for the fundamental translational period in the direction of analysis, considering the cracking of the concrete, multiplied by a factor of 1.3, as shown in Figure 12.

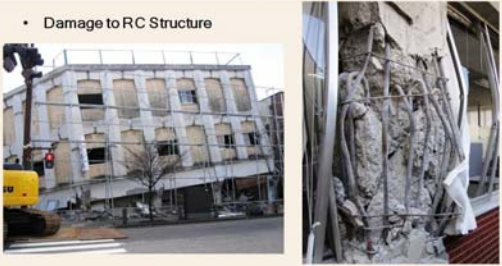
• **Damage to RC Structure**

• 1<sup>st</sup> story of 3 storied RC building was collapsed. Front side is frame structure and back side is frame with wall structure.

• Shear failure in columns on 1<sup>st</sup> story of 4 storied RC building which shows 180 degree hooks of main bars.

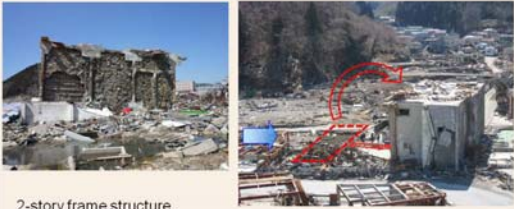
• **Damage to RC Structure**  
**Buildings swept-away and fallen-over**

2-story frame structure (refrigerators)  
Few openings  
Swept-away and fallen-over

Distance from the coast: ~200 m  
Depth of inundation: Over 6.5 m

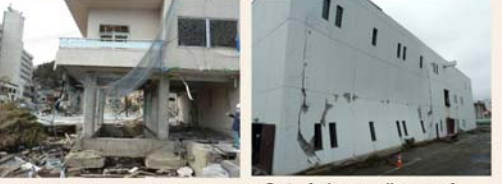
• **Damage to RC Structure**

4 storied RC frame building      3 storied RC factory building

• Soil flowed away by tsunami.  
• Photo shows the footing basement under columns.

• Out of plane collapse of exterior wall with frame and without inside floor.  
• The right side of photo shows no collapse of wall with floor.

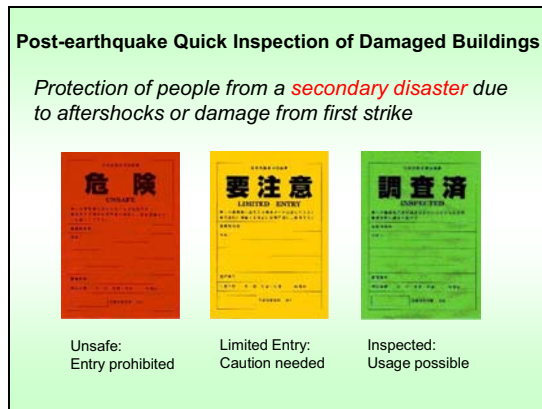
**Figure 5.** Post-earthquake quick inspection of Damaged buildings

In the field of buildings and housing, the MLIT has carried out post-earthquake quick inspections of damaged buildings for the purpose of protecting people from secondary disasters due to aftershocks or damage from the first strike, by posting colored stickers on those buildings (Figure 5). After the Great East Japan Earthquake, 95,381 buildings were inspected by 8,541 inspectors, of which 11,699 buildings were judged unsafe (Figure 6).

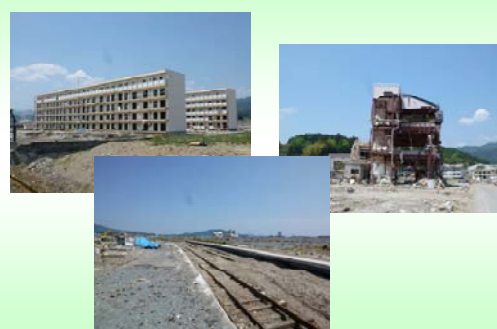
**Figure 20.** Tsunami-induced damage in Rikuzentakata city, Iwate (2011 ©T. Imamura)

Figure 19 through Figure 24 show some photos of damaged buildings in tsunami-affected area which were taken by the author in June 2011. The third floor of 4-storied RC construction apartments was completely flooded by the tsunami. There remained some 3-storied steel construction buildings, but only the framework. No wooden construction buildings survived, except for their RC foundation.

Although most of wooden houses were washed away, some remained standing. Wooden houses attacked by tsunami waves of less than 2m did not suffer much. Only 15% of those attacked by tsunami waves of 2-4m was heavily damaged. Most of those attacked by tsunami waves of more than 4m were totally destroyed or washed away.

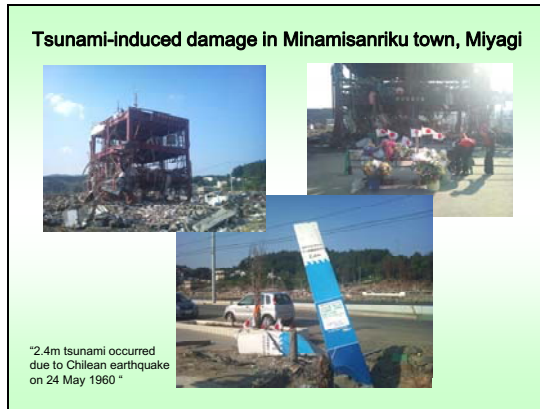
**Figure 22.** Tsunami-induced damage in Minamisanriku town, Miyagi (2011 ©T. Imamura)

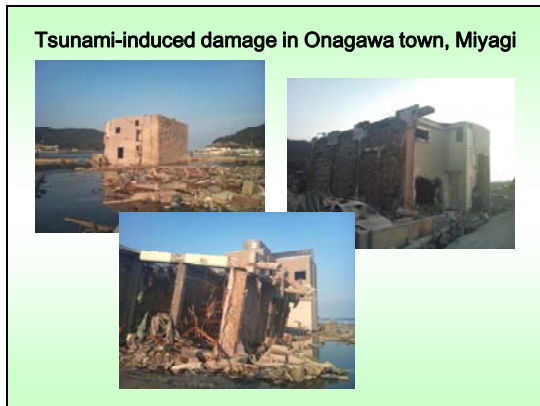
**Figure 23.** Tsunami-induced damage in Onagawa town, Miyagi (2011 ©T. Imamura)

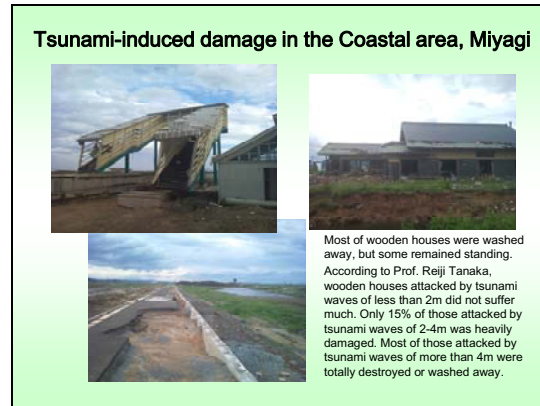
**Figure 24.** Tsunami-induced damage in the coastal area, Miyagi (2011 ©T. Imamura)

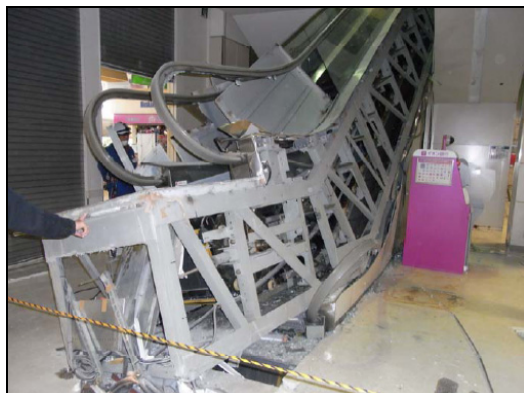
**Figure 33.** An escalator fallen down at the Sendai-Saiwaicho shopping center (Sendai city)

In addition, some escalators (4 escalators at 3 shopping centers) were found to be fallen down due to the 2011 earthquake. The MLIT is considering the establishment of a new seismic regulation for escalators.

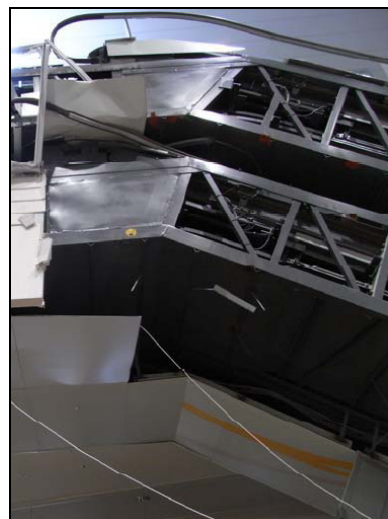
**Figure 34.** Escalators stuck together at the Izumi-osawa shopping center (Sendai city)

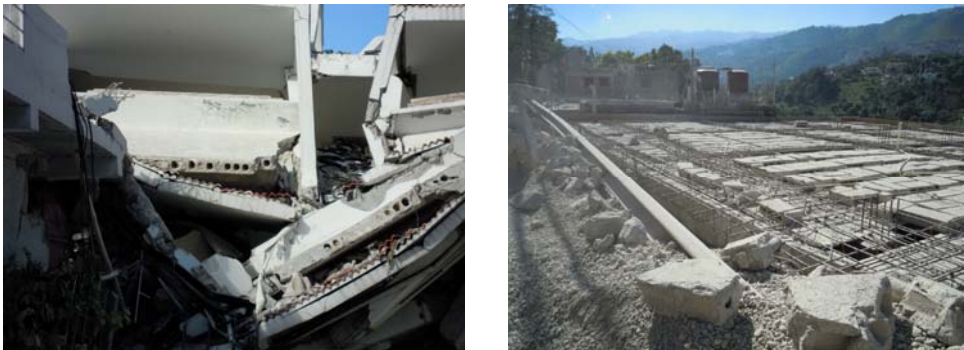
**Figure 1.** Lightweight elements used in floor systems without reinforcement. In the right side photo it is clear the lack of reinforcement in the wall – slab joint, these procedure do not allow the coupling of vertical elements to withstand seismic demands

The generalized use of poor materials like plain steel bars and concrete with highly porous materials contributed to a high degree of vulnerability.

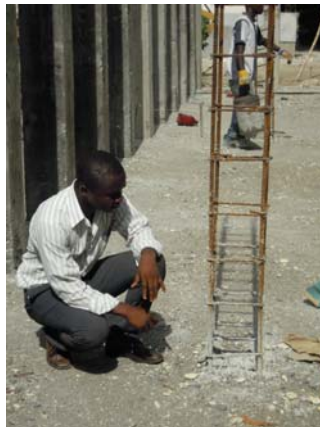
**Figure 2.** The reinforcement detail in the Haitian Construction Code is not adequate for medium to severe seismic demands

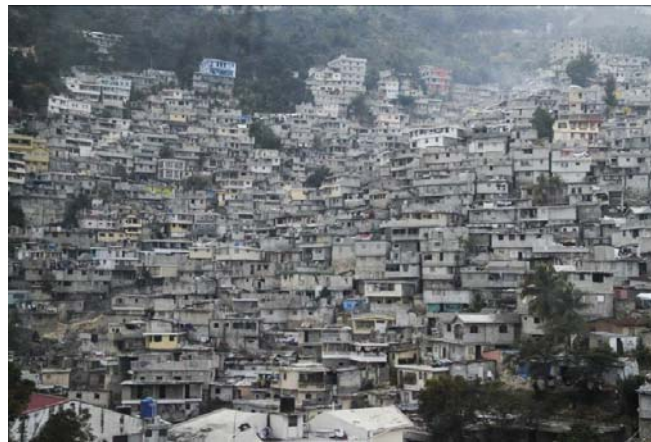
**Figure 3.** The chaotic urban development in Port-au-Prince has led to increased vulnerability of slope stability under seismic demand, as well as under gravitational load (Photo by Eduardo Miranda, 2010)

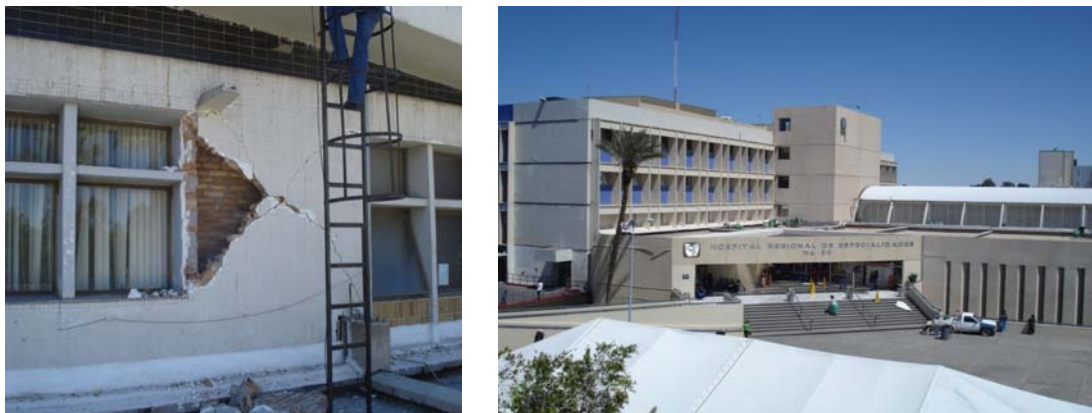
**Figure 5.** Hospital temporarily closed due to non-structural damage

Another main issue with respect to structural behaviour of critical facilities is that a general hospital in the area of Mexicali presented damage in non-structural elements. Under that condition the responsible authorities made the decision of closing it temporarily, which appears unacceptable.

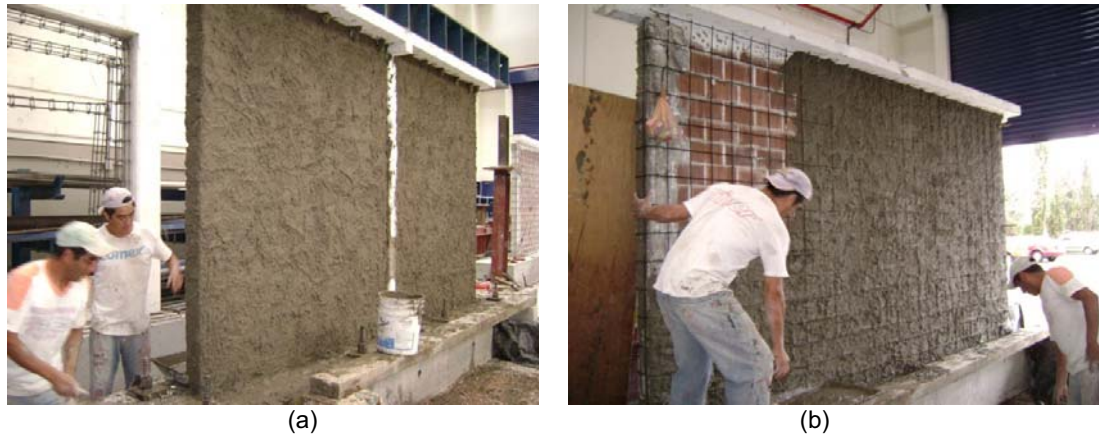
**Figure 7.** Confined ceramic masonry walls with different type of retrofitting procedures: A) Mortar with steel fiber; B) Mortar with wire mesh as examples of current experiments

The information and conclusions were used for the preparation of experiments about the behaviour of partially prefabricated slabs under seismic load pattern (Figure 6) and experimental studies on the behaviour of confined ceramic masonry walls with different types of retrofitting methods (Figure 7). Particularly in the case of the partially prefabricated slabs the purpose was to verify the rigidity in the floor system (rigid diaphragm), and once it is damaged by lateral forces the remaining capacity is studied under vertical load.

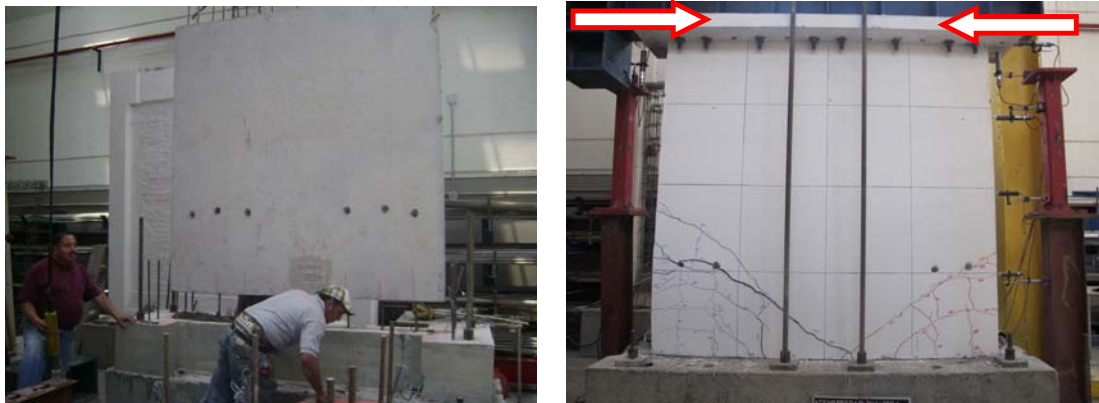
**Figure 8.** Reinforced concrete precast panel construction system for low cost housing has been tested at LSL of CENAPRED during the last year

During the last 8 years the number of housing builders that look for advice from CENAPRED with the purpose of assessing the quality of materials being used and building procedures has increased. Recently, mainly due to last earthquakes, the interest in laboratory tests has grown. Two of the biggest building companies in the country have shown interest in testing their products before applying them for low and medium cost housing, an example of those researches is shown in Figure 8.

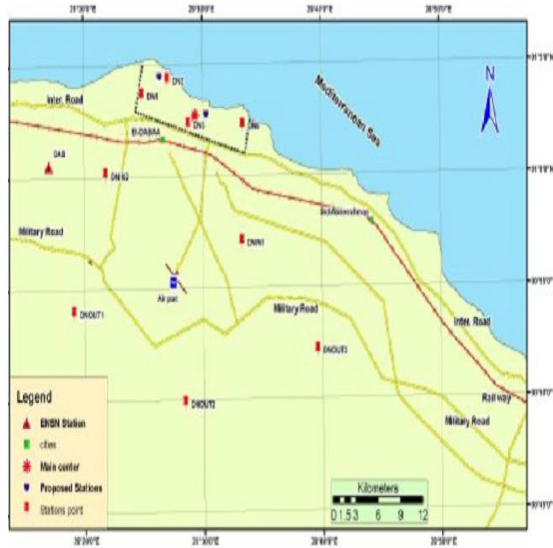
**Figure 15.** Dabbaa local seismic network (2006) for monitoring seismic activity around the proposed site of the nuclear power plant

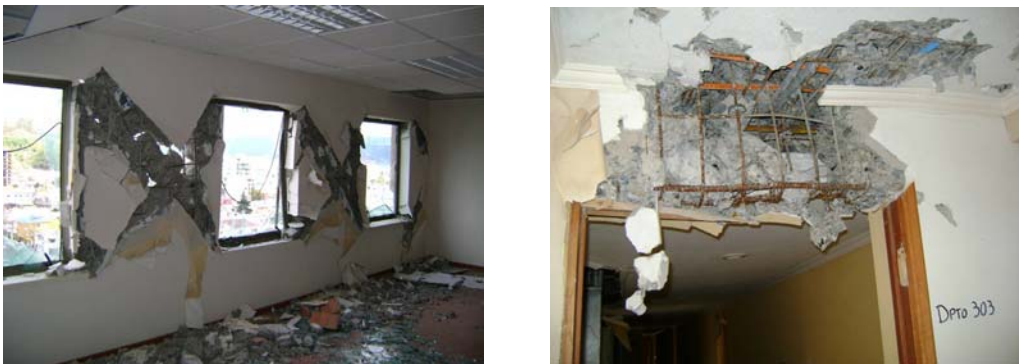
**Figure 6.** Typical failure of short columns and coupling beams

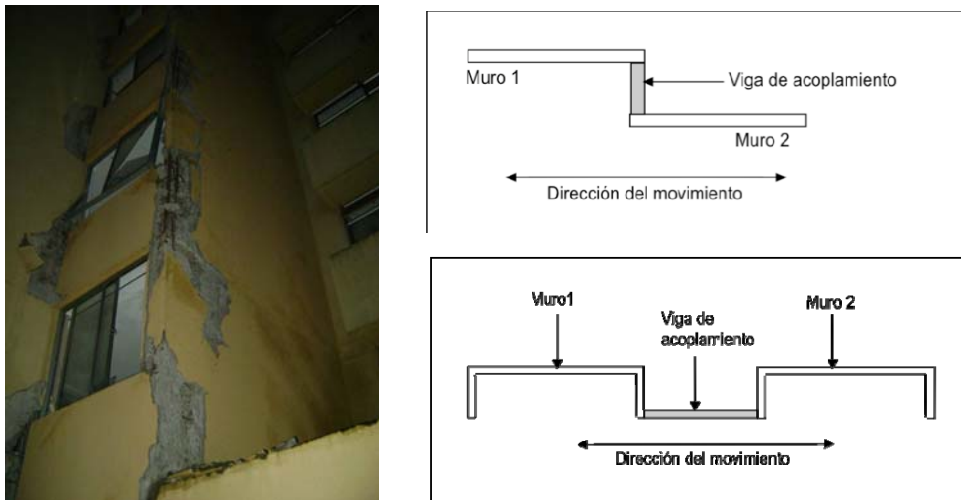
**Figure 7.** Failure due to poor detailing of the anchor of coupling beams.

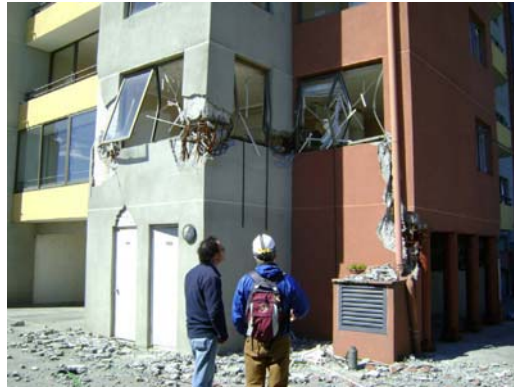
**Figure 8.** Failure due to bad modeled singularities

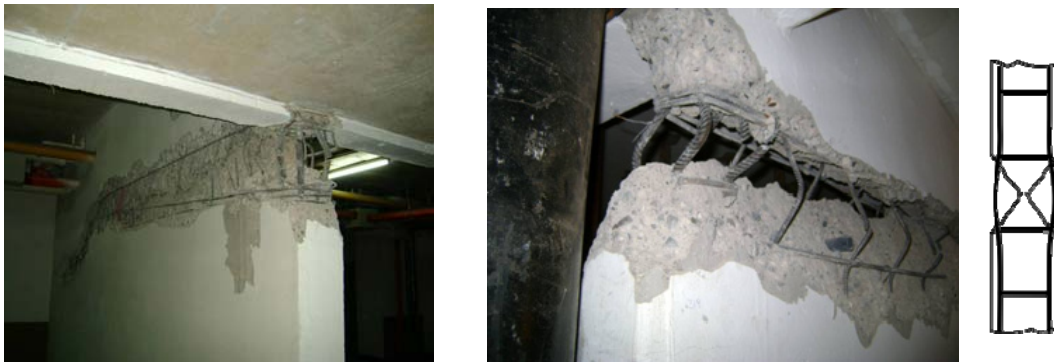
**Figure 9.** Typical compression failure of heavily loaded thin walls

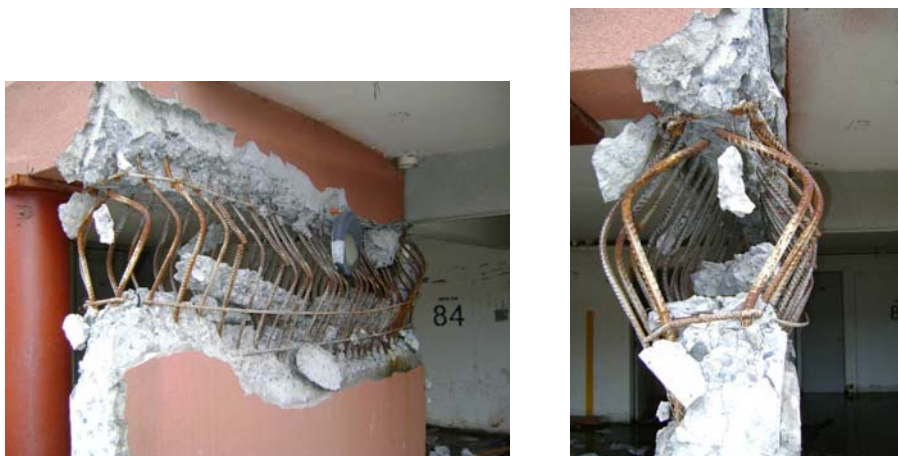
**Figure 10.** Typical compression failure of heavily loaded thin walls

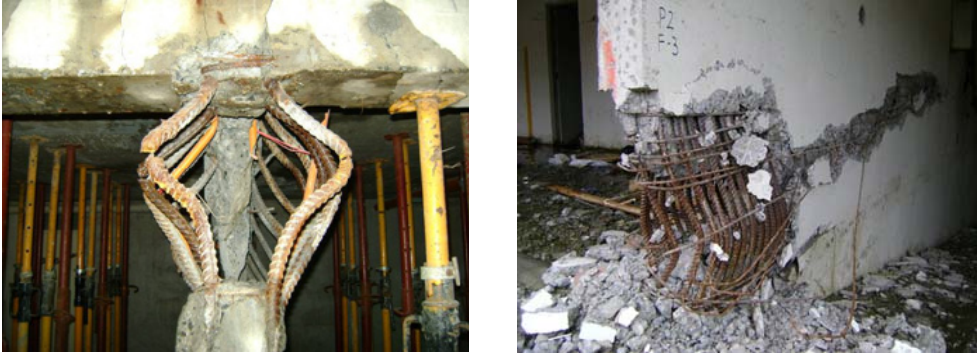
**Figure 11.** Typical compression failure of heavily loaded thin walls

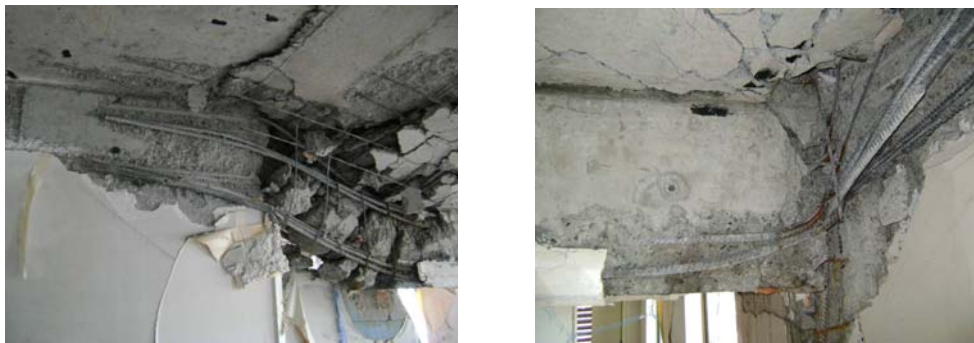
**Figure 12.** Poor anchorage of beam reinforcement in thin walls

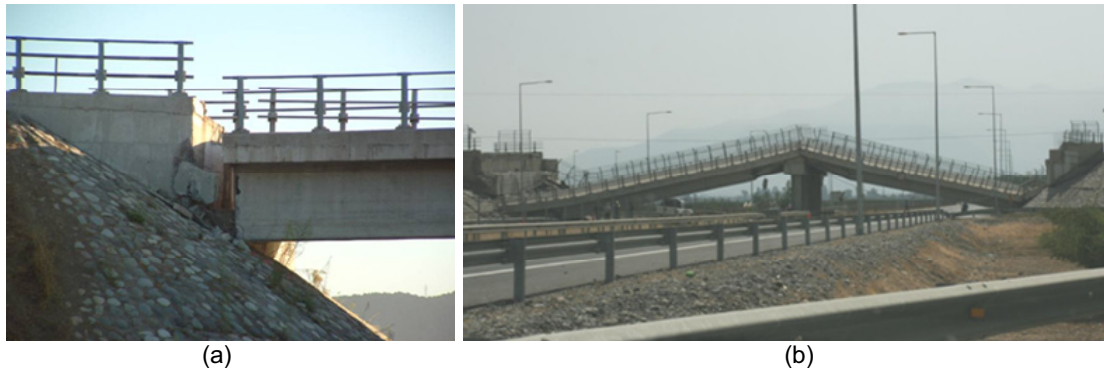
**Figure 8.** (a) Partial collapse of the superstructure, (b) total collapse of the superstructure. All photographs were taken at Ruta 5 Highway

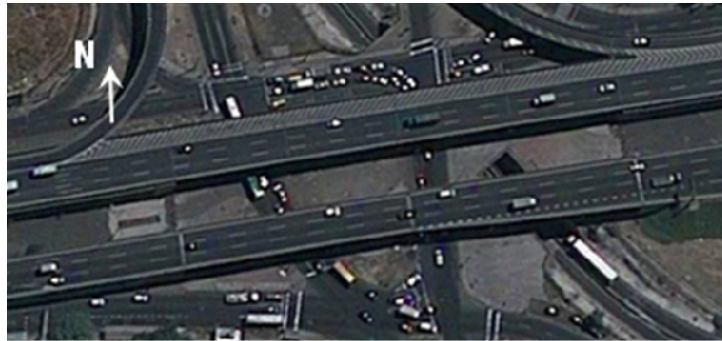
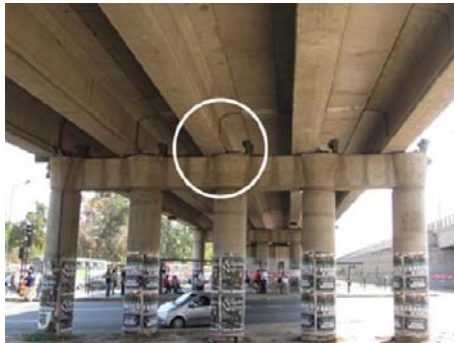
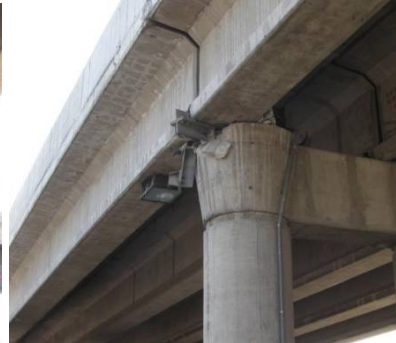
**Figure 9.** South bridge in Americo Vespucio Norte over Independencia Avenue: (a) relative location of the south and north bridges (Source: Google Earth); large lateral displacement at a central pier: (b) front view, (c) detail

This type of structure suffered large amount of damage. The damage is shown in Figures 9 through 12. In Figure 9 is shown the south bridge in Americo Vesputio Norte, over Independencia Avenue. It can be seen in Figure 9(a) that the south bridge is very close to the north bridge (about 27 m center-to-center), which suffered limited lateral displacement of the superstructure (see Figure 4(a) above). On the other hand, Figure 9(b) shows the large lateral displacement that occurred in the south bridge, which can be noticed within a white circle. Figure 9(c) shows that beams were close to lose vertical support. Steel hold-downs were not able to limit the displacement, and were destroyed by the beams. Figure 9(b) confirms that those hold downs just fell to the floor. This bridge was closed to traffic for a long time period.

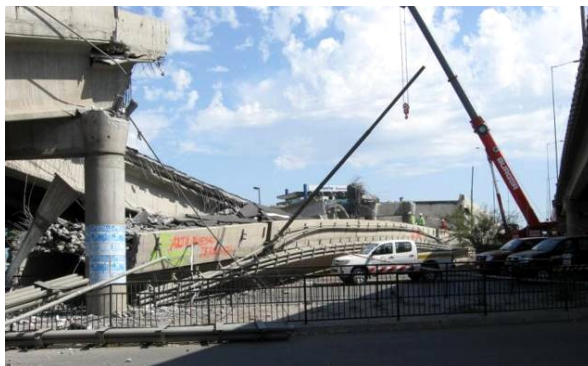
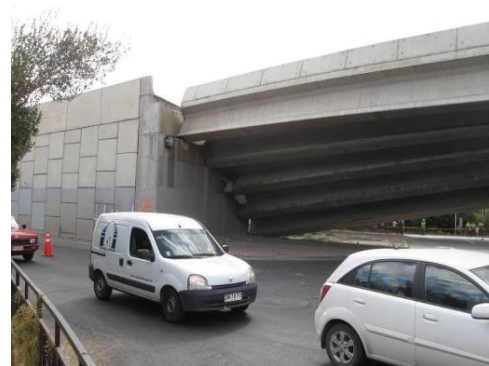
**Figure 10.** Collapsed bridges in Americo Vespucio Norte highway: (a) at Lo Echevers, (b) at Miraflores

Two overpasses suffered total collapse of at least one span, as seen in Figure 10. In both cases the bridges were skewed. Collapse occurred at spans supported by abutments in one end or by intermediate piers at both ends. Most probably local site effects produced amplification of the lateral displacement demands, because bridges with the same structural type located at Vespucio Sur, less than 20 km south of Vespucio Norte, did not show residual lateral displacement. On the other hand, a bridge with Type 1 structure suffered much smaller lateral displacements than a bridge with Type 3 structure located less than 30 m from the first one. This suggests that Type 3 structure was not a safe structural solution to the support of the bridges.

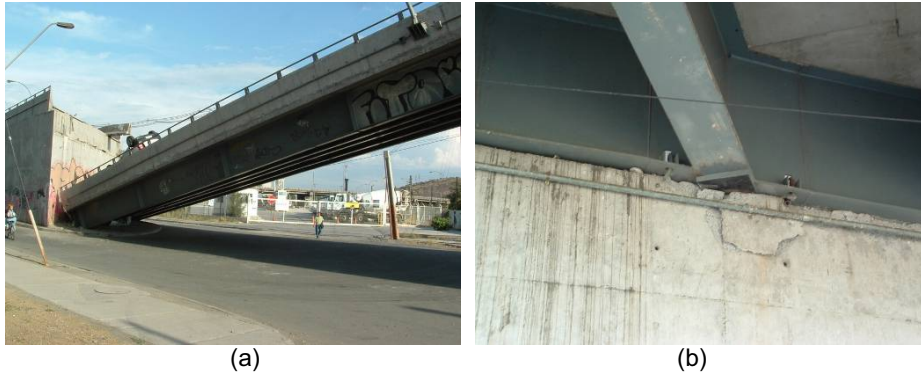
**Figure 11.** Bridge in Matta Av.: (a) collapsed span, (b) support at the abutment

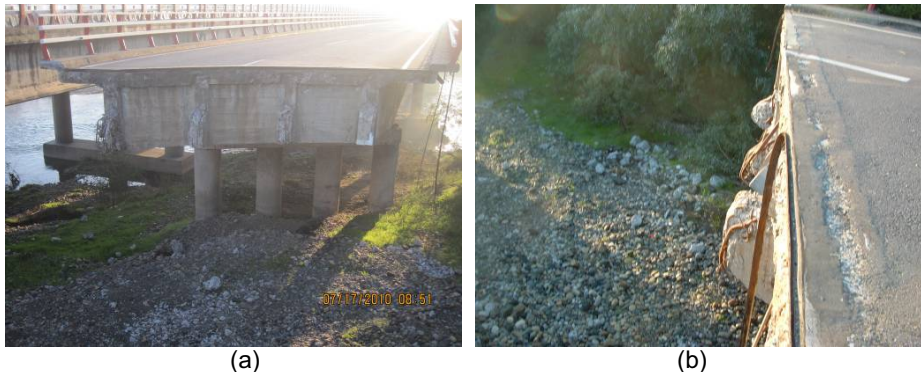
**Figure 12.** Nebuco Bridge: (a) collapsed span, (b) support of collapsed span

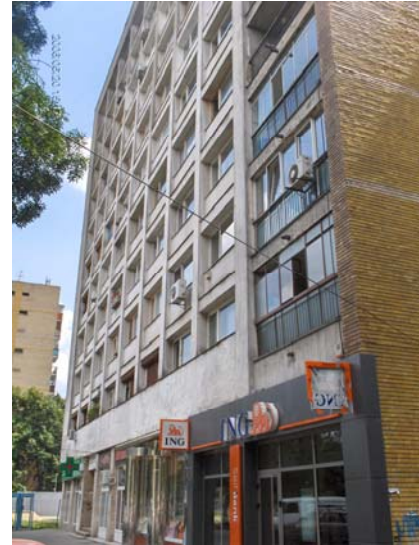
**Figure 3.** Main façade of the building A

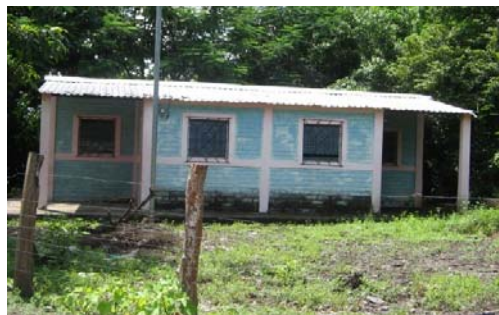
**Figure 3.** Intermediate beam used in confined masonry in El Salvador

The common practice used by laborers for confined masonry is not reflected in the current guidelines. In El Salvador, the common practice for single floor houses is to add an extra horizontal concrete element at the center of the walls (**Figure 3**). This element is known as “*solera intermedia*” (intermediate beam) which is prolonged from the bottom of the windows openings as a continuous element on the walls.

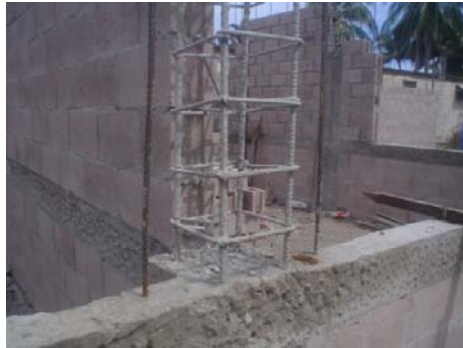
**Figure 4.** Intermediate beam used in hollow concrete block construction in El Salvador

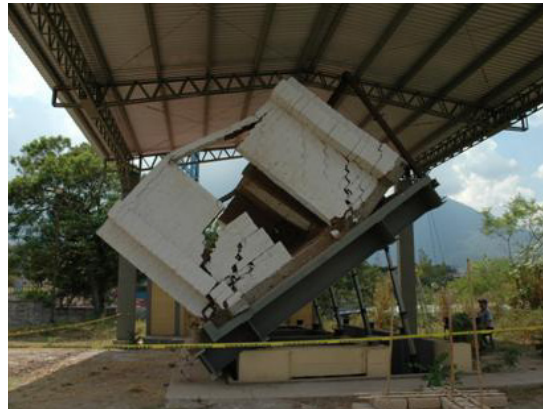
**Figure 6.** Tilting table system constructed in UES.

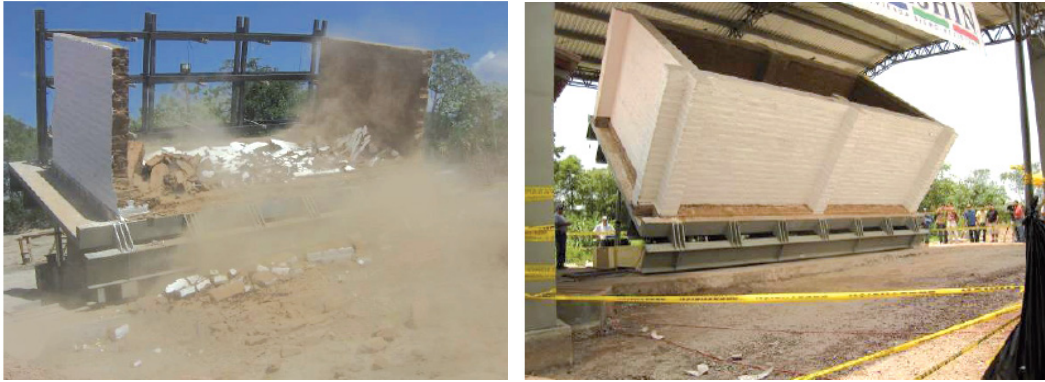
**Figure 7.** Test on adobe houses

In order to improve the behavior of adobe constructions, a new constructive technique for new houses is being studied. The modification includes the use of internal reinforcement and buttresses to improve the out of plane behavior of adobe walls. In order to evaluate the improvement of internally reinforced adobe constructions a series of experiments were conducted. The comparison was conducted by testing unreinforced and reinforced specimens against lateral loads on a tilting table (**Figure 7**).

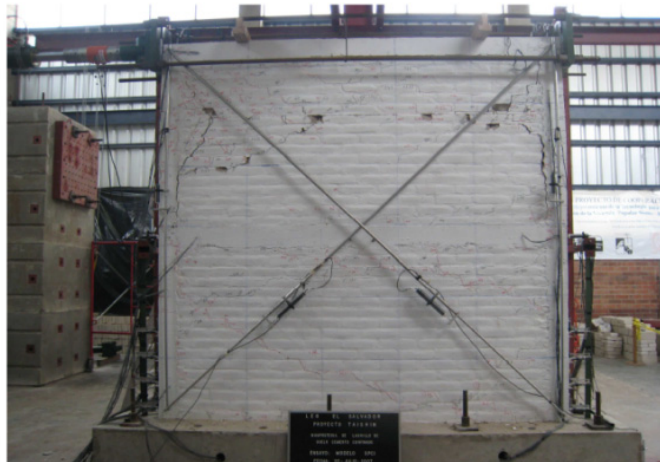
**Figure 8.** Test on confined masonry wall

The current practice used in the country for this type of construction involves the manufacturing of fired clay bricks, which produce pollution and deforestation. During this research, the use of bricks constructed with soil and cement as substitute of traditional bricks was studied. At same time, because the guideline does not specify the use of the intermediate beam in walls (as used by workers), the evaluation of the improvement of the in-plane behavior of walls when the intermediate beam is included was studied (**Figure 8**).

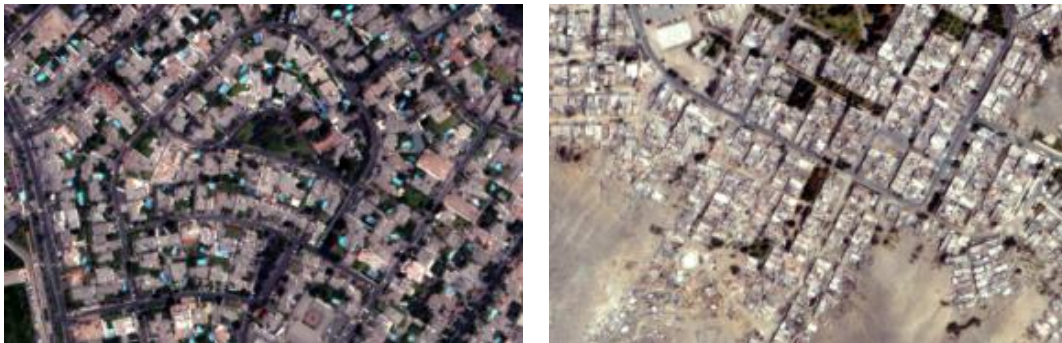
**Figure 12:** Two different of land use in La Molina district

On Figure 12, the left side present the image of a very high social class on La Molina district [3]. Here it is possible to identify the pools inside the houses. However of the right side of the figure we can identify another land use, typically of low income social class. Using the spectrometer donated by JICA in order to identify the spectral characteristic of pools in the area, it is possible to generate an automatic process for the identification of the number of pools in the district. Here the diagnosis is presented on Figure 13, where the non-existence of a pool is identify in red color, following by orange color that means 1 pool, 2 to 5 pools in yellow color and continue. This prove that in the case of town attack by a quake, the application of this technique will be used generating the identification of debris instead of pools.

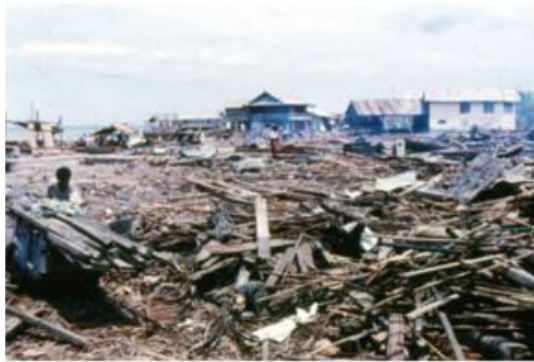
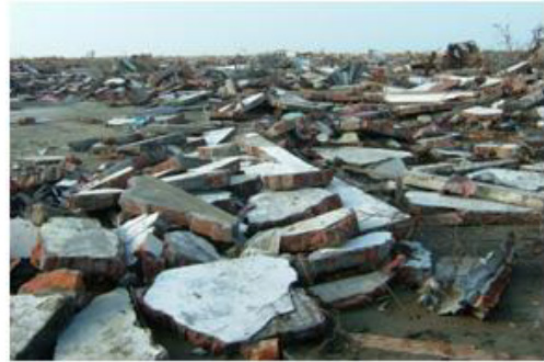
(a) 1992 Flores Earthquake

(b) 2004 Aceh Earthquake

**Figure 2.** Damage caused by tsunami (Indonesia)

This revised edition essentially retains the Guidelines in the original form except for some minor editorial changes and modifications. Some building damage photographs from recent earthquakes have been included for illustration (see Figs.2, 3, 5, 6 and 7) so that the concept of the guidelines will be easily understood. A major addition is Confined Masonry in Chapter 4 (see Fig.4) and Appendices in Chapter 10 giving the MSK Intensity Scale as related to buildings, a table for assessment of seismic safety of a masonry building, and examples of posters (see Fig. 8) on brick and wooden buildings.

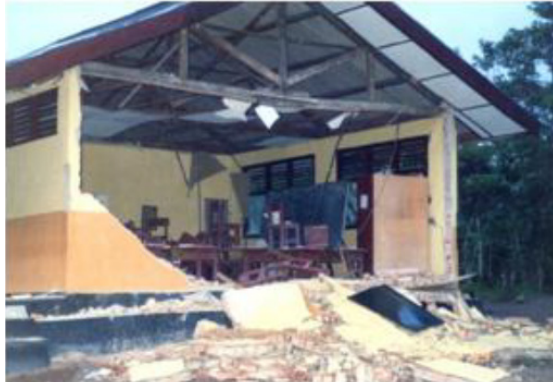
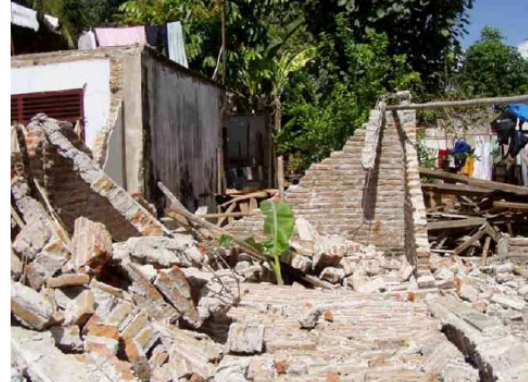
(a) 1994 Liwa Earthquake

(b) 2006 Central Java Earthquake

**Figure 3.** Out-of-plane failure of brick masonry wall (Indonesia)

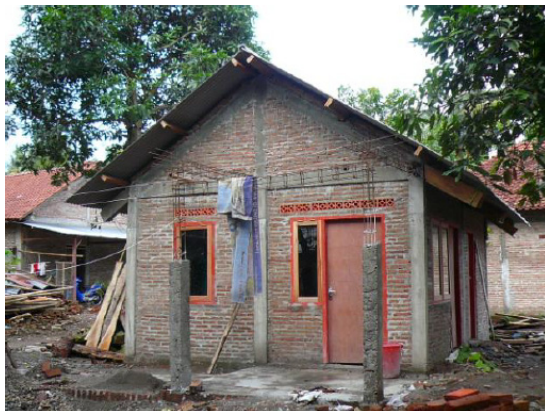
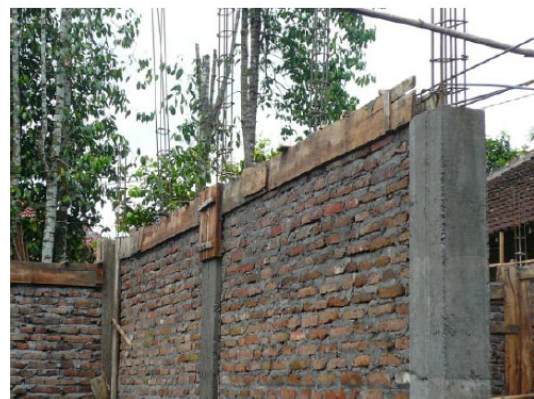
(a) Single storey house (Aceh)

(b) Two storey house under construction (Jawa)

**Figure 4.** Construction of confined masonry (Indonesia)

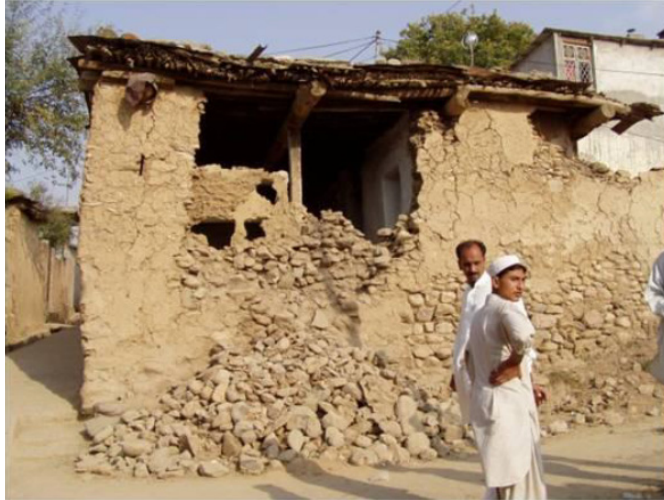
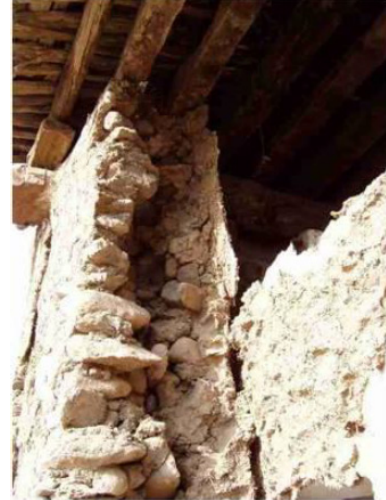
(a) Unreinforced stone masonry

(b) Damage to the stone masonry wall

**Figure 5.** Damage to stone masonry (2005 Northern Pakistan Earthquake)

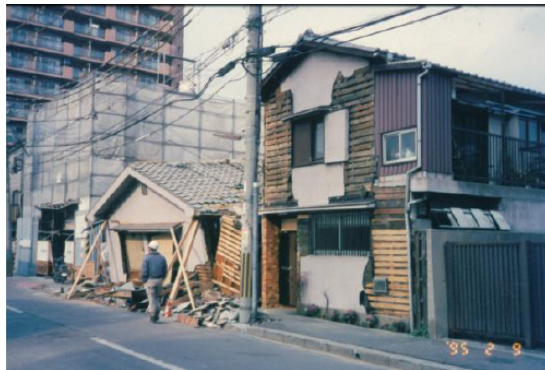
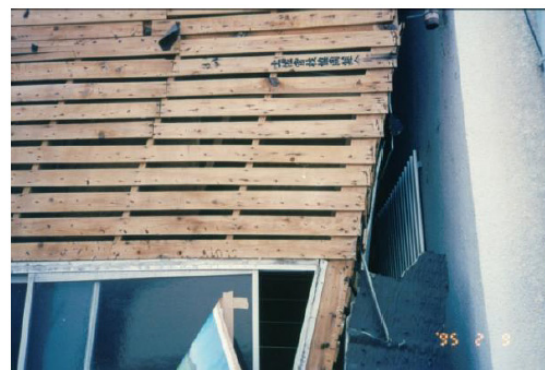
(a) Damage concentrated to the first storey

(b) Detail of the damaged wooden house

**Figure 6.** Damage to wooden houses (1995 Kobe Earthquake, Japan)

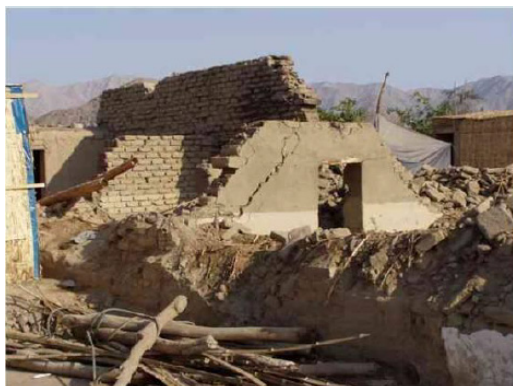
(a) Damaged adobe (2007 Pisco Earthquake)

**Figure 7.** Damage to earthen buildings (Peru)

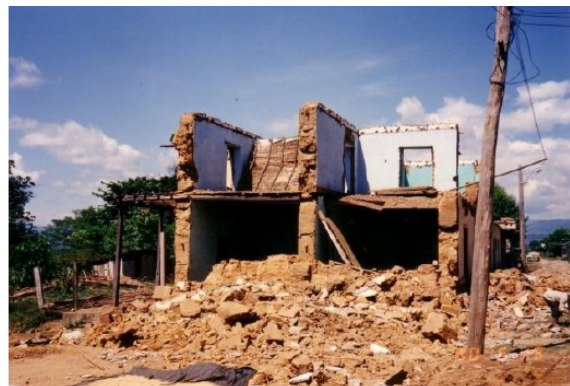
(b) Damaged tapial (1990 Rioja Earthquake)
