JAK/2013/PI/H/17 REV.

Conserving the Borobudur Temple for the Future

The Temple as an Image of the Universe

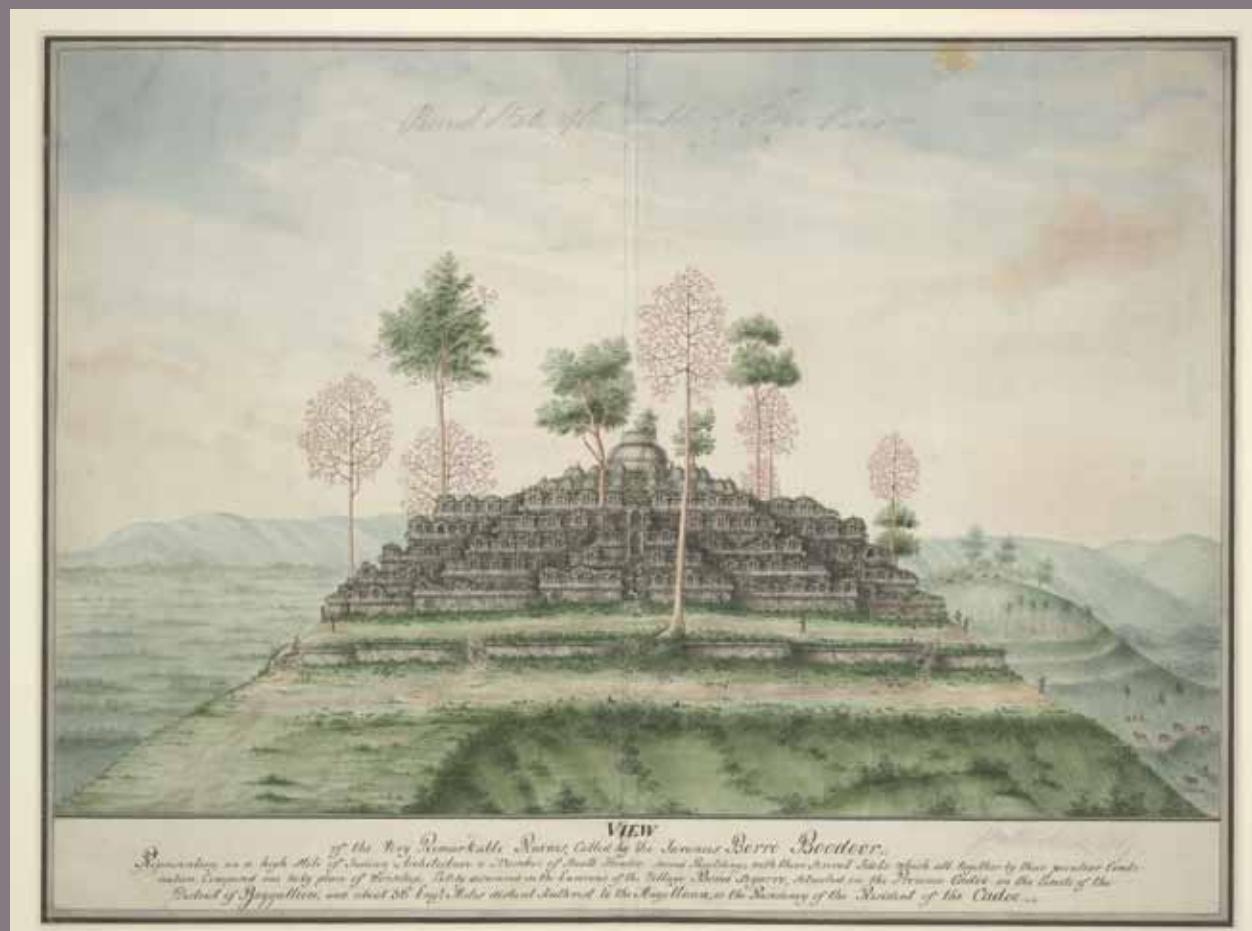
Water color painting of the Borobudur Temple by Sir Stamford Raffles
Lukisan cat air Candi Borobudur oleh Sir Stamford Raffles

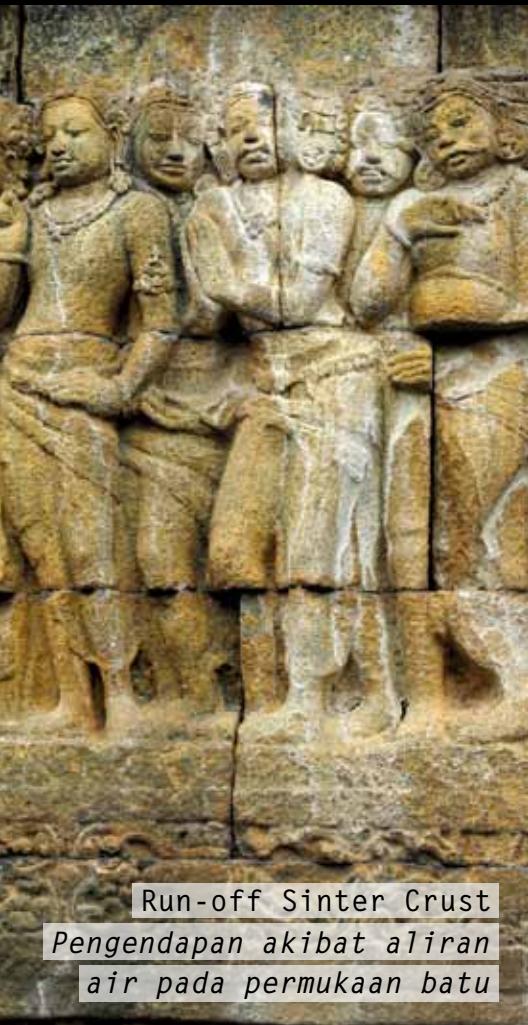
Run-off Sinter Crust
*Pengendapan akibat aliran
air pada permukaan batu*

There are still two major unsolved problems for the preservation of Borobudur with water seepage through the stone reliefs remaining a damaging factor and crusts and pustules affecting the precious reliefs. The BCO and German conservation experts are working together, within the framework of UNESCO/German Funds-in Trust Project, to find answers. Here new individual solutions can help to preserve the Borobudur temple.

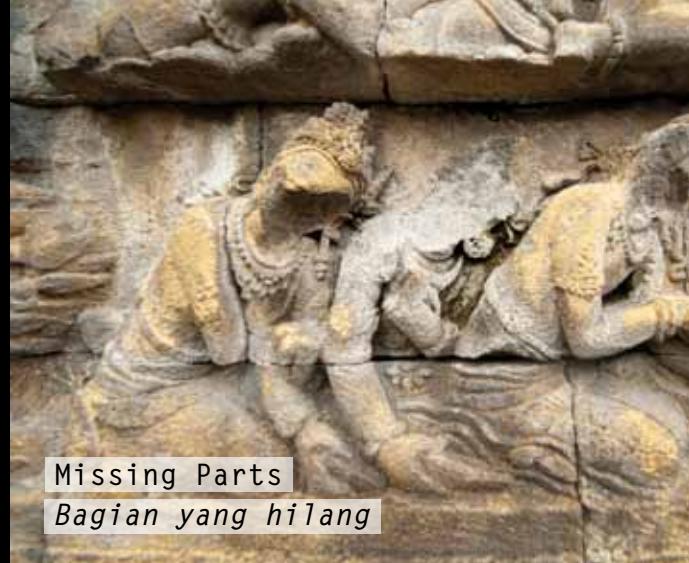
Missing Parts
Bagian yang hilang

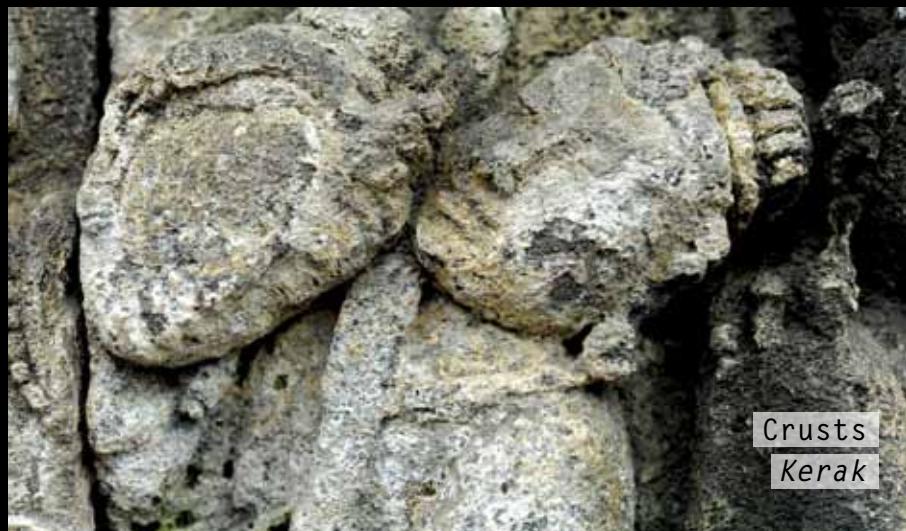
Crusts
Kerak

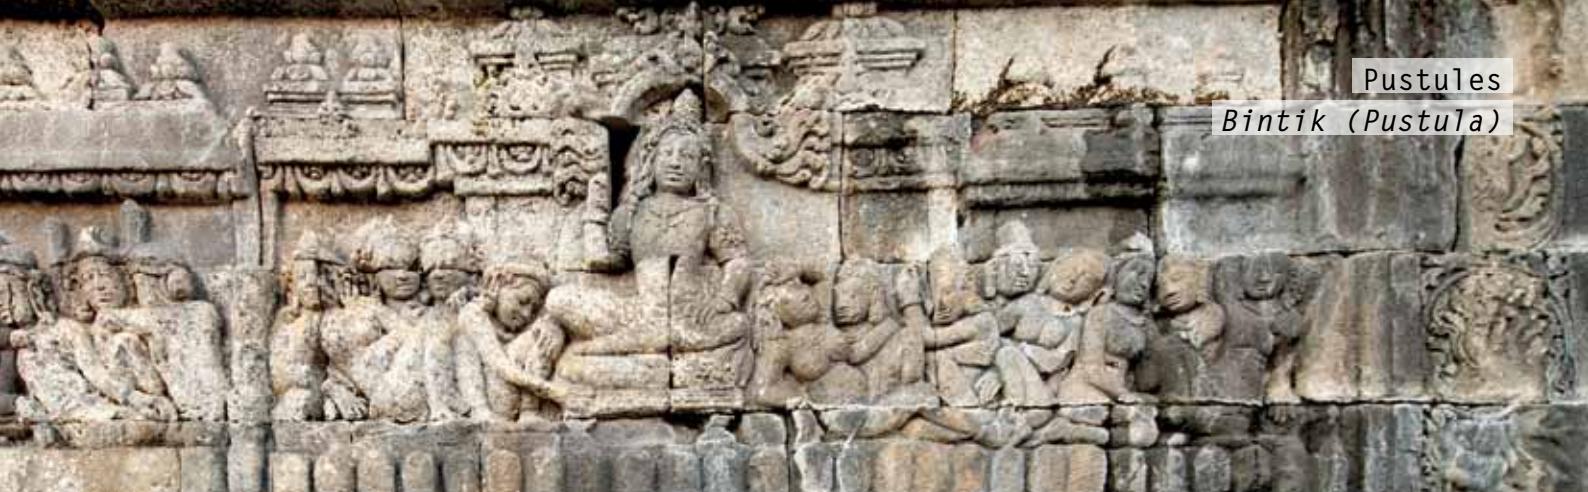
Pustules

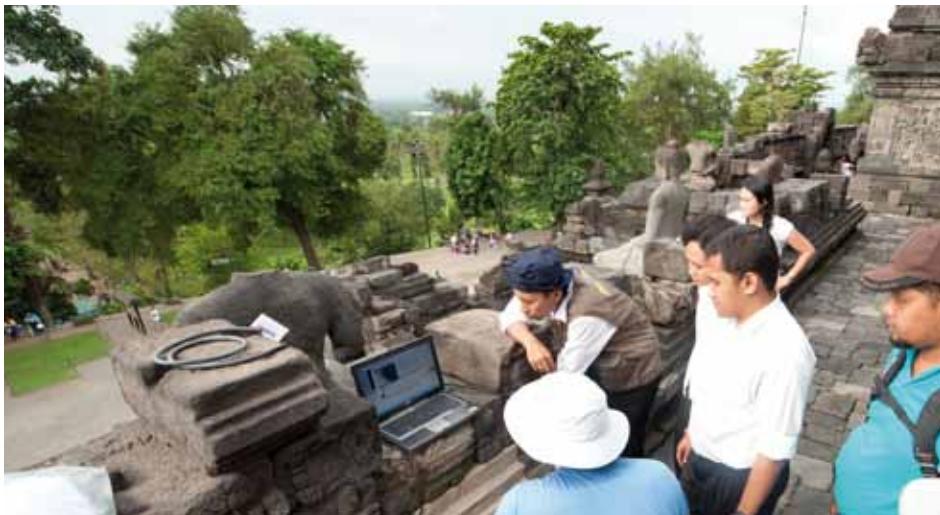
The successful operation of Borobudur's internal drainage system is checked by endoscope cameras.

At the time of the large scale conservation project during the 1970s and 1980s massive concrete was used on the galleries and surrounding the foot of the platforms in order to reinforce the vulnerable structure. This period also saw the introduction of a new drainage system.

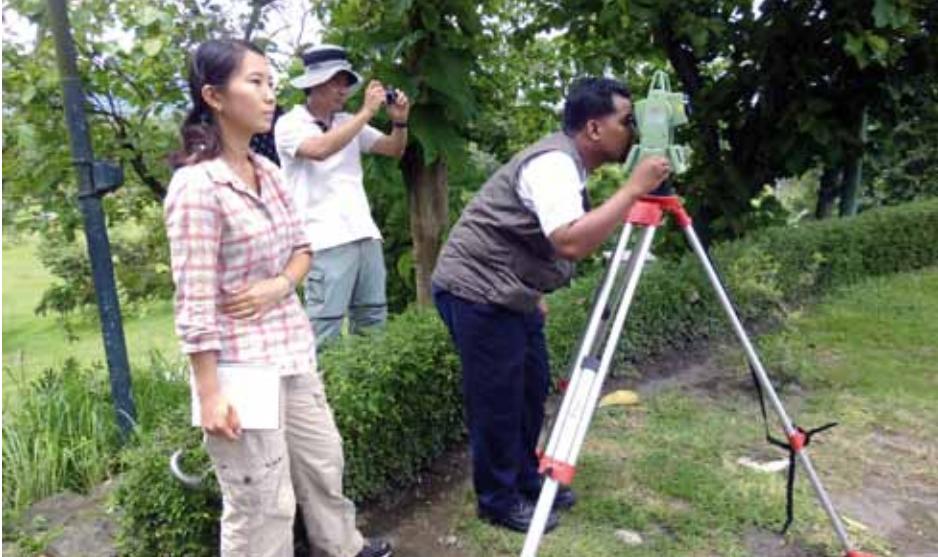
Using the Total Station to monitor the entire behavior of the stone structure and hill.

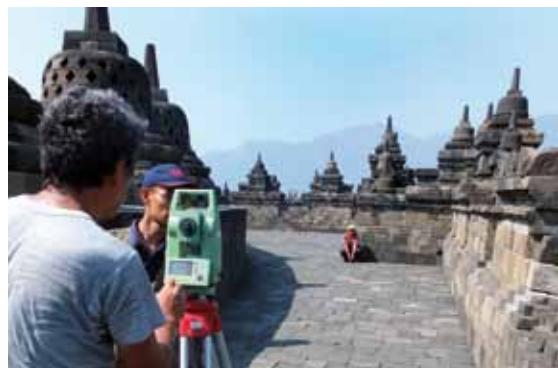
Structural monitoring by GPS and digital inclinometer.
