Protecting cultural heritage and community roots

Susan Barr

Directorate for Cultural Heritage

Threats to Arctic cultural heritage

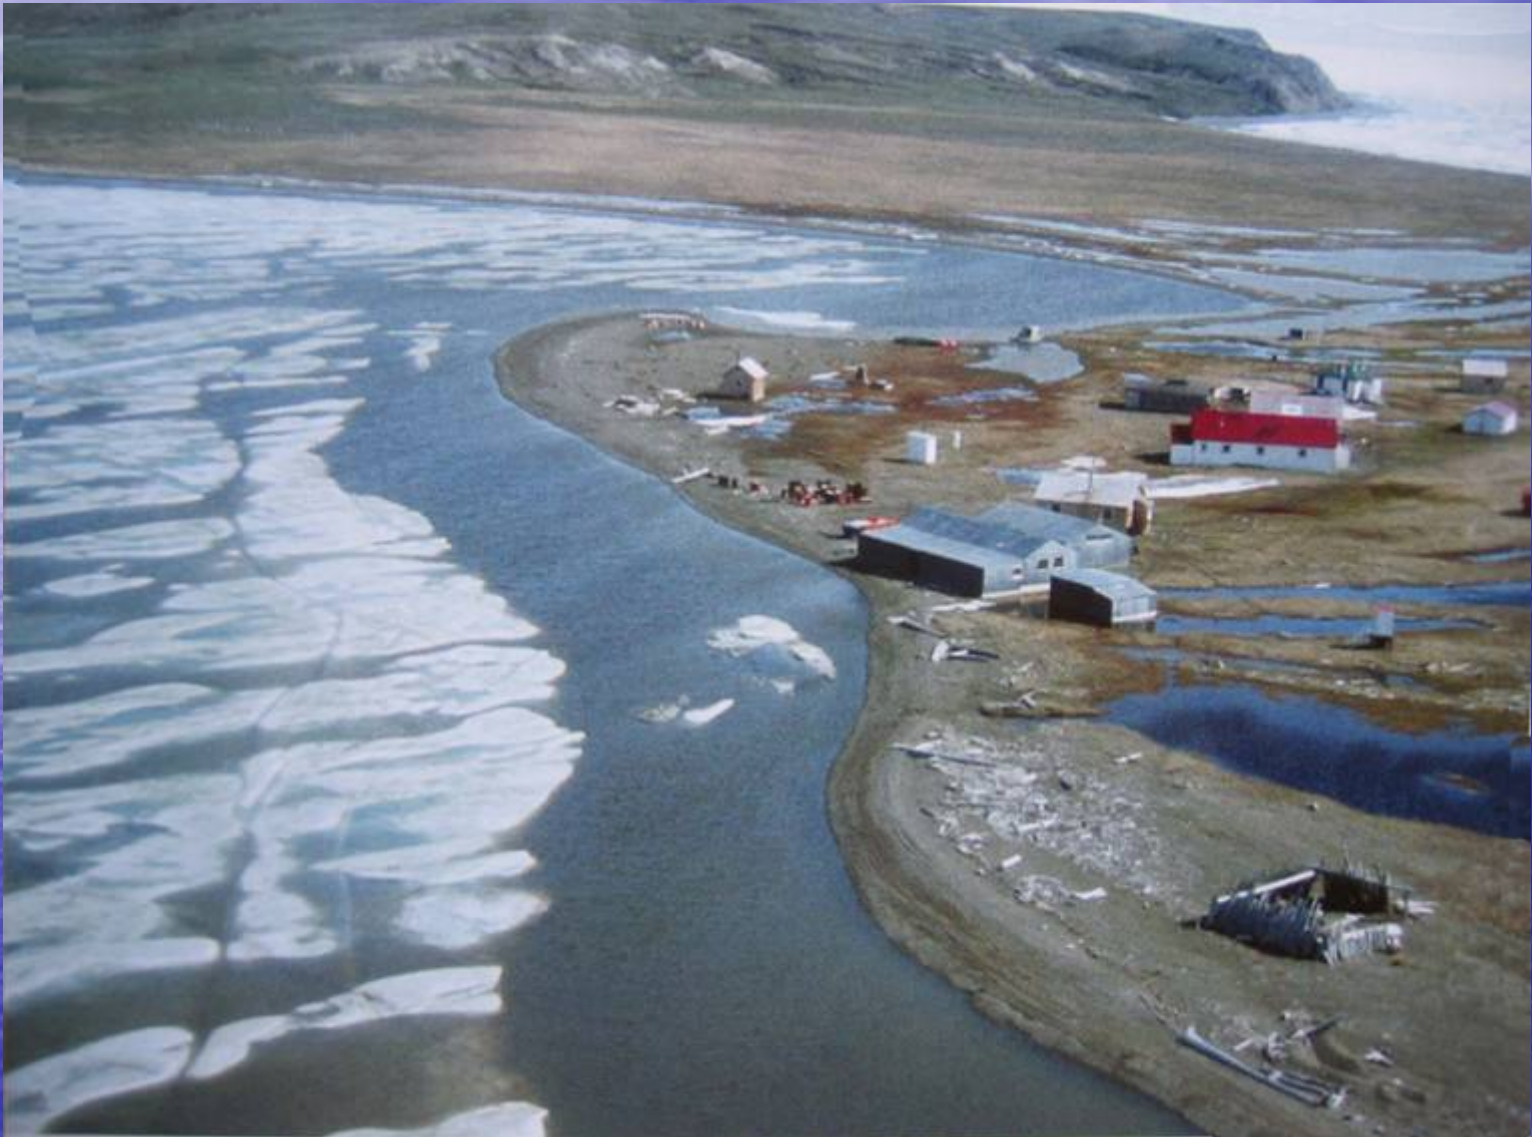
Herschel Island, Yukon

**SIMPSON POINT and PAULINE COVE
Herschel Island (Qikiqtaruk)
YUKON TERRITORY, CANADA**

Illustrating the former and current locations of Building #1, Building #3, and the Hunters & Travellers Cabin; and illustrating approximate variations in the shoreline from the 1920s to the present

Plan showing building relocations as of 2006. Building #1 is the NW&TCo Store, Building #2 is the Canada Customs Warehouse (Credit: Government of Yukon)

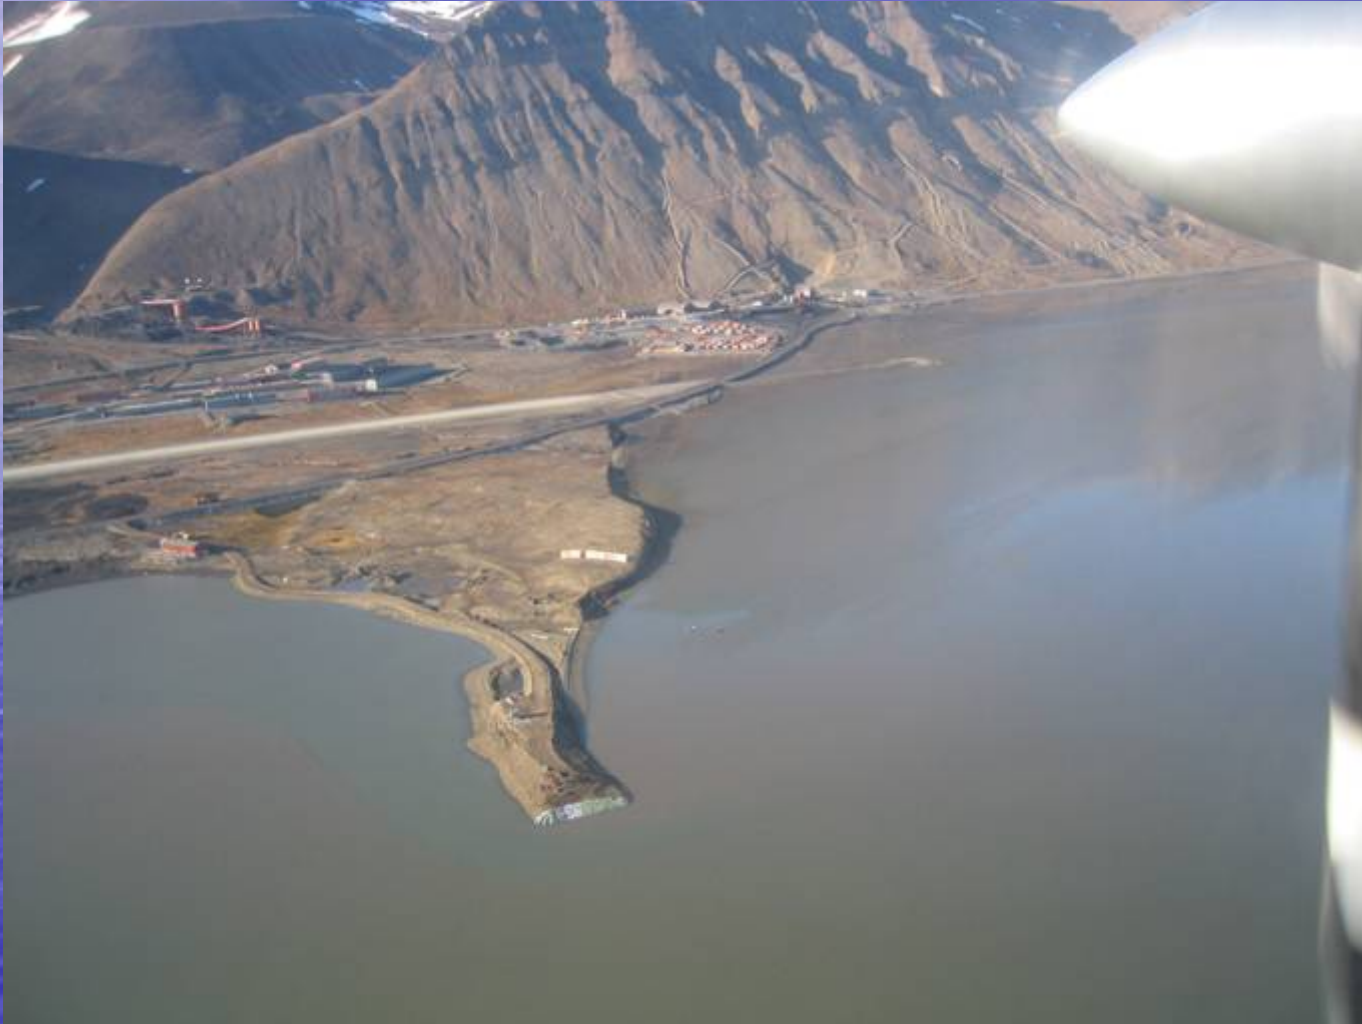
Test with geosynthetic material

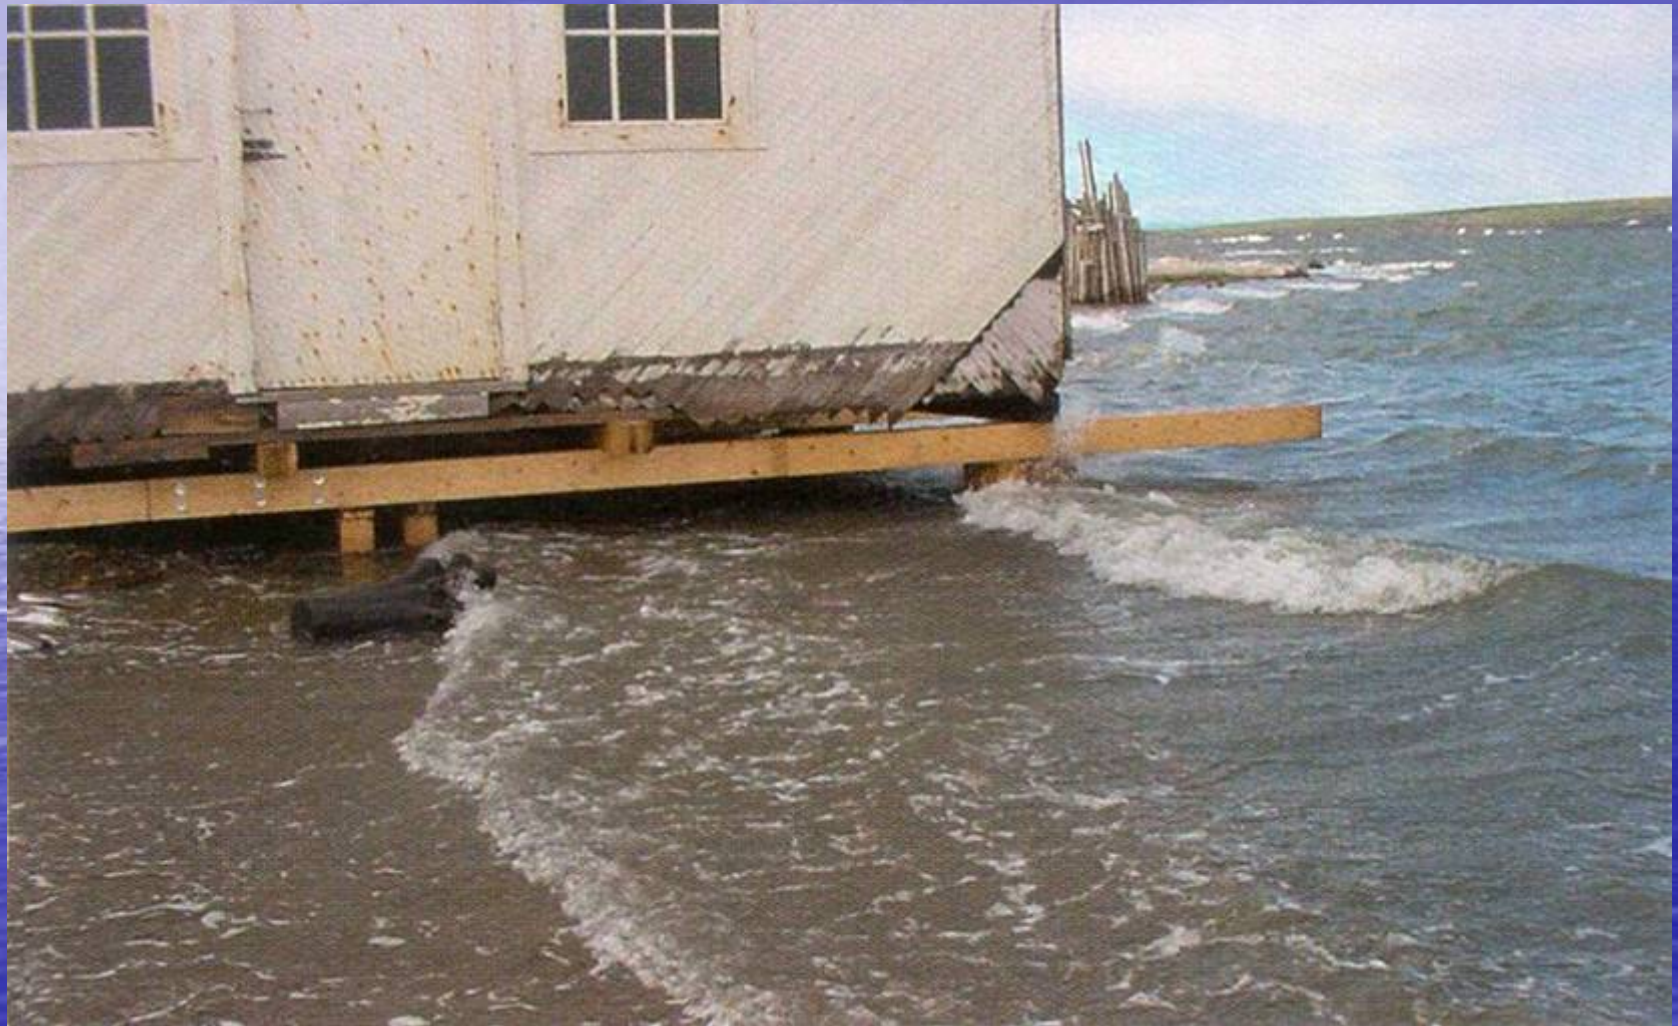
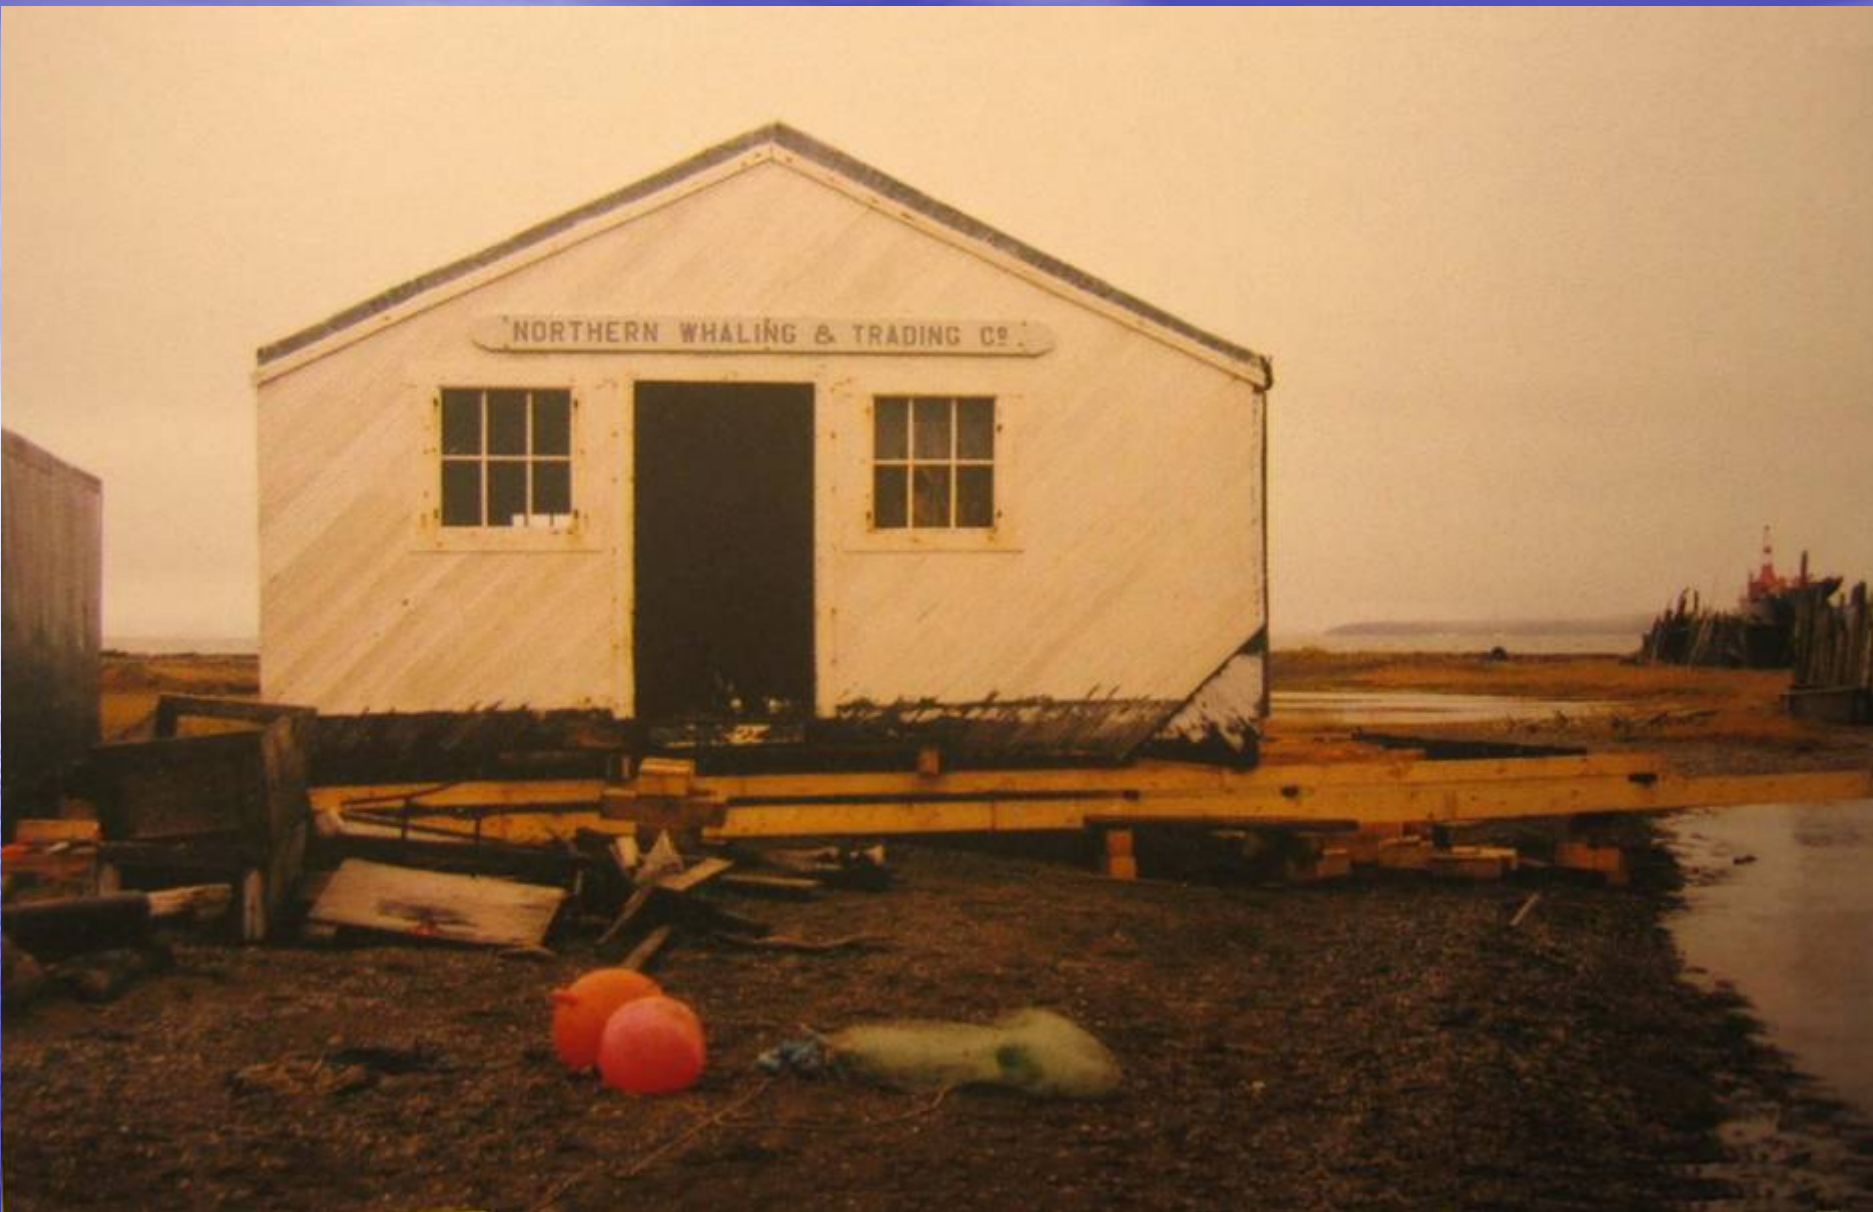
Herschel Island, Canada

Physical moving of the heritage object

- Can only be used on certain objects, mainly small buildings
- Disturbs the historical context, but can be acceptable with sufficient documentation
