Satellite-Based Damage Assessment of Cultural Heritage Sites

2015 Summary Report of
Iraq, Nepal, Syria & Yemen

June 2016

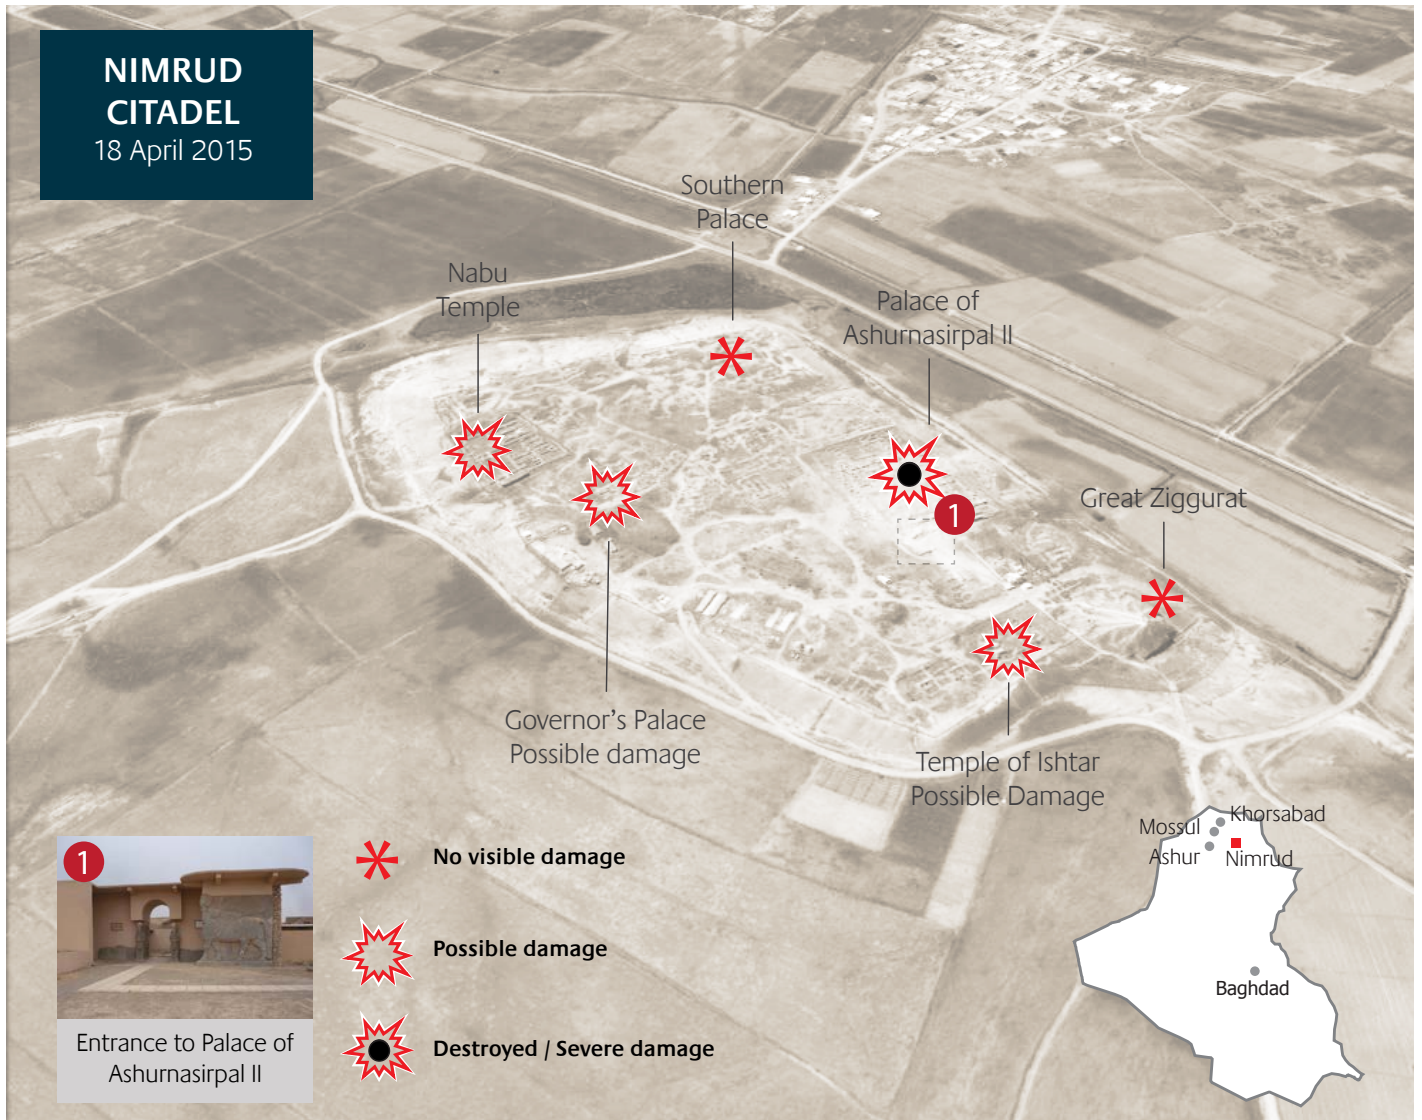
Source: Airbus Defense & Space Pléiades Imagery ©2016, 18 April 2015. Satellite imagery analysis by UNITAR-UNOSAT.

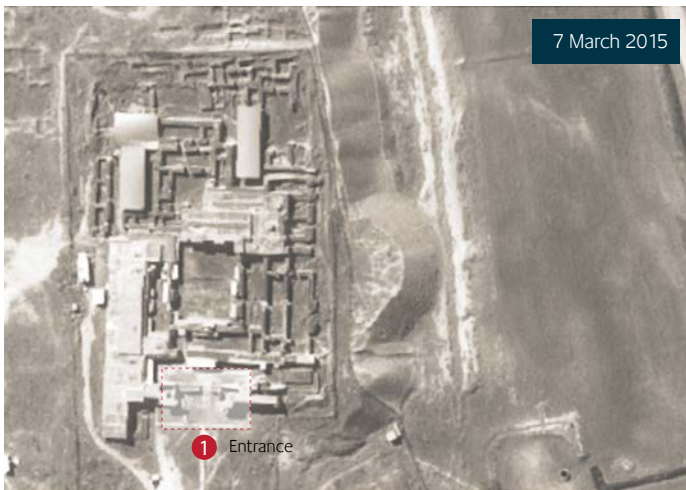
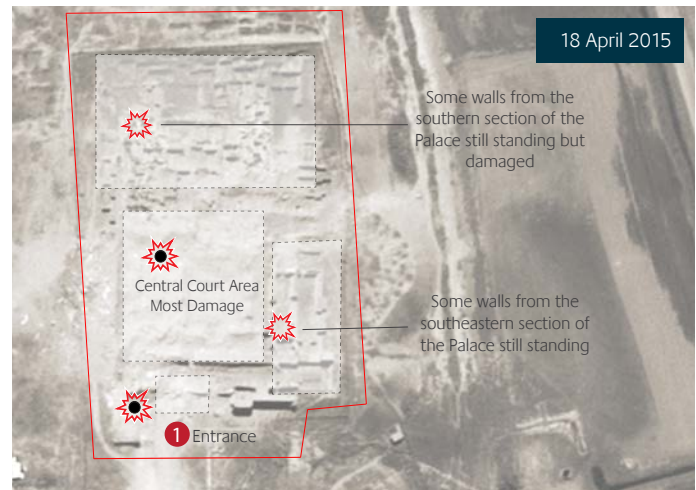
PALACE OF ASHURNASIRPAL II - UNOSAT confirmed the destruction and extent of the damage using satellite imagery from 18 April, 2015 compared to imagery collected on 7 March 2015 (see before and after images). The satellite derived damage assessment showed extensive damage over the Ashurnasirpal II Palace, inside the Nimrud Citadel. The main court area inside the palace and the surrounding building structures, including the entrance, appeared to be completely destroyed. Some of the surrounding corridors walls appeared to be intact, but most likely damaged. (Source: Before image (left) - Airbus Defense & Space Pléiades Imagery ©2016, 7 March 2015. After image (right) - Airbus Defense & Space Pléiades Imagery ©2016, 18 April 2015. Satellite imagery analysis by UNITAR-UNOSAT.)

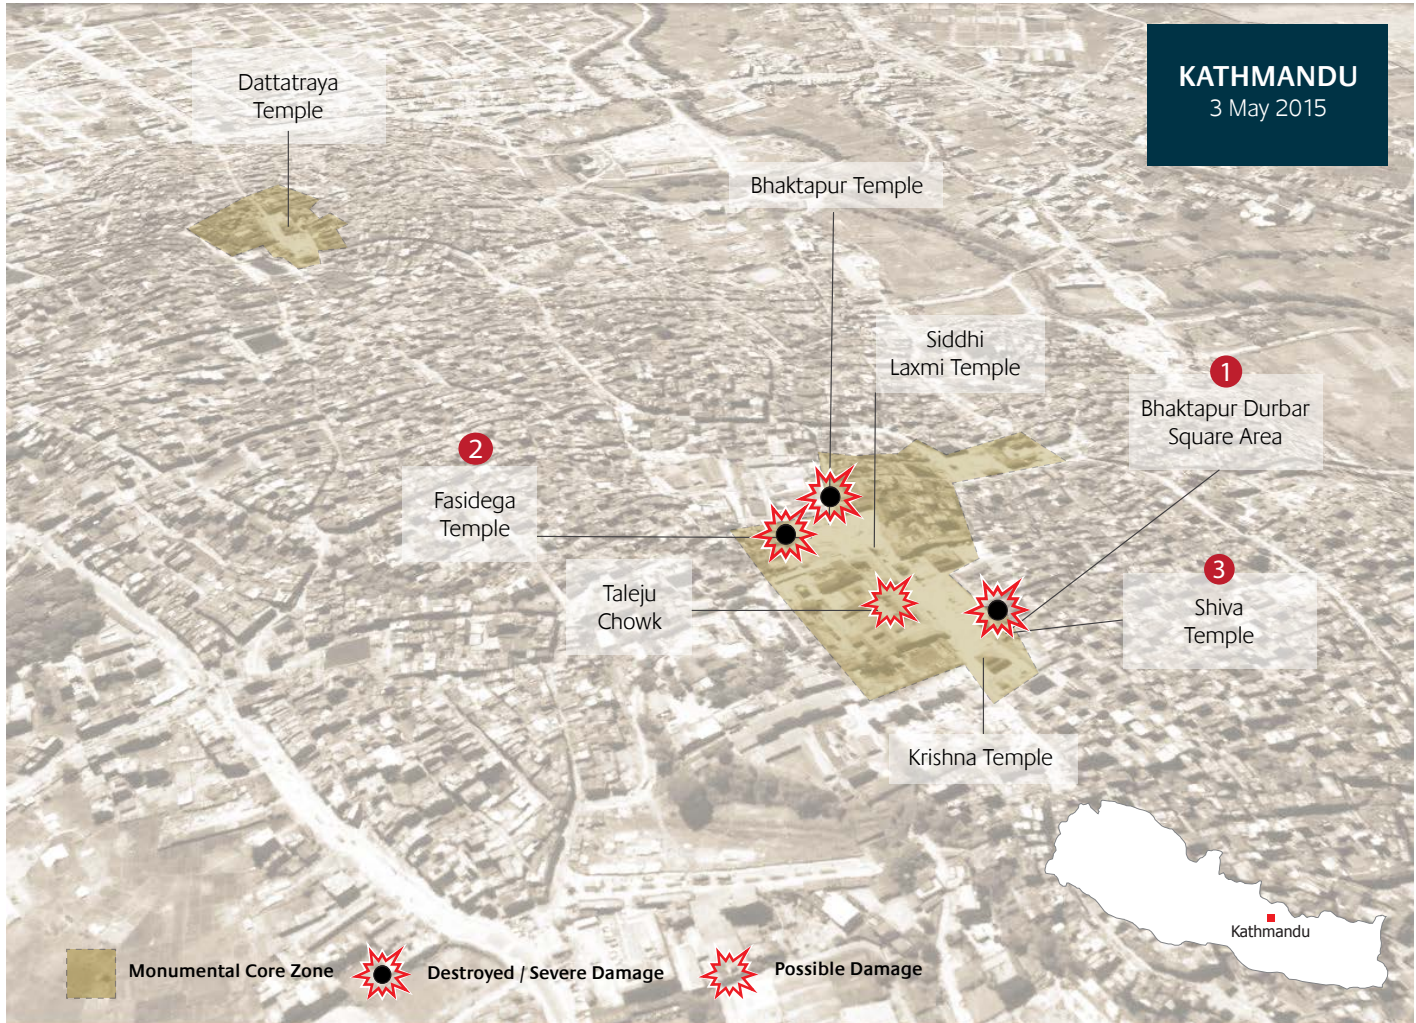
Boudhanath was the only monument zone which did not suffer visible damage that could be observed in satellite imagery. Regarding the other six monumental zones, a total of 175 structures (monuments and buildings) located in the core and buffer zones were affected: 43 structures have been destroyed, 53 structures show severe damage and 79 have been moderately damaged. Satellite image analysis of Bhaktapur Durbar Square Monumental Zone from 3 May 2015 shows severe damage to Fasidega Temple and Vatsala Durga Temple and moderate damage to Taleju Chowk and Siddhi Lazmi Temple as seen in the UN-ASIGN* pictures on page 8. Inside the perimeter of the monumental zone, a total of 45 structures were identified in satellite imagery as affected by the earthquake.

Source: Digital Globe WorldView 2 ©2016, 3 May 2015. Satellite imagery analysis by UNITAR-UNOSAT.

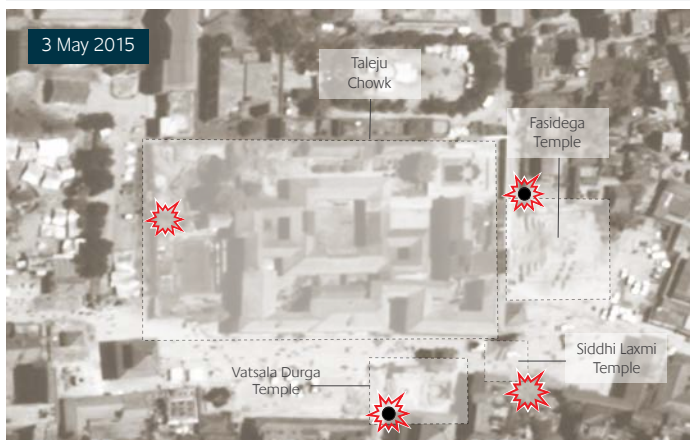
Bhaktapur Durbar Square Monument Zone shows severely damage to the Fasidega Temple and Vatsala Durga Temple and moderate damage to the Taleju Chowk and Siddhi Lazmi Temples. Inside the perimeter of the monument zone a total of 45 structures were affected by the earthquake.

Source: Digital Globe WorldView 2 ©2016, 3 May 2015. Satellite imagery analysis by UNITAR-UNOSAT.

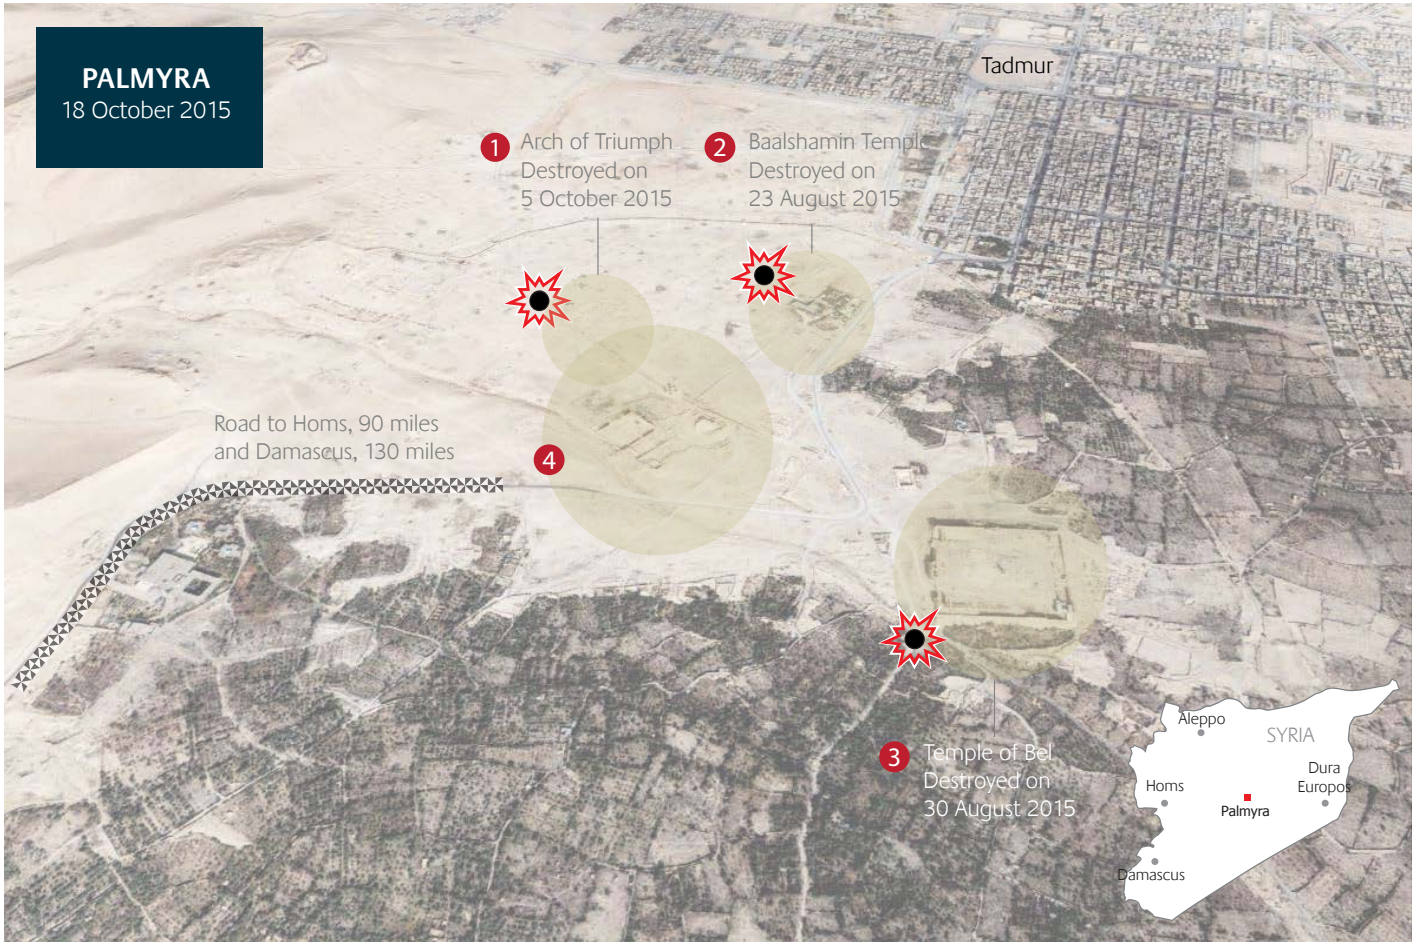
Damaged Locations in Palmyra - Between 23 August 2015 and 5 October 2015 (43 days) ISIL/Daesh destroyed a total of three Cultural Heritage Sites in Palmyra, Syria. (Source: Airbus Defense and Space Pléiades Imagery ©2016. Satellite imagery analysis by UNITAR-UNOSAT.)

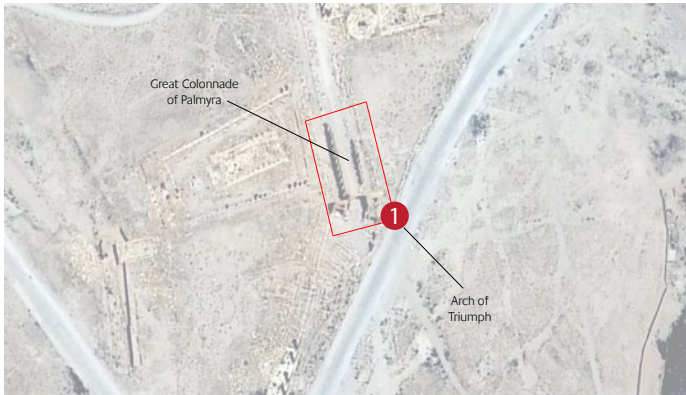
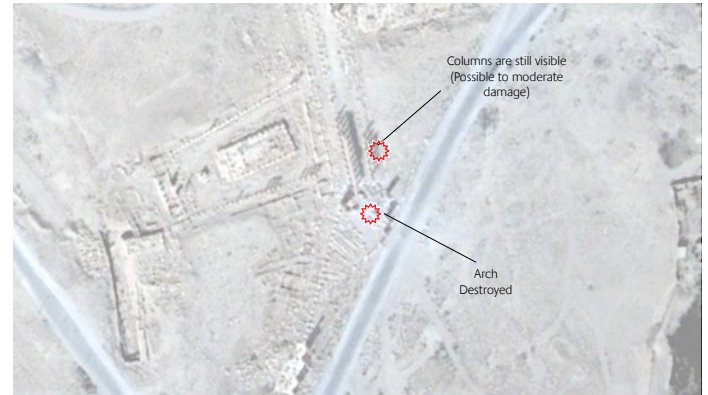
Arch of Triumph - The damage caused by the alleged explosive devices placed at the Arch of Triumph in Palmyra, Syria, destroyed the arch and most likely damaged many of the adjacent columns of the colonnade. (Source: Before image (left) - Airbus Defense & Space Pléiades Imagery ©2016, 26 June 2016. After imagery (right) - Airbus Defense & Space Pléiades Imagery ©2016, 18 October 2016. Satellite imagery analysis by UNITAR-UNOSAT.)

On 5 October 2015 ISIL/Daesh destroyed the Arch of Triumph at the entrance of the Great Colonnade of Palmyra. Using a satellite image collected on 18 October 2015 and comparing it to a 14 February 2014 satellite image, UNOSAT assessed the extent of the damage and reported the complete destruction of the Arch (see page 11).

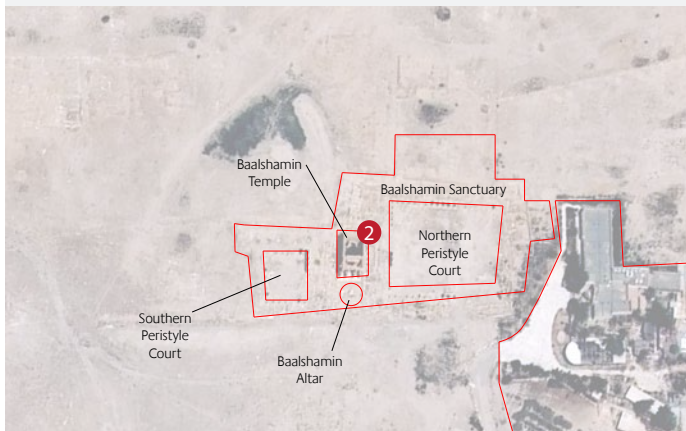
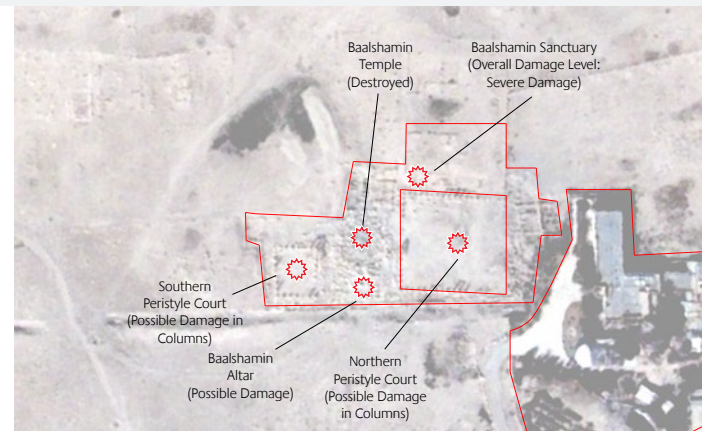
Baalshamin Temple - The damage caused by the detonation of a large quantity of explosives placed inside the Baalshamin Temple destroyed the temple and the Baalshamin Altar inside the sanctuary grounds. The expansive explosion possibly damaged all the other surrounding columns and structures that are within the sanctuary. (Source: Before image (left) - Airbus Defense & Space Pléiades Imagery ©2016, 26 June 2015. After image (right) - Airbus Defense & Space Pléiades Imagery ©2016, 18 October 2016. Satellite imagery analysis by UNITAR-UNOSAT.)

On 13 May 2015, ISIL/Daesh launched an attack on the modern town of Tadmur, sparking fears that the group would destroy some of the many heritage sites in the adjacent ancient site of Palmyra (see QR Code). On 23 August 2015 ISIL/Daesh militants reportedly detonated a large quantity of explosives inside the Baalshamin Temple. Using a 25 August 2015 satellite collected image compared to a 26 June 2015 satellite image, UNOSAT assessed the extent of the damage and reported the complete destruction of the temple, which is estimated to have occurred between the 25 and 27 August 2015 (see page 11).

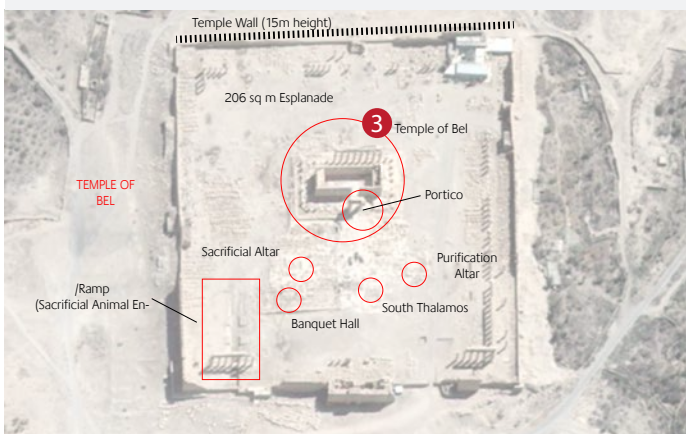
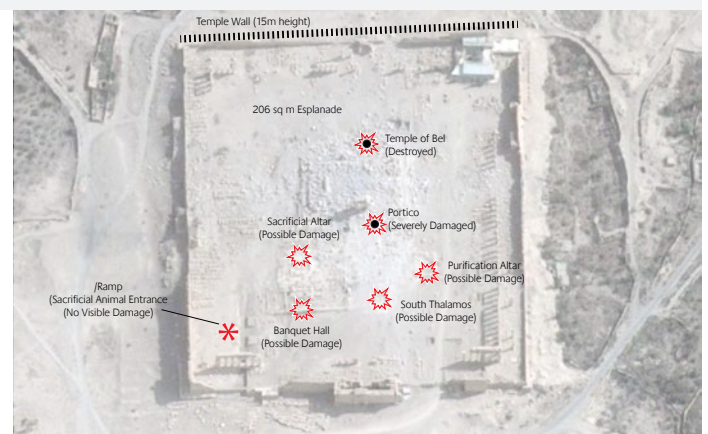
Temple of Ba'al - The damage caused by the alleged explosive devices placed inside the Temple of Ba'al in Palmyra, Syria, destroyed the Temple of Ba'al at the centre of the esplanade, severely damaged the portico and possibly damaged all the other surrounding structures that are within the temple walls. (Source: Before image (left) - Airbus Defense & Space Pléiades Imagery ©2016, 27 August 2015. After image (right) - Airbus Defense & Space Pléiades Imagery ©2016, 18 October 2016. Satellite imagery analysis by UNITAR-UNOSAT.)

Shortly after, on 30 August 2015, ISIL/Daesh reportedly destroyed the Temple of Ba'al. Using a satellite image collected on 31 August 2014 compared with a satellite image collected on 27 August 2015, UNOSAT confirmed the destruction of the main temple inside the temple grounds.

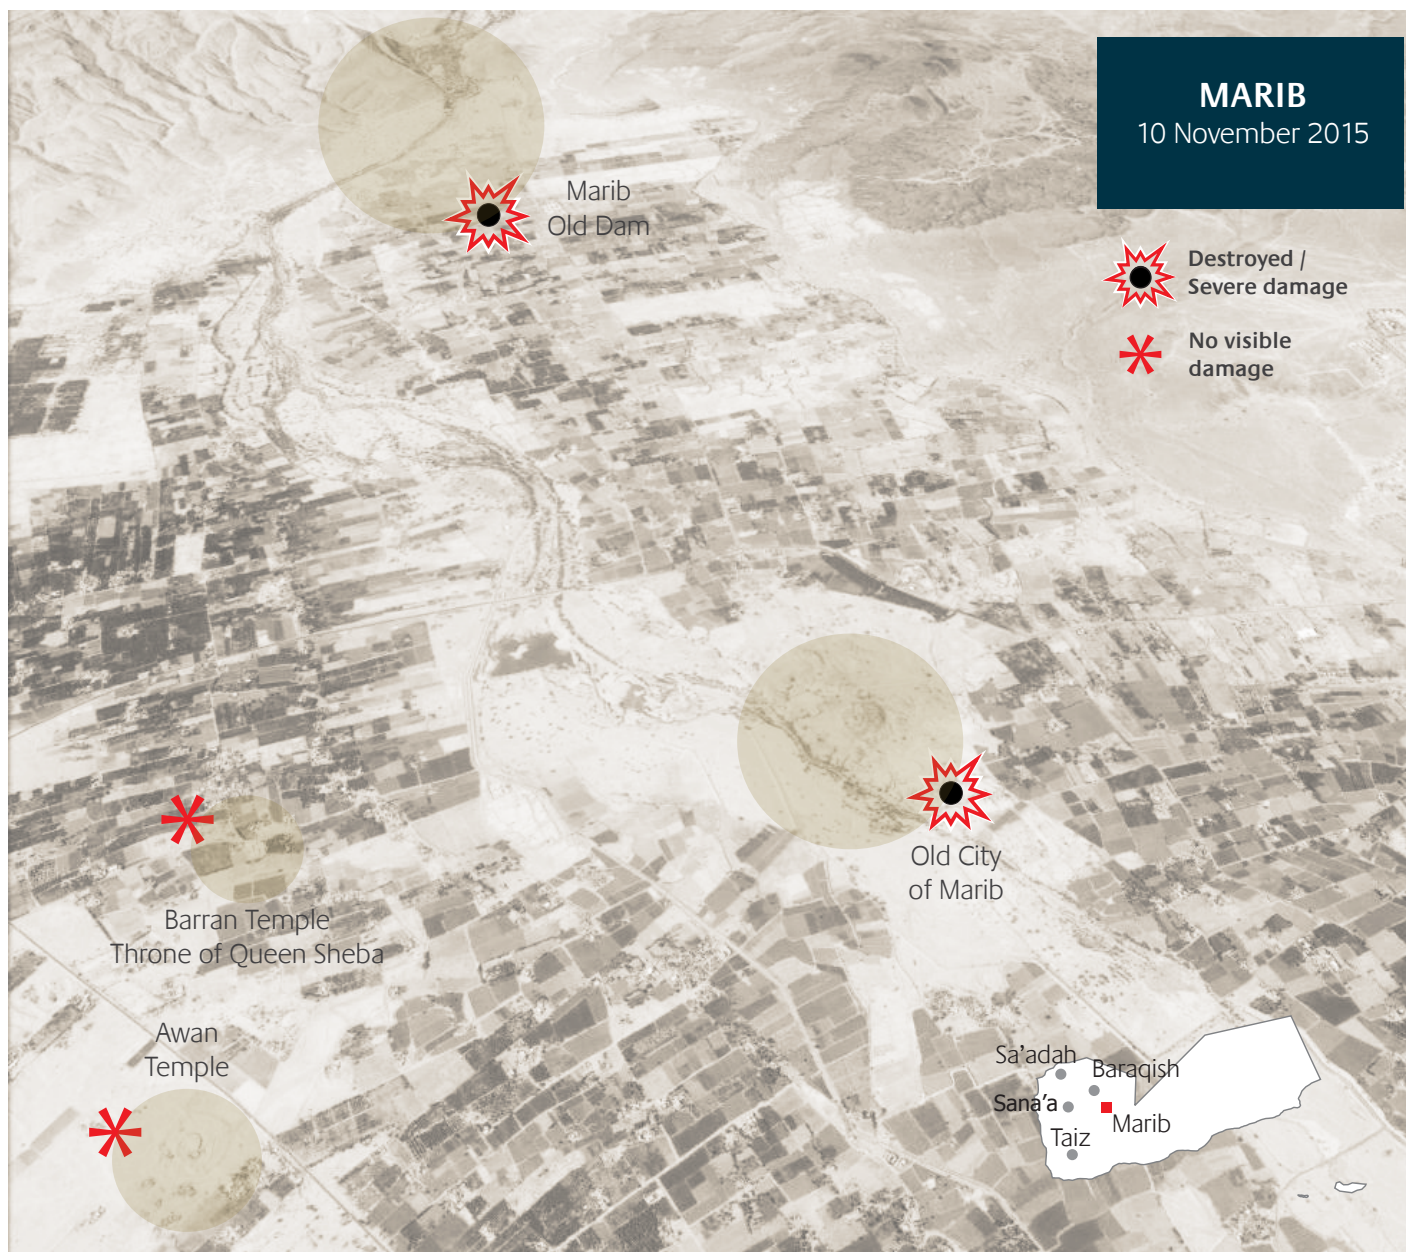
Source: Marib, Yemen, 10 November 2015. © US Department of State, Humanitarian Information Unit, NextView license. Satellite imagery analysis by UNITAR-UNOSAT.

Sallah palace, built in the 20th century and used as a museum until the beginning of the conflict, was also targeted and severely damaged. Satellite imagery from 1 November, 2015 shows severe damage to the north-eastern corner of the main museum buildings.

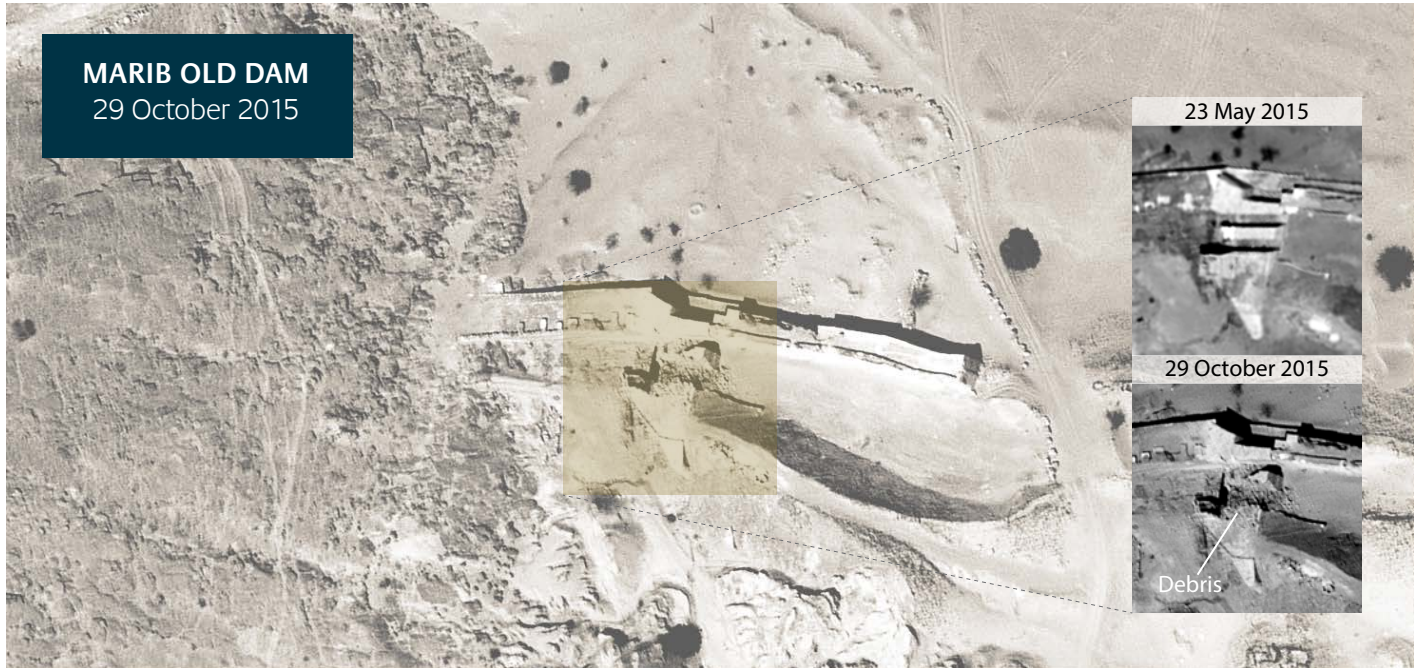
Source: Marib, Yemen, 29 October 2015. © US Department of State, Humanitarian Information Unit, NextView license. Satellite imagery analysis by UNITAR-UNOSAT.

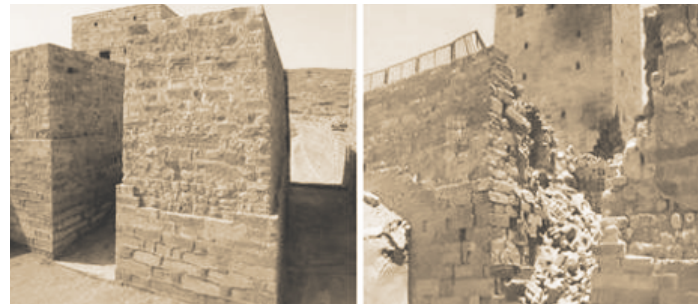
Marid Old Dam before and after image. Photo credit: Hussain Bukhaiti. Satellite imagery collected on 29 October 2015 shows one of the retention towers severely damaged with visible debris in the middle section of the Southern Dam sluice.

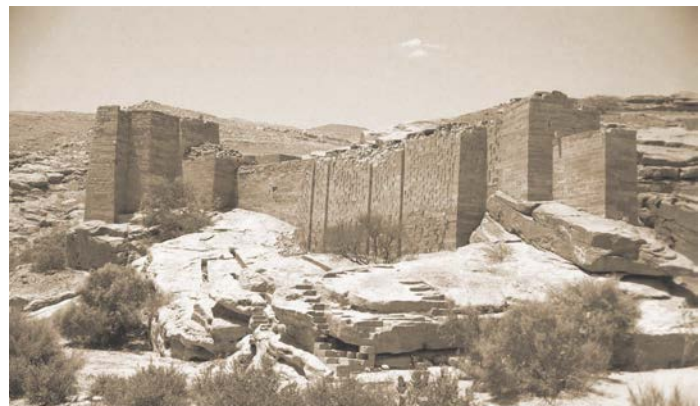
Marib Old Dam before destruction. Photo credit: Jordi Zaragoza Anglès, Mikaku planet, 1995 (www.mikakuplanet.com).
