# Protecting BAALBEK'S Integrity

## A PROPOSAL FOR AN INTEGRATED RISK PREPAREDNESS STRATEGY

CAPACITY BUILDING OF HUMAN RESOURCES FOR  
DIGITAL DOCUMENTATION OF WORLD HERITAGE SITES  
AFFECTED BY THE 2006 WAR IN LEBANON

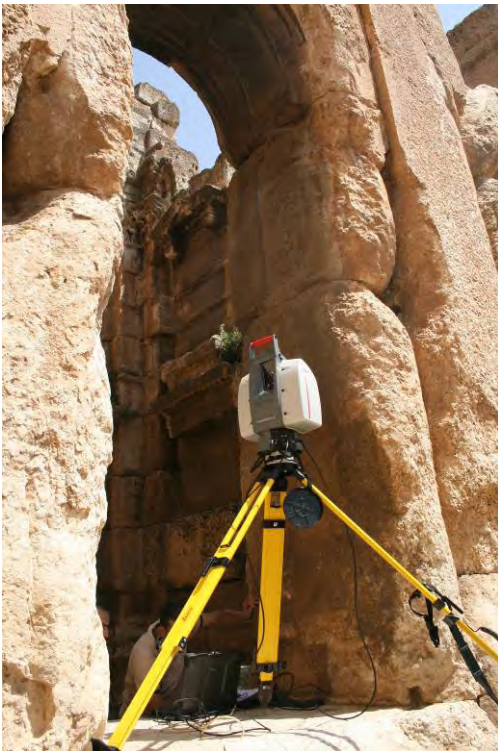
Figure 6.1: Laser scanner set up in Baalbek historical site

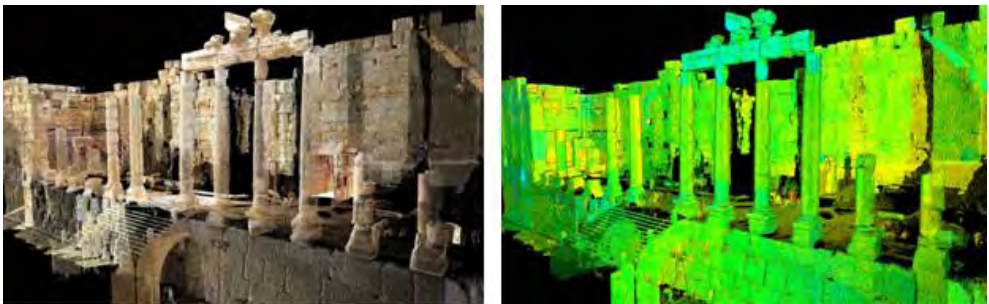
Figure 6.2: Representation of a laser scanner point cloud: (left) coloured using panoramic images, (right) coloured using the laser scanner reflectance values

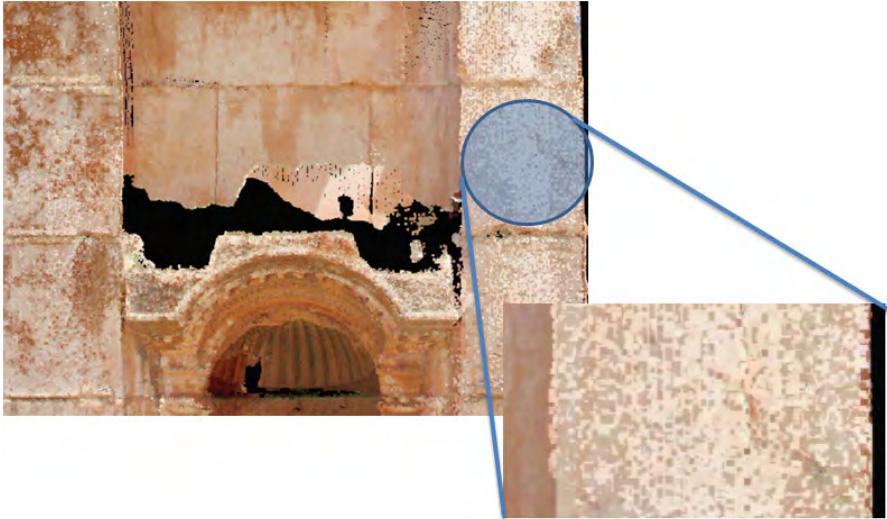
Figure 6.3: Orthophotographical view of the point cloud. Using colours from different scans results in noisy colour information in the orthophotograph

A major issue in the production of orthophotographs using this approach is the fact that the final ortho-images are being composed out of different scans. Each of these scans is taken at a different time of the day and so are their high-resolution panoramic images. The large differences in colours between different scan worlds are not relevant in the 3D point cloud, however, in the final orthophotographs this results in apparent noise, as shown on Figure 6.3.

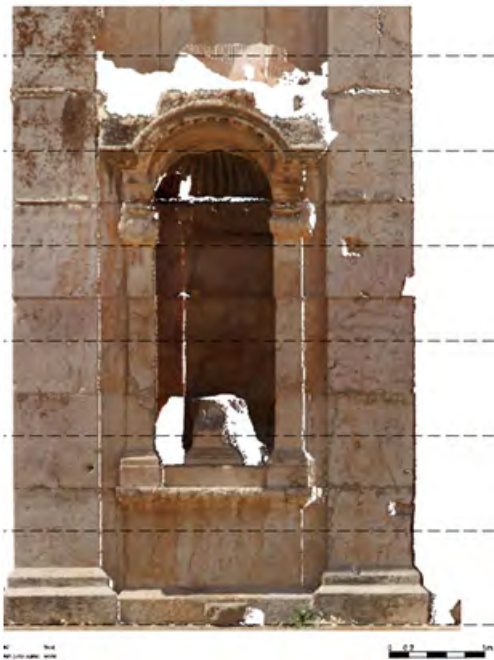
Figure 6.4 : Completed orthophotograph

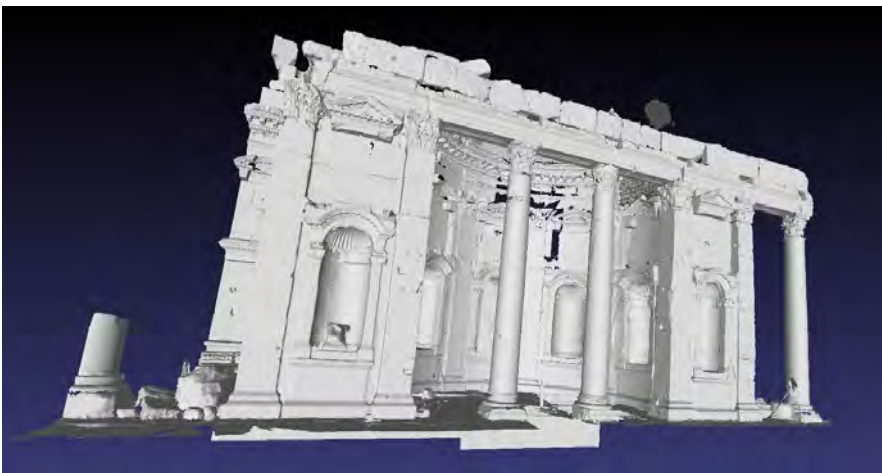
Figure 6.5: Meshed model of the semicircular room

One part of the temple was chosen as pilot case on which the full risk assessment procedure was performed. This part consists of a semi-circular room with niches, containing a lot of decorations still in a relatively good state. The laser scan data of this part was used to create a full surface representation using the software Geomagic.<sup>13</sup> Geomagic is a processing software with specific tools to filter point clouds and create high accuracy meshes. The algorithms used provide very good results, but require a substantial amount of computer power and memory. As the total point cloud of the room consists of 30 million points and Geomagic can only create meshes of point clouds up to 5 to 10 million points depending on the hardware, the point cloud was first split in multiple sections, containing approximately 15 million points. Each of these sections was intelligently resampled (decimated) resulting in a point cloud having approximately 6 million points. The resampling throws away points based on their local surface curvature. More points are removed in relatively flat areas, while more points are kept in areas that impose high curvature. Each section of the point cloud was then meshed and finally all meshes were again registered together to get a complete surface representation as can be seen in figure 6.5.

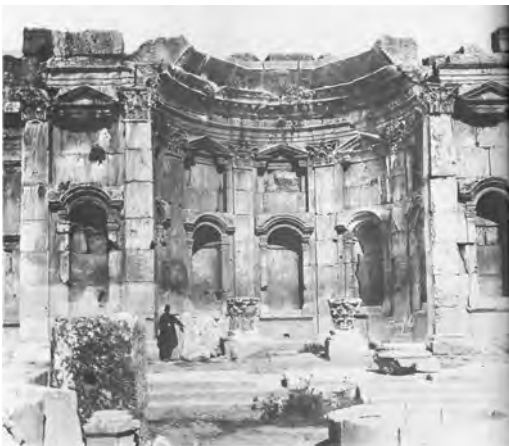
Figure 7.1: North-western semicircular chamber before the reconstruction, view from the Great Court. Photograph from 1900. (In: Nina Jideian, *Baalbek Heliopolis 'Cité du Soleil'*, Librairie Oriental, Beirut, 1986, p:66)

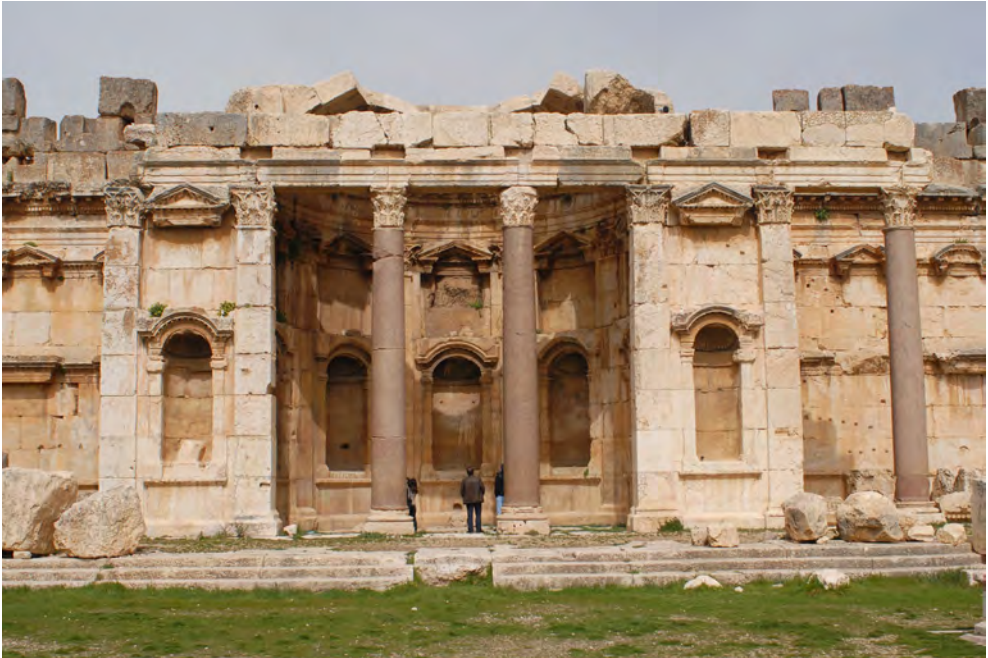
Figure 7.2: The North-western semicircular chamber of the Great Court. Photograph from 2010 (Pierre Smars)

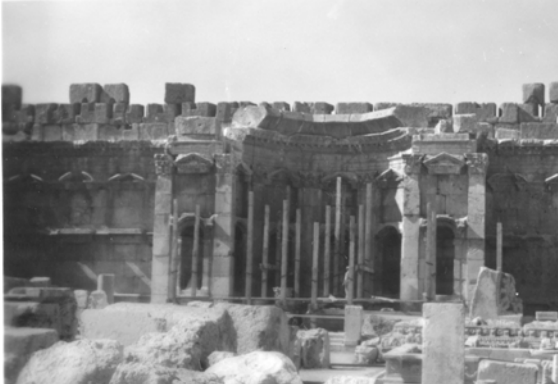
Figure 7.3: The starting of the restoration works, view from the Great Court. Photograph around 1960. (DGA iconographical inventory)

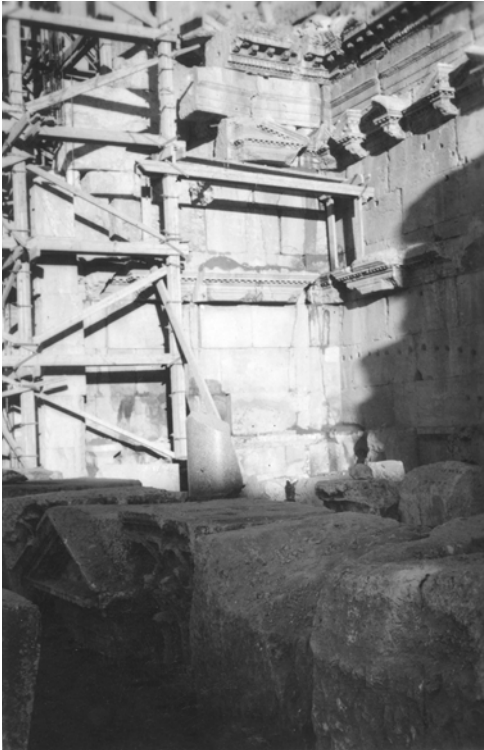
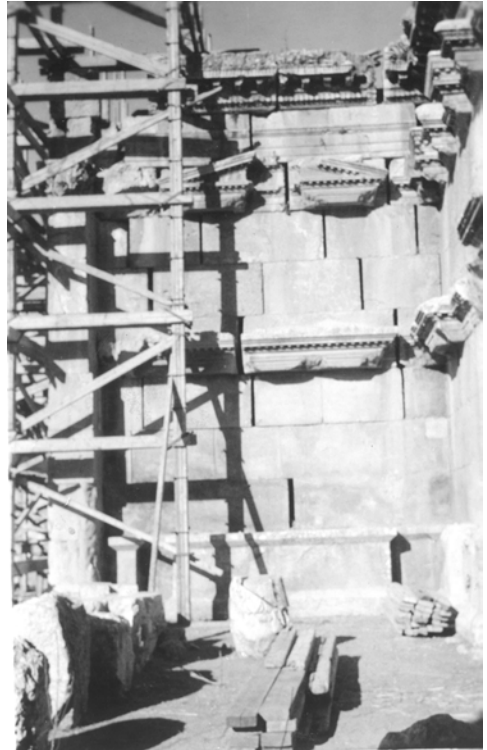
Figure 7.4 & 7.5: The restoration of the south wall of the chamber: dismantling the deformed wall (left), repositioning the carved stone blocs into their original positions (right). Photograph around 1960. (DGA iconographical inventory)

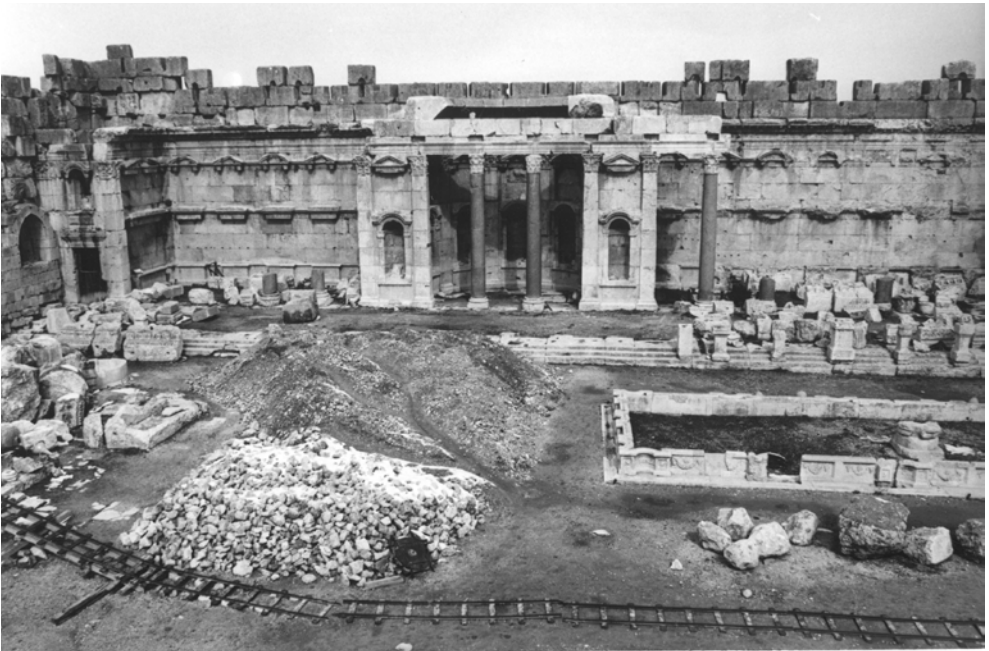
Figure 7.6: The North-western semicircular chamber after the restoration works, view from the Great Court. Photograph around 1960. (DGA iconographical inventory)

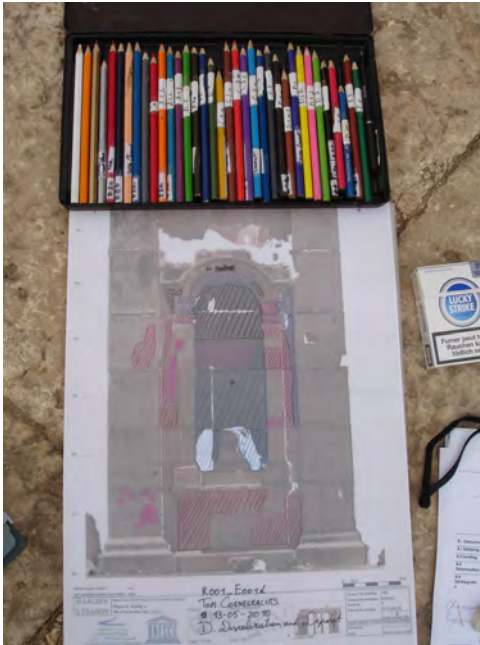
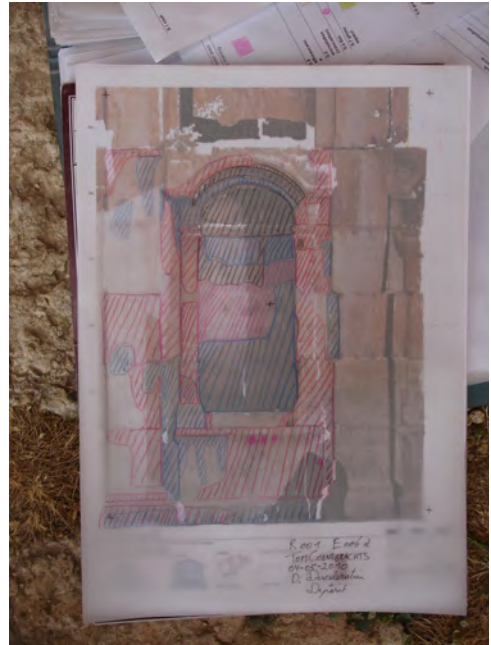
Figure 8.1: Graphical survey of the surface degradations on transparent sheets with coloured pencils.

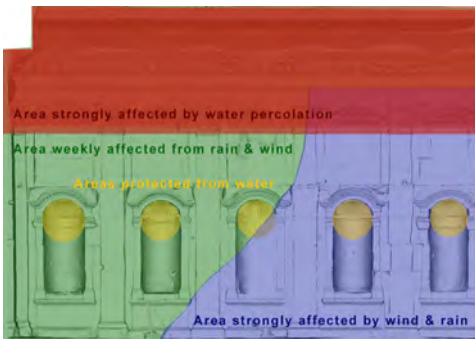
Figure 8.6: The interior façade of the semicircular chamber, schematic representation of the areas affected by rainwater and wind.

The semicircular chamber is like a microclimate with alternate long time span of shadow and moisture/sun exposure: the entire interior is in shadow during the morning, while some parts are exposed to the sun during the afternoon. From December till March, strong rains (even if the monthly average is low) together with the freeze-thaw cycles, considerably affect the original stone surfaces. In the summer, the strong and quite permanent south-west wind erodes the surfaces mainly in the interior north corner of the chamber. Measurements and monitoring of climate conditions should be developed specific to this chamber.

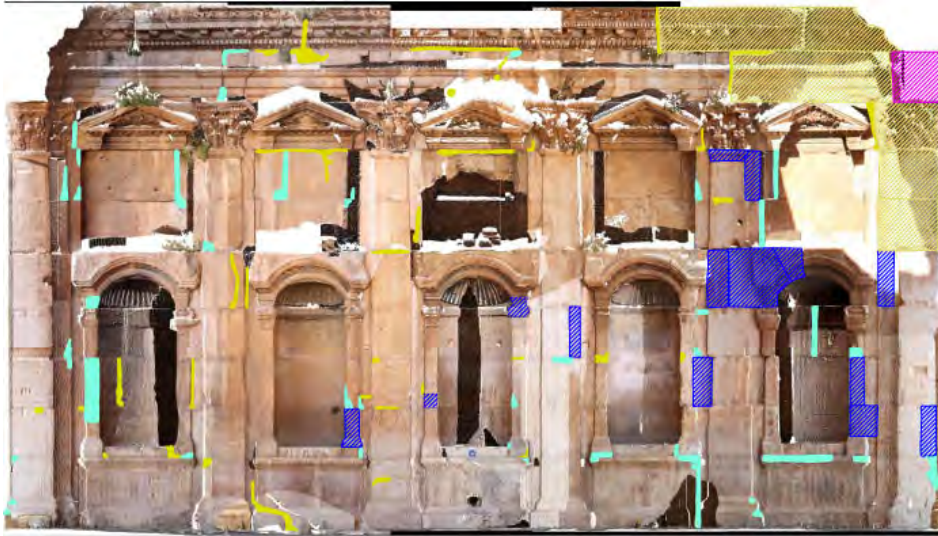
Figure 8.7: Mapping of the previous interventions and materials on the interior wall of the semicircular chamber.

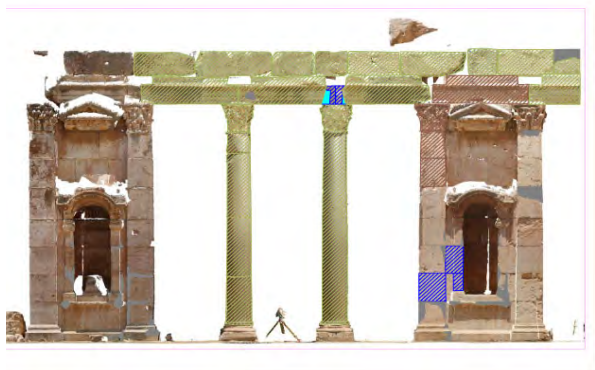
For a proper understanding of the degradations' evolution, the notion of time is fundamental, because it greatly facilitates the evaluation of the risks. For this reason, the risk assessment takes into account the historical data and the reported changes through time. During the Surface Condition Mapping all the transformations and historical phases of the structure were added to the maps (restorations, new additions, and new materials). The north-western semicircular chamber suffered several modifications through time, such as reconstruction (colonnade, entablature and roof), surface restorations and the completion of missing parts (with new stone blocks, concrete and iron). To complete the information about the

various interventions in the past that might have had an effect on the degradations of the material surfaces, the DGA reports and iconographical inventory were consulted and various images from the 1960's restoration works were selected to be included in the GIS system.

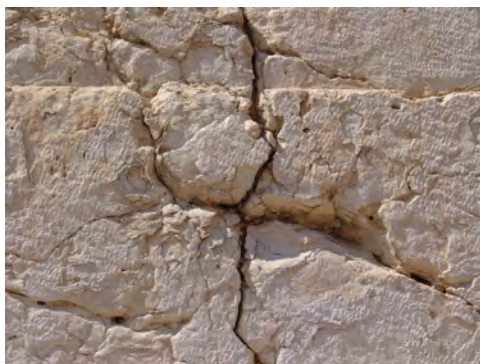
Figure 8.10: Restoration of a stone block with cement. The stone surface is already very highly fissured

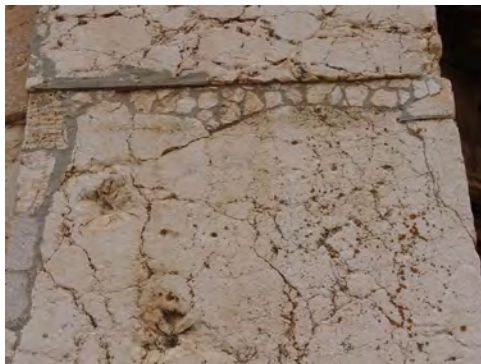
- Iron within the structure (probably suffering from corrosion) provokes several fissuring phenomena visible on the stone surfaces. The presence of iron is a result of the 20<sup>th</sup> century interventions, consisting mainly of the re-erection of carved stone blocks, using reinforced concrete.

Figure 8.11: Star crack probably due to an internal iron peg from the interventions of the 60s

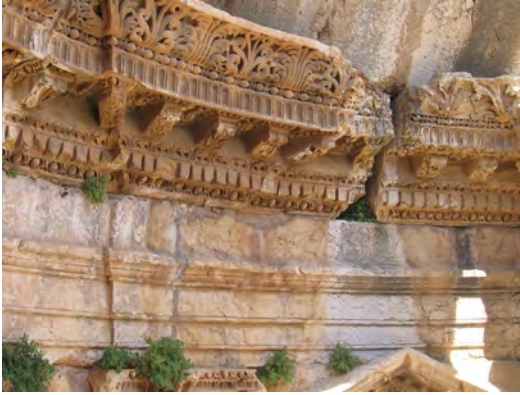
Figure 8.12: Entablature, the erosion due to rainwater leakage is visible

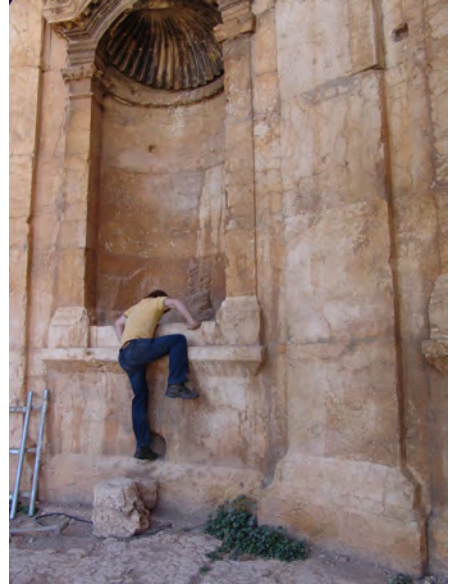
Figure 8.13: Anthropogenic action related to the behaviour of the visitors. The fact that a capital is near the niche helps the visitors climb over. The stone surface is already much damaged with a glossy layer. In some parts, the original stone surface is completely lost.

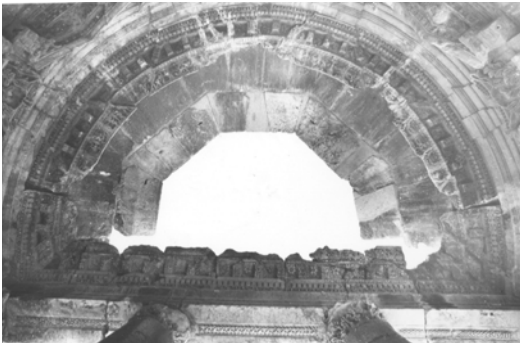
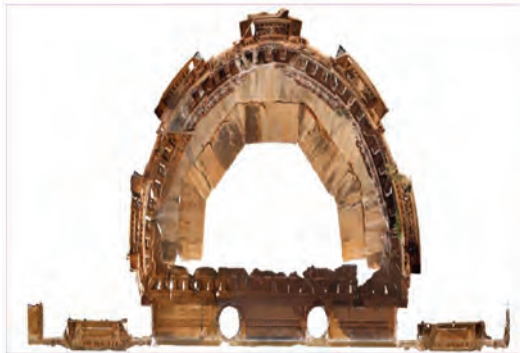
Figure 8.14 & 8.15: The ceiling of the semicircular chamber. The left image is from the 60s (DGA iconographical inventory), the right image is an orthophotograph from the 3D laser scanner. The erosion on parts exposed to rainwater leakage is visible.

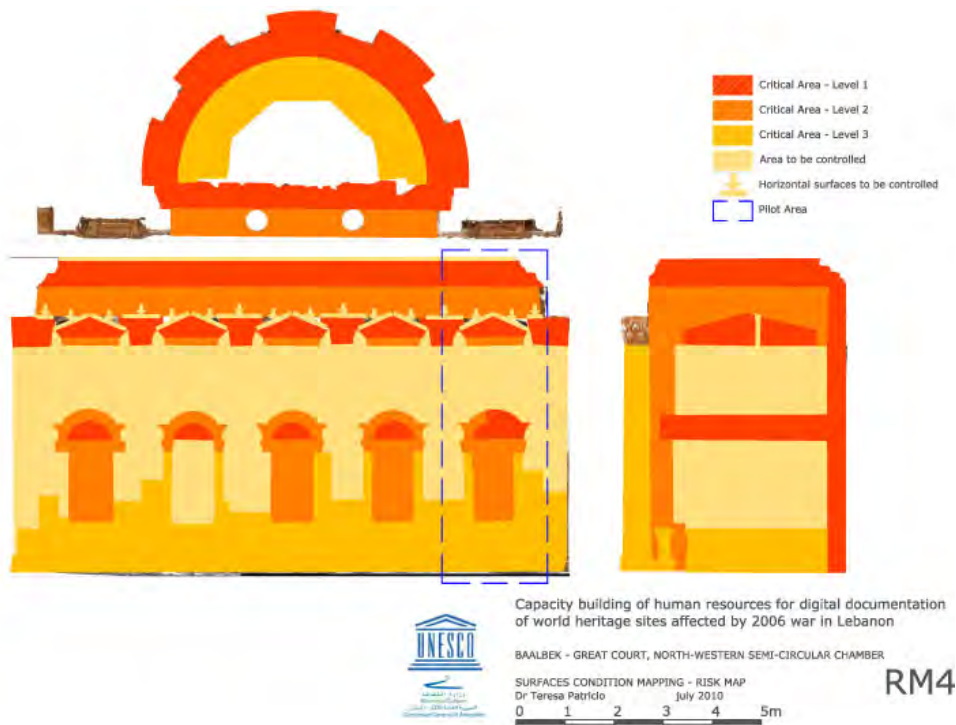
- Critical areas - risk of irreversible damage and loss of integrity.
  - o Level 1: surfaces with severe level of degradation – High level of integrity loss.
  - o Level 2: surfaces with advanced state of degradation – Moderate level of integrity loss.
  - o Level 3: surfaces with advanced state of degradation – Low level of integrity loss.
- Areas to be controlled – reversible damages and low level of integrity loss. These areas are characterized by soft and reversible damages, if prompt conservation action is taken and should be controlled regularly (monitoring the damages through time).
- Pilot area – area characterized by all types of damages, where the hazards are more recurrent. The monitoring of this area is fundamental for the comprehension of the damages' evolution, the impacts of hazards, and the impacts on values.

Figure 8.16 - Great Court semicircular chamber - Mapping of the risk estimation for the interior wall, ceiling and exterior north wall.

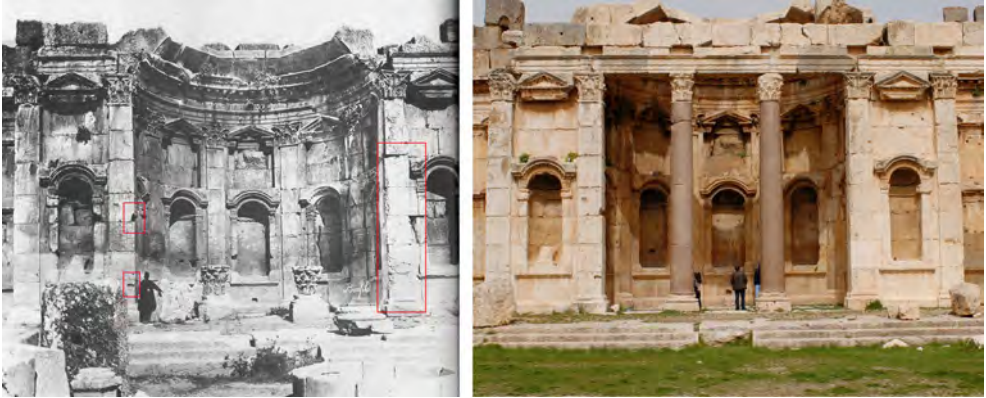
Figure 9.1: Left: semicircular chamber of the Great Court in 1900. Right: same semicircular chamber in March 2010. The parts in red rectangles on the left side show areas which did not change, and on the right side where stones were replaced.

- Historical information (Fig. 9.1): Many structures of the site still hold traces of past earthquakes (the last important one occurred in 1759) and previous interventions. Analysing them can help us understand the behaviour of the structures and also evaluate the effects to be expected in case of a new occurrence.

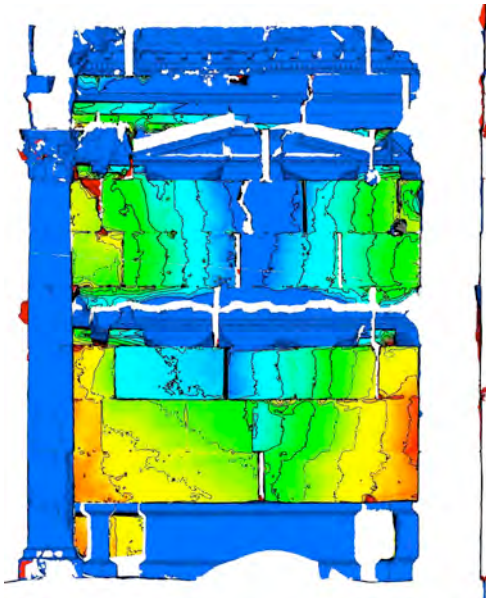
Figure 9.2: Eastern wall elevation of the semicircular chamber of the Great Court (1/100). Colours indicate the distance between the surface of the wall and a vertical reference plane fitting the wall (distance from red to blue: 10cm, blue is closer). They show that the wall is broken (along a roughly vertical hinge line clearly marked by cracks). Variations of colours indicate also that the precise deformation of the structure is more complex. Isolines (interval: 1cm) help a quantitative interpretation.

- Changes should be monitored22: The implementation of the “risk map” will allow an easy comparison of the situation at different periods.
- Structural pathology analysis: A good understanding of existing pathologies (resulting from past events) and their possible evolution greatly facilitates the evaluation of risks. Interpretation maps were prepared using data gathered by a laser scanner (Fig. 9.2).

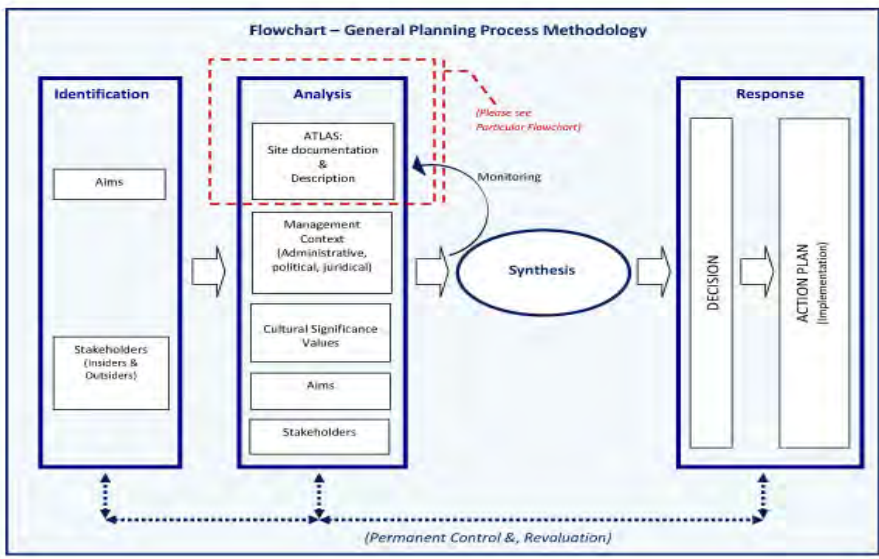
Flowchart 1: General planning process methodology

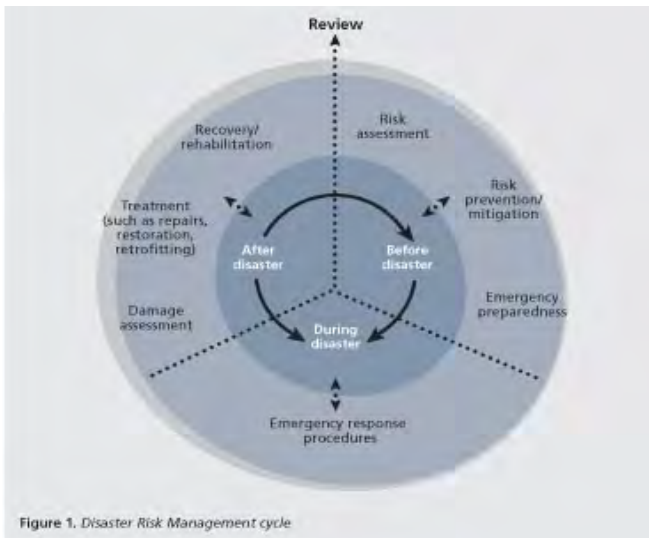
Figure 11.1: Disaster Risk Management cycle.
