UNESCO AND ITALY COLLABORATE TO PROTECT THE 'SIQ' OF PETRA

The 'Siq' is a 1.2 km long natural gorge that snakes through the sandstone cliffs, serving as the main entrance to the World Heritage Site of Petra, one of the world's richest archaeological sites. Due to its unique geological and cultural characteristics, the 'Siq' is one of Petra's most endangered areas, impacted by natural and geological hazards.

Thanks to the generous support of the Government of Italy, since 2011 the UNESCO Amman Office has been supporting the national and local authorities in assessing, managing and mitigating natural hazards at the site through the implementation of the "Siq Stability" programme (2011-2018).

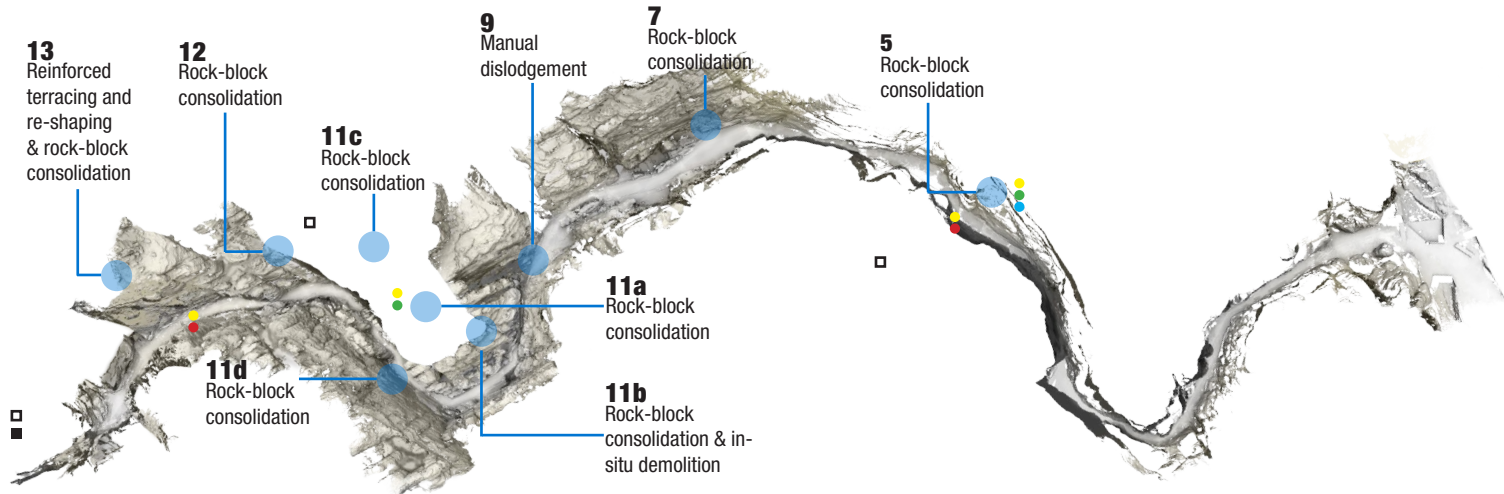
- Net panels**
Double twisted (or enchainned rings) galvanized net, reinforced with galvanized steel wires/ropes and anchored in stable bedrock with steel bars for temporary or permanent consolidation of unstable blocks.

- Dislodgement**
Scaling of small unstable blocks with hand lever or hydraulic jack. In-situ demolition and removal of medium-large unstable blocks with high-expansion cement. For safety reasons, the blocks are reinforced with anchored net panels before the demolition.

- Anchoring**
Steel bars or wire rods placed in drilled boreholes, reaching the stable bedrock, for consolidation of unstable rock blocks. After installation, anchors are injected at low pressure with cement grout.

- Wall / Dam**
Construction of reinforced concrete wall for the consolidation of large unstable blocks. The wall is further reinforced to the stable bedrock with steel bars and then covered with 'Petra rock color' pigments.

- MONITORING SYSTEM**
- Repeater
 - Gateway
 - Air Temperature
 - Humidity
 - Crack meter
 - Tilt meter
 - Deformometer
