SITE NAME: Decani Monastery

**NOMINATION OF THE CULTURAL MONUMENT
FOR INCLUSION ON
THE WORLD HERITAGE LIST**

**NOMINATION DOSSIER COMPILED BY
THE REPUBLIC INSTITUTE FOR THE PROTECTION OF
THE CULTURAL MONUMENTS - BELGRADE**

2002

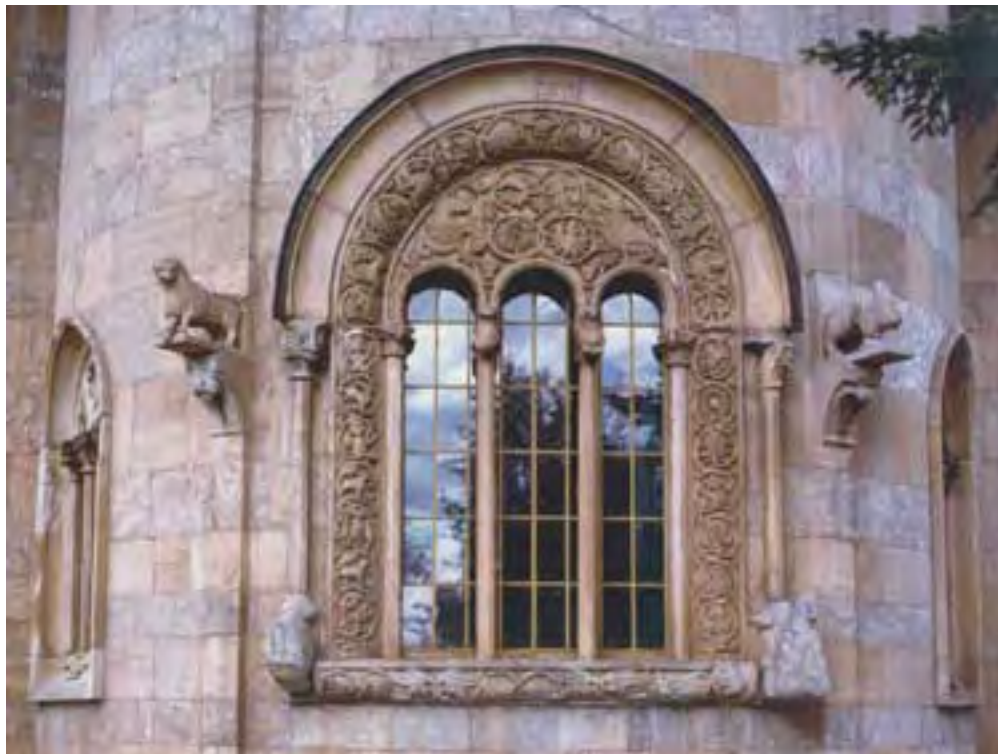
Figure 12. Dečani Monastery, Altar triforia /photo by Branislav Strugar/

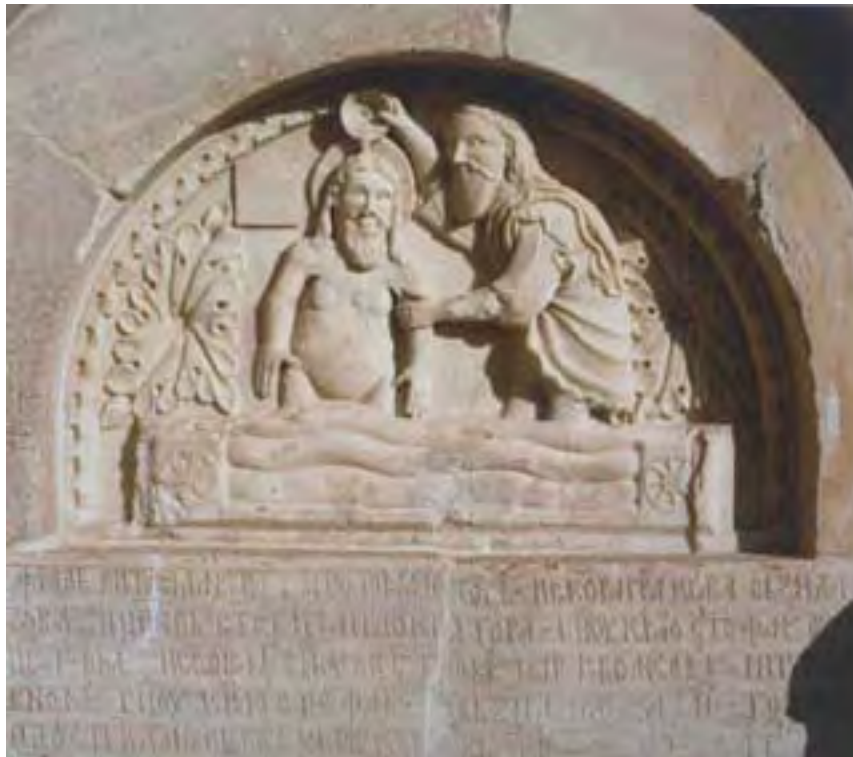
Figure 13. Dečani Monastery, Lunette over the south portal with the founder's inscription /photo by Branislav Strugar/

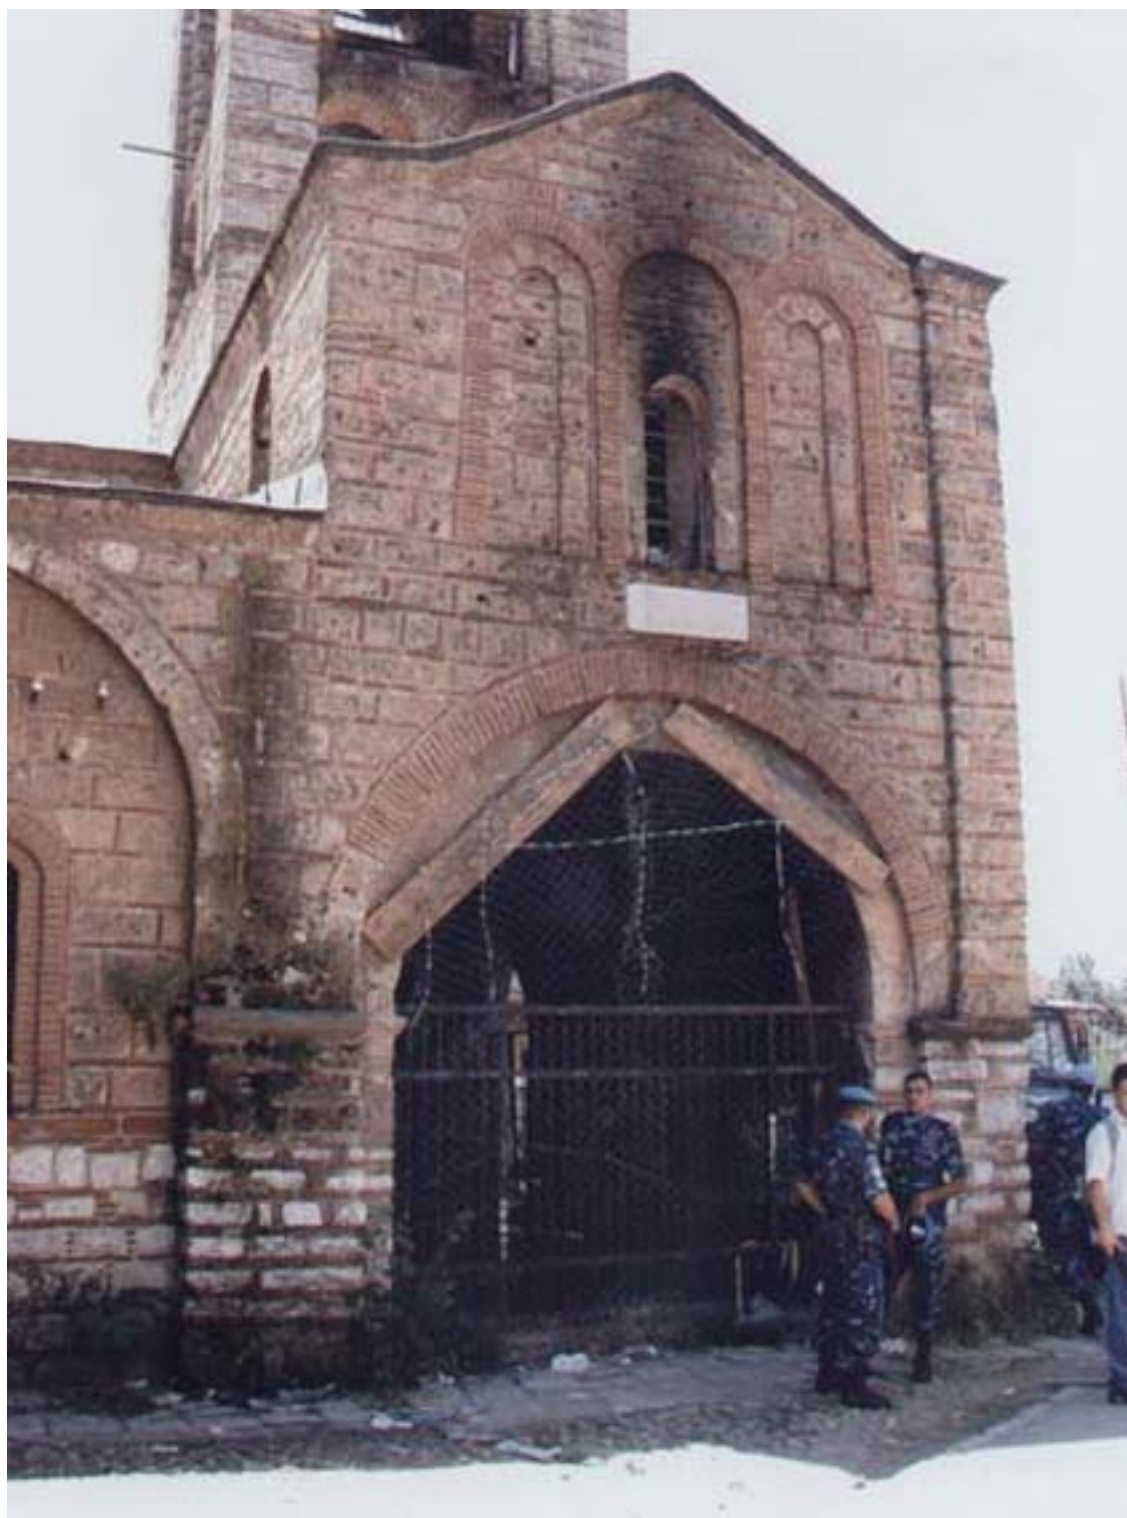
34. Church of the Virgin of Ljeviša, North view of the exonarthex after March 2004 /photo by Dragan Stanojević/

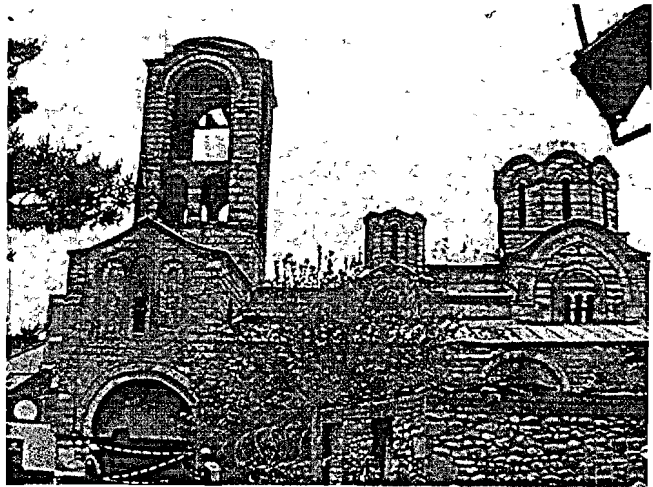
Church of the
Holy Virgin of Ljeviska,
Prizren

Bell-tower damaged by fire

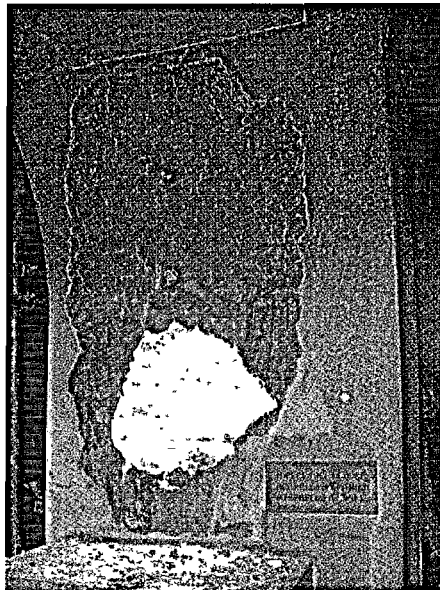
Burned fresco of the Mother of God with Christ
