SITE NAME: Tombs of Buganda Kings at Kasubi

NOMINATION OF PROPERTIES FOR INCLUSION
ON THE WORLD HERITAGE LIST

Kasubi Tombs UGANDA

May 2000

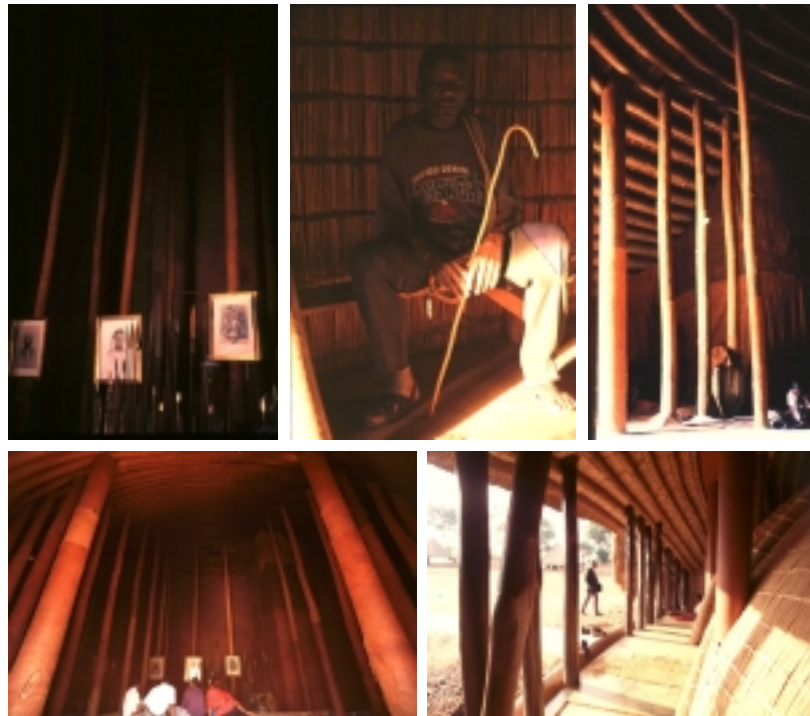
Muzibu-Azaala-Mpanga

From this forecourt, one enters the main courtyard (*Olugya*), enclosed by a reed fence and several houses built for the widows of the *Kabakas* and for other ritual purposes. The entrance into this courtyard is a striking experience as one immediately faces the main tomb building known as *Muzibu-Azaala-Mpanga*, which is the architectural masterpiece of this ensemble. The building is circular in plan and has a dome-like shape. Its massive scale can be seen in its external diameter of 31 meters and an internal height of 7.5 meters. Entrance to the *Muzibu-Azaala-Mpanga* is through a low, wide arch flanked on both sides by richly woven reeds. Its inside is partitioned with a huge bark cloth which hides the “sacred forest” where the four royal graves lie. Entrance to the “sacred forest” is limited to the widows of the *Kabakas*, the royal family, the *Nalinya*, and *Katikkiro*. The inside of the hut is adorned with power insignias such as drums, spears, shields, medals, and pictures of the *Kabakas* buried there. The floor is covered with a thick layer of lemon grass and palm leaves mats. On entering the courtyard, however, the attention of the visitor is immediately captured by the beauty of the thick thatched roof which extends all the way down to the ground and is reinforced underneath by 52 woven rings of palm fronds and spear grass, representing the 52 *Ganda* clans. The whole structure is carried by gigantic straight wooden columns wrapped in bark cloth. This results in a striking impression of harmony

and power.

In regard to the *Muzibu-Azaala-Mpanga*, the structure of this building is in good condition. The wooden columns and the ringed ceiling appear sound with no signs of deterioration. The thatch on the roof is, however, in need of major work. Although most of the gullies that were present in 1998 were repaired during the work done at that time, new gullies have appeared which need attention. In addition, there is some plant material growing on the left side above the entrance to the tomb. This needs to be removed. At the rear of the tomb, a large area of thatch was reduced in thickness for testing purposes and was only partially replaced. This section needs to be redone to restore the proper shape of the building and to ensure that there is adequate protection from the rain. Several other small areas of the roof on the back are missing their thatch altogether. These areas should be re-thatched as soon as possible. Draining works initiated in 1998 seem to be holding up well. This work needs to be completed, however, on the left side of the tomb.

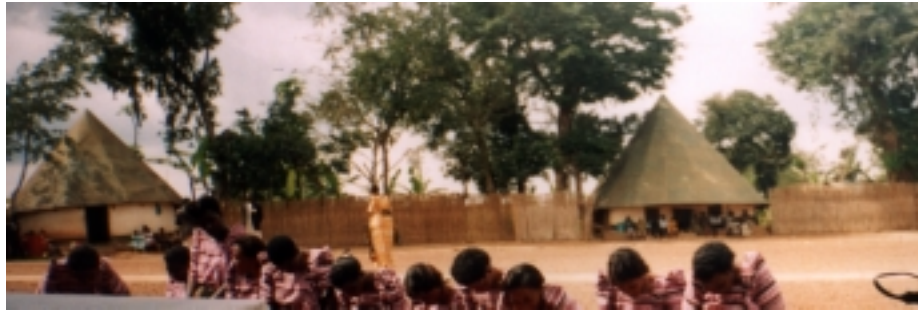
Olugya

Entrance into the area behind the *Olugya* is through a number of gaps in the reed fence which are hidden by overlaps. Within this area are scattered a large number of buildings which include houses for the widows of the *Kabakas* and some members of the royal family. In addition, some houses are used to store sacred objects and others as tombs for senior members of the royal family. There is also a cemetery used for burying people of the immediate royal family. Most of the houses are quite simple in shape and plan, and are of 1 storey. Their average size is 15 to 20 square meters. Construction materials for the houses vary, ranging from wattle and daub to bricks and cement. Roofs are of galvanized metal. Over time, this part of the site has added and lost buildings according to the traditional needs. This practice still continues. This whole area is considered sacred and is not open to visitors. While a reed fence screens off this area from the main courtyard, to the rear the fence that used to exist has long since disappeared. Currently, this area gradually moves into the agricultural land behind it.

The state of conservation of the reed fence in the main courtyard is currently adequate with no major weaknesses observed. The decorative finishes of the fence, however, are not at the standard that they were traditionally, and further work to restore the traditional aesthetic aspects of the fence may be carried out in the future. The courtyard itself is kept very clean and plant growth is regularly removed.

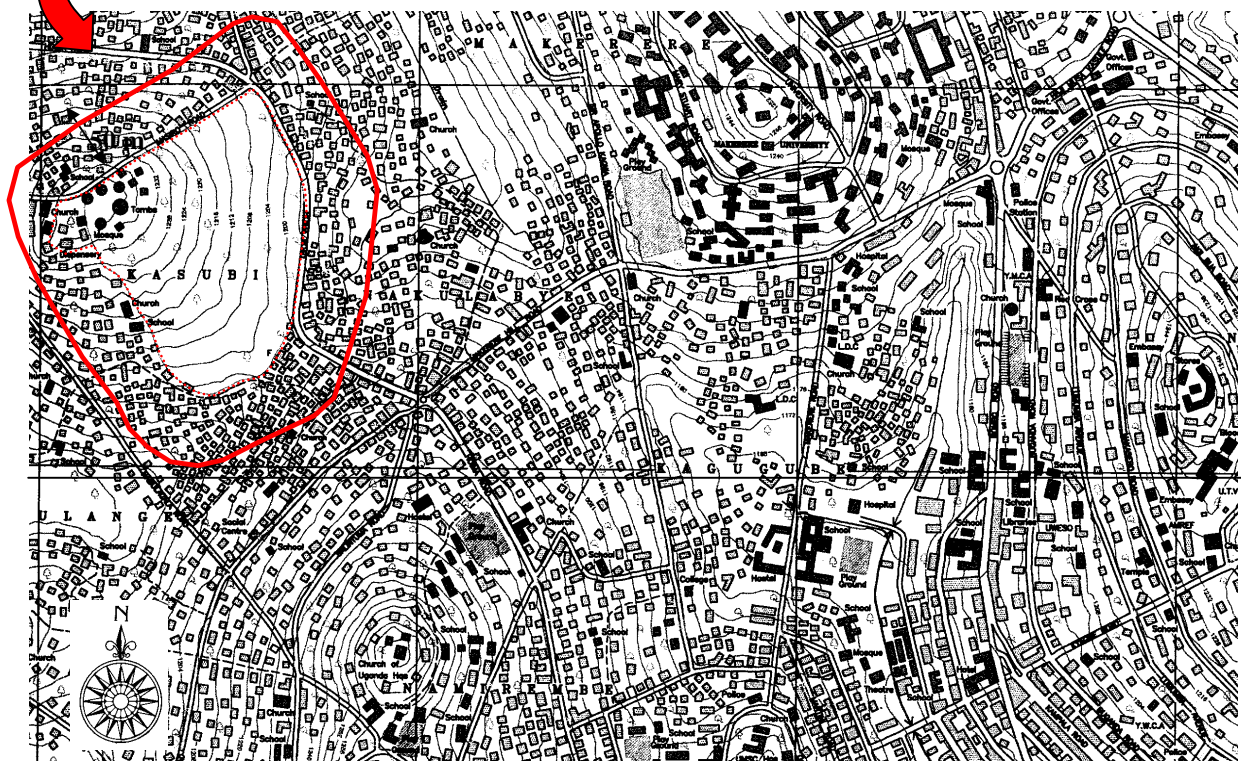
Boundary of nominated property and buffer zone.

Plan scale 1/20 000
