**STATE OF CONSERVATION REPORT ON OSUN OSOGBO SACRED GROVE,  
WORLD HERITAGE SITE – C1118**

# STATE OF CONSERVATION REPORT ON OSUN OSOGBO SACRED GROVE

**REPORT ON THE INVESTIGATION OF OSUN GROVE WATER QUALITY CONDUCTED BY NATIONAL ENVIRONMENTAL STANDARDS AND REGULATIONS ENFORCEMENT AGENCY (NESREA) OSUN STATE FIELD OFFICE, 27 APRIL – 2 MAY 2018.**

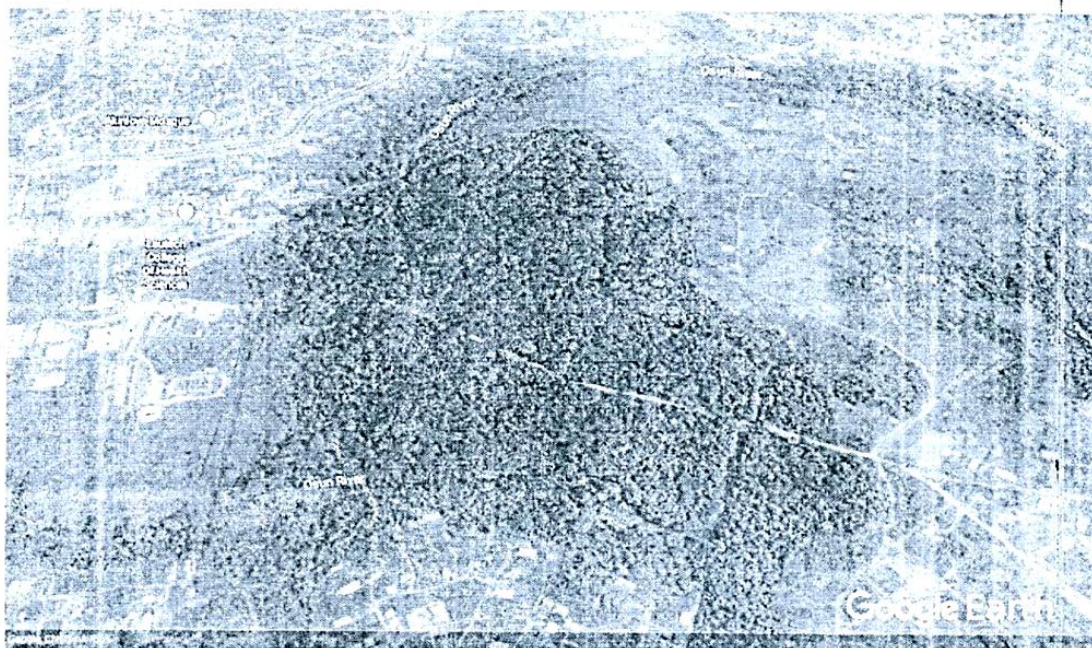
Table 1: Sampling points and geolocation of points

Sampling Point	Description	Geo-Location	Elevation
-1	Point U1	Upstream 1 (Wéré)	N 07° 45' 28.7" E004° 33' 08.6"	335m
0		Oguba-Groove	N 07° 45' 20.7" E004° 33' 05.1"	311m
1	Point D1	Downstream 1 (Suspended Bridge)	N 07° 45' 15.4" E004° 33' 09.7"	338m
2	Point D2	Downstream 2 (Elewure)	N 07° 45' 00.7" E004° 32' 52.8"	371m
3	Point D3	Downstream 3 (Elewure)	N 07° 45' 02.0" E004° 32' 51.4"	336m

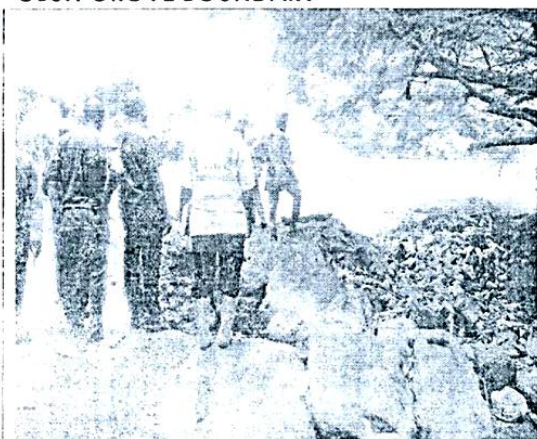
PLATE 1: View of plastic pollution at the river bank

**Downstream 1:** It was also characterized by a rocky substratum, and the river bank was strewn with heaps of single use plastic waste (PET bottles, plates, etc. see plate 1).

In conclusion, the stretch of river Osun within the groove is not significantly impacted and possess chemical and physical properties necessary to support aquatic biodiversity, however, the introduction of organic matter into the river within the groove and downstream may increase coliform count, thus rendering the water unsafe for drinking. Further and more extensive studies are recommended to provide information on suitability for human and ecological risks, if any.

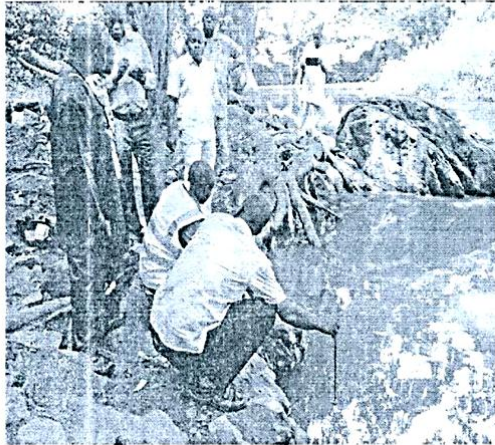
PLATE 4: Analyses using hand held meter, ExStik EC-Sal-TDS Model for confirmatory purposes.

A hand held multi-meter, Consort C933 Model (PLATE 5) was used for in-situ analyses of the water at various points. Another hand held meter, ExStik EC-Sal-TDS Model (PLATE 4), was also used for confirmatory test.
