## **State of Conservation Report**

**Birthplace of Jesus**

**Church of the Nativity and the Pilgrimage Route, Bethlehem**

February 2015

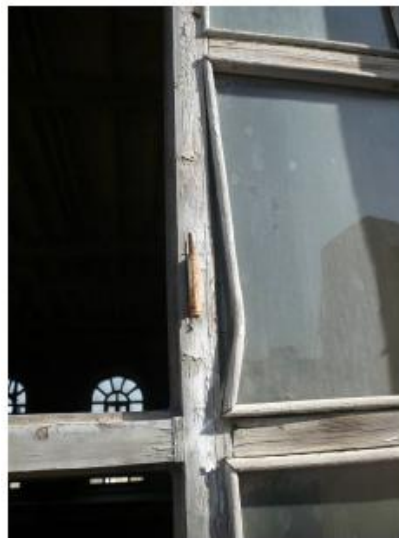
The grey paint is often detached from the wood due to shrinkage and swelling of wood during the daily and seasonal hygrometric variations. This weathering effect is more pronounced in the southern part due to the more severe exposition to sunlight with the consequence that some wooden part are warped (Figure 9).

Figure 9: deformation of wood frame due to the weathering

As all these windows were installed during the XIX century and have no significant artistic value, the diffused presence everywhere of a serious physical decay suggests their replacement rather than a restoration which might not guarantee long lasting beneficial effects. However, this does not exempt from defining a scheduled maintenance plan even after the replacement.

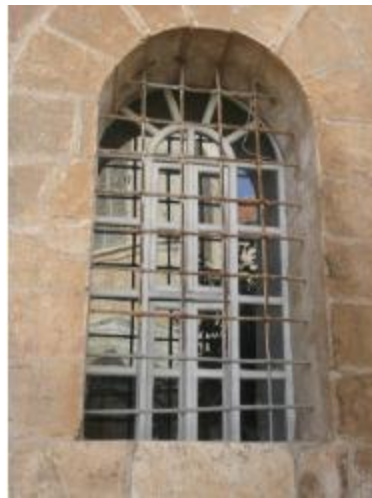
The conservation status of the windows on the ground floor is a little better than that at the higher level because such windows are sheltered from weathering (Figure 11). Nevertheless some fungal decay was also observed in the windows placed at the high level of north transept. In the majority of them a detachment of paint from the wooden support was observed.

Figure 11: ground level window in the Franciscan garden, apse

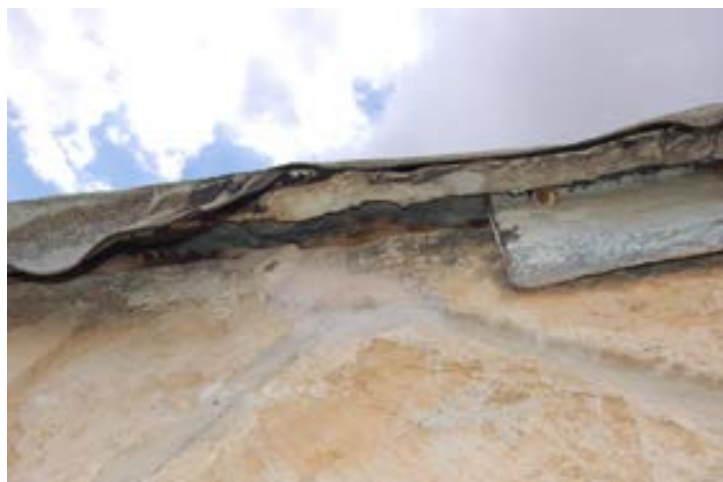
First of all it must be underlined that the roof is covered by a lead sheet with a layer of bitumen (see Figure 13) which is not suitable any more to guarantee the waterproofing of the roof. In fact, in occasion of the rain the water leaks from the roof through the areas not covered any more by the bitumen and along many intersection lines between roof and wall. The recommendations will take into account such an element and they will propose one or more solutions in the respect of the historical and architectural aspects. It must be pointed out that at the moment there are no horizontal drainpipes collecting the rain along the perimeter of the roof and, for this reason, all the rain collected by the central nave roof flow on the lateral naves and finally to the ground by few connecting points.

Figure 13: Lead and bitumen covering the roof

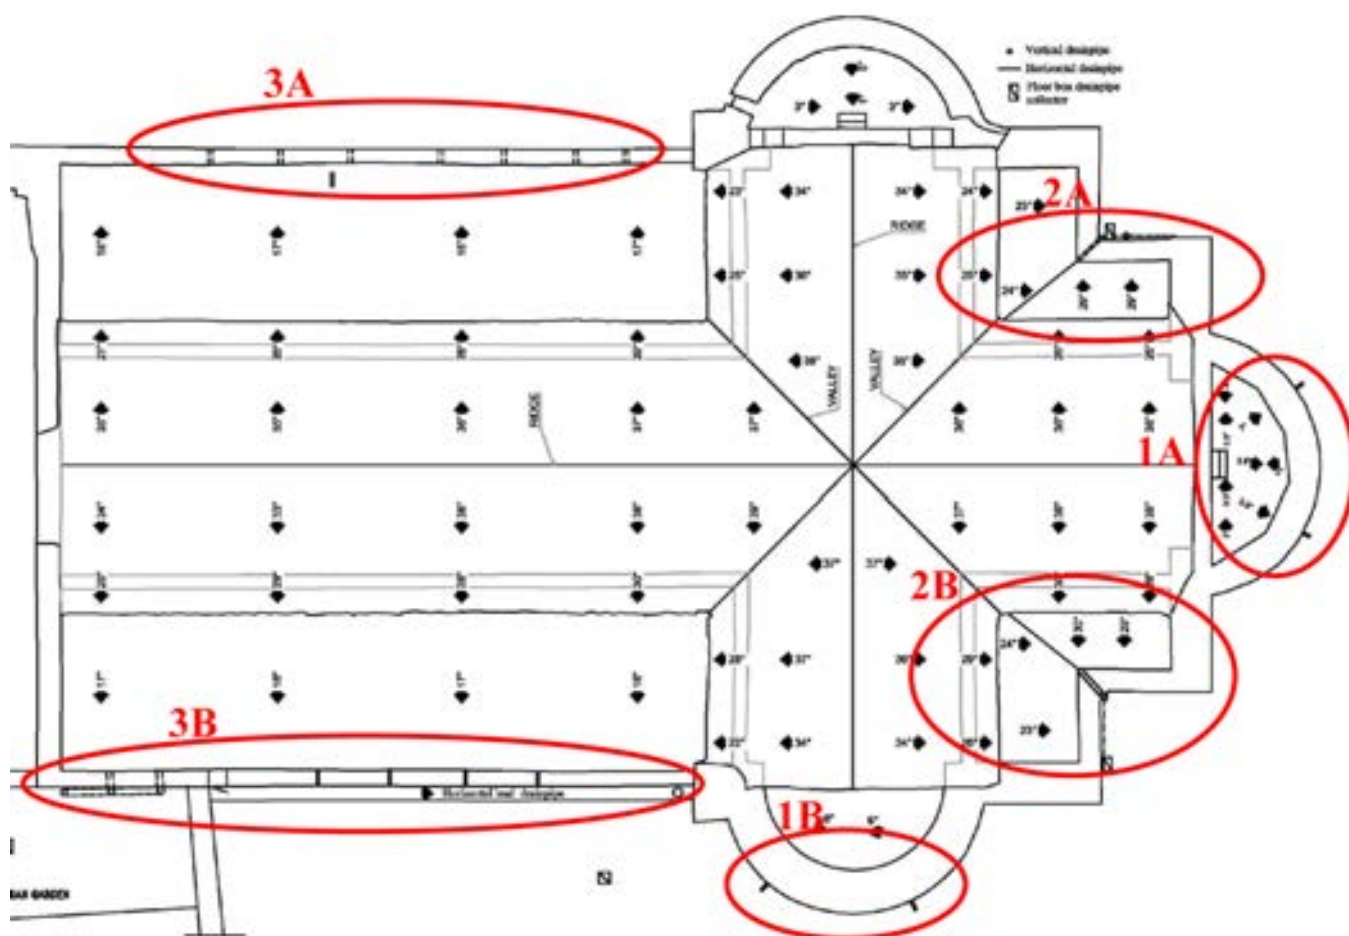
In Figure 14 different critical positions are located and named with different capital letter. Three situations are identified. Number 1 refers to the way the rainwater is carried from the apses' terraces to outside the church; number 2 copes with the rain water which is collected on the entire orthodox quarter of the Church; finally, number 3 locates the ways, mainly through the boundary walls, through which the rain falling on the central nave is conducted towards the Franciscan terrace and the Orthodox and Armenian gardens.

Figure 14: Location of the critical points with reference to the transportation of the rain water

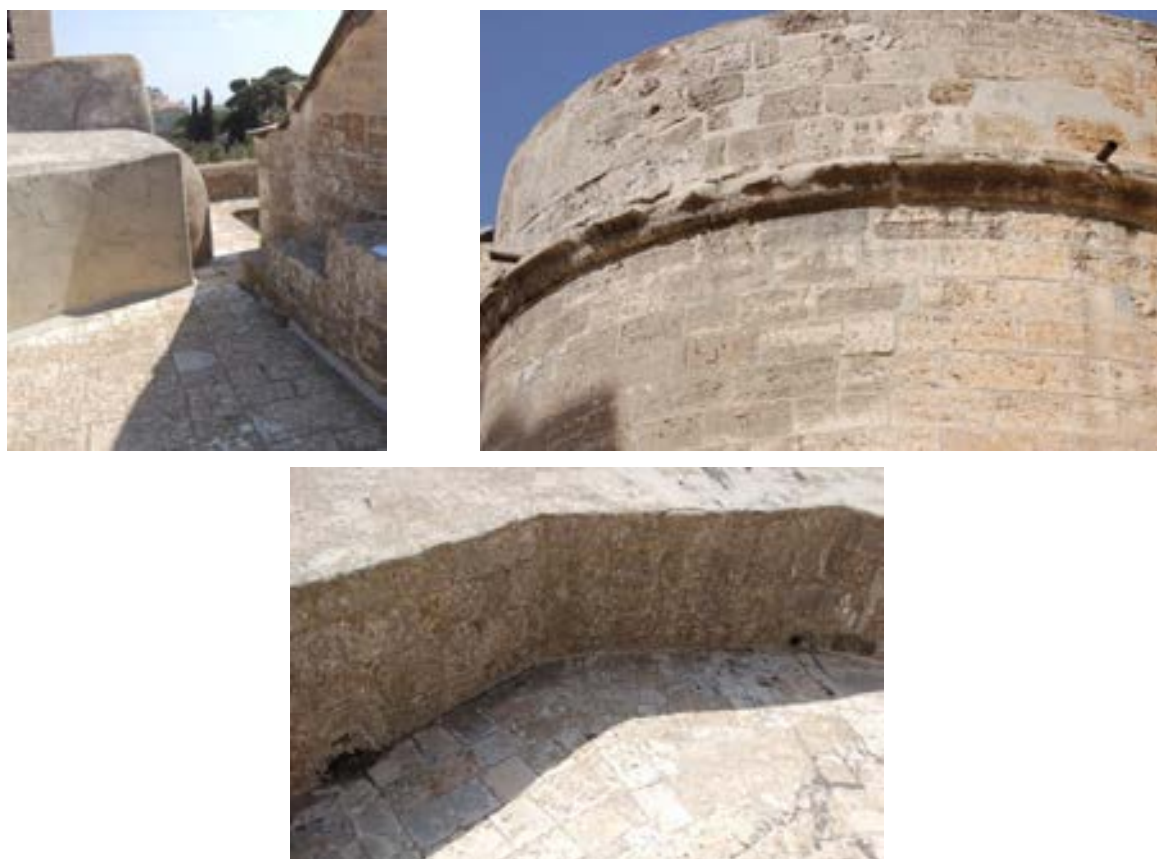
The system which conducts the rain water from the apses' terraces outside does not seem to have created damages so far even though there are some aspects which may overload other drainpipes. The apse's terrace of the transept at the Franciscan side has no connection through the battlement and the rain water is led by the slope directly to the lateral nave on the Armenian corner (see Figure 15 left). In 1A and in 1B two horizontal drainpipes through the wall (see Figure 15 centre, right) take the water pouring to the garden (with or without tiles) below; such pipes seem not leaking inside the wall but the substitution (and the successive continuous ordinary maintenance) will be warmly recommended.

Figure 15: (Left) Apse on the Franciscan side; (right) drainpipes in A1; (bottom) drainpipes in B1

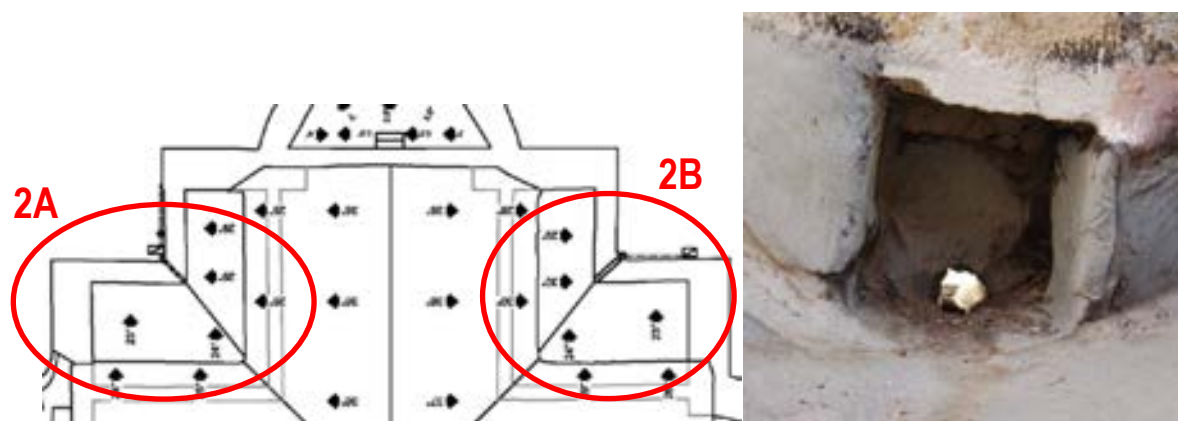
The path covered by the rainwater falling on the Armenian and Orthodox corners (see Figure 16 left) have both a critical point in the drainpipe located through the masonry wall corner (see Figure 16 right). The pipe in 2A continues into an external pipe in the Franciscan garden (see Figure 17 left) and then in a horizontal pipe underneath; such an element is very probably leaking as damage due to humidity has occurred inside the Church (Armenian corner – see Figure 18). As a matter of fact it must be pointed out that the external surface of the wall under discussion is directly faced to the soil and thus directly hit by the water filtering from above. The question is even more critical in the Orthodox corner 2B; here the pipe is hidden in the masonry (see Figure 19) and then taken horizontally in a pipe running parallel (and very close) to the masonry wall (see Figure 19 right). The lack of waterproof in the system is evidenced by the damage depicted in Figure 20.

Figure 16: (Left) Armenian (2A) and Orthodox (2B) corners. (Right) Drainpipe through the corner wall

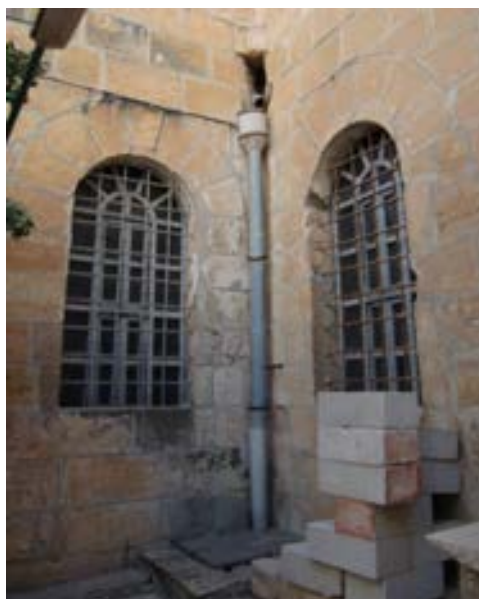
Figure 17: Pipe collecting the rainwater in 2A

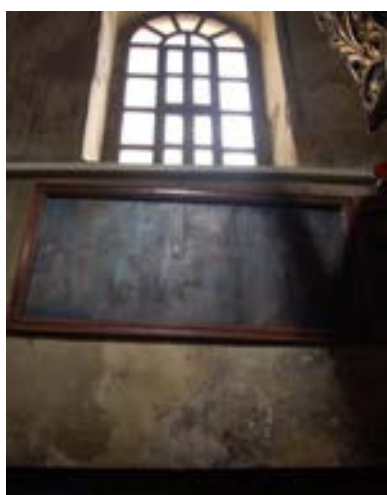
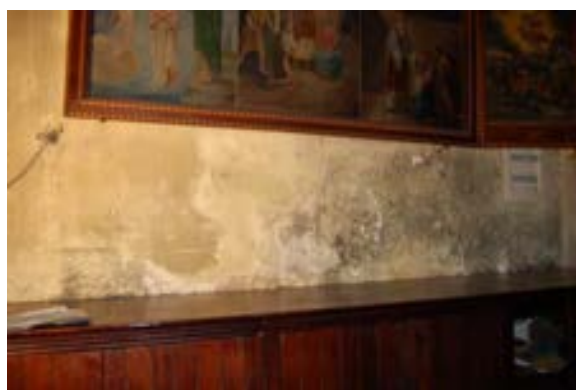
Figure 18: Damages on the wall due to the humidity on the other side (2A)

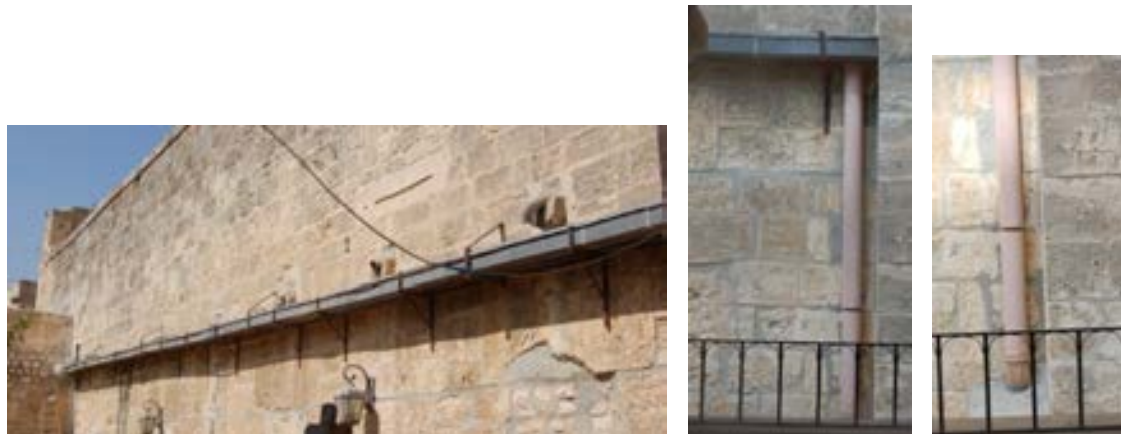
Finally let's take into examination the perimeter line of the lateral naves' roof. Both lines are not open thus they do not let the rain water to leak outside the Church along the perimeter. The external side of each lateral nave is closed by a battlement, and such a short masonry wall is crossed by inclined drainpipe which conduct the rainwater on the other side. On one side (3A) the rain water spills on the Franciscan side 3A (see Figure 21) whereas on the other side (see Figure 22) the water is conducted to a lead channel that, very probably, has been added successively to mitigate the fall effect. In both cases the lack of waterproof of the intersection between roof and battlement is evident from the leakage signs visible in the lateral naves as depicted in Figure 23. The recommendations will surely have to take into account the need to design a robust and waterproof system to protect such lines.

Figure 22: Orthodox side 3B.

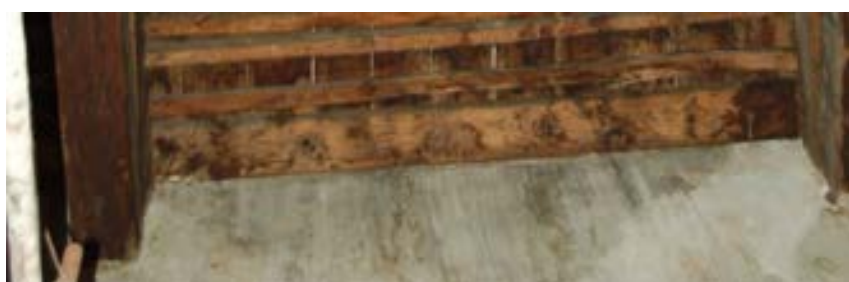
Figure 23: Rainwater leakage signs in the lateral nave close to the Orthodox side 3B

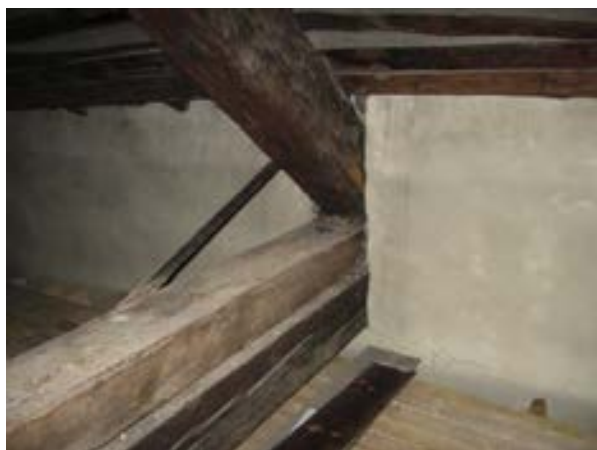
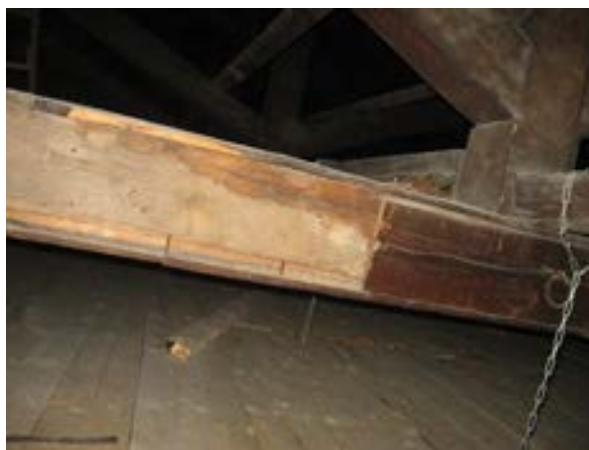
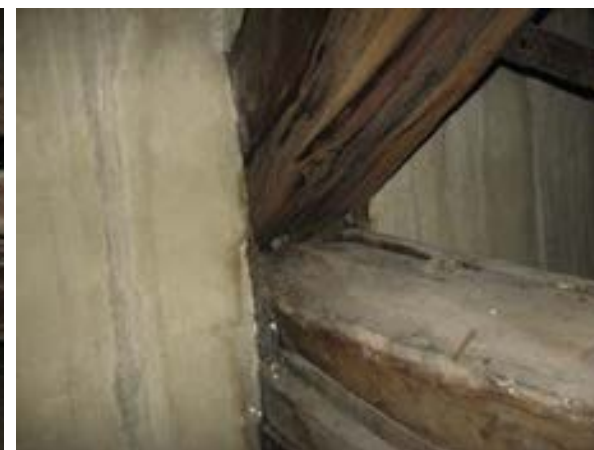
The northern rafter has an inner decay 25 – 50% along the whole length. Probably the defect was already on the standing tree.

Resistographic drillings didn't reveal any decay on the southern side of the truss.

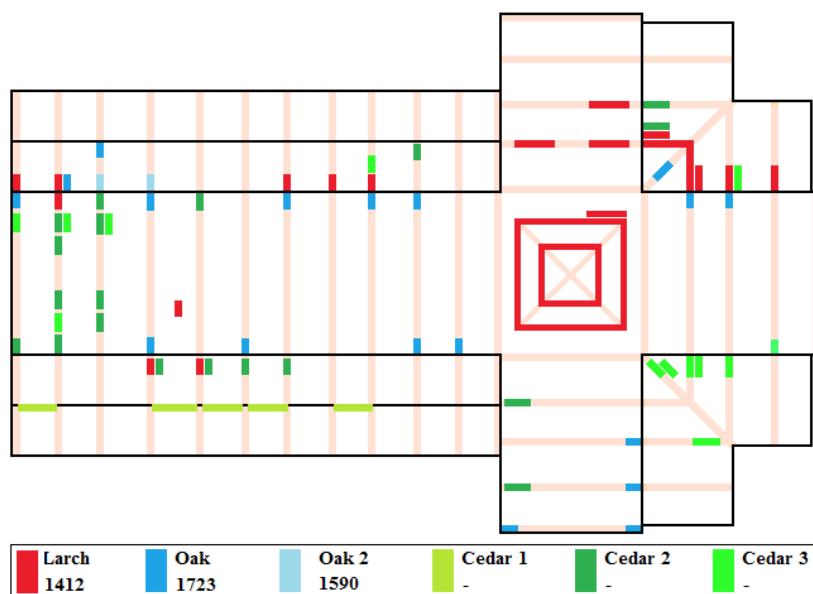
Figure 37: position and wood species of dendrochronological dated elements.

The three groups of cedar chronologies (chrono 1, chrono 2, chrono 3, fig. 6) showing good internal correlation, but no relationship with each other and this could be the results of different geographic provenances and/or different age.

The samples analysis had shown that only the architrave could be considered homogeneous both by species (cedar) and age: in fact, although an exact date is not still picked out, architrave samples clearly had shown the origin from a precise and common age. On the contrary, various ages and various woods, such as larch, oak, cedar, pine, etc., arose by the analysis of the sampled elements scattered around the current roof structure. In the light of such results, it could be assumed that Nativity Church roof was at times disassembled and reconstructed, using also prior elements still considered useful and appropriate.

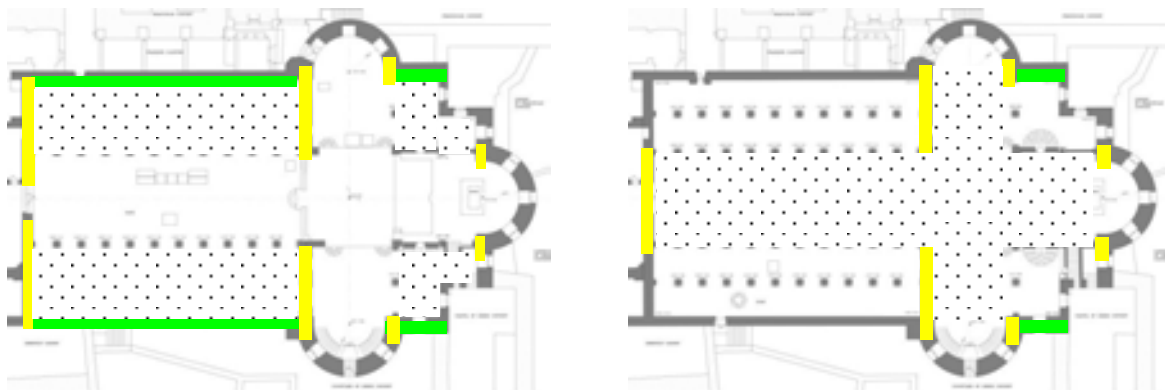
Figure 38 – Seismic bearing walls in the principal directions: below (left) and above (right) the aisle's roof.

Furthermore, Figure 38 shows the seismic bearing walls which absorb the seismic actions (or horizontal shear loads) in the y or N-S direction (in yellow) and in the x or W-E direction (in green) transferred by the roof of the aisles (Figure 38 - left) and by the roof of the nave (Figure 38 - right) respectively. In both cases the roof is represented by dotted surfaces.

As a matter of fact, such a consideration is valid in general only if the connections between the roofs and the walls are reliable and capable to transfer horizontal loads. Moreover, in Figure 38 - right it is sufficiently clear that the total area of the horizontal sections of the seismic bearing walls in the W-E direction (green walls) is a small percentage (around 3%)

On the basis of the above considerations and of the results obtained in the second report, the following recommendations can be given in relation to the structural interventions proposed:

- a. Reliable connections must be guaranteed in various positions (details are given in the enclosed Technical Forms) both to limit the out-of-plane movement and to guarantee a suitable transferring of the seismic actions to the bearing walls.
- b. The in-plane stiffness of the roof must be increased in order to better transfer the seismic actions to the foundations.

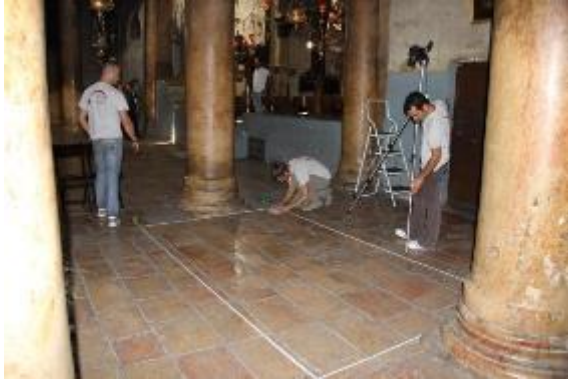
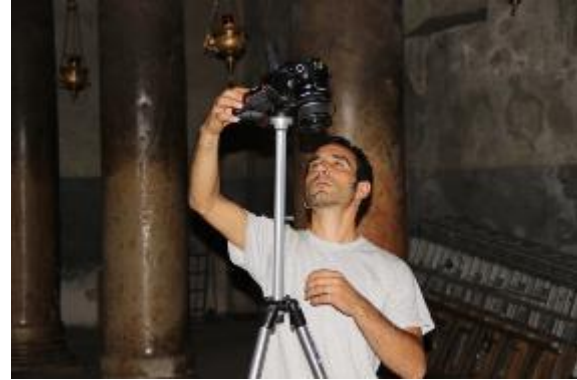
Figure 39: dilapidation survey

A Dilapidation Survey was required for submittal prior to the start of the works (Figure 39). This survey was carried out so as to provide a historical documentation of the existing site conditions prior to the start of construction. This is for the benefit of the Owner, the CMC, the Engineer and the Contractor.

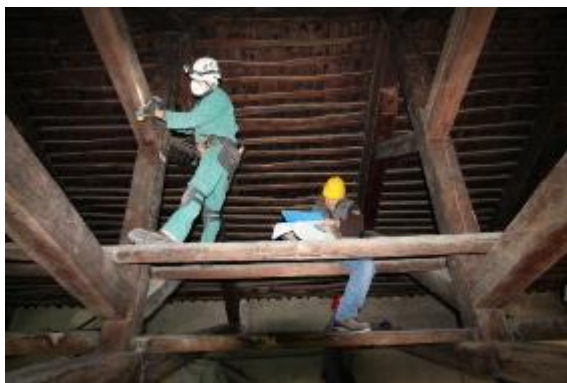
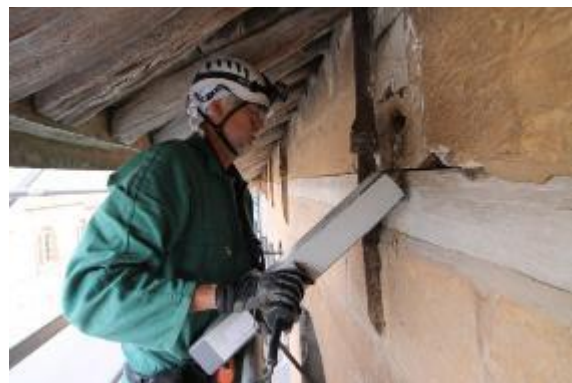
Figure 73: recent surveys in the roof structure

Starting from December 2, 2013 wood experts have been evaluating the current condition of the existing wooden structure supporting the roof; they have also performed several non-destructive tests and direct, visual inspections for central nave, aisles, transept, apse and corners to provide updated information regarding geometry, dimensions, characteristics of connections, wood species, humidity, damages and class of mechanical quality of the wood to prepare the design and shop drawings with respect to the Tender documents. All information, notes, observations and test results are the necessary reference to prepare the design and shop drawings for each truss and for the consolidation of purlins and boards.

This new survey (Figure 73) was necessary because the previous survey had been carried out by the Consortium team only by inspecting the structures from the inside only. Moreover the heads of the trusses could not be inspected because it was not possible, at the time of the inspection, remove plaster and stones around them, so as to check their actual physical conditions. In the end, the rainfalls of the last two years have probably increased the level of damage of many timber elements, which has made it necessary to update the existing survey data.

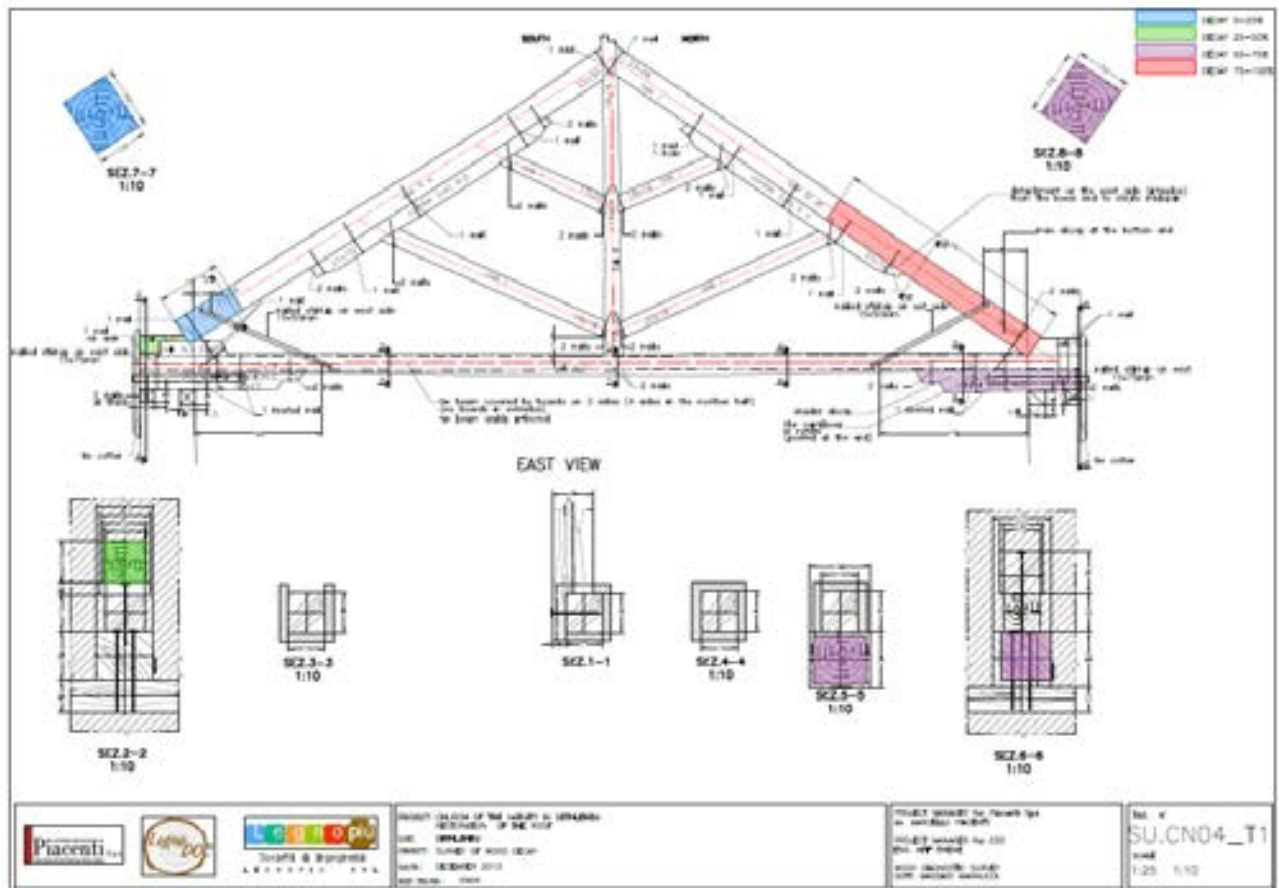
Figure 74: example of truss surveyed (CN04)

75-100%) and the causes of damage (insect and fungi attacks, moisture etc.) as well as the most visible irregularities in wood (shrinkage, inflection, sinuosity etc.) detected and declared (Figure 74). Moreover, for each truss member the wooden species and the structural grading were defined.

In most cases the results of the previous surveyed have been confirmed. The majority of the divergent results concern the heads of the trusses, which in the second campaign could be inspected both from inside and outside.

For each truss the structural analysis was carried out by taking into account the load conditions prescribed by the current technical regulations and the effects of the surveyed physical damage on the resistant transverse sections. Usually the intervention (either total replacement or prosthesis) (Figure 75) is carried out when the result of the structural analysis confirms the scarce reliability deduced from the surveyed decay. In the case of great uncertainties, for instance when the level of reliability defined by the structural analysis is at the last threshold of admissibility, preference is given to the evaluation based on the onsite inspection. That is justified by the exceptionality of the intervention, the impossibility to intervene in the short term, the risk of a not continuous and planned monitoring of the structures.

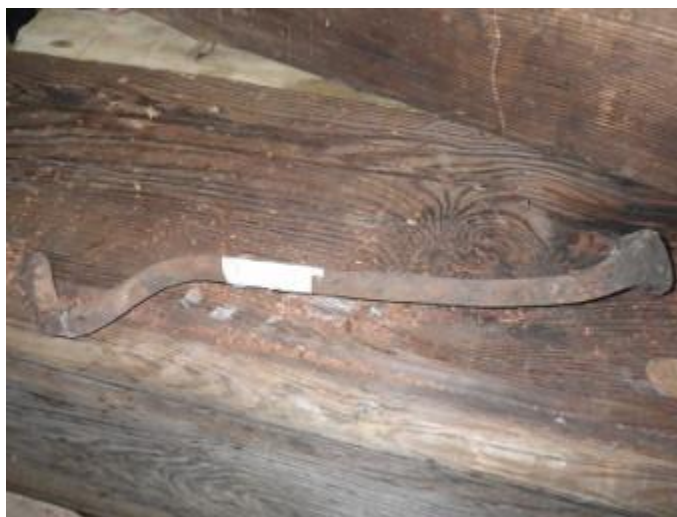
Figure 76: nail catalogued and stored

Most of the existing nails, once removed to allow the intervention, have been either re-used or catalogued and stored (Figure 76).

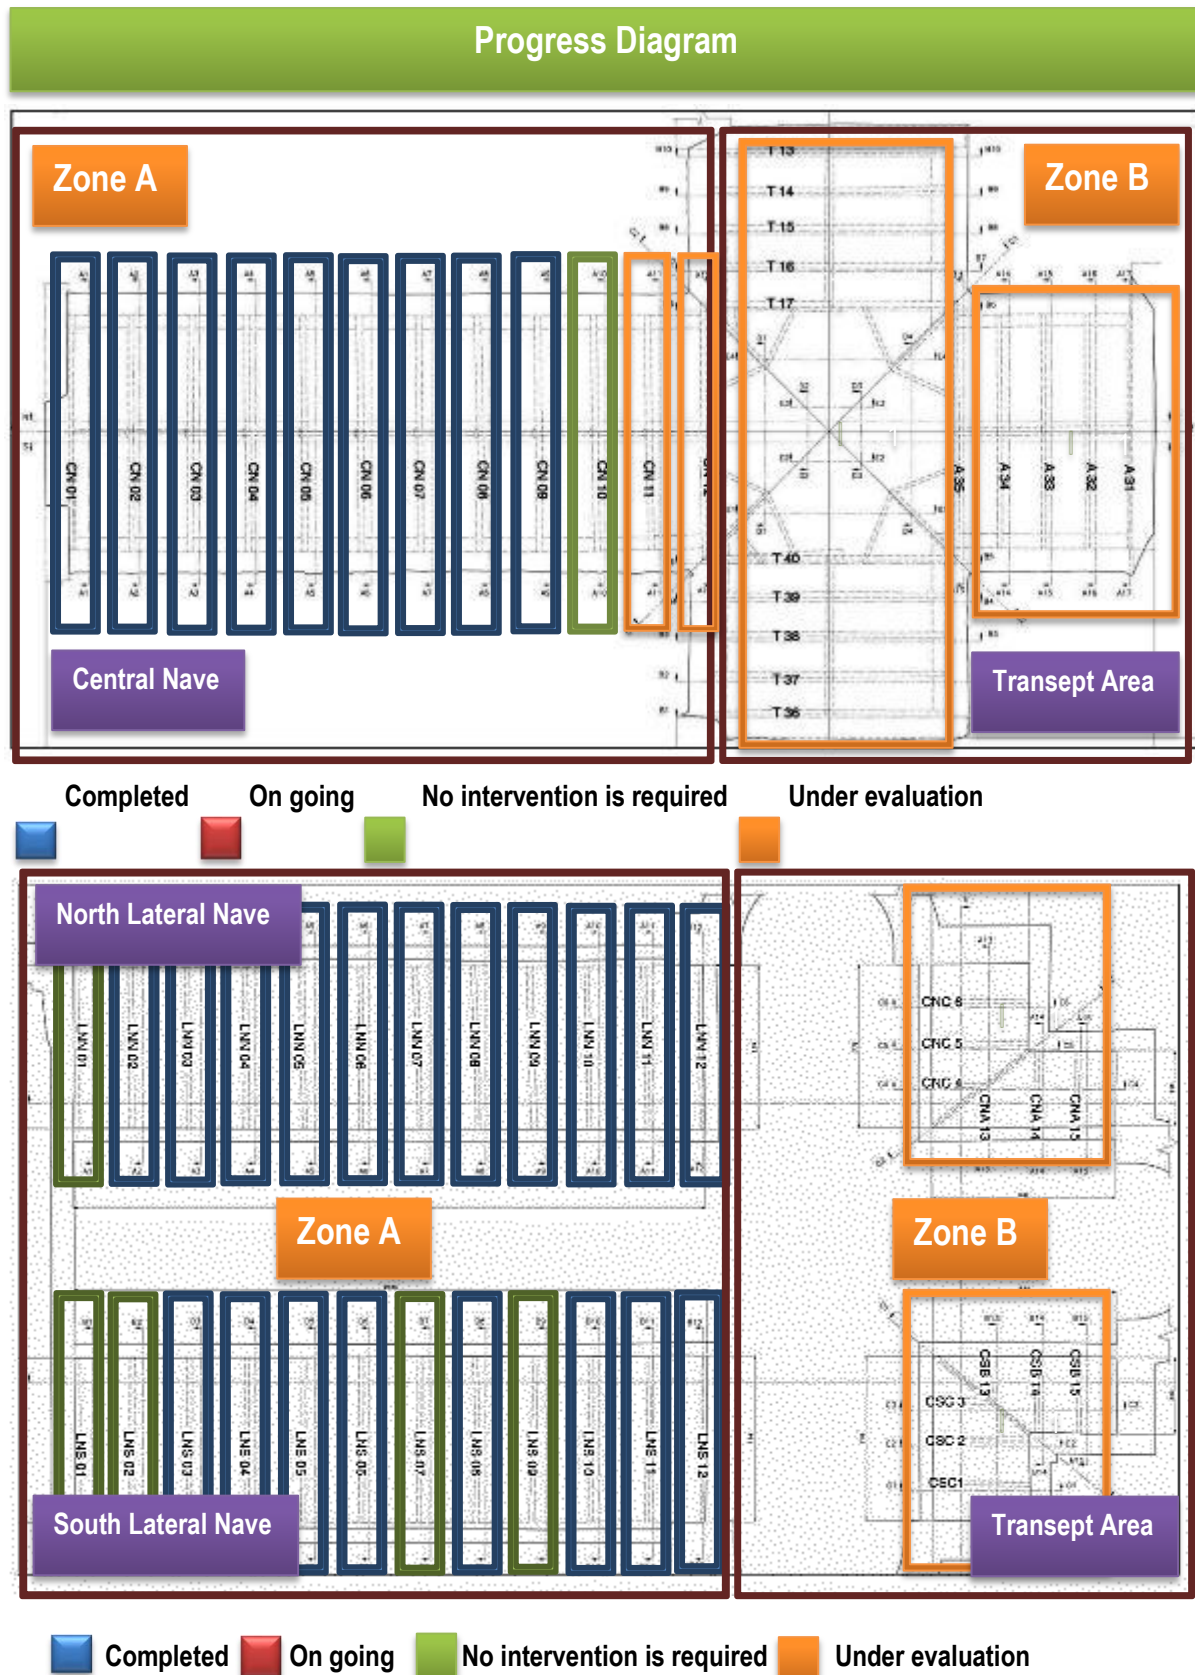
Figure 80: state of the work at the end of June

In the following (Figure 80) the state of the works in June 2014.

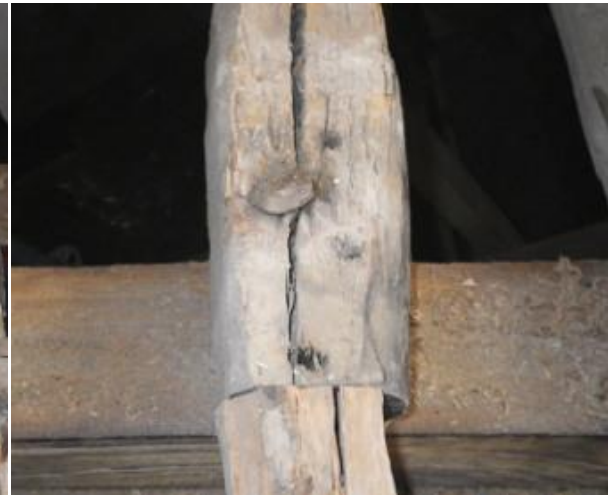
b)

In Figure 85 some examples in which the purlins do not need to be replaced is shown. Figure 85a shows a purlin in which the shrinkage crack stops to the pith. Figure 85b and Figure 85c show two examples in which, although a crack is present, the lateral contact between nails and wood (which allow the longitudinal stresses to be transferred from rafter to walls through purlins) is still present and active.

Figure 85: some examples of purlins that do not need to be replaced.

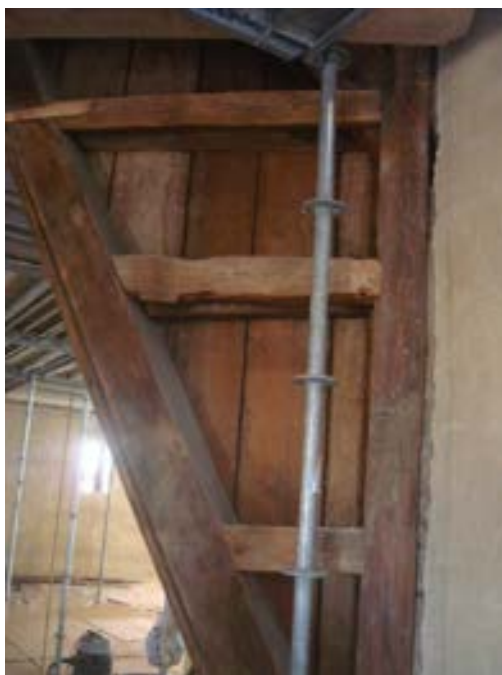
*Figure 90: internal structure of the cantilevers*

*According to what was possible to survey, the structural part of each cantilever (Figure 90) is made of one horizontal beam on the upper part, supported by two inclined, parallel props, one from the external extremity of the horizontal beam to the wall corner, and the other from half of the beam to the corner wall.*

- *Personnel must be competent on both structural timber diagnosis and resistographic analyses.*
- *This point previews the performing of a specialist analysis of wood degradation through resistographic drillings.*
- *Resistographic driller having a needle at least 40 cm long. The complete cross section must be investigated.*

1. *Removal of the covering boards. Connections with walls of the structural beams must be completely available.*
2. *When the portion of wood is visible some measurements must be taken: dimensions of the two sides of the section of each element; wood moisture content by means of electrical wood hygrometer.*

4. *In the presence of decay, perform diagonal drillings from the lower corners, but on a section perpendicular to the inspected element, at the connection between wood and wall.*

5. *In the presence of decay at point 4, continue inspecting, performing drilling as in point 4, a section each 20 cm moving from the wall, up to when no more decay is detected.*

6. *The obtained results must be graphically uniform to the specific part of the Final Report of the diagnostic phase. More specifically the presence of possible decay must be reported in decay classes: 0-25% / 25 – 50% / 50 – 75% / 75-100% (percentage of cross section covered by decay).*

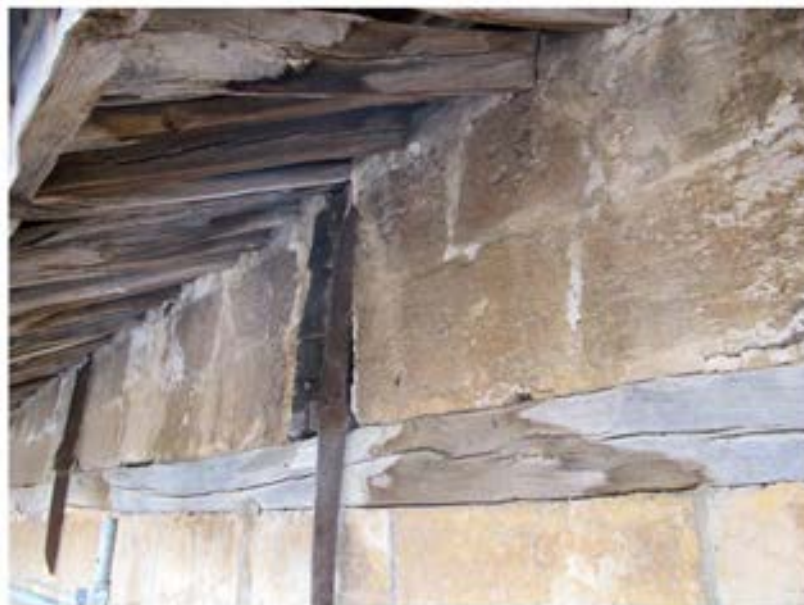
Figure 105: top portion of the wall with the wooden sleeper

The assembly of scaffolding outside the Basilica has allowed to analyze closely the top portions of the walls (Figure 105), at the connection points of the roof with the walls. In particular, the stratigraphic analysis of this part of the walls, the chemical analysis of the mortars used in these parts, compared with the mortars of the lower levels, the analysis of the wooden species of the sleeper under the truss heads (inspected this time from both parts, from outside and inside) allow to advance new hypotheses about the changes undergone over the centuries by the masonry walls and the whole roof. For these reasons the chemical analysis of further mortar samples and the dendrochronological and C14 analysis of some samples of the wooden sleeper have been requested to the Project Manager.

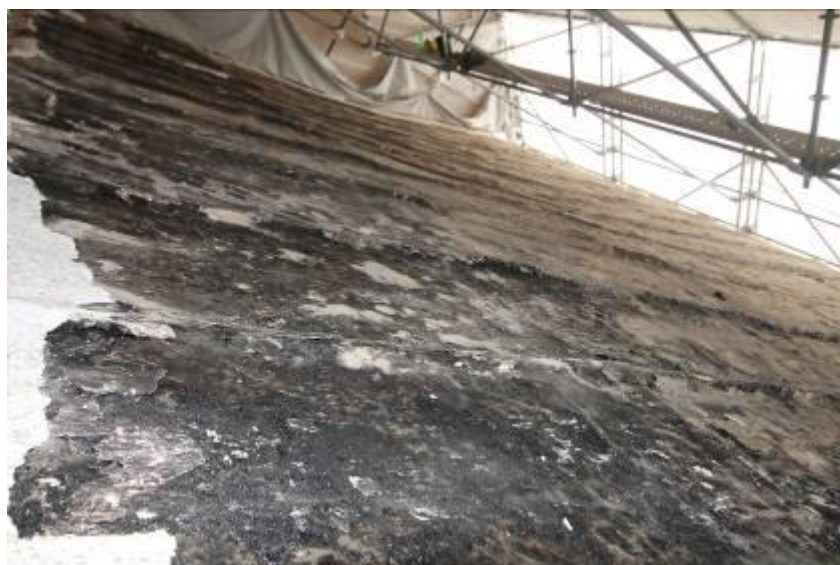
Figure 110: external surface of the roof made of bitumen and fabric

Before removing the lead sheets a stratigraphic and chemical analysis of the various layers of bitumen and fabric forming the external surface of the roof was carried out (Figure 110, Figure 111).

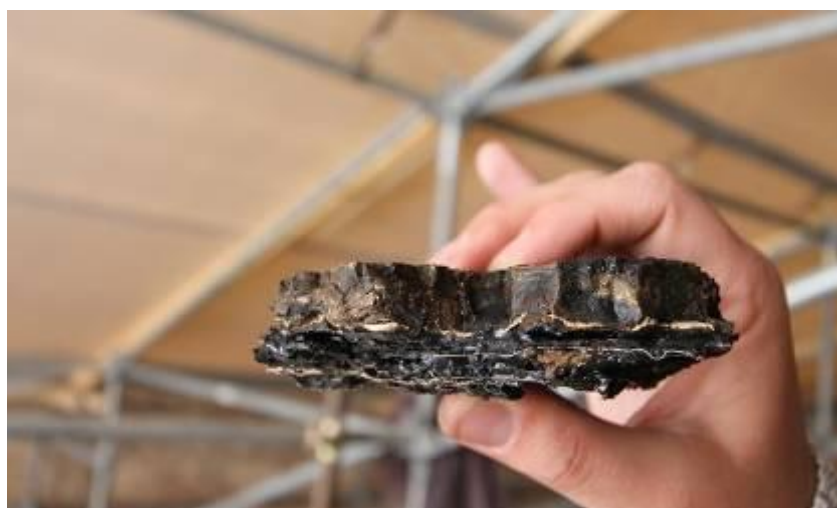
Figure 111: thickness of the bitumen layer changing from 2-3 cm on the top of the roof to 4-5 cm at the lower levels

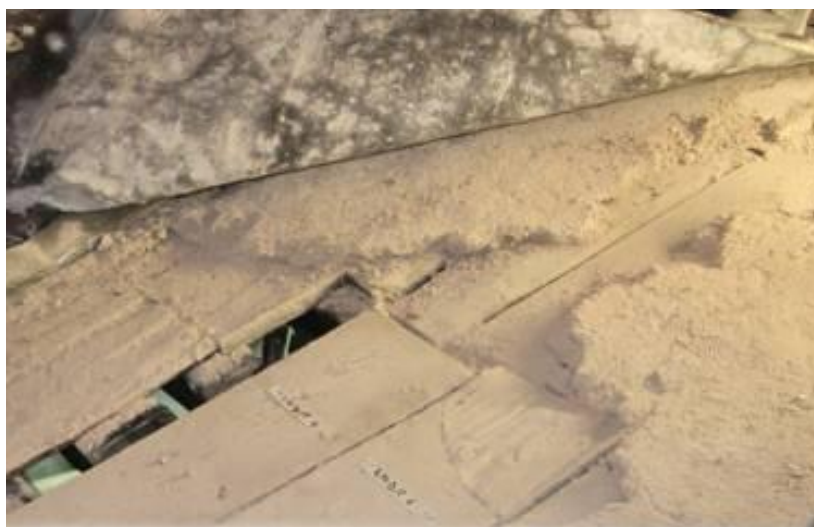
The removal of the lead sheets allowed to discover an unexpected insulating layer between lead sheets and boards, made of clay and straw (Figure 115).

Figure 115: insulating layer made of clay and straw

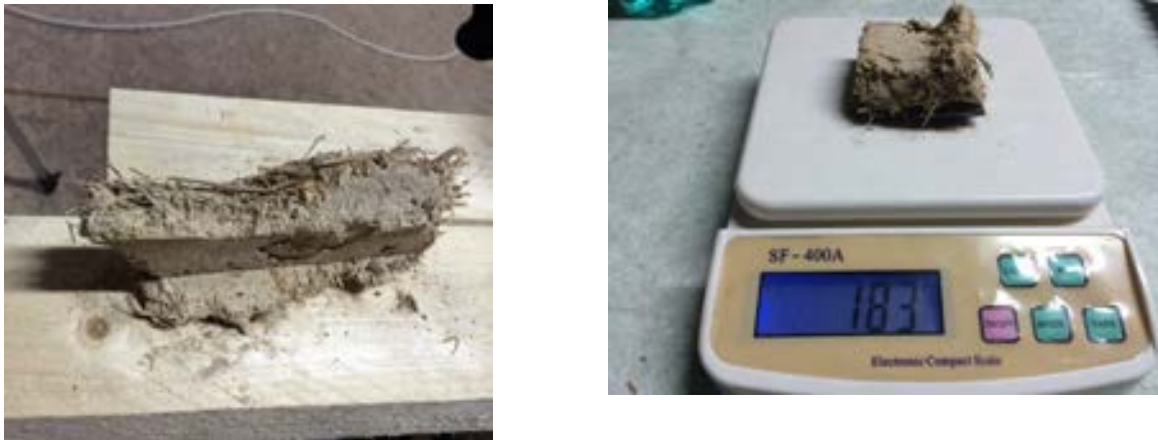
Samples of this layer were analysed in their properties and inner composition and measured in their thickness (Figure 116)

Figure 116 : analyses on samples of insulating layer

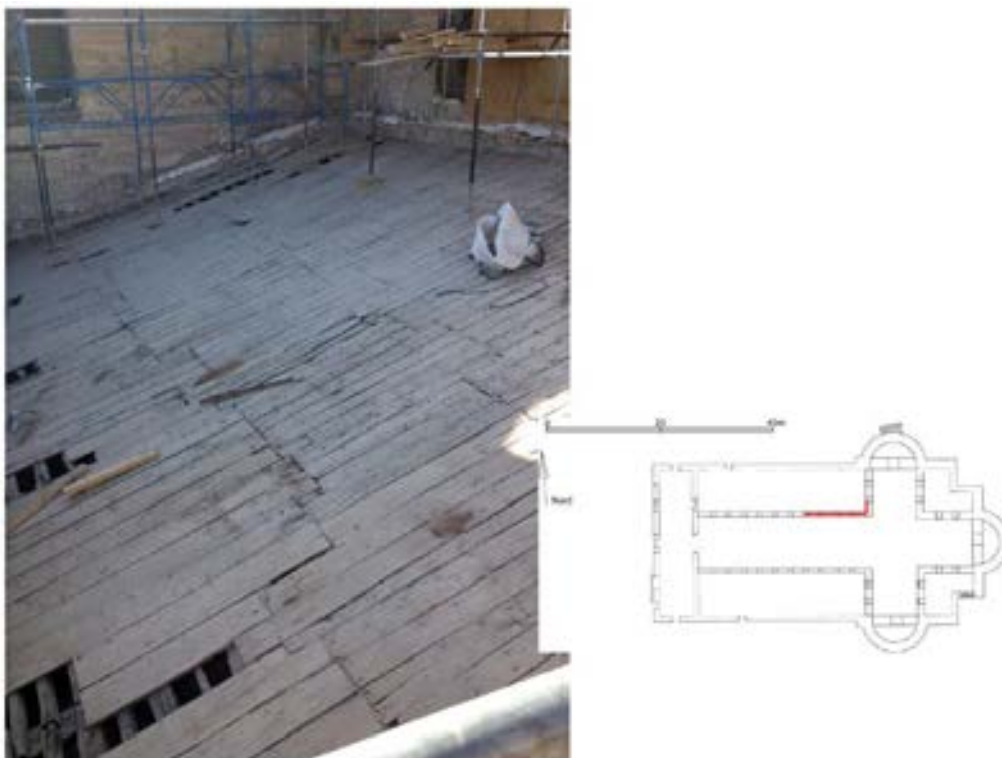
The removal of the roof covering above the aisles has brought to light those parts of the walls which were hidden by the layers of bitumen and by the lead sheets. It revealed a number of interesting traces that contribute to clarify the past history of the Church and to discover the several changes occurred over the ages. All these data have been properly recorded (Figure 117, Figure 118).

Figure 117: traces of previous roof structures in the areas between walls and present roof covering

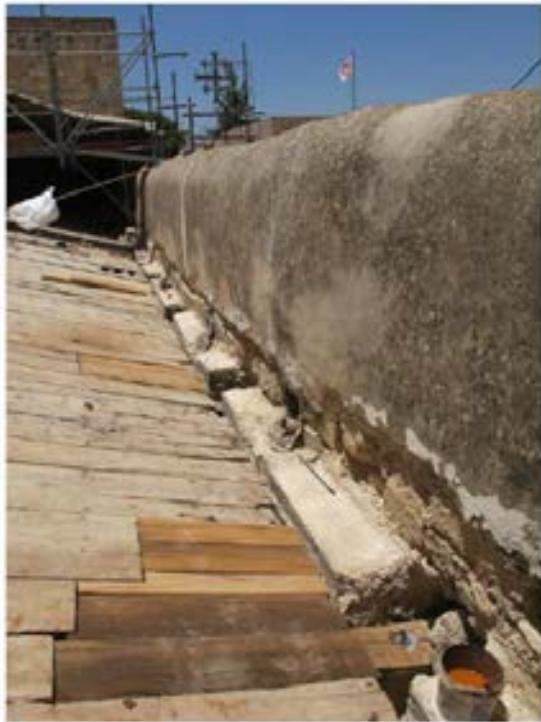
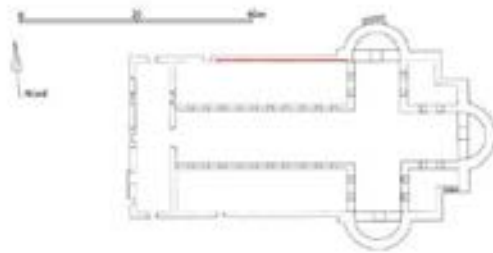
Figure 118: traces of the original drainage and rainwater collection system

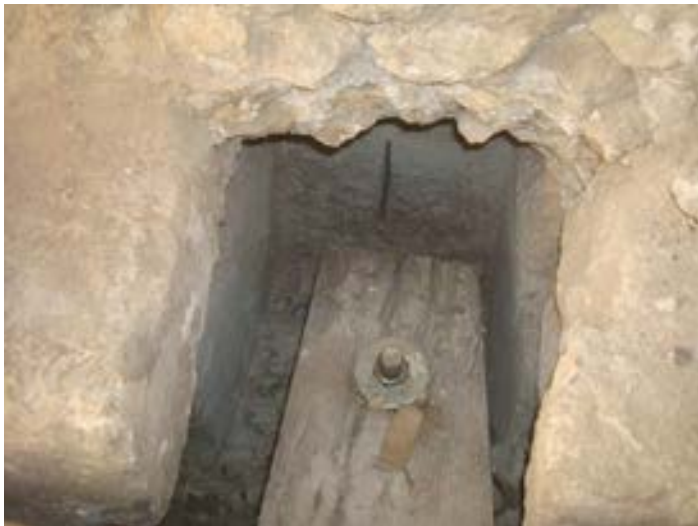
The restoration of the truss heads and the seismic reinforcement by means of threaded bars has allowed to open the spaces around the heads (Figure 119), which had been covered for centuries by loose material and stones, responsible, together with the rainwater infiltration and the consequent moisture, of the damage of the truss heads. All these spaces will be kept free to allow a better ventilation of the truss heads.

Figure 119: the original space around the truss head

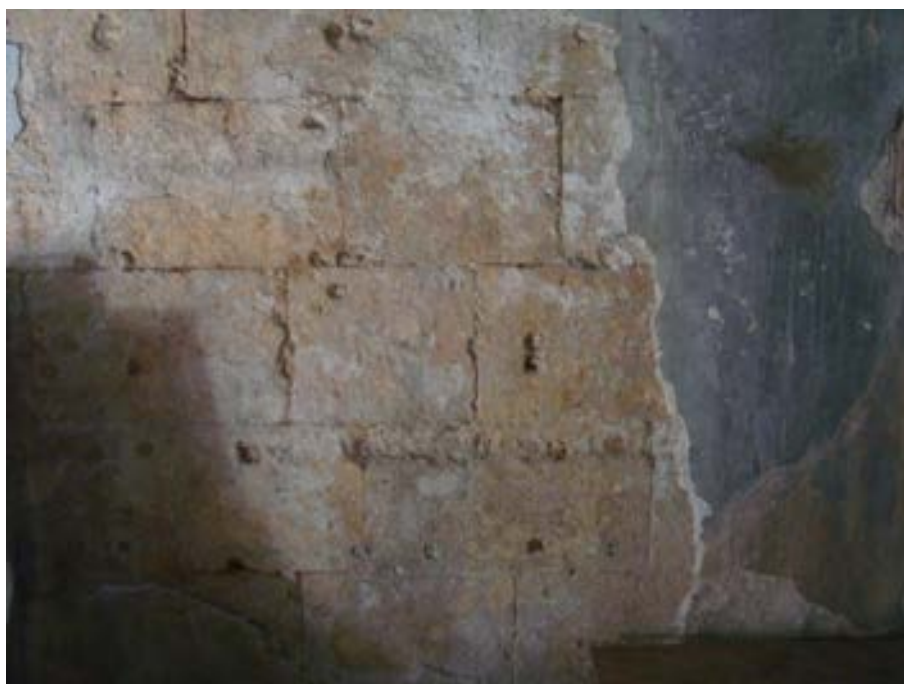
During the removal of some parts of the plasters in the aisles, seriously damaged and without any possibility of consolidation, the original masonry *apparatus* has once again become visible showing the holes of the metallic

devices used to hang the marble slabs on the wall (Figure 120). Moreover it possible to see crosses, dates, names carved on the stone (Figure 121).

Figure 120: Holes hosting the metallic devices to hang the marble slabs on the walls

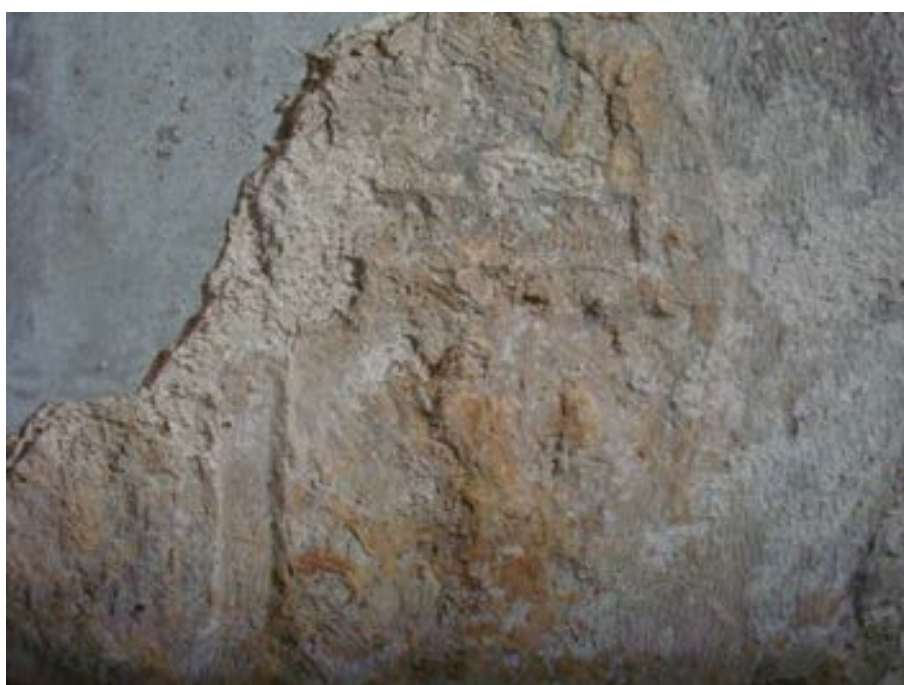
Figure 121: cross carved on the stone

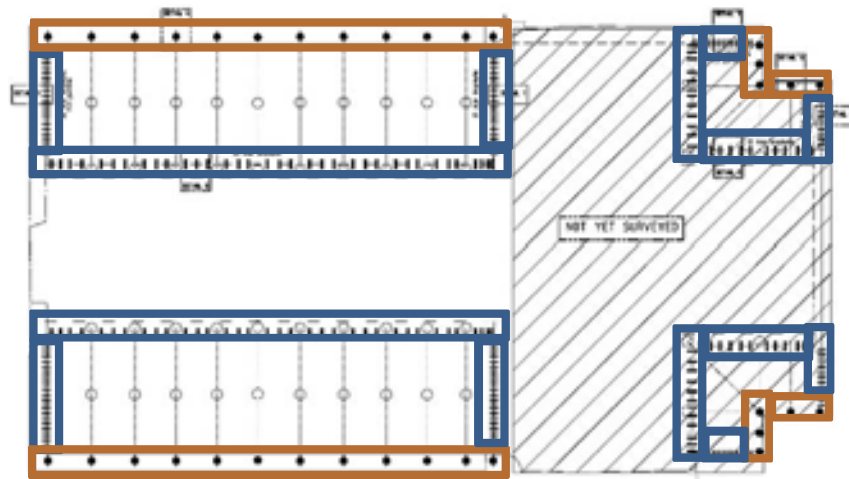
Completed purlins connectors

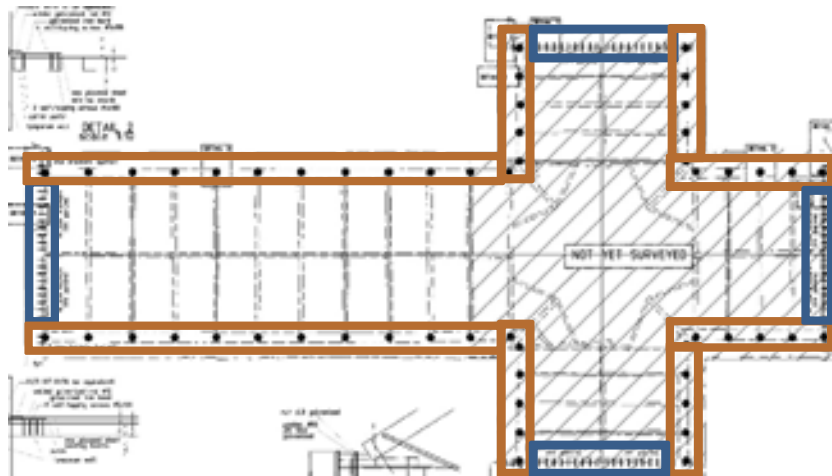
Completed steel insertion bars
