## **State of Conservation Report**

**Birthplace of Jesus**

**Church of the Nativity and the Pilgrimage Route, Bethlehem**

February 2015

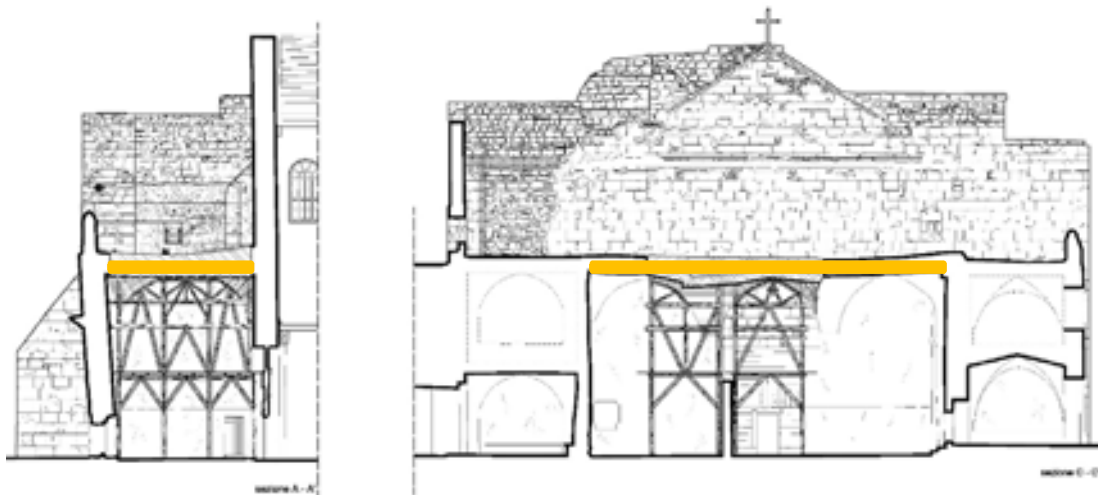
The location of the archaeological excavations

The preliminary structural reports have showed that the existing cracks on the roof are extended from the damaged vault to the adjacent vaults. This fact has made the excavation on additional two vaults to uncover the stone of the vaults are extremely necessary for better understanding of the structural stability of the narthex and to make the structural simulations and analysis more realistic in order to identify the most suitable solution.
