2015 Earthquake Damage Mapping
Changunarayan Monument Zone
Kathmandu Valley World Heritage Property

November 2015

This assessment was supported by
UNESCO Office in Kathmandu

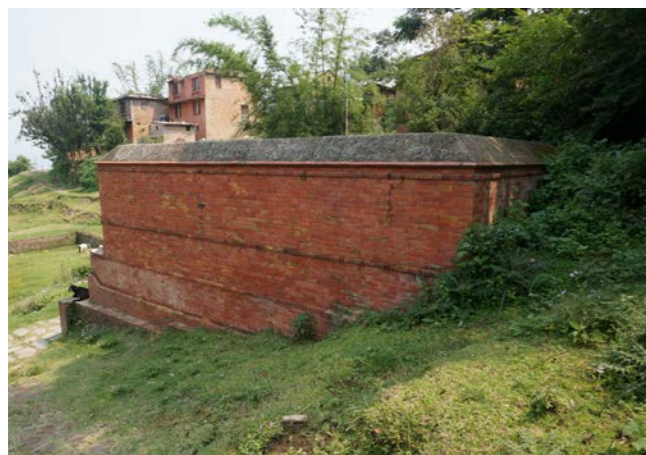
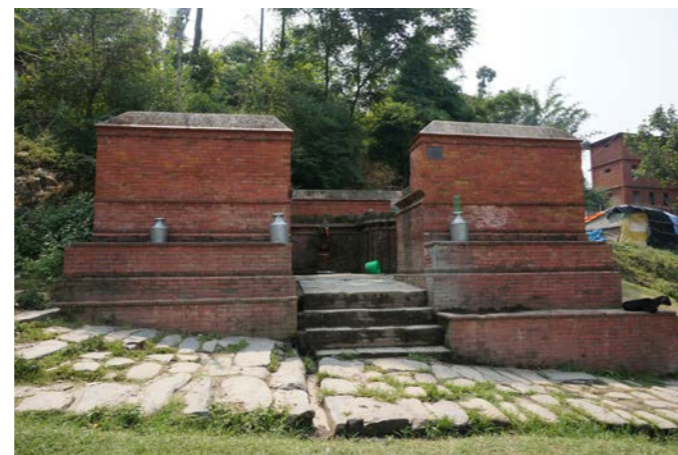
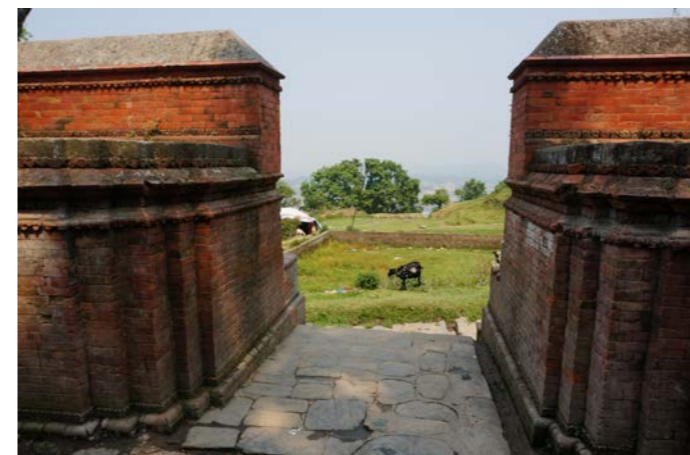
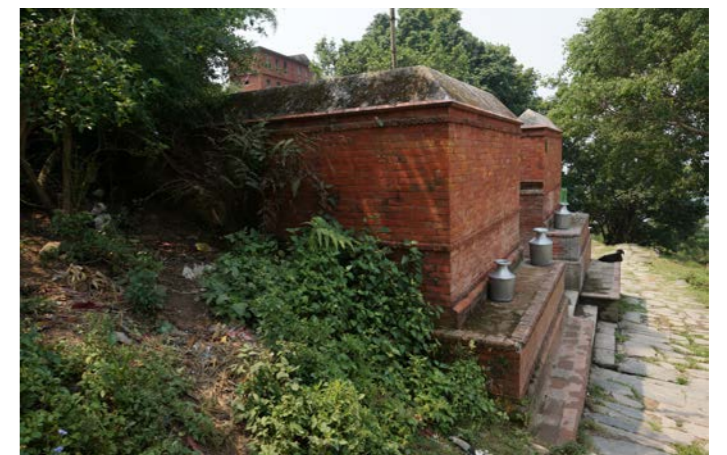
1 WATER SPOUT

NUMBER	NAME	DATE A.D.	TYOLOGY	GENERAL DESCRIPTION	DESCRIPTION OF DAMAGE	DANGER
1			Water Spout	Brick and carved stone in cement mortar Walls recently renovated	No visible structural damage Rising damp Needs maintainance

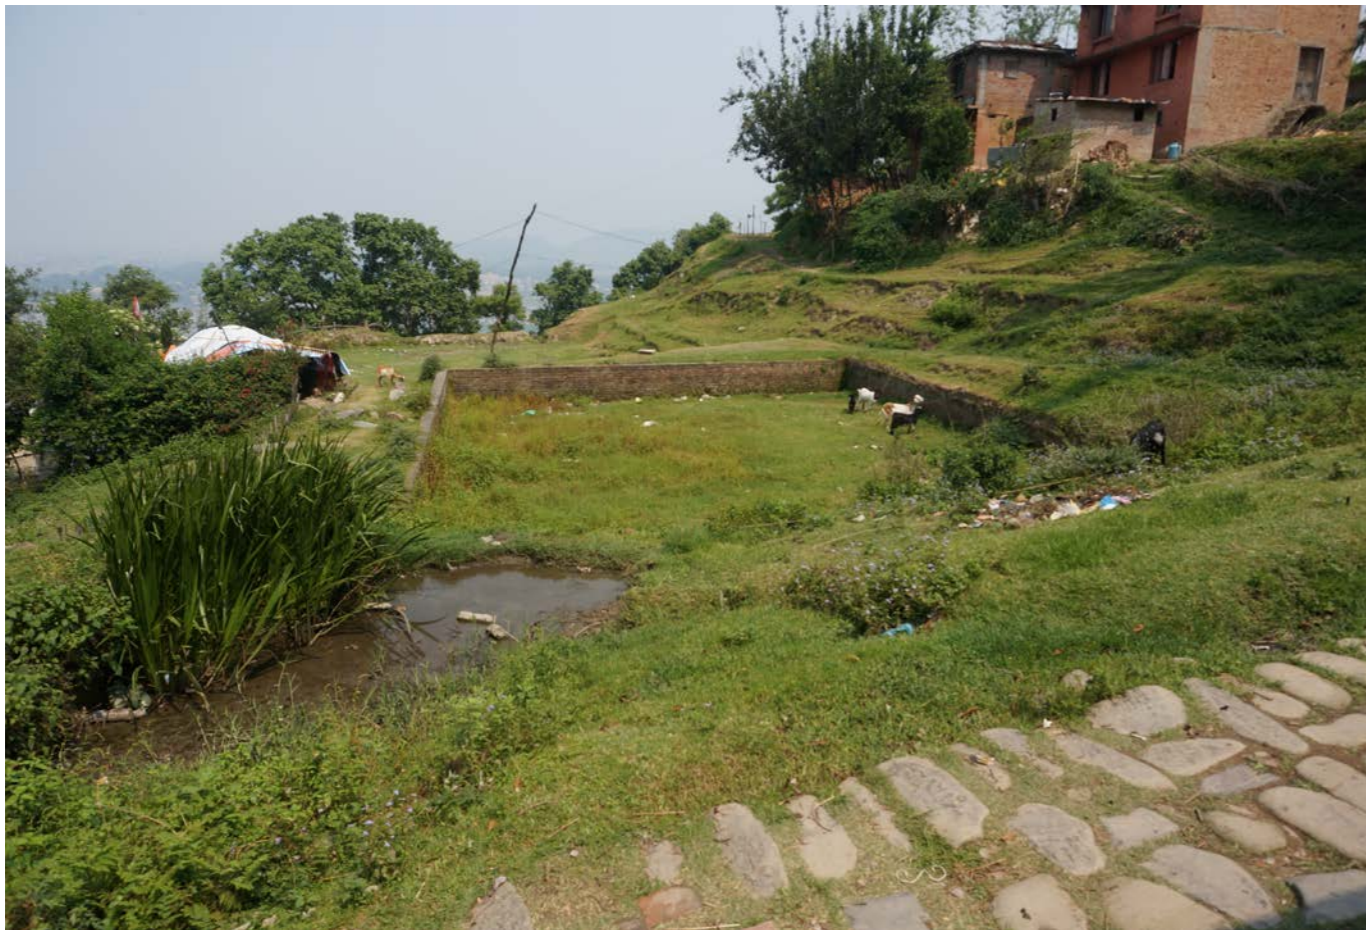
2 POND

NUMBER	NAME	DATE A.D.	TYPOLOGY	GENERAL DESCRIPTION	DESCRIPTION OF DAMAGE	DANGER	
2			Pond	Brick made walls	Dried up and filled with grass Eroded brick walls		
6			Open shrine	Cult deity of Shresthas' Recent brick work

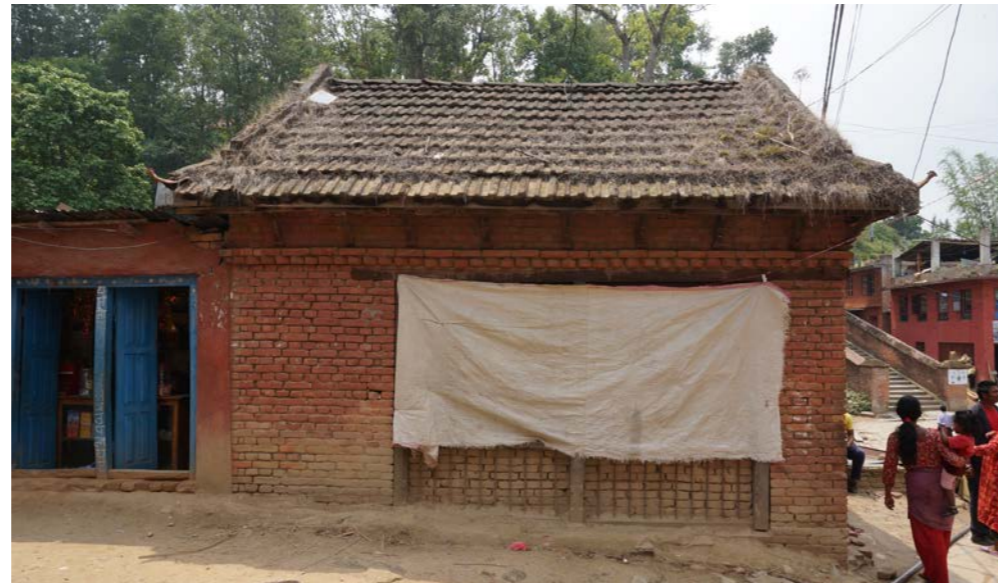
11 REST HOUSE

NUMBER	NAME	DATE A.D.	TYPOLOGY	GENERAL DESCRIPTION	DESCRIPTION OF DAMAGE	DANGER
11			<i>Pati</i> (Rest house)	Brick and timber structure with pan tile roof cover	No visible structural damage but poorly maintained. Parts of the roof are unstable

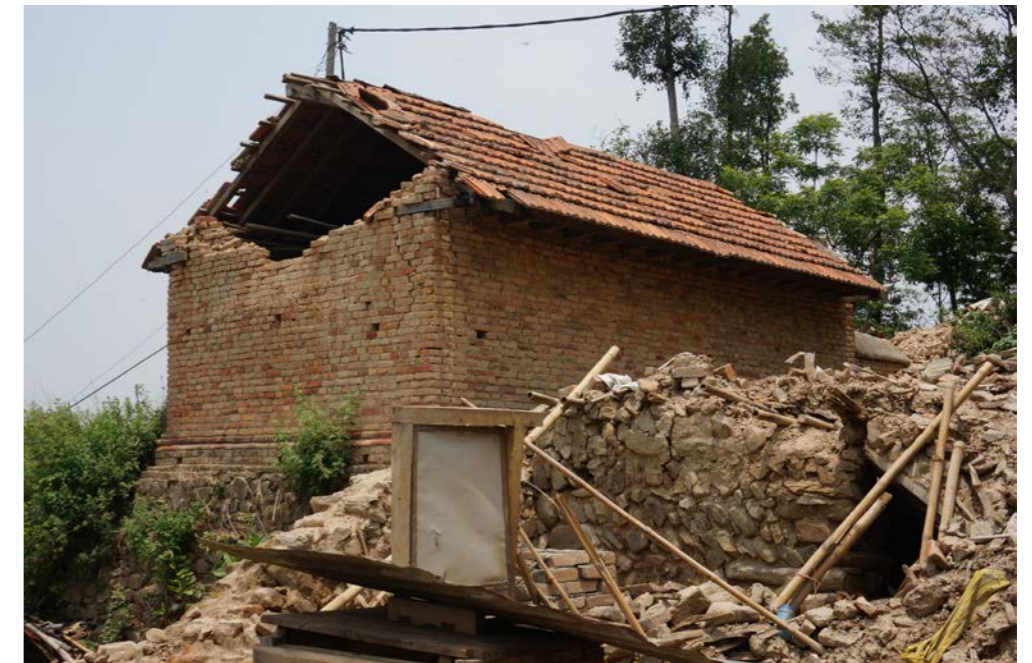
12 REST HOUSE (BHAIRAV PATI)

NUMBER	NAME	DATE A.D.	TPOLOGY	GENERAL DESCRIPTION	DESCRIPTION OF DAMAGE	DANGER	
12	Bhairav Pati		<i>Pati</i>	Brick and timber structure	Roof partially collapsed Gable end walls partially collapsed Large cracks on N-wall Boundary wall collapsed

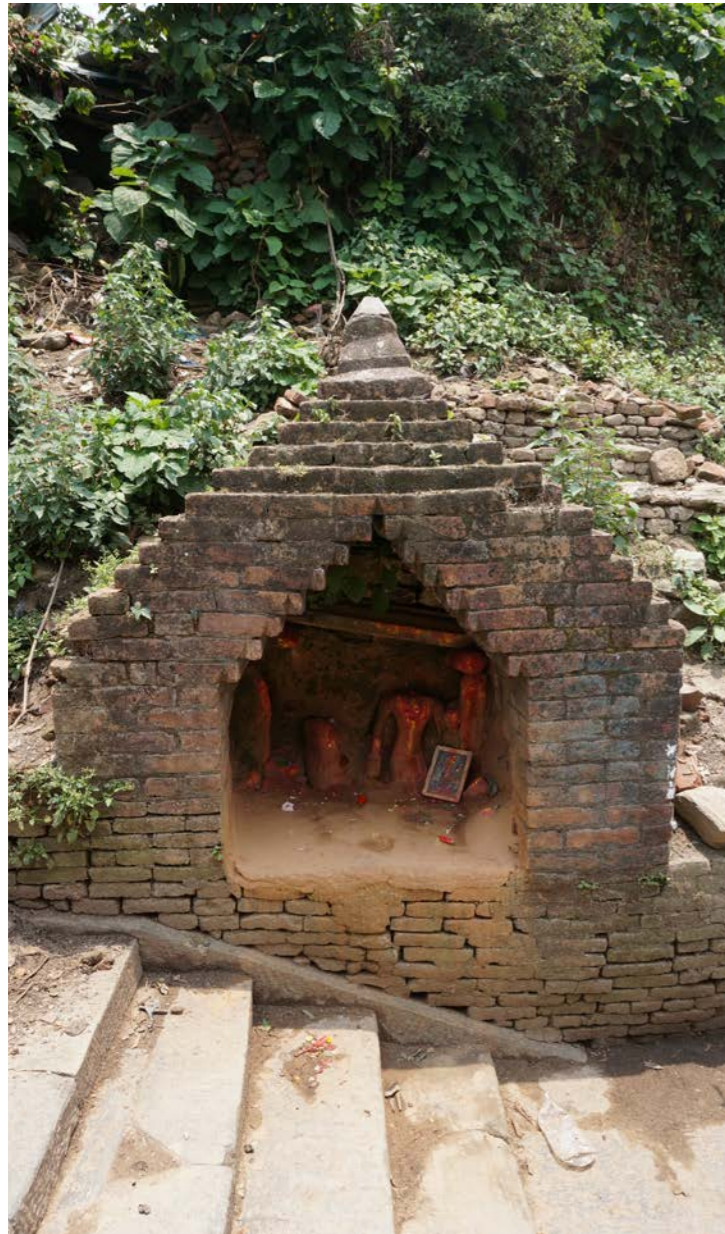
14 SHRINE

NUMBER	NAME	DATE A.D.	TPOLOGY	GENERAL DESCRIPTION	DESCRIPTION OF DAMAGE	DANGER
14			Open Shrine		Brick deteriorated and vegetation growth	
15	Bhairav Pati		<i>Pati</i>	Single storey brick and timber structure with jingati tile roof	North roof tile cover collapsed. Dislocated bricks and vertical cracks on the 2 inner walls Major vertical crack in the South-West corner	⚠

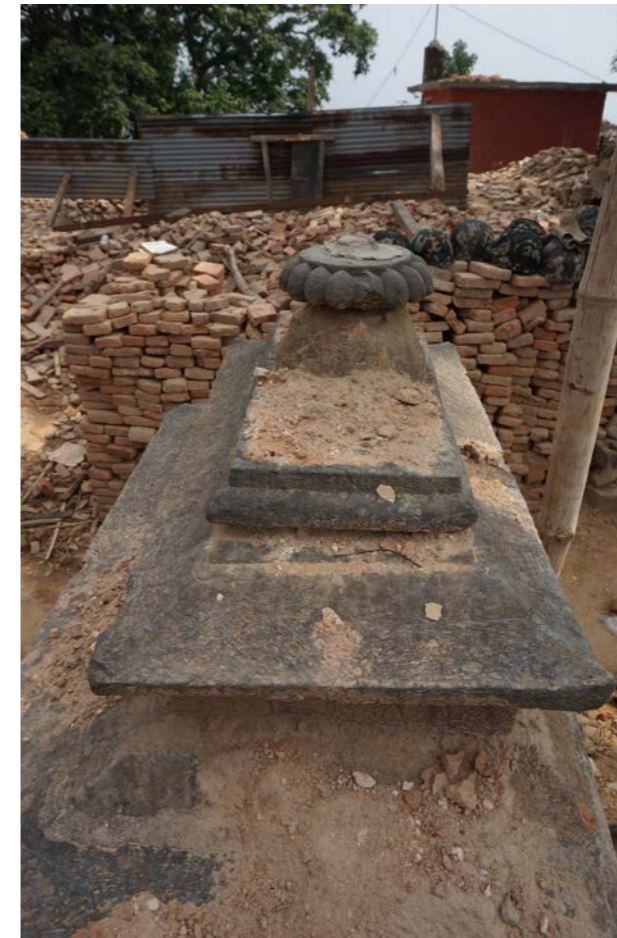
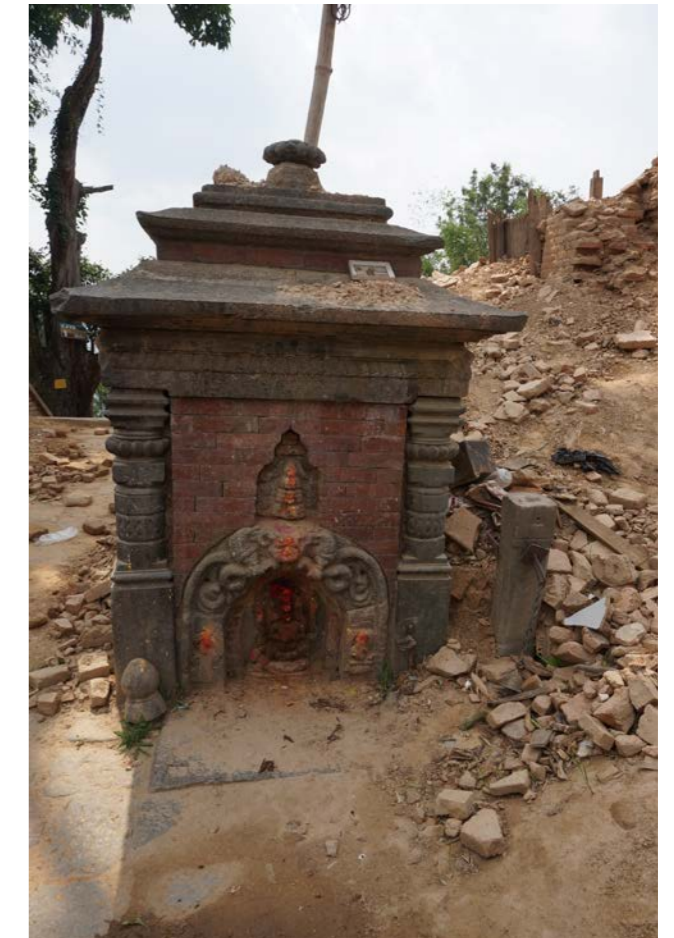
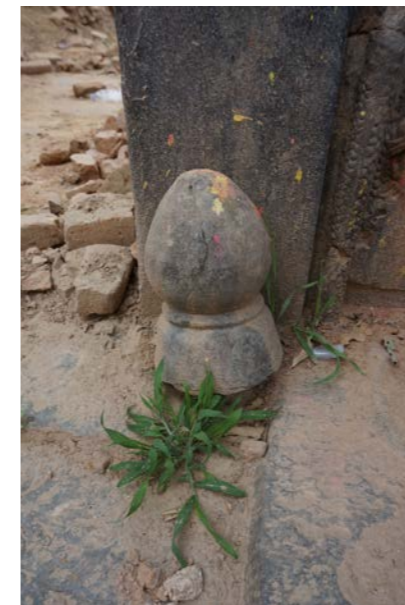
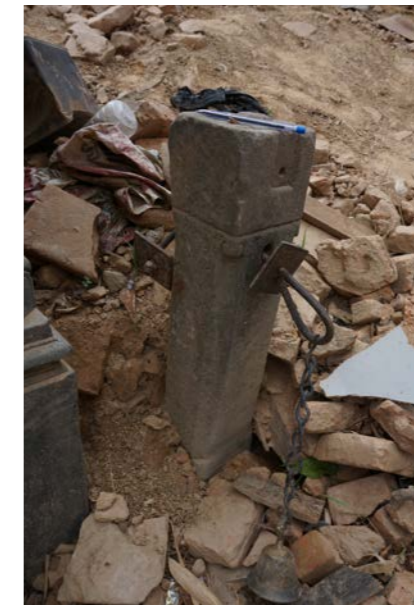
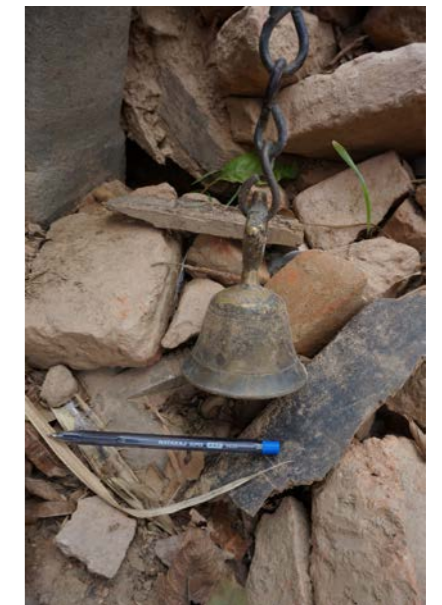
16 MAHANKAL SHRINE

NUMBER	NAME	DATE A.D.	TPOLOGY	GENERAL DESCRIPTION	DESCRIPTION OF DAMAGE	DANGER
16	Mahankal shrine		Shrine	Shrine made of stone and brick. Stone post supports a small bell	The dislocated <i>Gajur</i> (finial) is kept next to the shrine

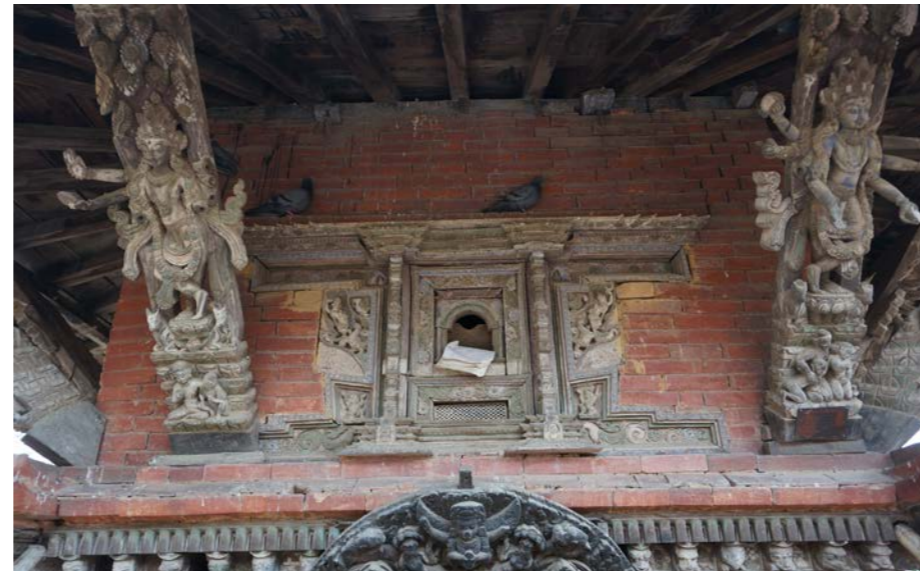
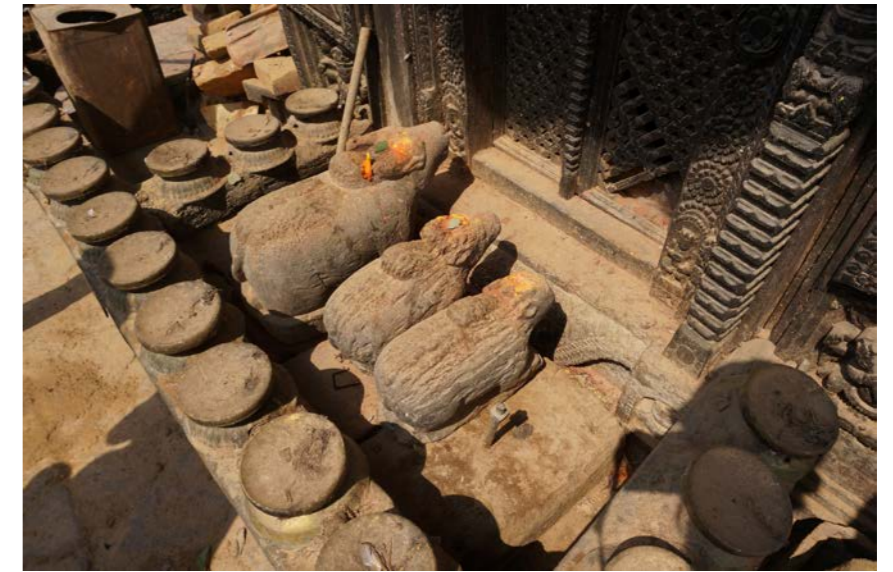
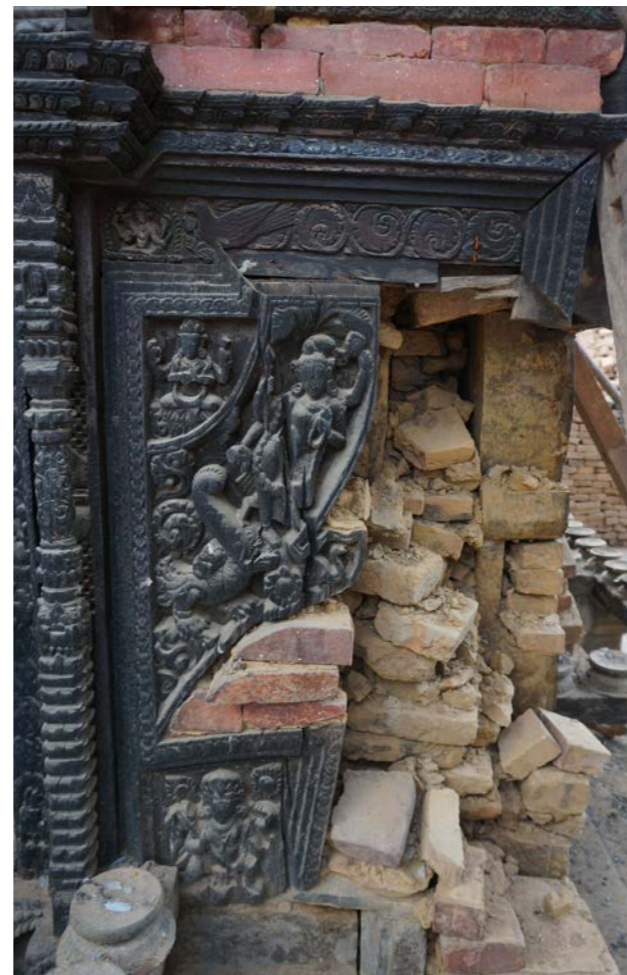
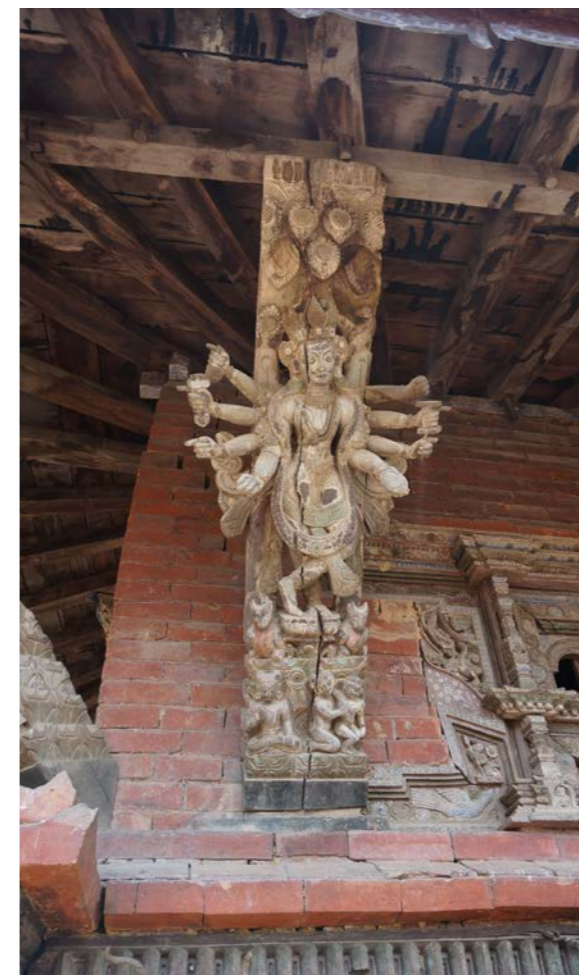
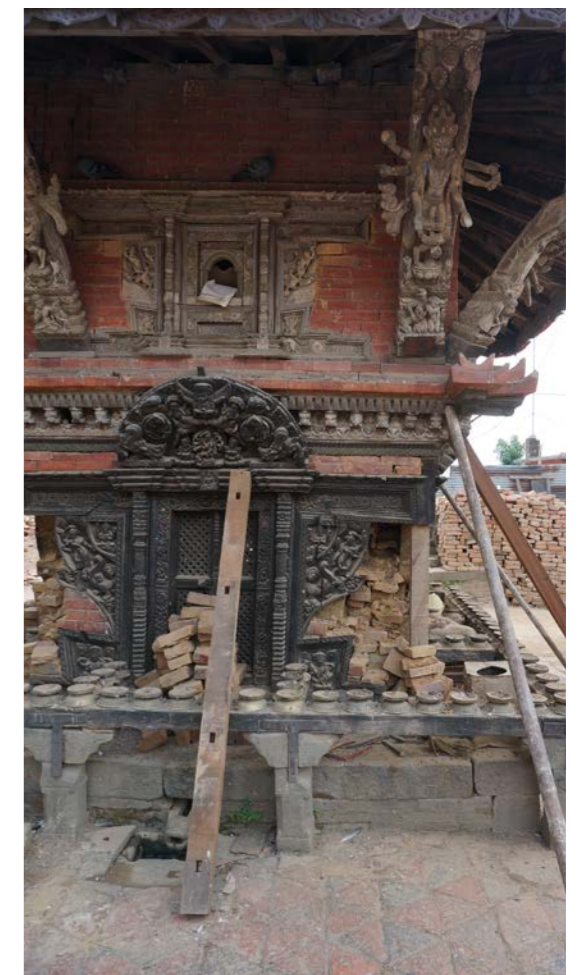
17 KILESHWOR MAHADEV TEMPLE

NUMBER	NAME	DATE A.D.	TYPOLOGY	GENERAL DESCRIPTION	DESCRIPTION OF DAMAGE	DANGER
17	Kileshwor Mahadev		Two-tiered Pagoda Temple	Pagoda temple with 3 nandis in front of West Door	All corners and N-W wall of ground floor have fallen. Cracks on 1st and ground floor. East door frame partially collapsed. Vertical cracks on the frame of East and West windows. Horizontal cracks on central frame of North window. Cracks in struts on the West and on the N-E corner.

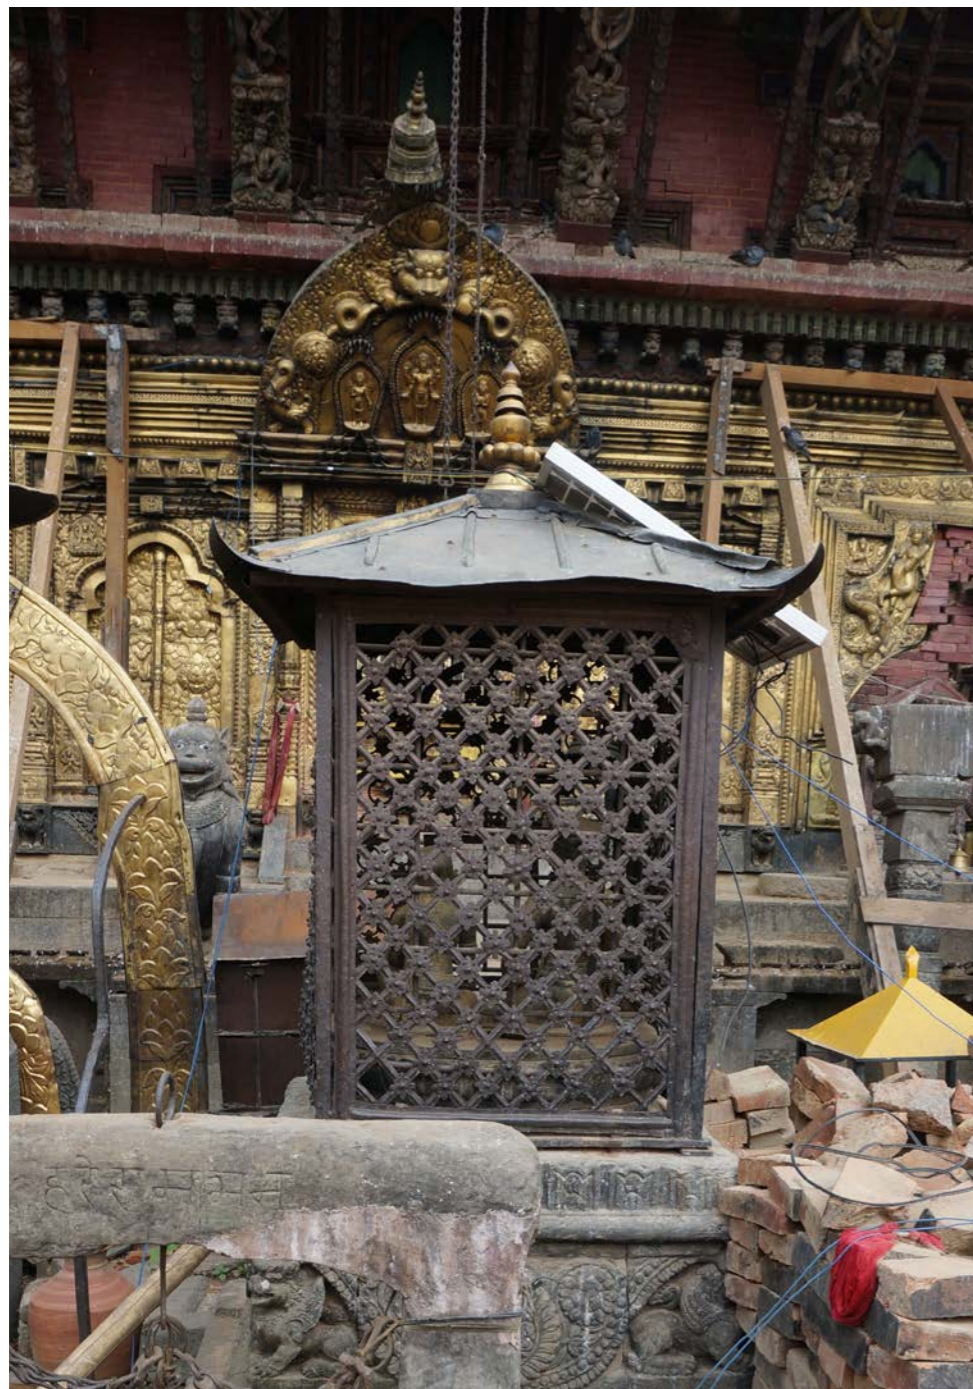
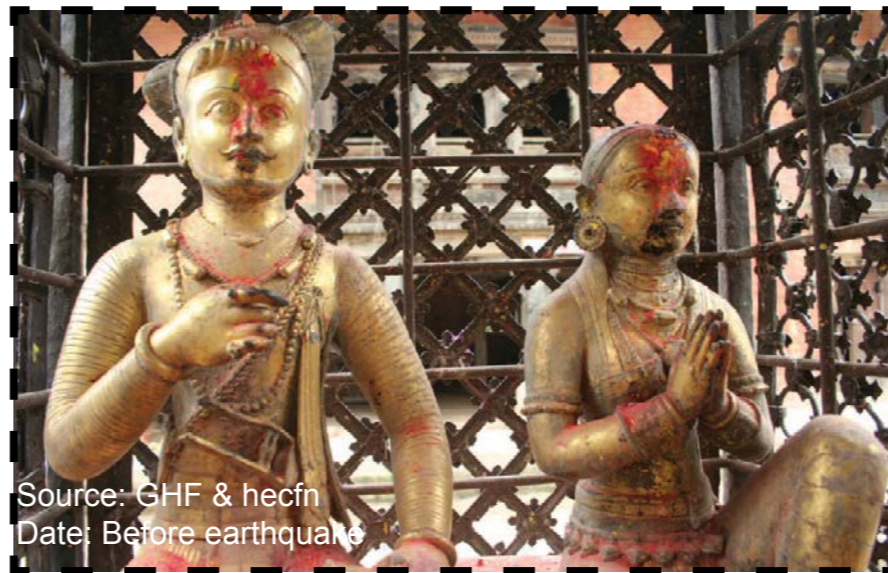
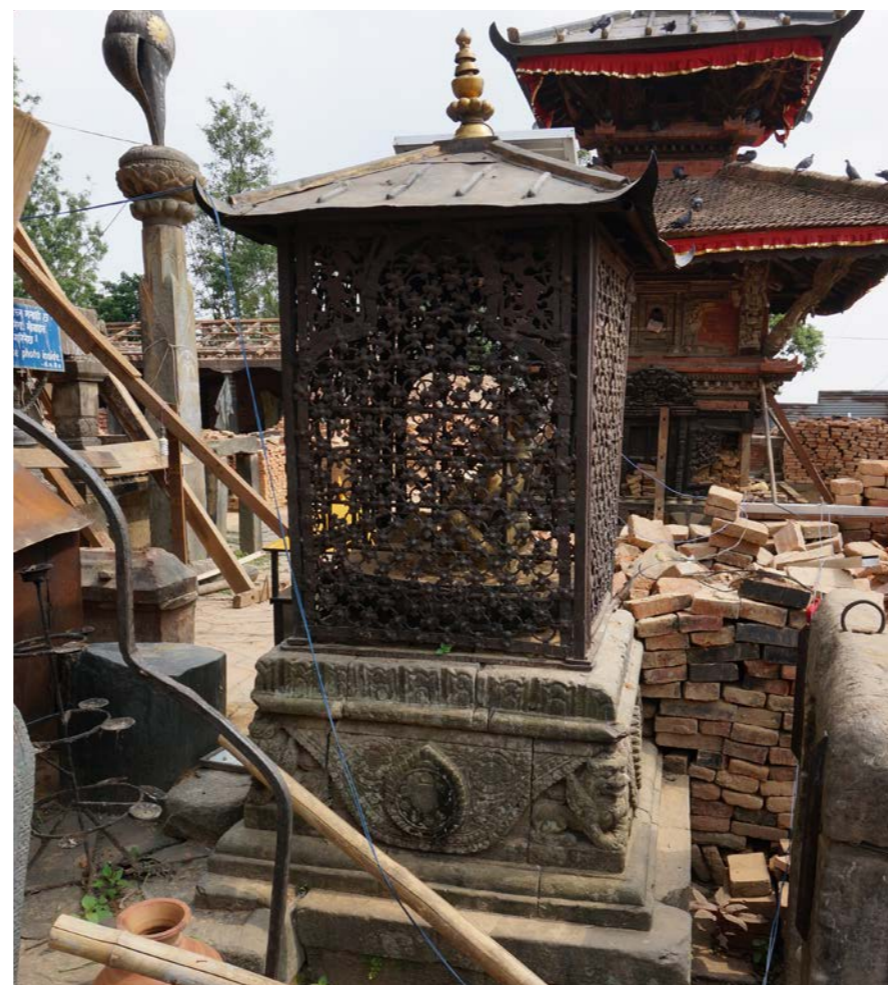
18 SHRINE

NUMBER	NAME	DATE A.D.	TYPOLOGY	GENERAL DESCRIPTION	DESCRIPTION OF DAMAGE	DANGER
18			Praying image of king and queen	Stone base with metal lattice enclosure, metal roof and metal gajur with statues of a king and a queen.	Minor damage on the roof	
19			Stone frame bell

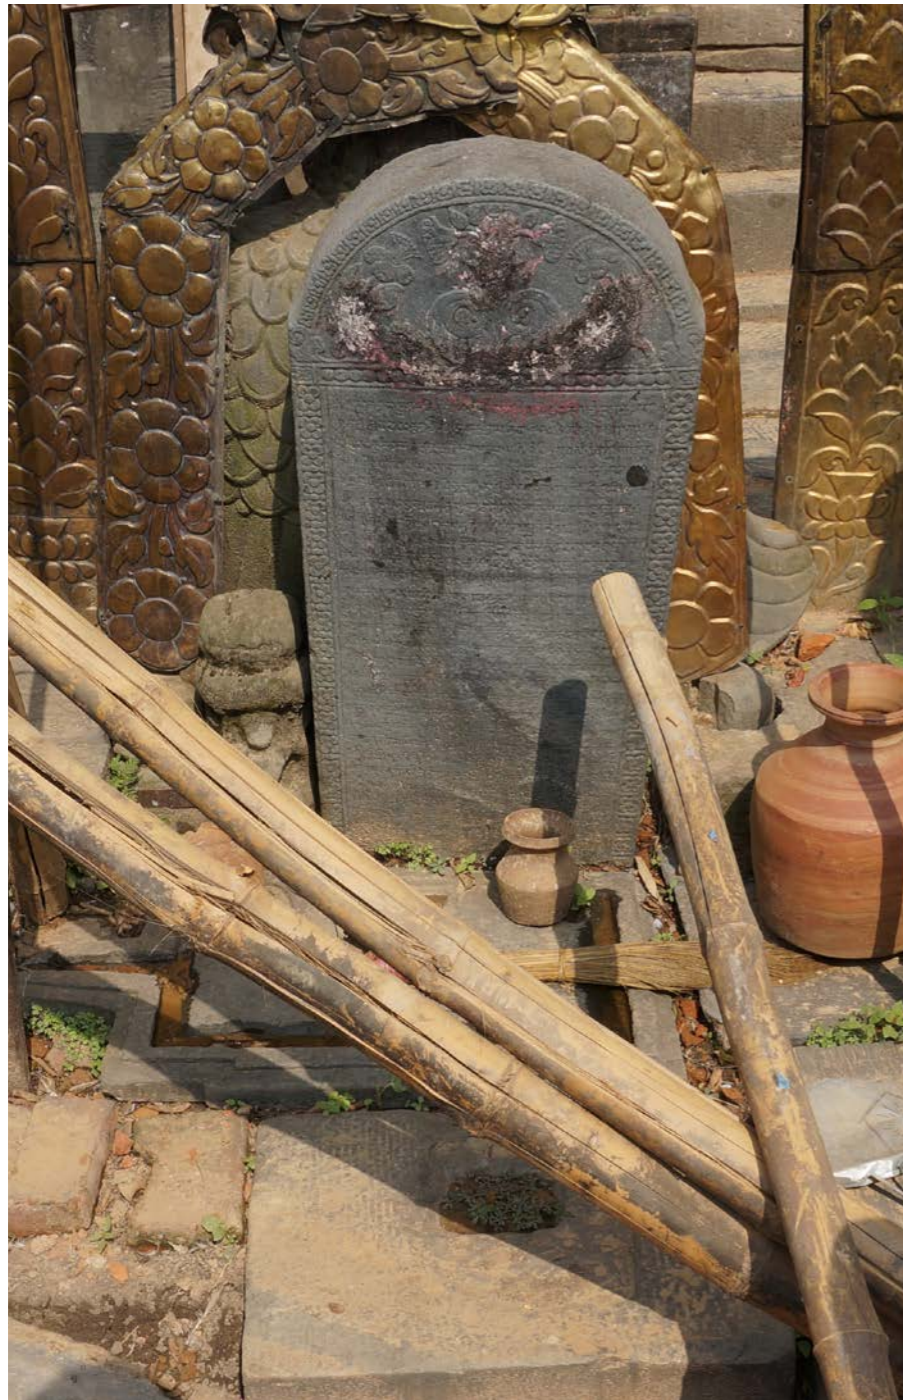
20 STONE STELE

NUMBER	NAME	DATE A.D.	TPOLOGY	GENERAL DESCRIPTION	DESCRIPTION OF DAMAGE	DANGER	
20			Stone stele	Stone inscription with a jalahari (base of shiva lingam) in front and a re-pouseé arch and gajur (finial) behind.	Stele slightly tilted to the South-West		
21			Stone frame and post with two bells	Stone frame supporting a bell. Another stone post rests next to it and also supports a bell.	The top of the stone post is broken and mended with wire.	⚠

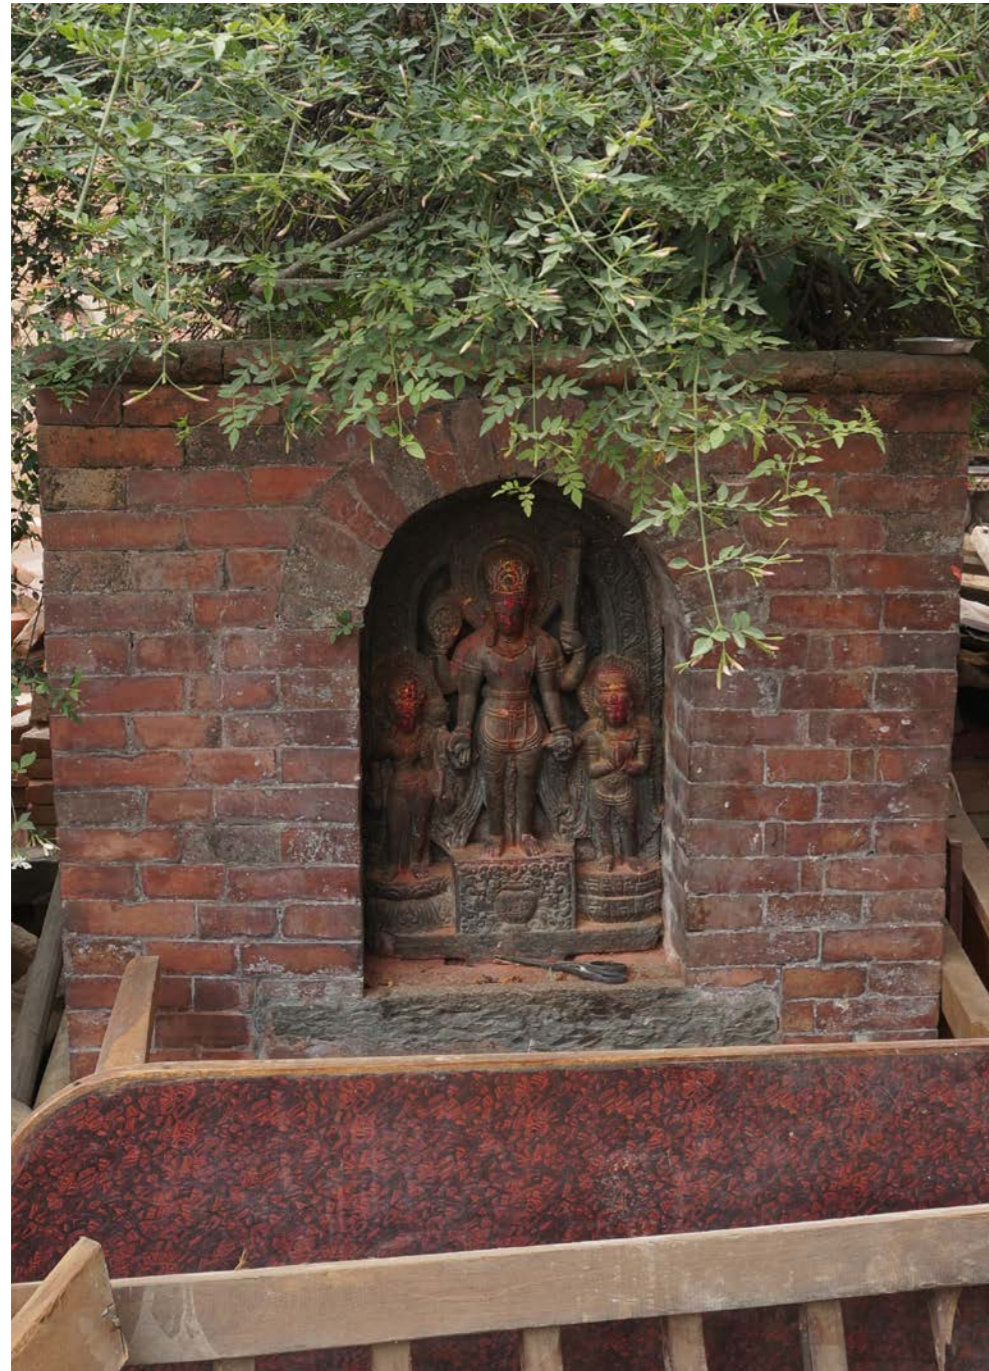
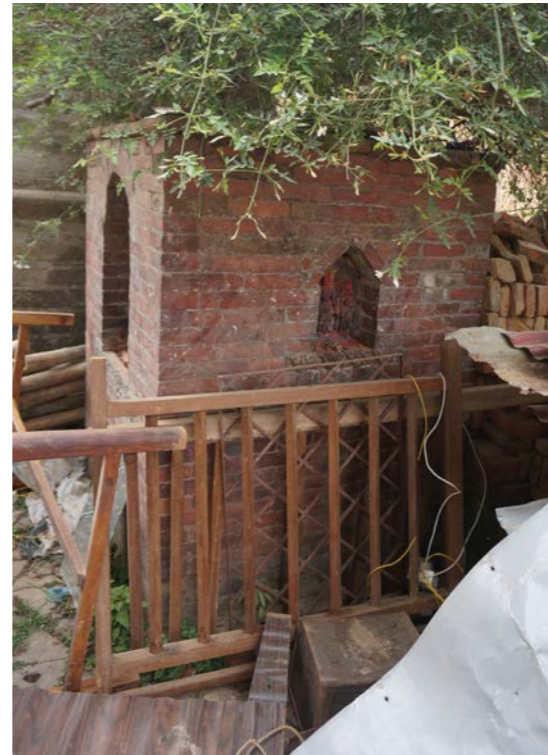
25 SHRINE (SHREEDHAR VISHNU)

NUMBER	NAME	DATE A.D.	TPOLOGY	GENERAL DESCRIPTION	DESCRIPTION OF DAMAGE	DANGER
25	ShreeDhar Bishnu		Open Shrine	Brick structure with stone sculpture	No Visible Damage	
27	Vishnu Statue		Open Shrine	Vishnu statue on stone pedestal with a headless devotee in front .Stone inscription of Sankha-Chakra-Padma-Gadha on W-S corner.	Stone cracks on the base of statue at S-W side Some stone of the base has slight separation

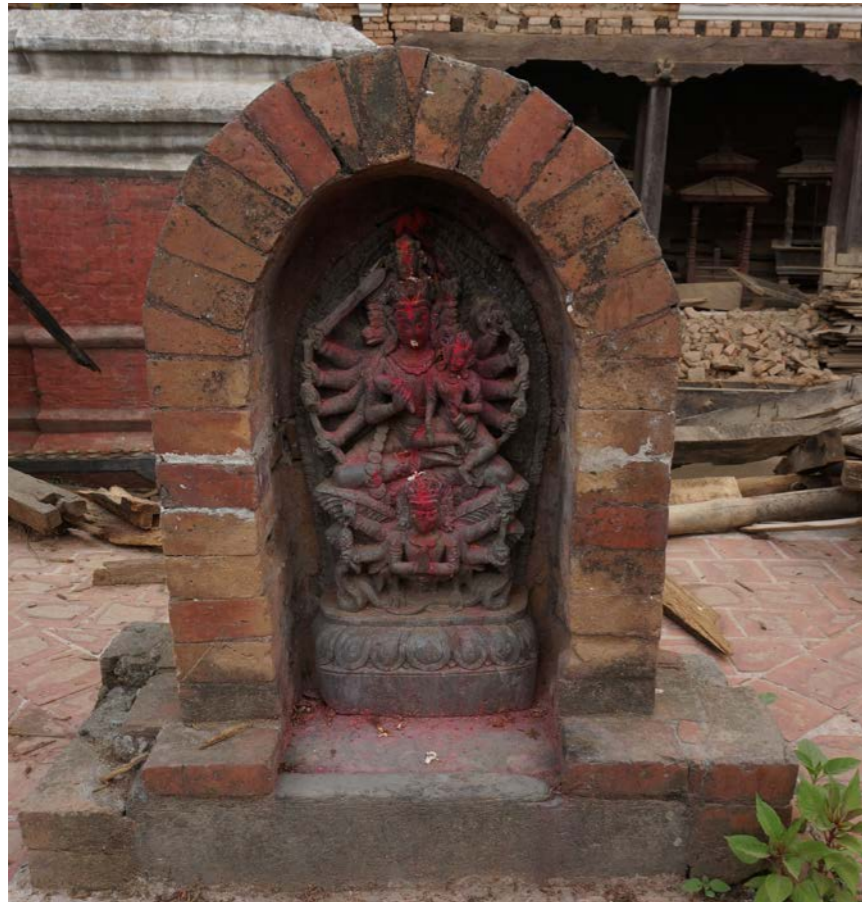
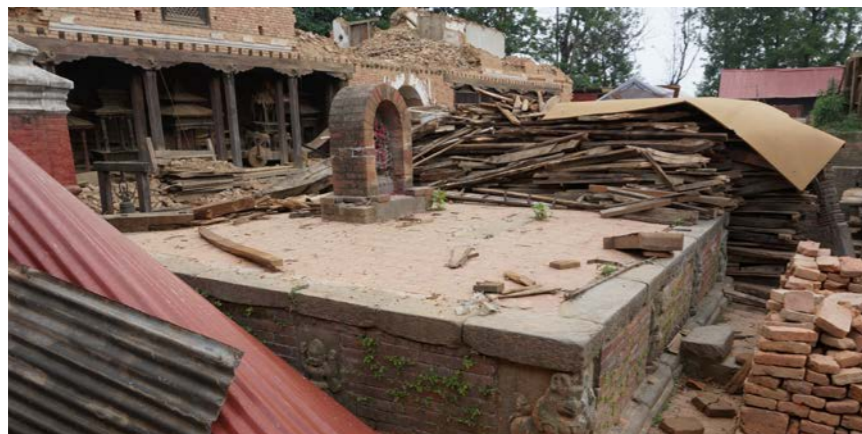
28 SHRINE OF LAXMI NARAYAN

NUMBER	NAME	DATE A.D.	TYPOLOGY	GENERAL DESCRIPTION	DESCRIPTION OF DAMAGE	DANGER
28	Laxmi Narayan		Open Shrine	Temple platform with a Laxmi-Narayan statue with a brick and stone enclosure	North side of sculpture base is broken	
29	Shiva Temple		Temple	Brick structure with a lime plastered roof	Dome has small hole on South side Plaster coming off on E and N side Gajur is missing

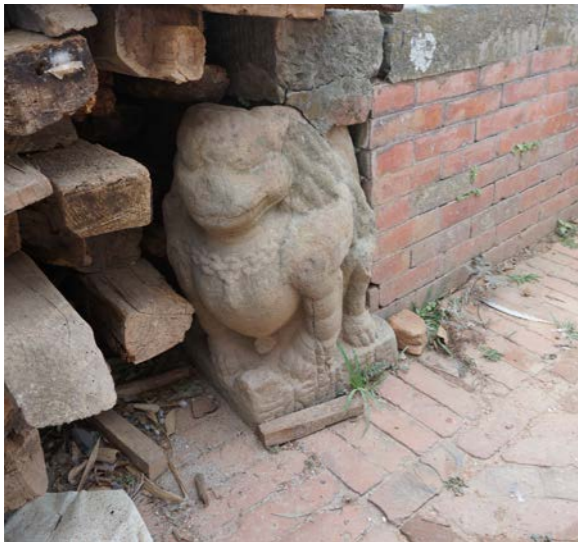
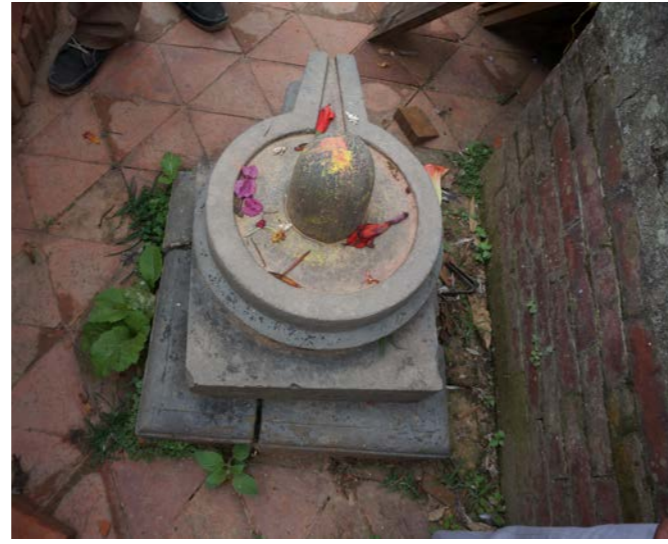
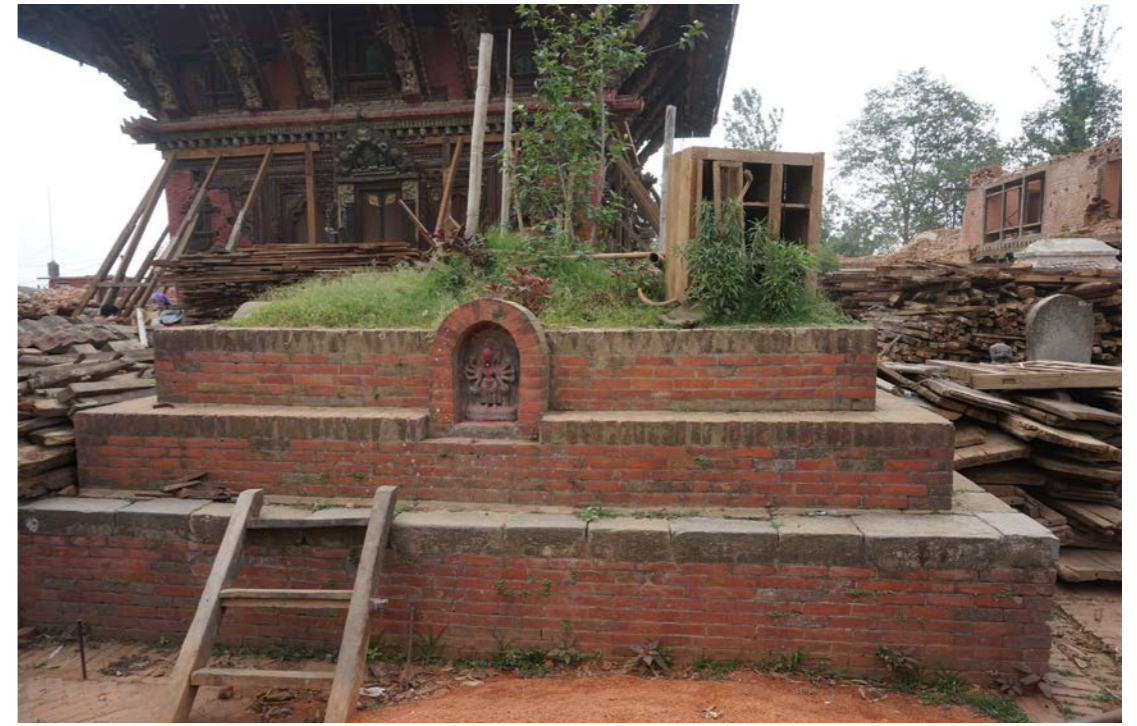
30 PLATFORM WITH IDOLS

NUMBER	NAME	DATE A.D.	TPOLOGY	GENERAL DESCRIPTION	DESCRIPTION OF DAMAGE	DANGER
30			Open Shrine	Shrine of Garud Narayan with stone and brick base Shiva Linga present at the West	Vegetation on top of platform Garud Narayan sculpture base is slightly broken Some portion of wing of Garud is damaged The top of Garuda's head is damaged

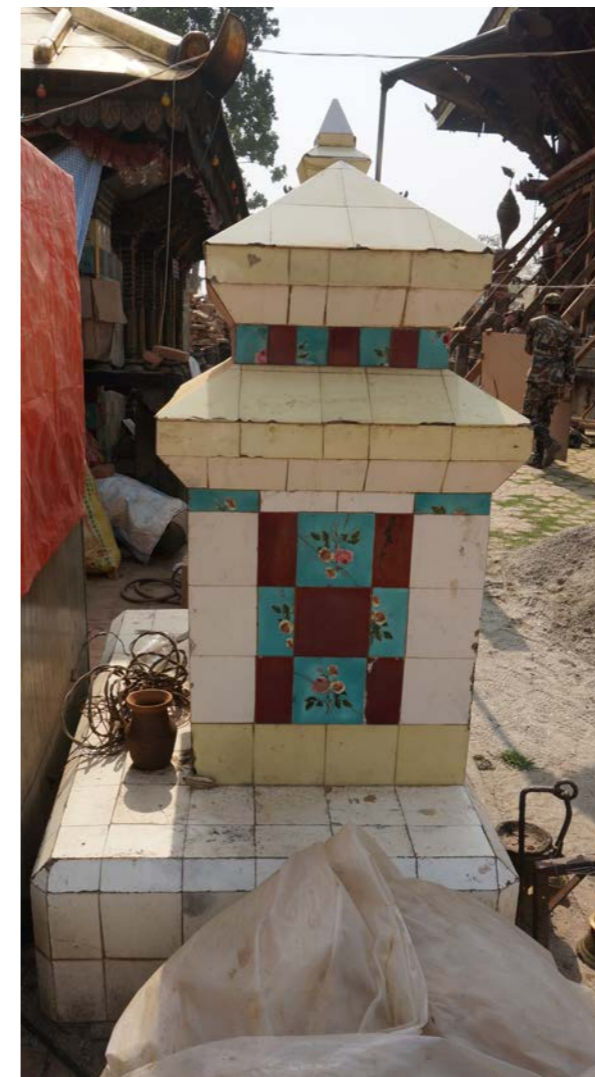
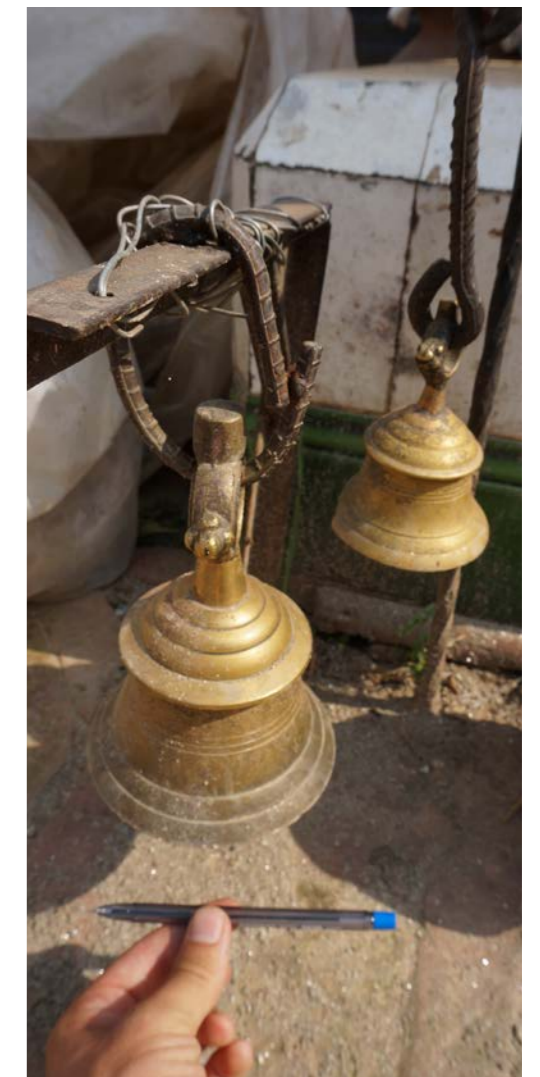
31 GANESH SHRINE

NUMBER	NAME	DATE A.D.	TYPOLOGY	GENERAL DESCRIPTION	DESCRIPTION OF DAMAGE	DANGER
31	<i>Ganesh</i>		Open Shrine	Ganesh shrine with ceramic tiled façade. Two small bells, a stone oil lamp and a jalahari are installed in front of it.	No major damage Some cracks on tile joint
