2015 Earthquake Damage Mapping
Changunarayan Monument Zone
Kathmandu Valley World Heritage Property

November 2015

This assessment was supported by
UNESCO Office in Kathmandu

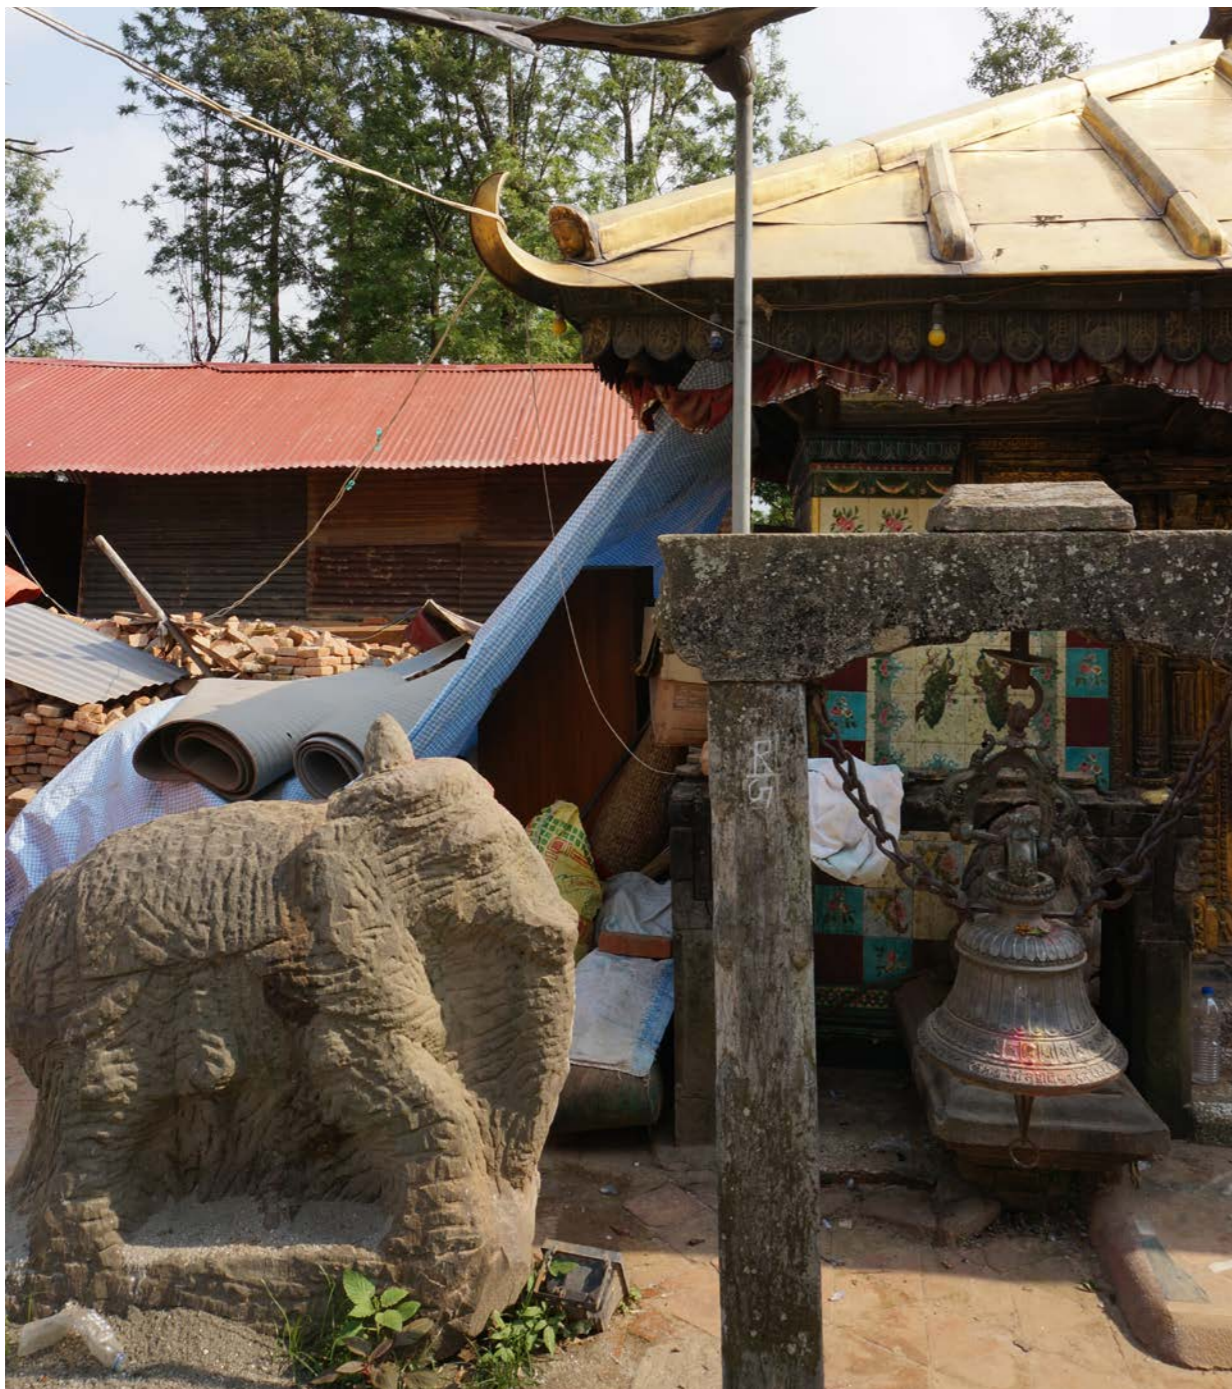
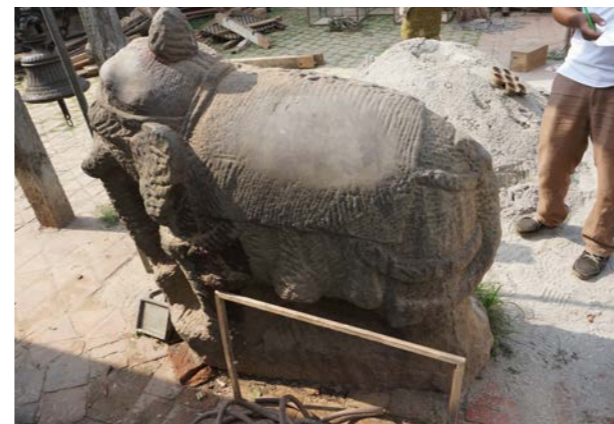
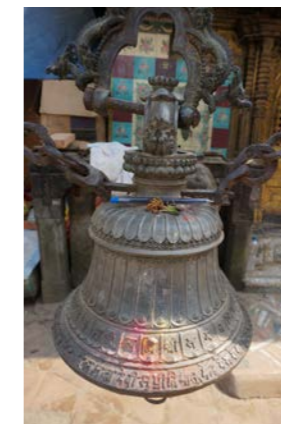
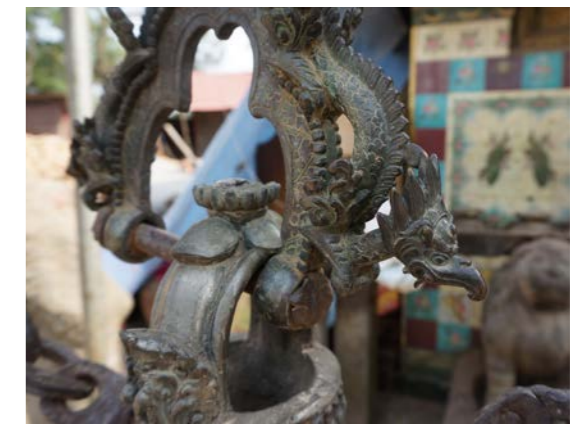
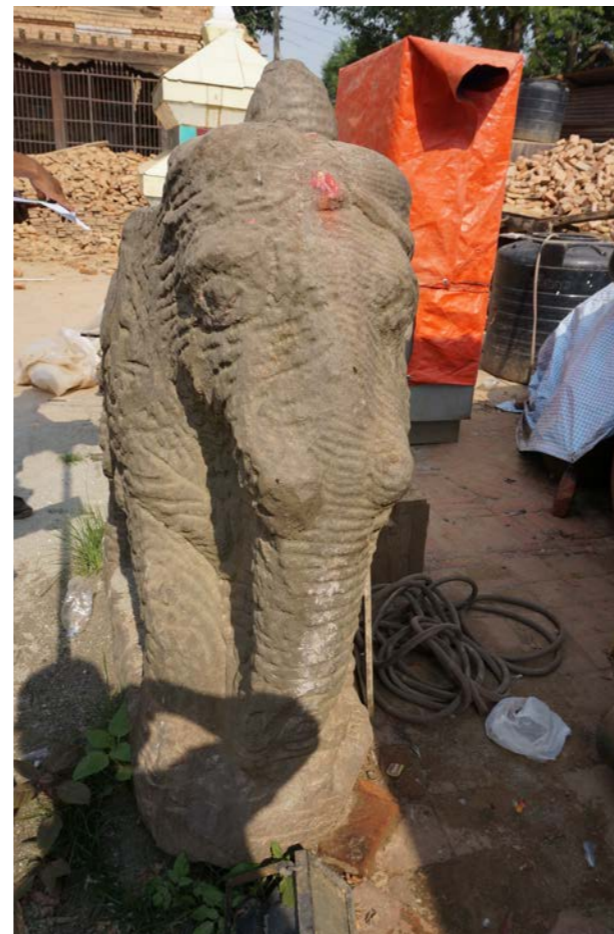
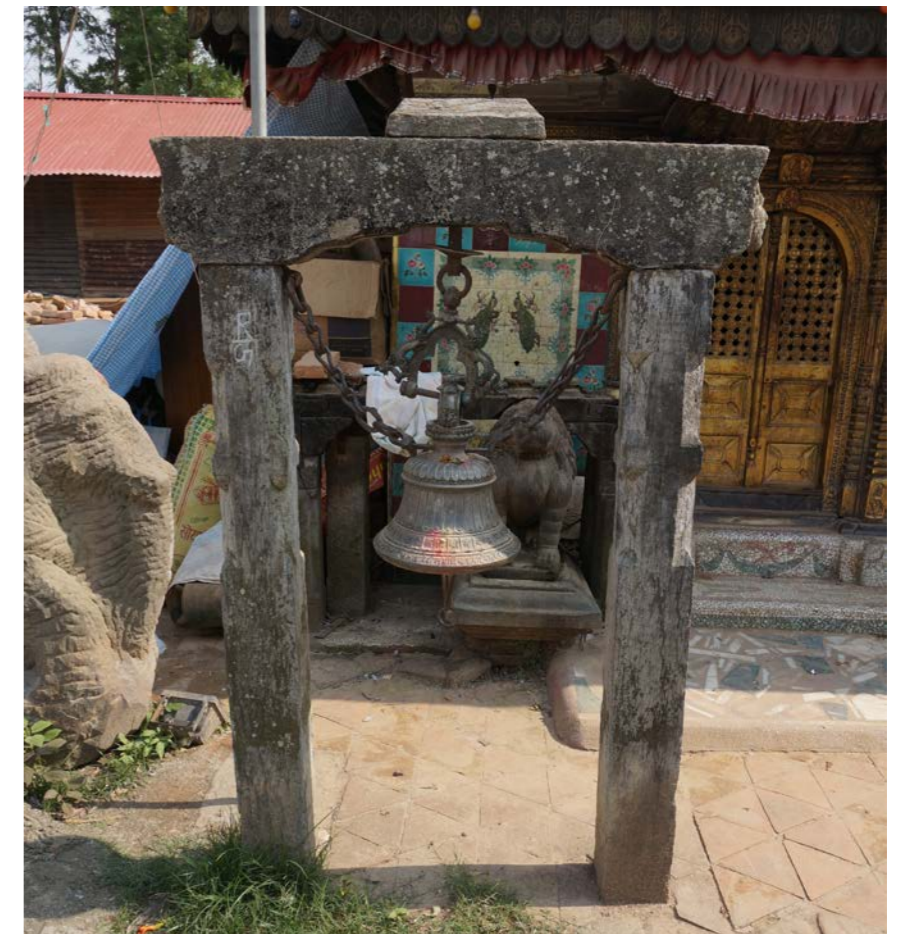
32 ELEPHANT SCULPTURE

NUMBER	NAME	DATE A.D.	TYOLOGY	GENERAL DESCRIPTION	DESCRIPTION OF DAMAGE	DANGER
32			Elephant sculpture	Stone elephant with unfinished carvings	No visible damage	
33			Stone frame bell	Stone structure with bronze bell	No visible damage

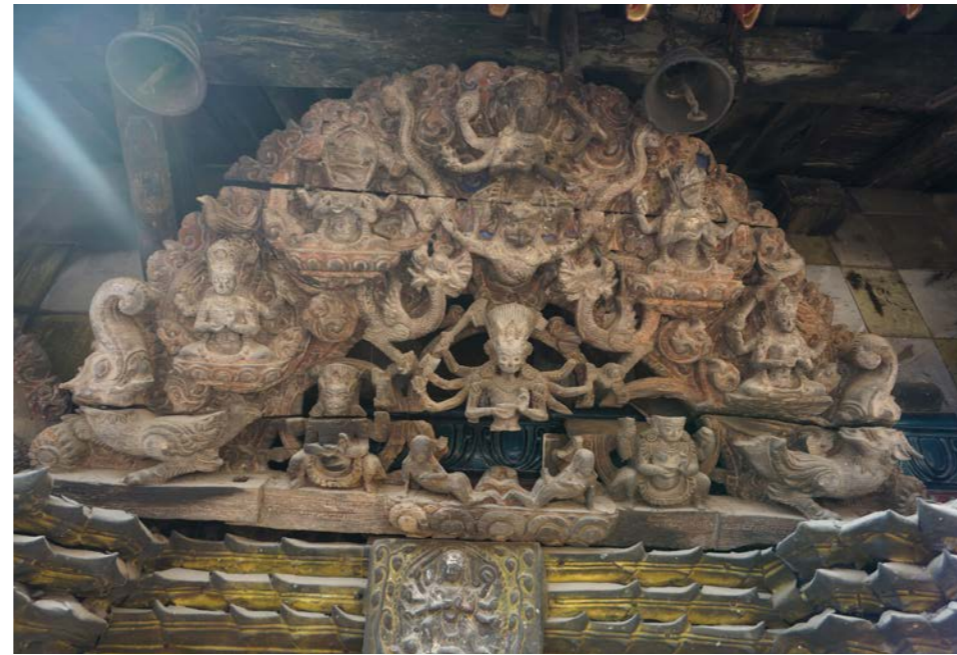
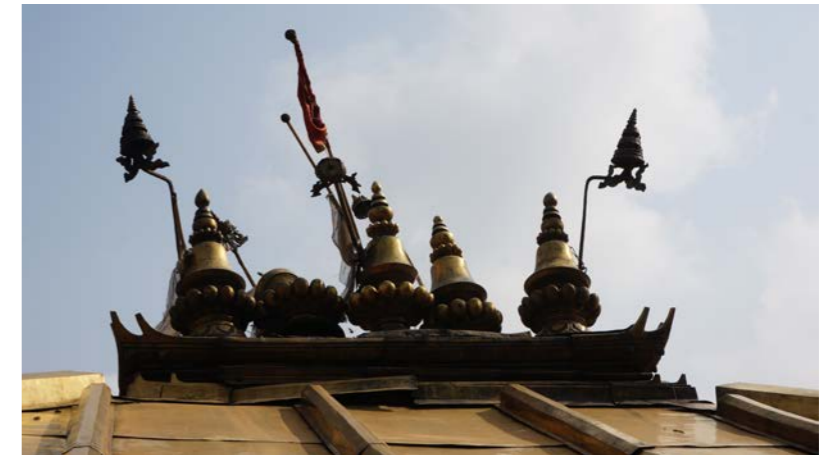
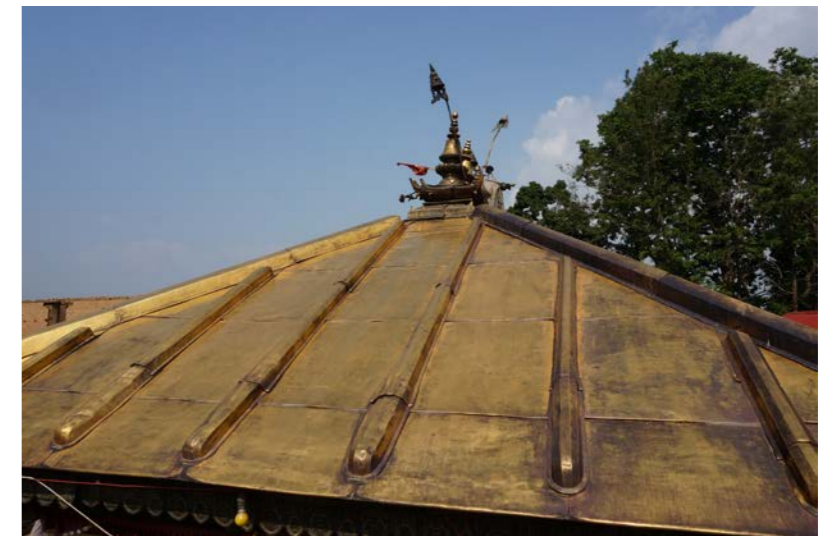
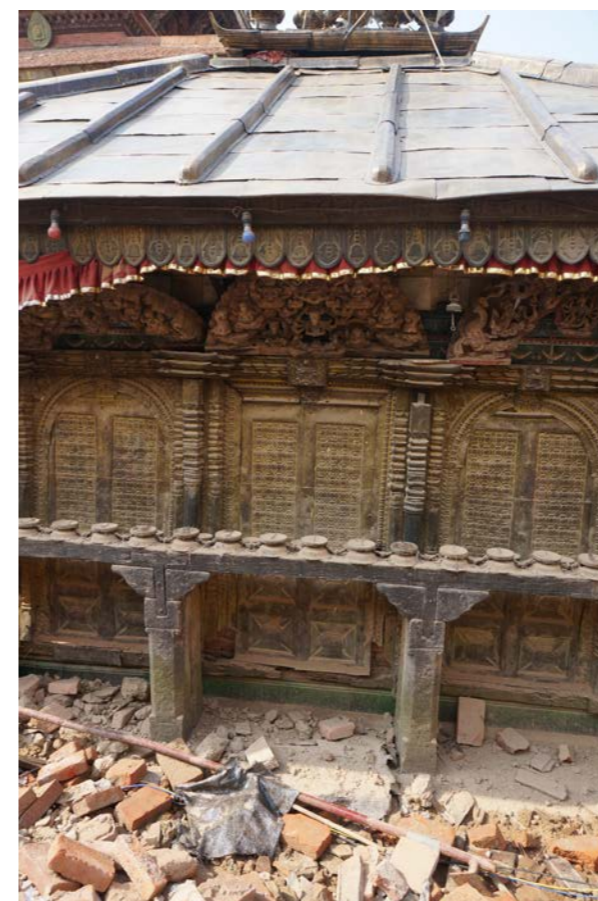
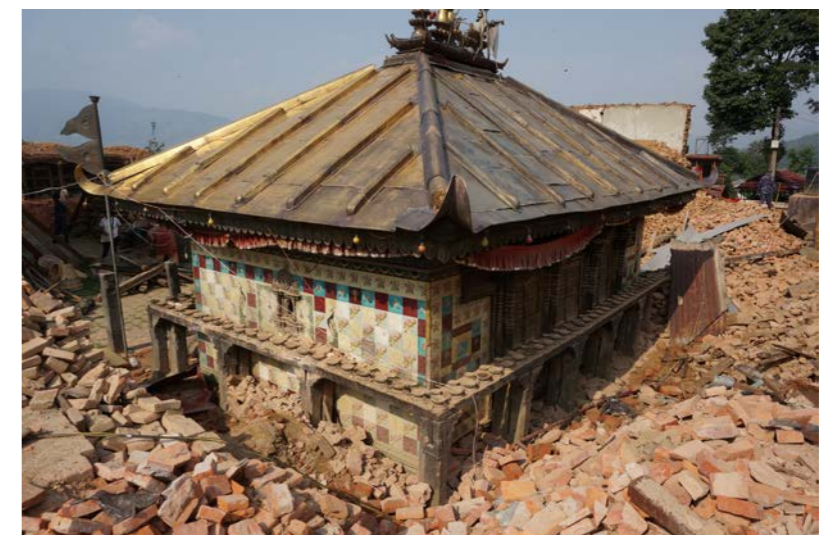
34 CHINNAMASTA TEMPLE

NUMBER	NAME	DATE A.D.	TYPOLOGY	GENERAL DESCRIPTION	DESCRIPTION OF DAMAGE	DANGER
34	Chinnamasta Temple		One-tiered pagoda temple	Rectangular shaped temple with tile and mosaic finish and gilded doors, roof and 5 gajurs.	2nd gajur from left is tilted back The flag pole on the left is bent 90 degrees. The flag (<i>dhwoja</i>) on the right is missing its finial. The N-W corner has some cracks. The lower part of the North door is damaged and parts of its lintels shifted. The toran has missing parts in the lower center.

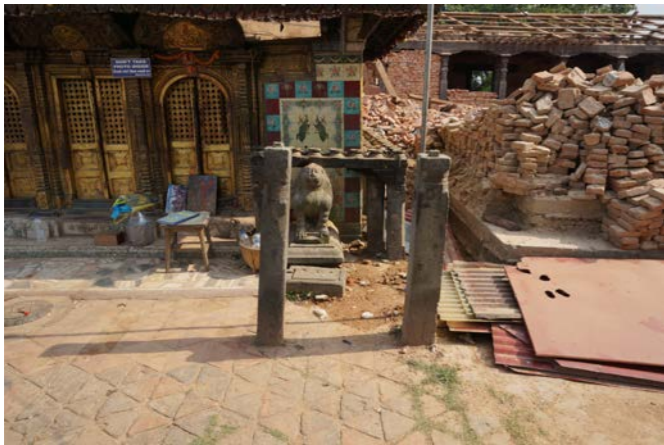
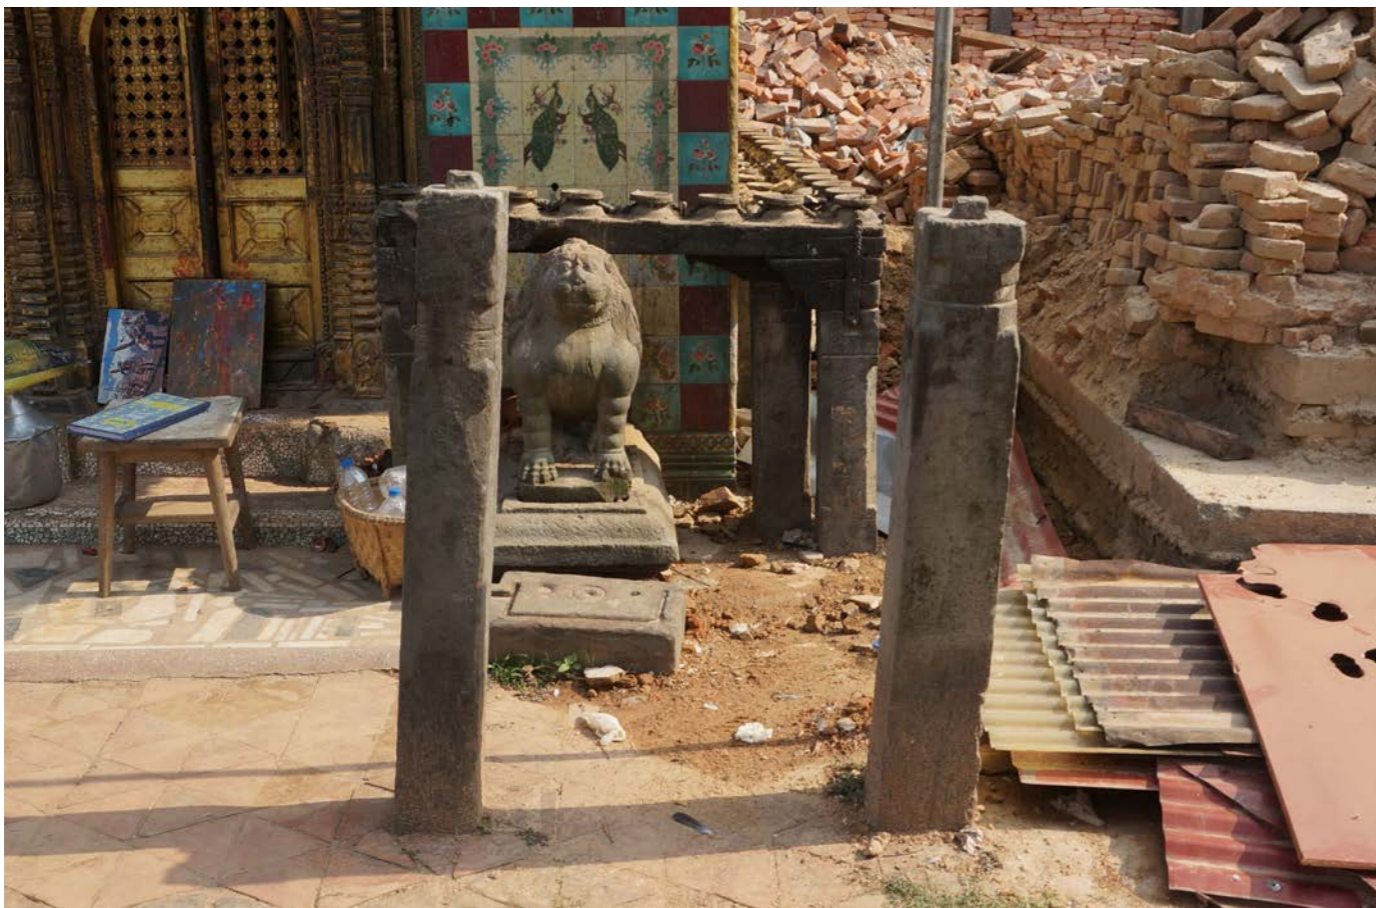
35 STONE FRAMED BELL

NUMBER	NAME	DATE A.D.	TPOLOGY	GENERAL DESCRIPTION	DESCRIPTION OF DAMAGE	DANGER
35			Stone framed bell	Stone structure	Only two posts remain, top part of the frame and the bell are missing The post at right is slightly tilted.	
36			Shiva Temple		Totally collapsed

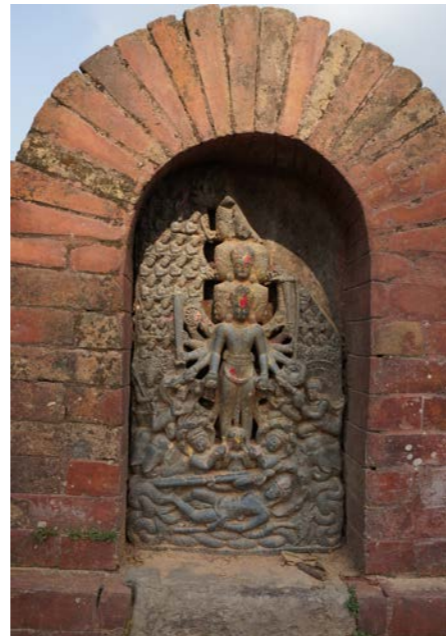
37 VISHWOROOP SHRINE

NUMBER	NAME	DATE A.D.	TPOLOGY	GENERAL DESCRIPTION	DESCRIPTION OF DAMAGE	DANGER
37	Vishworoop		Open Shrine	Brick enclosed Vishnu statue resting on the platform of a former temple.	Sculpture of Vishnu was damaged before the earthquake. Many bricks and images/elements are kept on top of it, threatening the main sculpture.	
38	Vishnu Temple		Temple	Statues of Baman Awatar and Narsingh resting on the lower platform of a former temple.	The statues are undamaged but the brick arch above Narsingh collapsed.

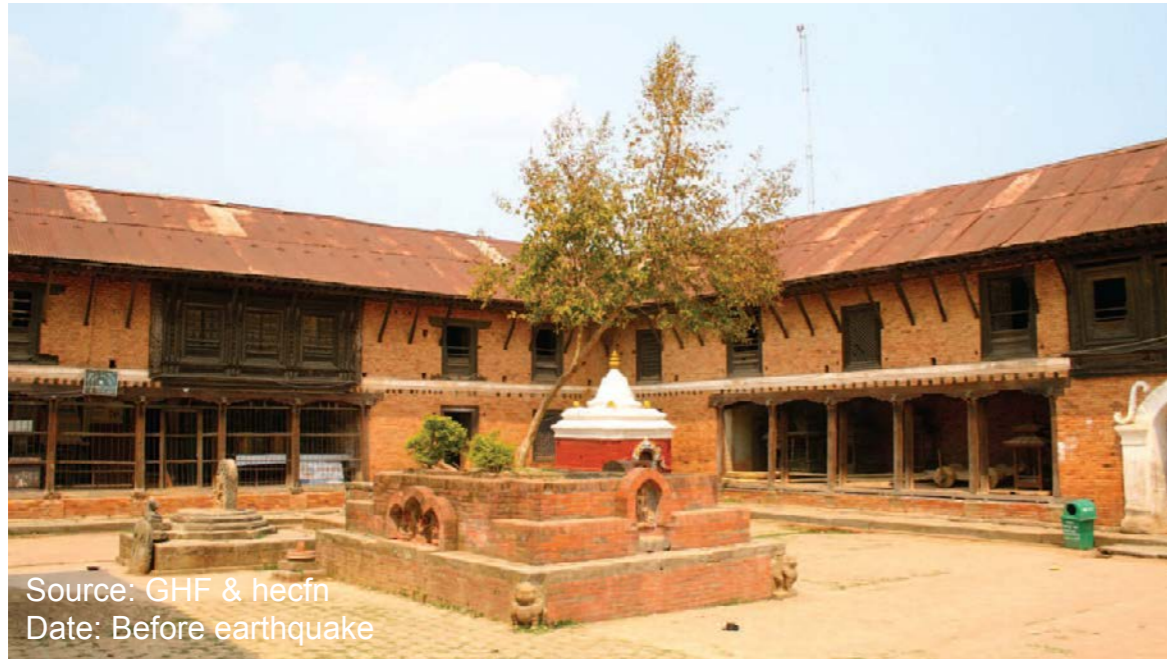
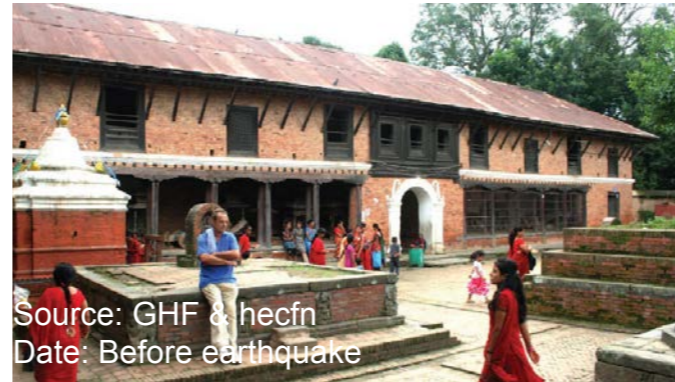
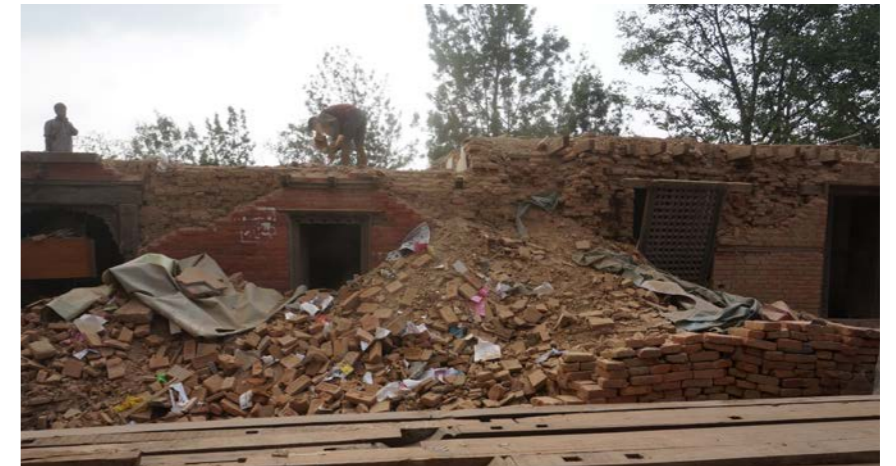
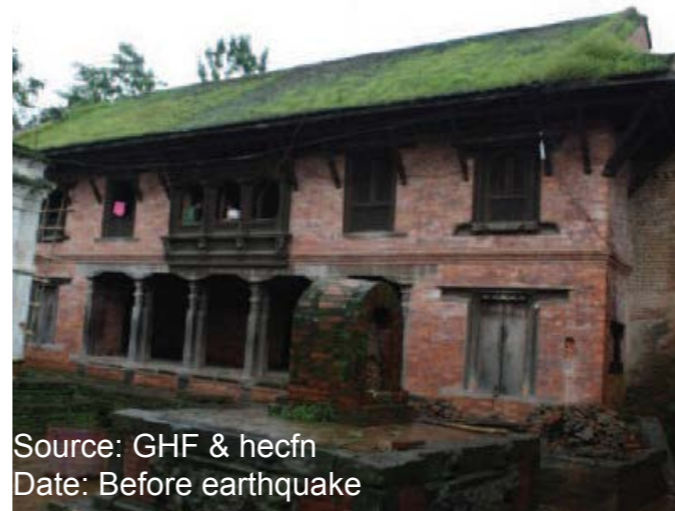
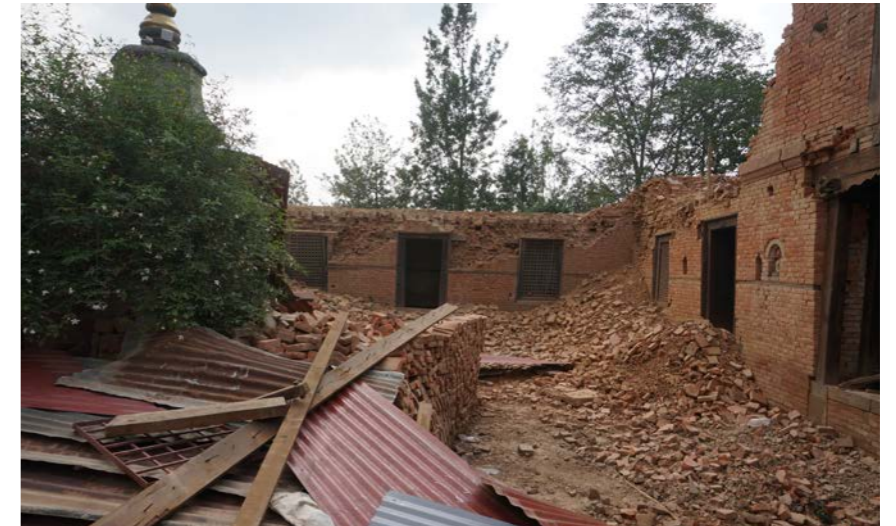
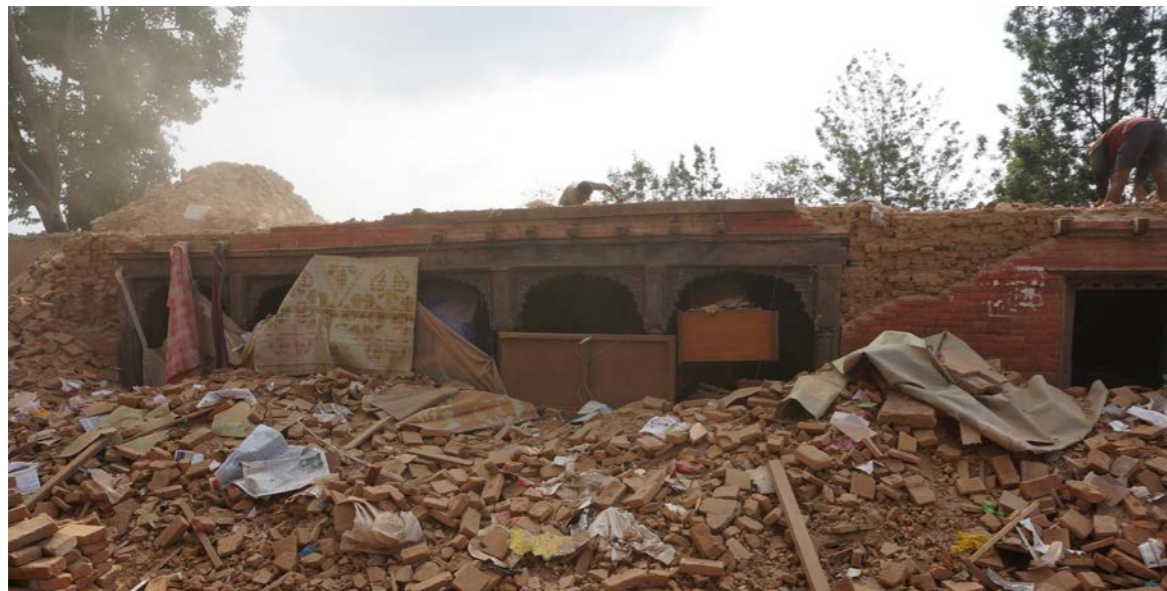
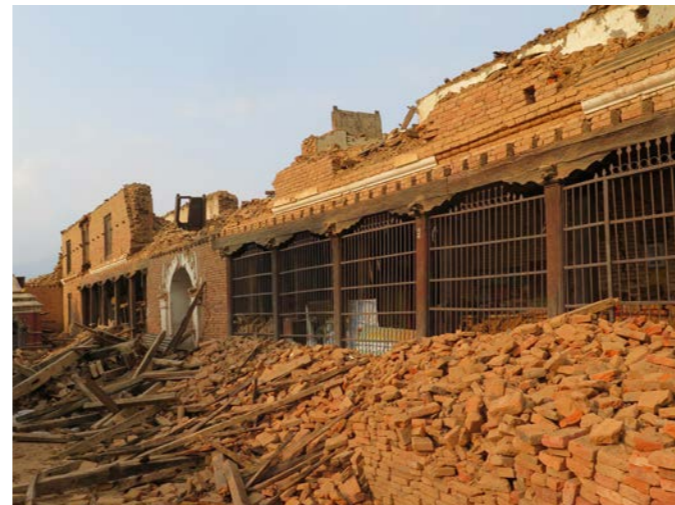
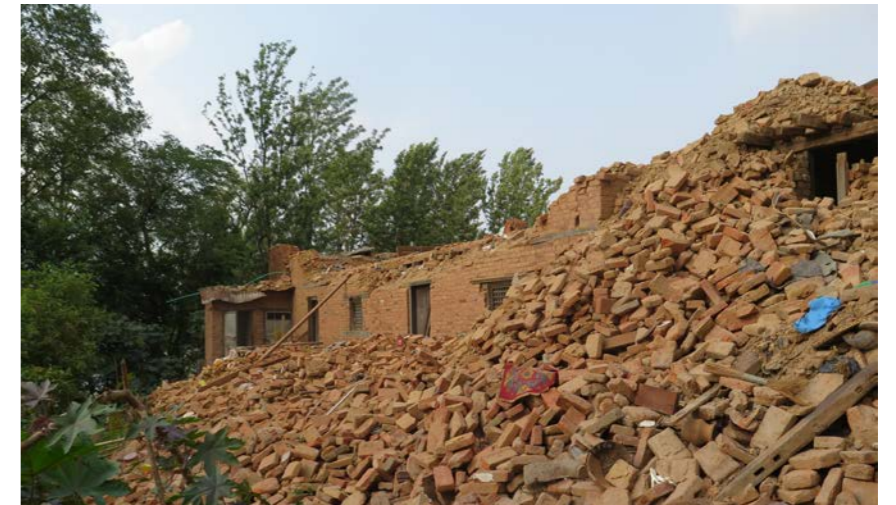
39 REST HOUSES (SATTAL)

NUMBER	NAME	DATE A.D.	TYPOLGY	GENERAL DESCRIPTION	DESCRIPTION OF DAMAGE	DANGER
39			<i>Sattal</i>	<i>Sattal</i> dwelled by priest families of Changunarayan	Upper parts are completely damaged and remaining parts are being demolished.

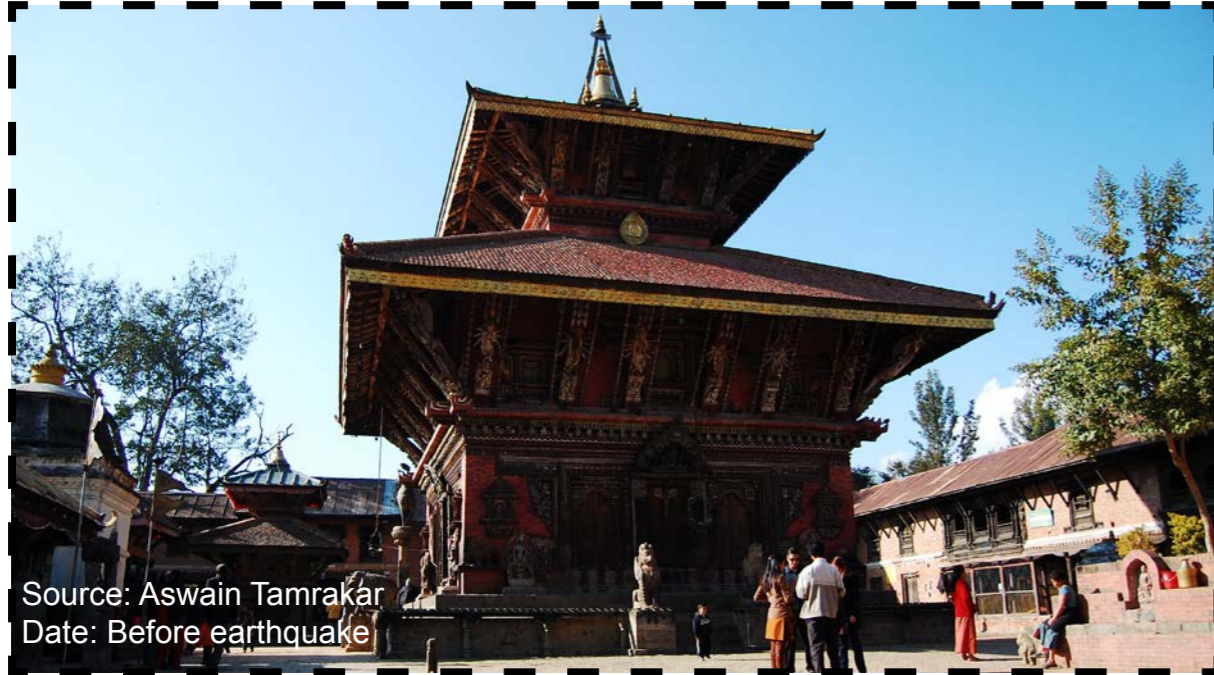
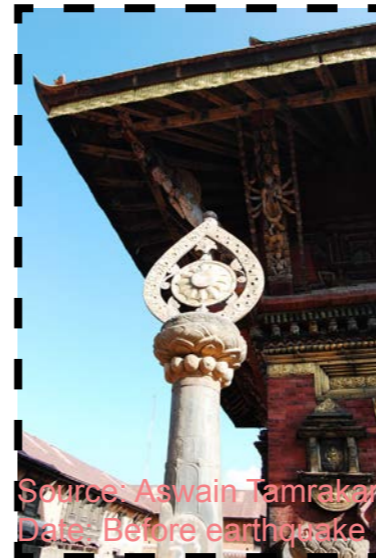
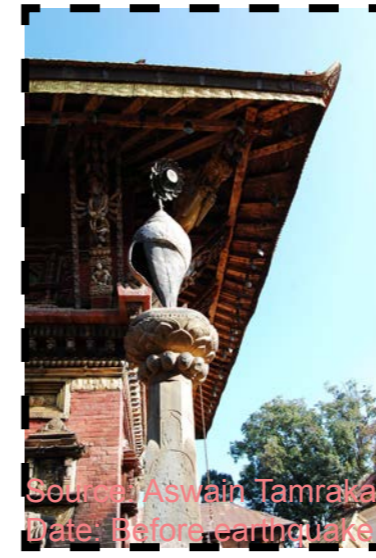
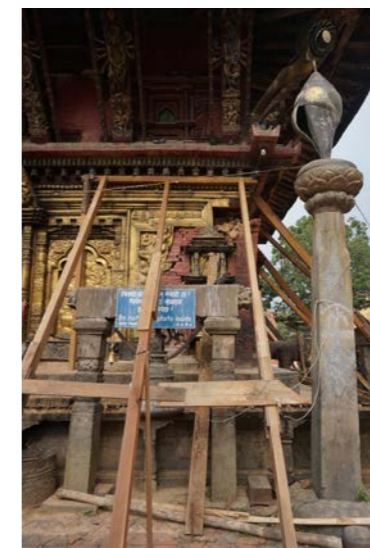
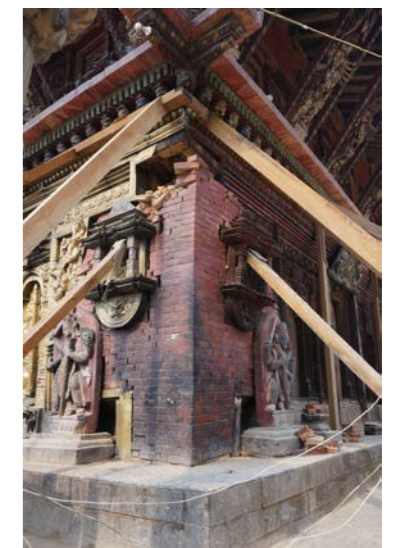
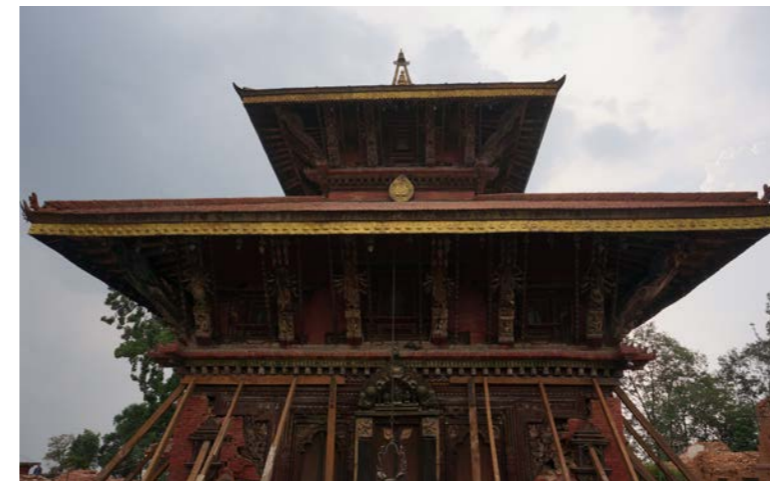
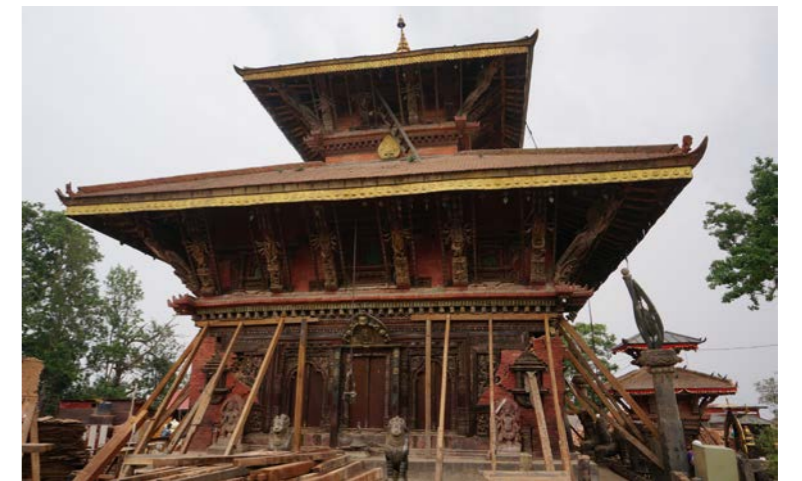
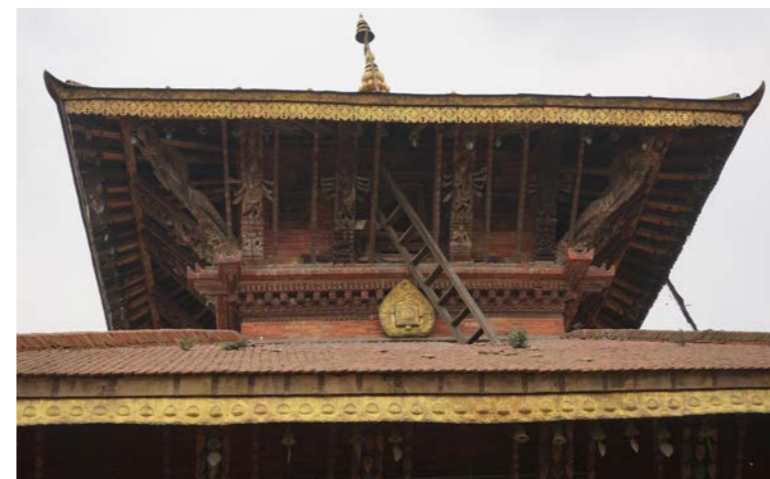
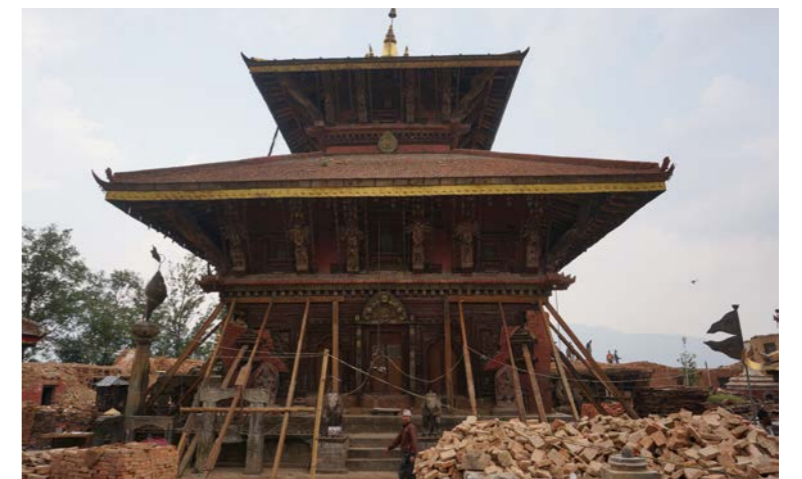
40 CHANGU NARAYAN TEMPLE

NUMBER	NAME	DATE A.D.	TYPOLOGY	GENERAL DESCRIPTION	DESCRIPTION OF DAMAGE	DANGER
40	Changu Narayan Temple		2 tiered Pagoda Temple	Pagoda temple constructed with dachi apa on outer façade and multiple inner walls in uncooked bricks Gilt metal roof	Corner cracks on all façades - most critical on W side (nearly in a state of collapsing). Stepped cracks above entrance gate and between tundals. Corner walls heavily damaged, Plinth are in good condition. Wooden ladder has damaged the roof. Gajur is tilted

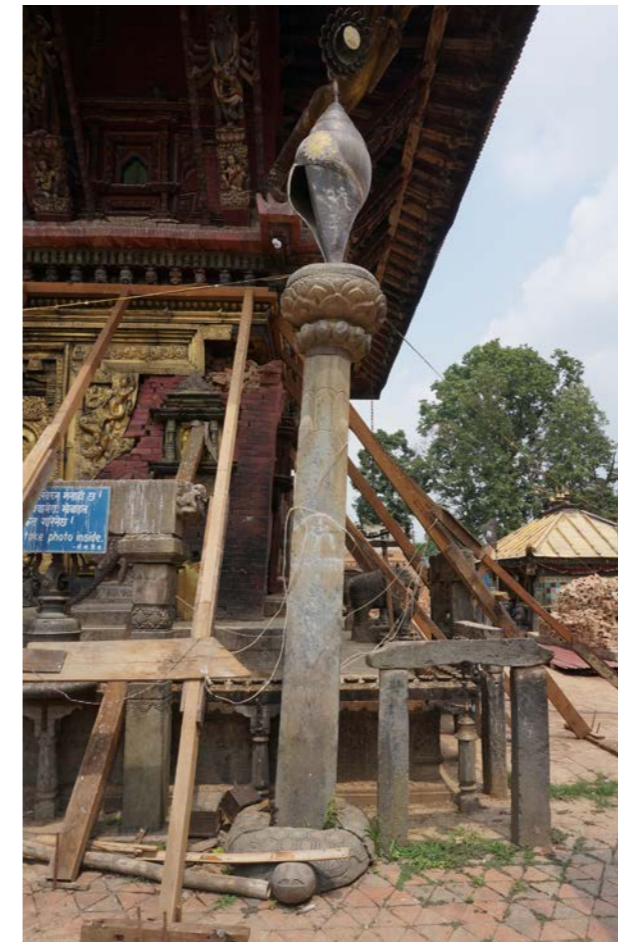
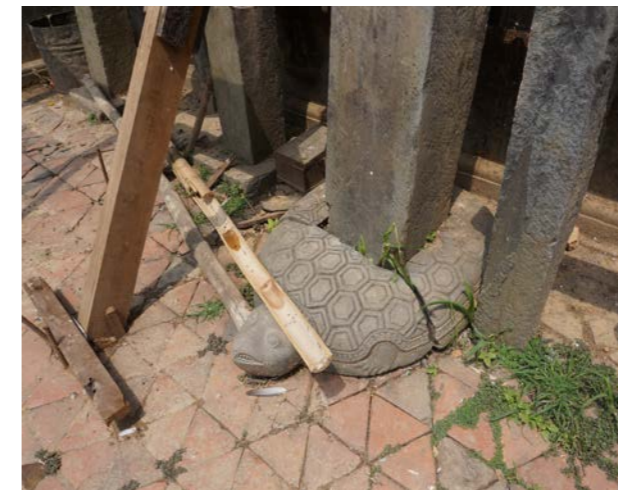
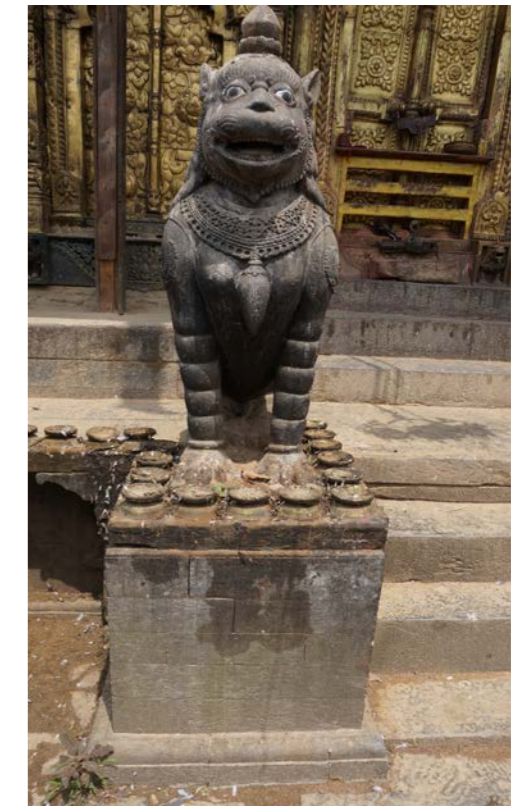
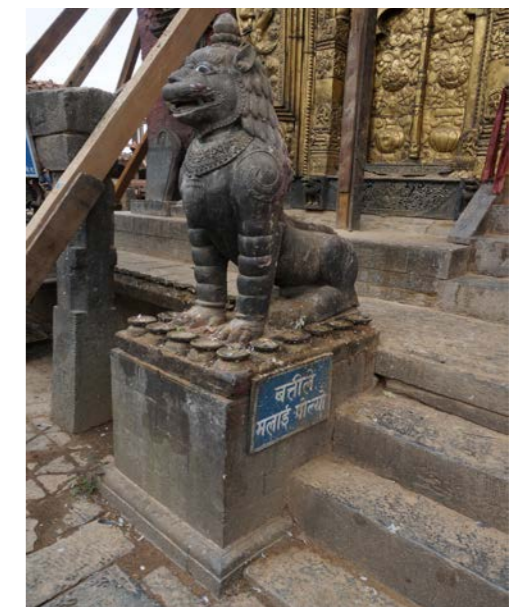
40 b STONE PILLAR 40 e LION STATUE

NUMBER	NAME	DATE A.D.	TPOLOGY	GENERAL DESCRIPTION	DESCRIPTION OF DAMAGE	ANGER
40 a			Stone framed bell	Stone frame with small bell	No major damages, Consolidated	
40 b			Stone pillar	Stone pillar on a turtle base supporting a stone lotus base and a metal conch	Tilting towards south. Cracked Stone turtle	
40 e			Statue of lion	Guardian Lions	Minor gap in the stone base No other damage

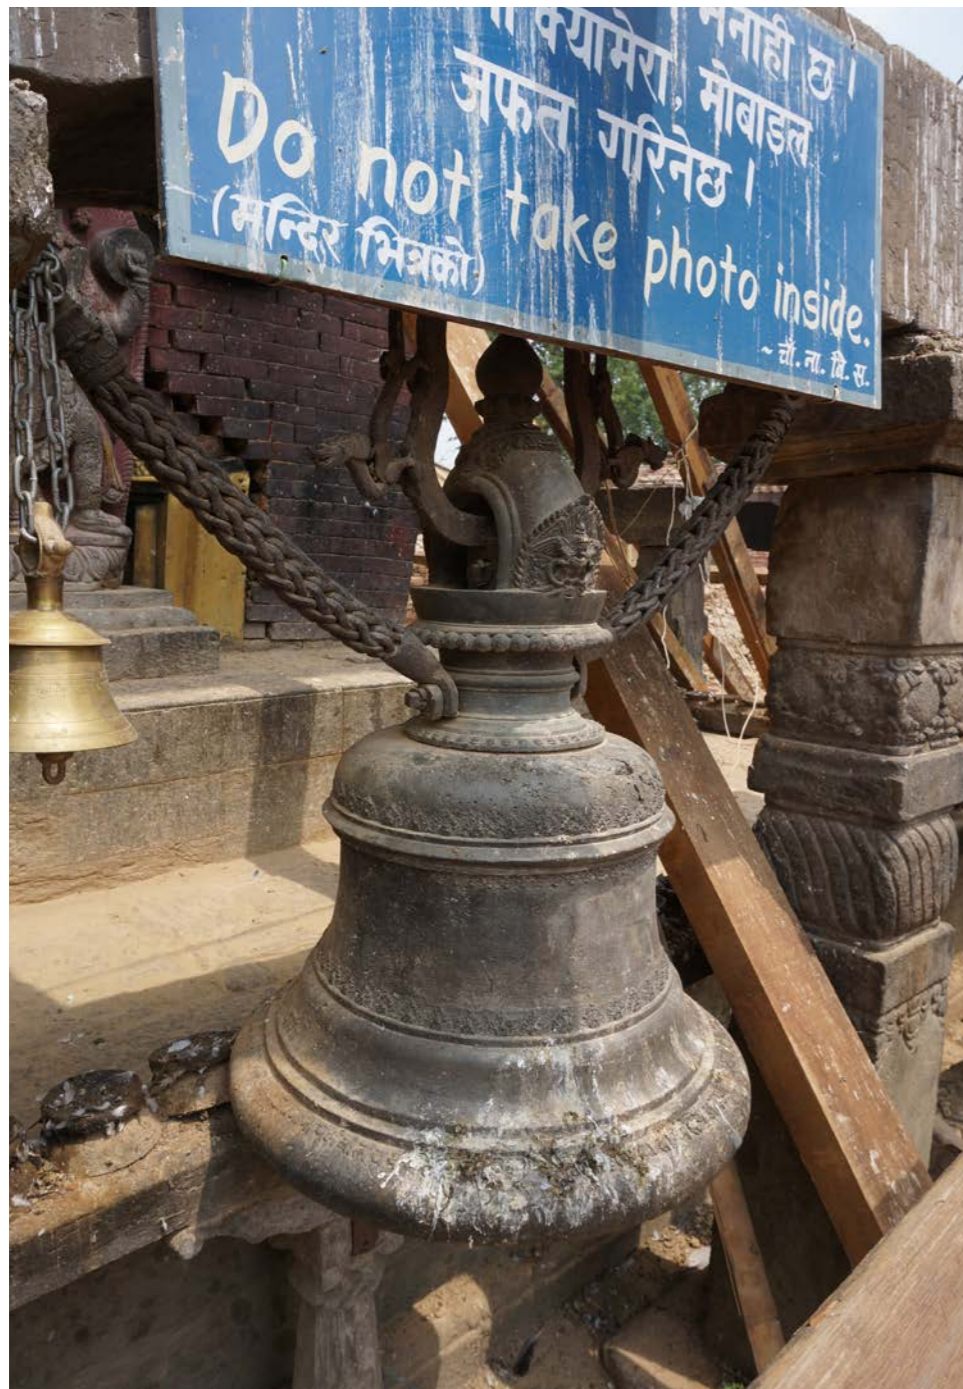
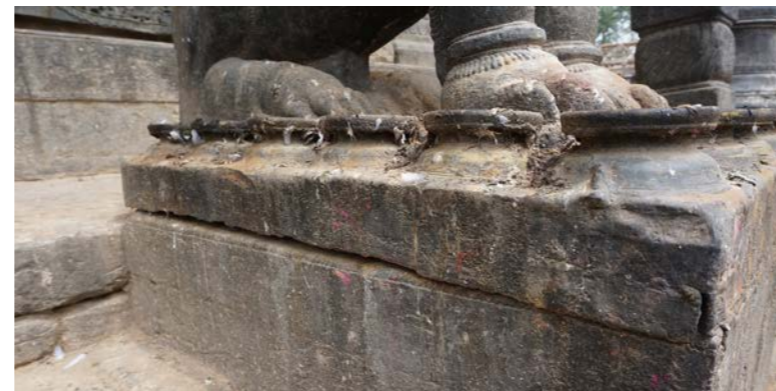
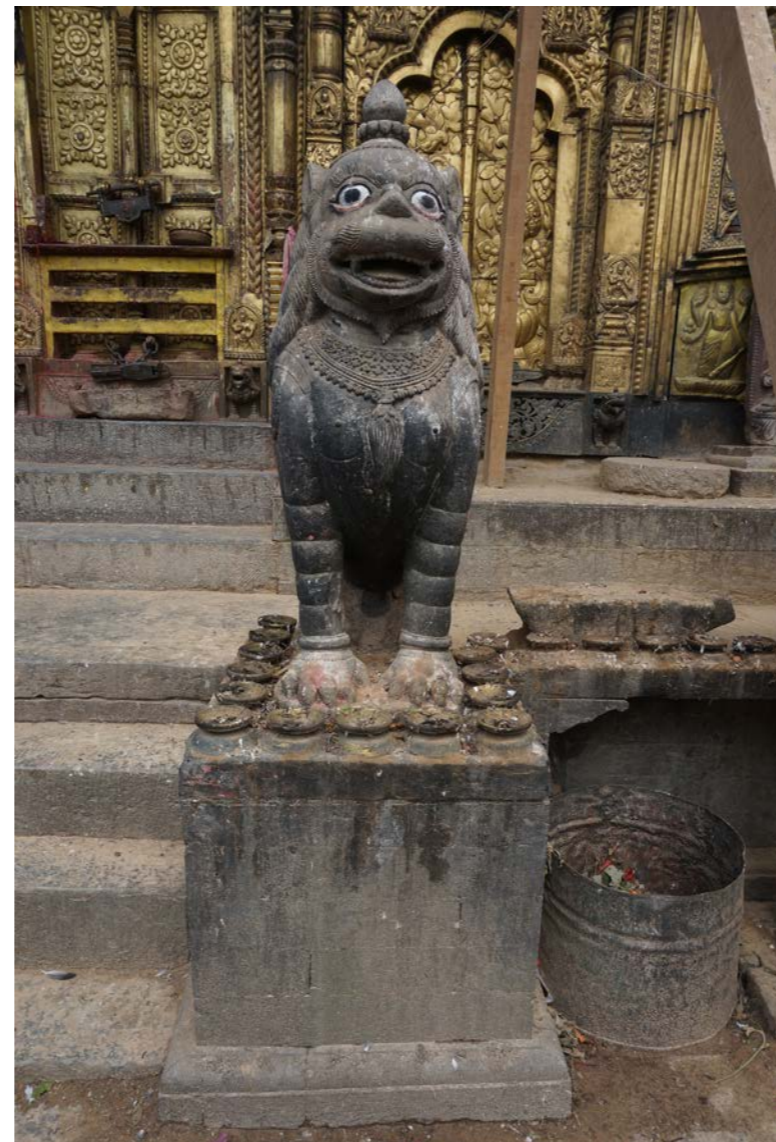
40 c STONE FRAMED BELL

NUMBER	NAME	DATE A.D.	TYPOLOGY	GENERAL DESCRIPTION	DESCRIPTION OF DAMAGE	DANGER
40 c	Stone framed bell		Stone Structure	Stone Structure	Cracked base of south post Upper part of the frame is not stable Entire Structure is tilted	
40 d	Statue of lion		Guardian Lions	Guardian Lions	Oil lamp base is slightly dislocated

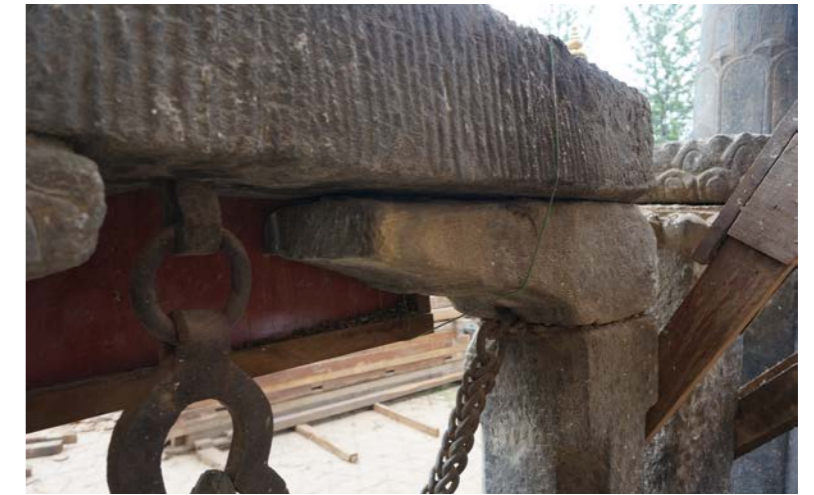
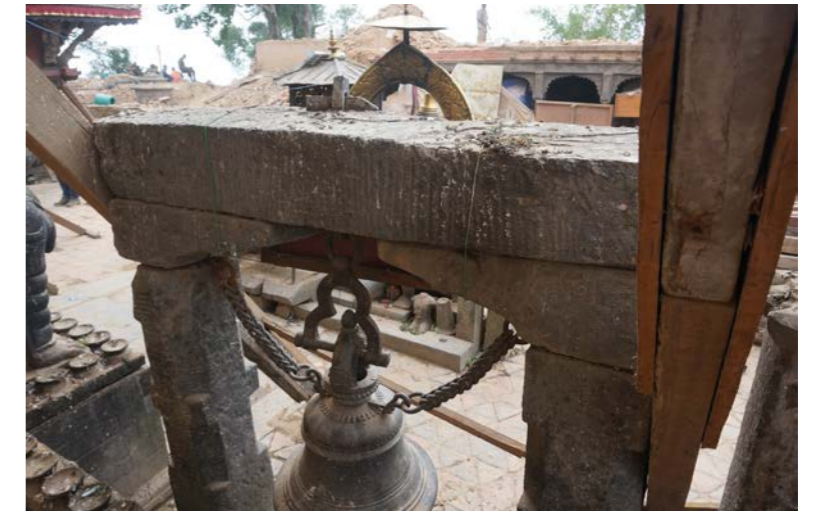
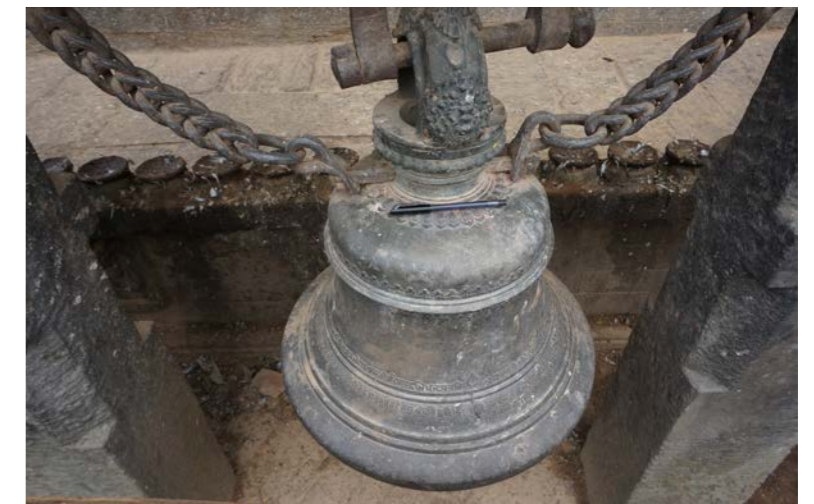
40 f STONE FRAMED BELL

NUMBER	NAME	DATE A.D.	TPOLOGY	GENERAL DESCRIPTION	DESCRIPTION OF DAMAGE	ANGER
40 f			Stone framed bell	Stone structure	Upper part of the frame is tilted

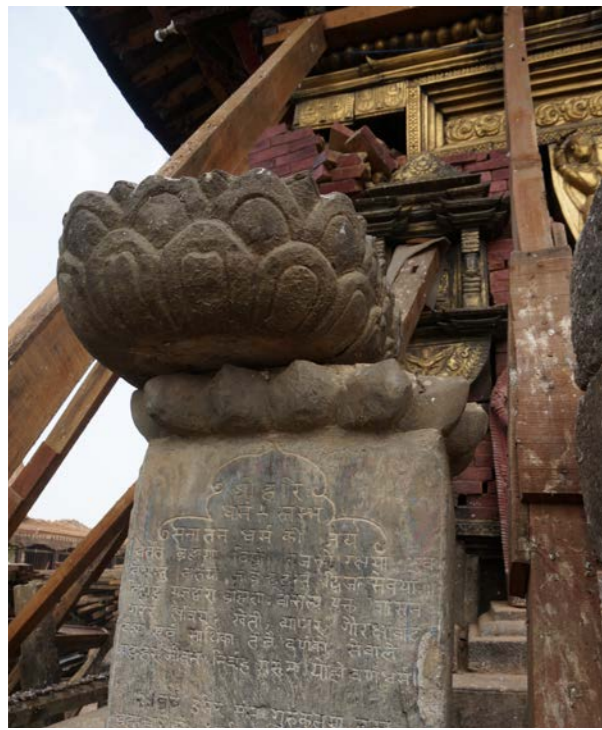
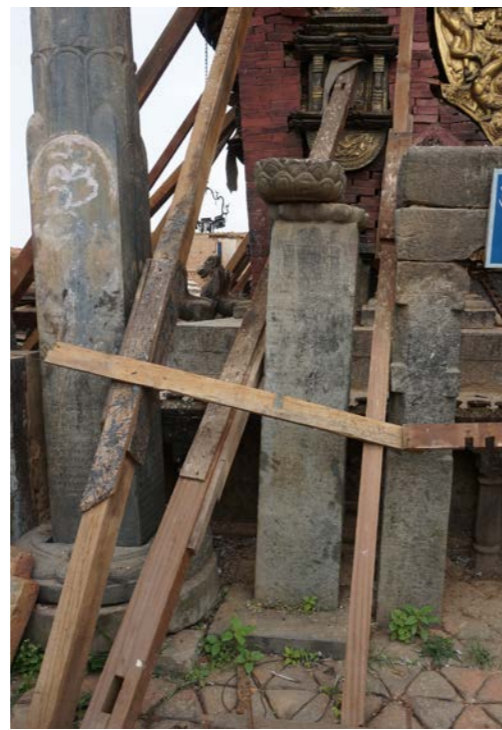
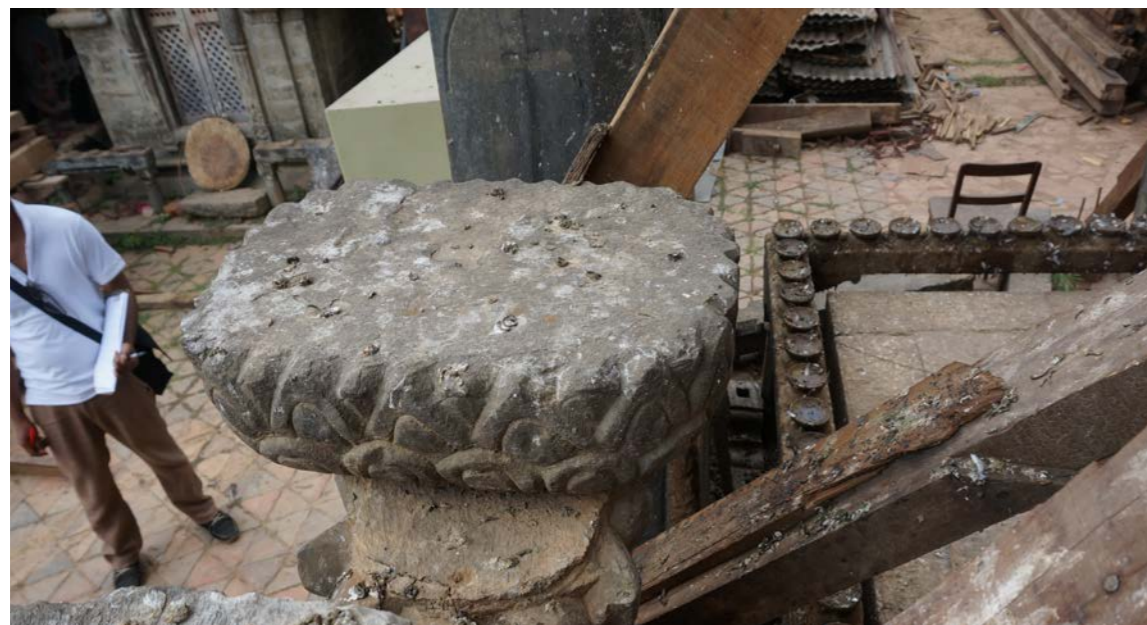
40 g STONE POST

NUMBER	NAME	DATE A.D.	TYPOLOGY	GENERAL DESCRIPTION	DESCRIPTION OF DAMAGE	DANGER
40 g			Stone Pillar	Stone post on a stone base Post has an ancient inscription	Post tilting towards south Lotus on top of post rotated 90 degree	
40 h			Stone Pillar	Stone Post on a stone serpent base there is a lotus structure on the top of the post with metal Chakra.	Tilted towards north east.
