2015 Earthquake Damage Mapping
Changunarayan Monument Zone
Kathmandu Valley World Heritage Property

November 2015

This assessment was supported by
UNESCO Office in Kathmandu

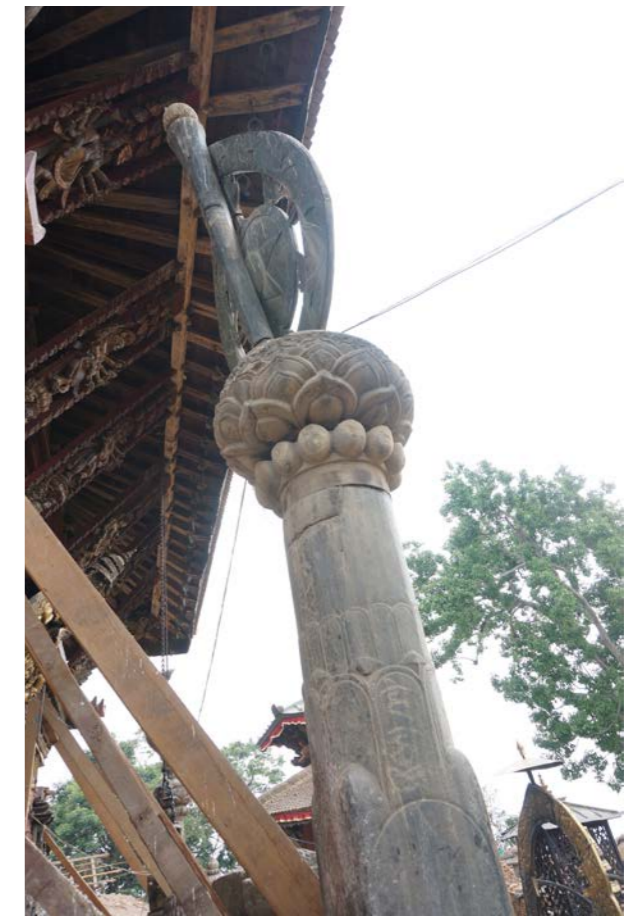
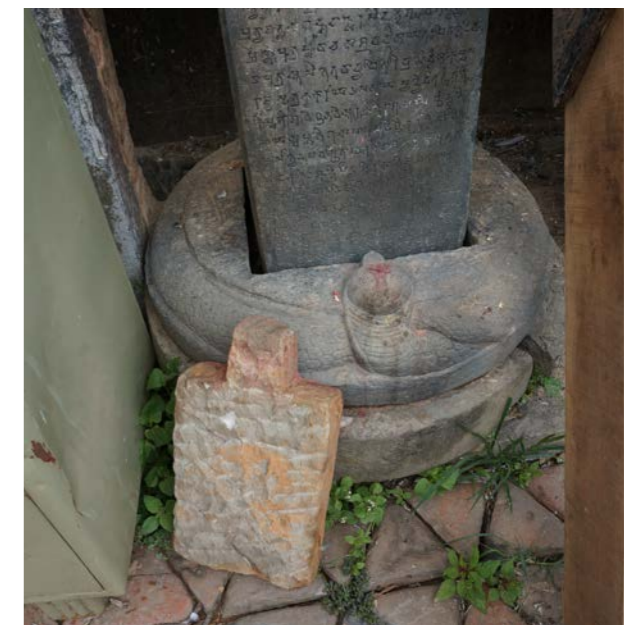
40 h STONE POST

NUMBER	NAME	DATE A.D.	TYPOLOGY	GENERAL DESCRIPTION	DESCRIPTION OF DAMAGE	DANGER
40 g			Stone Pillar	Stone post on a stone base Post has an ancient inscription	Post tilting towards south Lotus on top of post rotated 90 degree	
40 h			Stone Pillar	Stone Post on a stone serpent base there is a lotus structure on the top of the post with metal Chakra.	Tilted towards north east.

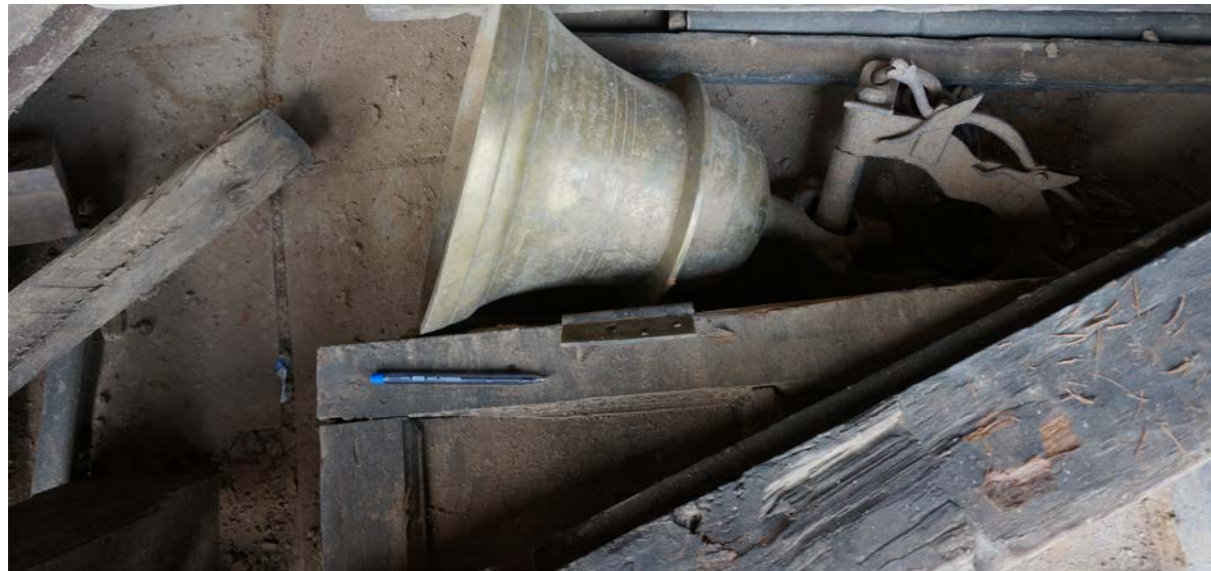
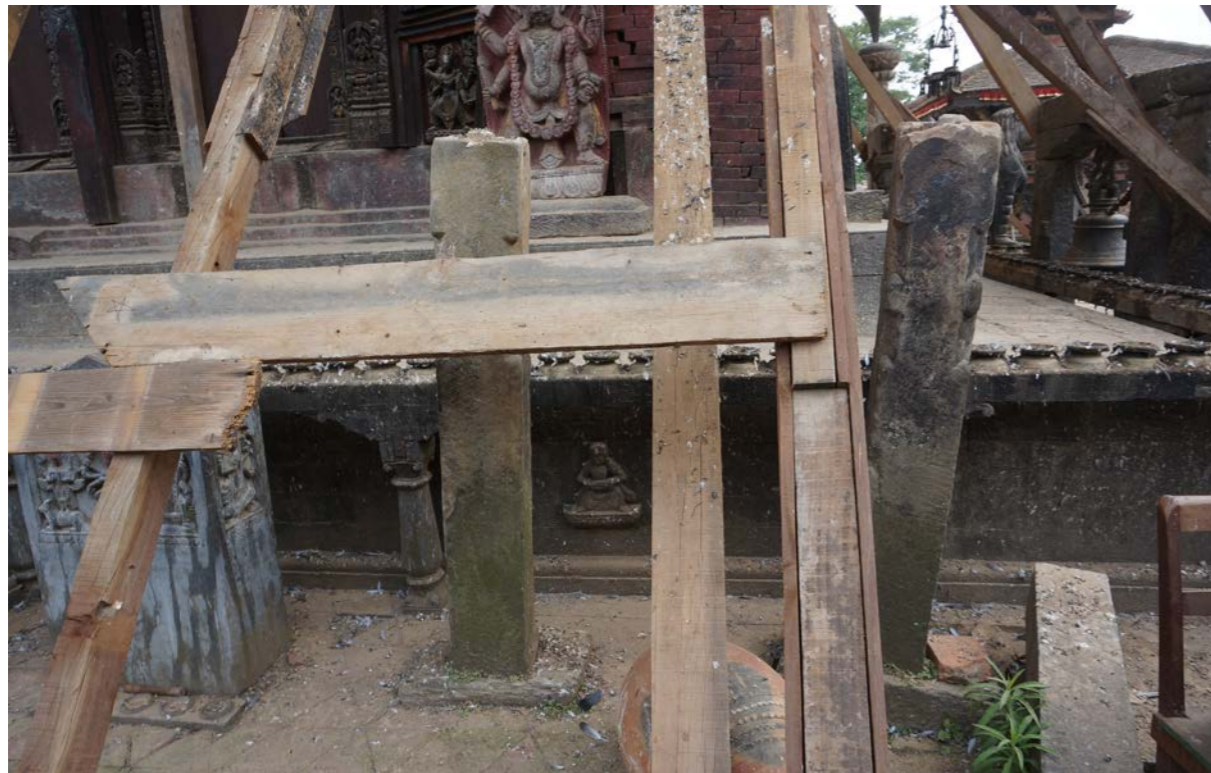
40 k STONE FRAMED BELL

NUMBER	NAME	DATE A.D.	TYPOLOGY	GENERAL DESCRIPTION	DESCRIPTION OF DAMAGE	DANGER
40k			Stone framed bell	Stone structure (Bells Stored by DoA)	Collapsed, stone post standing but tilted	
40 l			Stone In-scription	Stone stele with 3 carved images on the front, Ganesh to the east and Narayan to the west	Slightly tilted towards back

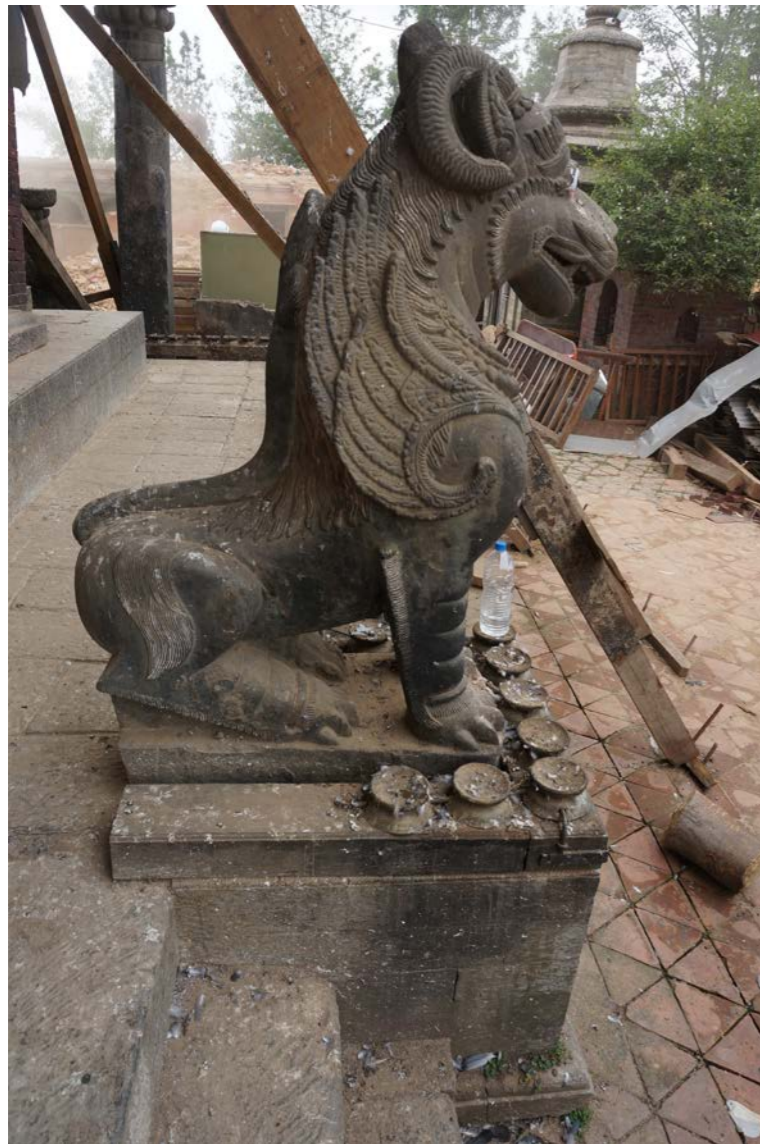
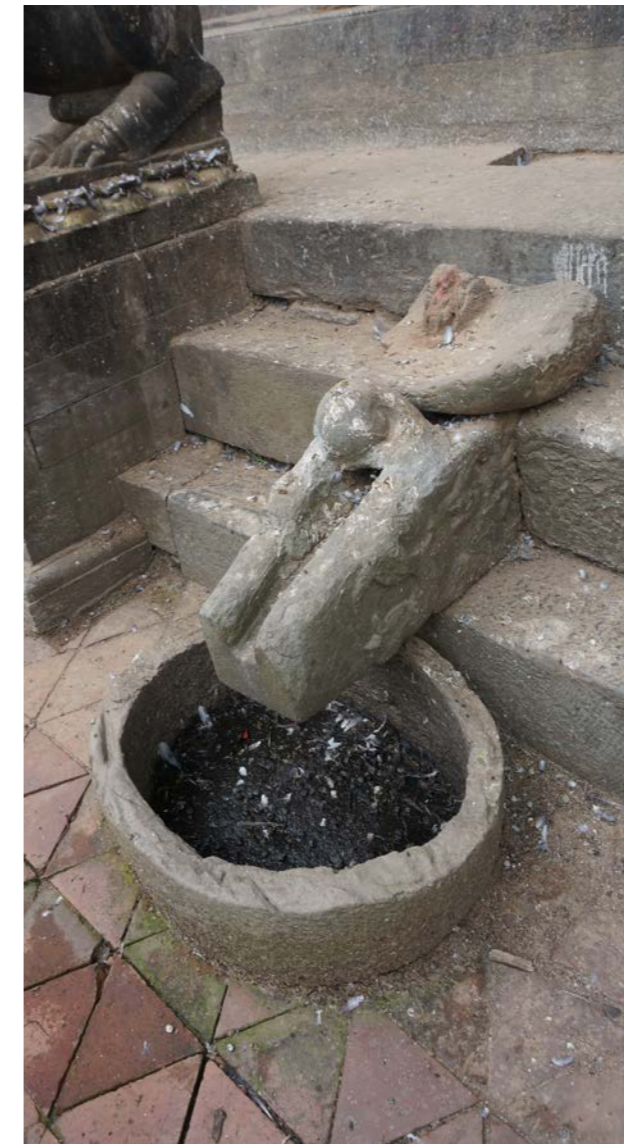
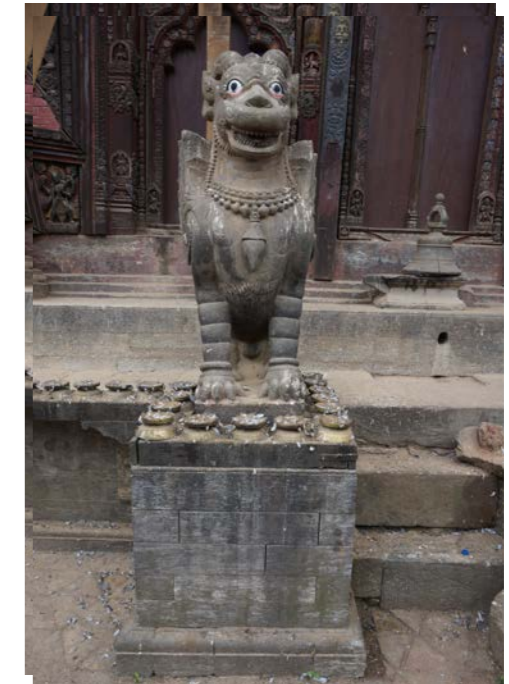
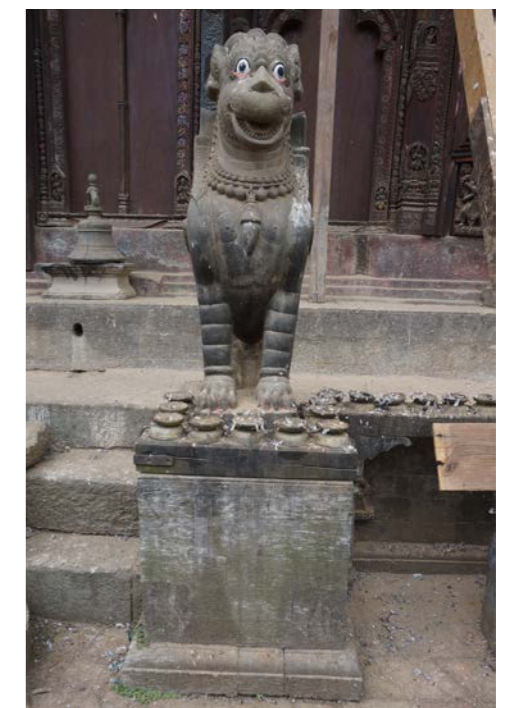
40 m STONE STATUE

NUMBER	NAME	DATE A.D.	TPOLOGY	GENERAL DESCRIPTION	DESCRIPTION OF DAMAGE	ANGER
40m			Stone statue		No visible Damage	
40n			Stone water spout	Stone statue with stone collecting bowl		
40o			Stone Statue		Small gaps between stones of the base, No other damages

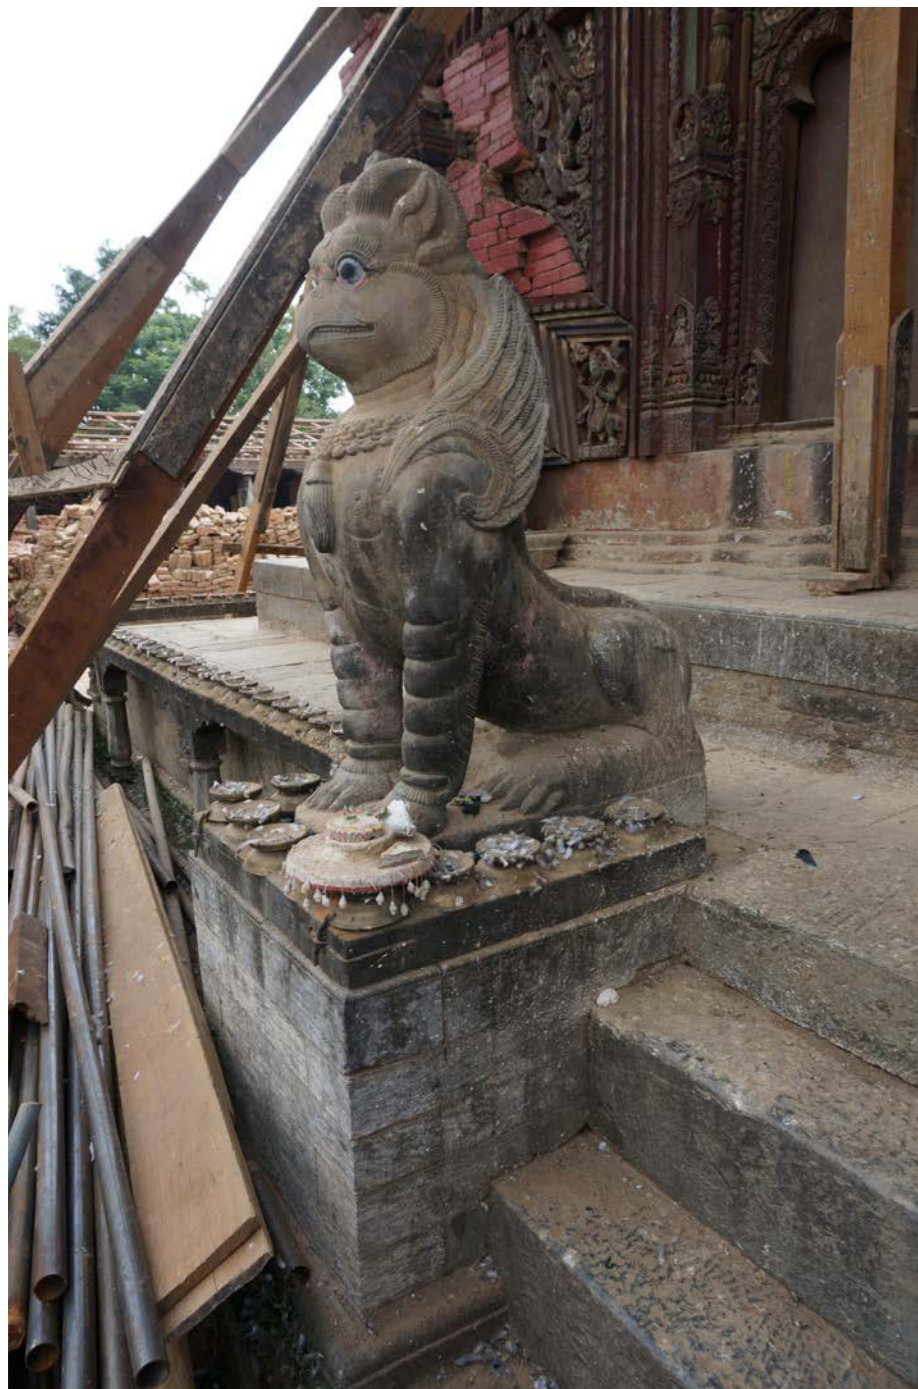
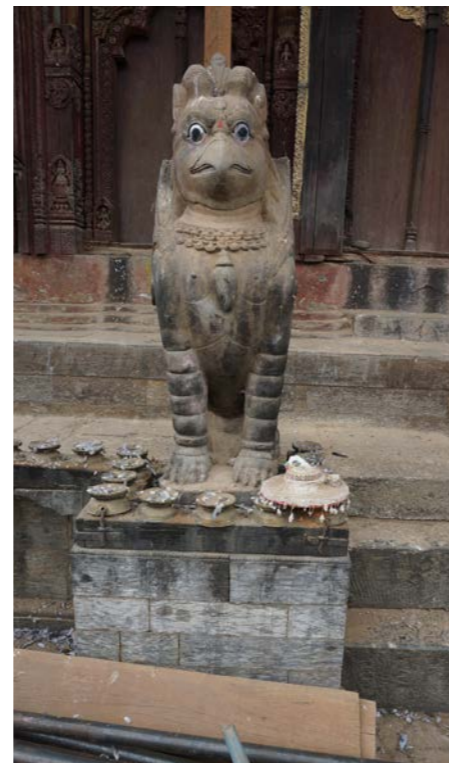
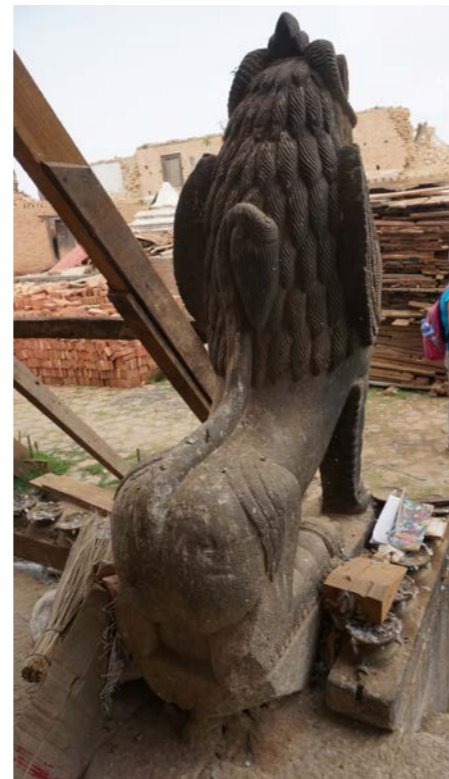
40 q STONE STATUE

NUMBER	NAME	DATE A.D.	TPOLOGY	GENERAL DESCRIPTION	DESCRIPTION OF DAMAGE	DANGER
40p			Stone Statue		No visible Damage	
40q			Stone Statue		No visible Damage	
40u			Stone framed bell	Stone structure about 4' tall	East post tilted. Metal consolidation done before earthquake.

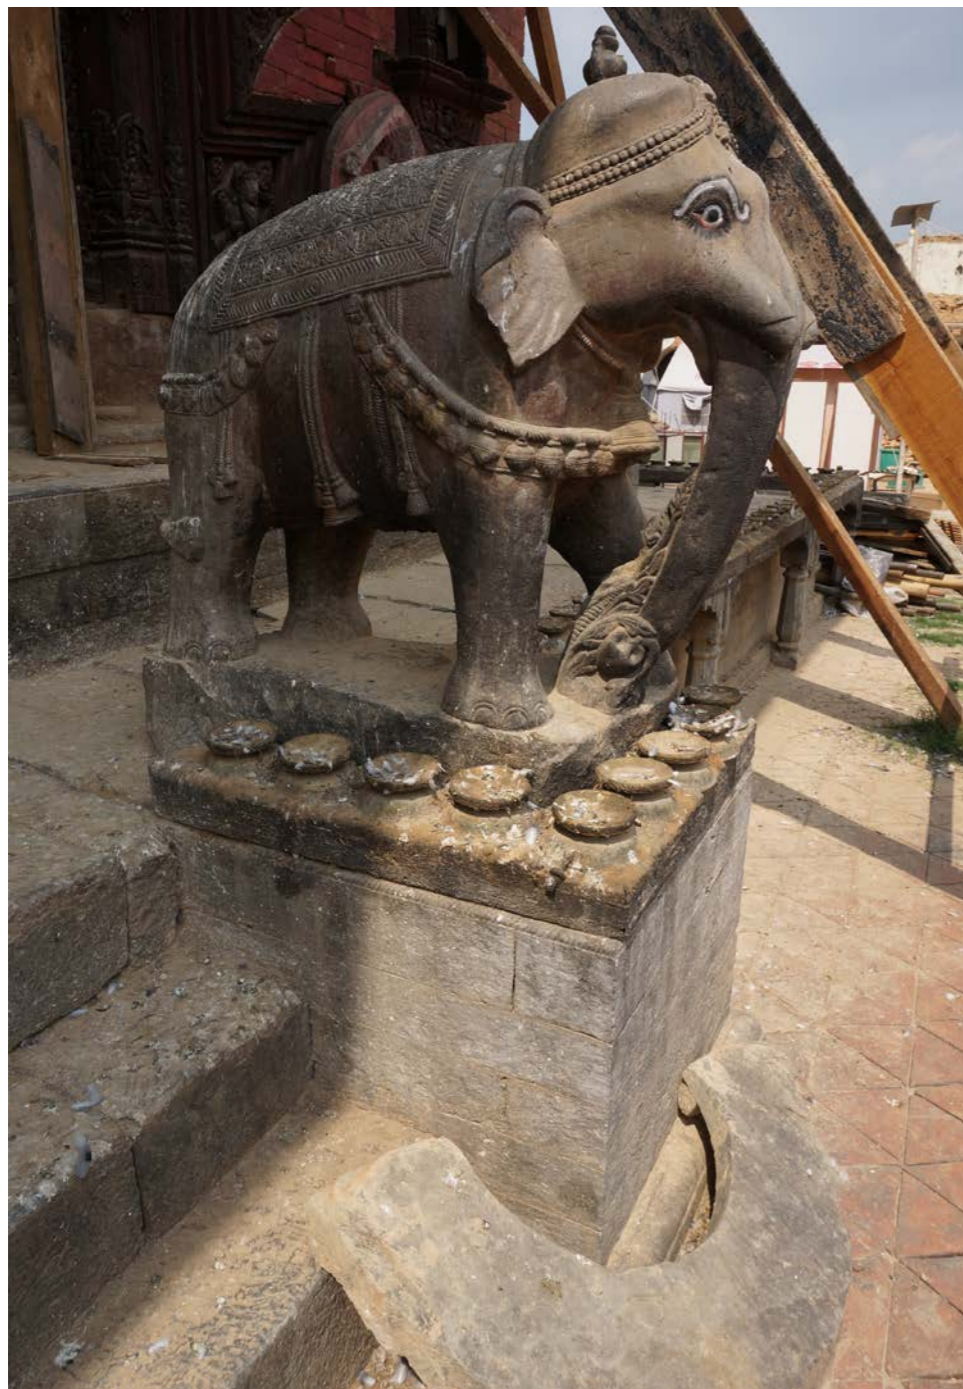
40 r STONE STATUE

NUMBER	NAME	DATE A.D.	TPOLOGY	GENERAL DESCRIPTION	DESCRIPTION OF DAMAGE	DANGER
40r			Elephant Statue	Stone Statue	No visible Damage	
40s			Elephant Statue	Stone Statue	Slightly tilted base	
40t			Stone framed bell	Stone Structure about 6.5' tall	Slightly tilted

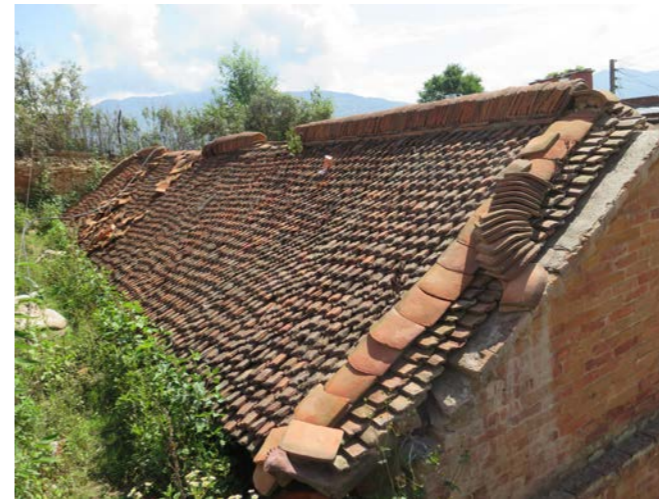
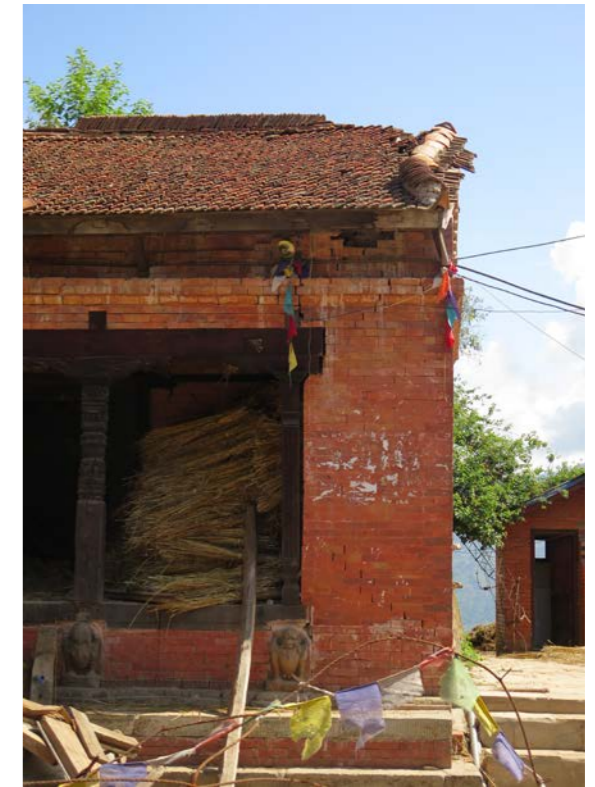
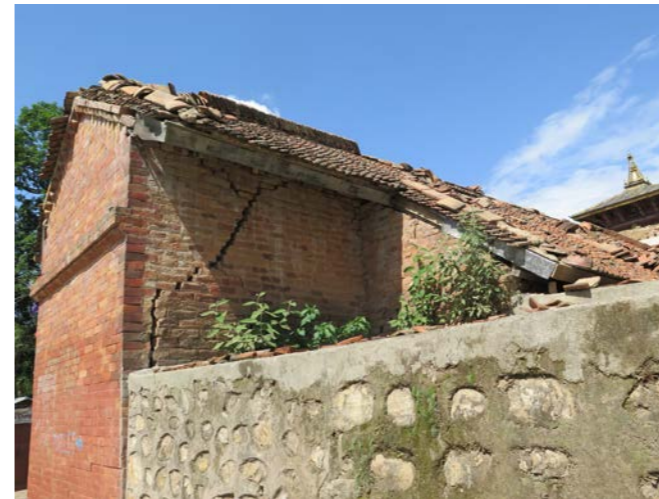
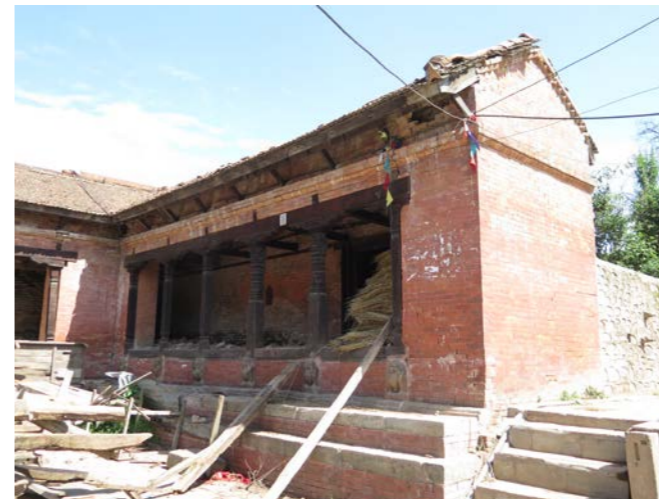
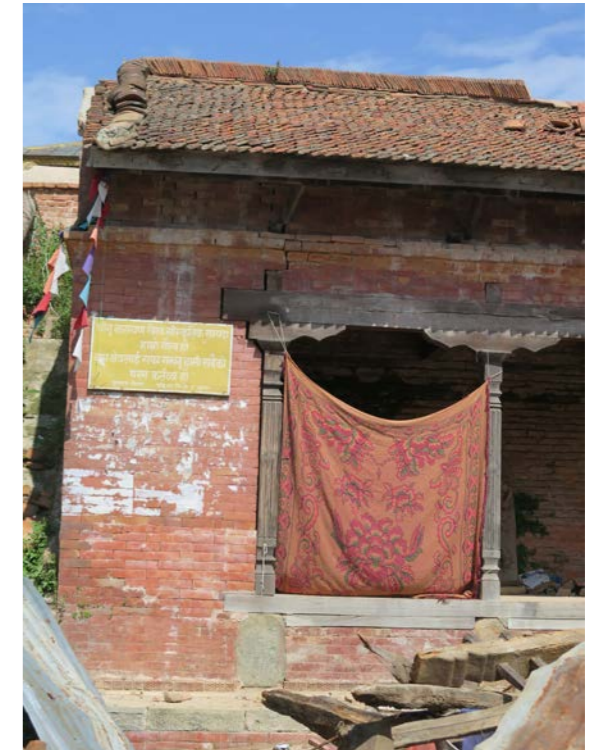
41 PATI

NUMBER	NAME	DATE A.D.	TYPOLOGY	GENERAL DESCRIPTION	DESCRIPTION OF DAMAGE	DANGER
41	17th Century (renovated on 2046 BS)		Pati	Brick and wooden structure with <i>jhingati</i> on the roof.	There are gaps between bricks and wooden post in S-façade There are cacks in the N-façade Roof tiles damages and fallen Inner walls have severe multiple cracks Wooden struts are displaced.

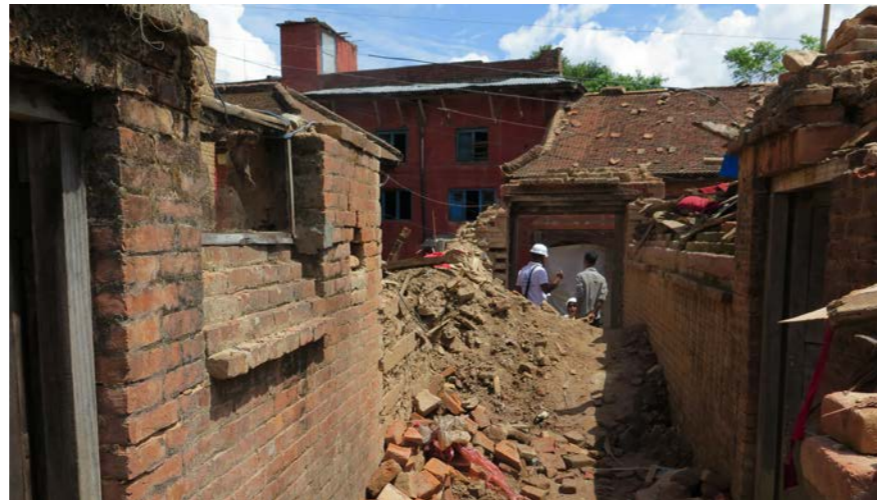
42 DOOR

NUMBER	NAME	DATE A.D.	TPOLOGY	GENERAL DESCRIPTION	DESCRIPTION OF DAMAGE	DANGER
42			Wooden Door	Wooden door of Open Sky Museum	Prone to collapse

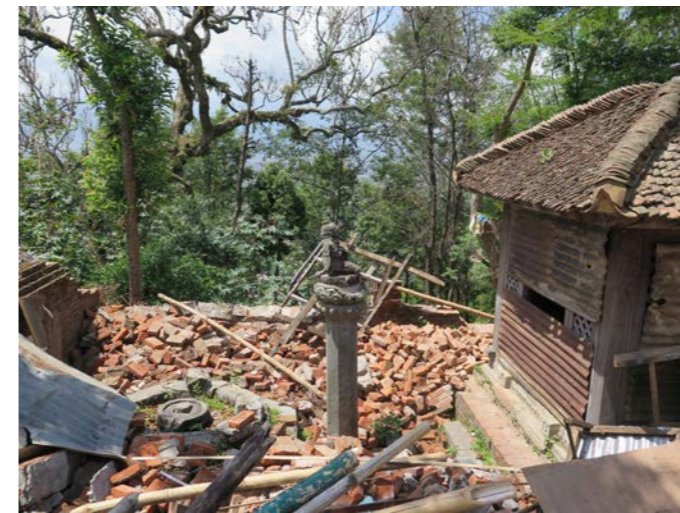
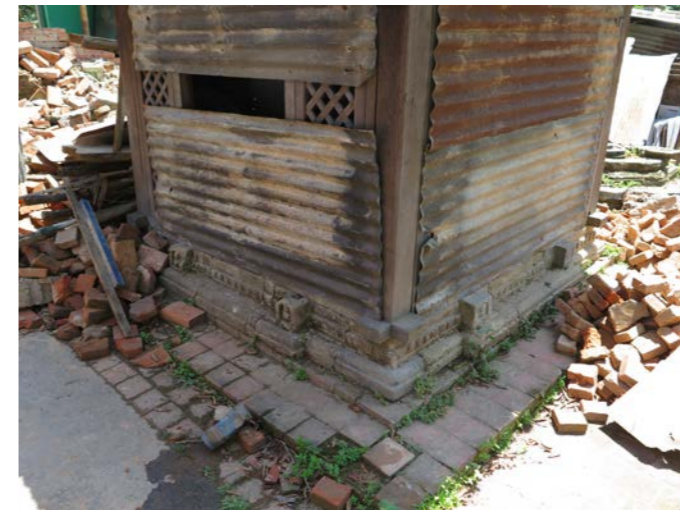
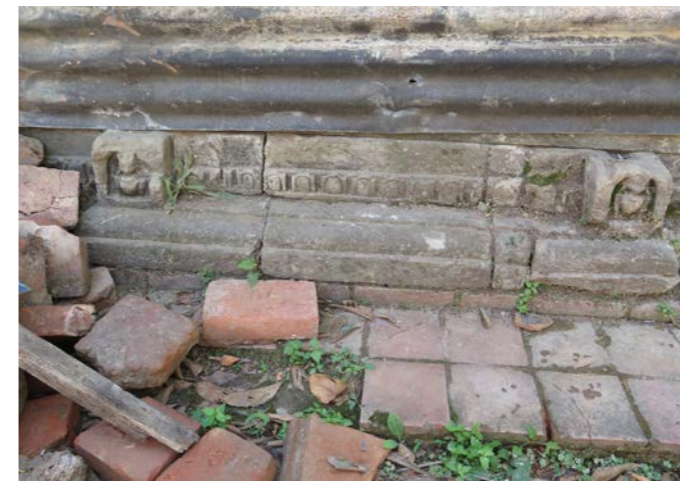
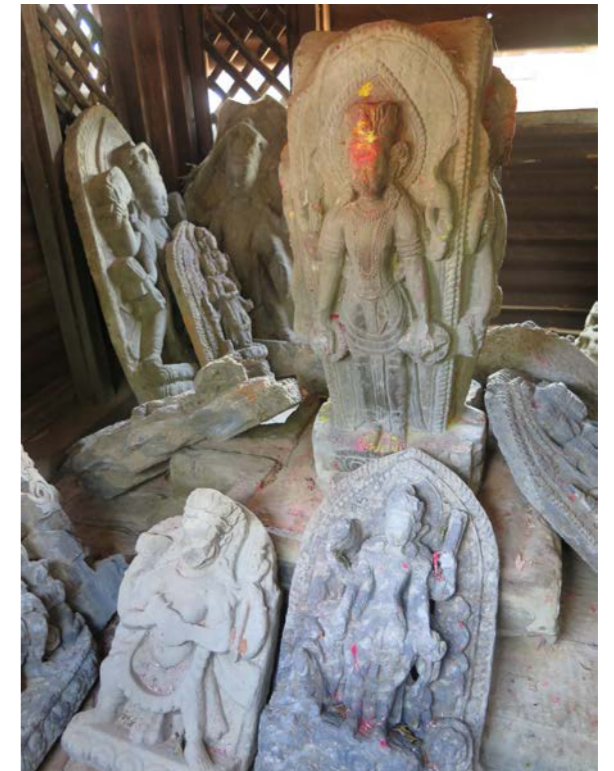
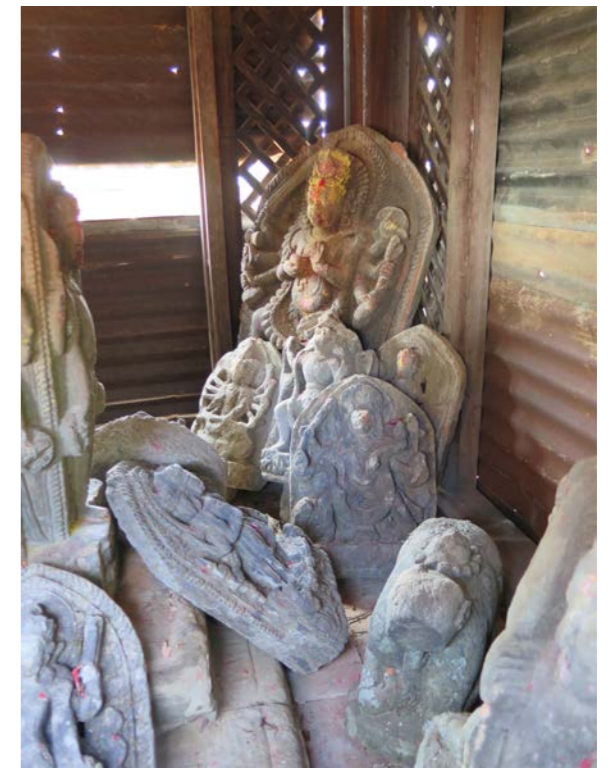
43 MUSEUM

NUMBER	NAME	DATE A.D.	TYPOLOGY	GENERAL DESCRIPTION	DESCRIPTION OF DAMAGE	DANGER
43		1998 BS	Museum	Single storey structure at middle of the museum.	Walls have collapsed

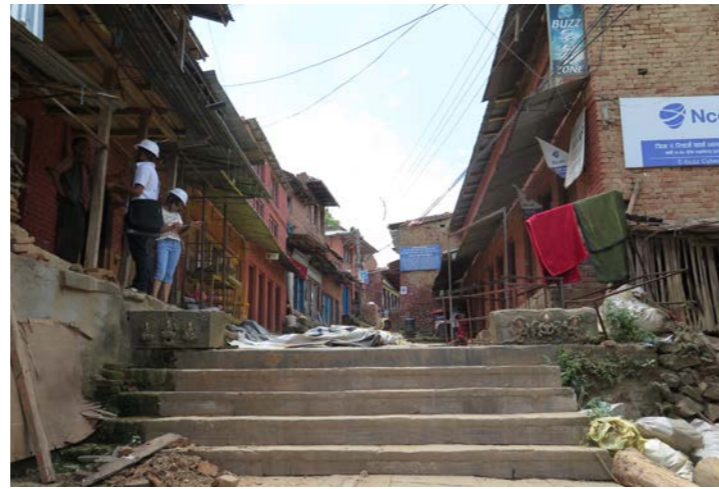
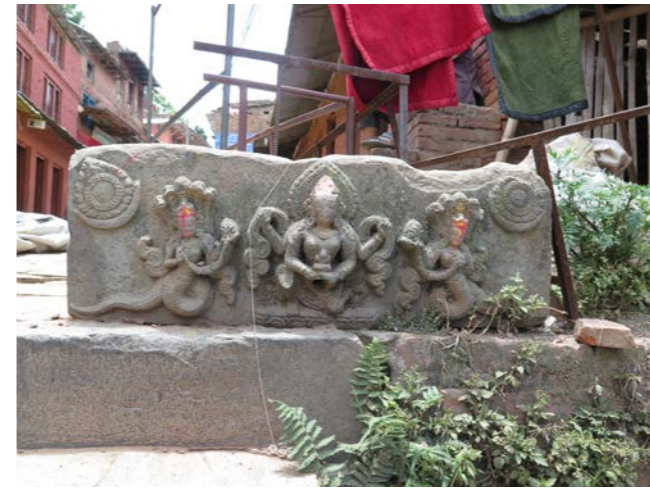
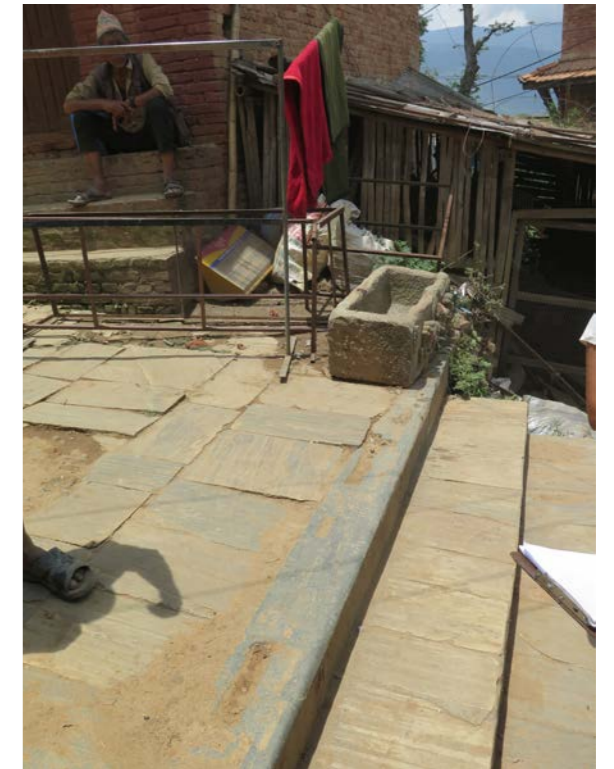
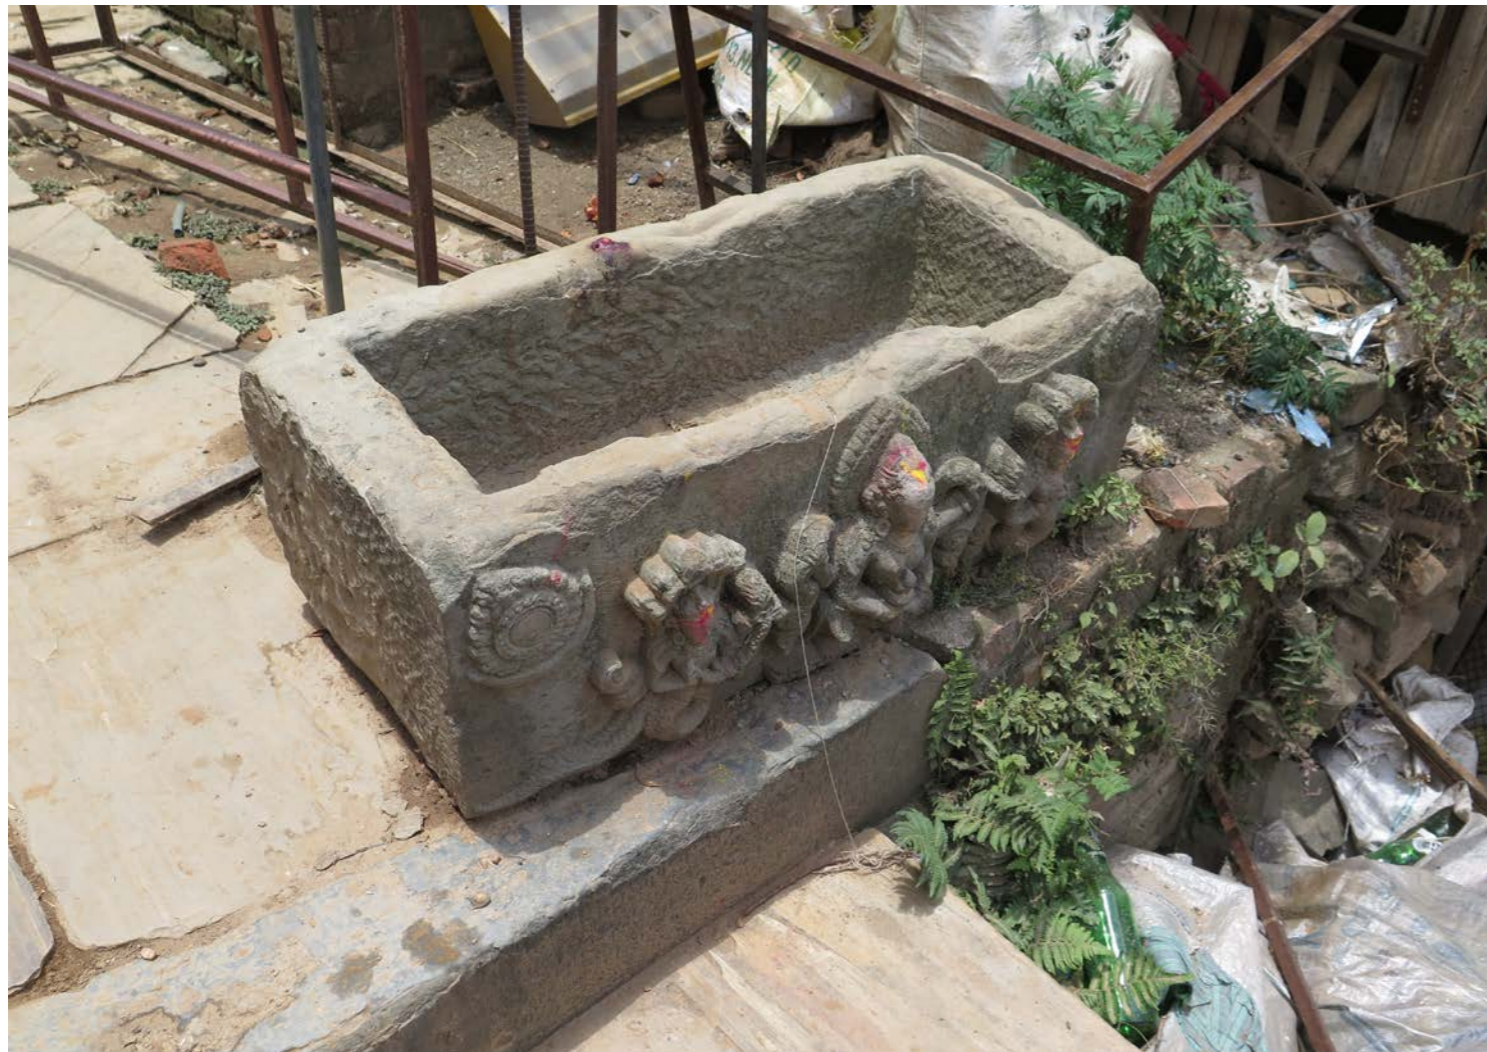
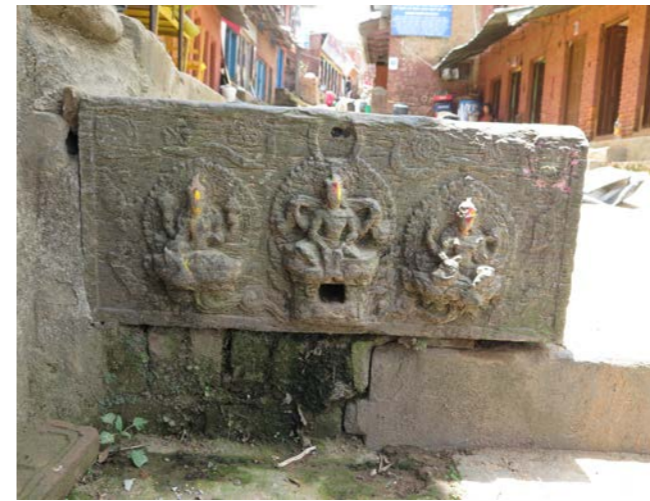
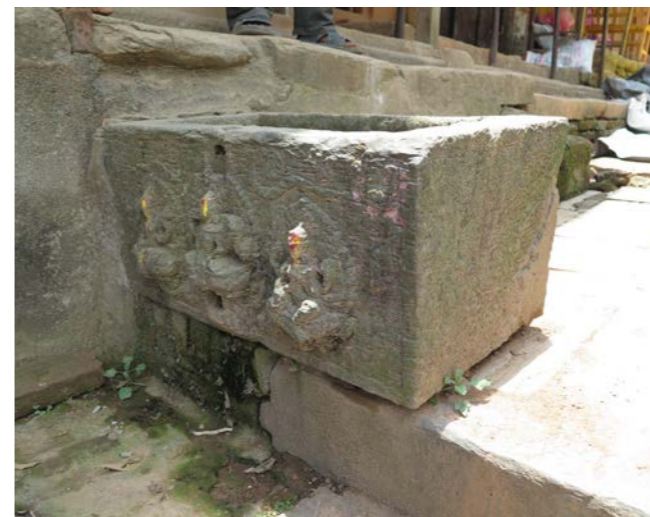
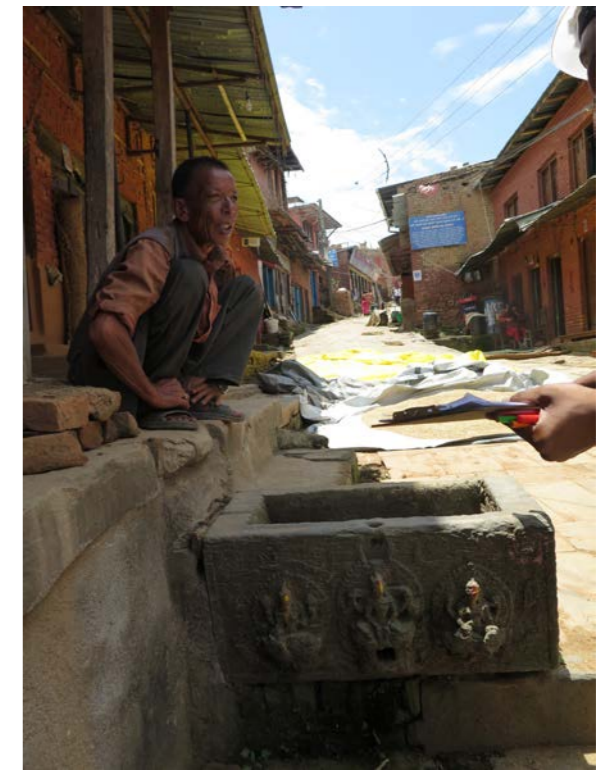
45 STONE WATER TANK

NUMBER	NAME	DATE A.D.	TPOLOGY	GENERAL DESCRIPTION	DESCRIPTION OF DAMAGE	DANGER
45			Stone Tank	Small stone water tank used previously by devotees to wash.	No visible damage

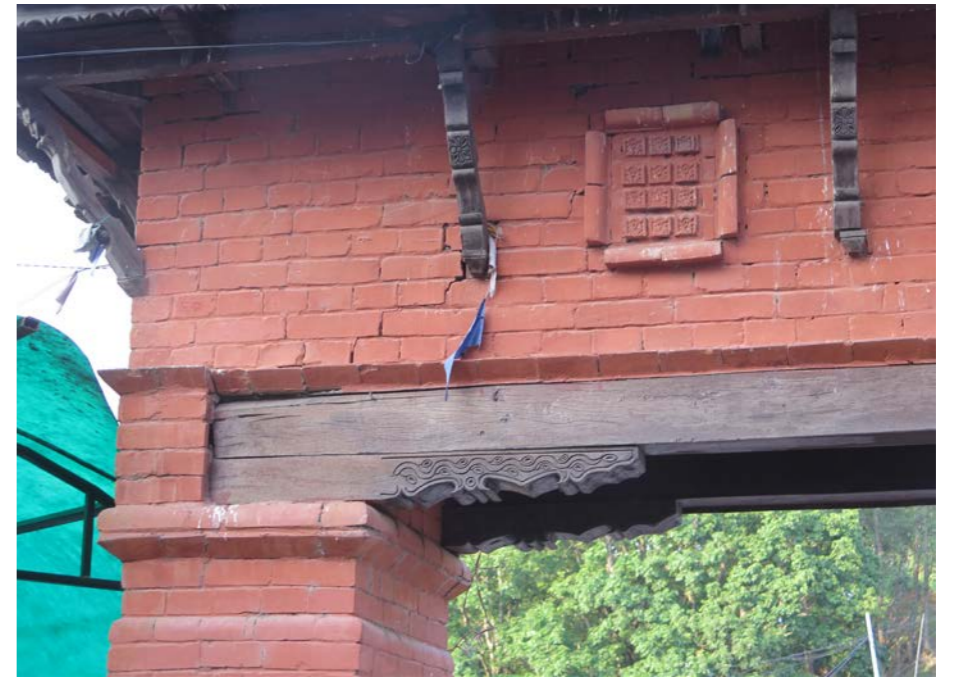
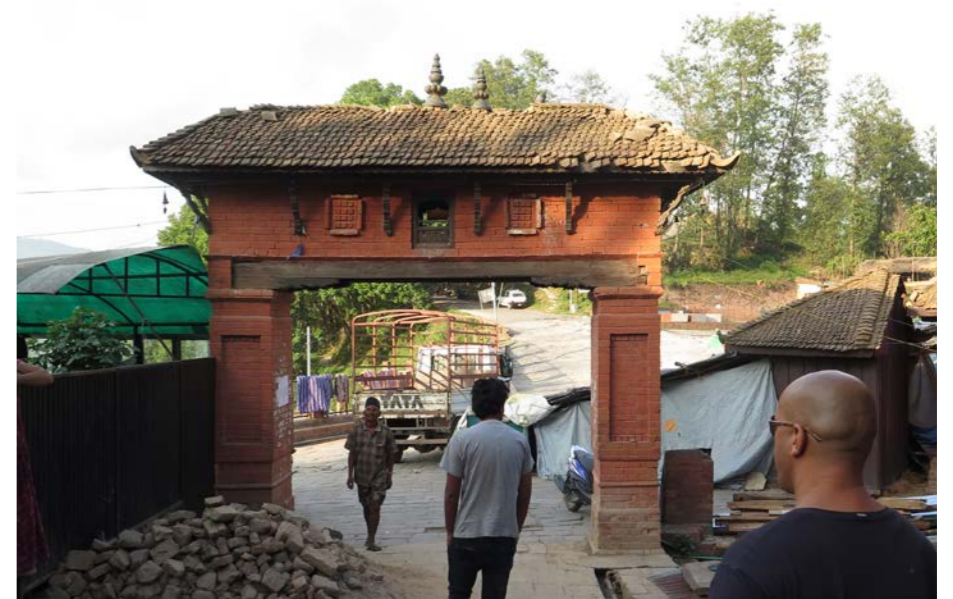
46 GATE

NUMBER	NAME	DATE A.D.	TPOLOGY	GENERAL DESCRIPTION	DESCRIPTION OF DAMAGE	DANGER
46			Gate	Brick structure in cement mortar	Cracks in West pillar.

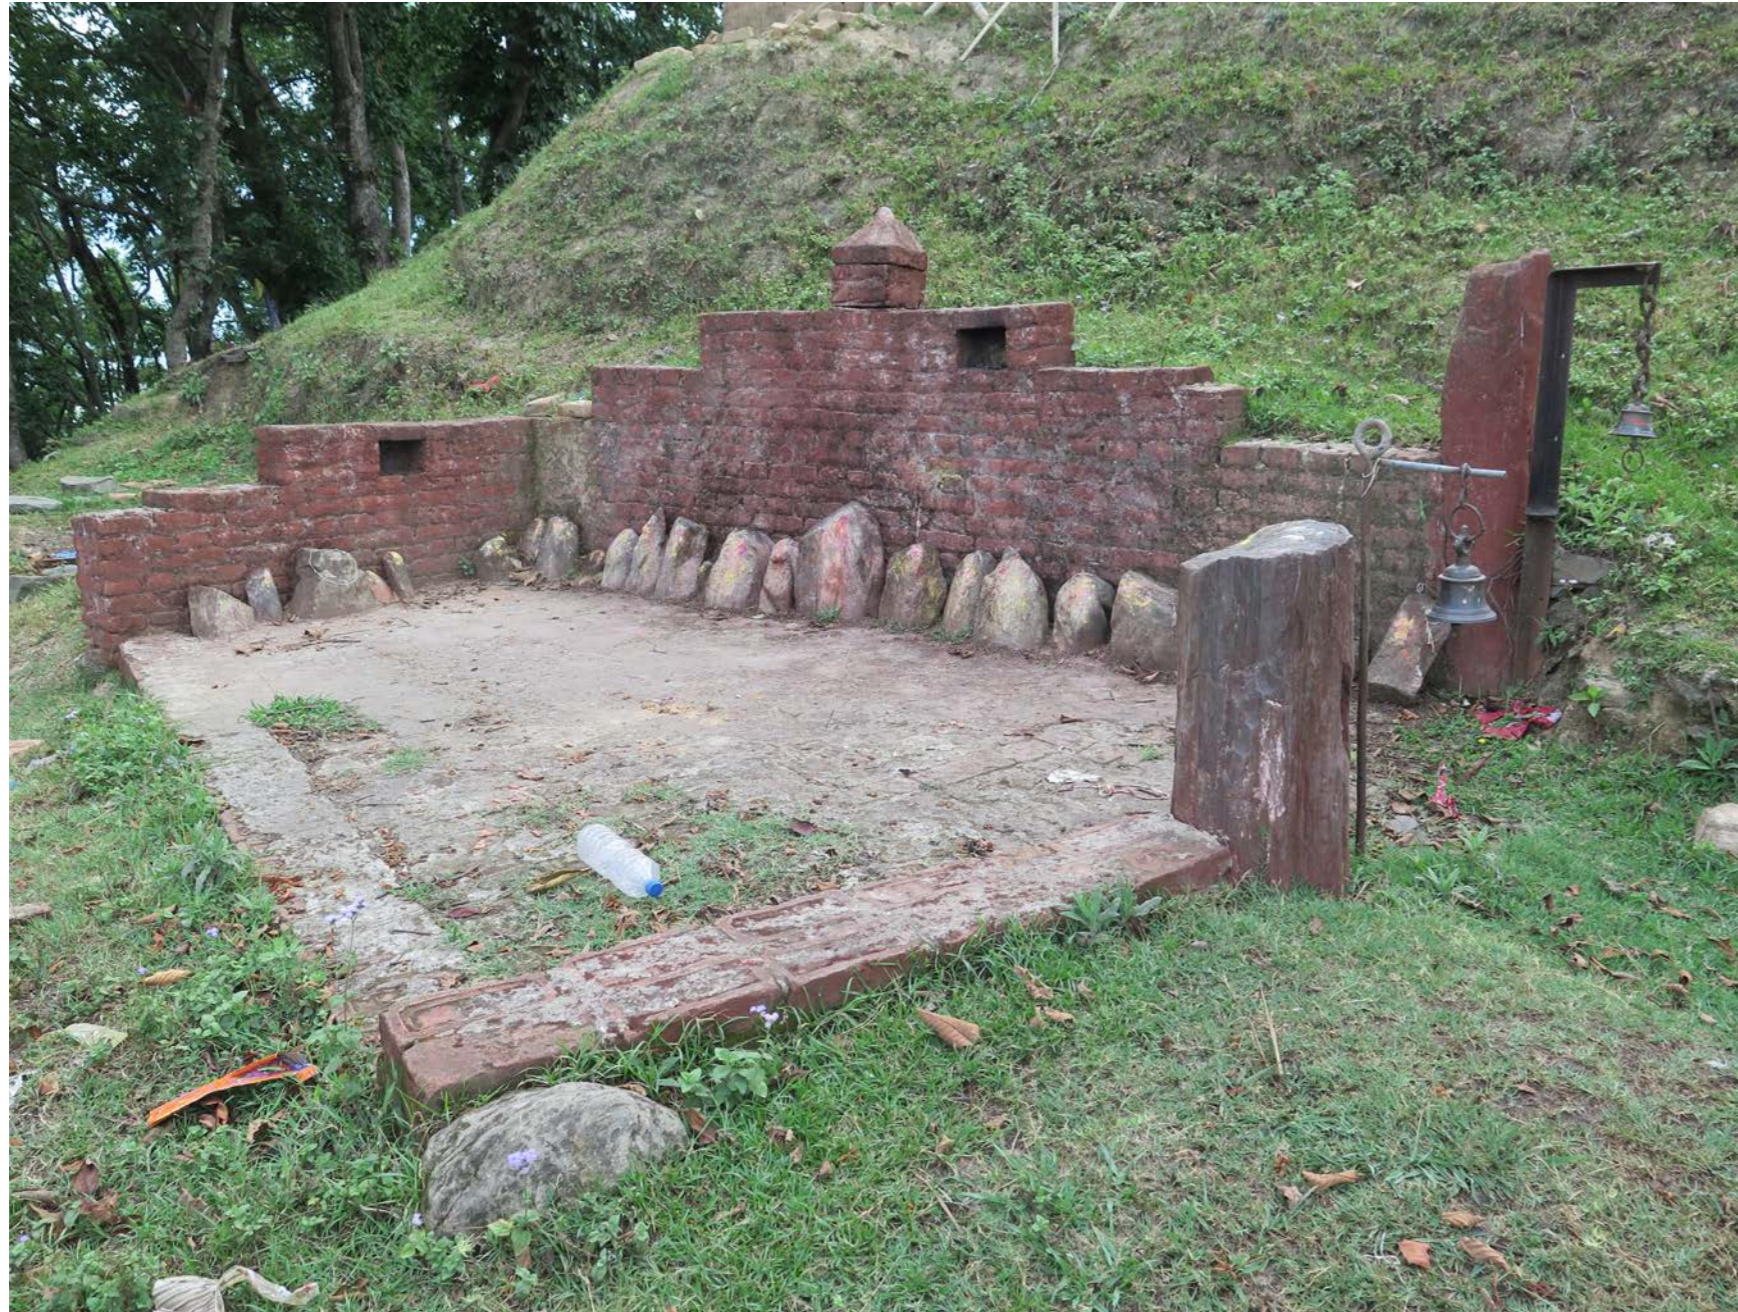
49 SHRINE

NUMBER	NAME	DATE A.D.	TPOLOGY	GENERAL DESCRIPTION	DESCRIPTION OF DAMAGE	DANGER	
49			Shrine		No visible damage		
50			Pond		No visible damage
