2015 Earthquake Damage Mapping
Changunarayan Monument Zone
Kathmandu Valley World Heritage Property

November 2015

This assessment was supported by
UNESCO Office in Kathmandu

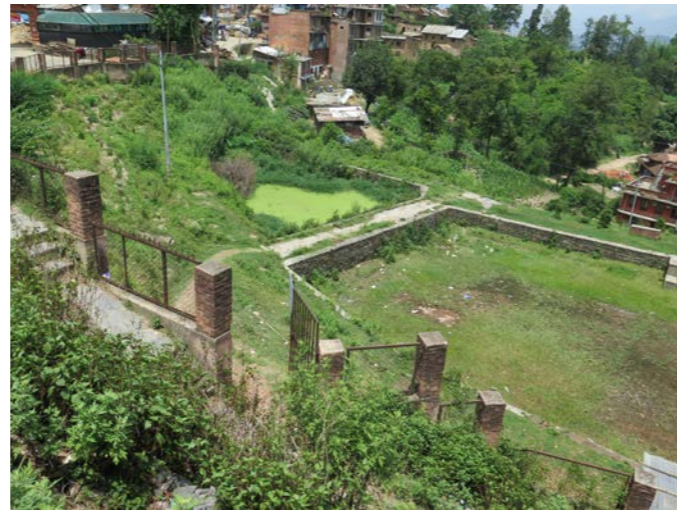
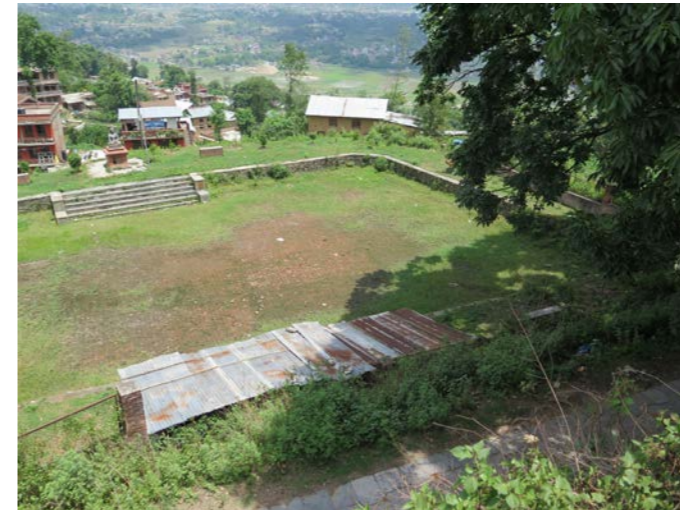
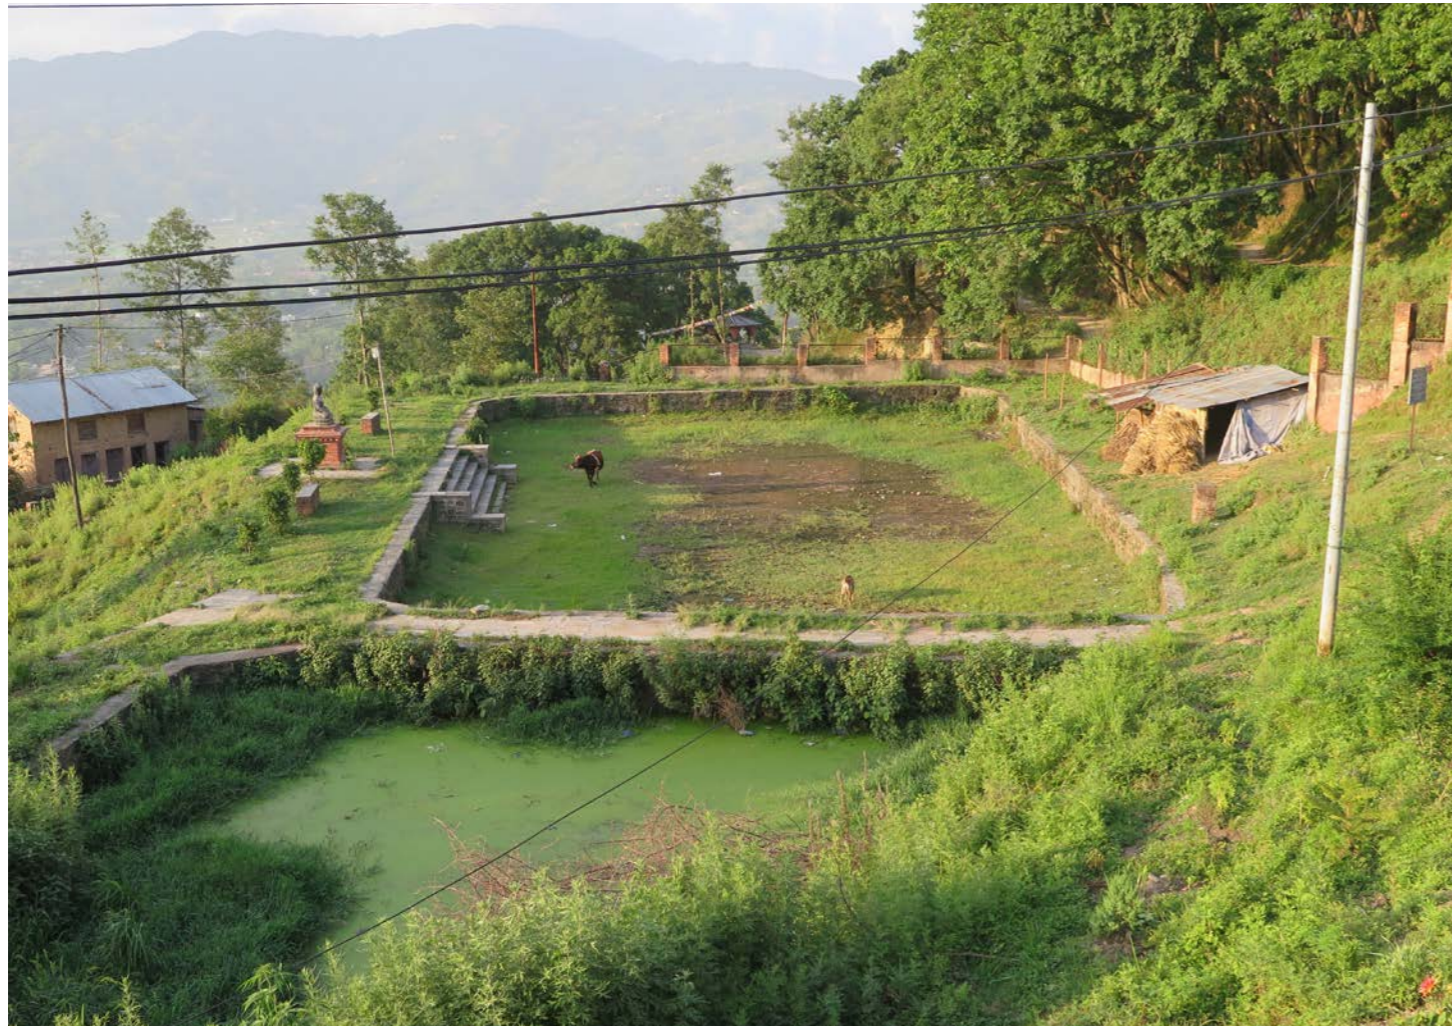
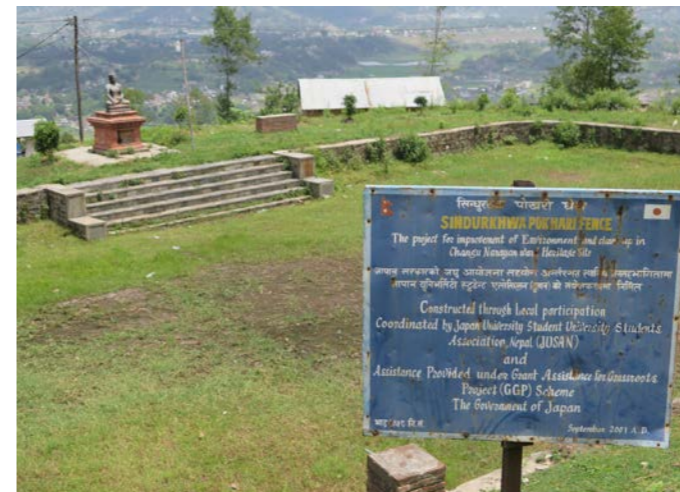
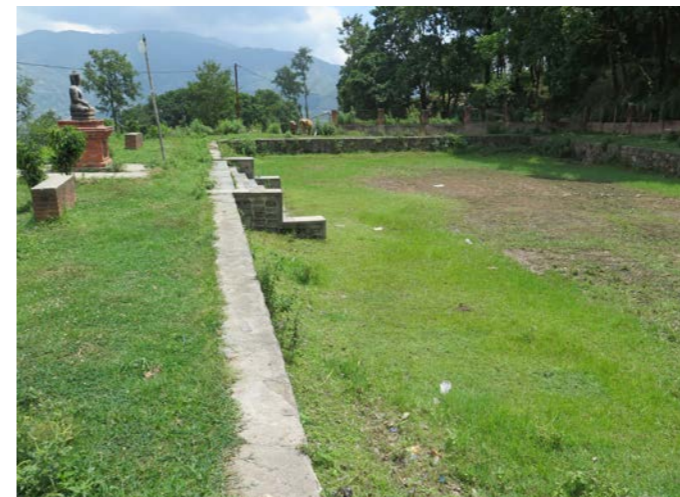
51 POND

NUMBER	NAME	DATE A.D.	TYPOLOGY	GENERAL DESCRIPTION	DESCRIPTION OF DAMAGE	DANGER	
51		2001 AD September	Pond	Brick and stone fenced pond. Brick paved path around the pond.	No visible damage. Vegetation and water weed growth		
52			Buddha Statue	Height of statue - 1.2 m tall Overall height with base - 2.4 m Situated to the north of the pond	No visible damage

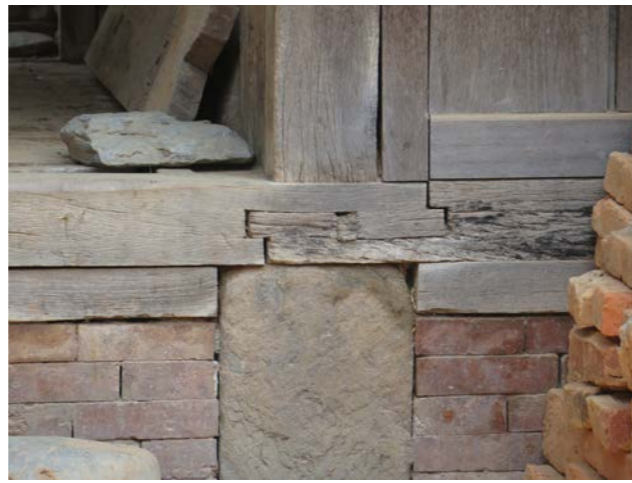
53 PATI

NUMBER	NAME	DATE A.D.	TYOLOGY	GENERAL DESCRIPTION	DESCRIPTION OF DAMAGE	ANGER
53			<i>Pati</i>	<i>Pati</i> is adopted as Water supply and sanitation office.	Missing few tiles of the roof Minor cracks in the walls

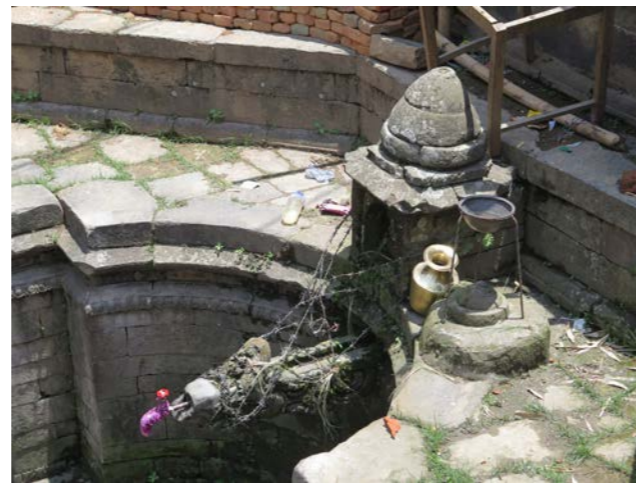
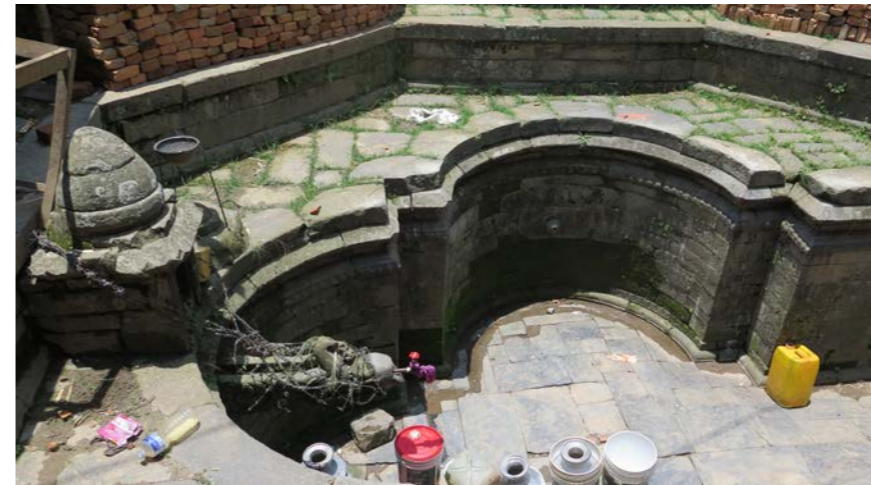
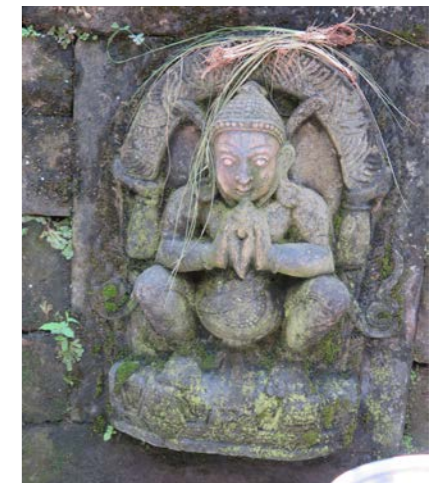
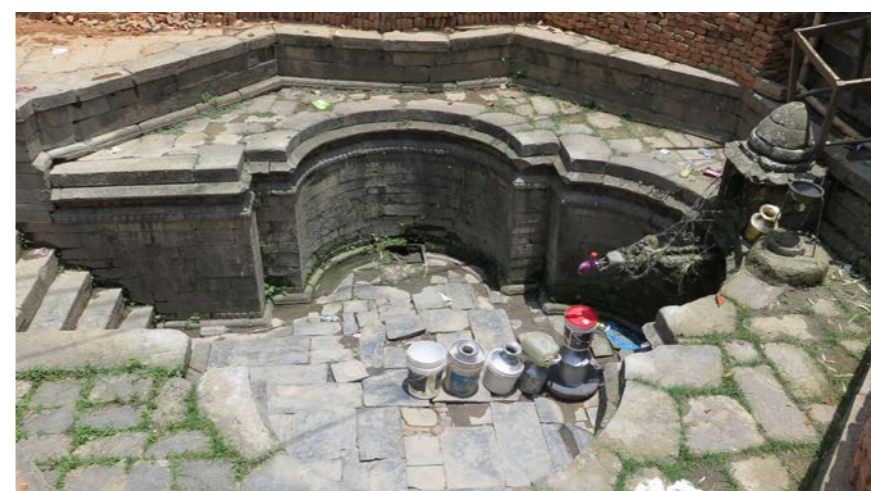
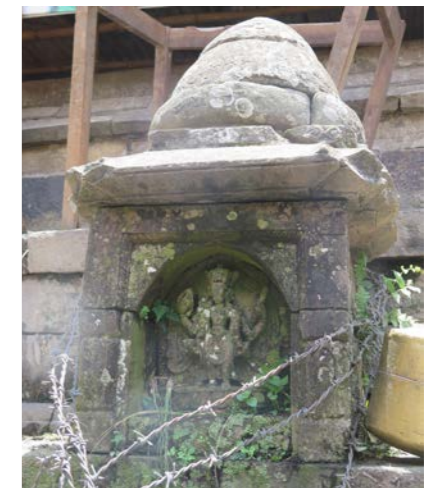
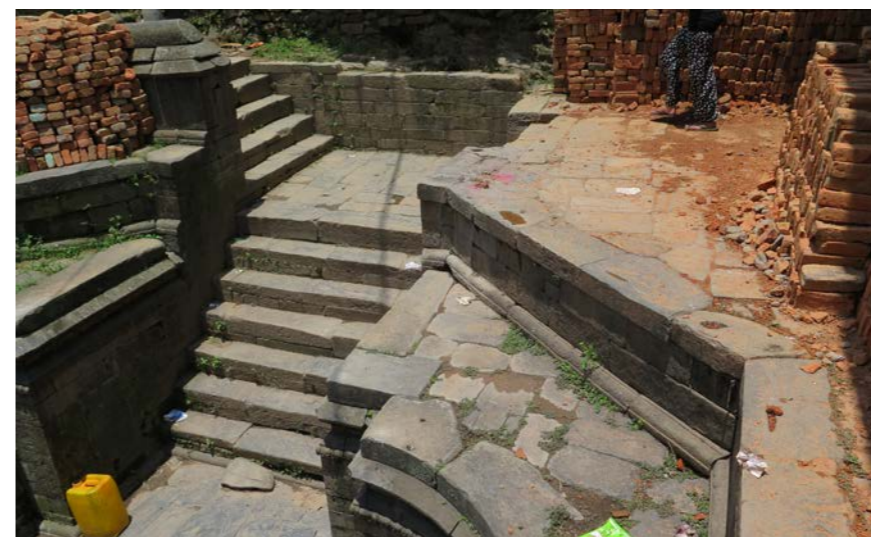
54 WATER SPOUT

NUMBER	NAME	DATE A.D.	TYPOLOGY	GENERAL DESCRIPTION	DESCRIPTION OF DAMAGE	DANGER
54			Hiti	Approximately 3 m deep stone water spout with various sculptures.	No visible structural damage Stone tap covered with barbed wire to prevent form theft of sculptures

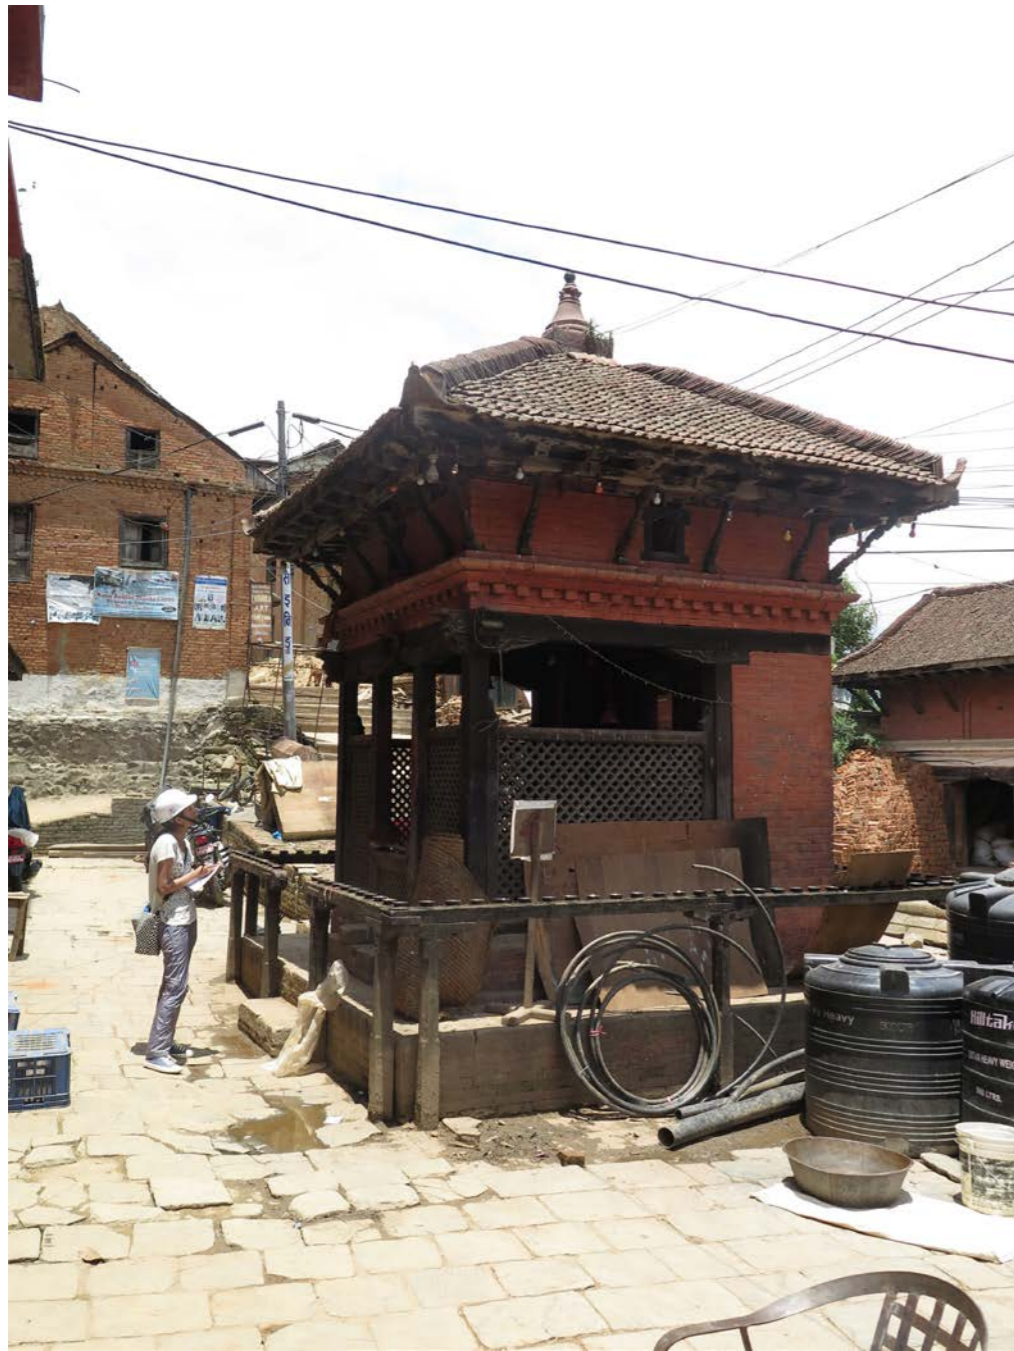
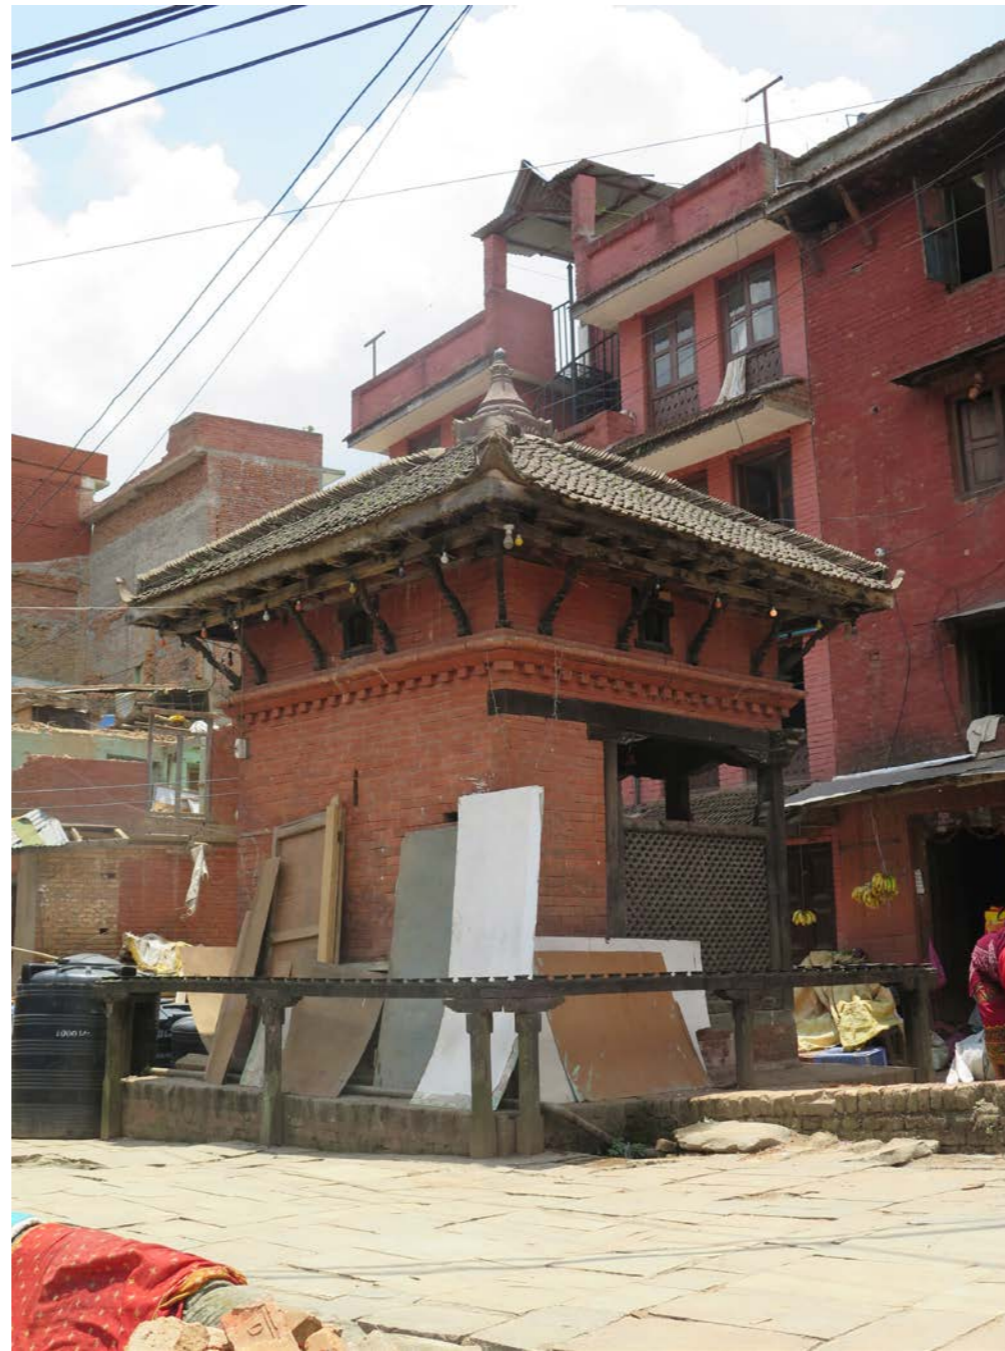
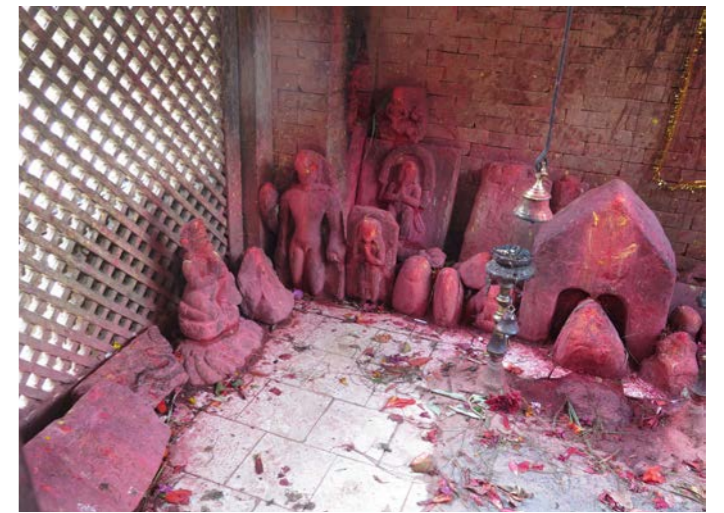
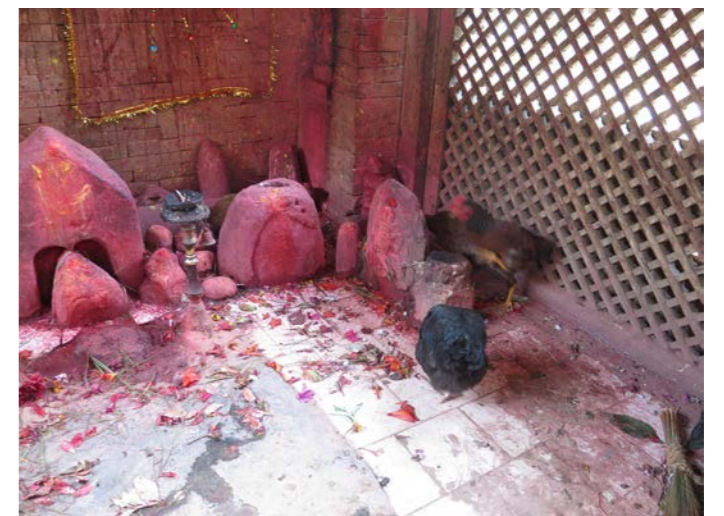
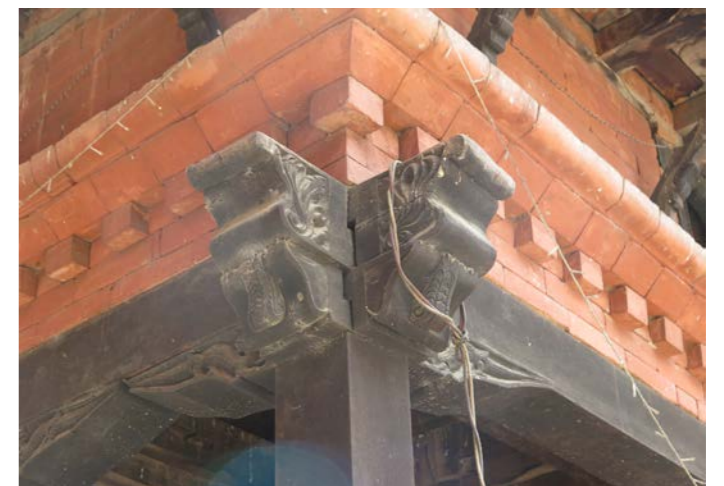
55 TEMPLE

NUMBER	NAME	DATE A.D.	TYOLOGY	GENERAL DESCRIPTION	DESCRIPTION OF DAMAGE	DANGER
55			Temple	Single storey temple Brick and wooden structure recently renovated using cement	No visible damage

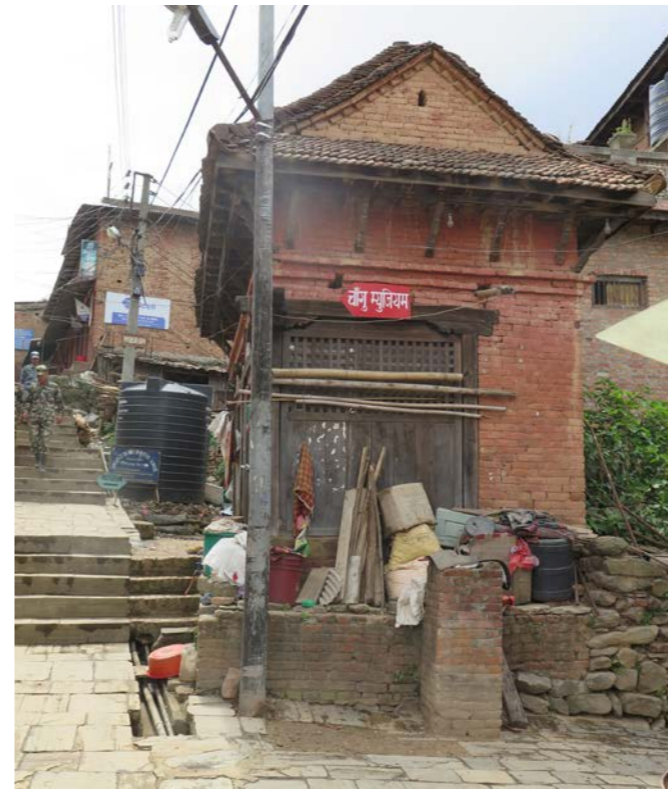
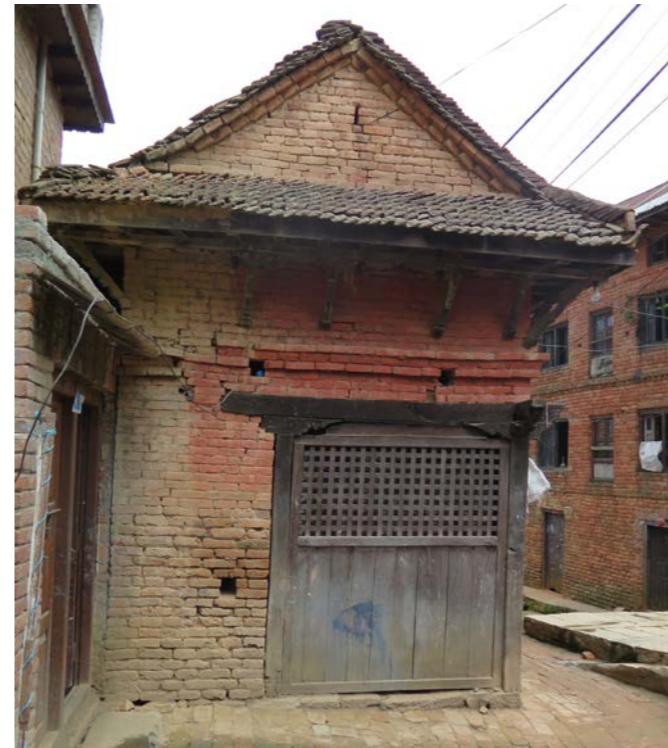
56 PATI

NUMBER	NAME	DATE A.D.	TYPOLOGY	GENERAL DESCRIPTION	DESCRIPTION OF DAMAGE	DANGER
56			<i>Pati</i> (<i>Bhajan ghar</i>)	Single storey <i>pati</i>	Minor cracks Few roof tiles are missing.	
57			Shrine (<i>Chetrapal</i>)	Stone Mandap like structure	No visible damage

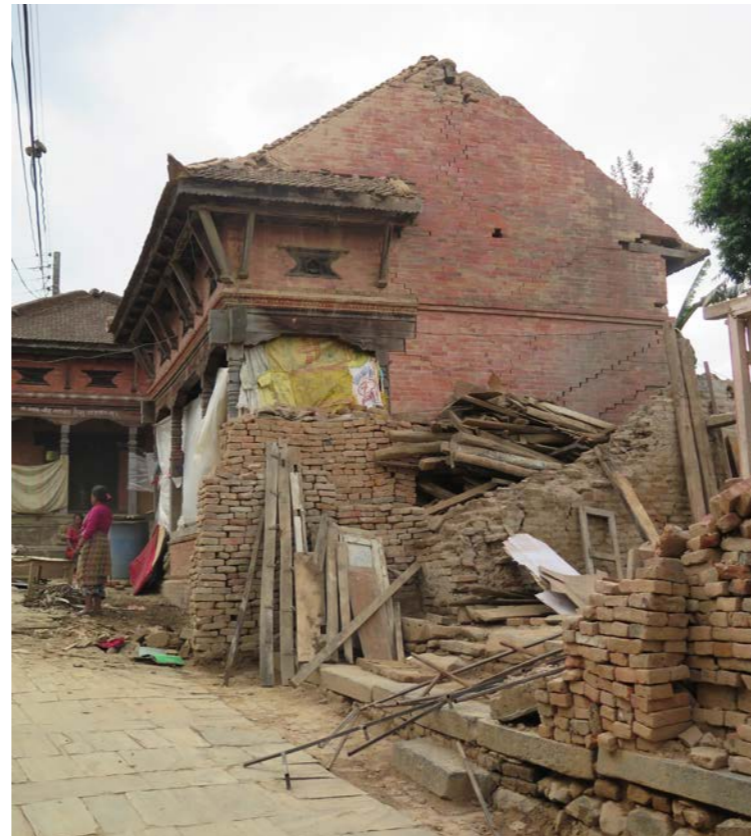
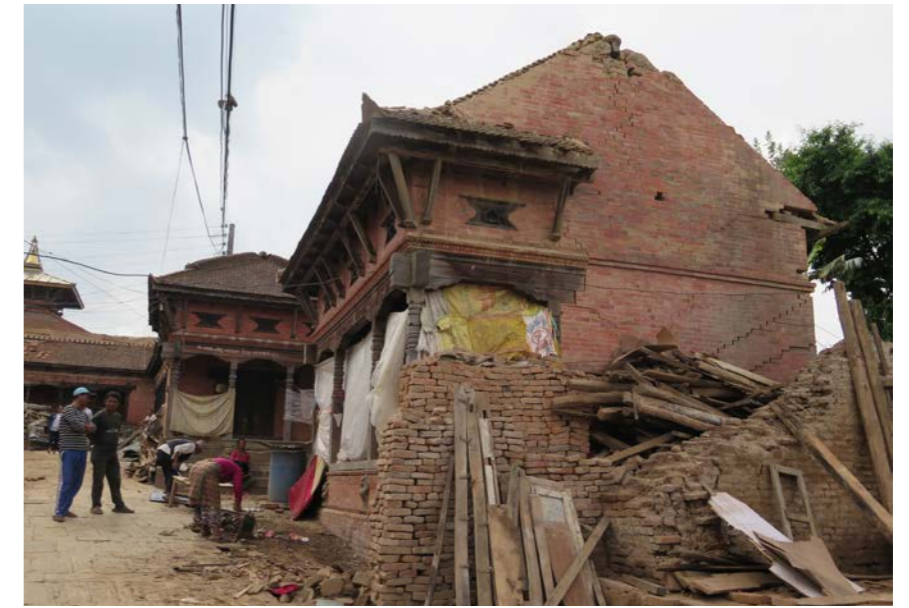
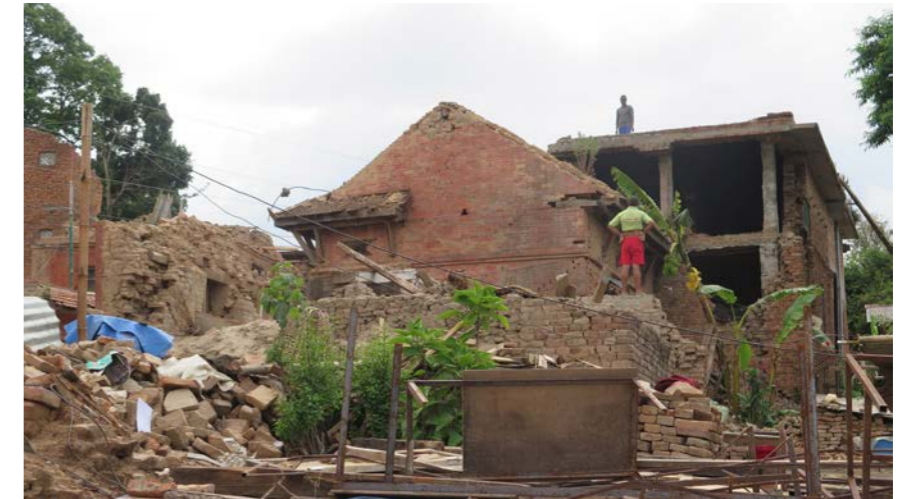
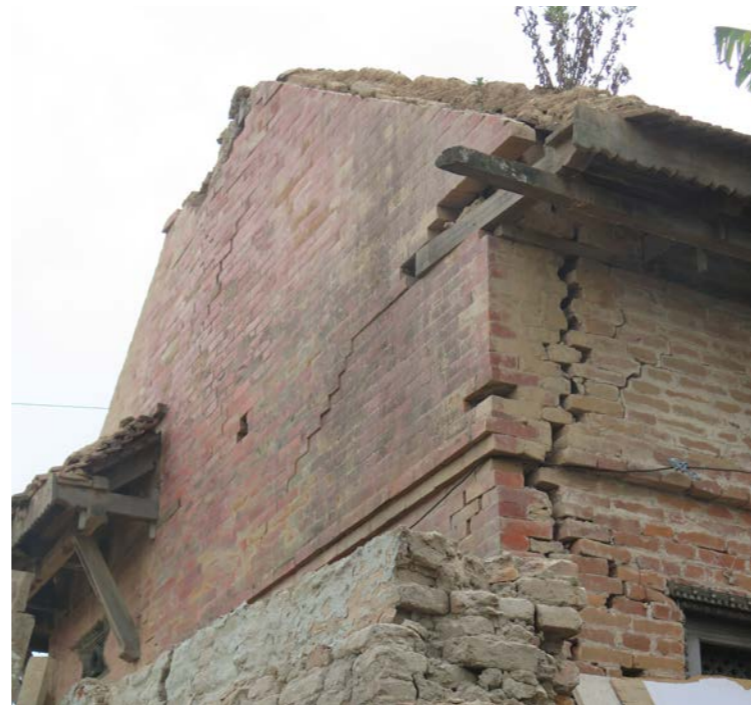
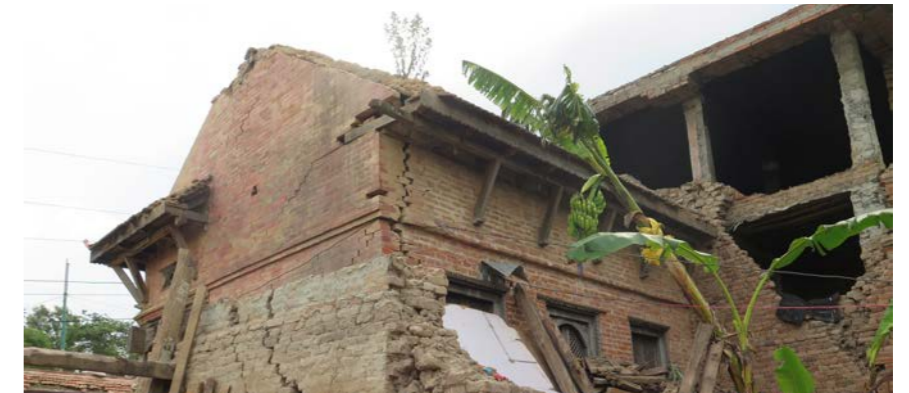
58 SATTAL

NUMBER	NAME	DATE A.D.	TPOLOGY	GENERAL DESCRIPTION	DESCRIPTION OF DAMAGE	DANGER
58			Sattal		Diagonal and vertical cracks on wall

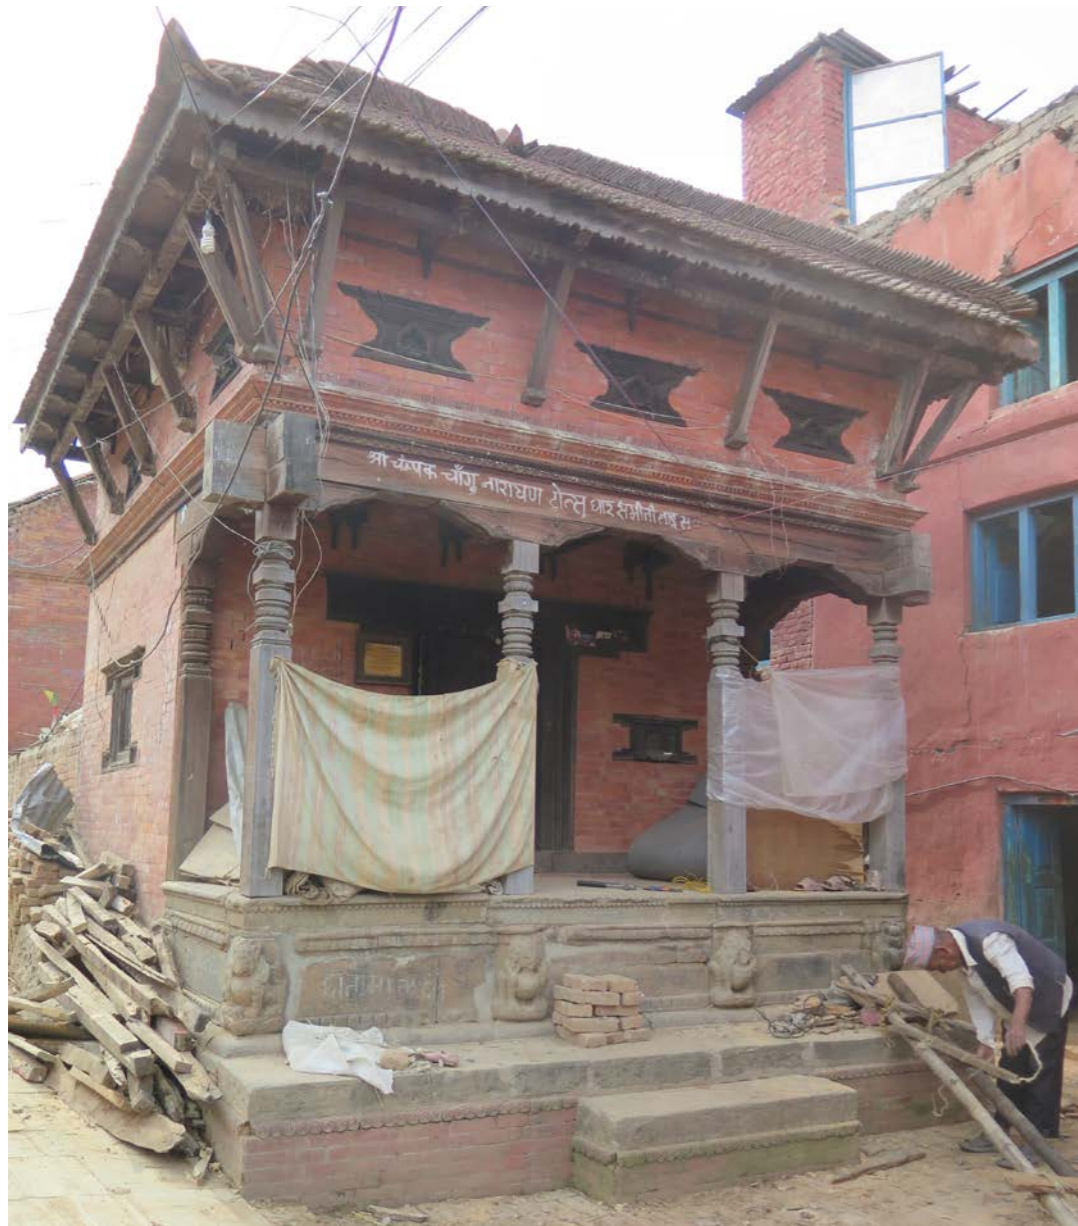
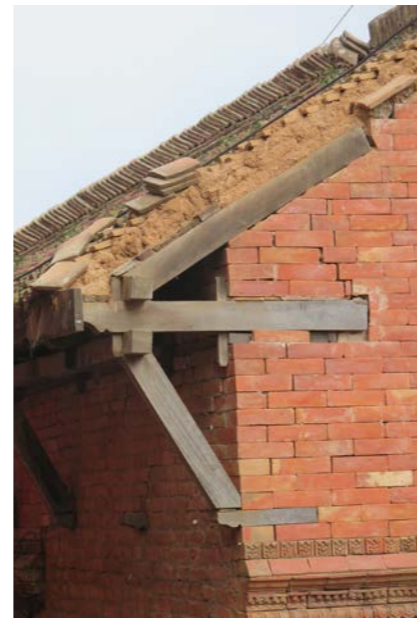
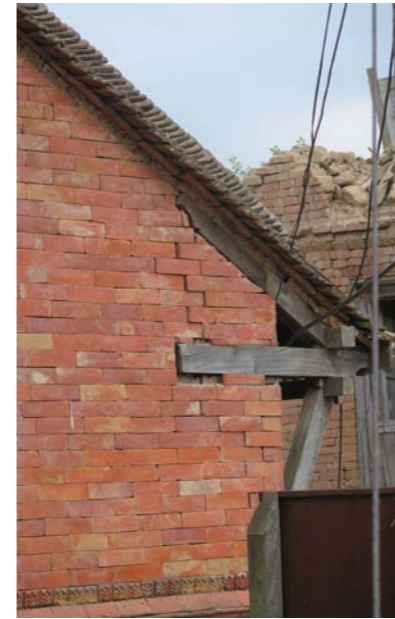
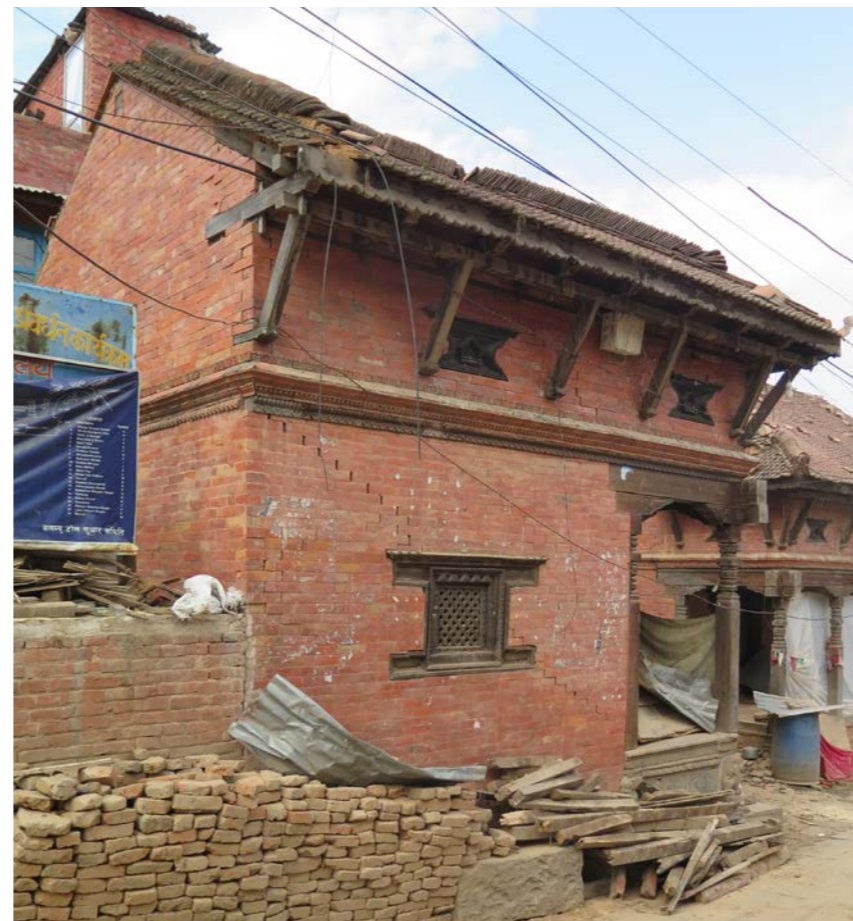
59 PATI

NUMBER	NAME	DATE A.D.	TPOLOGY	GENERAL DESCRIPTION	DESCRIPTION OF DAMAGE	DANGER
59			Pati		There are diagonal cracks in the walls Roof has partially collapsed.	
64			Pond	Brick wall and cement plastered pond with public tap nearby	No water in the pond Vegetation growth

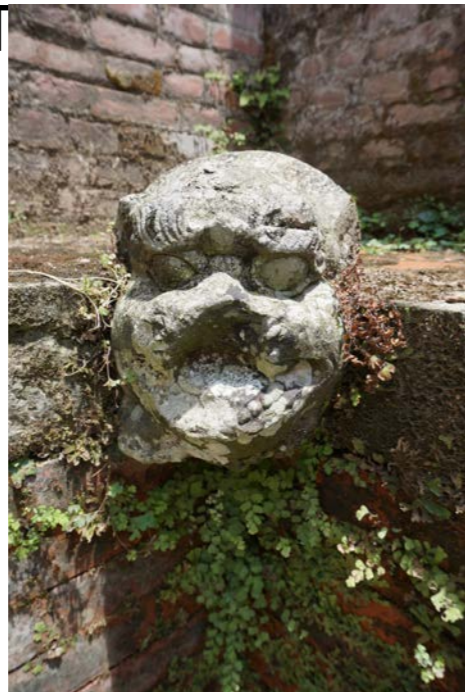
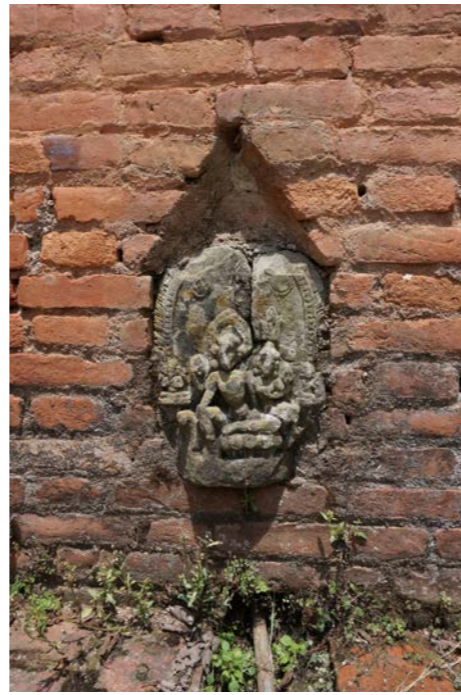
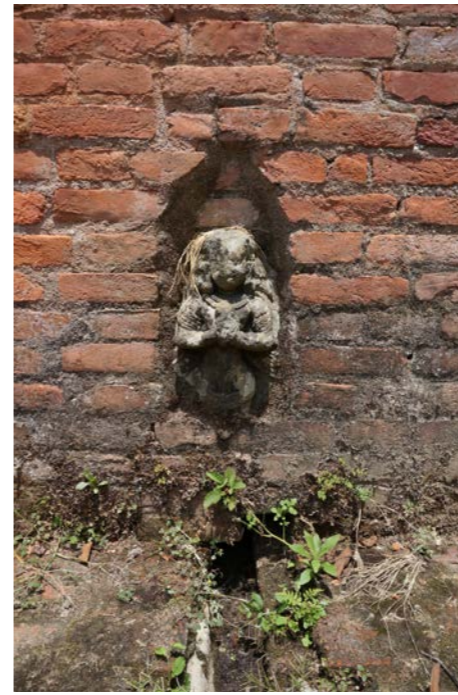
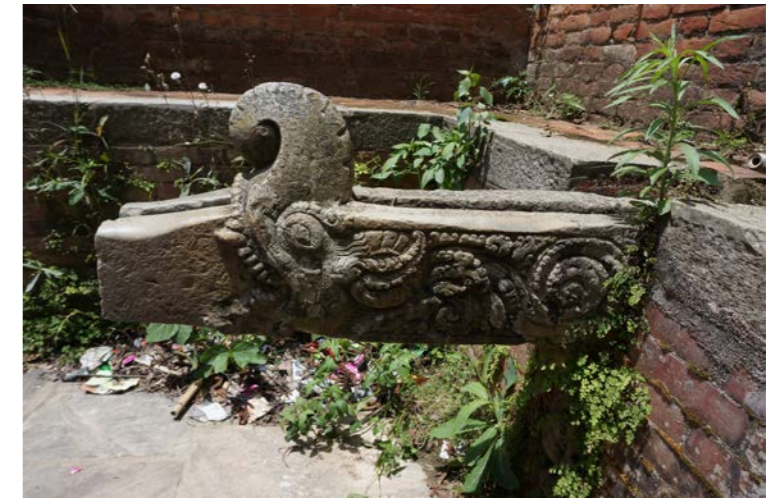
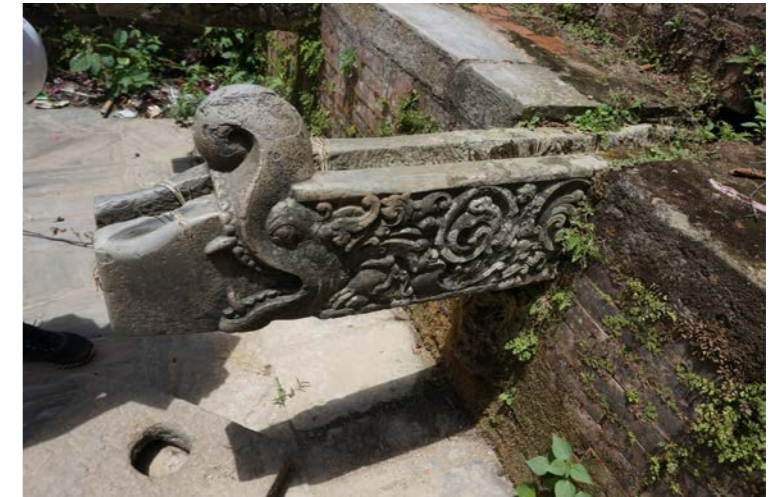
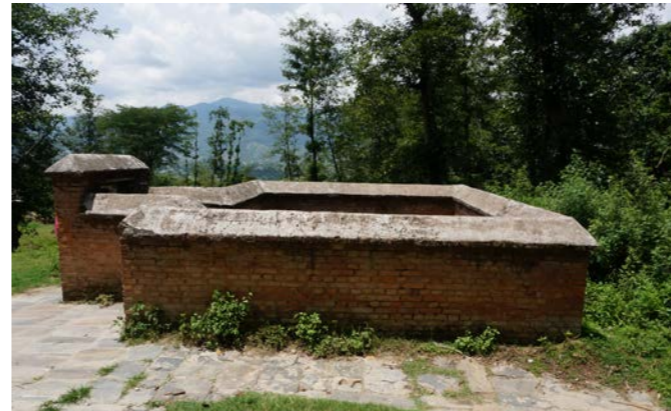
66 WATER SPOUT

NUMBER	NAME	DATE A.D.	TPOLOGY	GENERAL DESCRIPTION	DESCRIPTION OF DAMAGE	DANGER
66			Water Spout	Stone water spout with stone base and steps. There is a Shiva Linga at east side of north wall. Stone artefacts in northeast corner. Two stone spouts with sculptures on the wall at the back.	No water flow after earthquake No visible damage.

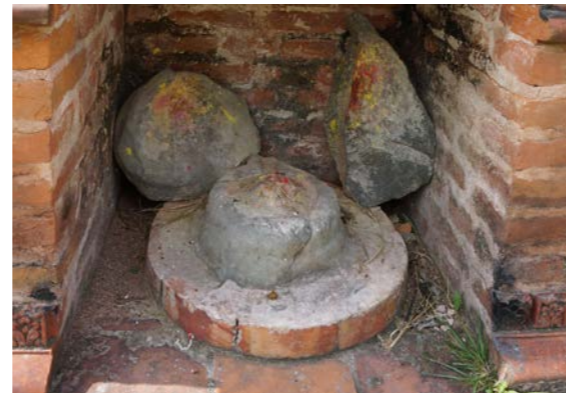
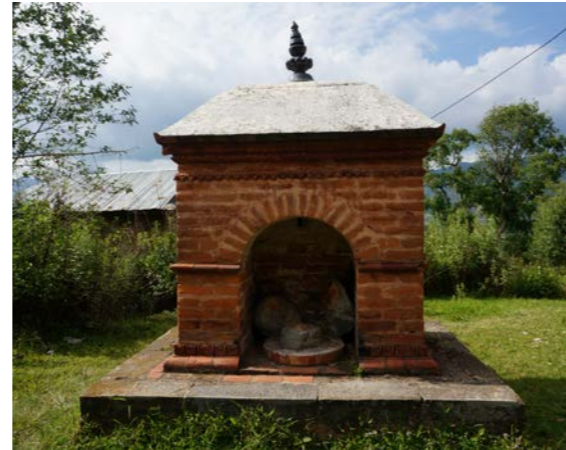
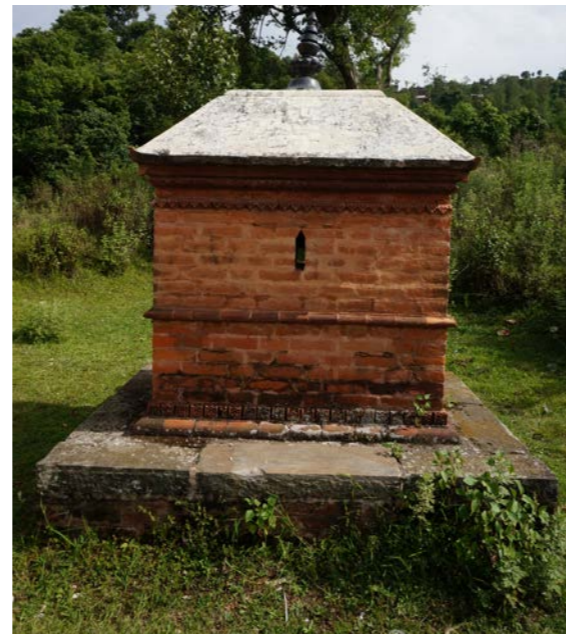
69 GANESH SHRINE

NUMBER	NAME	DATE A.D.	TPOLOGY	GENERAL DESCRIPTION	DESCRIPTION OF DAMAGE	DANGER
69	Ganesh shrine		Open Shrine	Statue of <i>ganesh</i> facing South is enclosed in a brick structure with white plastered roof.	There is a minor crack at South west corner Gajur is new and not properly fixed	
70	Shiva Shrine		Open Shrine	Small Shrine with <i>Jalahari</i> Brick structure with white plastered top and a metal <i>gajur</i>	<i>Gajur</i> is new and not properly fixed No other visible damage.

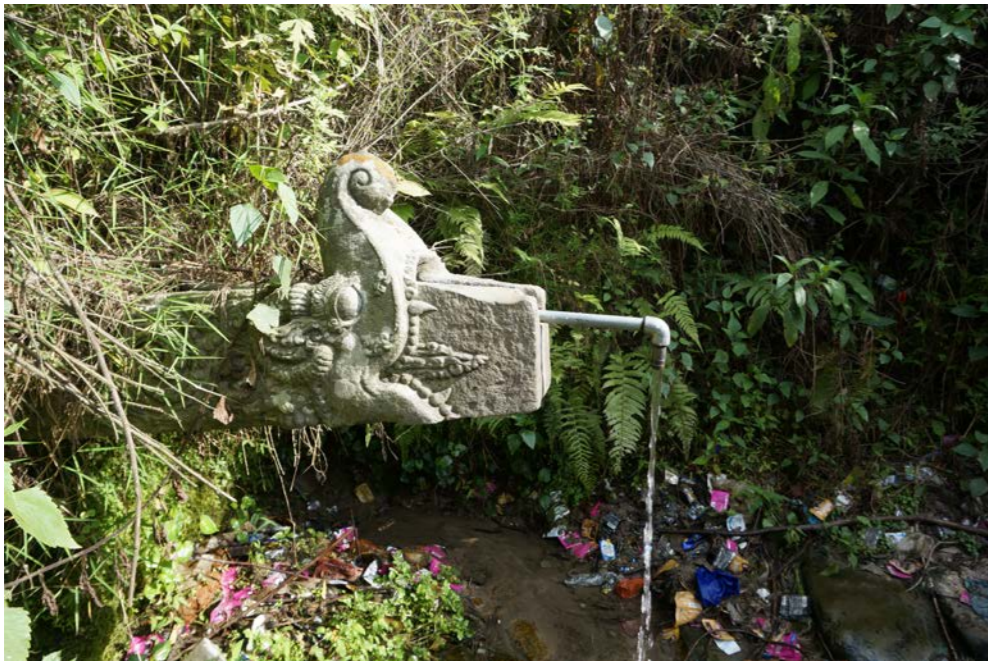
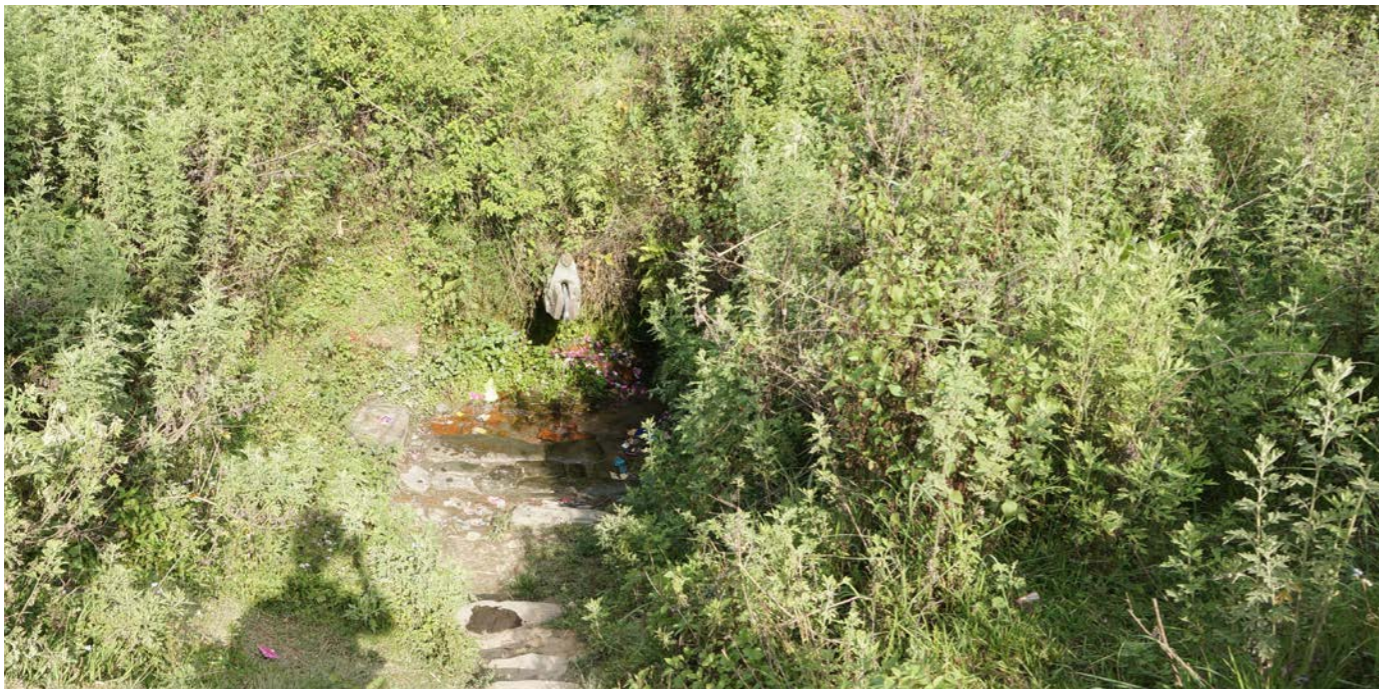
71 WATER SPOUT

NUMBER	NAME	DATE A.D.	TYPOLOGY	GENERAL DESCRIPTION	DESCRIPTION OF DAMAGE	DANGER
71			Water Spout	Stone water spout without any enclosures.	No structures around the stone spout.	
72			Open Shrine	Open Shrine of many deities, is closed three sides by brick walls.

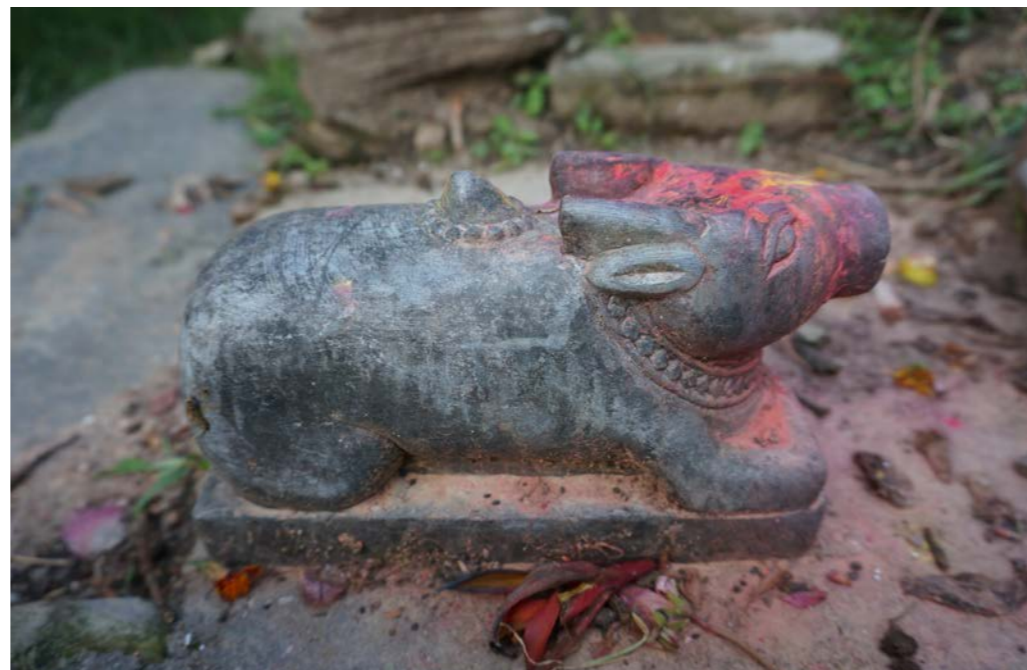
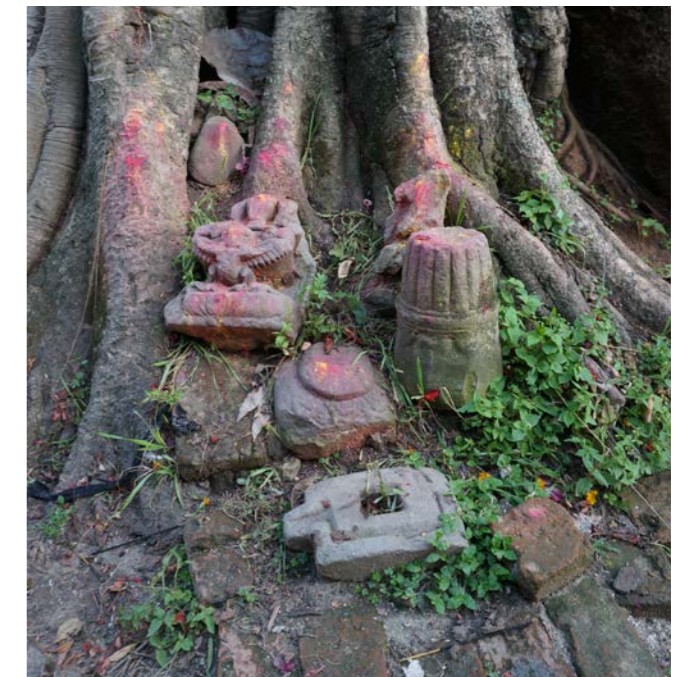
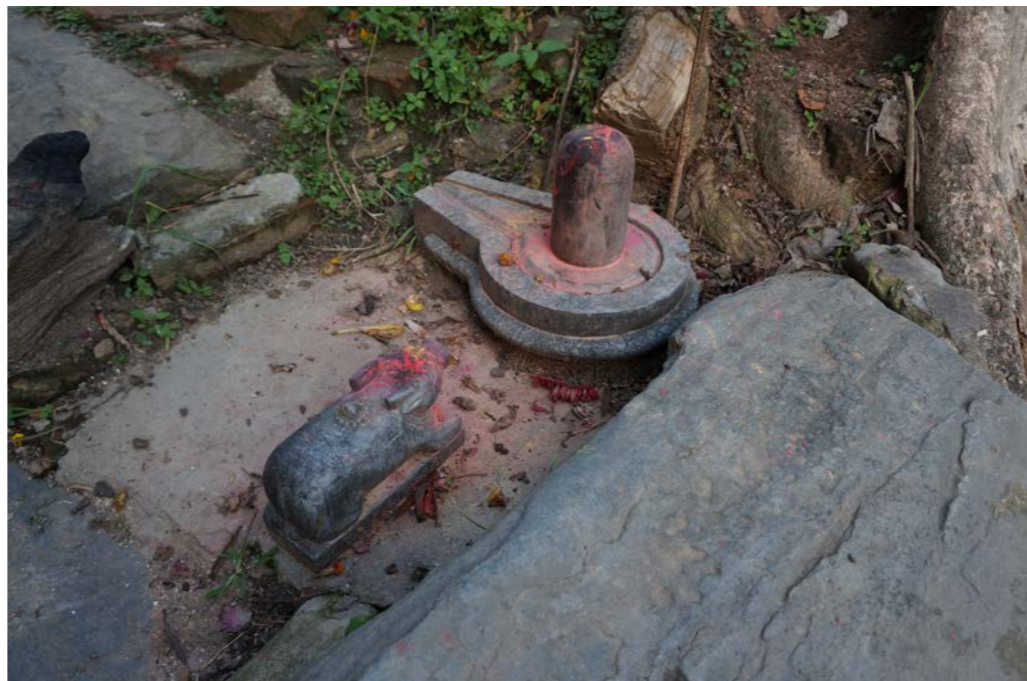
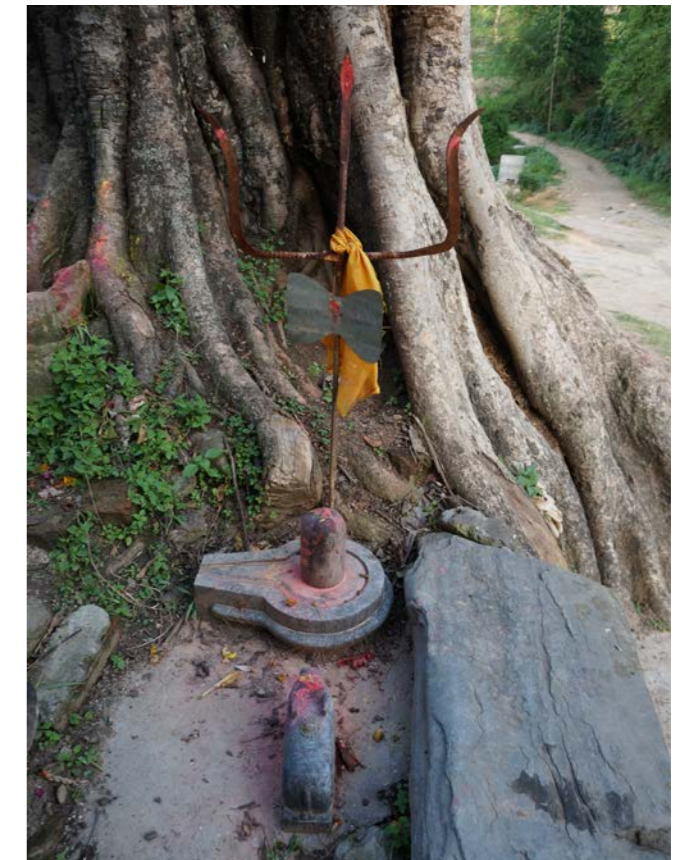
73 SHRINE

NUMBER	NAME	DATE A.D.	TPOLOGY	GENERAL DESCRIPTION	DESCRIPTION OF DAMAGE	DANGER
73			Open shrine	Open shrine below <i>peepal</i> tree There are statues of <i>shiva linga</i> , <i>nandi</i> etc.	Broken image of Garuda Narayan
