2015 Earthquake Damage Mapping
Changunarayan Monument Zone
Kathmandu Valley World Heritage Property

November 2015

This assessment was supported by
UNESCO Office in Kathmandu

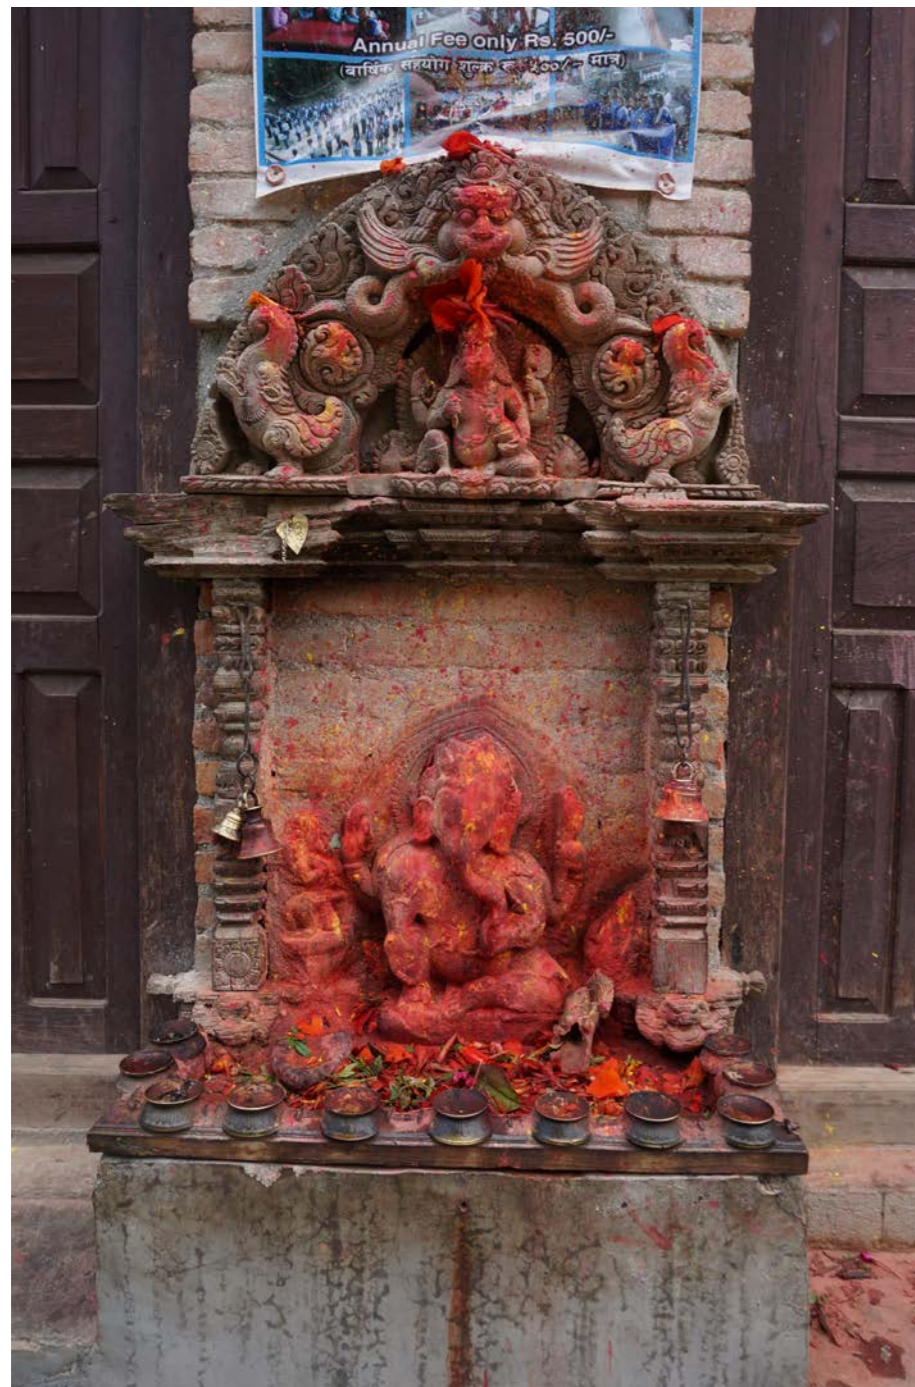
76 GANESH SHRINE

NUMBER	NAME	DATE A.D.	TYPOLOGY	GENERAL DESCRIPTION	DESCRIPTION OF DAMAGE	DANGER
76	Ganesh Mandir		Open Shrine	Open shrine with stone statue of <i>Ganesh</i> which is more than 100 years old.	No visible damage	
77	Magam Tole Falcha		<i>Pati</i>	Brick walled pati with tiled roof.	Roof is delapidated. Half of roof has collapsed.	⚠

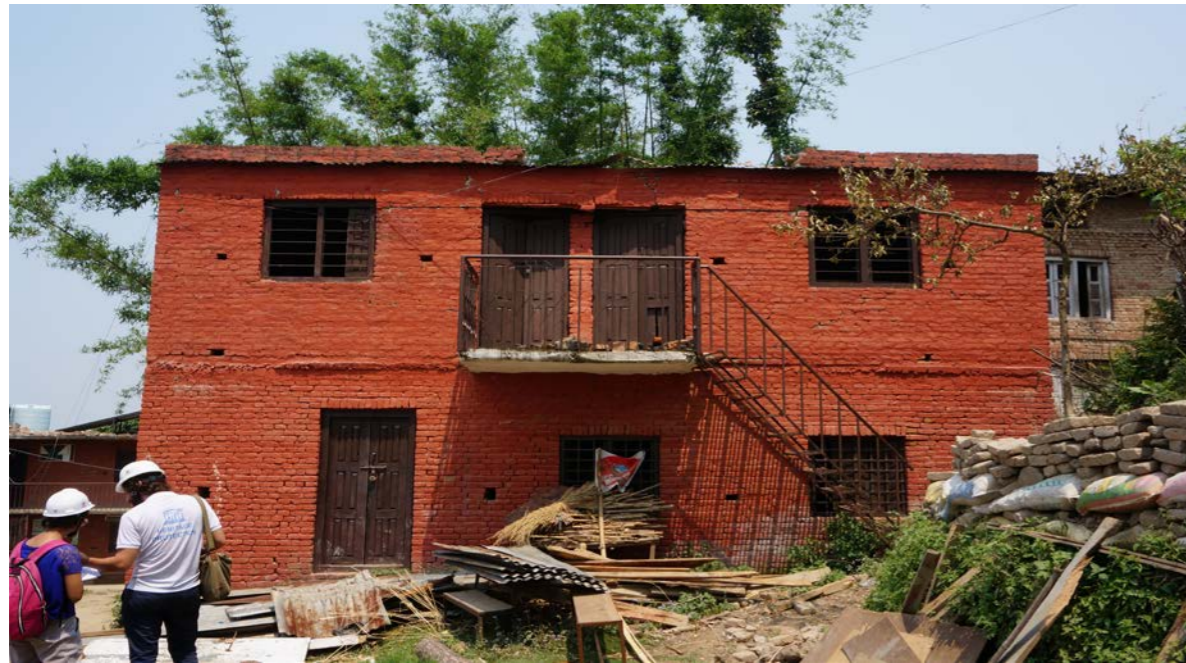
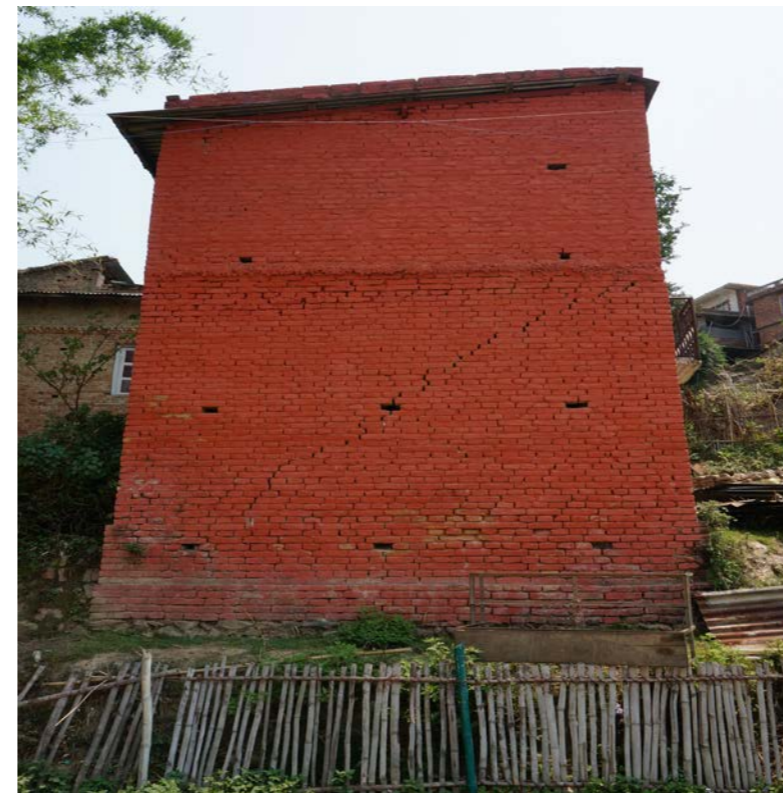
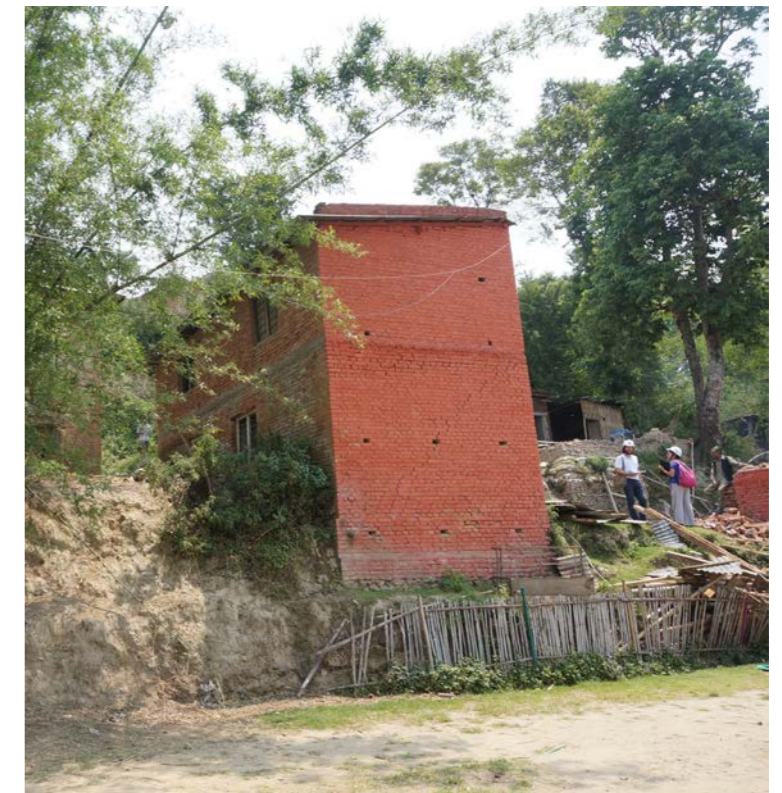
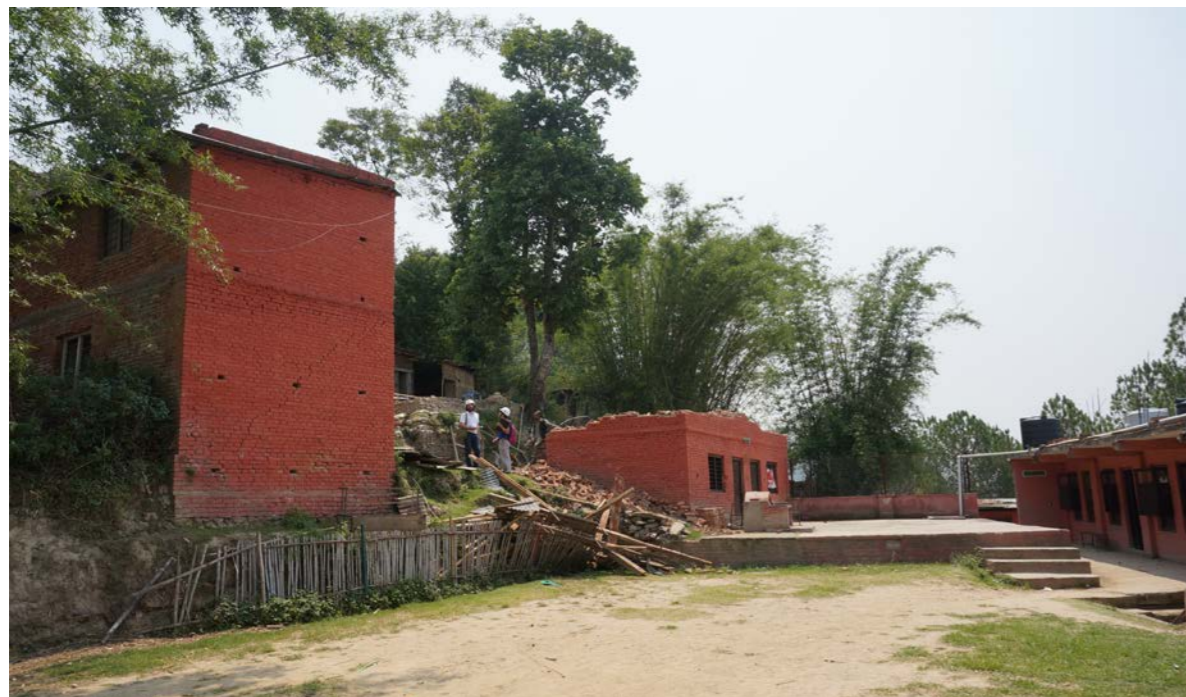
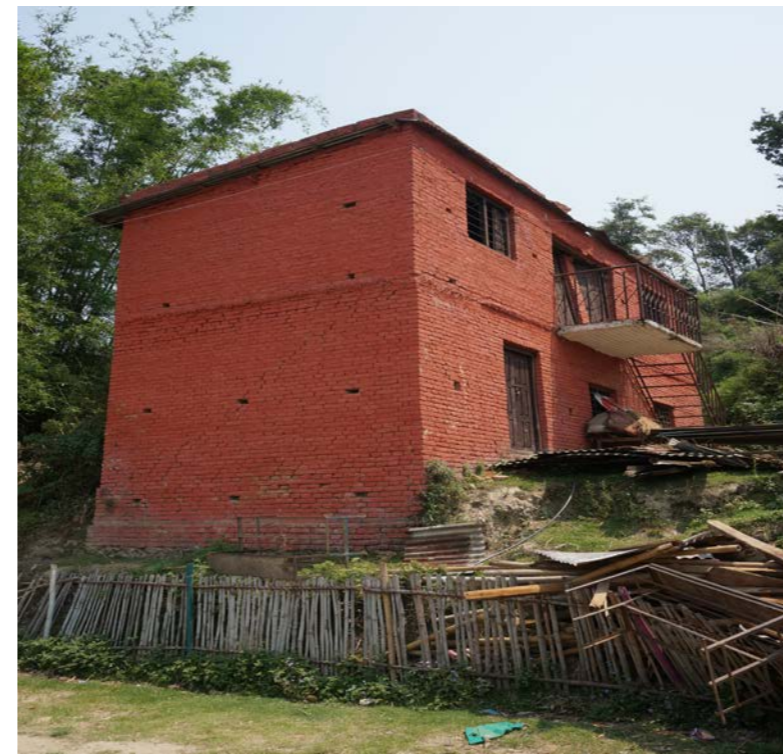
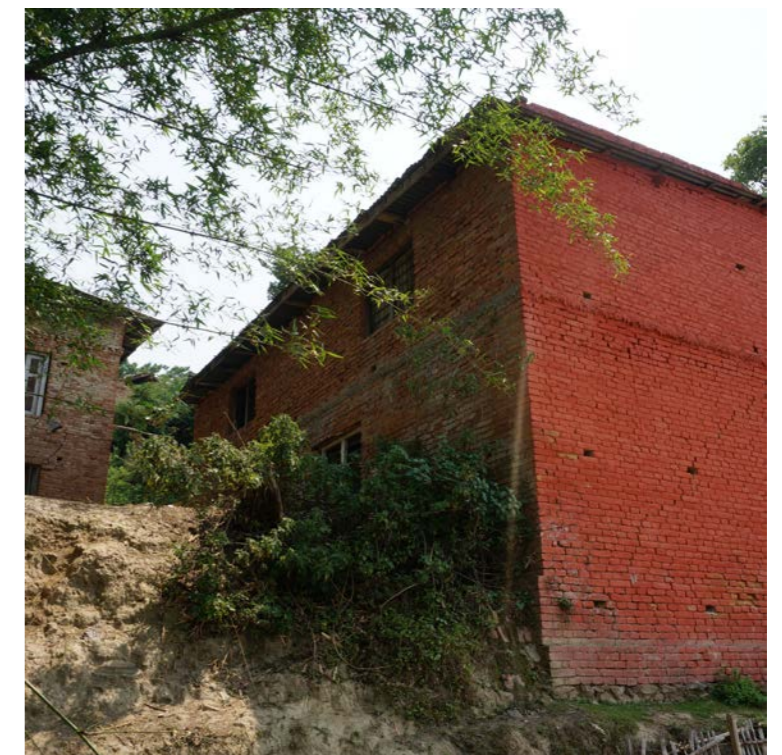
4. DOLAGIRI HIGH SECONDARY SCHOOL

NUMBER	NAME	DATE A.D.	TYOLOGY	GENERAL DESCRIPTION	DESCRIPTION OF DAMAGE	DANGER	
4	Dolagiri H.S. School Pancha Narayan Bhadel (Principal) 9841430973		School	G+1 Load bearing structure. Brick and concrete structure.	Major cracks are seen.

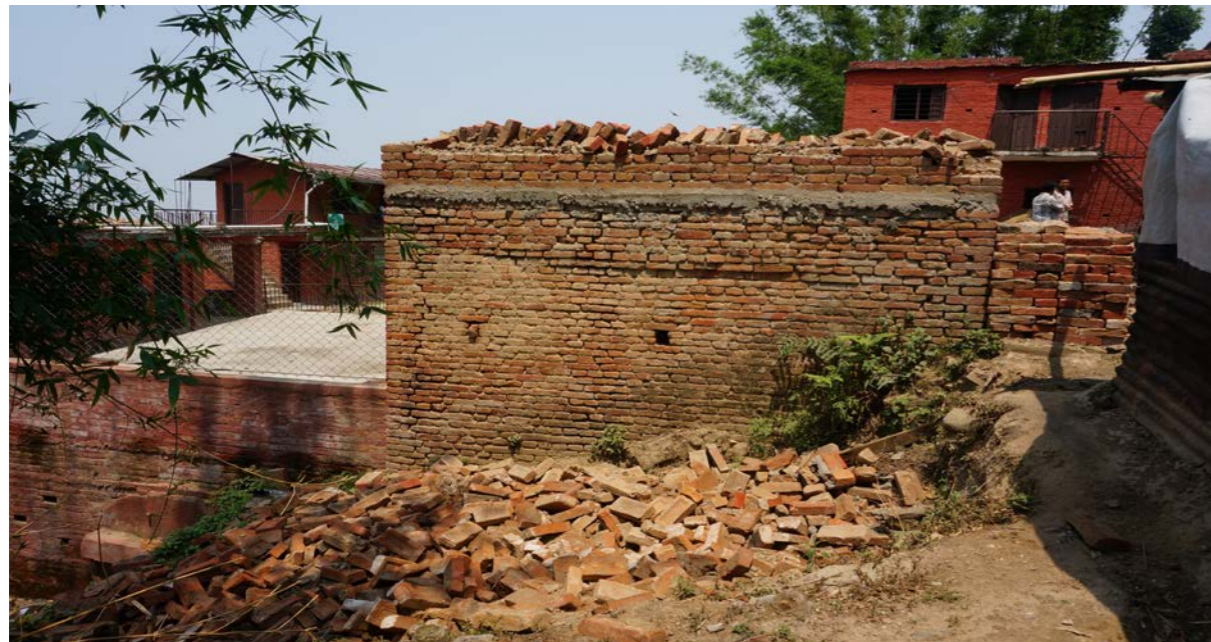
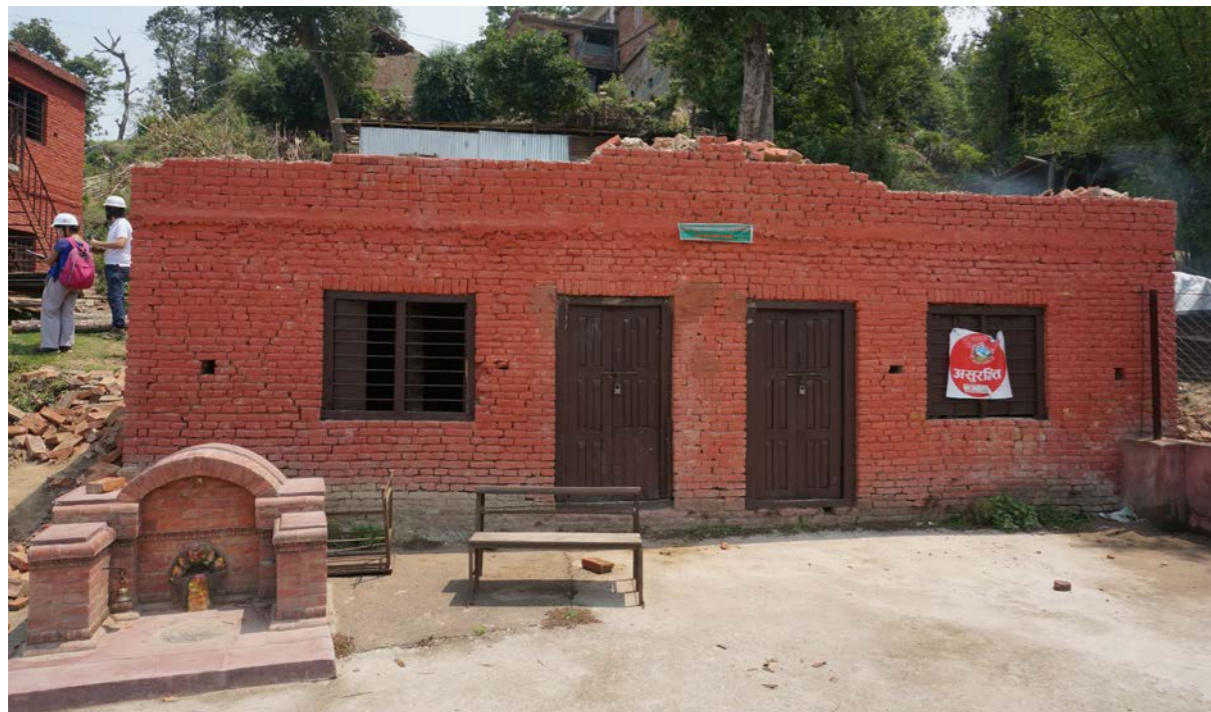
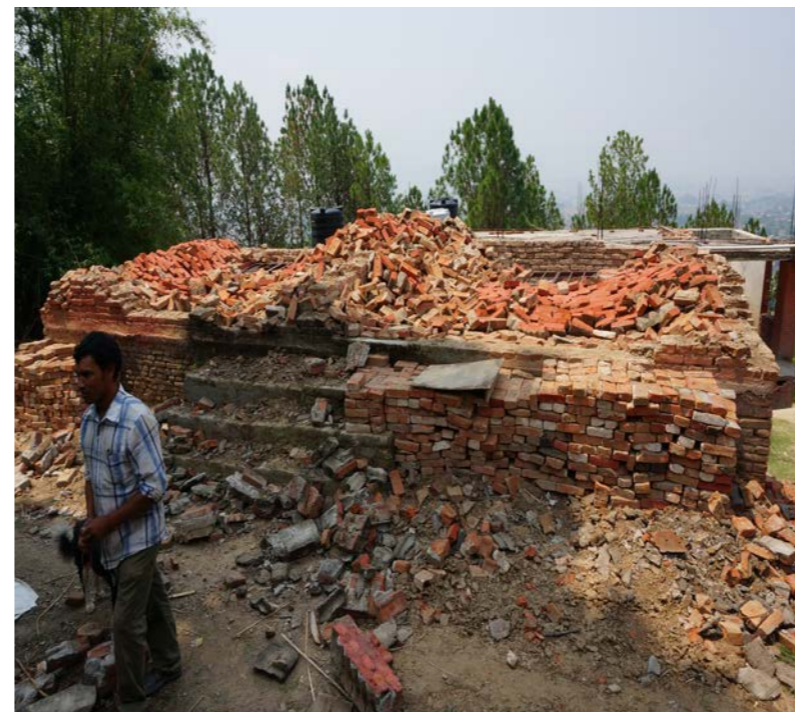
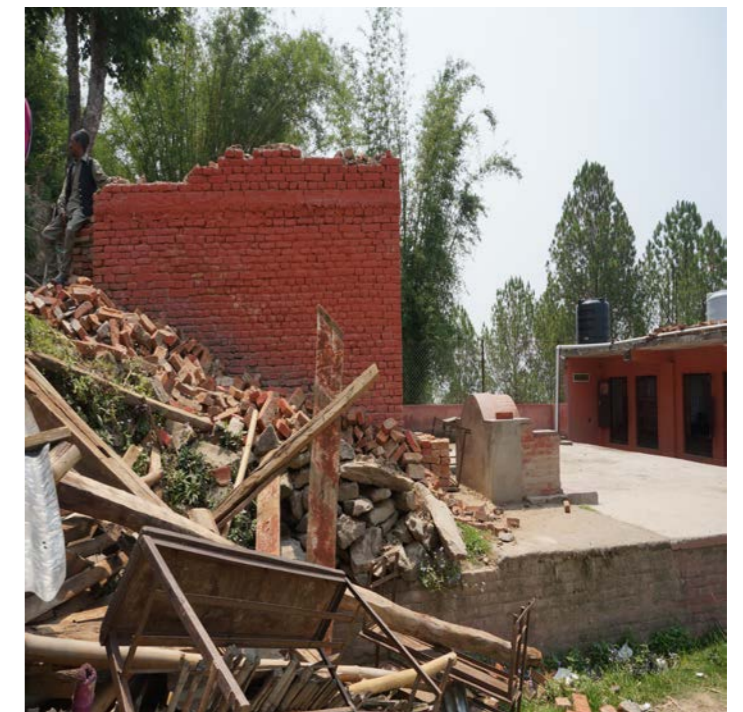
5 DOLAGIRI HIGH SECONDARY SCHOOL

NUMBER	NAME	DATE A.D.	TYPOLOGY	GENERAL DESCRIPTION	DESCRIPTION OF DAMAGE	DANGER	
5	Dolagiri H.S. School Pancha Narayan Hadel (Principal) 9841430973		School	G+1 Load bearing, Brick and concrete structure.	First floor collapsed. Ground floor is unstable

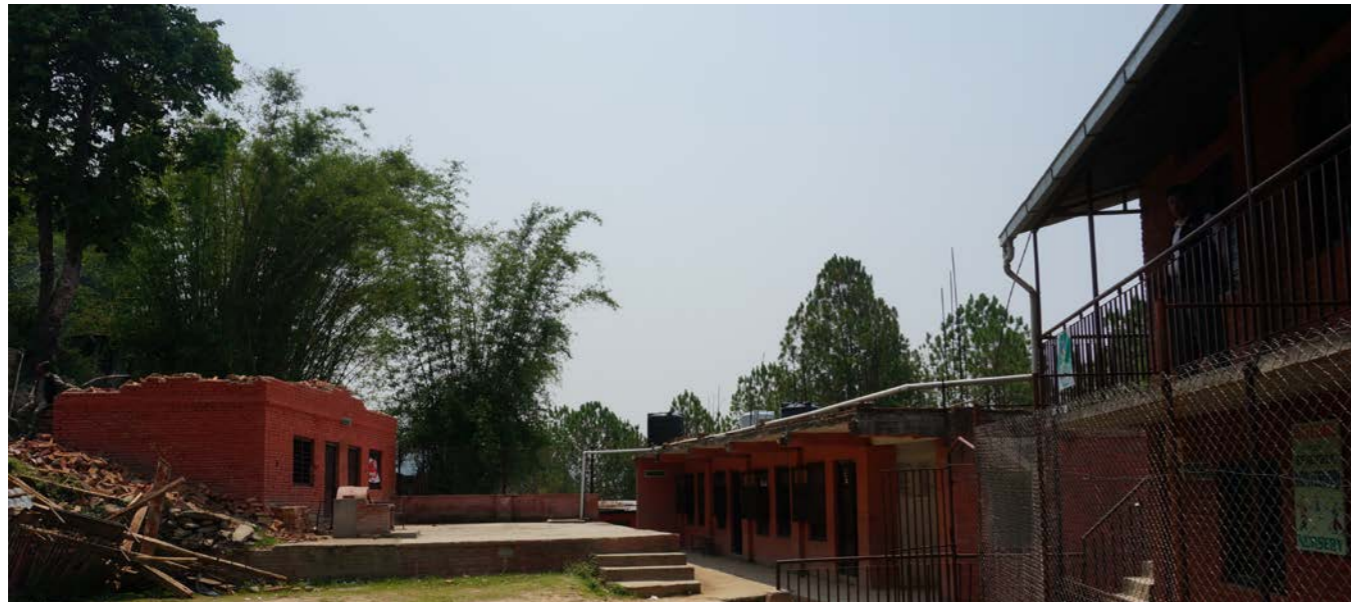
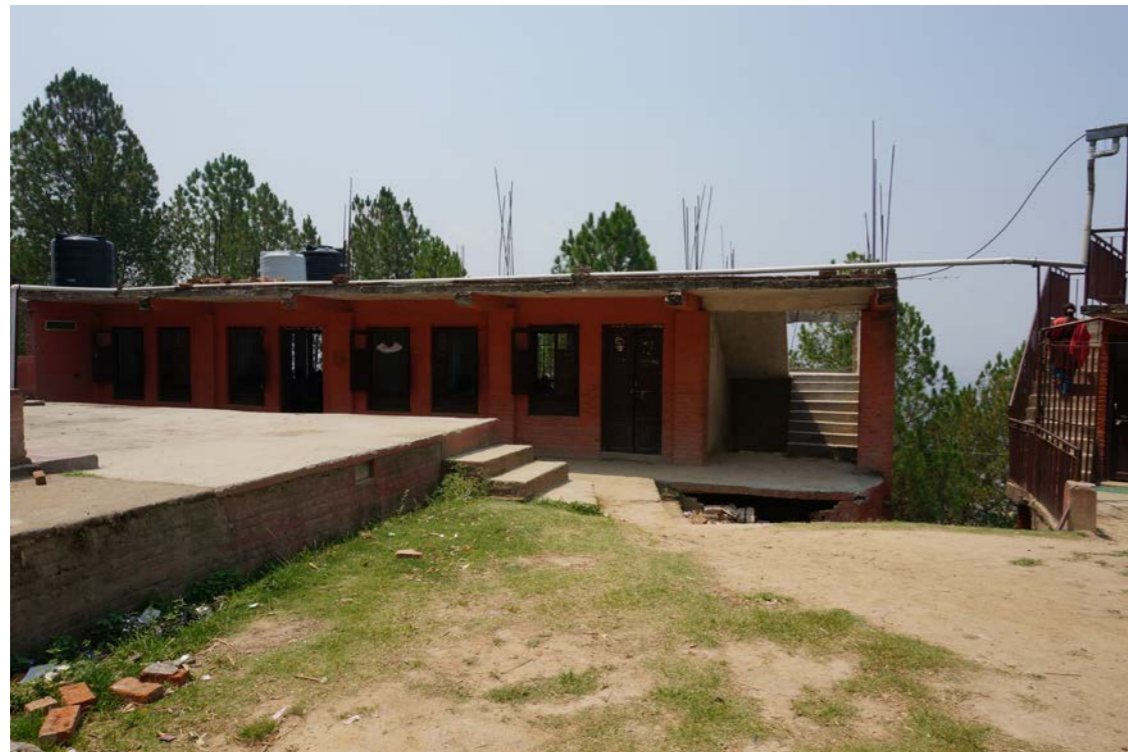
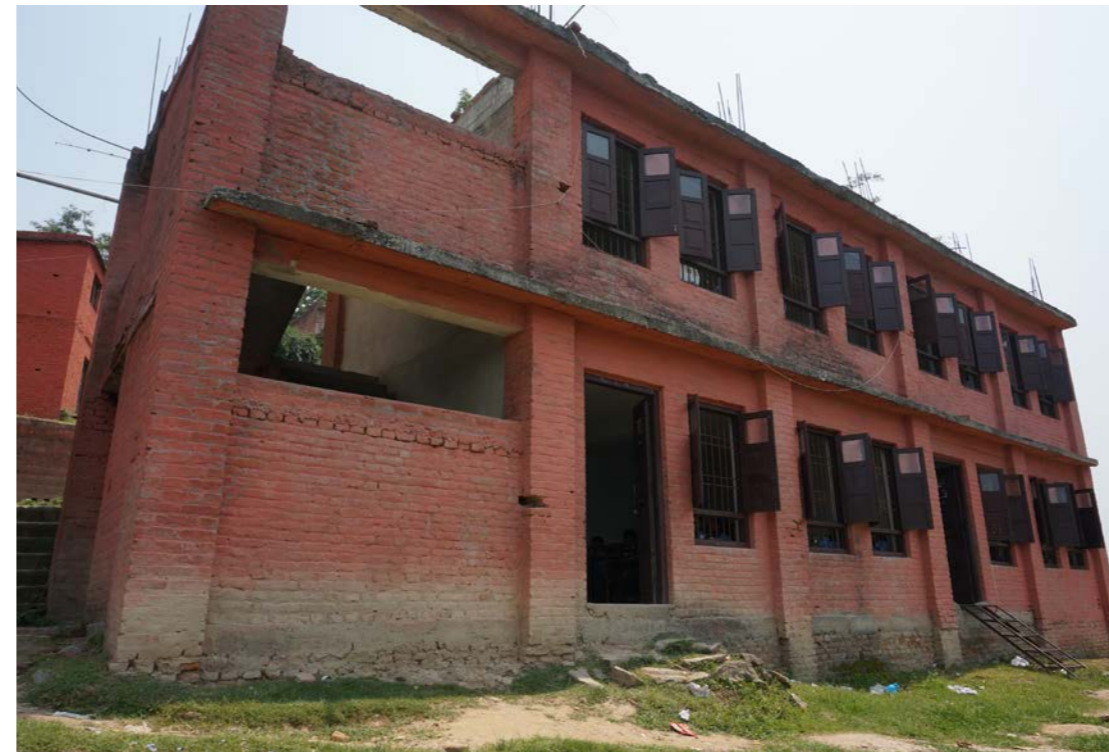
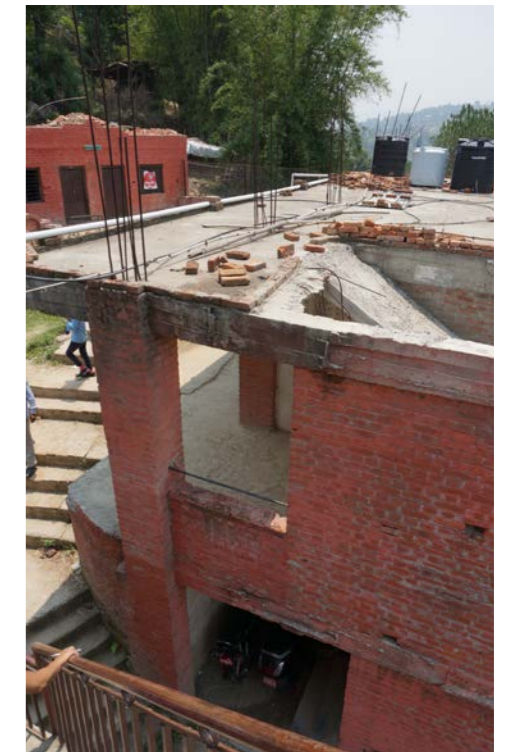
7 DOLAGIRI HIGH SECONDARY SCHOOL

NUMBER	NAME	DATE A.D.	TPOLOGY	GENERAL DESCRIPTION	DESCRIPTION OF DAMAGE	DANGER	
7	Dolagiri H.S. School Pancha Narayan Bhadel (Principal) 9841430973		School	G+1 Concrete structure.	Minor cracks in infill walls

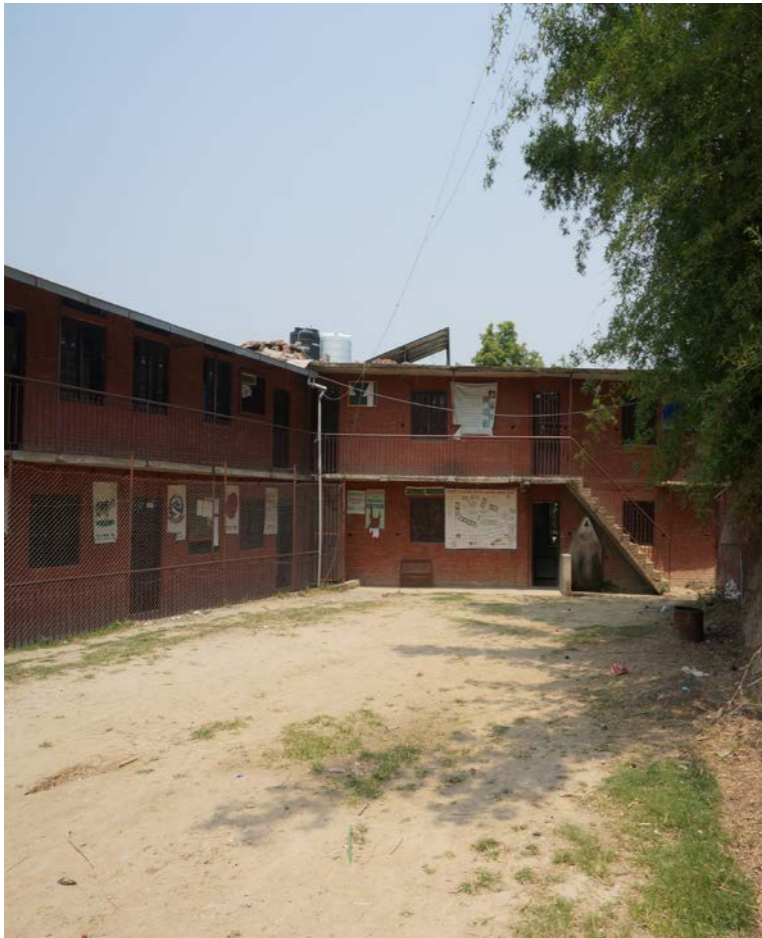
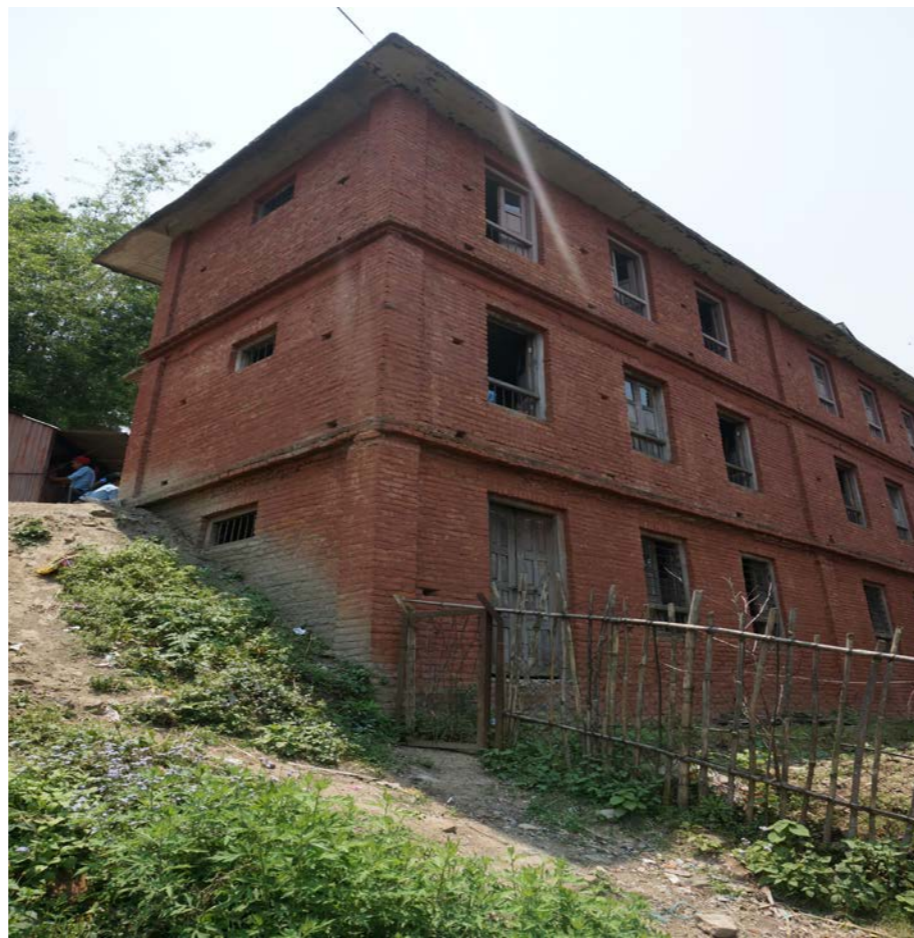
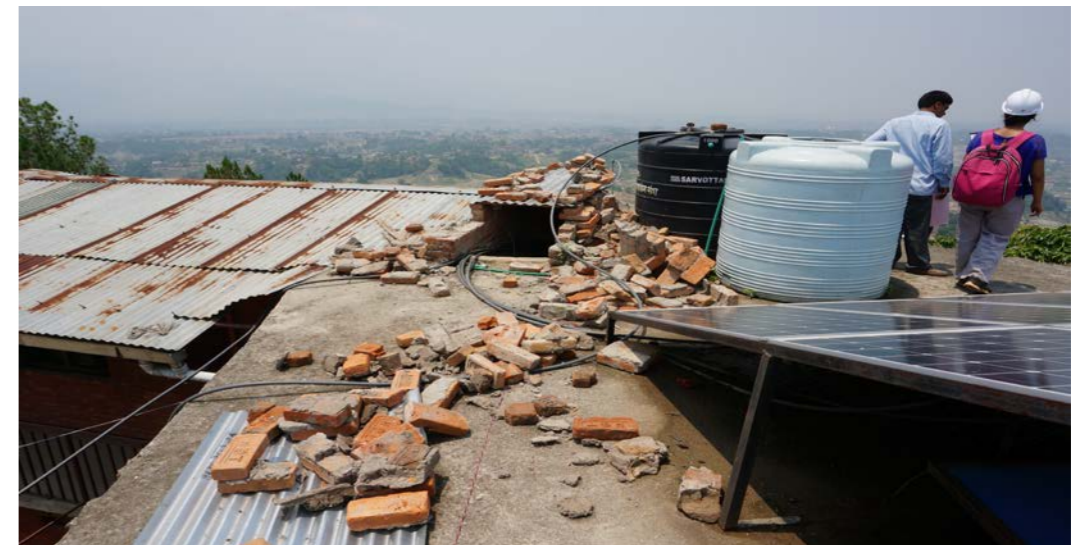
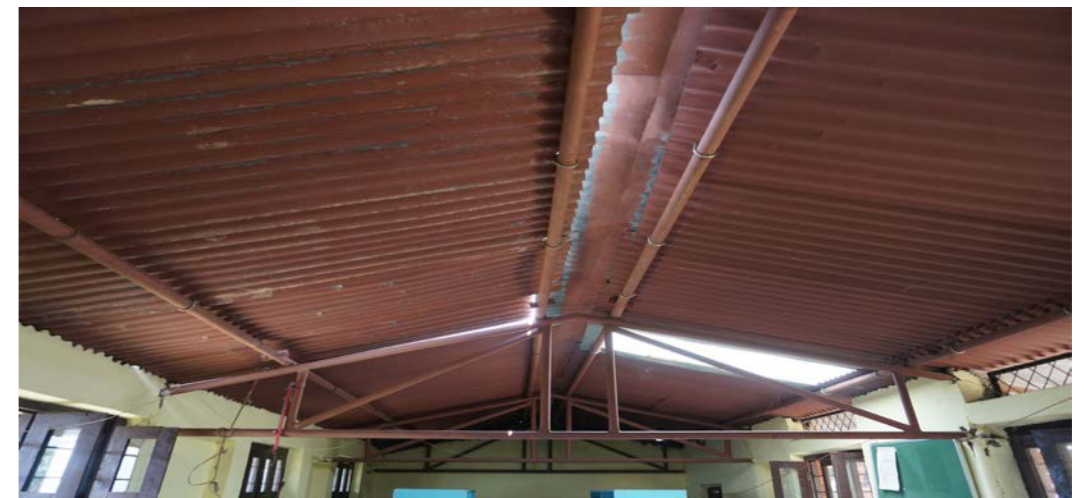
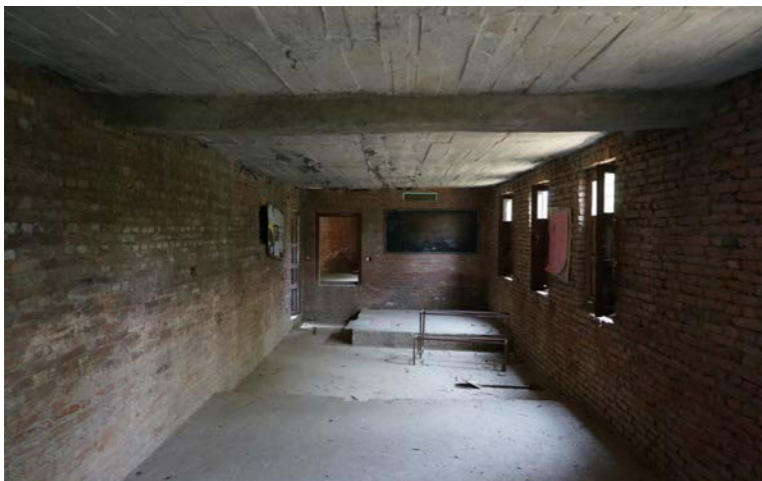
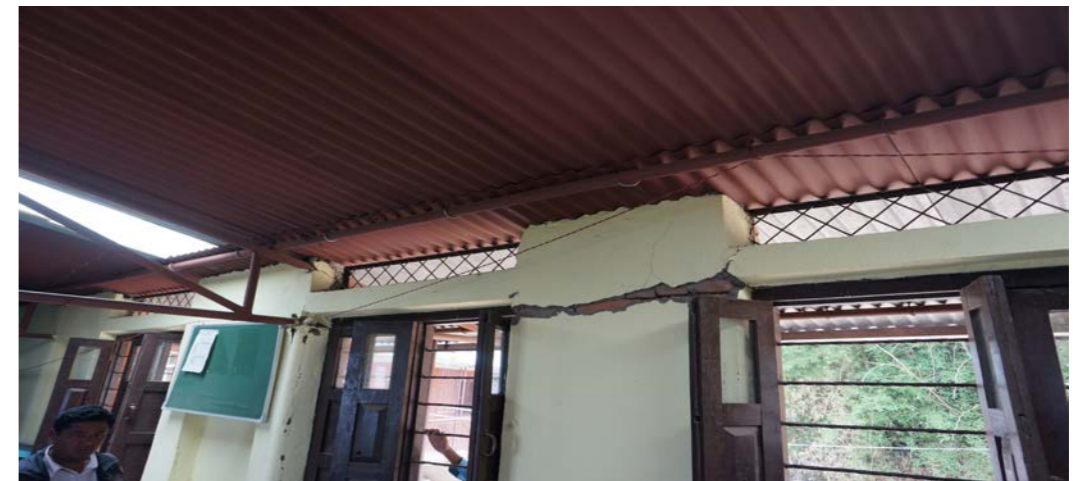
8 DOLAGIRI HIGH SECONDARY SCHOOL

NUMBER	NAME	DATE A.D.	TYPOLOGY	GENERAL DESCRIPTION	DESCRIPTION OF DAMAGE	DANGER
8	Dolagiri H.S. School [Pancha Narayan Bhadel Principal 9841430973]		School	G+2 Brick and concrete structure	Minor cracks. Needs repair and replacement of CGI sheet in roof. Rising Dampness.

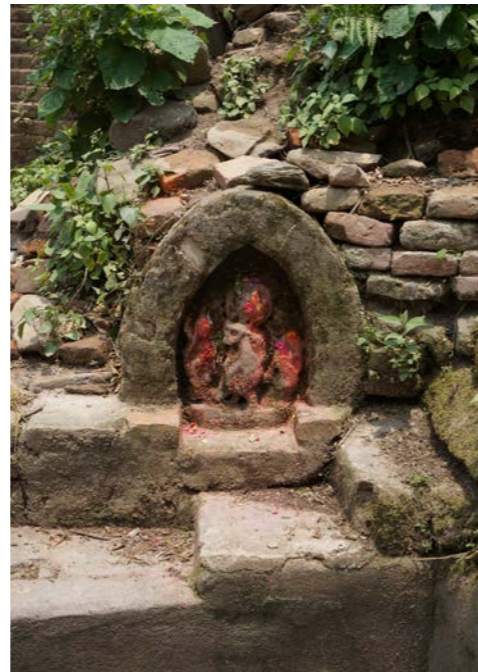
13 PUBLIC WATER TAP

NUMBER	NAME	DATE A.D.	TPOLOGY	GENERAL DESCRIPTION	DESCRIPTION OF DAMAGE	DANGER
10			Public water tank	Stone and concrete structure	The tank is not in use currently. A stone on top of it is missing.	
13			Water tap	Sculpture of Krishna and Radha	No visible damage	
44			Public Water tank	Concrete and brick structure.	Water leakage from the tank.	
47			Public Toilet	Brick structure with cement mortar	Few roof tiles are missing.

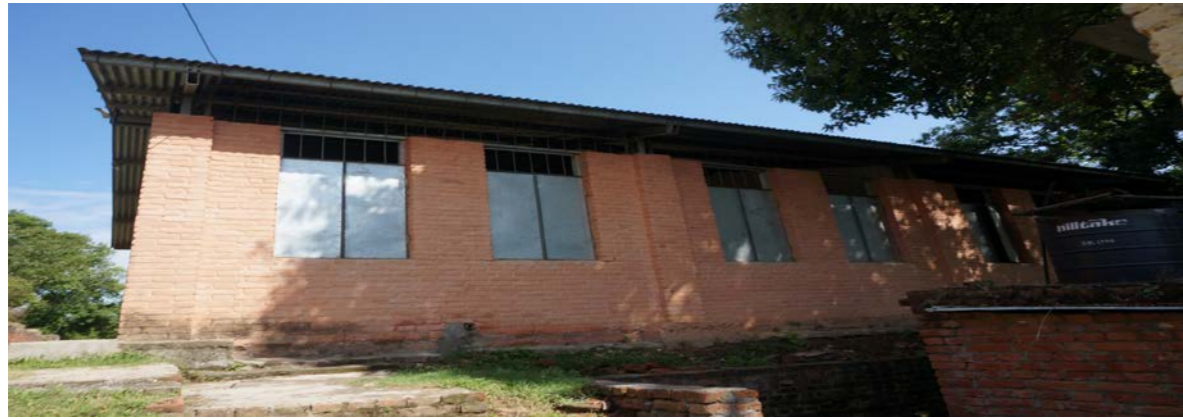
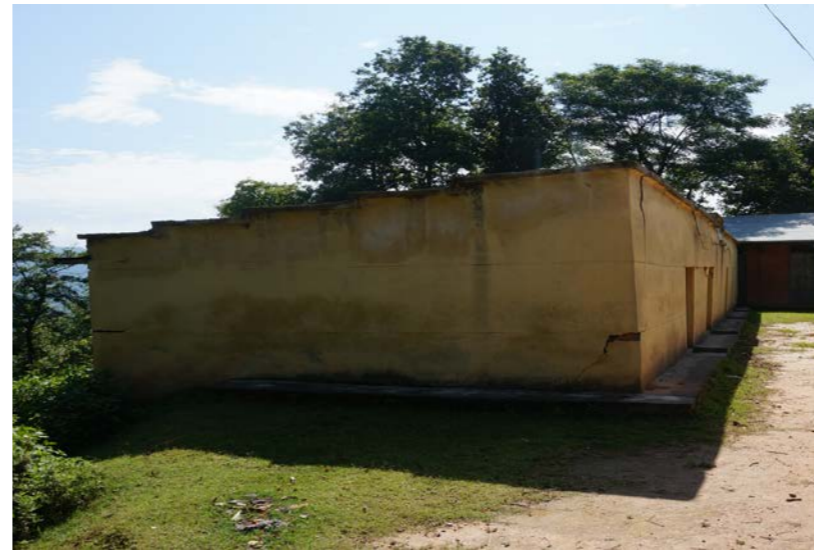
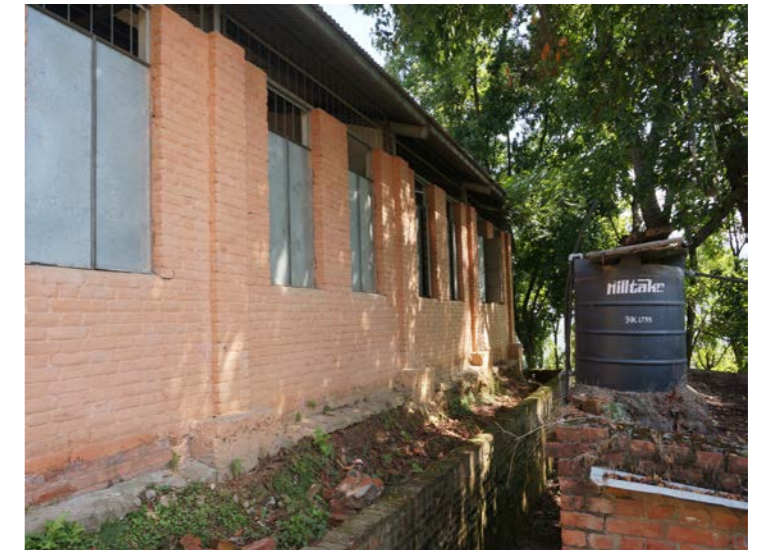
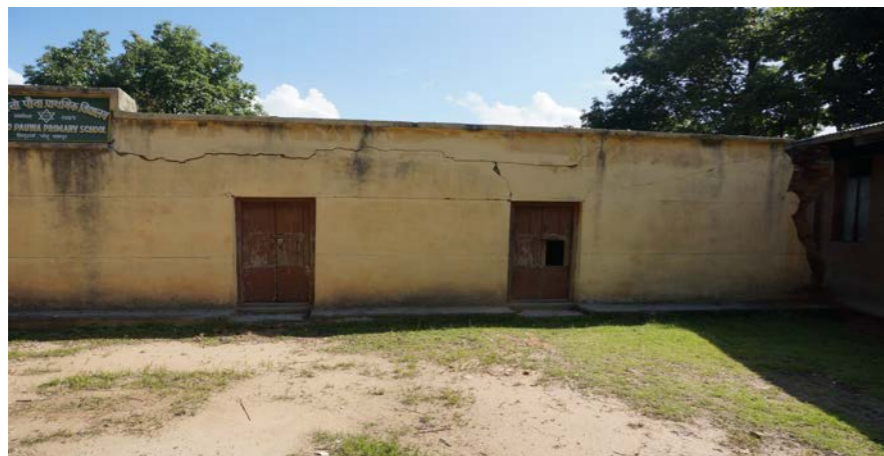
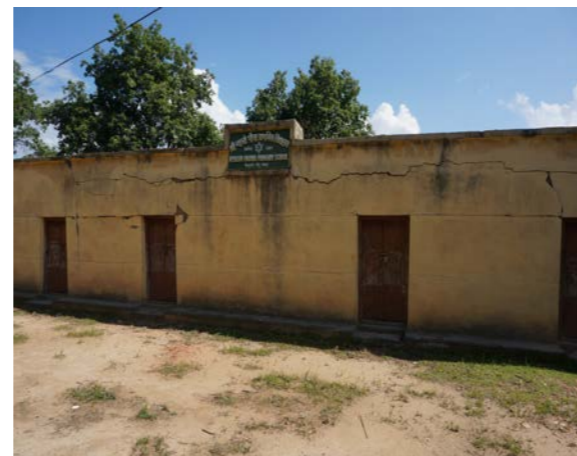
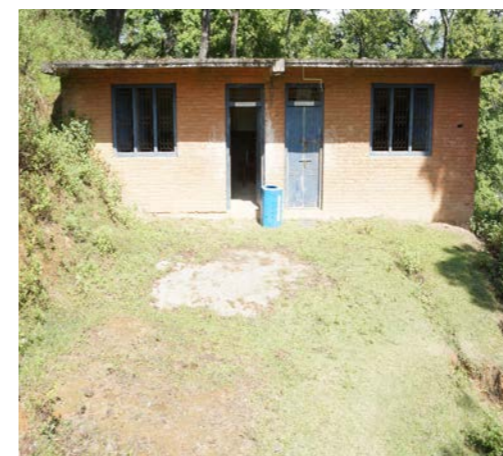
60,61 &62 NYACHO PAUWAA PRIMARY SCHOOL

NUMBER	NAME	DATE A.D.	TYPOLOGY	GENERAL DESCRIPTION	DESCRIPTION OF DAMAGE	DANGER	
60 61 62	Nyacho Pauwaa Primary School (Santosh Shrestha - 9841849042)		School	Single storey Brick structure with concrete pillars and CGI roof. Toilet block at the east	Minor cracks on the floor. No other visible damage Major horizontal crack on front façade in ground floor. South east corner collapsed. Northern wall partially collapsed. Vertical separation at south west corner No visible damage.

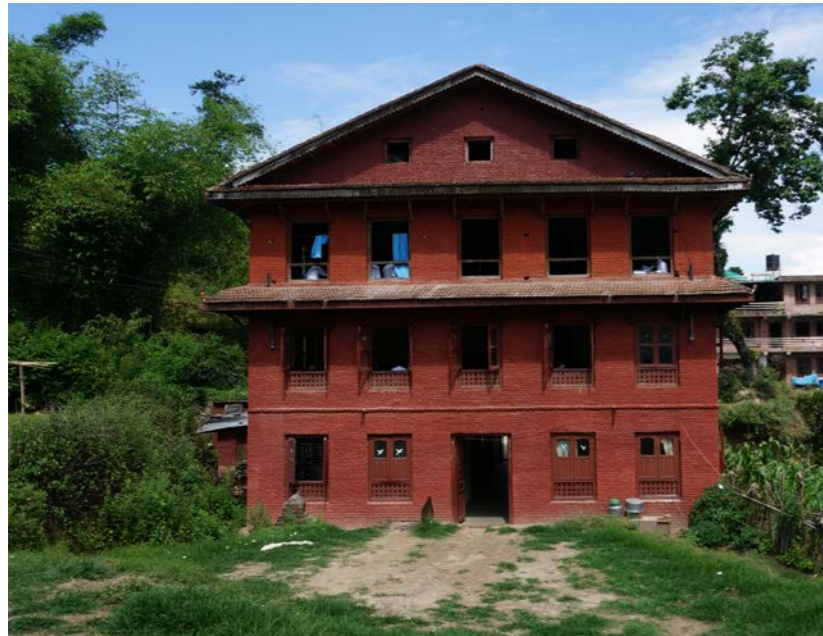
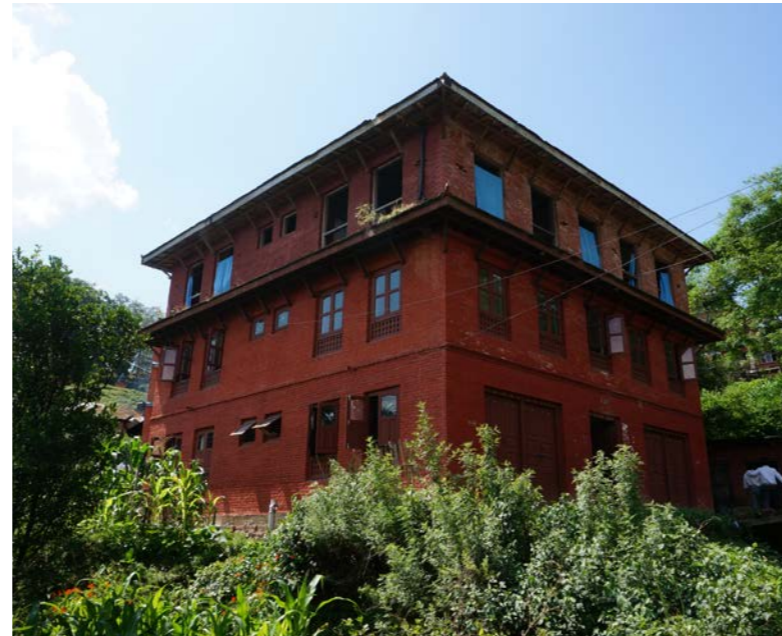
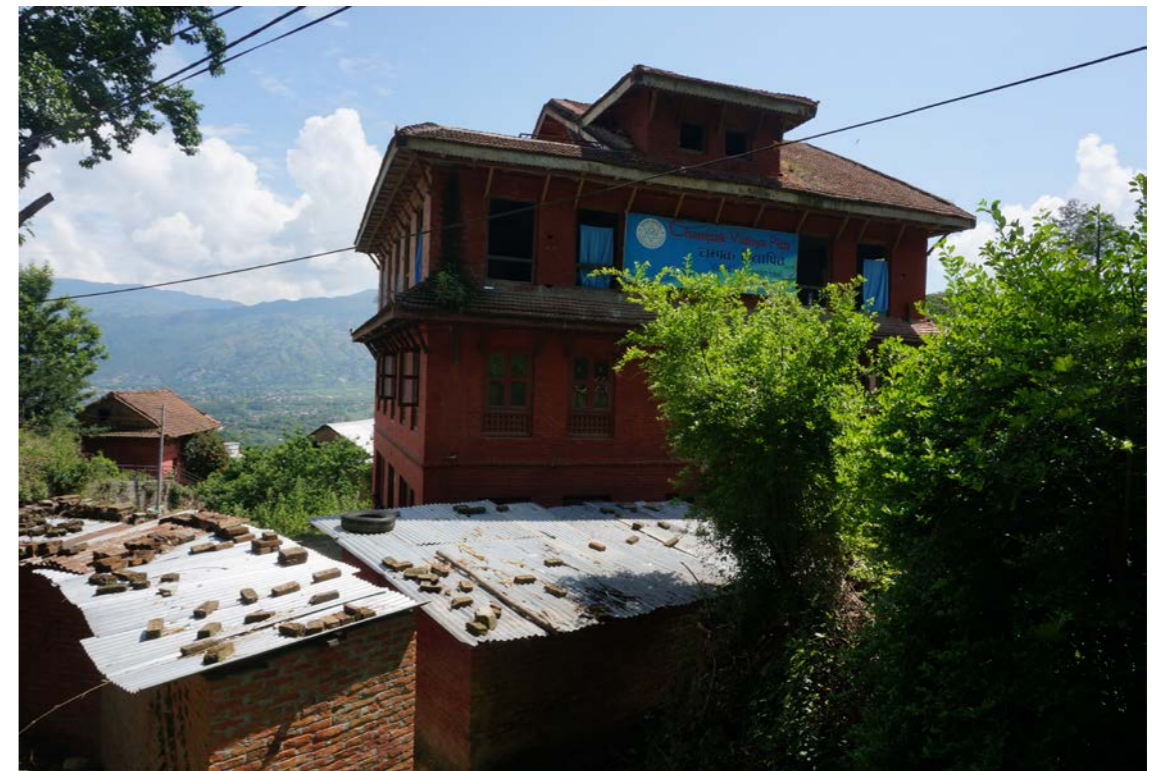
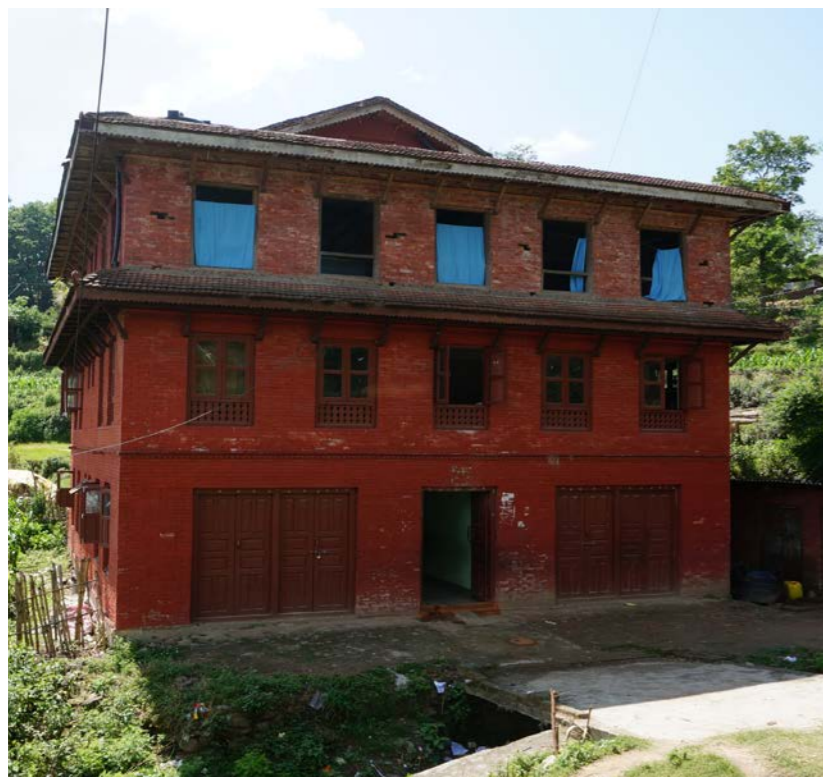
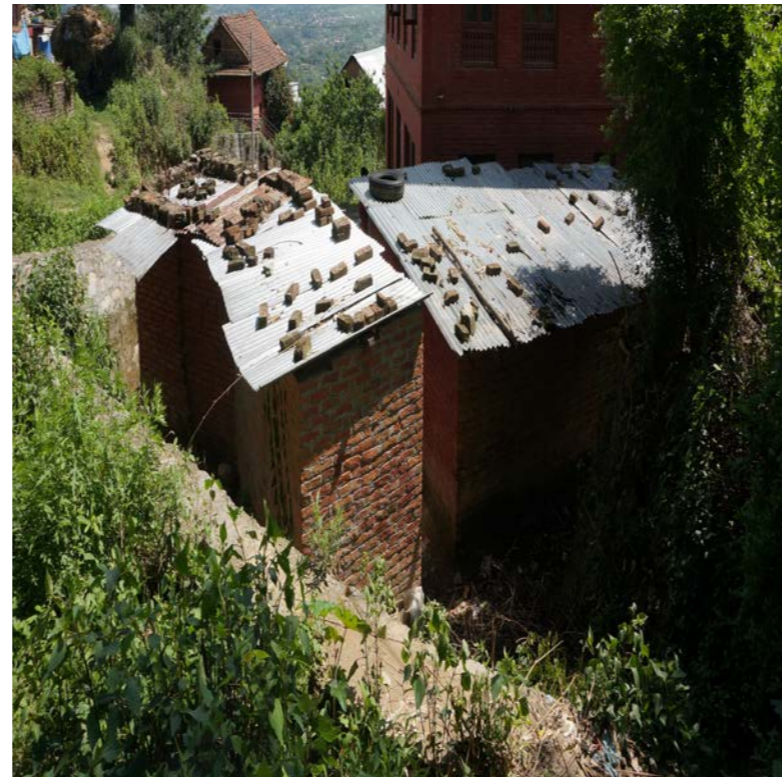
63,65 & 74 CHAMPAK VIDHYA PITH

NUMBER	NAME	DATE A.D.	TYOLOGY	GENERAL DESCRIPTION	DESCRIPTION OF DAMAGE	ANGER
63	Champak Vidhya Pith (Ramesh Suwal - 5141183)		School	G+3 Concrete frame structure	No visible structural damage. Vegetation growth in wall and roof.	
65				G+2 Concrete frame structure	Minor cracks in plaster	
74				Brick structure with wooden rafters and CGI sheet on the Roof.	Vertical cracks in joints of inner walls. Tilted inner walls. No other major damage.

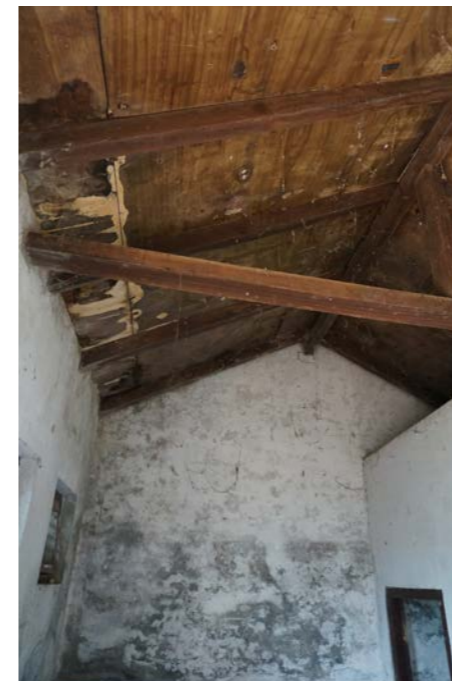
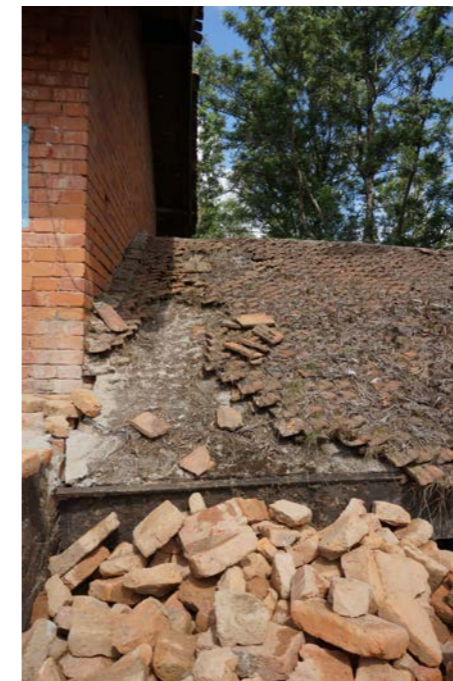
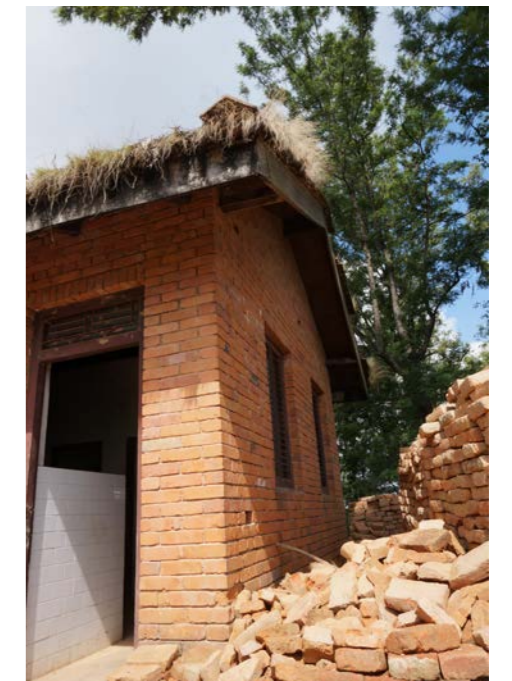
75 PUBLIC TOILET

NUMBER	NAME	DATE A.D.	TYPOLOGY	GENERAL DESCRIPTION	DESCRIPTION OF DAMAGE	DANGER	
75			Public Toilet	Single storey structure. Brick and cement mortar. Jhingati used in roofing.	Roof tiles have fallen. Cracks and slight bulging at left brick pillar near entrance opening. Upper ridge tile damaged. Eave boards and purlins are uncovered.

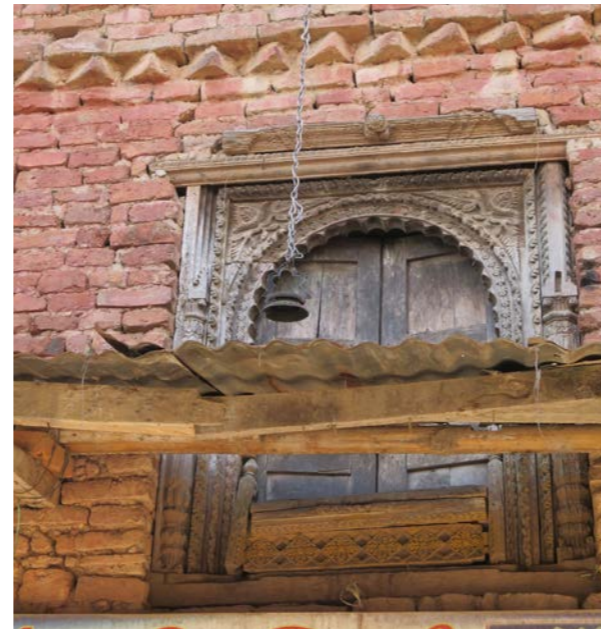
66 PREM BAHADUR BHADEL

NUMBER	CONTACT	STOREY NO. RELATIVE POSITION	STRUCTURAL SYSTEM	DESCRIPTION OF DAMAGE	DANGER	CONDITION
66	Prem Bahadur Bhadel	G+2	B	Cracks on floors and walls		1/3
124	Seti Maya Shrestha	G+3	B	Top floor collapsed. There are cracks on the walls.
