2015 Earthquake Damage Mapping
Changunarayan Monument Zone
Kathmandu Valley World Heritage Property

November 2015

This assessment was supported by
UNESCO Office in Kathmandu

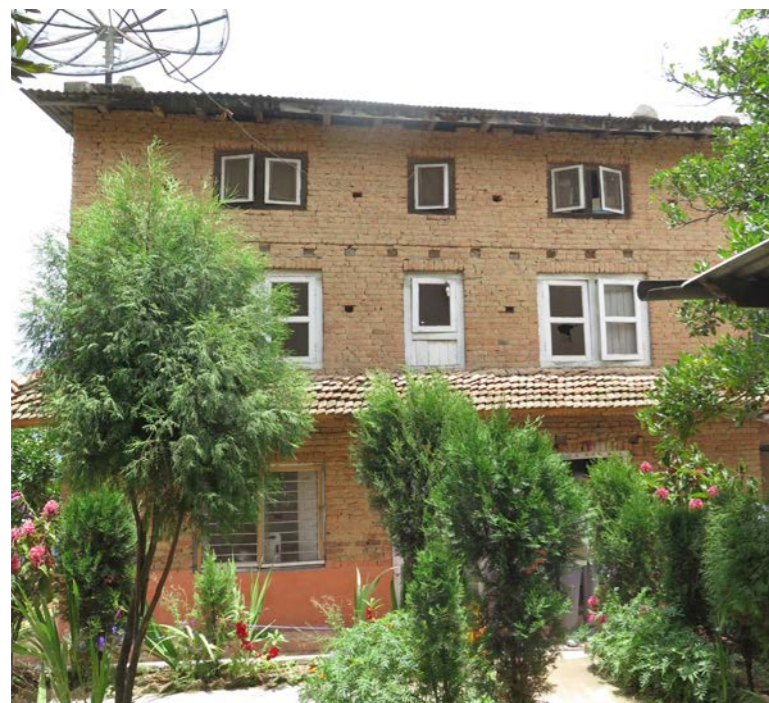
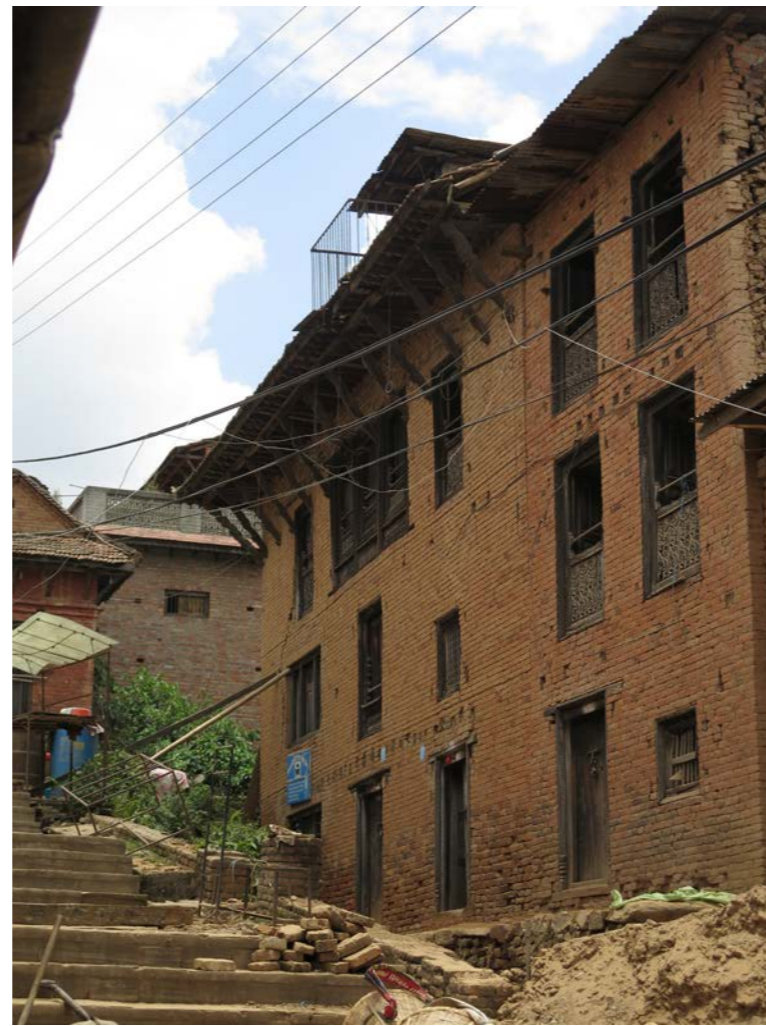
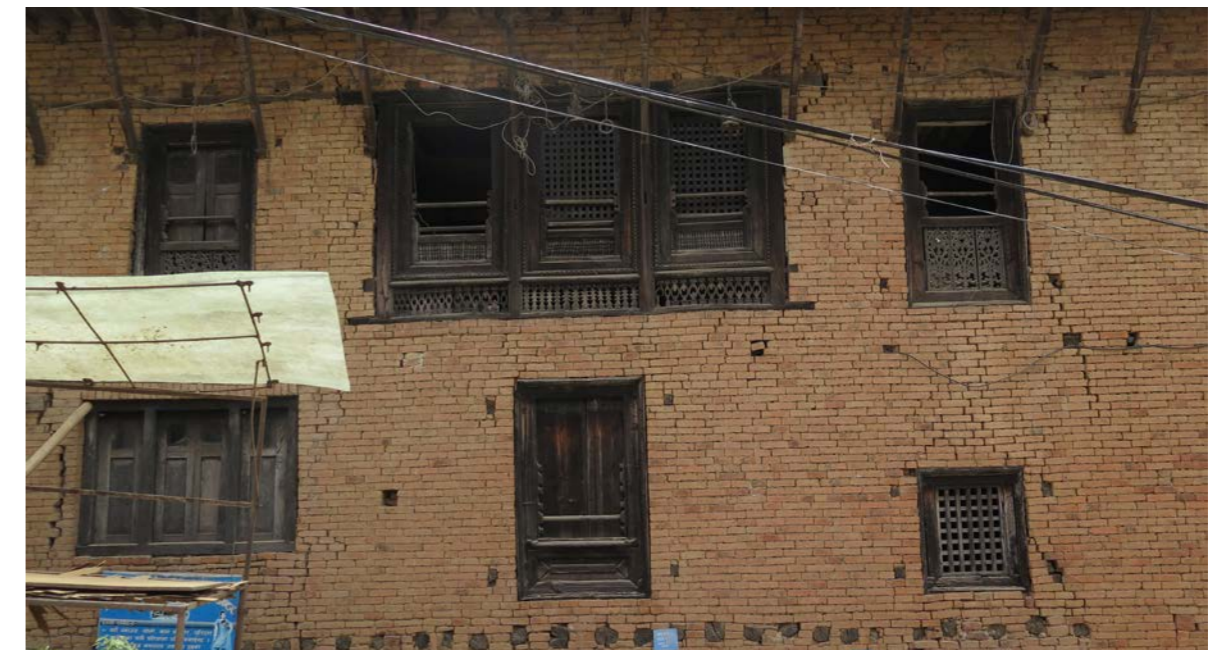
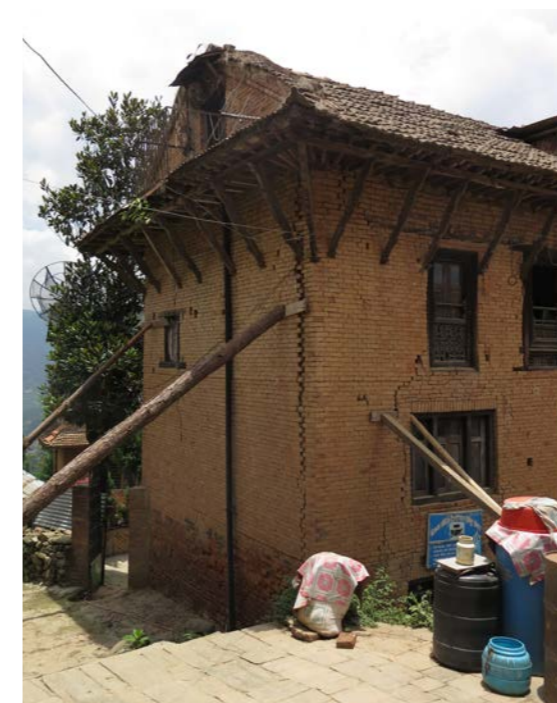
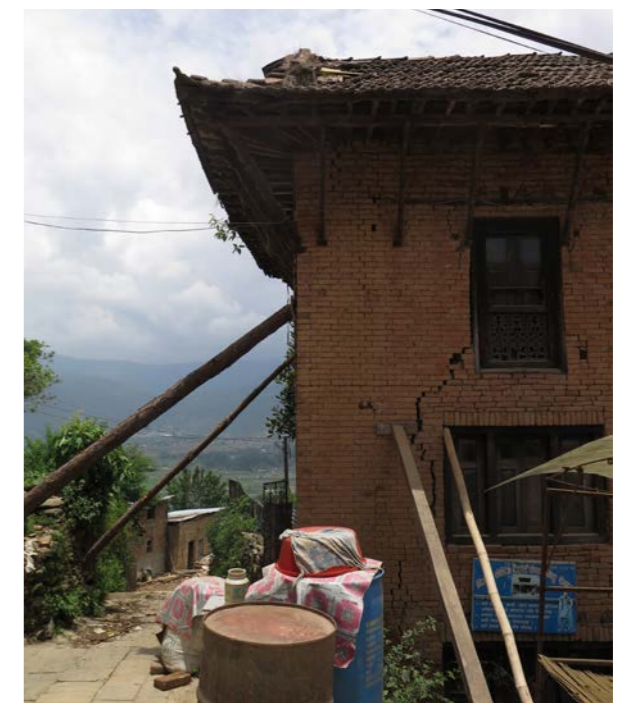
127 SHIVA RAJ SHRESTHA

NUMBER	CONTACT	STOREY NO. RELATIVE POSITION	STRUCTURAL SYSTEM	DESCRIPTION OF DAMAGE	DANGER	CONDITION
127	Shiva Raj Shrestha (9841228Z903)	G+2	B	There are vertical wall cracks and floors deflected.		
128	Baishnav Raj Shrestha (9841848781)	G+3(EH)	B	Second floor slab collapsed and vertical wall cracked

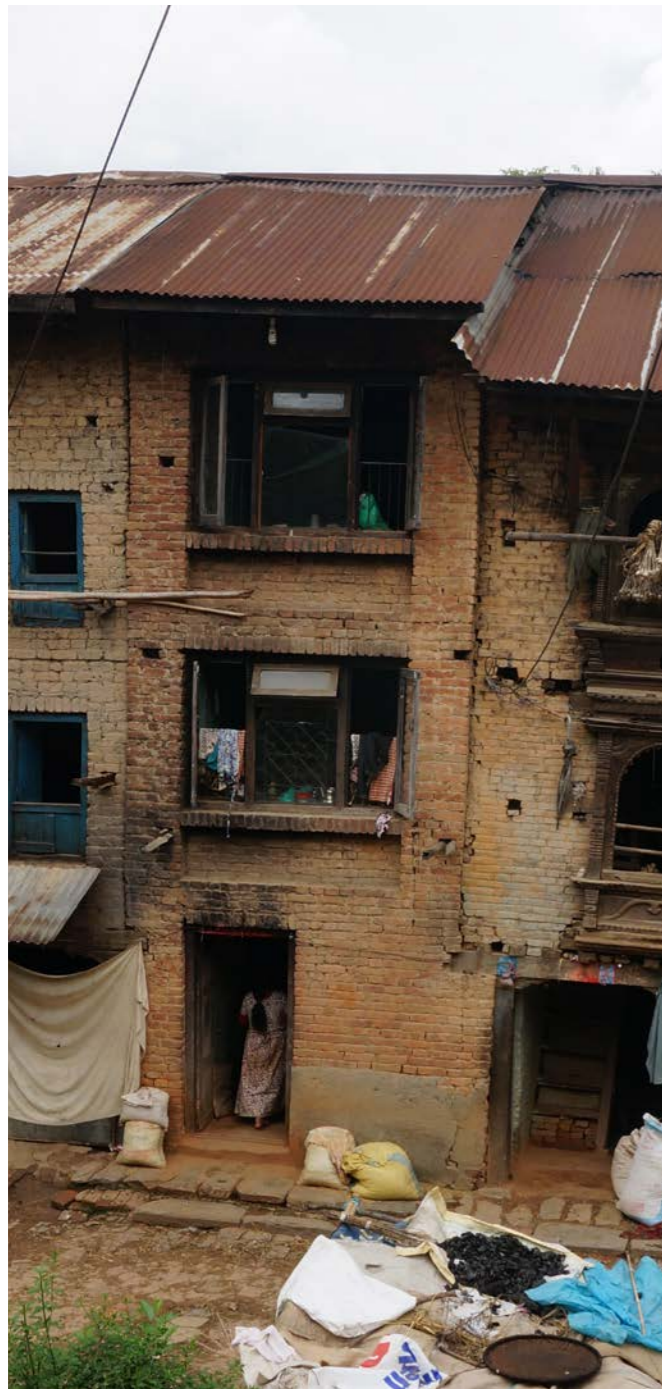
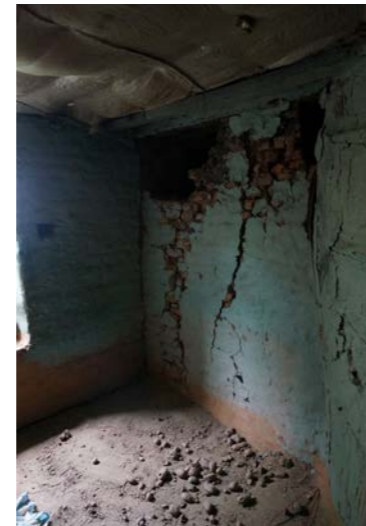
215 CHANDRA L. S.

NUMBER	CONTACT	STOREY NO. RELATIVE POSITION	STRUCTURAL SYSTEM	DESCRIPTION OF DAMAGE	DANGER	CONDITION
215	Chandra L.Shrestha/ Navraj Shrestha 9843453720	G+3	UnB + B	Vertical cracks in corners, diagonal and stepped shear cracks in the walls. Staircase dislocated.		
216	Dherja Bir Shrestha	G+3	UnB + B			
217	Krishna B.Shrestha/ Chakra B Shrestha	G+3	UnB + B
