2015 Earthquake Damage Mapping

Hanuman Dhoka Darbar Square Monument Zone
Kathmandu Valley World Heritage Property

December 2015

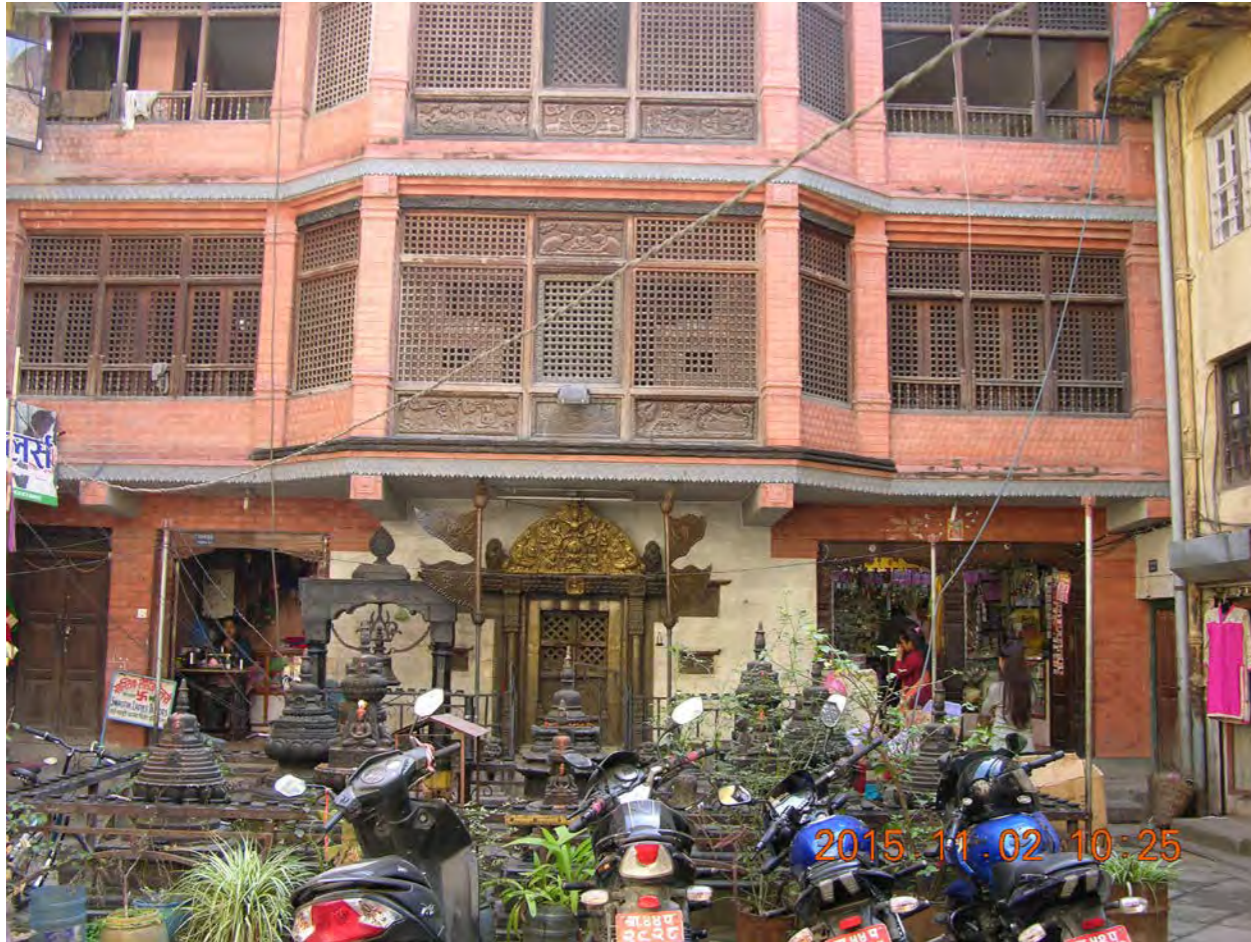
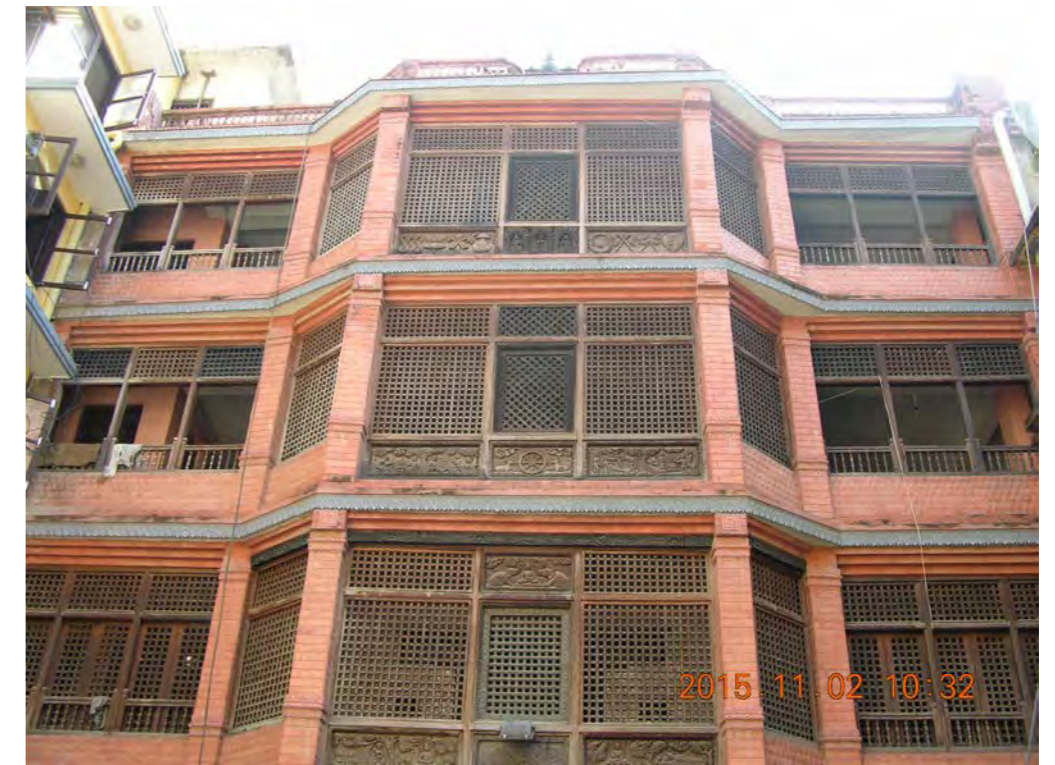
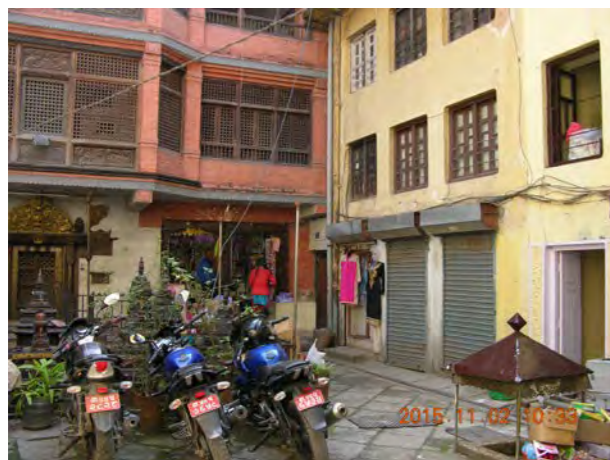
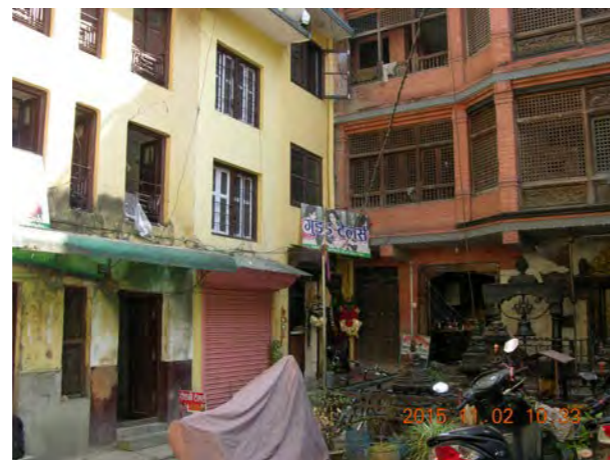
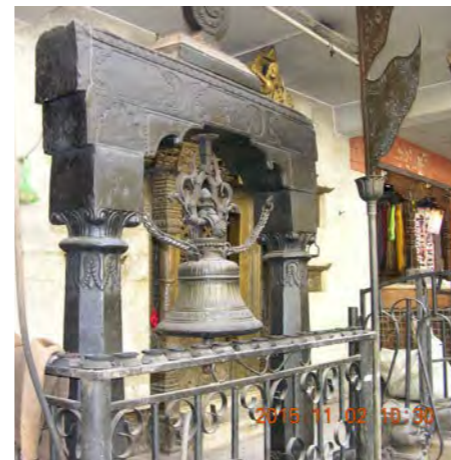
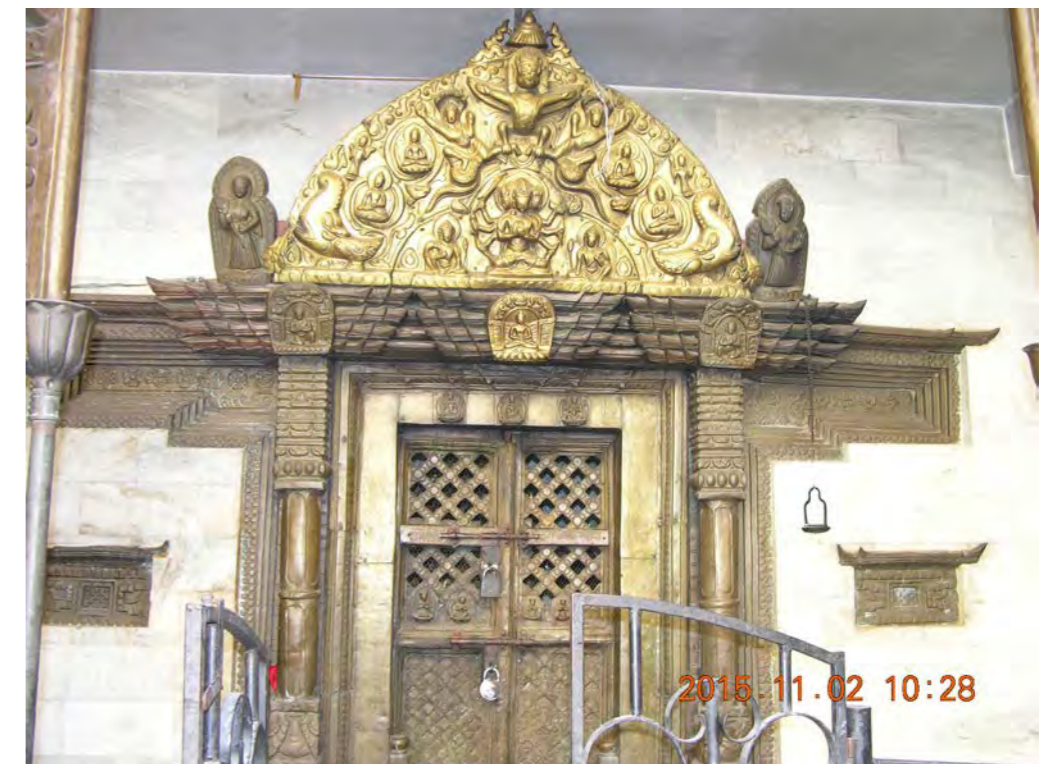
1 MAKHAN BAHIL

CODE NO	TYOLOGY	MONUMENT NAME	ESTABLISHED/ RENOVATED	STRUCTURAL SYSTEM	MATERIAL	GENERAL DESCRIPTION	PROBLEM DESCRIPTION	DANGER	REMARKS
1	Bahal courtyard with shrine	Makhan Bahil	1827, after 1934 & 2013 B.S as per inscrption	Frame	Brick	G+4.5/courtyard with 8 votive chaityas, a mandala stone & the shrine with torana of manjusri	No visible damage

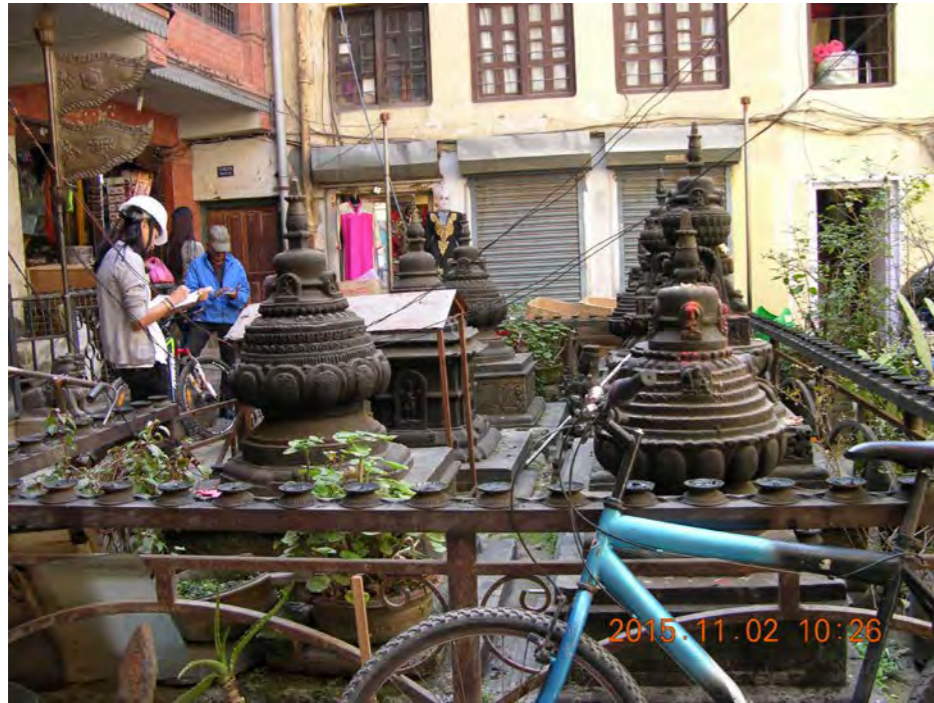
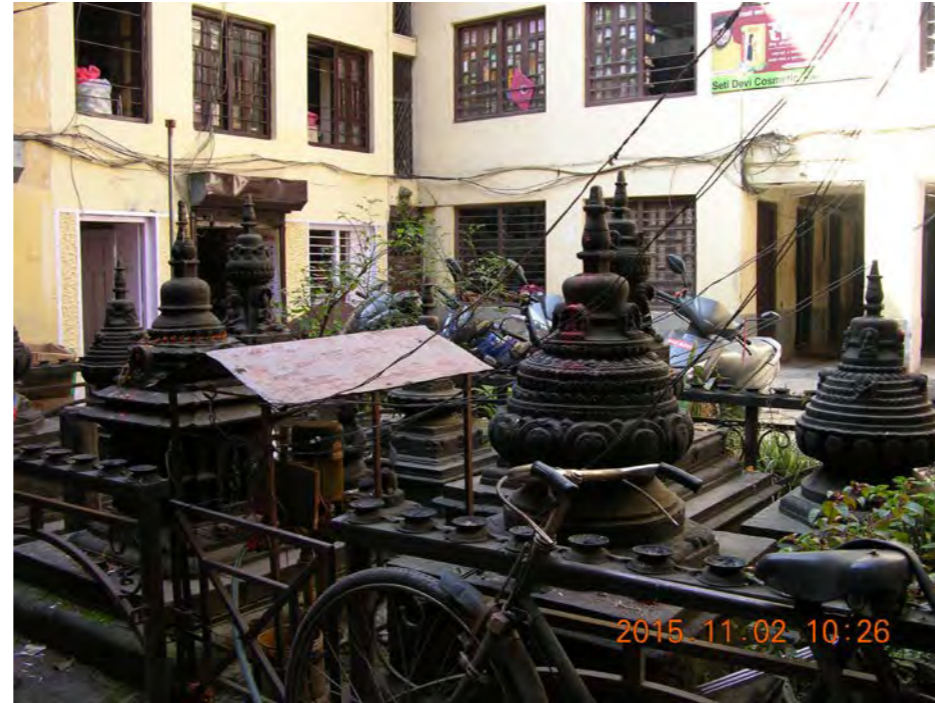
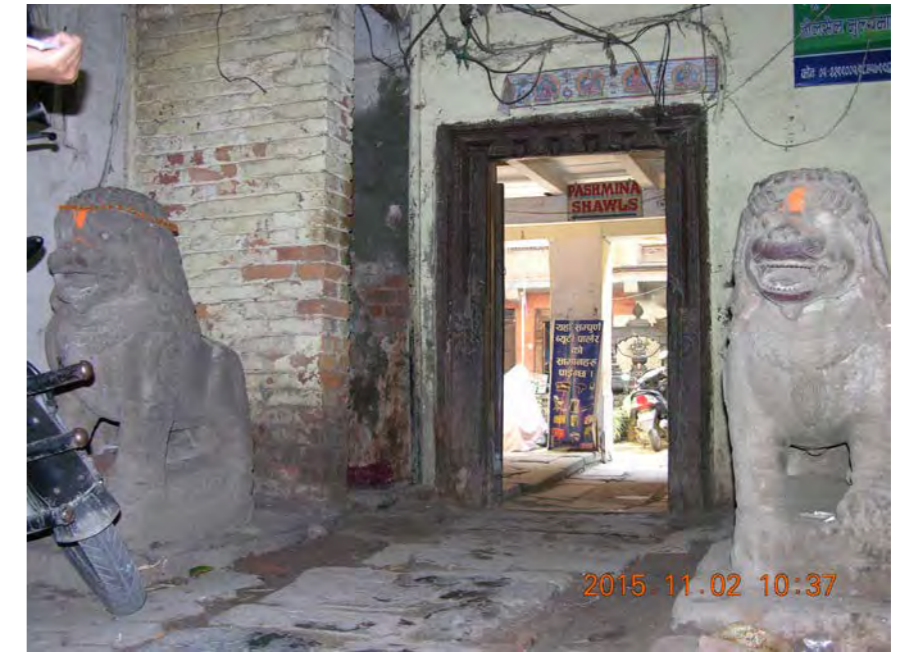
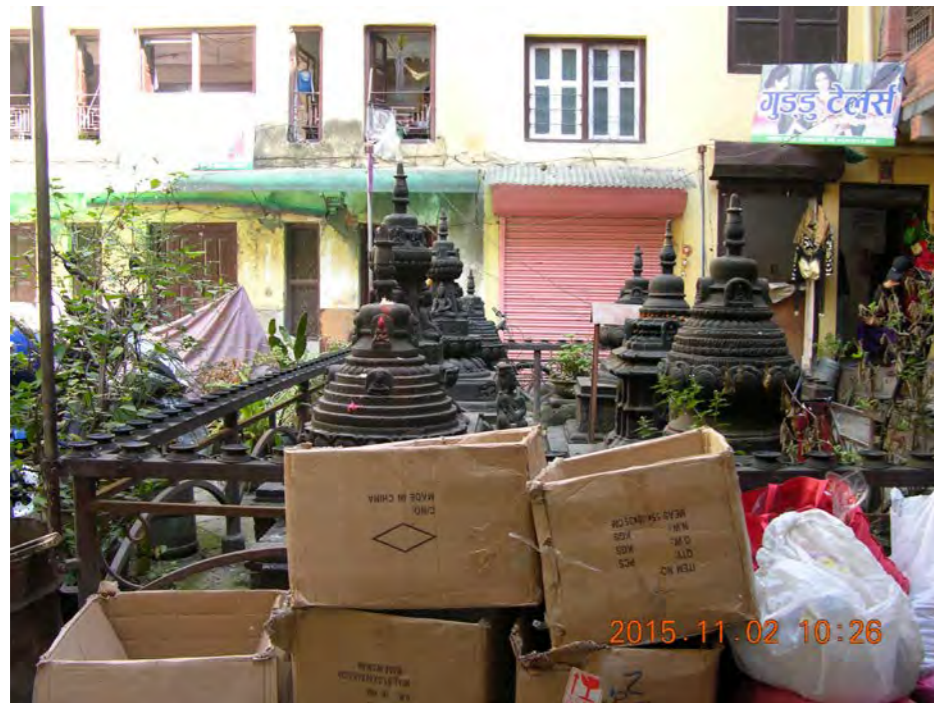
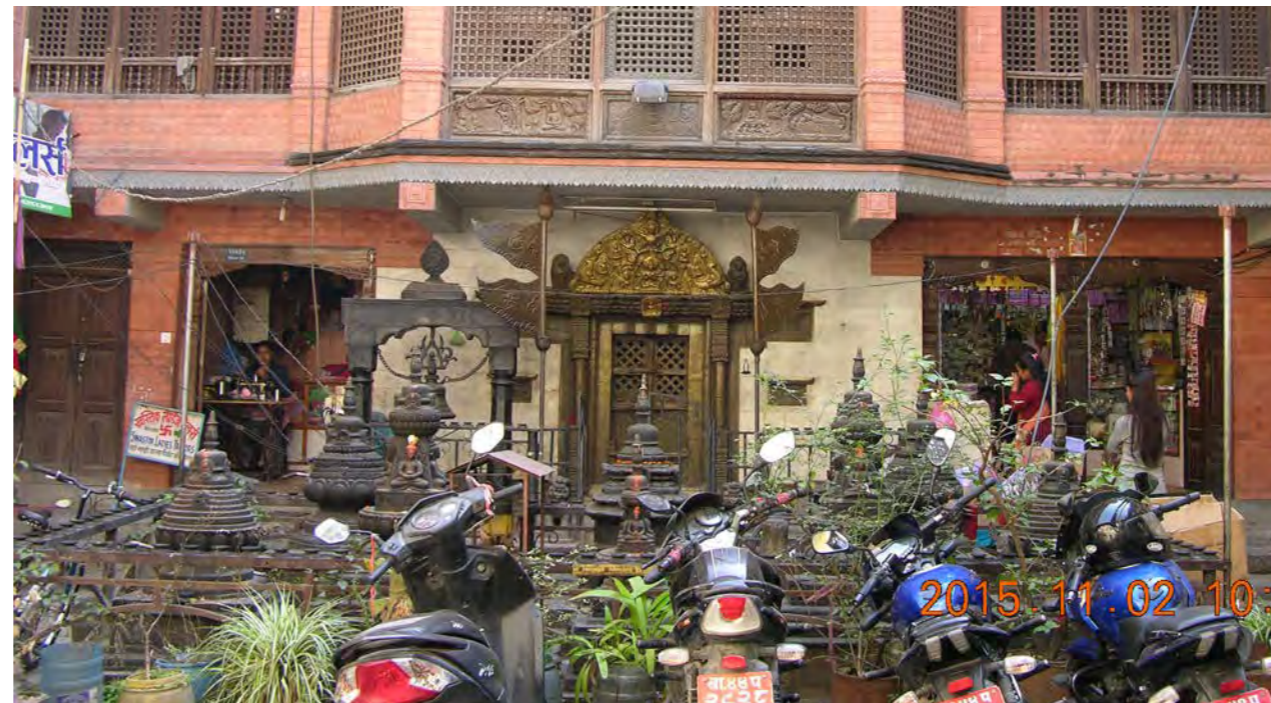
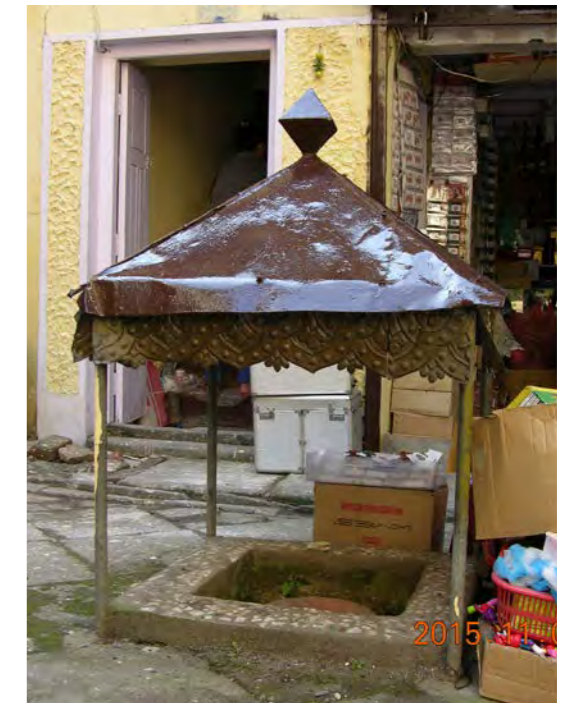
1a, 1b, 1c, 1d, 1e, 1f, 1g, 1h 1i, 1j

CODE NO	TYOLOGY	MONUMENT NAME	ESTABLISHED/ RENOVATED	STRUCTURAL SYSTEM	MATERIAL	GENERAL DESCRIPTION	PROBLEM DESCRIPTION	DANGER	REMARKS
1a, 1b, 1c, 1d, 1e, 1f, 1g, 1h	Chaitya				Stone	stone chaitya	No visible damage		
1i	Mandap						No visible damage		
1j	Stone lions

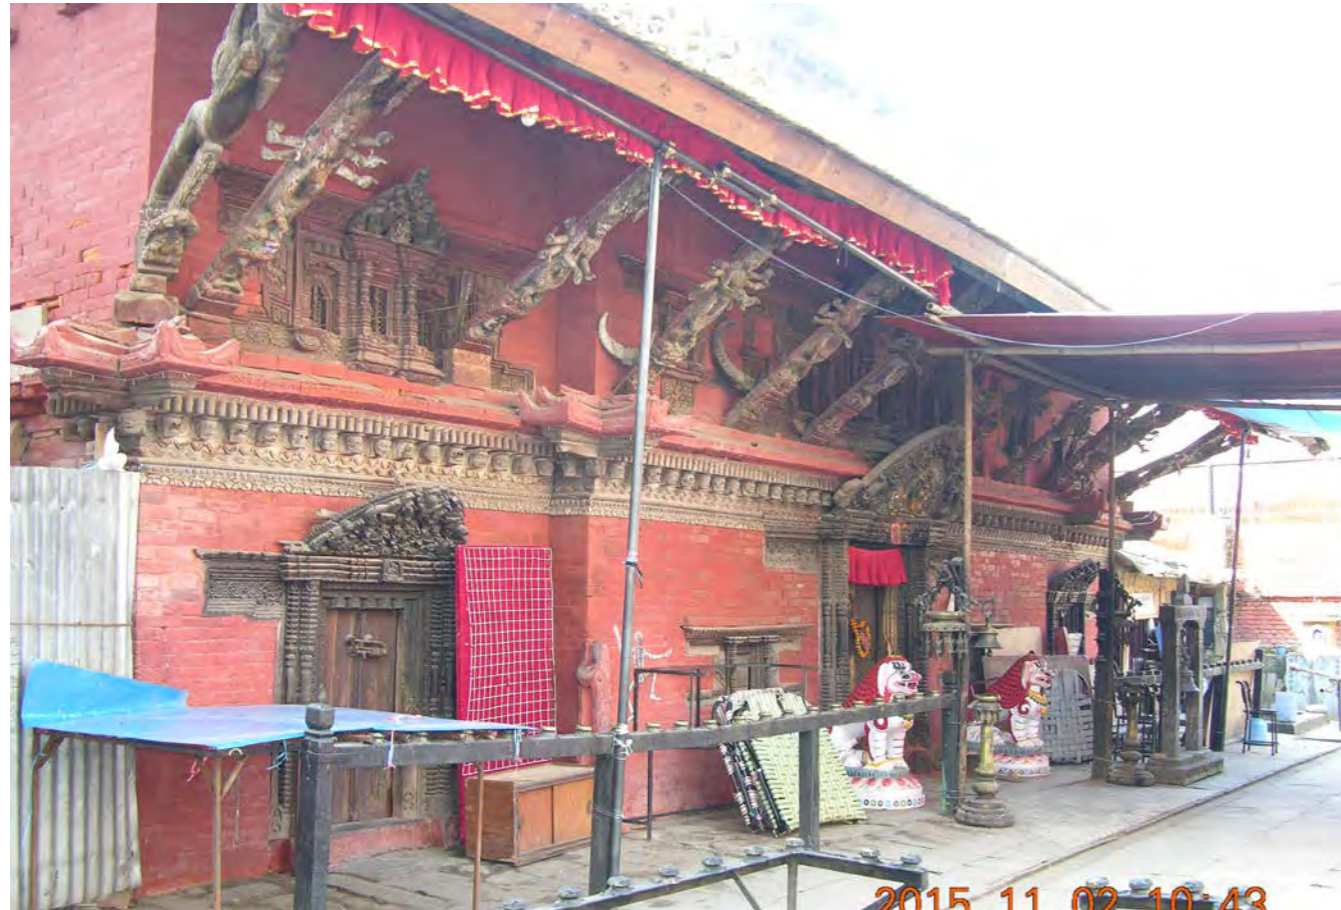
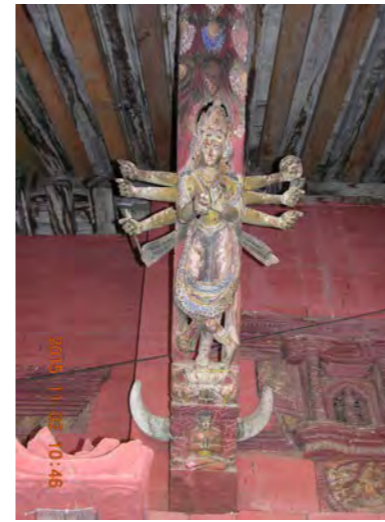
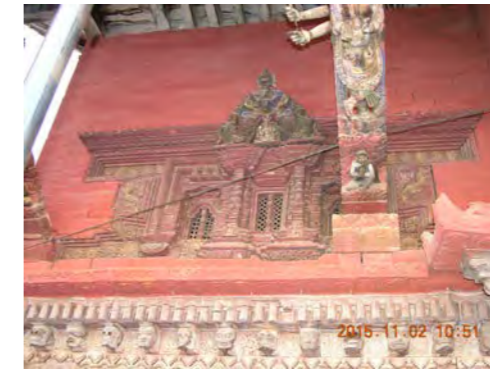
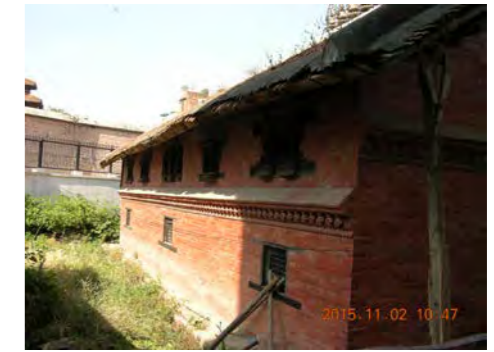
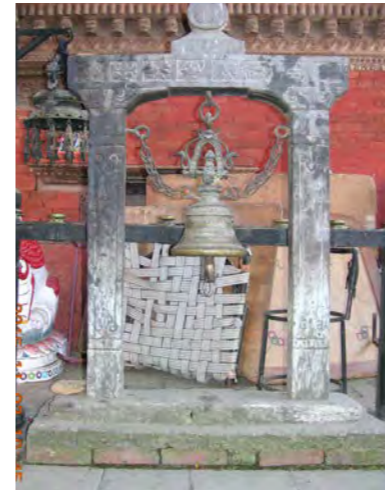
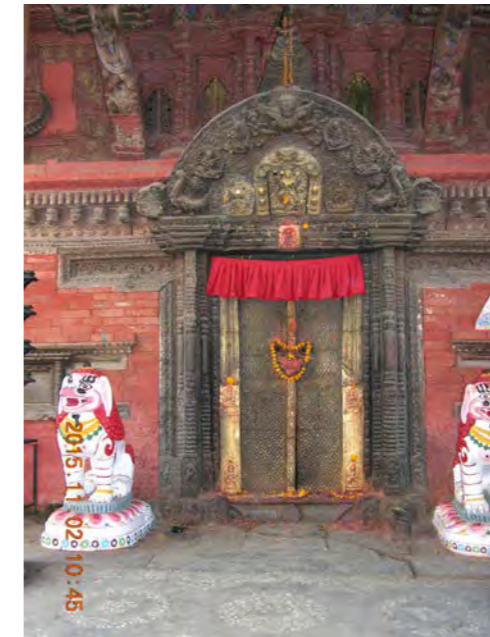
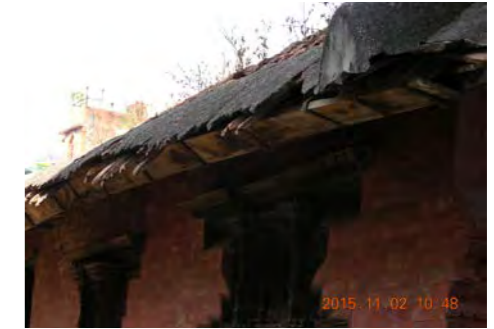
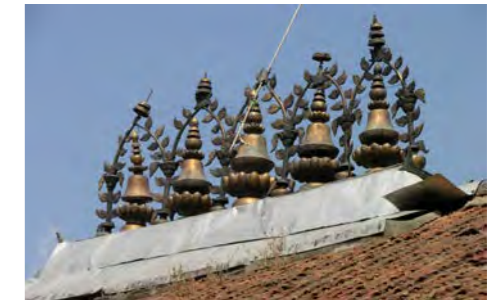
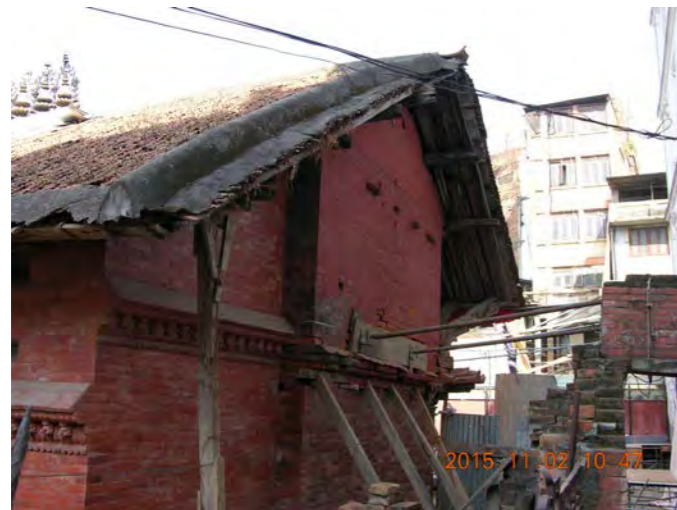
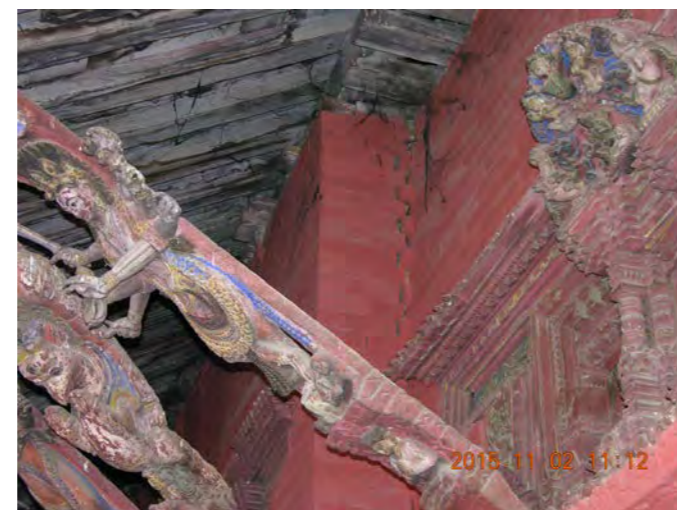
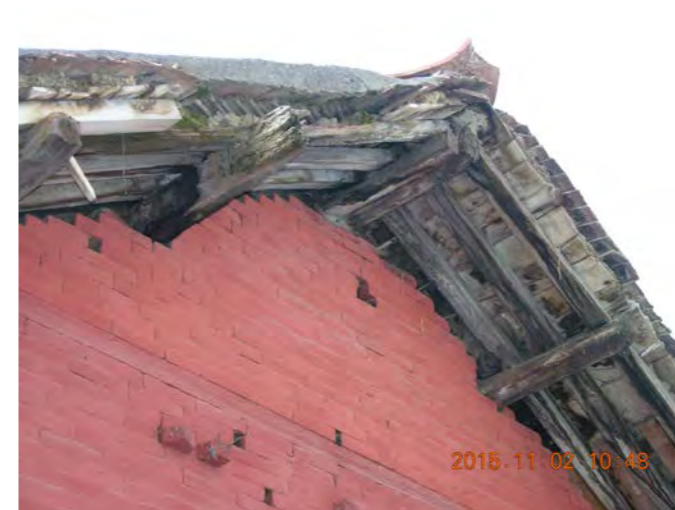
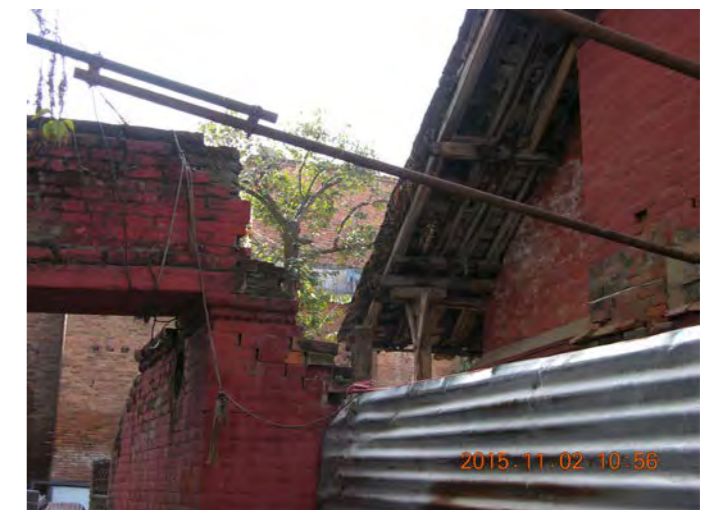
2 TARANI DEVI TEMPLE

CODE NO	TYOLOGY	MONUMENT NAME	ESTABLISHED/ RENOVATED	STRUCTURAL SYSTEM	MATERIAL	GENERAL DESCRIPTION	PROBLEM DESCRIPTION	DANGER	REMARKS
2	Single Storey Temple	Tarani Devi Temple (Tana Devi Temple)	Older Than Taleju/eleveth century Licchavi King Shankara Deva.	Load Bearing	Brick	worshipped every 14th day of the lunar calendar, open to visitors on Mha Puja during Tihar festival, Back part renovated before 1 year before Earthquake	West face bricks out of face, Door half collapsed, rising damp

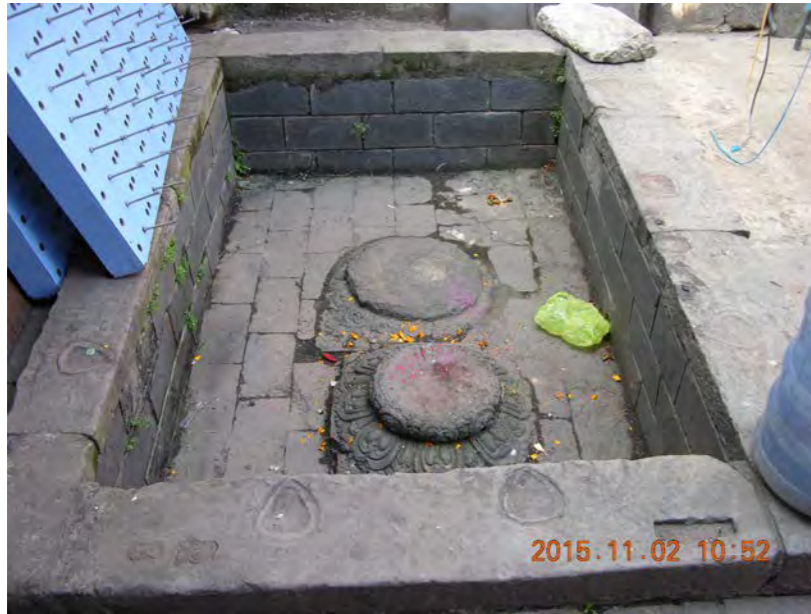
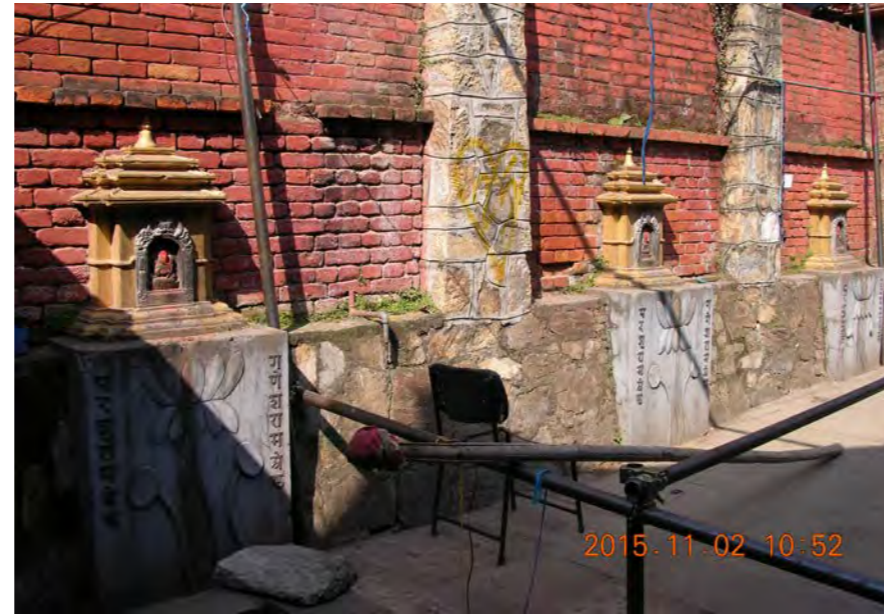
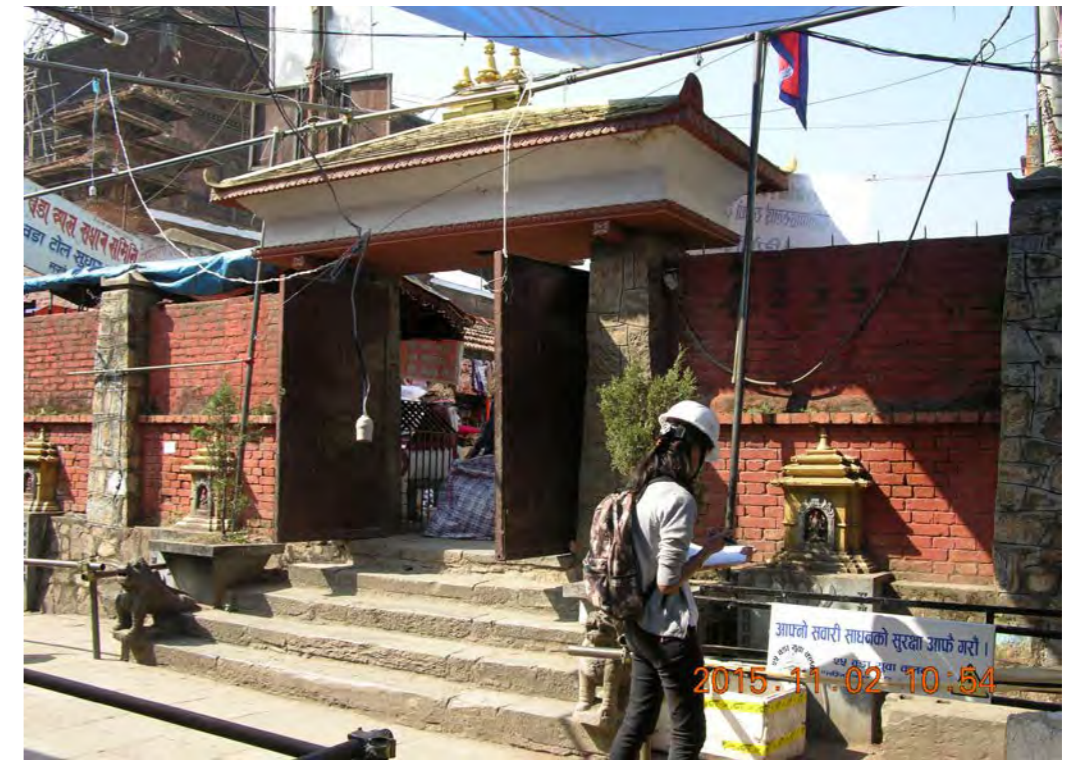
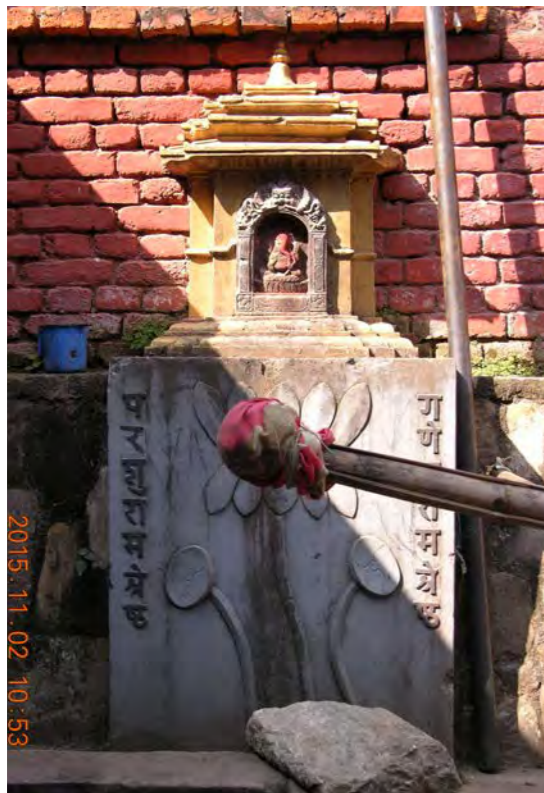
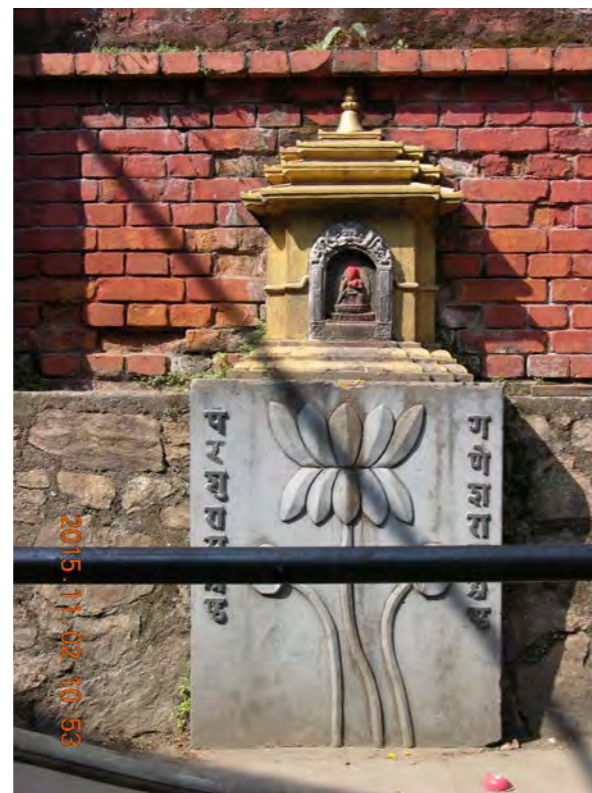
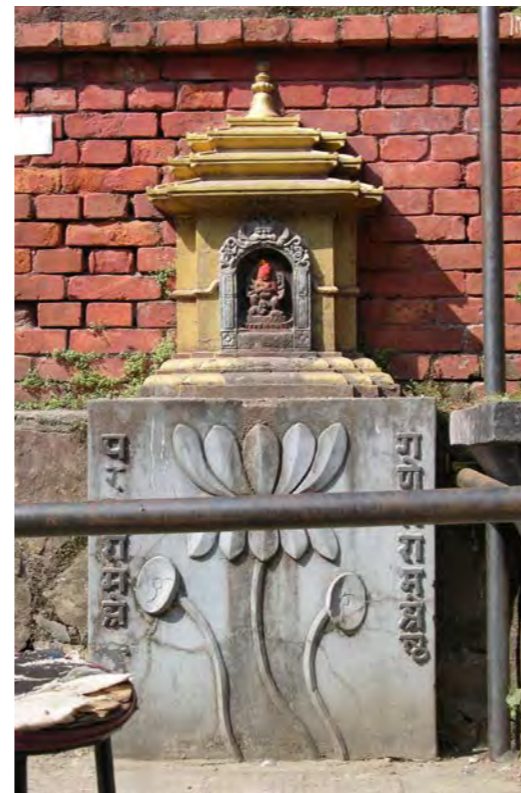
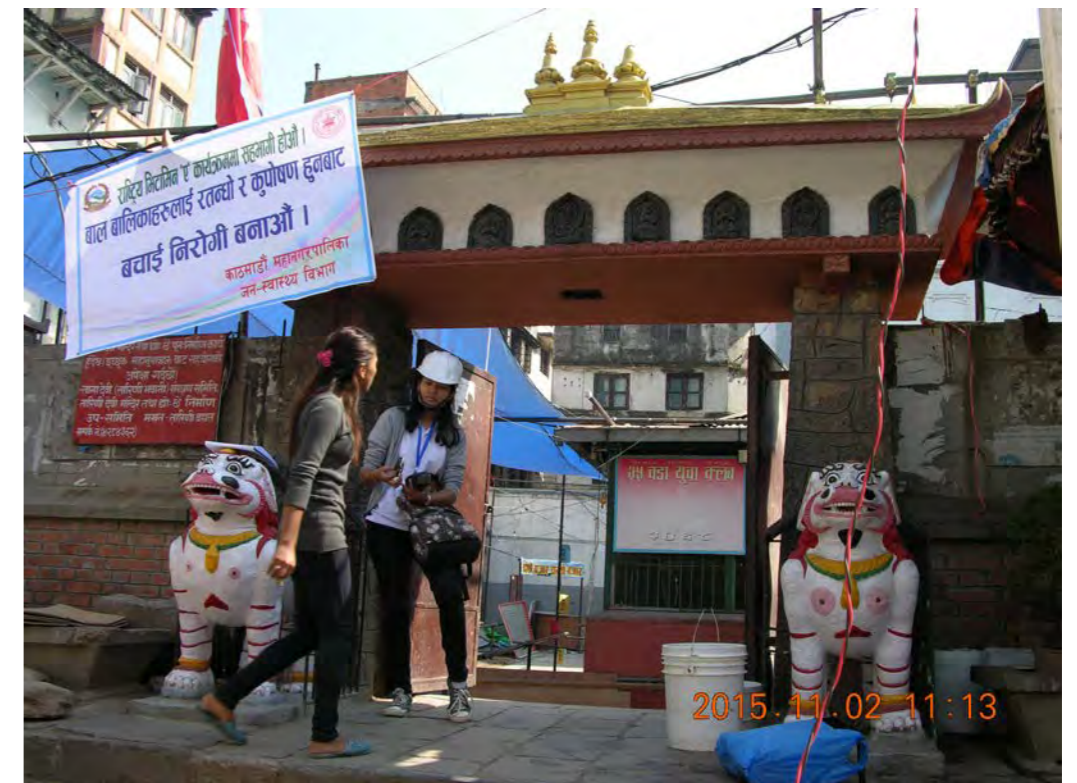
2a, 2b, 2c, 2d, 2e

CODE NO	TYOLOGY	MONUMENT NAME	ESTABLISHED/ RENOVATED	STRUCTURAL SYSTEM	MATERIAL	GENERAL DESCRIPTION	PROBLEM DESCRIPTION	DANGER	REMARKS
2a	Mandapa						stone deleated		
2b	open shrine	ganesh			Stone	stone idol on wall	No visible damage		
2c	open shrine	Bhimsen			Stone	stone idol on wall	No visible damage		
2d	open shrine				Stone	stone idol on wall	No visible damage		
2e	Gate				Stone	gate with two stone lion	stone idols dilapadated

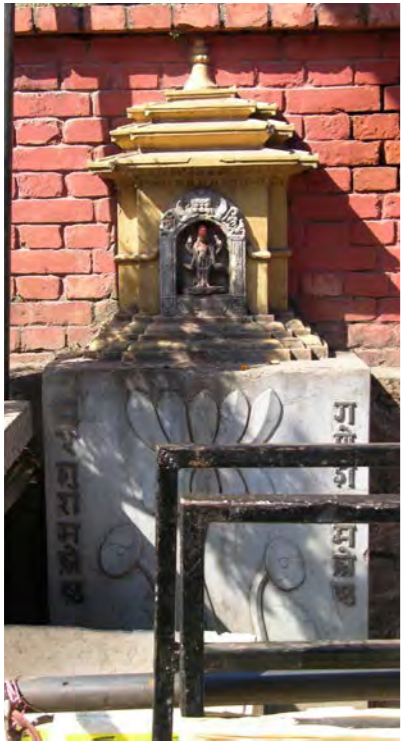
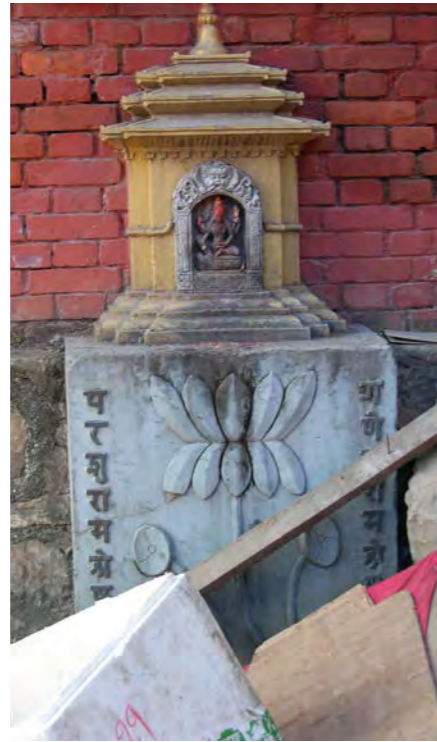
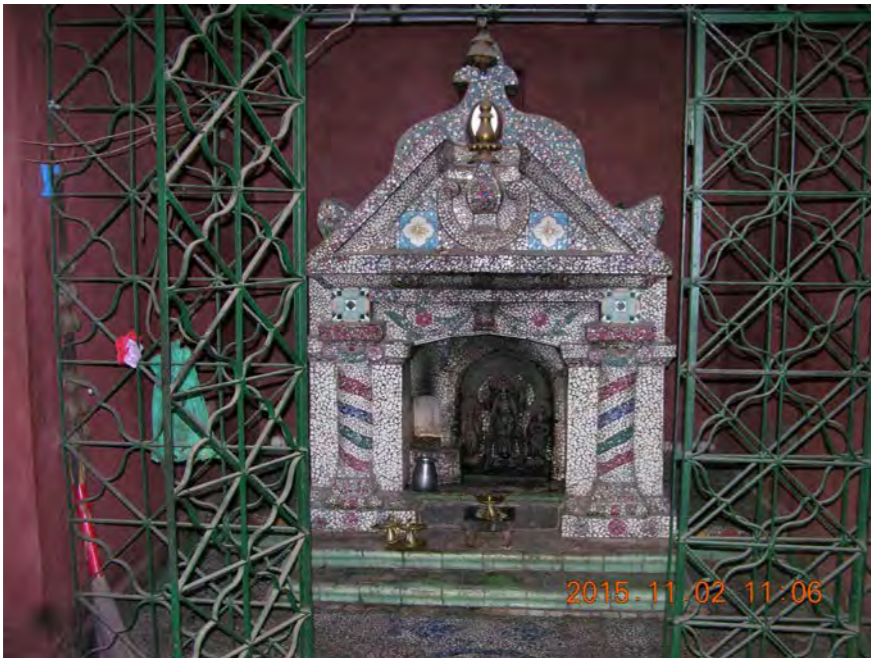
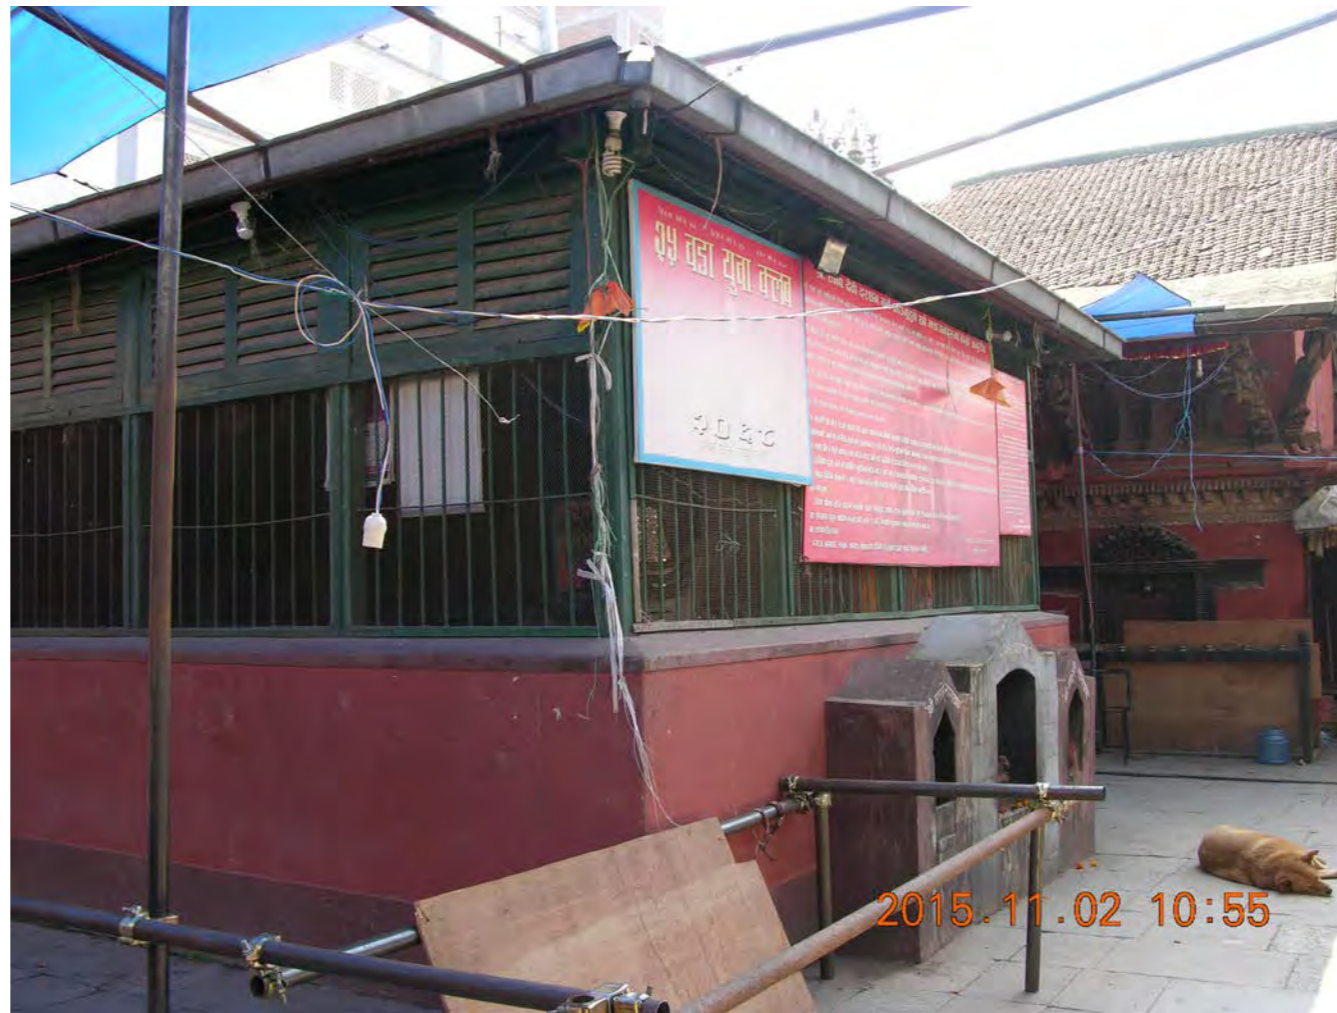
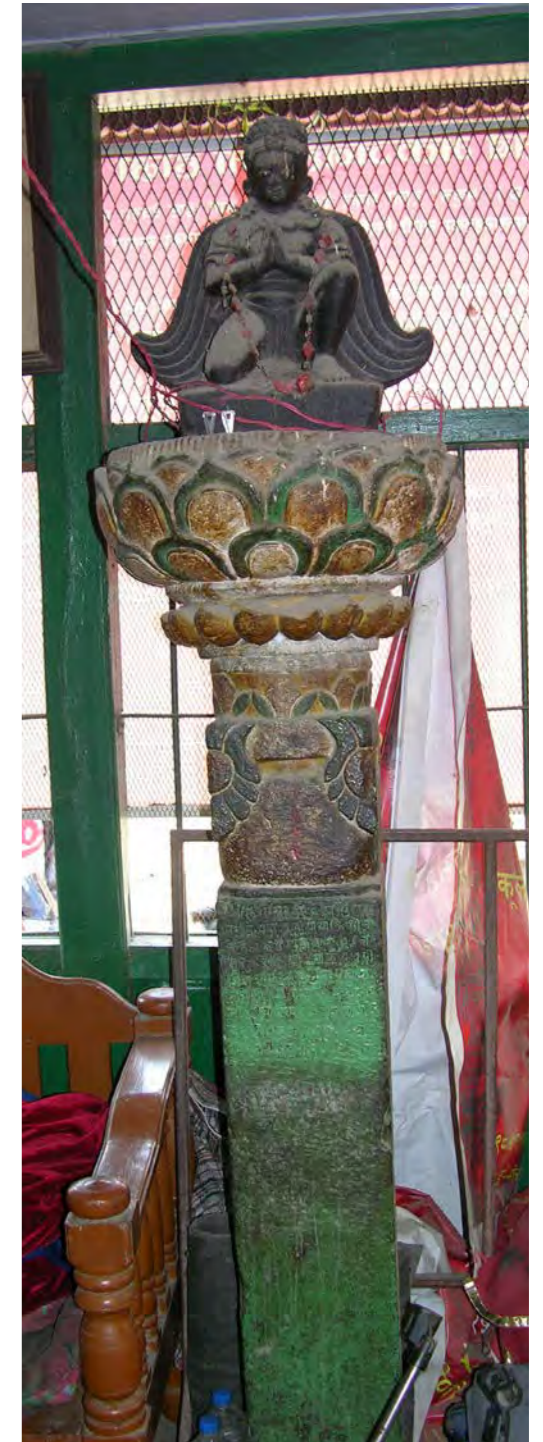
2f, 2g, 2h

CODE NO	TYOLOGY	MONUMENT NAME	ESTABLISHED/ RENOVATED	STRUCTURAL SYSTEM	MATERIAL	GENERAL DESCRIPTION	PROBLEM DESCRIPTION	DANGER	REMARKS
2f	open shrine	Bishnu			Stone	stone idol on wall	No visible damage		
2g	open shrine								
2h	open shrine	Narayan with Garuda			Stone	open shrine	vertical crack on northern part

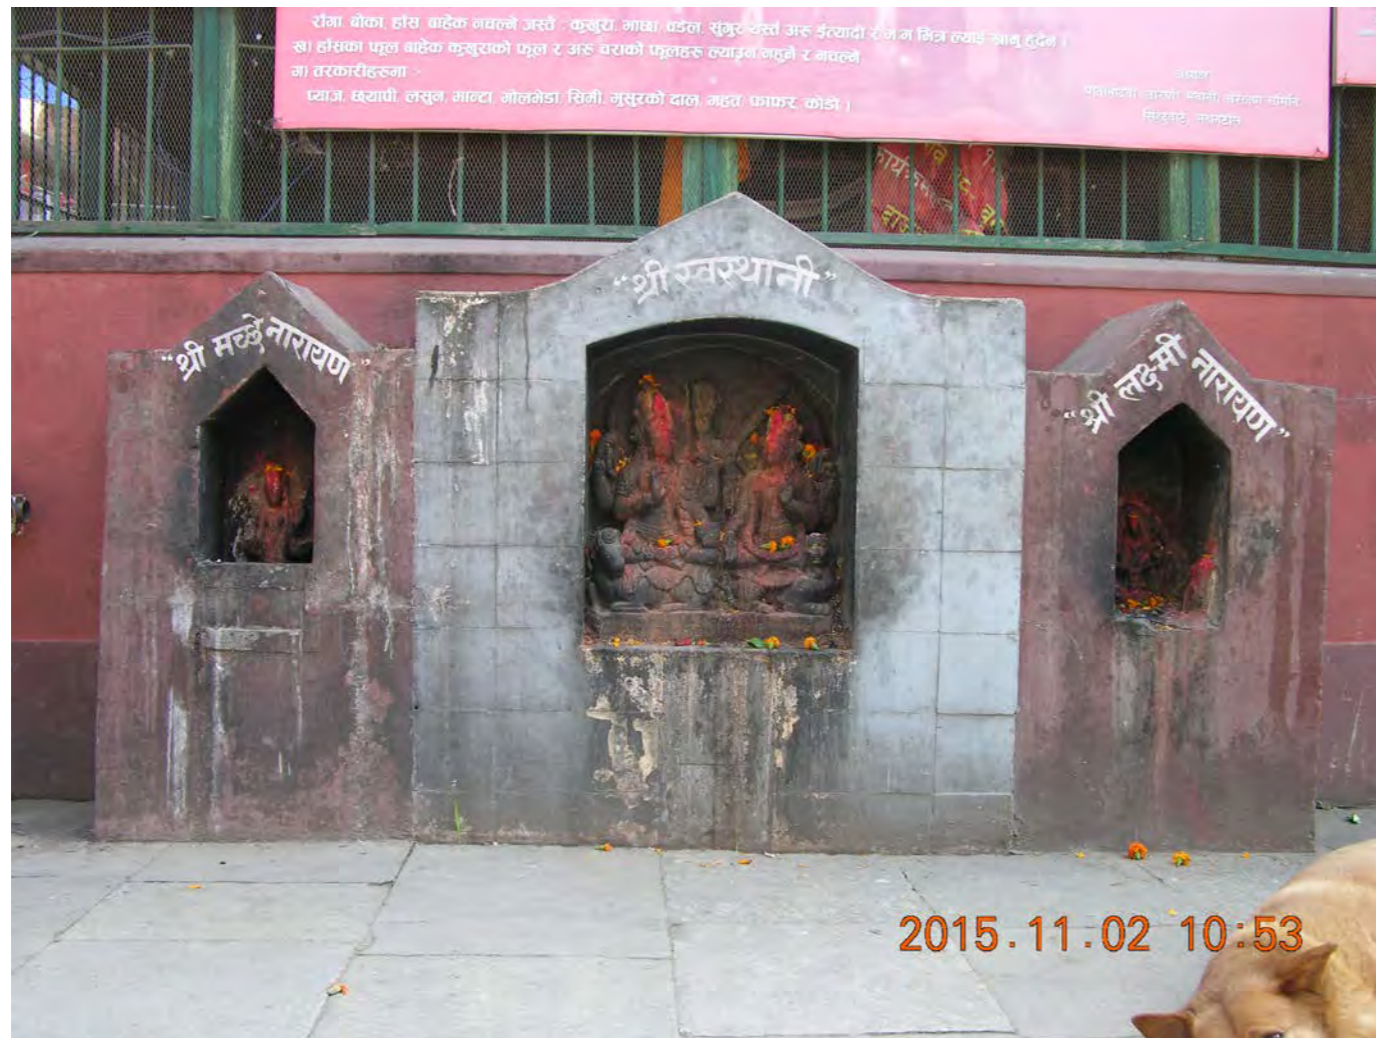
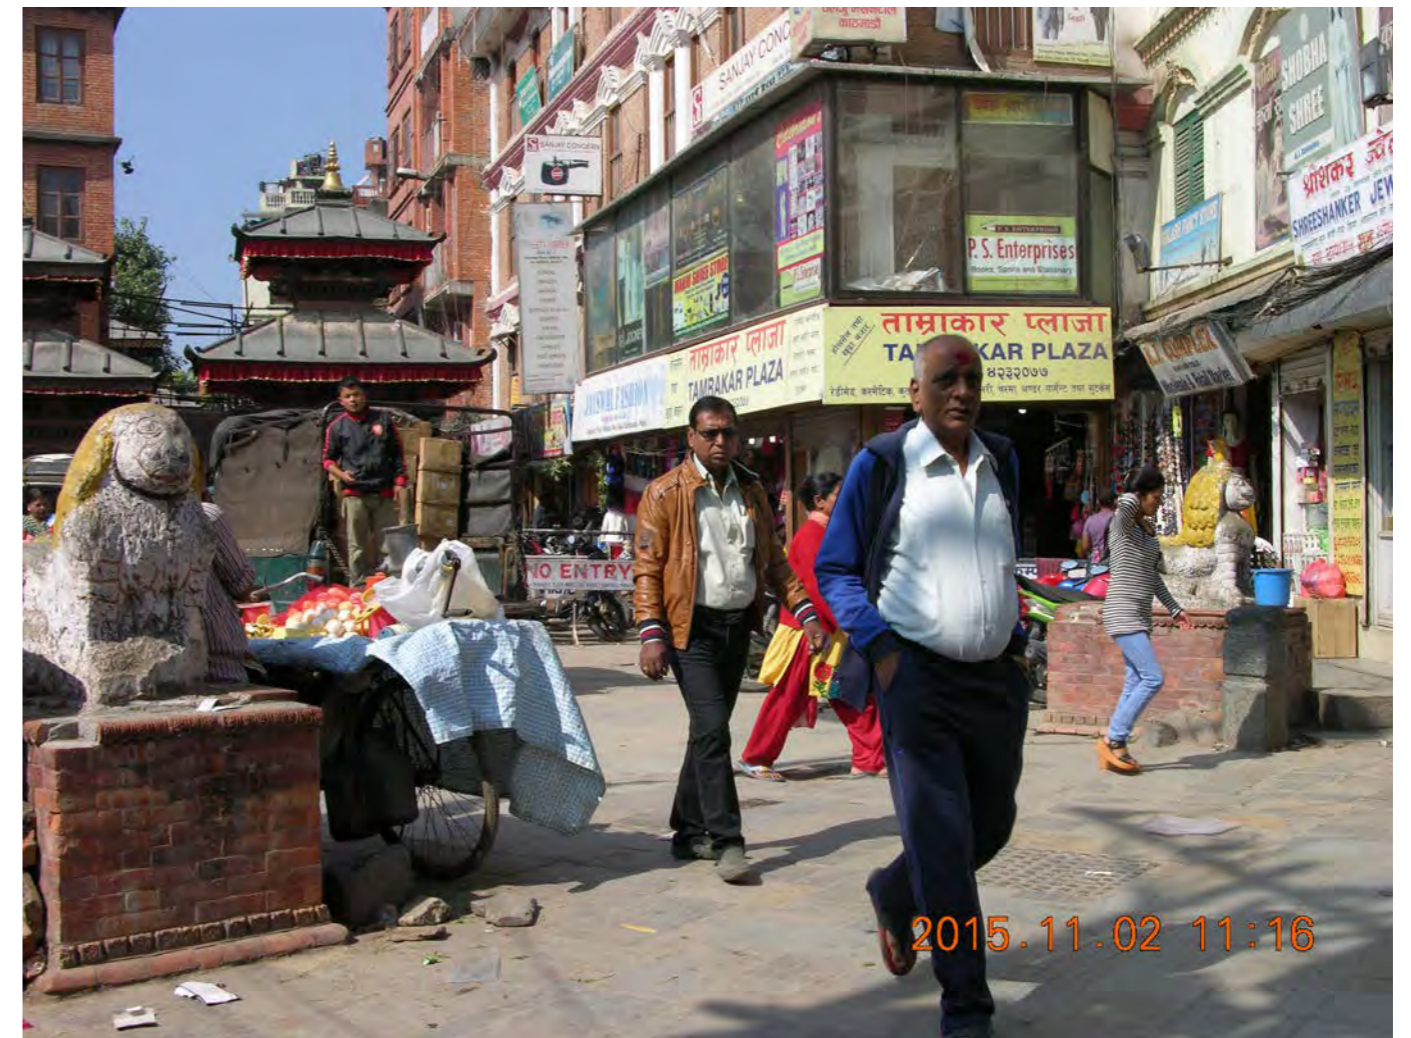
2i, 2j, 2k, 2l, 2m

CODE NO	TYOLOGY	MONUMENT NAME	ESTABLISHED/ RENOVATED	STRUCTURAL SYSTEM	MATERIAL	GENERAL DESCRIPTION	PROBLEM DESCRIPTION	DANGER	REMARKS	
2i	open shrine	Matye Narayan					No visible damage			
2j	open shrine	Swasthani					No visible damage			
2k	open shrine	Laxmi Narayn					No visible damage			
2l	stone lion					coloured, carved by grill	No visible damage			
2m	stone lion					stone delipated	No visible damage
