2015 Earthquake Damage Mapping

Hanuman Dhoka Darbar Square Monument Zone
Kathmandu Valley World Heritage Property

December 2015

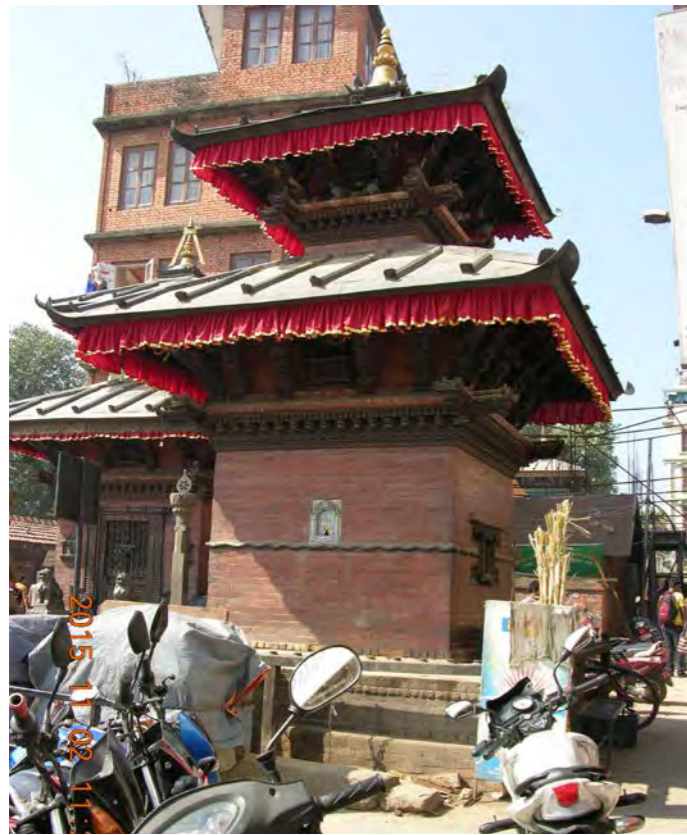
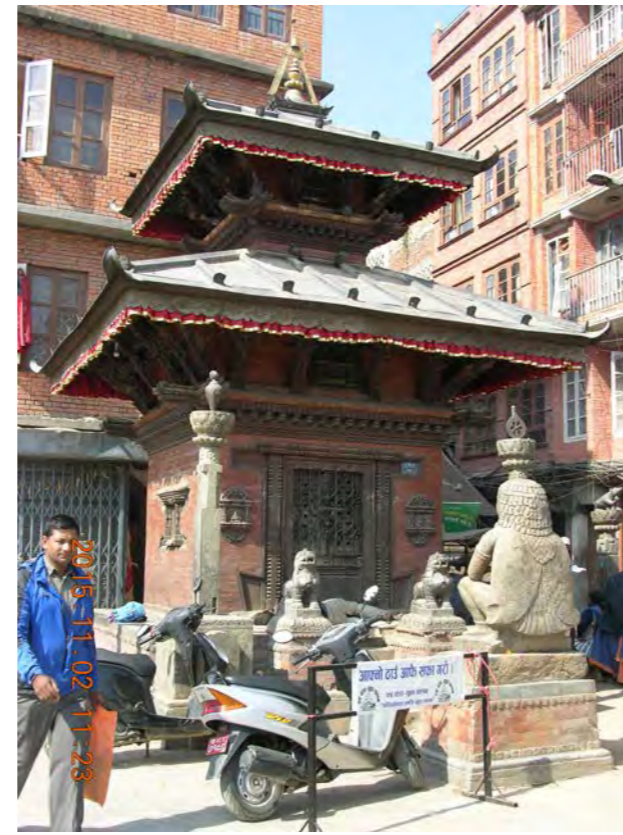
3 GANESH TEMPLE

CODE NO	TYOLOGY	MONUMENT NAME	ESTABLISHED/ RENOVATED	STRUCTURAL SYSTEM	MATERIAL	GENERAL DESCRIPTION	PROBLEM DESCRIPTION	DANGER	REMARKS
3	Two storey temple	Ganesh Temple		Load Bearing	Brick	Two tiered temple	Base bricks degraded on east		
3a	Two storey temple	Bishnu Temple		Load Bearing	Brick	Two tiered temple	Bell on south missing, no visible damage on temple		
3b	Single storey temple	Kalika temple		Load Bearing	Brick	other idol is wall	rising damp wall , covered with rubbles, stone lions scattered

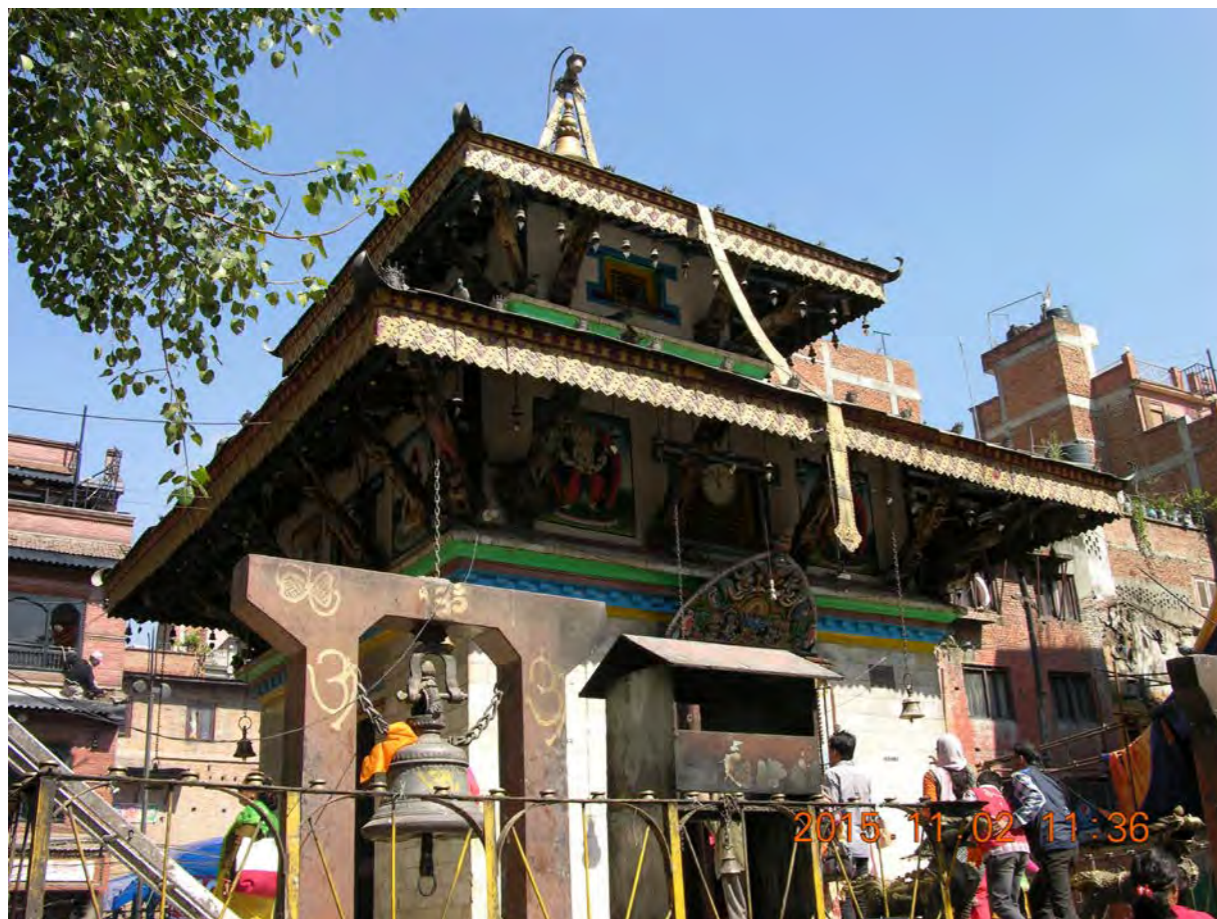
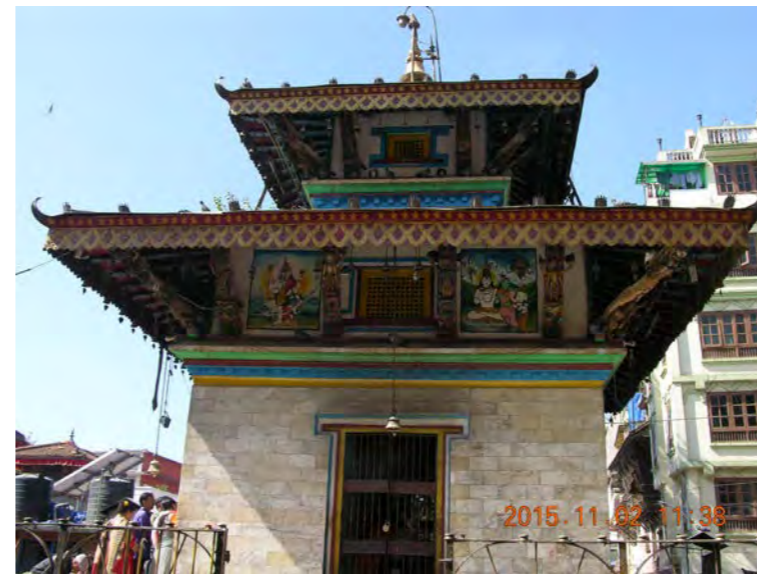
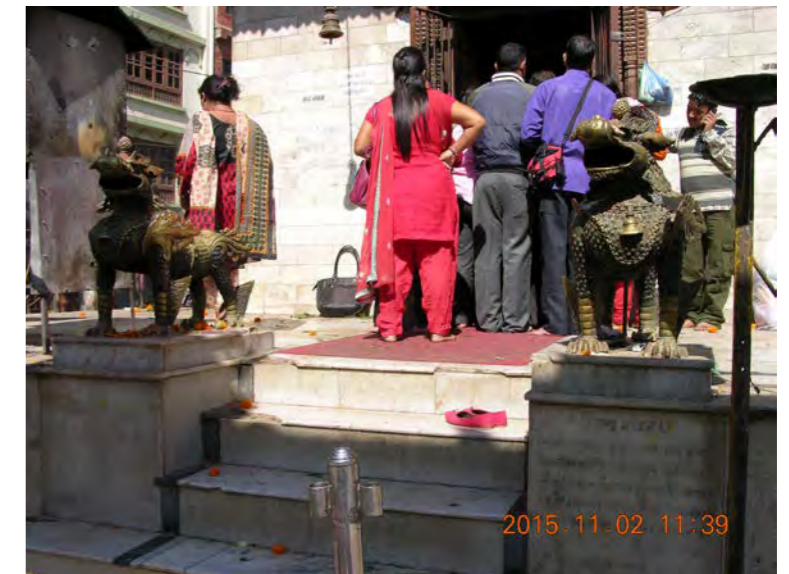
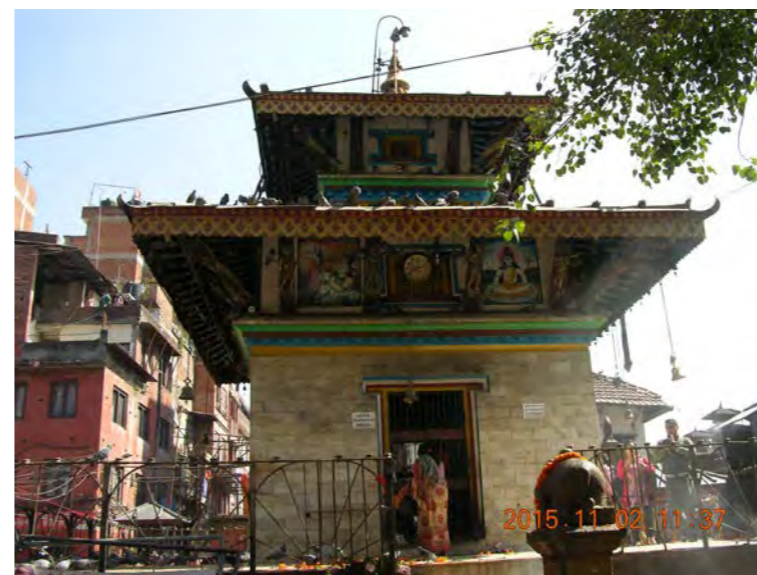
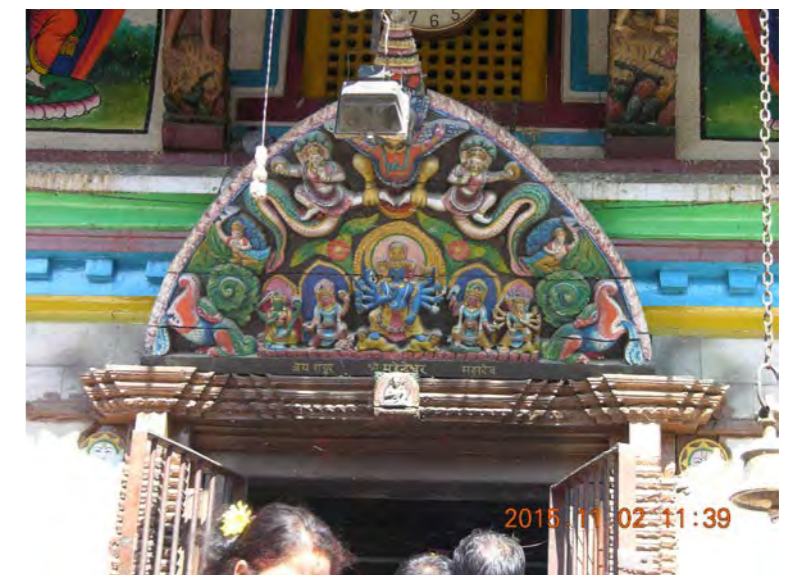
4 MAHENDRASHWOR MAHADEV TEMPLE

CODE NO	TYOLOGY	MONUMENT NAME	ESTABLISHED/ RENOVATED	STRUCTURAL SYSTEM	MATERIAL	GENERAL DESCRIPTION	PROBLEM DESCRIPTION	DANGER	REMARKS
4	Two Storey Temple	Mahendraswor Mahadev temple	1561 A.D/1963 A.D			The temple is dedicated to shiva in the phallic form-cladded with marble tile, cladding cracked

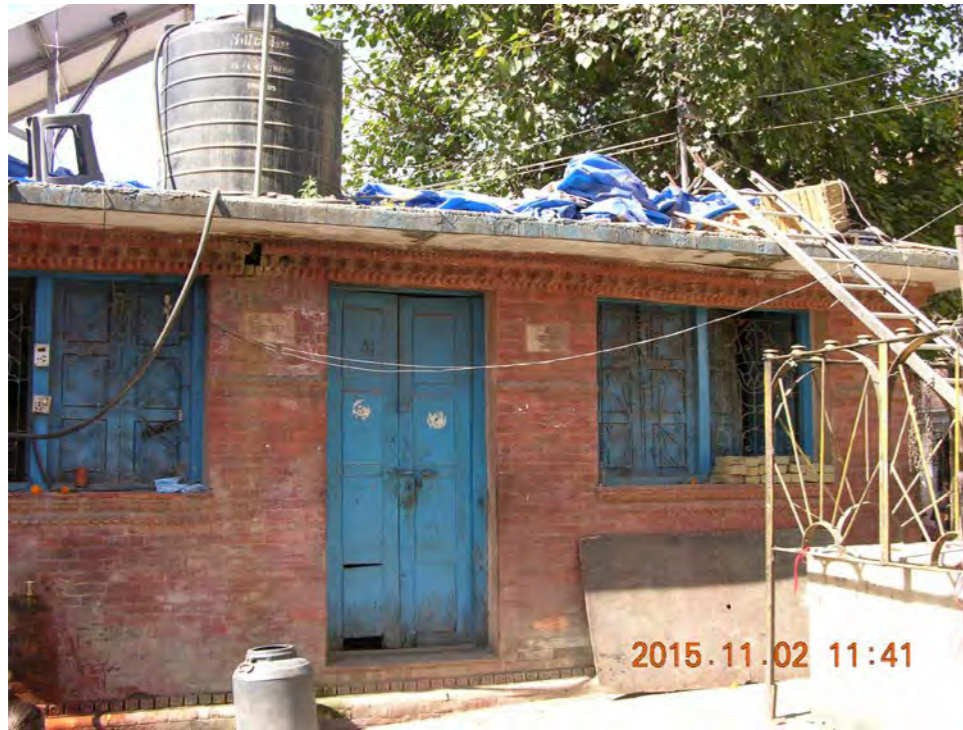
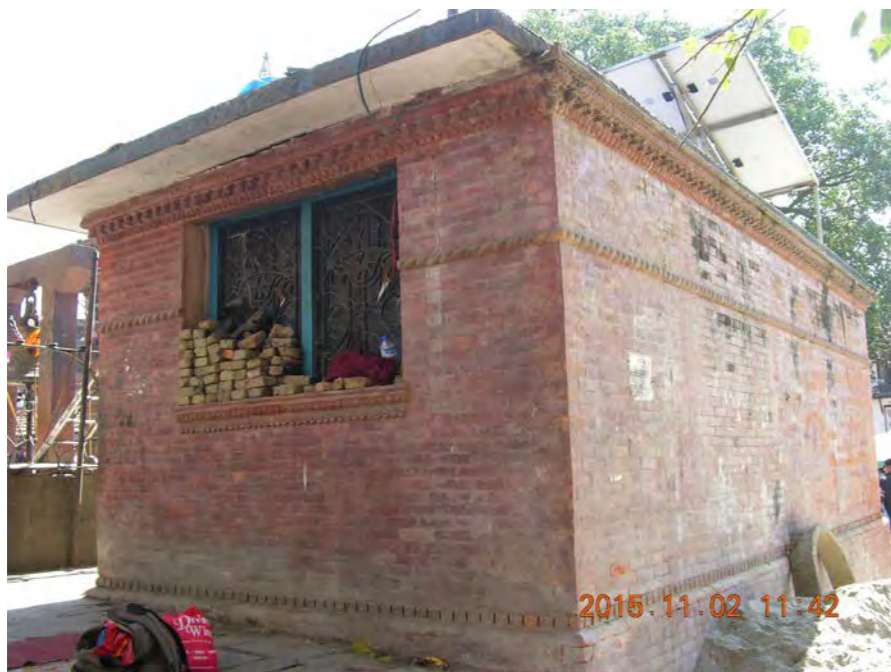
4a STORE HOUSE

CODE NO	TYOLOGY	MONUMENT NAME	ESTABLISHED/ RENOVATED	STRUCTURAL SYSTEM	MATERIAL	GENERAL DESCRIPTION	PROBLEM DESCRIPTION	DANGER	REMARKS
4a	single storey	Store house	2025			1st floor concrete structure	dampness , no visible damage		
4b		Nandi					No visible damage		
4c	2 kalash					covered by metal roof	brick falls on NE, SW corner missing		
4d	trishul						No visible damage

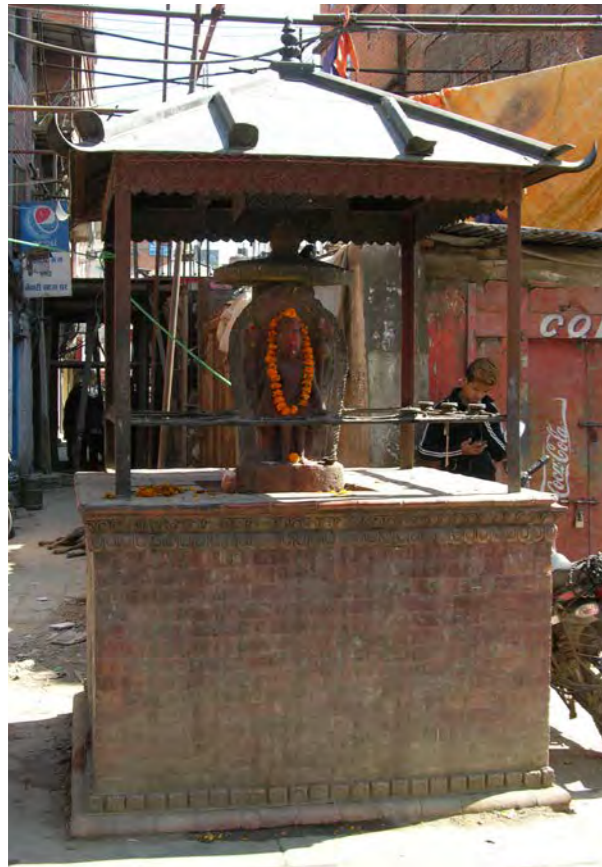
4e OPEN SHRINE

CODE NO	TYOLOGY	MONUMENT NAME	ESTABLISHED/ RENOVATED	STRUCTURAL SYSTEM	MATERIAL	GENERAL DESCRIPTION	PROBLEM DESCRIPTION	DANGER	REMARKS
4e	open shrine	shiva parbati ganesh & ..	2066 B.S			covered by metal roof	No visible damage		
4f	enclosed shrine					2 sculptures	gajur broken		
4g	enclosed shrine					No visible damage			
4h	gate					gate newly constructed	No visible damage, stone lions degraded & painted

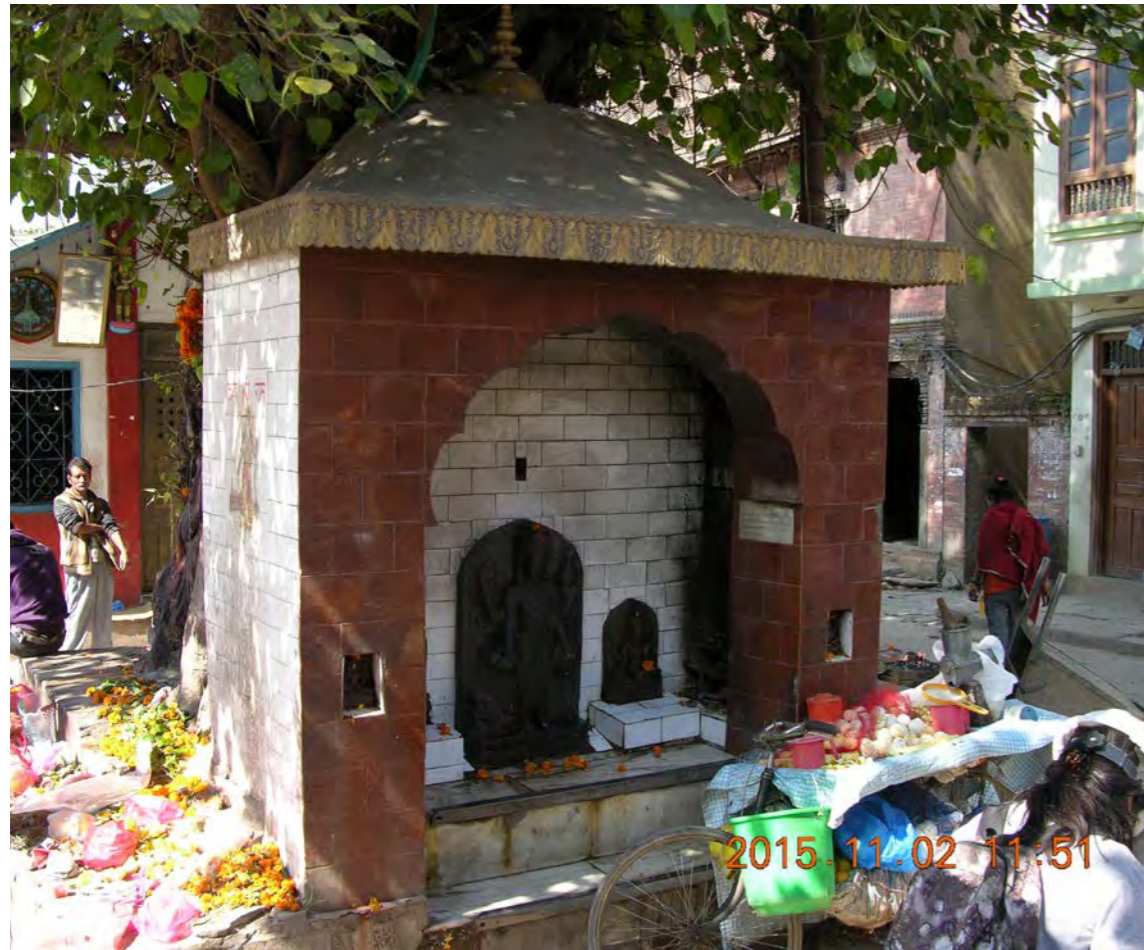
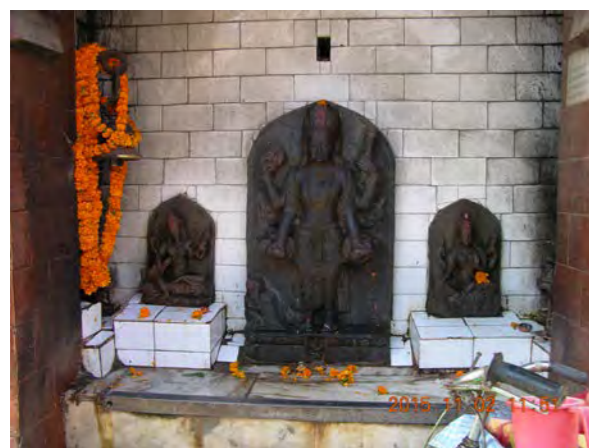
4i ENCLOSED SHRINE

CODE NO	TYOLOGY	MONUMENT NAME	ESTABLISHED/ RENOVATED	STRUCTURAL SYSTEM	MATERIAL	GENERAL DESCRIPTION	PROBLEM DESCRIPTION	DANGER	REMARKS
4i	Enclosed shrine	Bishnu saraswoti &...	2056			total 5 idols, concrete roof	some tiles missing		
4j	Chaitya						Damaged by pipal tree		
4k	Chaitya						delepatated plaster		
4l	Chaitya						delepatated plaster

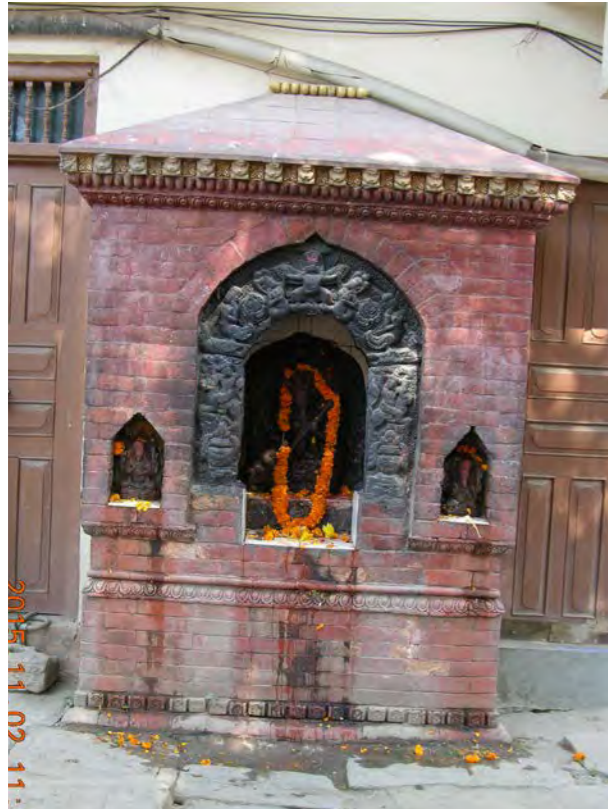
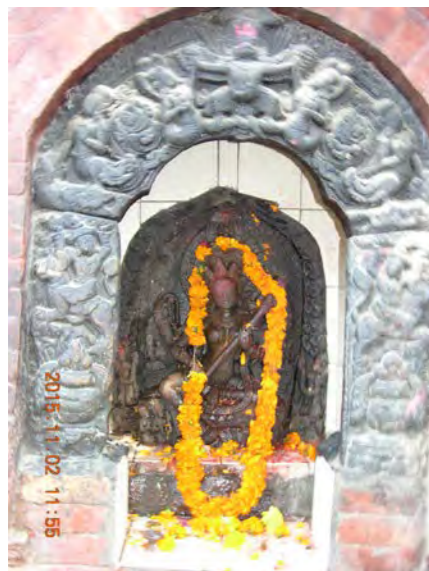
4m ENCLOSED SHRINE

CODE NO	TYOLOGY	MONUMENT NAME	ESTABLISHED/ RENOVATED	STRUCTURAL SYSTEM	MATERIAL	GENERAL DESCRIPTION	PROBLEM DESCRIPTION	DANGER	REMARKS
4m	Enclosed shrine	Balaram Krishna Temple		Load Bearing		single storey covered by CGI sheet pinnacle missing	No visible damage		
4n			crack on west wall						
4o	Chaitya		stone member dislocating						
4p	Chaitya		stone member dislocating

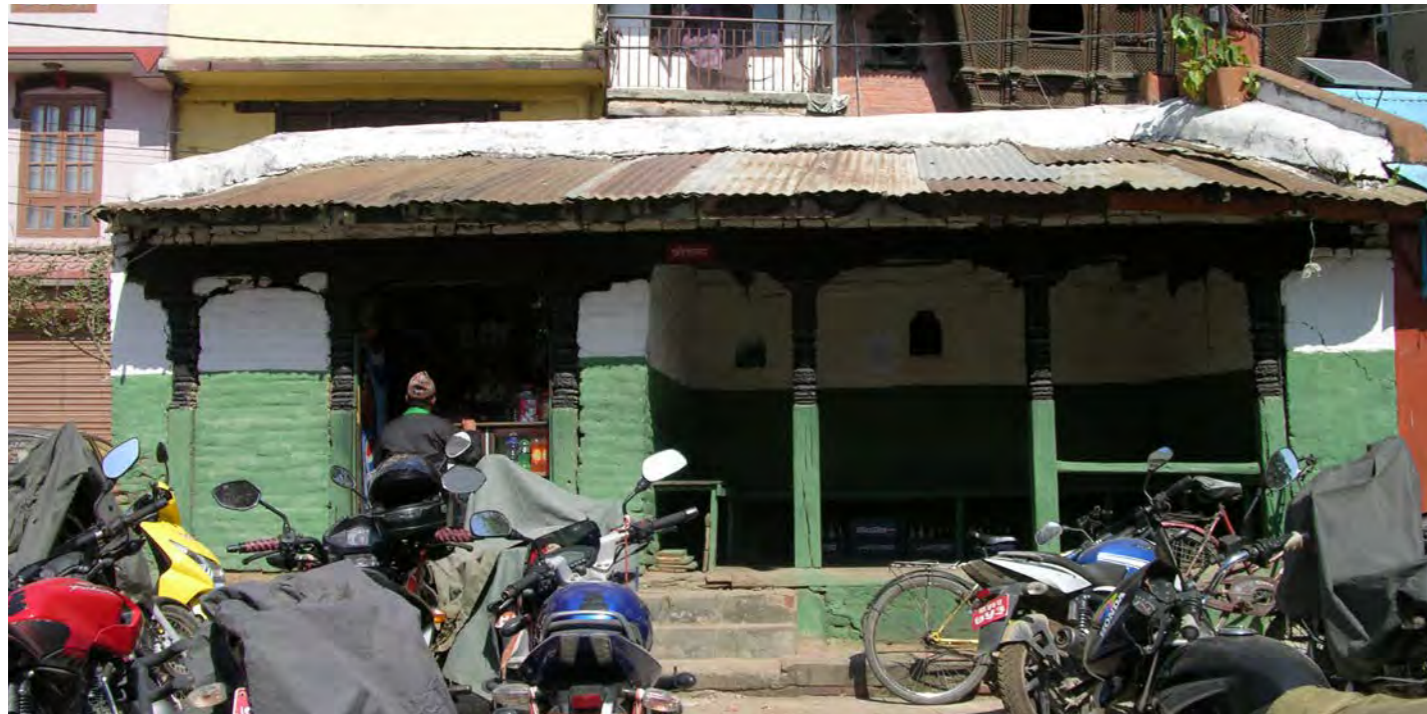
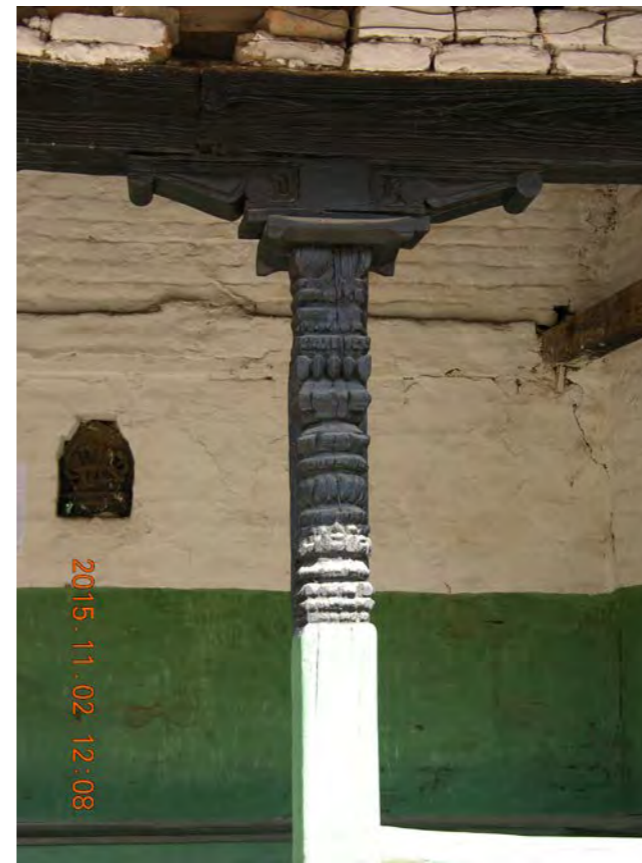
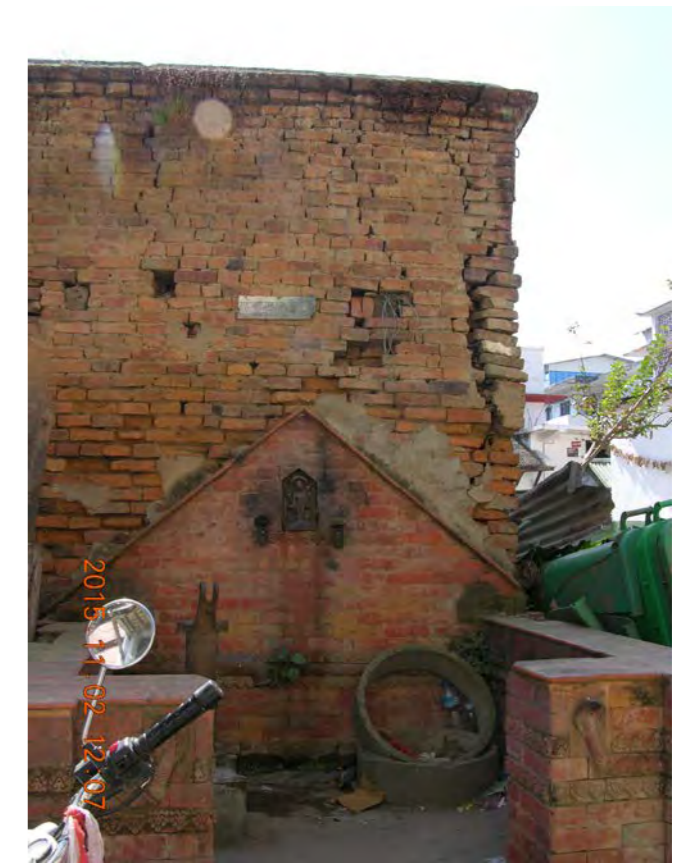
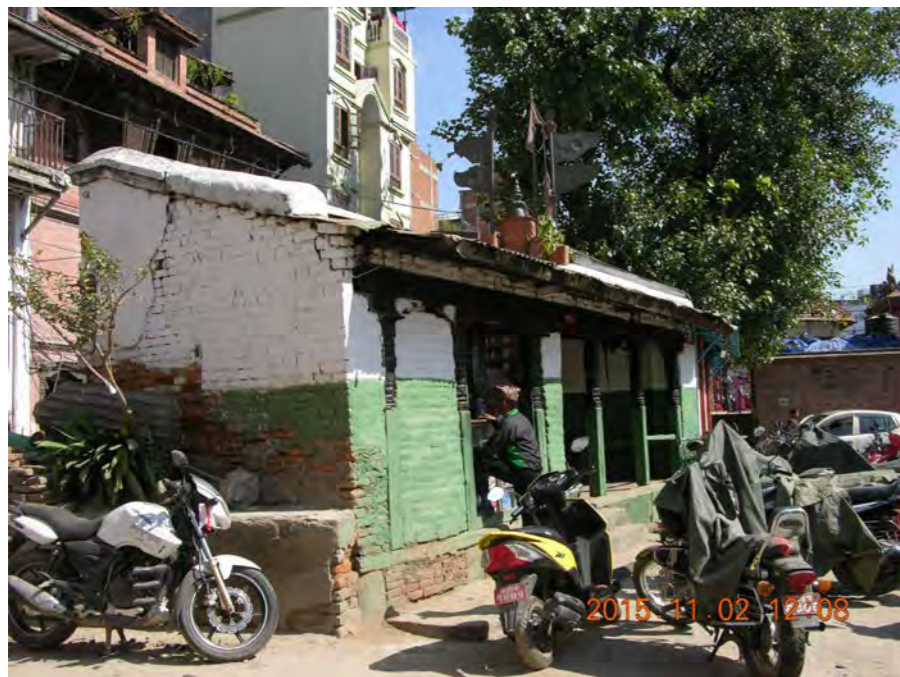
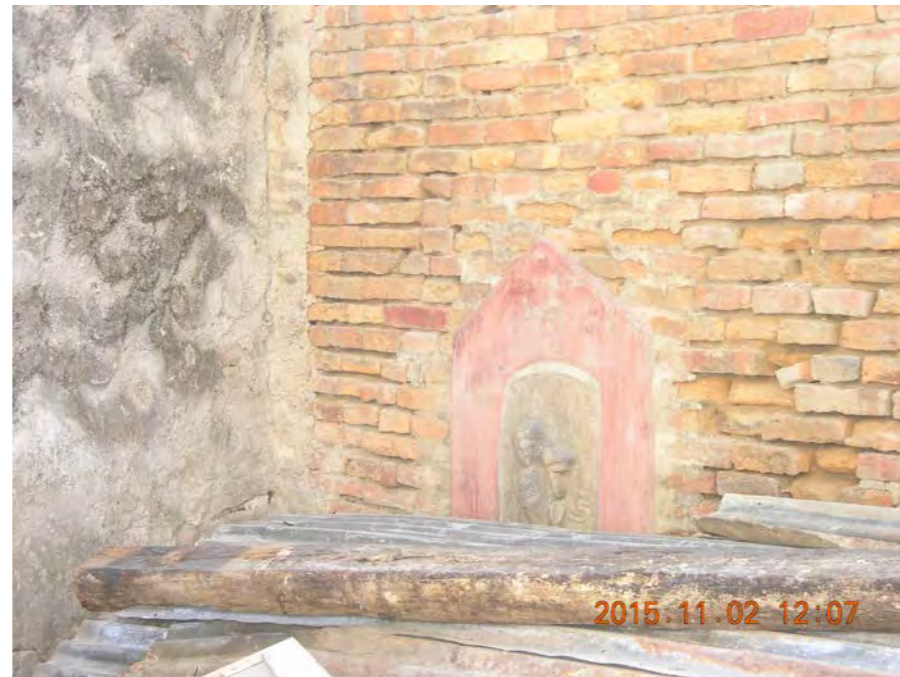
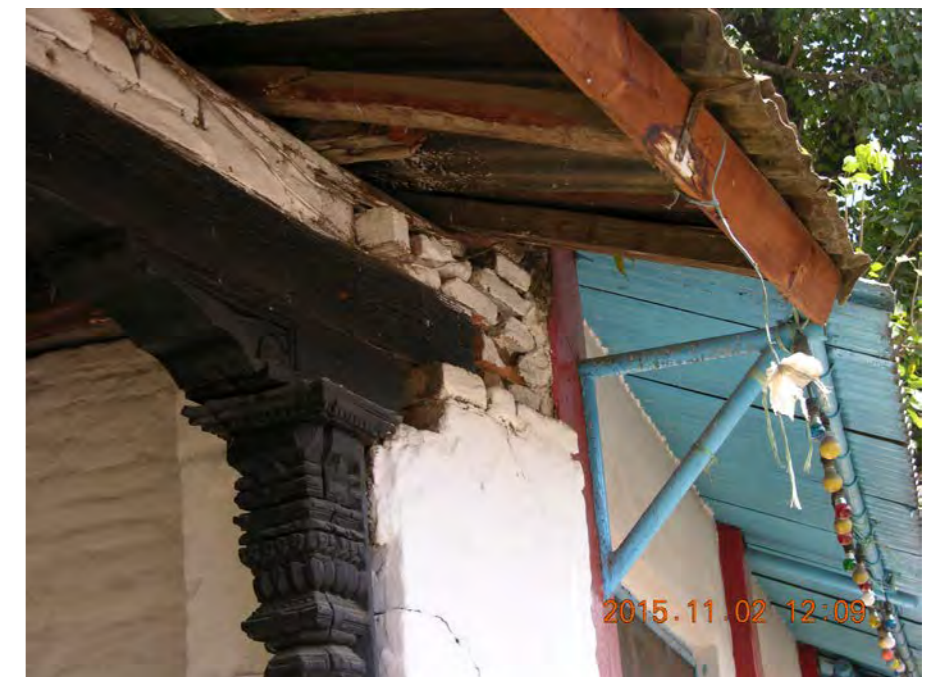
4s PATI

CODE NO	TYOLOGY	MONUMENT NAME	ESTABLISHED/ RENOVATED	STRUCTURAL SYSTEM	MATERIAL	GENERAL DESCRIPTION	PROBLEM DESCRIPTION	DANGER	REMARKS	
4s	Pati					image on west	brick degraded due to dampness, SW corner separating

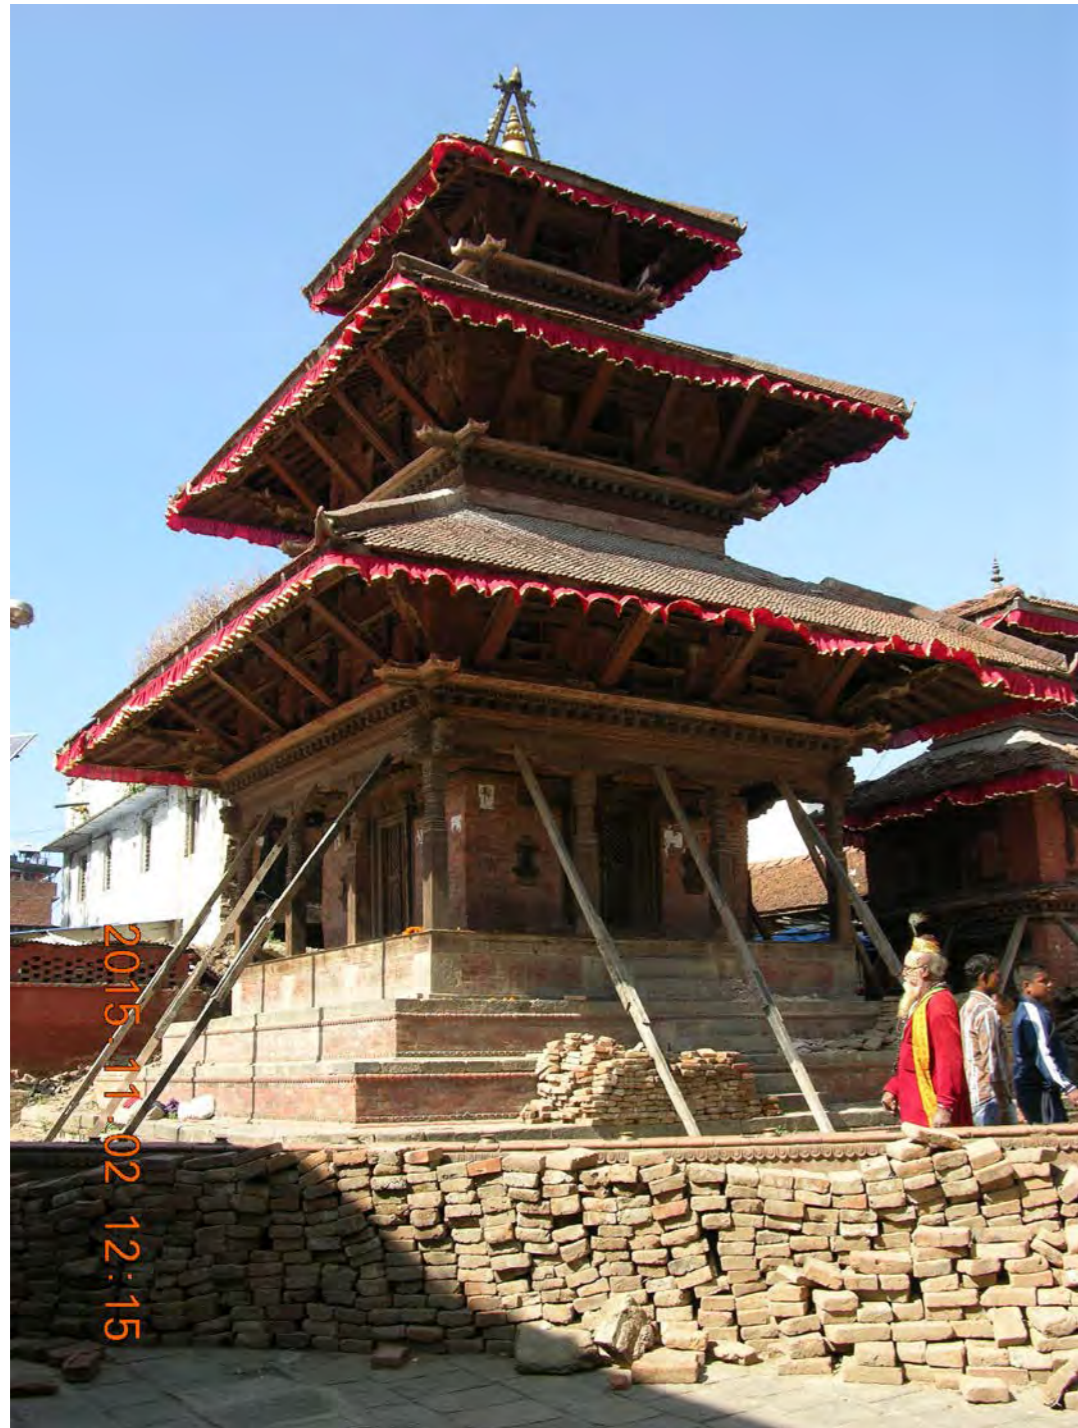
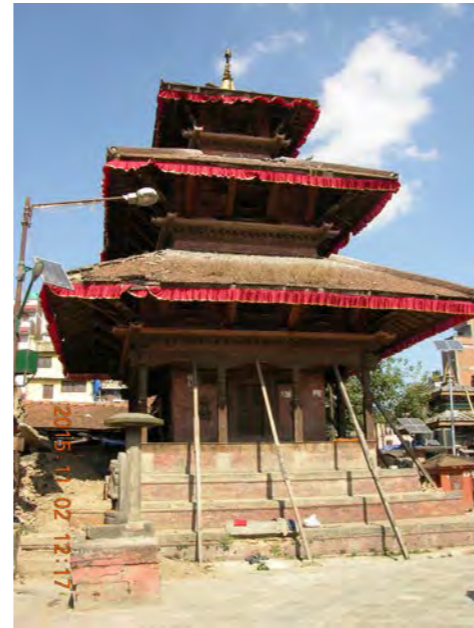
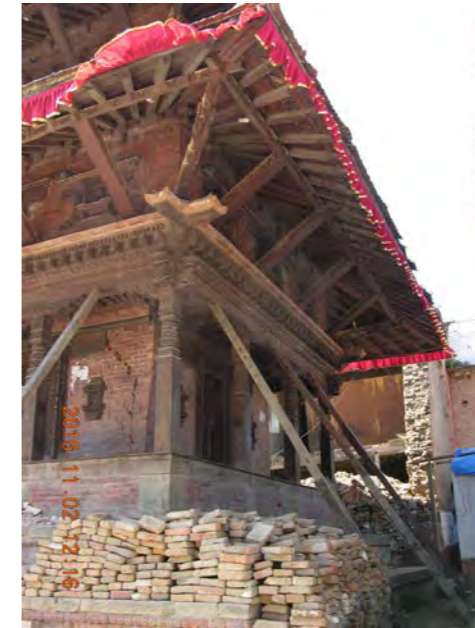
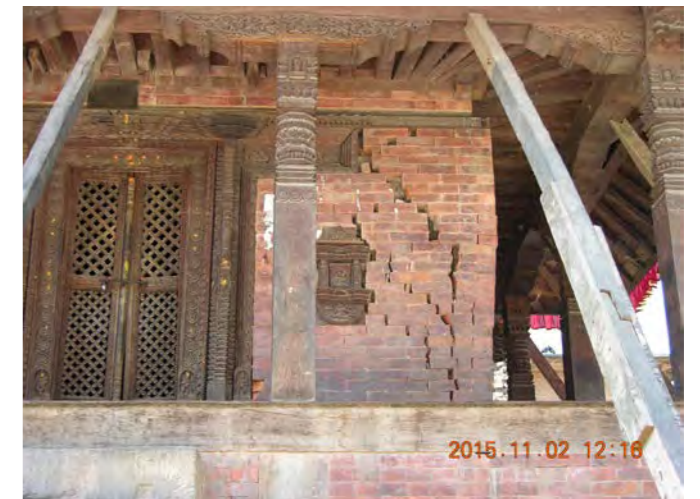
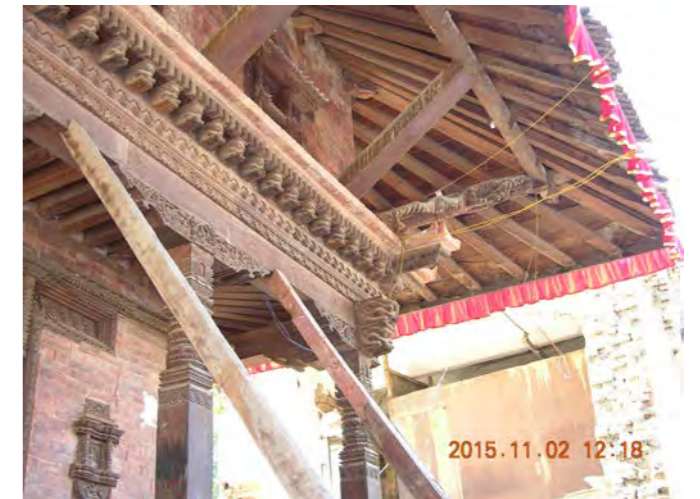
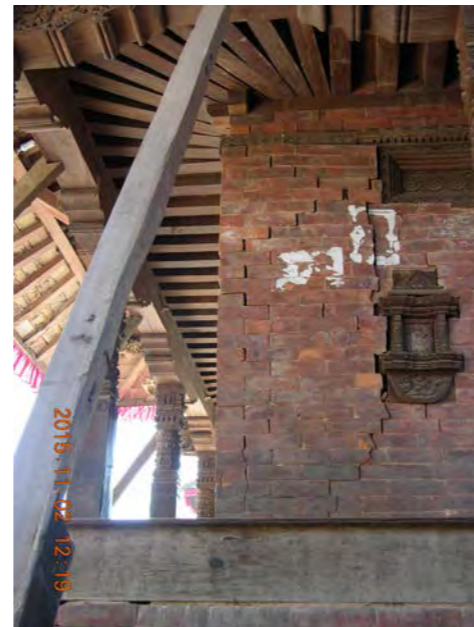
5 PANCHAMUKHI LAXMI NARAYAN TEMPLE

CODE NO	TYOLOGY	MONUMENT NAME	ESTABLISHED/ RENOVATED	STRUCTURAL SYSTEM	MATERIAL	GENERAL DESCRIPTION	PROBLEM DESCRIPTION	DANGER	REMARKS	
5	Two Storey temple		17th Century			Built on three step bases	major cracks all around bricks disassociating, roof tiles missing, vegetation growth on roof

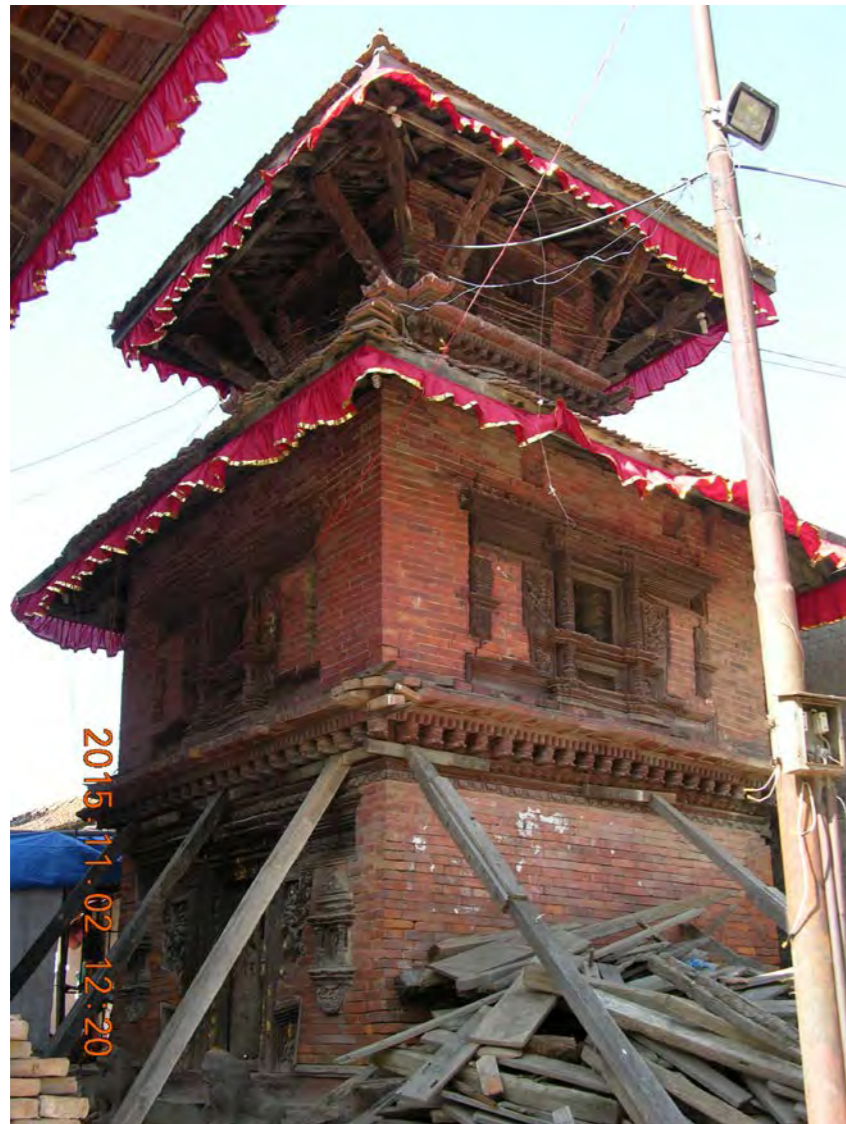
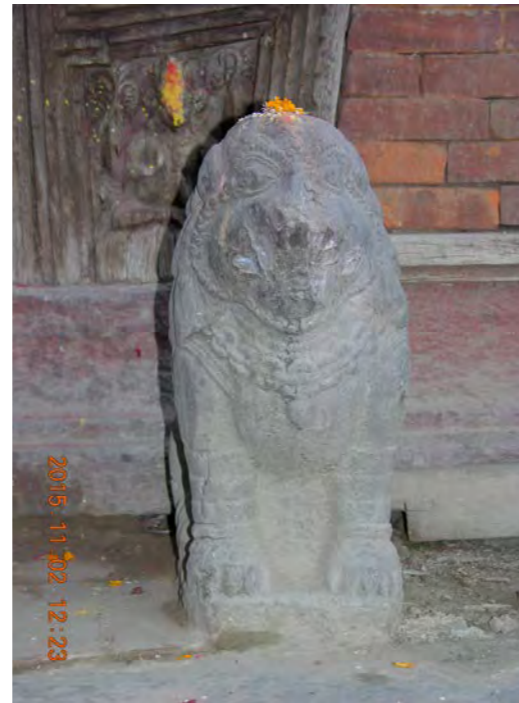
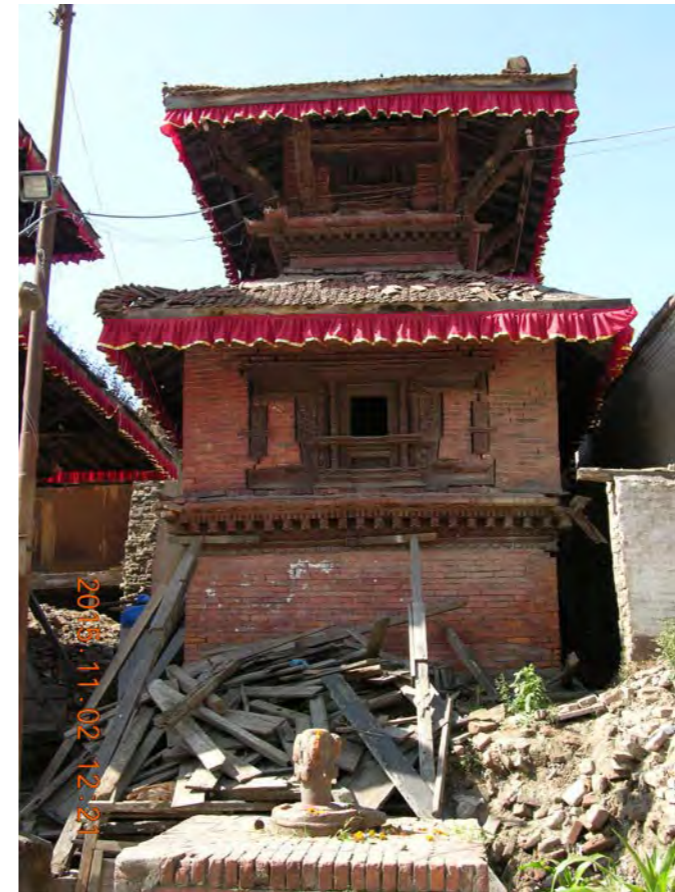
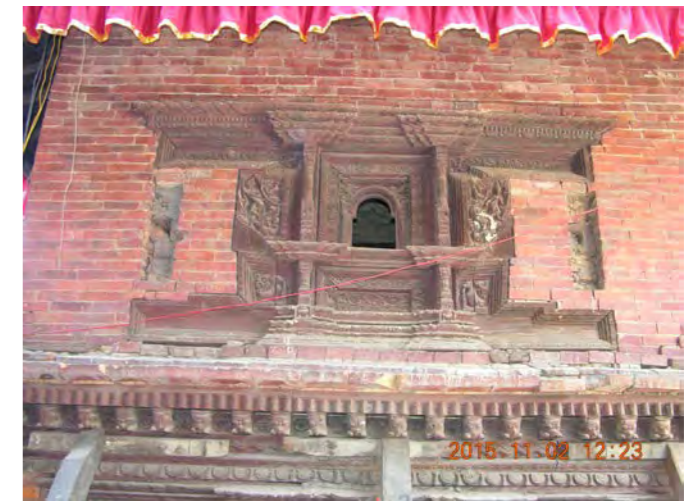
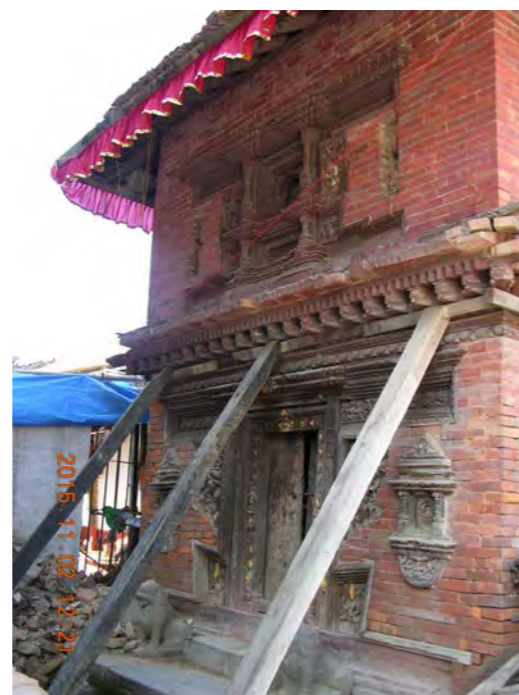
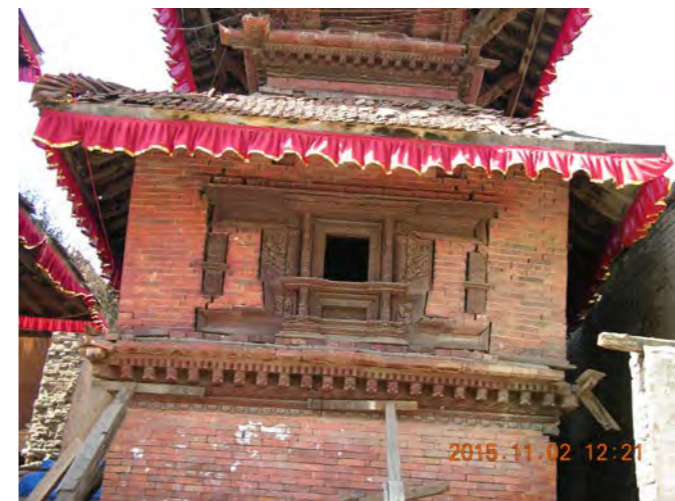
CODE NO	TYOLOGY	MONUMENT NAME	ESTABLISHED/ RENOVATED	STRUCTURAL SYSTEM	MATERIAL	GENERAL DESCRIPTION	PROBLEM DESCRIPTION	DANGER	REMARKS	
5a	Two Storey and Three floor						structure incline, brick degadated

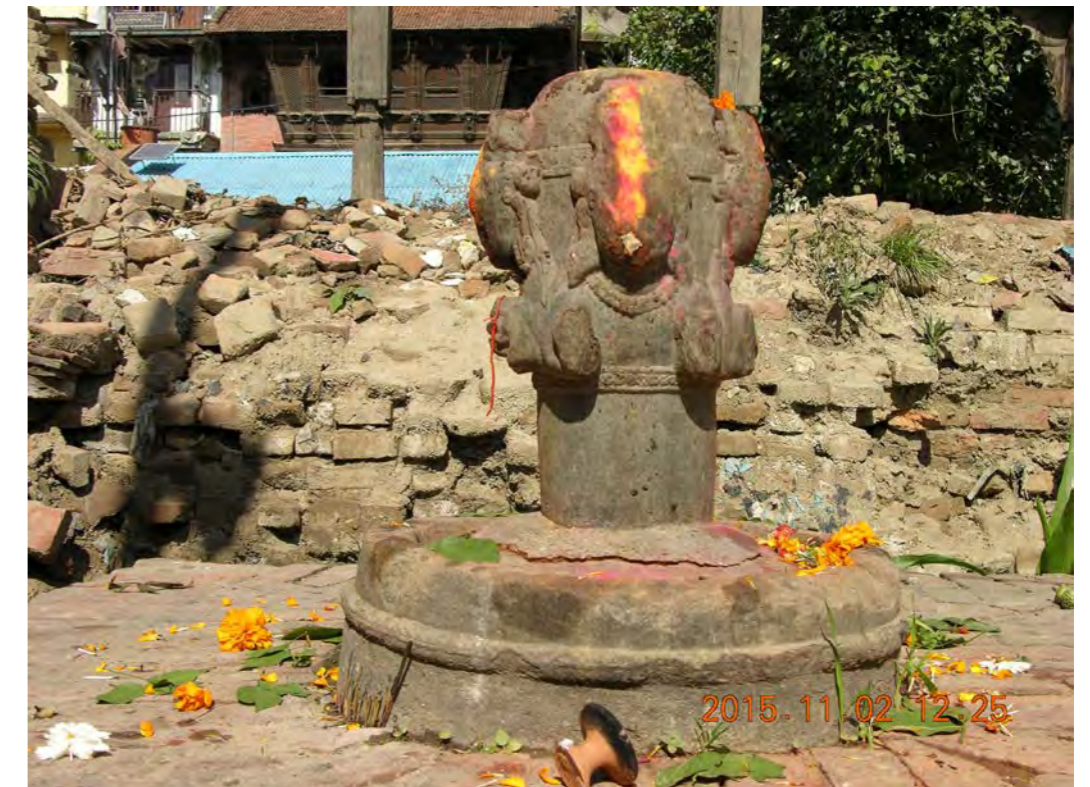
5b SHIVA LINGA

CODE NO	TYOLOGY	MONUMENT NAME	ESTABLISHED/ RENOVATED	STRUCTURAL SYSTEM	MATERIAL	GENERAL DESCRIPTION	PROBLEM DESCRIPTION	DANGER	REMARKS	
5b	Shiva linga					Stone 4 faced shiva linga on brick base	No visible damage
