2015 Earthquake Damage Mapping

Hanuman Dhoka Darbar Square Monument Zone
Kathmandu Valley World Heritage Property

December 2015

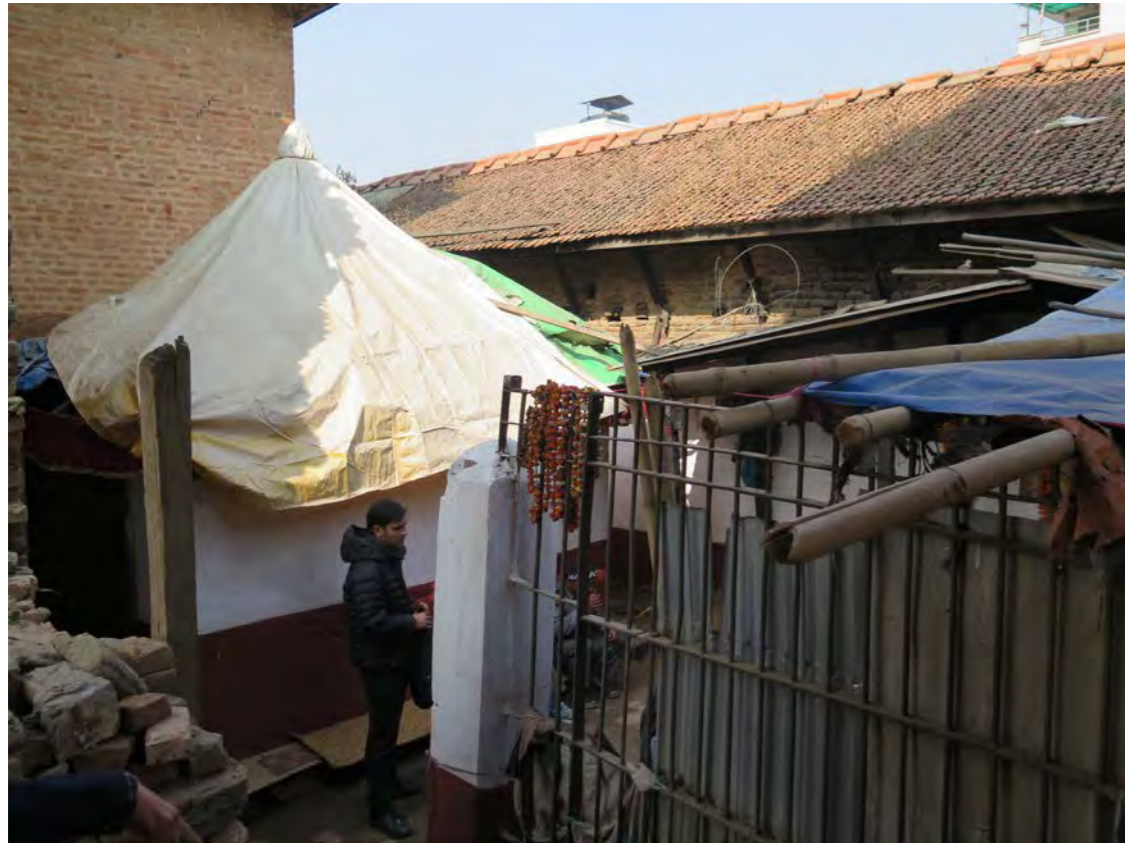
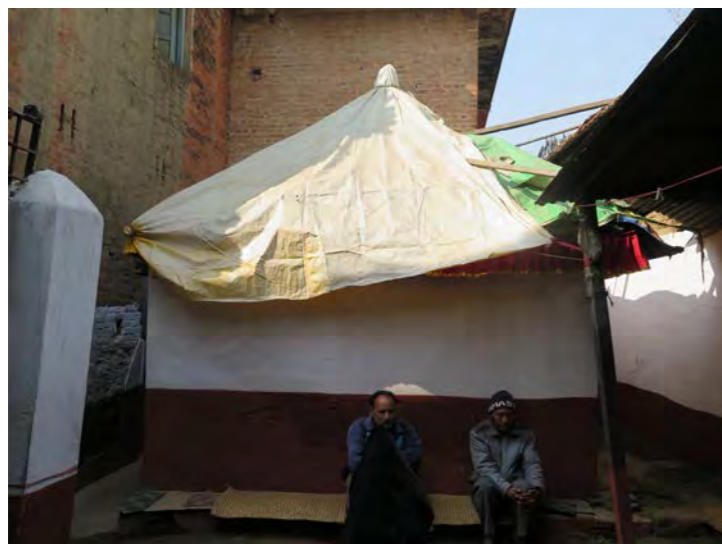
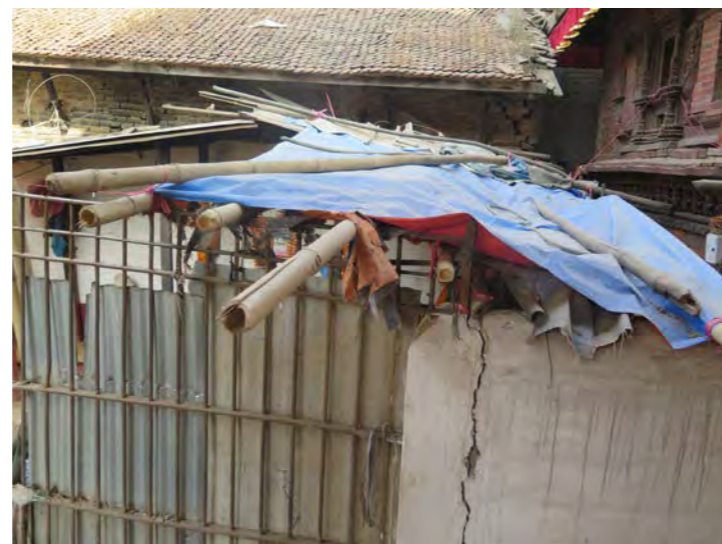
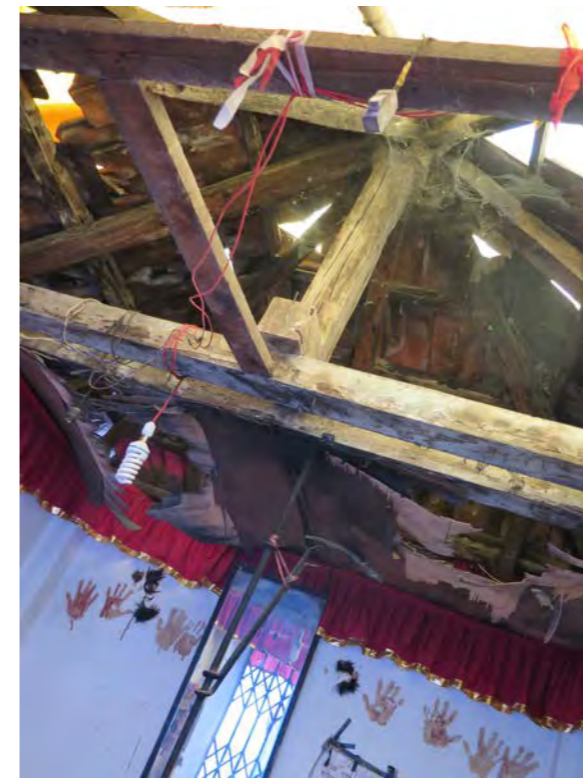
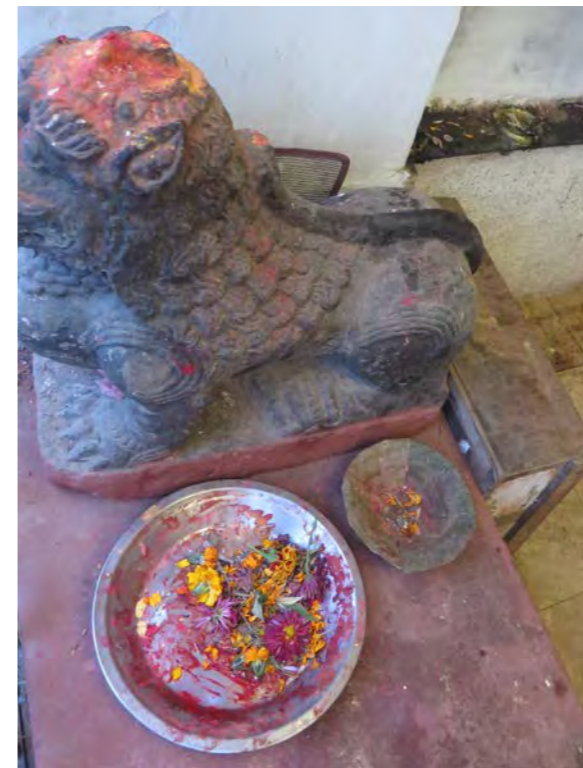
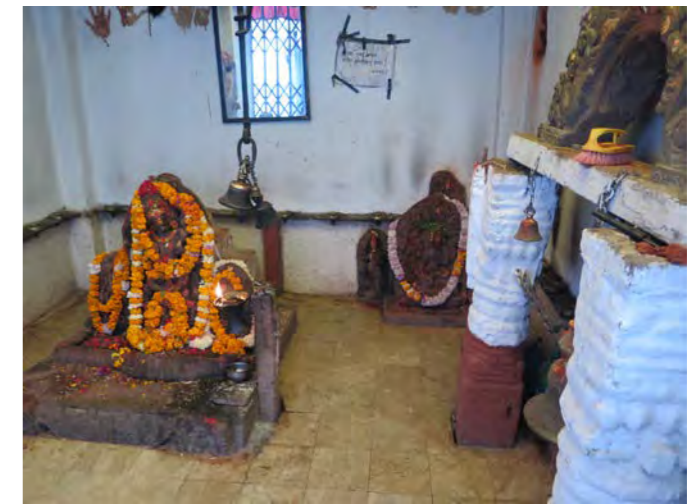
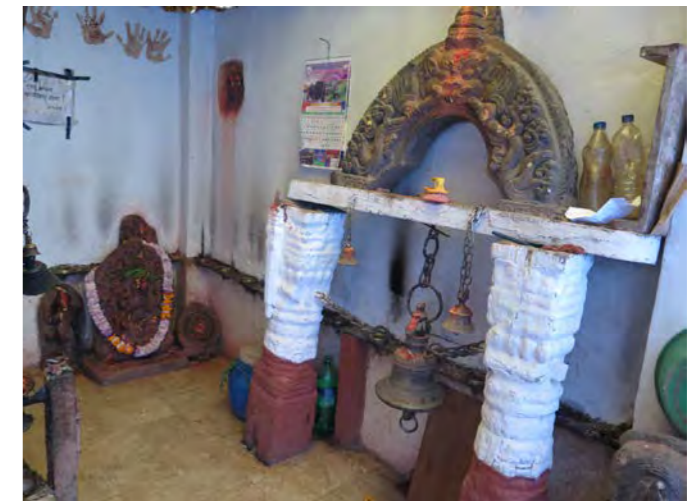
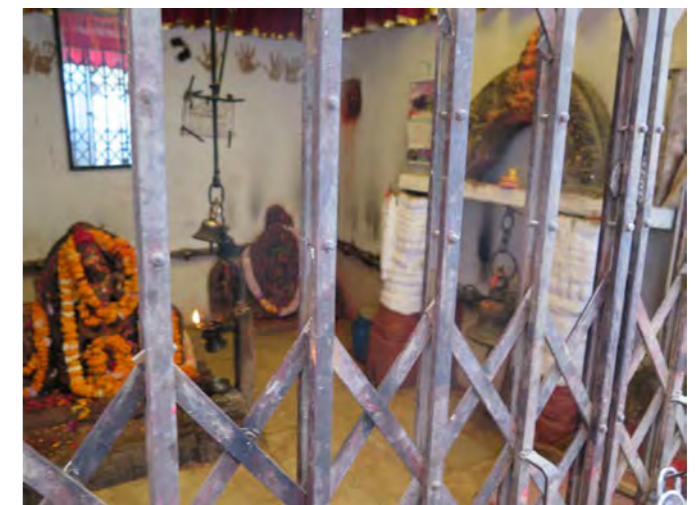
5c NIL BARAHI

CODE NO	TYOLOGY	MONUMENT NAME	ESTABLISHED/ RENOVATED	STRUCTURAL SYSTEM	MATERIAL	GENERAL DESCRIPTION	PROBLEM DESCRIPTION	DANGER	REMARKS	
5c	Single storey temple	Nil Barahi		Load Bearing			Deteriorated roof

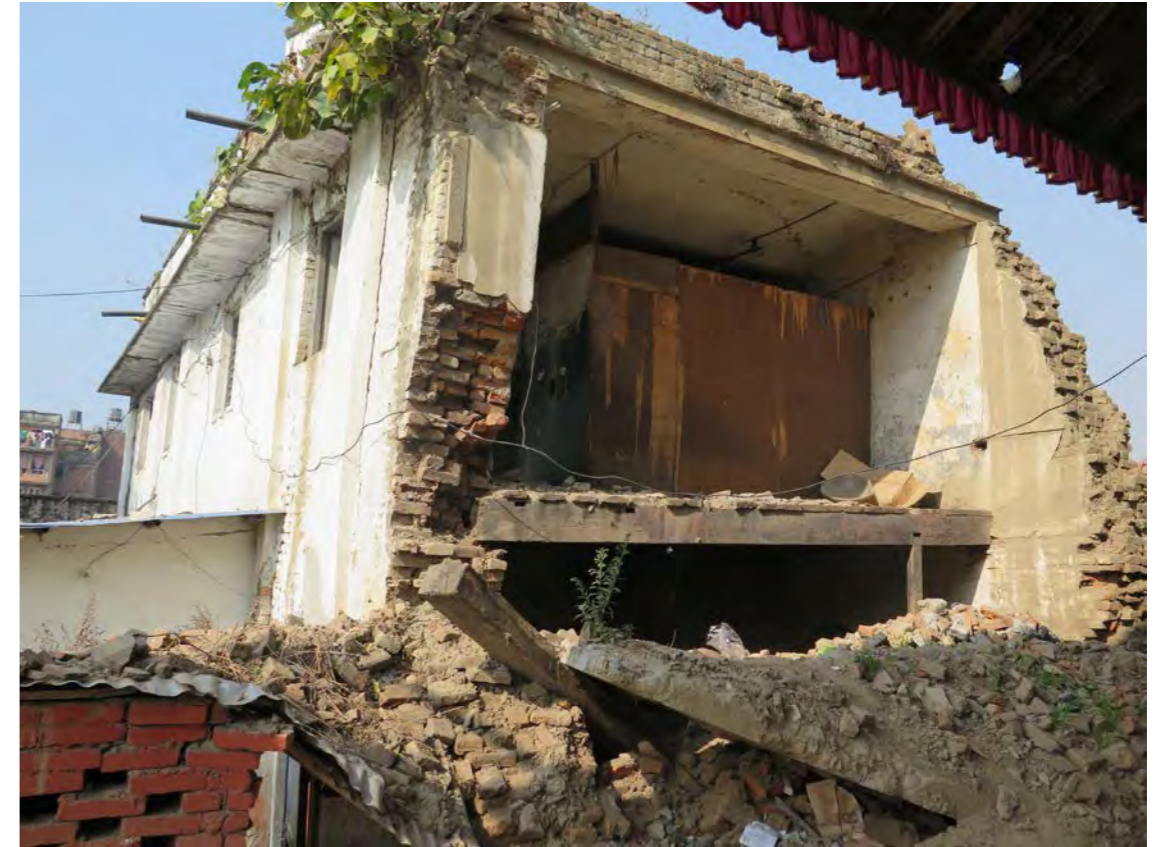
CODE NO	TYOLOGY	MONUMENT NAME	ESTABLISHED/ RENOVATED	STRUCTURAL SYSTEM	MATERIAL	GENERAL DESCRIPTION	PROBLEM DESCRIPTION	DANGER	REMARKS	
5d						Two storeyed building used by Police Station	Half part collapsed. Remaining structure has extensive crack.

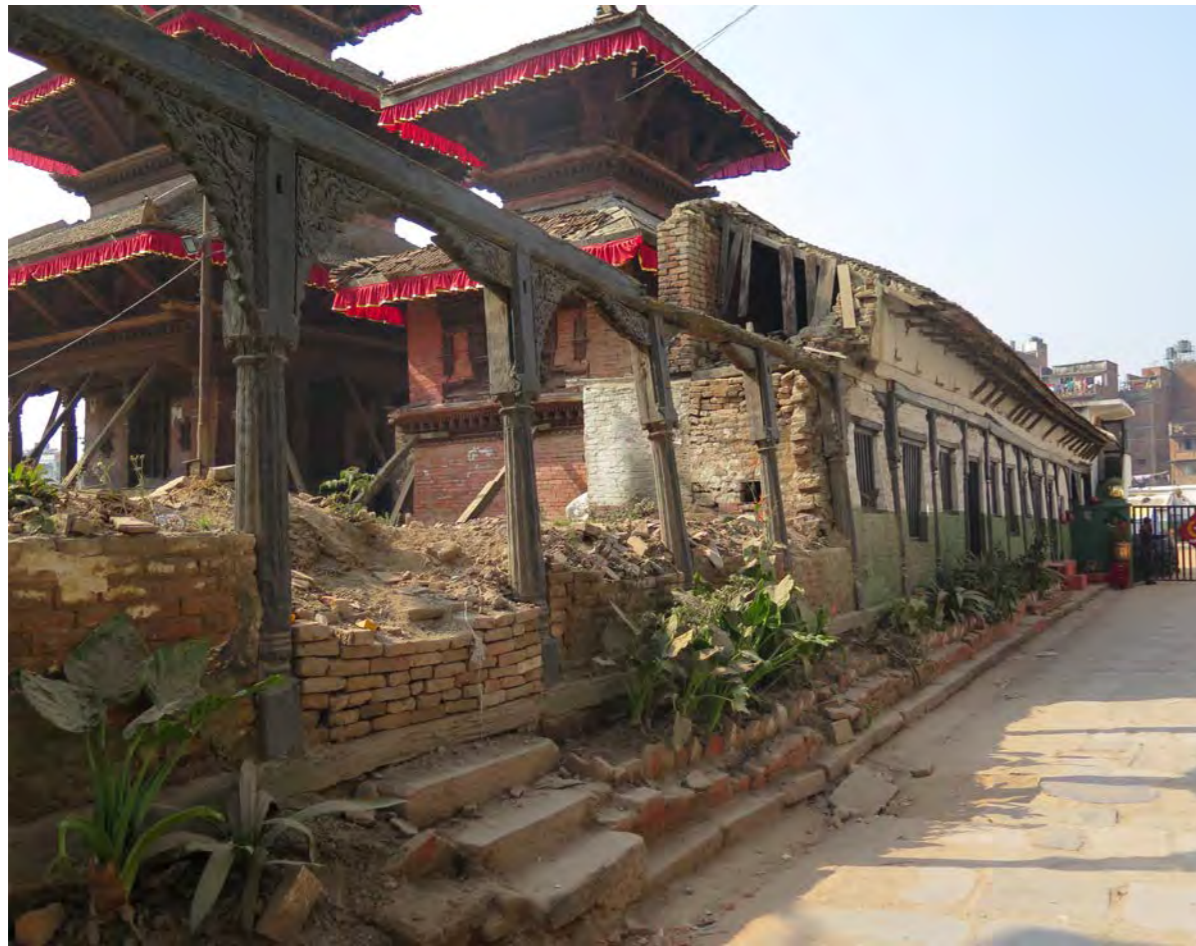
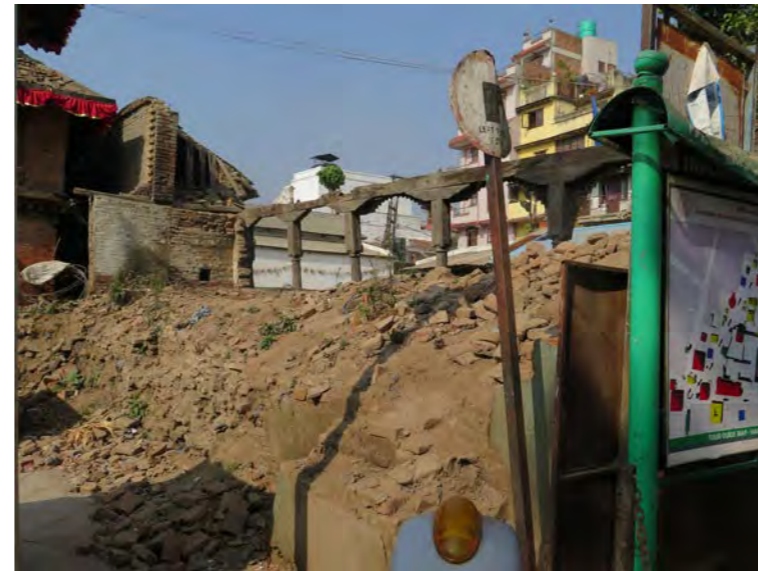
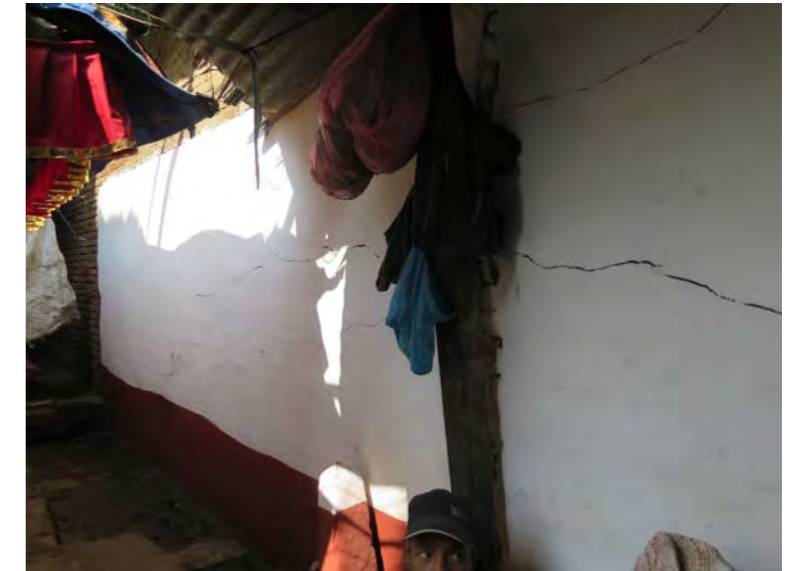
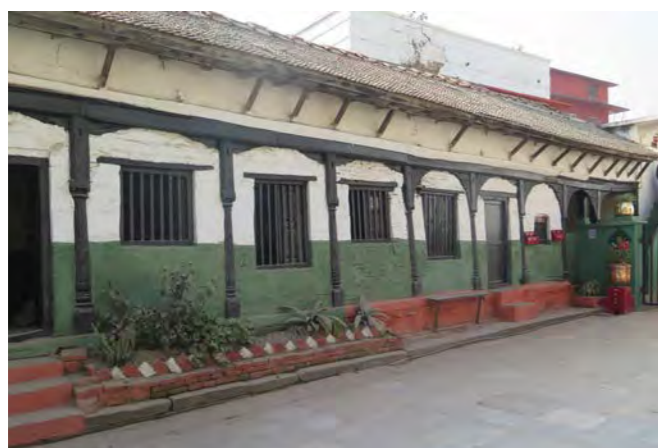
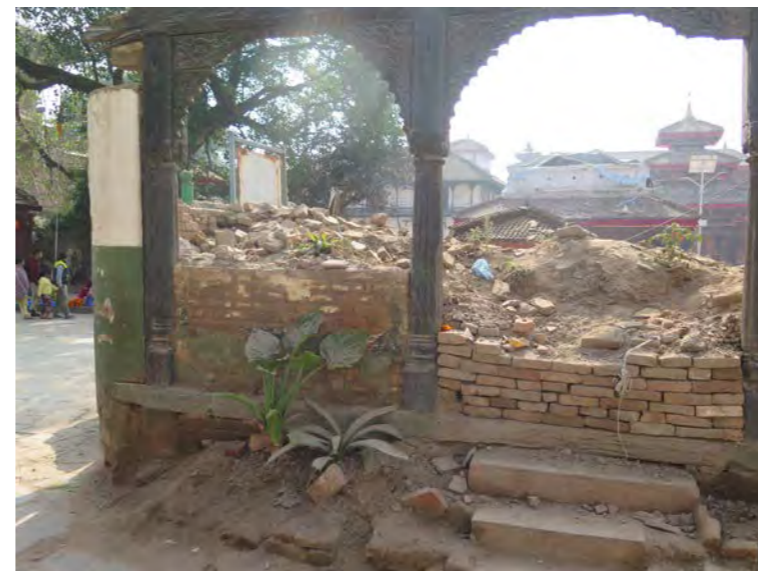
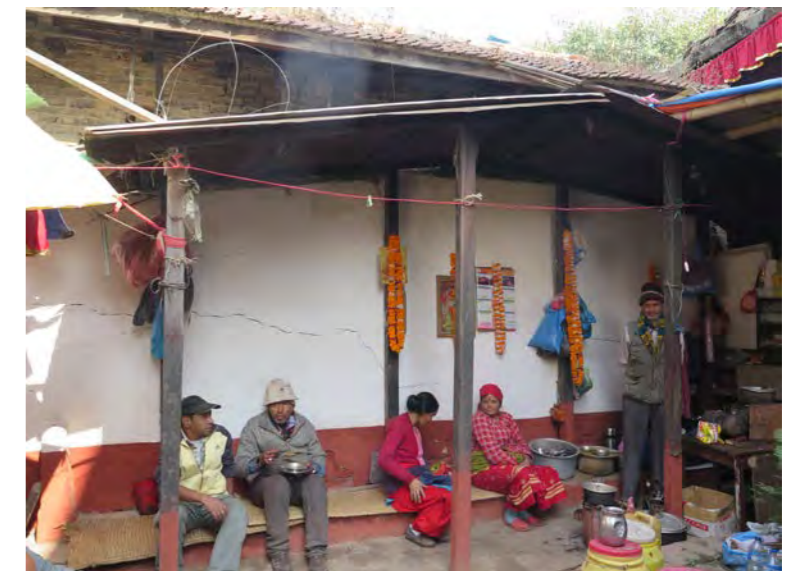
CODE NO	TYOLOGY	MONUMENT NAME	ESTABLISHED/ RENOVATED	STRUCTURAL SYSTEM	MATERIAL	GENERAL DESCRIPTION	PROBLEM DESCRIPTION	DANGER	REMARKS	
5e	Pati					Used by Army.	Half part collapsed. Remaining structure has extensive cracks. Vegetation growth on roof. Roof tile detached.

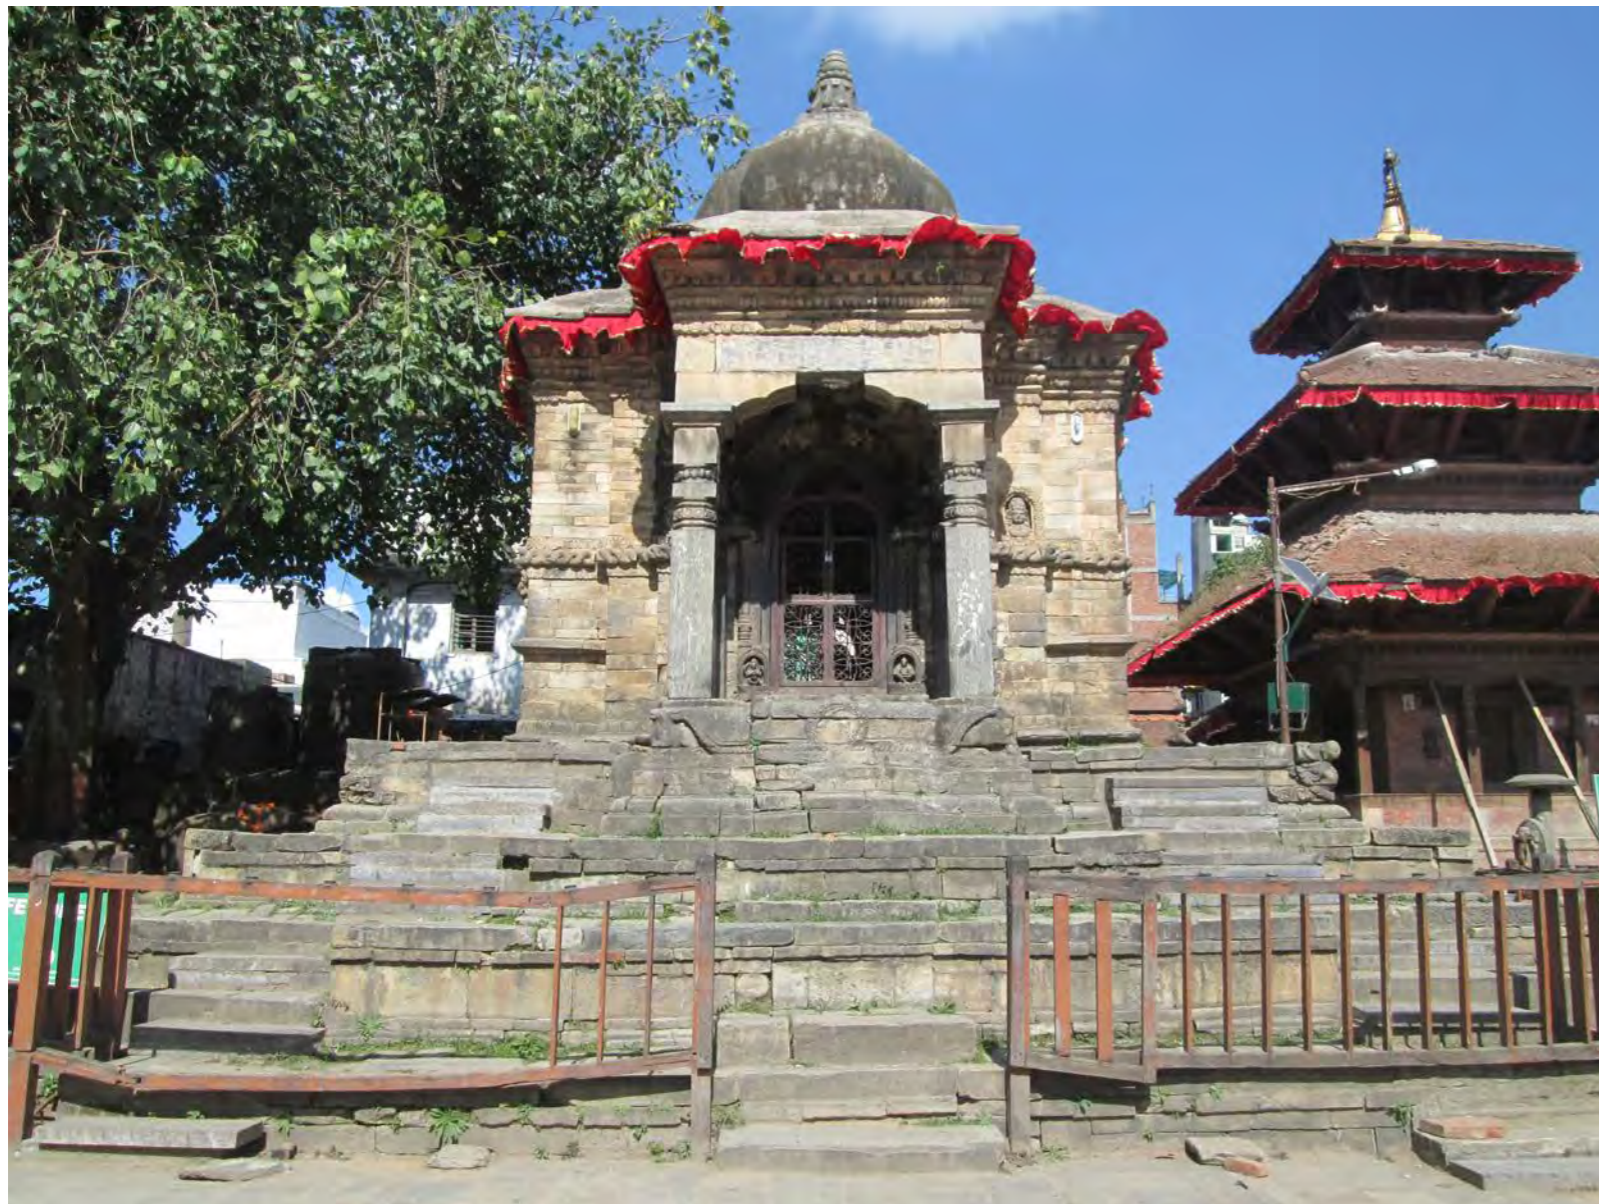
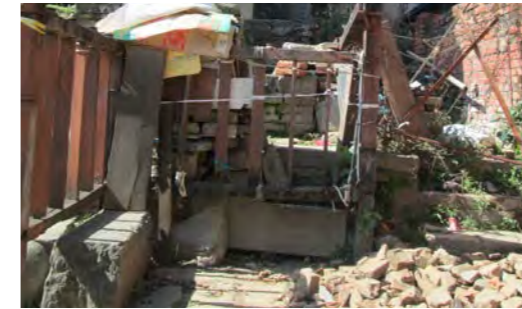
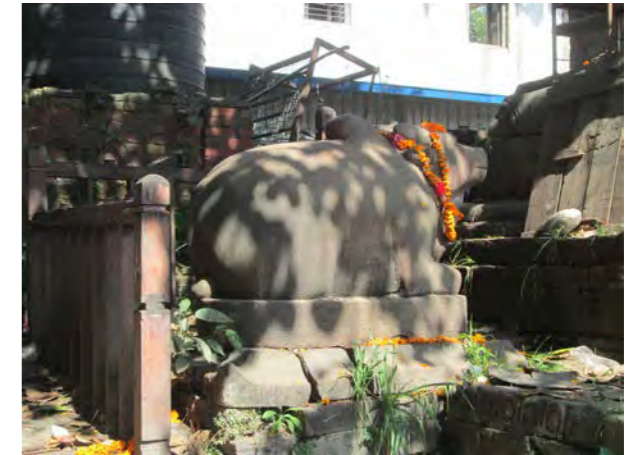
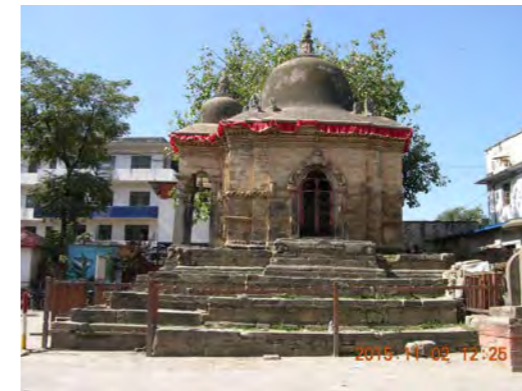
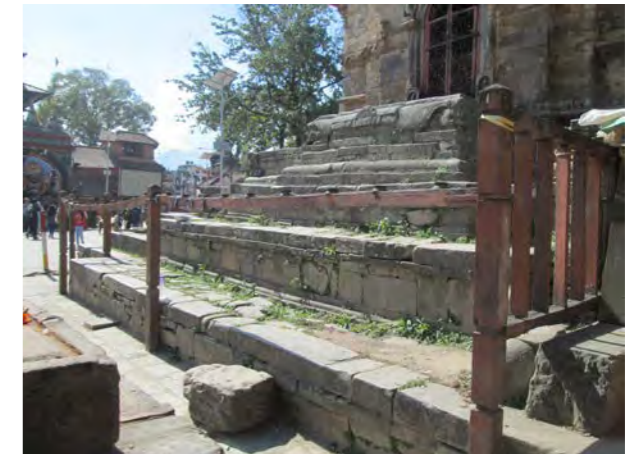
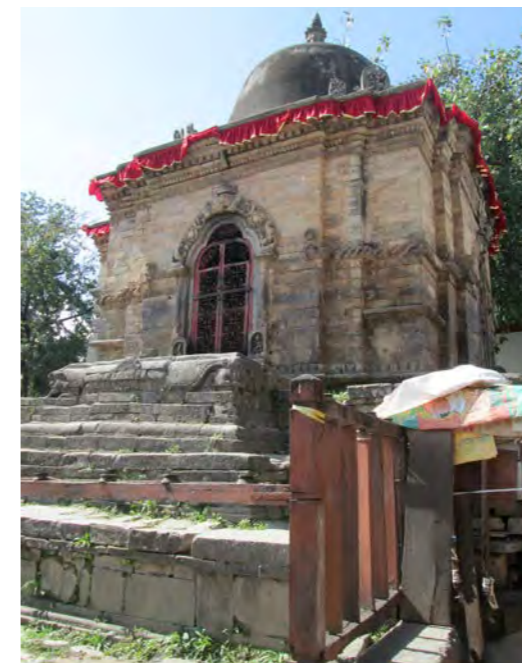
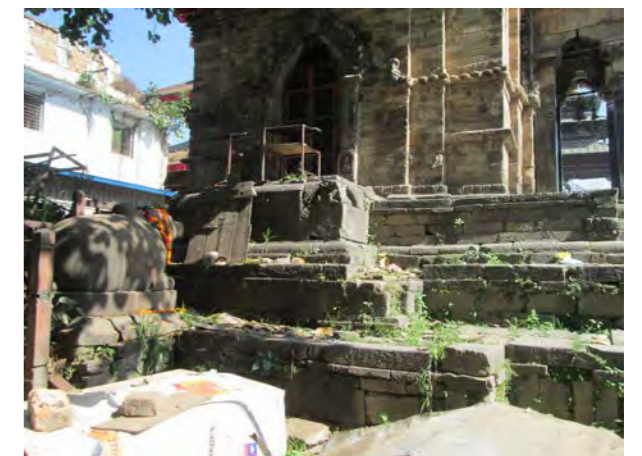
6 MAHADEV

CODE NO	TPOLOGY	MONUMENT NAME	ESTABLISHED/ RENOVATED	STRUCTURAL SYSTEM	MATERIAL	GENERAL DESCRIPTION	PROBLEM DESCRIPTION	DANGER	REMARKS	
6	Dome temple	Mahadev	18th century/ 1934			Temple of stone stands on a stone base in three stages, contains deity of Chaturmukhalinga	Plinth setting down, stone dislocation, vegetation growth

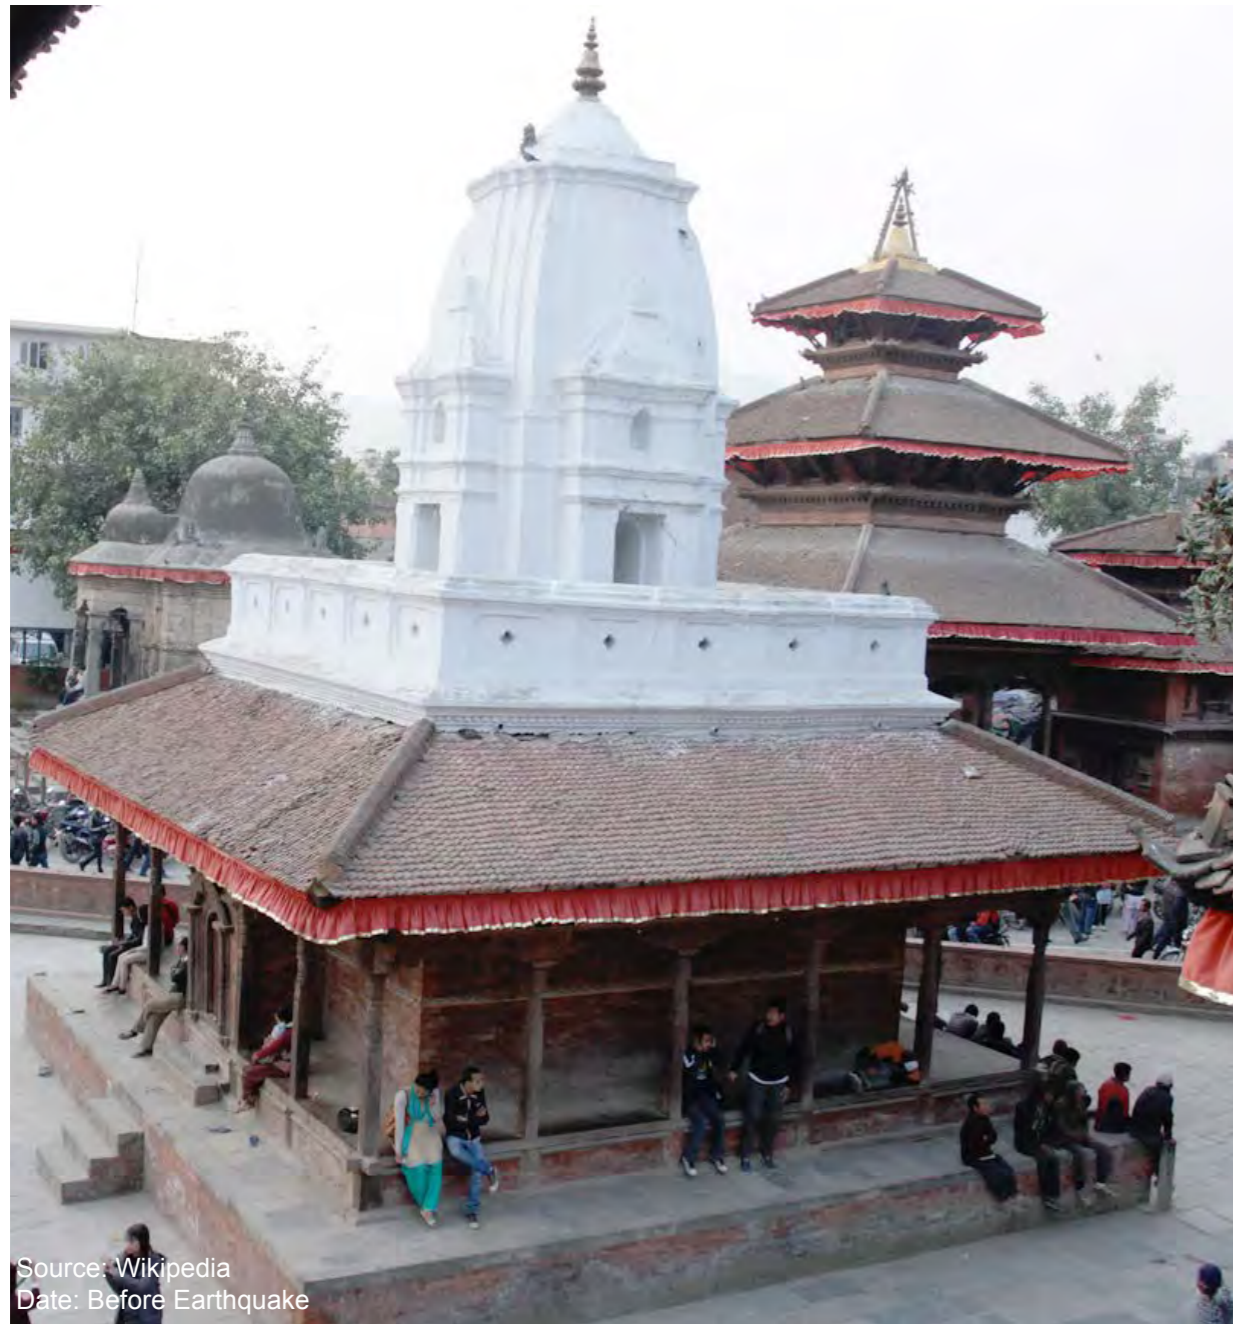
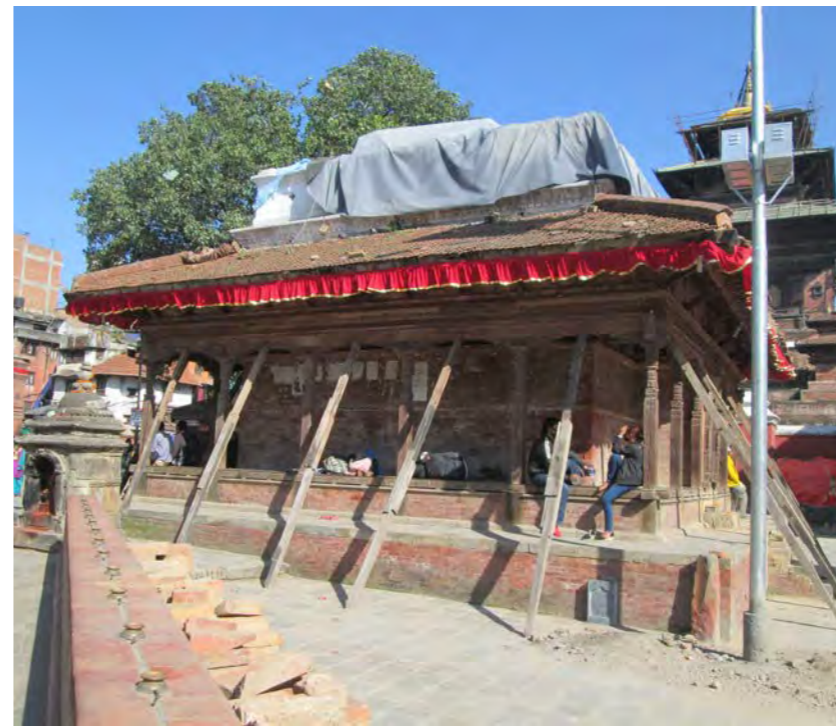
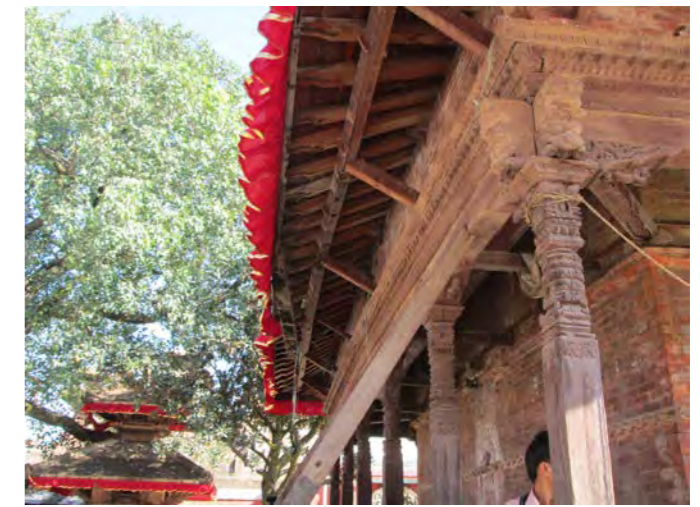
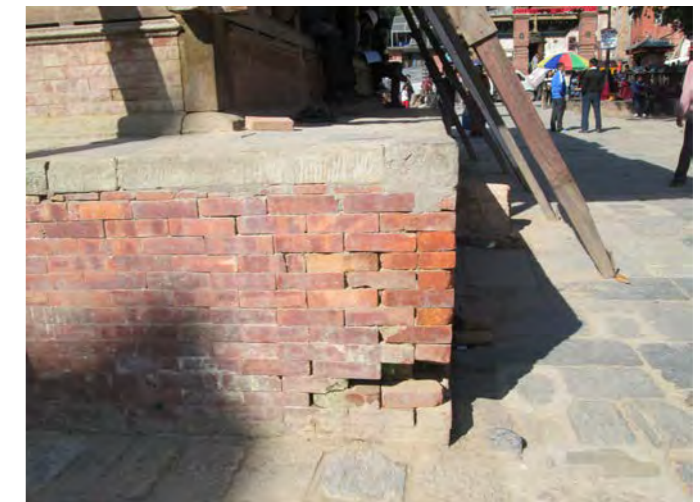
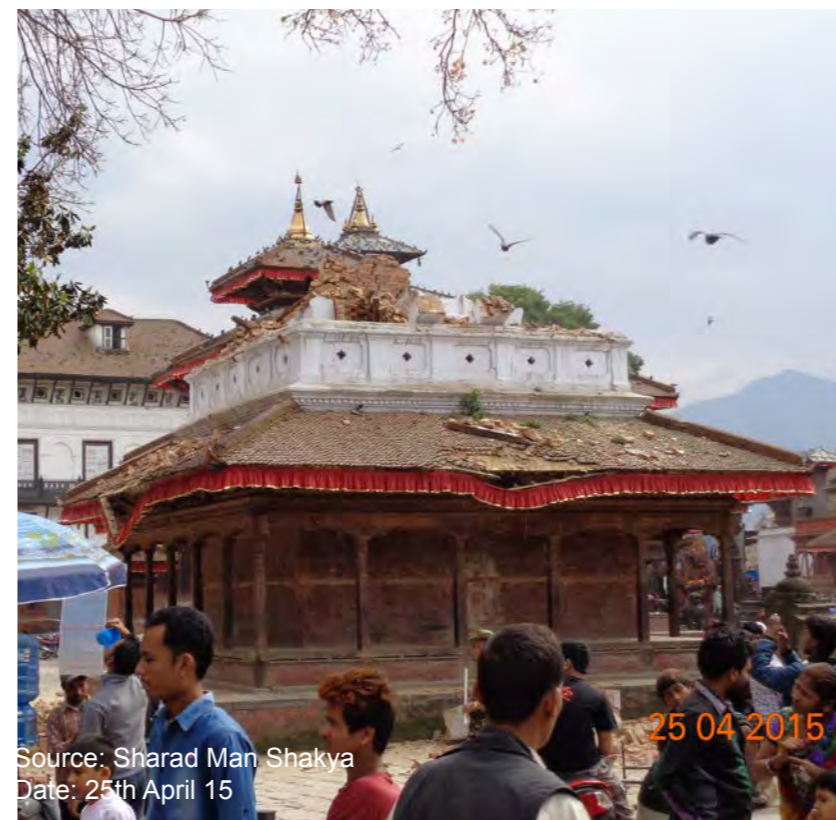
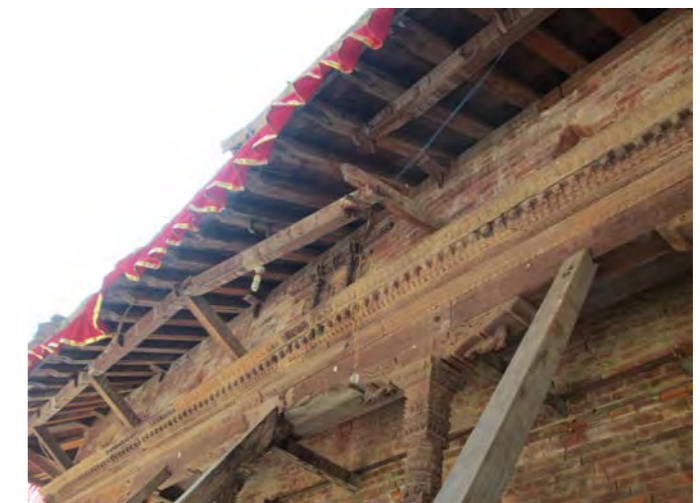
7 KAGESWOR

CODE NO	TYOLOGY	MONUMENT NAME	ESTABLISHED/ RENOVATED	STRUCTURAL SYSTEM	MATERIAL	GENERAL DESCRIPTION	PROBLEM DESCRIPTION	DANGER	REMARKS
7	Composite Temple	Kvageswor					upper part collapsed, structure unstable, plinth setting & tudal out of place		
7a	Enclosed shrine						stone delipated, gajur top missing

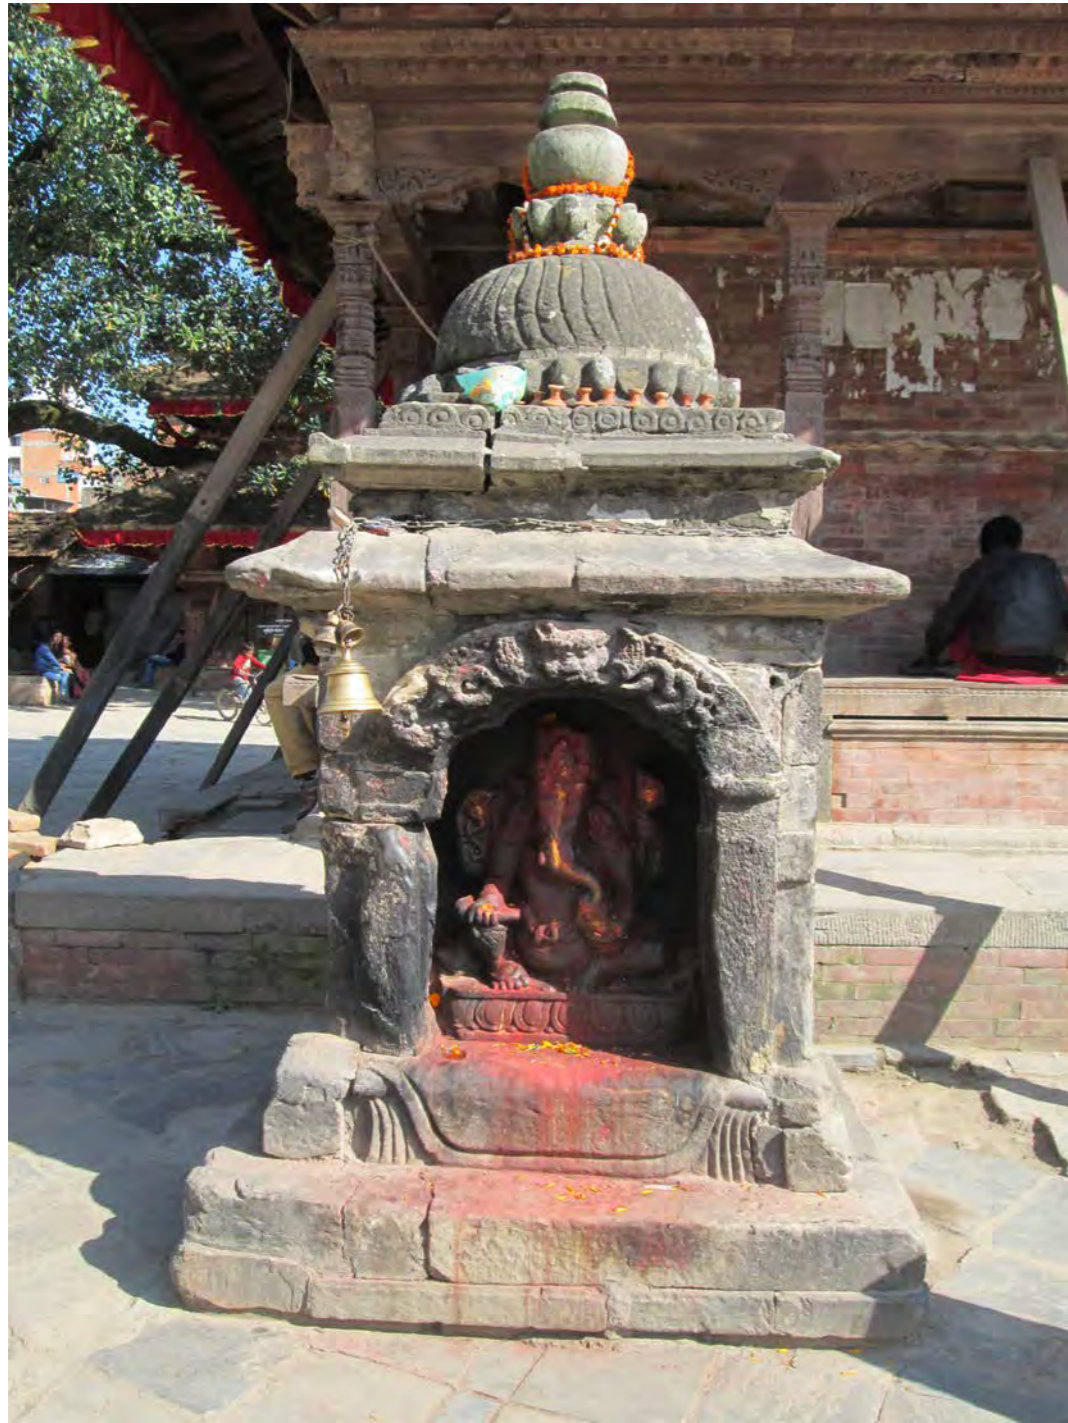
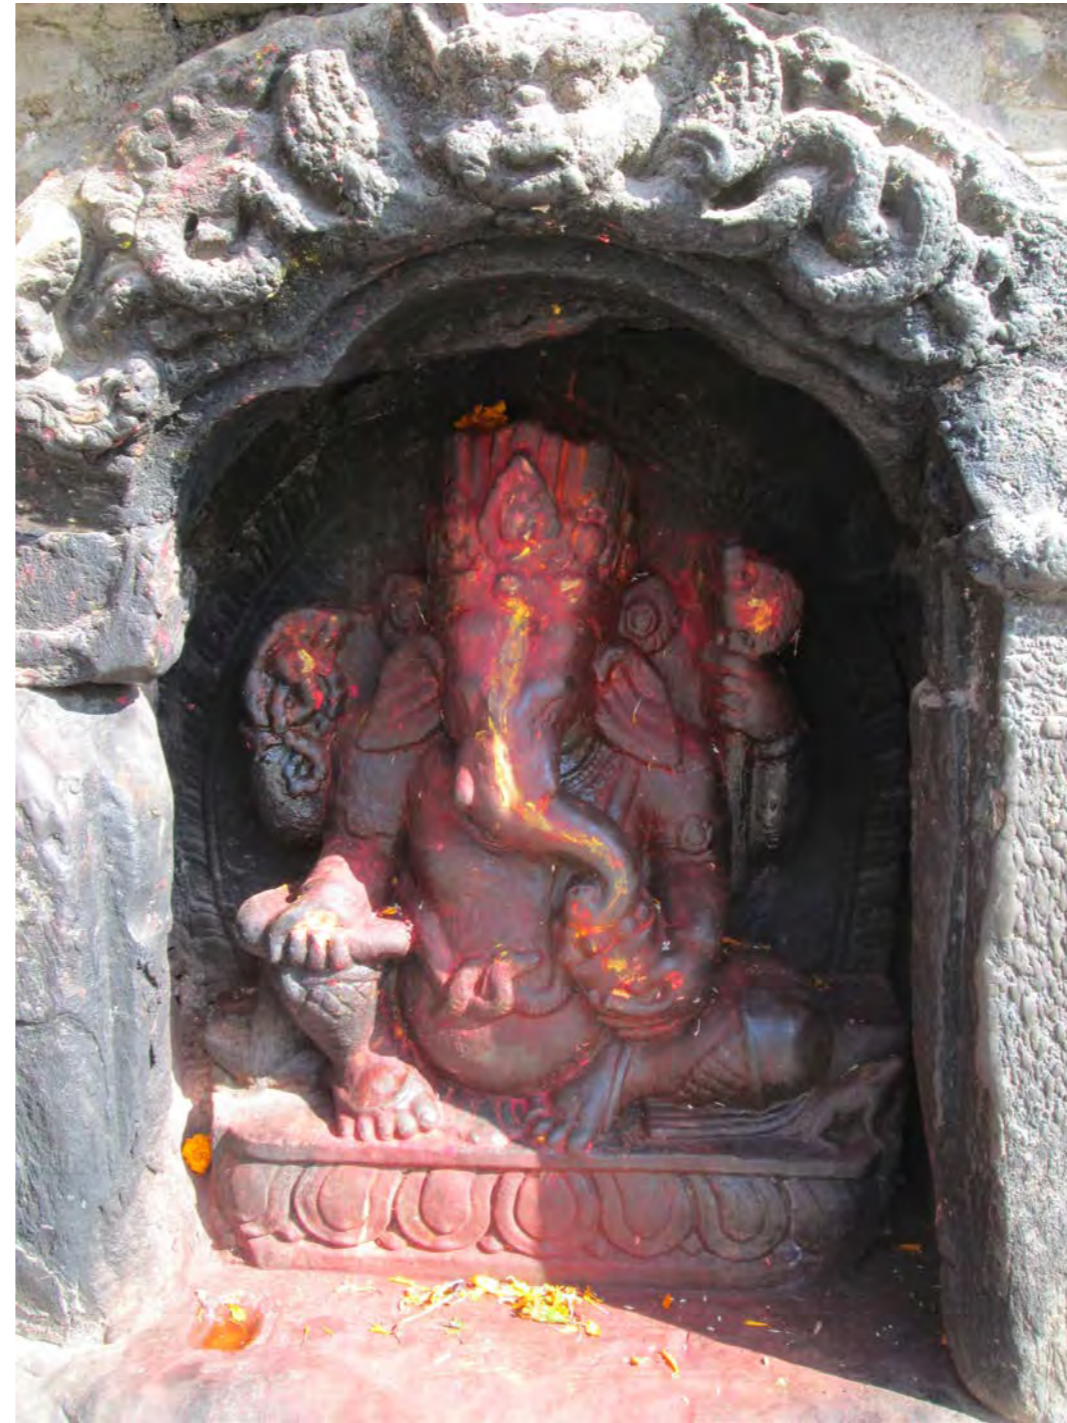
7a ENCLOSED SHRINE

CODE NO	TYOLOGY	MONUMENT NAME	ESTABLISHED/ RENOVATED	STRUCTURAL SYSTEM	MATERIAL	GENERAL DESCRIPTION	PROBLEM DESCRIPTION	DANGER	REMARKS
7a	Enclosed shrine						stone delipated, gajur top missing

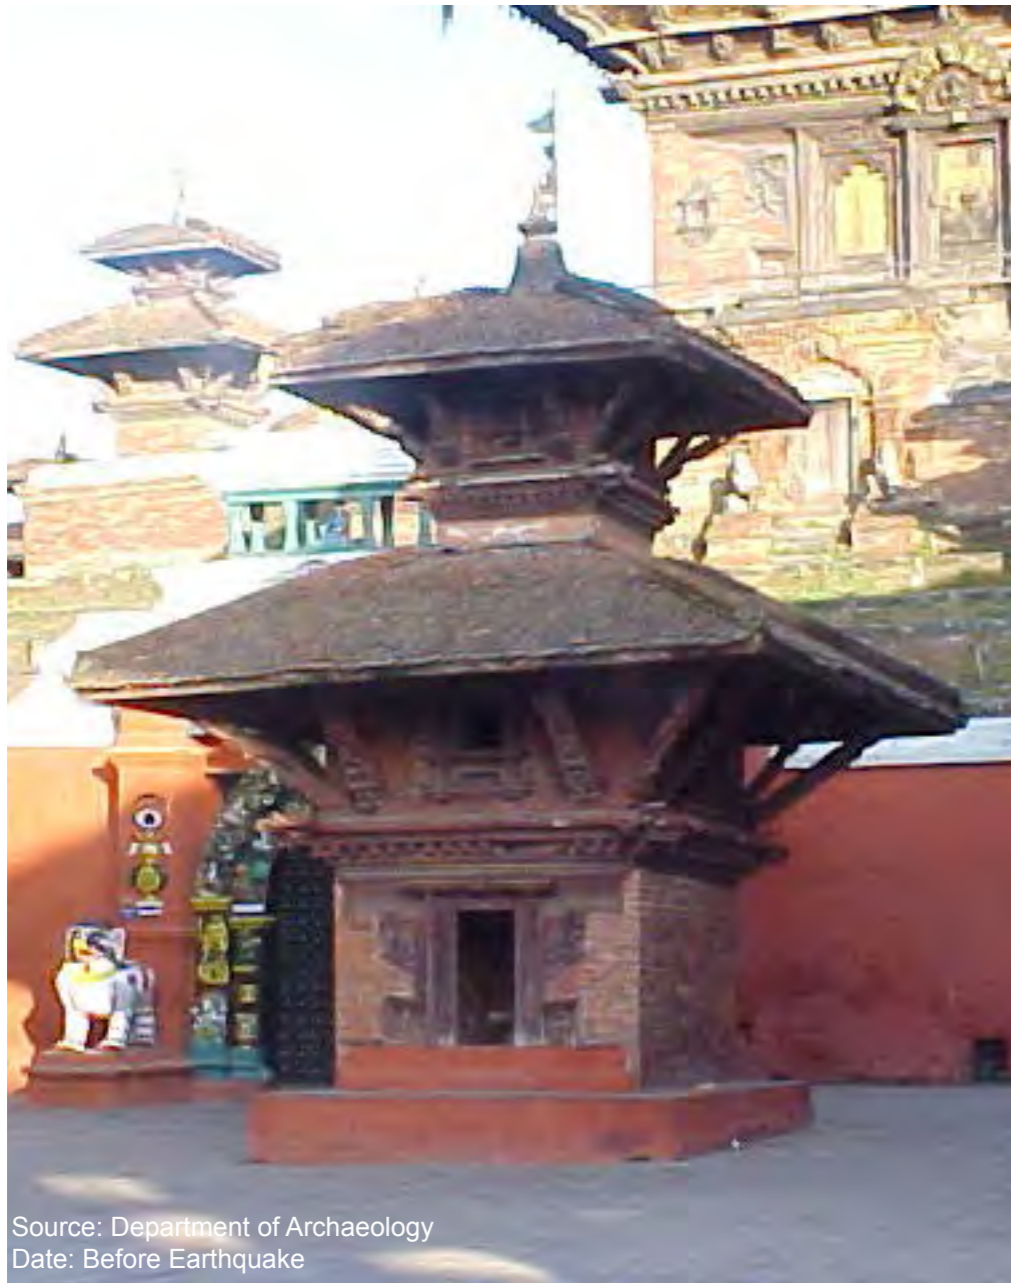
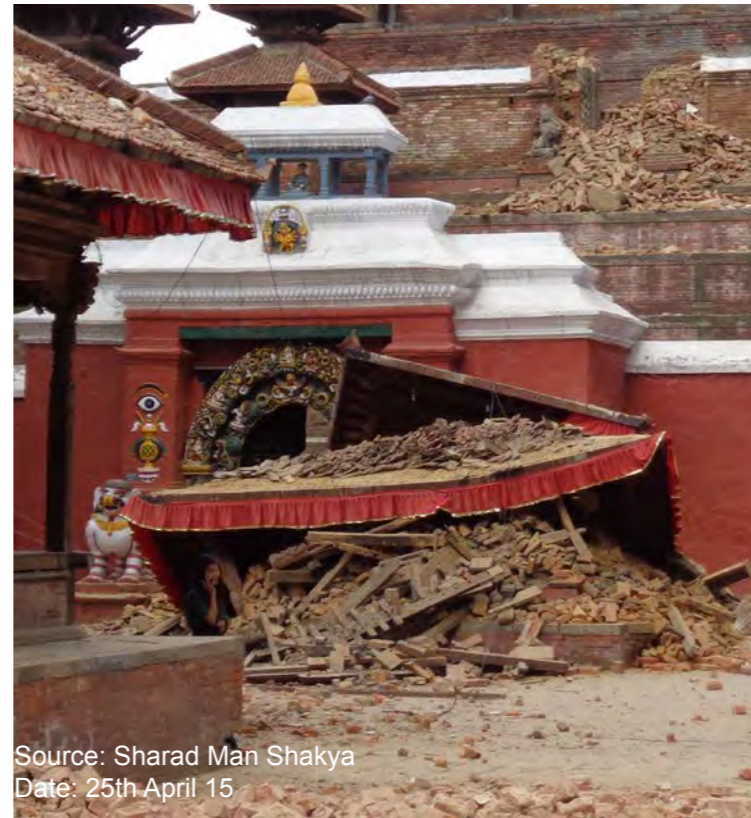
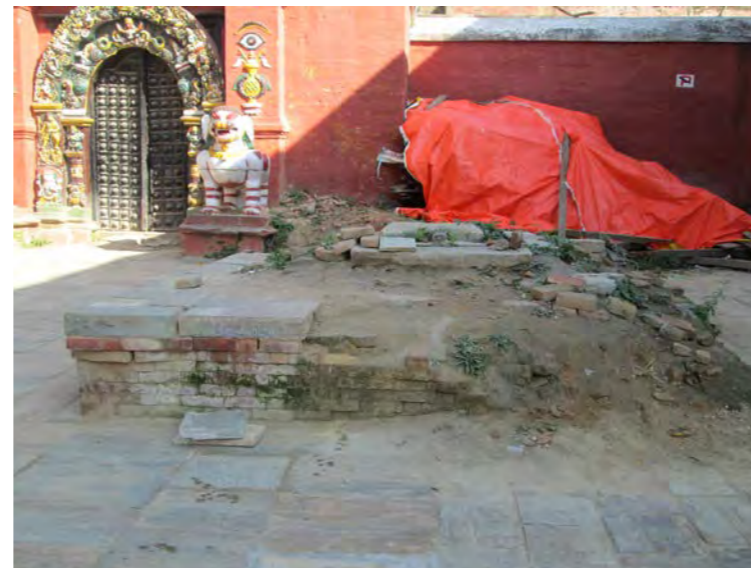
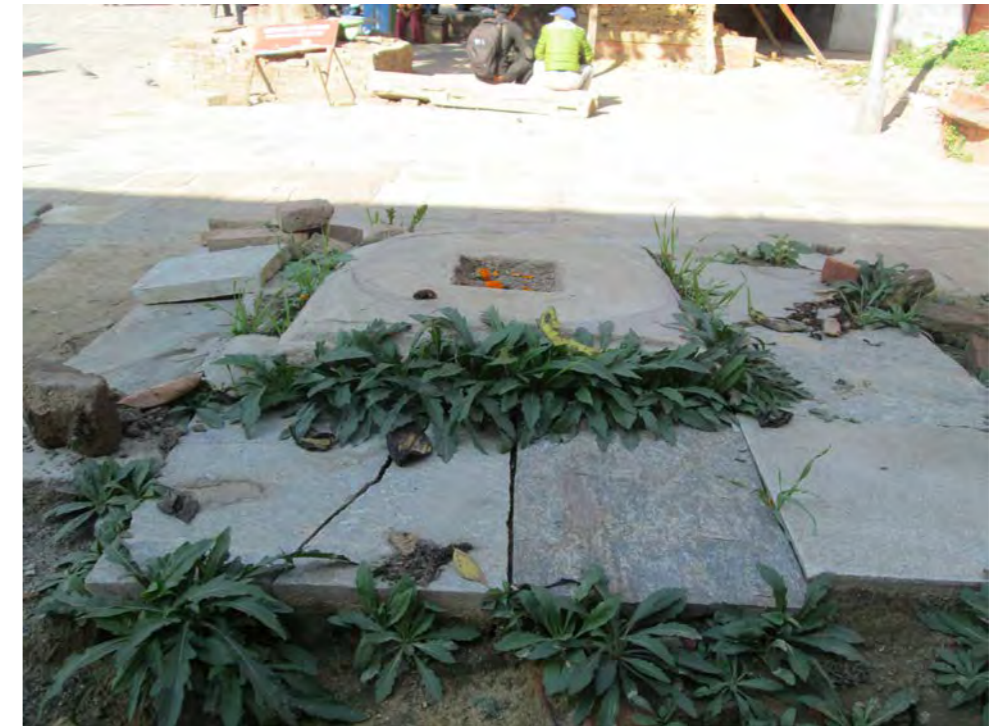
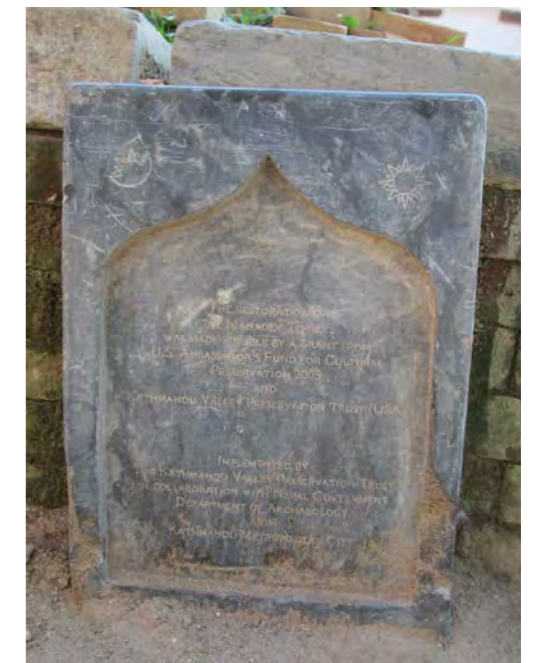
8 MAHADEV TEMPLE

CODE NO	TYOLOGY	MONUMENT NAME	ESTABLISHED/ RENOVATED	STRUCTURAL SYSTEM	MATERIAL	GENERAL DESCRIPTION	PROBLEM DESCRIPTION	DANGER	REMARKS
8	Two Storey Temple	Mahadev temple	17th century				totally collapsed
