2015 Earthquake Damage Mapping

Hanuman Dhoka Darbar Square Monument Zone
Kathmandu Valley World Heritage Property

December 2015

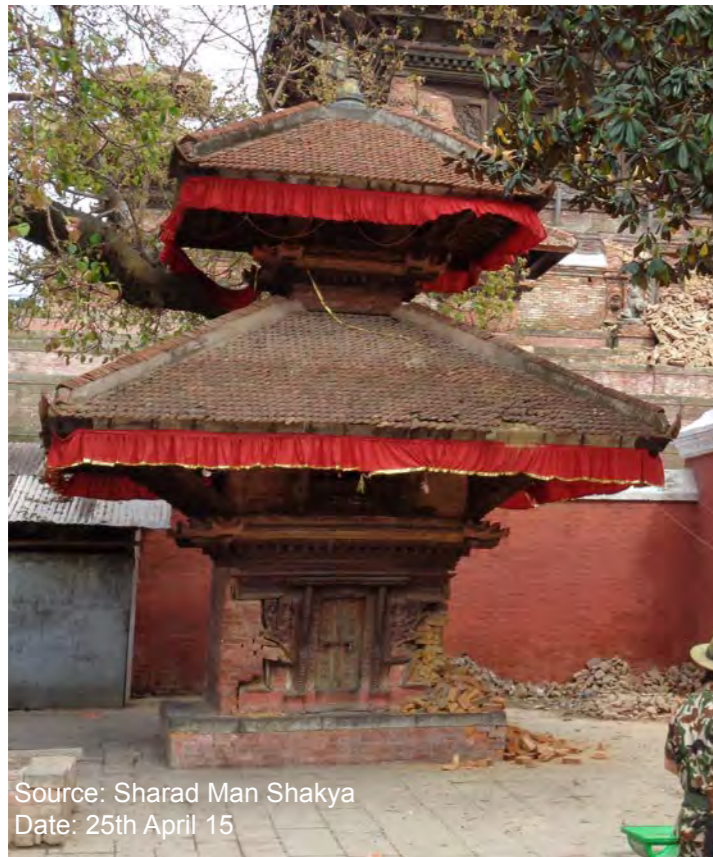
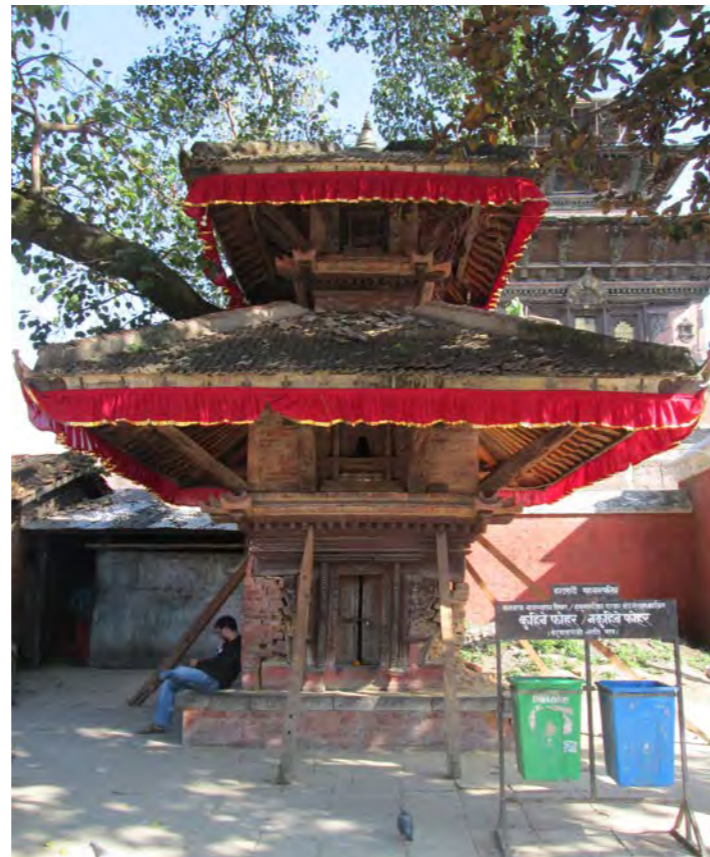
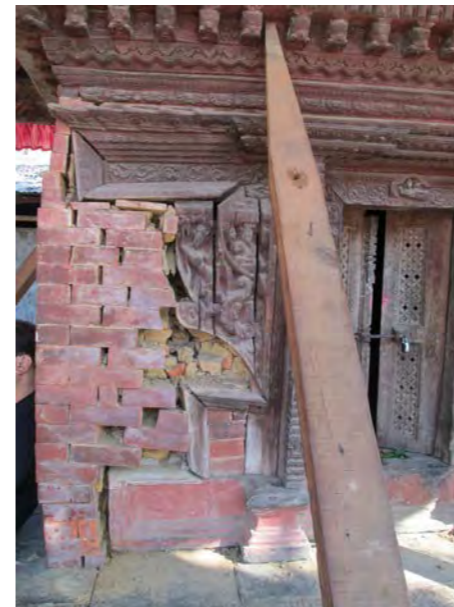
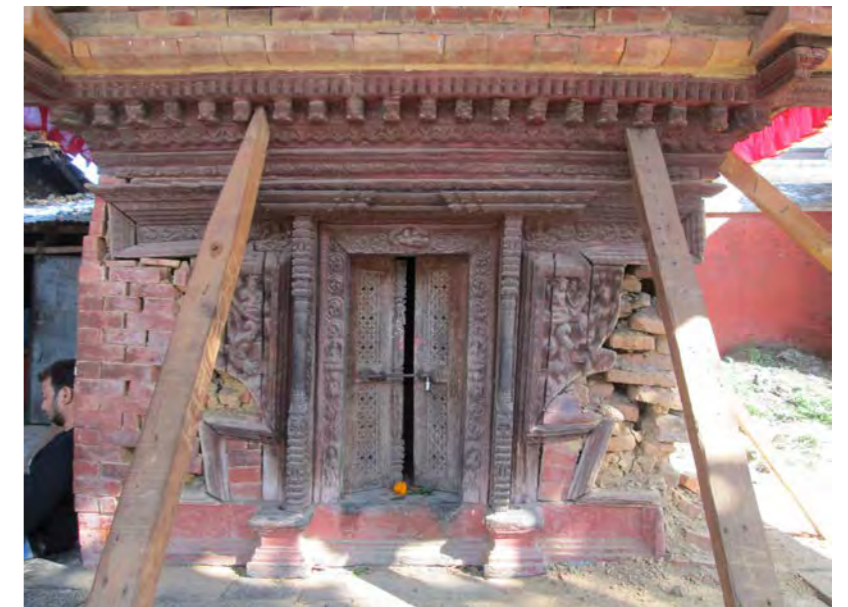
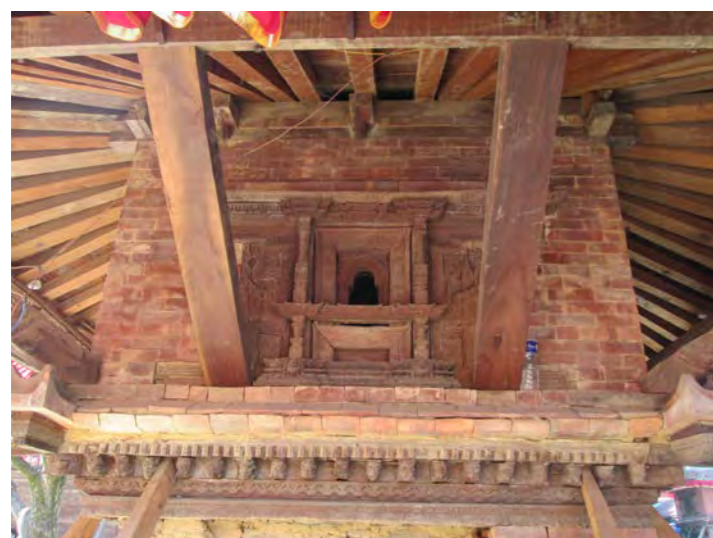
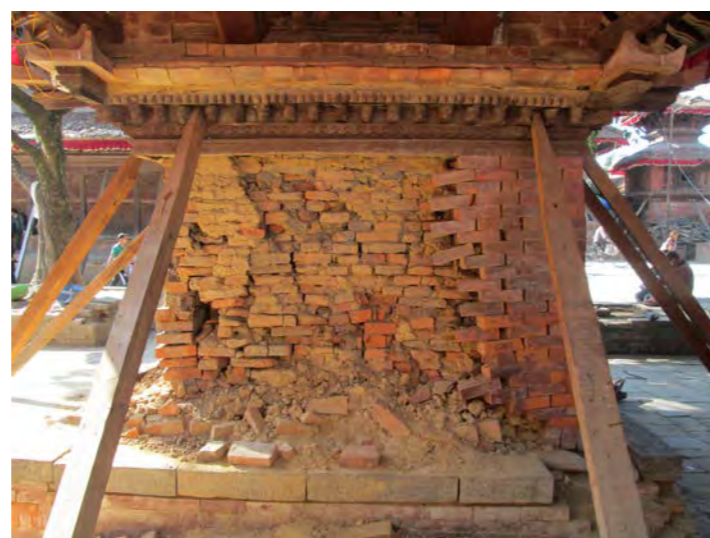
9 MAHADEV TEMPLE

CODE NO	TYOLOGY	MONUMENT NAME	ESTABLISHED/RENOVATED	STRUCTURAL SYSTEM	MATERIAL	GENERAL DESCRIPTION	PROBLEM DESCRIPTION	DANGER	REMARKS
9	Two Storey Temple	Mahadev temple	17th century			Built on a shallow base. Both door and windows contain struts which represent various forms of shiva	South wall very degraded and unstable

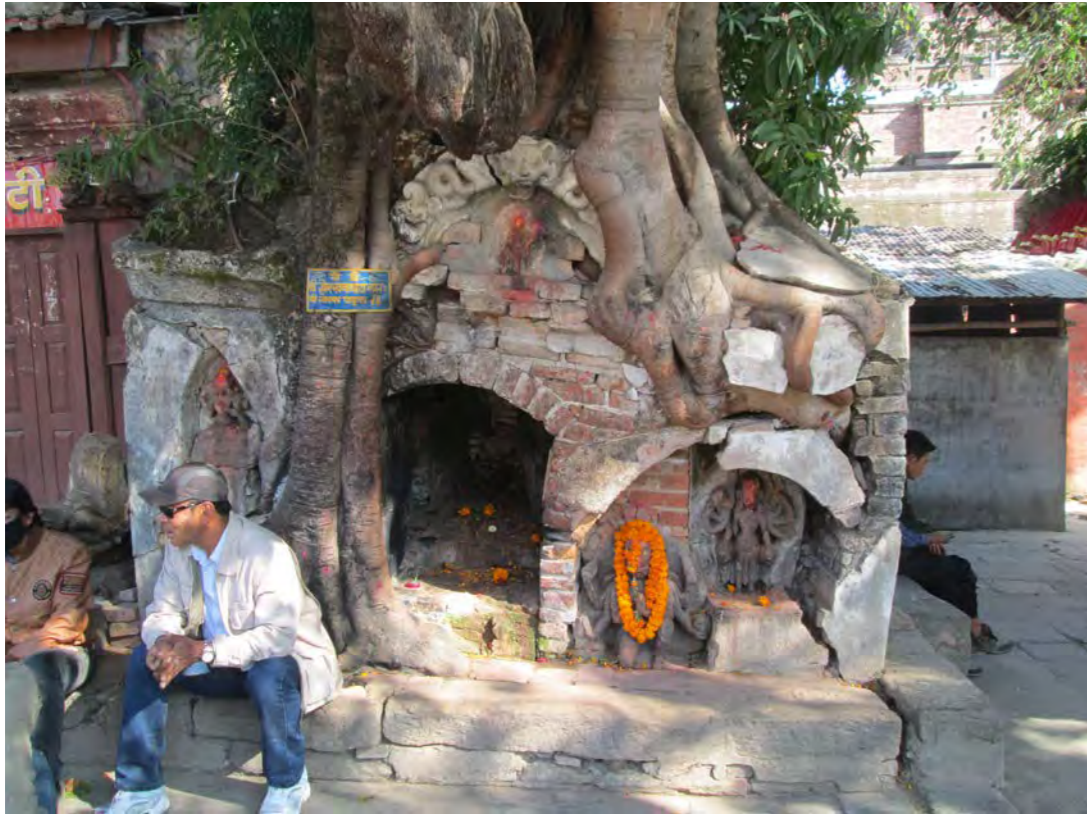
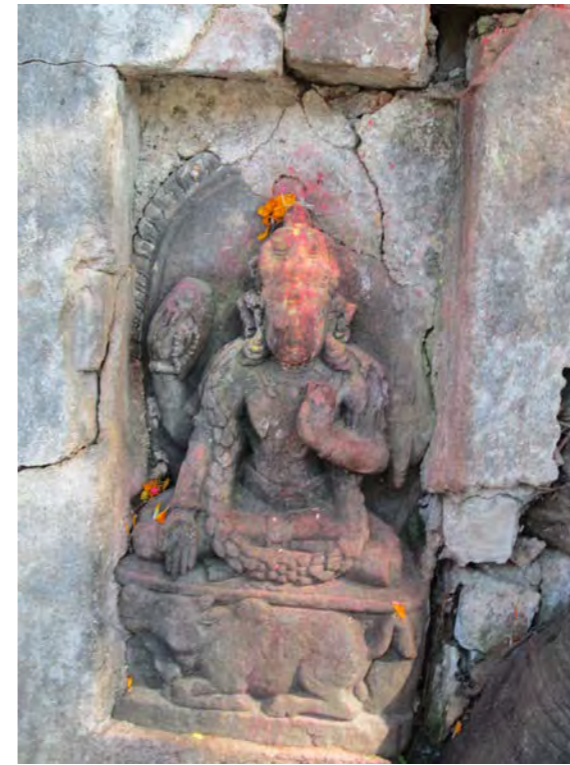
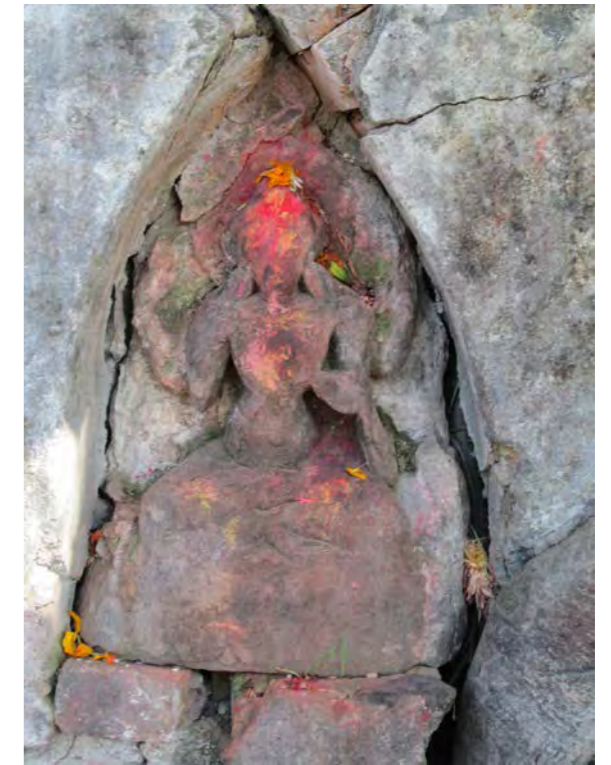
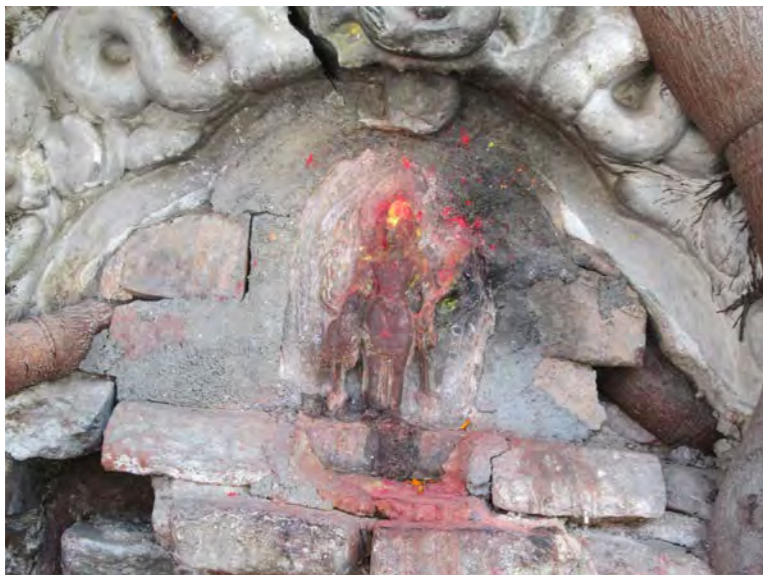
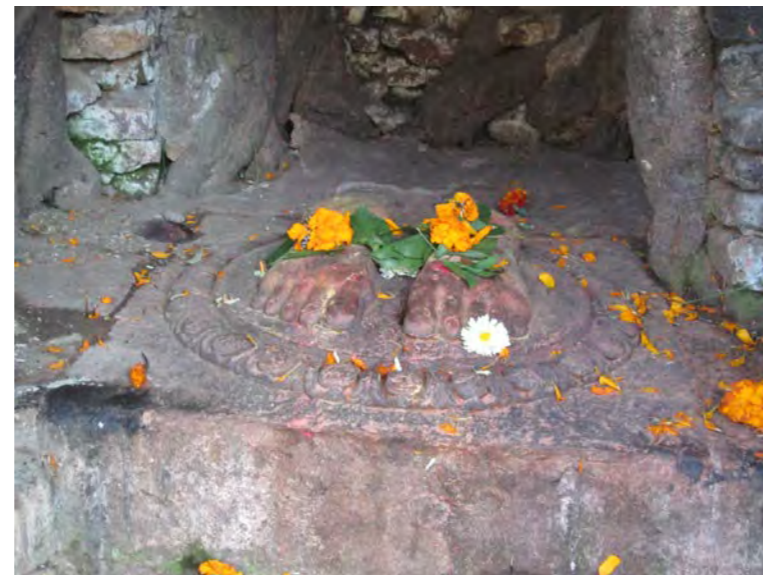
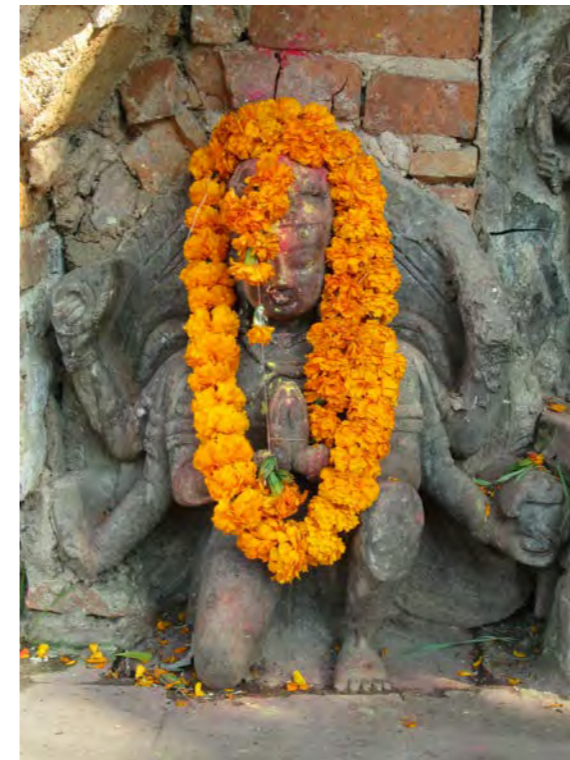
9a GORAKHNATH

CODE NO	TYOLOGY	MONUMENT NAME	ESTABLISHED/ RENOVATED	STRUCTURAL SYSTEM	MATERIAL	GENERAL DESCRIPTION	PROBLEM DESCRIPTION	DANGER	REMARKS	
9a		Gorakhnath				Temple at bottom of peepal tree, 4 idols

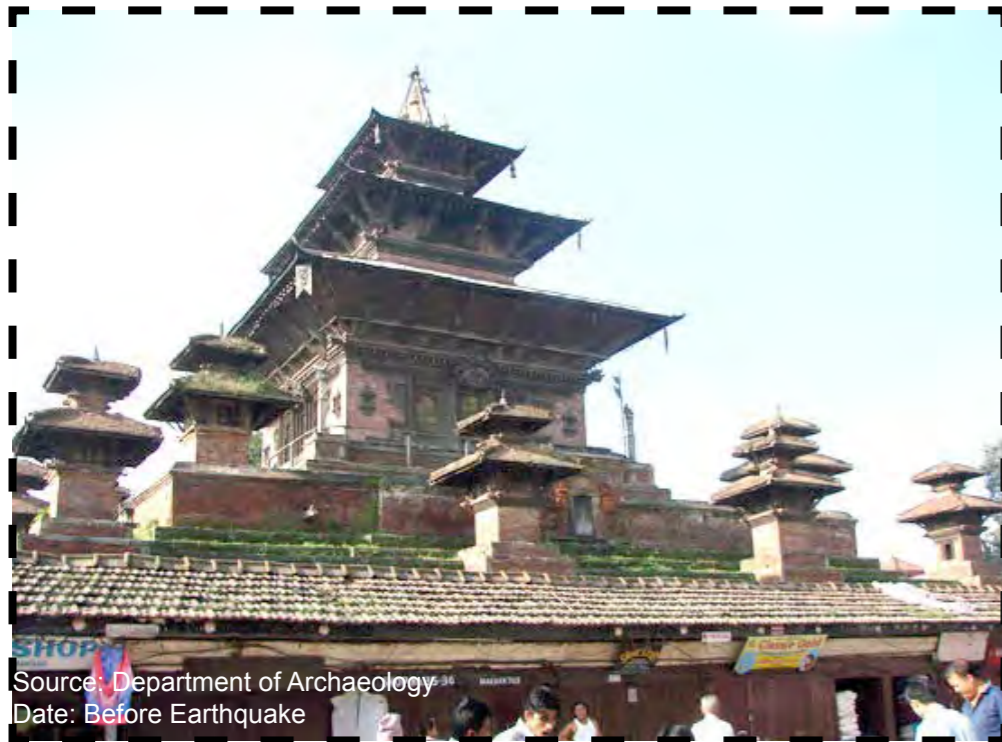
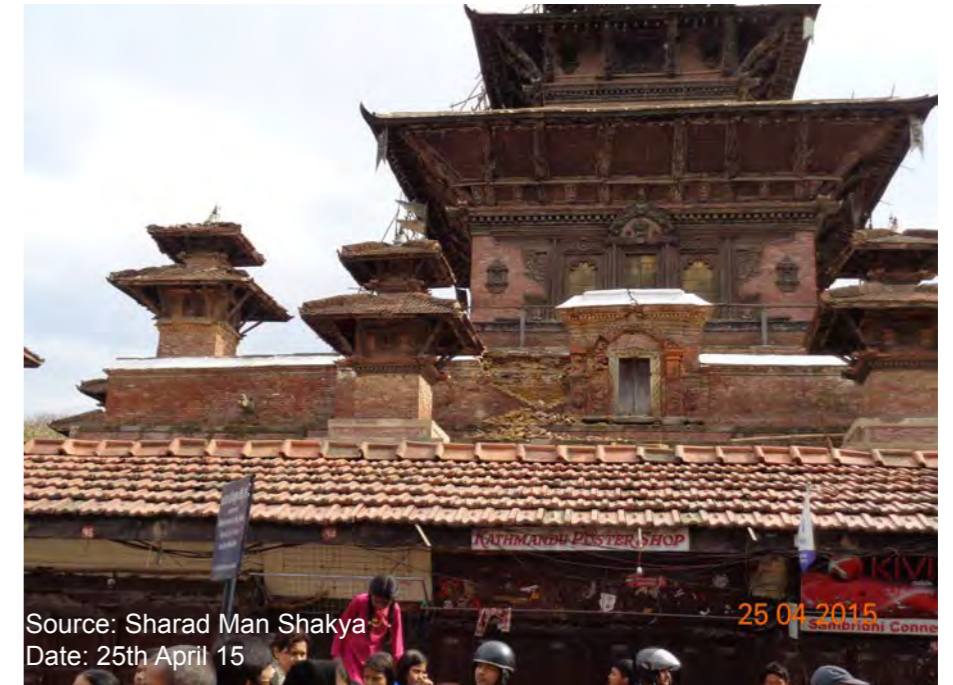
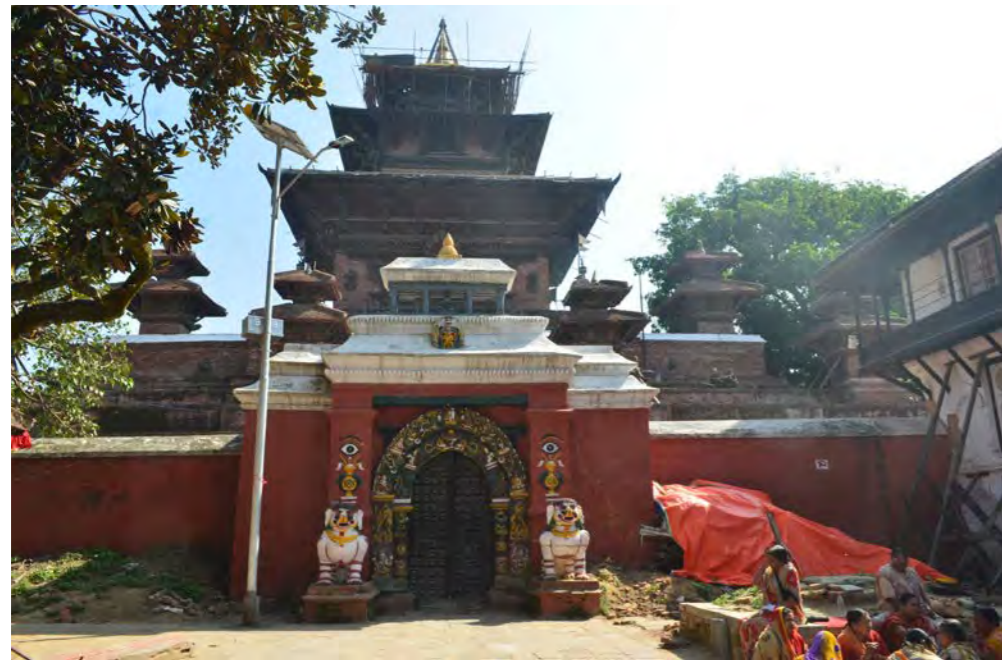
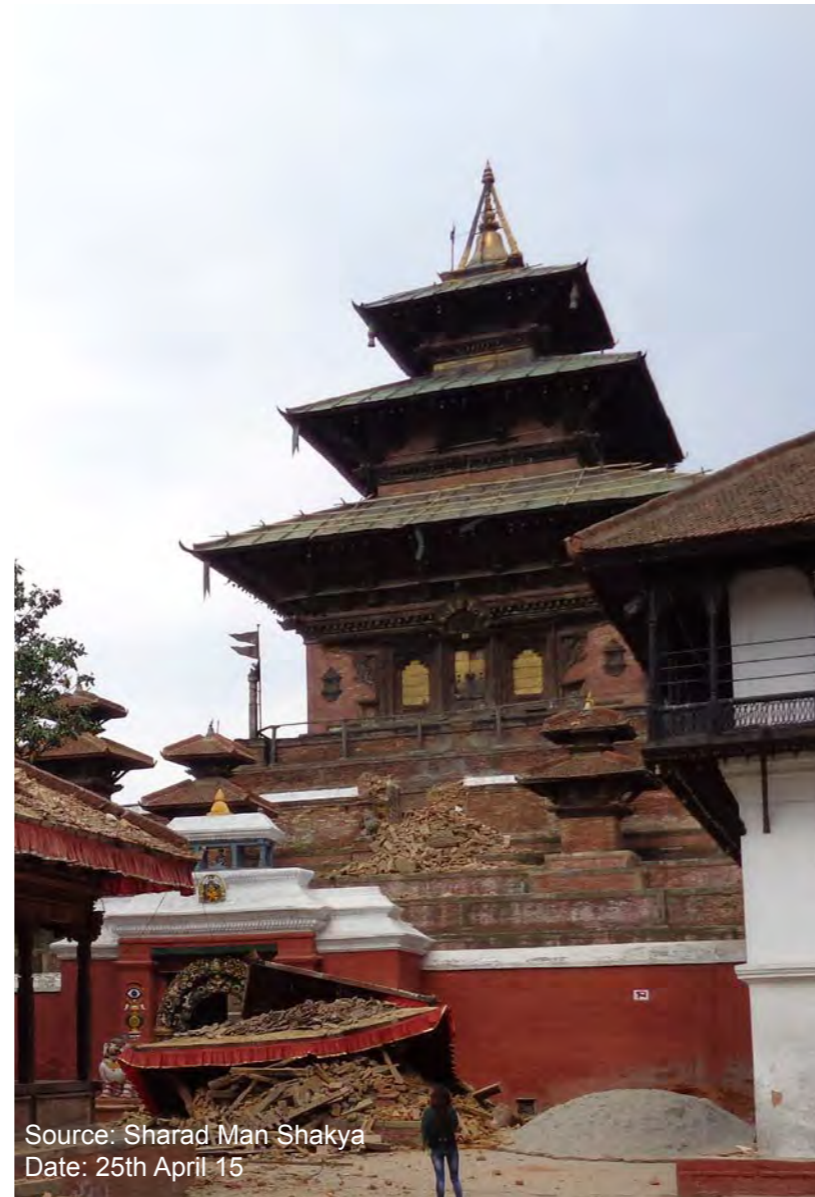
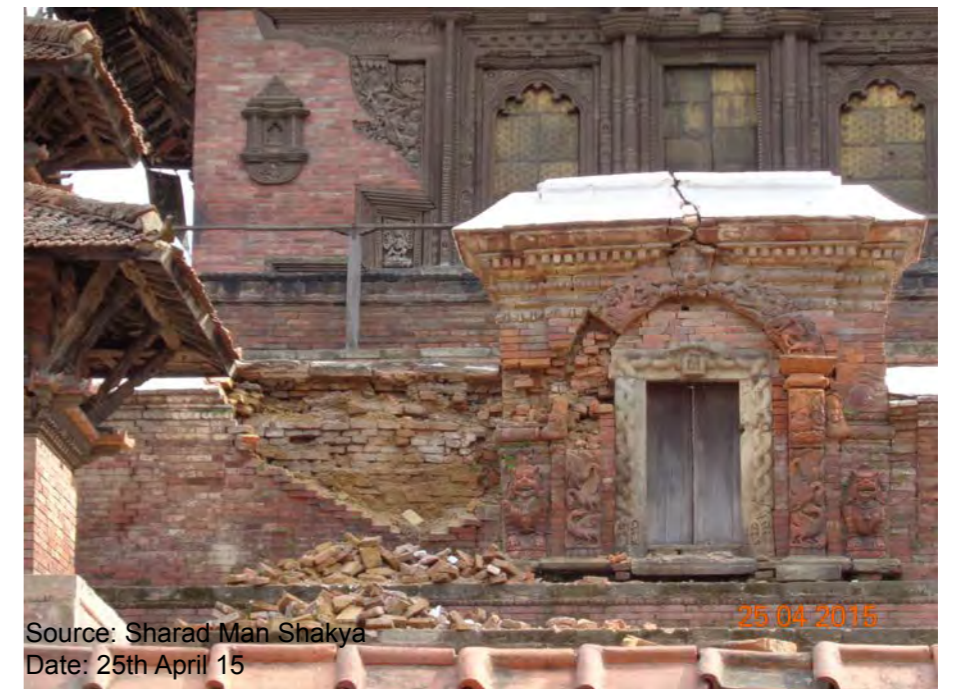
10 TALEJU TEMPLE

CODE NO	TYOLOGY	MONUMENT NAME	ESTABLISHED/ RENOVATED	STRUCTURAL SYSTEM	MATERIAL	GENERAL DESCRIPTION	PROBLEM DESCRIPTION	DANGER	REMARKS	
10	Three Storey Temple	Taleju Bhawani temple	1576	Load Bearing	Brick	Built on a series of brick pedestals. Consists of carved doors and metal torana	Cracks present in plinth but no visible cracks in main temple		Photographs not allowed

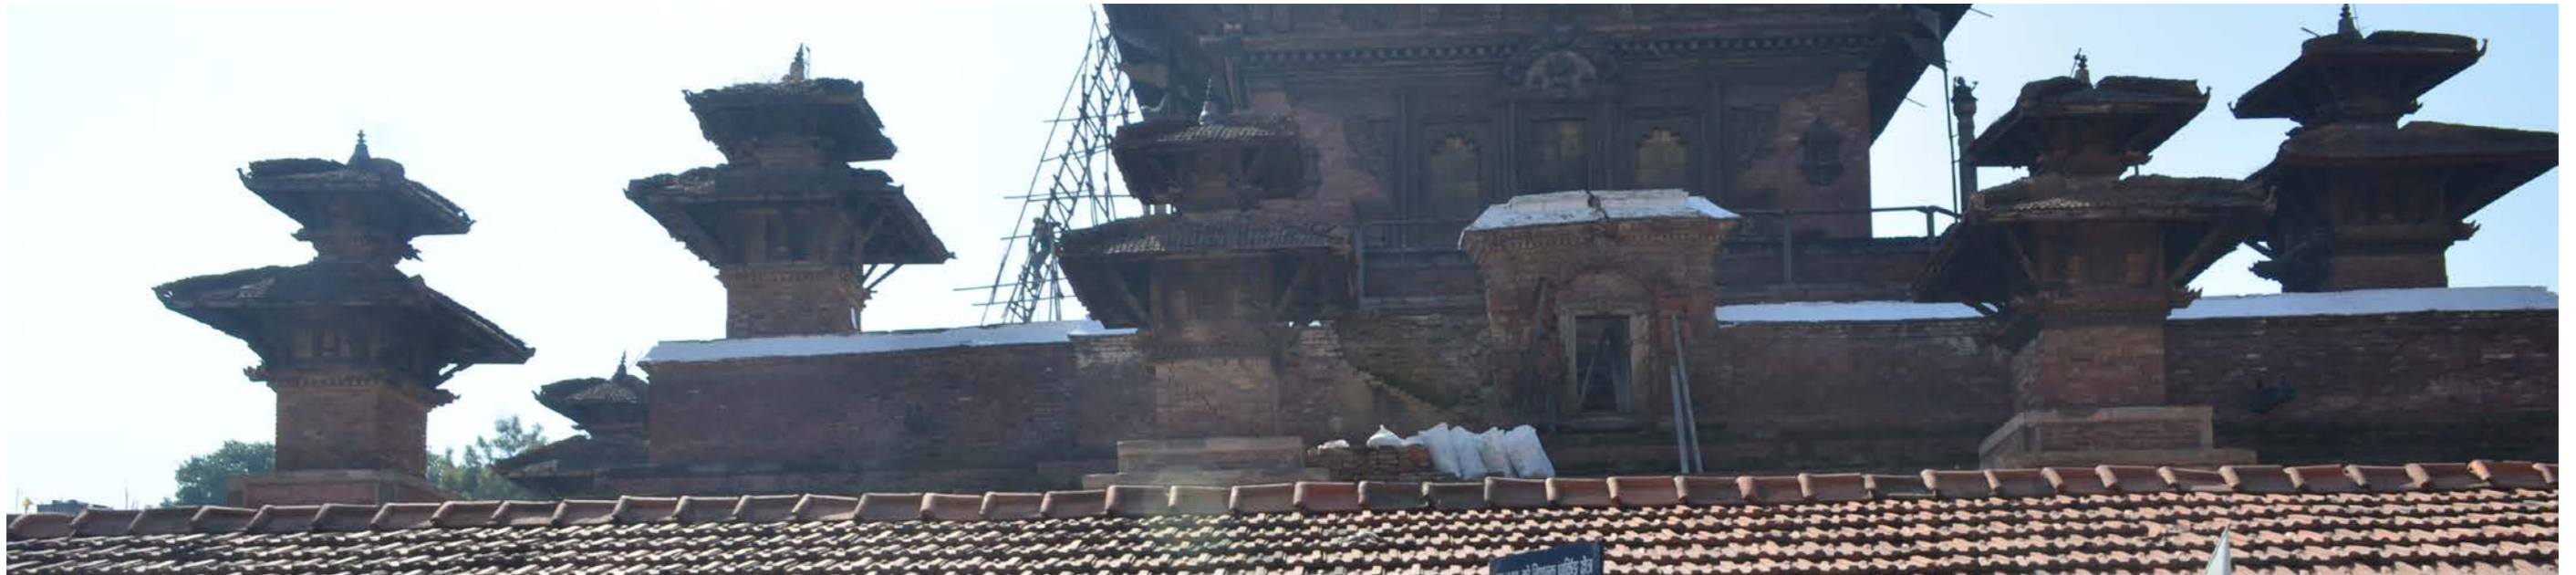
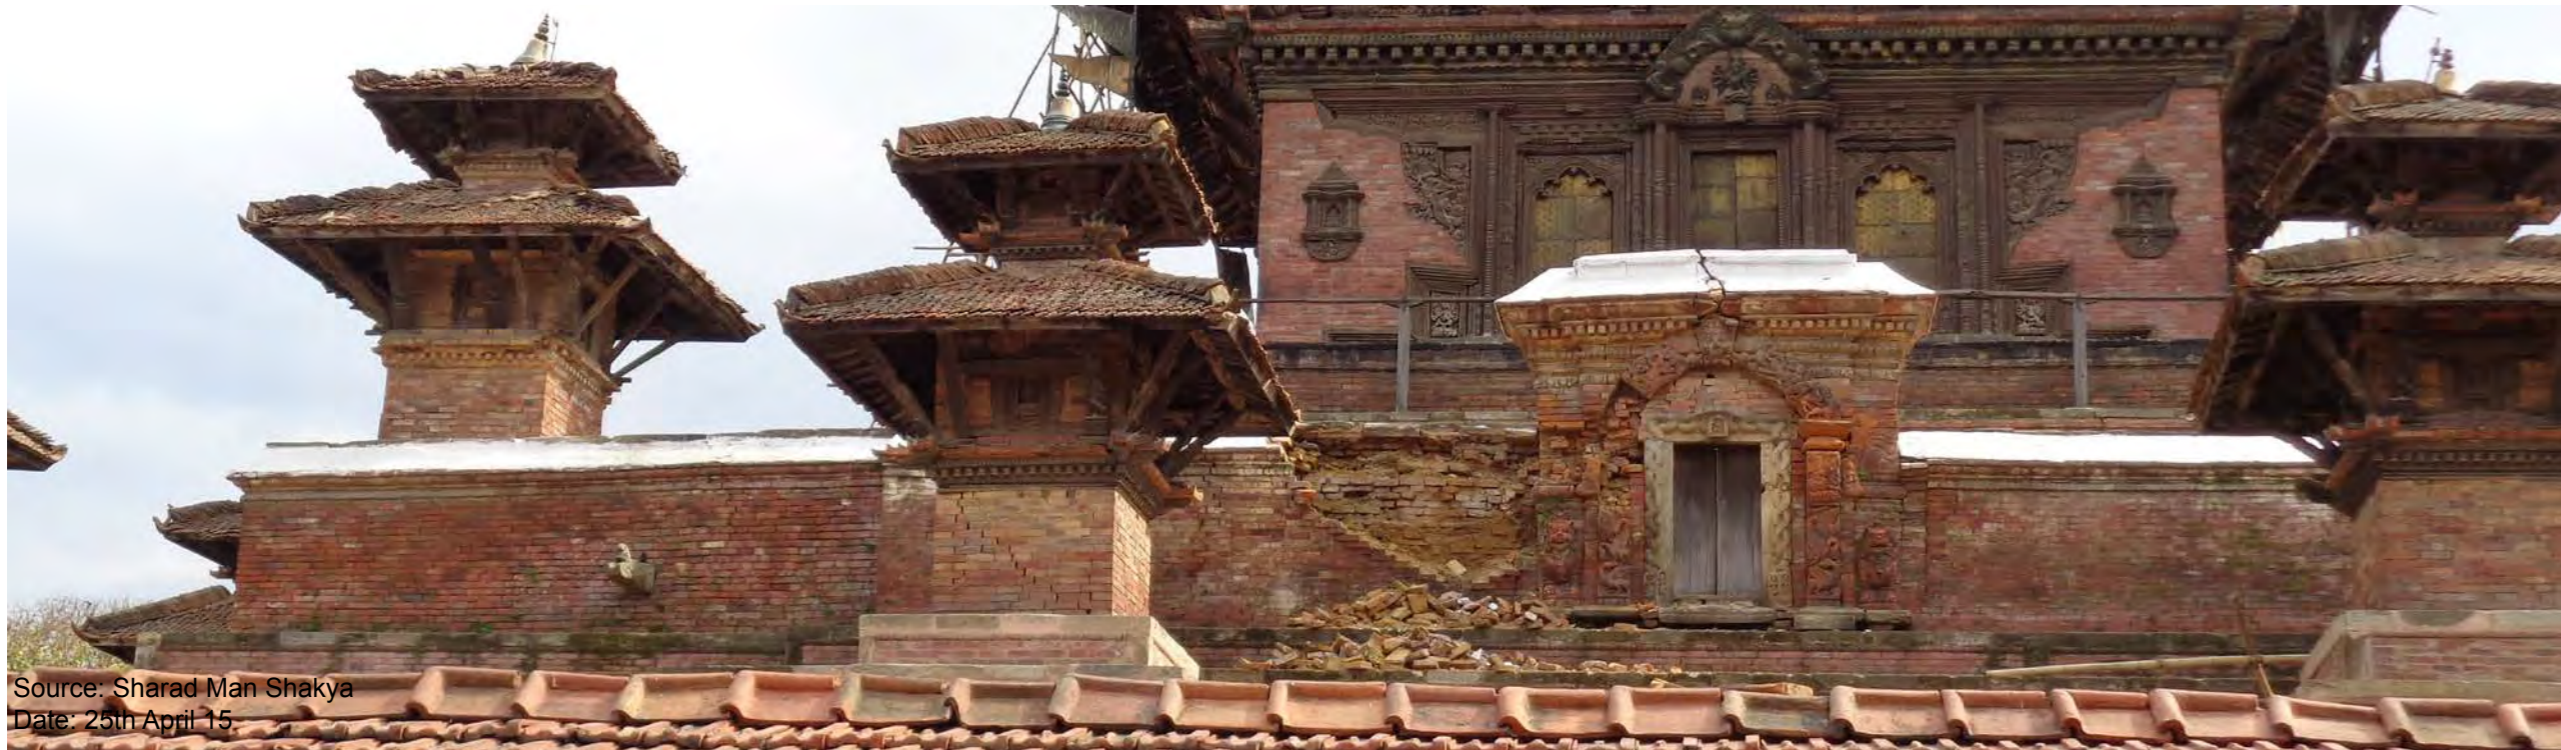
10a - 10p

CODE NO	TYOLOGY	MONUMENT NAME	ESTABLISHED/ RENOVATED	STRUCTURAL SYSTEM	MATERIAL	GENERAL DESCRIPTION	PROBLEM DESCRIPTION	DANGER	REMARKS
10a, 10b				Load Bearing	Brick	Pagoda style temple on brick pedestal of Taleju.	Bricks dislocated		Photographs not allowed
10c				Load Bearing	Brick	Pagoda style temple on brick pedestal of Taleju.	Bricks dislocated and structure tilted		Photographs not allowed
10d-10p				Load Bearing	Brick	Pagoda style temple on brick pedestal of Taleju.	Bricks dislocated		Photographs not allowed

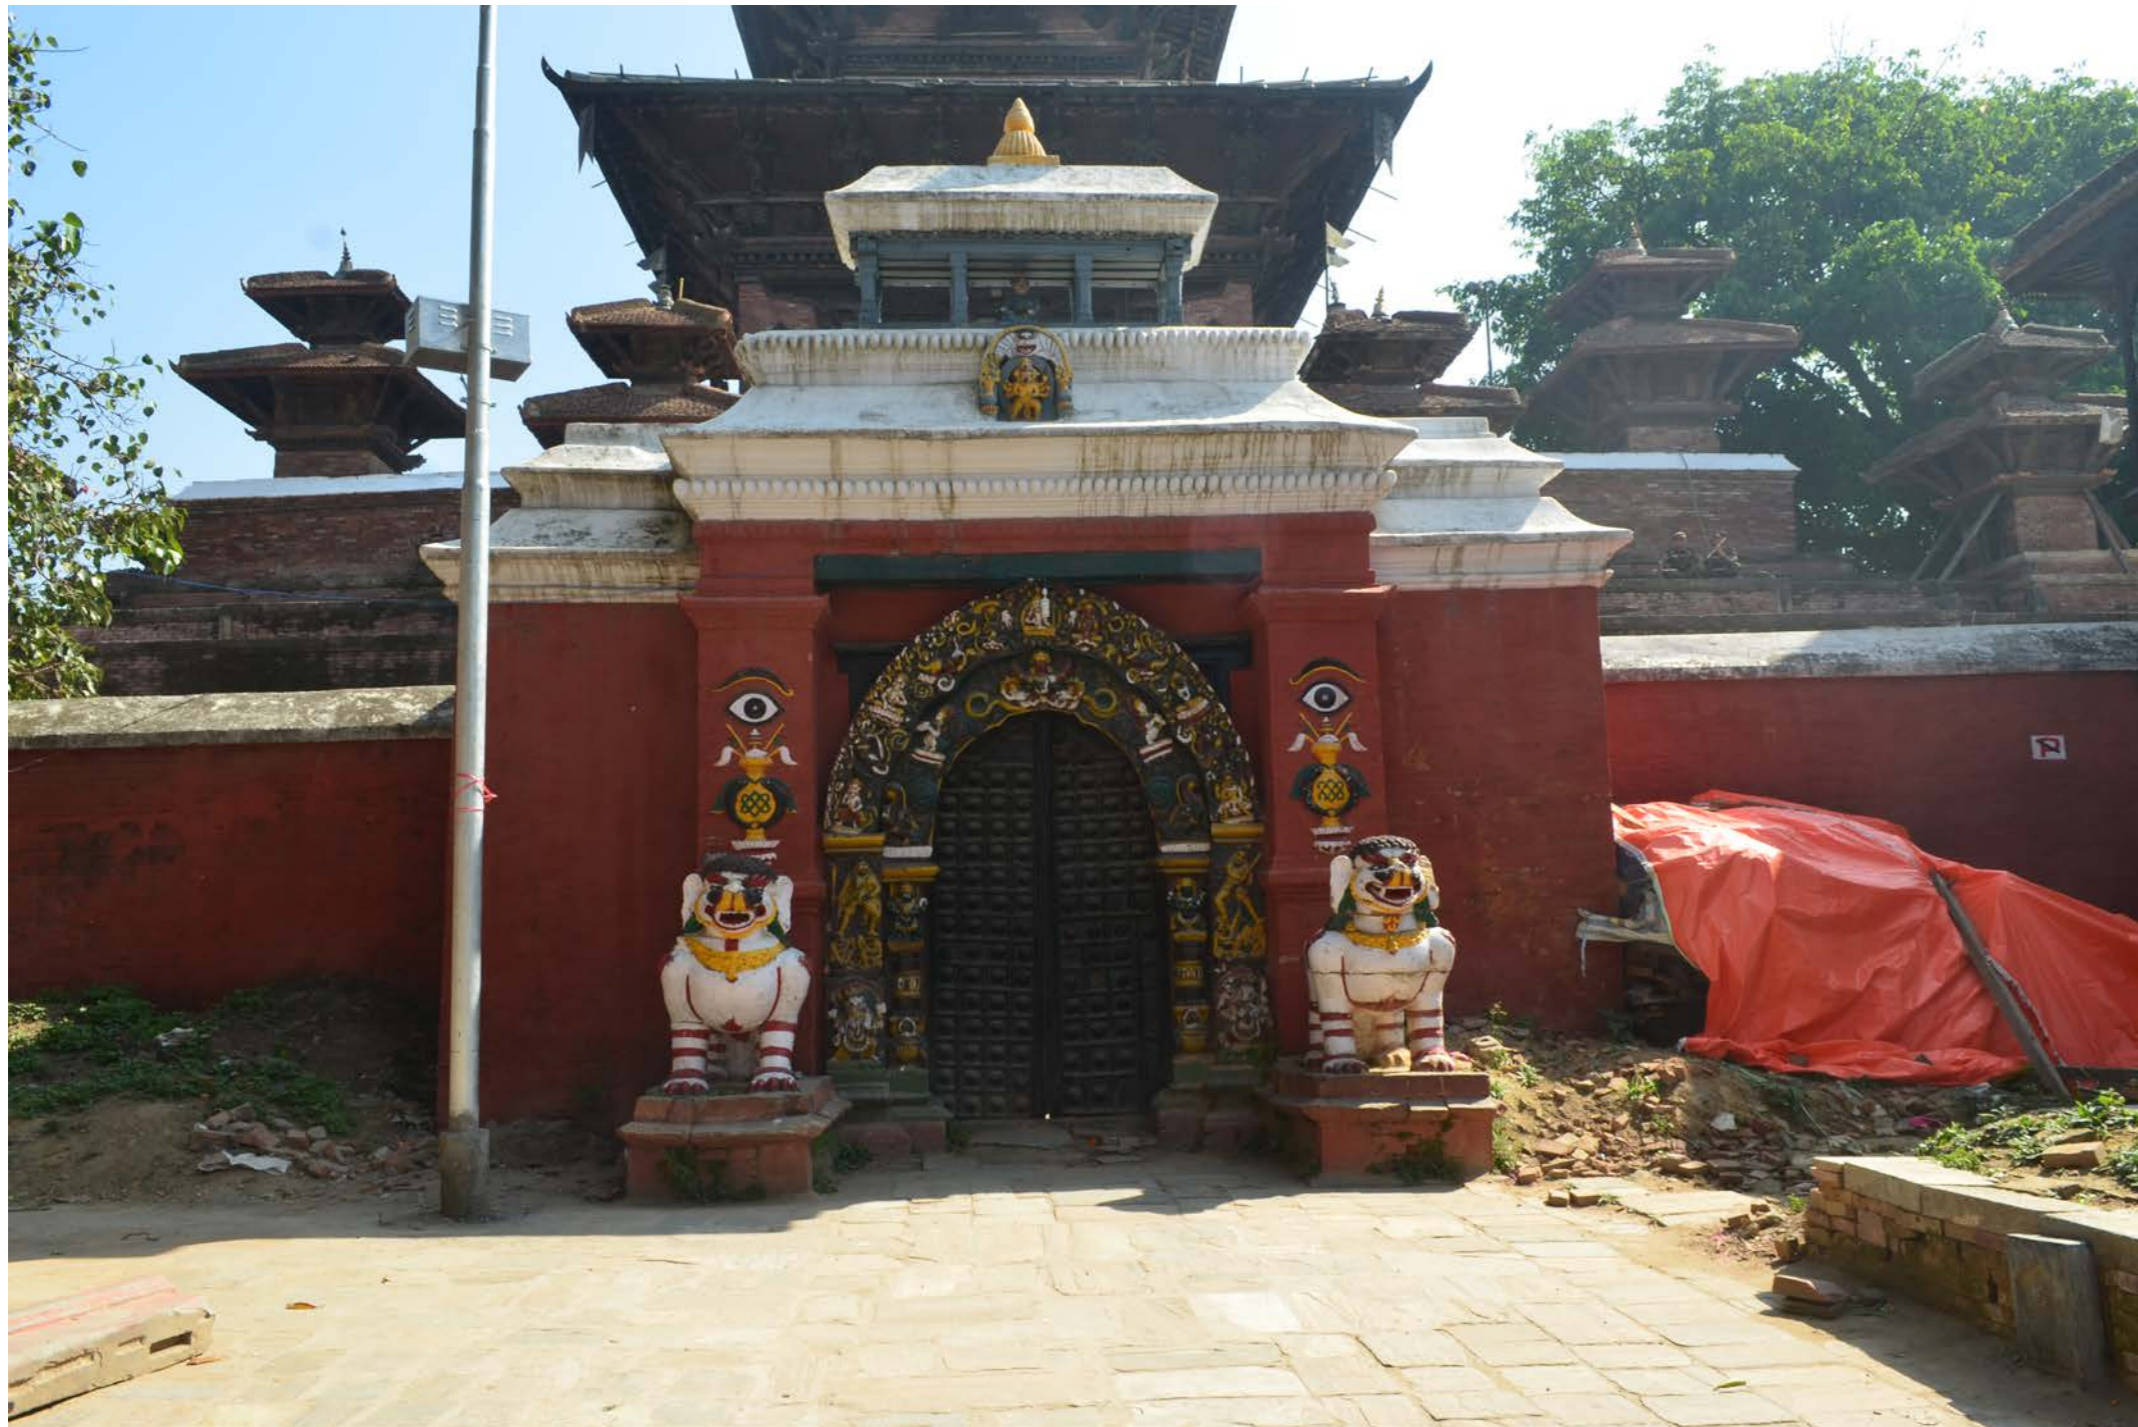
10s TALEJU GATE

CODE NO	TPOLOGY	MONUMENT NAME	ESTABLISHED/ RENOVATED	STRUCTURAL SYSTEM	MATERIAL	GENERAL DESCRIPTION	PROBLEM DESCRIPTION	DANGER	REMARKS
10s	Gate	Taleju Gate		Load Bearing	Brick	Main gate of Taleju Temple	No visible Damage

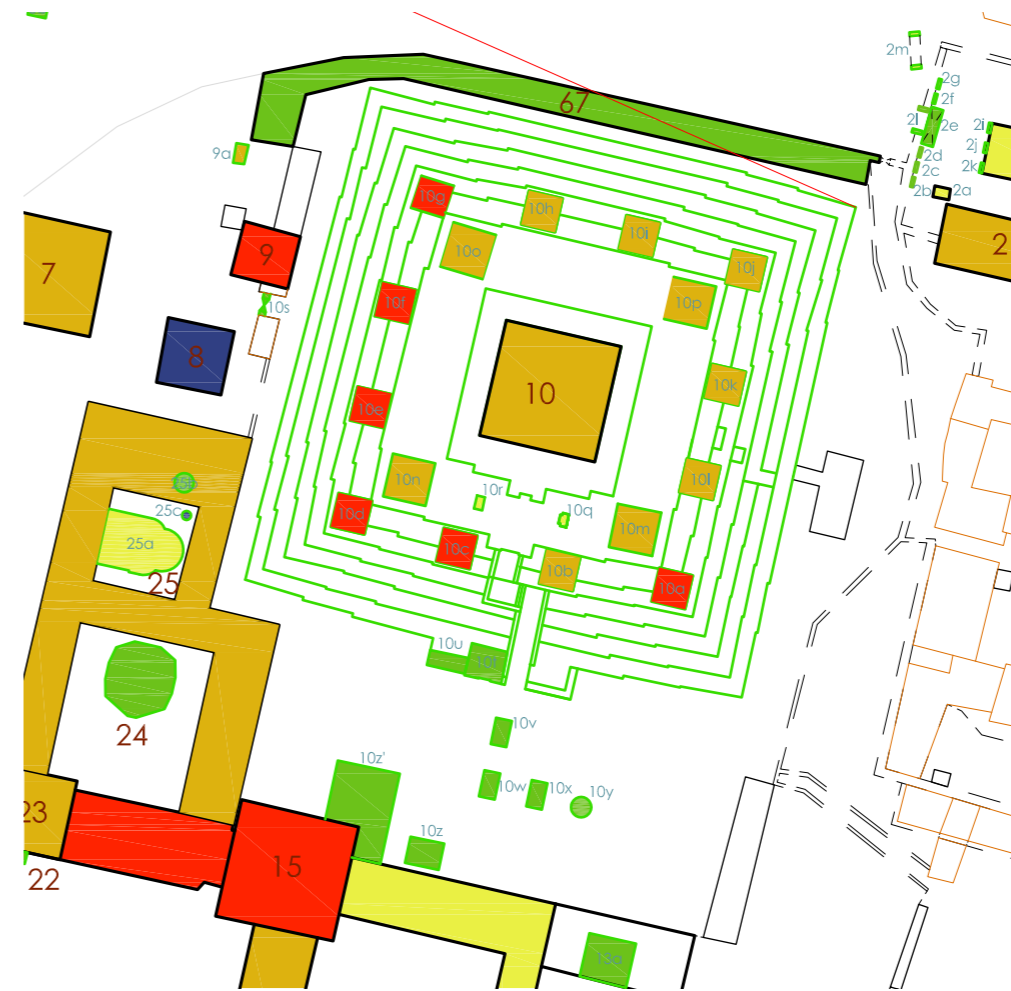
10r, 10t - 10z'

CODE NO	TYOLOGY	MONUMENT NAME	ESTABLISHED/ RENOVATED	STRUCTURAL SYSTEM	MATERIAL	GENERAL DESCRIPTION	PROBLEM DESCRIPTION	DANGER	REMARKS
10q	Jharu	Jharu			Stone, Brick	Reconstruction going on			Photographs not allowed
10r	Jharu	Jharu			Stone, Brick				Photographs not allowed
10t	Stone trishul						No visible damages.		Photographs not allowed
10u	Inscription						No visible damages.		Photographs not allowed
10v	Stone pole with image				Stone, Brick		No visible damages.		Photographs not allowed
10w	Stone pole with lion image				Stone		Slightly tilted.		Photographs not allowed
10x	Stone pole with image and tortoise base				Stone		Slightly tilted.		Photographs not allowed
10y	Well								Photographs not allowed
10z	Dome				Stone		No visible damages		Photographs not allowed
10z'	Dabali						No visible damages		Photographs not allowed

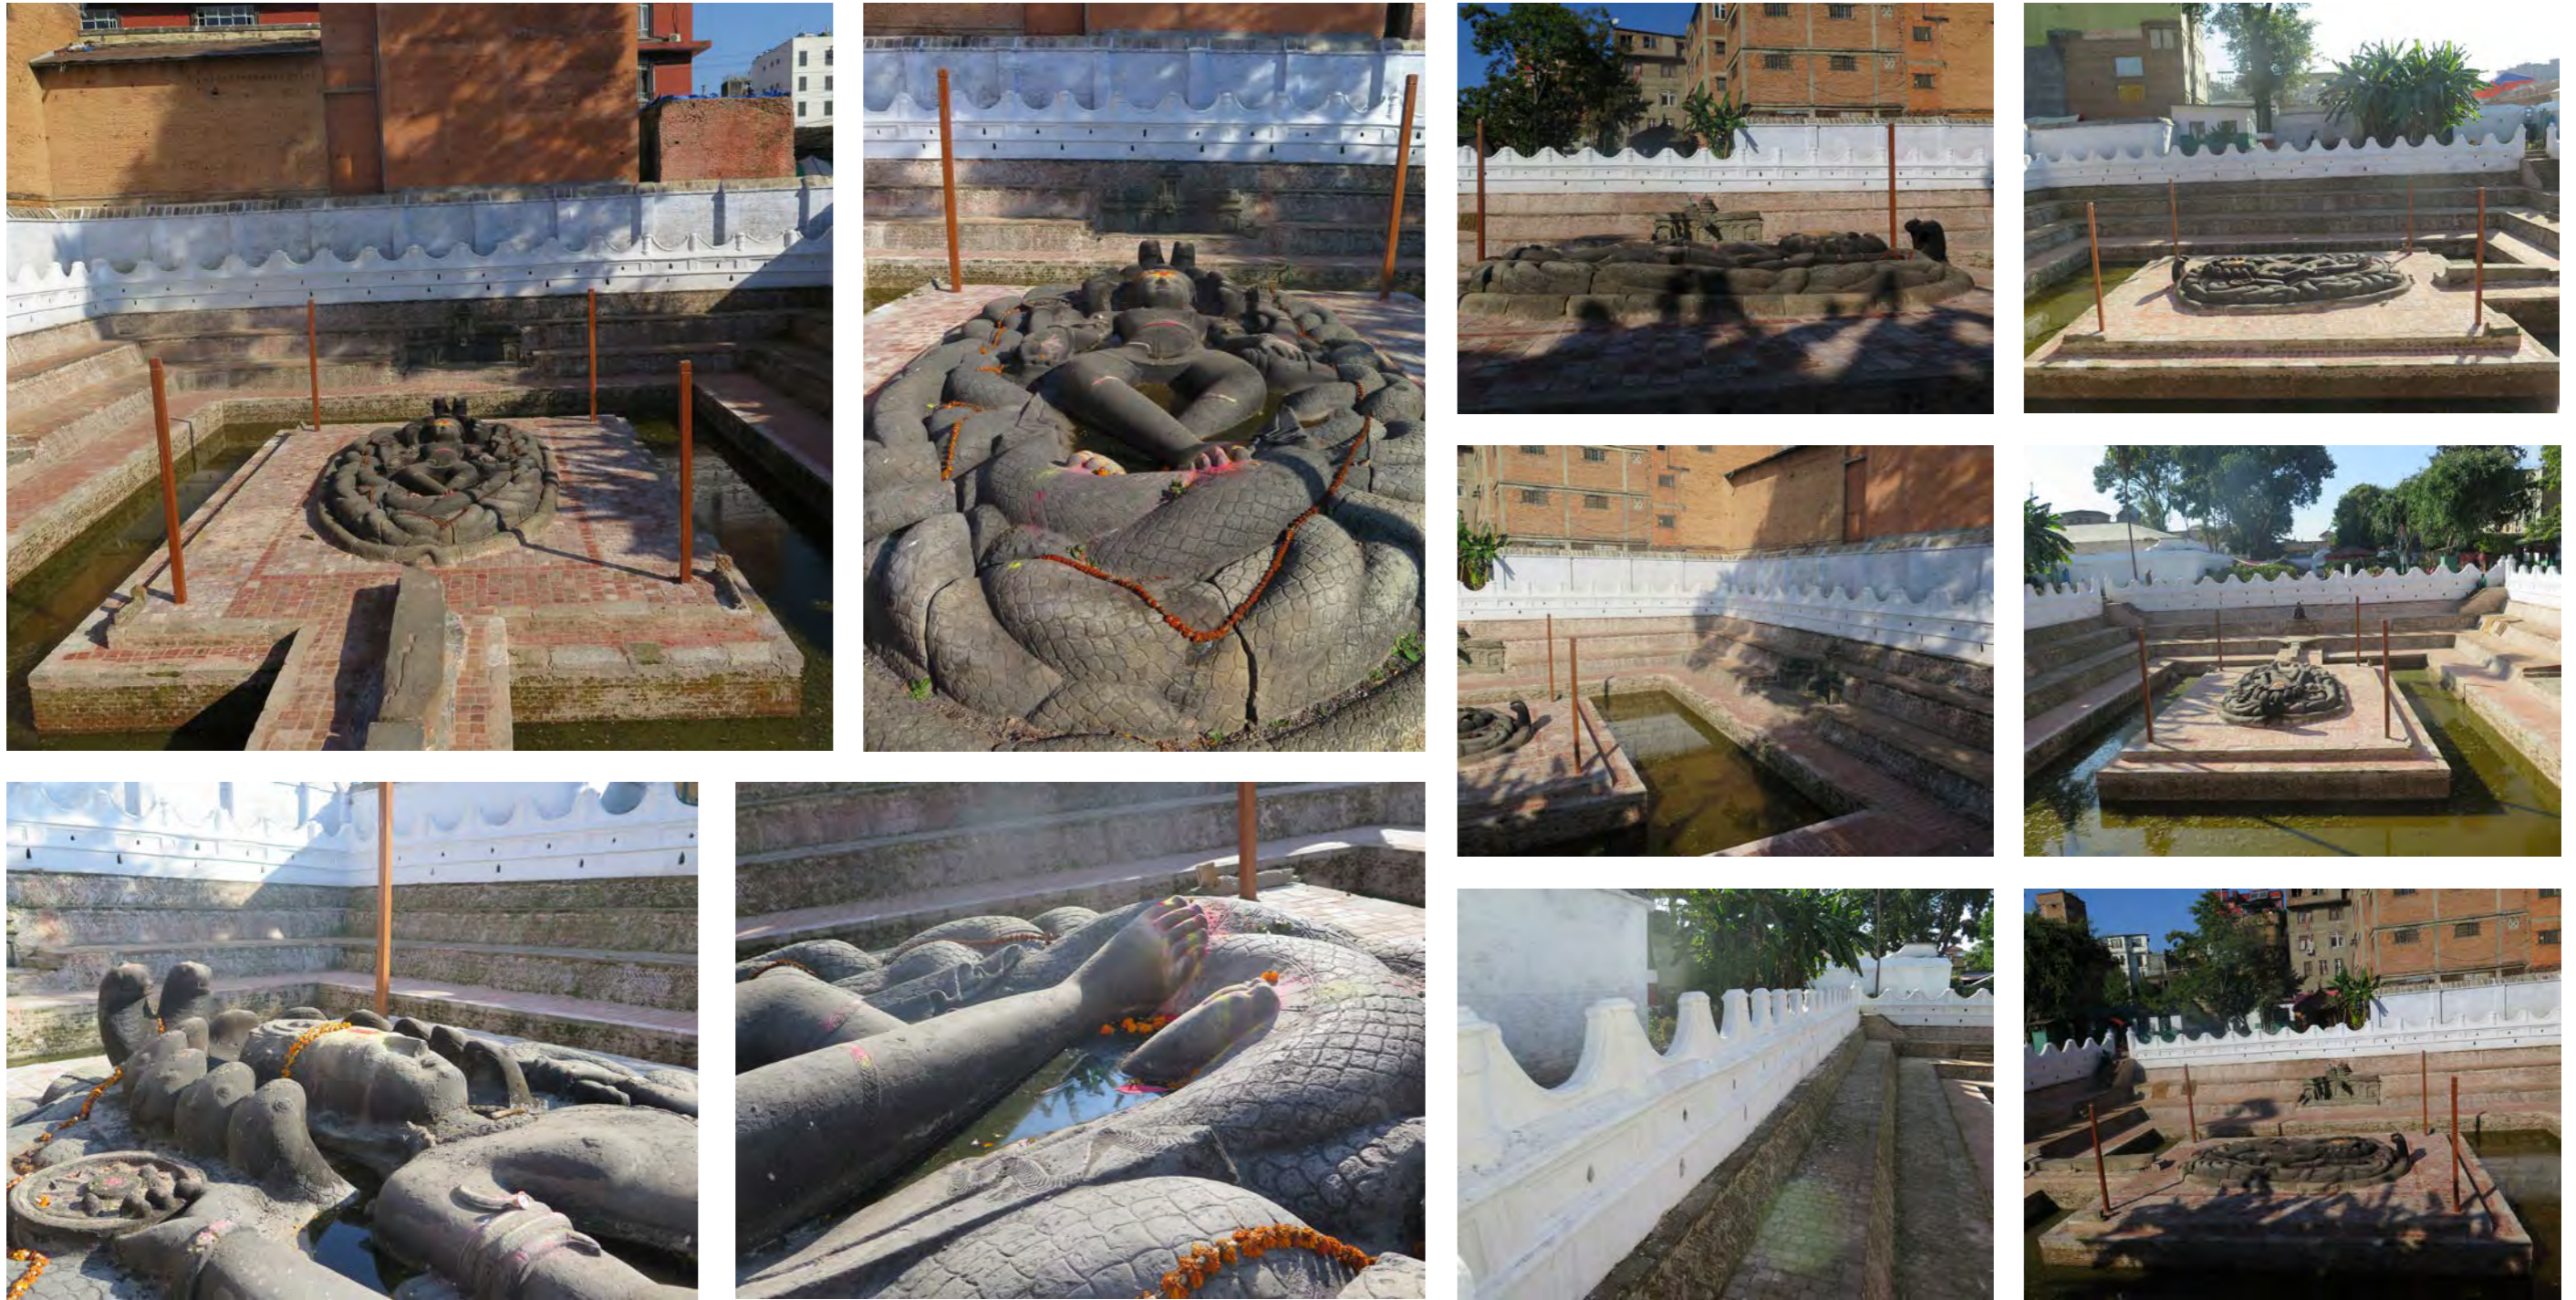
11 BUDHANILKANTHA NARAYAN

CODE NO	TYOLOGY	MONUMENT NAME	ESTABLISHED/ RENOVATED	STRUCTURAL SYSTEM	MATERIAL	GENERAL DESCRIPTION	PROBLEM DESCRIPTION	DANGER	REMARKS
11		Budhanilkantha Nrayan Image	16th century		Stone	Stone image of Vishnu in elevated platform surrounded by water, garden and other images	Good condition but minor cracks formed and boundy walls tilted
