2015 Earthquake Damage Mapping

Hanuman Dhoka Darbar Square Monument Zone
Kathmandu Valley World Heritage Property

December 2015

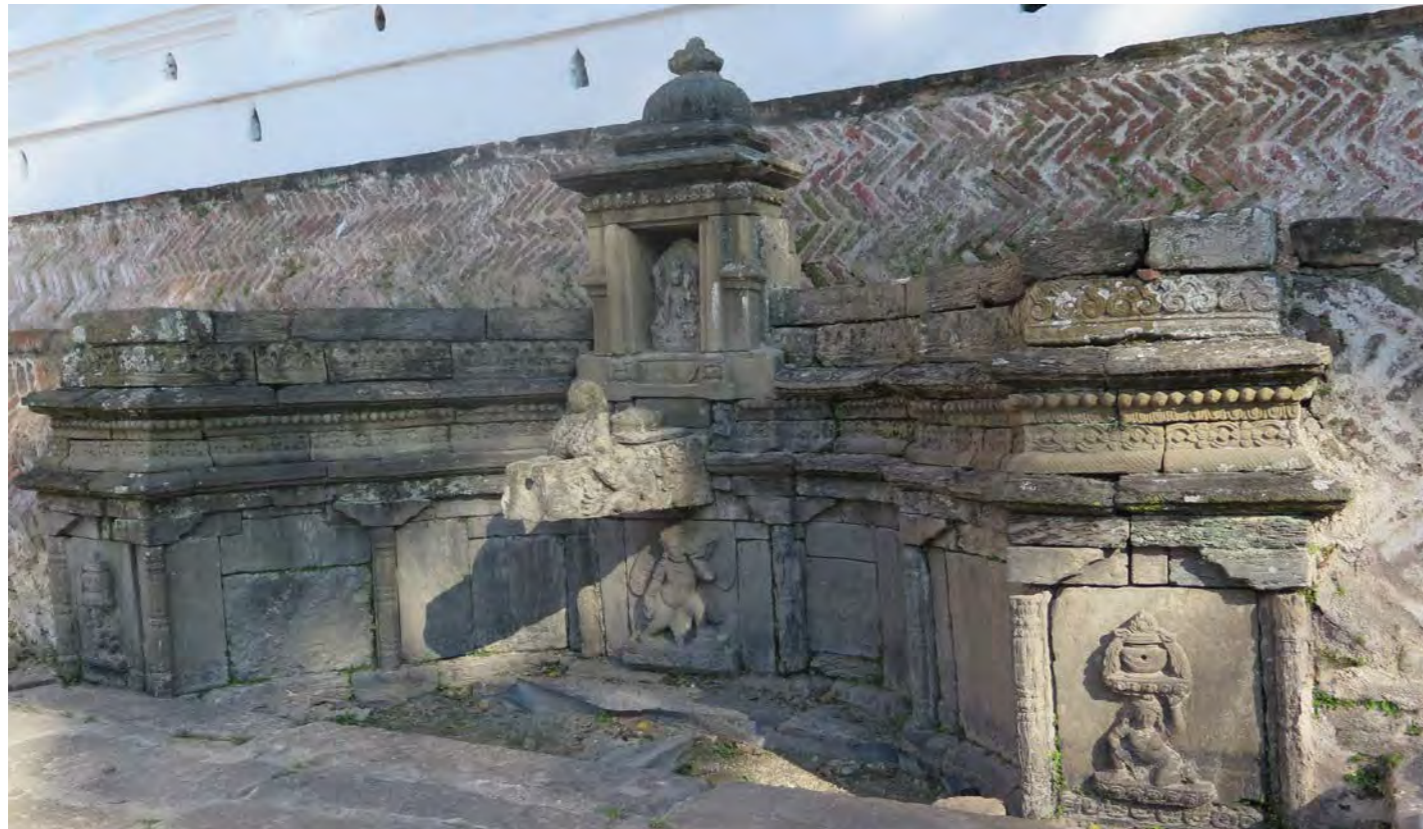
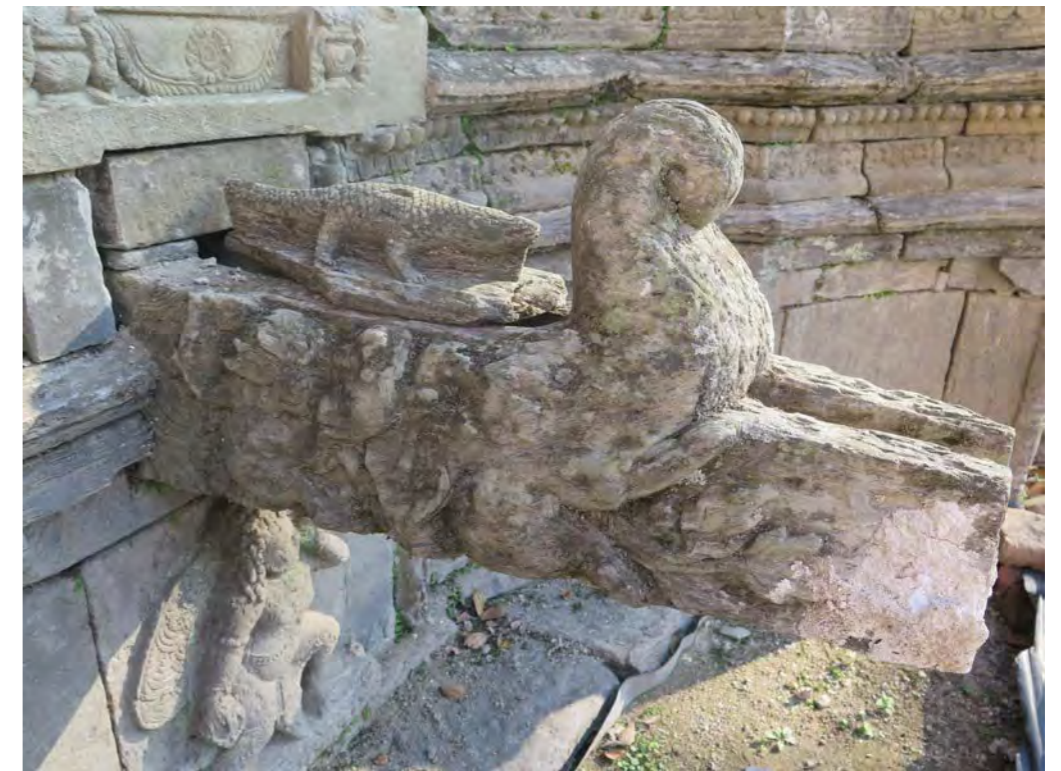
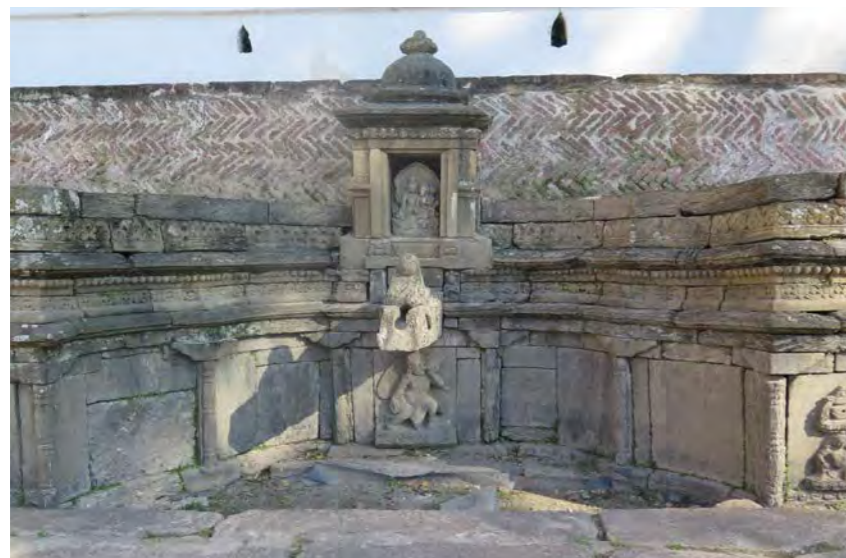
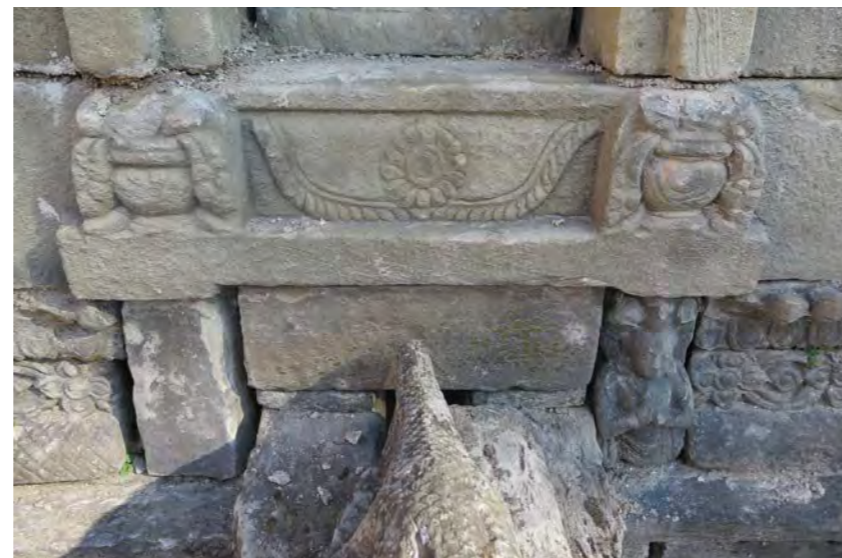
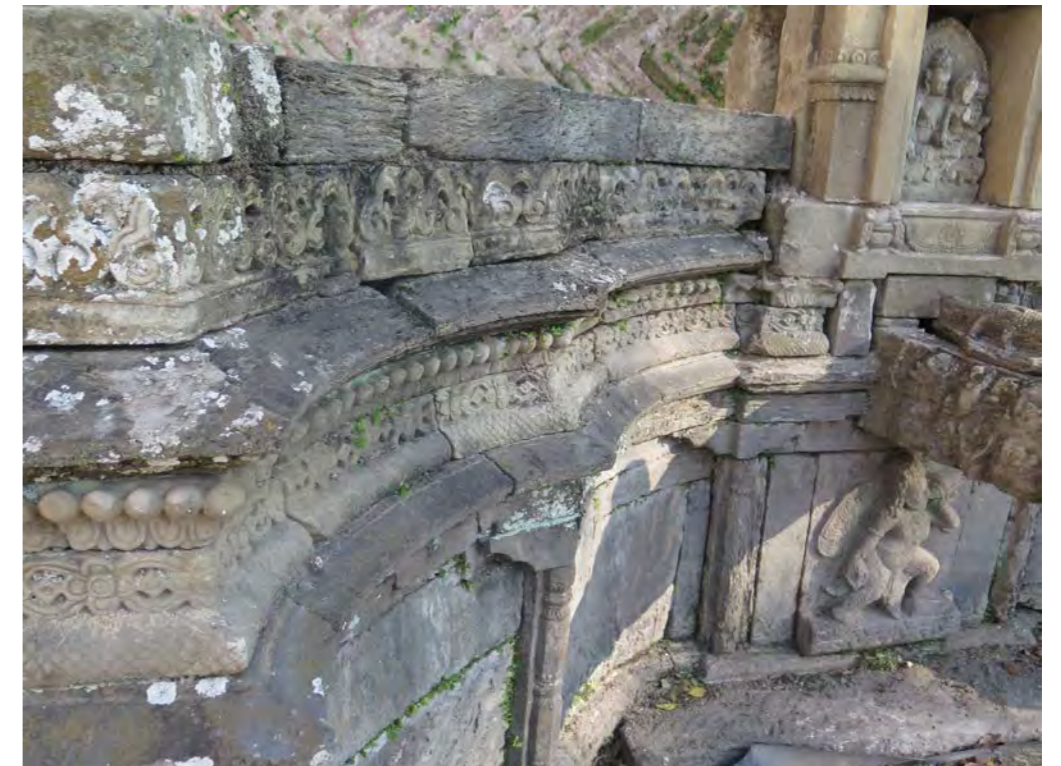
11a STONE WATER SPOUT

CODE NO	TYOLOGY	MONUMENT NAME	ESTABLISHED/ RENOVATED	STRUCTURAL SYSTEM	MATERIAL	GENERAL DESCRIPTION	PROBLEM DESCRIPTION	DANGER	REMARKS	
11a	Stone water spout				Stone		Vegetation Growth;Cracks at base			
11b	Stone water spout				Stone		Vegetation Growth;Cracks at base			
11c	Statue				Stone	Stone image in front of Budhanilkantha	Good Condition

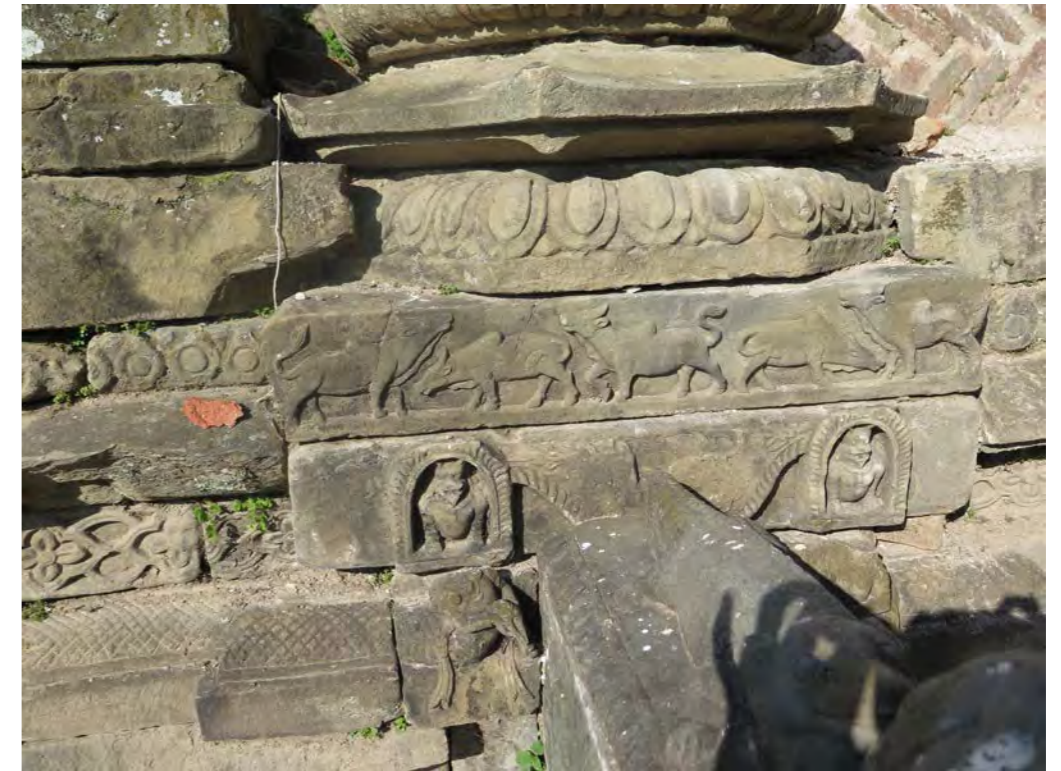
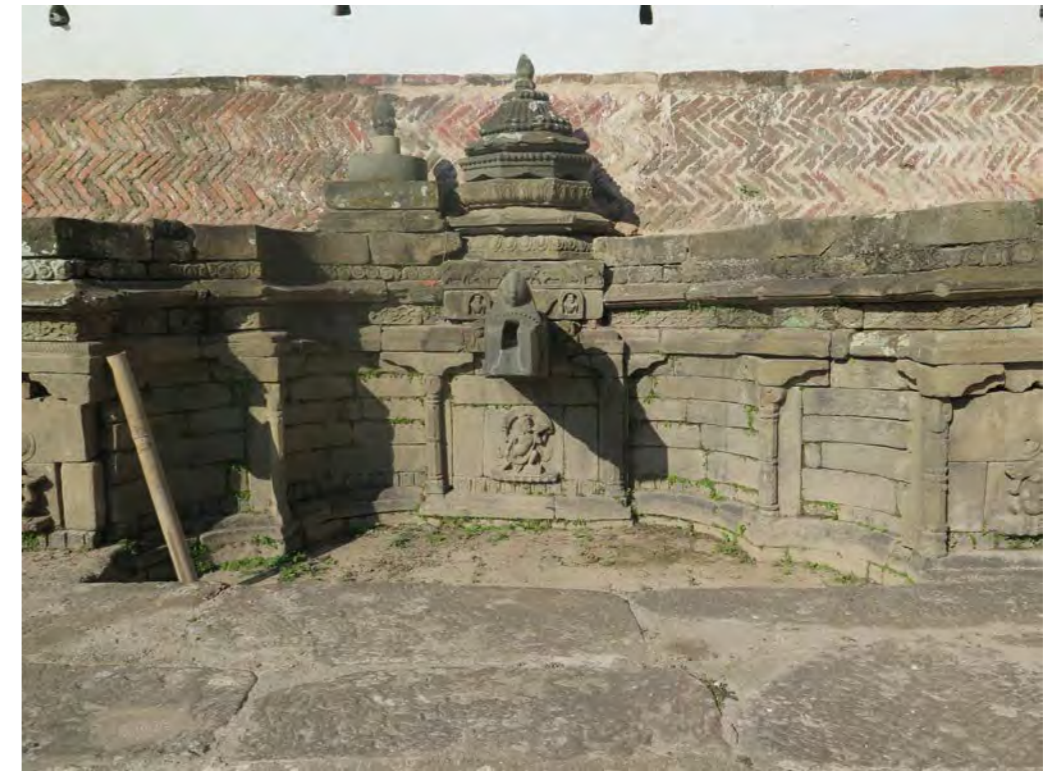
11b STONE WATER SPOUT

CODE NO	TYOLOGY	MONUMENT NAME	ESTABLISHED/ RENOVATED	STRUCTURAL SYSTEM	MATERIAL	GENERAL DESCRIPTION	PROBLEM DESCRIPTION	DANGER	REMARKS	
11b	Stone water spout				Stone		Vegetation Growth;Cracks at base

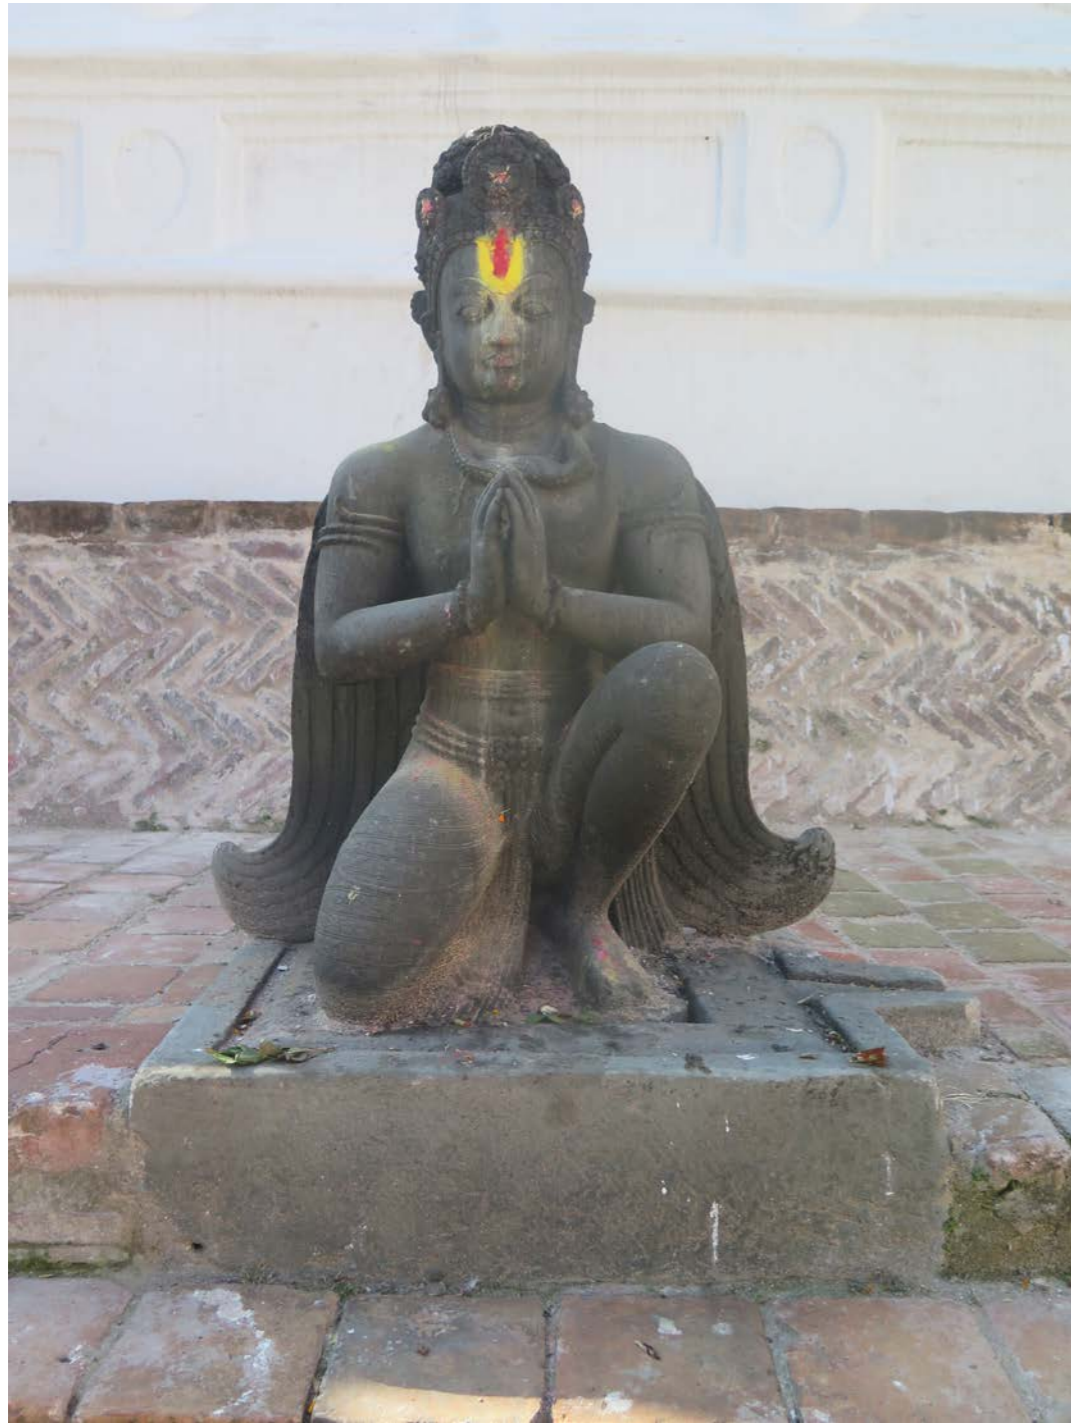
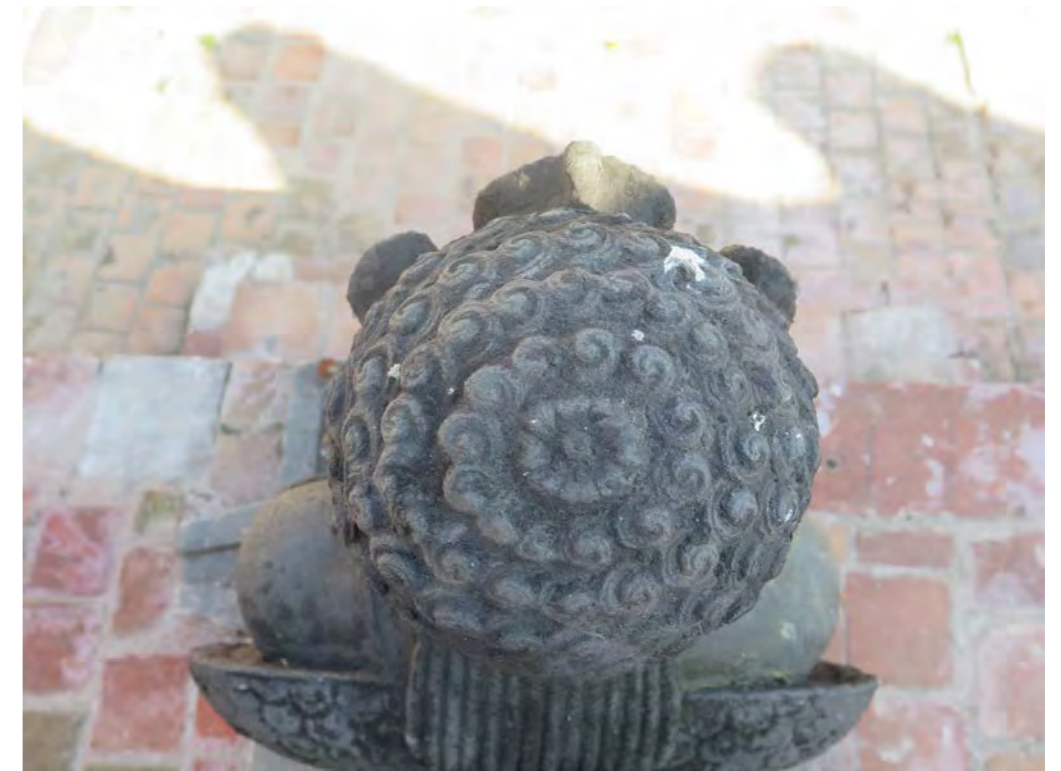
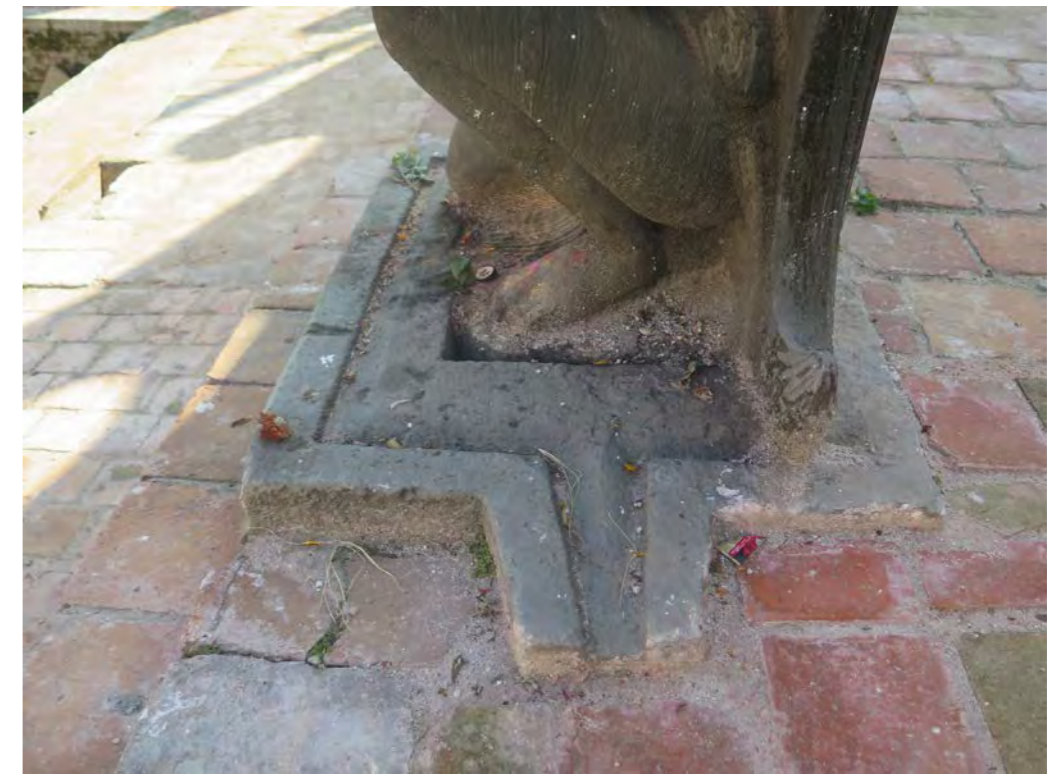
11c STATUE

CODE NO	TYOLOGY	MONUMENT NAME	ESTABLISHED/ RENOVATED	STRUCTURAL SYSTEM	MATERIAL	GENERAL DESCRIPTION	PROBLEM DESCRIPTION	DANGER	REMARKS	
11c	Statue				Stone	Stone image in front of Budhanilkantha	Good Condition

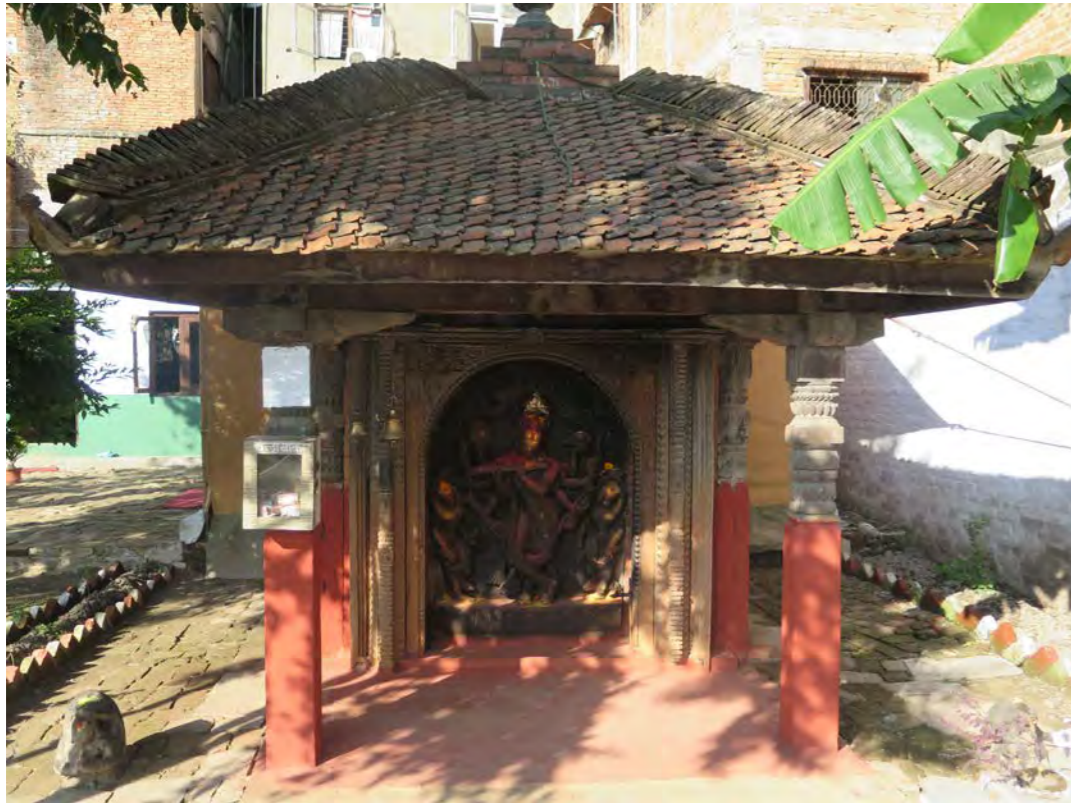
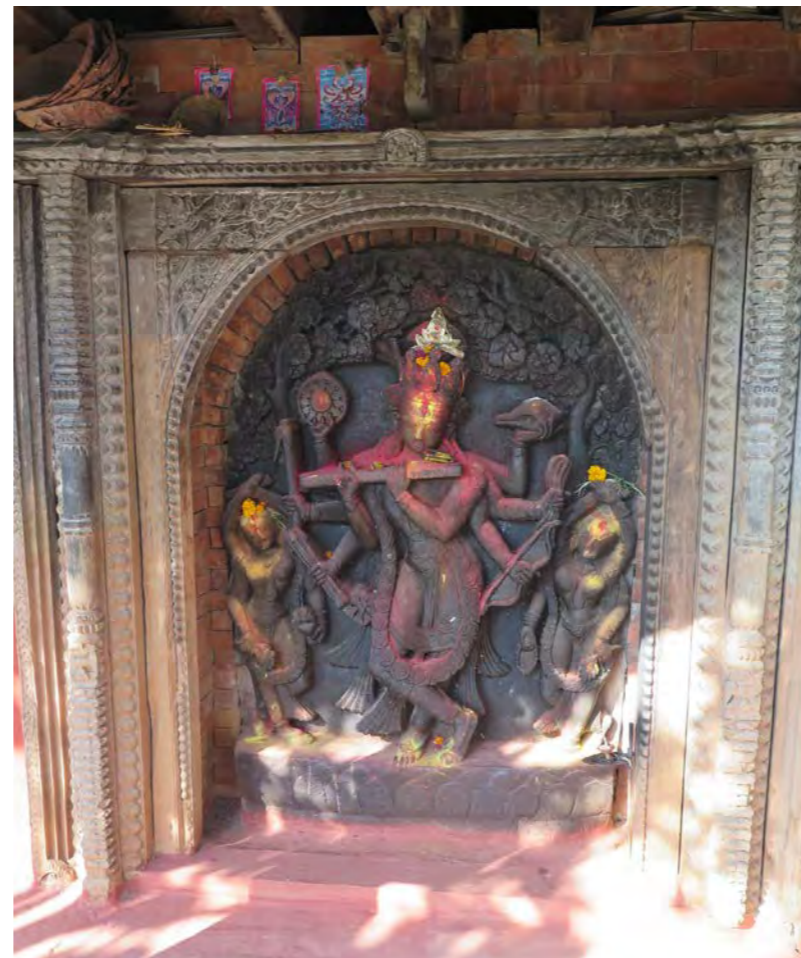
11d SINGLE STOREY TEMPLE

CODE NO	TYOLOGY	MONUMENT NAME	ESTABLISHED/ RENOVATED	STRUCTURAL SYSTEM	MATERIAL	GENERAL DESCRIPTION	PROBLEM DESCRIPTION	DANGER	REMARKS	
11d	Temple			Load Bearing	brick, timber	Temple with statue of krishna	Cracks in timber columns and wall			
11e	Stone statue				stone	Stone statue of a snake	Good Condition			
11f	Stone statue				stone	Stone statue of a snake	Good Condition

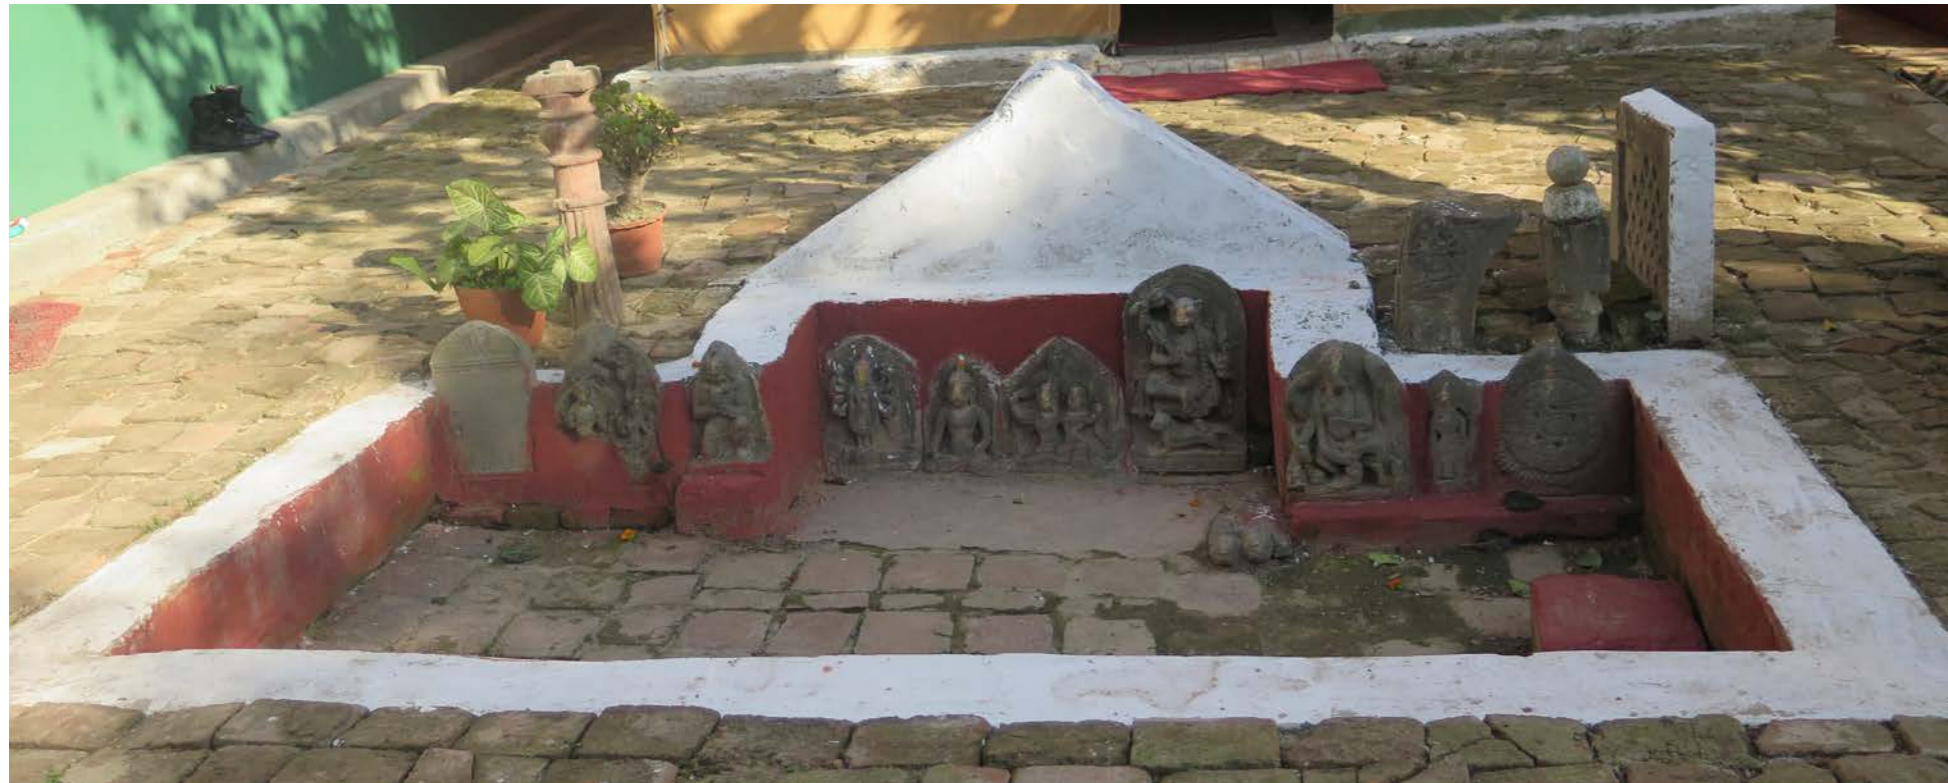
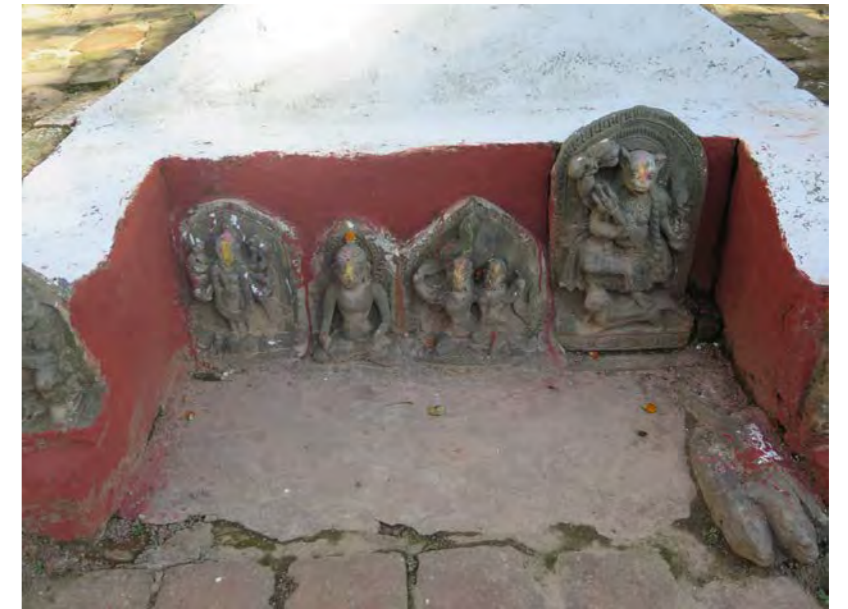
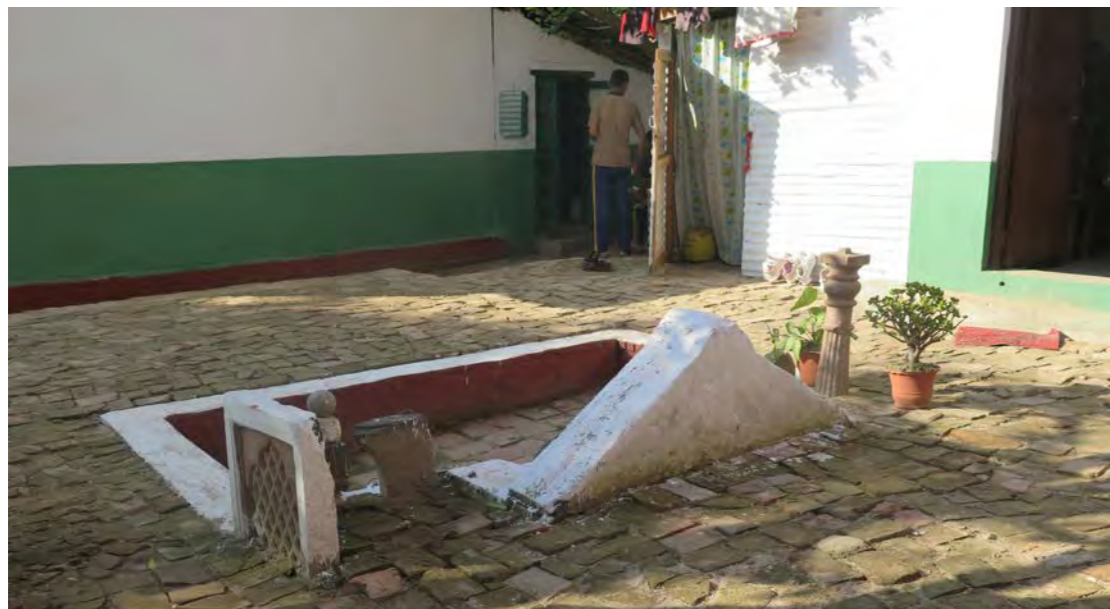
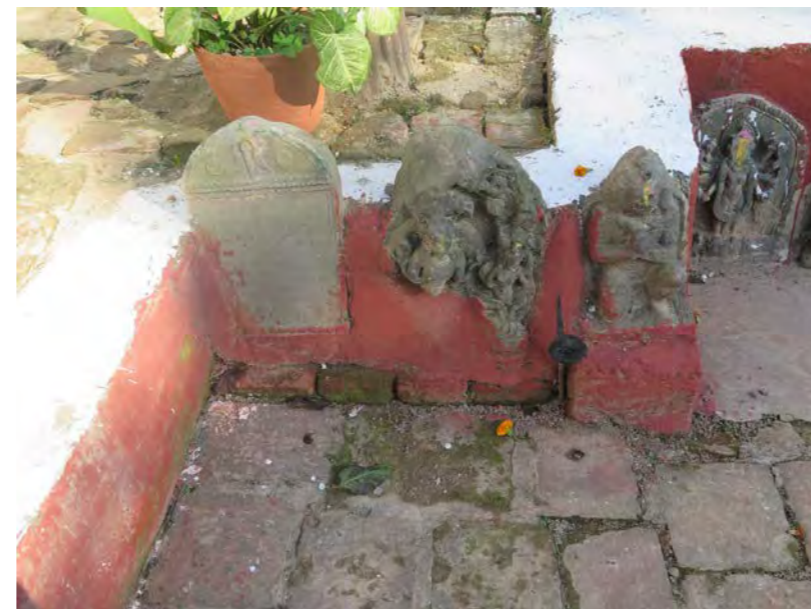
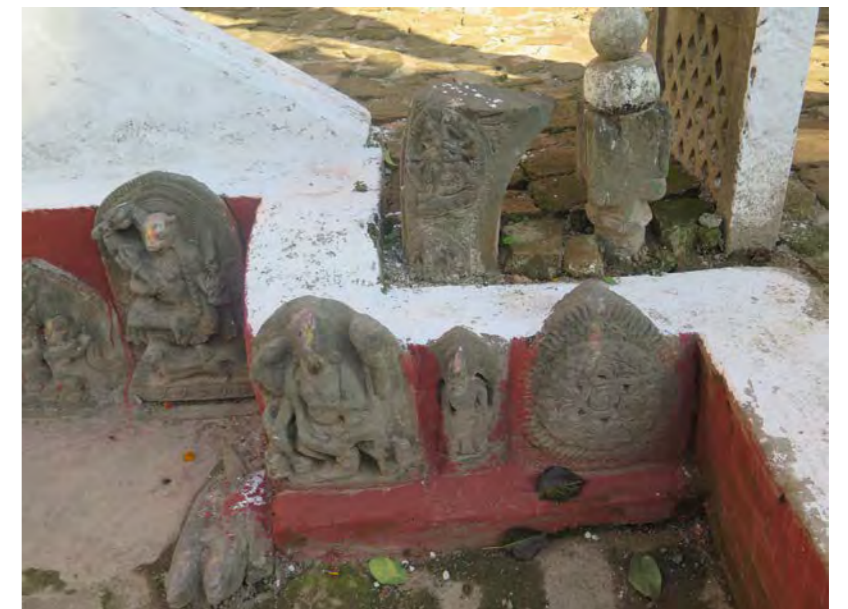
11g OPEN SHRINE

CODE NO	TYOLOGY	MONUMENT NAME	ESTABLISHED/ RENOVATED	STRUCTURAL SYSTEM	MATERIAL	GENERAL DESCRIPTION	PROBLEM DESCRIPTION	DANGER	REMARKS
11g	Open Shrine				Stone, Brick	Rectangular area with stone sculptures.	Good Condition

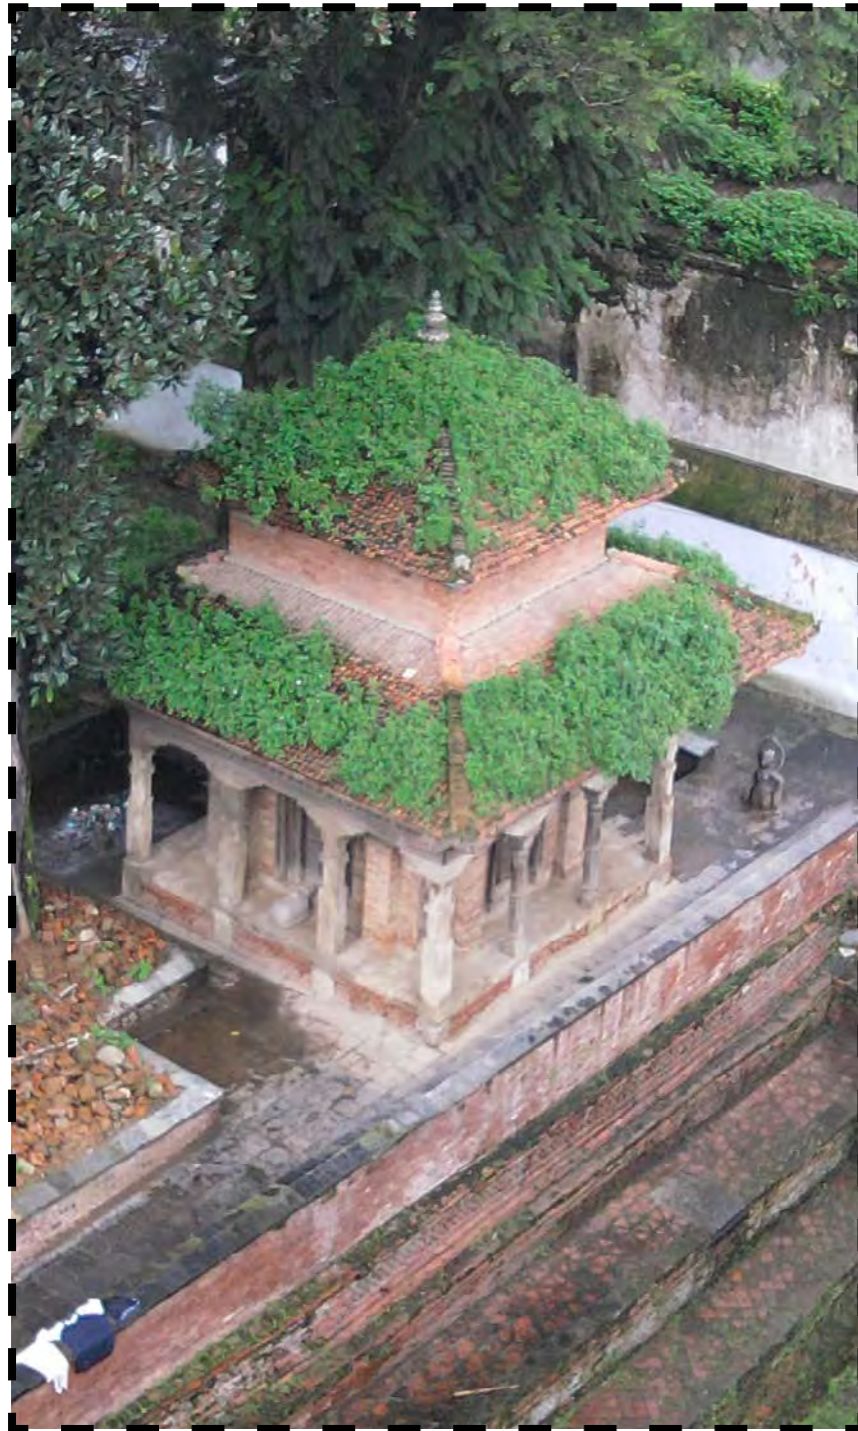
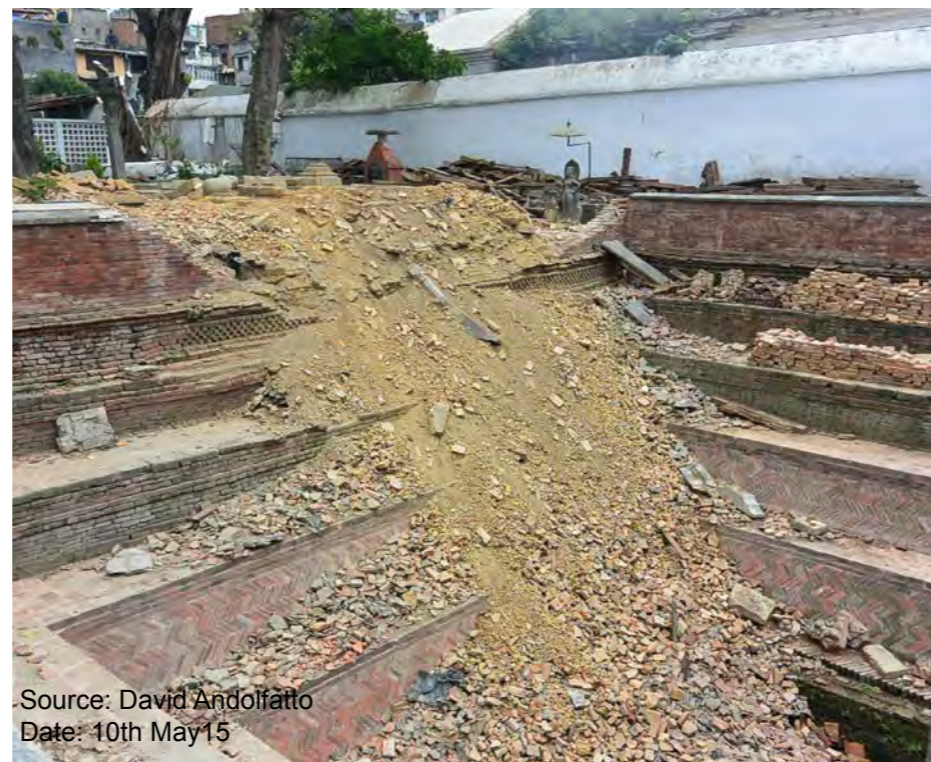
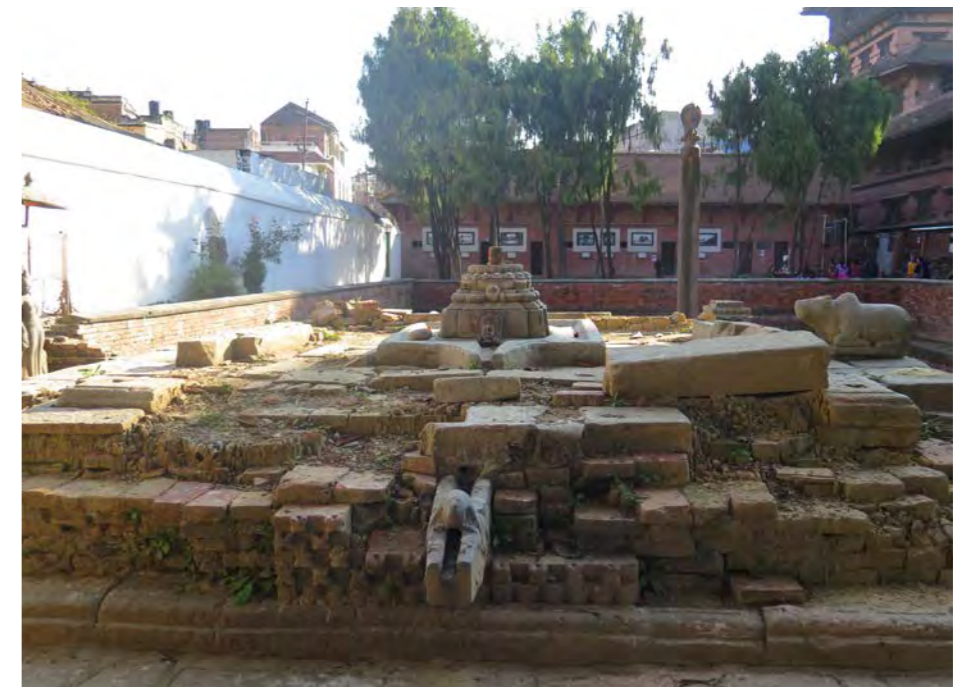
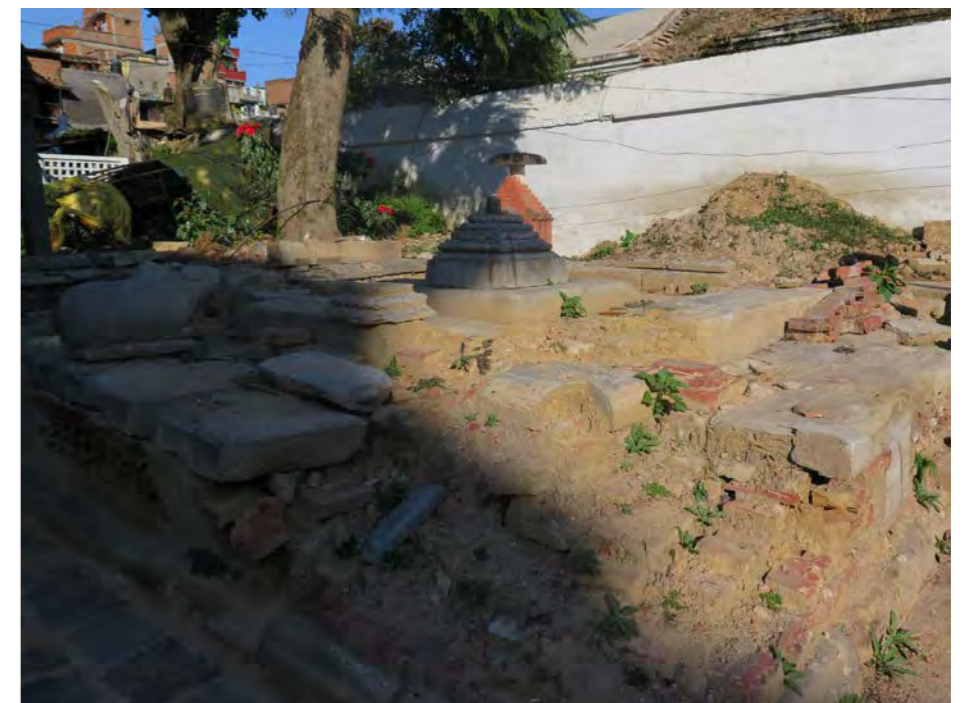
12 MAHADEV TEMPLE

CODE NO	TYOLOGY	MONUMENT NAME	ESTABLISHED/ RENOVATED	STRUCTURAL SYSTEM	MATERIAL	GENERAL DESCRIPTION	PROBLEM DESCRIPTION	DANGER	REMARKS
12	Two storey temple	Madhev Temple	17th century	Load Bearing	Brick;Timber	Supporting pillars carved;tiled roofs	Totally Collapsed

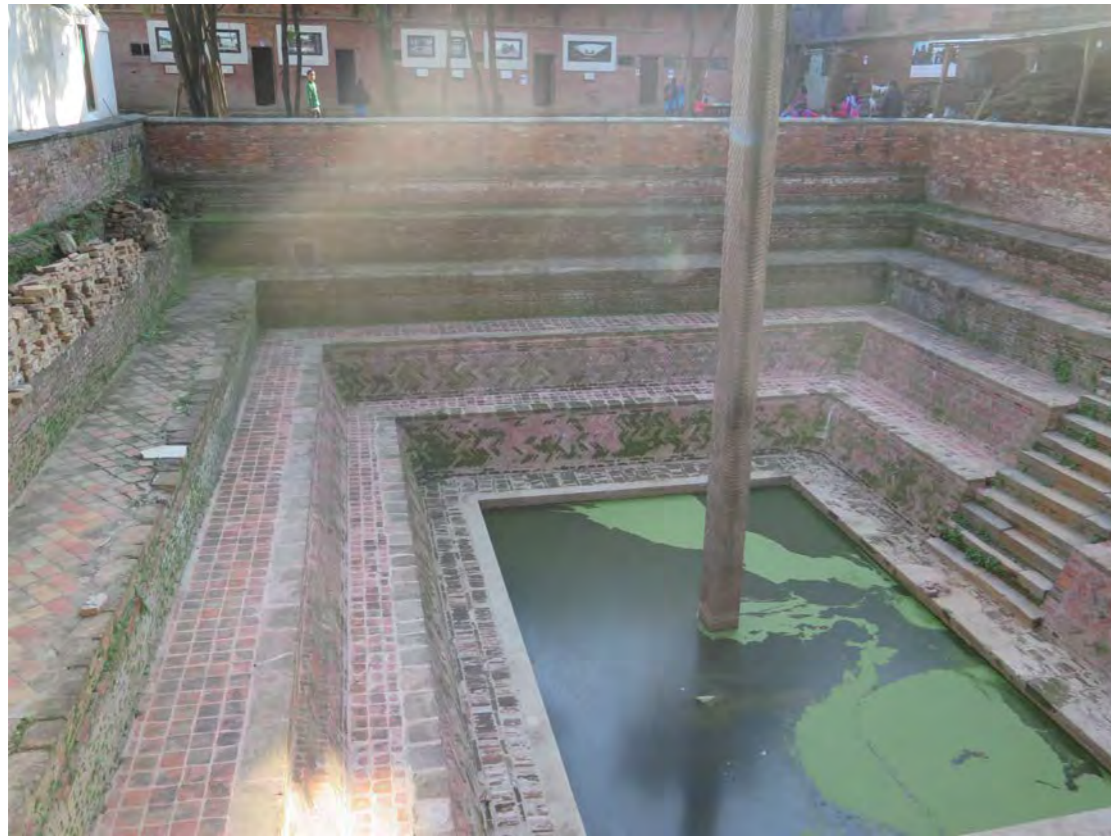
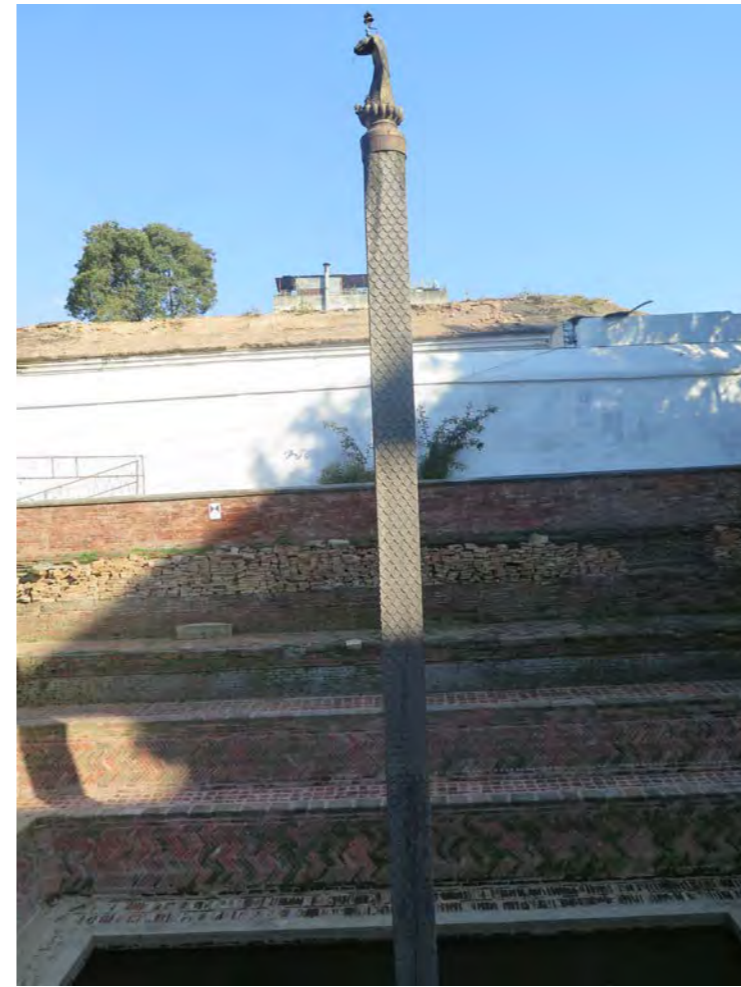
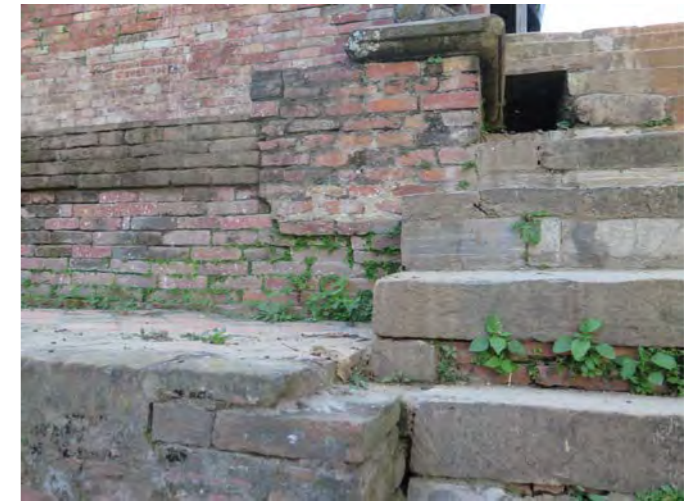
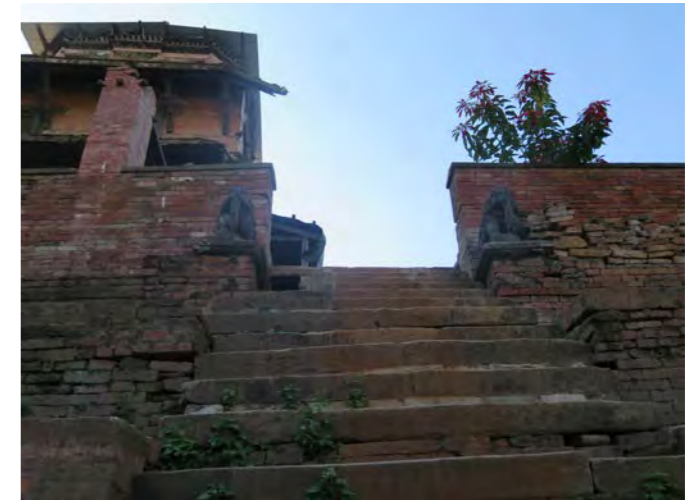
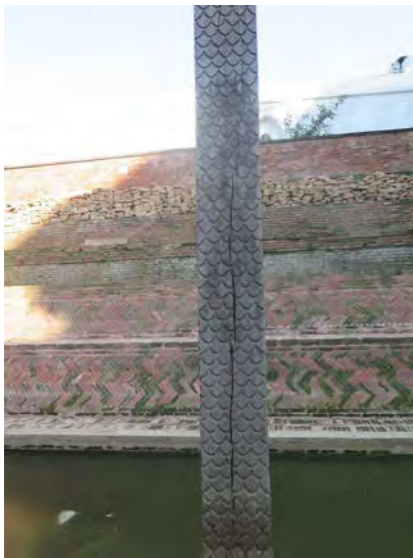
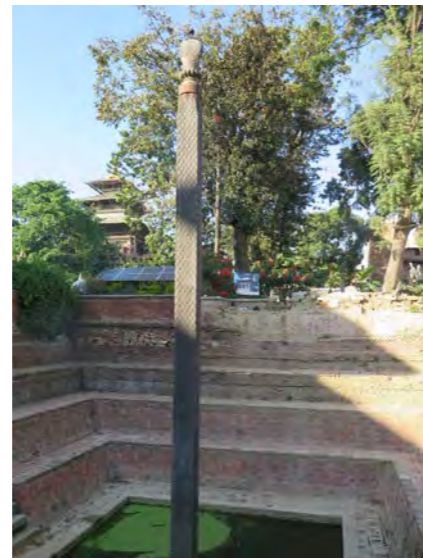
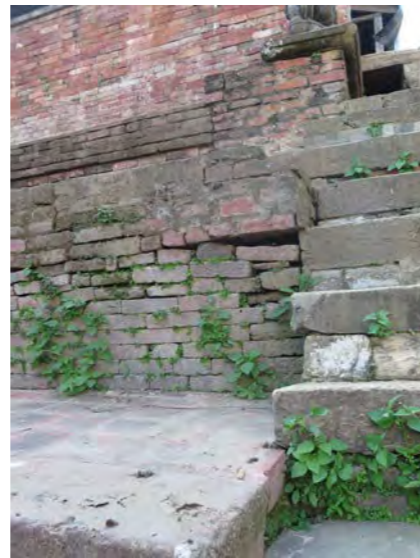
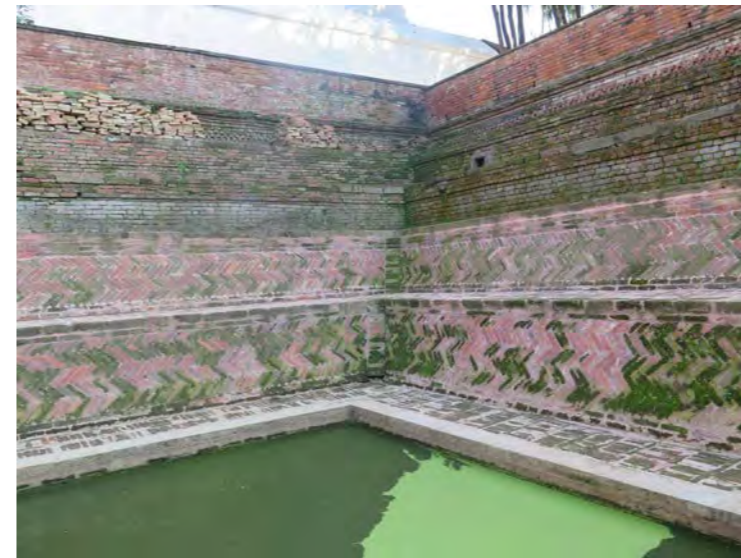
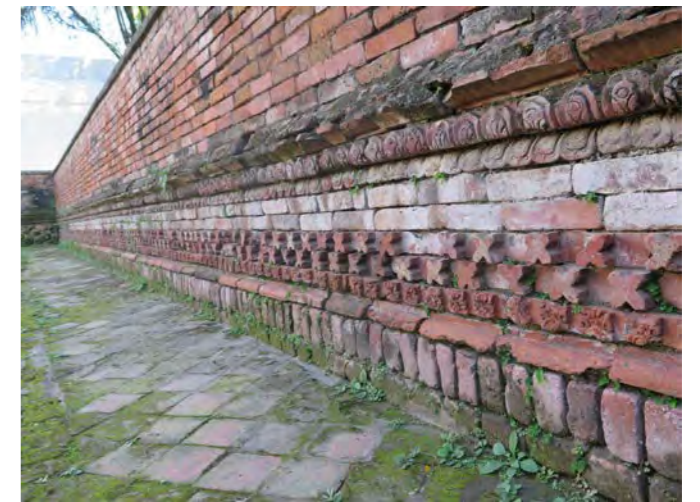
12a POND

CODE NO	TYOLOGY	MONUMENT NAME	ESTABLISHED/ RENOVATED	STRUCTURAL SYSTEM	MATERIAL	GENERAL DESCRIPTION	PROBLEM DESCRIPTION	DANGER	REMARKS	
12a	Pond				Stone, Brick	Wooden post at the center with metallic snake statue on top	Pillar slightly tilted and vertical cracks present at pillar base; boundry wall collapsed;

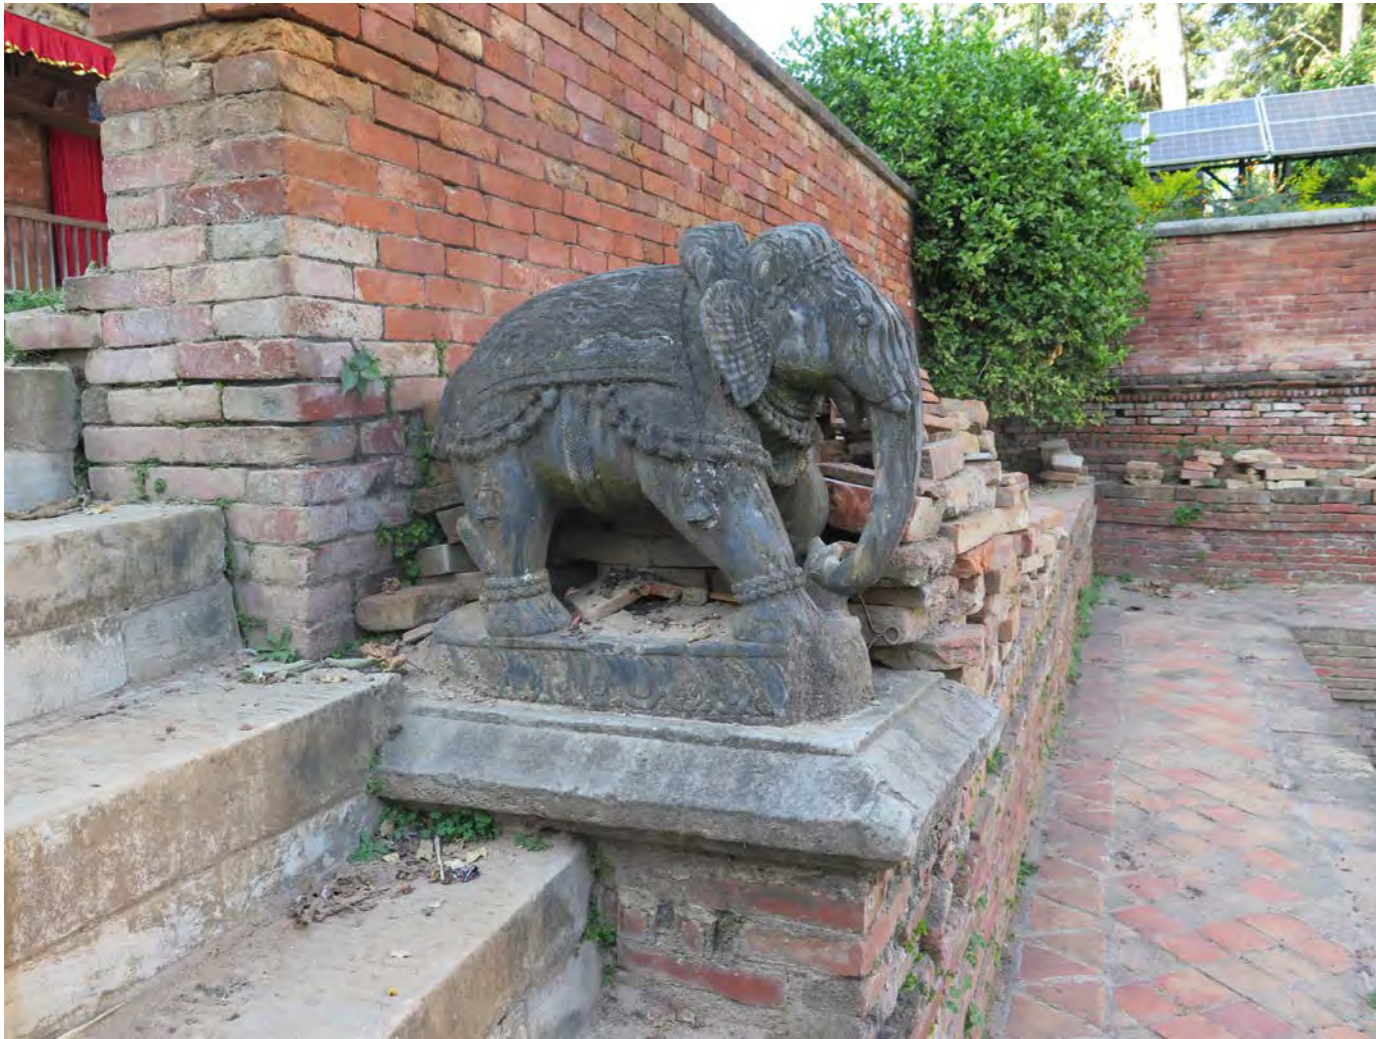
12b ELEPHANT STATUE

CODE NO	TYOLOGY	MONUMENT NAME	ESTABLISHED/ RENOVATED	STRUCTURAL SYSTEM	MATERIAL	GENERAL DESCRIPTION	PROBLEM DESCRIPTION	DANGER	REMARKS	
12b	Elephant Statue				Stone	Stone elephant statue on left side of entrance	Good Condition			
12c	Elephant Statue				Stone	Stone elephant statue on right side of entrance	Good Condition
