2015 Earthquake Damage Mapping

Hanuman Dhoka Darbar Square Monument Zone
Kathmandu Valley World Heritage Property

December 2015

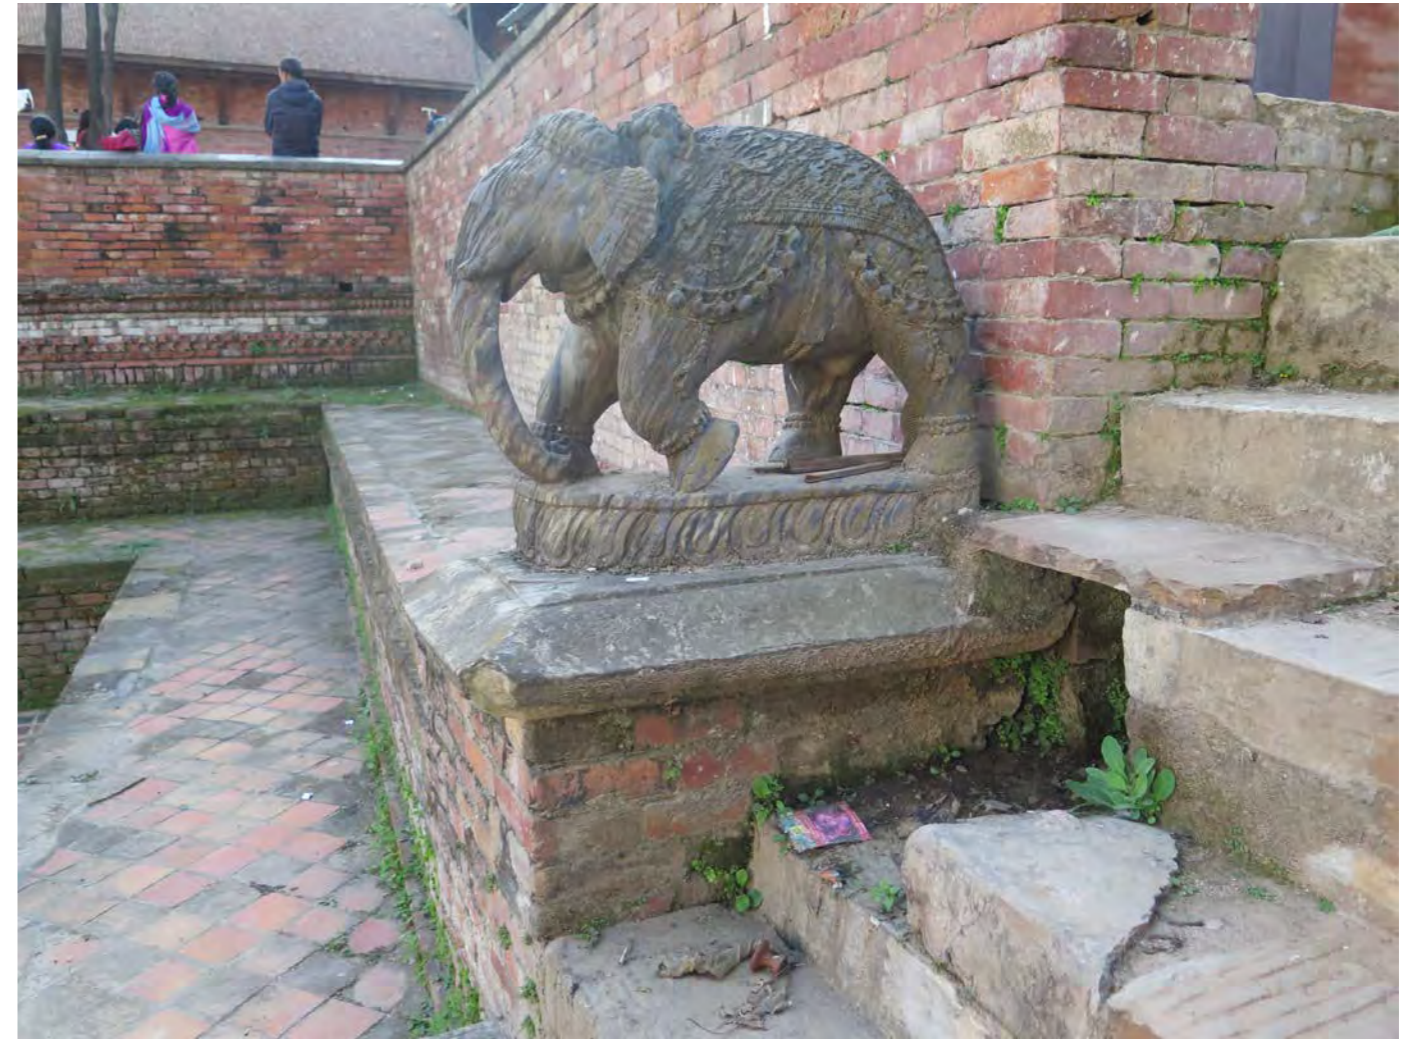
12c ELEPHANT STATUE

CODE NO	TYOLOGY	MONUMENT NAME	ESTABLISHED/ RENOVATED	STRUCTURAL SYSTEM	MATERIAL	GENERAL DESCRIPTION	PROBLEM DESCRIPTION	DANGER	REMARKS	
12b	Elephant Statue				Stone	Stone elephant statue on left side of entrance	Good Condition			
12c	Elephant Statue				Stone	Stone elephant statue on right side of entrance	Good Condition

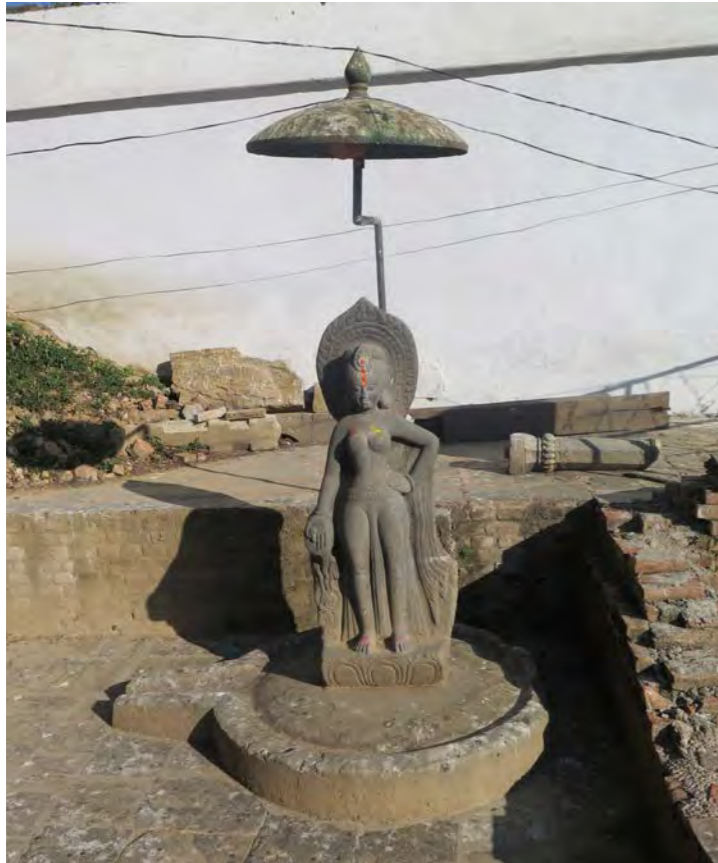
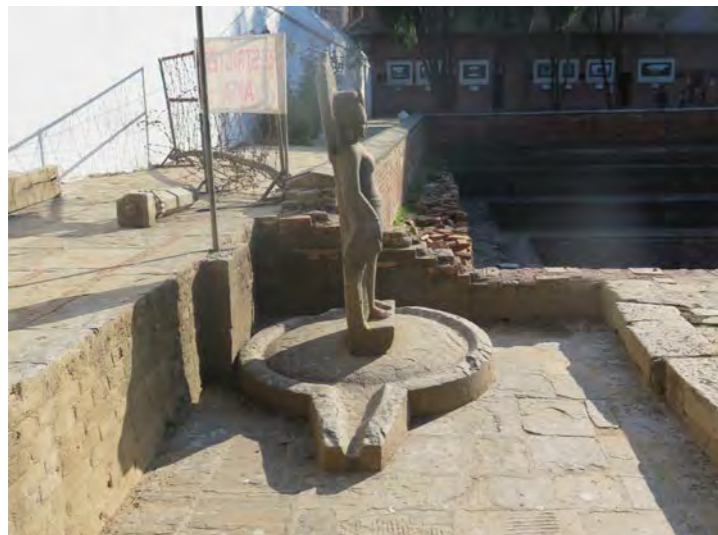
12d STATUE

CODE NO	TYOLOGY	MONUMENT NAME	ESTABLISHED/ RENOVATED	STRUCTURAL SYSTEM	MATERIAL	GENERAL DESCRIPTION	PROBLEM DESCRIPTION	DANGER	REMARKS	
12d	Statue				Stone	Stone statue with metal umbrella	Parts of the statue detached			
12e	Statue				Stone, Brick	Stone statue on brick wall with stone umbrella	Good Condition

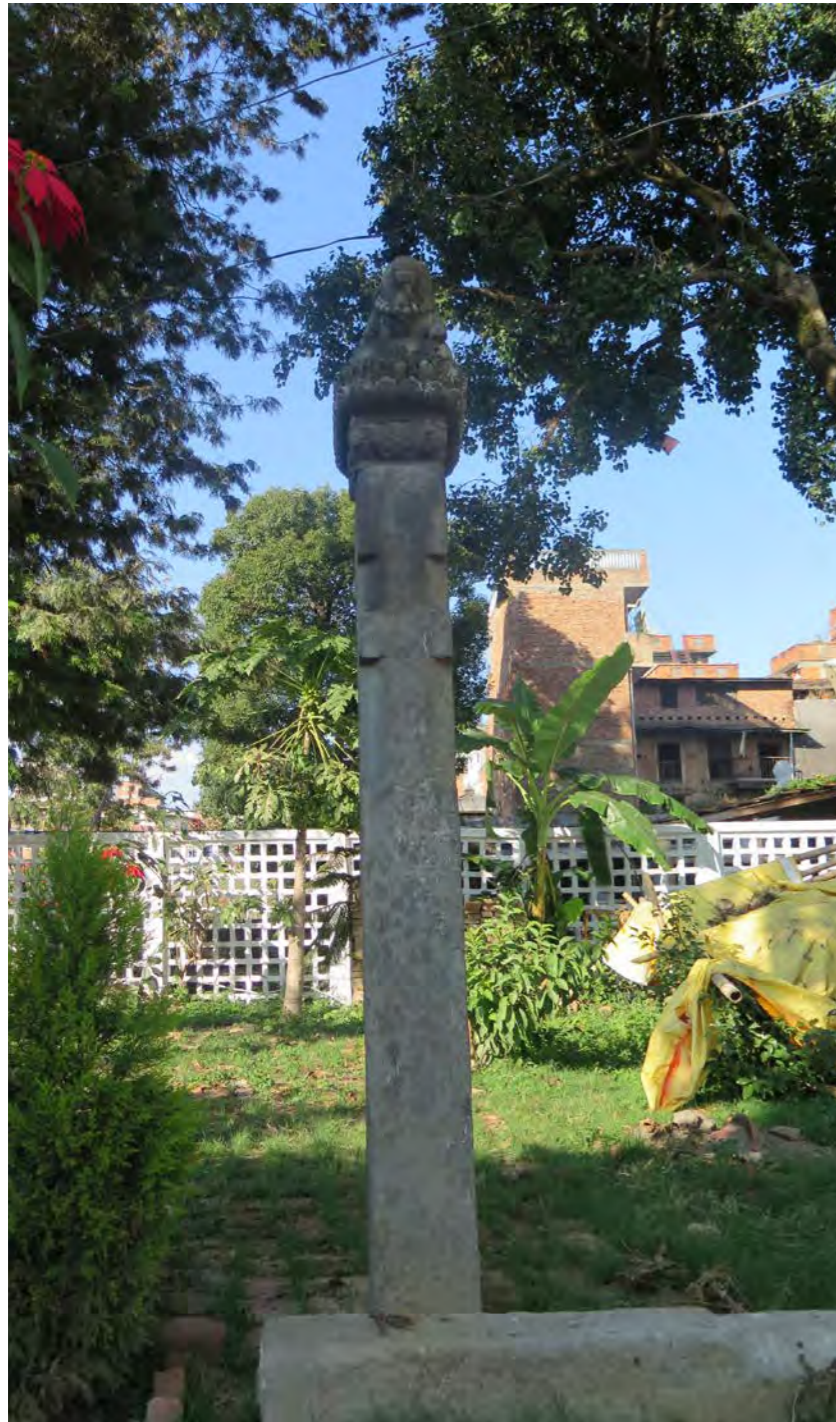
12f PILLAR

CODE NO	TYOLOGY	MONUMENT NAME	ESTABLISHED/ RENOVATED	STRUCTURAL SYSTEM	MATERIAL	GENERAL DESCRIPTION	PROBLEM DESCRIPTION	DANGER	REMARKS	
12f	Pillar				Stone	Stone pillar with bull on top	Pillar slightly tilted.			
12g	Bull				Stone	Stone bull in front of temple	Cracks at base; Slightly tilted			
12h	Statue				Stone; Brick	Stone statue on elevated brick platform	Good Condition

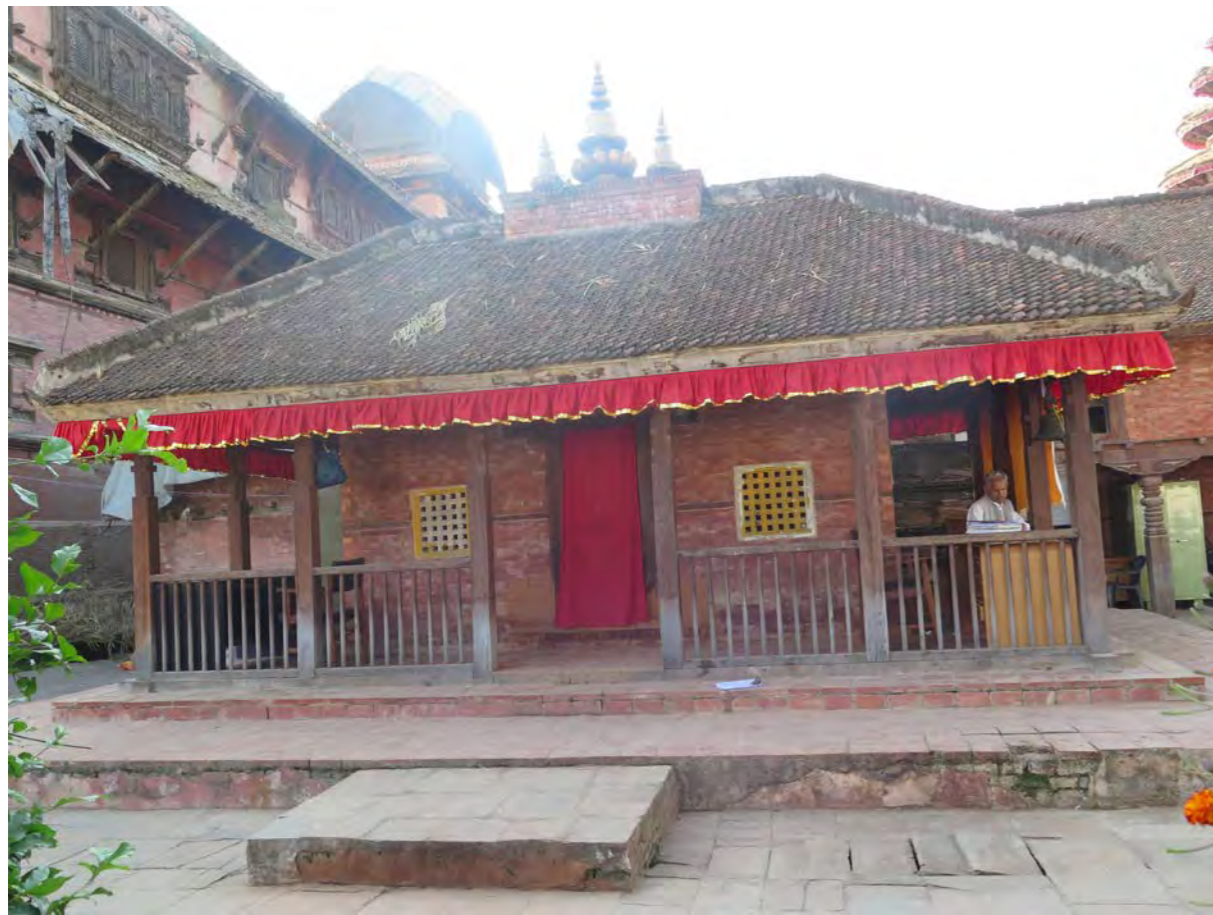
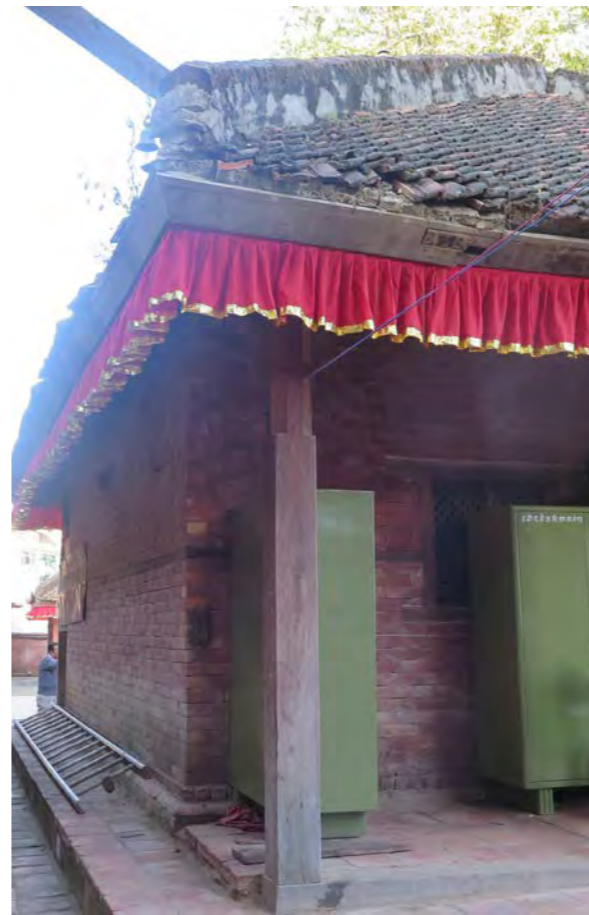
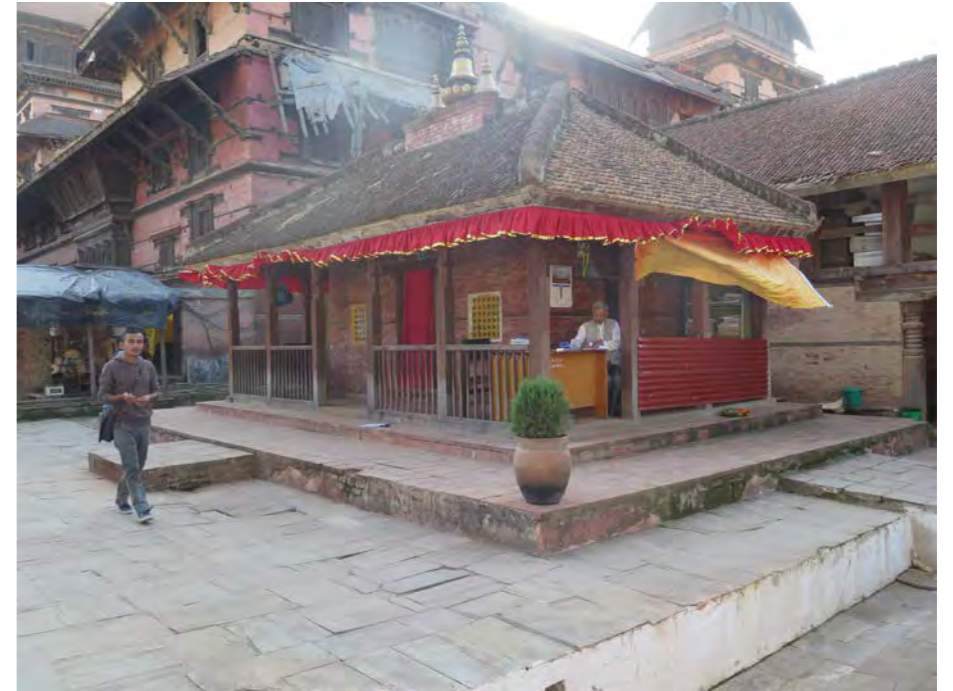
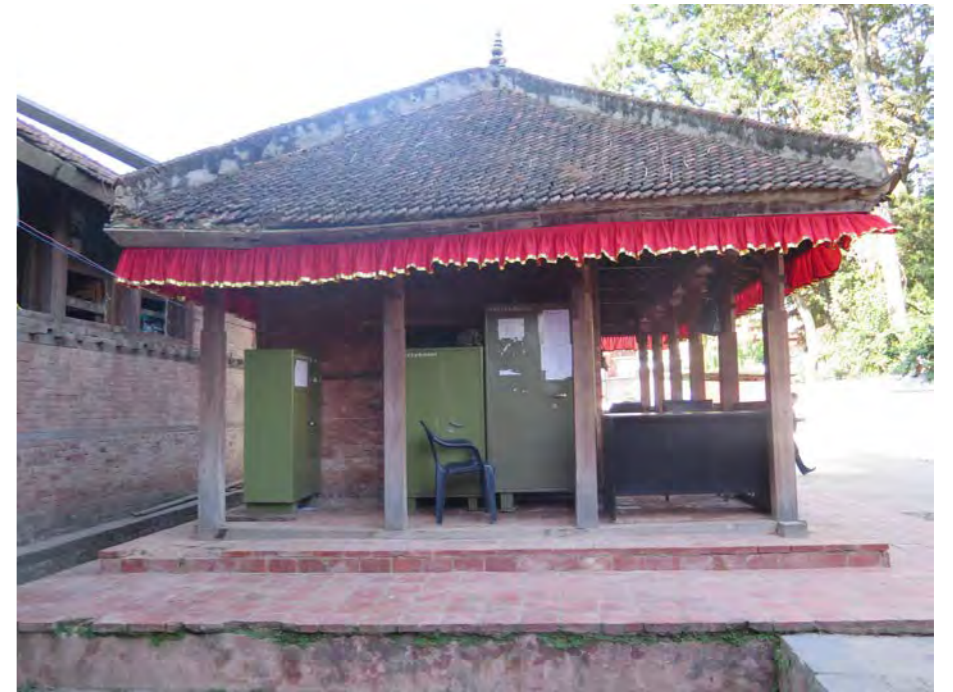
13 DASHAIN GHAR

CODE NO	TYOLOGY	MONUMENT NAME	ESTABLISHED/ RENOVATED	STRUCTURAL SYSTEM	MATERIAL	GENERAL DESCRIPTION	PROBLEM DESCRIPTION	DANGER	REMARKS
13	Single Storey temple	Dashain Ghar	19th century	Load Bearing	Brick;Timber	Single storey structure on raised plinth;Roof supported by timber column	Bricks in plinth detached;Roof tiles detached;Walls and columns in good condition

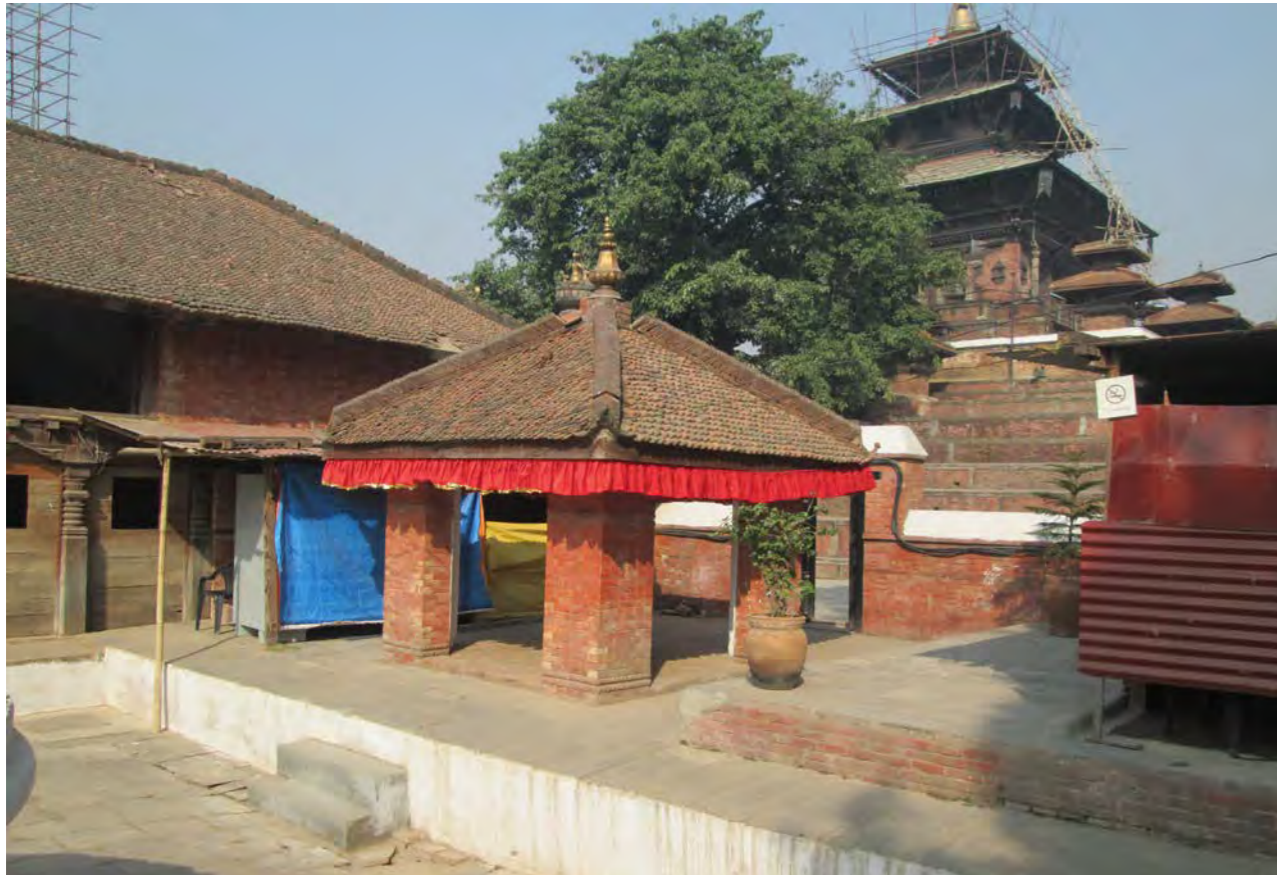
CODE NO	TYOLOGY	MONUMENT NAME	ESTABLISHED/RENOVATED	STRUCTURAL SYSTEM	MATERIAL	GENERAL DESCRIPTION	PROBLEM DESCRIPTION	DANGER	REMARKS
13a	Single-storey temple	Jug Bahadur Well					No visible damages		
13b	Well					No visible damages

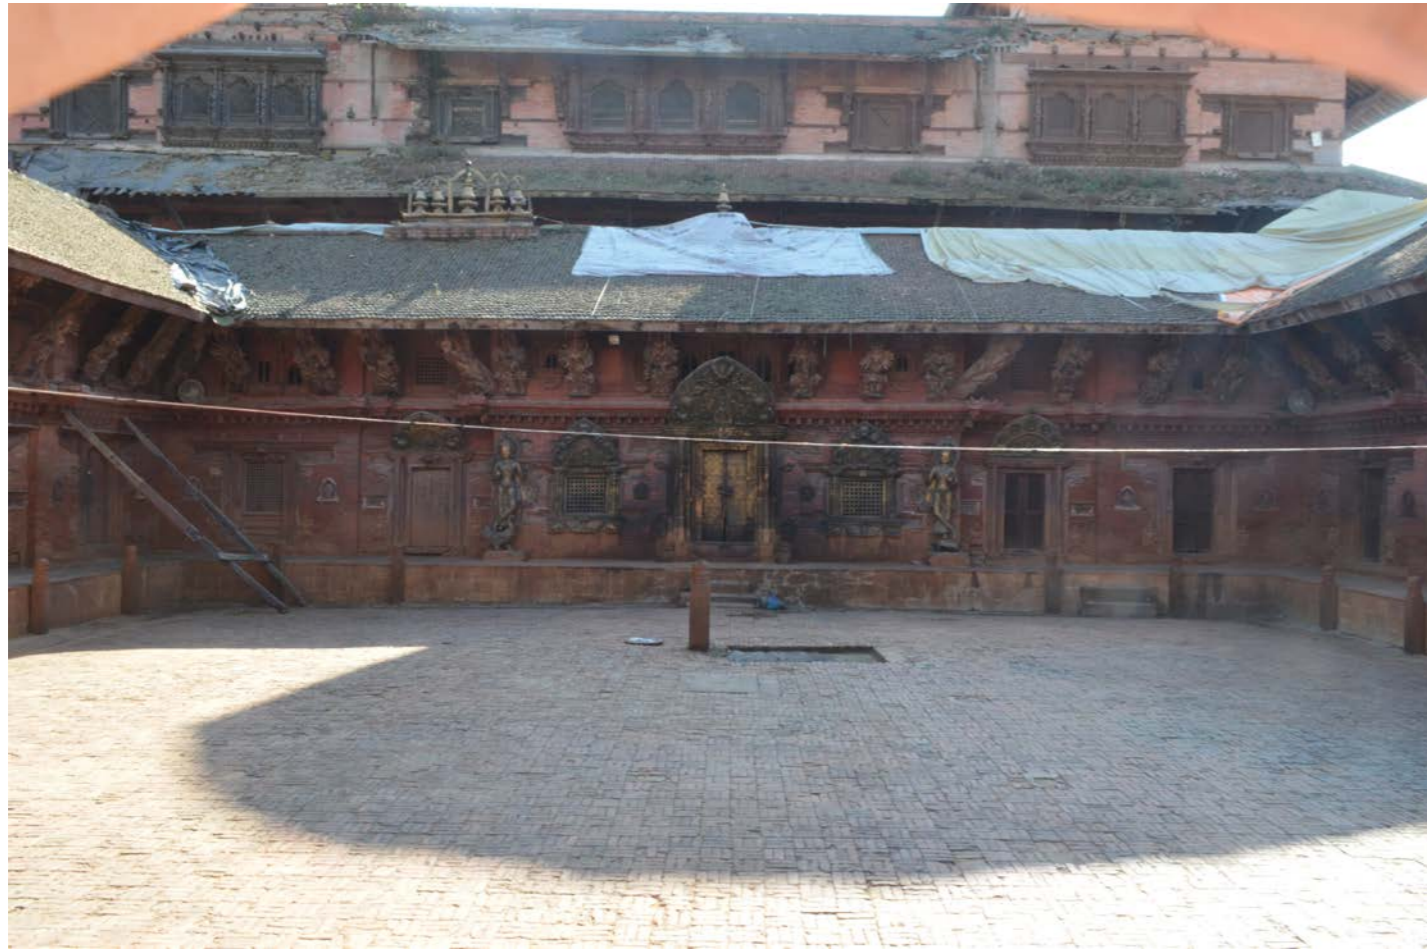
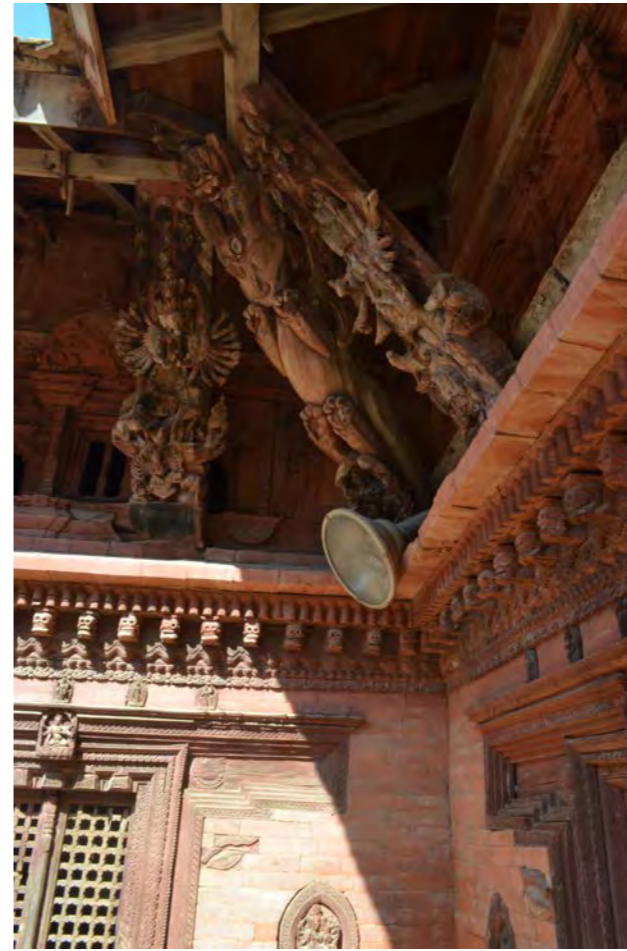
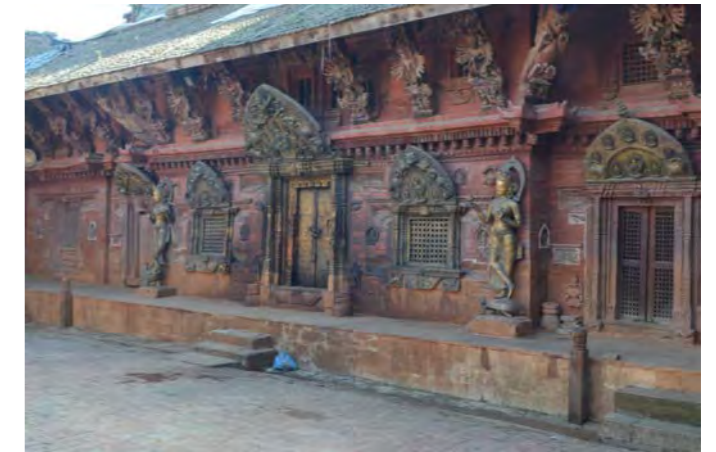
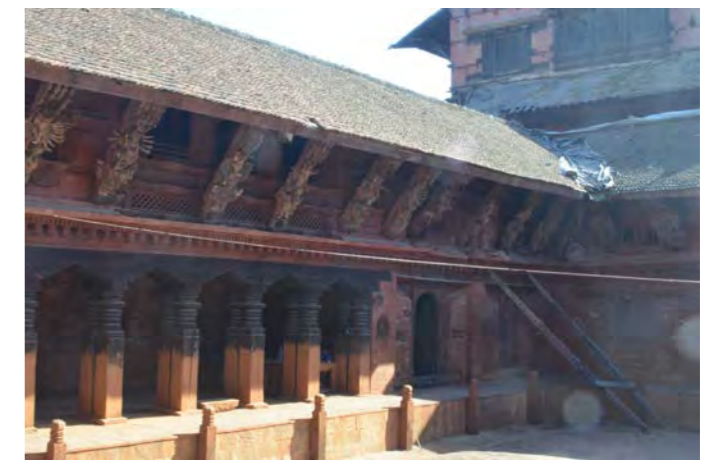
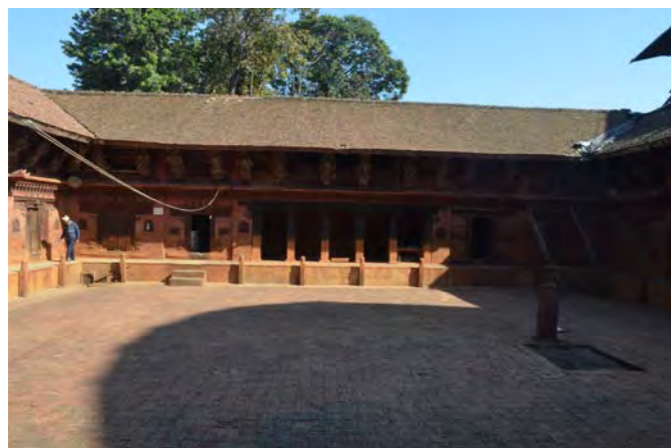
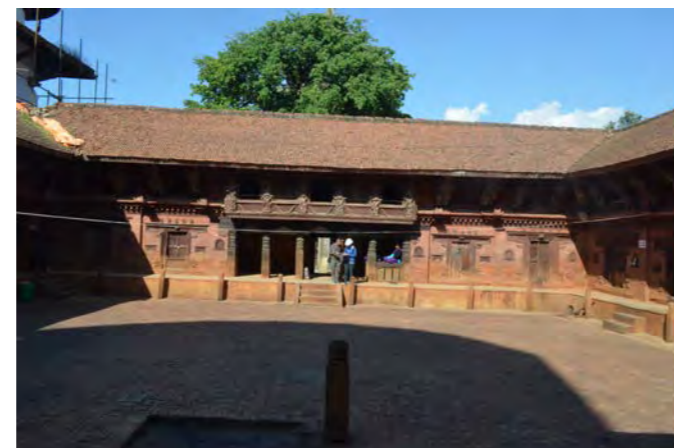
14 MOOL CHOWK

CODE NO	TYOLOGY	MONUMENT NAME	ESTABLISHED/ RENOVATED	STRUCTURAL SYSTEM	MATERIAL	GENERAL DESCRIPTION	PROBLEM DESCRIPTION	DANGER	REMARKS
14	Chwok	Mool Chowk	16th century			Main courtyard of the palace with uniform height on four sides;	slightly damage on roof of surrounding temple

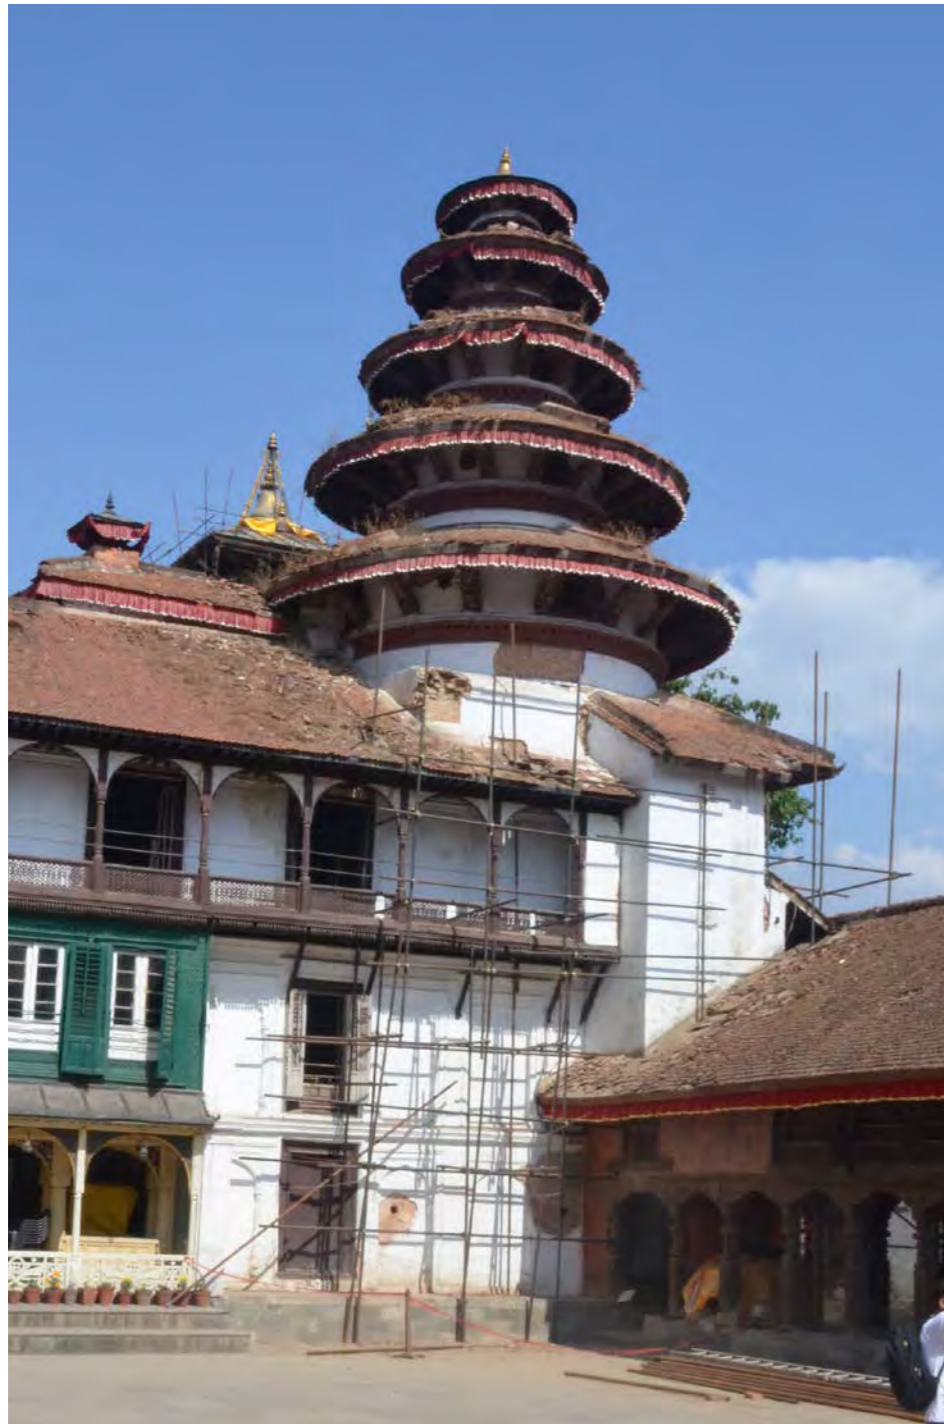
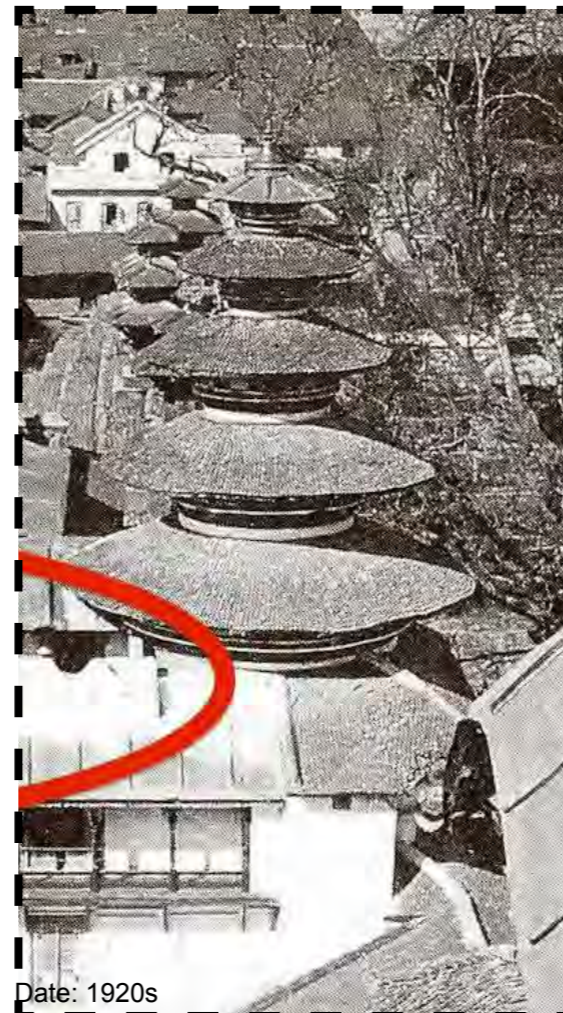
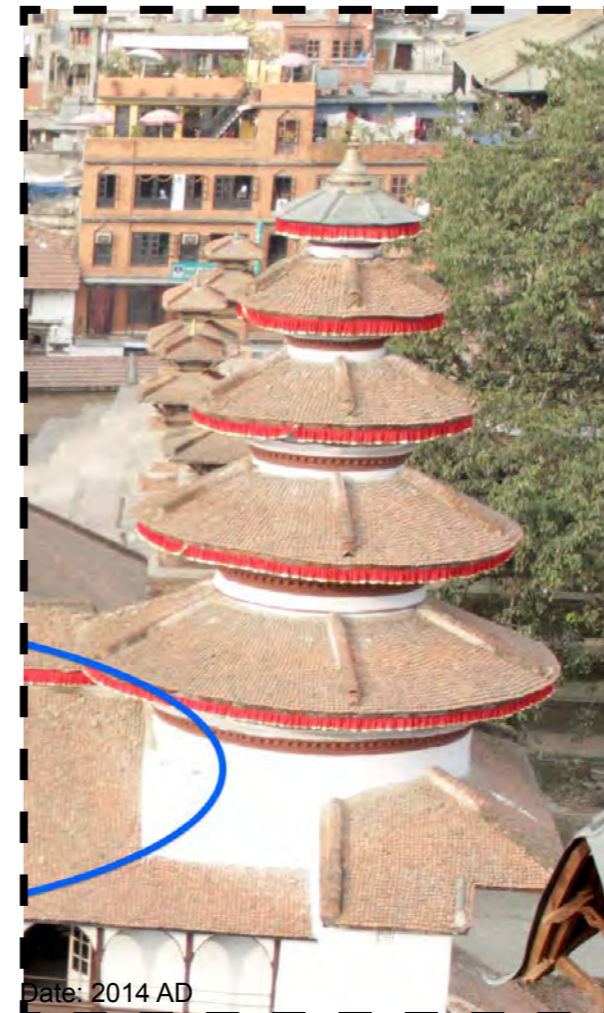
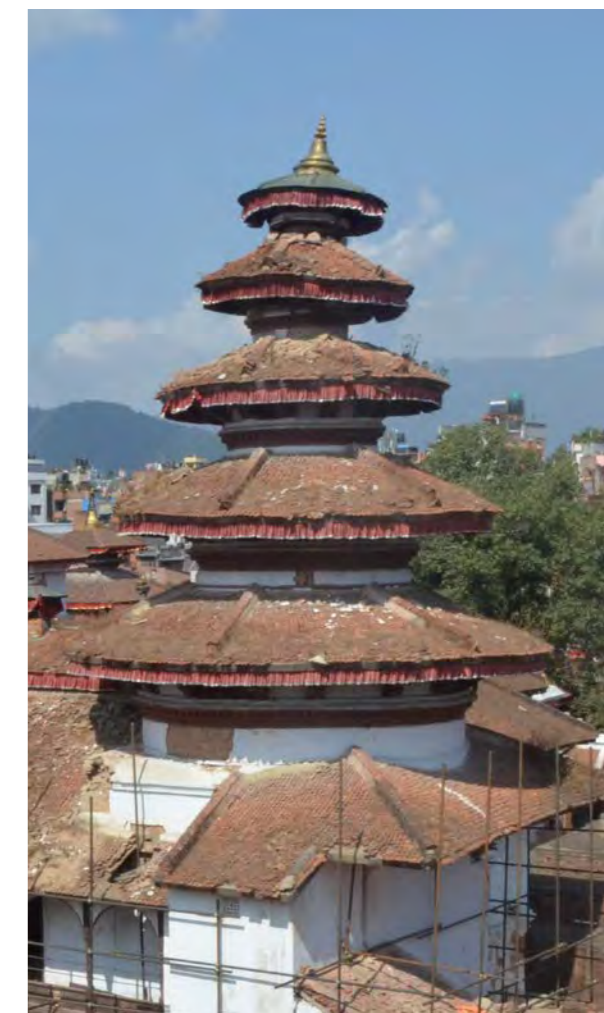
15 PANCHAMUKHI HANUMAN TEMPLE

CODE NO	TYOLOGY	MONUMENT NAME	ESTABLISHED/ RENOVATED	STRUCTURAL SYSTEM	MATERIAL	GENERAL DESCRIPTION	PROBLEM DESCRIPTION	DANGER	REMARKS
15	Multitiered temple	Panchmukhi Hanuman	17th century	Load Bearing	Brick;Timber	Made up of five circular storeys;Temple of five faced hanuman	Extensive external and internal cracks; Top part tilted

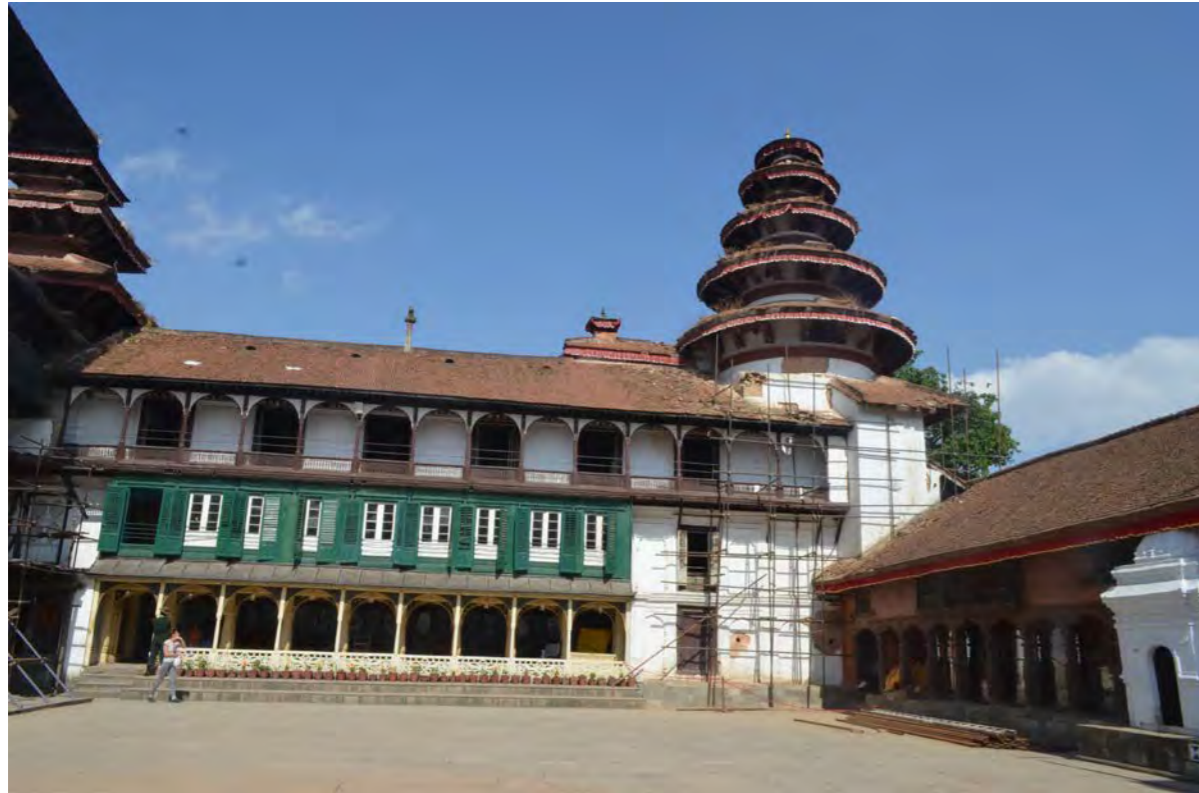
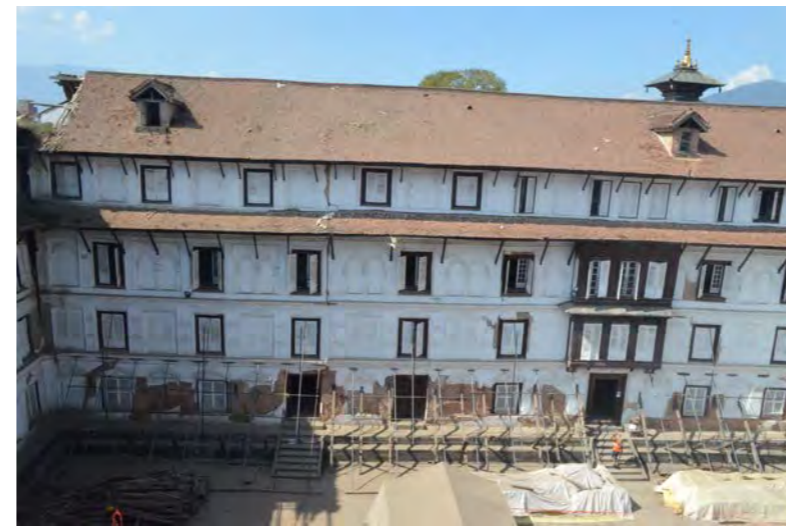
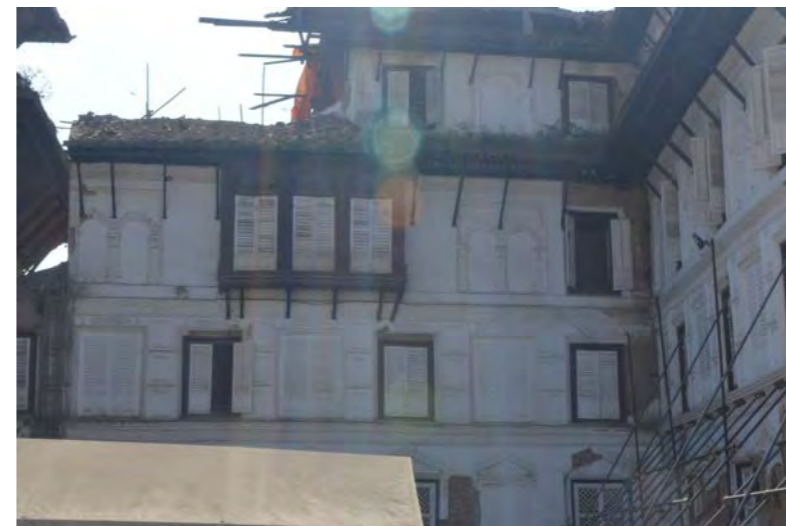
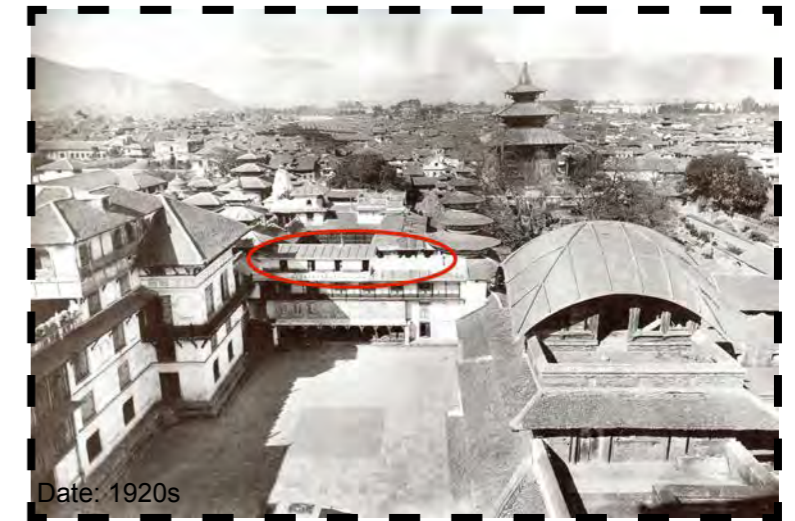
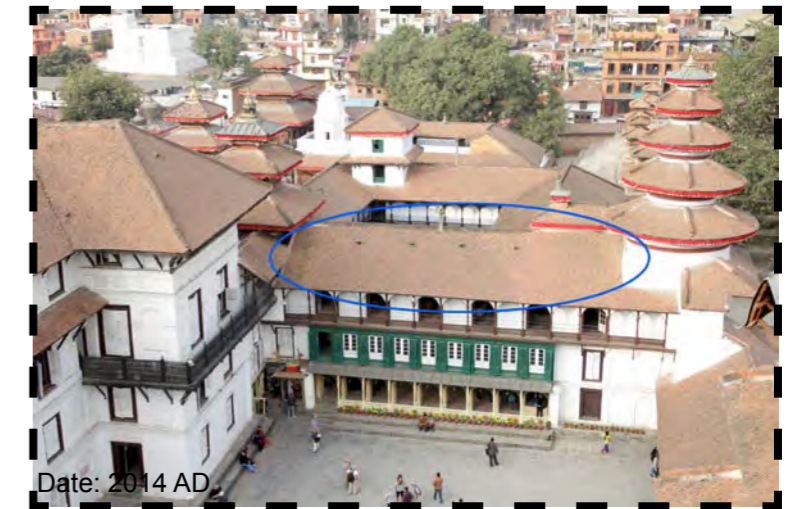
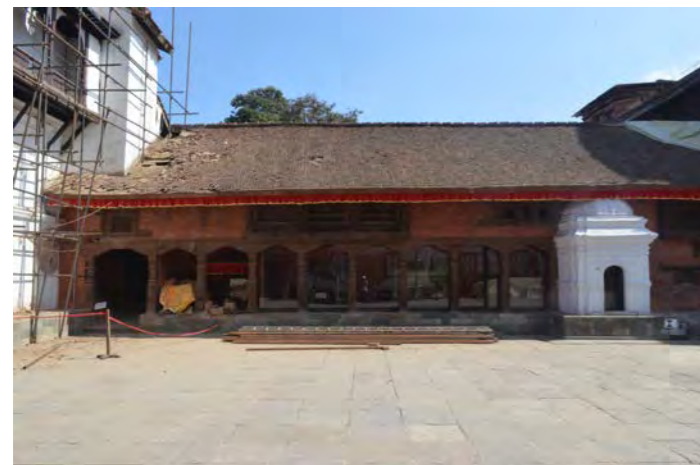
16 NASAL CHOWK

CODE NO	TYOLOGY	MONUMENT NAME	ESTABLISHED/ RENOVATED	STRUCTURAL SYSTEM	MATERIAL	GENERAL DESCRIPTION	PROBLEM DESCRIPTION	DANGER	REMARKS
16	Courtyard	Nasal Chowk	17th century			Structures on northern,western and southern side of the courtyard are 19th century.	South side building collapsed. Bulging of walls in east side;walls unstable and currently supported by struts.

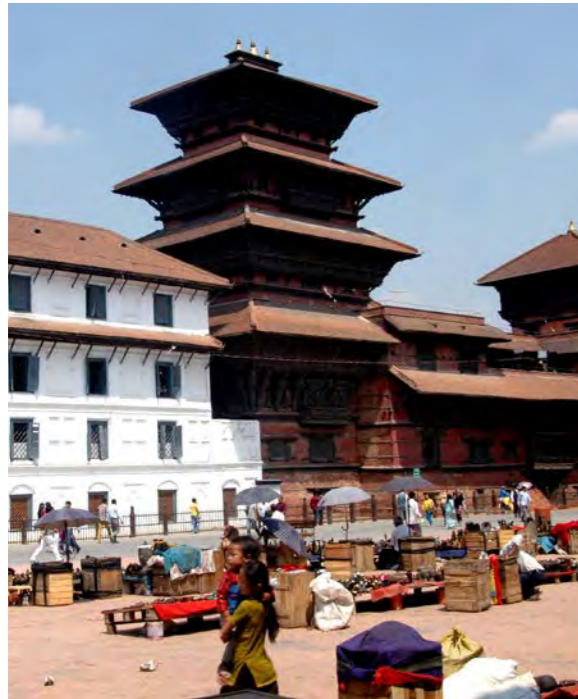
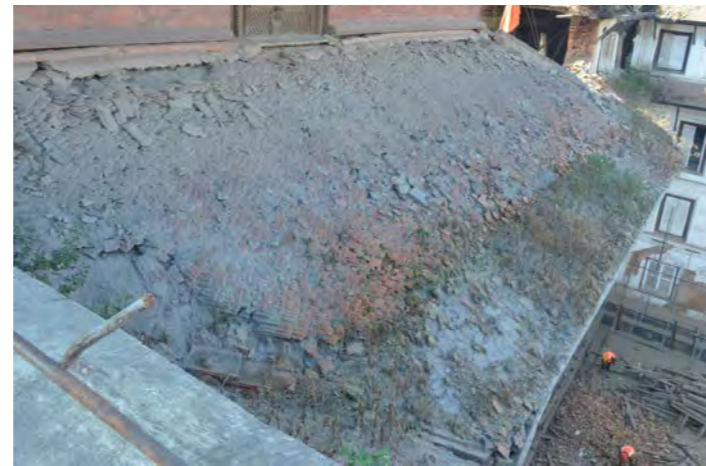
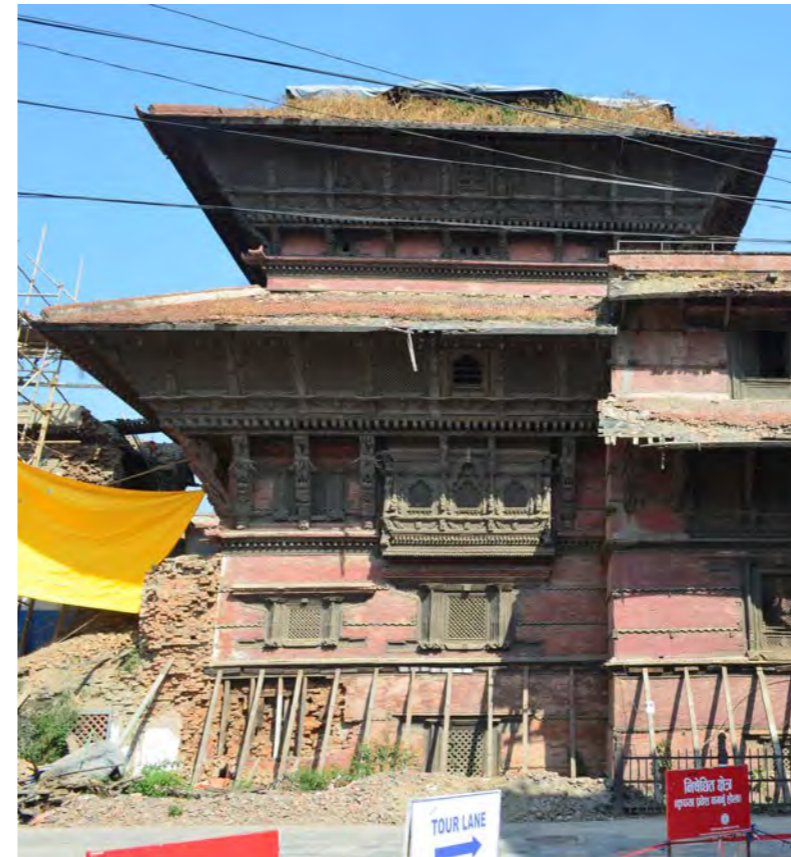
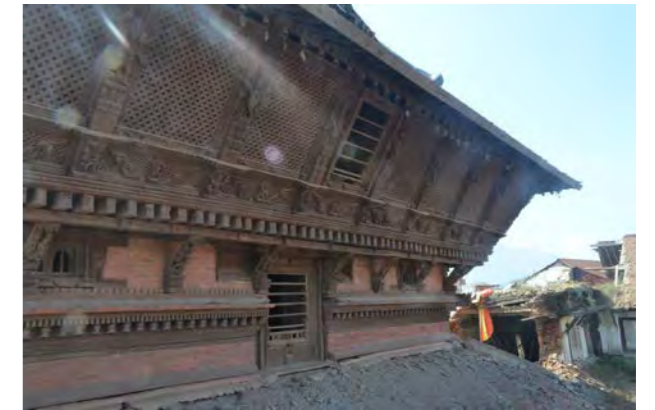
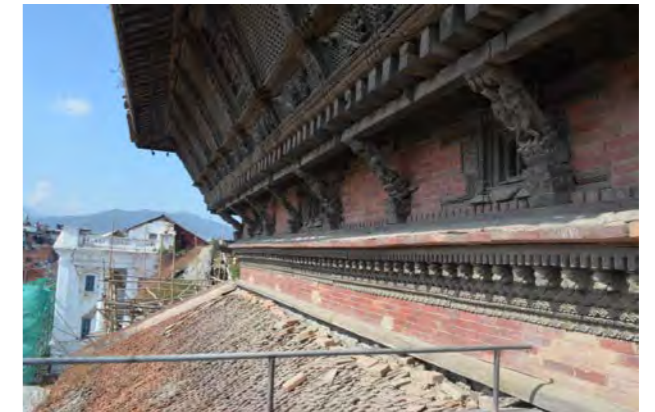
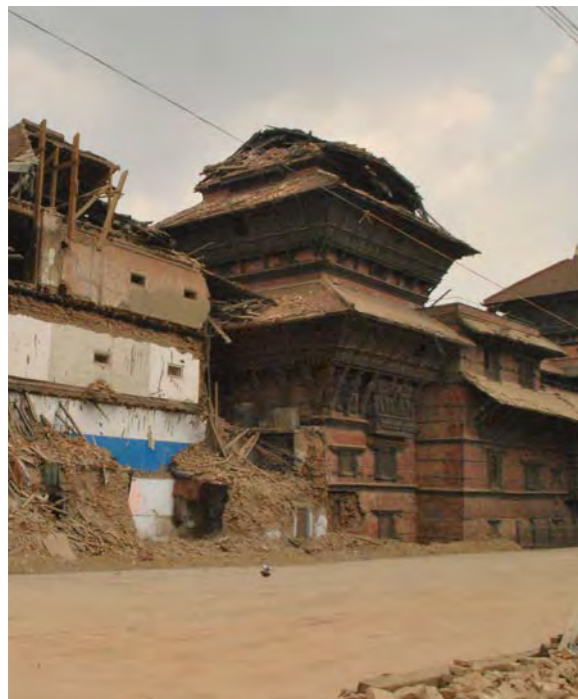
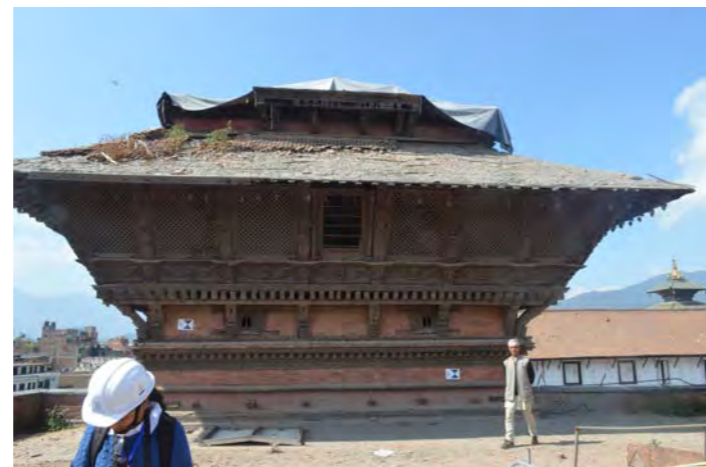
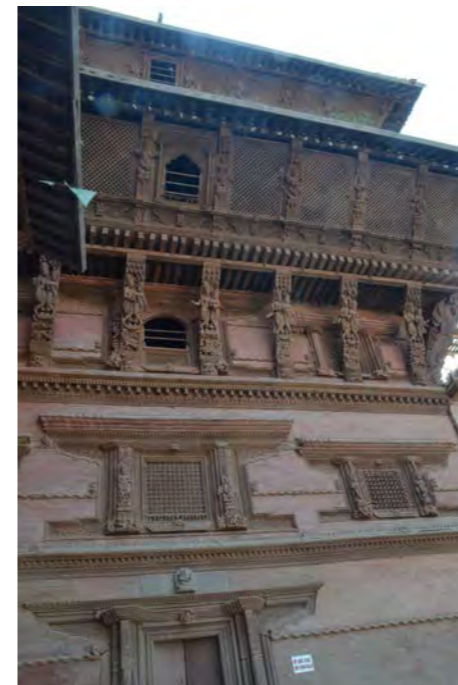
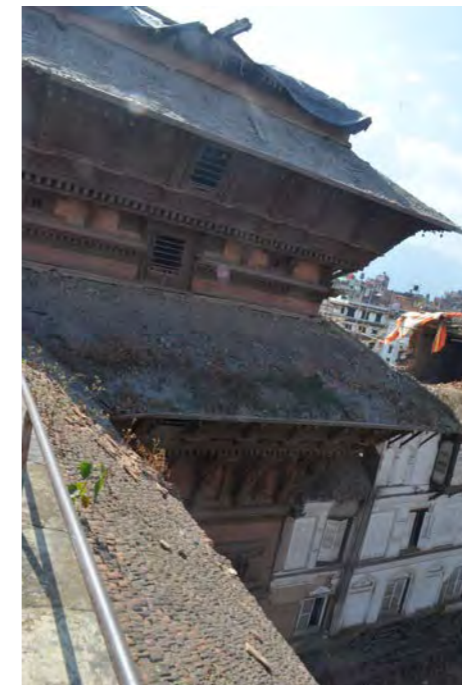
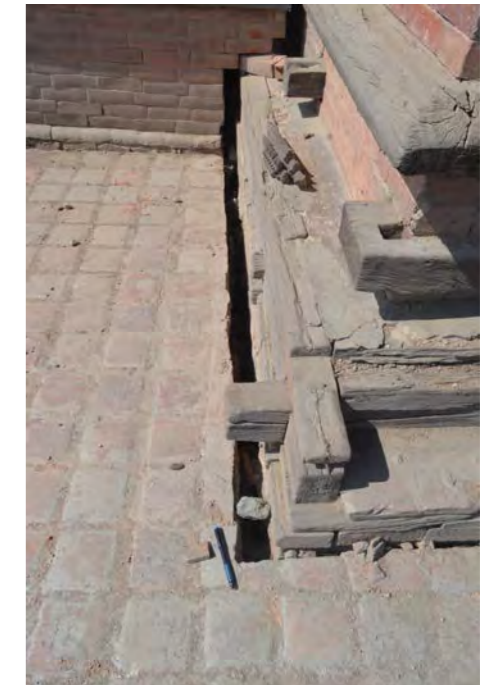
17 BASANTAPUR BHAWAN

CODE NO	TYOLOGY	MONUMENT NAME	ESTABLISHED/ RENOVATED	STRUCTURAL SYSTEM	MATERIAL	GENERAL DESCRIPTION	PROBLEM DESCRIPTION	DANGER	REMARKS
17	Nine Storeyed structure	Basantapur Bhawan	1770	Load Bearing	Brick	Pavilions/tower on the SW corner of Lohanchok	3 floor fallen down, concrete beam introduced, vegetation growth on roof
