2015 Earthquake Damage Mapping

Hanuman Dhoka Darbar Square Monument Zone
Kathmandu Valley World Heritage Property

December 2015

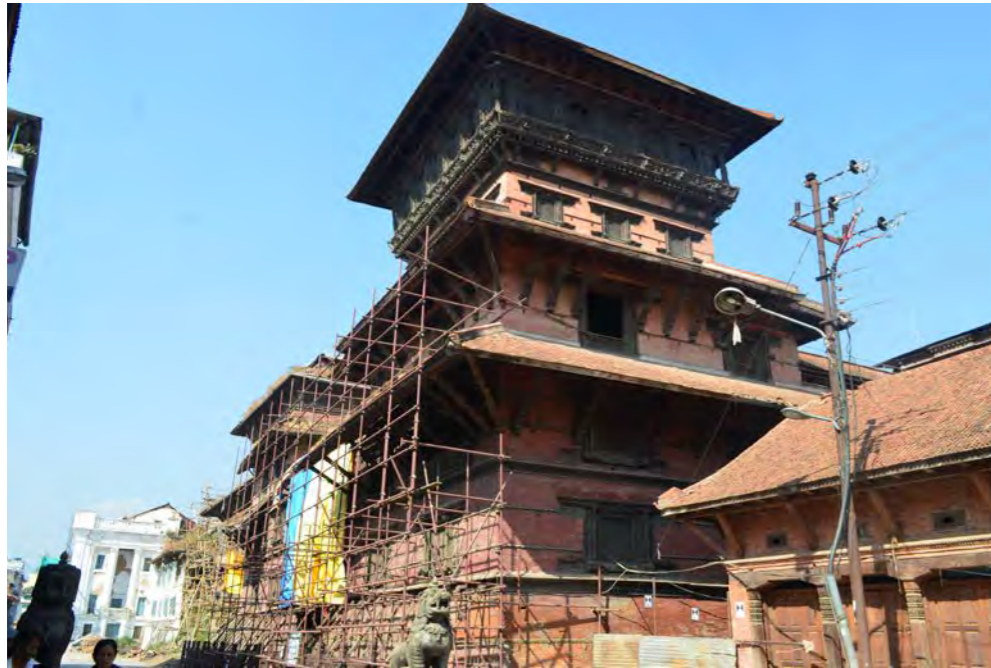
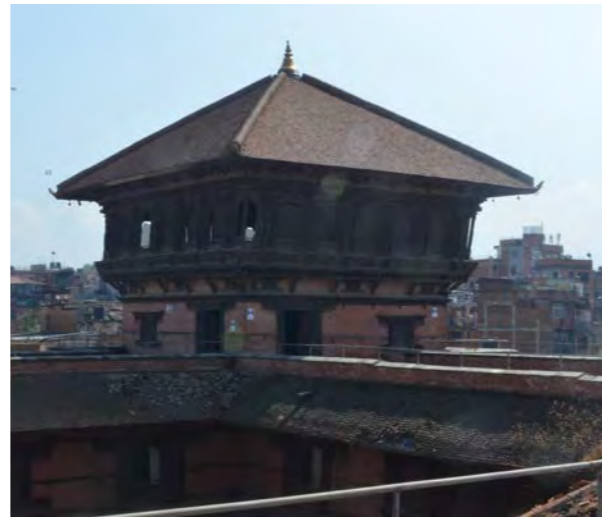
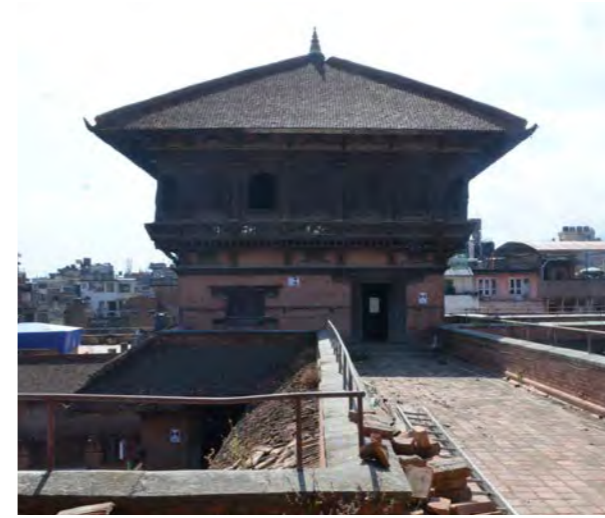
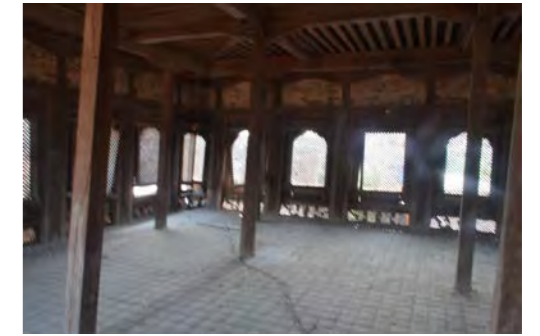
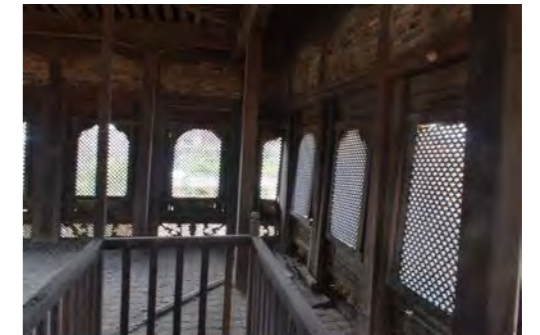
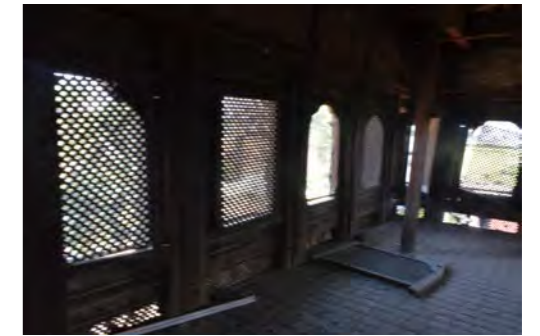
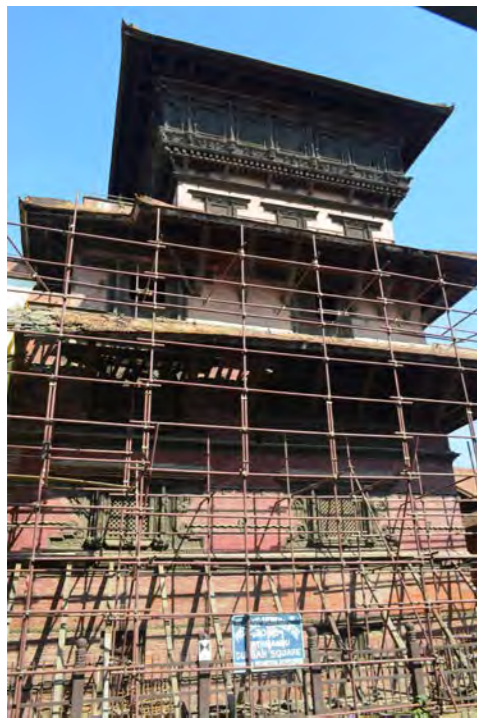
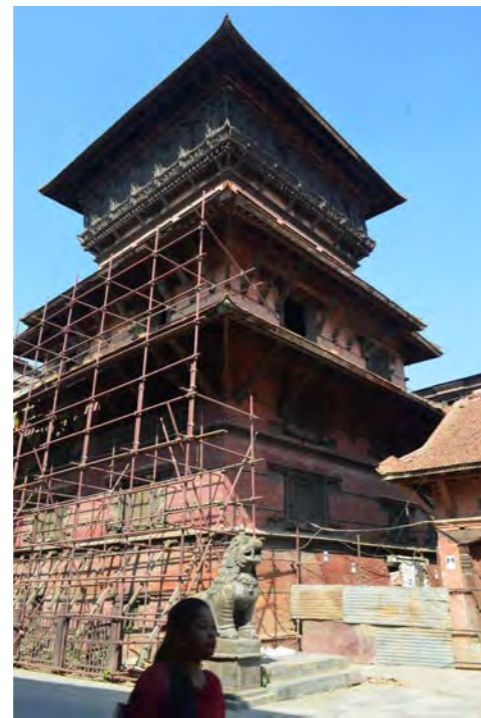
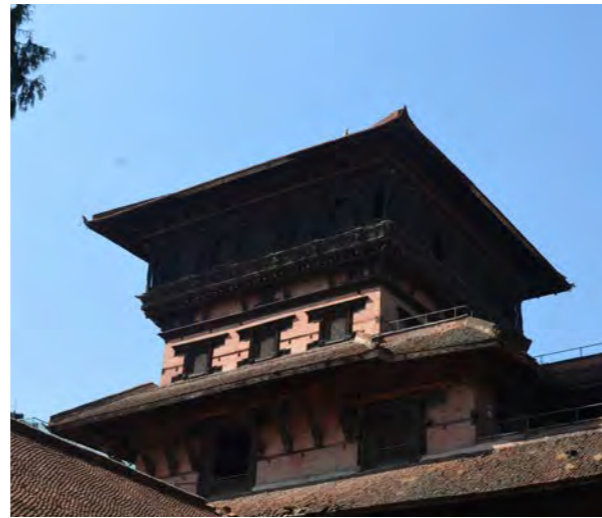
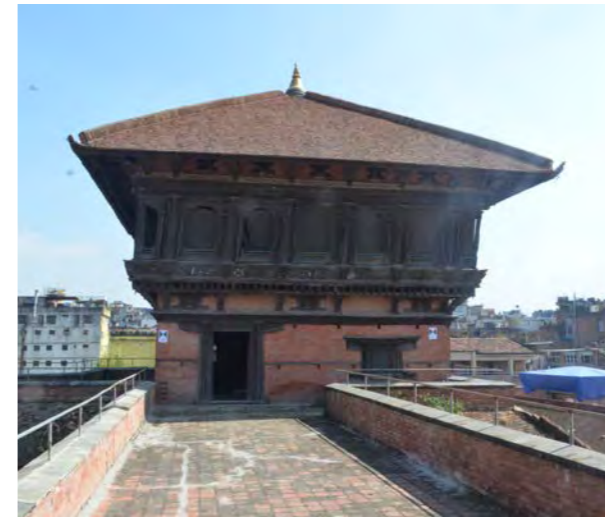
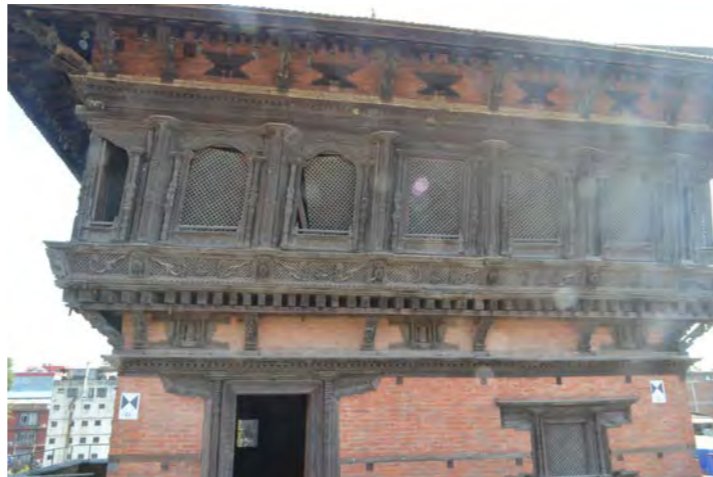
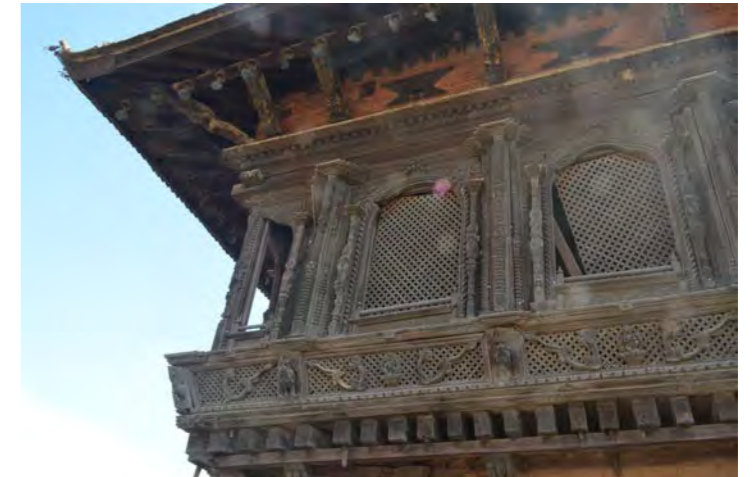
18 LALITPUR BHAWAN

CODE NO	TYOLOGY	MONUMENT NAME	ESTABLISHED/ RENOVATED	STRUCTURAL SYSTEM	MATERIAL	GENERAL DESCRIPTION	PROBLEM DESCRIPTION	DANGER	REMARKS
18	Six Storey Structure	Lalitpur Bhawan	1770	Load Bearing	Brick	Pavilions built on ES corner of Lohan chok, served as watchtowers for the palace	Tilted to north, vegetation growth on roof, vertical crack on wall

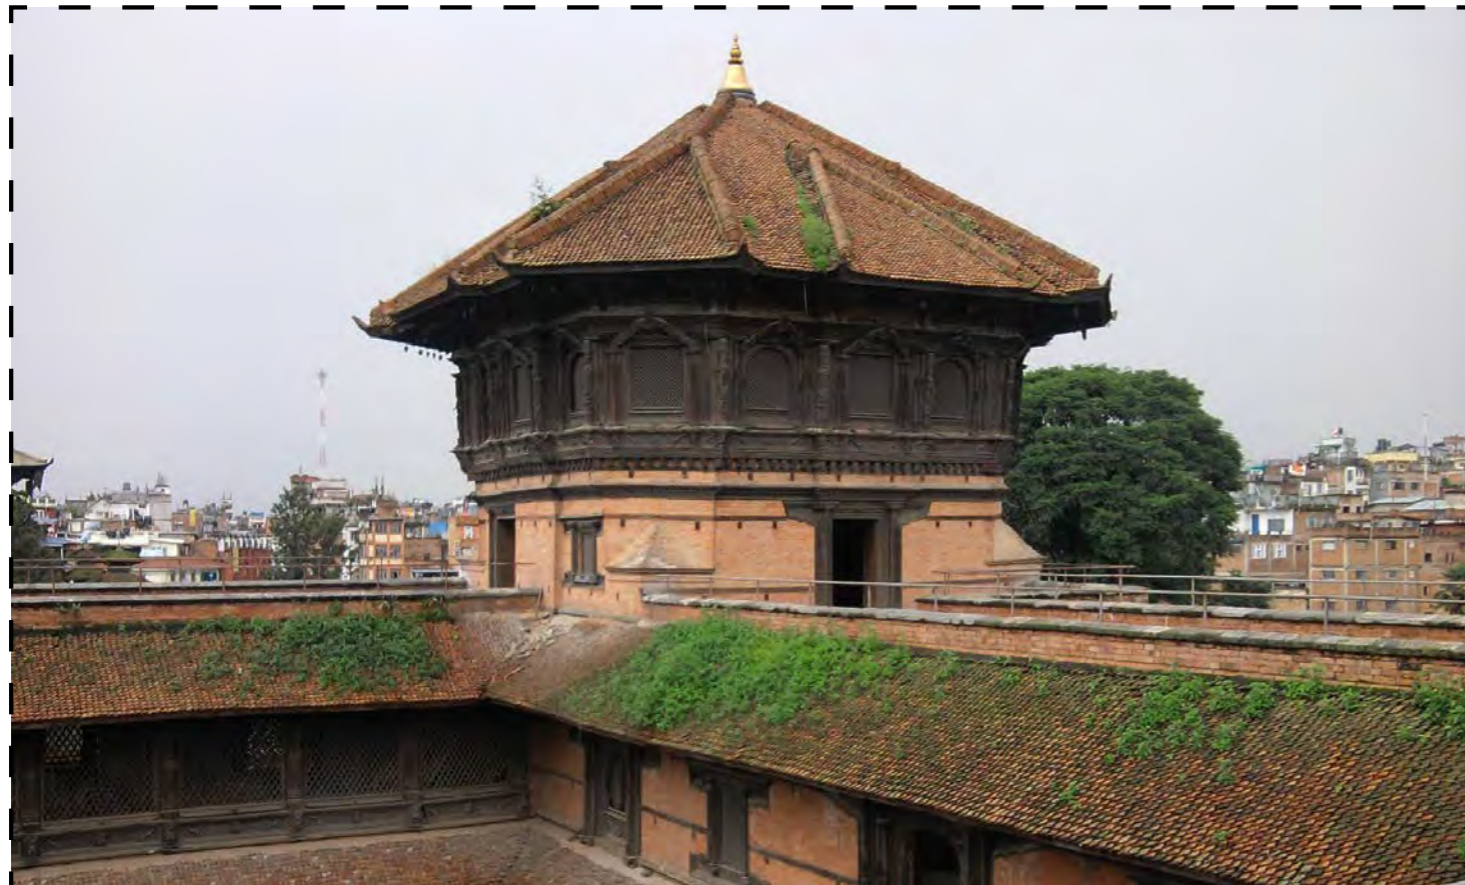
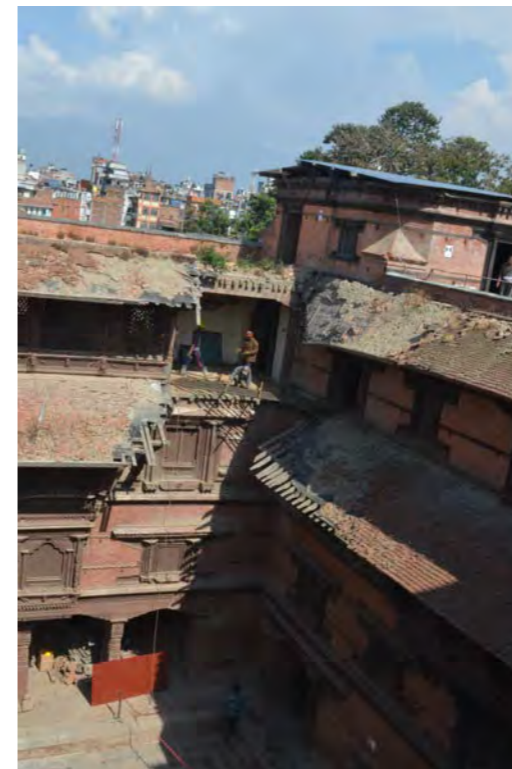
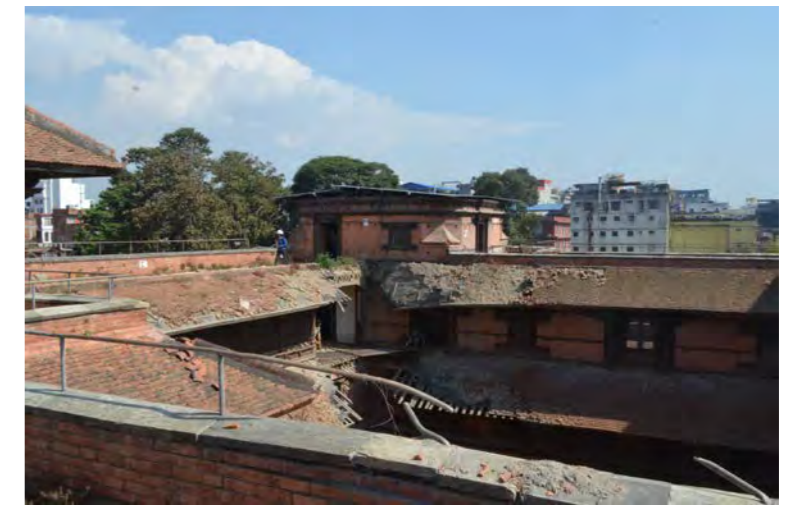
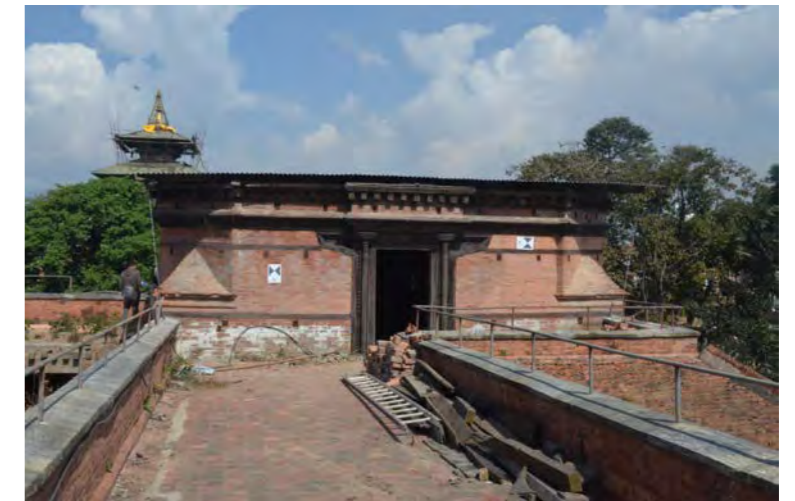
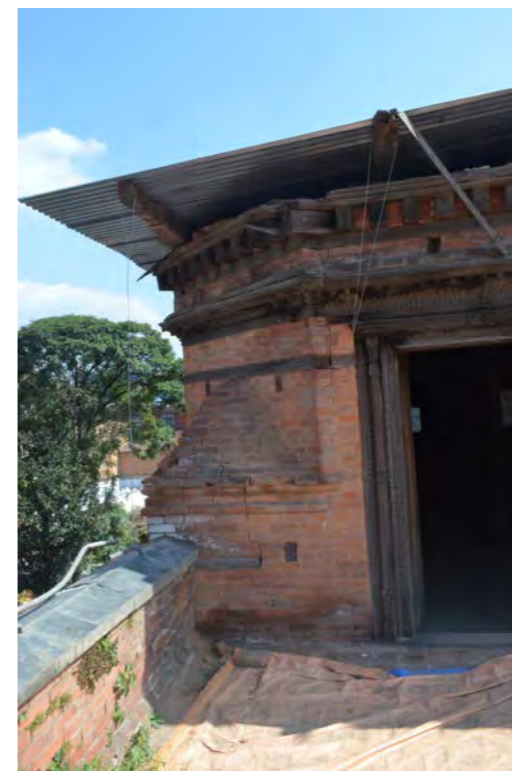
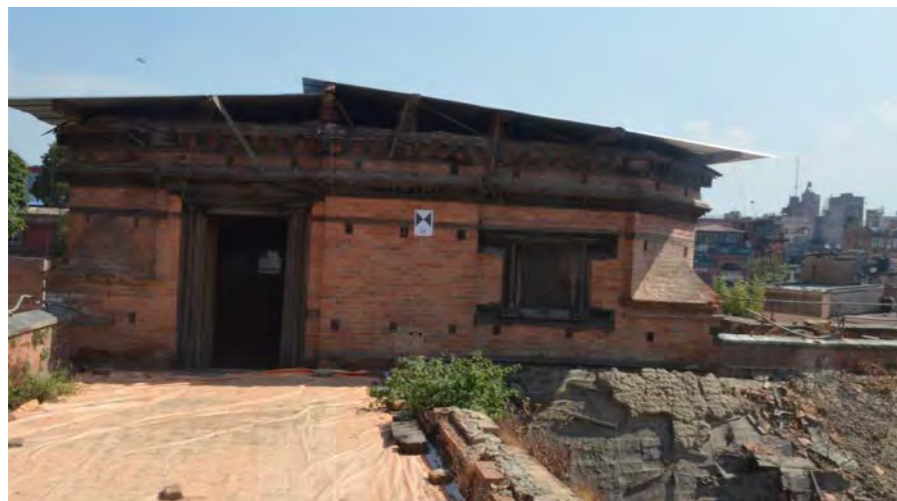
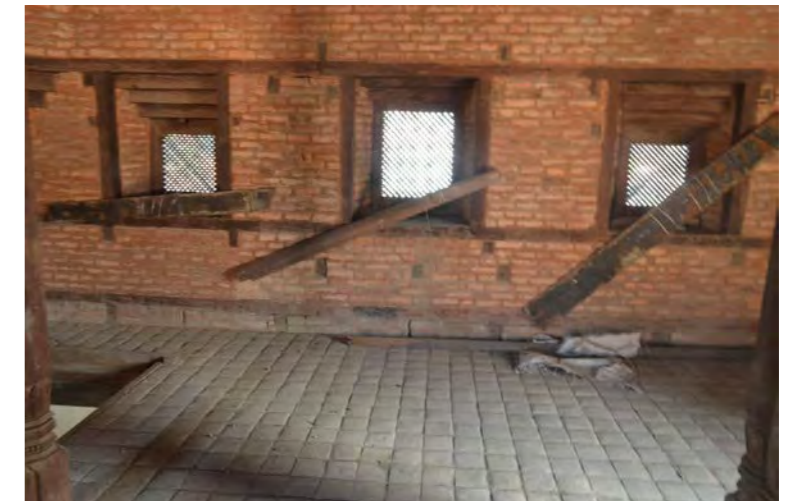
19 BHAKTAPUR BHAWAN

CODE NO	TYOLOGY	MONUMENT NAME	ESTABLISHED/RENOVATED	STRUCTURAL SYSTEM	MATERIAL	GENERAL DESCRIPTION	PROBLEM DESCRIPTION	DANGER	REMARKS	
19	Six Storey Structure	Bhaktapur Bhawan	1770	Load Bearing	Brick	Octagonal timber structure with tiled roof, towers on the NE corner. The façade consists of series of carved windows	Roof has fallen down, dampness on dalin & ceiling

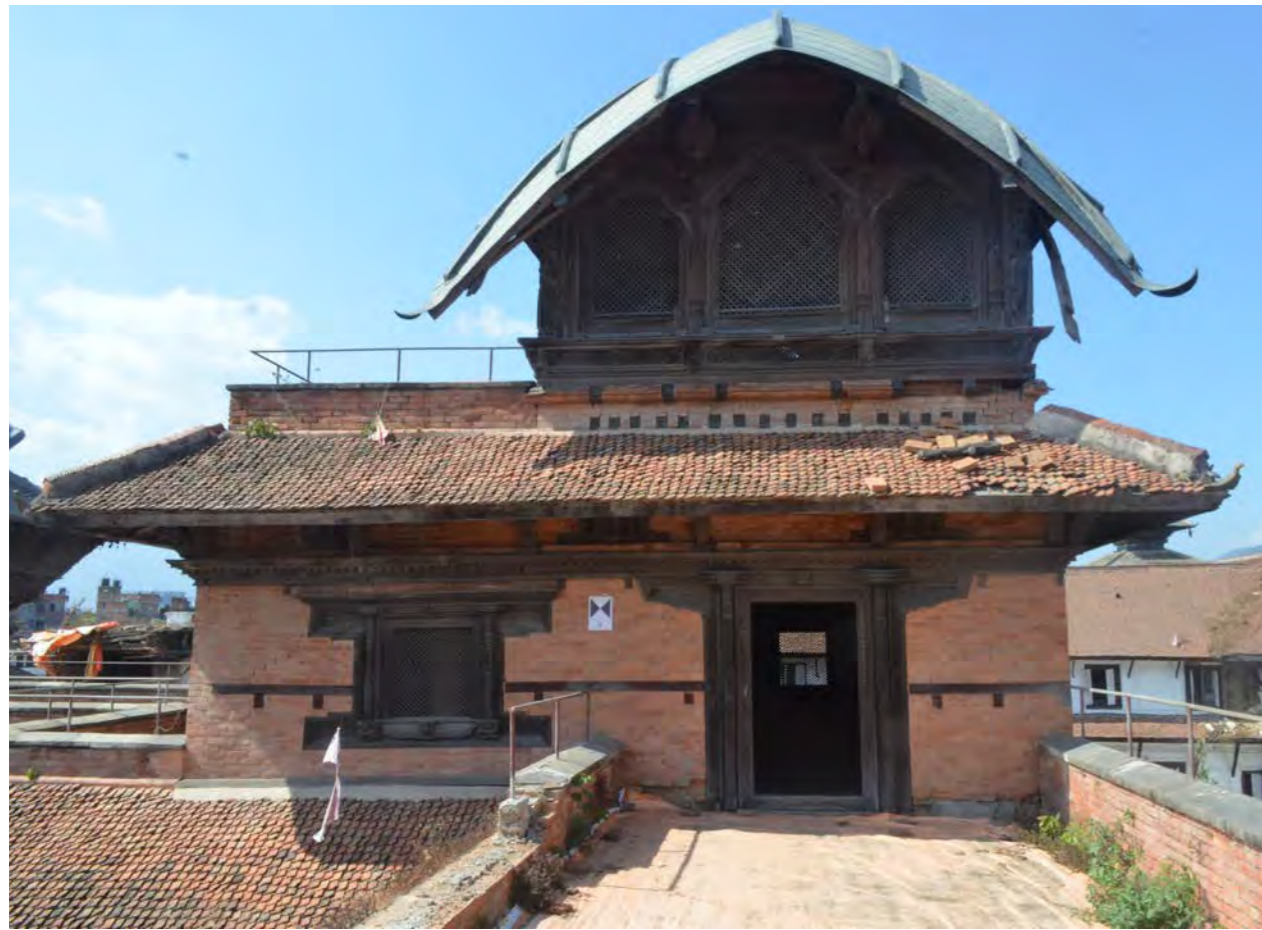
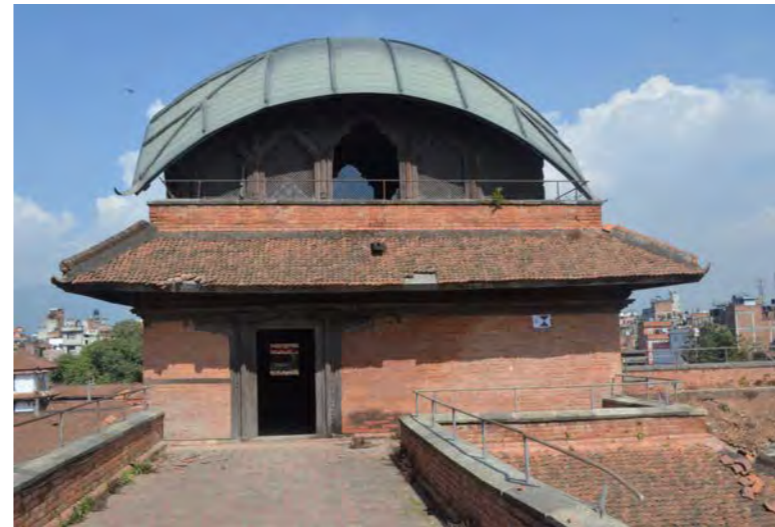
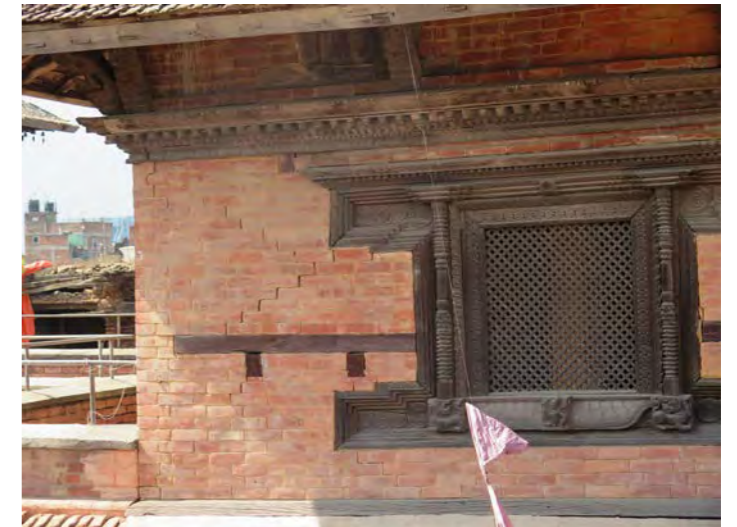
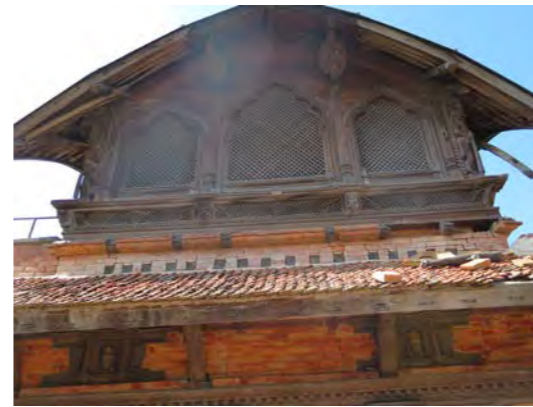
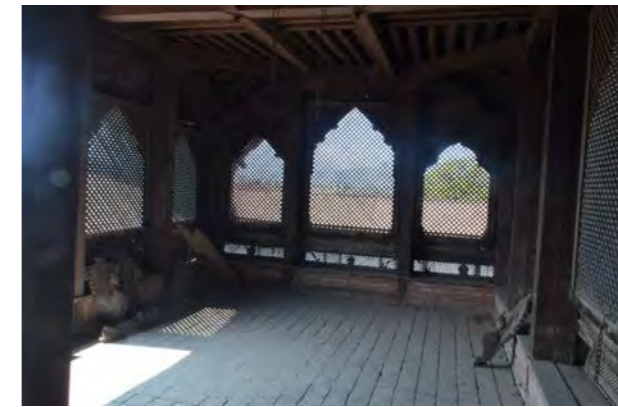
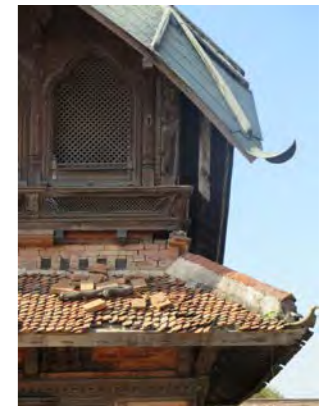
20 KRITIPUR BHAWAN

CODE NO	TYOLOGY	MONUMENT NAME	ESTABLISHED/ RENOVATED	STRUCTURAL SYSTEM	MATERIAL	GENERAL DESCRIPTION	PROBLEM DESCRIPTION	DANGER	REMARKS
20	Six Storey Structure	Kirtipur Bhawan	18th Century	Load Bearing	Brick; Timber	Timber structure raised on brick base forming part of the fifth storey. Roof has curvilinear form and covered with metal sheets.	Extensive cracking of walls; Settlement of walls; timber columns cracked and tiles detached.

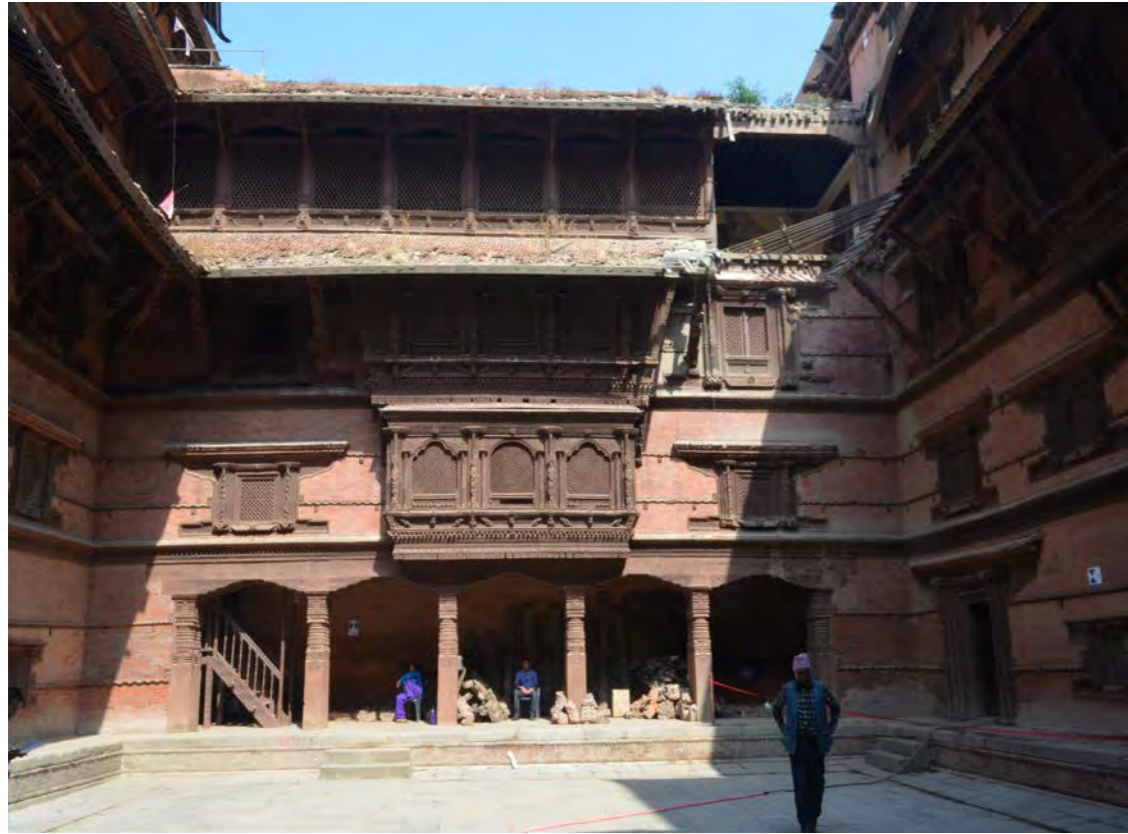
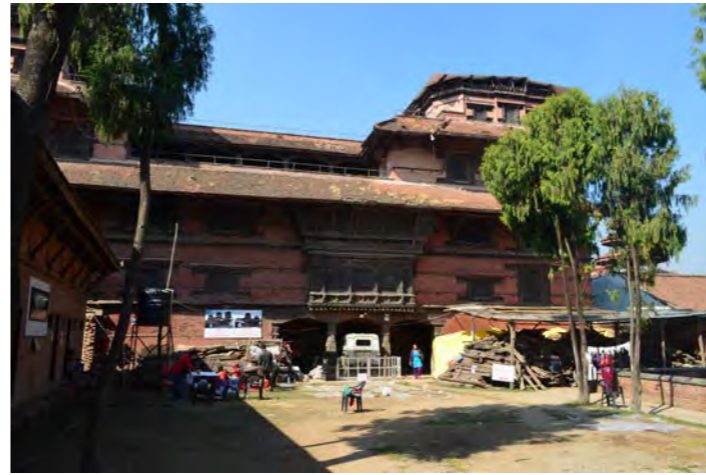
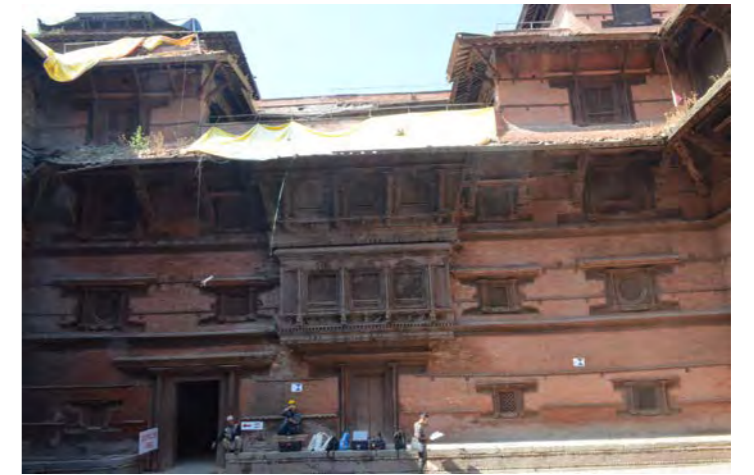
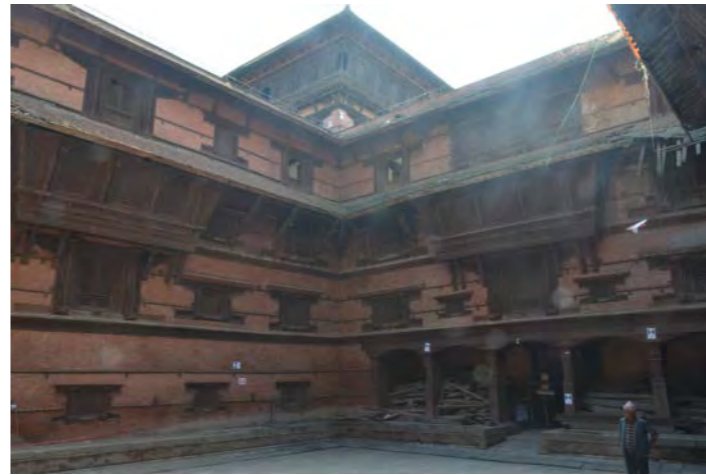
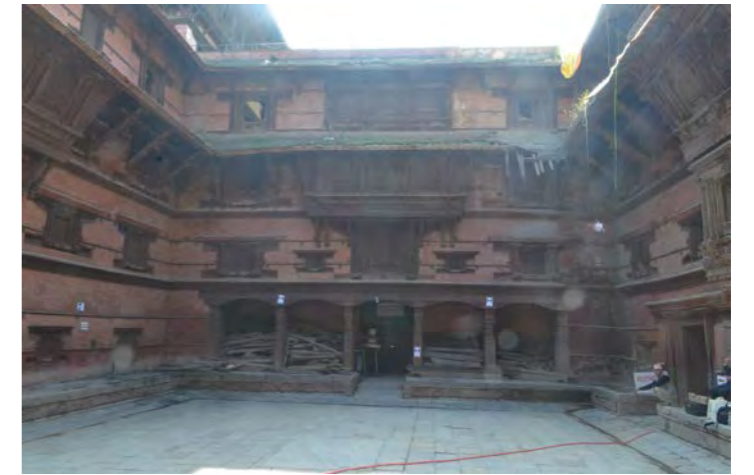
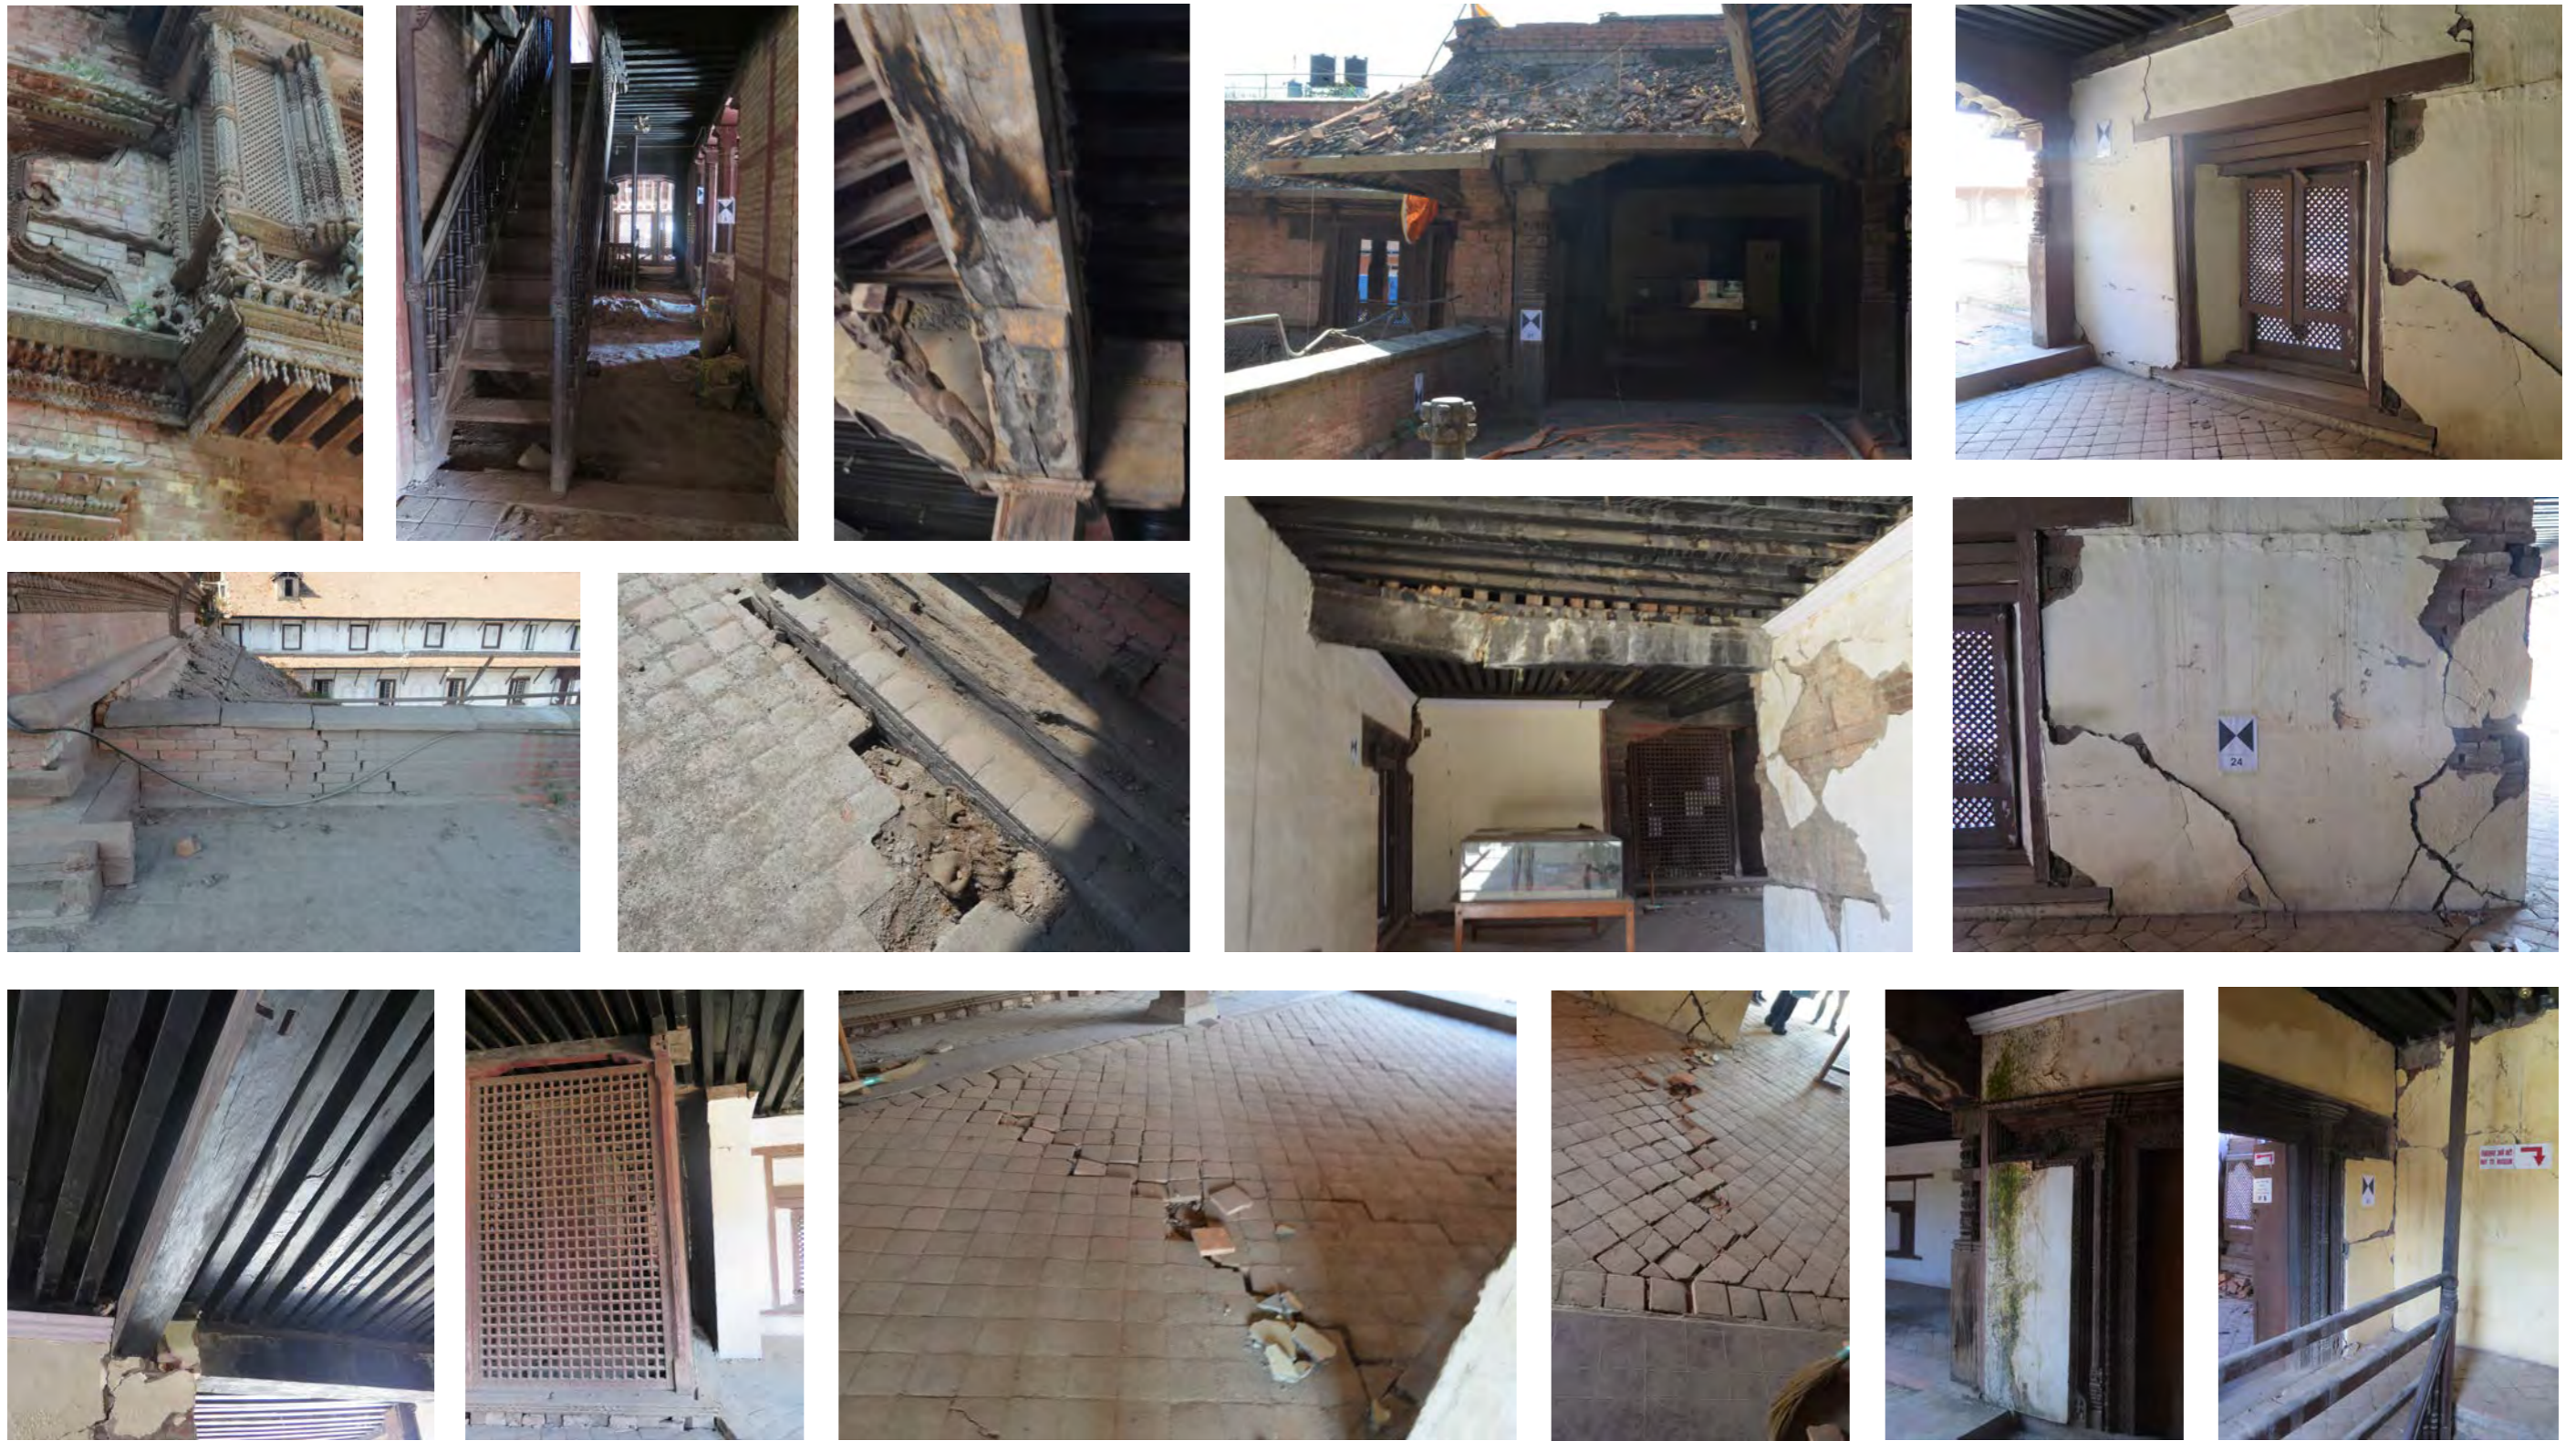
21 LOHAN CHOWK

CODE NO	TYOLOGY	MONUMENT NAME	ESTABLISHED/ RENOVATED	STRUCTURAL SYSTEM	MATERIAL	GENERAL DESCRIPTION	PROBLEM DESCRIPTION	DANGER	REMARKS
21	Courtyard	Lohon Chowk	1769	Load Bearing		It is a part of Basantapur palace. It consists of stone pavings. Elaborately decorated by carved pillars and window	Buildings around the courtyard are highly damaged with large wall and floor cracks and broken beams. The overhanging roof has been damaged making the carved windows susceptible to rain and dampness.		Damage assessment of buildings surrounding Lohan chowk.

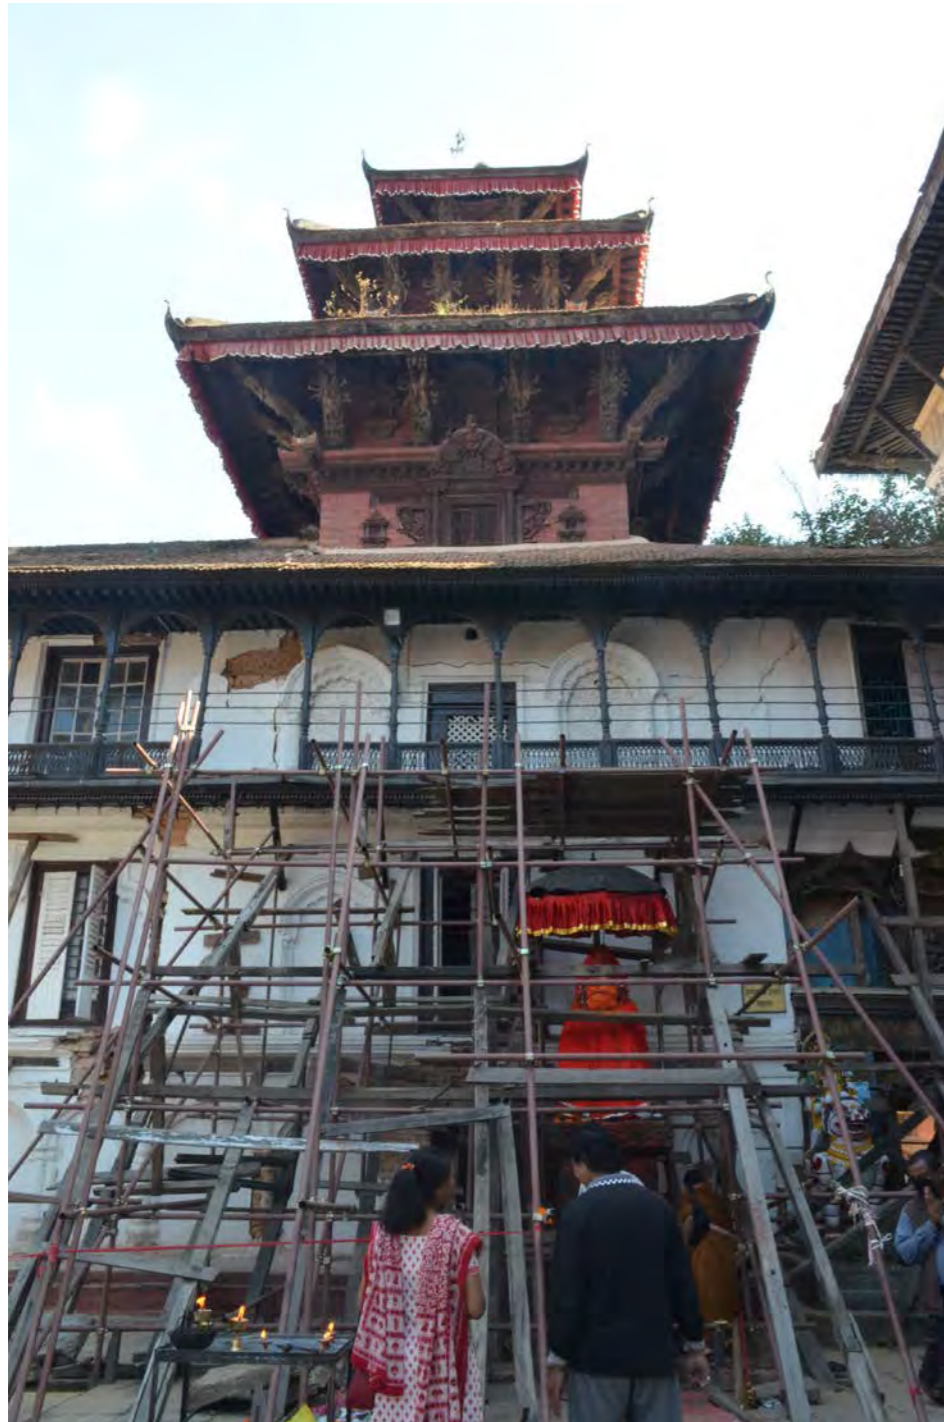
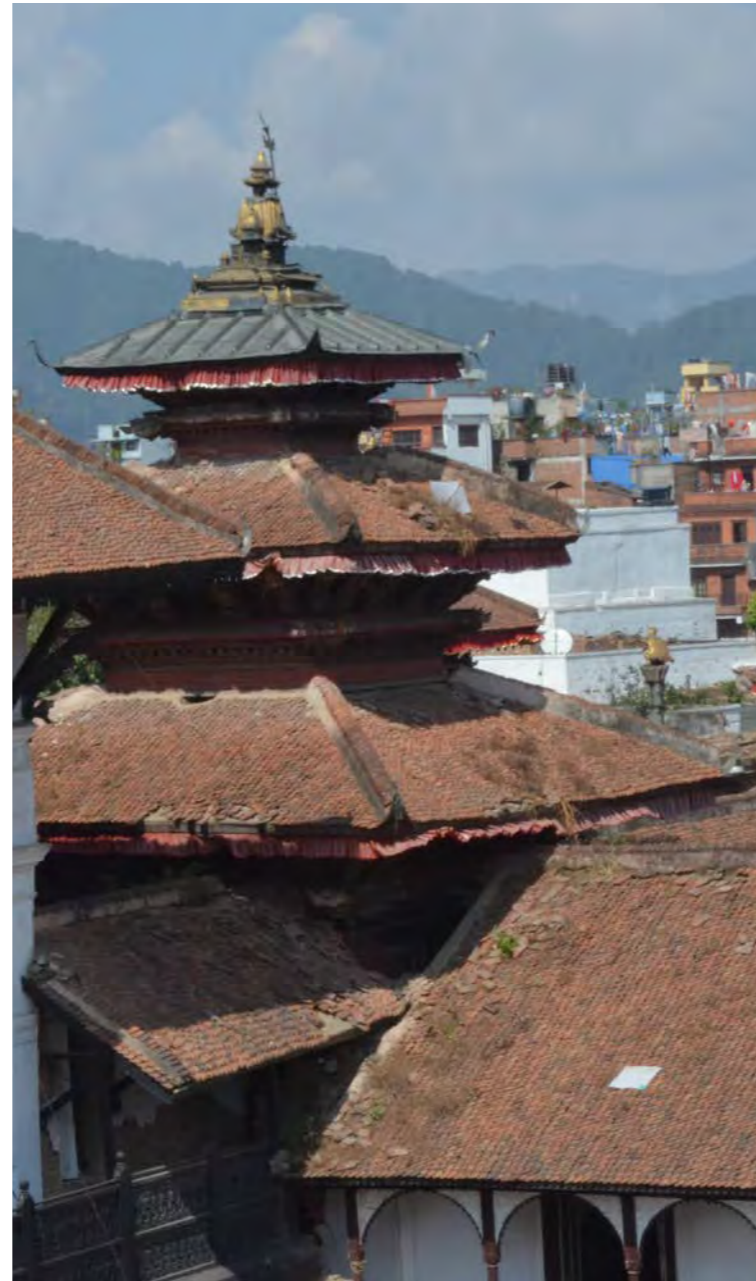
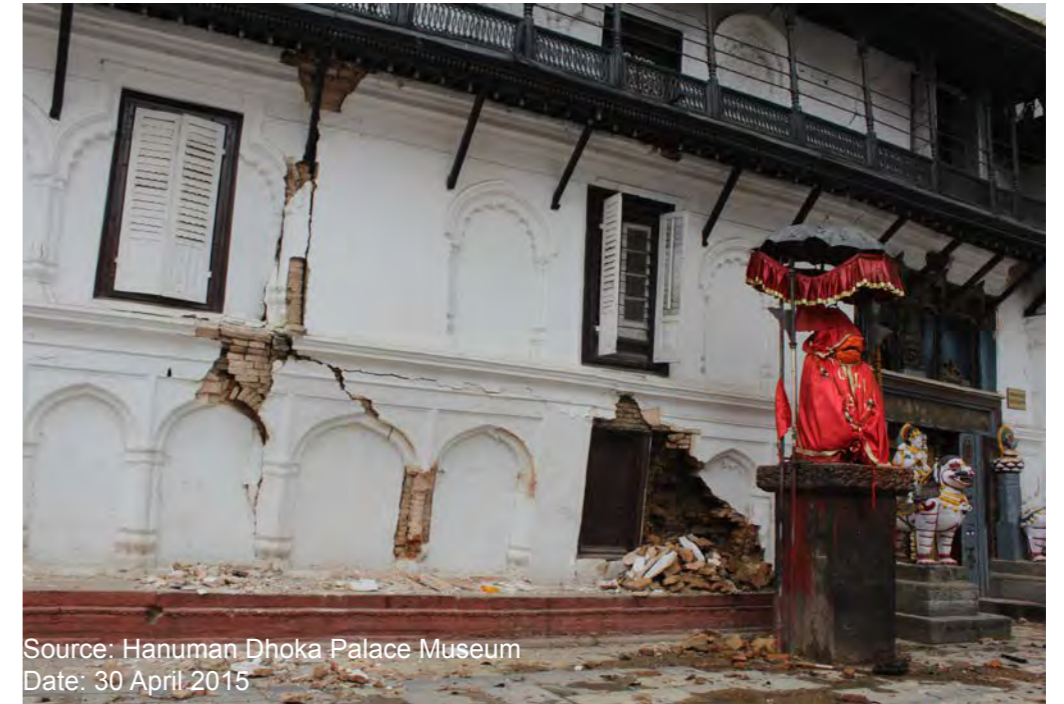
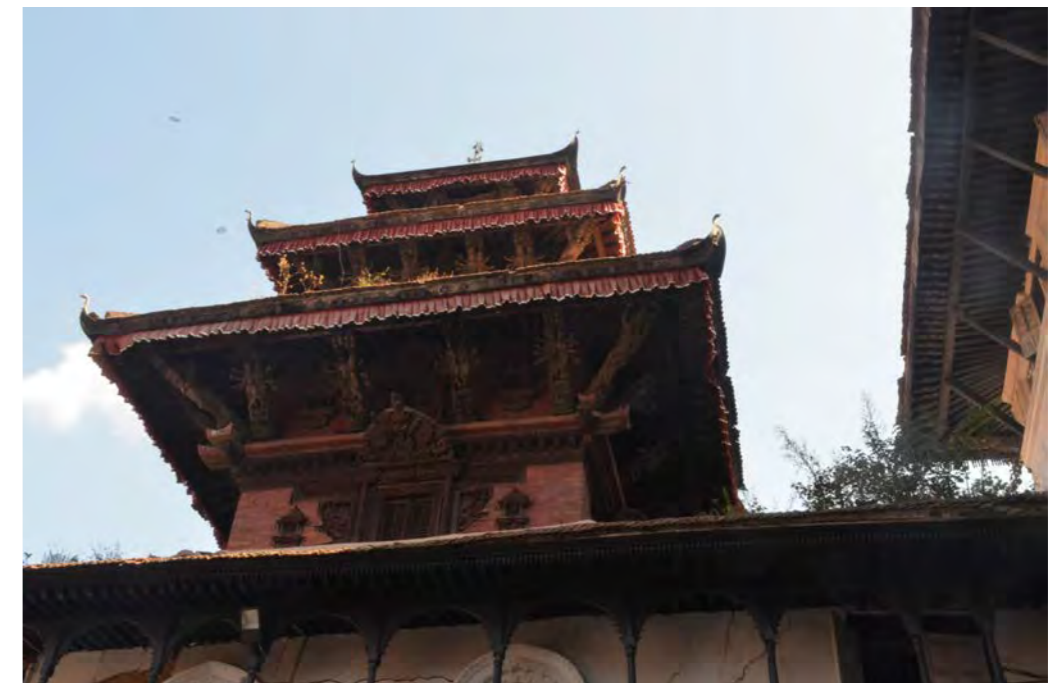
23 AAGAN TEMPLE

CODE NO	TYOLOGY	MONUMENT NAME	ESTABLISHED/ RENOVATED	STRUCTURAL SYSTEM	MATERIAL	GENERAL DESCRIPTION	PROBLEM DESCRIPTION	DANGER	REMARKS	
23	Three storey temple	Aagan temple	1967			Built on 2nd floor of the old palace, carved figure struts; most of which are shiva, deity of this temple was the family god of malla kings	Vertical crack, tilted, vegetation growth on roof
