2015 Earthquake Damage Mapping

Hanuman Dhoka Darbar Square Monument Zone
Kathmandu Valley World Heritage Property

December 2015

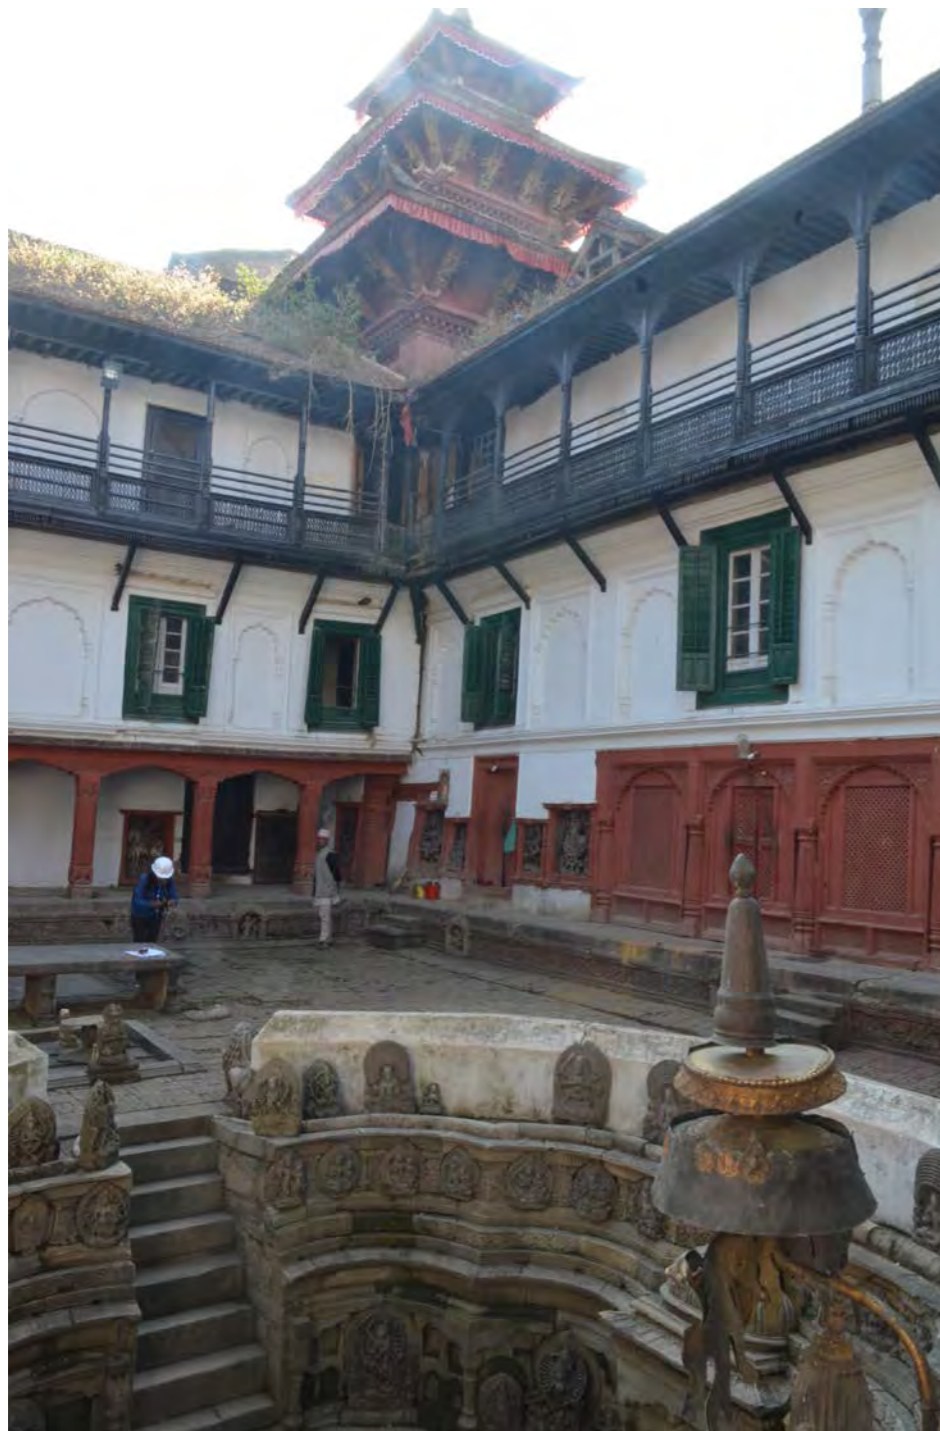
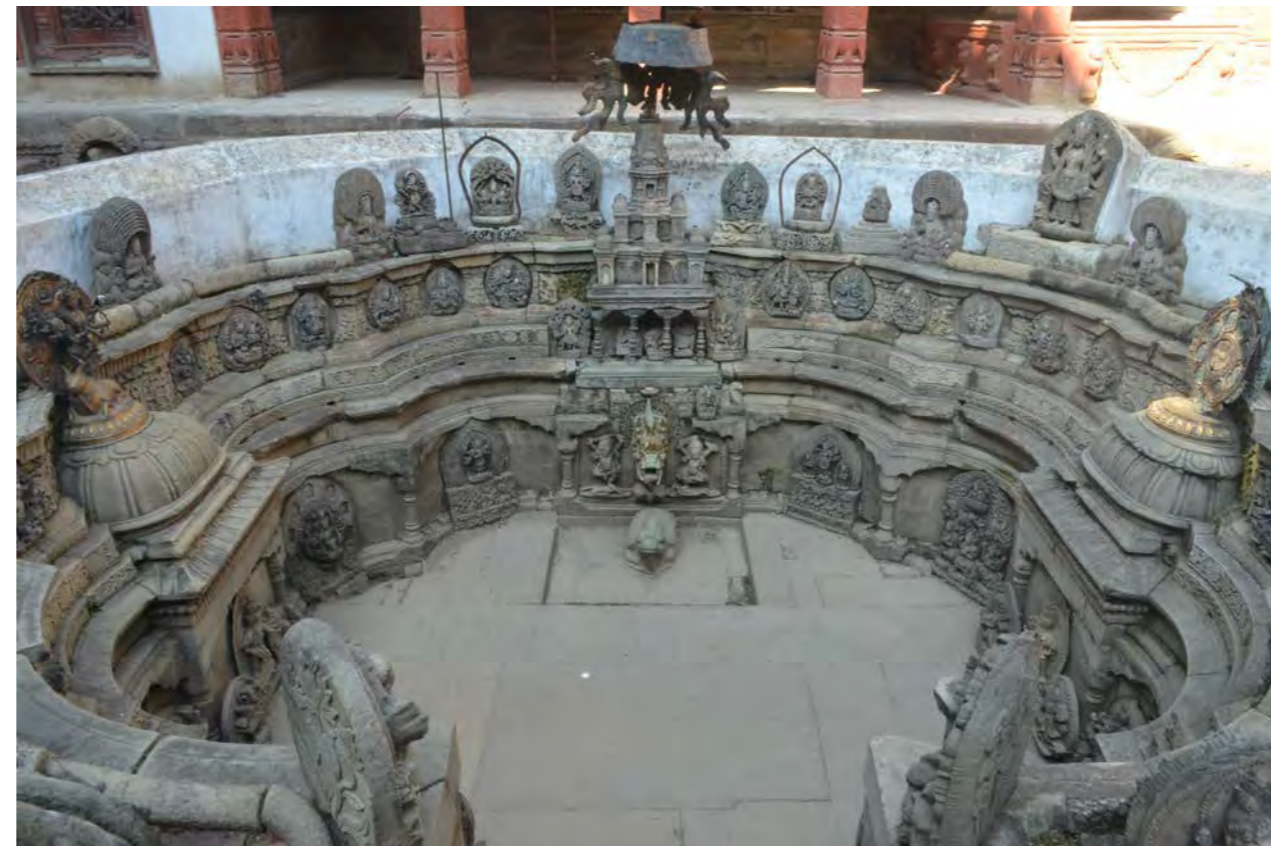
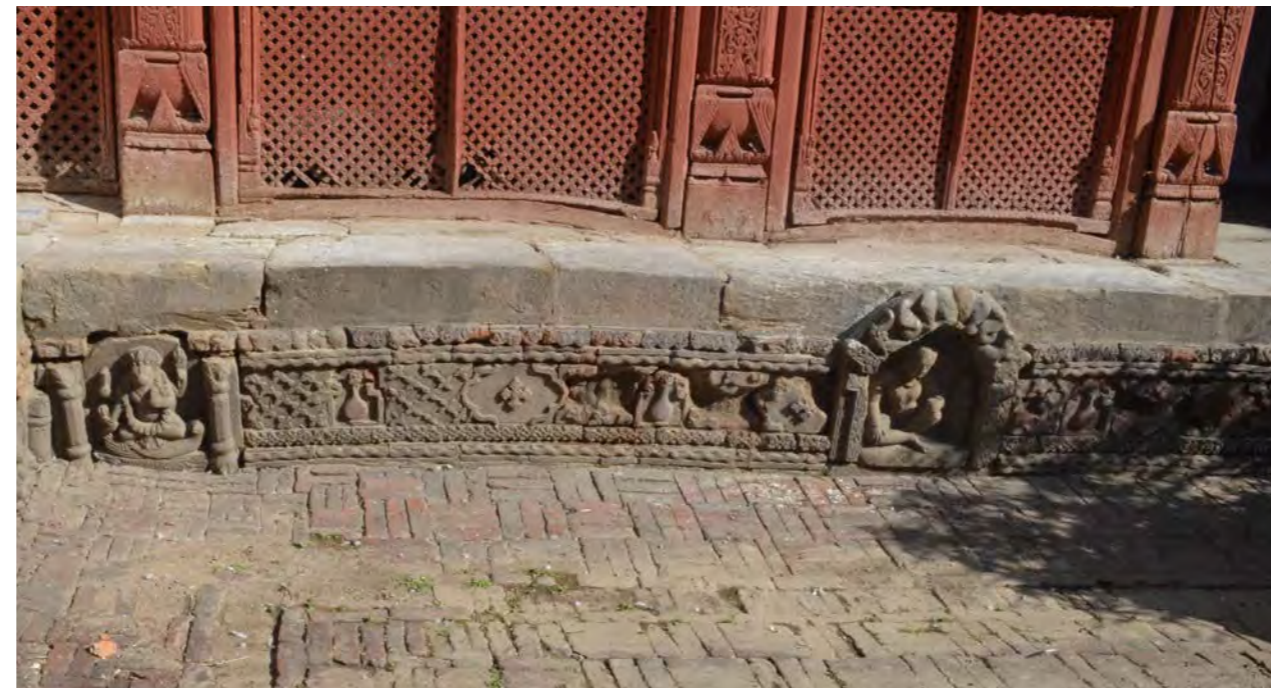
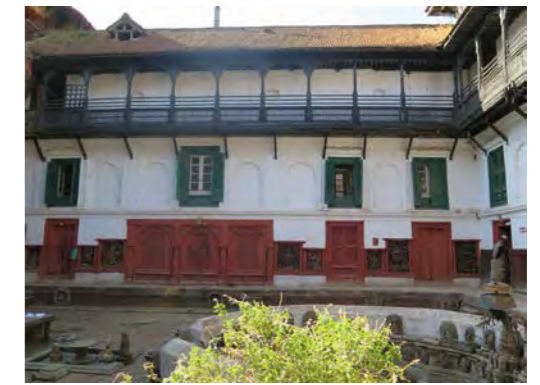
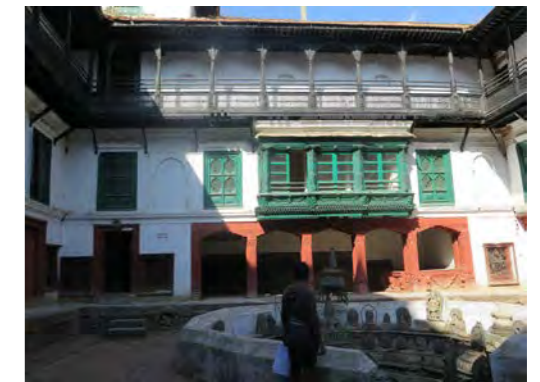
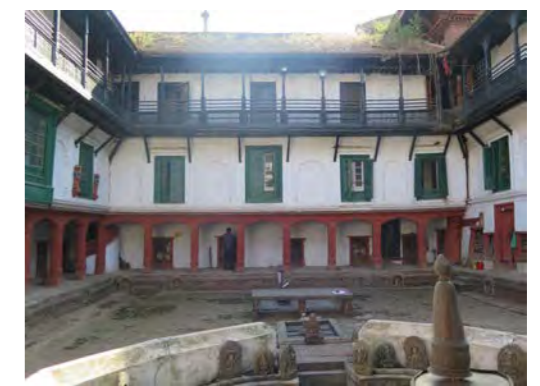
24 MOHAN CHOWK

CODE NO	TYOLOGY	MONUMENT NAME	ESTABLISHED/ RENOVATED	STRUCTURAL SYSTEM	MATERIAL	GENERAL DESCRIPTION	PROBLEM DESCRIPTION	DANGER	REMARKS
24	Courtyard	Mohab Chowk	1648			Courtyard used as private residence of Pratap malla. Has some notable examples of sculputres including pieces depicting krishna defeating kaliya serpent.	Walls surrounding the courtyard cracked and bulging

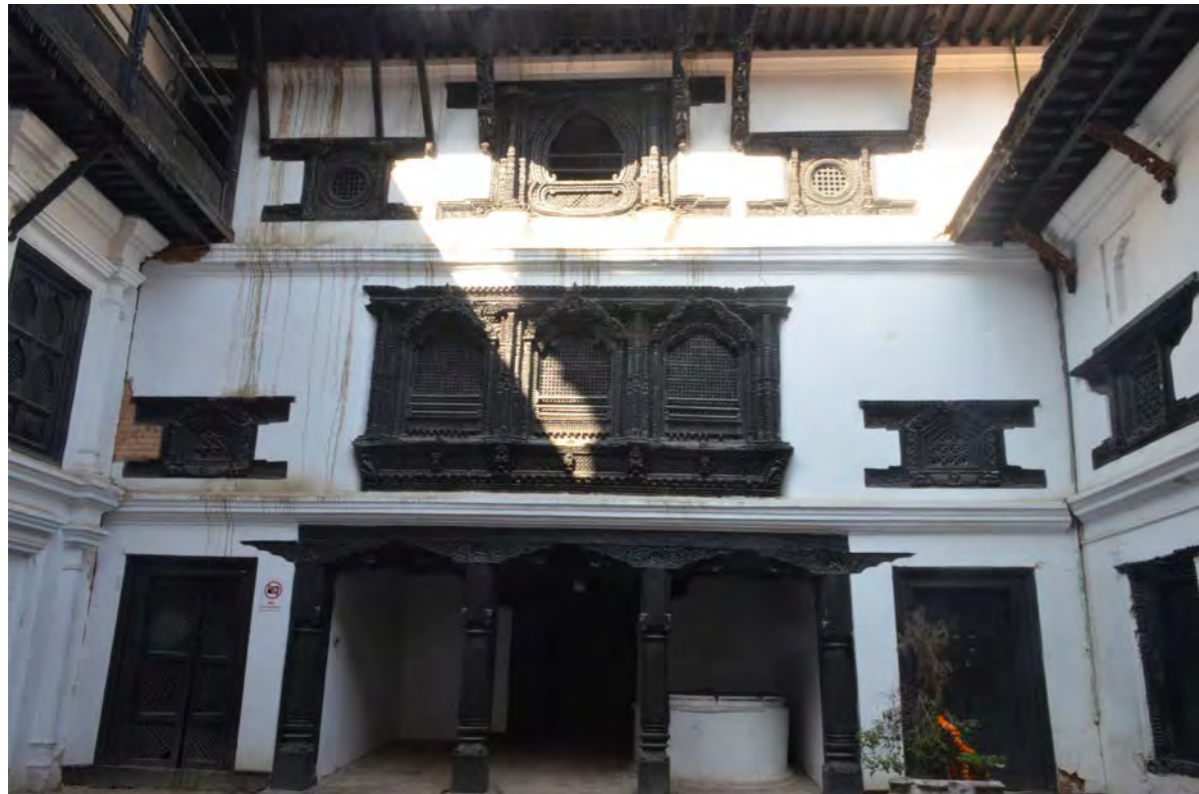
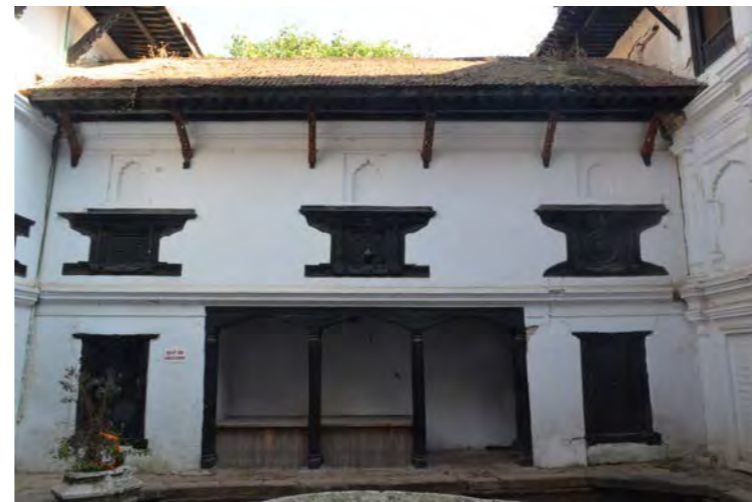
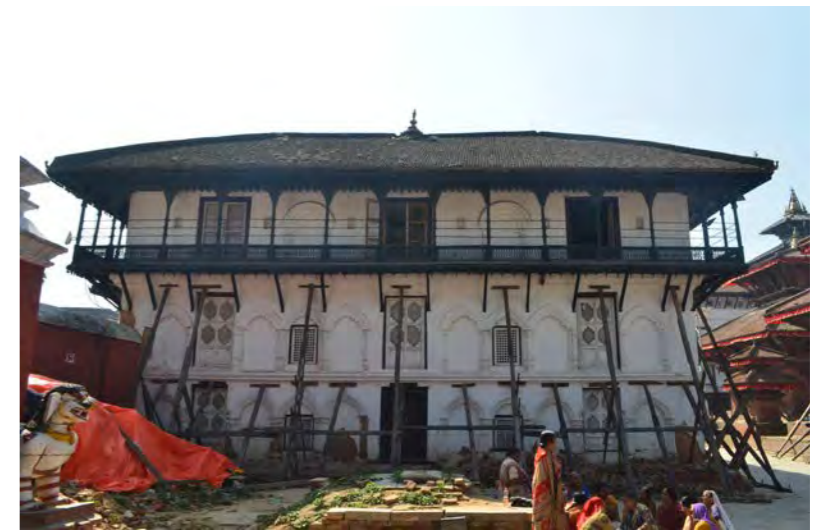
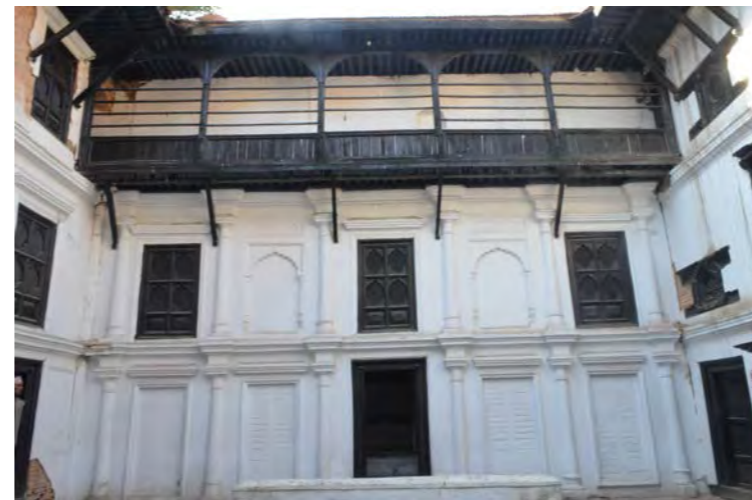
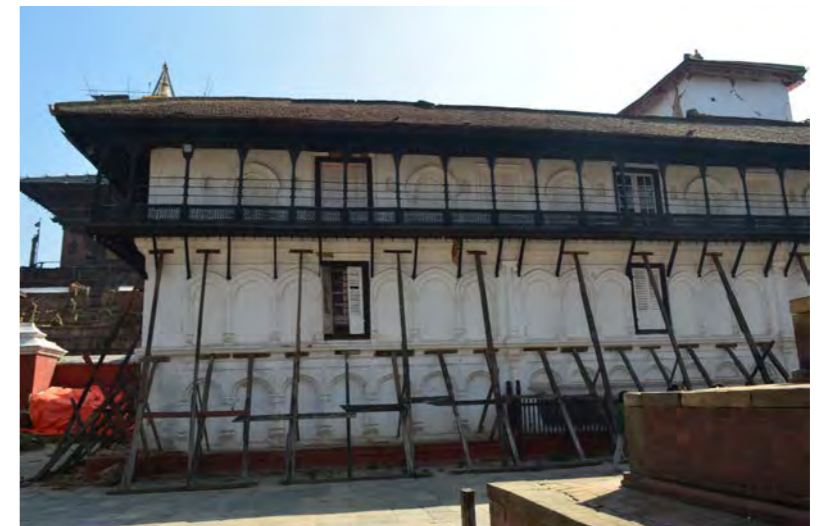
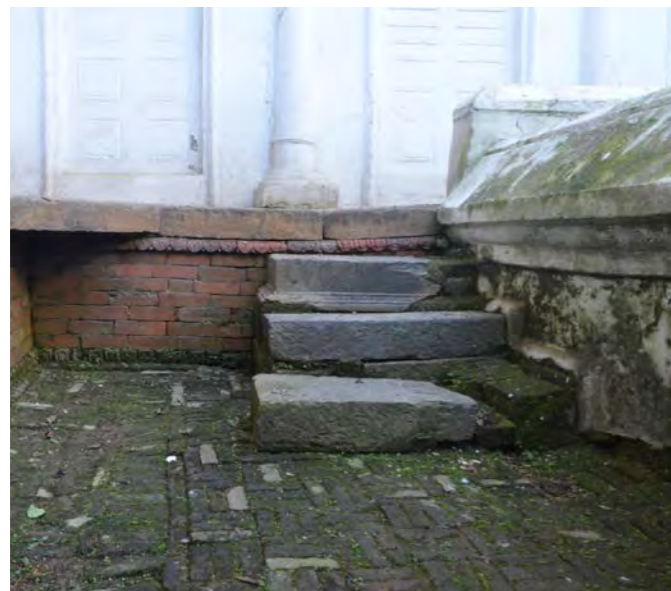
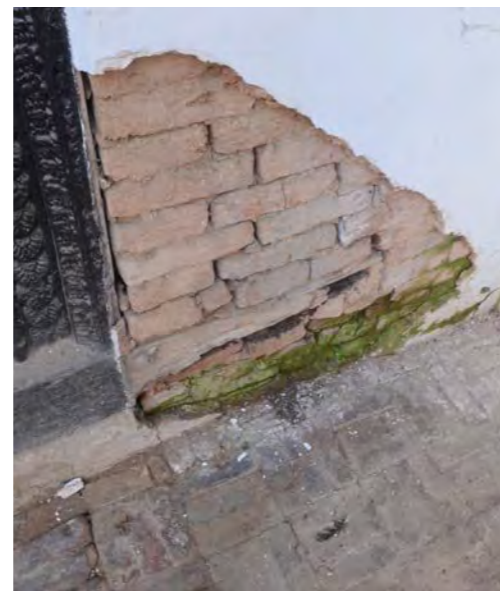
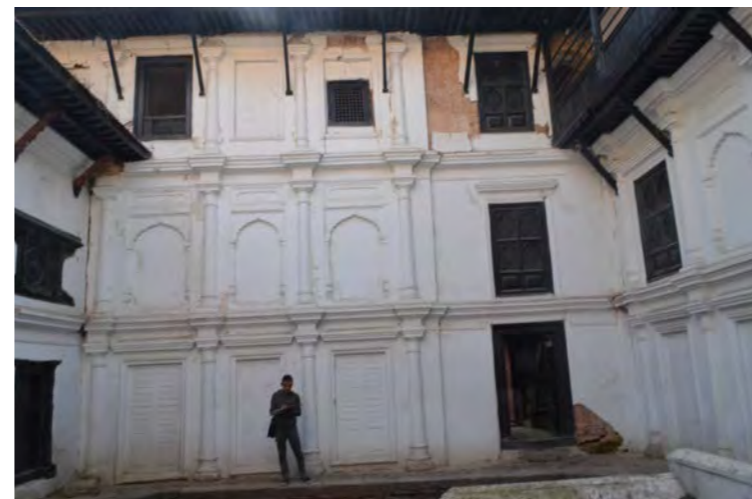
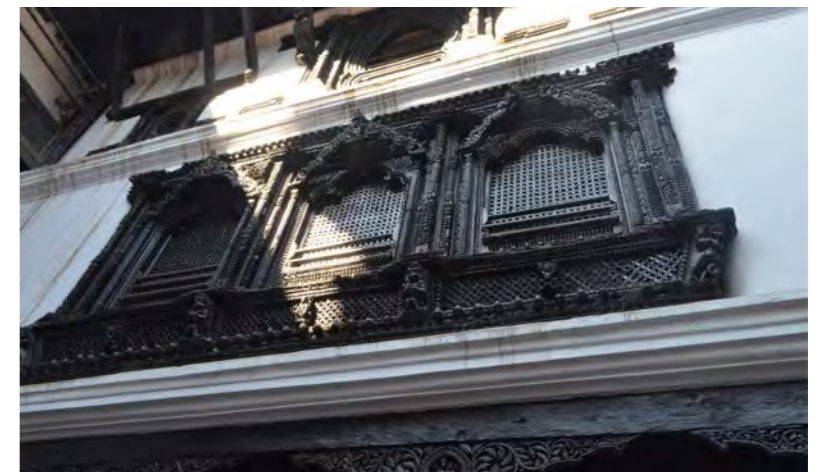
25 SUNDARI CHOWK

CODE NO	TYOLOGY	MONUMENT NAME	ESTABLISHED/ RENOVATED	STRUCTURAL SYSTEM	MATERIAL	GENERAL DESCRIPTION	PROBLEM DESCRIPTION	DANGER	REMARKS
25	Courtyard	Sundari chok	1649			Located in north of Nasal-chowk, water conduit in the middle, used to lay the dying king, usually closed to visitors	crack on surrounding building, dampness on the wall due to leakage of water from roof, dampness rises		Damage assessment of buildings around the chowk.

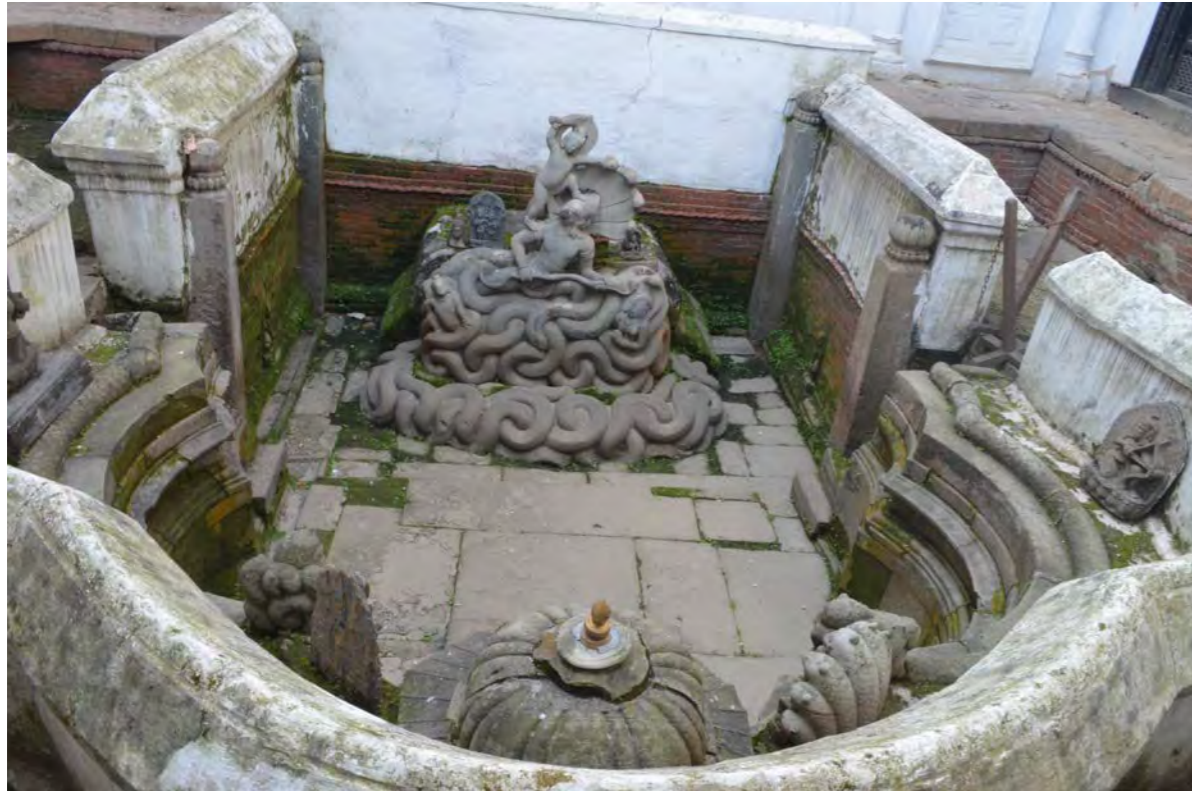
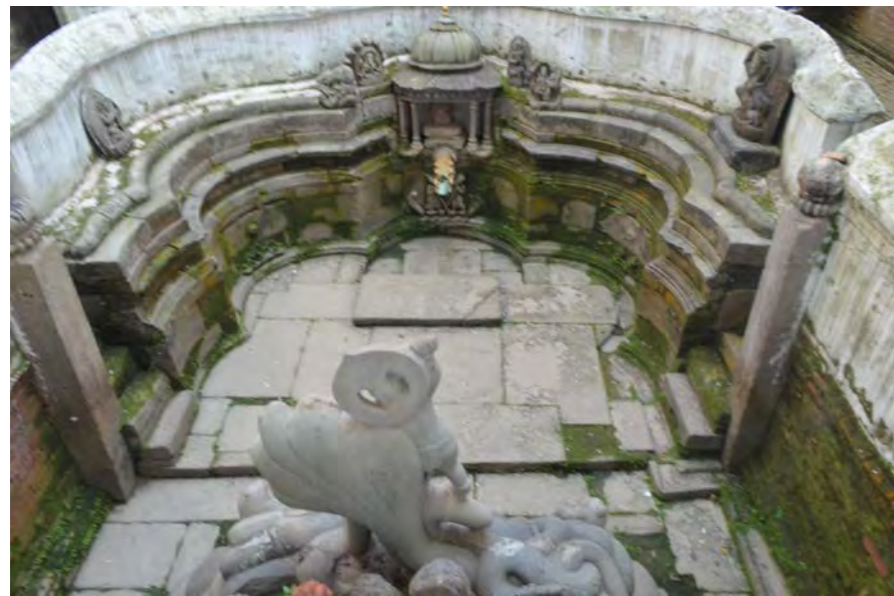
25A SUNDARI DHARA

CODE NO	TYOLOGY	MONUMENT NAME	ESTABLISHED/ RENOVATED	STRUCTURAL SYSTEM	MATERIAL	GENERAL DESCRIPTION	PROBLEM DESCRIPTION	DANGER	REMARKS
25a	Stone Spout	Sundari dahra		Stone sculpture	Stone	sculpture of krishna staying above Nagaraj just opposite of tap	fungi, algea growth, dampness rises		
25b		Tulsi			Brick	Tulsi with brick base	No visible damage		
25c		well			Brick	Well within the building.	No visible damage

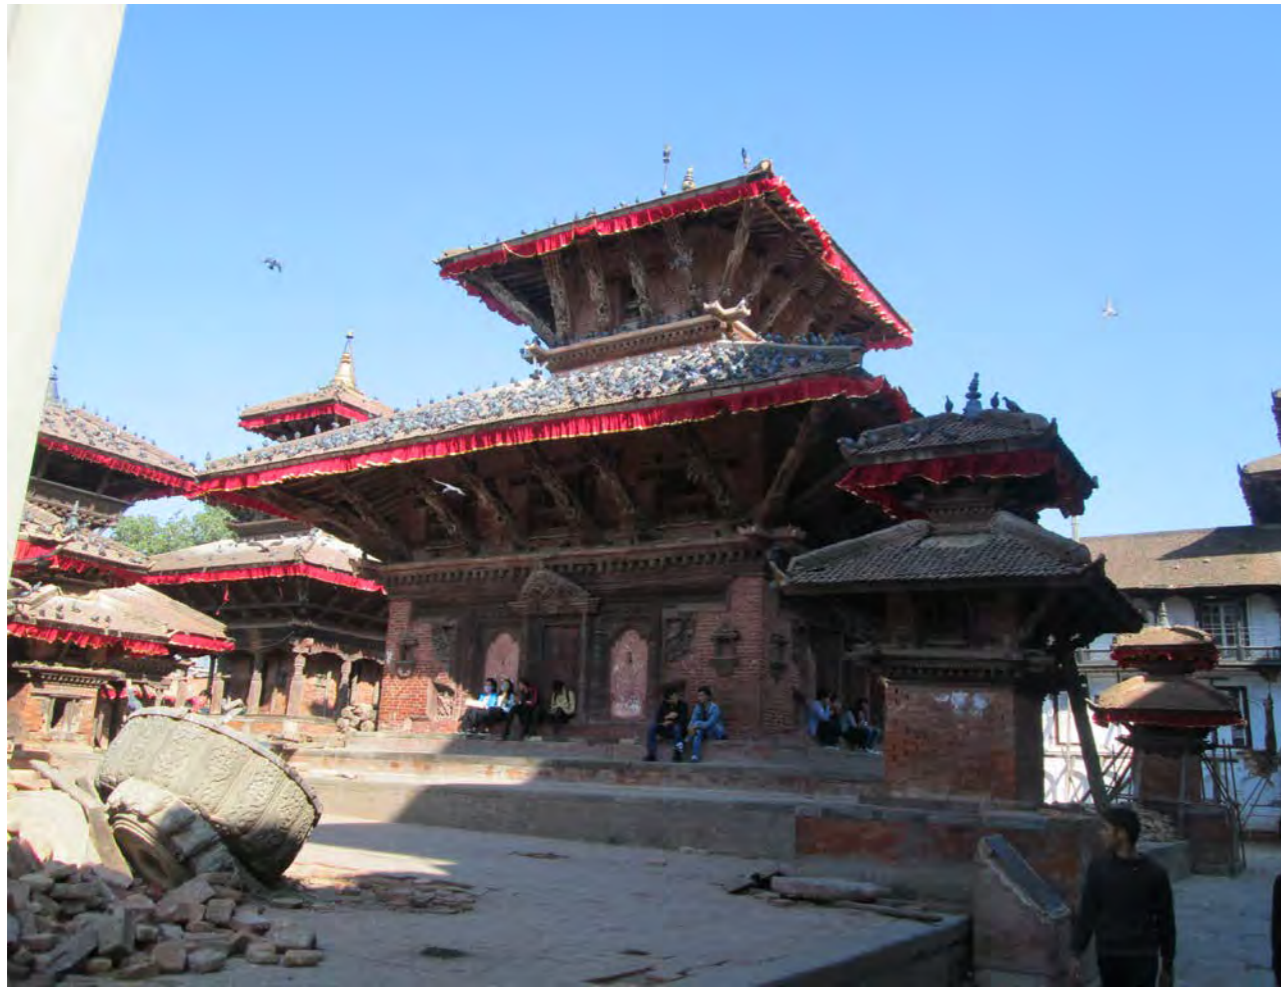
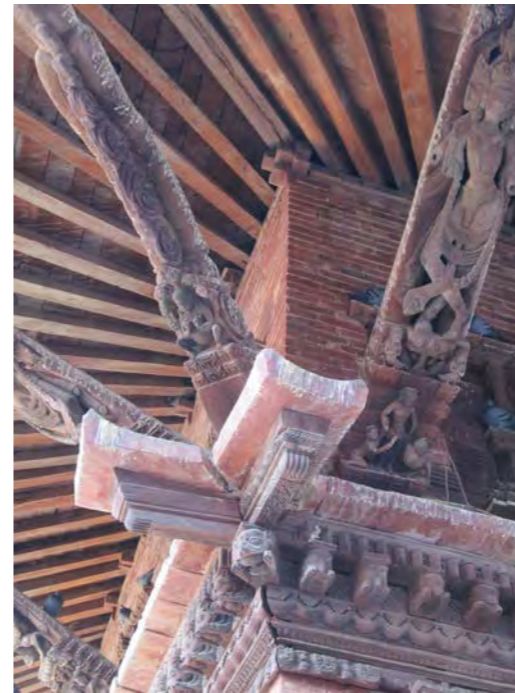
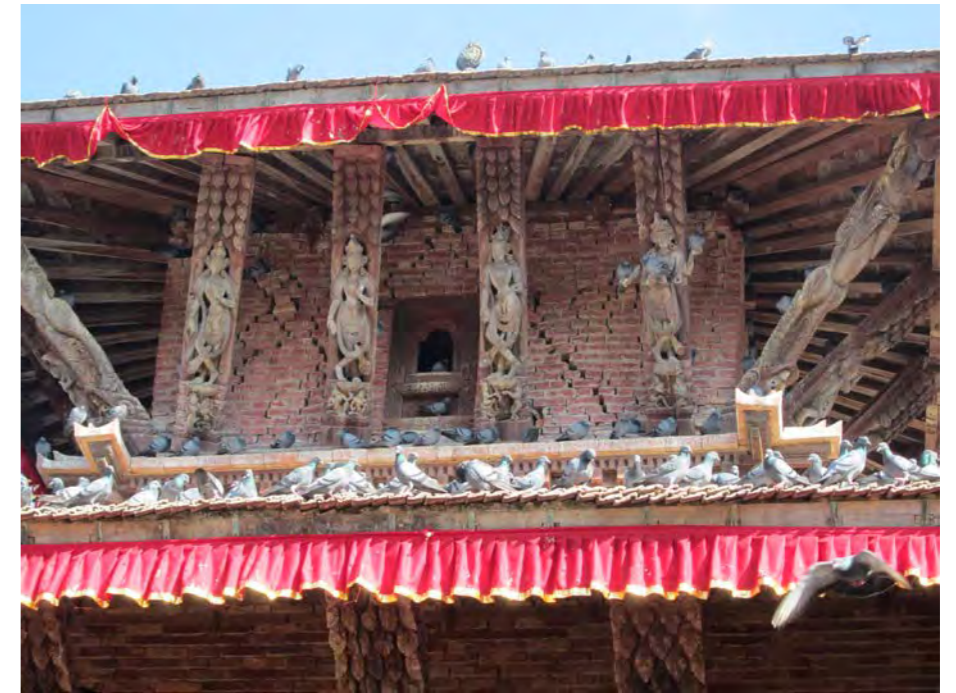
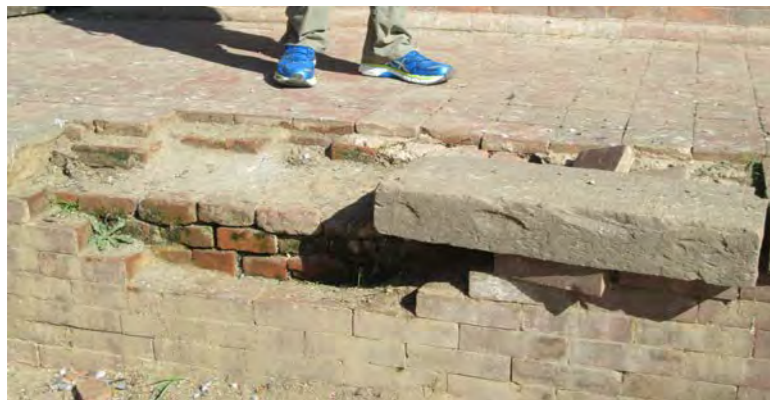
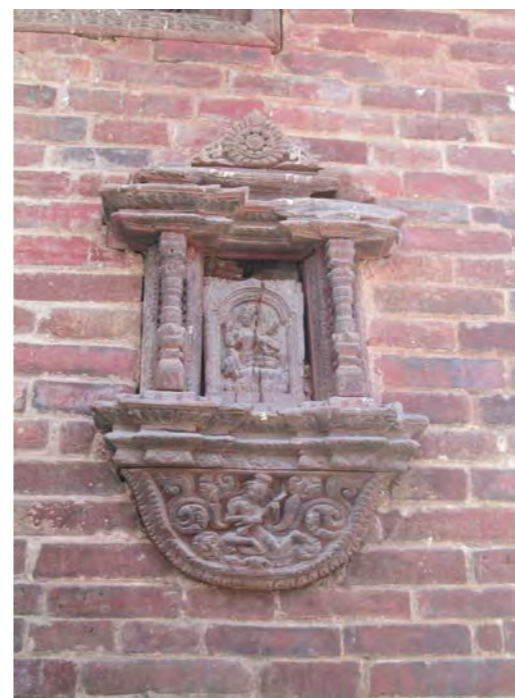
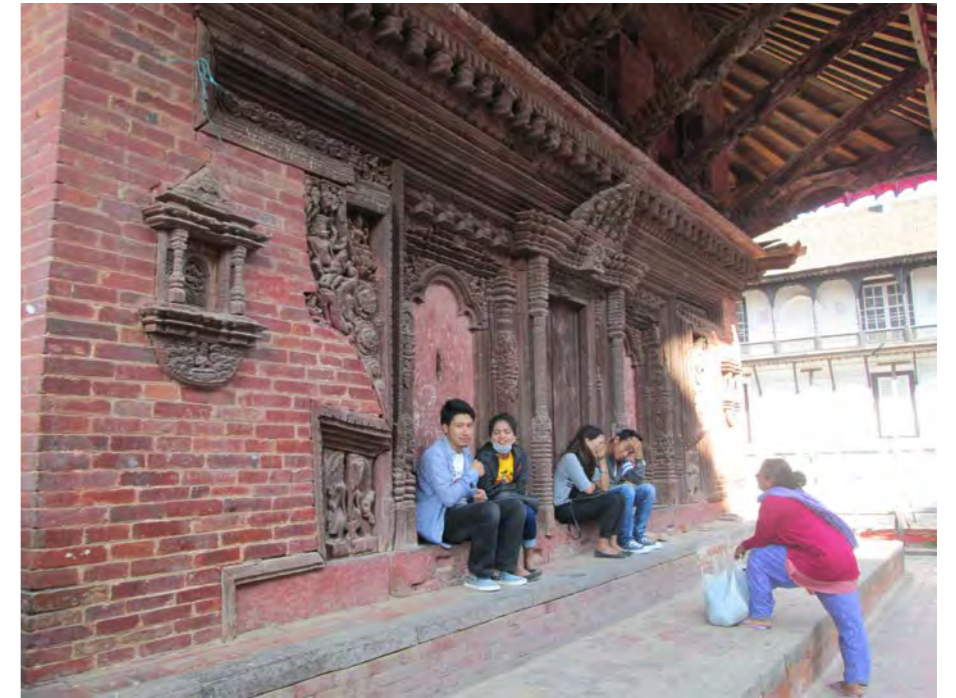
27 JAGANNATH

CODE NO	TYOLOGY	MONUMENT NAME	ESTABLISHED/ RENOVATED	STRUCTURAL SYSTEM	MATERIAL	GENERAL DESCRIPTION	PROBLEM DESCRIPTION	DANGER	REMARKS
27	Two storey temple	Jagannath	Renovated 2006				cracks on upper storey, some stones on plinth missing on west, minor cracks on north plinth

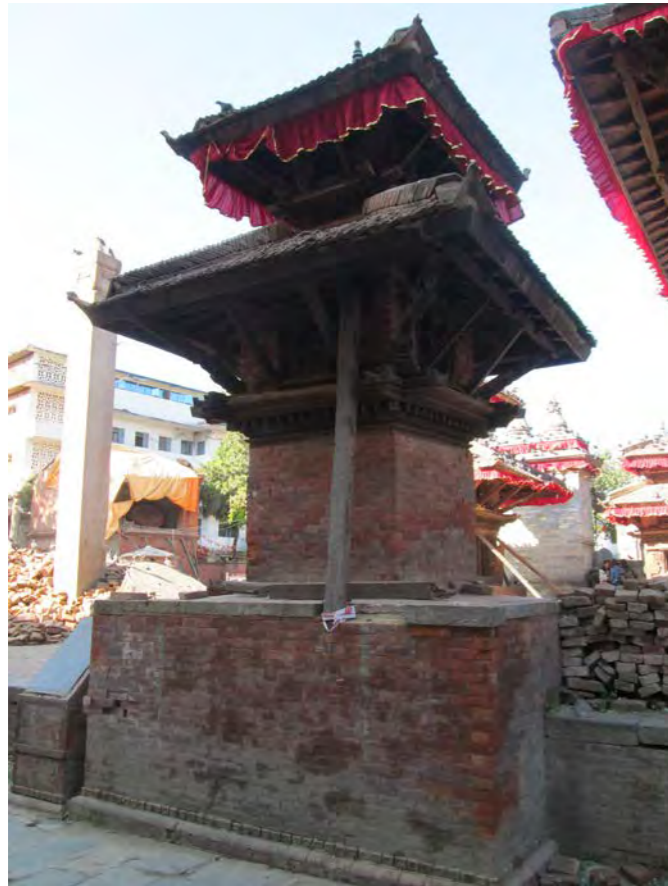
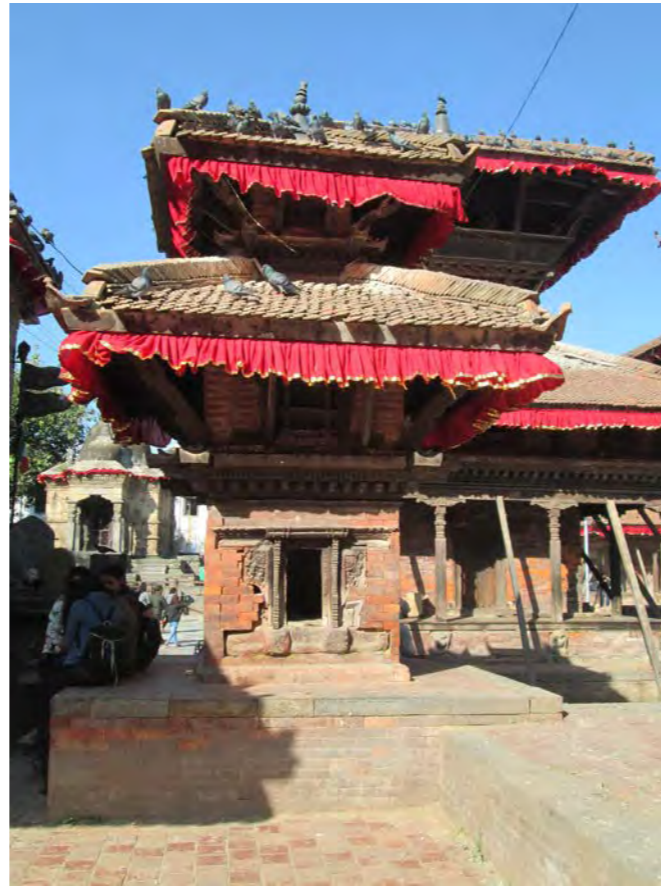
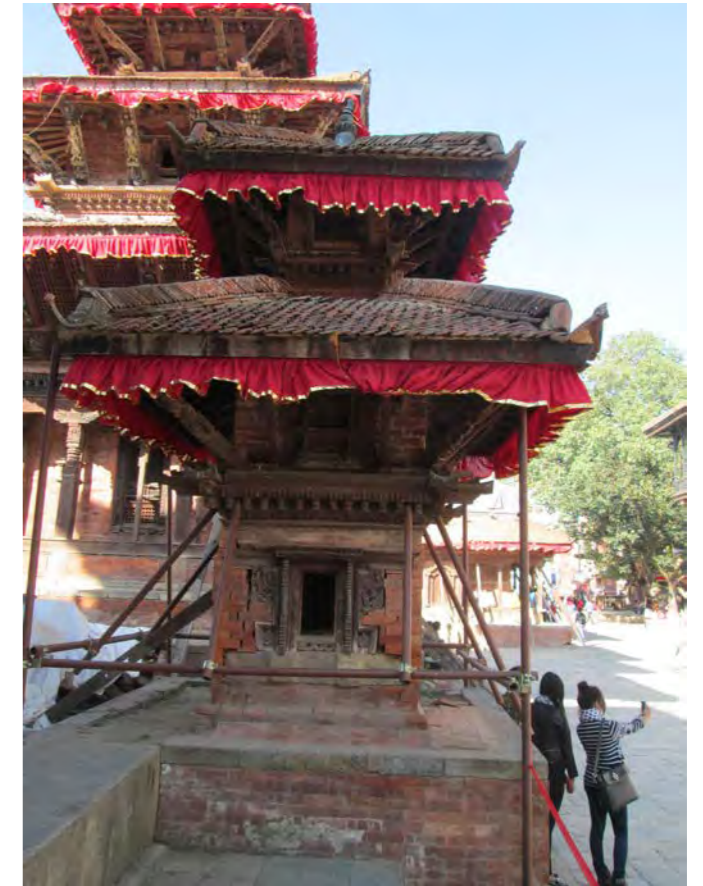
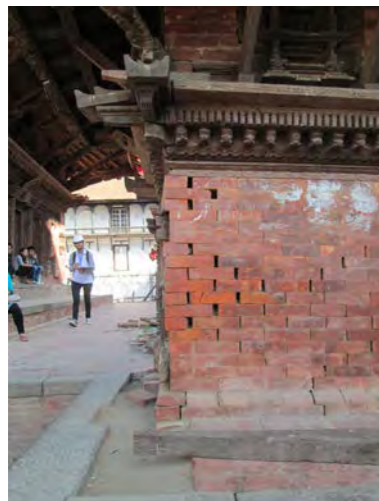
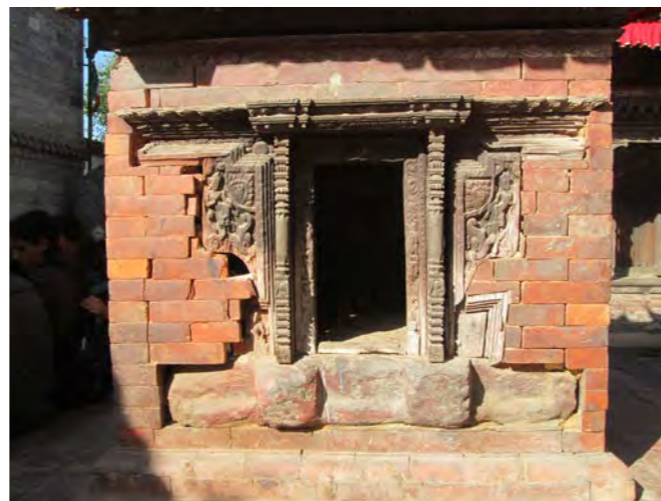
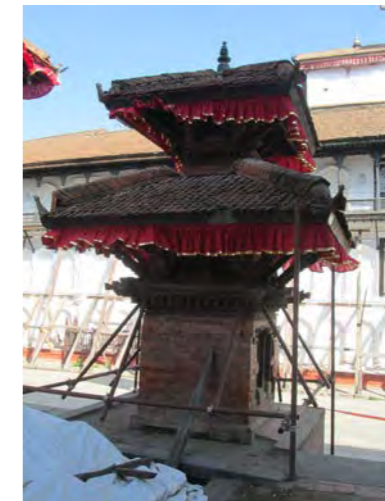
27a, 27b, 27c TWO STOREY TEMPLES

CODE NO	TYOLOGY	MONUMENT NAME	ESTABLISHED/ RENOVATED	STRUCTURAL SYSTEM	MATERIAL	GENERAL DESCRIPTION	PROBLEM DESCRIPTION	DANGER	REMARKS
27a	Two storey temple					No idol inside	tilted to south, bricks dislocation		
27b	Two storey temple					No idol inside	bricks dislocation, minor cracks		
27c	Two storey temple					No idol inside	bricks dislocation

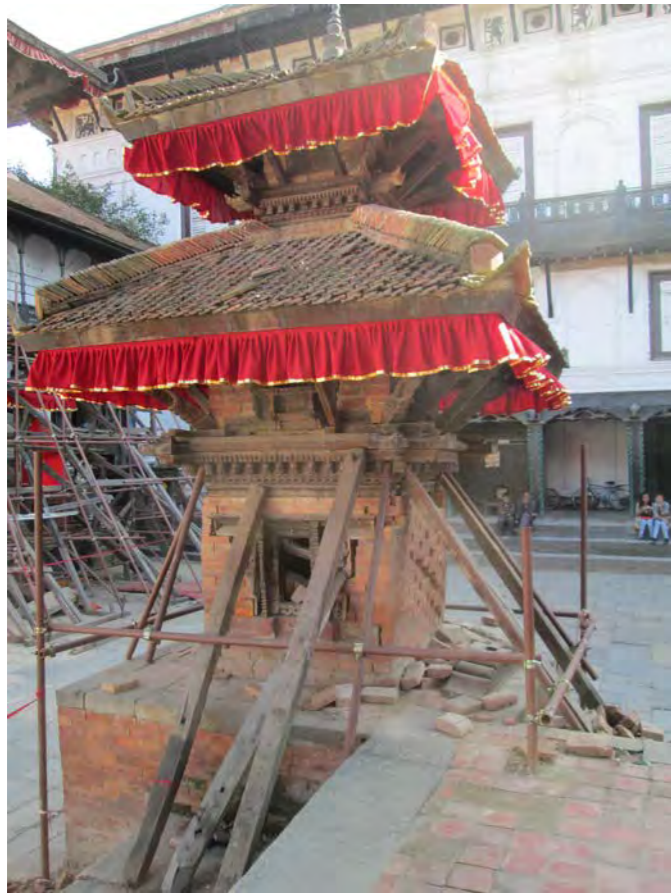
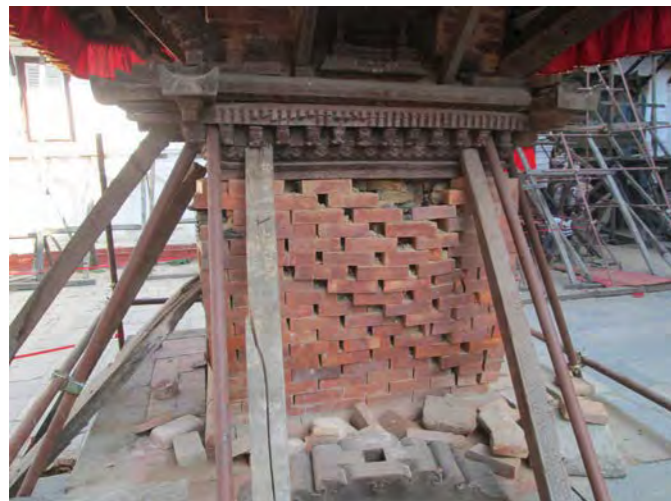
27d TWO STOREY TEMPLE

CODE NO	TYOLOGY	MONUMENT NAME	ESTABLISHED/ RENOVATED	STRUCTURAL SYSTEM	MATERIAL	GENERAL DESCRIPTION	PROBLEM DESCRIPTION	DANGER	REMARKS
27d	Two storey temple						bricks dislocation, unstable, easetern wall buldging out		
27e	Shiva Linga					shiva linga on plinth of 27a	stone delapated		
27f	Stone post					stone post with capital at top	top part fall down

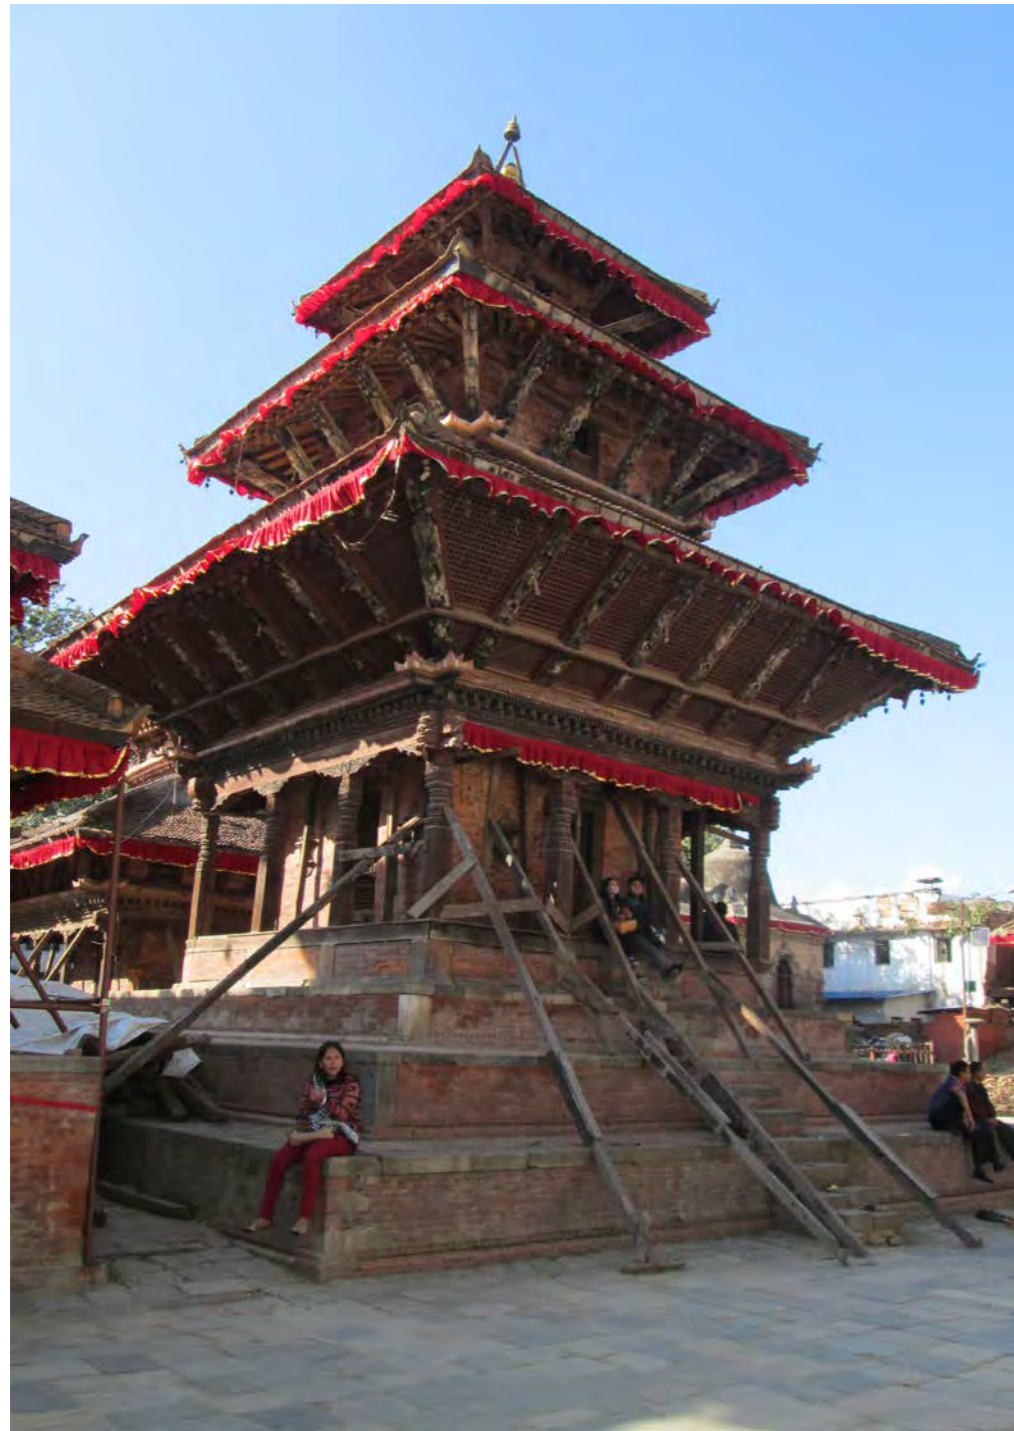
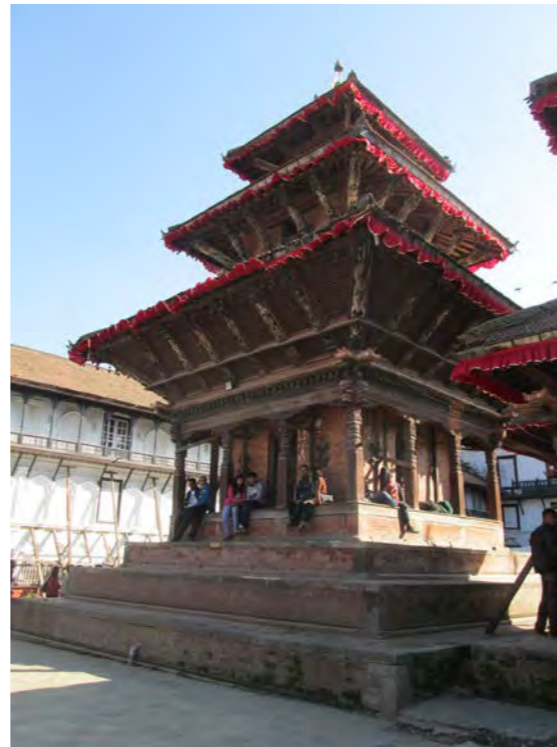
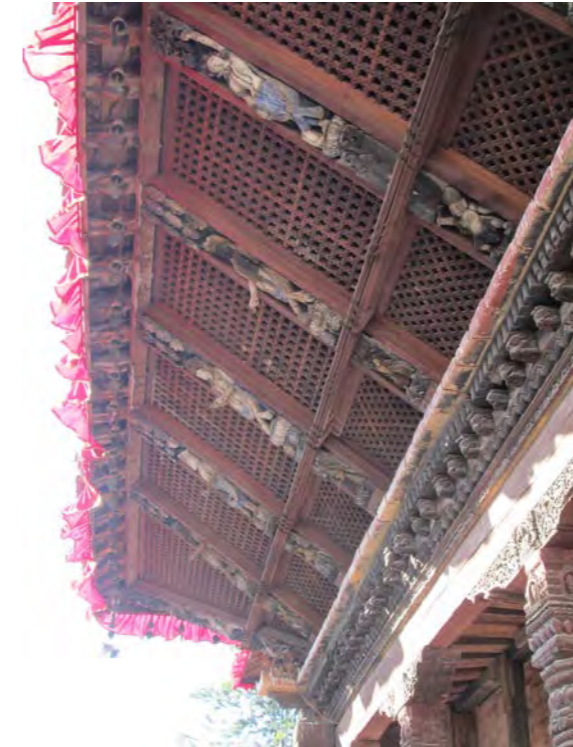
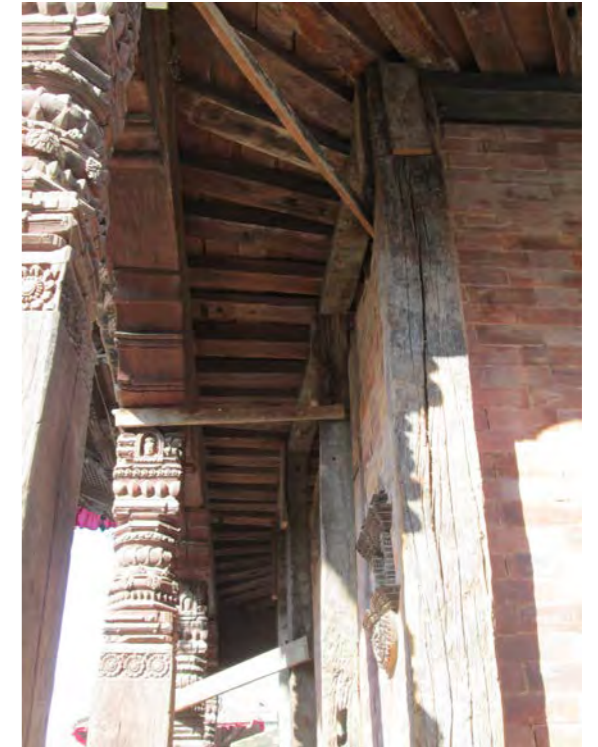
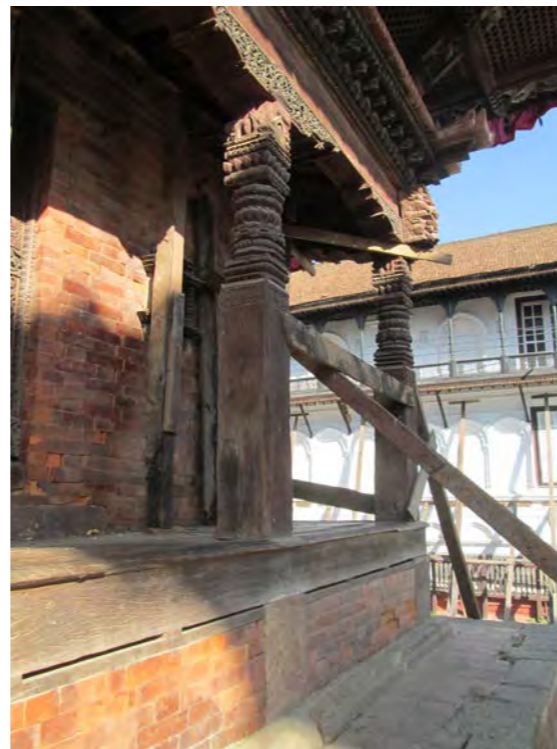
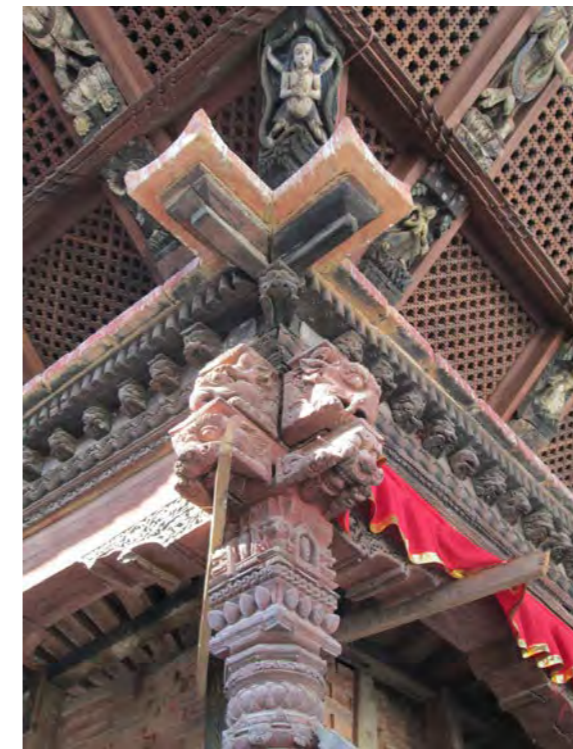
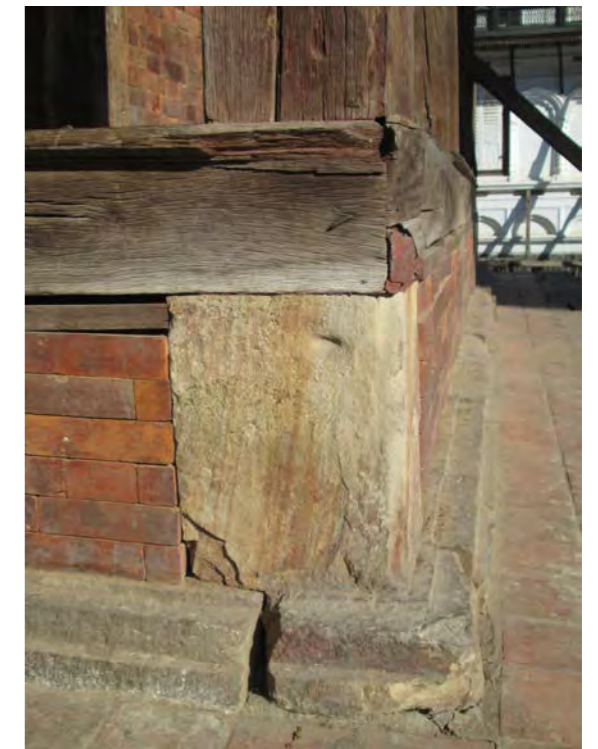
28 GOPINATH

CODE NO	TYOLOGY	MONUMENT NAME	ESTABLISHED/ RENOVATED	STRUCTURAL SYSTEM	MATERIAL	GENERAL DESCRIPTION	PROBLEM DESCRIPTION	DANGER	REMARKS	
28	Three Storey Temple	Gopinath	17th century	Load Bearing	Brick		bricks dislocation, south east corner bulging out
