2015 Earthquake Damage Mapping

Hanuman Dhoka Darbar Square Monument Zone
Kathmandu Valley World Heritage Property

December 2015

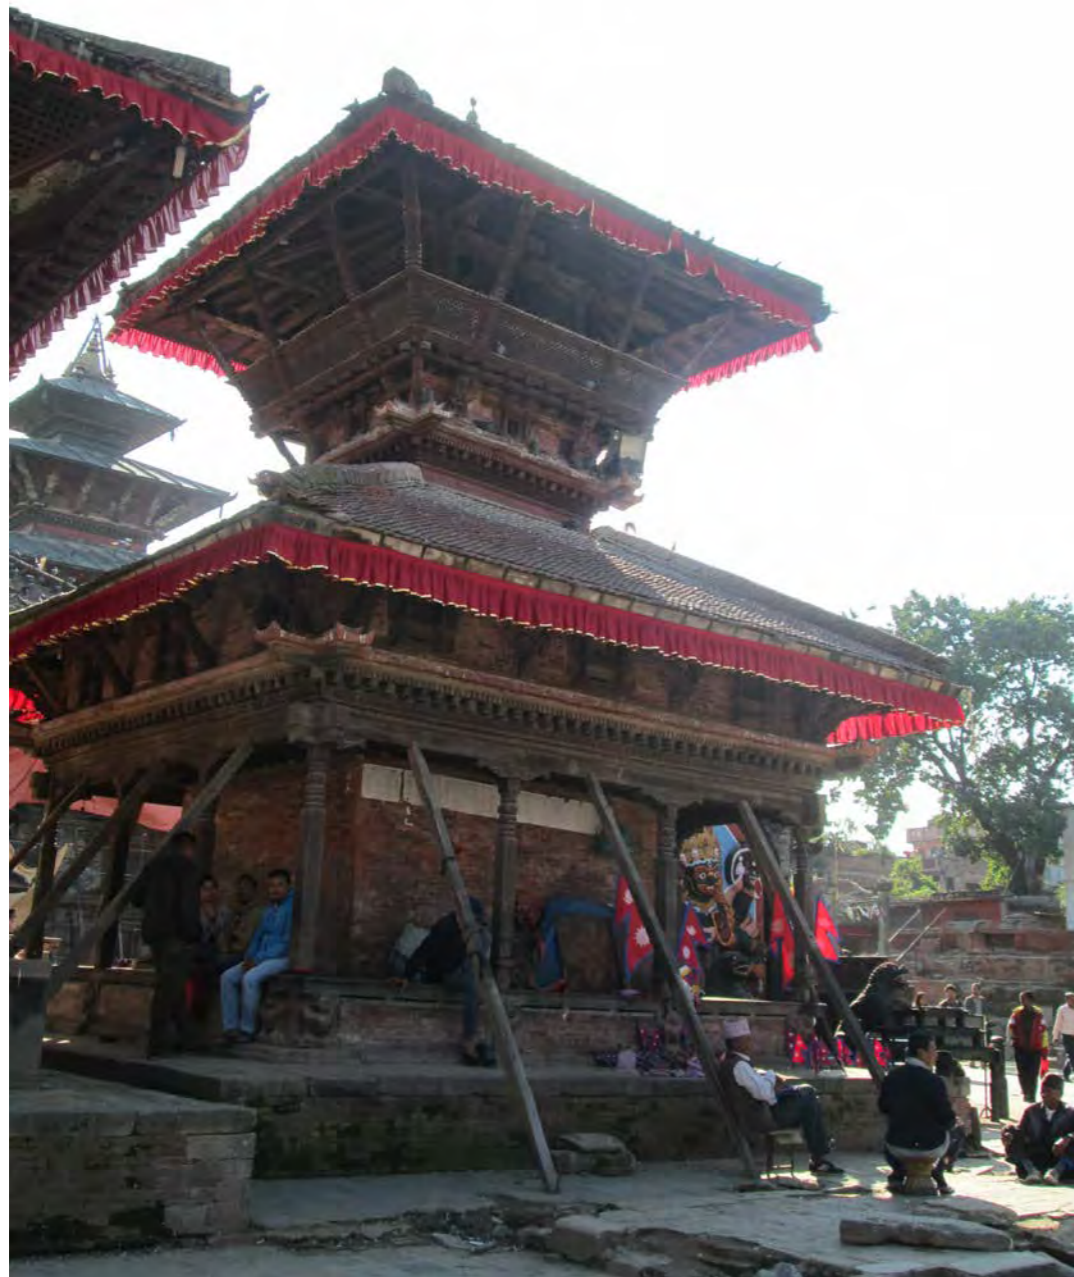
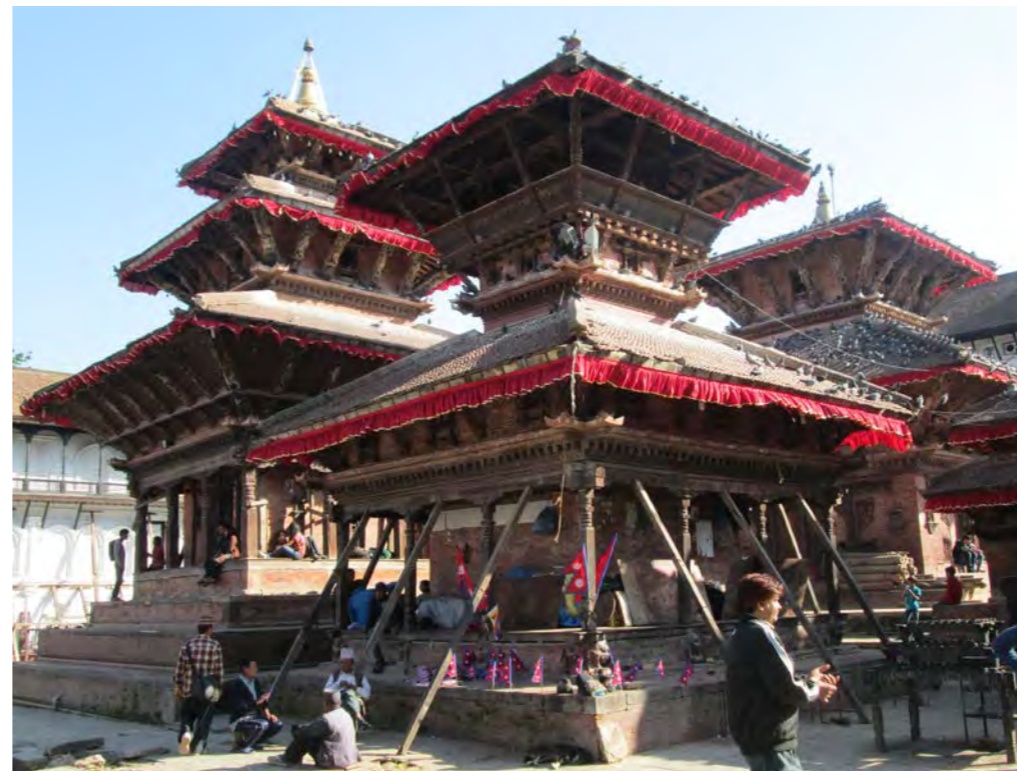
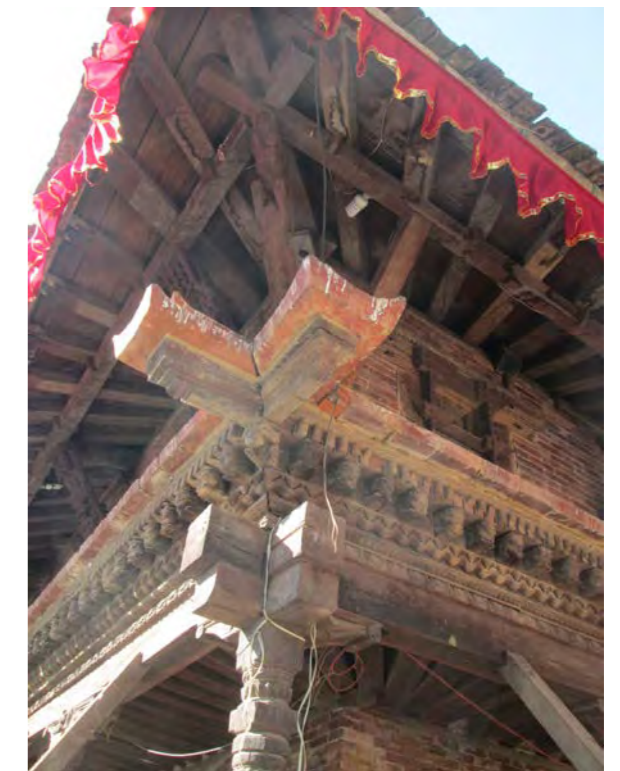
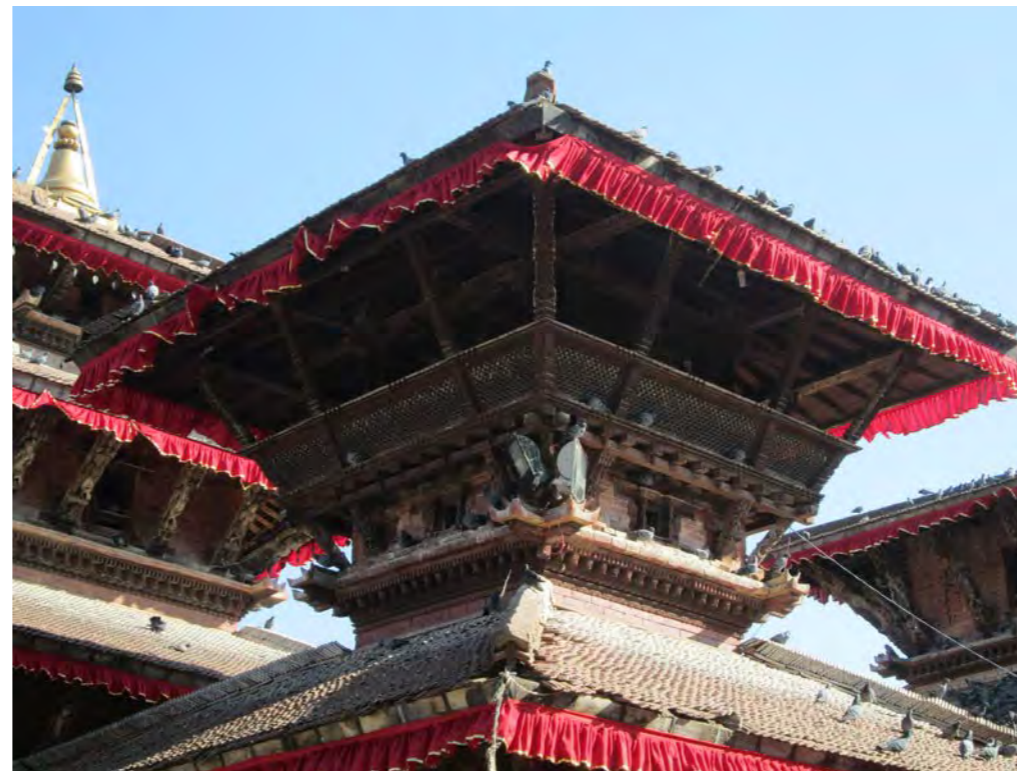
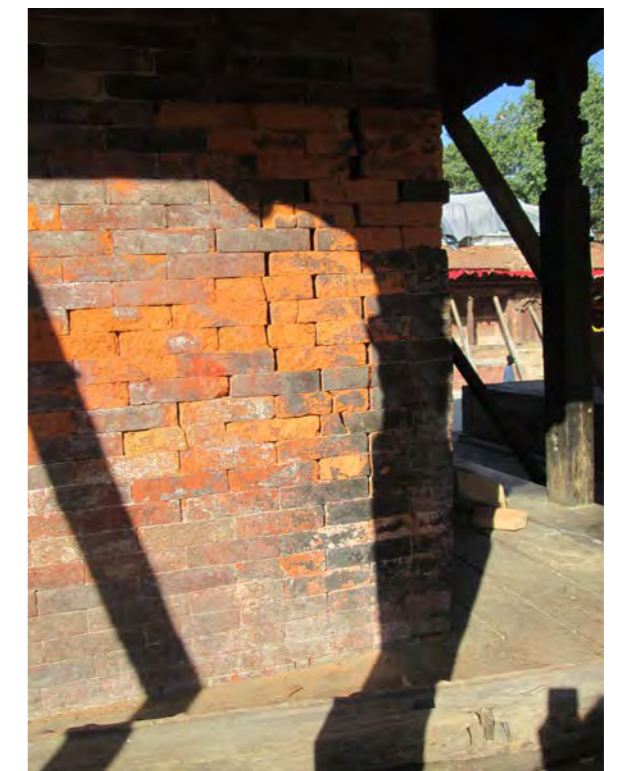
29 CHATURMUKH LINGASHA

CODE NO	TYOLOGY	MONUMENT NAME	ESTABLISHED/ RENOVATED	STRUCTURAL SYSTEM	MATERIAL	GENERAL DESCRIPTION	PROBLEM DESCRIPTION	DANGER	REMARKS	
29	Two Storey temple	Chaturmukh Lingasha	17th century				south wall brick disintegration, brick deterioration

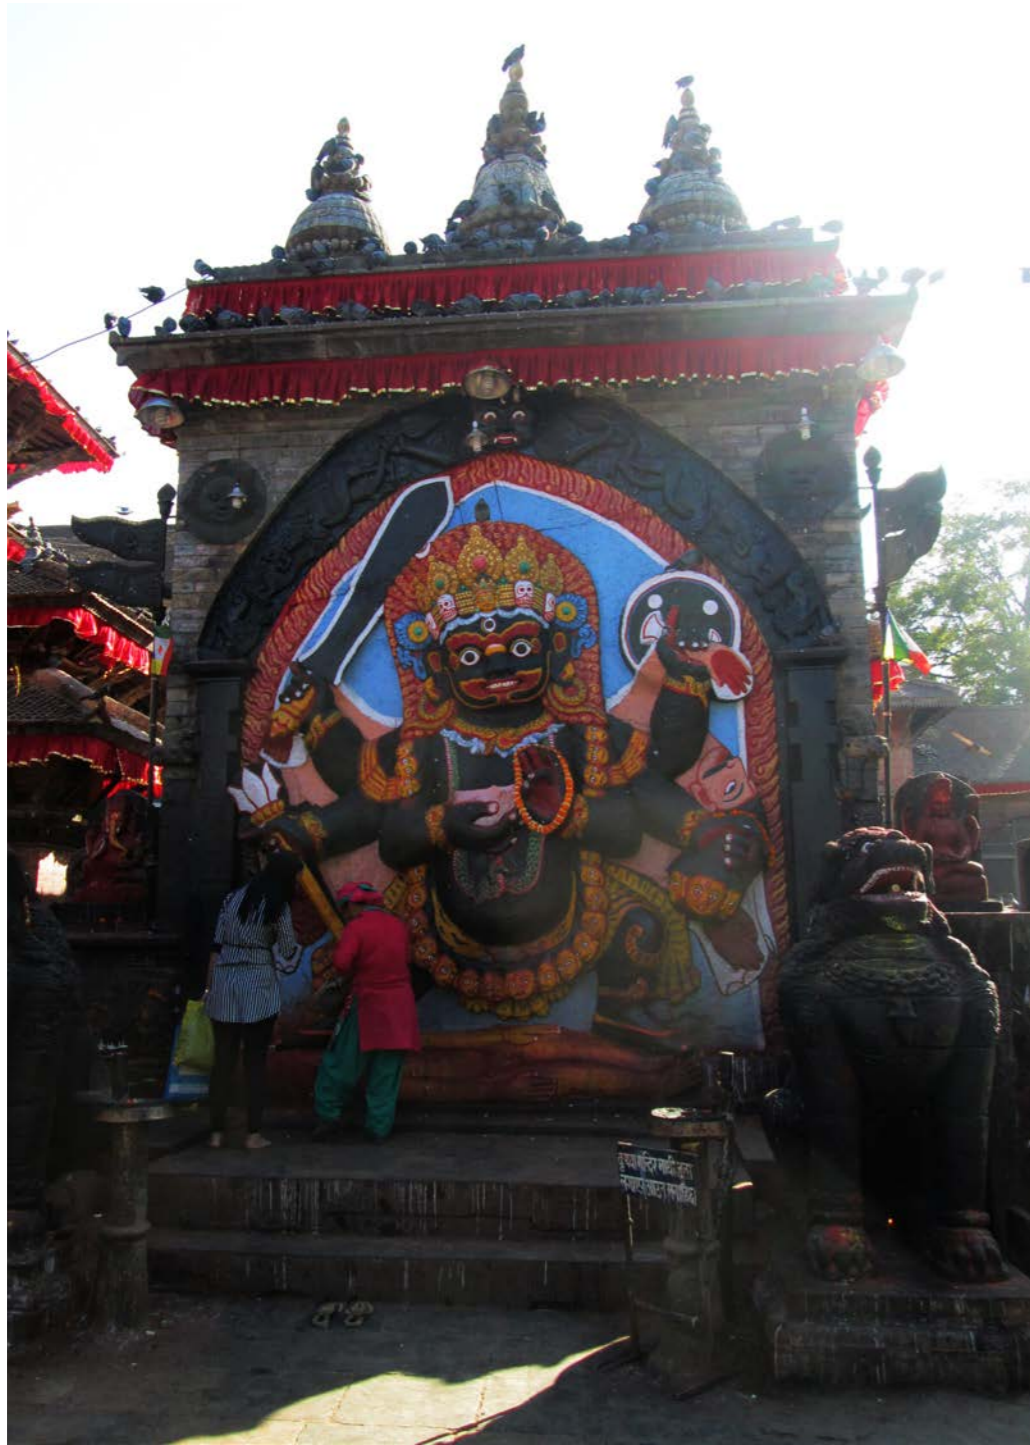
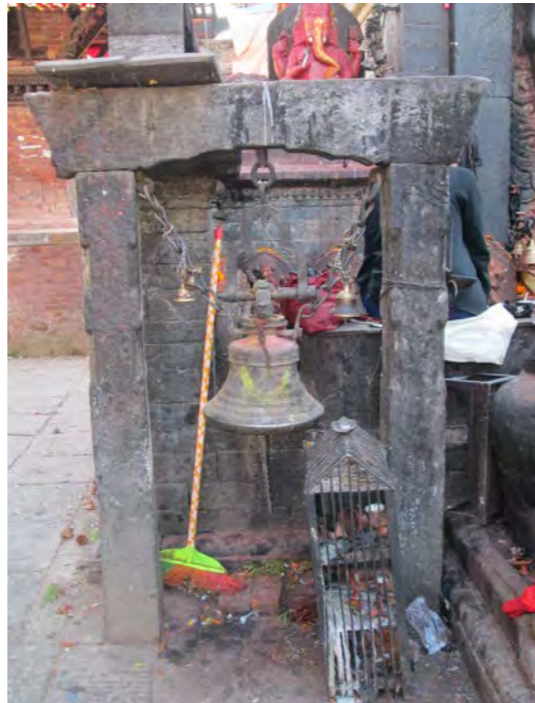
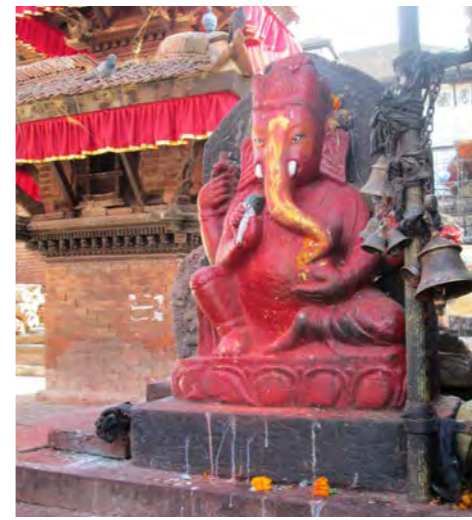
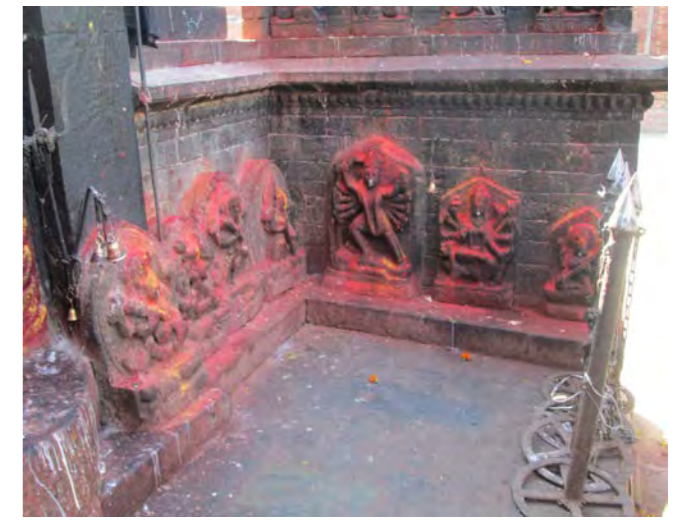
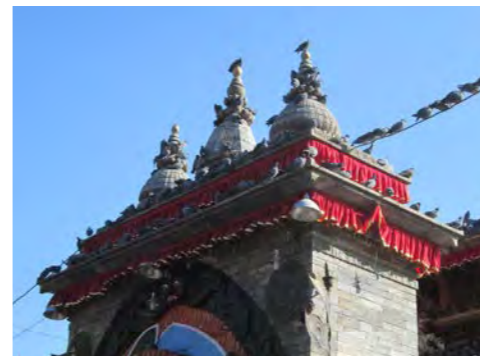
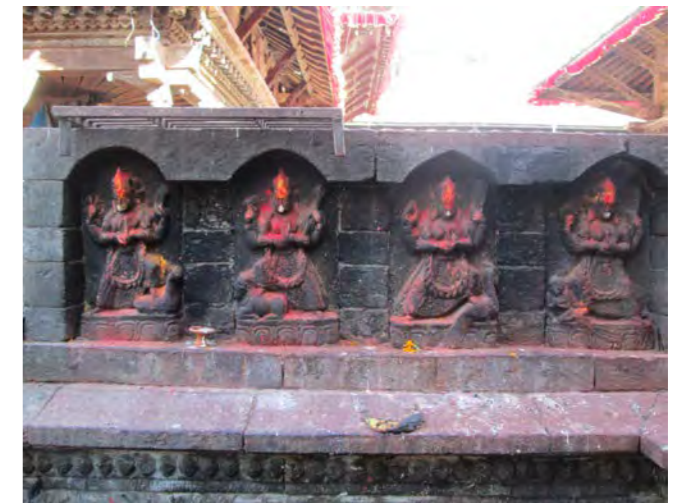
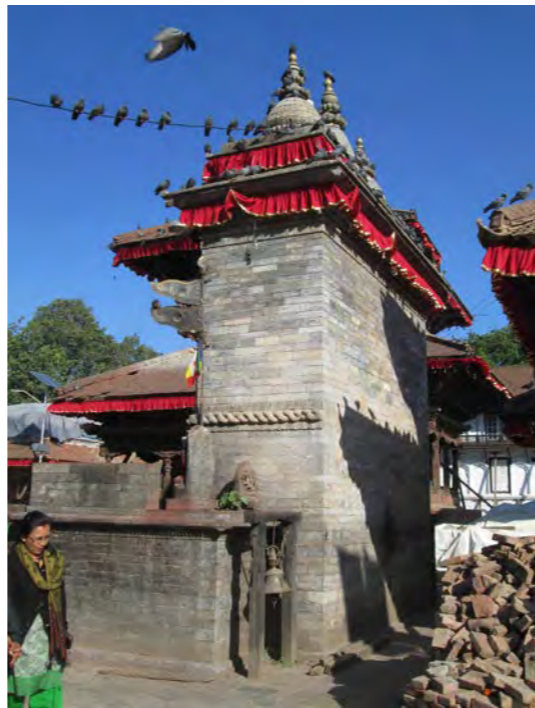
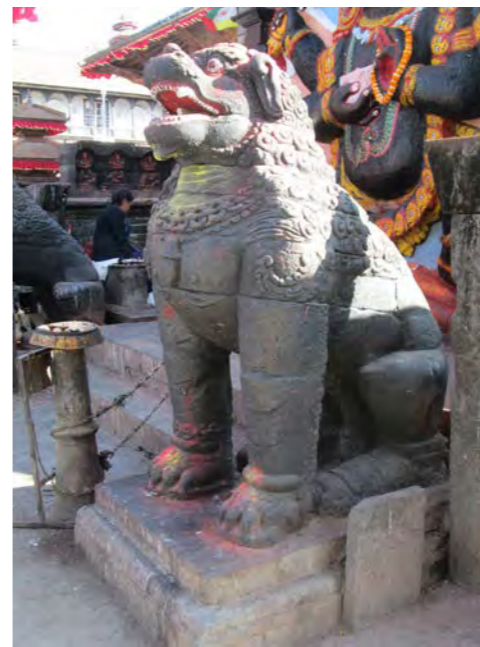
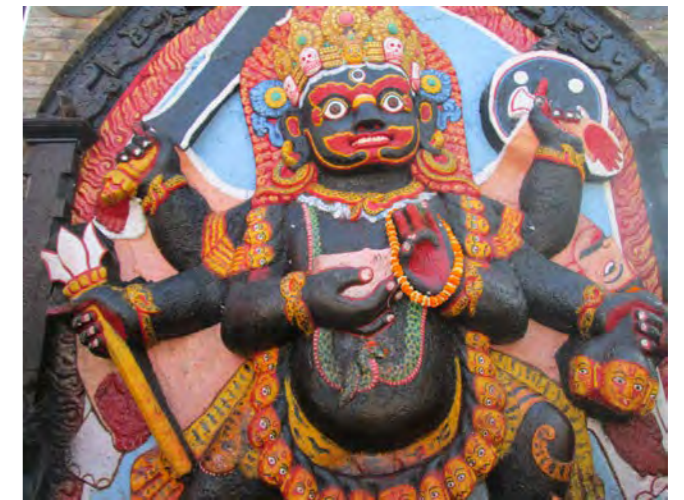
30 KAL BHAIRAV

CODE NO	TYOLOGY	MONUMENT NAME	ESTABLISHED/ RENOVATED	STRUCTURAL SYSTEM	MATERIAL	GENERAL DESCRIPTION	PROBLEM DESCRIPTION	DANGER	REMARKS	
30	open shrine	Kal Bhairav	1660				No visible damage

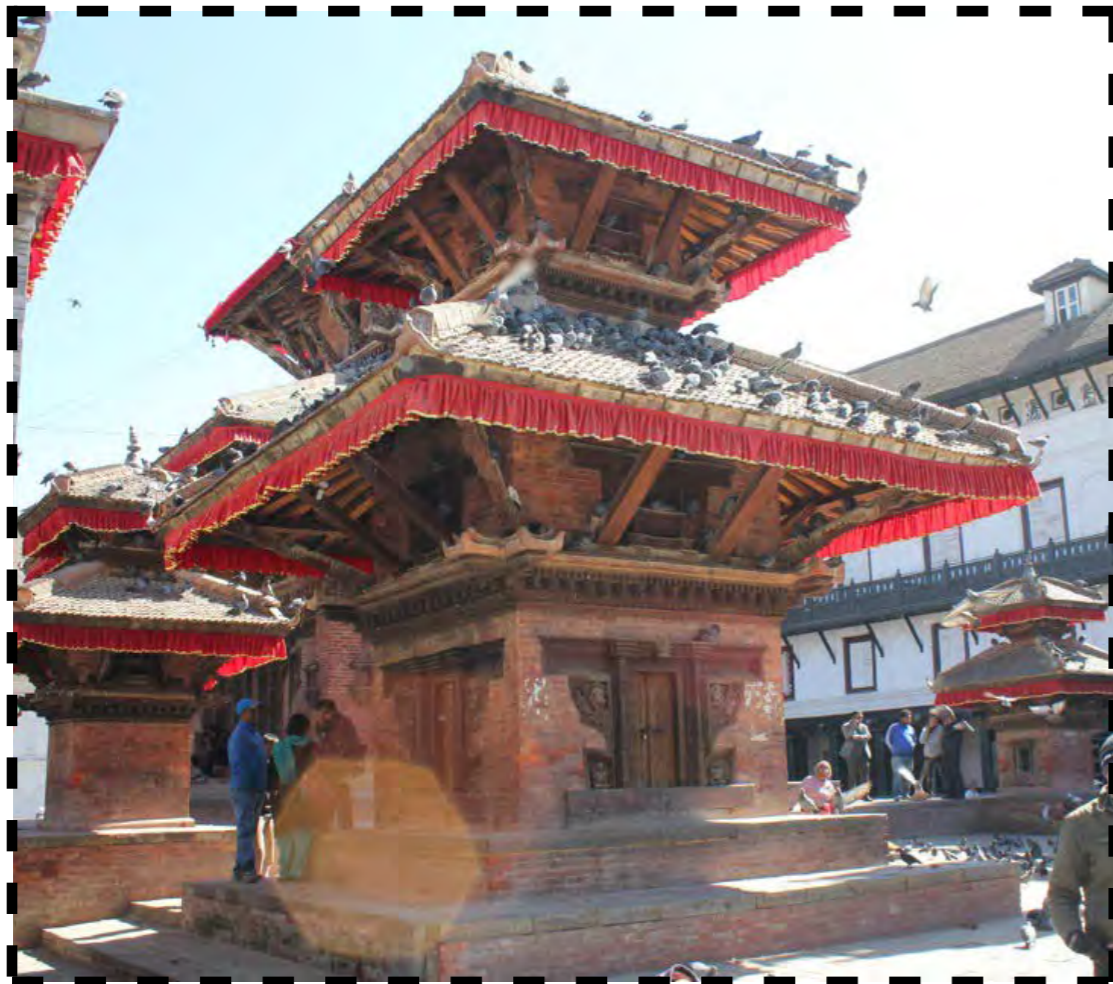
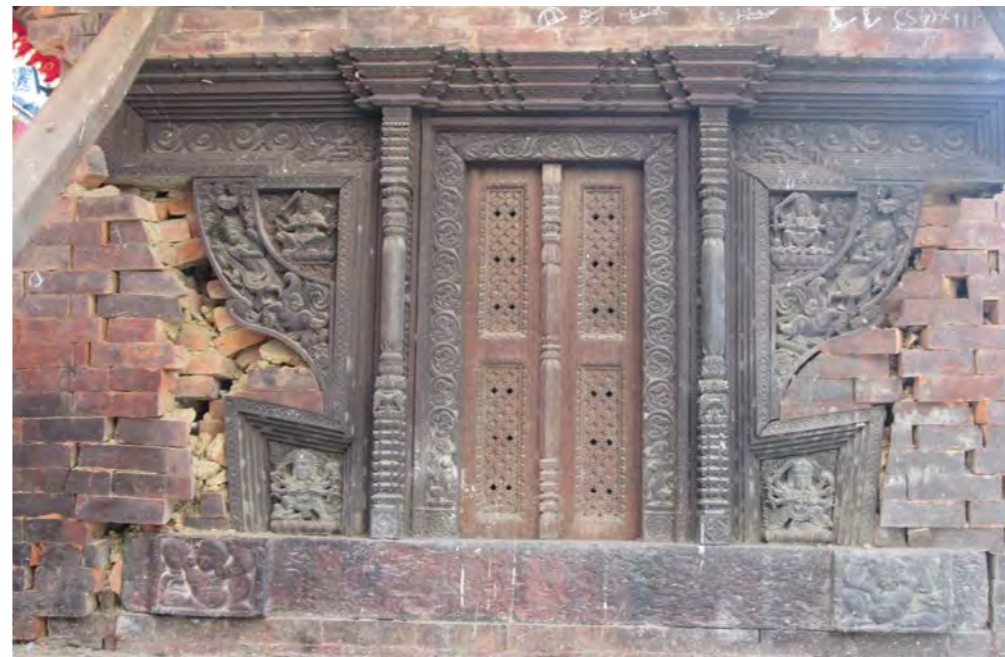
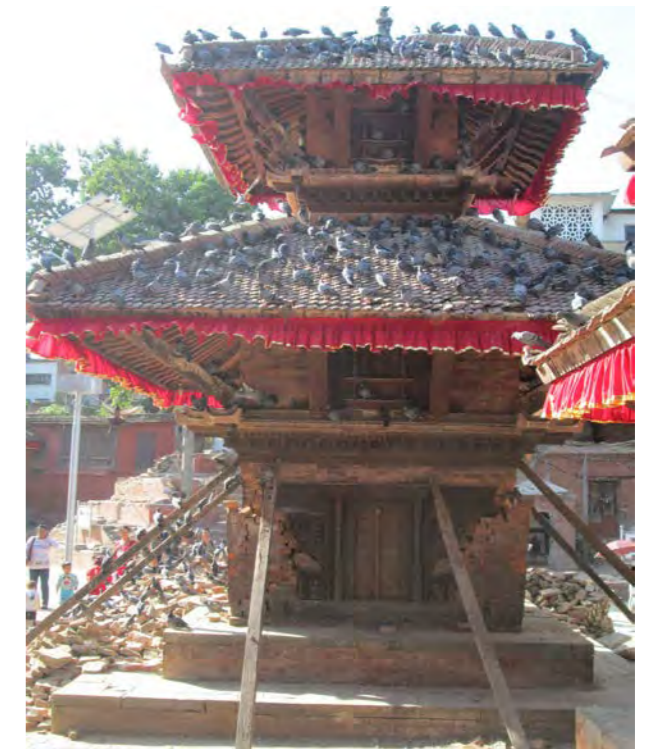
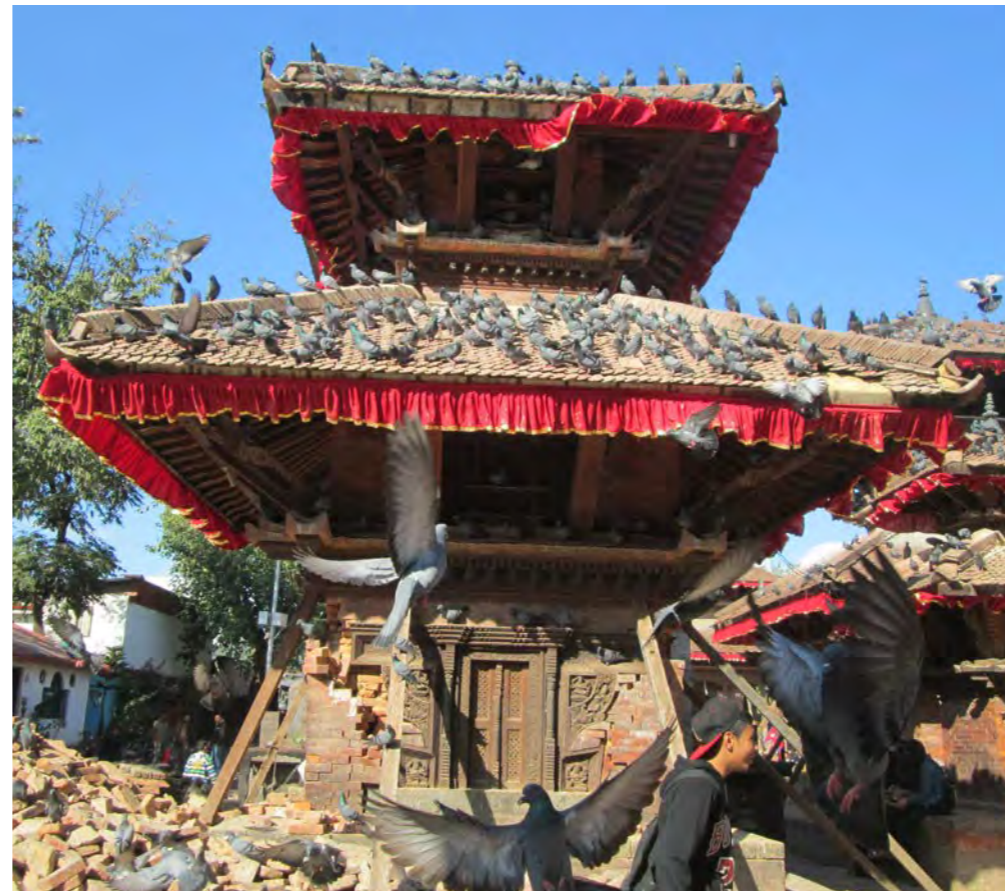
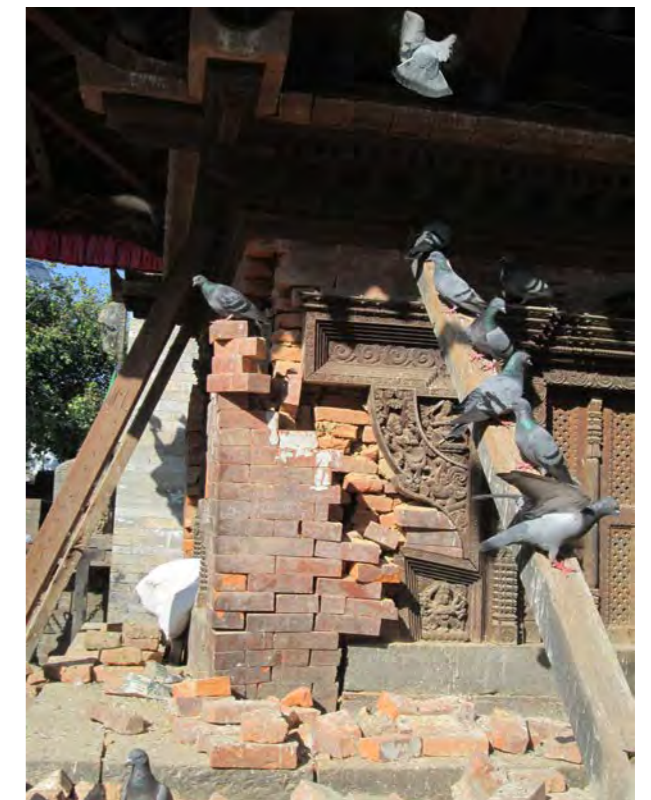
31 LAXMI NARAYAN

CODE NO	TYOLOGY	MONUMENT NAME	ESTABLISHED/ RENOVATED	STRUCTURAL SYSTEM	MATERIAL	GENERAL DESCRIPTION	PROBLEM DESCRIPTION	DANGER	REMARKS	
31	Two storey temple	Laxmi Narayan	18th Century				All 4 corners separating out

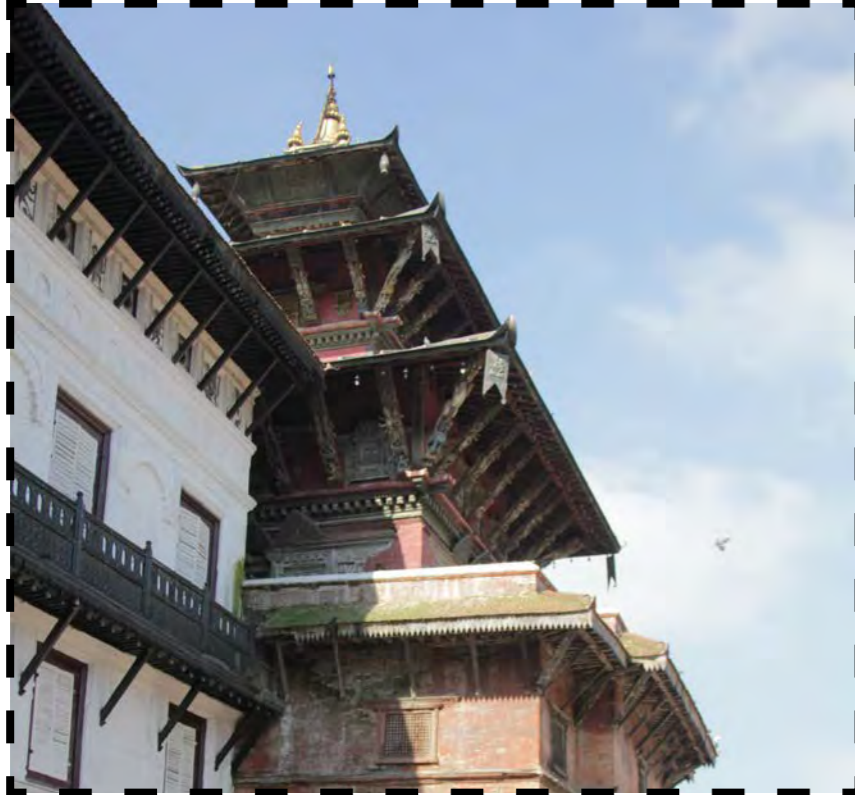
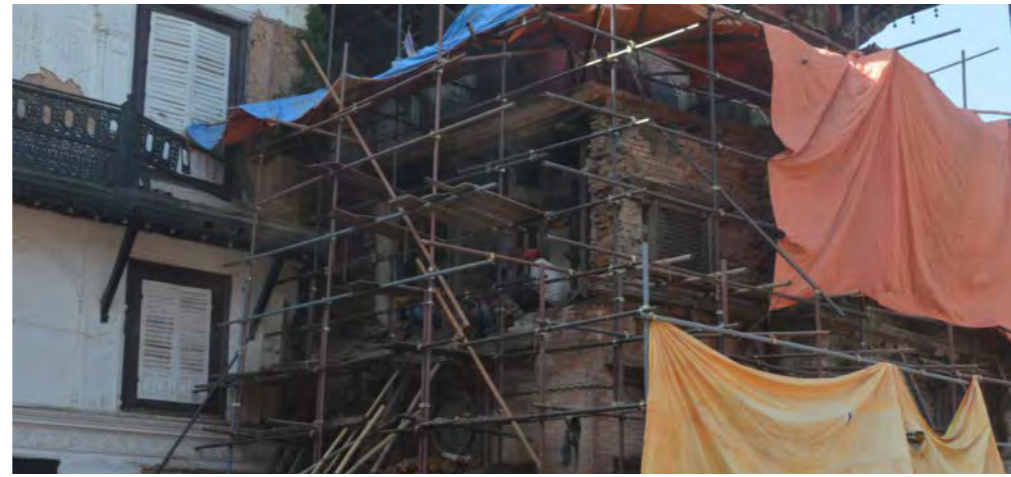
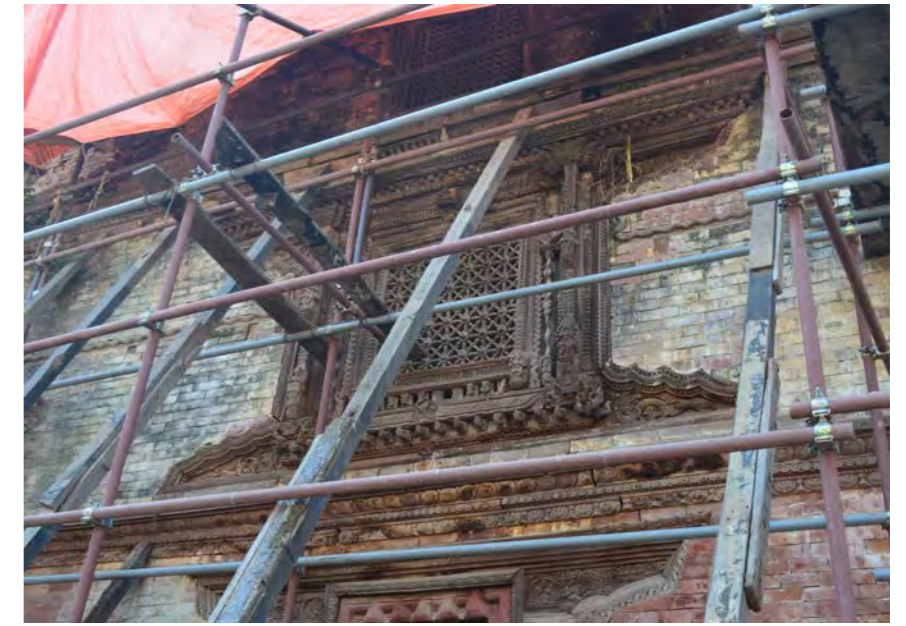
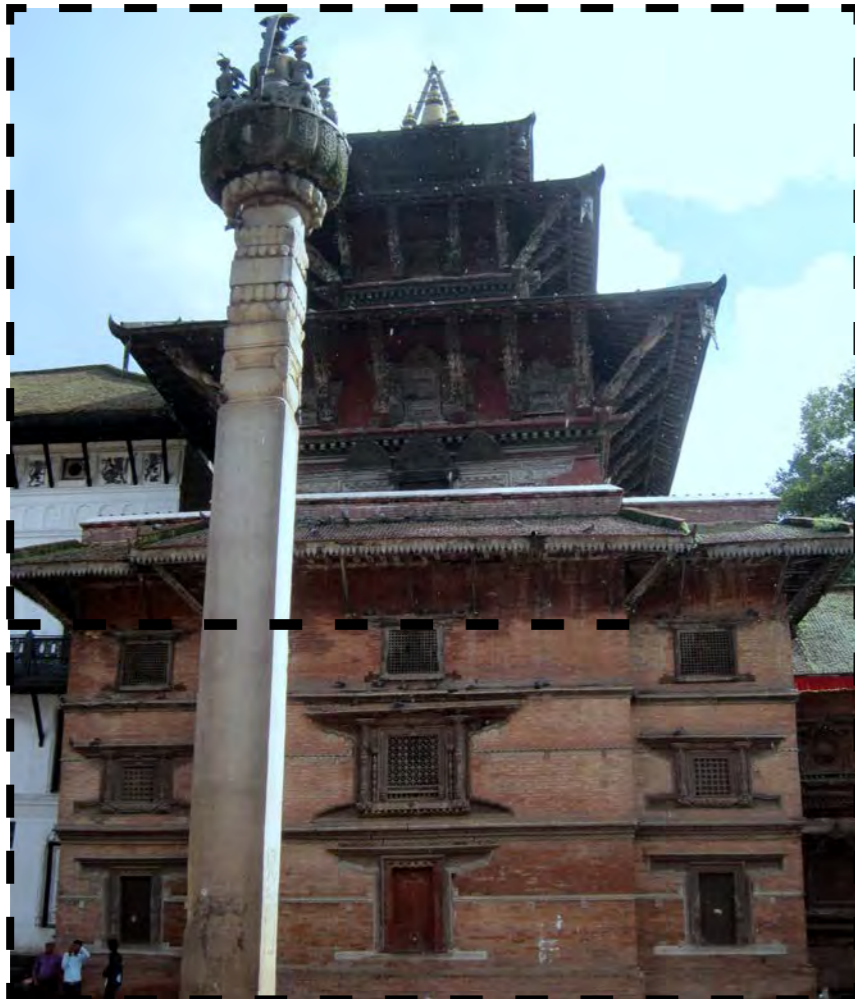
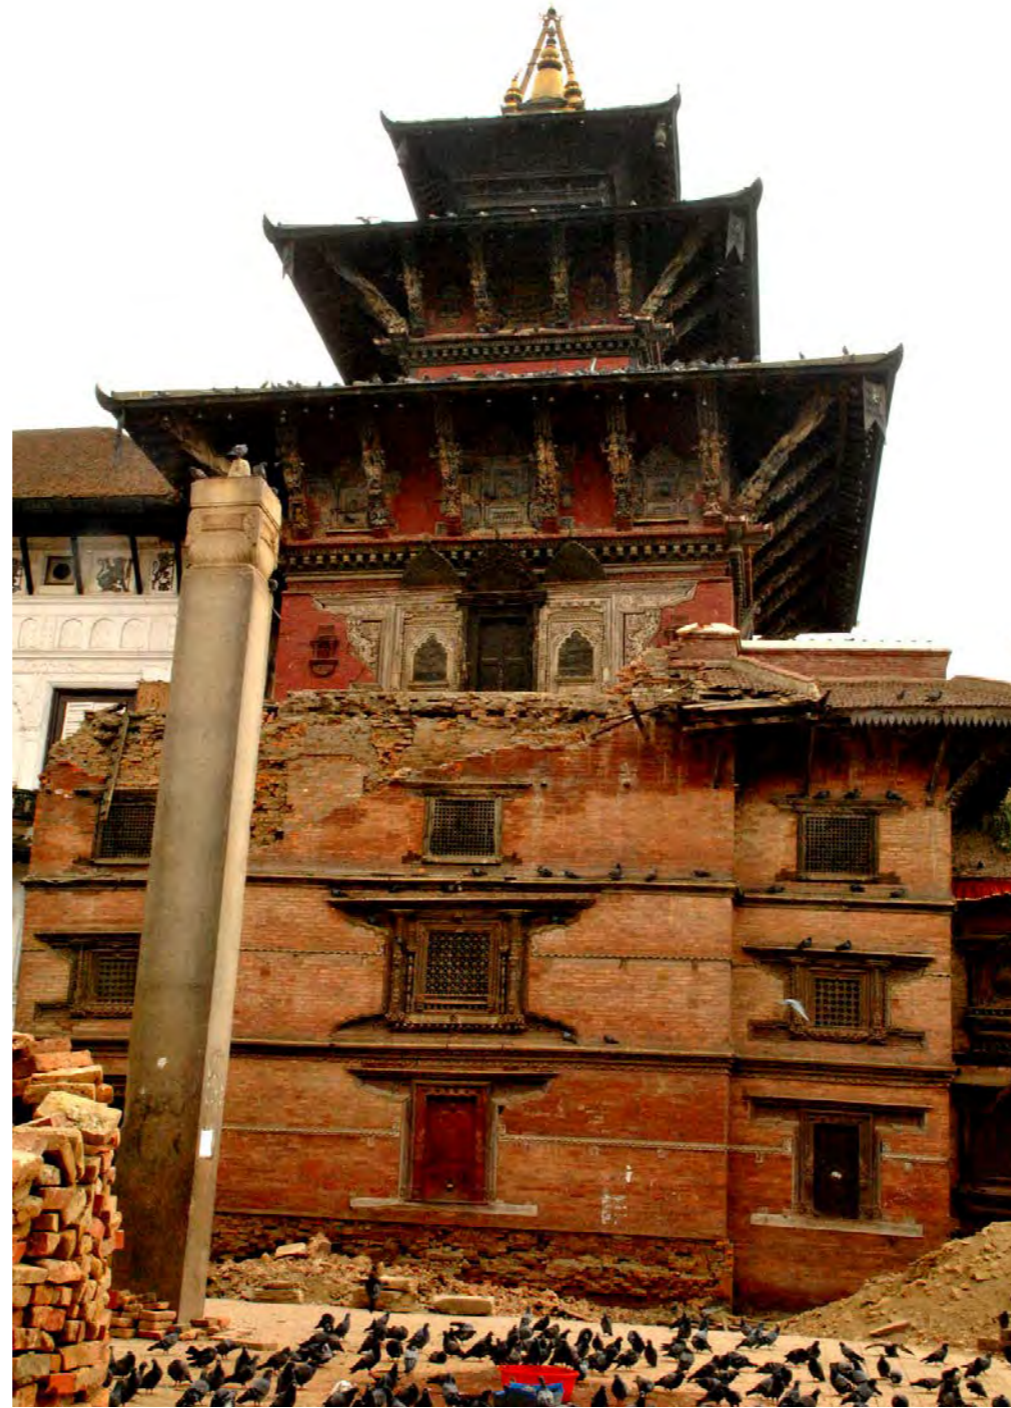
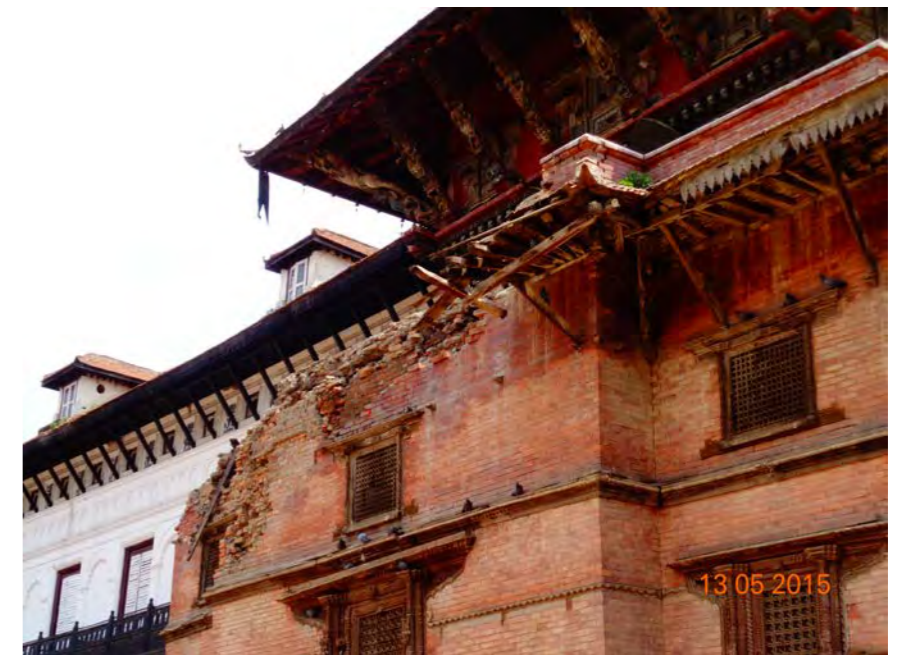
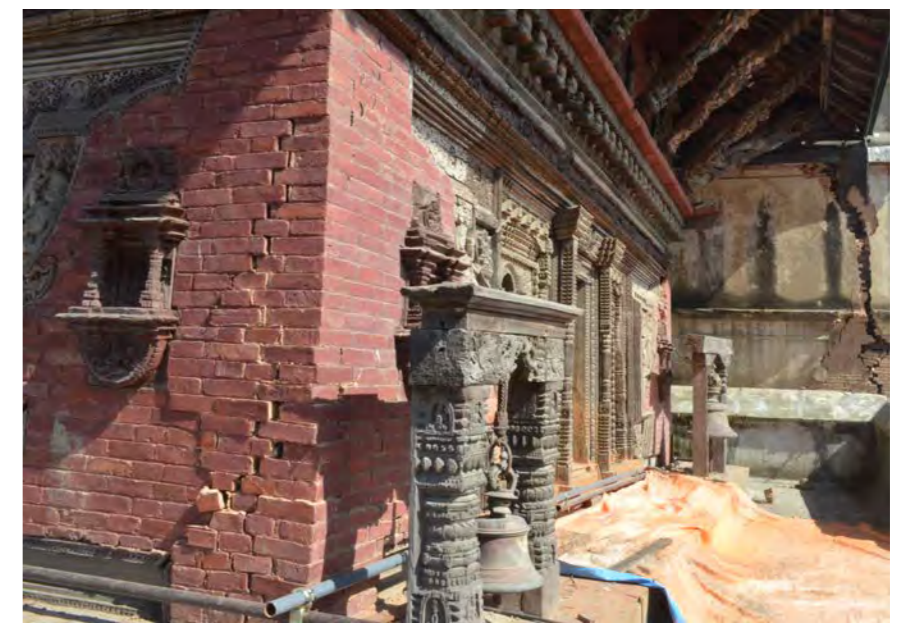
32 DEGU TALLE TEMPLE

CODE NO	TYOLOGY	MONUMENT NAME	ESTABLISHED/ RENOVATED	STRUCTURAL SYSTEM	MATERIAL	GENERAL DESCRIPTION	PROBLEM DESCRIPTION	DANGER	REMARKS
32	Three Tired Temple	Degu Talle Temple		Load bearing	Brick	Build on 2nd storey of the living quarter. Houses Family divinity of Malla Kings hence assessible form palace only.	WS corner part wall fallen down, major cracks, shoring at south side

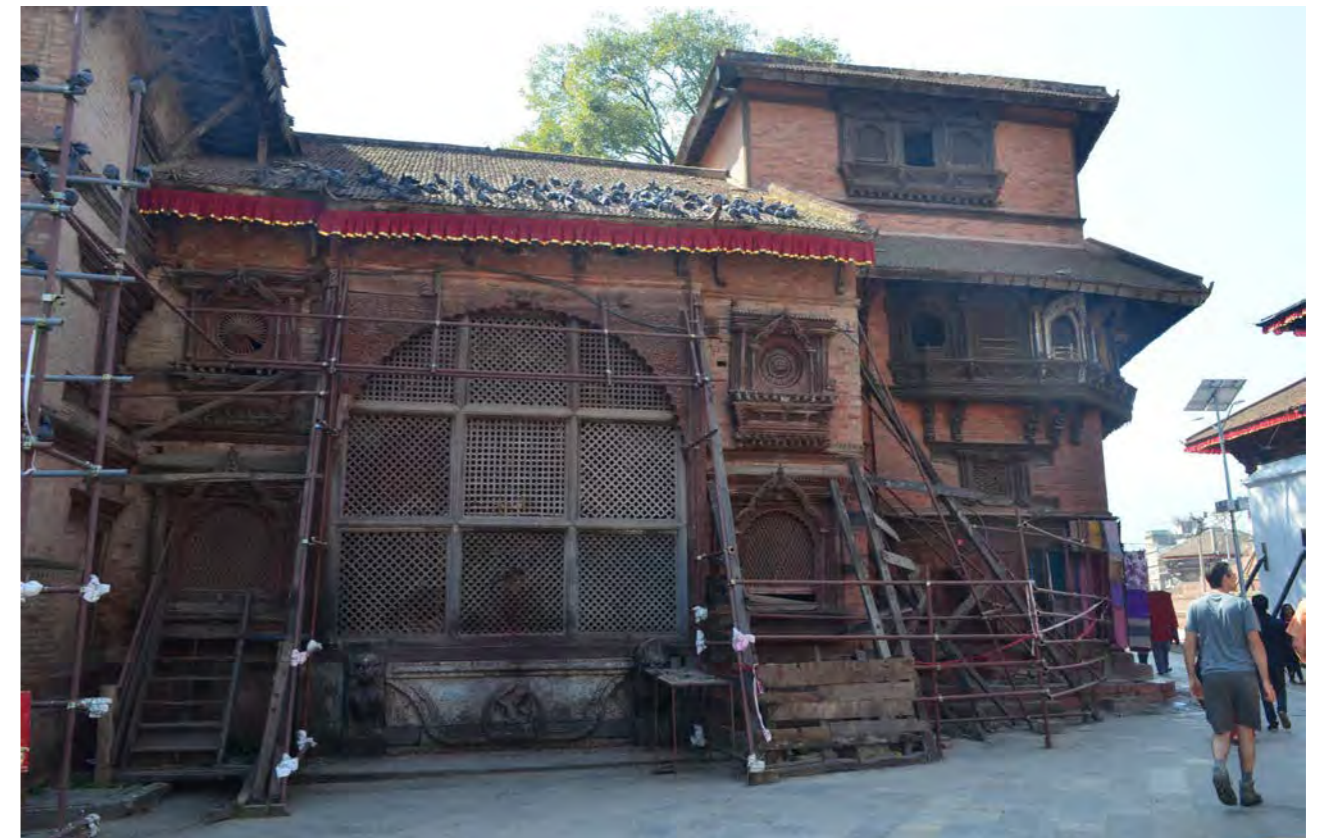
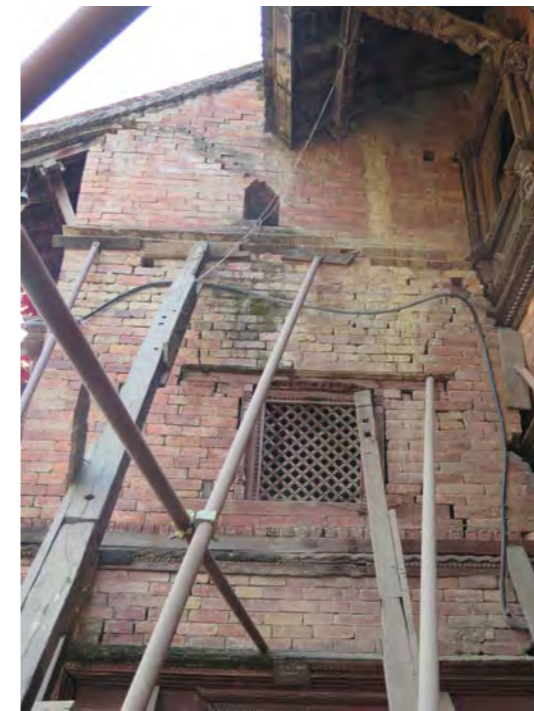
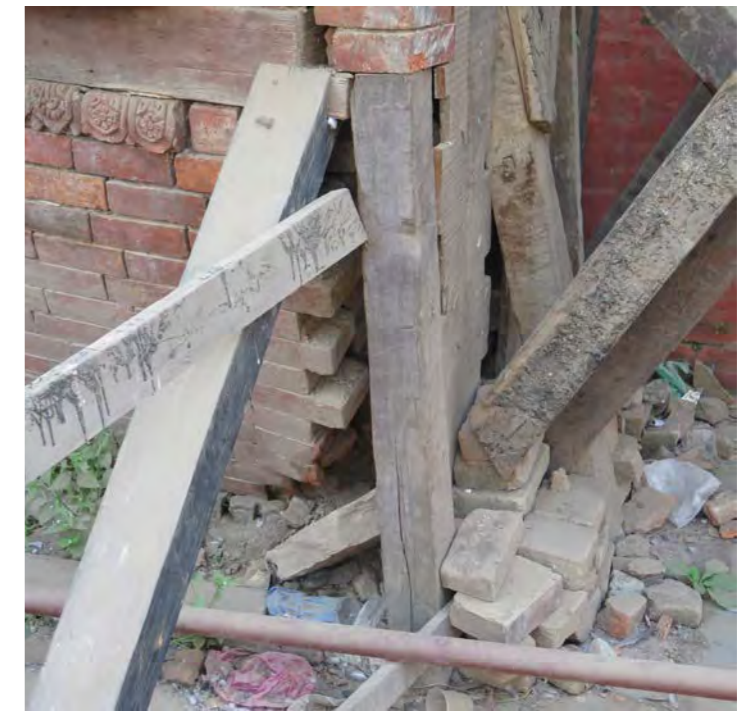
33 SWETA BHAIRAV TEMPLE

CODE NO	TYOLOGY	MONUMENT NAME	ESTABLISHED/ RENOVATED	STRUCTURAL SYSTEM	MATERIAL	GENERAL DESCRIPTION	PROBLEM DESCRIPTION	DANGER	REMARKS
33		Swet Bhairab	1795 by king Raha Bahadur Shah	Load Bearing	Brick;Stucco	The façade almost covered with carved windows. The central large window covers the large face of Bhairav.	Major cracks, tilted and bulging on the north. Bricks in the base falling down. Structure unstable.
