2015 Earthquake Damage Mapping

Hanuman Dhoka Darbar Square Monument Zone
Kathmandu Valley World Heritage Property

December 2015

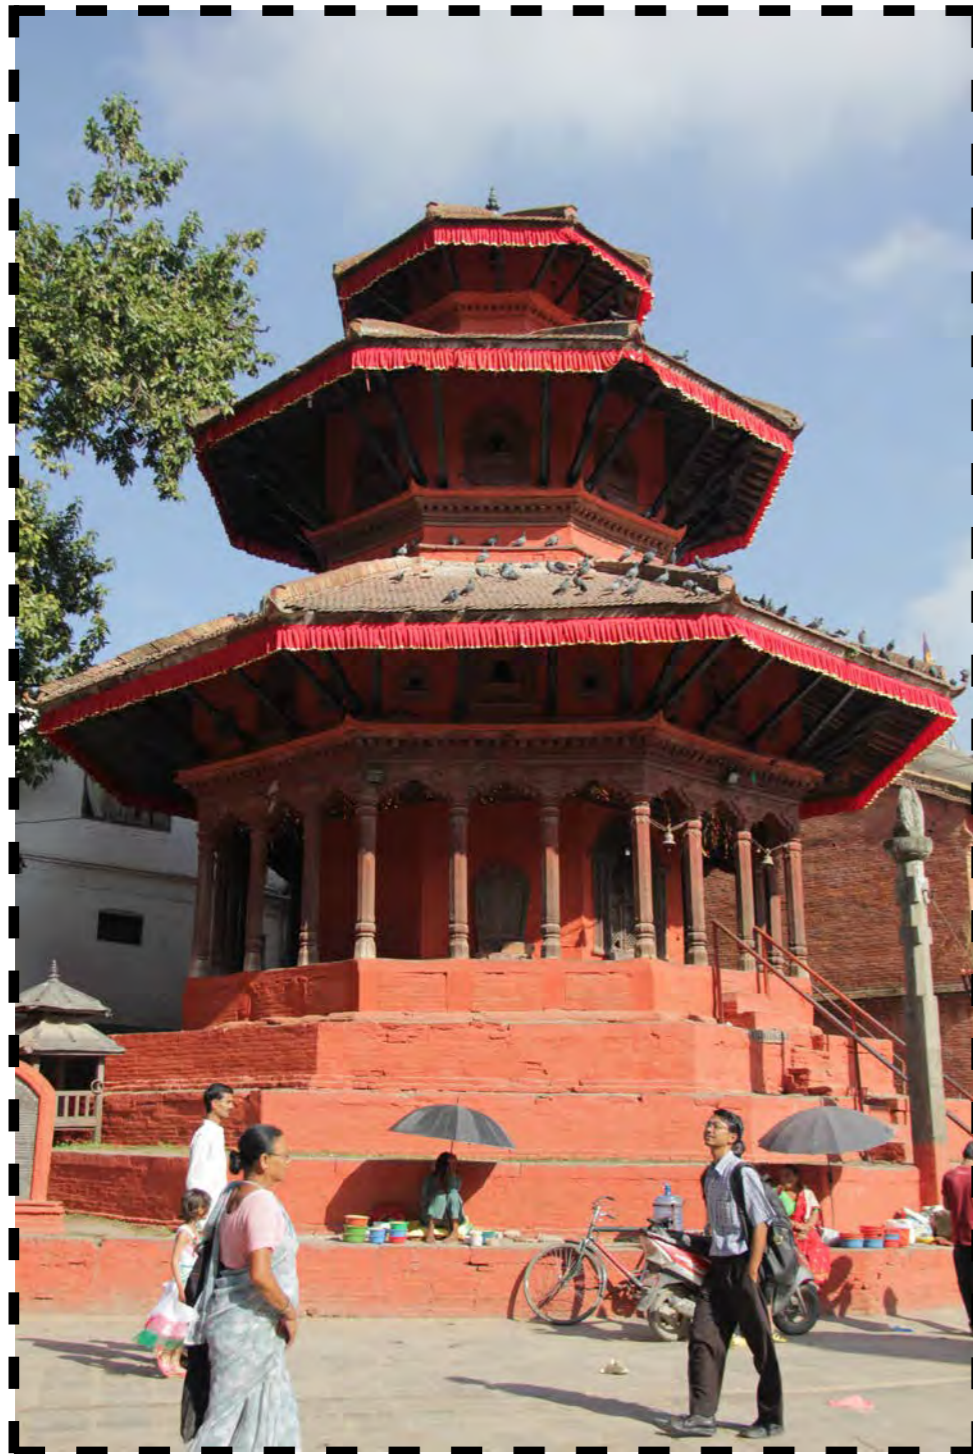
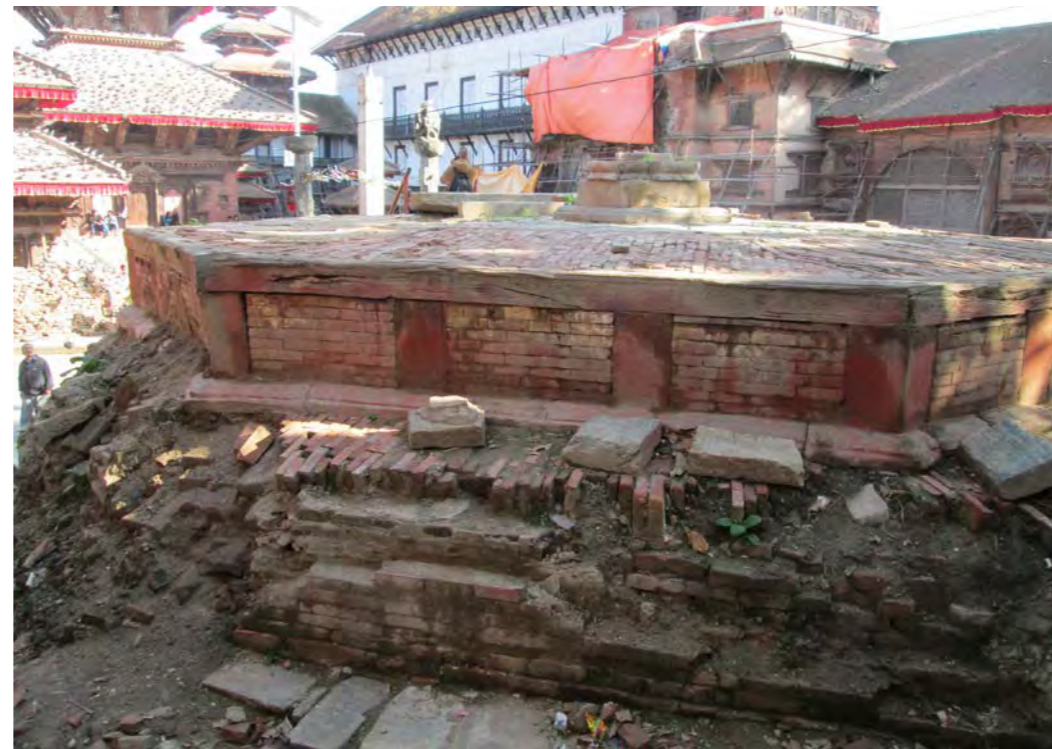
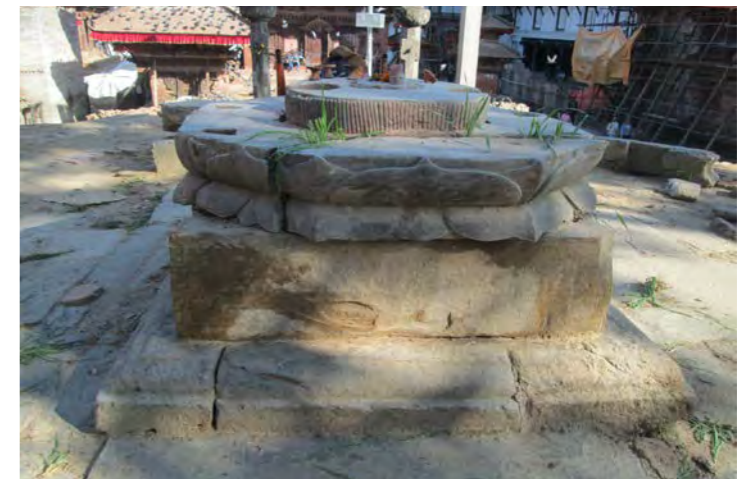
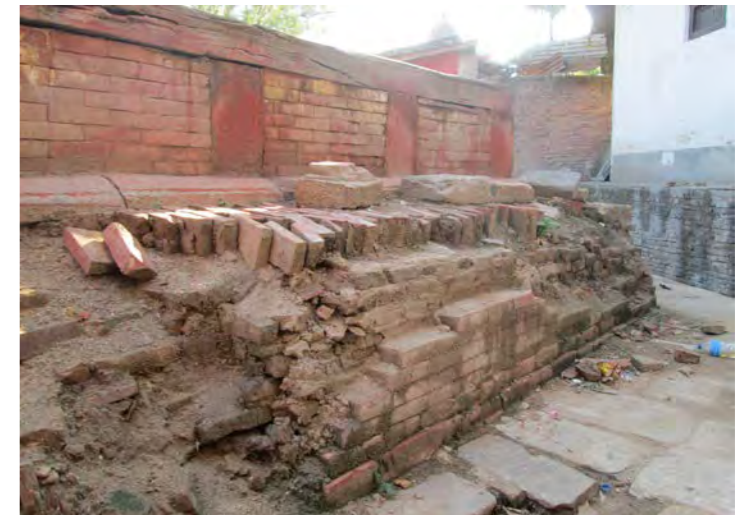
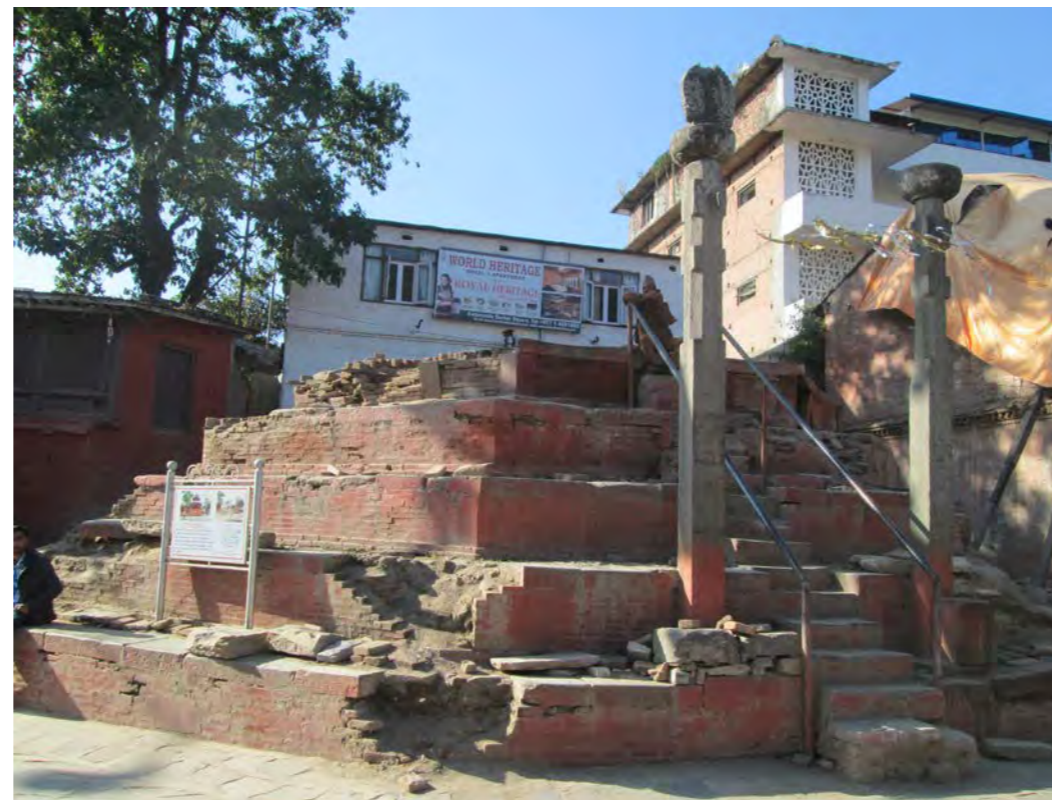
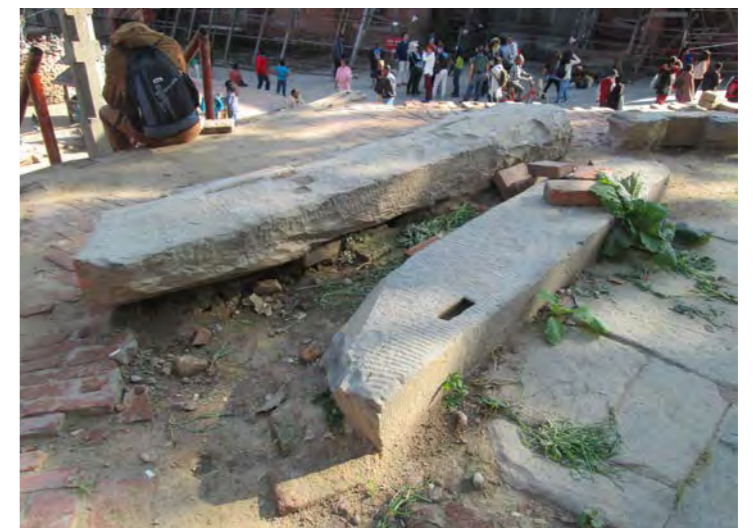
34 CHASIN DEGA TEMPLE

CODE NO	TYOLOGY	MONUMENT NAME	ESTABLISHED/ RENOVATED	STRUCTURAL SYSTEM	MATERIAL	GENERAL DESCRIPTION	PROBLEM DESCRIPTION	DANGER	REMARKS
34	Three storey Temple	Chasin Dega	1649/1947	Load Bearing	Brick	Octagonal temple	Totally collapsed

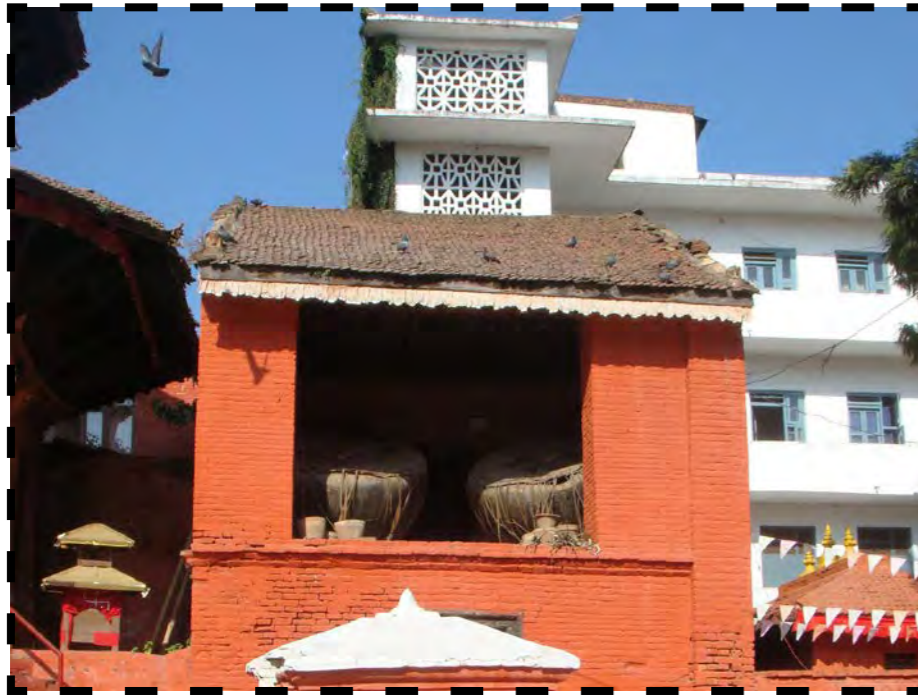
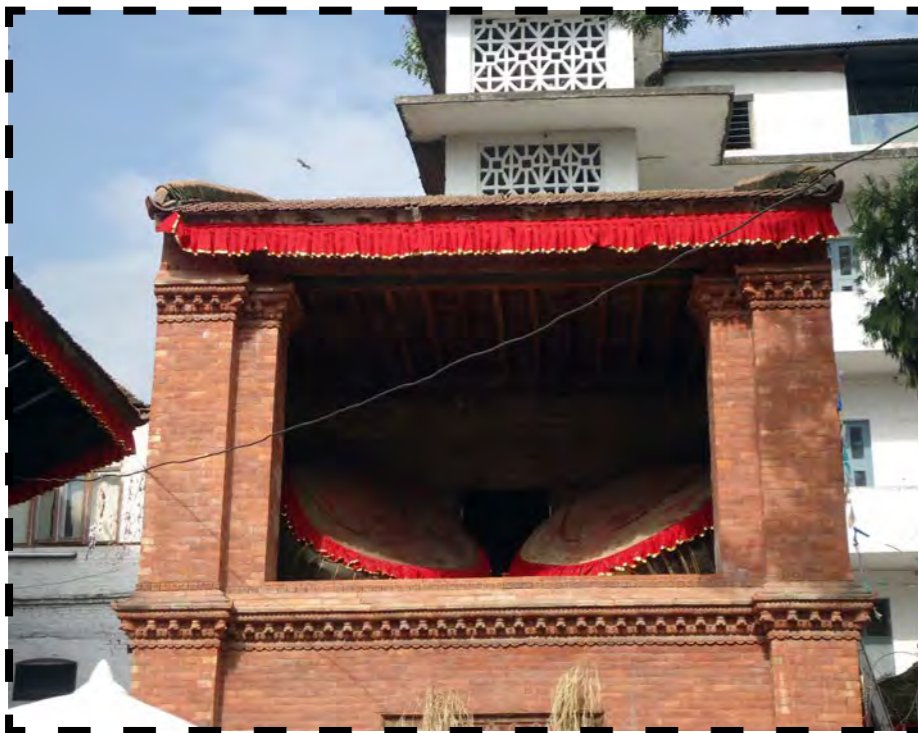
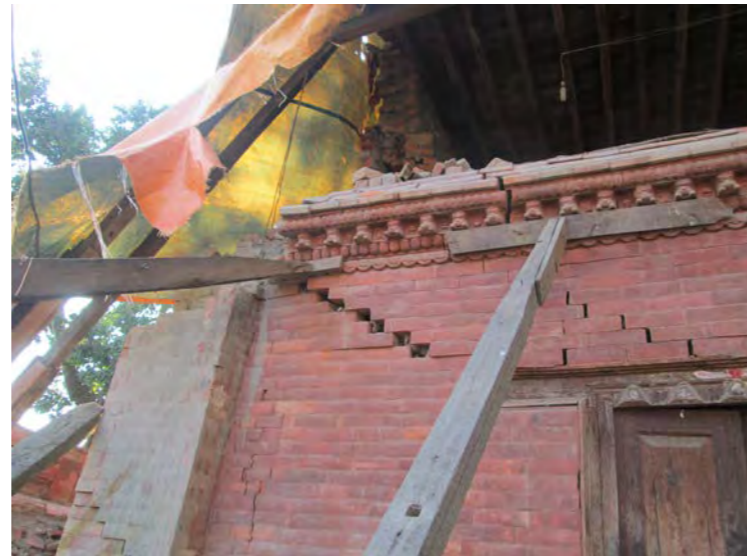
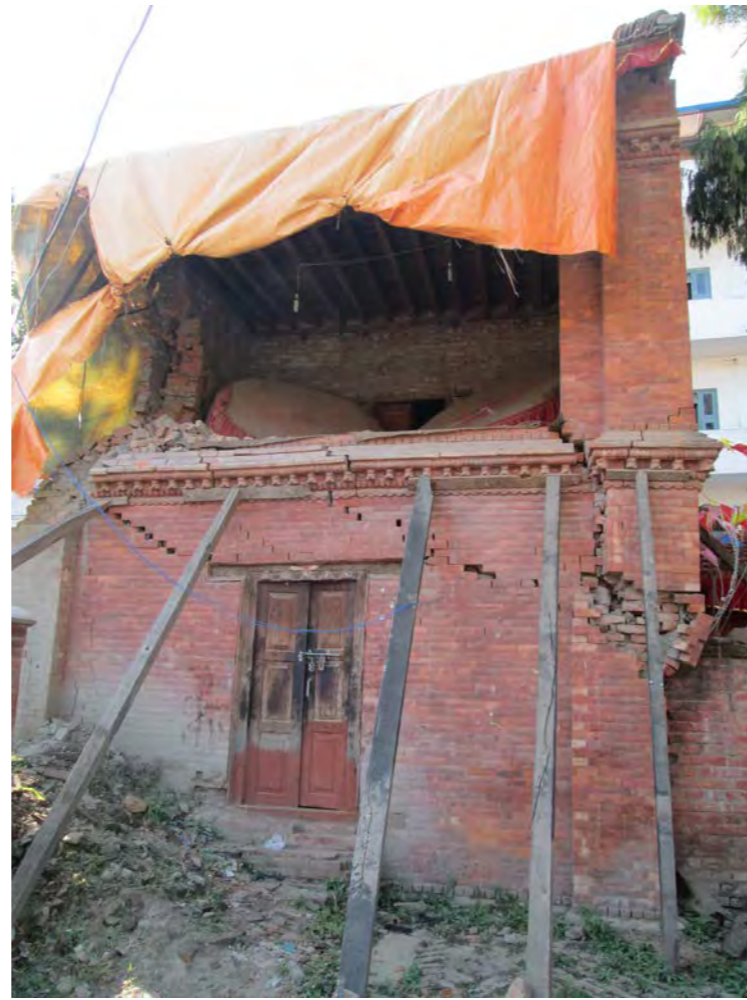
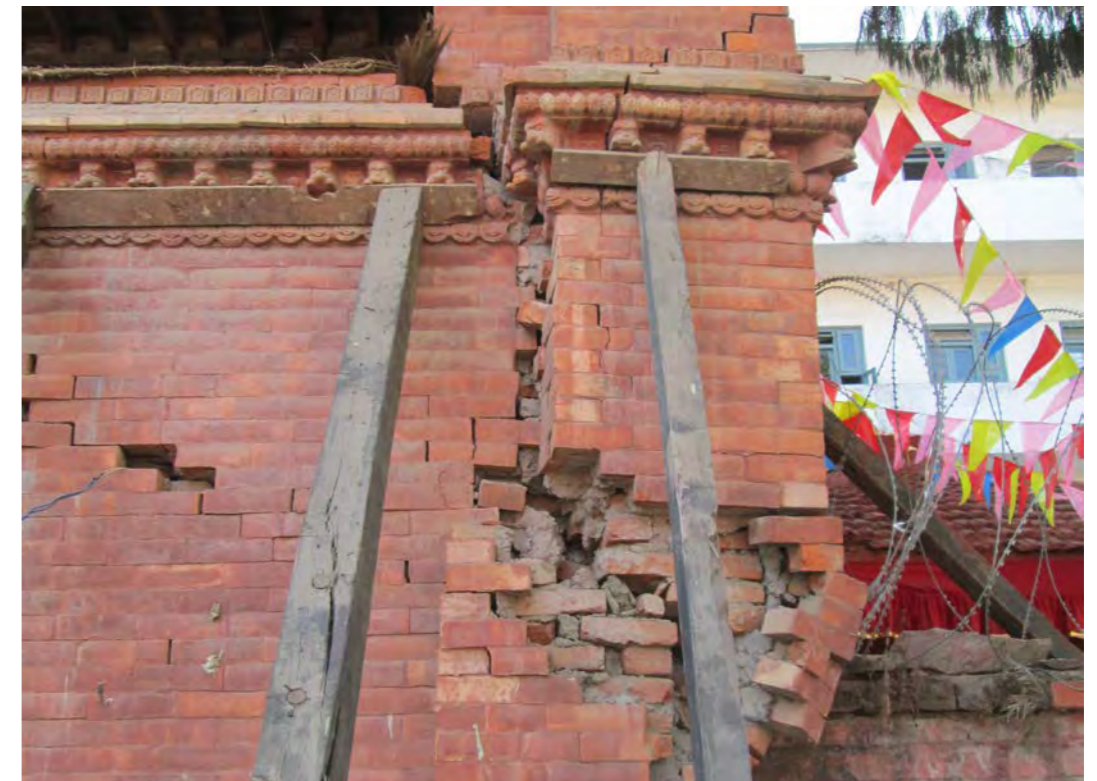
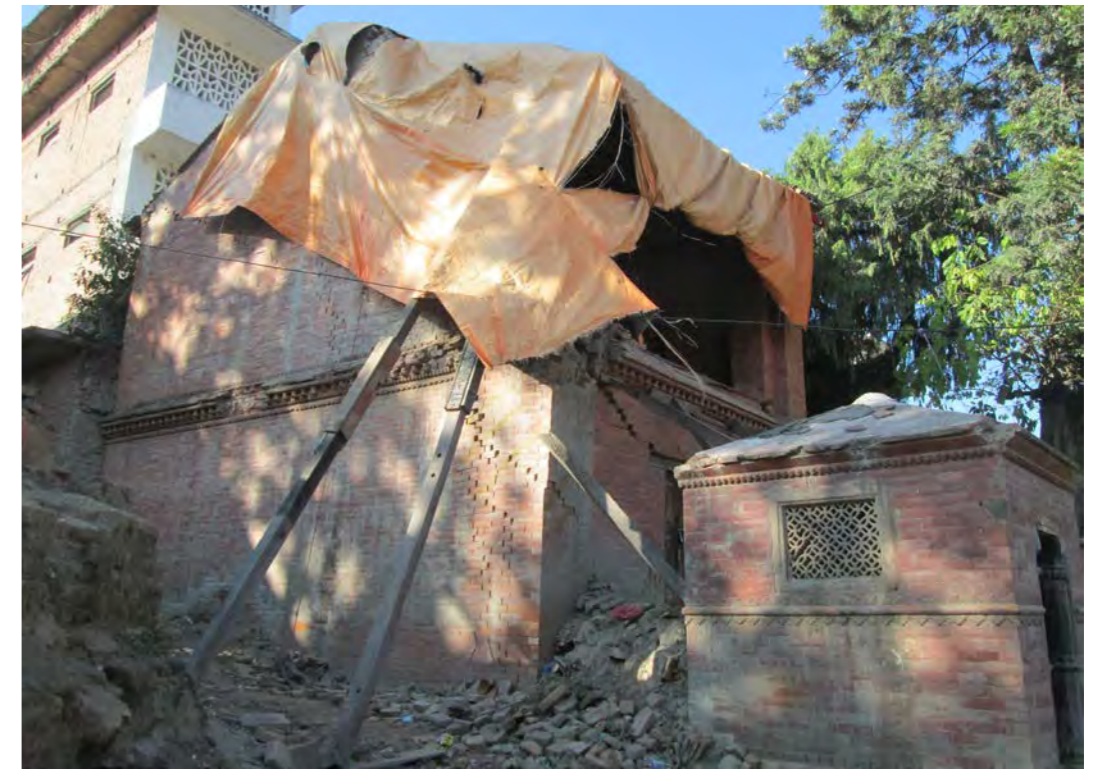
34b NAGARA GHAR

CODE NO	TYOLOGY	MONUMENT NAME	ESTABLISHED/ RENOVATED	STRUCTURAL SYSTEM	MATERIAL	GENERAL DESCRIPTION	PROBLEM DESCRIPTION	DANGER	REMARKS	
34b		Nagara Ghar				Pair of huge drums an raised platform	Unstable, tilted to north, major cracks

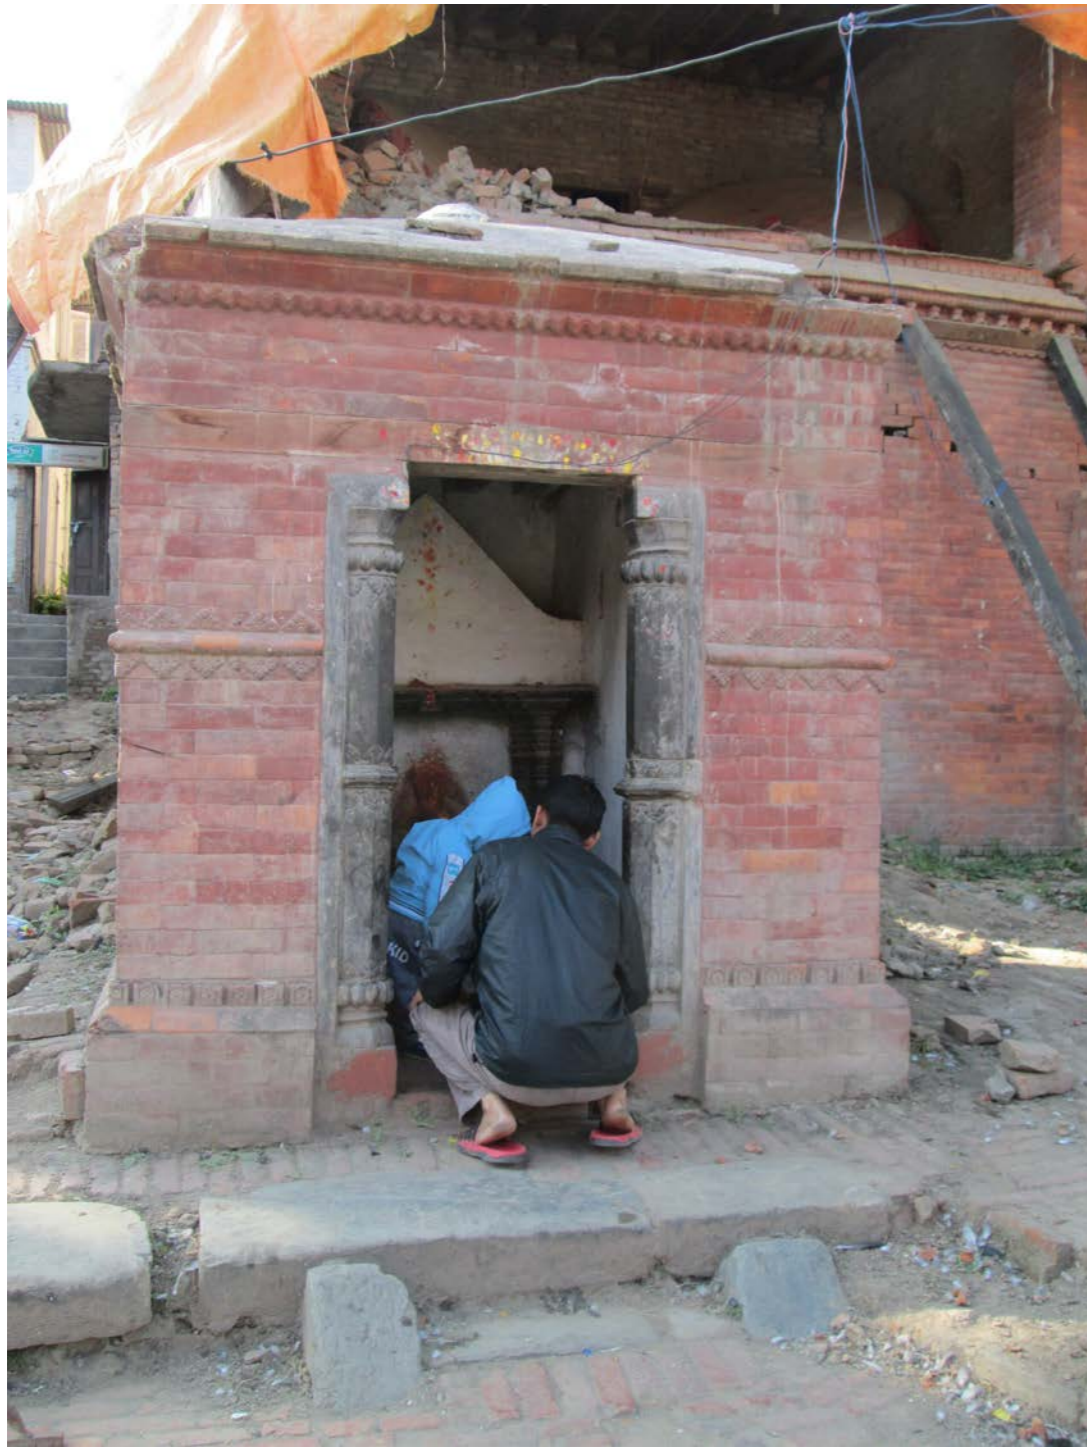
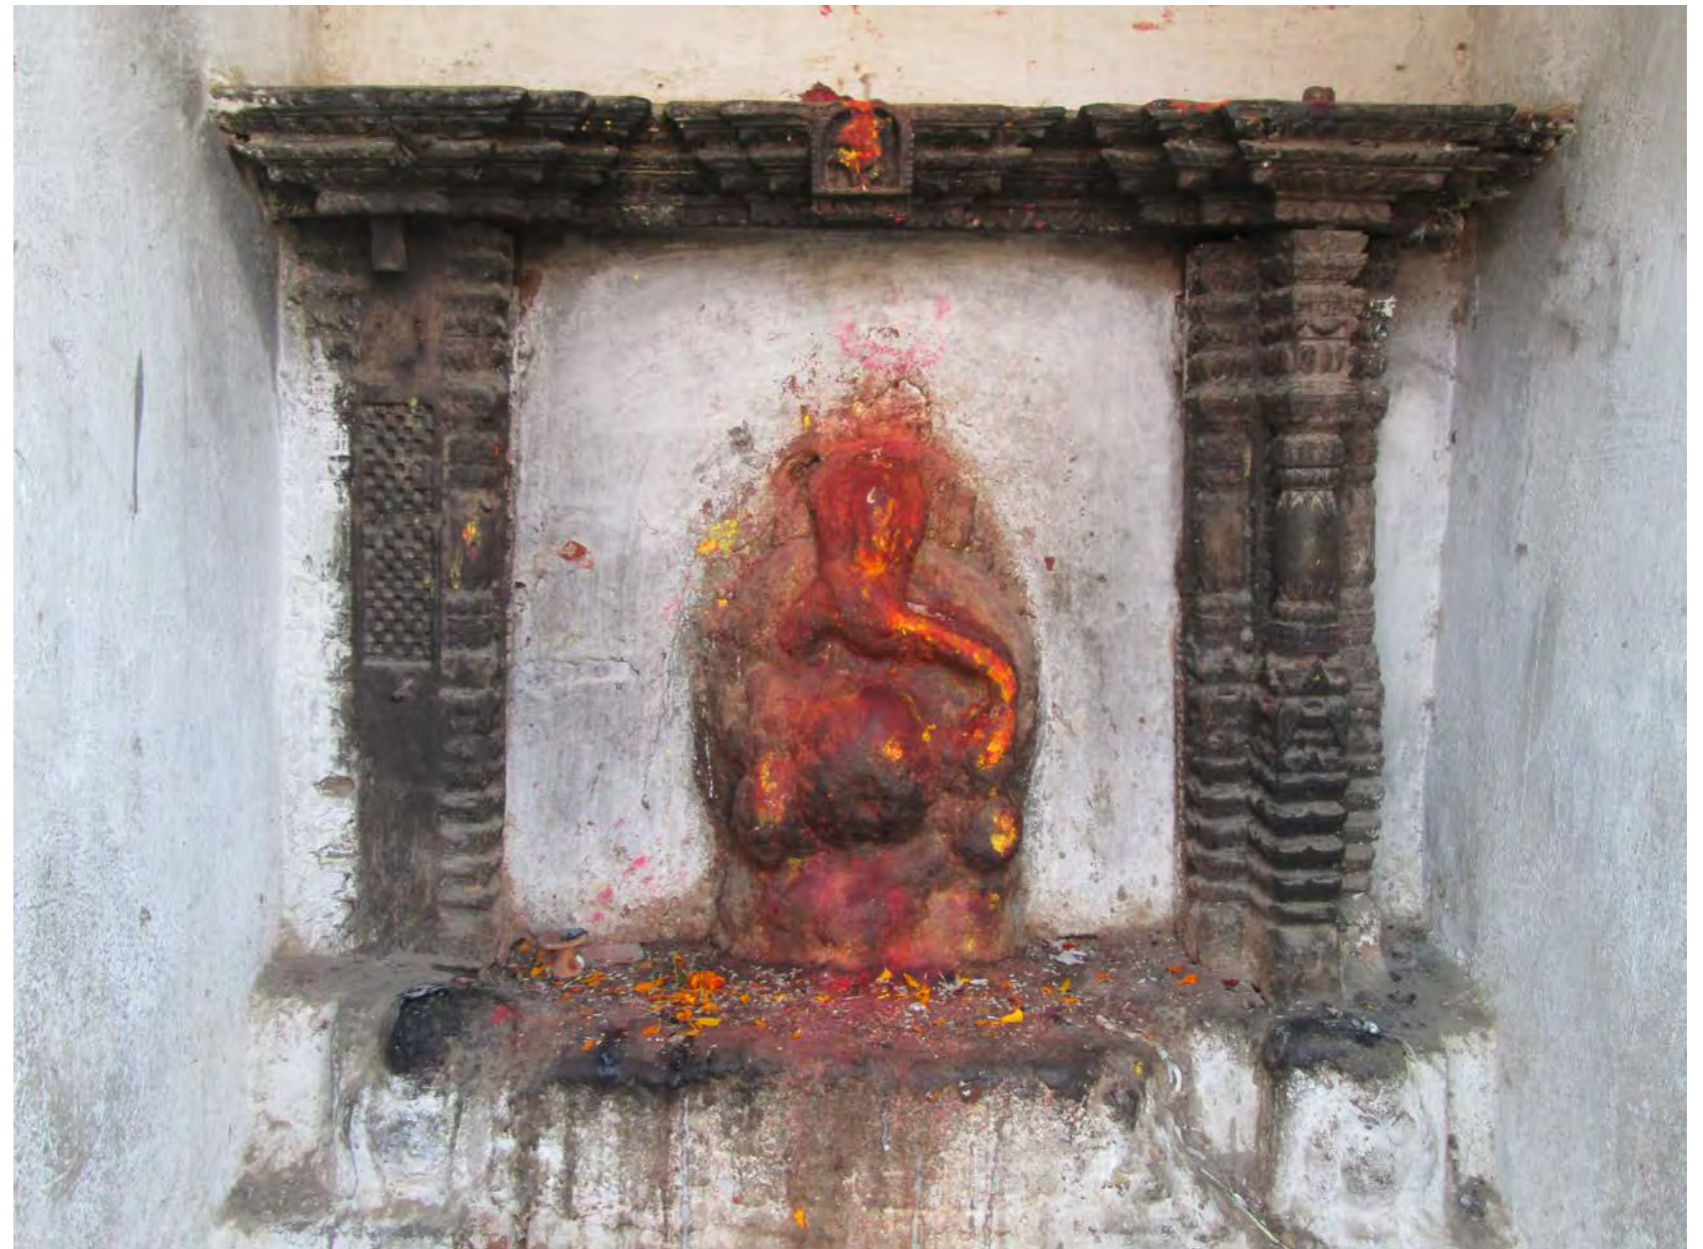
34c GANESH

CODE NO	TPOLOGY	MONUMENT NAME	ESTABLISHED/RENOVATED	STRUCTURAL SYSTEM	MATERIAL	GENERAL DESCRIPTION	PROBLEM DESCRIPTION	DANGER	REMARKS
34c	Enclosed shrine	Ganesh					No gajur, roof corner missing		A small site plan map in the bottom right corner of the table. It shows a grid of buildings. A blue octagonal shape is labeled '34'. To its left are two green rectangular shapes labeled 'c7c' and 'c7b'. To its right is a red rectangular shape labeled '34d'. The map also shows some streets and other buildings in the area.

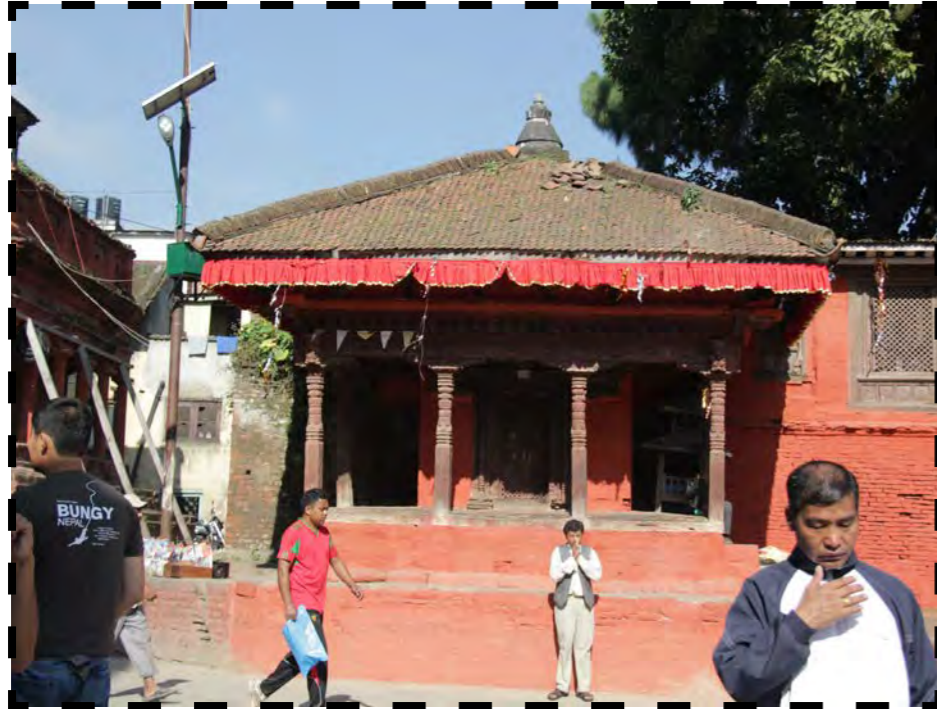
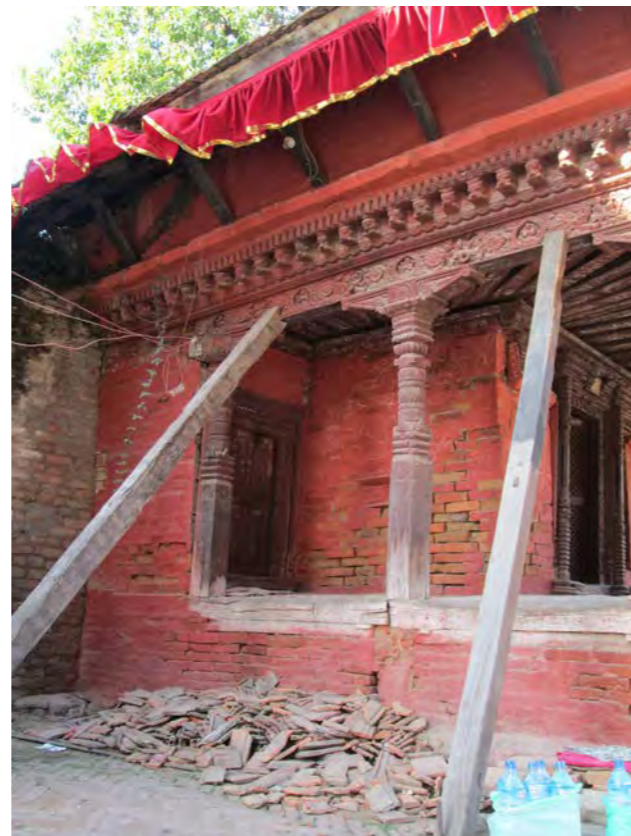
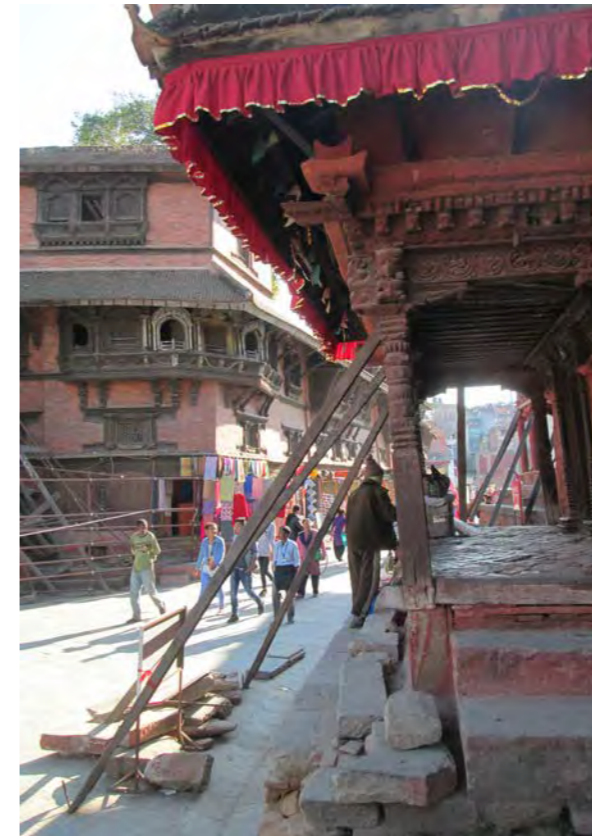
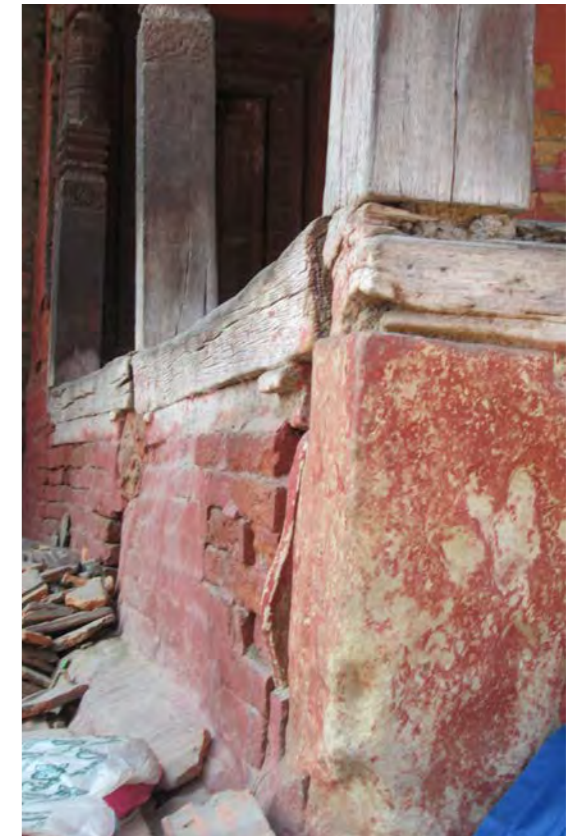
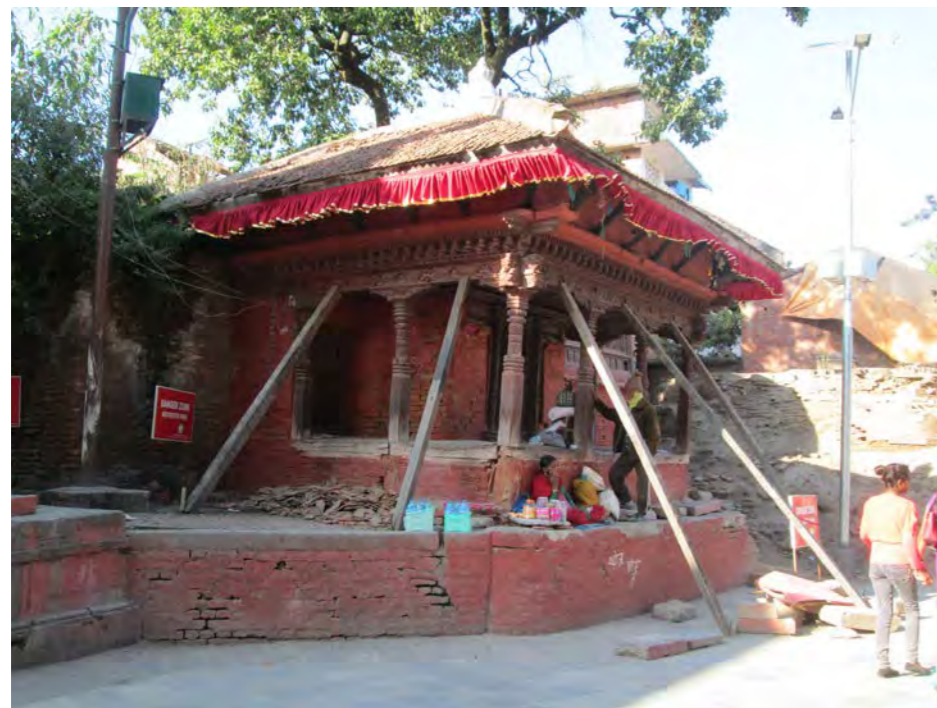
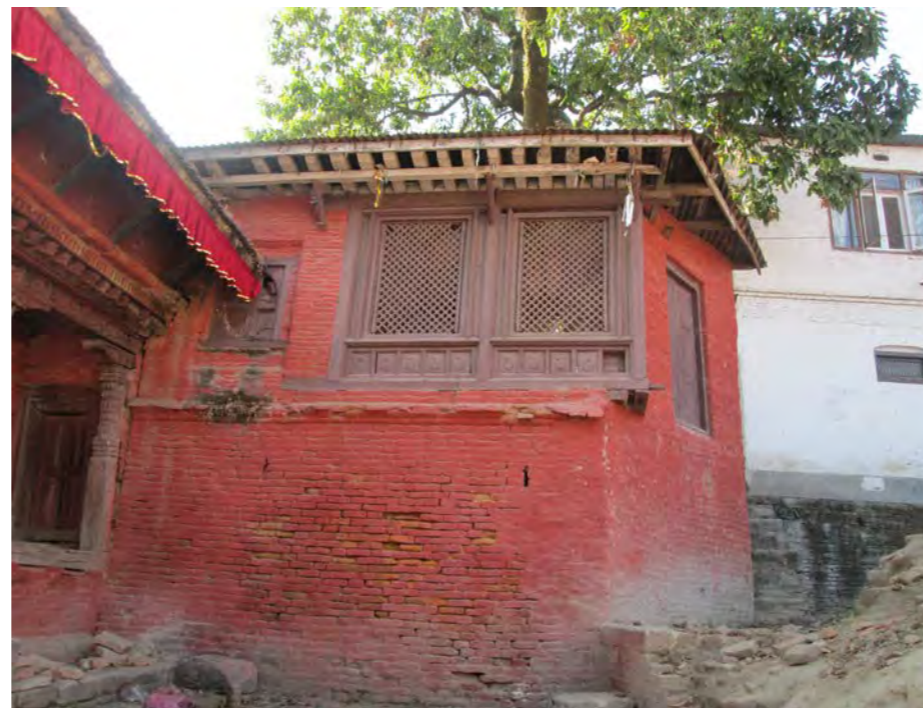
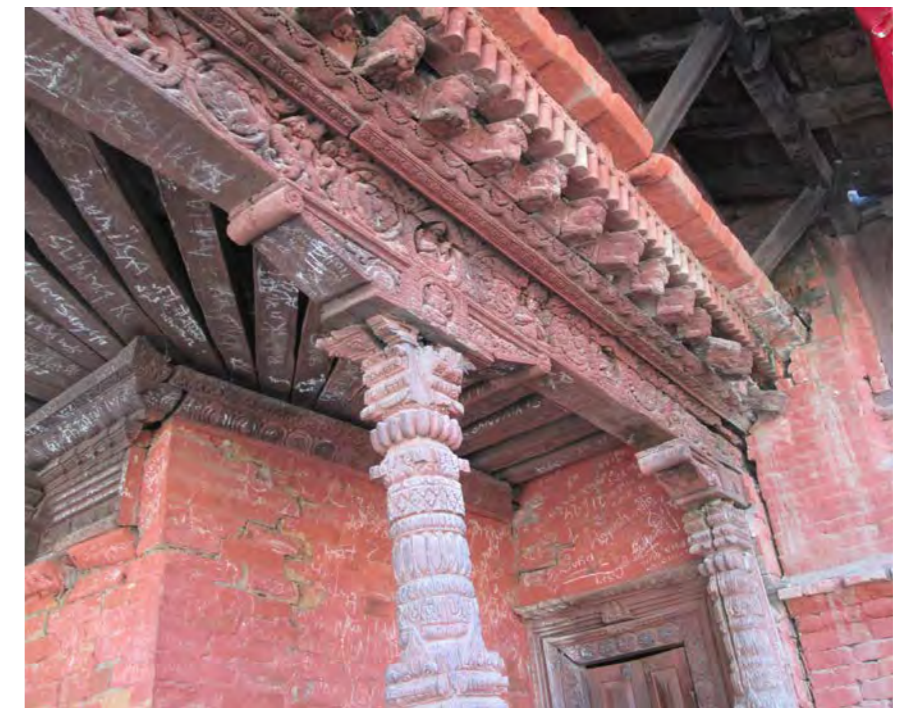
35 SARASWOTI TEMPLE

CODE NO	TYOLOGY	MONUMENT NAME	ESTABLISHED/ RENOVATED	STRUCTURAL SYSTEM	MATERIAL	GENERAL DESCRIPTION	PROBLEM DESCRIPTION	DANGER	REMARKS
35	Single storey Temple	Saraswati	18th century	Load Bearing	Brick		major cracks, tilted to south, bricks dislocation, NE corners plinth part missing, bricks deteriorated by damp

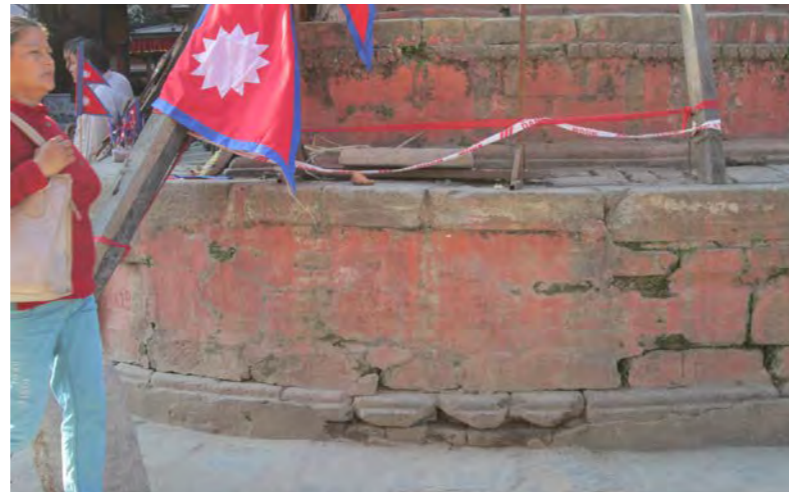
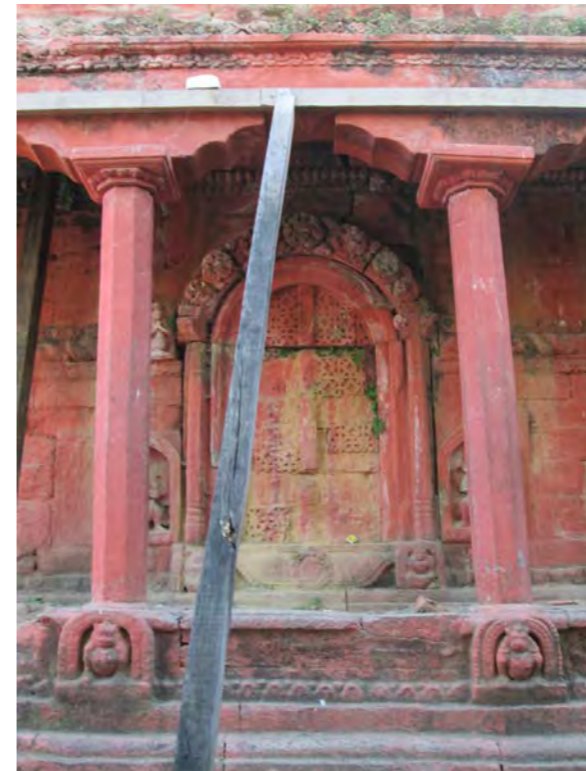
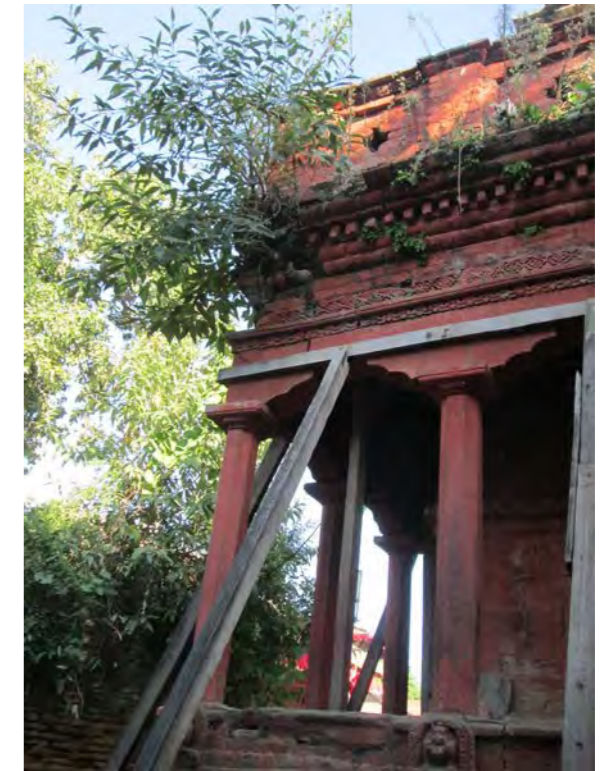
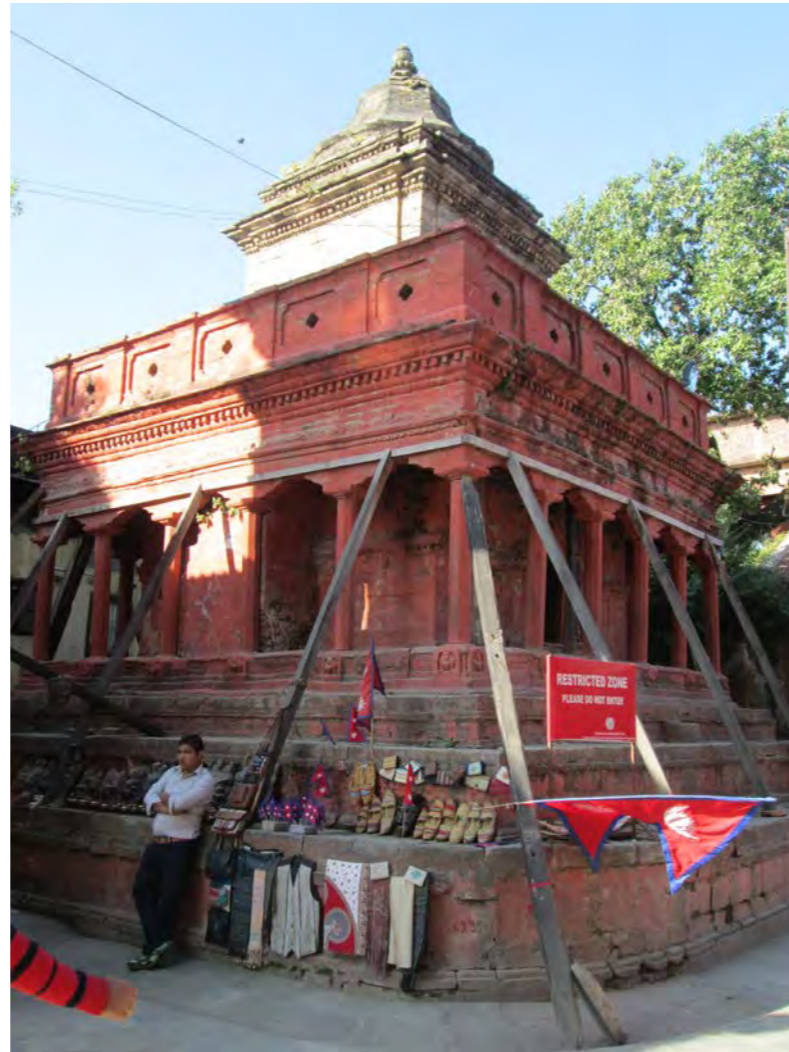
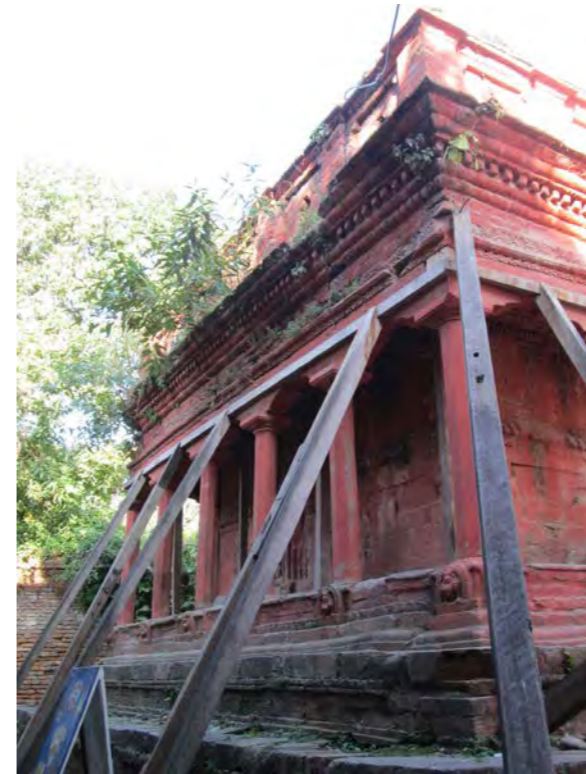
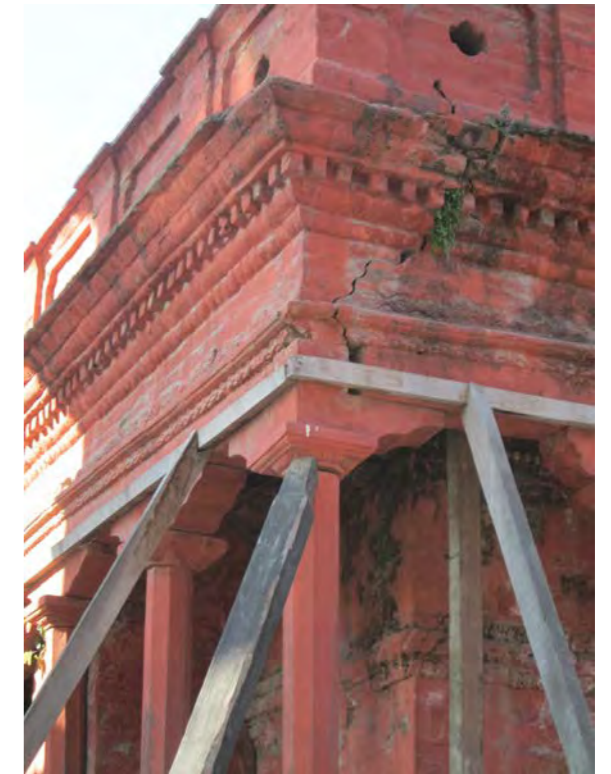
36 KRISHNA TEMPLE

CODE NO	TPOLOGY	MONUMENT NAME	ESTABLISHED/ RENOVATED	STRUCTURAL SYSTEM	MATERIAL	GENERAL DESCRIPTION	PROBLEM DESCRIPTION	DANGER	REMARKS
36	Three storey Temple	4 armed krishna					wall cracks all over, tilted to SE
