2015 Earthquake Damage Mapping

Hanuman Dhoka Darbar Square Monument Zone
Kathmandu Valley World Heritage Property

December 2015

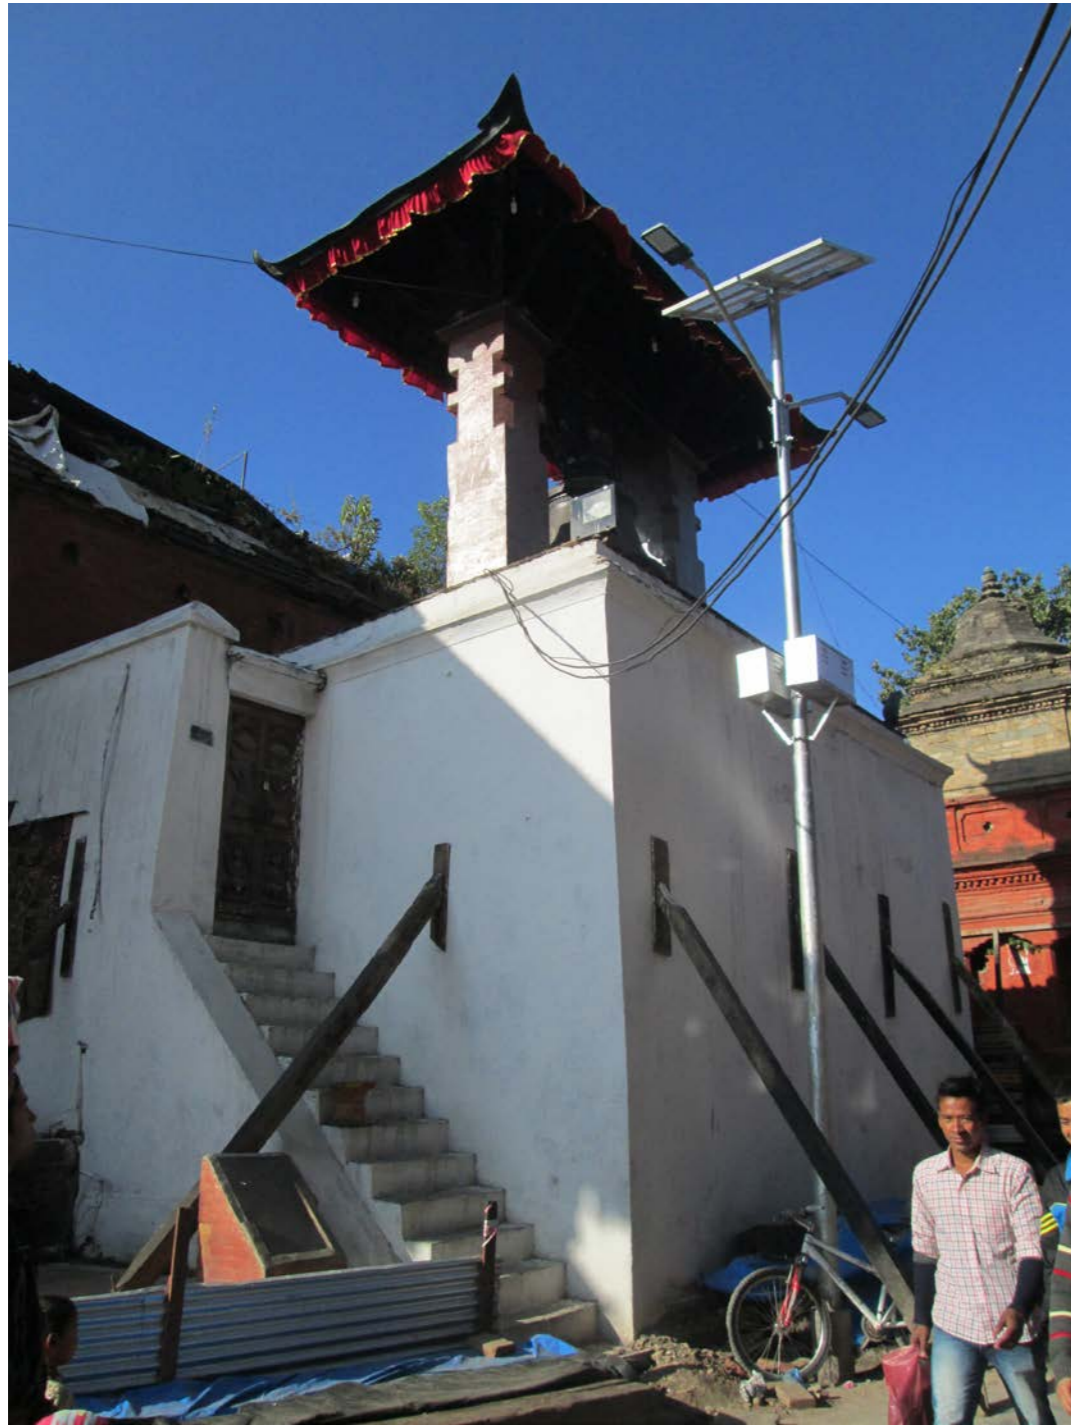
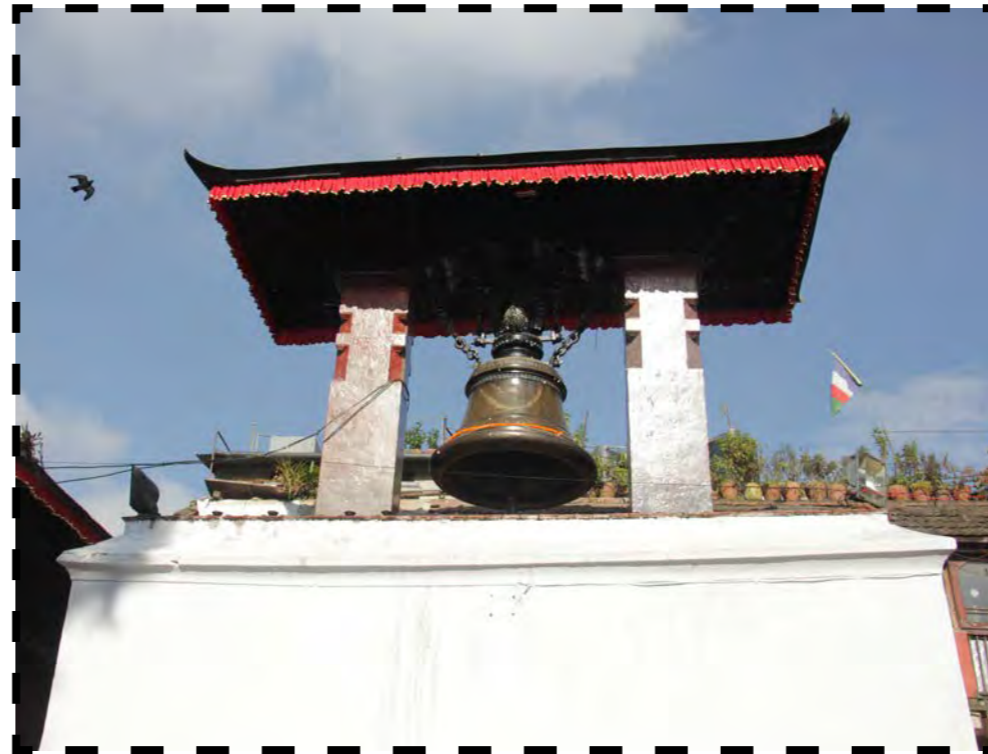
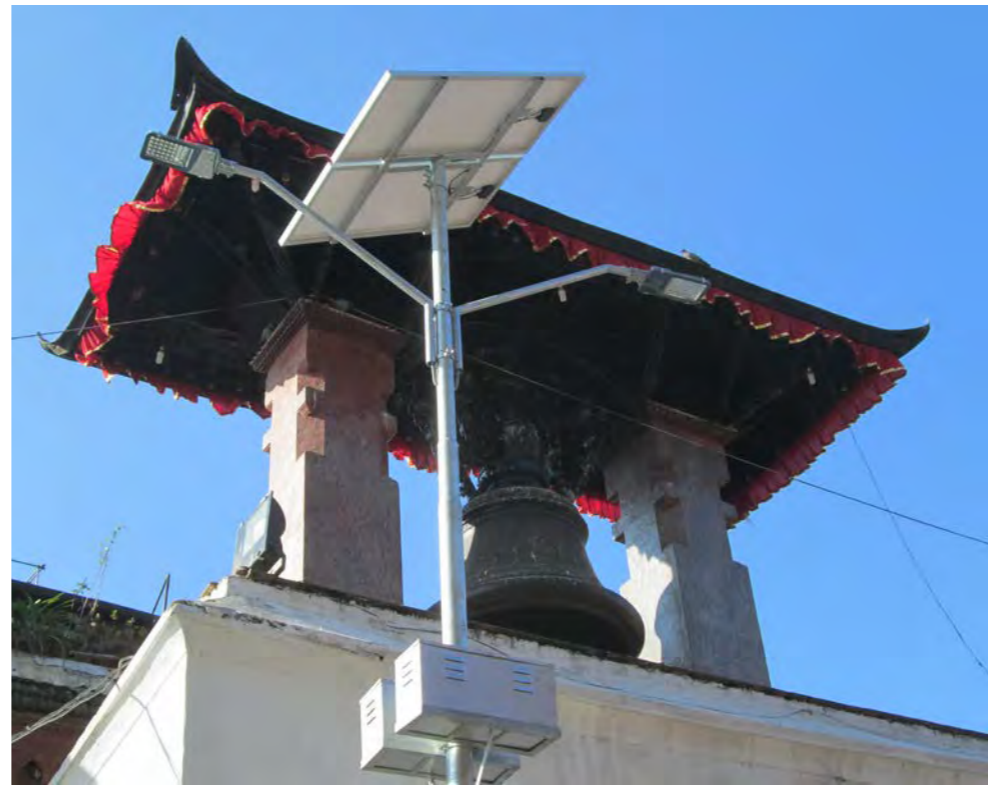
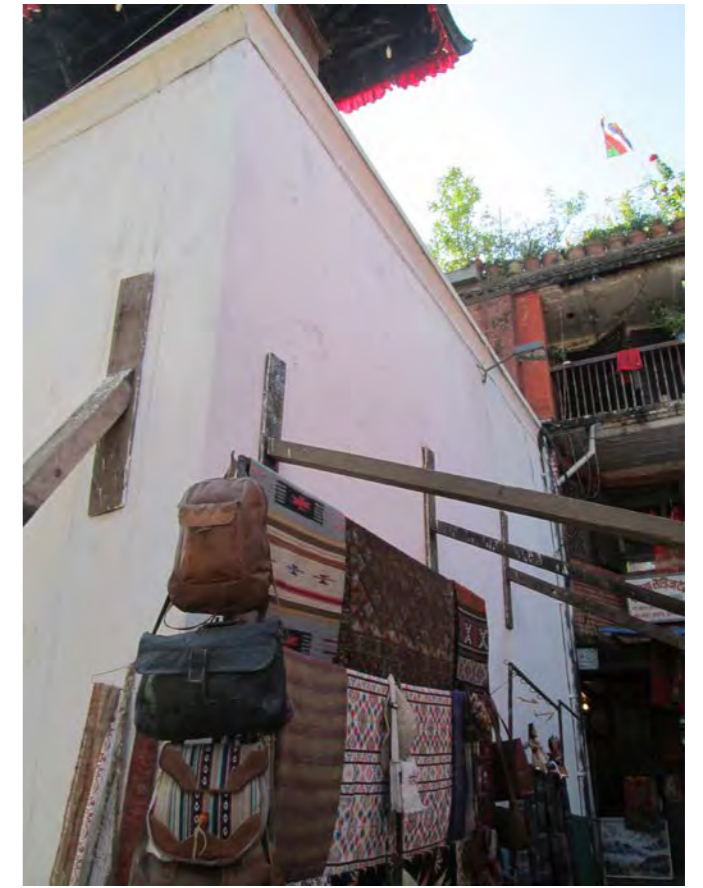
37 TAGA GAN

CODE NO	TYOLOGY	MONUMENT NAME	ESTABLISHED/ RENOVATED	STRUCTURAL SYSTEM	MATERIAL	GENERAL DESCRIPTION	PROBLEM DESCRIPTION	DANGER	REMARKS
37		Taga Gan	1779				Base may be unstable

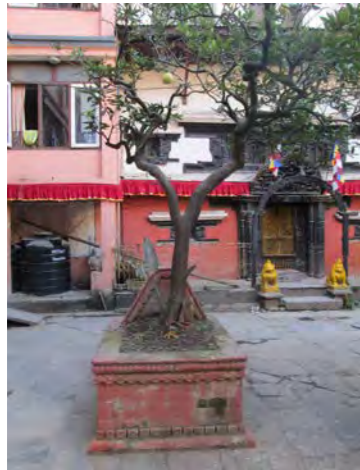
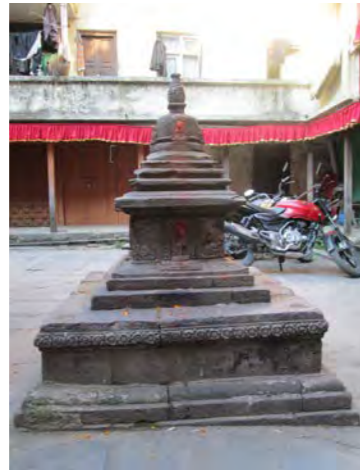
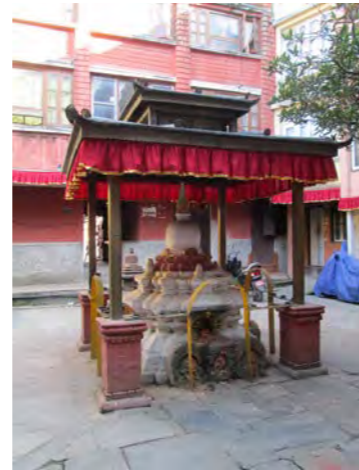
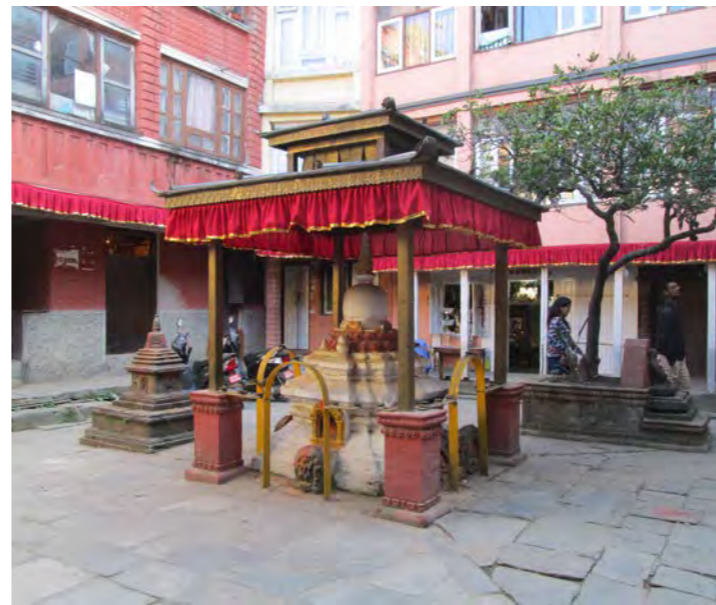
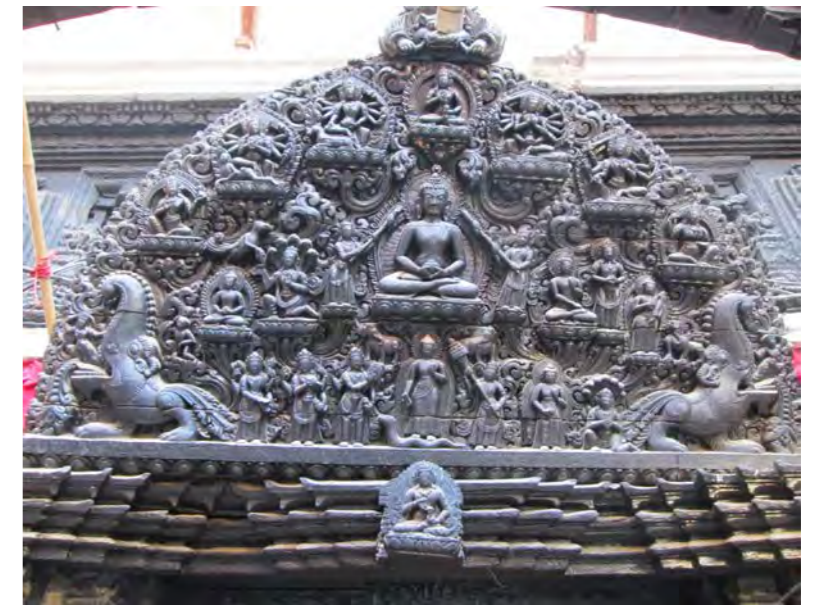
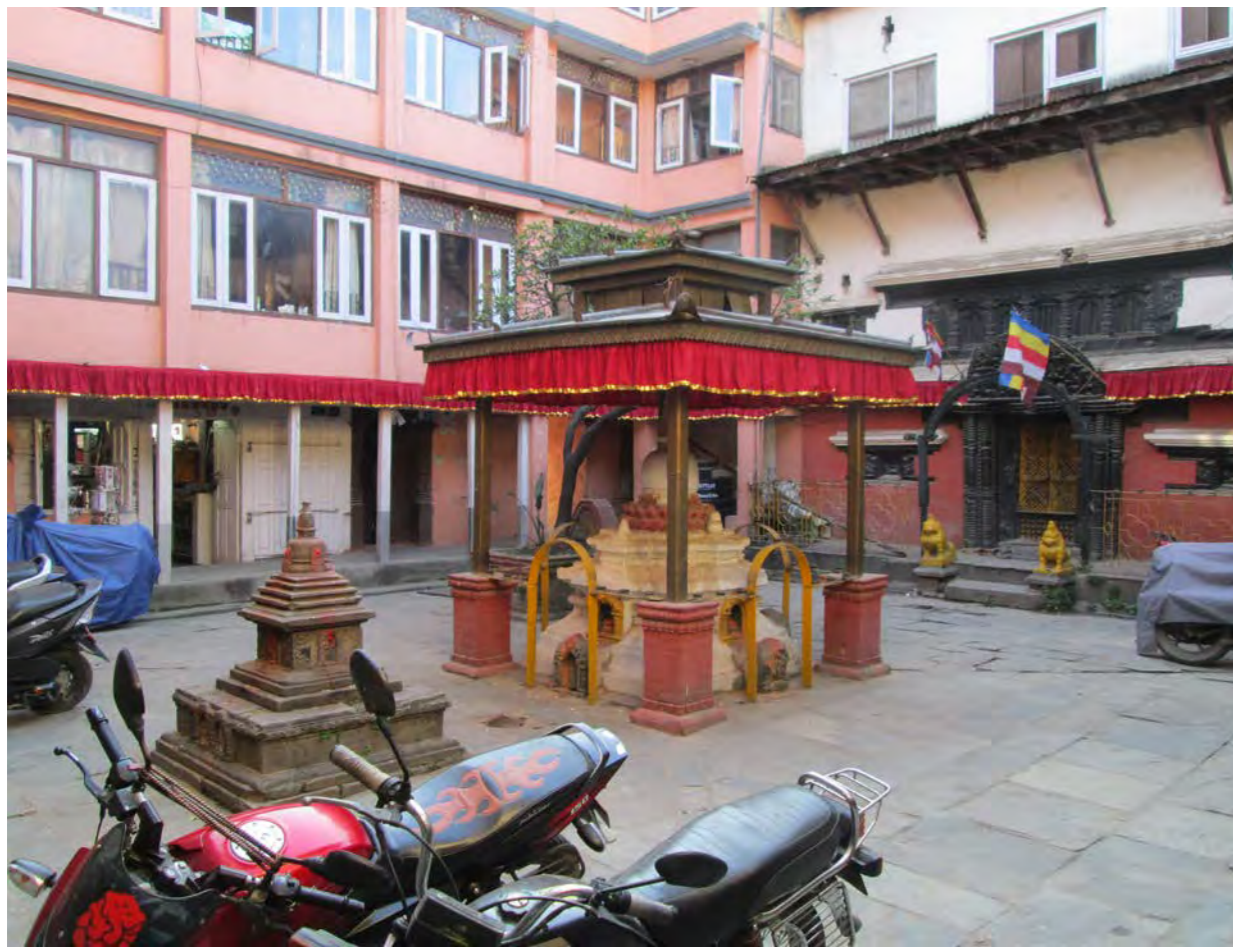
38 LYAKU BAHU

CODE NO	TYOLOGY	MONUMENT NAME	ESTABLISHED/ RENOVATED	STRUCTURAL SYSTEM	MATERIAL	GENERAL DESCRIPTION	PROBLEM DESCRIPTION	DANGER	REMARKS	
38	Bahi	Lyaku Bahi		Load Bearing	Brick	G+2	Minor cracks on outer wall

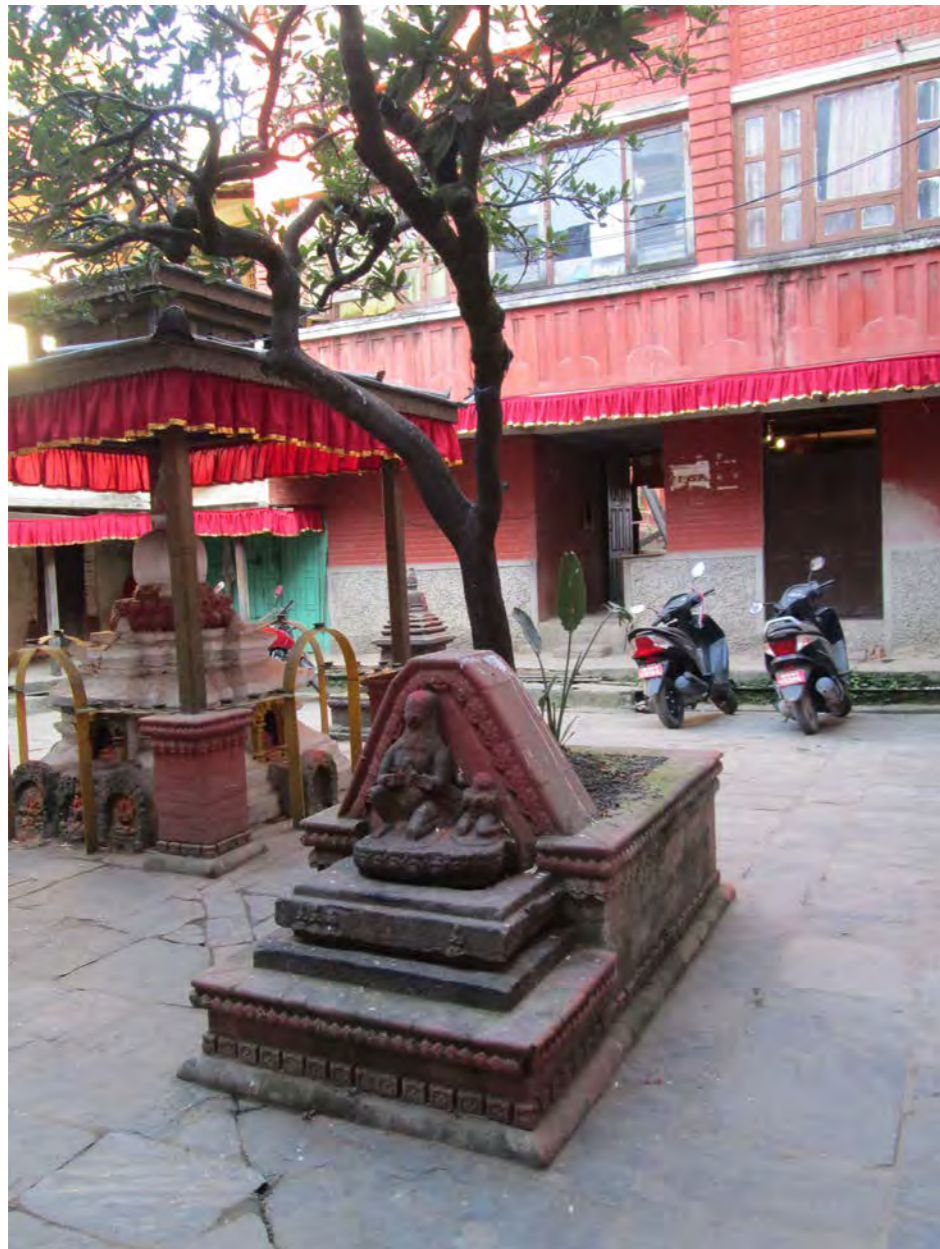
CODE NO	TYOLOGY	MONUMENT NAME	ESTABLISHED/ RENOVATED	STRUCTURAL SYSTEM	MATERIAL	GENERAL DESCRIPTION	PROBLEM DESCRIPTION	DANGER	REMARKS
38a	Open Shrine					shrine under tree	No visible damage		
38b	Chaitya					covered by metal roof	No visible damage		
38c	Chaitya						No visible damage

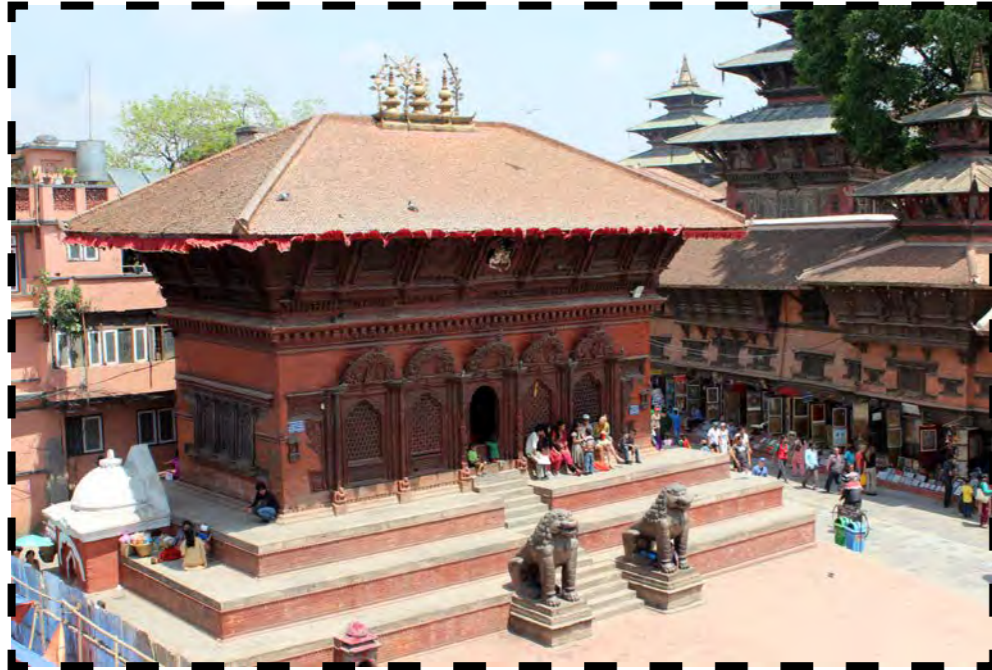
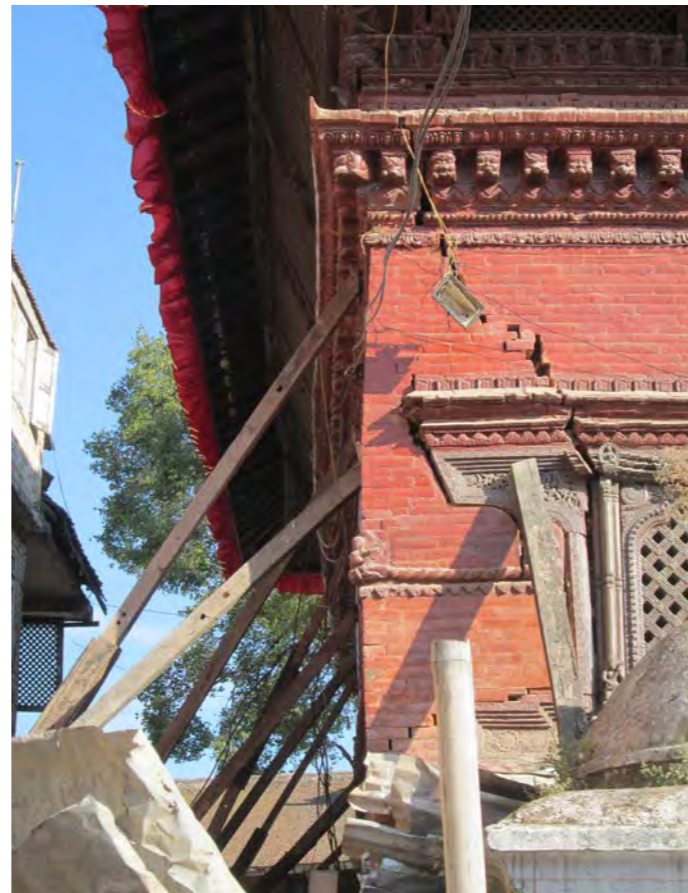
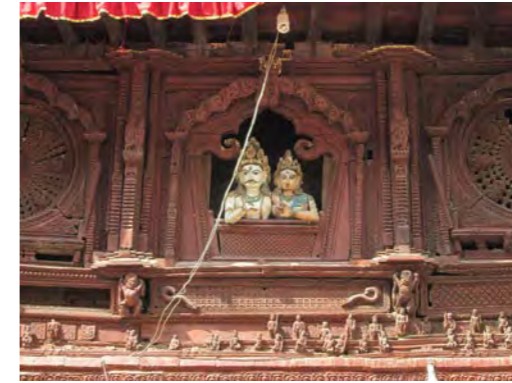
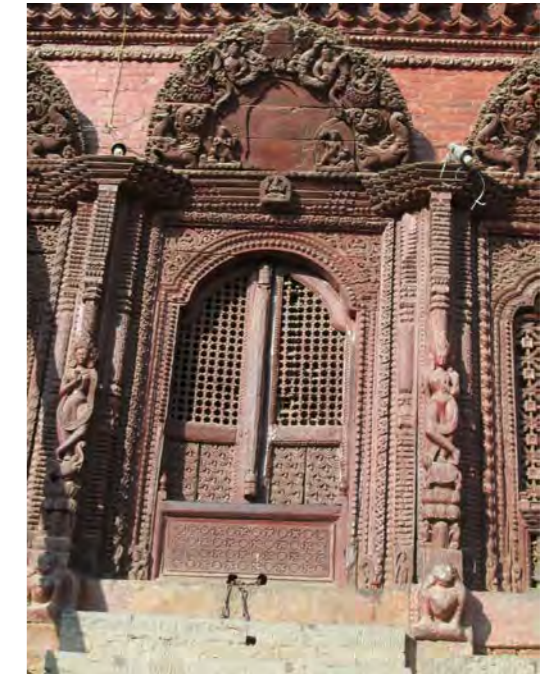
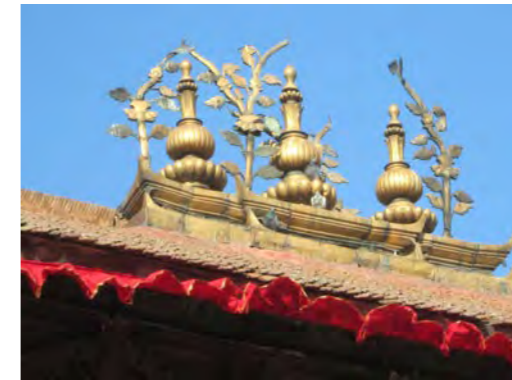
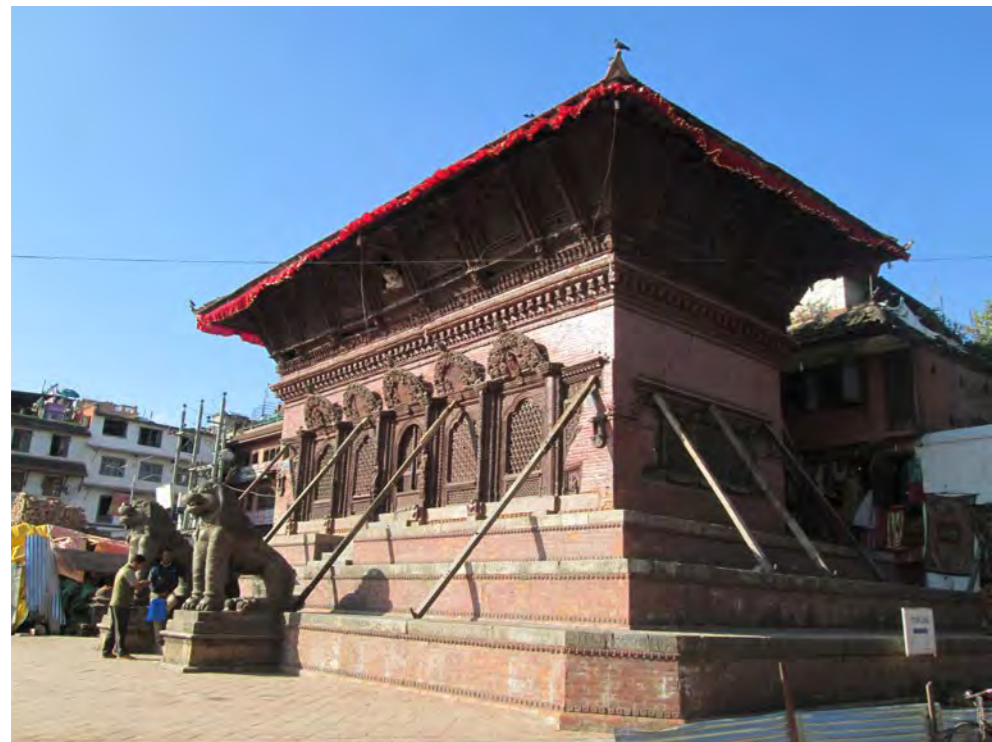
39 NAVA JOGINI HOUSE (SHIVA PARBATI TEMPLE)

CODE NO	TYOLOGY	MONUMENT NAME	ESTABLISHED/ RENOVATED	STRUCTURAL SYSTEM	MATERIAL	GENERAL DESCRIPTION	PROBLEM DESCRIPTION	DANGER	REMARKS
39	Single storey temple	Nava Jogini		Load Bearing	Brick	Rectangular temple on stepped brick platform. Figures of Shiva and Parvati looking down the street	Tilted to north, major cracks in walls

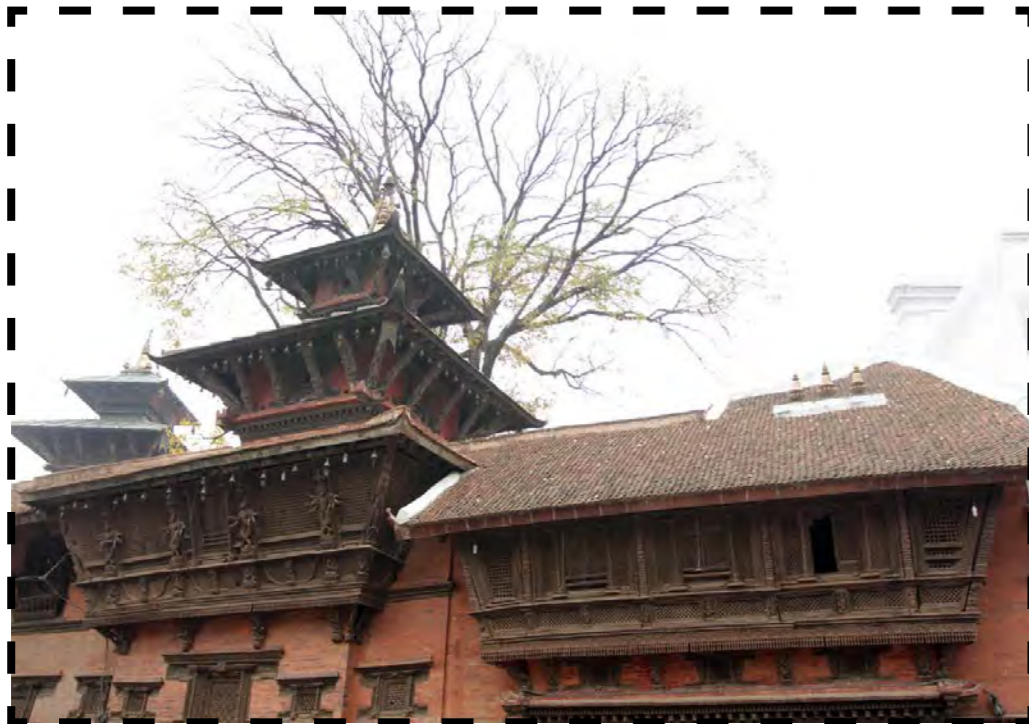
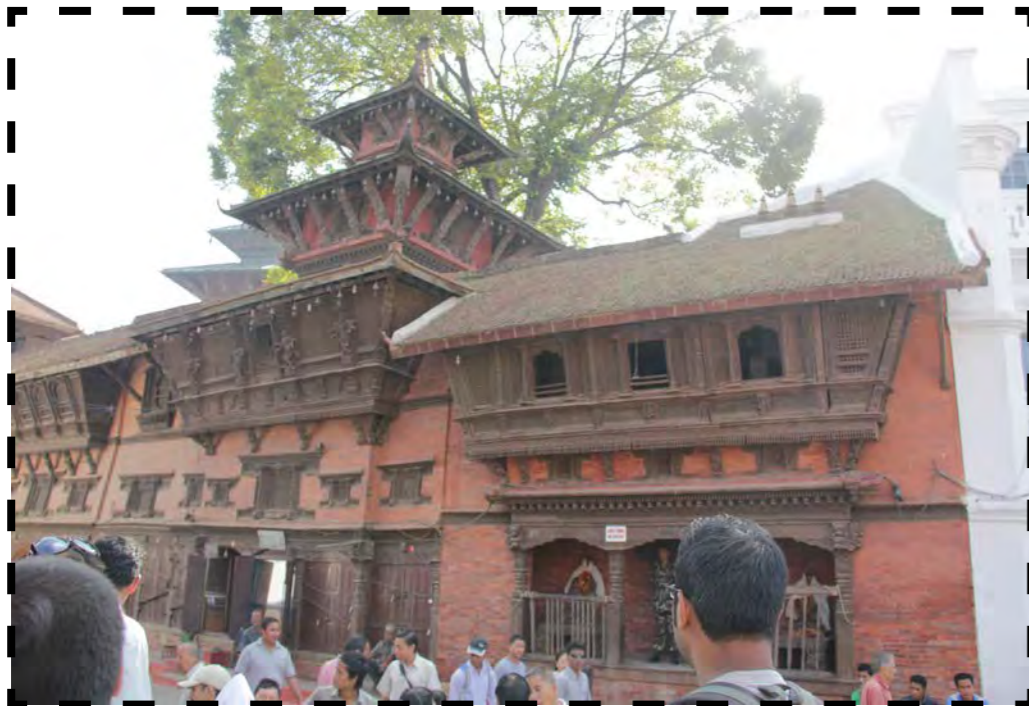
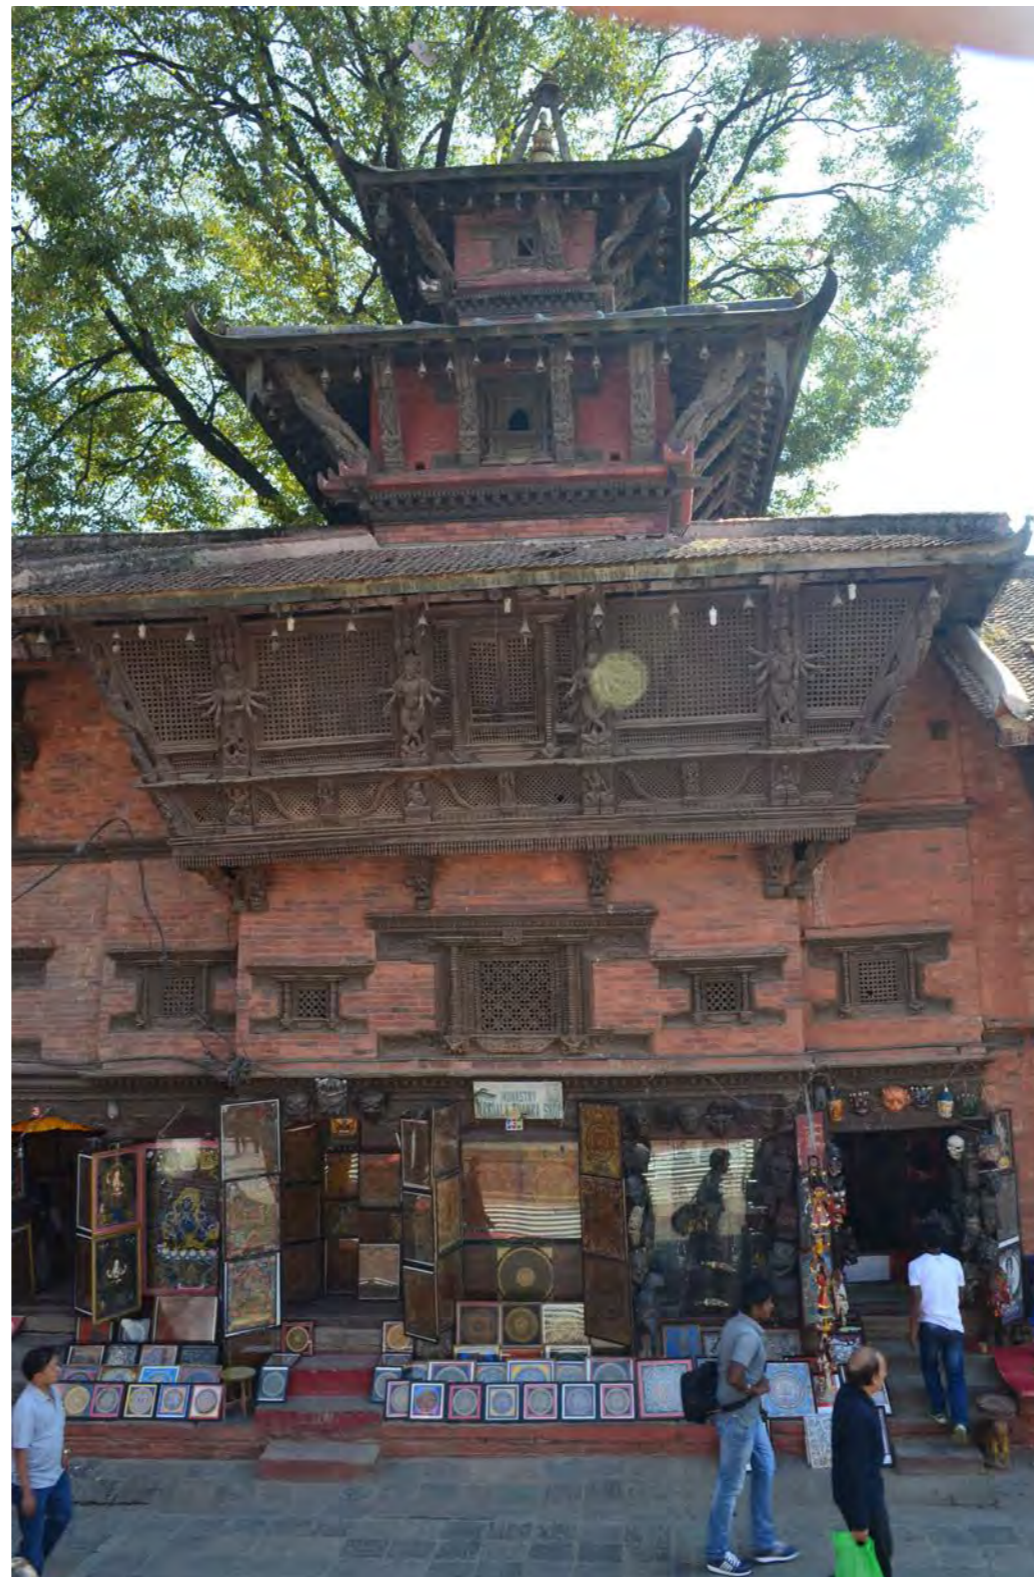
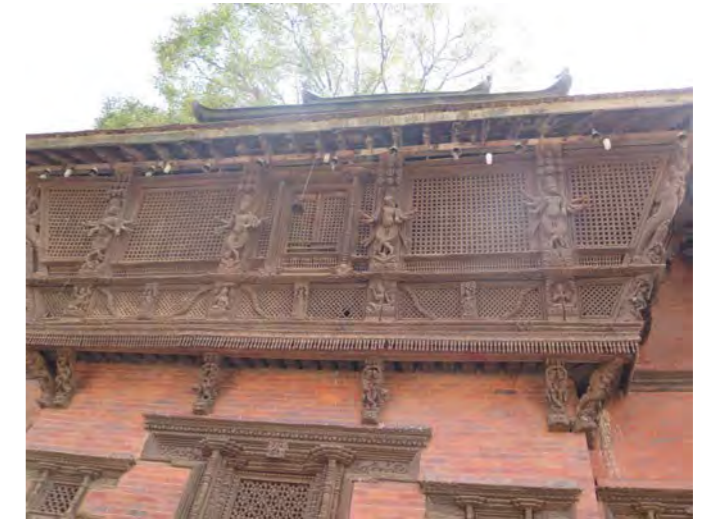
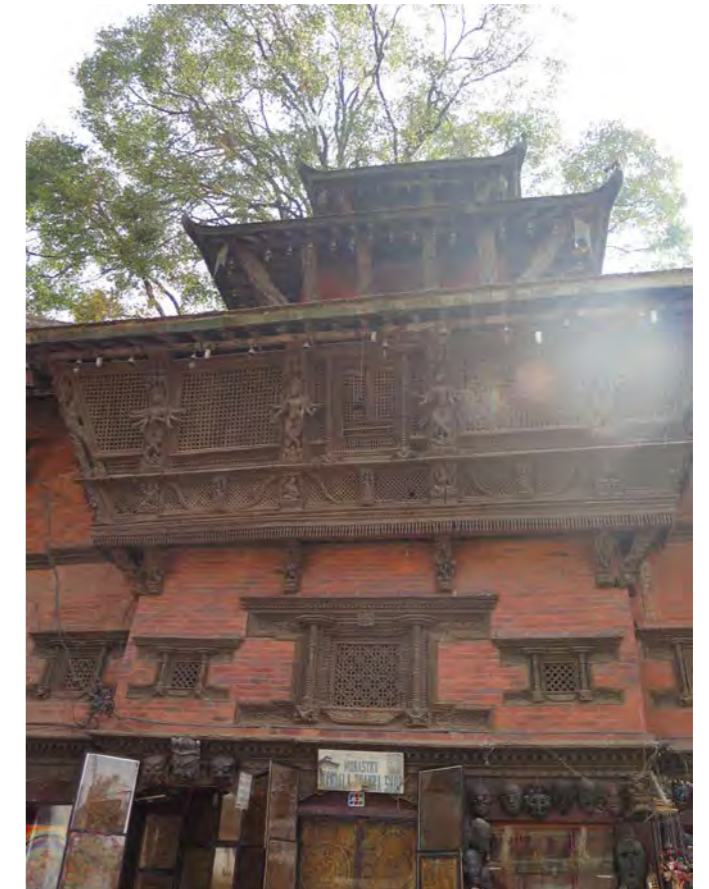
40 BHAGWATI TEMPLE

CODE NO	TYOLOGY	MONUMENT NAME	ESTABLISHED/ RENOVATED	STRUCTURAL SYSTEM	MATERIAL	GENERAL DESCRIPTION	PROBLEM DESCRIPTION	DANGER	REMARKS
40	Two Storey Temple	Bhagvati		Load Bearing	Brick	Bhagvati shrine built over the palace. Wooden struts and latted balcony are carved.	Bulging of walls

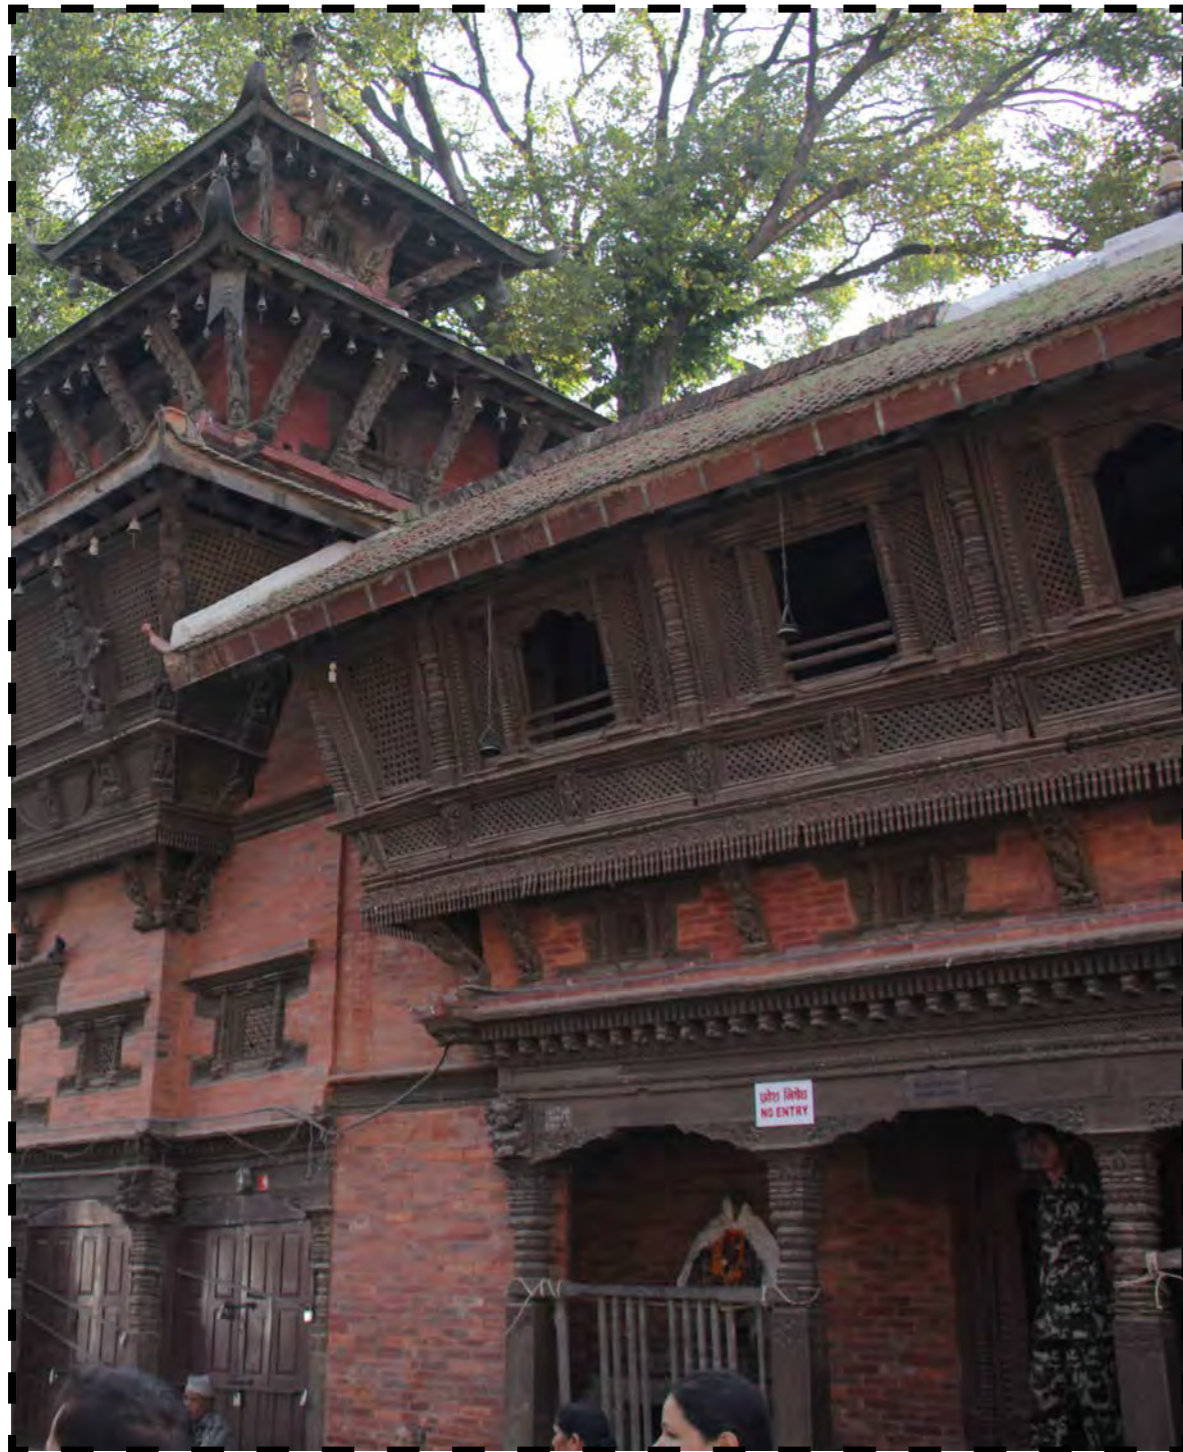
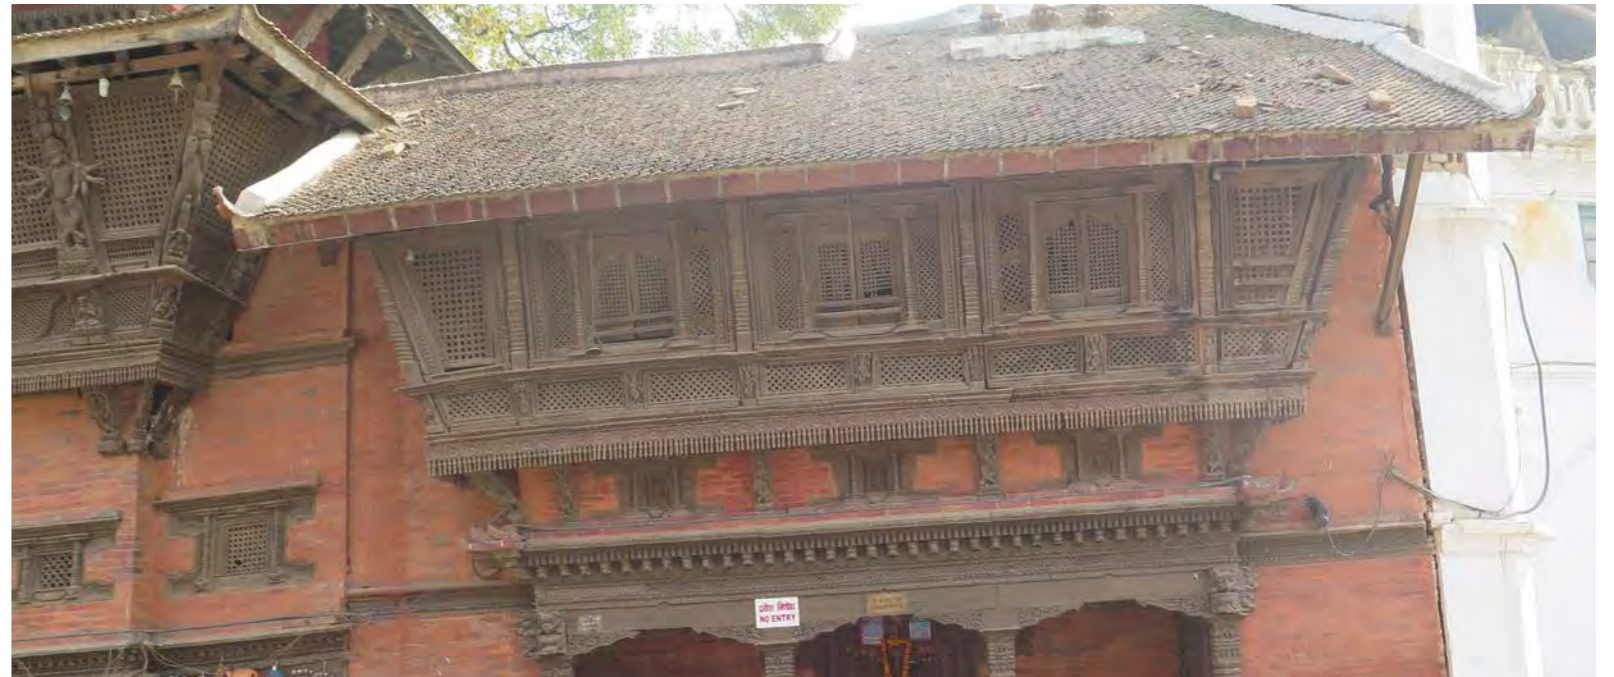
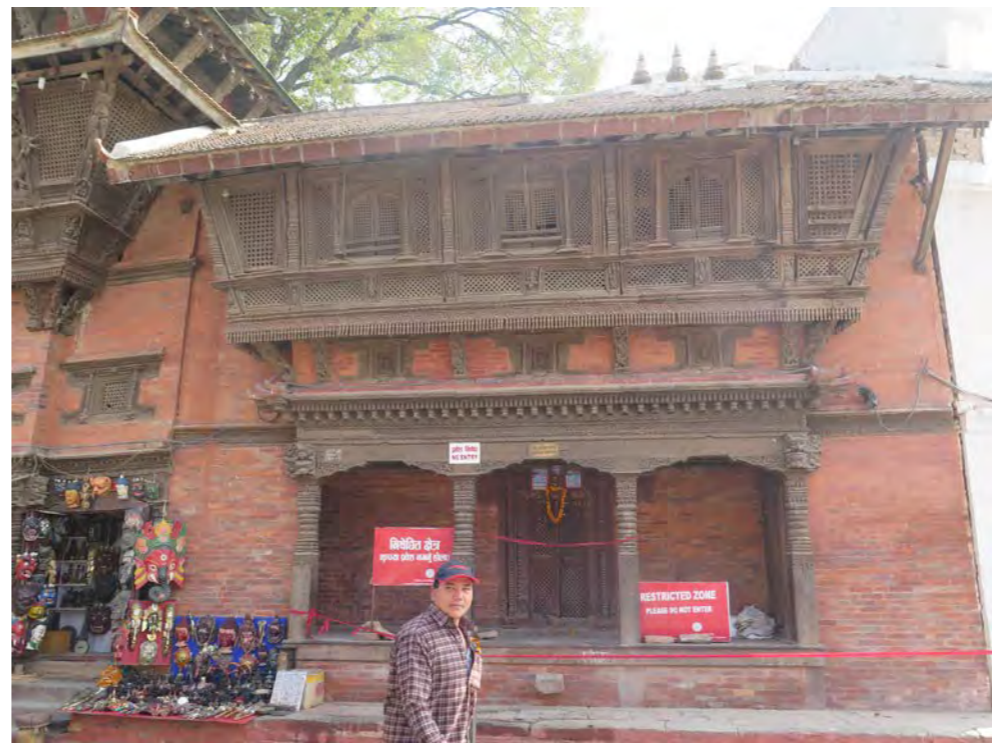
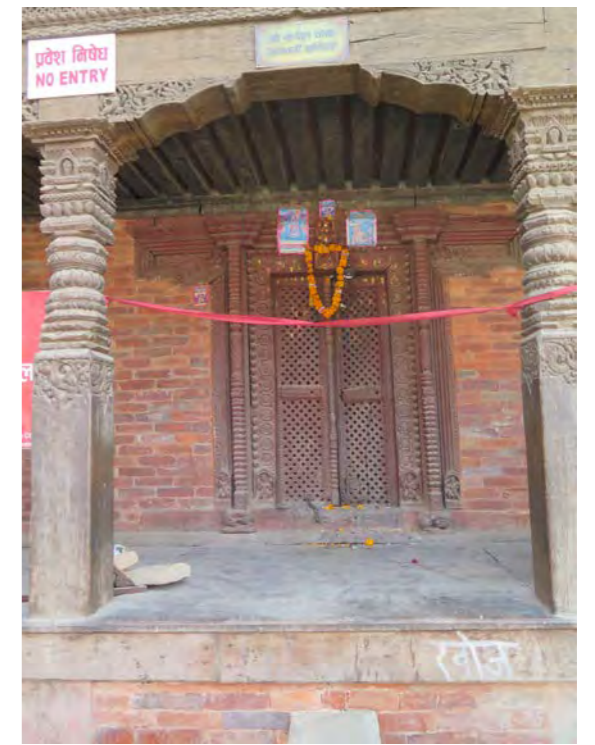
41 KUMARI TEMPLE

CODE NO	TYOLOGY	MONUMENT NAME	ESTABLISHED/ RENOVATED	STRUCTURAL SYSTEM	MATERIAL	GENERAL DESCRIPTION	PROBLEM DESCRIPTION	DANGER	REMARKS
41	Two Storey Temple	Kumari	1741	Load Bearing	Brick	Small shrine made in form of normal storeyed temple	Bulging of walls

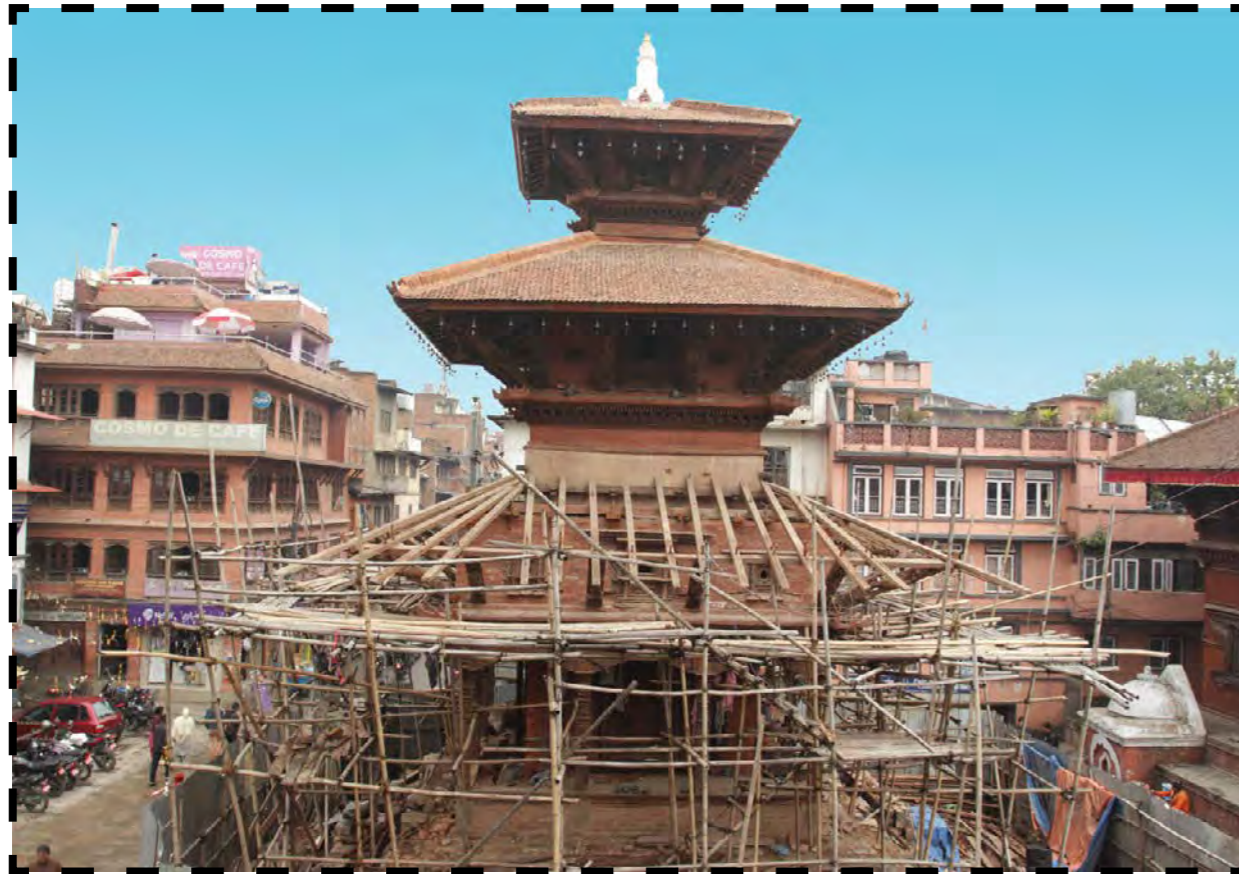
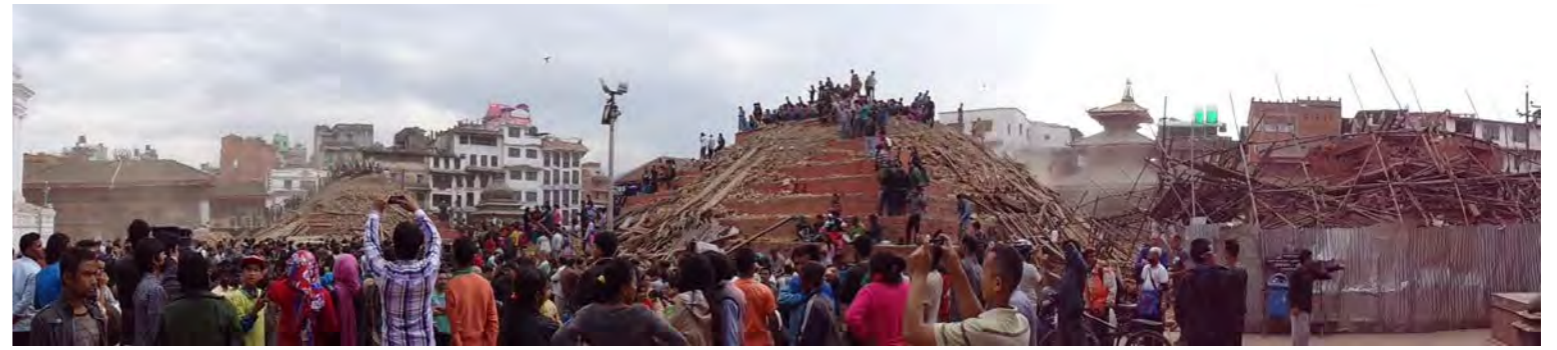
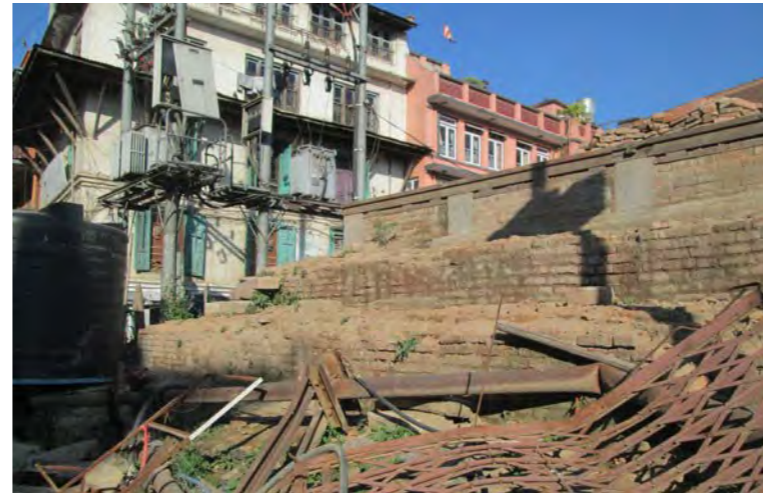
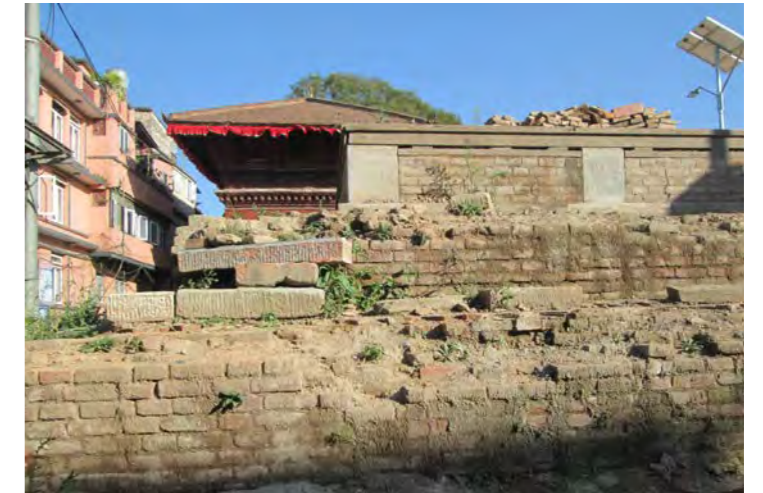
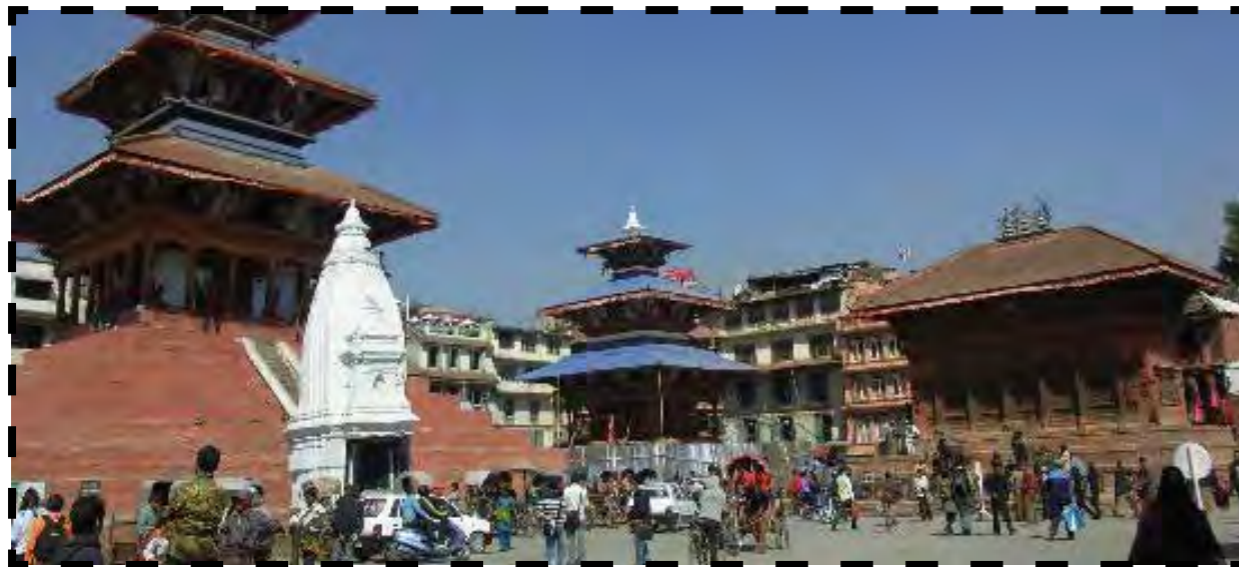
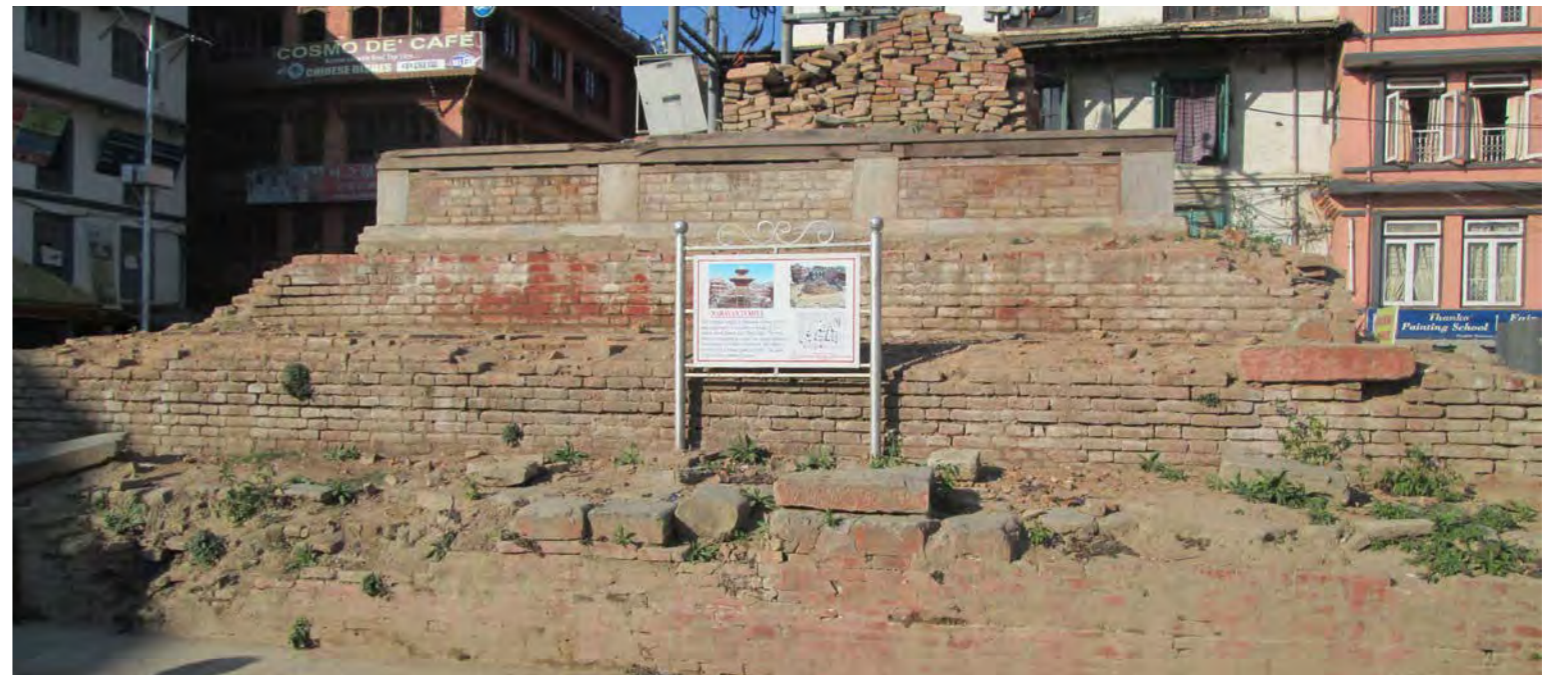
42 NARAYAN TEMPLE

CODE NO	TYOLOGY	MONUMENT NAME	ESTABLISHED/ RENOVATED	STRUCTURAL SYSTEM	MATERIAL	GENERAL DESCRIPTION	PROBLEM DESCRIPTION	DANGER	REMARKS
42	Three storey temple	Narayan				Was being renovated during Eq	Totally collapsed
