2015 Earthquake Damage Mapping

Hanuman Dhoka Darbar Square Monument Zone
Kathmandu Valley World Heritage Property

December 2015

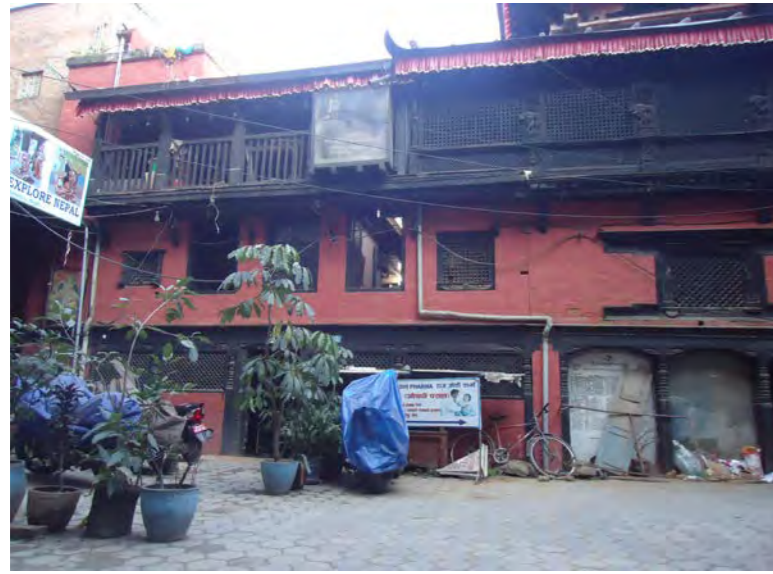
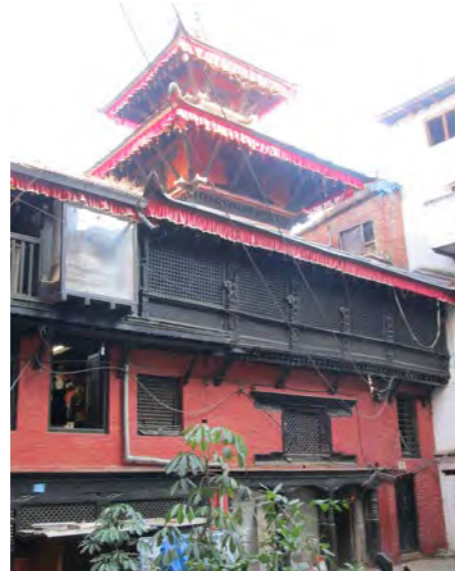
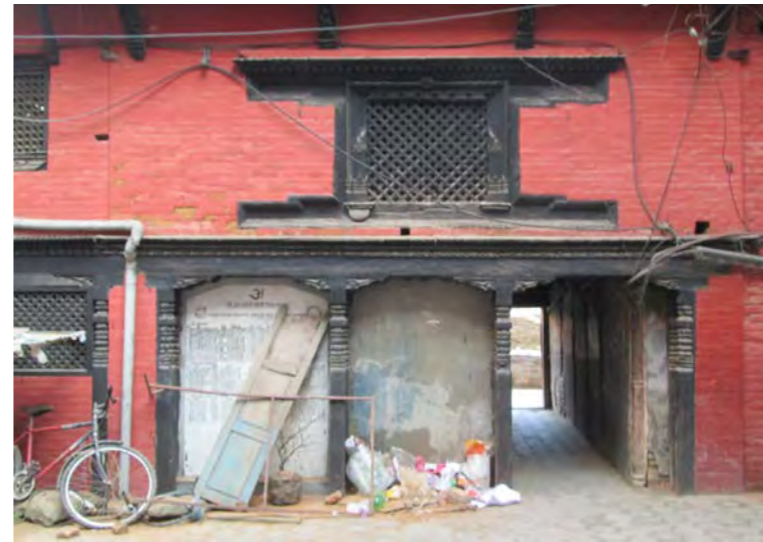
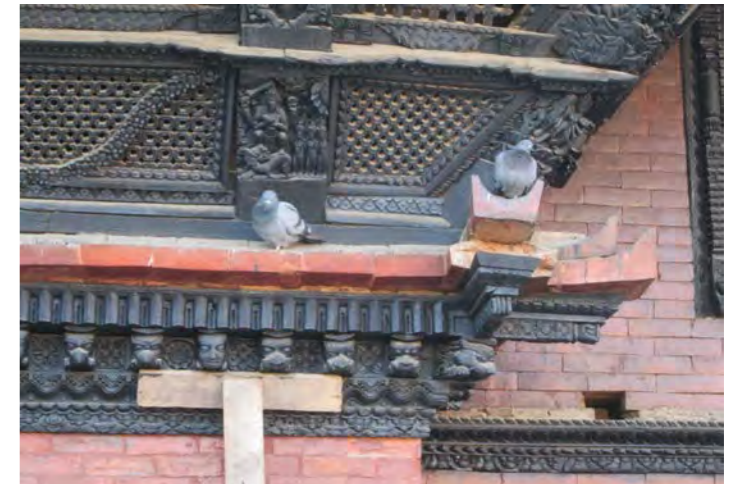
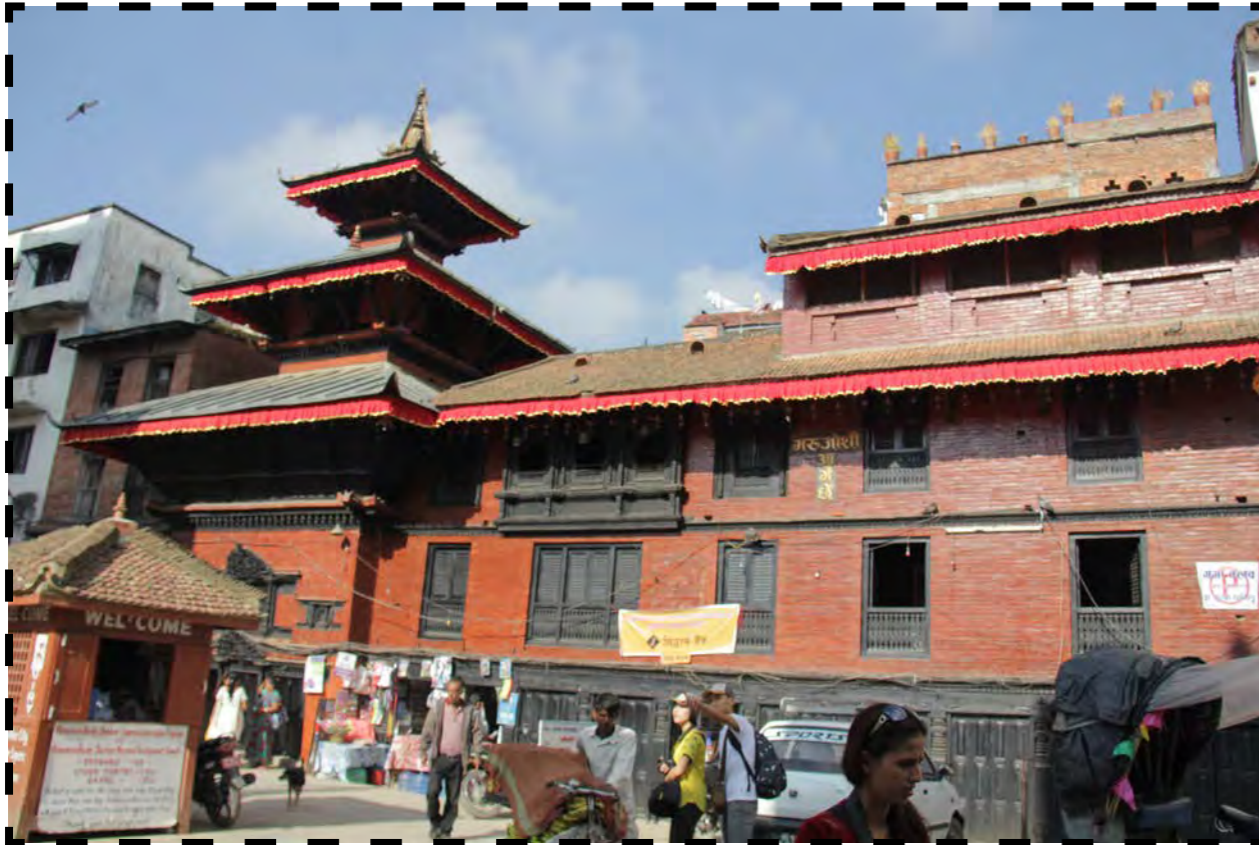
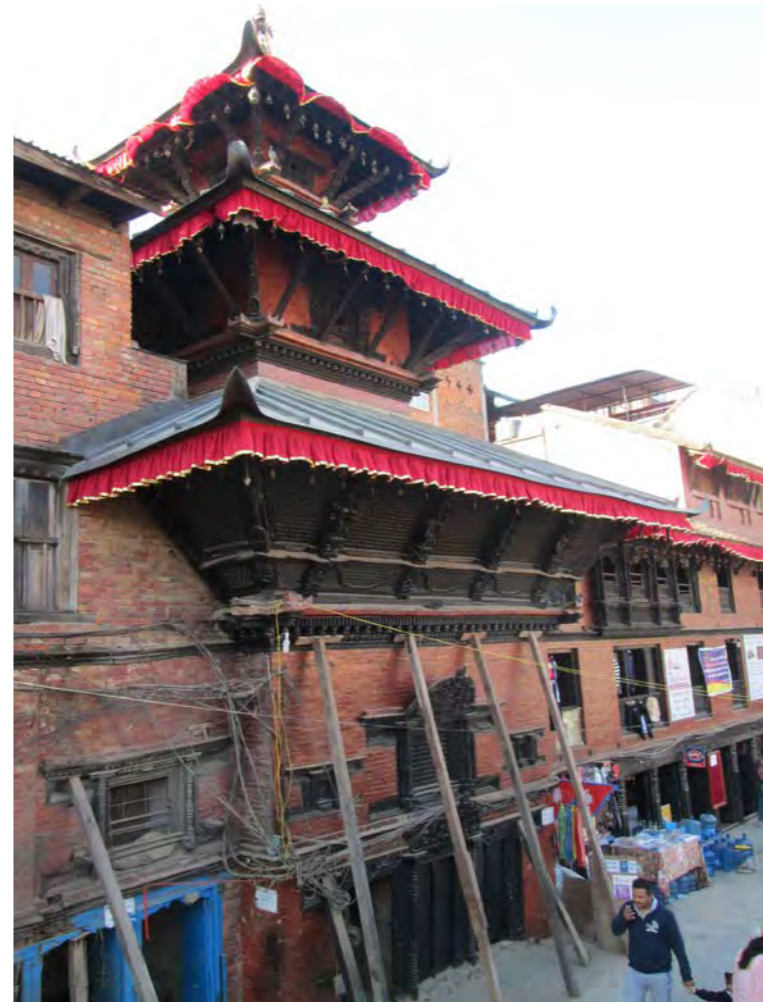
43 MARU JOSHI AAGAN CHEIN

CODE NO	TYOLOGY	MONUMENT NAME	ESTABLISHED/ RENOVATED	STRUCTURAL SYSTEM	MATERIAL	GENERAL DESCRIPTION	PROBLEM DESCRIPTION	DANGER	REMARKS
43	Three storey temple	Maru Joshi Aagan chein					eastern wall bulging

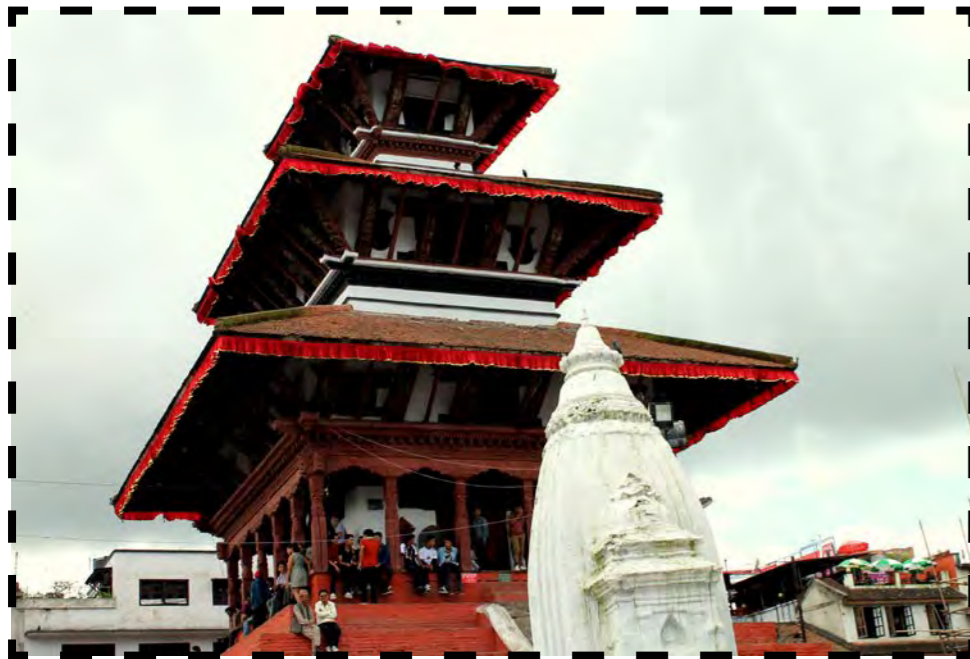
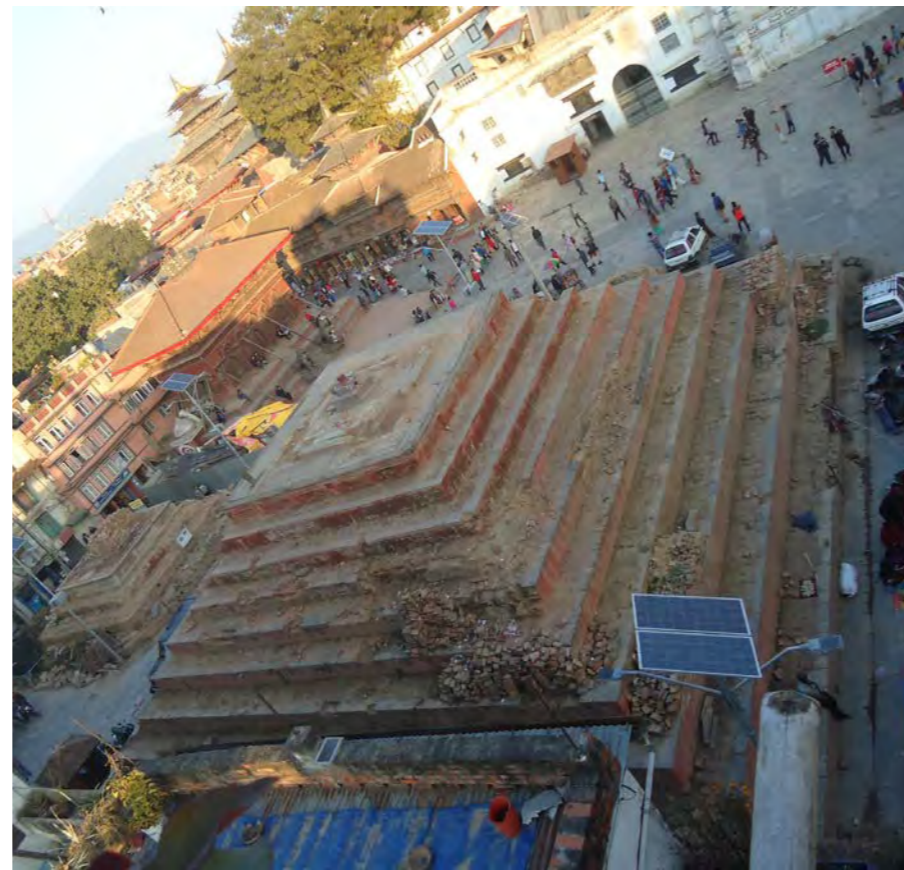
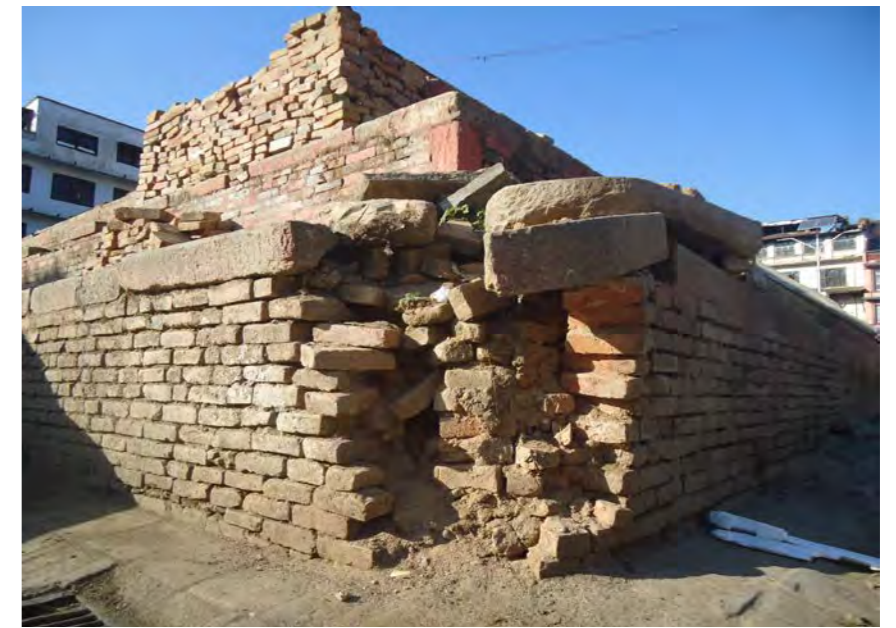
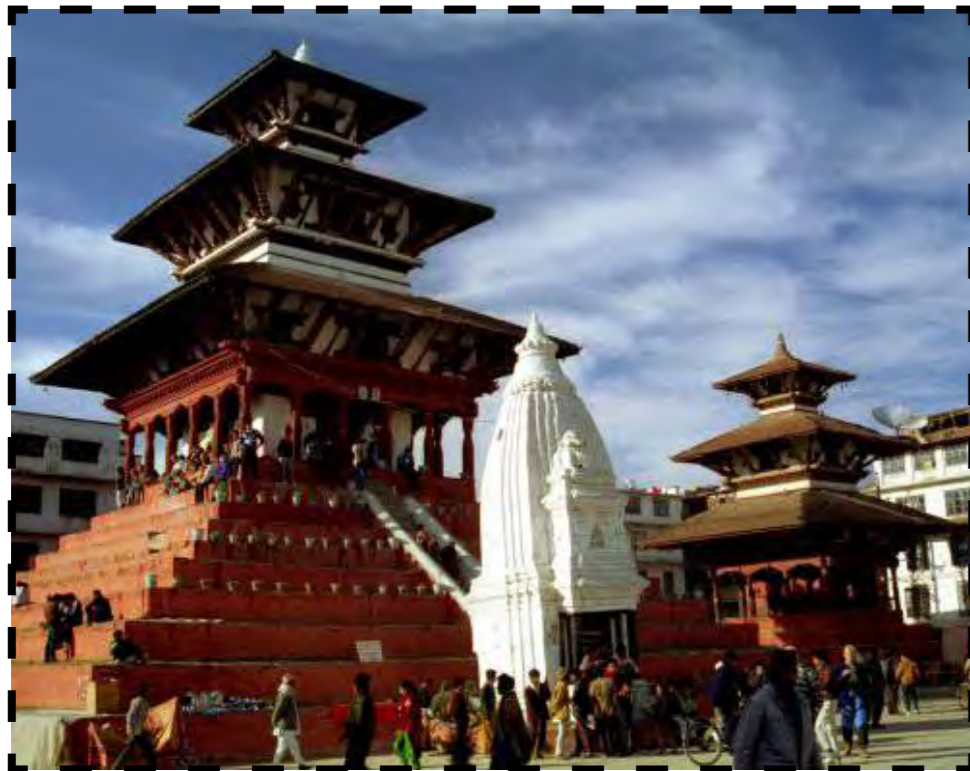
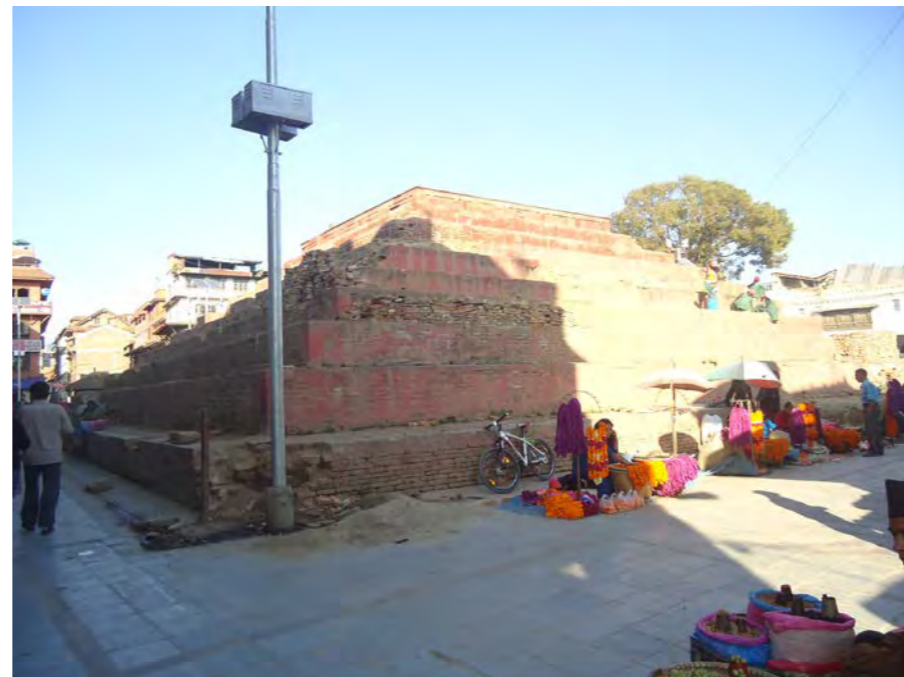
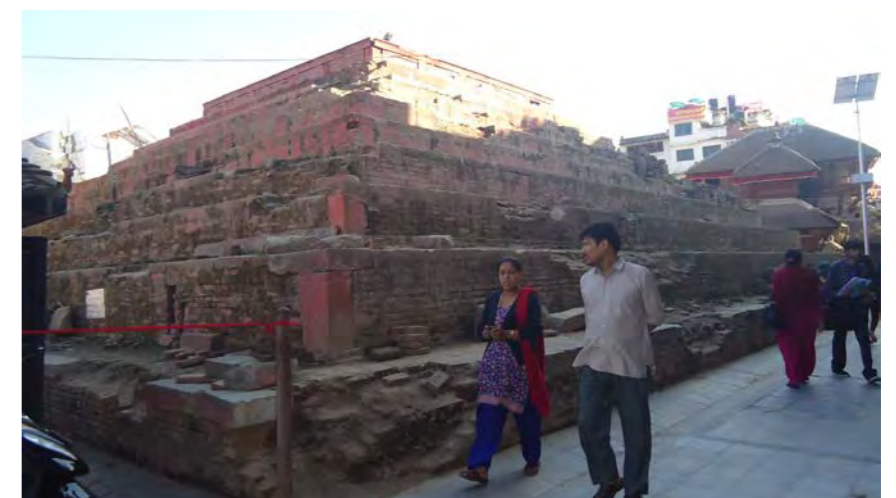
44 NARAYAN TEMPLE

CODE NO	TYOLOGY	MONUMENT NAME	ESTABLISHED/ RENOVATED	STRUCTURAL SYSTEM	MATERIAL	GENERAL DESCRIPTION	PROBLEM DESCRIPTION	DANGER	REMARKS
44		Maju Dega	1692	Load Bearing	Brick; Timber	Temple on top of nine storied brick base; Carved wooden doors and windows;	Totally collapsed; Corners of plinth detached

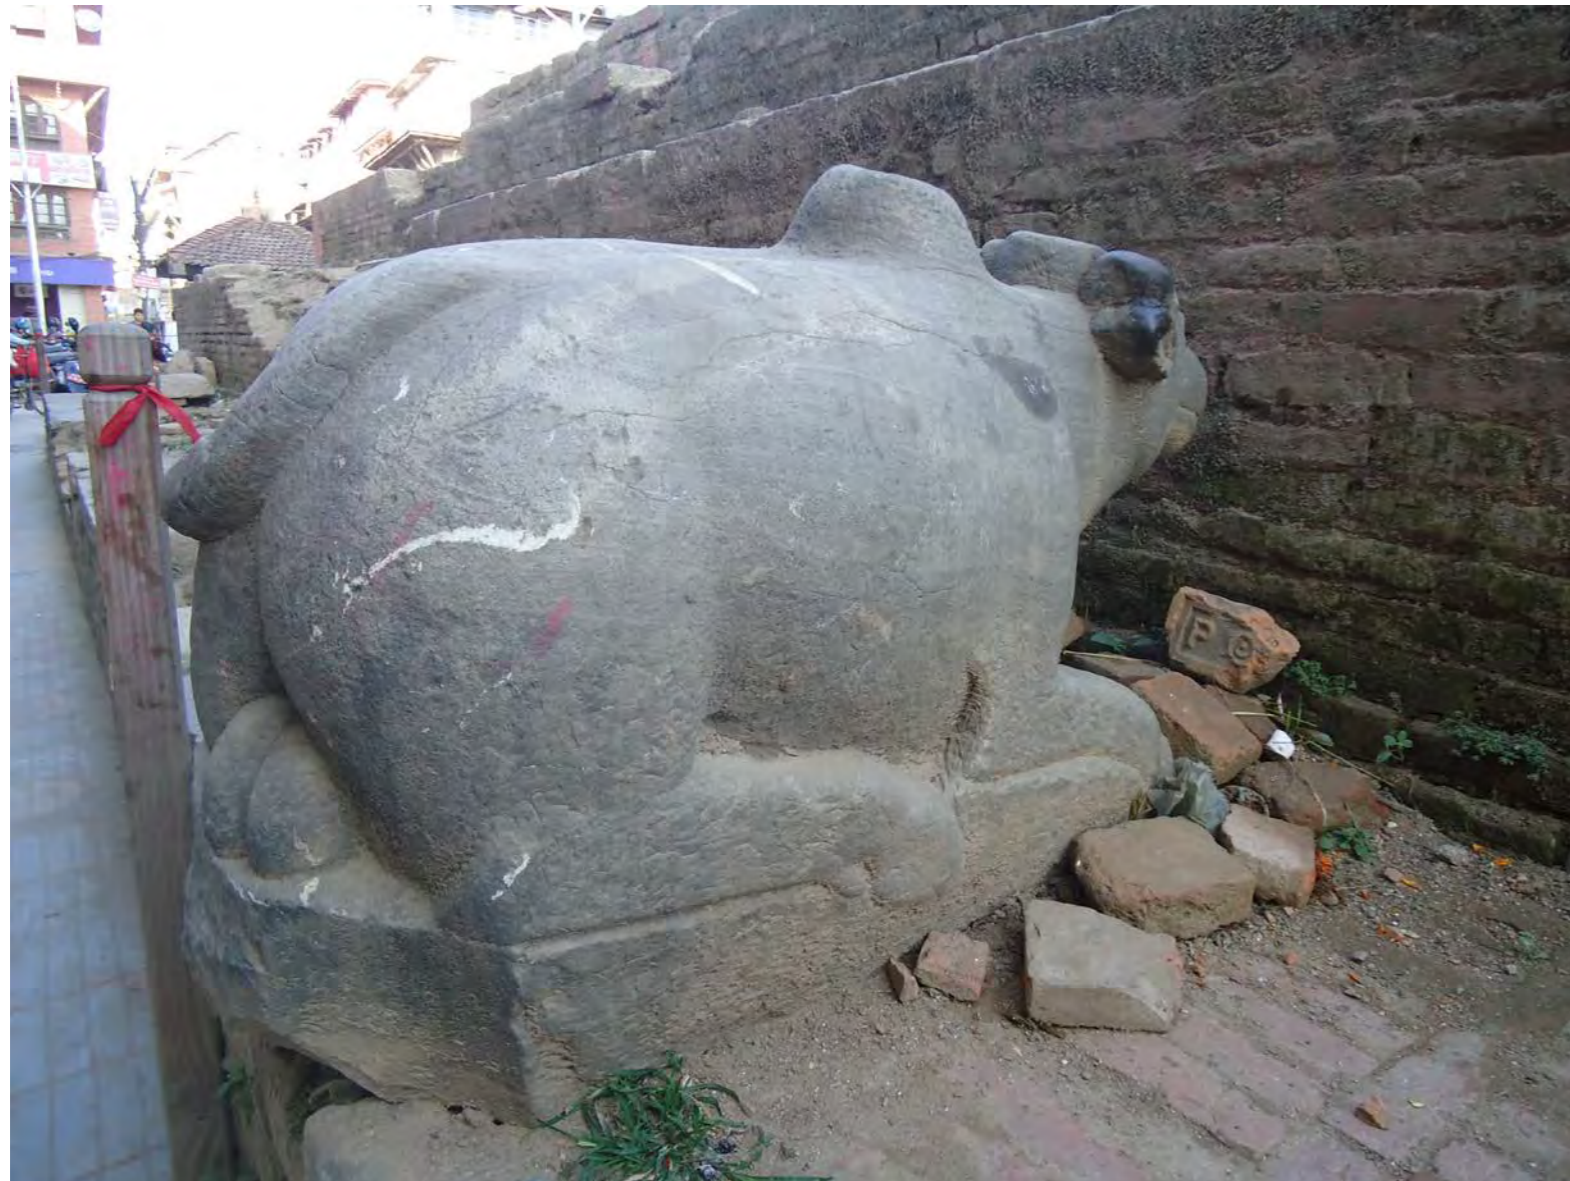
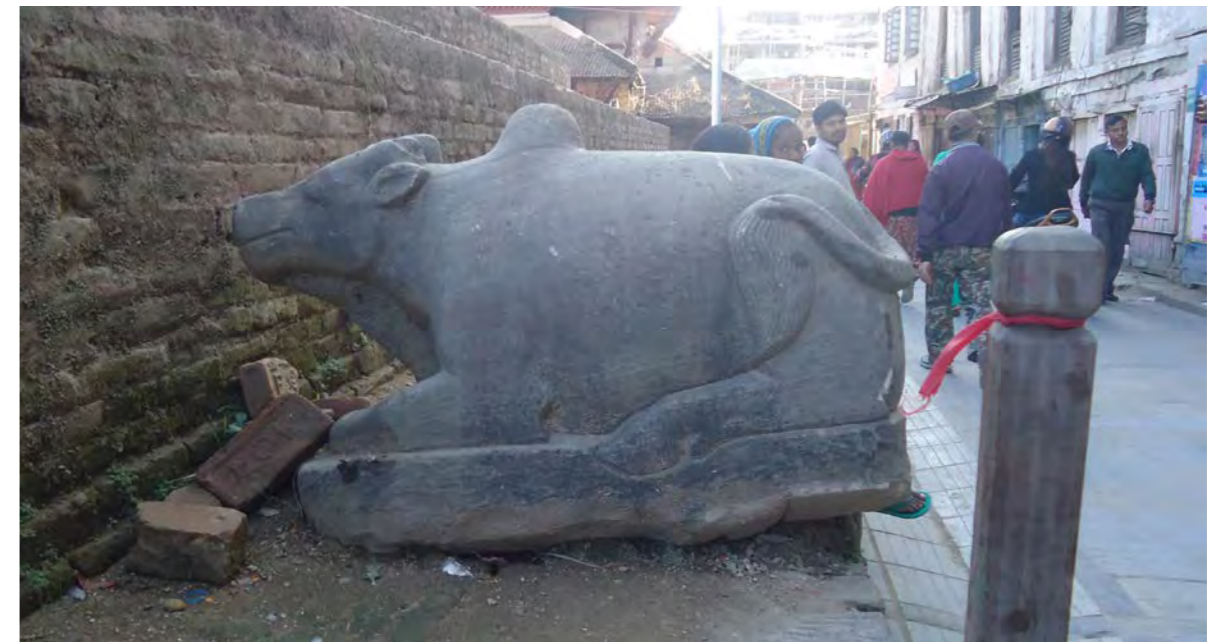
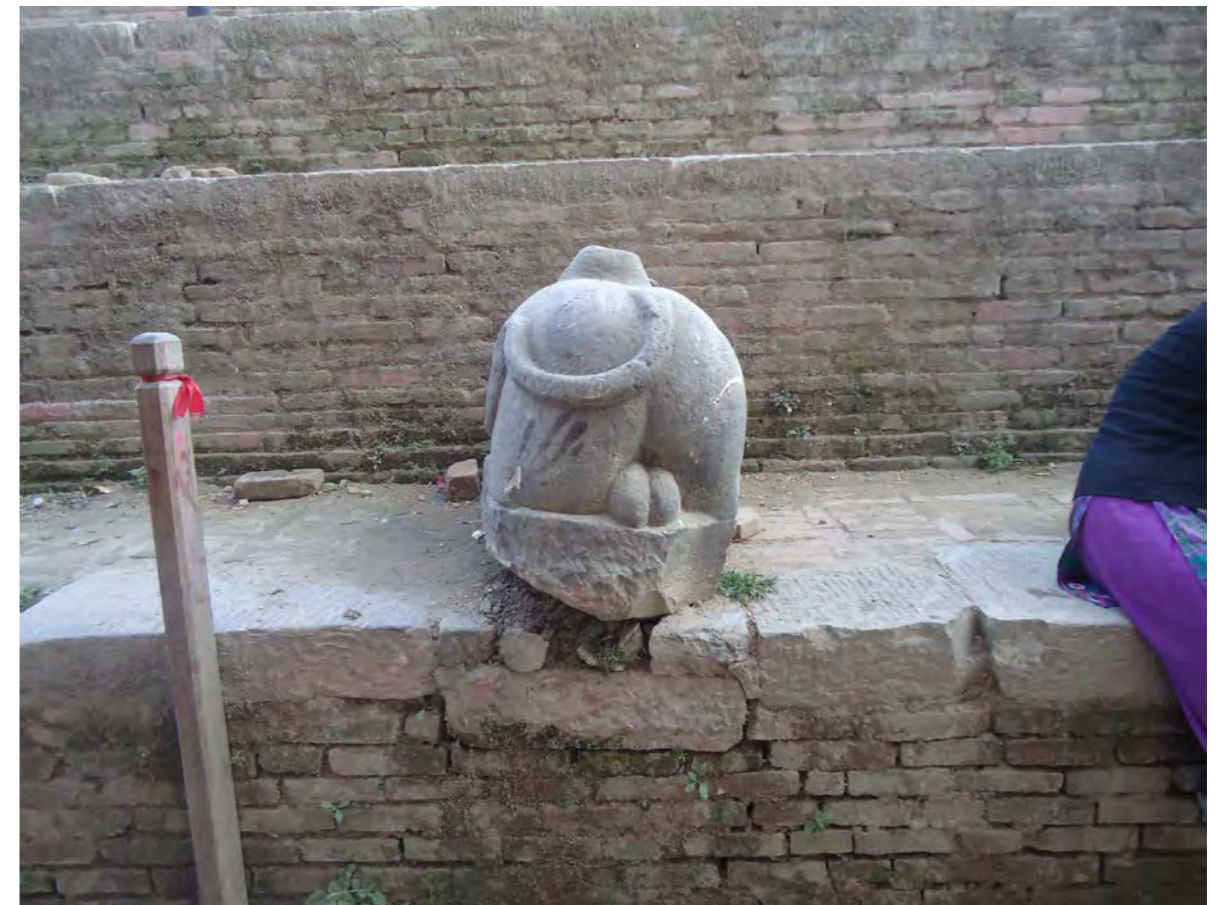
44a BULL

CODE NO	TYOLOGY	MONUMENT NAME	ESTABLISHED/ RENOVATED	STRUCTURAL SYSTEM	MATERIAL	GENERAL DESCRIPTION	PROBLEM DESCRIPTION	DANGER	REMARKS
44a		Bull			Stone	Stone bull facing temple on raised plinth	Slightly tilted and settled

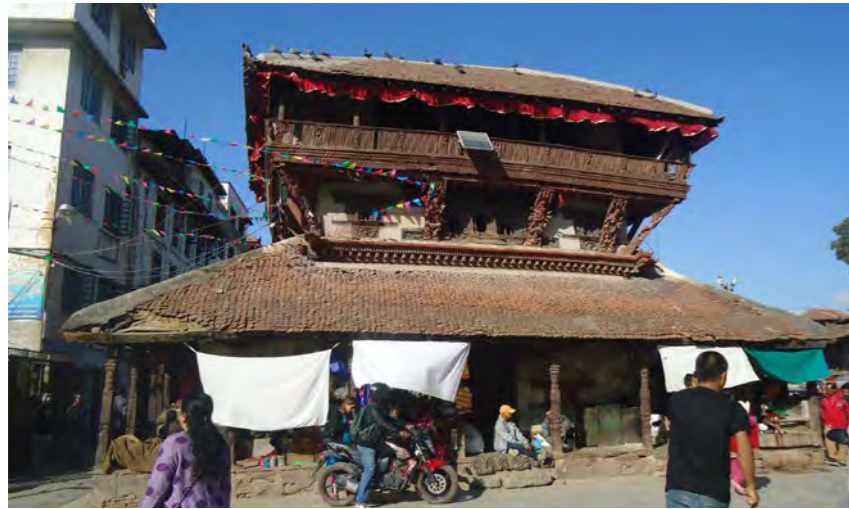
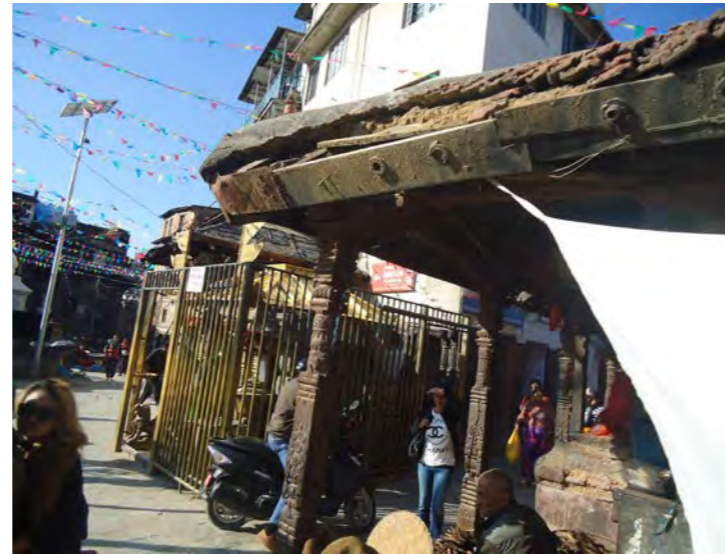
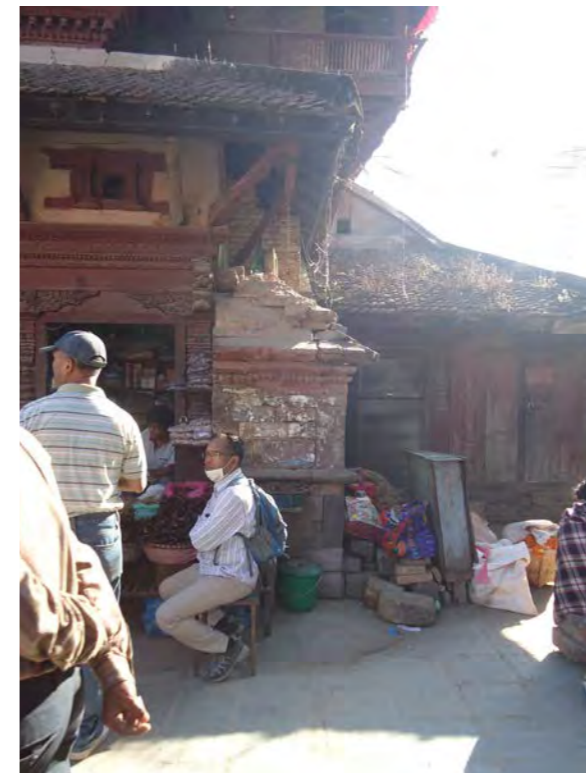
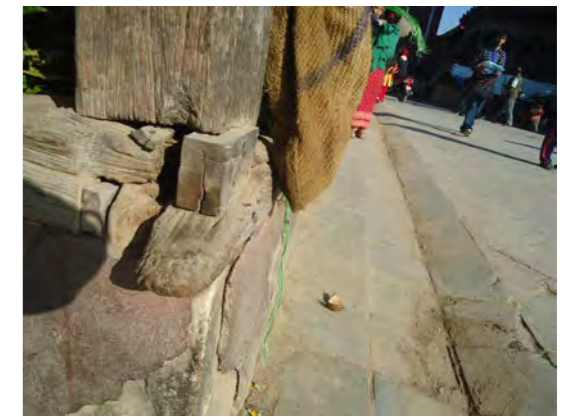
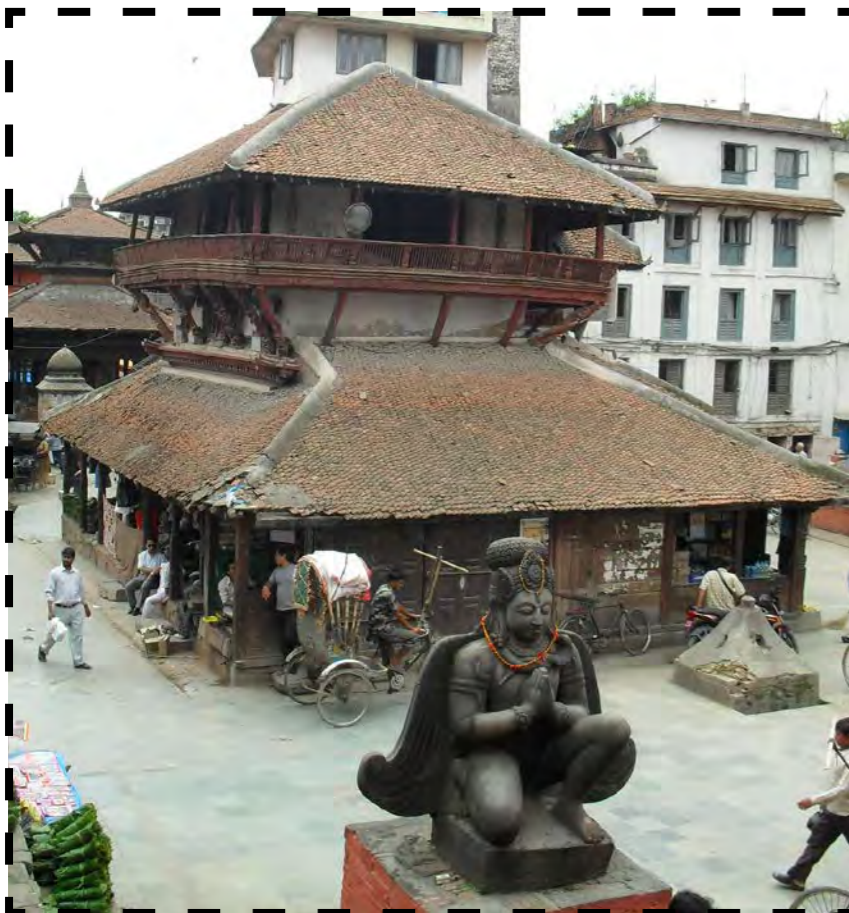
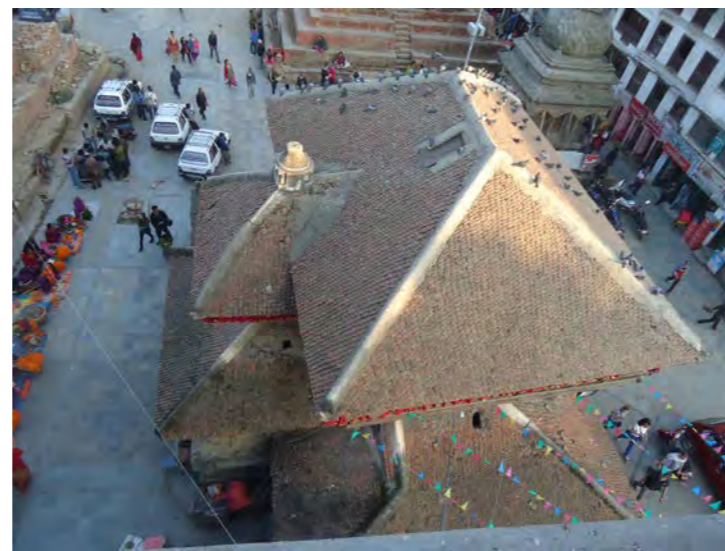
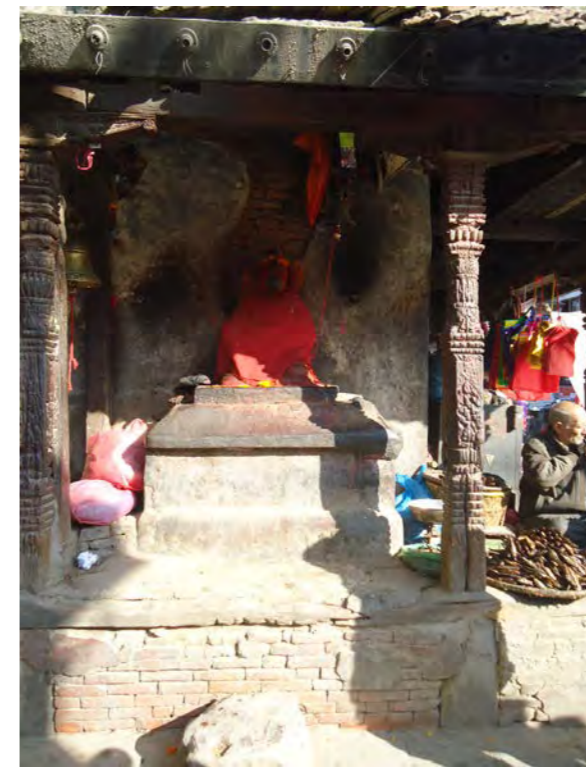
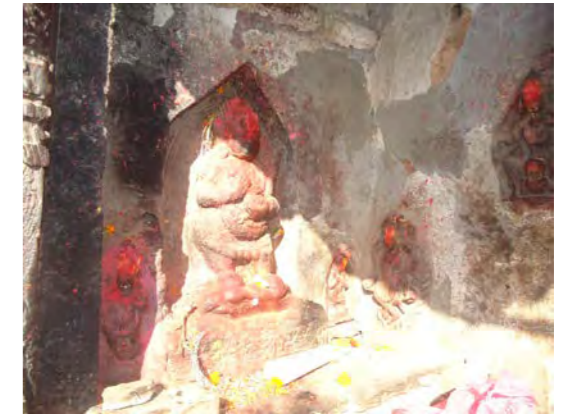
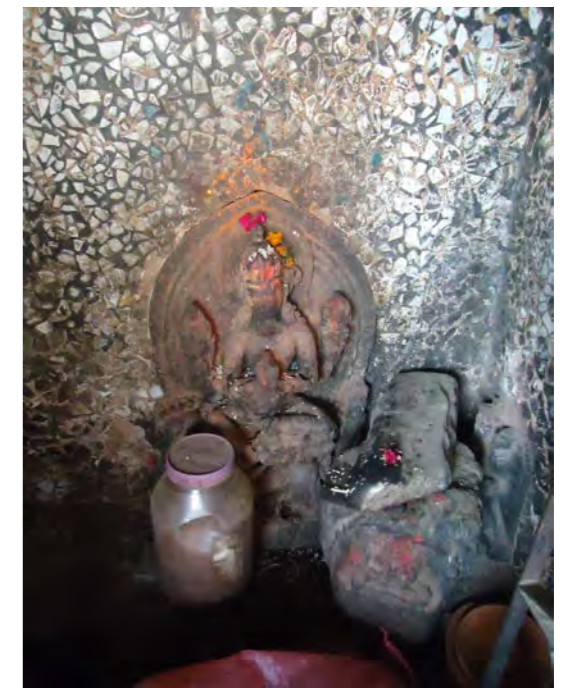
45 GARUD NARAYAN TEMPLE

CODE NO	TYOLOGY	MONUMENT NAME	ESTABLISHED/ RENOVATED	STRUCTURAL SYSTEM	MATERIAL	GENERAL DESCRIPTION	PROBLEM DESCRIPTION	DANGER	REMARKS
45	Two storey temple	Garuda Narayan Temple	16 Century	load Bearing	brick;Timber	Tiles on roof. Hanuman sculpture on back face	Extensive cracks on top floor and Bulging of walls

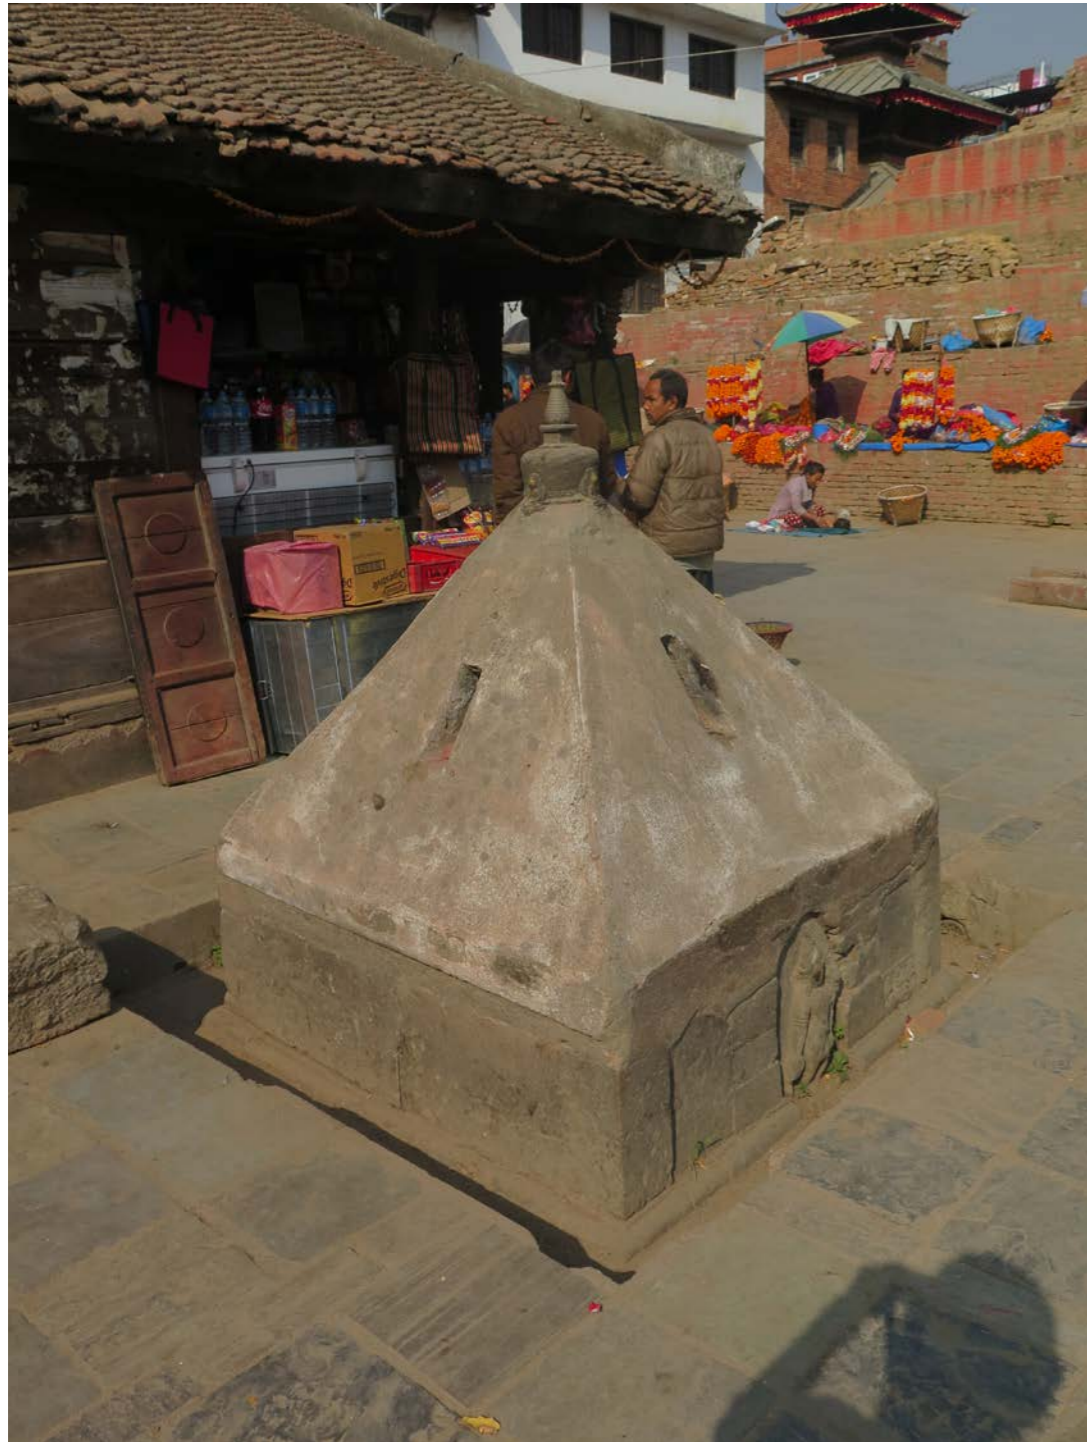
45a STUPA

CODE NO	TYOLOGY	MONUMENT NAME	ESTABLISHED/ RENOVATED	STRUCTURAL SYSTEM	MATERIAL	GENERAL DESCRIPTION	PROBLEM DESCRIPTION	DANGER	REMARKS
45a	Stupa					Stupa cemented and only top part visible	No visible damage		
45b	Water Tank				Stone	Stone water tank attached to temple not in use	highly dilapadated and about to collapse

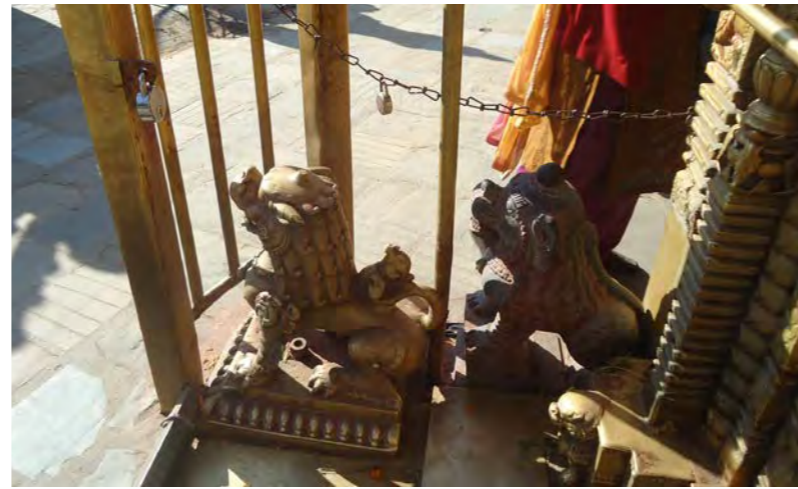
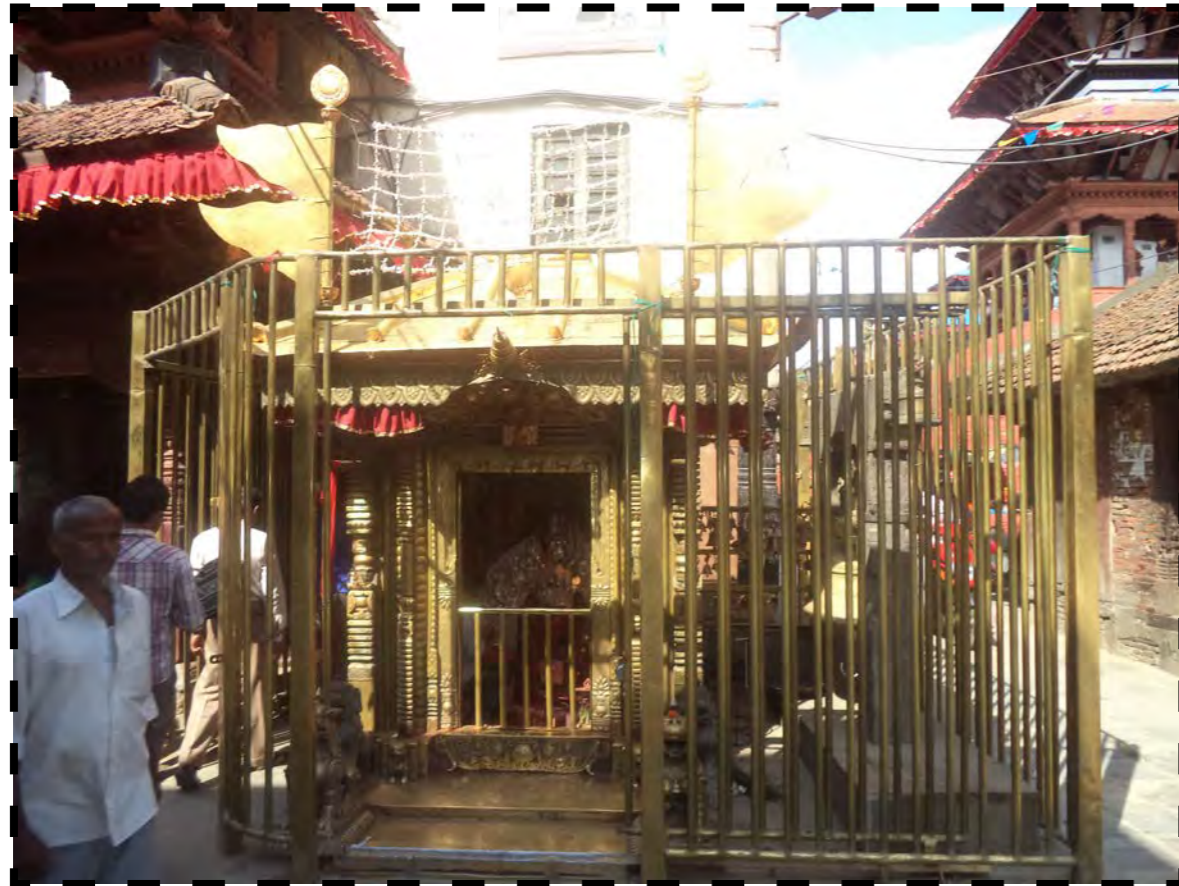
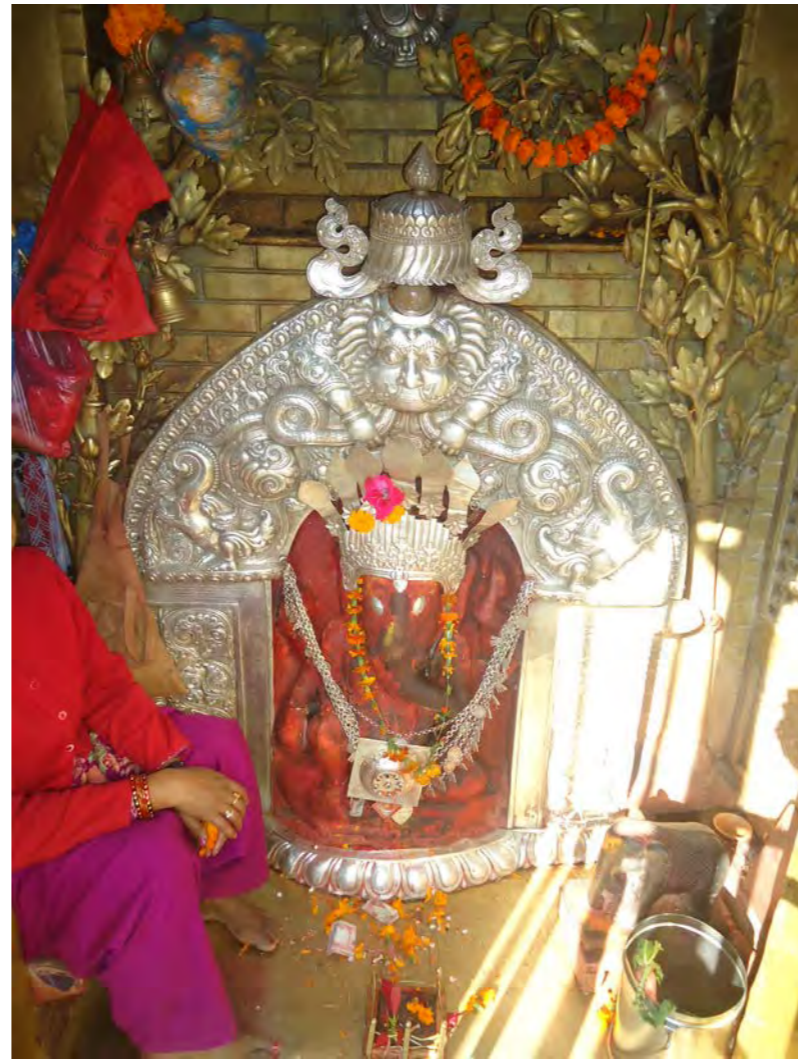
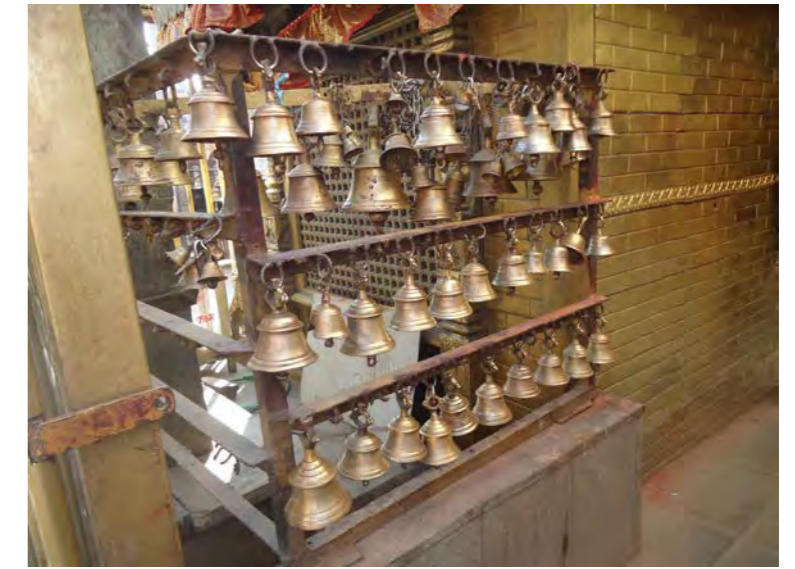
46 ASHOK BINAYAK

CODE NO	TYOLOGY	MONUMENT NAME	ESTABLISHED/ RENOVATED	STRUCTURAL SYSTEM	MATERIAL	GENERAL DESCRIPTION	PROBLEM DESCRIPTION	DANGER	REMARKS
46	Single-Storey Temple	Ashok Binayak		Load Bearing	Brick;Metal	Metal cladding on front face;Brass roof;temple wovrshipped by hindu and budhhists both	No visible damage

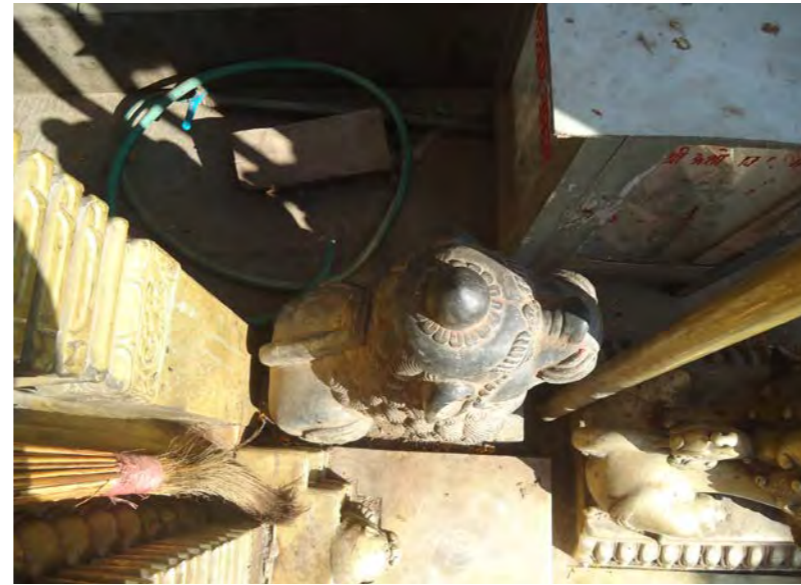
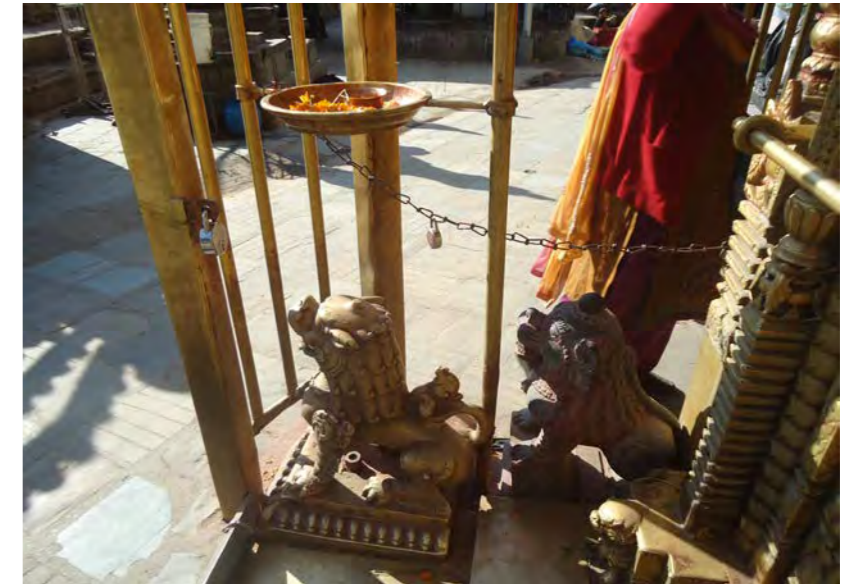
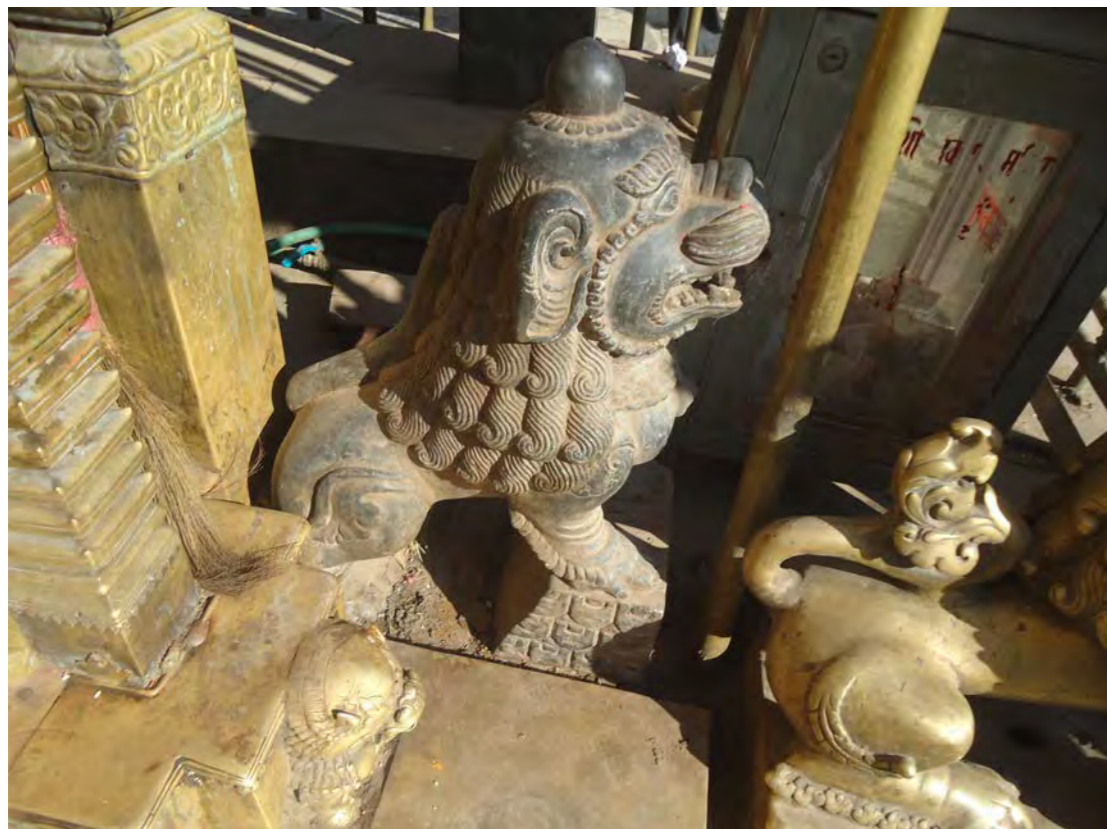
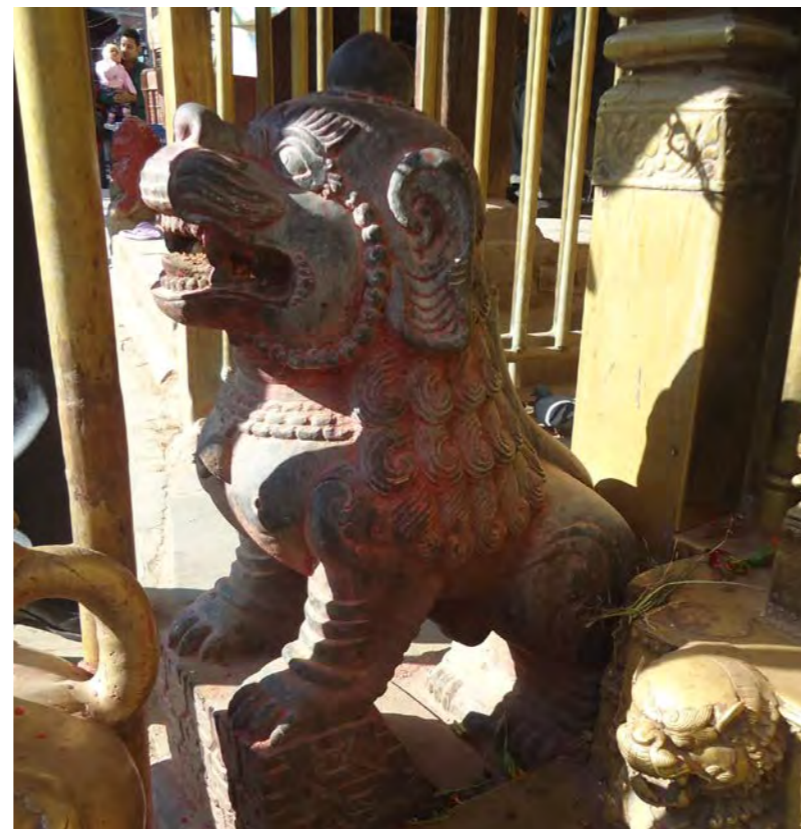
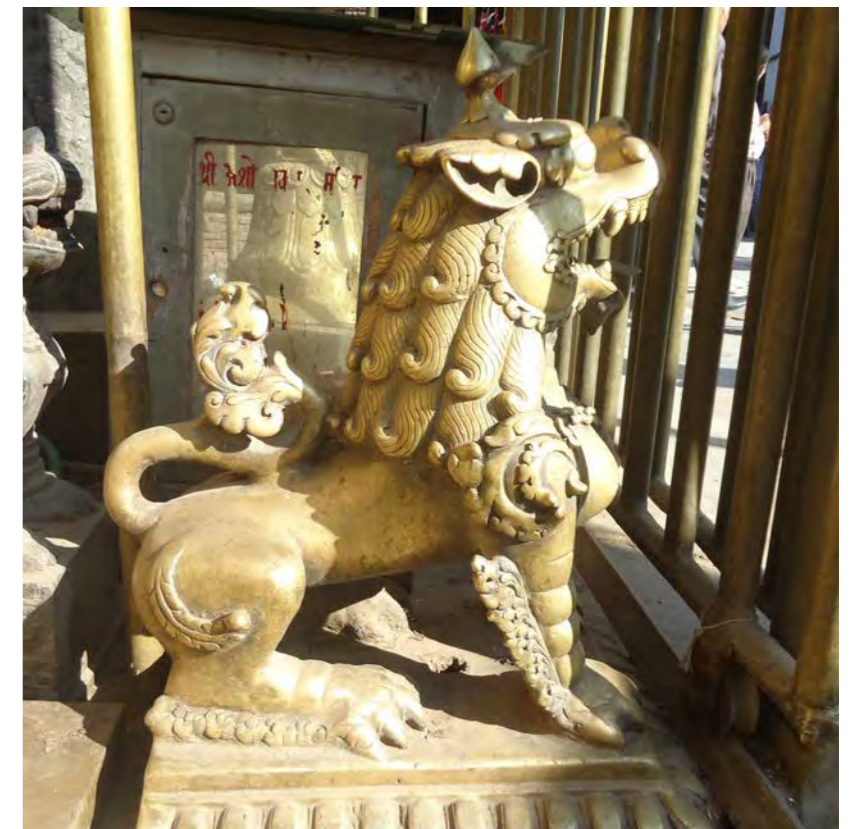
CODE NO	TYOLOGY	MONUMENT NAME	ESTABLISHED/ RENOVATED	STRUCTURAL SYSTEM	MATERIAL	GENERAL DESCRIPTION	PROBLEM DESCRIPTION	DANGER	REMARKS
46a	Guard lion				Stone	Guard lion on right side	No visible damage		
46b	Guard lion				Stone	Guard lion on left side	No visible damage		
46c	Guard lion				Metal	Guard lion on right side	No visible damage		
46d	Guard lion				Metal	Guard lion on left side	No visible damage
